# Marty Asbestos and Waste Site Update

## USEPA Region 8

Operational Period 05:

Monday, June 13<sup>th</sup>, 2022 – Sunday, June 26<sup>th</sup>, 2022

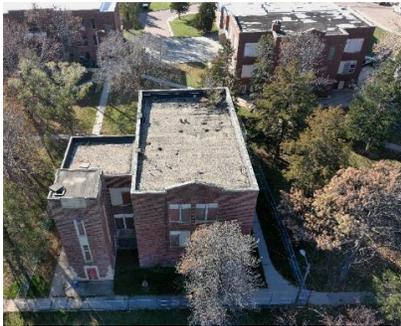
**St. Joseph and St. Katherine**

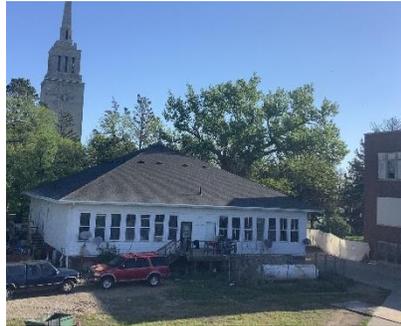
**White Frame Building**

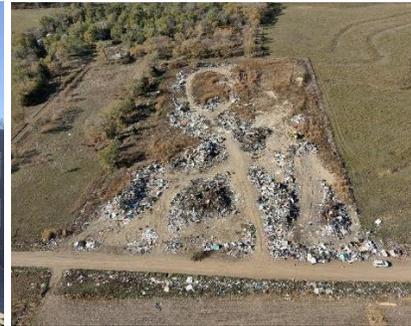
The unregulated dumping location is used dozens of times each day by people and businesses from as far away as Nebraska and often catches fire.

**Unregulated Dump Site**

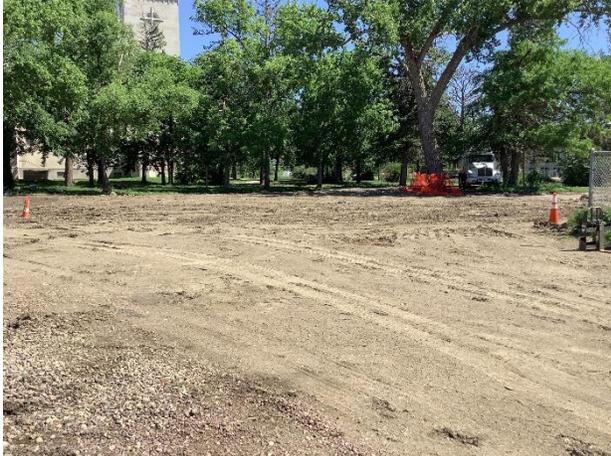
**Work is concluded at the White Frame building**

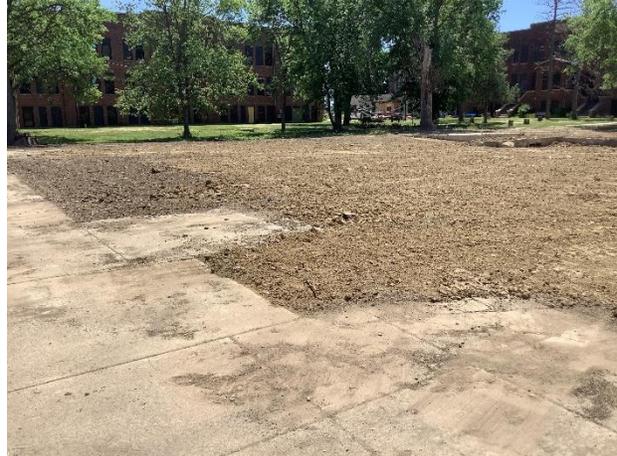
**Work is concluded at the St. Josephs building**

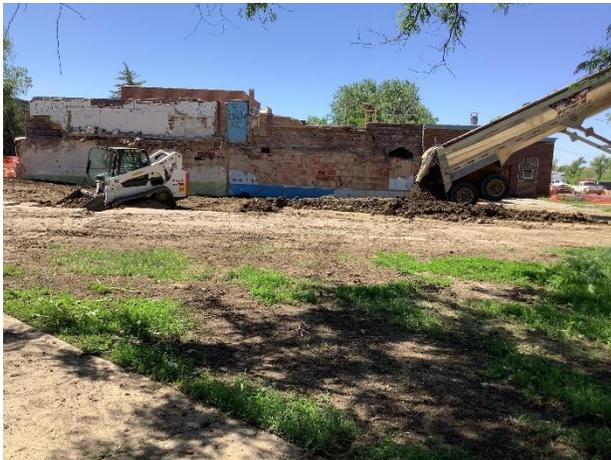
**Backfill unloaded onto St. Katherine footprint**

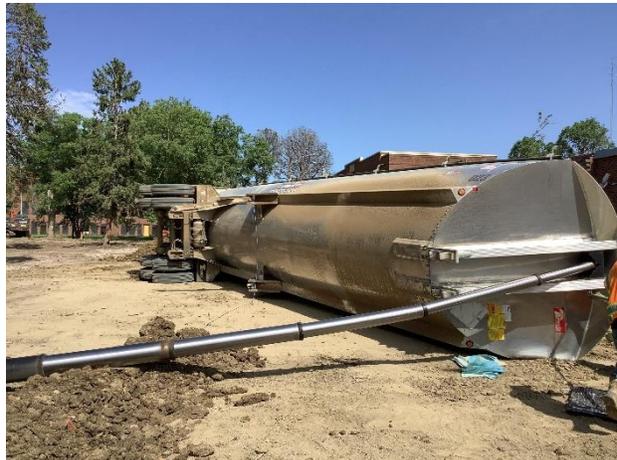
1. The placement of backfill at the Marty School location was completed on June 21, 2022. There was one non-injury incident that occurred during the back fill operations of the St. Katherine Building. On Friday, June 17, 2022, a 30 cubic yard end-dump was delivering backfill to the Site. While the truck was unloading clean back fill, the concrete underneath the truck trailers' rear tires collapsed as the dump was a full extension. This resulted in the trailer assembly tipping over onto its side. (additional photographs [here](#)). The truck cab remained upright and the driver unhurt. The ERRS crew was able to detach the cab from the trailer, and it was driven off-site.

The dump trailer assembly was removed from the work area and staged on-site. Normal operations were resumed within an hour of the incident. It appeared that a small void (3' diameter, 2' deep) existed underneath the concrete (it was a pre-existing slab) and that the concrete was unsupported where it collapsed. The void was filled, and the remaining backfill deliveries were done using an articulated haul truck.

**Truck is tipped over due to concrete giving way**

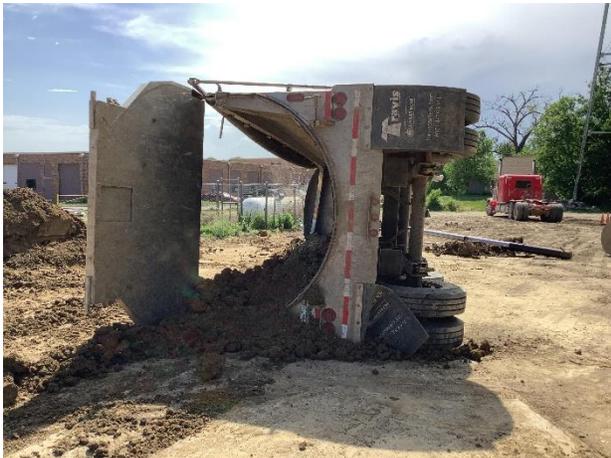
**Truck tipped over while unloading backfill**

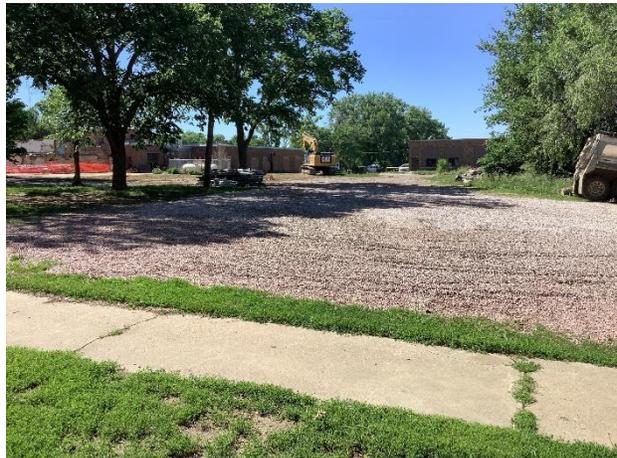
**Driveway and parking lot are graveled**

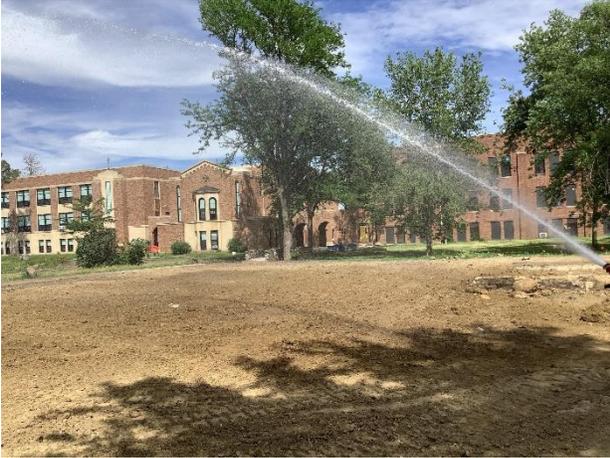
Grass seed is spread over St. Joseph and watered

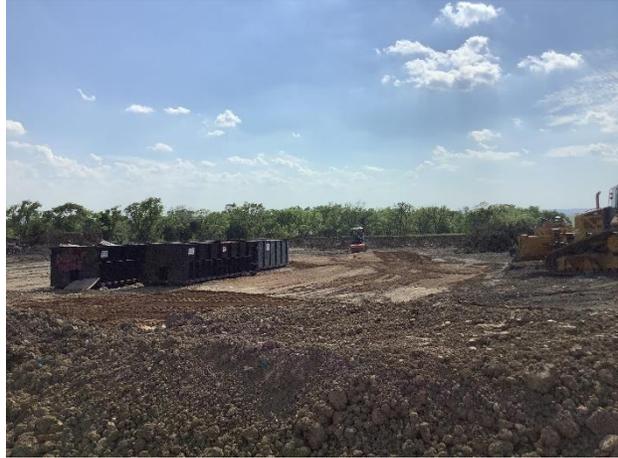
Maintenance at the repository continues

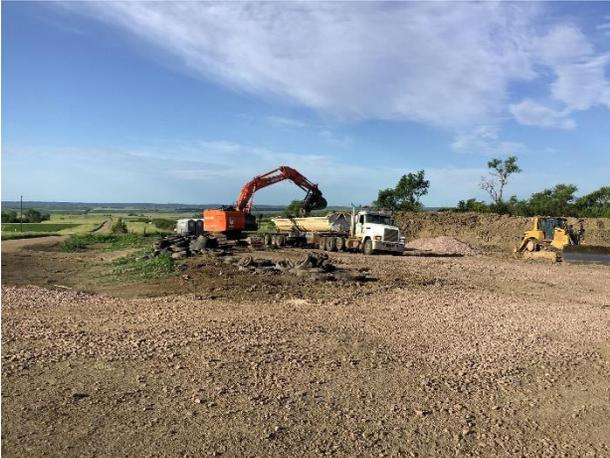
The last load of discarded tires are loaded

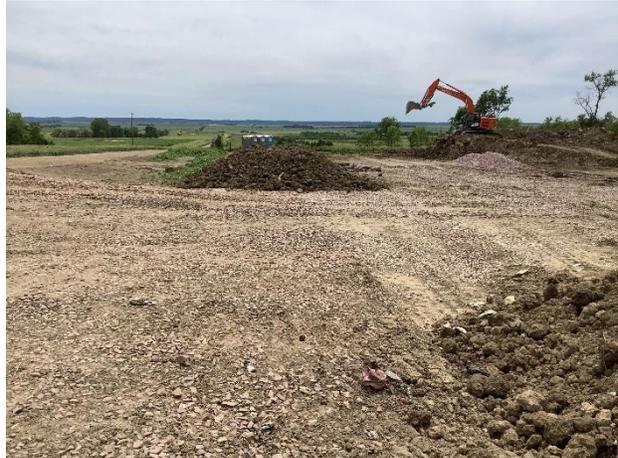
Soil is positioned to begin building a berm
