**Sampling Activities Report
2019 Pre-CERCLA Screening
July 2019 and September 2019
Final**

**Little Dora and North Star Mines
San Juan County, Colorado**

May 2020

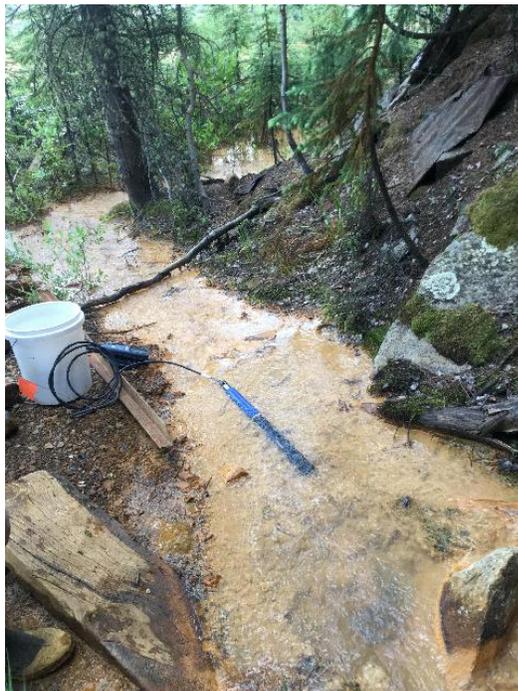
LD_1_DM Downstream

Sample/Location ID	Comments	Stream Conditions	Weather Conditions	Field Scribe	Field Sampler
LD_1_DM	Audit discharge at the portal before split in flow; Bag flume method from DRMS; Fine aluminum precipitation and sludge like sediment	Audit, Calm; Algae Present; White Staining	Partly Cloudy; No Precip.; No Wind	Robyn Blackburn	Jeff Litteral
LD_2_DM	Bag flume method from DRMS; Sample collected just down from pooled area that's on the road	Cascading, Clear, Muddy; Marsh; Orange Staining	Partly Cloudy; No Precip.; No Wind	Michael Carney	Kristen Brown
LD_3_DM	Bag flume method from DRMS	Not recorded	Partly Cloudy; No Precip.; No Wind	Robyn Blackburn	Jeff Litteral
LD_4_unk	Bag flume method from DRMS	Calm, Pool, Stagnant, Trickle; Algae Present, Sandy; No Staining	Partly Cloudy; No Precip.; low Wind	Robyn Blackburn	Jeff Litteral
LD_5	Flagged sampling location - same one that was sampled during high flow	Clear; Algae Present, Marsh, Gravel, Cobble; No Staining	Partly Cloudy; No Precip.; No Wind	Michael Carney	Kristen Brown

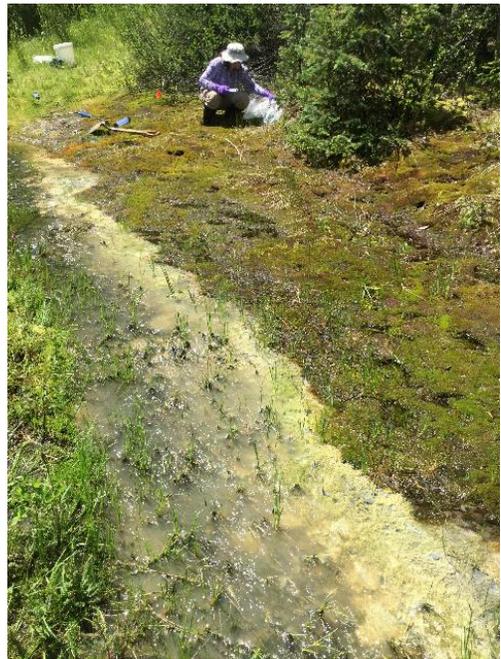
LD_6_SS Downstream

LD_6_SS	Seep at toe of aspen and shrubs on right bank of flowpath down old road. Mossy with pockets of open water	Trickle, Clear, Calm; Algae Present, Marsh; White Staining	Sunny; Low Wind	Michael Carney	Candace Whitten
LD_7_L	None	Cascading, Clear; Algae Present, Cobble, Gravel; White Staining	Partly Sunny; Lightning; Low Wind	Landon Bailey	Ryan Monahan
LD_7_R	None	Cascading, Clear; Algae Present, Cobble, Gravel; No Staining	Partly Sunny; No Precip.; Low Wind	Landon Bailey	Kyle Sandor
LD_8A	Supposed to be called LD_8A. Was directed to call it LD_8	Trickle, Clear; Cobble, Gravel, Sandy; No Staining	Partly Sunny; No Precip.; Low Wind	Ryan Monahan	Kyle Sandor
LD_09	Diffuse flow over side road	Trickle, Clear; Gravel; Orange Staining	Sunny; No Wind	Michael Carney	William Schroeder
LD_10	Flow along side of road	Trickle, Clear; Sandy, Gravel; No Staining	Sunny; No Wind	Ryan Monahan	Ryan Monahan
LD_11	Just above pooled area just above culvert.	Trickle, Clear; Algae Present, Gravel, Sandy; Orange Staining	Sunny; No Wind	Michael Carney	Candace Whitten

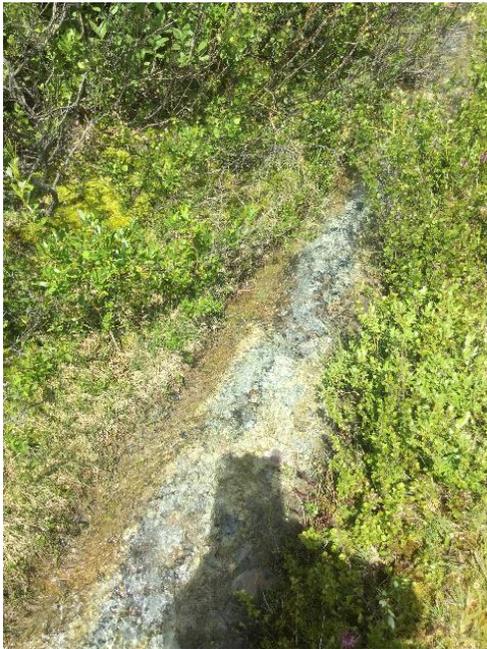
LD_7_L Downstream

LD_7_L	Flow path on left side of road. Continues down road towards culvert. All flow goes to culvert during low flow at time of sampling	Clear, Cascading; Gravel; White Staining	Partly Cloudy; No Precip.; No Wind	Michael Carney	Kristen Brown
LD_7_R	Some of his flow reports to LD8A; but some flow enters culvert that discharges into Mineral Creek; 5% loss	Clear; Sandy, Algae Present, Cobble; No Staining	Partly Cloudy; No Precip.; No Wind	Robyn Blackburn	Jeff Litteral
LD_8A	2-5 % loss around flume	Clear; Sandy, Gravel, Cobble; Orange Staining	Partly Cloudy; No Precip.; No Wind	Robyn Blackburn	Jeff Litteral
LD_09	Bag flume method from DRMS; Flow path coming down road from LD mine area	Clear; Gravel, Sandy; Orange Staining	Partly Cloudy; No Precip.; No Wind	Michael Carney	Kristen Brown
LD_10	Flow path on side of road before culvert	Clear; Gravel, Sandy, Algae Present; White Staining	Partly Cloudy; No Precip.; No Wind	Michael Carney	Robyn Blackburn

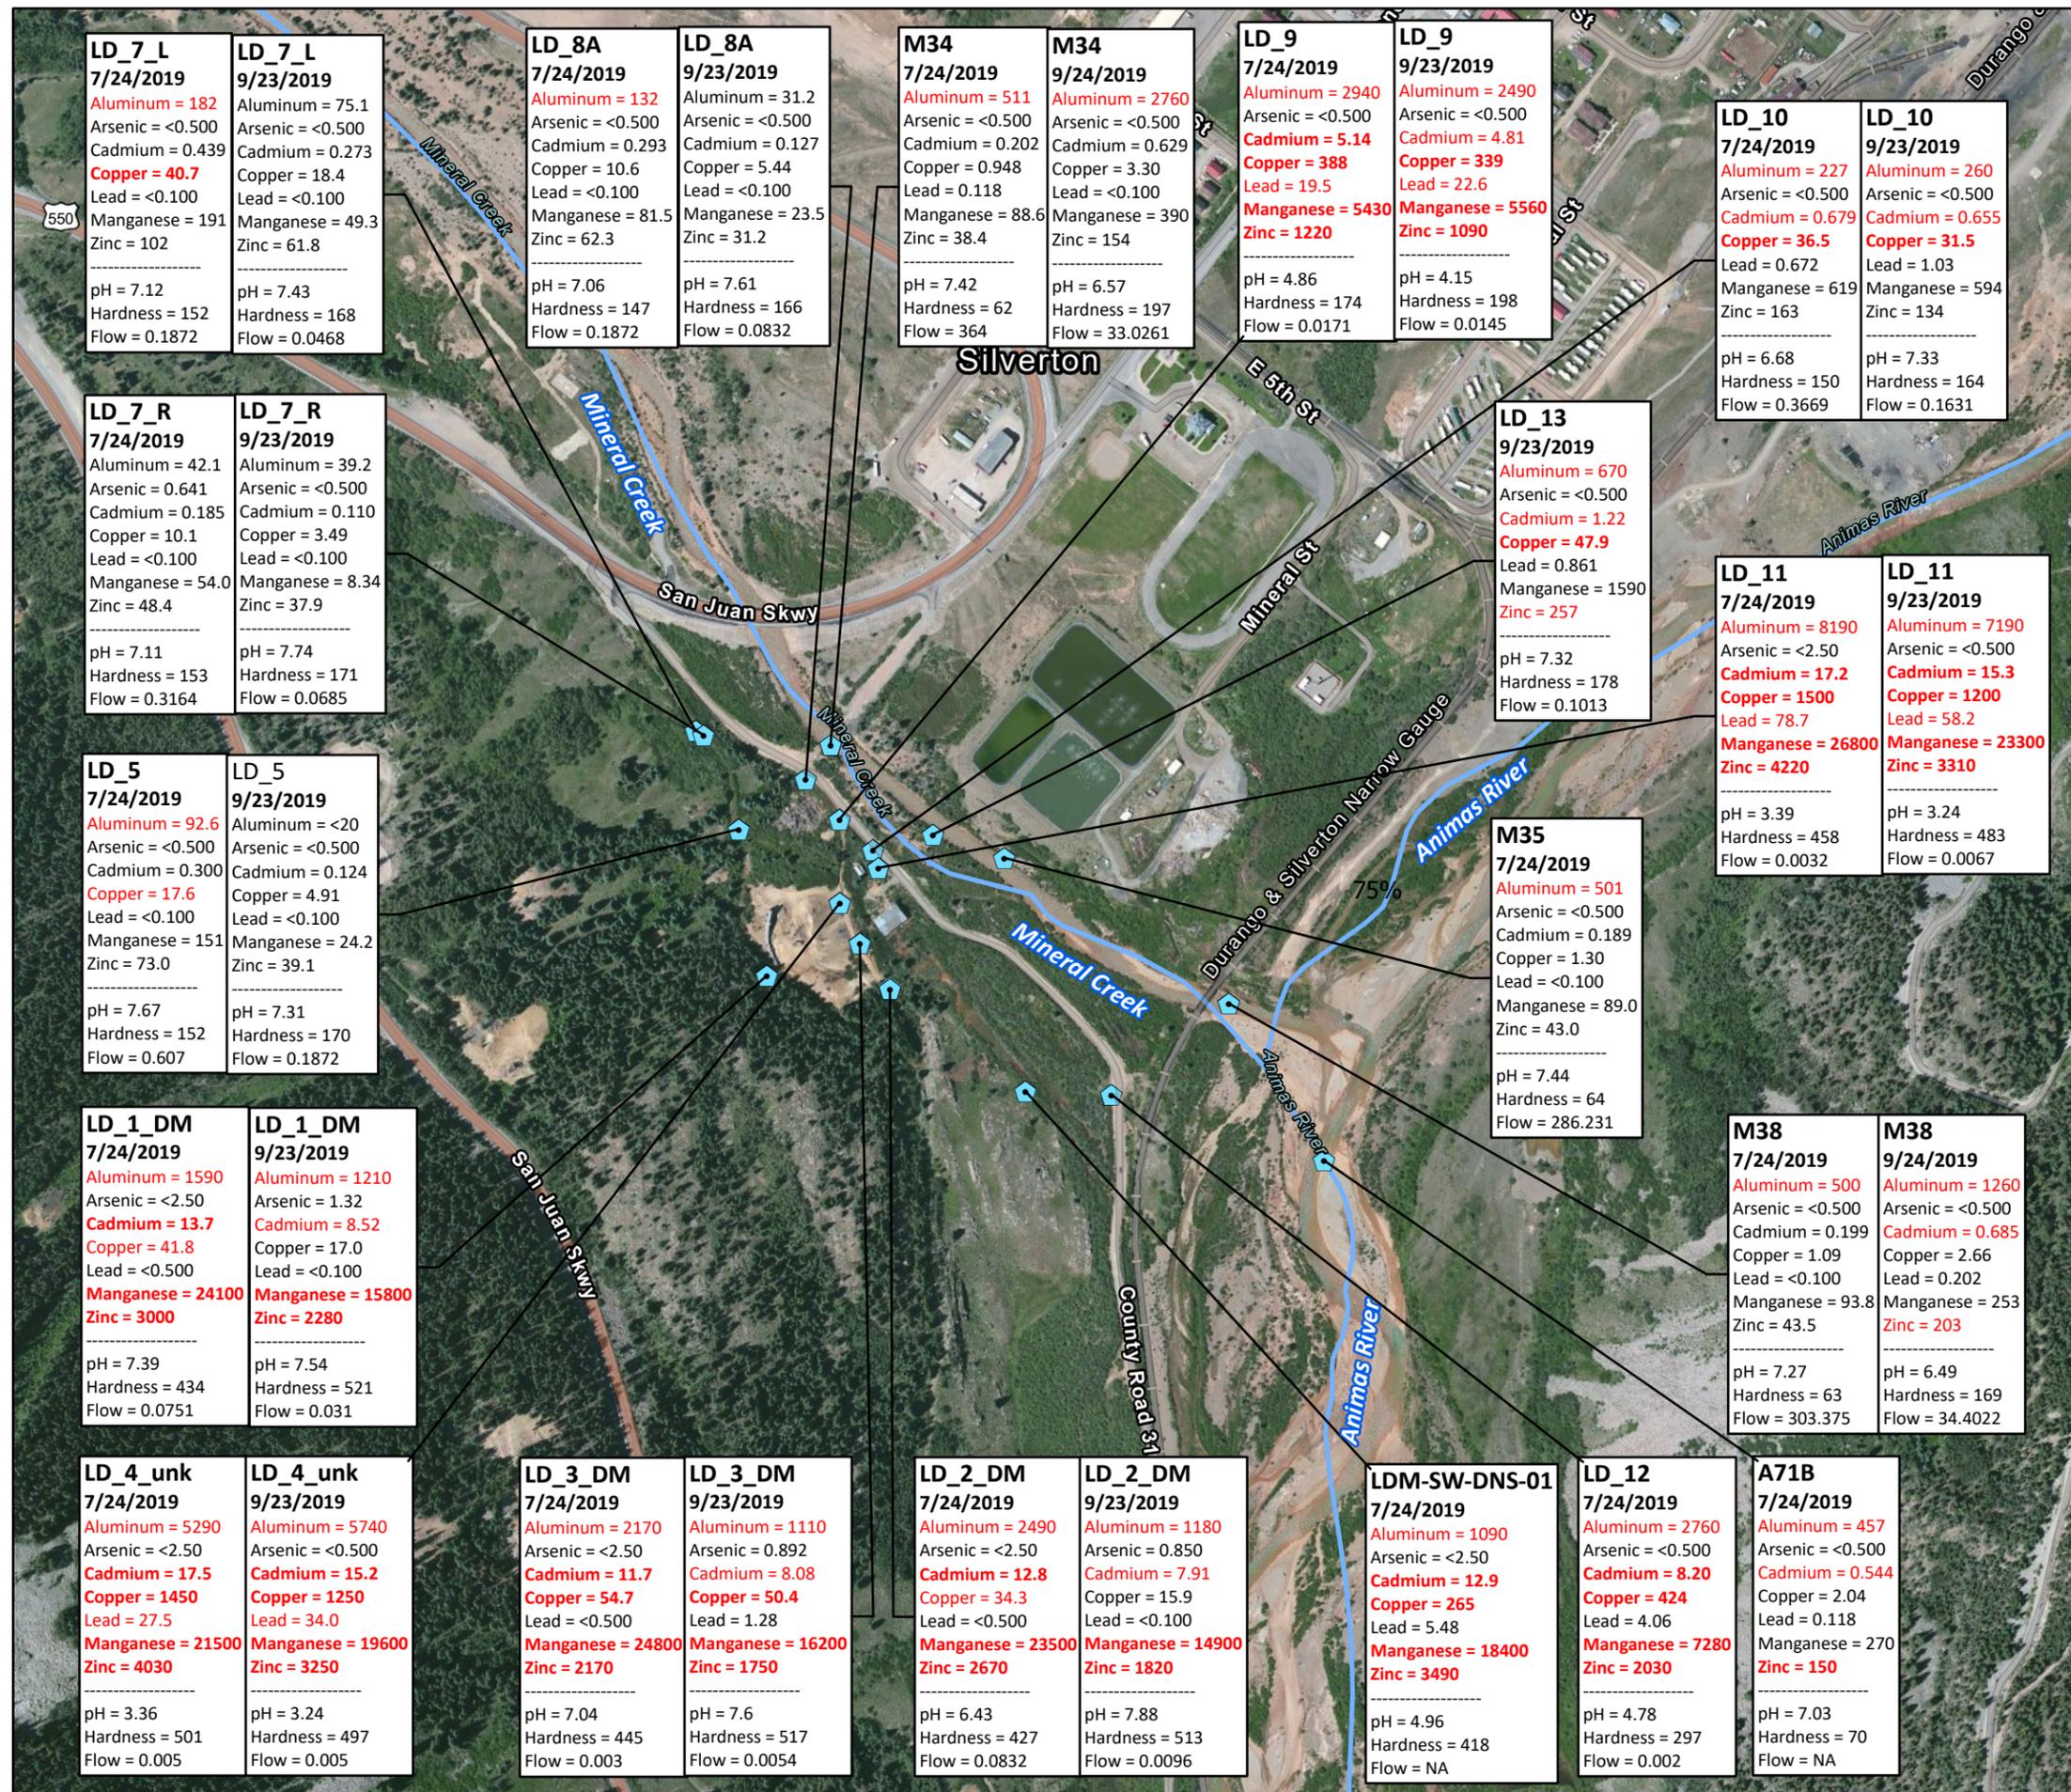
Figure A.1b
Little Dora Mine, Silverton
 Mineral Creek and Animas River
 San Juan County, Colorado

2019 Pre-CERCLA Screening
July and September 2019
Surface Water Sample Locations/Key Results*

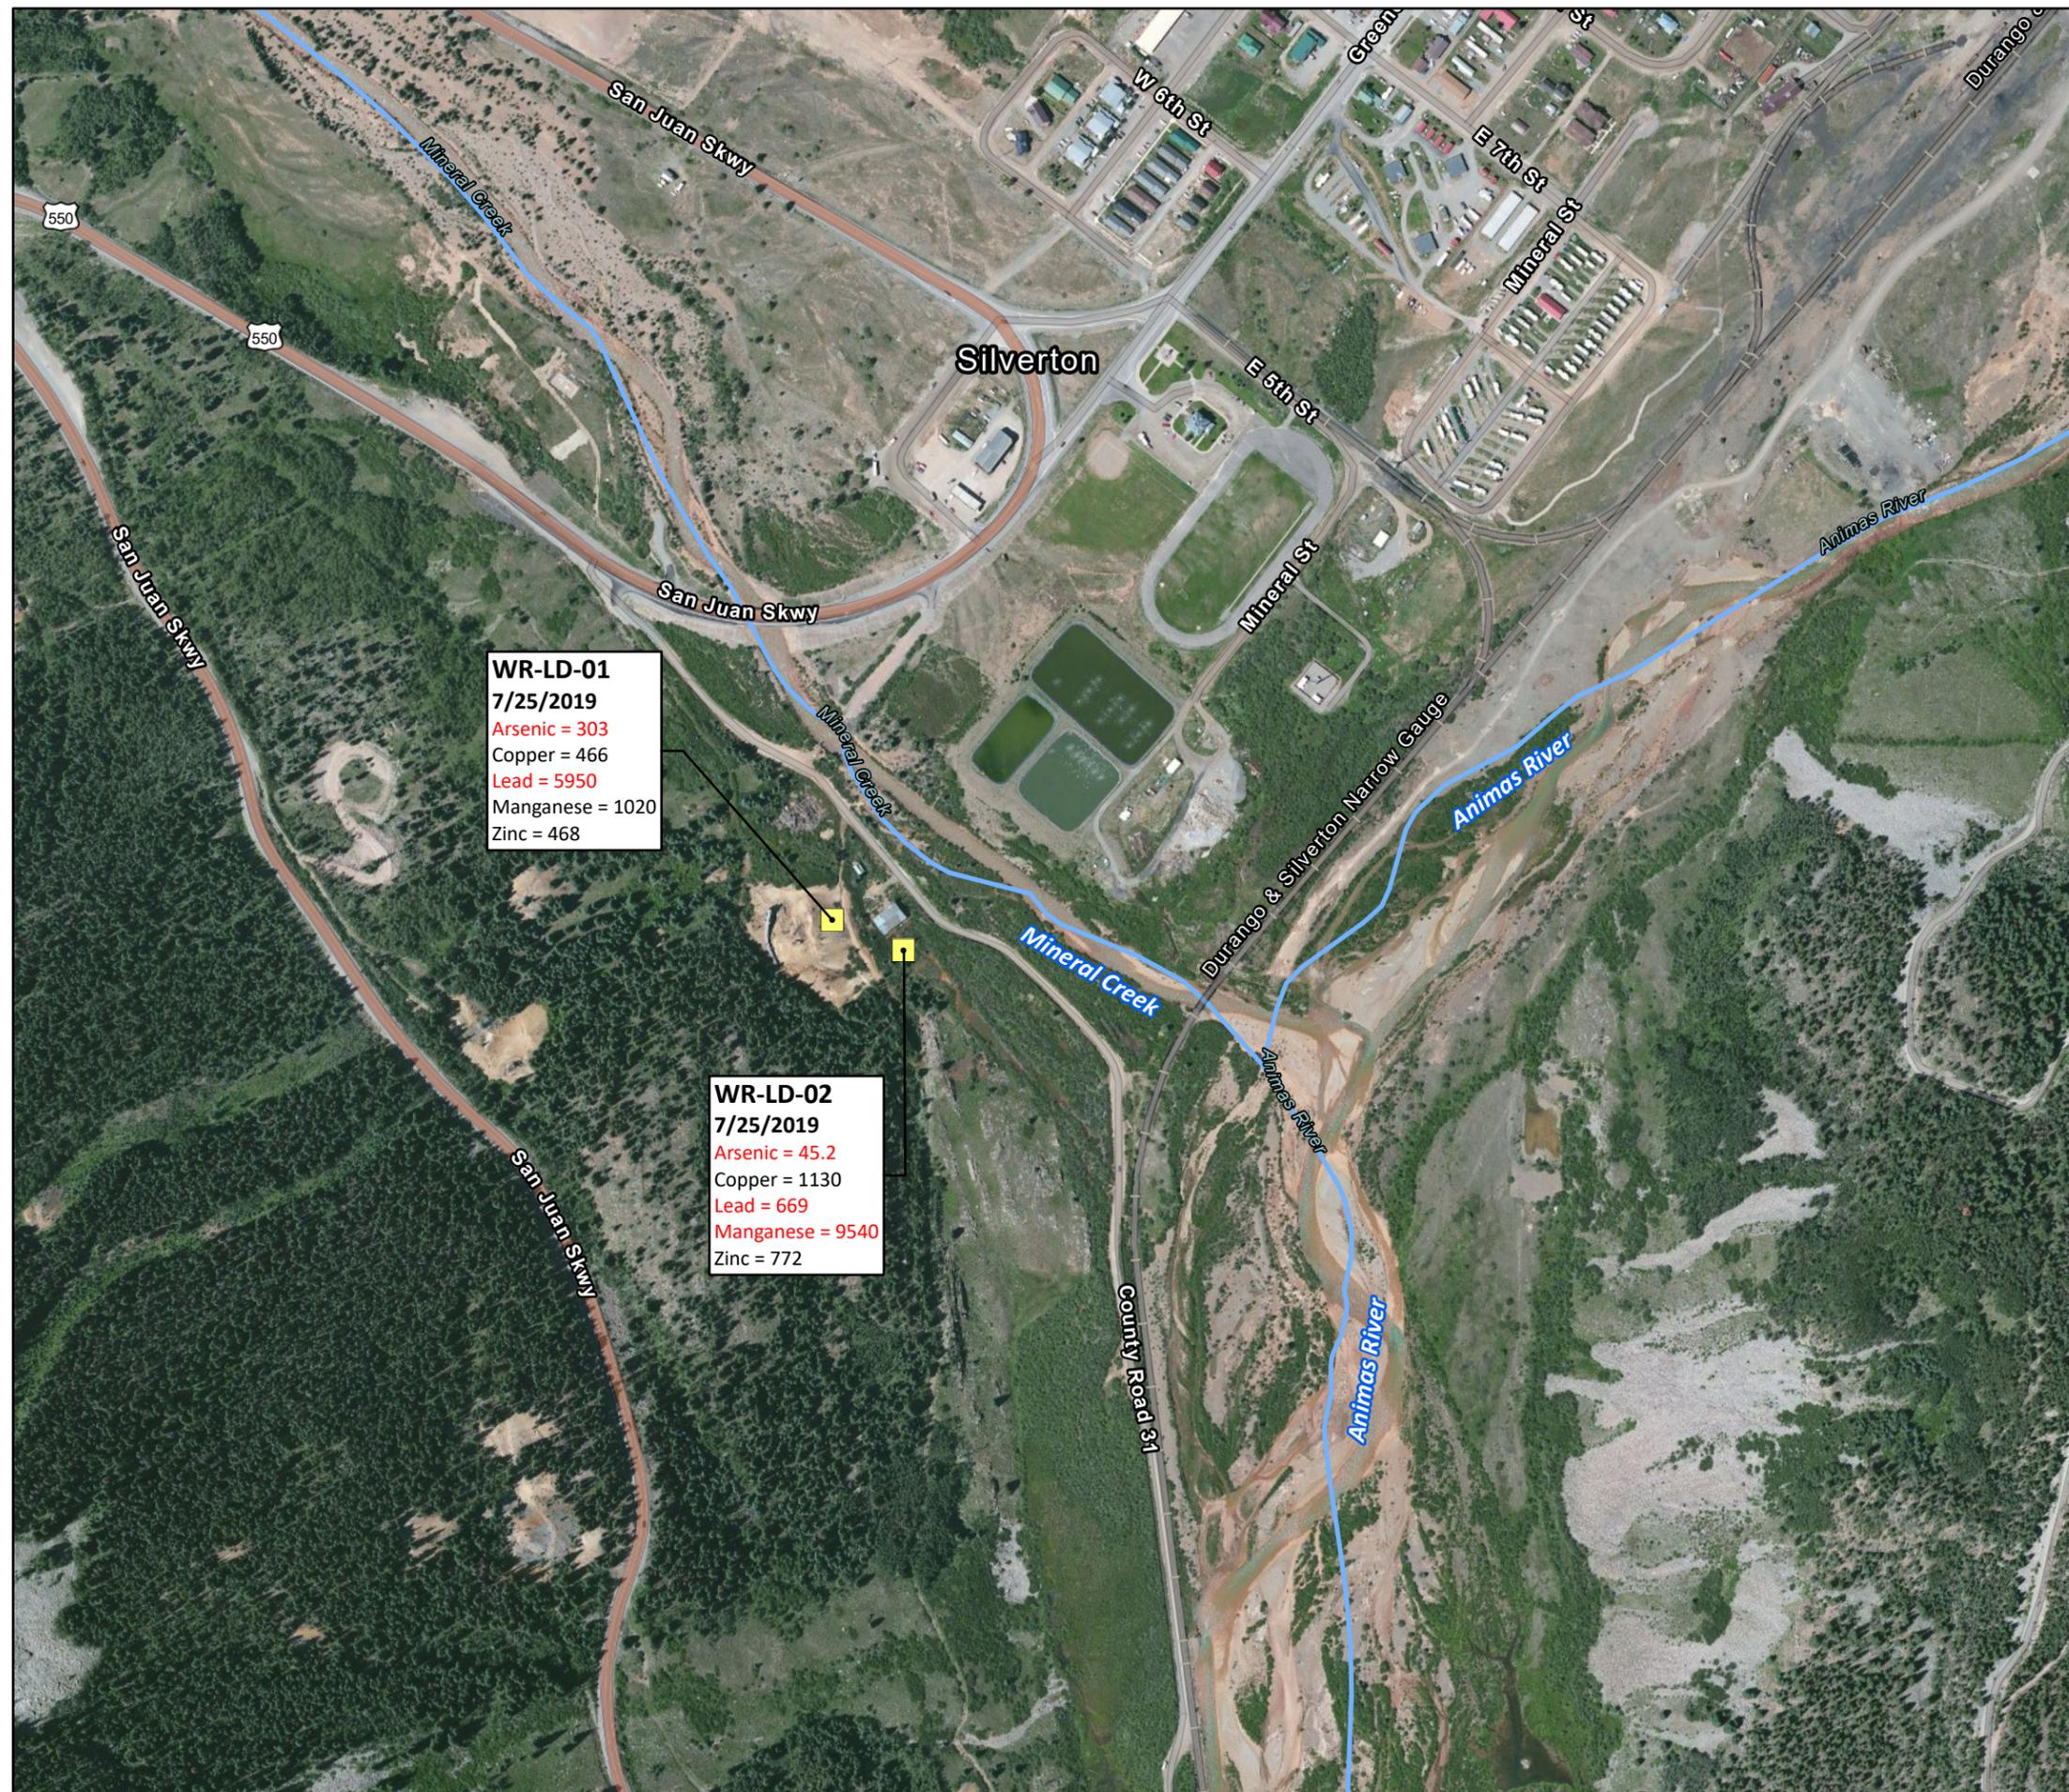
WR-LD-01
 7/25/2019
 Arsenic = 303
 Copper = 466
 Lead = 5950
 Manganese = 1020
 Zinc = 468

WR-LD-02
 7/25/2019
 Arsenic = 45.2
 Copper = 1130
 Lead = 669
 Manganese = 9540
 Zinc = 772

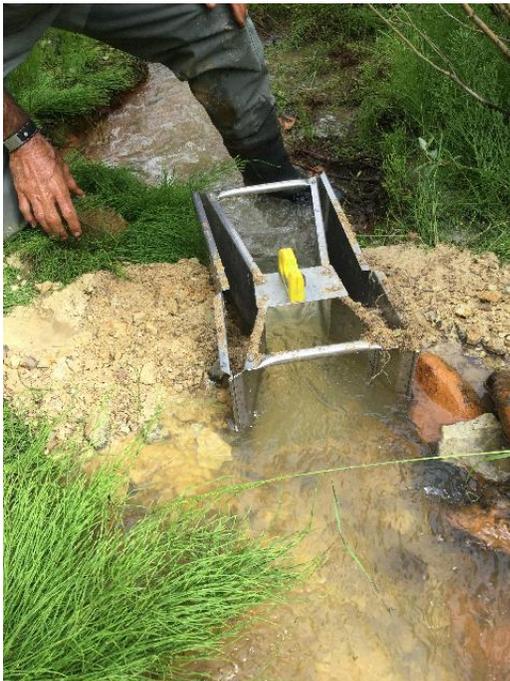
NS7_4_DM Flume

NS7_4_DM	Same location as high flow event. Side channel along waste pile area. Estimated ~30% of total water is overflowing the channel bank into pile area just below sampling location; 10 to 15% blow by	Cascading, Cloudy, Turbulent; Gravel, Cobble; Orange Staining	Sunny; No Wind	Michael Carney	Robyn Blackburn
NSM-SW-OPP-01	Same located in same spot as during high flow. Adit discharge just prior to Mineral Creek; Bag flume method from DRMS	Calm, Clear, Pool; Sandy; Orange Staining	Partly Cloudy; No Precip.; No Wind	Robyn Blackburn	Kirstin Brown
M32	None	Cascading, Turbulent, Cloudy; Cobble, Gravel; Orange Staining	Sunny; Low Wind	Alex hedgepath	Landon bailey
M33	None	Cascading, Turbulent, Clear; Cobble, Gravel; Orange Staining	Sunny; Low Wind	Ale hedgepath	Landon bailey
M32C	Sample location just below waste pile/ore shoot.	Cascading, Clear; Boulder, Cobble, Gravel; Orange Staining	Sunny; No Wind	Michael Carney	Tanner Banks

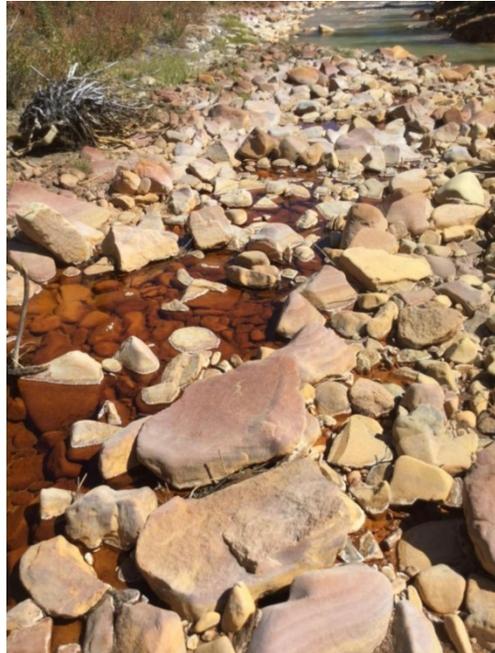
M32 Red water, slow flow, adjacent, north of river

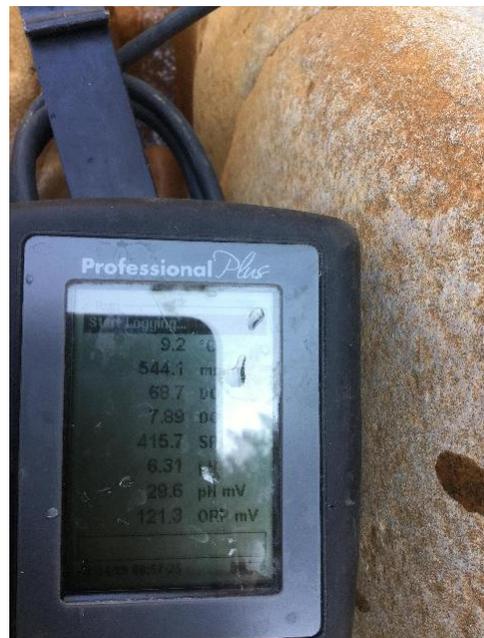
M32 Water Screen Shot

Professional Plus	
TEMP (°C)	9.2
TEMP (°F)	544.1
COND (µS/cm)	68.7
COND (mS/cm)	7.89
SPH (ppm)	416.7
CL (ppm)	6.31
ORP (mV)	29.6
ORP (mV)	121.3

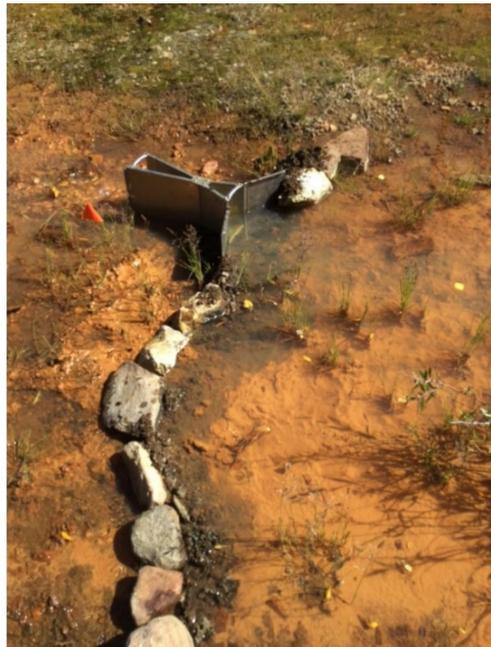
Sample/Location ID	Comments	Stream Conditions	Weather Conditions	Field Scribe	Field Sampler
NS7_1_DM	Main adit sample location just outside of tunnel; Existing sample location also collected during high flow event. Adit discharge just outside of portal; Two flume sets added together to get total adit flow path. 2 in flume $H_a = 0.56$ $H_b = 0.16$; 1 in flume $H_a = 0.28$ $H_b = 0.04$	Adit, Cloudy, Pool, Turbulent, Tinge; Gravel, Cobble; Orange Staining	Sunny; No Wind	Robyn Blackburn	Tanner Banks
NS7_2_DM	Bag flume method from DRMS; Bottom of cascades	Cascading, Clear, Turbulent; Gravel, Cobble; Orange Staining	Partly Cloudy; No Precip.; No Wind	Michael Carney	Jeff Litteral
NS7_3_DM	Sampling point just before flow enters Mineral Creek. Flow path above sampling point flows over pile. Stressed and dead vegetation throughout. Flow taken well above sampling point where it is channelized; 5% blow by	Muddy, Cloudy; Marsh; Orange Staining	Sunny; Low Wind	Michael Carney	Robyn Blackburn

NS7_1_DM New location, main adit
sample location just outside of tunnel

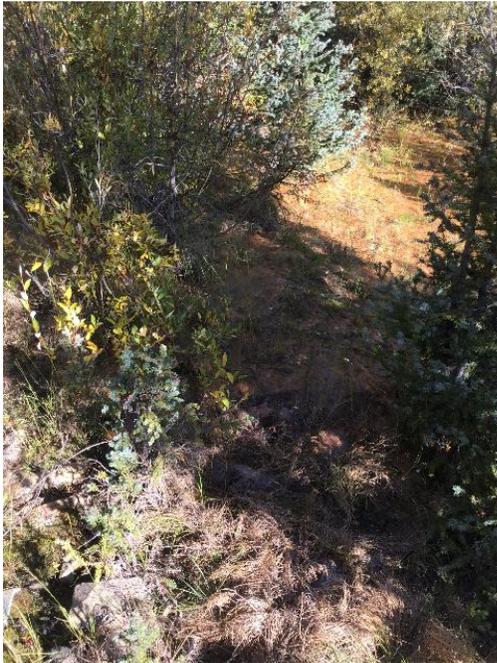
NS7_4_DM Overflow area

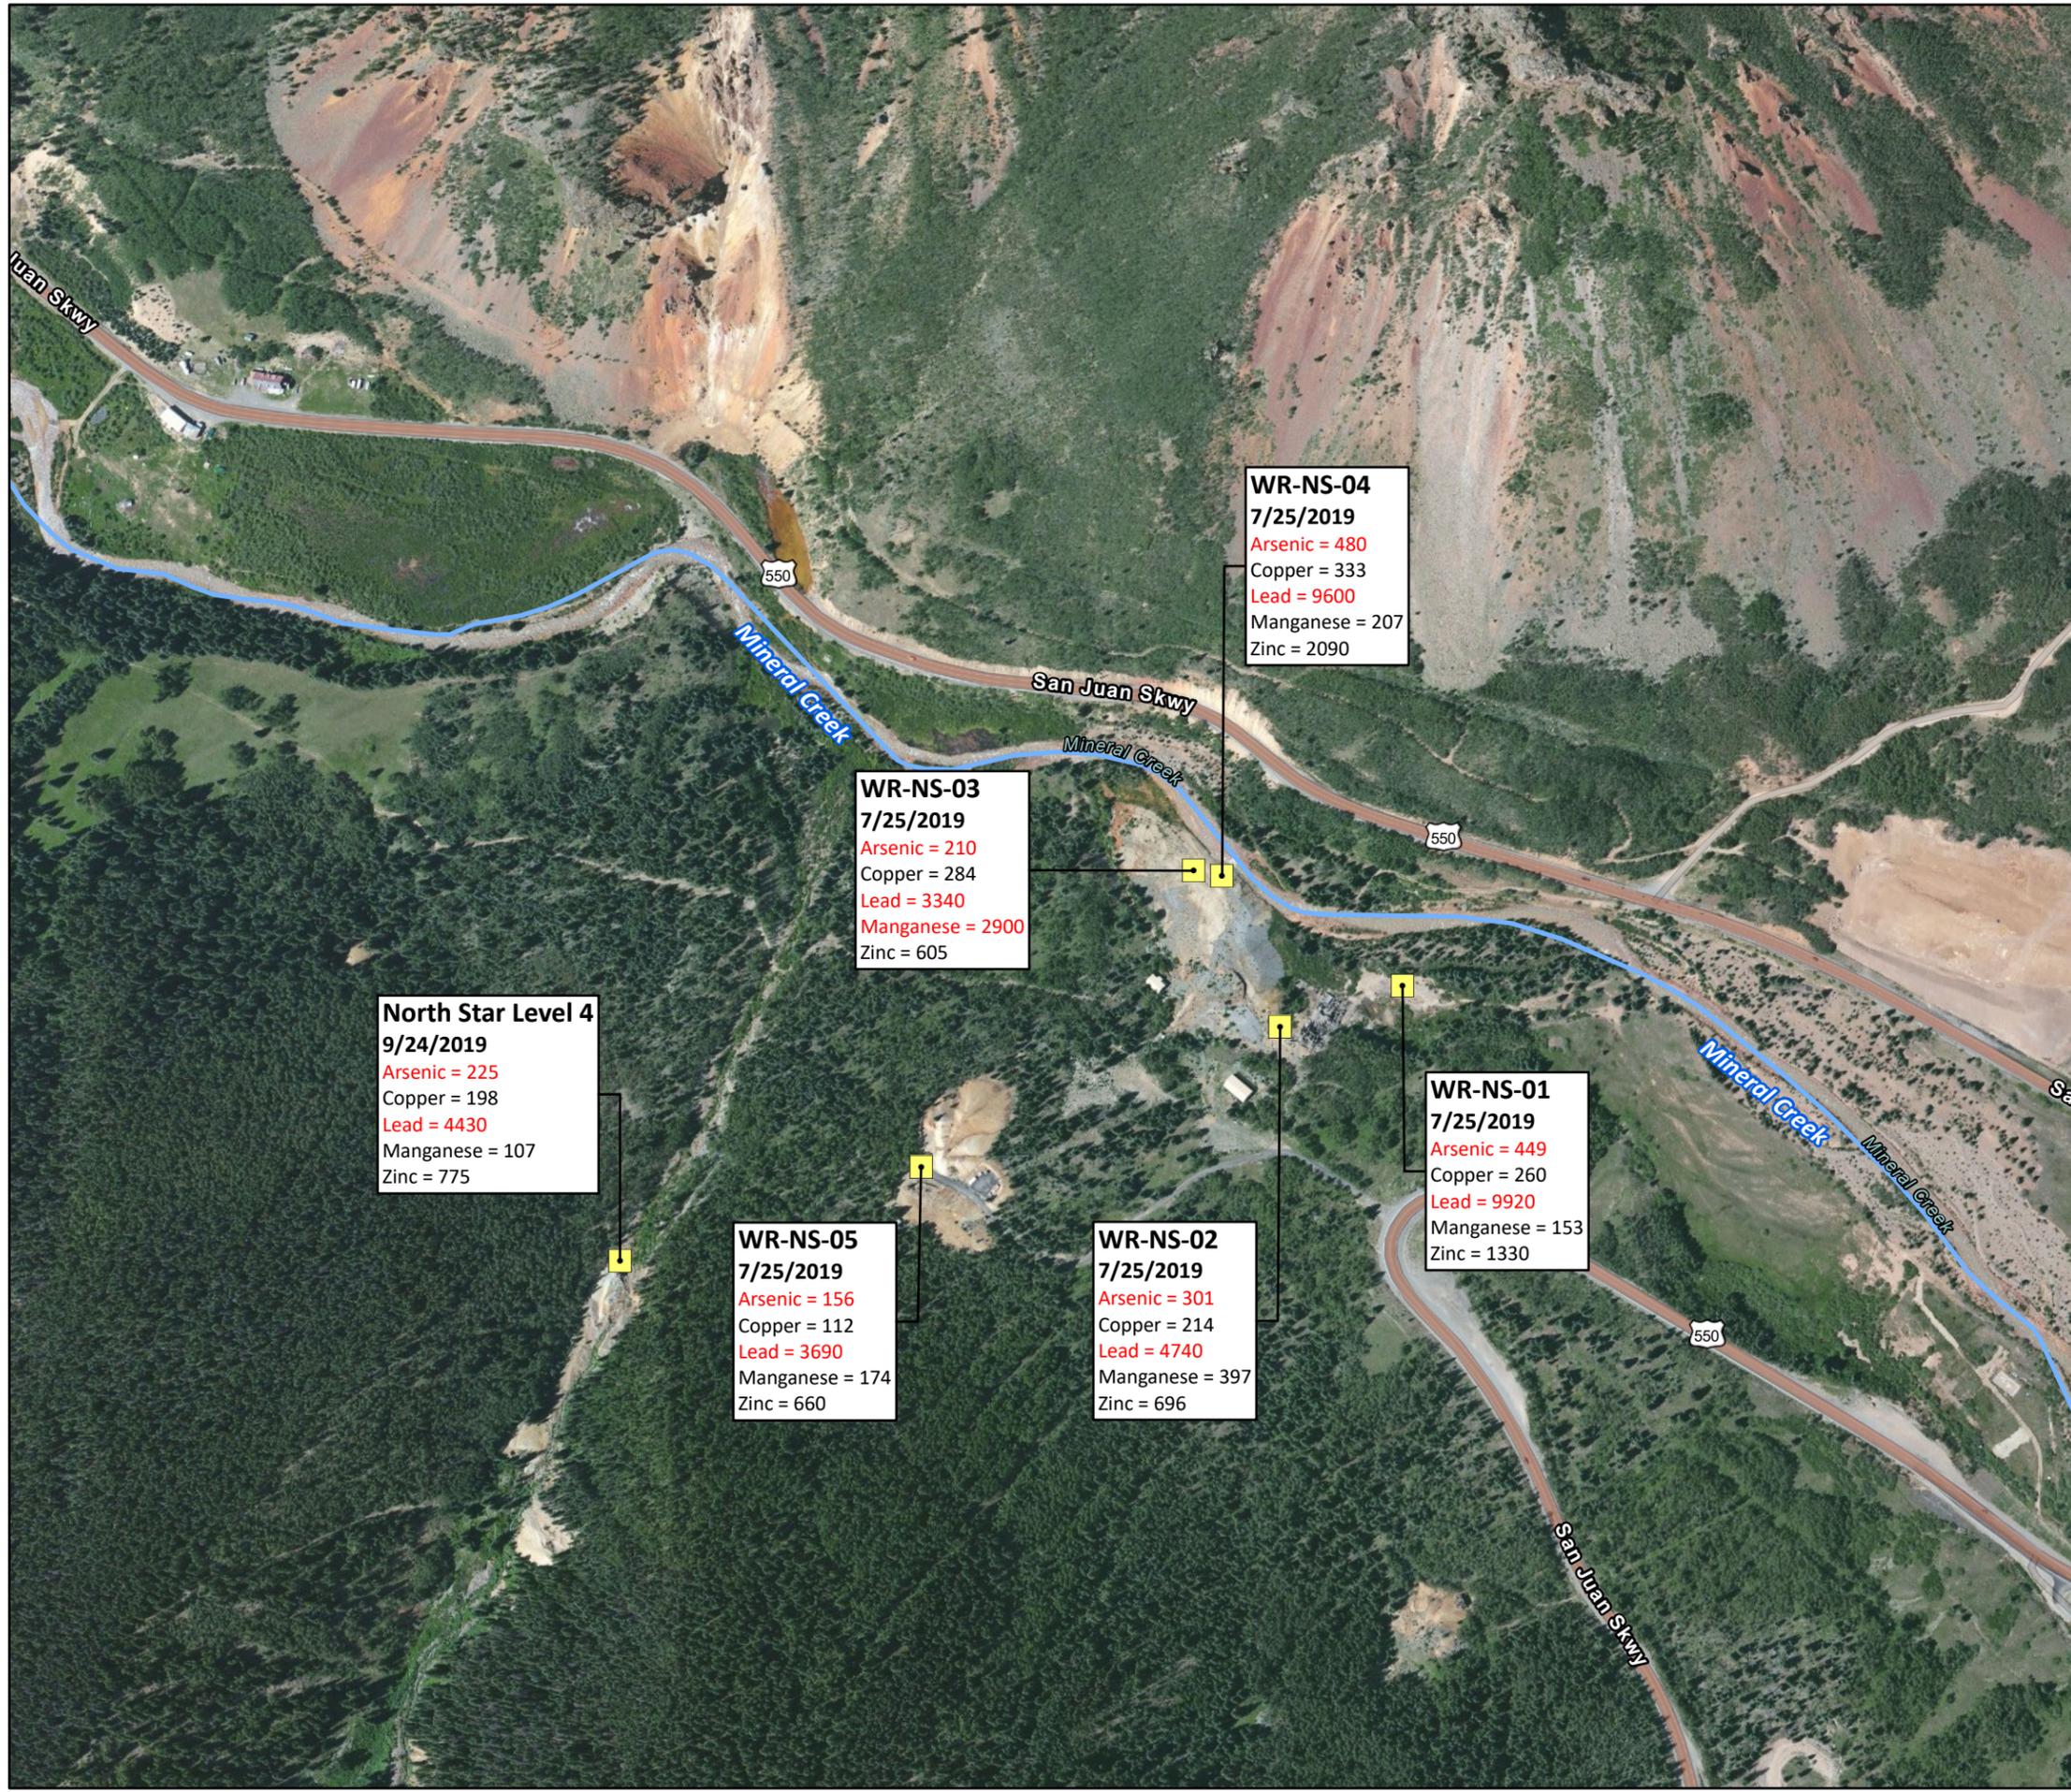
WR-NS-04
 7/25/2019
 Arsenic = 480
 Copper = 333
 Lead = 9600
 Manganese = 207
 Zinc = 2090

WR-NS-03
 7/25/2019
 Arsenic = 210
 Copper = 284
 Lead = 3340
 Manganese = 2900
 Zinc = 605
