**Subject: After Action Report – Revision 2
Paint Waste Burial Site
Response Actions and Soil Confirmation Sampling
EPA Contract No. 68-HE-0320-D0003
Technical Direction (TD) No. T601-21-12-004
Document Control No. 0397**

PAINT WASTE BURIAL SITE CONFIRMATION SOIL SAMPLING RURAL RETREAT, WYTHE COUNTY, VIRGINIA

EPA CONTRACT NO. 68-HE-0320-D0003
TECHNICAL DIRECTION NO. T601-21-12-004
DOCUMENT TRACKING 0397

August 2022

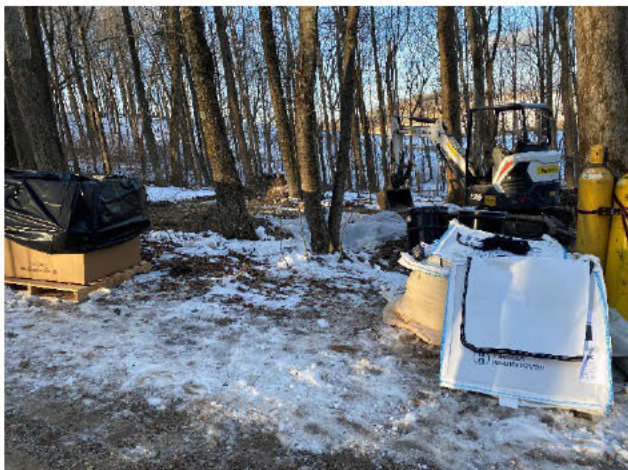
Photo No. 1: Taken on 01/26/2022 at 08:47 by START_ [REDACTED] ([REDACTED]). Facing west (W). Burial pit setup for excavation.

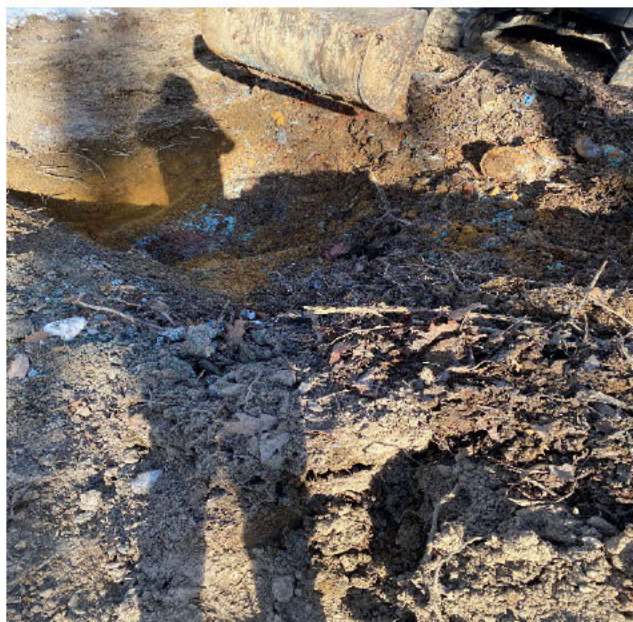
Photo No. 2: Taken on 01/26/2022 at 10:44 by START_ [REDACTED]. Looking down at pit. Blue and red paint waste visible within the soils of the pit.

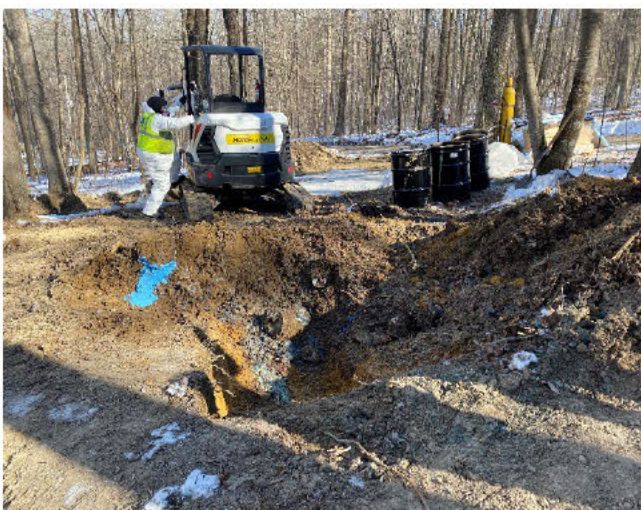
Photo No. 3: Taken on 01/26/2022 at 11:23 by START_ [REDACTED]. Facing East (E). Paint waste visible within the soils of the pit.

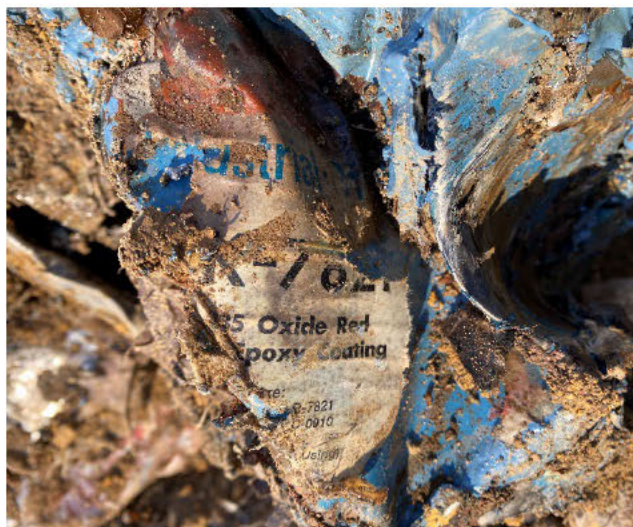
Photo No. 4: Taken on 01/26/2022 at 15:37 by START_ [REDACTED]. Looking at debris material. Partially crushed waste paint can.

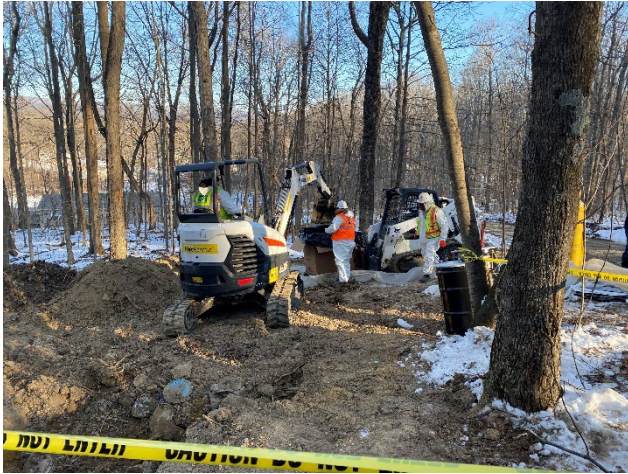
Photo No. 5; Taken on 01/27/2022 at 09:13 by START [REDACTED]. Facing North (N). Filling cubic yard bags with soils.

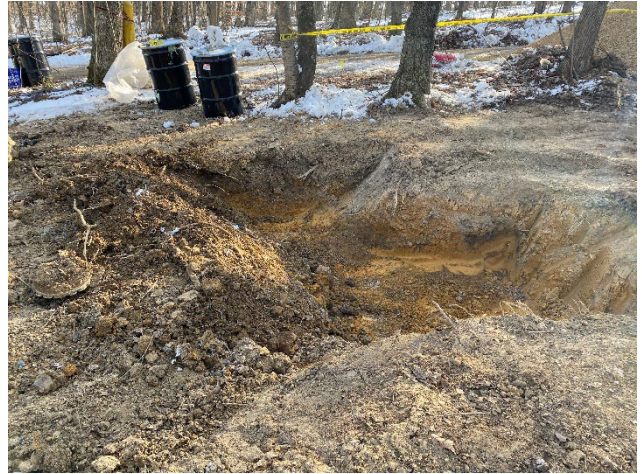
Photo No. 6; Taken on 01/27/2022 at 09:56 by START [REDACTED]. Facing Southwest (SW). Excavation of waste burial pit in progress.

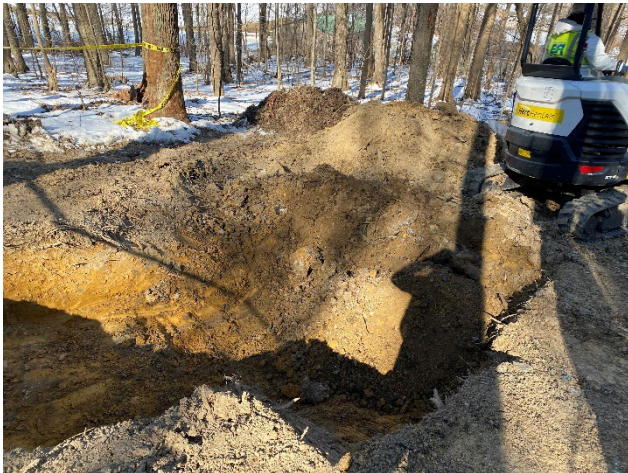
Photo No. 7; Taken on 01/27/2022 at 11:22 by START [REDACTED]. Facing Northwest (NW). Excavation of waste burial pit in progress.

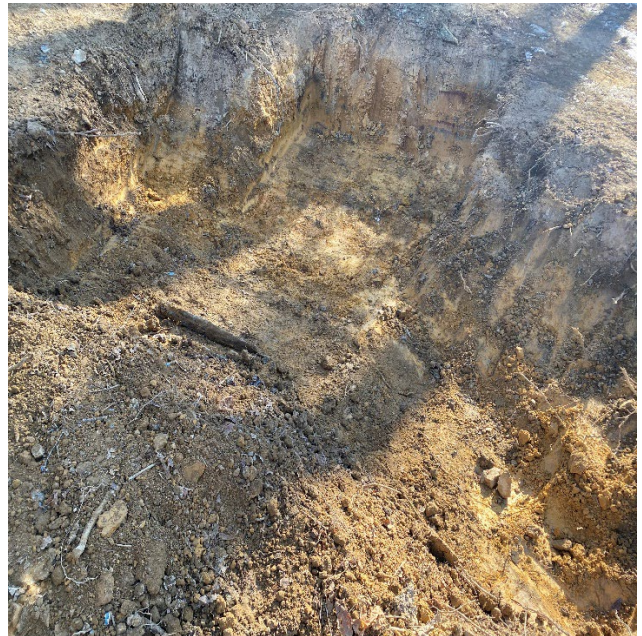
Photo No. 8; Taken on 01/27/2022 at 14:27 by START [REDACTED]. Looking down at the pit. Excavation of waste burial pit in progress.

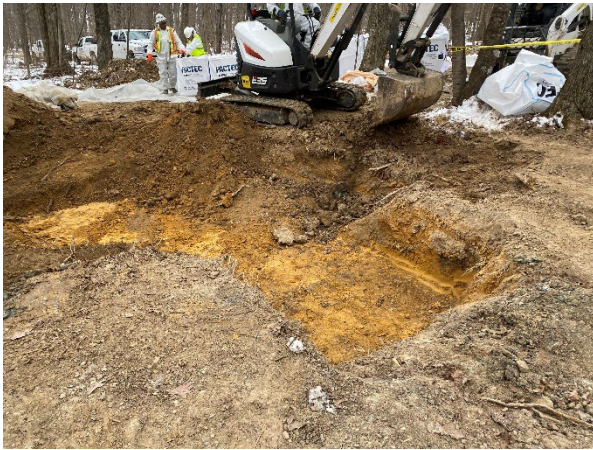
Photo No. 9; Taken on 01/28/2022 at 09:20 by START [REDACTED]. Facing N. Excavation of waste burial pit in progress, loading soil bags.

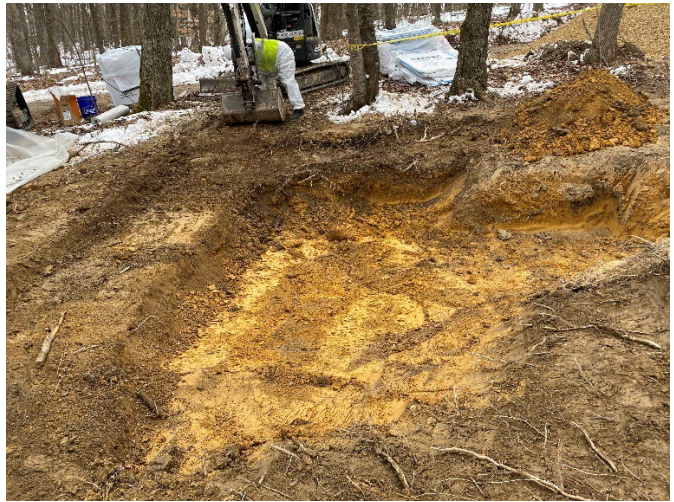
Photo No. 10; Taken on 01/28/2022 at 11:07 by START [REDACTED]. Facing E. Excavation of waste burial pit in progress, loading soil bags, and removing waste paint containers from soils.

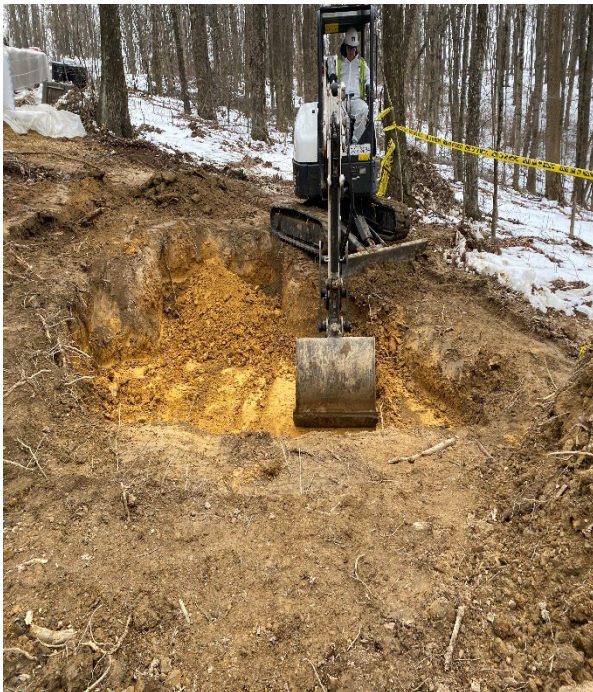
Photo No. 11; Taken on 01/28/2022 at 13:16 by START [REDACTED]. Facing SW. Excavation of waste burial pit in progress, loading soil bags. Less impacted soils can be seen.

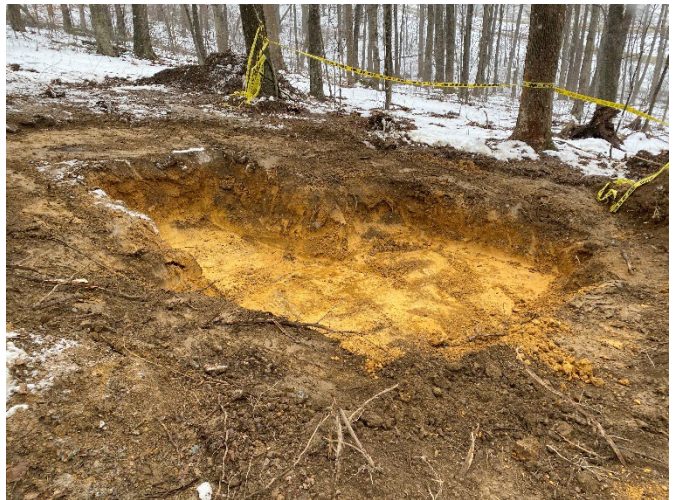
Photo No. 12; Taken on 01/28/2022 at 14:42 by START [REDACTED]. Facing SW. Less impacted soils can be seen.

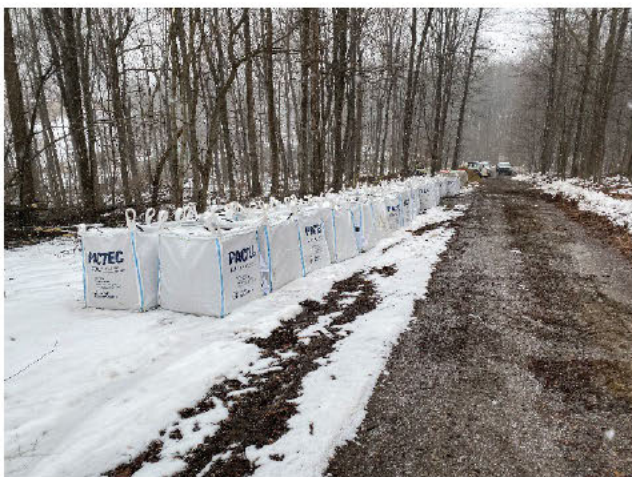
Photo No. 13; Taken on 01/28/2022 at 14:45 by START [REDACTED]. Facing N. Arrangement of soil bags along Oak Park Lane.

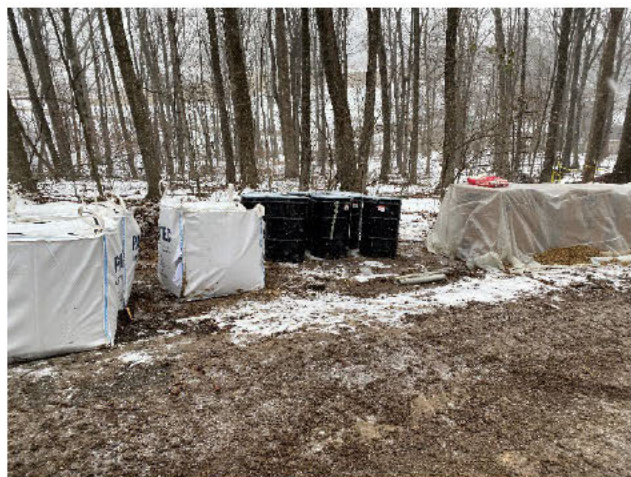
Photo No. 14; Taken on 01/28/2022 at 14:45 by START [REDACTED]. Facing W. Arrangement of liquid waste drums and waste container boxes along Oak Park Lane.

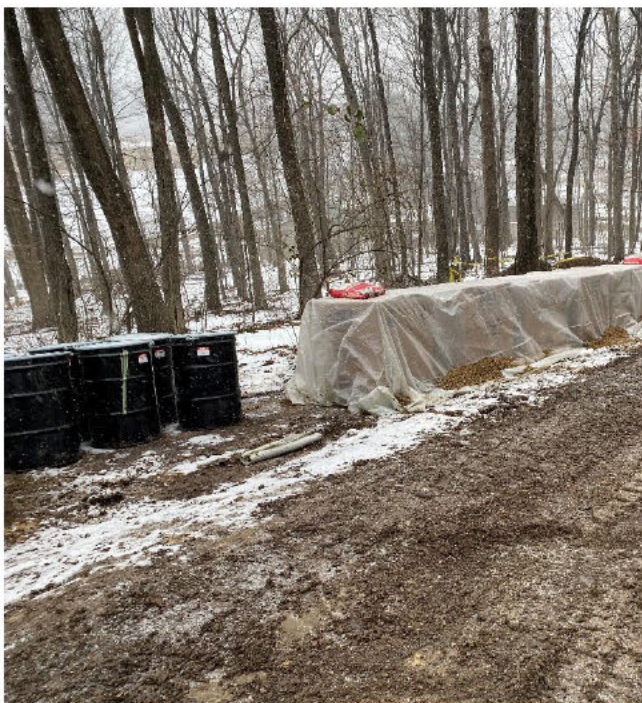
Photo No. 15; Taken on 01/28/2022 at 14:45 by START [REDACTED]. Facing NW. Arrangement of liquid waste drums and waste container boxes along Oak Park Lane.

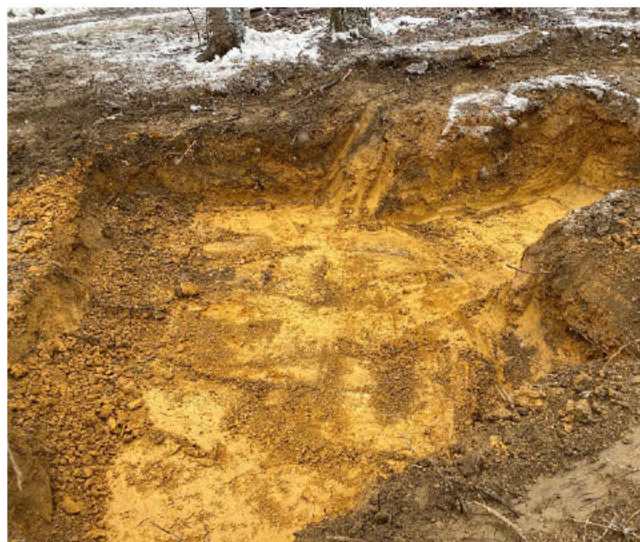
Photo No. 16; Taken on 01/28/2022 at 14:59 by START [REDACTED]. Facing S. Less impacted soils can be seen. Excavation work completed.

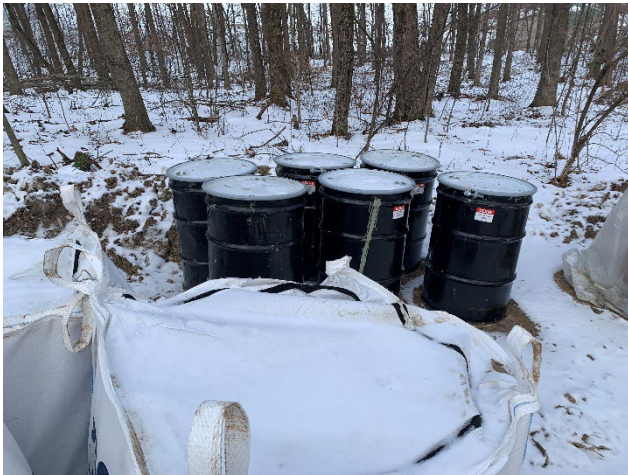
Photo No. 17; Taken on 01/31/22 at 09:05 by START [REDACTED] (REDACTED). Facing W. Arrangement of liquid waste drums and waste container boxes along Oak Park Lane.

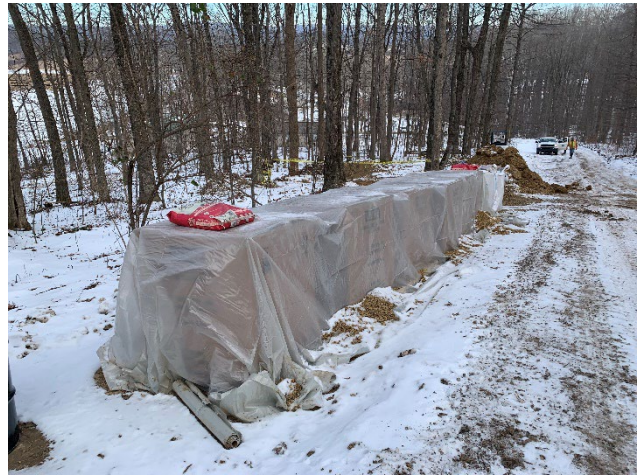
Photo No. 18; Taken on 01/31/22 at 09:05 by START [REDACTED]. Facing NW. Arrangement of liquid waste drums and waste container boxes along Oak Park Lane.

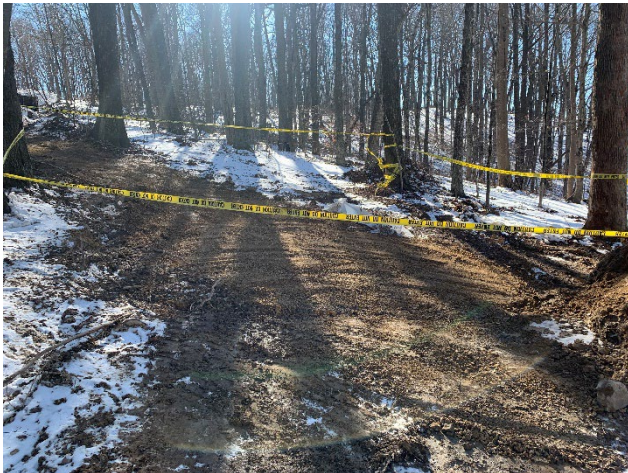
Photo No. 19; Taken on 01/31/22 at 14:21 by START [REDACTED]. Facing W. Backfilled excavation pit, with polyethylene liner, filled with pea gravel to grade surface.

After START collected the confirmation soil samples, VADEQ personnel placed polyethylene liner in the base of the excavated area. EPA's ERRS contractor backfilled the area with pea gravel to grade level.

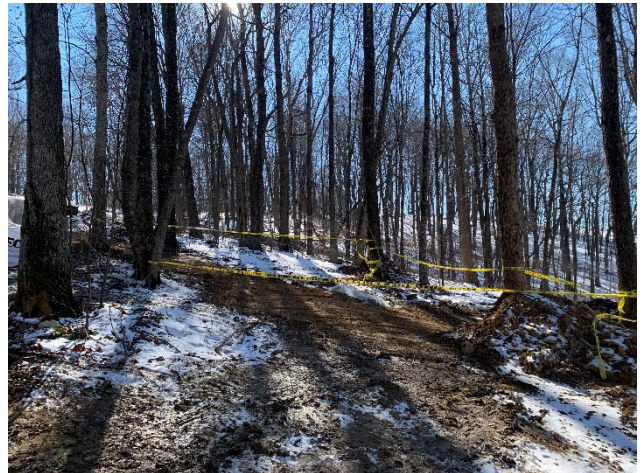
Photo No. 20; Taken on 01/31/22 at 14:21 by START [REDACTED]. Facing W. Backfilled excavation pit, with polyethylene liner, filled with pea gravel to grade surface.
