**Subject: Final Comprehensive Environmental Response, Compensation, and Liability Act
(CERCLA) Emergency Response Action Report
Cherokee NC Boundary Tree UST Release
Cherokee, Swain County, North Carolina
EPA Contract No. EP-W-05-054
TDD No. TTEMI-05-002-0002**

**FINAL CERCLA EMERGENCY RESPONSE ACTION REPORT
CHEROKEE NC BOUNDARY TREE UST RELEASE
CHEROKEE, SWAIN COUNTY, NORTH CAROLINA
EPA CONTRACT NO. EP-W-05-054
TDD NO. TTEMI-05-002-0002**

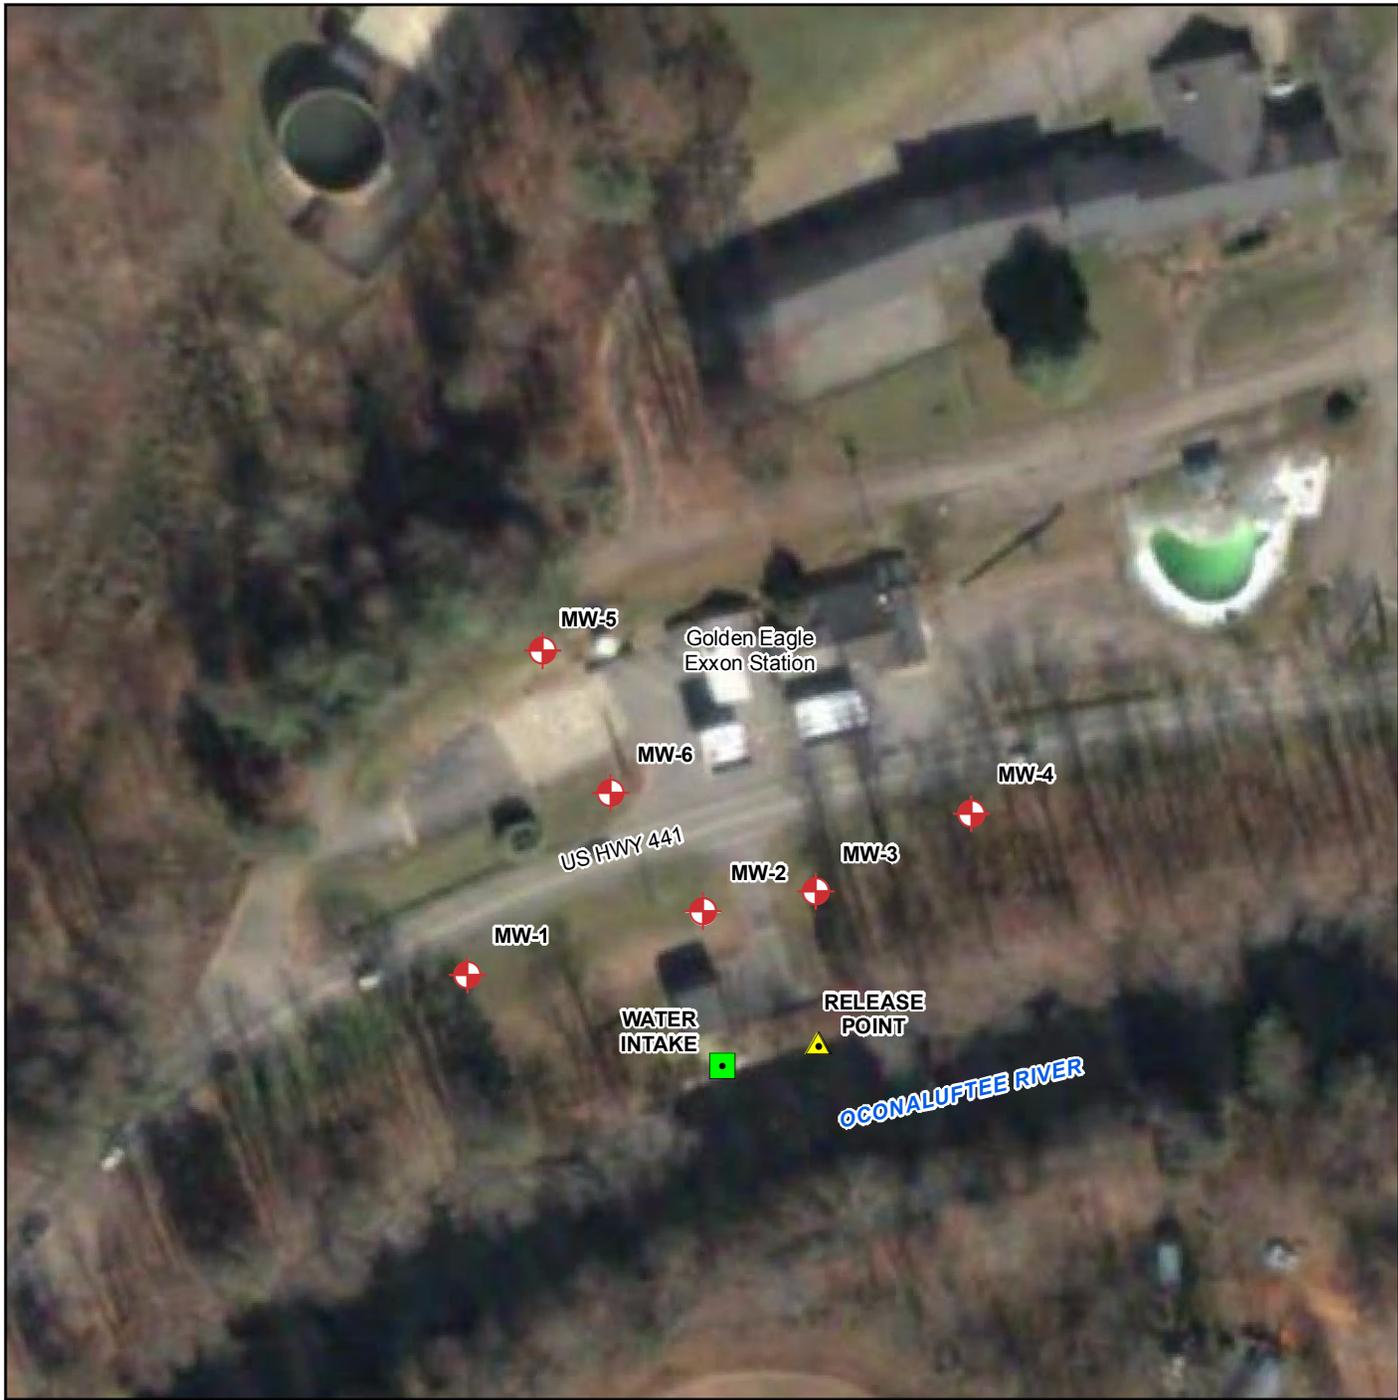
**FIGURE 2
SITE LAYOUT MAP**

The Cherokee site is located at 1693 Tsali Boulevard in Cherokee, Swain County, North Carolina, on the Eastern Band of the Cherokee Indians (EBCI) Reservation (see Figure 1). Site-specific geographic coordinates for the site are 35.50032 north latitude and 83.31135 west longitude. Although technically within Swain County, the EBCI Reservation is considered independent of the county and the State of North Carolina. Furthermore, EPA policy states that “the Agency will view Tribal Governments as the appropriate non-federal parties for making decisions and carrying out program responsibilities... consistent with agency standards and regulations.” The Cherokee site encompasses the Golden Eagle Exxon station and the reservation's public drinking water intake on the Oconaluftee River (see Figure 2).

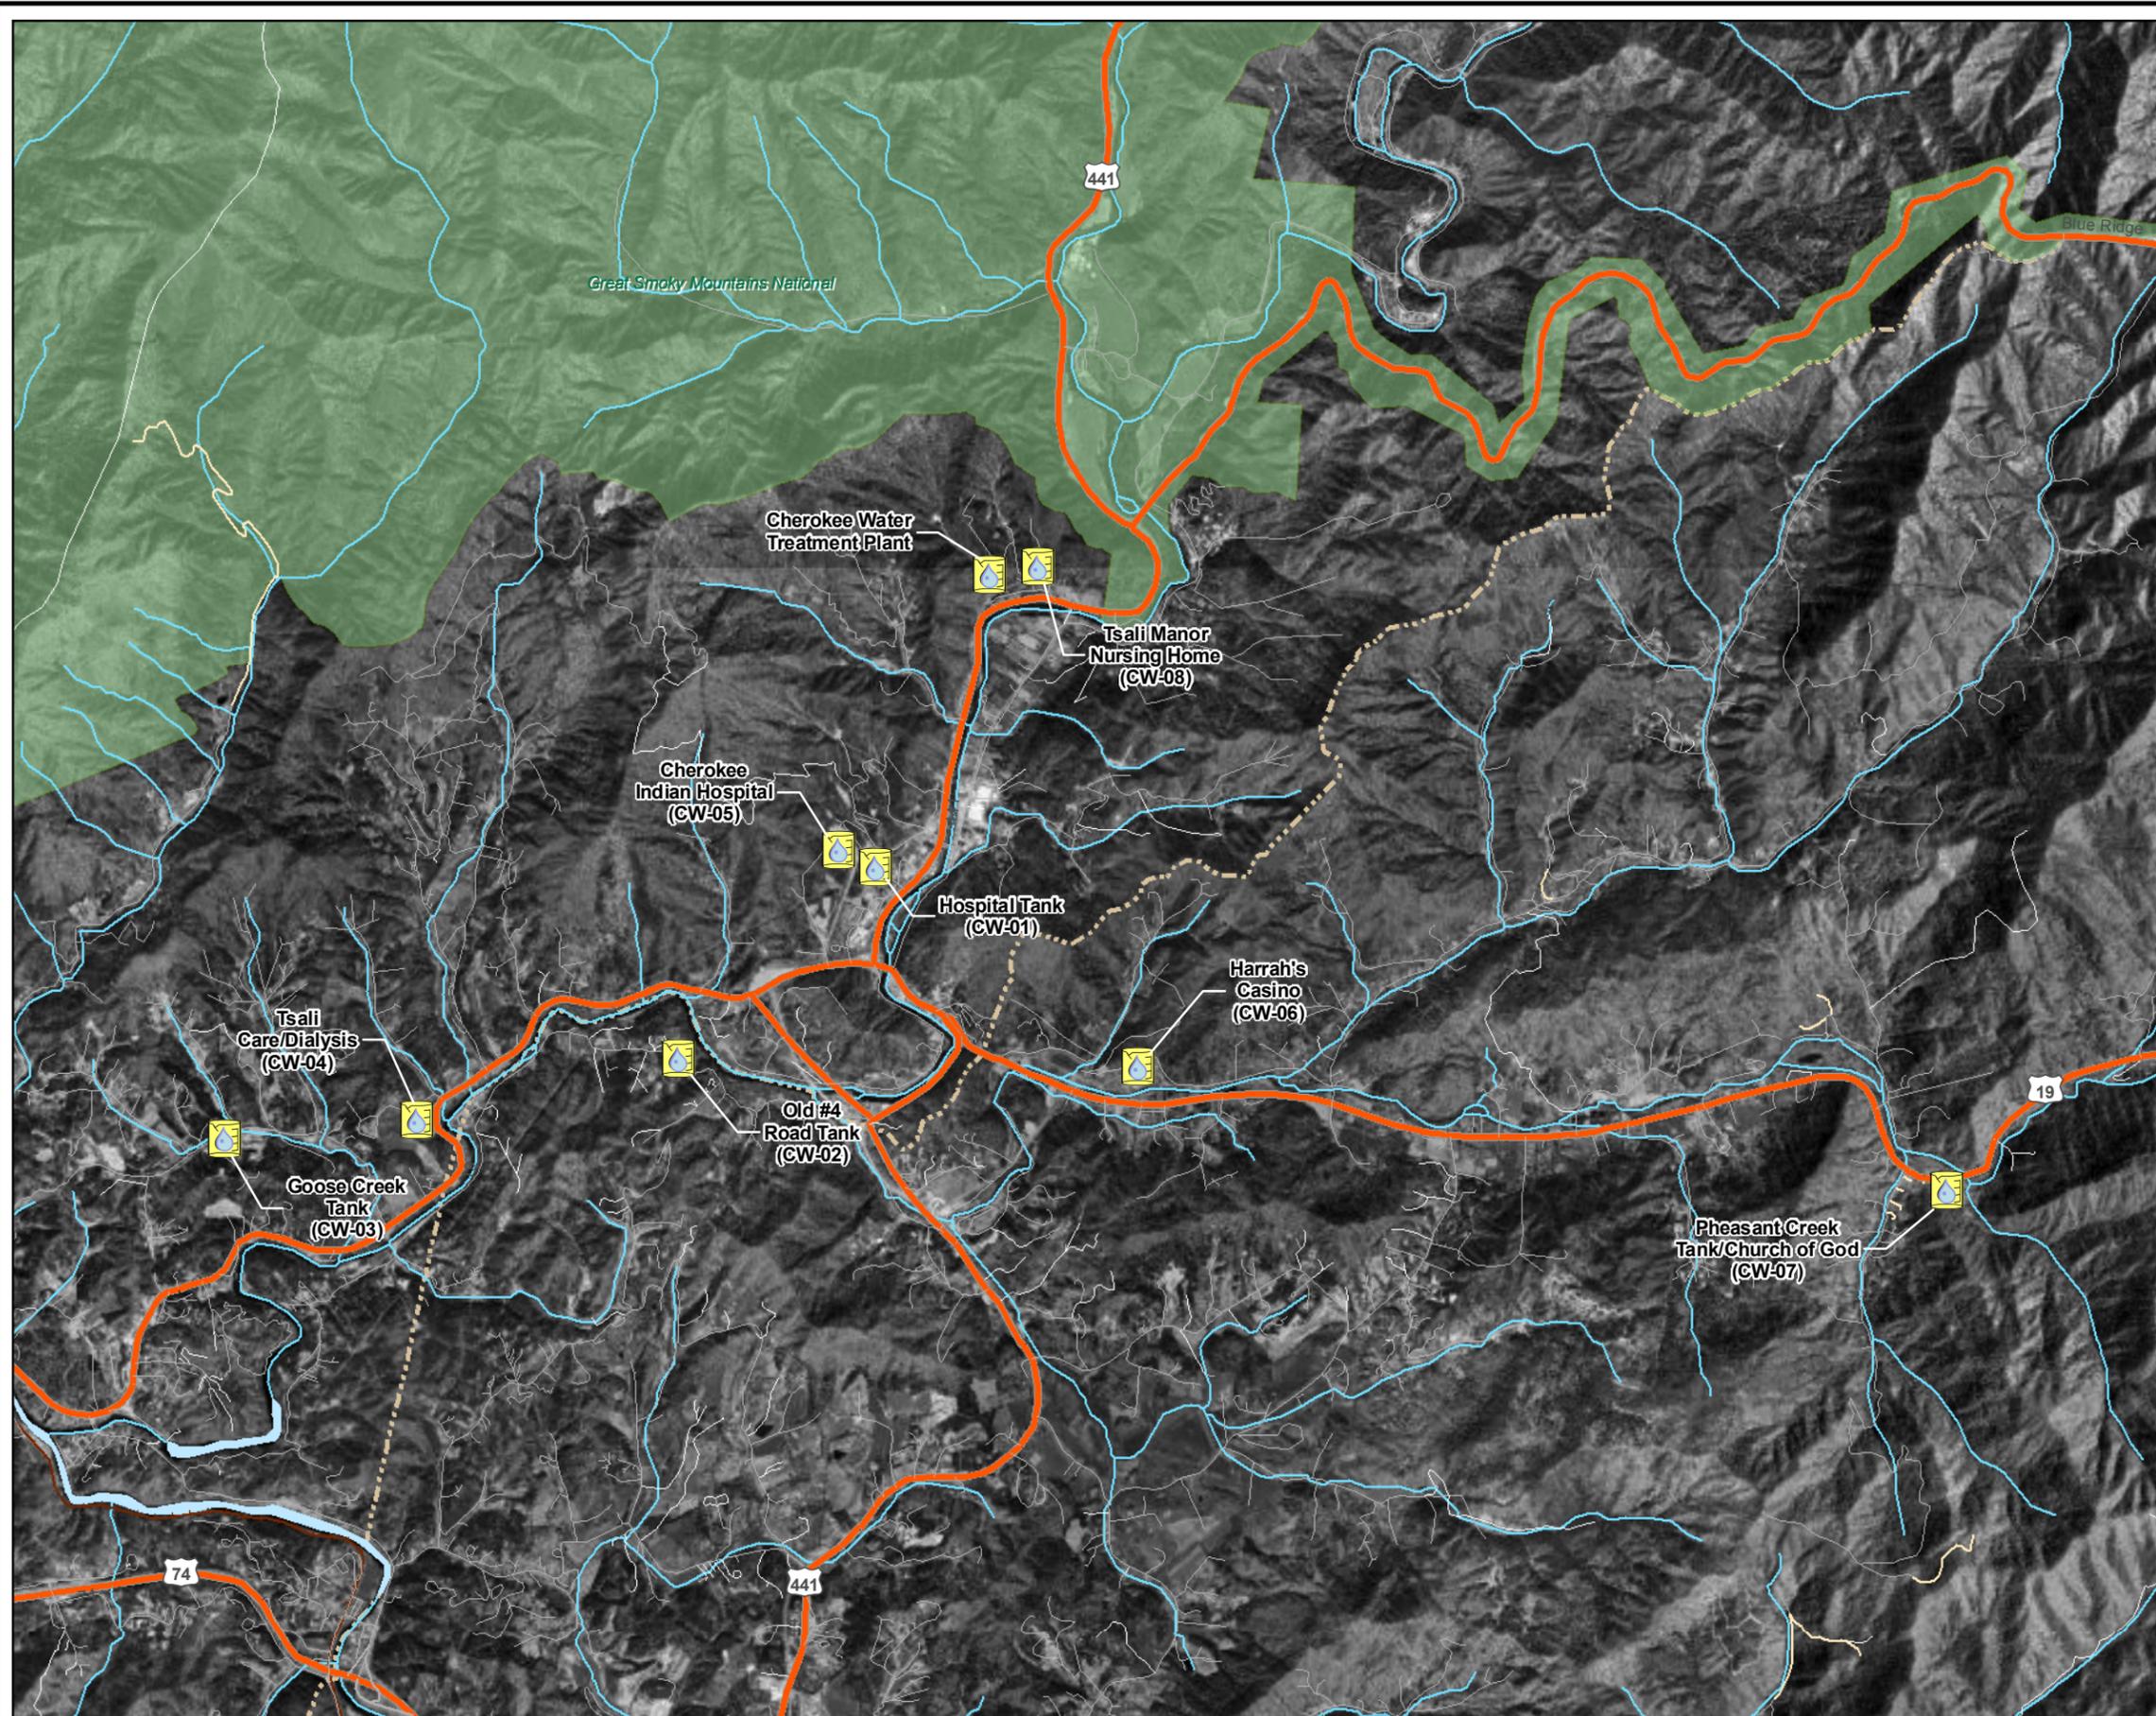
**FIGURE 3
POTABLE WATER
SAMPLING LOCATIONS**

The original plan was to collect samples directly from the five storage tanks that serve the system. Additionally, five priority sites (medical centers, entertainment complexes, etc) were targeted for sampling (See Figure 3). Upon arriving at the first storage tank, it was discovered that the only sample inlet was located on the top of the tank accessed from a 40-foot-high ladder on the side of the tank. CWTP personnel stated each tank was of similar design. Because of obvious safety considerations, it was decided to collect samples from the fire hydrant closest to the tanks. CWTP employees accompanying Tetra Tech START and EPA confirmed the hydrants were fed by the storage tanks.

Although 10 potable water locations were originally slated for sampling, two priority sites were combined into one location because they were located next to each other with a hydrant in between. Even though most of the storage tanks were empty by this time, only one distribution line was found to be completely dry, the line fed by the Junior Wright tank. Consequently, this line was not sampled. A total of eight samples were collected from the distribution system for VOC analysis, four tank samples and four priority location samples. EISOPQAM suggests purging for 15 minutes prior to the collection of potable water samples. In accordance with EISOPQAM, the water flow was cut back to a trickle before sample collection. Because of the deadline for sample delivery to Raleigh, TETRA TECH START consulted with OSC Byrd about cutting the purging time for each sample from 15 minutes down to 3 minutes. At an average purge rate of 150 gallons per minute, each location was purged of approximately 450 gallons prior to sample collection. Reduction of the purge time saved over 1.5 hours.

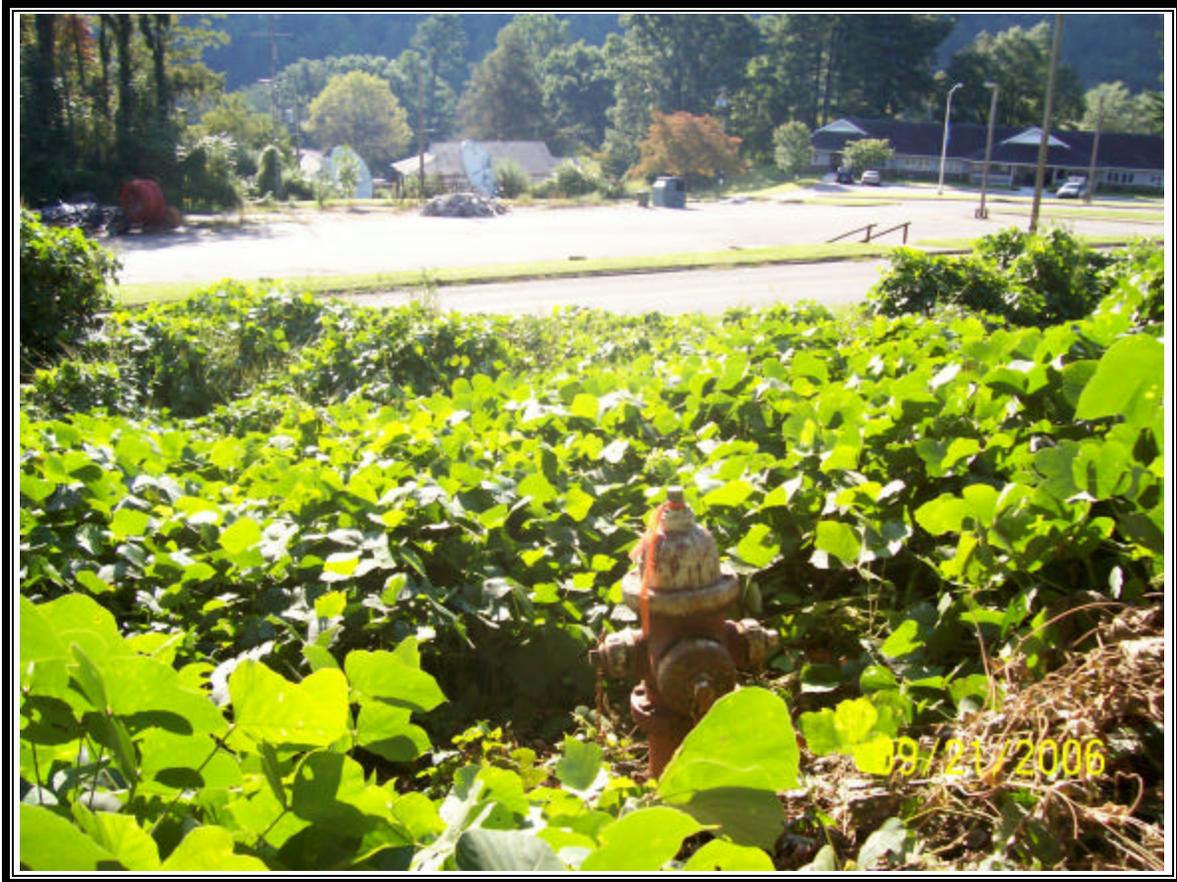
**OFFICIAL PHOTOGRAPH NO. 1
U.S. ENVIRONMENTAL PROTECTION AGENCY**

Subject: Sampling location CW-01 directly downhill from the Hospital Tank.

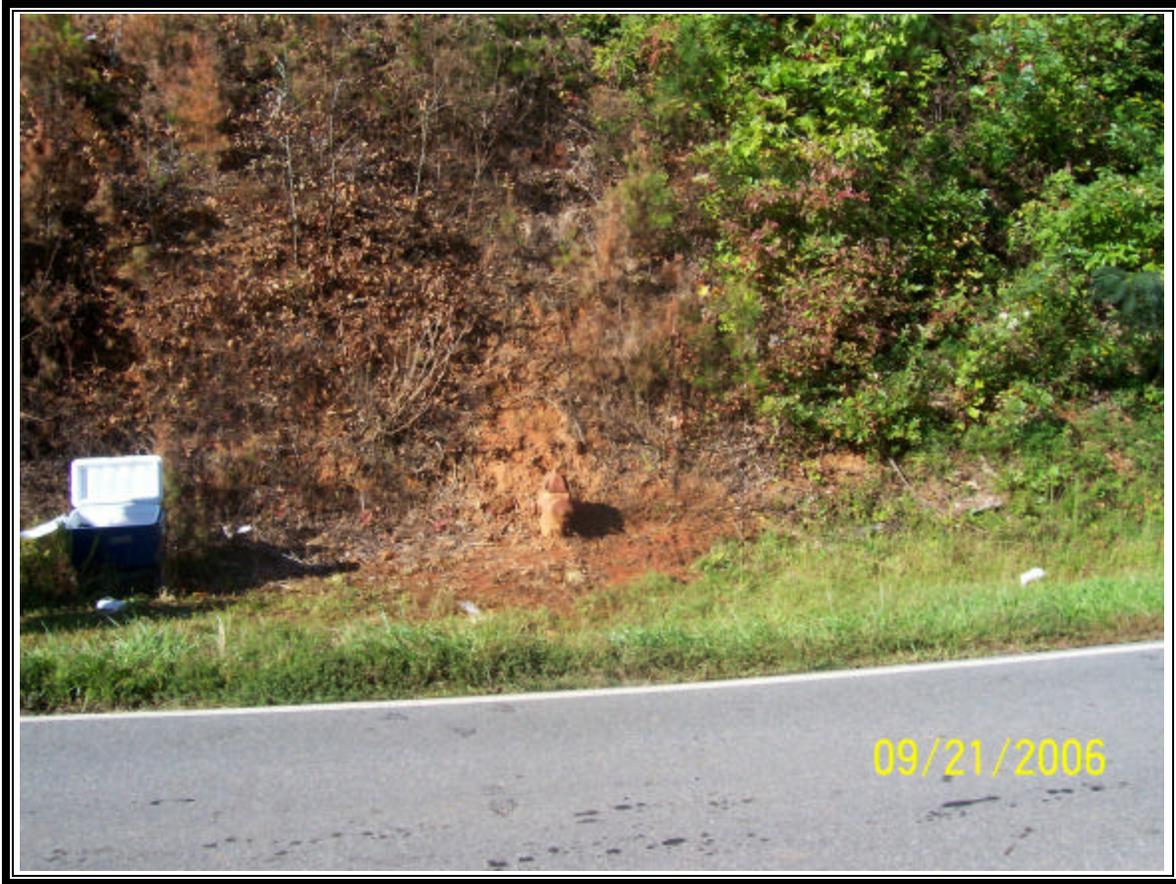
**OFFICIAL PHOTOGRAPH NO. 2
U.S. ENVIRONMENTAL PROTECTION AGENCY**

Subject: Sampling location CW-02, at the Old #4 Road Tank; the tank is on the hillside about 100 feet up on the slope.

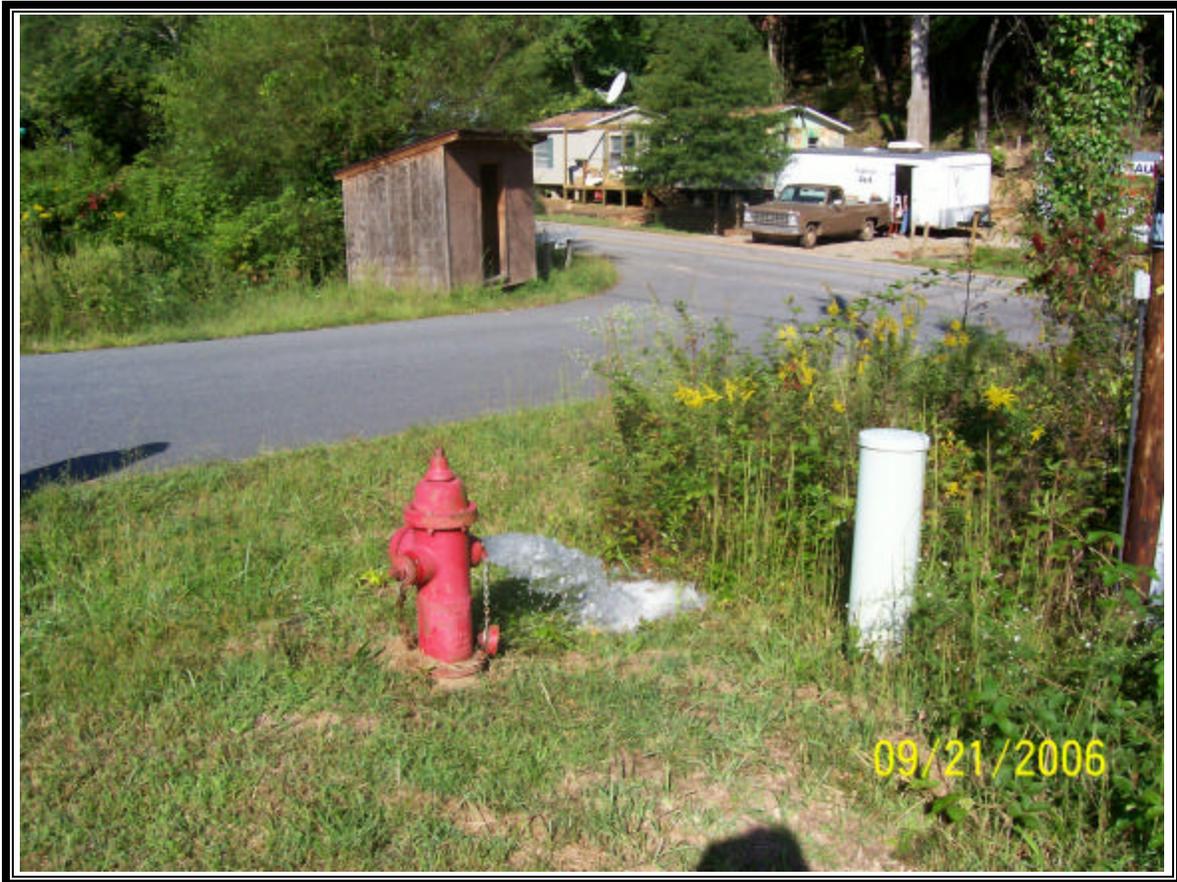
OFFICIAL PHOTOGRAPH NO. 3
U.S. ENVIRONMENTAL PROTECTION AGENCY

Subject: Sampling location CW-03 at Goose Creek tank; the hydrant is located at Goose Creek Road and Jim Bowman Drive; the tank is located left of the photograph about 100 meters away.

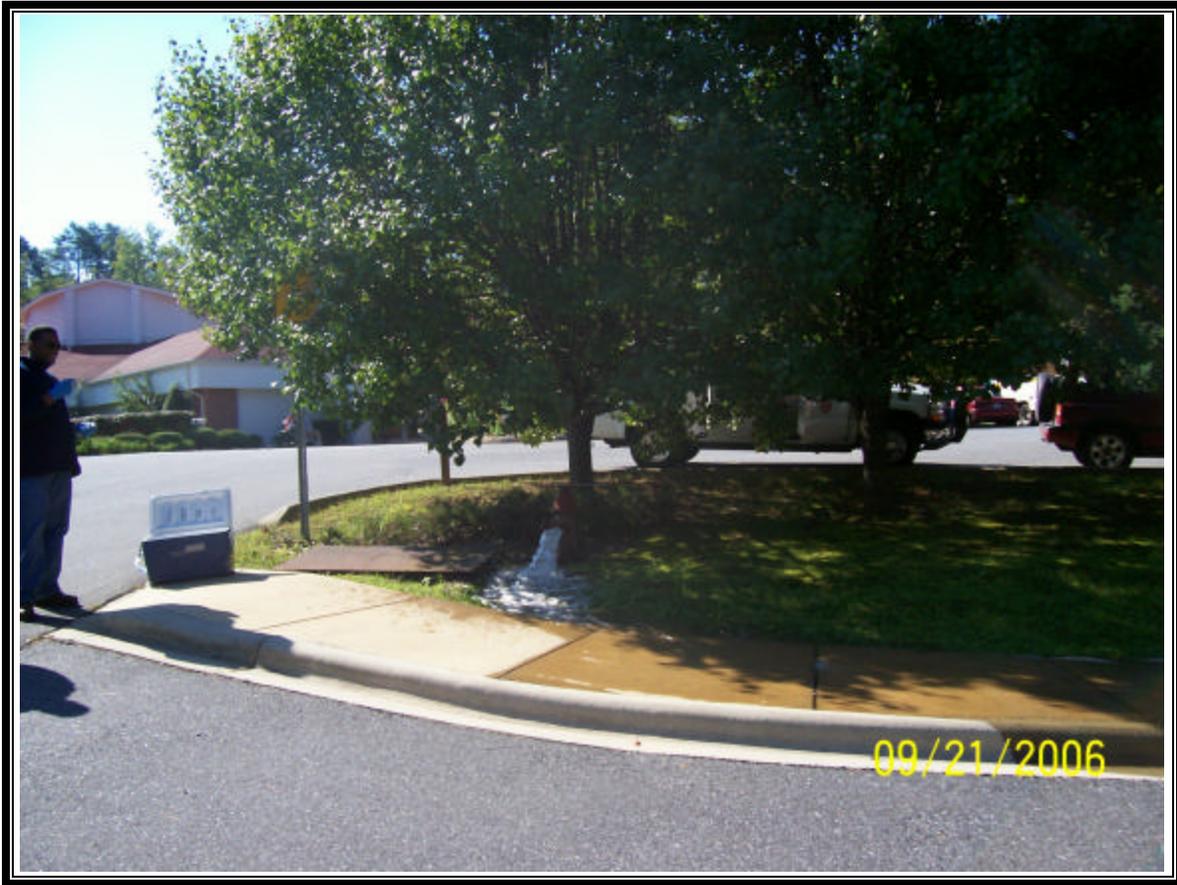
OFFICIAL PHOTOGRAPH NO. 4
U.S. ENVIRONMENTAL PROTECTION AGENCY

Subject: Sampling location CW-04 at the hydrant between the Tsali Care Center and the Tsali Dialysis Clinic ; this is a “priority location”

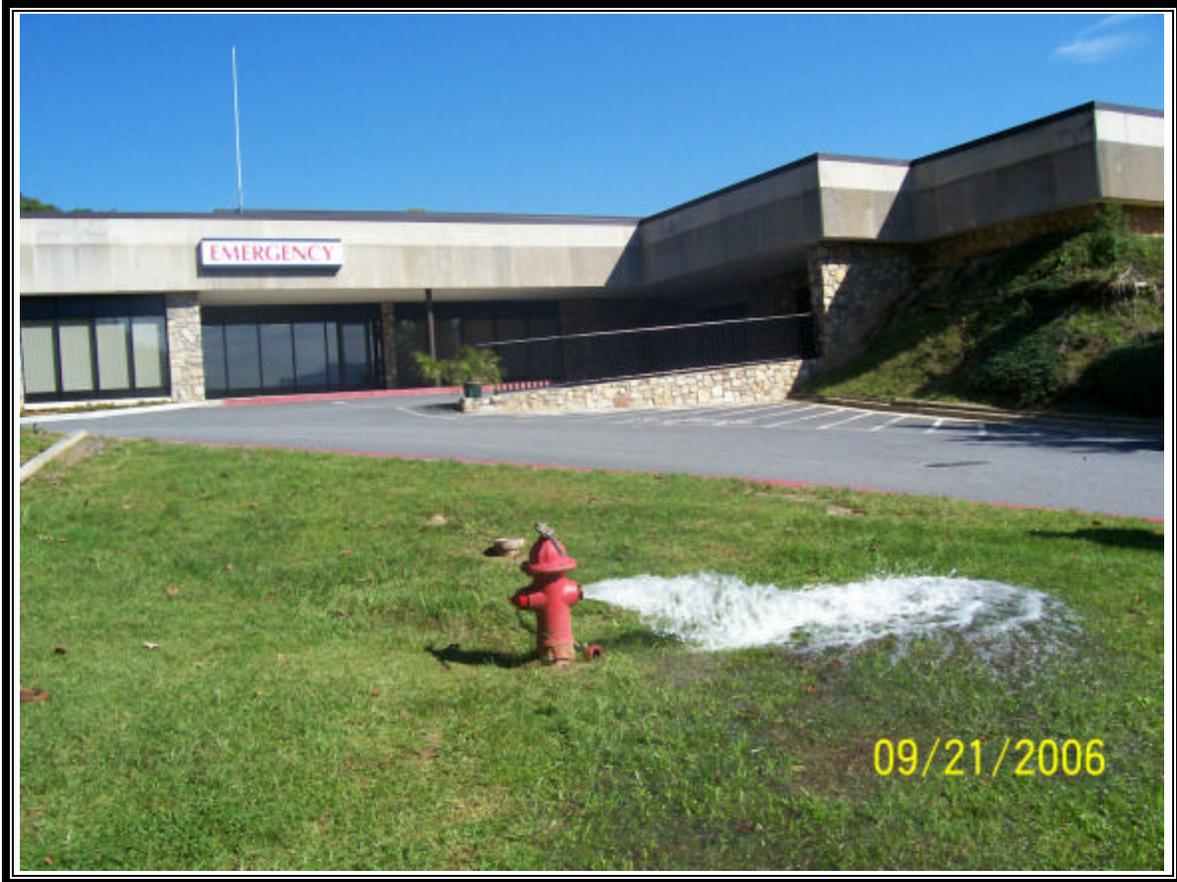
**OFFICIAL PHOTOGRAPH NO. 5
U.S. ENVIRONMENTAL PROTECTION AGENCY**

Subject: Sample location CW-05 at Cherokee Indian Hospital; the hospital has its own tank that is fed from the CWTP Hospital tank sampled at CW-01; this is a "priority location"

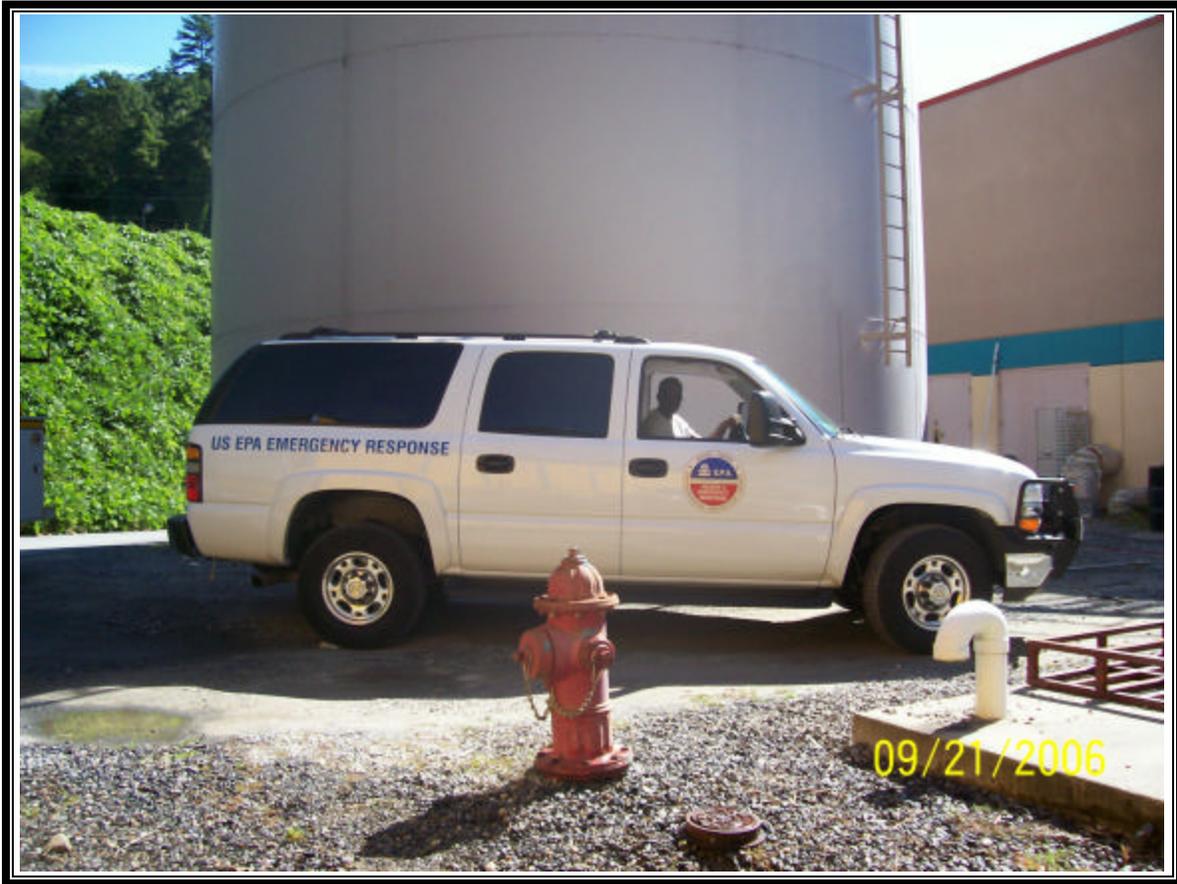
**OFFICIAL PHOTOGRAPH NO. 6
U.S. ENVIRONMENTAL PROTECTION AGENCY**

Subject: Sampling location CW-06 at Harrah's Casino; the hydrant is located at the northwest corner of the building; this is a "priority location."

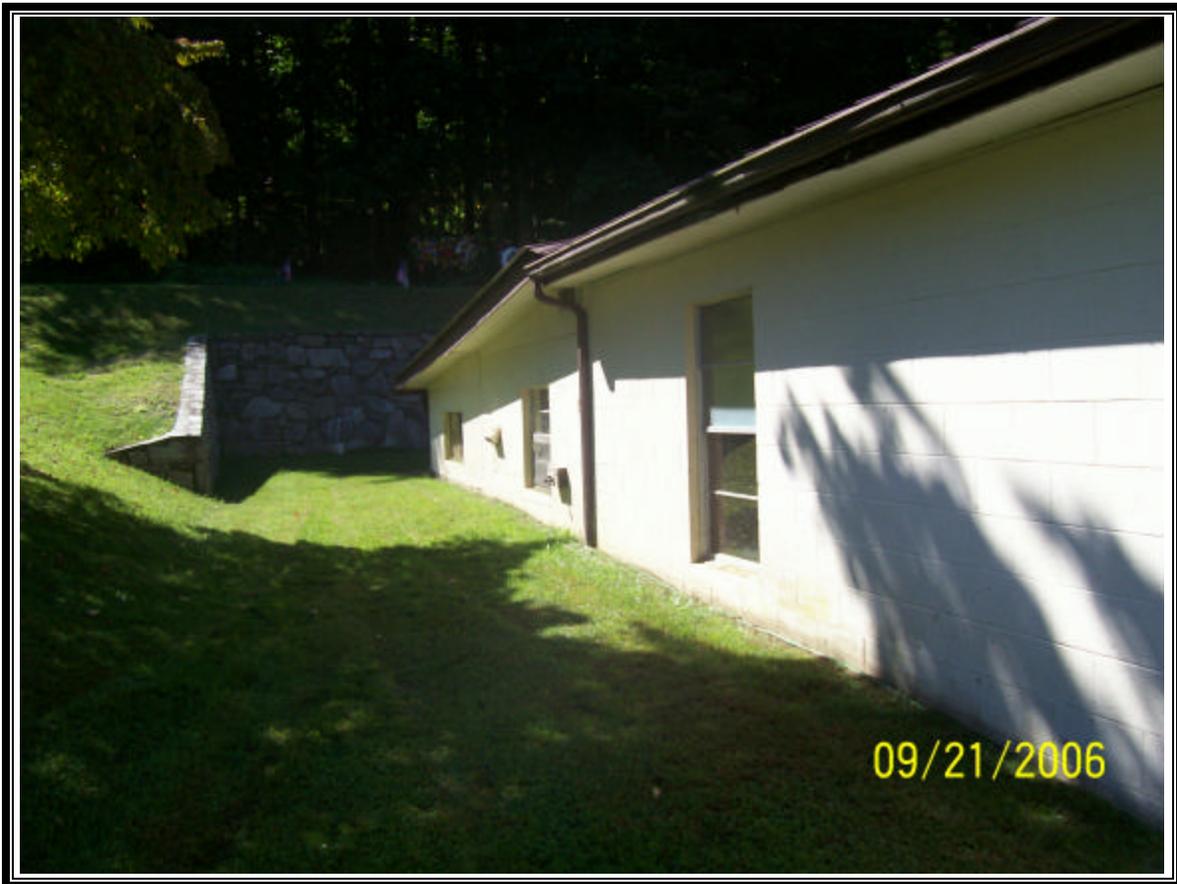
OFFICIAL PHOTOGRAPH NO. 7
U.S. ENVIRONMENTAL PROTECTION AGENCY

Subject: Sampling location CW-07 at the Church of God located at the intersection of Wolfetown Road and Church of God Drive; this is CWTP's normal testing site for the Pheasant Creek Tank located about 300 meters to the left in the photograph; the sample was collected from the spigot located in the middle on the side of the building.

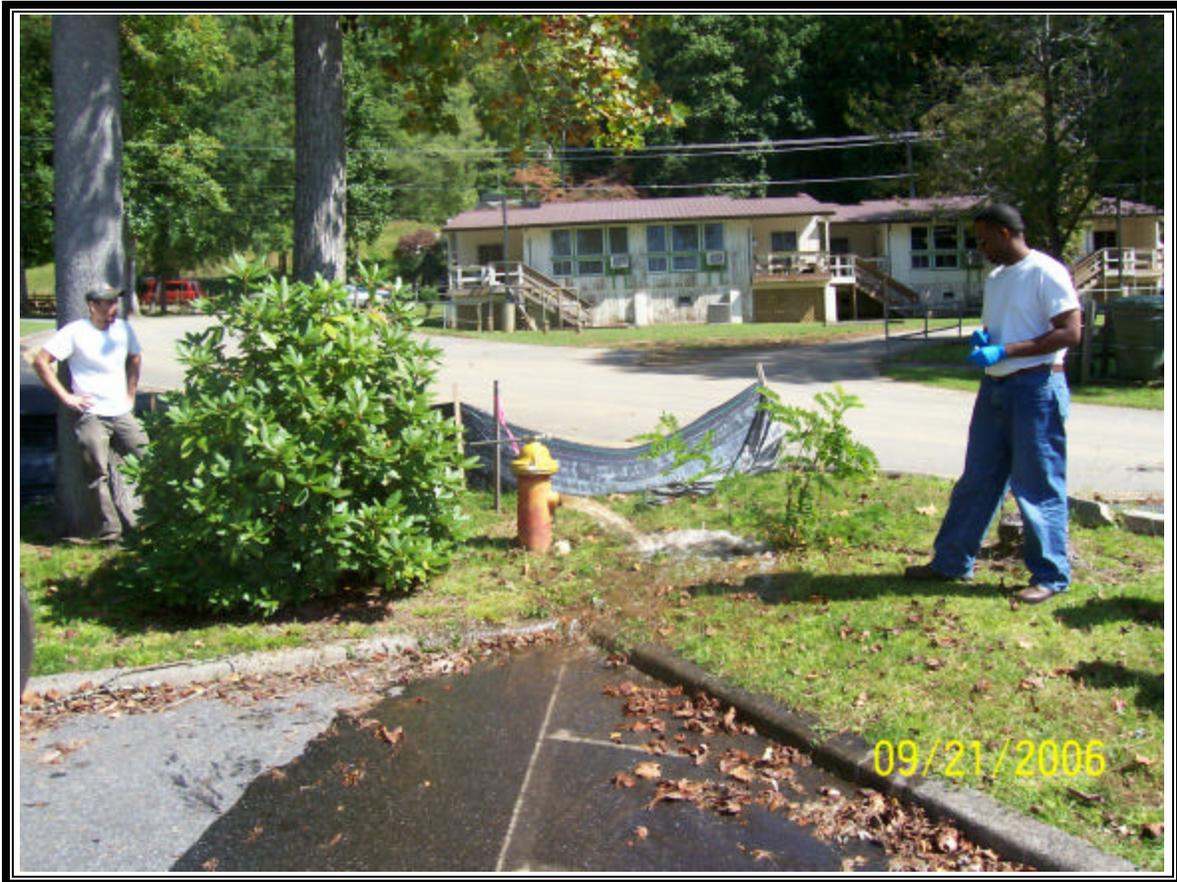
OFFICIAL PHOTOGRAPH NO. 8
U.S. ENVIRONMENTAL PROTECTION AGENCY

Subject: Sampling location CW-08 at Tsali Manor Nursing Home; this location is closest to the treatment facility, which is located 50 meters to the left (not shown in photograph).

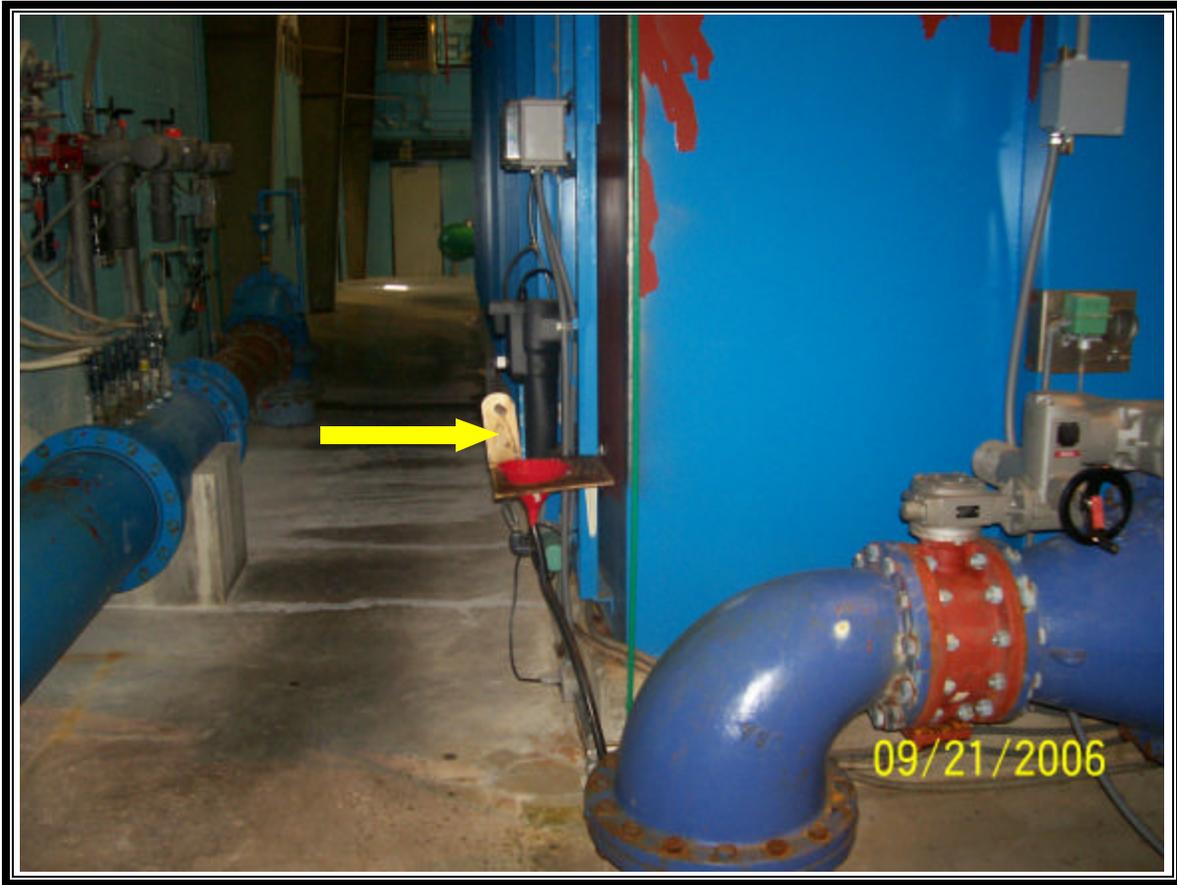
OFFICIAL PHOTOGRAPH NO. 9
U.S. ENVIRONMENTAL PROTECTION AGENCY

Subject: Sampling location CW-09 at CWTP Filter 1; the sample was collected from a constantly-running flow indicated by the arrow.

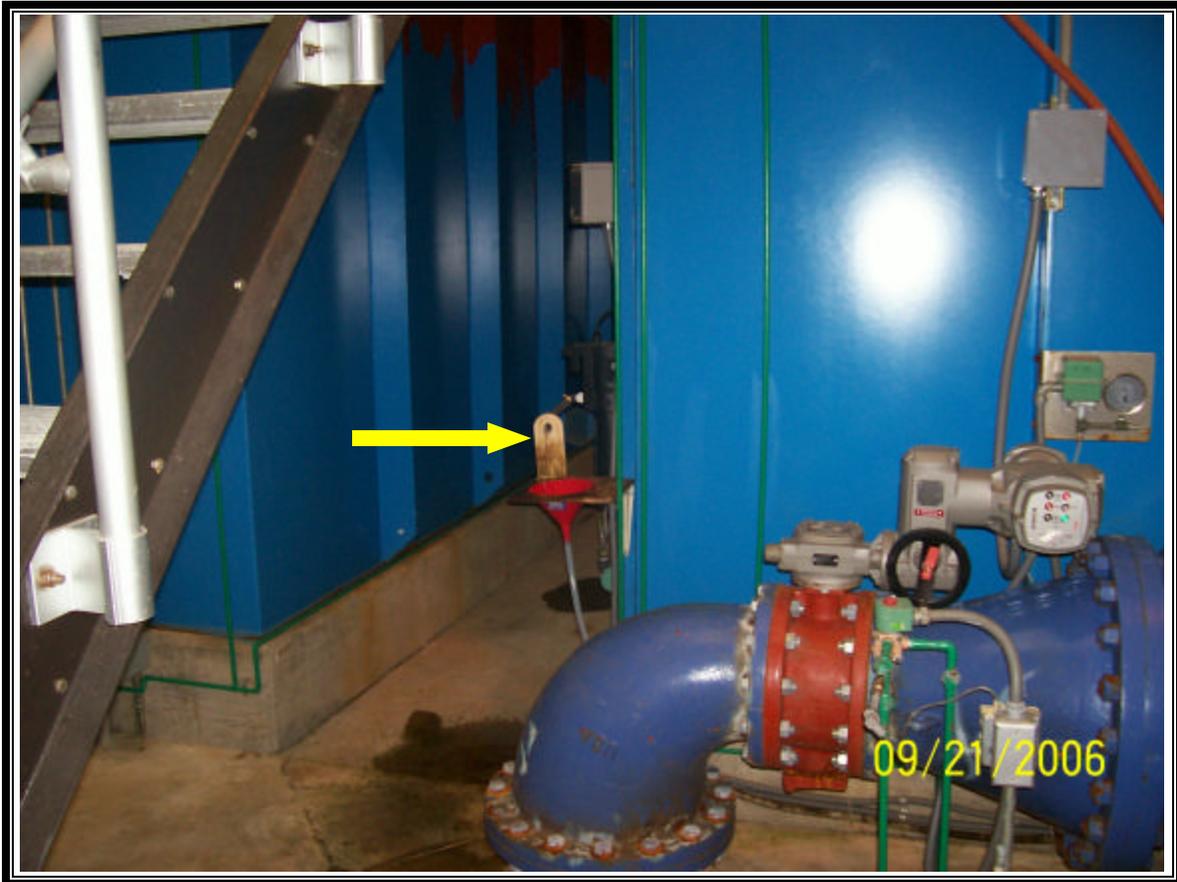
OFFICIAL PHOTOGRAPH NO. 10
U.S. ENVIRONMENTAL PROTECTION AGENCY

Subject: Sampling location CW-10 at CWTP Filter 2; the sample was collected from a constantly-running flow indicated by the arrow.

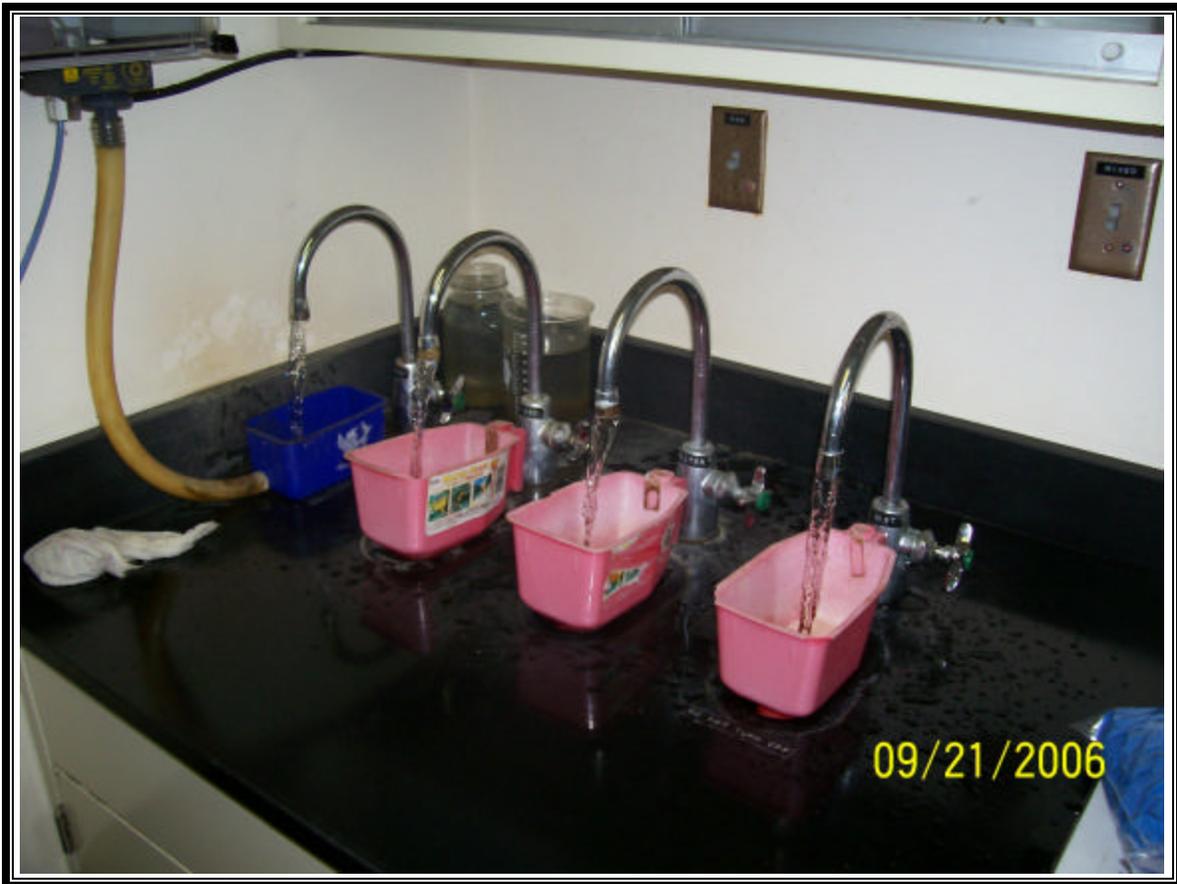
OFFICIAL PHOTOGRAPH NO. 11
U.S. ENVIRONMENTAL PROTECTION AGENCY

Subject: Sampling locations CW-11, Raw Water Intake, CW-12, Distribution, and CW-13, Clear Well, in the CWTP laboratory; the plant pumps water from the system into the laboratory to allow technicians to easily and quickly sample the water.

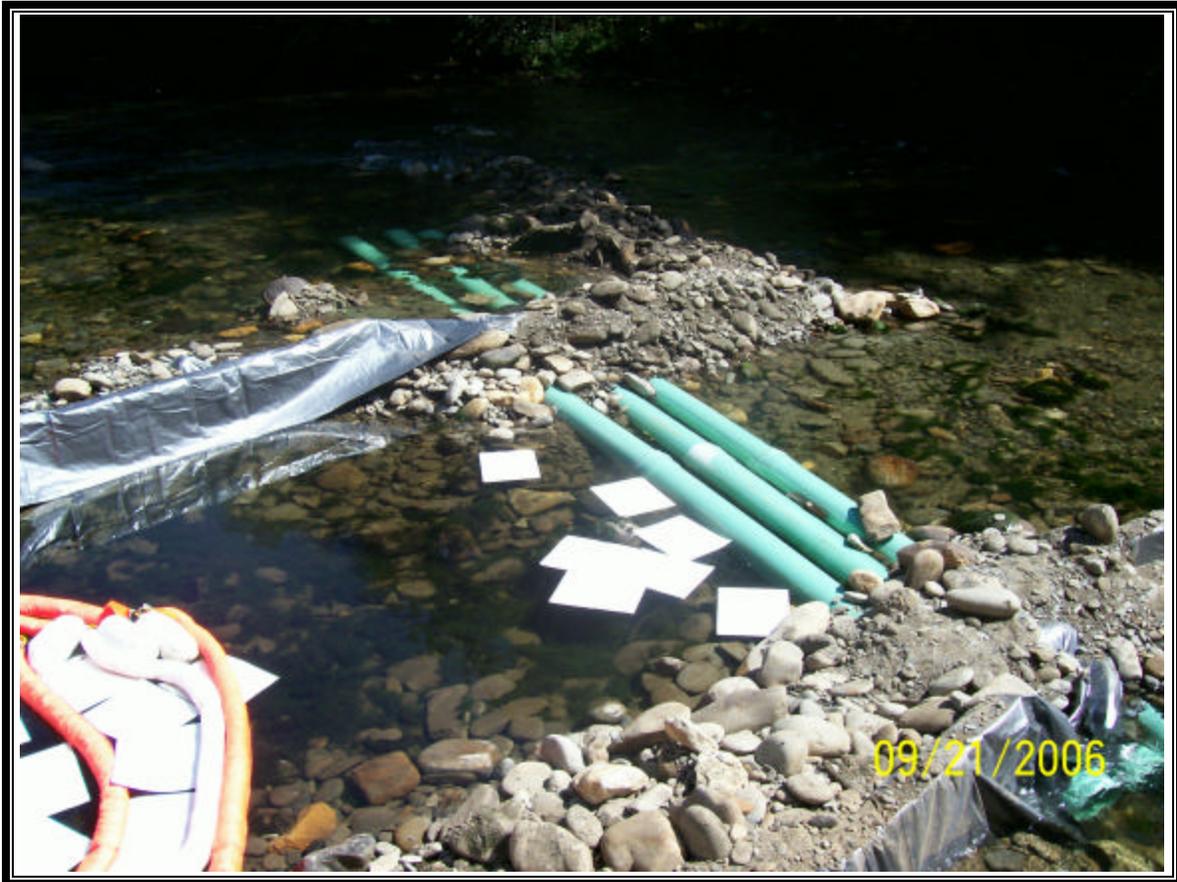
OFFICIAL PHOTOGRAPH NO. 12
U.S. ENVIRONMENTAL PROTECTION AGENCY

Subject: Diversionary dams created by EBCI crews during the night in order to divert sheen escaping from the boom and absorbent pads out into the river channel away from the intake which is located directly beneath the photographer.

Through the early morning on September 21, 2006, CWTP crews built a diversionary dam to prevent additional petroleum from entering the intake once it was turned back on. An excavator was used to place concrete road barriers in the river, and additional river rock was piled up to create walls both upstream and downstream of the release point, with the downstream wall between the release point and the intake. Three 12-inch-diameter drainage pipes were run under the walls from the intake to point upstream of the release. CWTP also placed boom and absorbent pads around the release point to collect petroleum as it escaped from the bank. The diversionary dams then channeled the remaining sheen out into the main channel flow away from the intake. Absorbent boom was placed in front of the intake to catch any residual sheen that may have passed the other barriers.

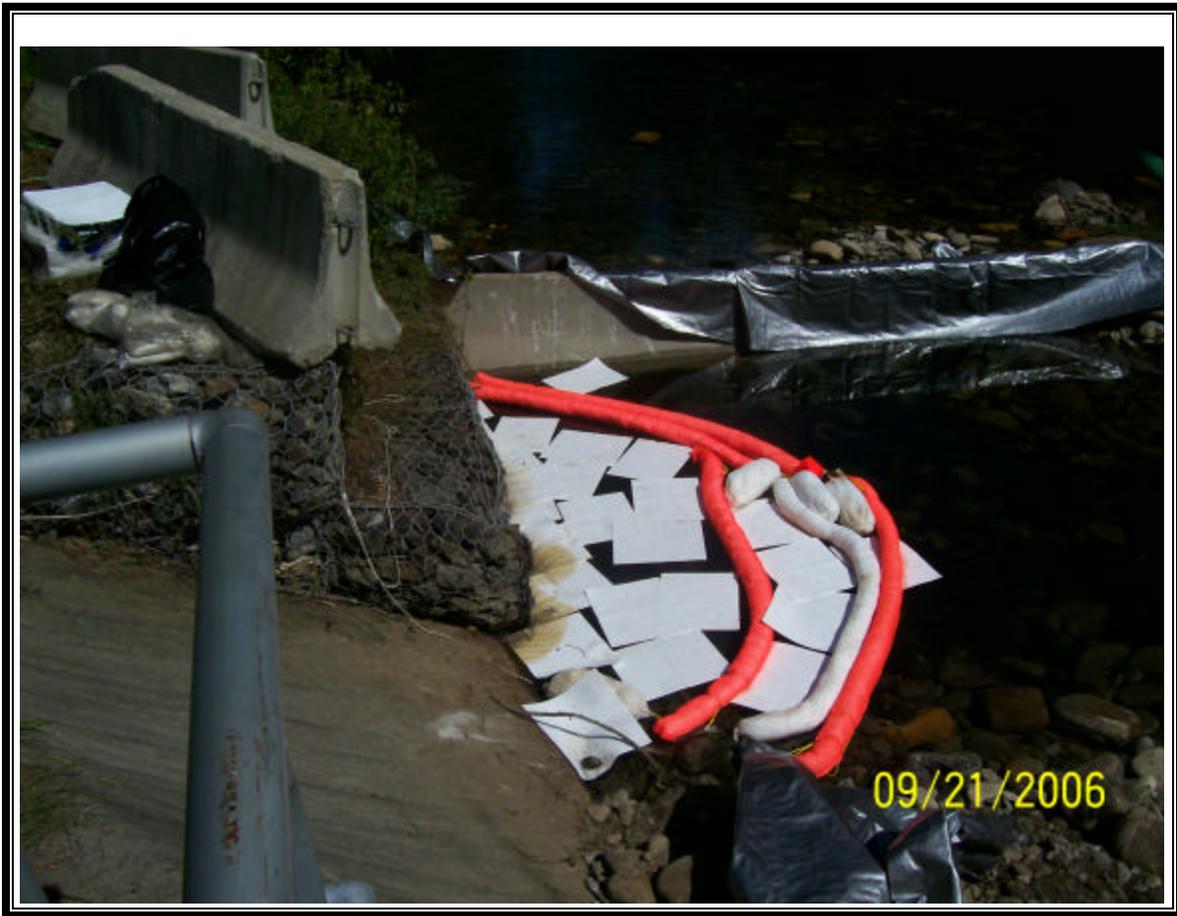
**OFFICIAL PHOTOGRAPH NO. 13
U.S. ENVIRONMENTAL PROTECTION AGENCY**

Subject: Boom deployed at the release point: note stains on white absorbent pads.

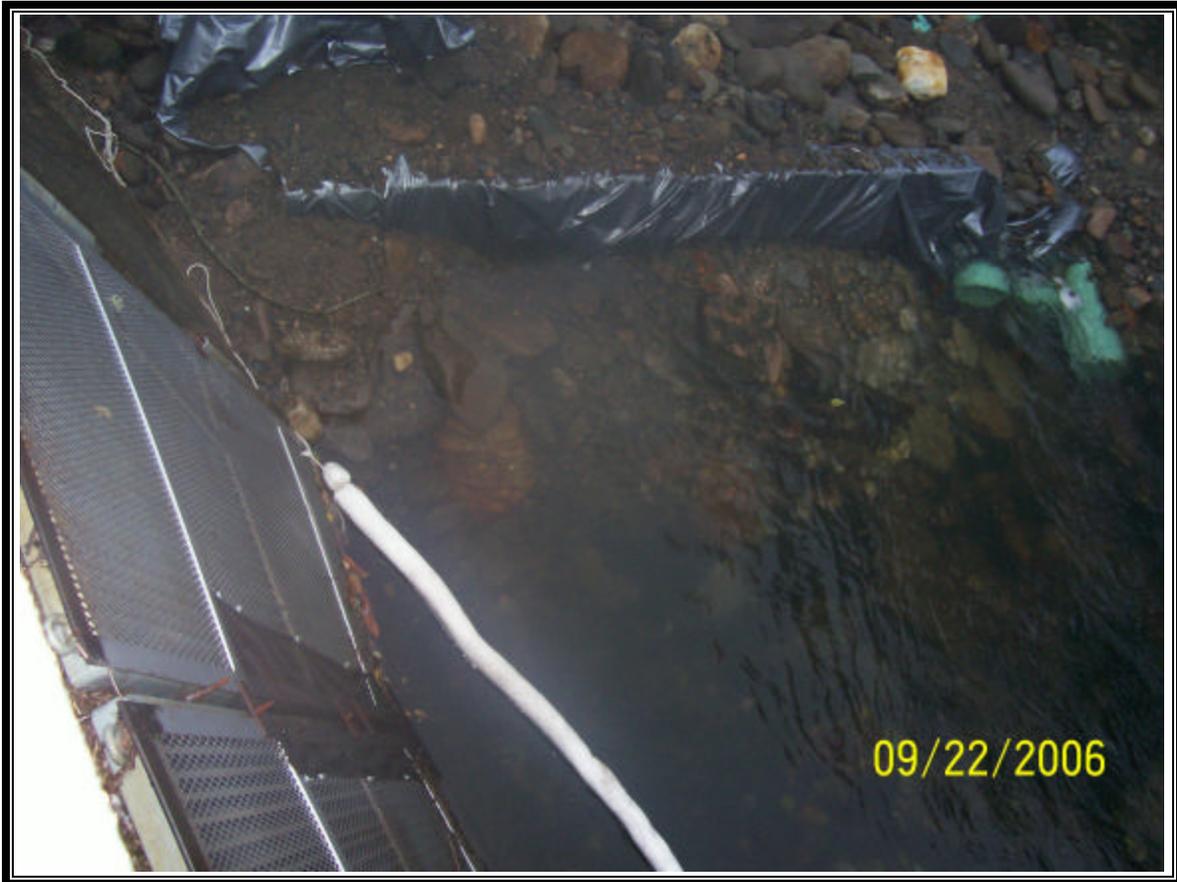
**OFFICIAL PHOTOGRAPH NO. 14
U.S. ENVIRONMENTAL PROTECTION AGENCY**

Subject: Vertical view of the intake grating.
