**Subject: Final Comprehensive Environmental Response, Compensation, and Liability Act
(CERCLA) Emergency Response Action Report
Cherokee NC Boundary Tree UST Release
Cherokee, Swain County, North Carolina
EPA Contract No. EP-W-05-054
TDD No. TTEMI-05-002-0002**

**FINAL CERCLA EMERGENCY RESPONSE ACTION REPORT
CHEROKEE NC BOUNDARY TREE UST RELEASE
CHEROKEE, SWAIN COUNTY, NORTH CAROLINA
EPA CONTRACT NO. EP-W-05-054
TDD NO. TTEMI-05-002-0002**

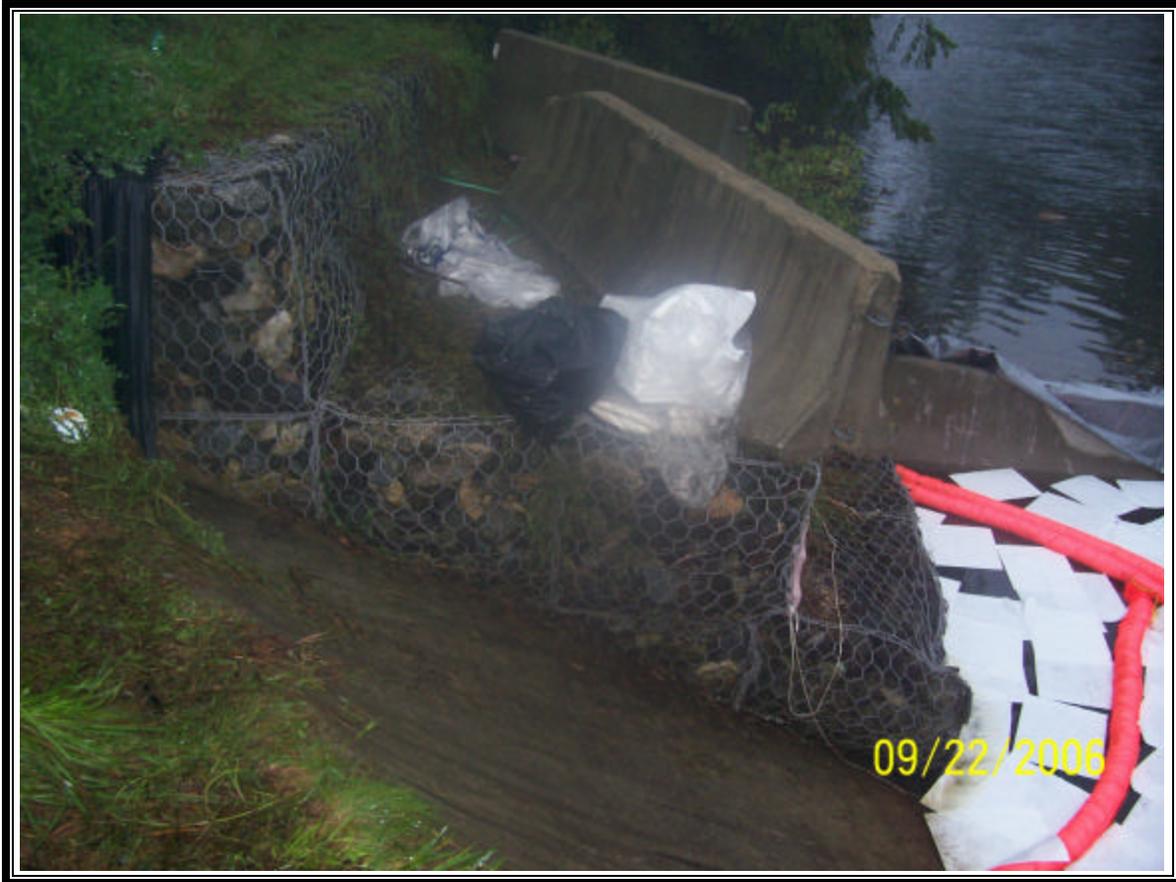
OFFICIAL PHOTOGRAPH NO. 15
U.S. ENVIRONMENTAL PROTECTION AGENCY

Subject: Release point on the Oconaluftee River; note the porosity of the fill material and the staining on the absorbent pads just behind the date stamp.

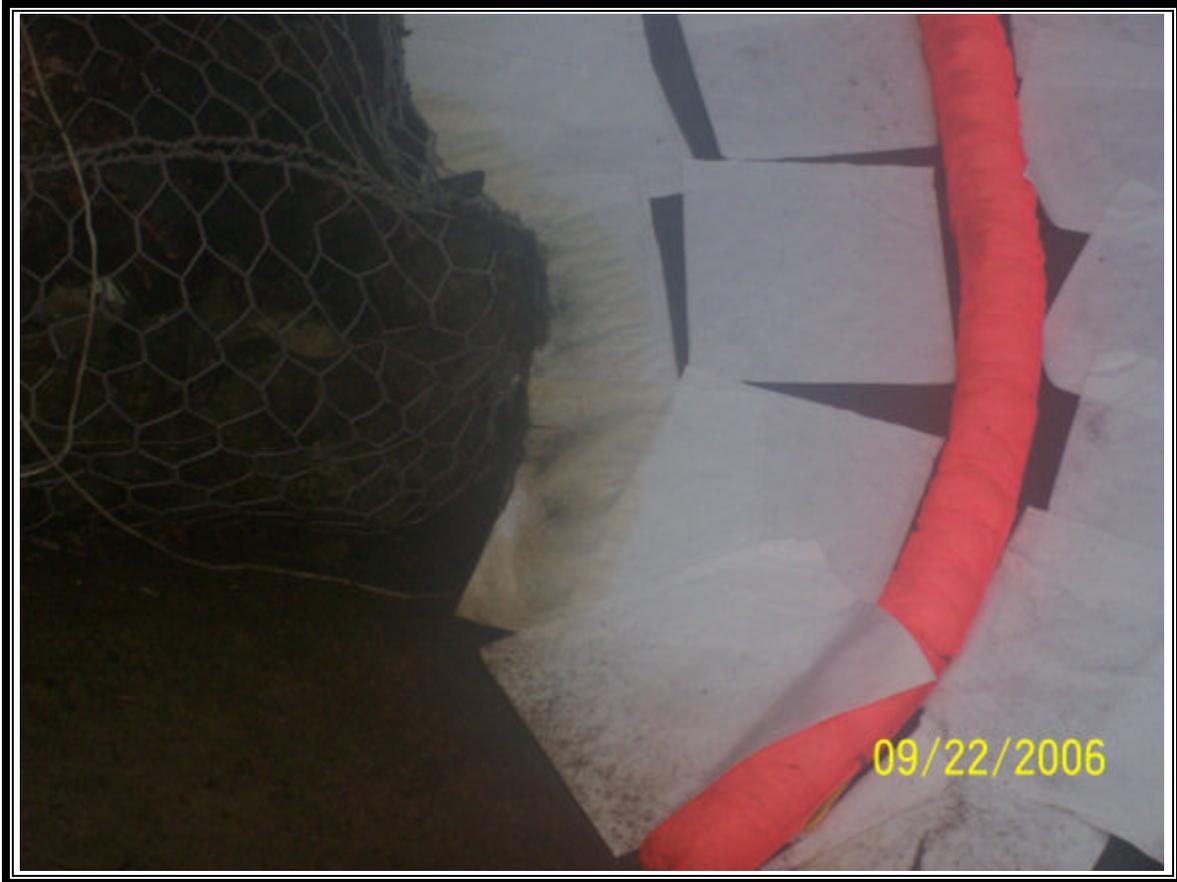
**OFFICIAL PHOTOGRAPH NO. 16
U.S. ENVIRONMENTAL PROTECTION AGENCY**

Subject: Close-up of the staining on the absorbent pads at the release point.

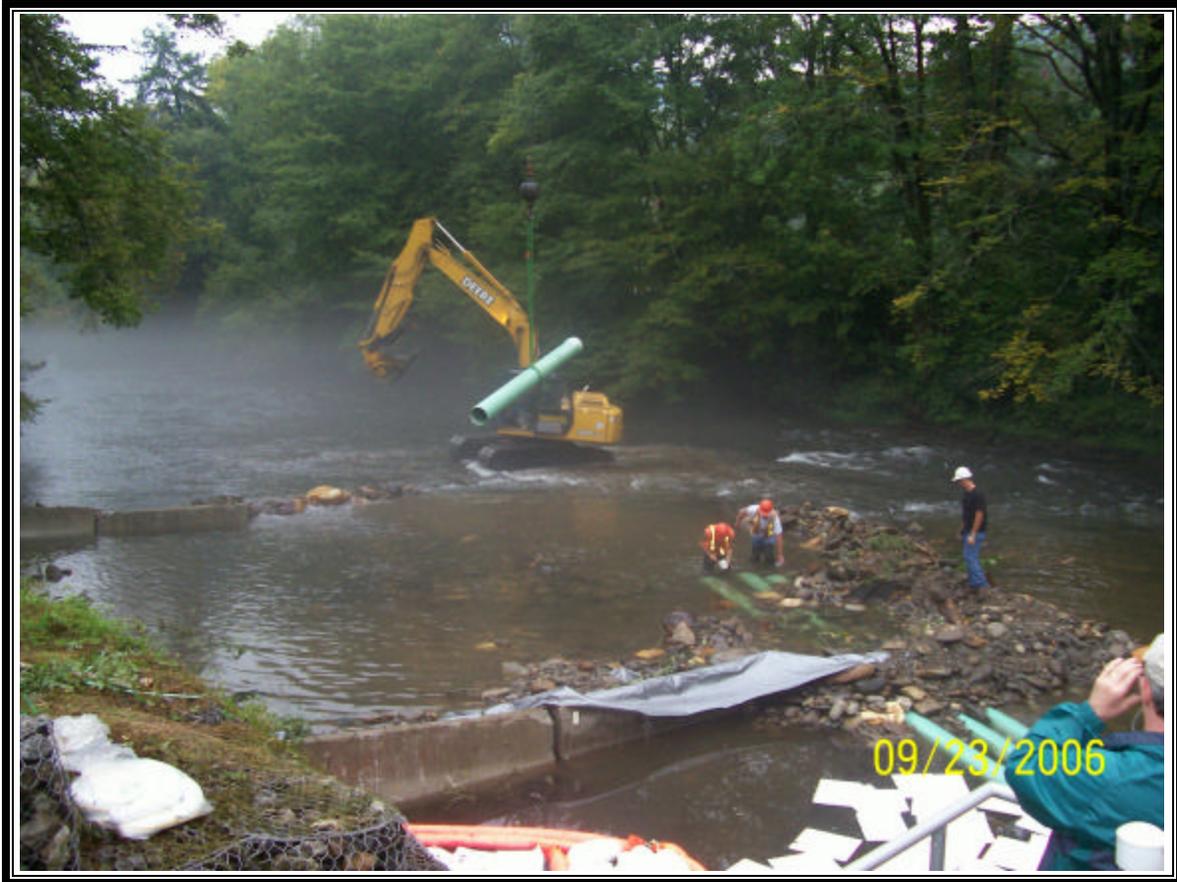
OFFICIAL PHOTOGRAPH NO. 17
U.S. ENVIRONMENTAL PROTECTION AGENCY

Subject: Neo Corporation extending diversionary piping and reinforcing the existing dam system.

A late-afternoon meeting was held at the CWTP with EPA, CWTP, OENR, Peak, Tetra Tech START, and EBCI council members. Peak agreed to reinforce the diversionary dam and begin removing the product from the groundwater. Neo Corporation from Waynesville, North Carolina, was employed and was expected to be on-site the next morning.

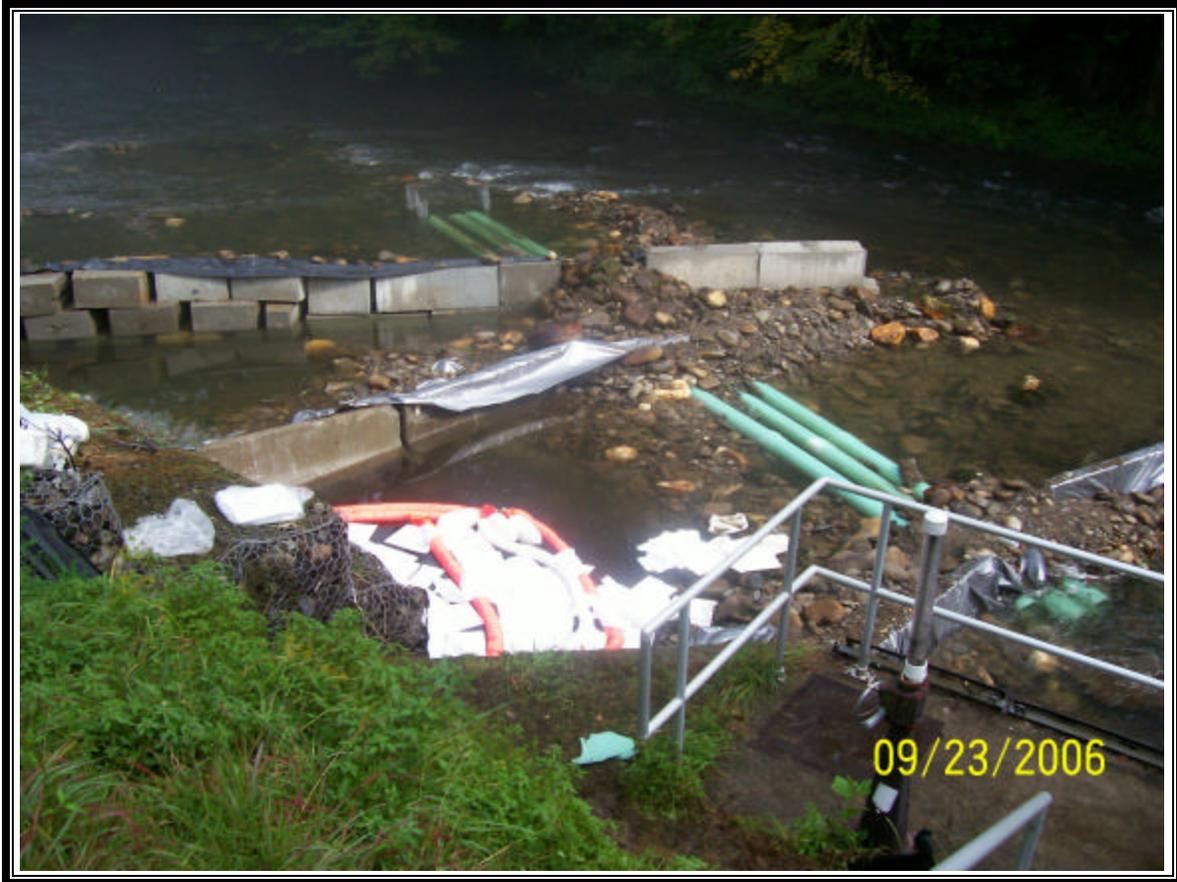
**OFFICIAL PHOTOGRAPH NO. 18
U.S. ENVIRONMENTAL PROTECTION AGENCY**

Subject: New diversionary piping and reinforced dam constructed by Neo Corporation at Peak Energy's request.

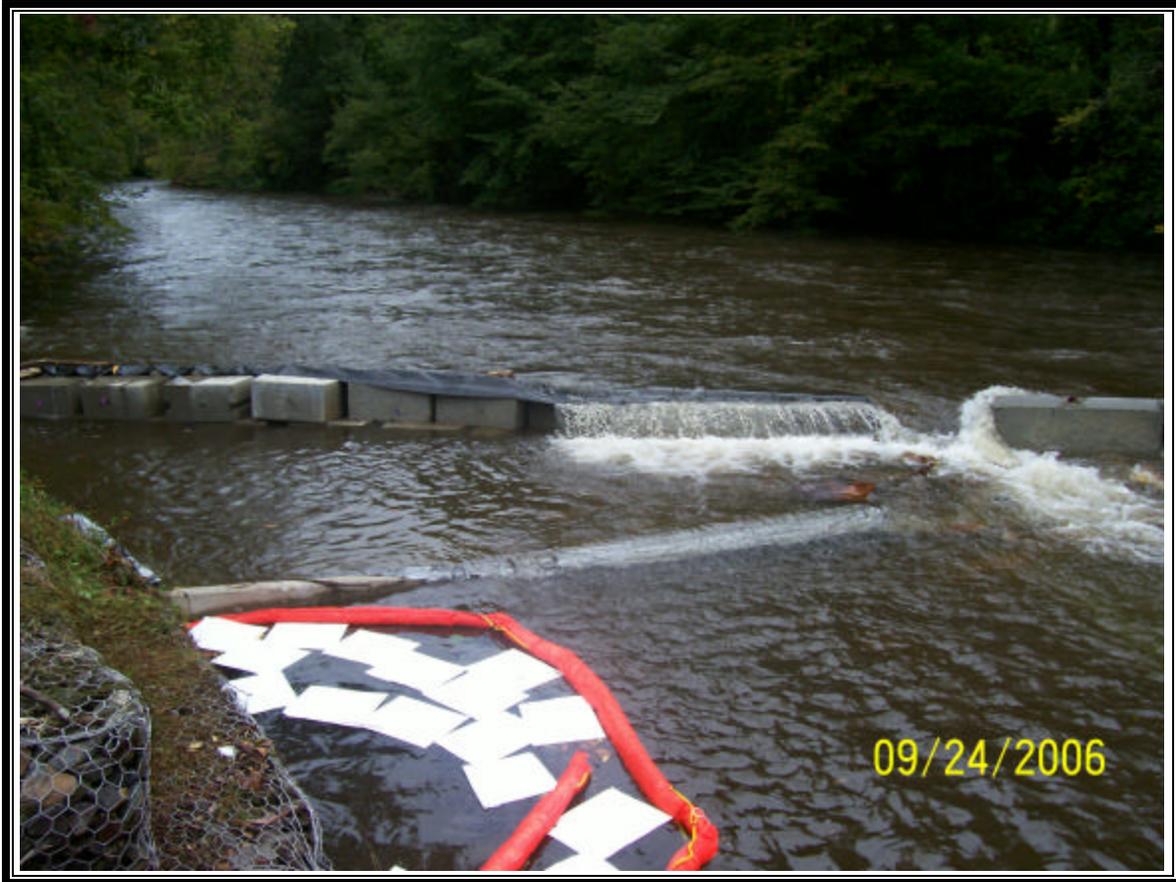
OFFICIAL PHOTOGRAPH NO. 19
U.S. ENVIRONMENTAL PROTECTION AGENCY

Heavy rains overnight on September 23, 2006, overflowed the dam, prompting EBCI officials to turn the pumps off again on the morning of September 24, 2006. Because of a fear of water pressure loss, a total usage ban was issued. An assessment of the release point and diversionary dam was conducted, and no sheen or petroleum was observed. Tribal officials restarted the water intake later in the day. The ban remained in effect until the water pressure was restored and the threat of bacterial growth was abated. Tribal leaders also decided to bypass the existing water intake. Two 12-inch diameter pumps were installed that fed upstream water directly into the pump house.

Subject: After heavy rains the previous evening, the dam was overflowing and damaged; the boom and pads shown here are replacements for the ones washed downriver the night before.

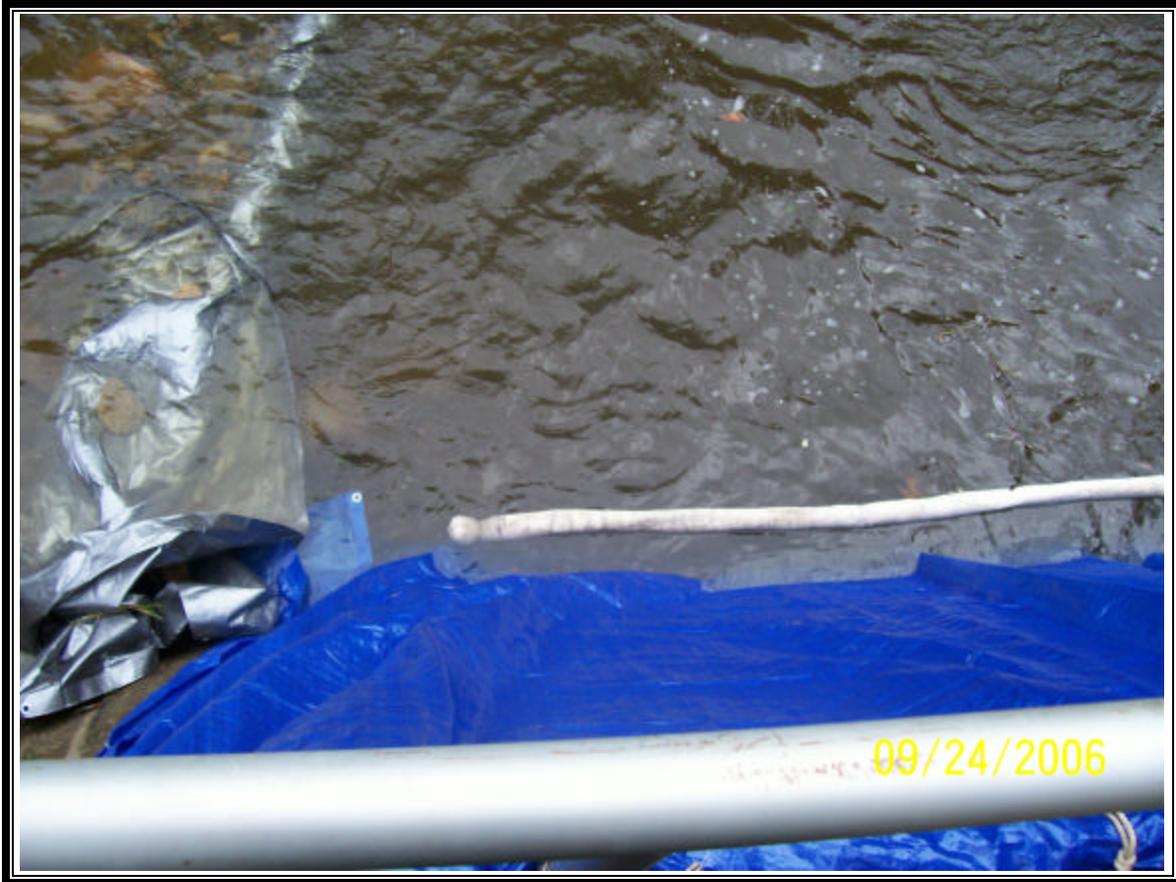
**OFFICIAL PHOTOGRAPH NO. 20
U.S. ENVIRONMENTAL PROTECTION AGENCY**

Subject: Vertical view of the tarpaulin acting as a diversionary dam across the intake grating; the tarp was put in place after heavy rains overflowed the diversionary dam and washed the boom and absorbent pads downriver.

night's incidents and returned to the intake. An assessment of the release point and surrounding area was made, and no visible contamination or sheen was observed. A tarpaulin was placed across the top portion of the intake grate, creating an underflow dam, and the intake pumps were turned back on at 1:00 p.m. Because the water level of the river was so high, no modifications or repairs to the dam were attempted. The "Do Not Use" ban remained in effect until the following morning to allow the system to re-pressurize.

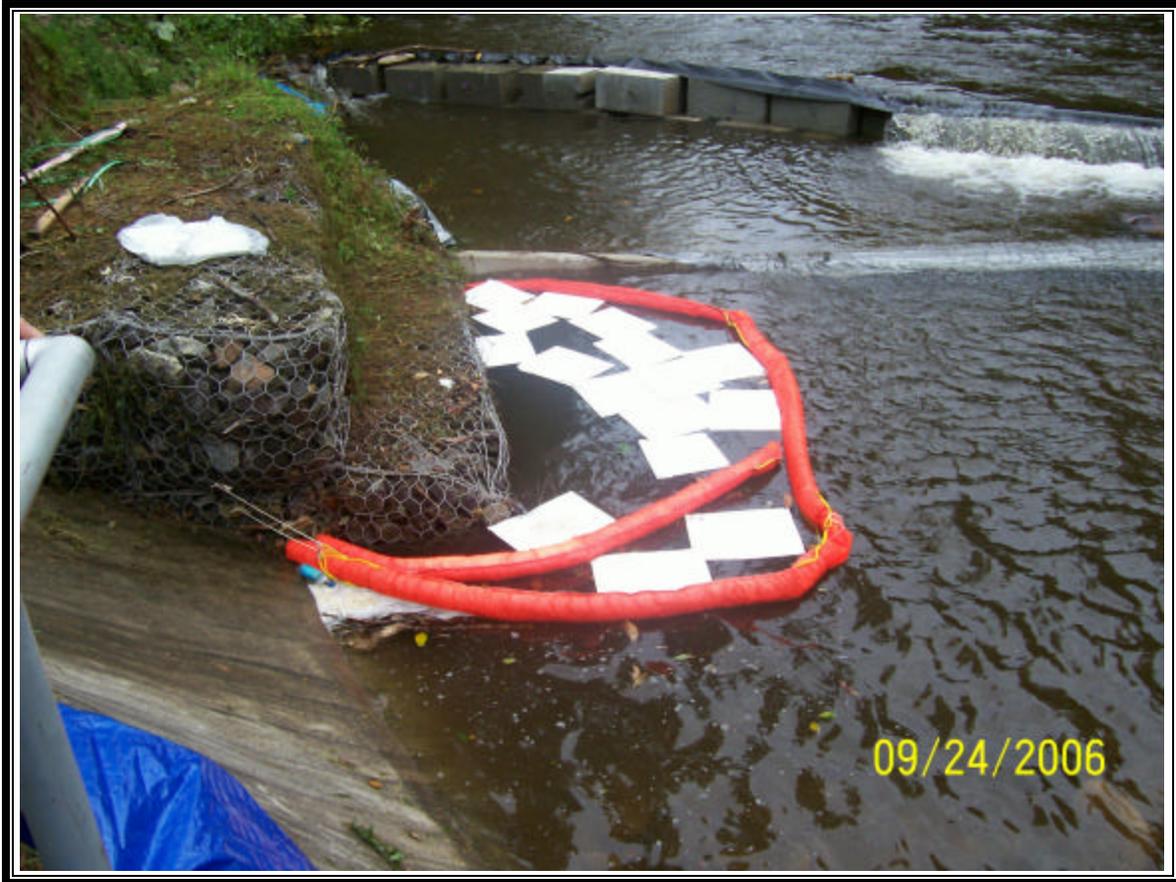
**OFFICIAL PHOTOGRAPH NO. 21
U.S. ENVIRONMENTAL PROTECTION AGENCY**

Subject: New booms and absorbent pads placed after heavy rains washed the original boom and absorbent pads downstream.

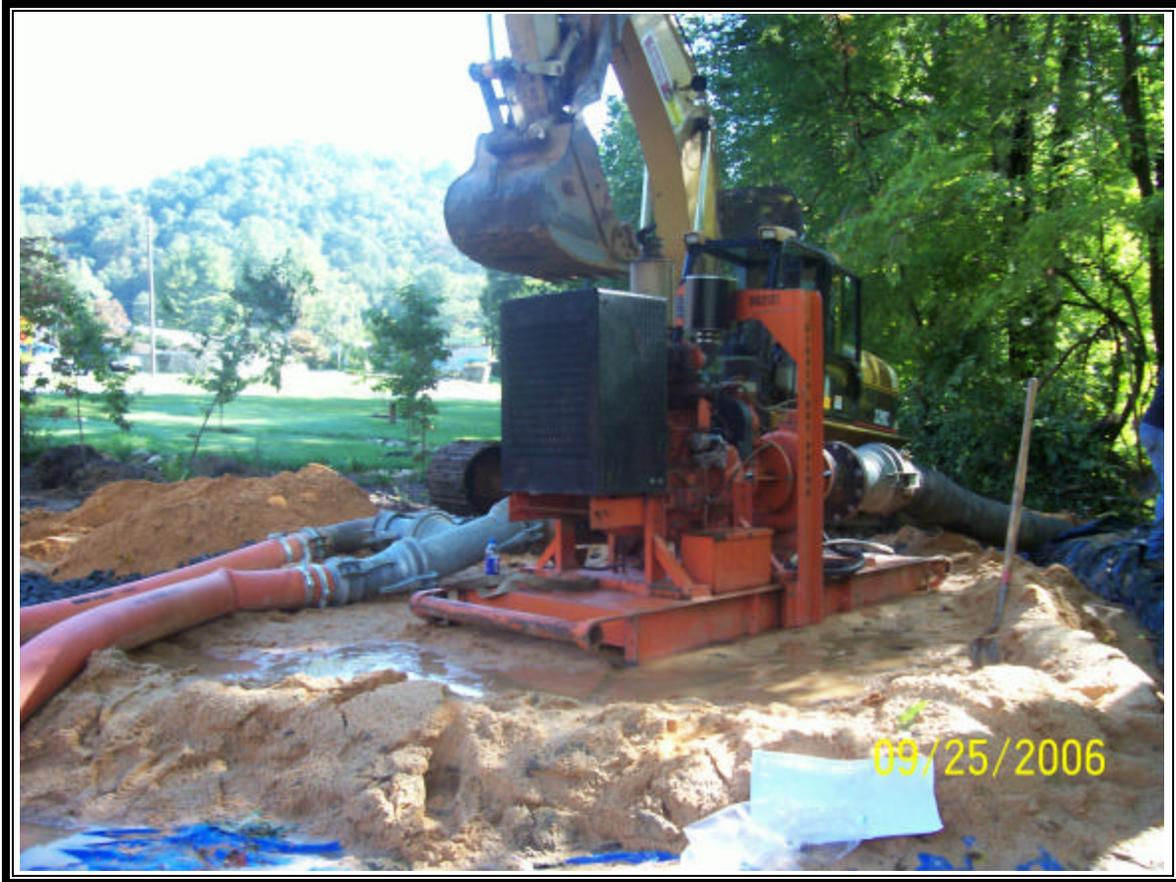
OFFICIAL PHOTOGRAPH NO. 22
U.S. ENVIRONMENTAL PROTECTION AGENCY

Subject: 12-inch diameter pumps being emplaced by EBCI to withdraw water from upstream of the release point.

- CBOC will replace new temp pumps just upstream of the spill & another further upstream on the other side of the ~~river~~ river. These pumps will supply water ~~upstream~~ ^{from} upstream directly into the pump house.

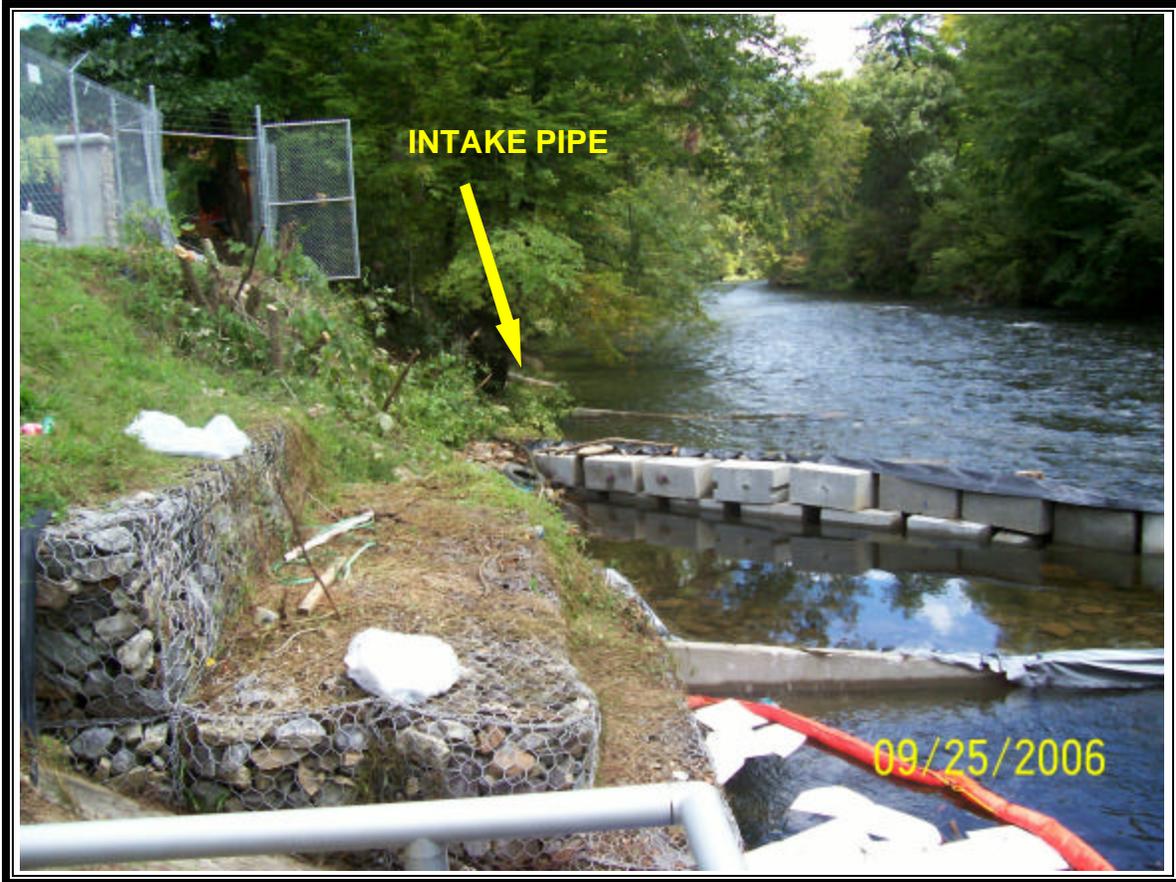
**OFFICIAL PHOTOGRAPH NO. 23
U.S. ENVIRONMENTAL PROTECTION AGENCY**

Subject: Relation of new intake piping to the release point; the arrow points to the barely-discernable pipe running downhill into the water upstream of the release point.

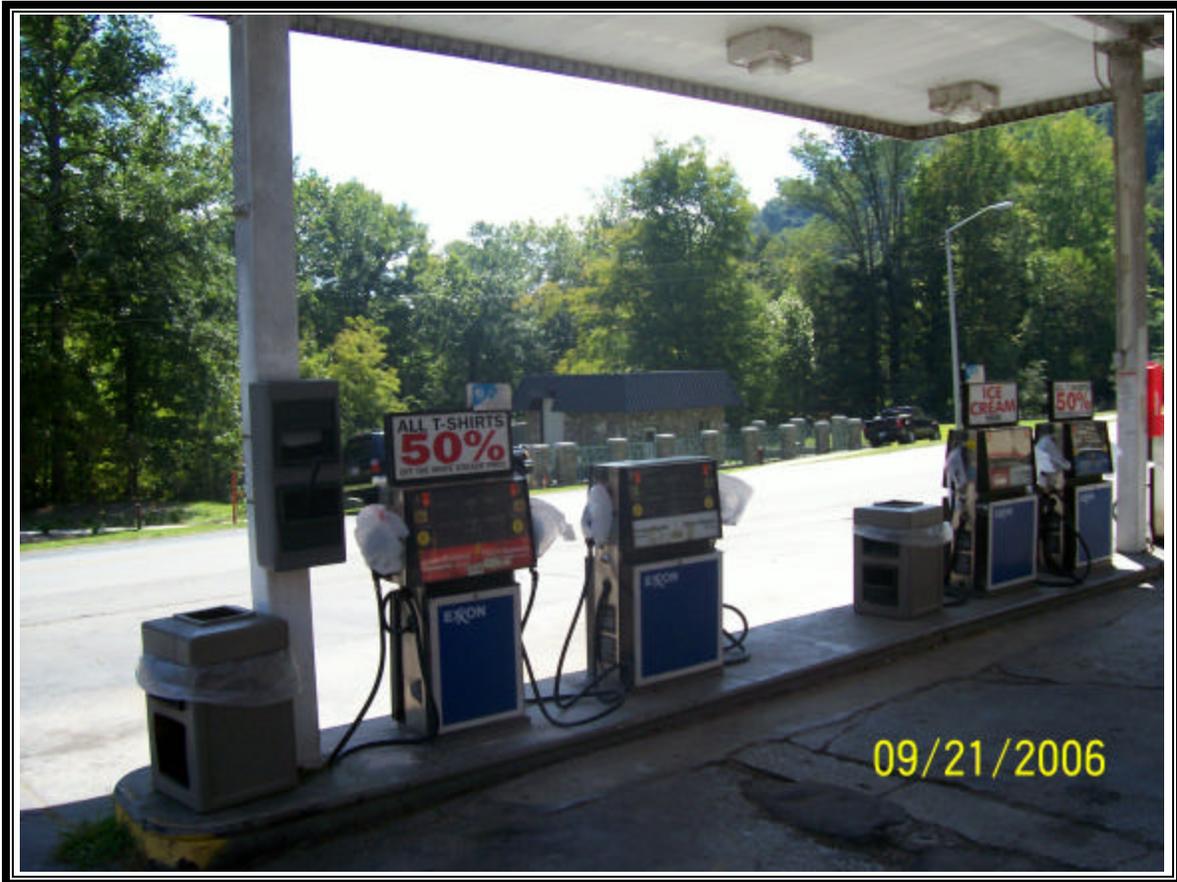
**OFFICIAL PHOTOGRAPH NO. 24
U.S. ENVIRONMENTAL PROTECTION AGENCY**

The cause of the release was determined to be groundwater contamination from the Golden Eagle gas station across the street from the water intake. The owner of the station, Peak, examined the USTs and piping, which at first passed the tests but subsequently failed static pressure tests. Groundwater contamination was previously remediated at the Golden Eagle in the late 1990s. Six monitoring wells in the gas station area were examined, and two were found to contain free product. Peak hired Neo Corporation to begin remediation efforts, starting with reinforcement of the existing diversionary dam. A vacuum truck was used to remove free product from the monitoring wells.

Subject: Orientation of the Golden Eagle Exxon station to the pumphouse in the background; the USTs are buried at the right side of the photograph.

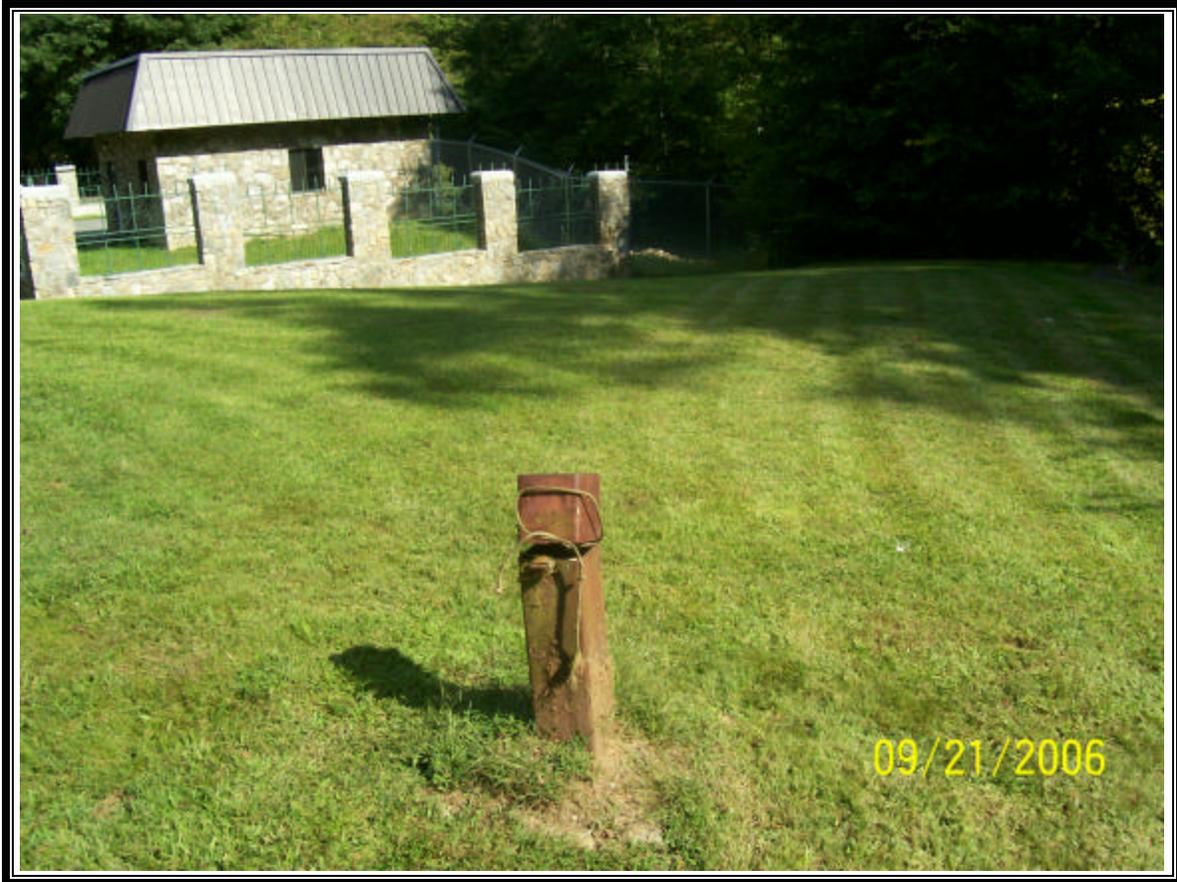
OFFICIAL PHOTOGRAPH NO. 25
U.S. ENVIRONMENTAL PROTECTION AGENCY

Subject: Monitoring well MW-1; the pumphouse is in the background and the Golden Eagle Exxon station is to the left.

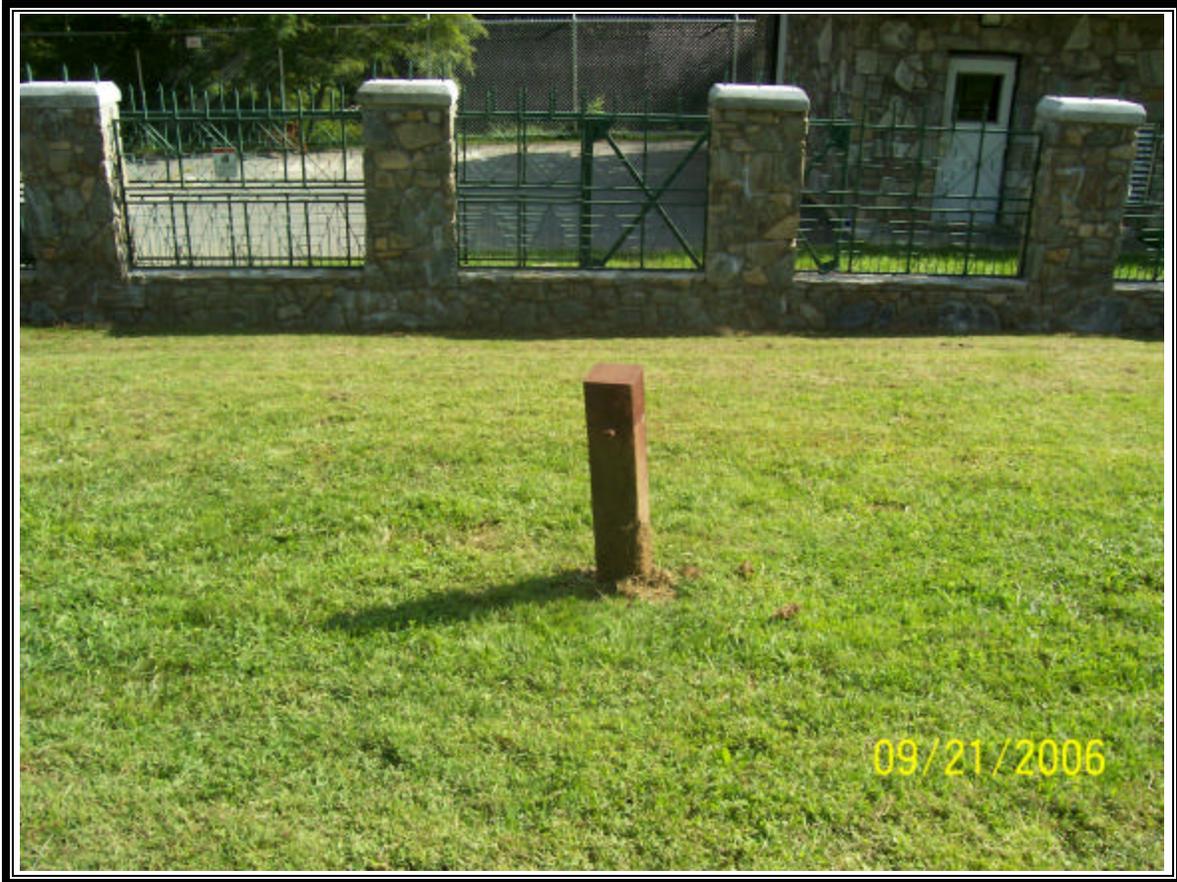
OFFICIAL PHOTOGRAPH NO. 26
U.S. ENVIRONMENTAL PROTECTION AGENCY

Subject: Monitoring well MW-2; the release point is directly ahead on the river, and the Golden Eagle Exxon station is directly behind the photographer.

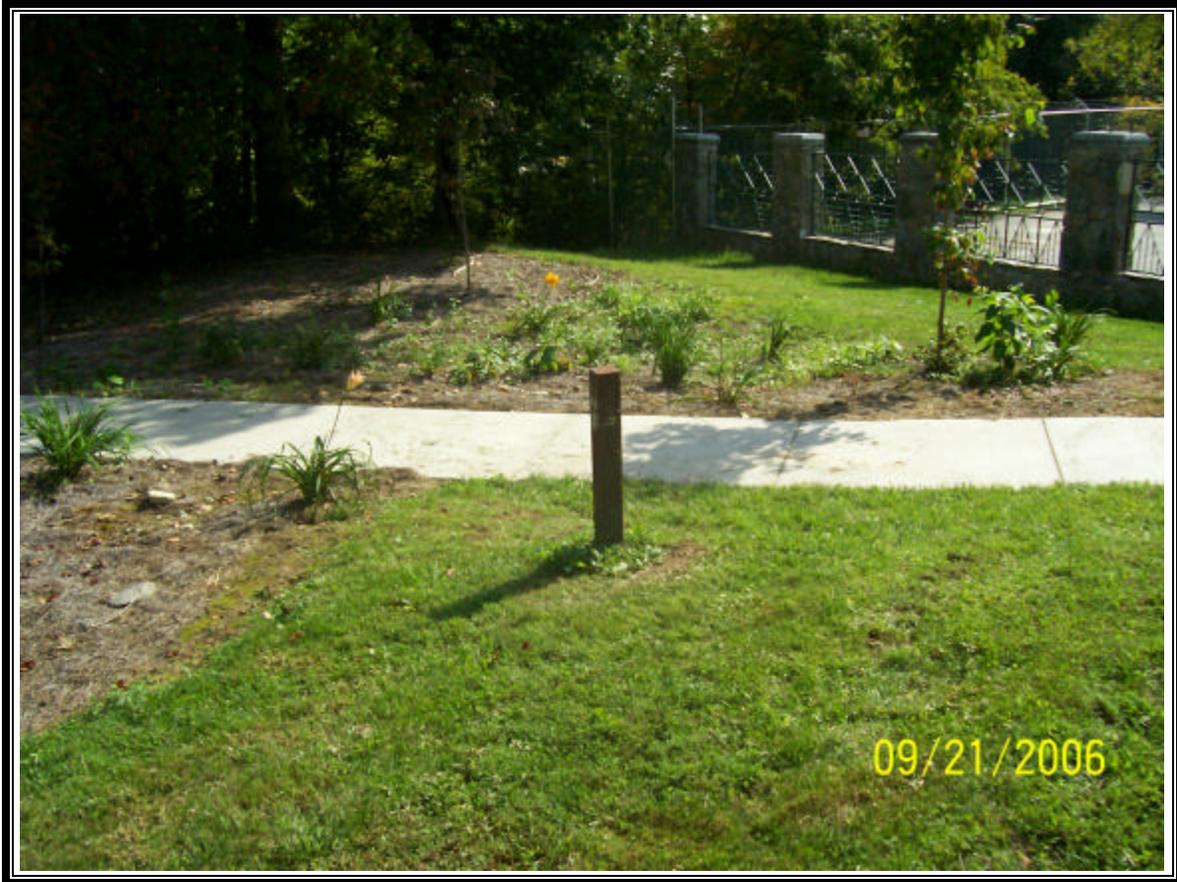
OFFICIAL PHOTOGRAPH NO. 27
U.S. ENVIRONMENTAL PROTECTION AGENCY

Subject: Monitoring well MW-3; the release point is directly ahead on the river, and the Golden Eagle Exxon station is to the right of the photographer.

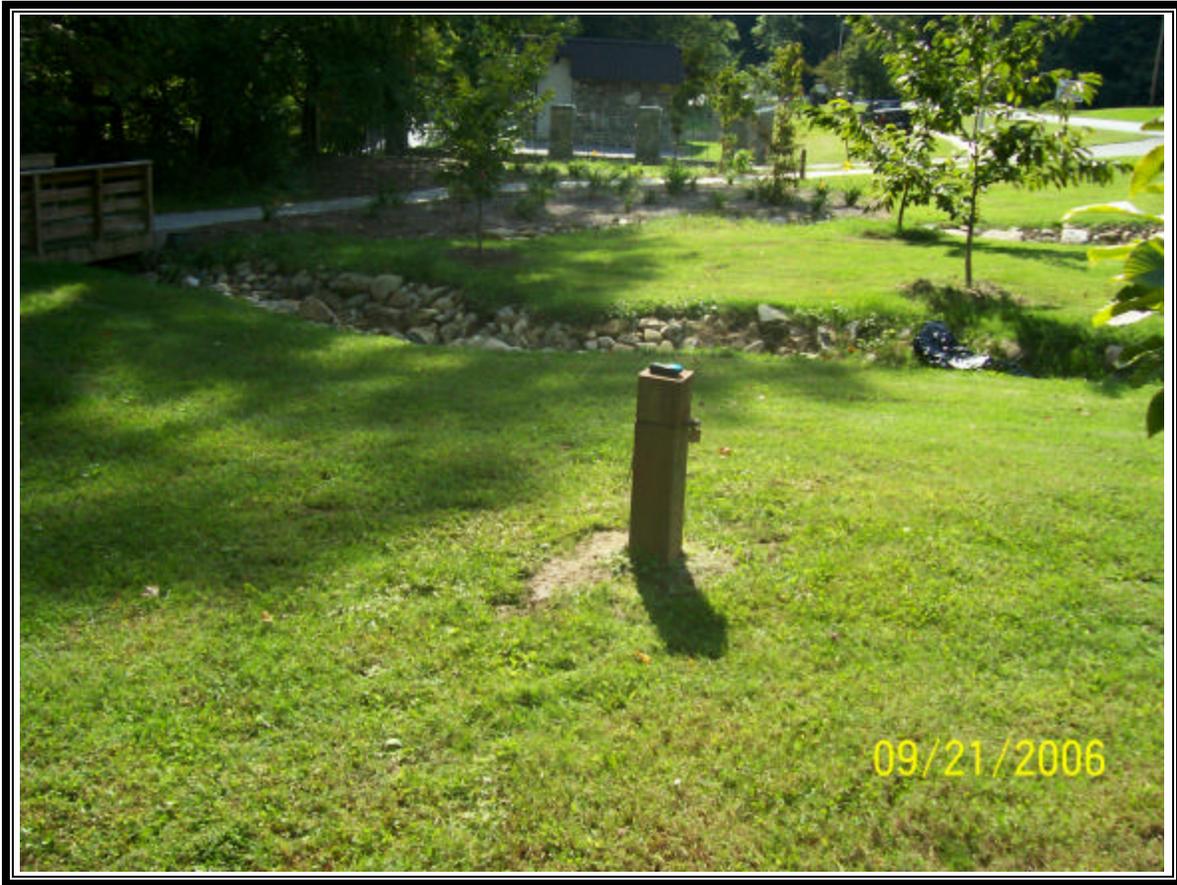
OFFICIAL PHOTOGRAPH NO. 28
U.S. ENVIRONMENTAL PROTECTION AGENCY

Subject: Monitoring well MW-4; the pumphouse is in the background, the river to the left, and the Golden Eagle Exxon station to the right.

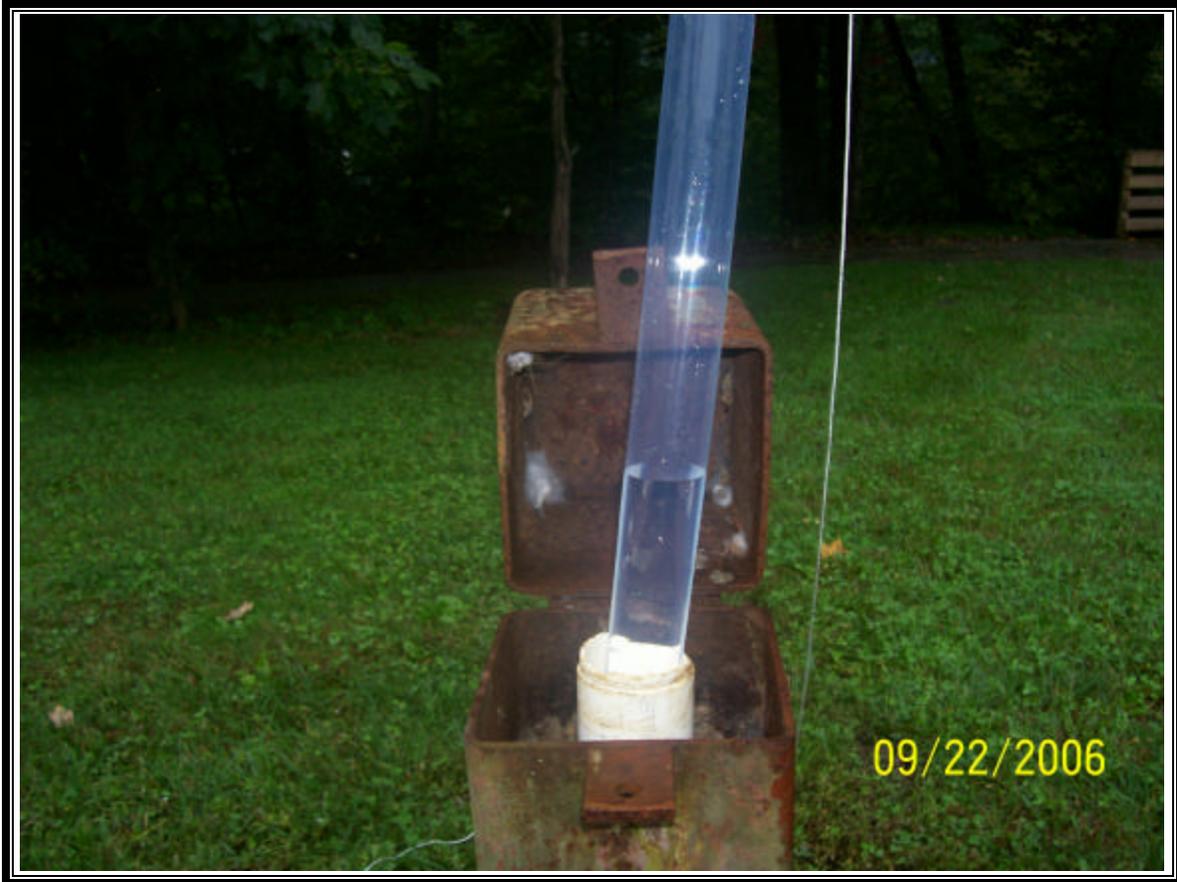
OFFICIAL PHOTOGRAPH NO. 29
U.S. ENVIRONMENTAL PROTECTION AGENCY

Subject: Sample from MW-4 showing no visible sheen or product on top of the water column.

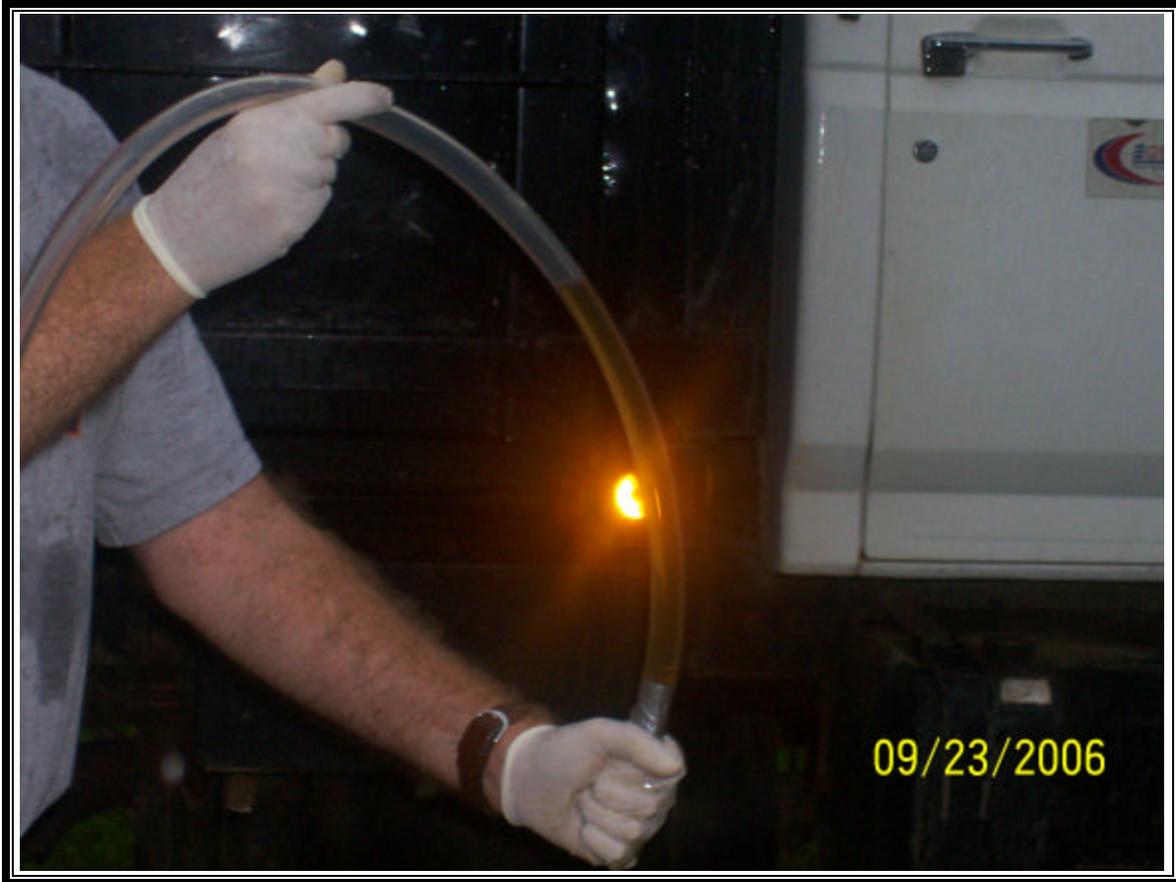
OFFICIAL PHOTOGRAPH NO. 30
U.S. ENVIRONMENTAL PROTECTION AGENCY

Subject: Product collected by Delta Environmental from MW-2 ; the thickness of the sample does not indicate the thickness of the product within the well; sample collection methods did not preserve the true product thickness which was determined to be 0.9 foot using a sounding tape.

Neo Corporation also used a vacuum truck to remove free product from MW-6 and MW-2. After evacuation, Tetra Tech START bailed MW-6, which showed no remaining free product.

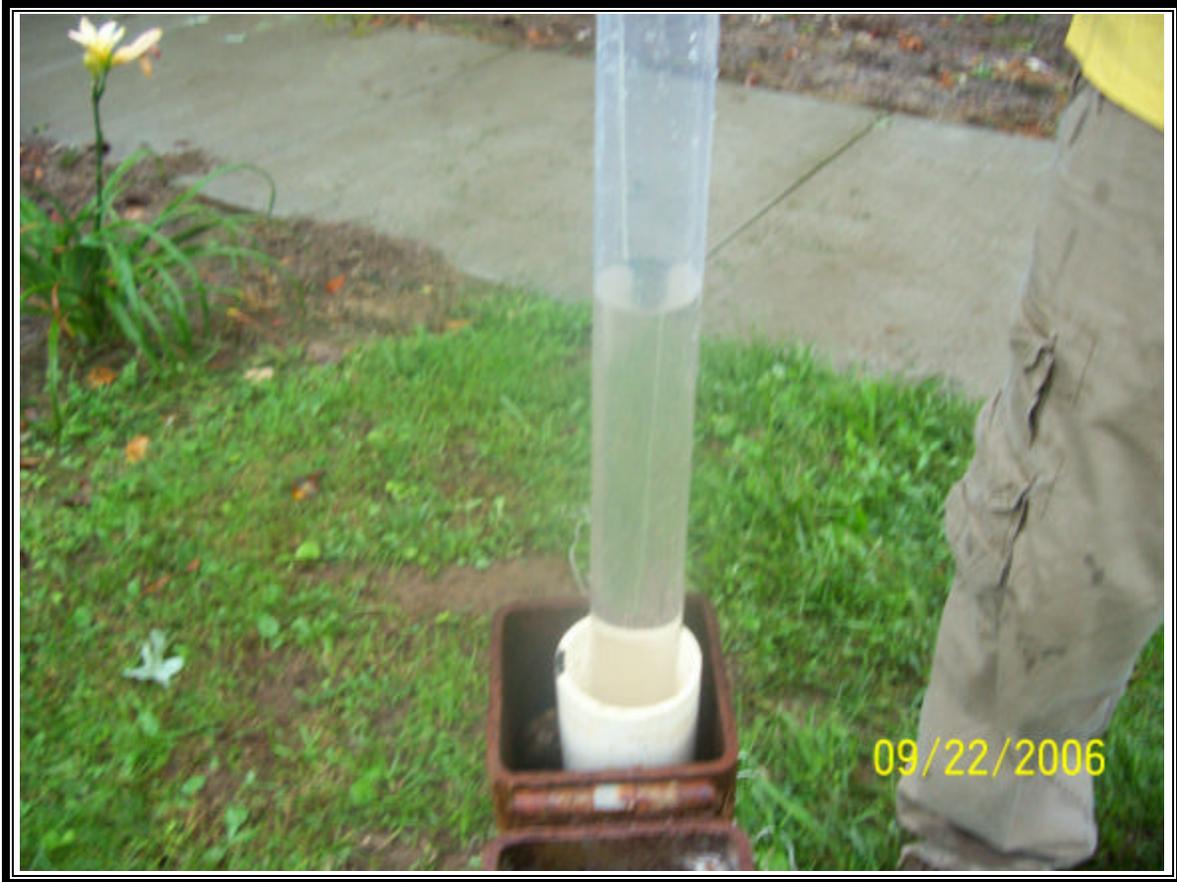
**OFFICIAL PHOTOGRAPH NO. 31
U.S. ENVIRONMENTAL PROTECTION AGENCY**

Subject: Sample from MW-3 showing a slight sheen on the top of the water column.

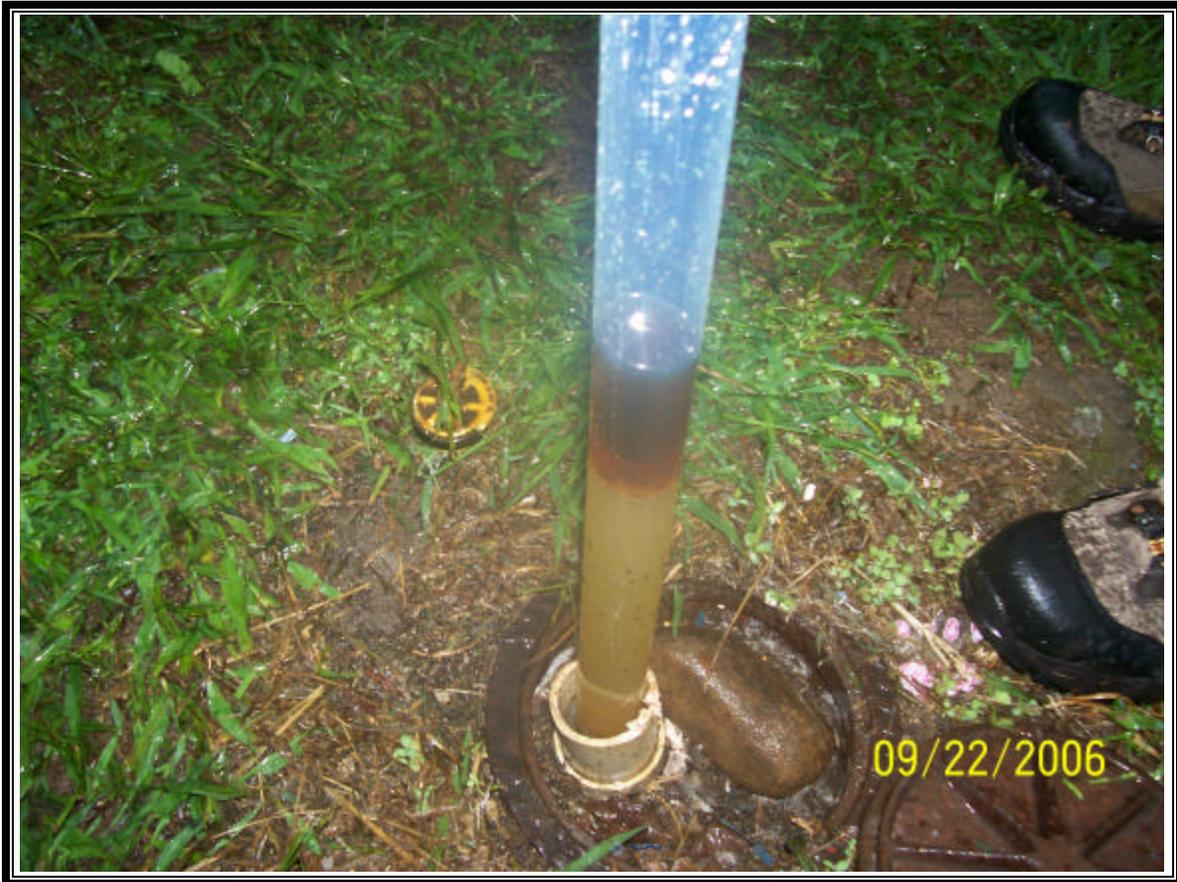
OFFICIAL PHOTOGRAPH NO. 32
U.S. ENVIRONMENTAL PROTECTION AGENCY

MW-6 reached 368 parts per million (ppm) with the cap off and after the well was allowed to vent all day, and for MW-2, the PID's capability was exceeded and the instrument faulted. The numbers stated here are adjusted for the response factor for gasoline products using a PID (0.5) and are twice the actual PID instrument reading noted in the field.

Subject: Sample from MW-6 showing about 3 inches of product on top of the water column.
