BUREAU OF INDIAN AFFAIRS – PACIFIC REGION OFFICE

Phase I Environmental Site Assessment Supply Creek Site

Using ASTM Practice E 1527-13

Site Assessment
Hoopa Valley Tribe
Parcel ID#: 525-171-009-000
Field Reconnaissance for the Property, May 09, 2019

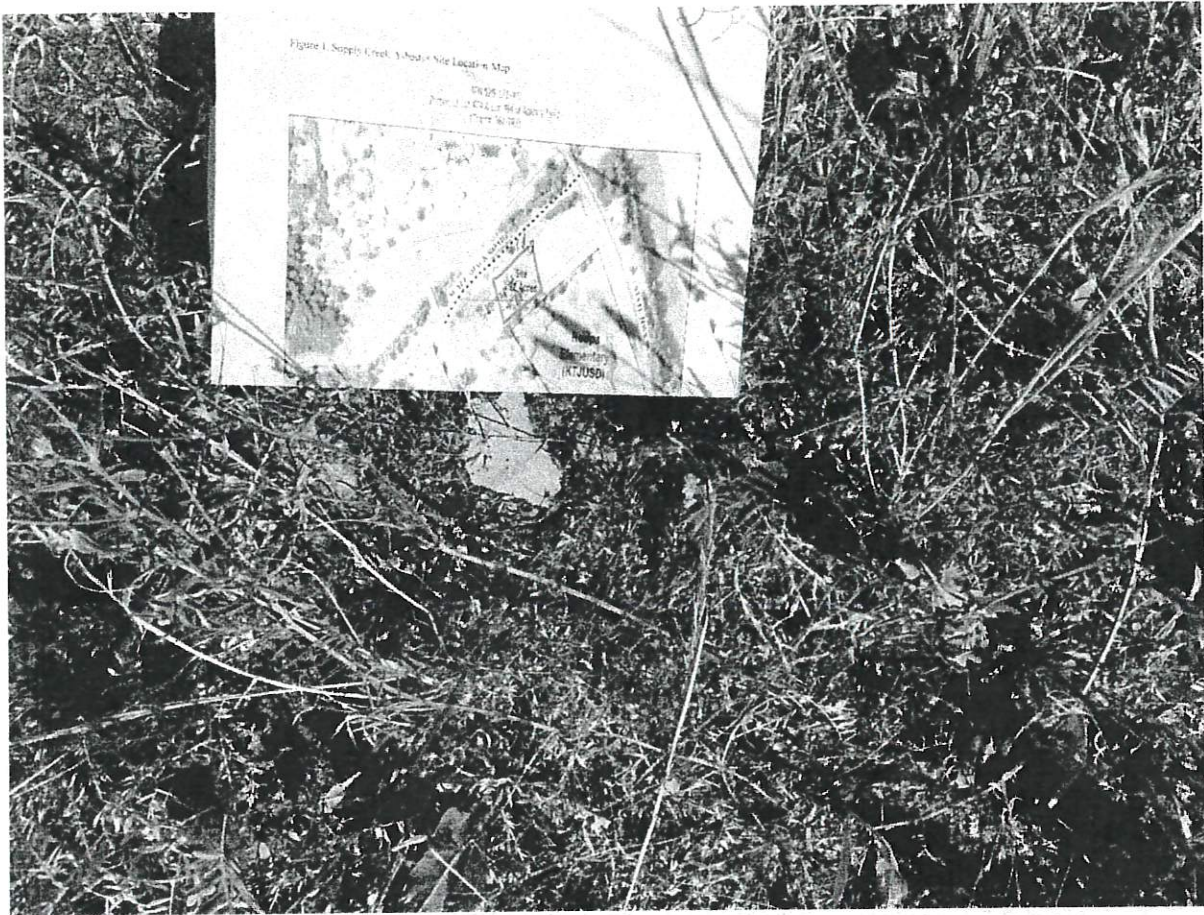
The site visit observed tile fragments in the northwestern, southwestern and southeastern quadrants of the subject property are suspected and/or known to possess Chrysotile asbestos as reported by TEM laboratories of Berkeley California. These tile fragment are in-situ and subject to temporary encapsulation to minimize potential fugitive air-borne transport of friable material and the potential exposure of school-aged children at the Hoopa Valley Elementary School. Therefore, in our opinion, these materials are considered a REC related to the presence of an environmental threat and the potential for conditions indicative of a release to the environment.

Photo #002: Tile Fragment in Northwestern Quadrant

Due to the evidence related to the presence of RECs on the 525-171-009-000 parcel(s) as a result of the due diligence completed as a part of the ASTM standard; the environmental professionals recommend that, at the discretion of the Hoopa Valley Tribe, an ASTM E1903 compliant study be commissioned to determine the nature and extent of suspect asbestos contamination on the subject property and publish the findings in the ASTM E1903 report.
