Freight Train Derailment and Chemical Spill

Goose Lake Federal Waterfowl Production Area
Albert Lea, Minnesota. May 15, 2021

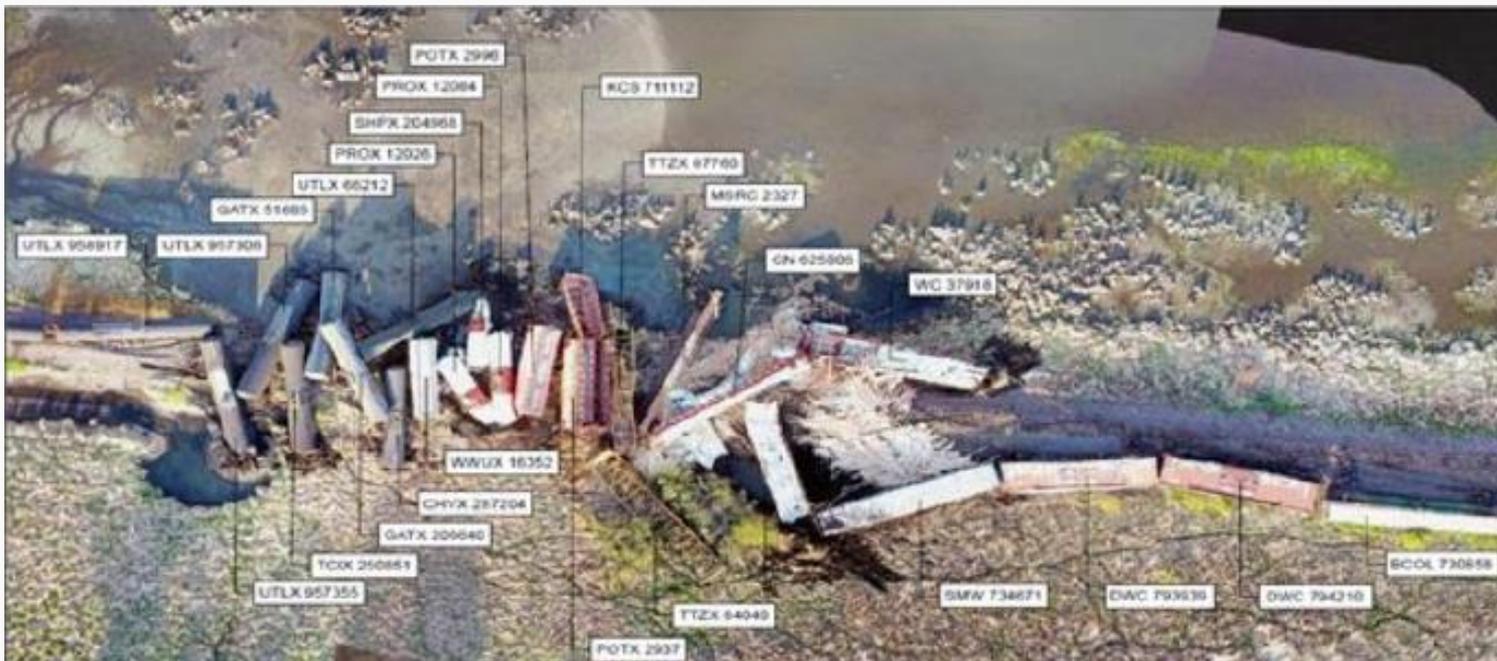
28 Train Cars Derailed:

(3) Liquefied Petroleum Gas (LPG) tankers,

(3) tanker cars of HCL (32% conc.),

(5) residual tank cars (lube oil),

(2) hopper cars with Potash (KOH)

and the rest were lumber, empties, and non-hazardous goods.

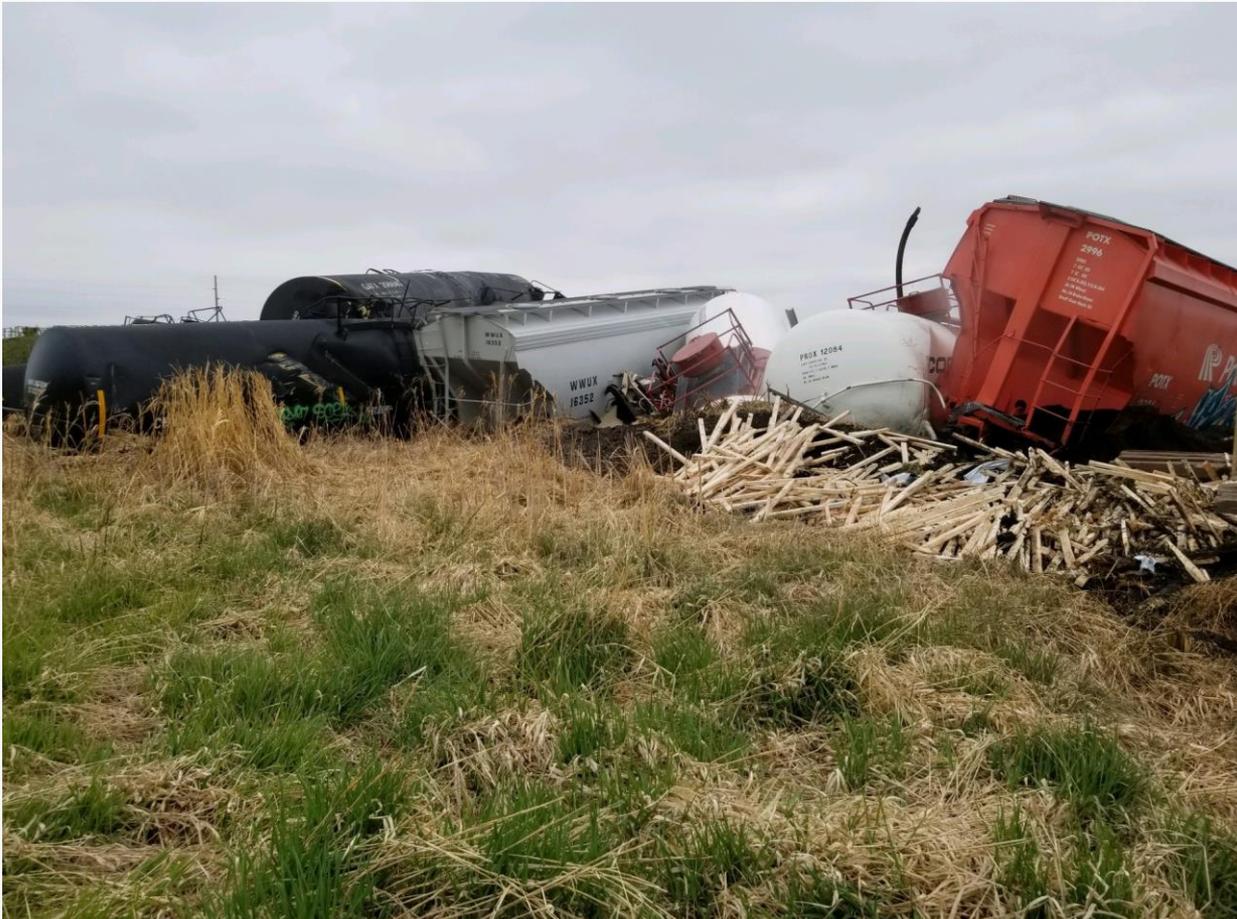
Two of the 20,000 gallon capacity HCL cars were punctured about half-way down, one was found to have a puncture at the bottom and had lost all contents.

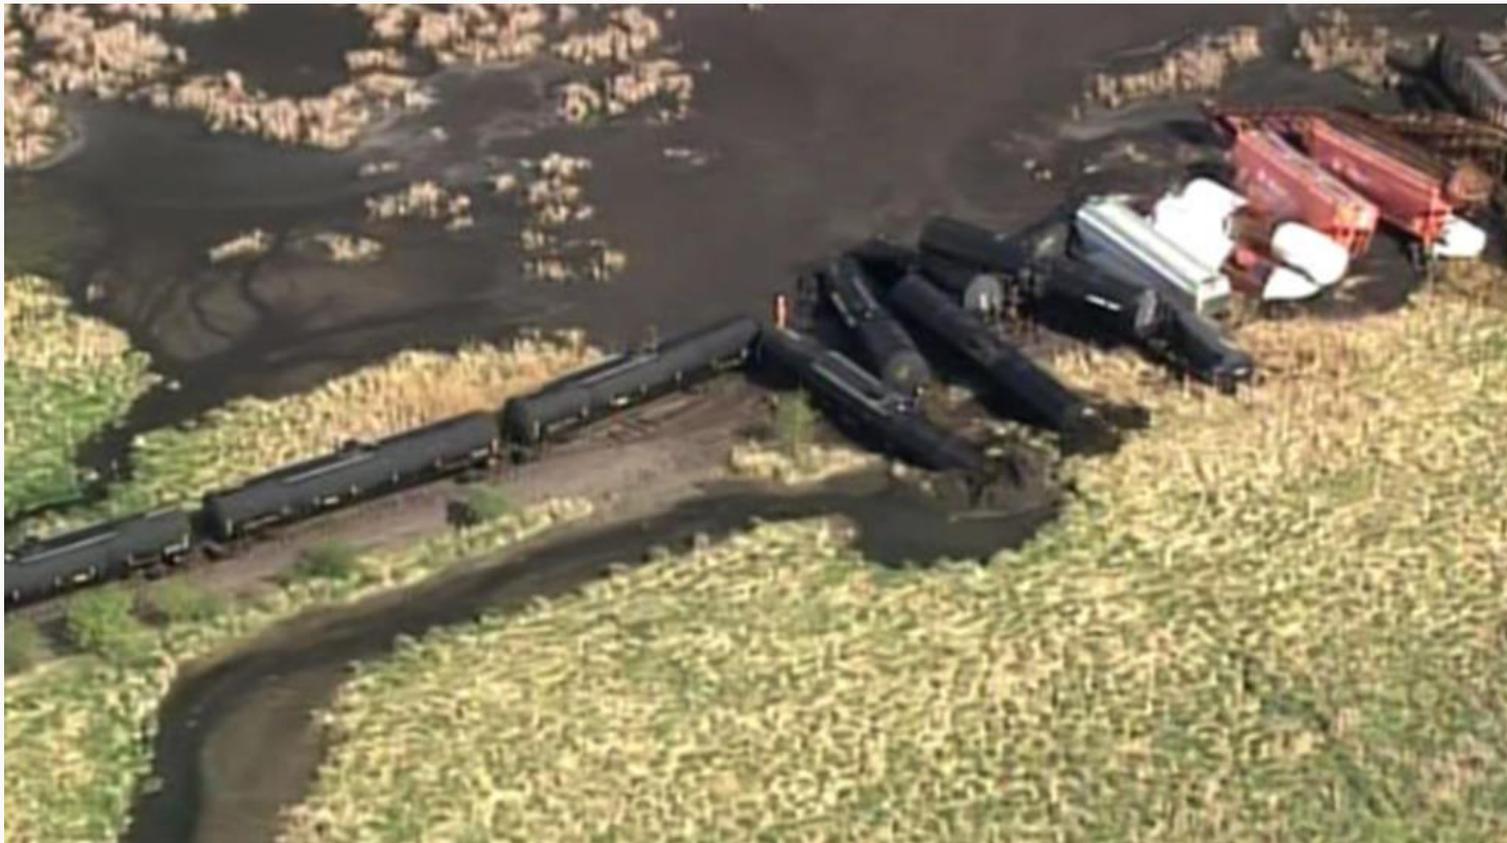
Photo: CBS News

The derailment destroyed the Bridge and the outfall from the Lake (Goose Creek).

- The leaked acid started to migrate into the lake.

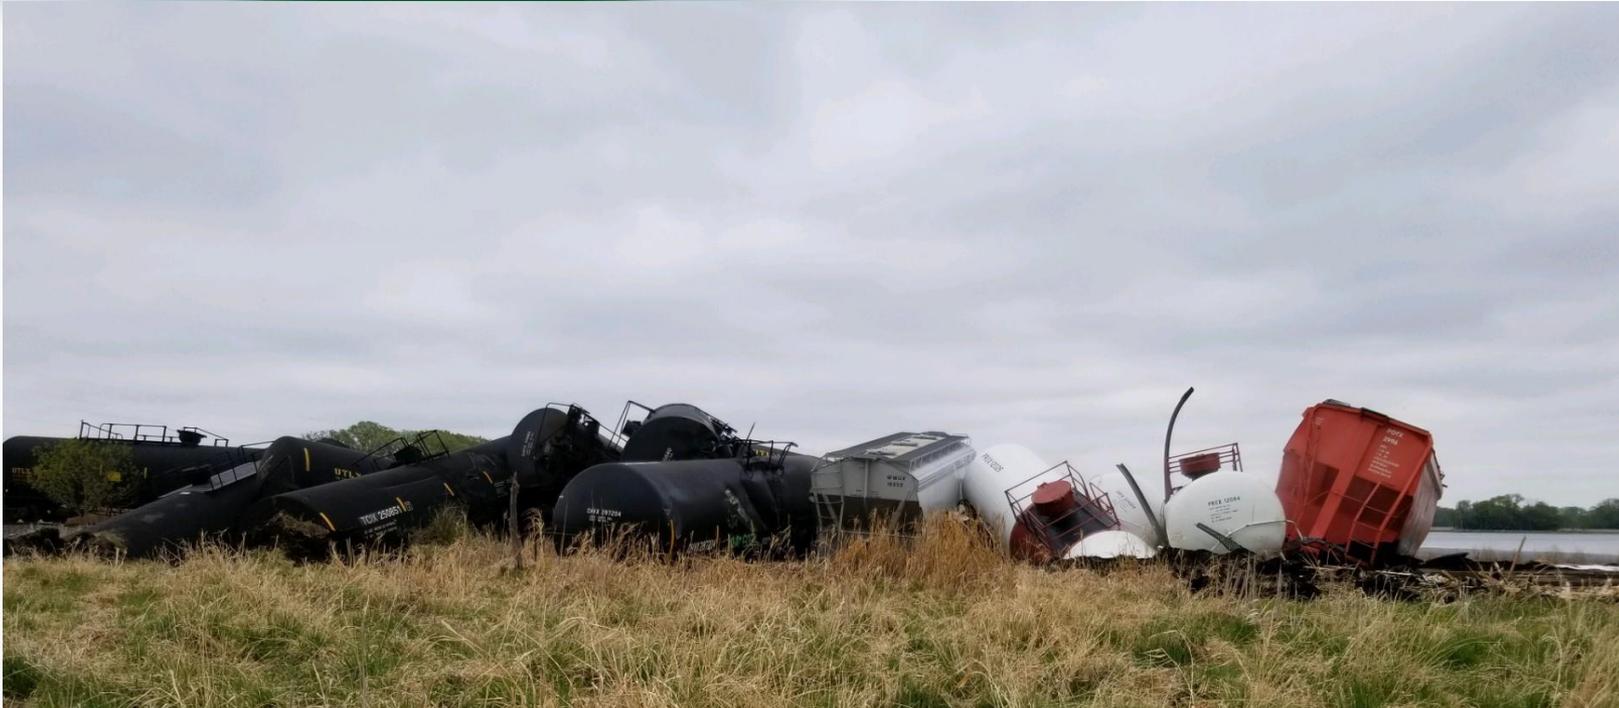
Vapor clouds were present at the work site well into the next day.

- Upon confirmation of a vapor or possible "offgassing", local first responders requested sheltering in place for nearby residences with air monitoring conducted by the State Chemical Assessment Team.

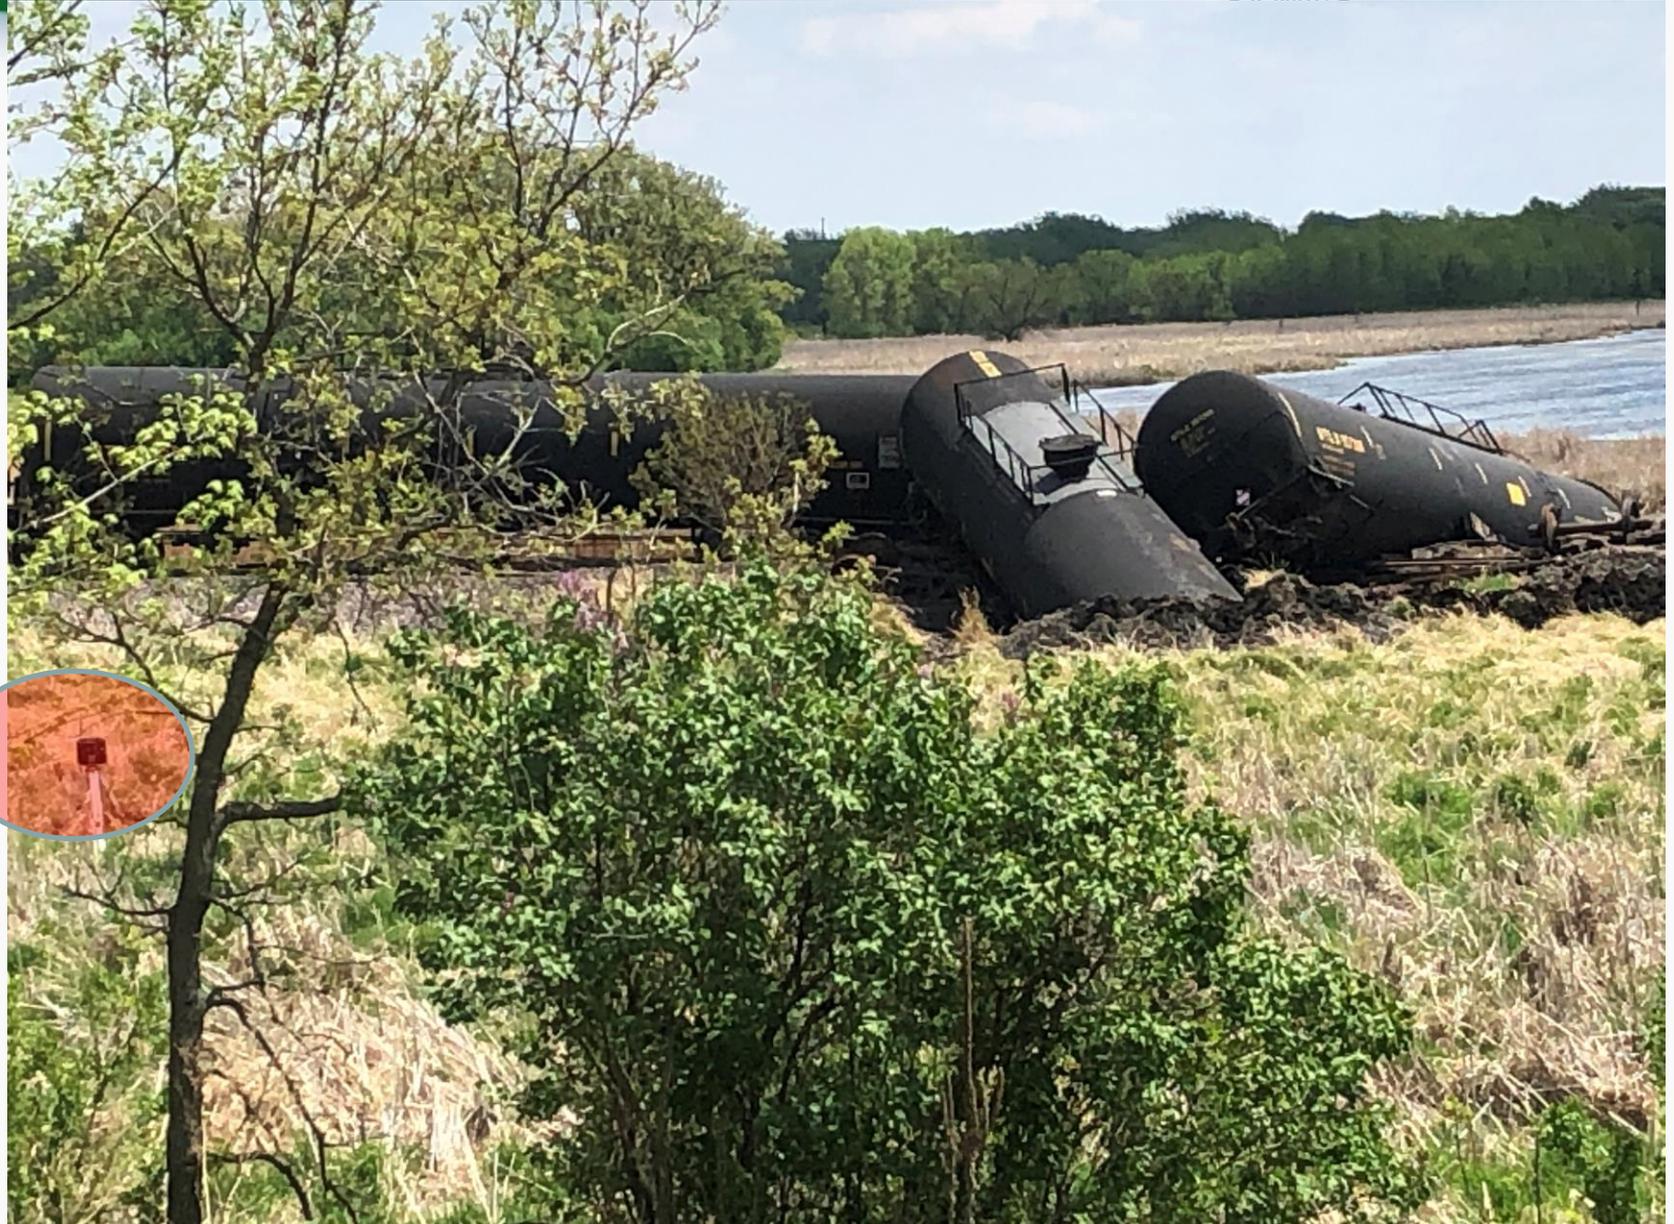
A line of air monitors was set up between the crash site and the residential housing.

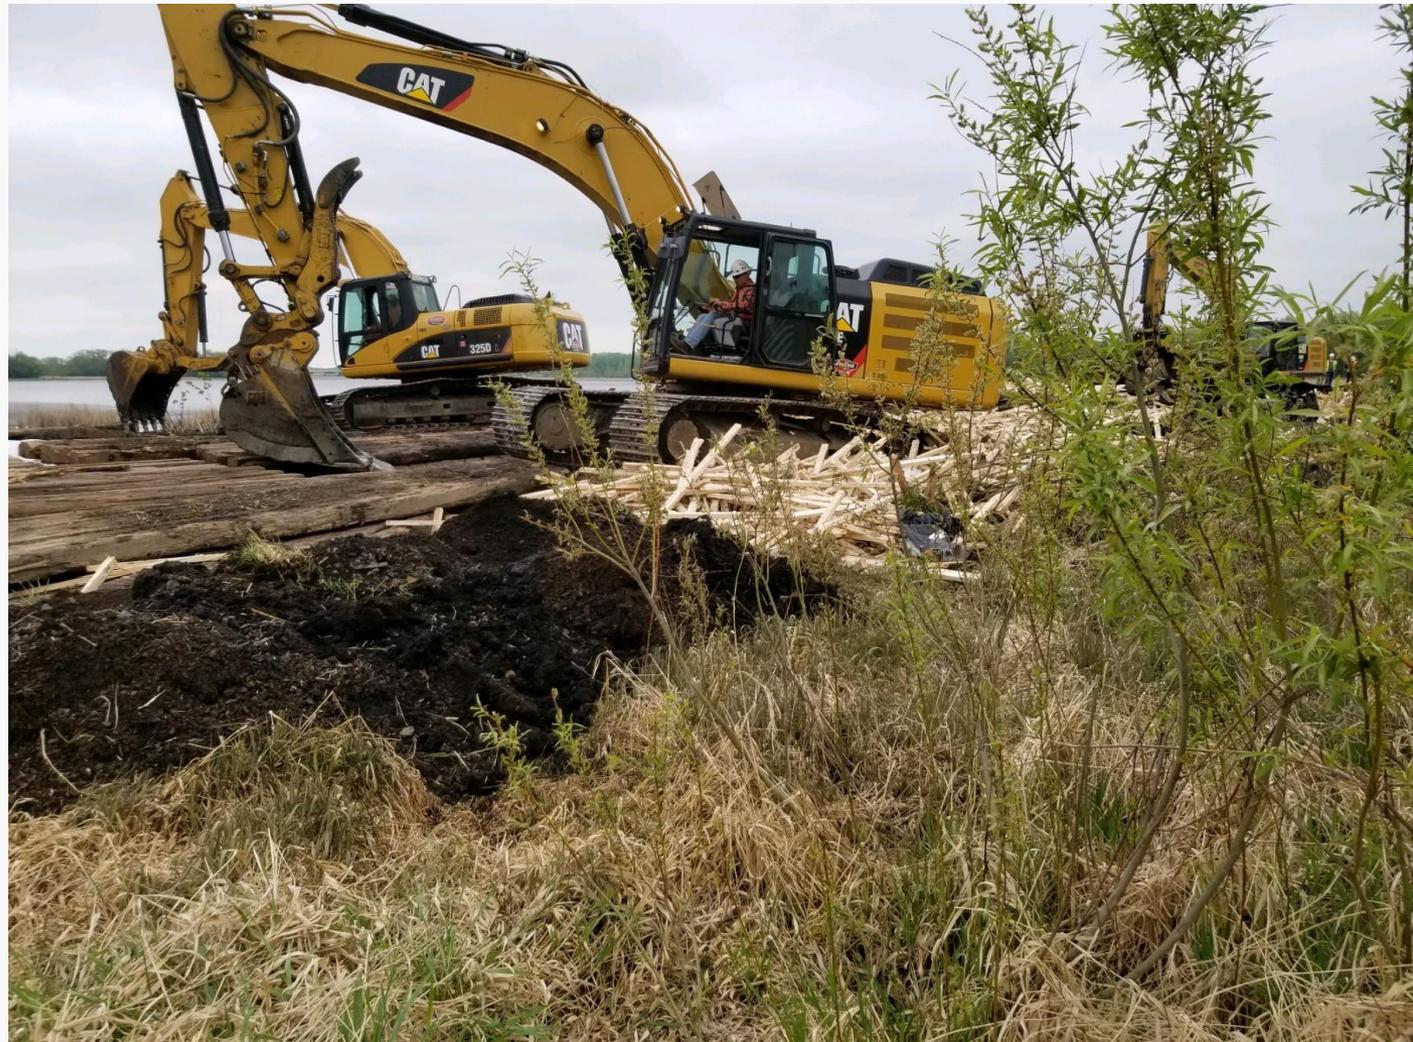
Matting was laid along the railroad right-of-way to help access the derailment area with heavy equipment.

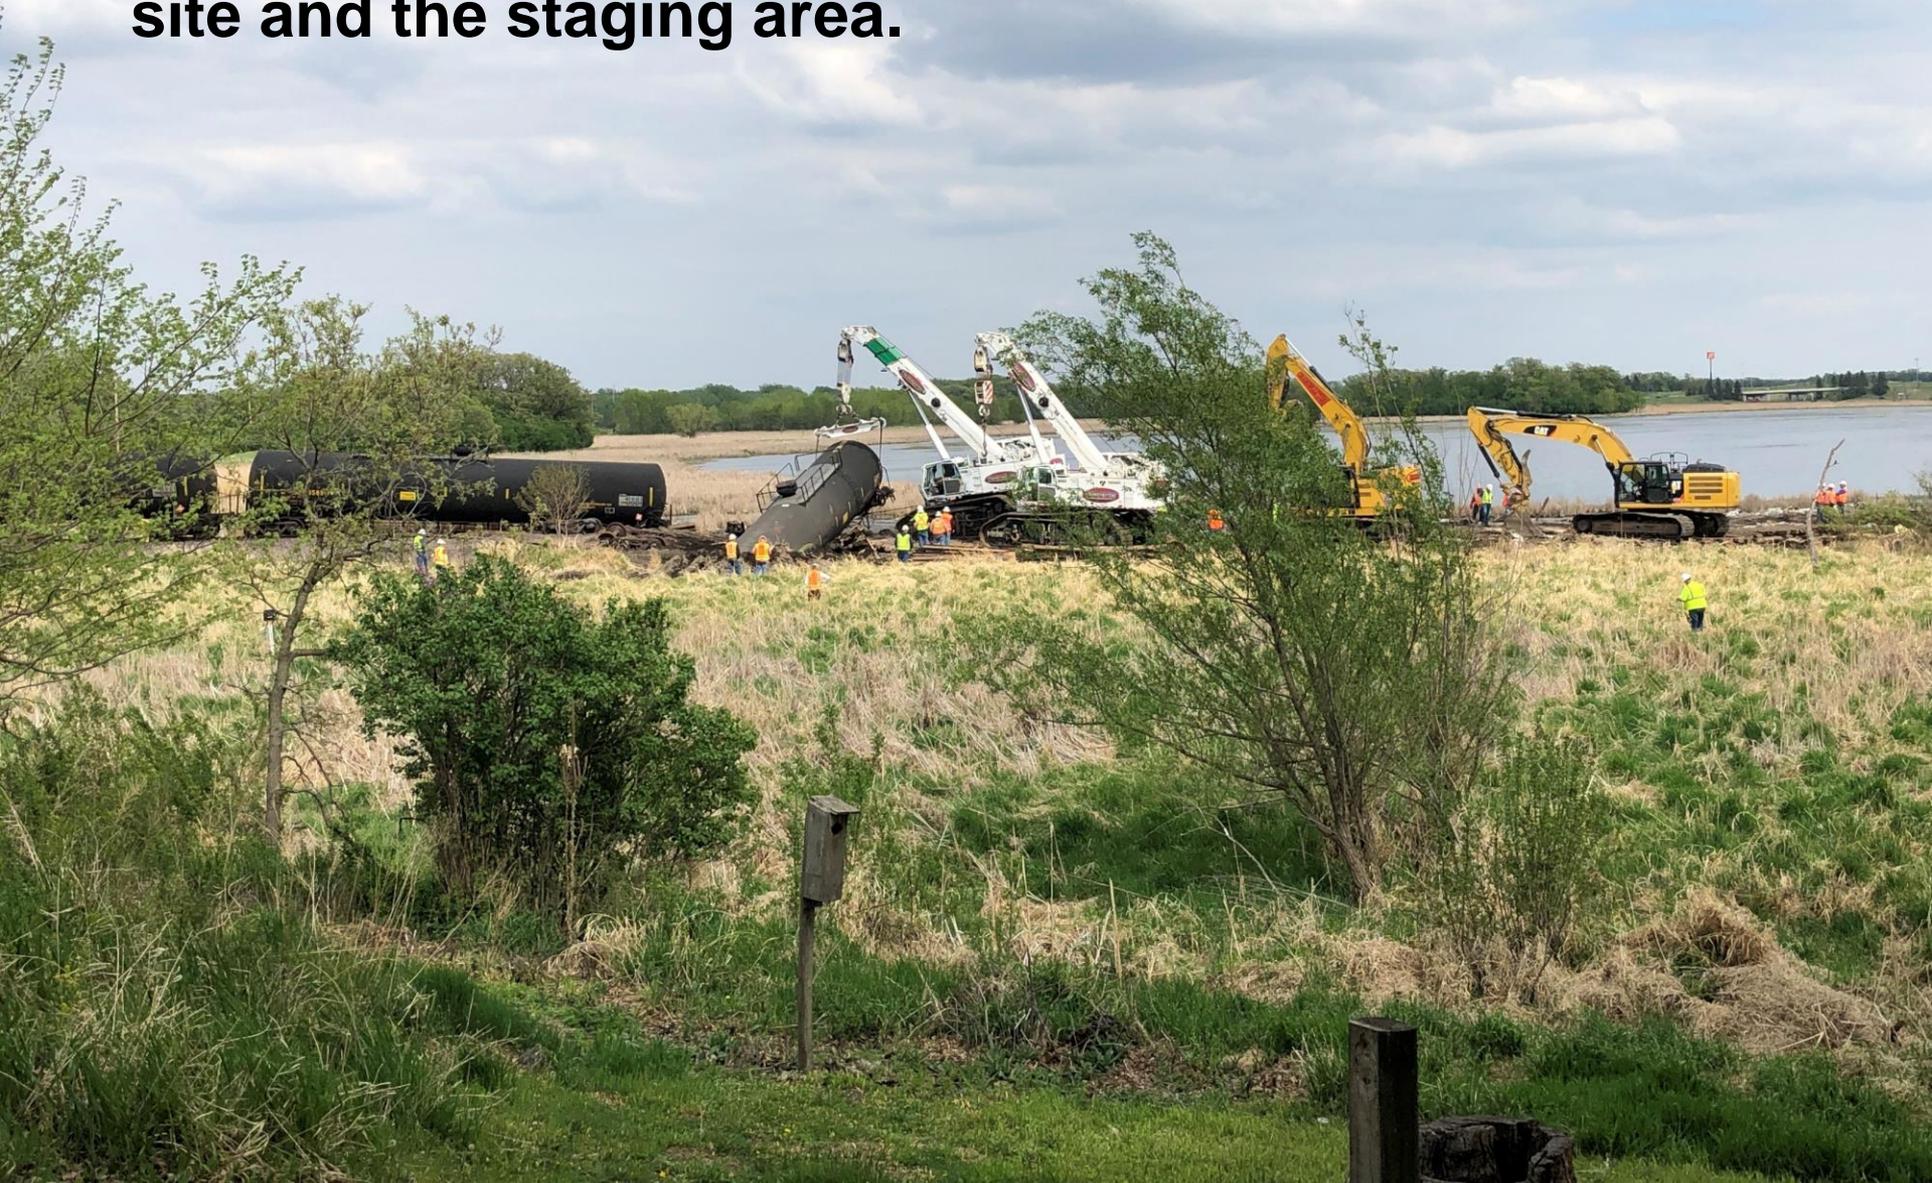
Movement of LPG cars, brought to staging area for off loading, continual air monitoring at the lake site and the staging area.

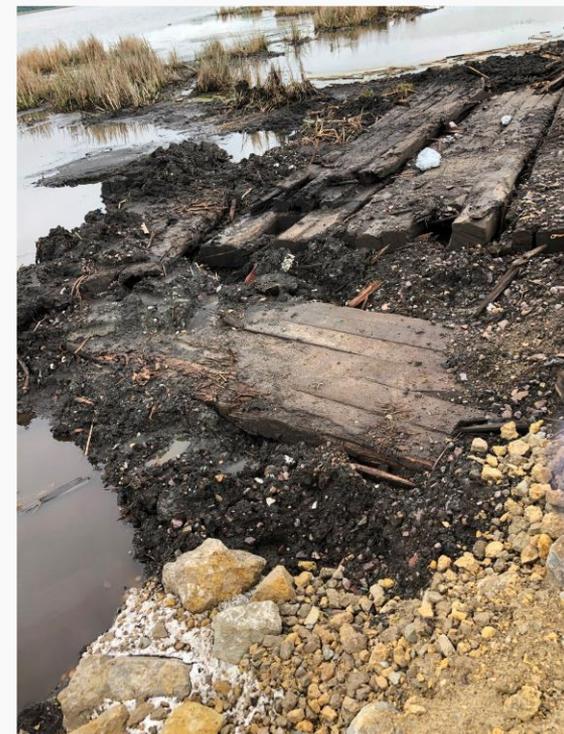
The contaminated sediments at the source area were neutralized by application of **soda ash** (sodium carbonate) and then the source area was excavated and stockpiled on plastic at the staging area.

Approximately **62 tons** of soda ash were utilized in the source area mitigation. The area was backfilled with lime rock for additional buffering for any residuals prior to rail reconstruction with granitic ballast rock.

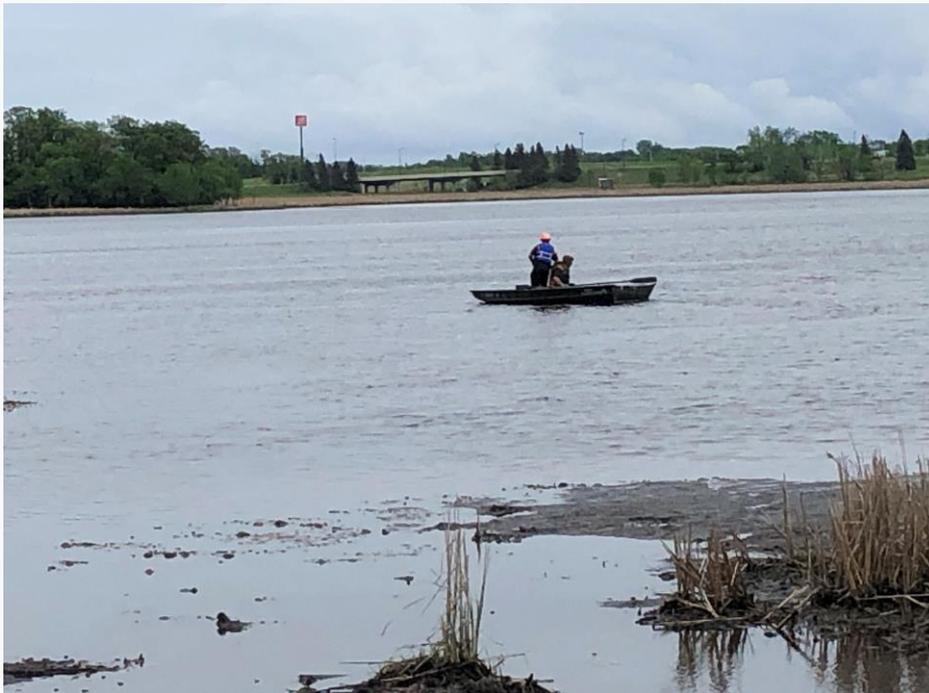
EPA OSC contacted Environmental Response Team (ERT) limnologists for review and comment on water sampling efforts. ERT provided a recommendation for mitigation/neutralization by the application of calcium carbonate.

2,400 pounds of calcium carbonate was applied to low pH areas in the lake for neutralization/buffering.

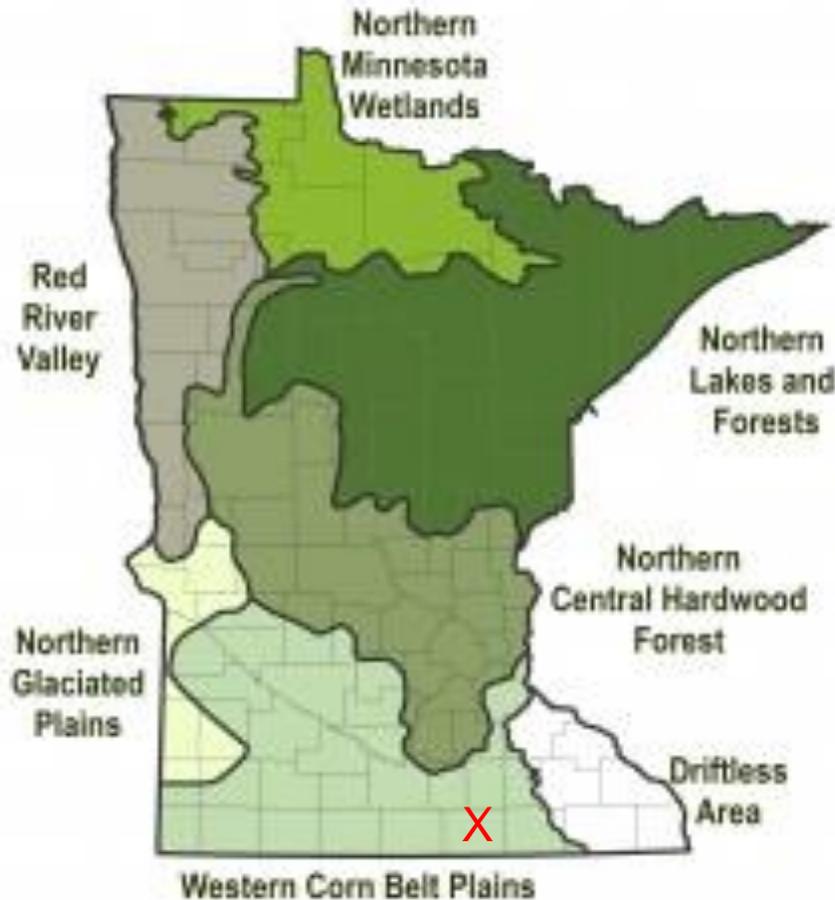
The USA (and Minnesota) has different ecoregions as defined by geography, geology, climate, habitats, etc.

Streams and Lakes in an ecoregion are often contrasted with the water quality and Index of Biological Indicators of the healthiest water bodies in that ecoregion.

Goose Lake is located in the Western Corn Belt Plains (WCBP) ecoregion of southern Minnesota.

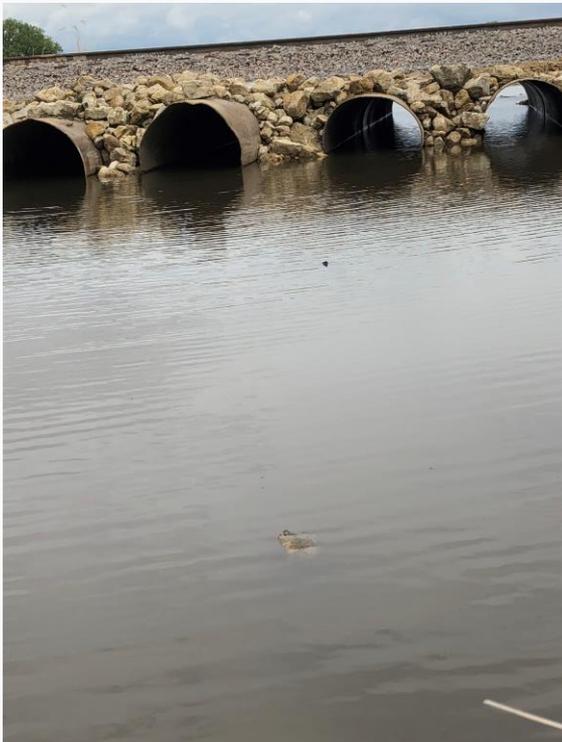
The Railroad replaced the former bridge with culverts and opened-up the flow to the creek and downstream receiving water (Fountain Lake). Neutralization efforts then expanded to include the creek.

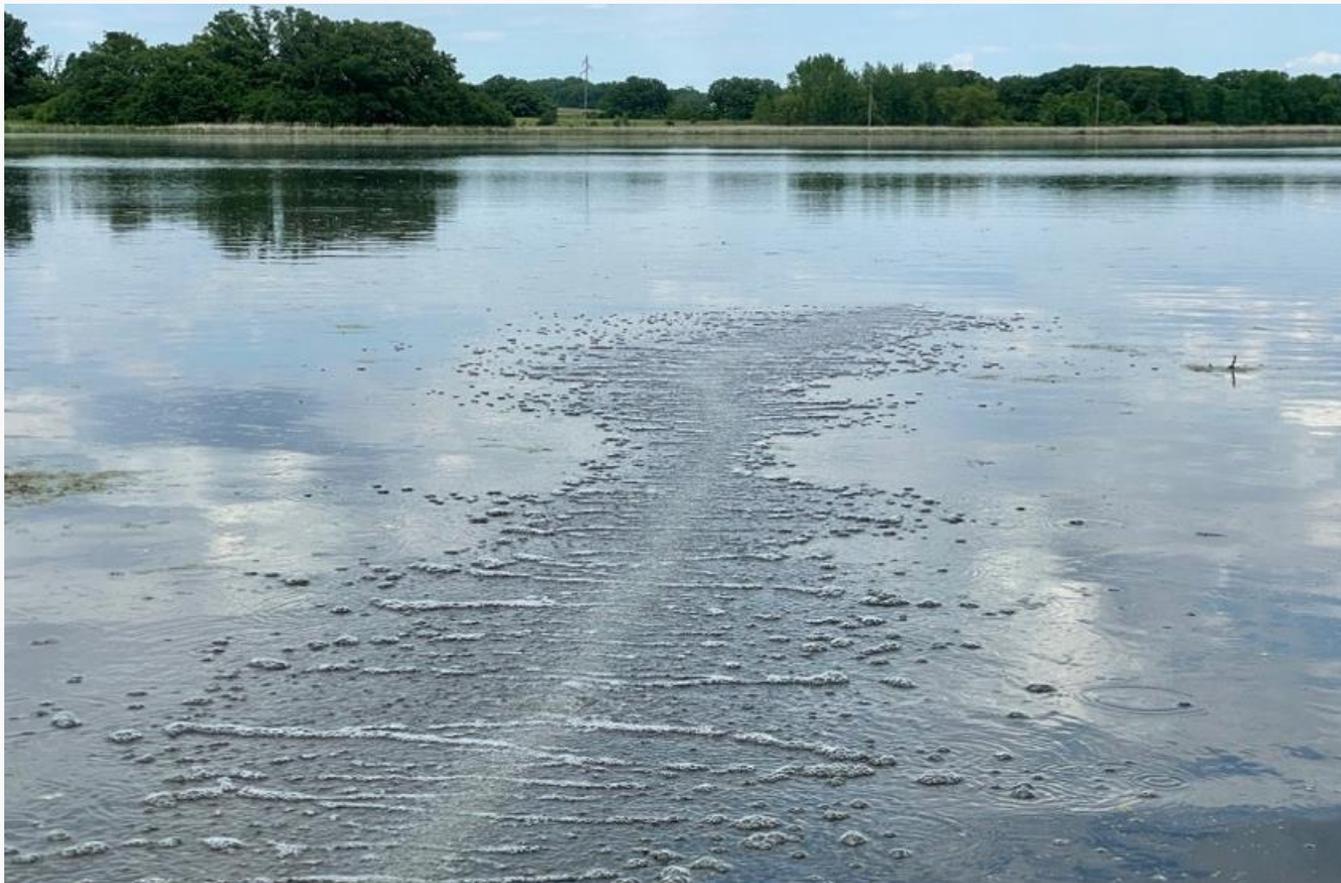
The low pH severely affected the photosynthetic production in the lake and Dissolved Oxygen (DO) levels dropped from 10 ppm down to 1 ppm in some parts of the lake.

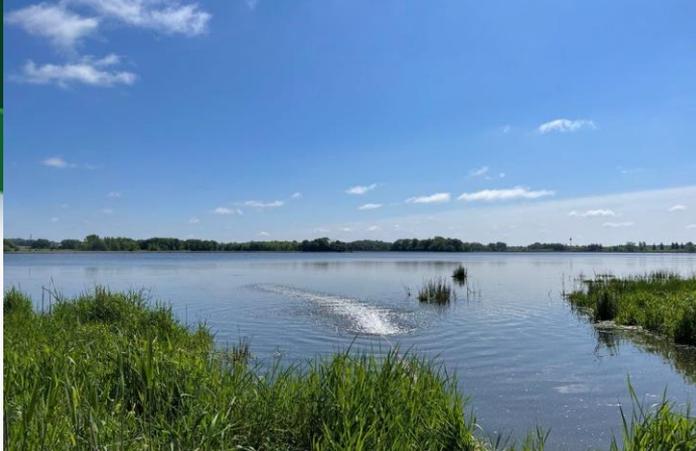
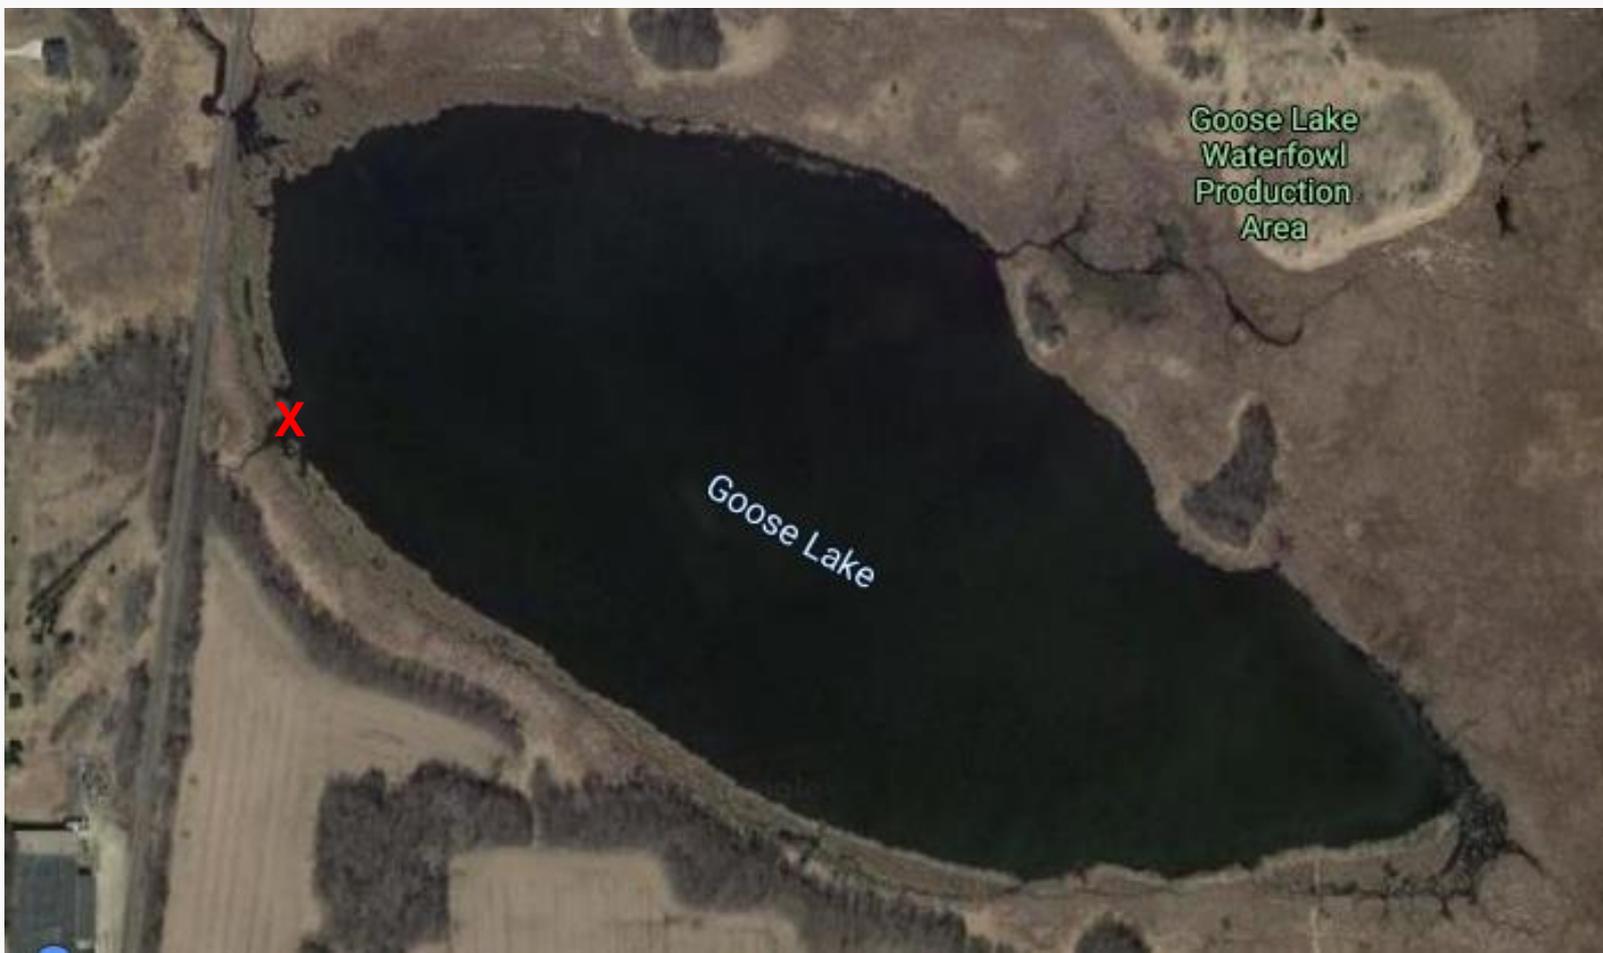
Aeration
System
installed.

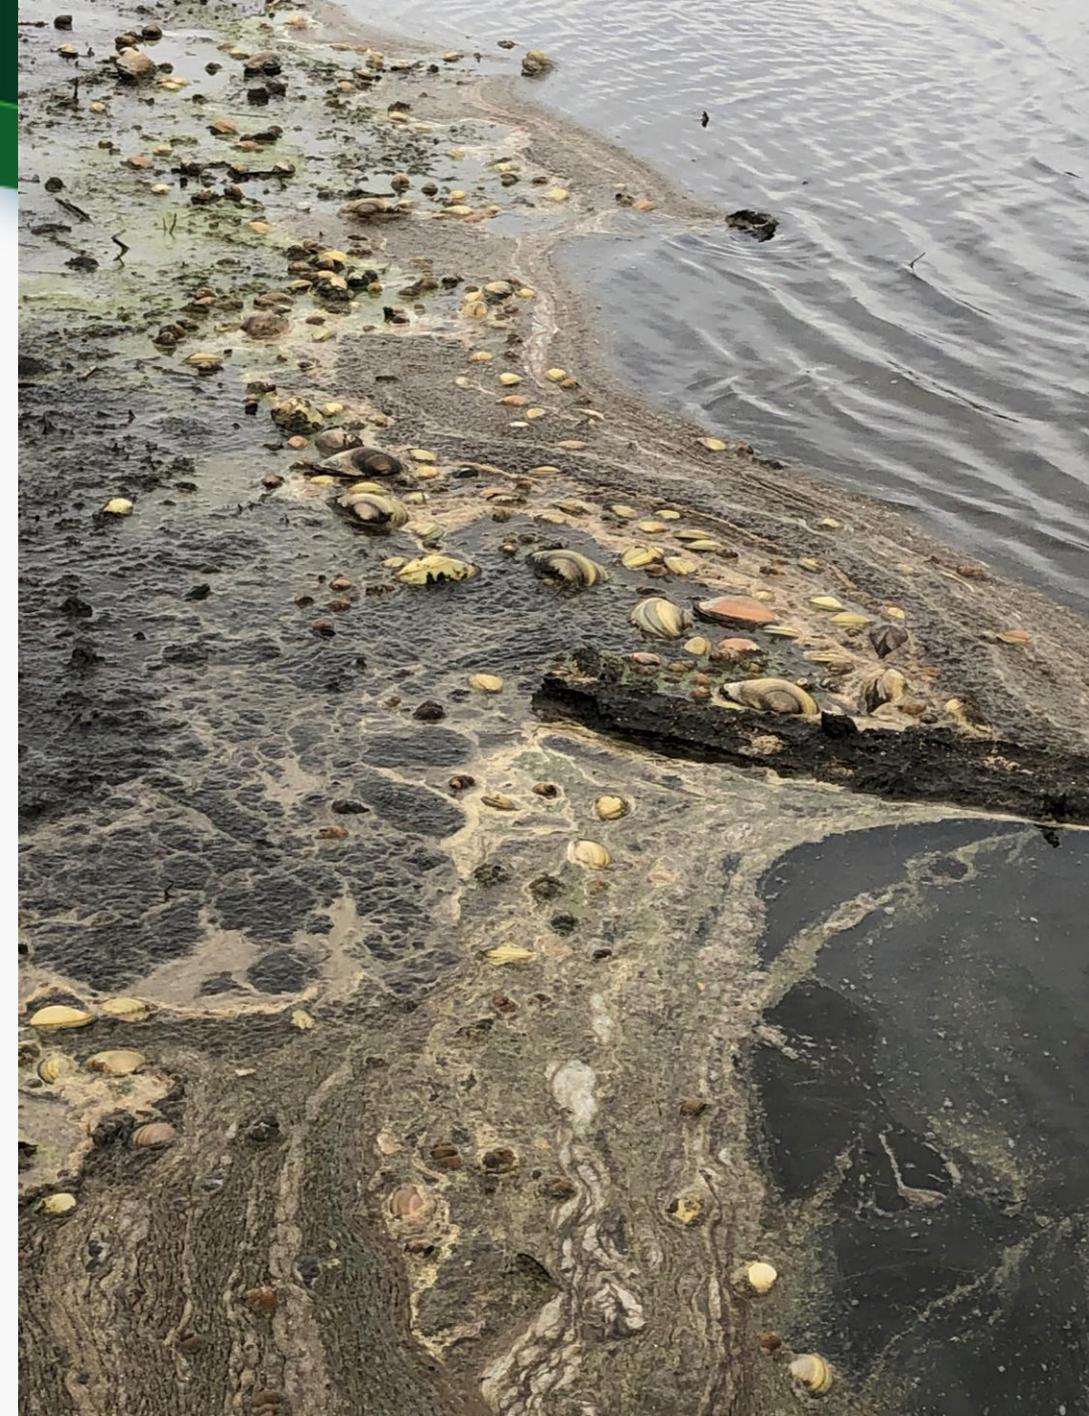
Serious benthic die-off.
Thousands of mollusks,
particularly of the
(common) *Giant Floater*
and the (Invasive)
Chinese Mystery Snail.

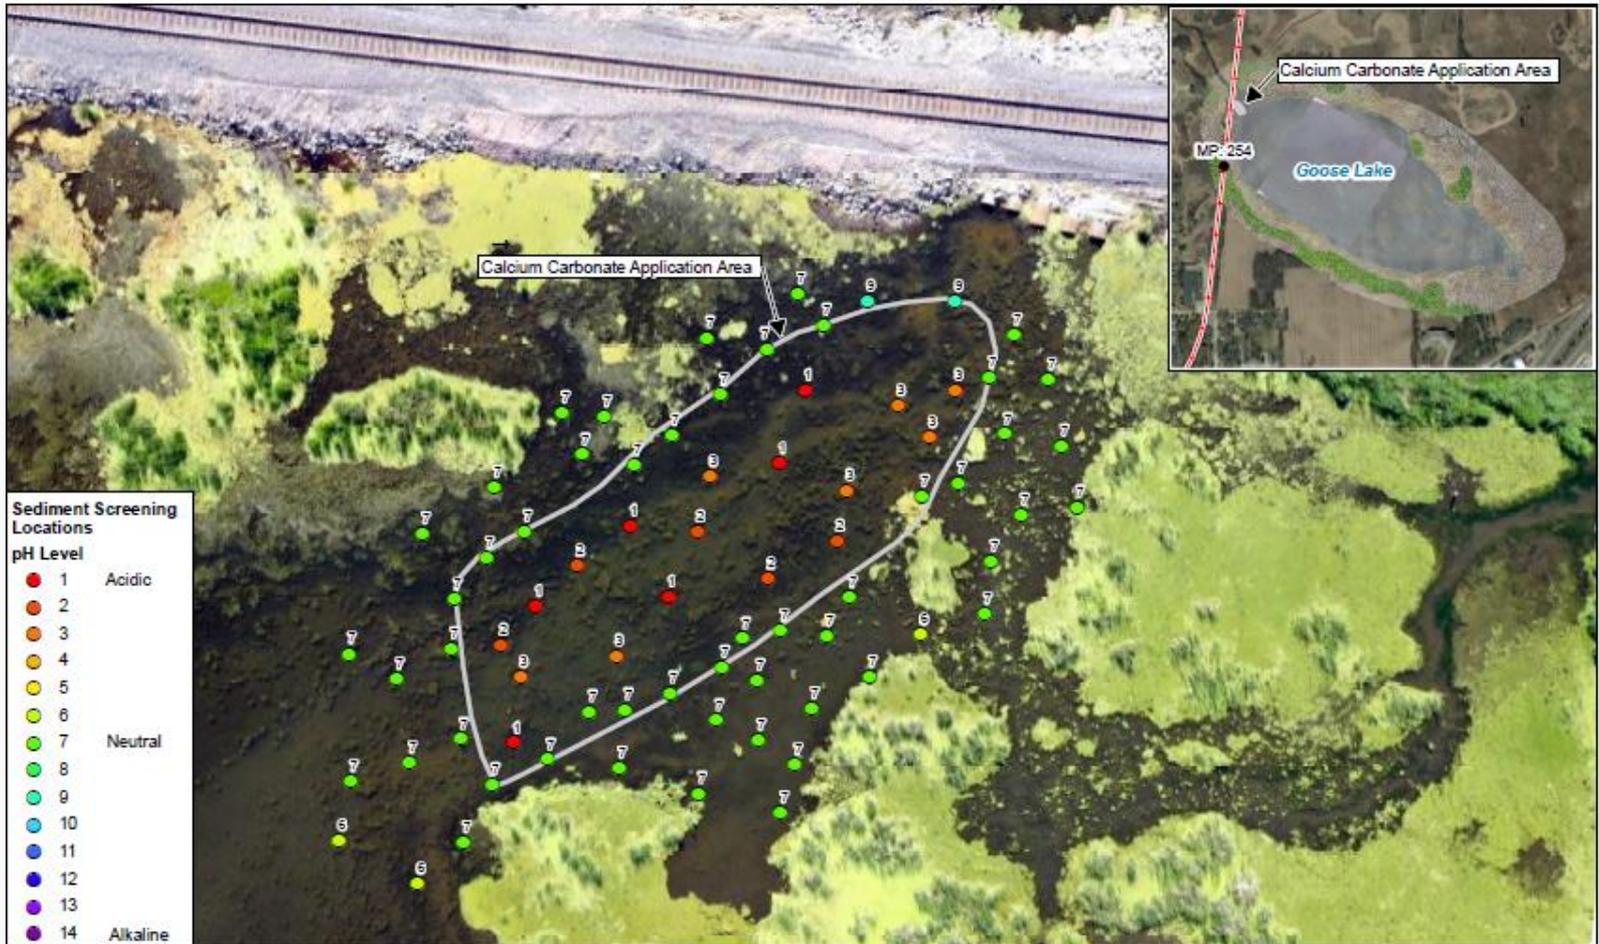
Well over a month later, further sediment pH delineation. An additional 5.65 tons of calcium carbonate (pH 9.2) was placed in the lake to address/buffer lake bottom sediment acidity.

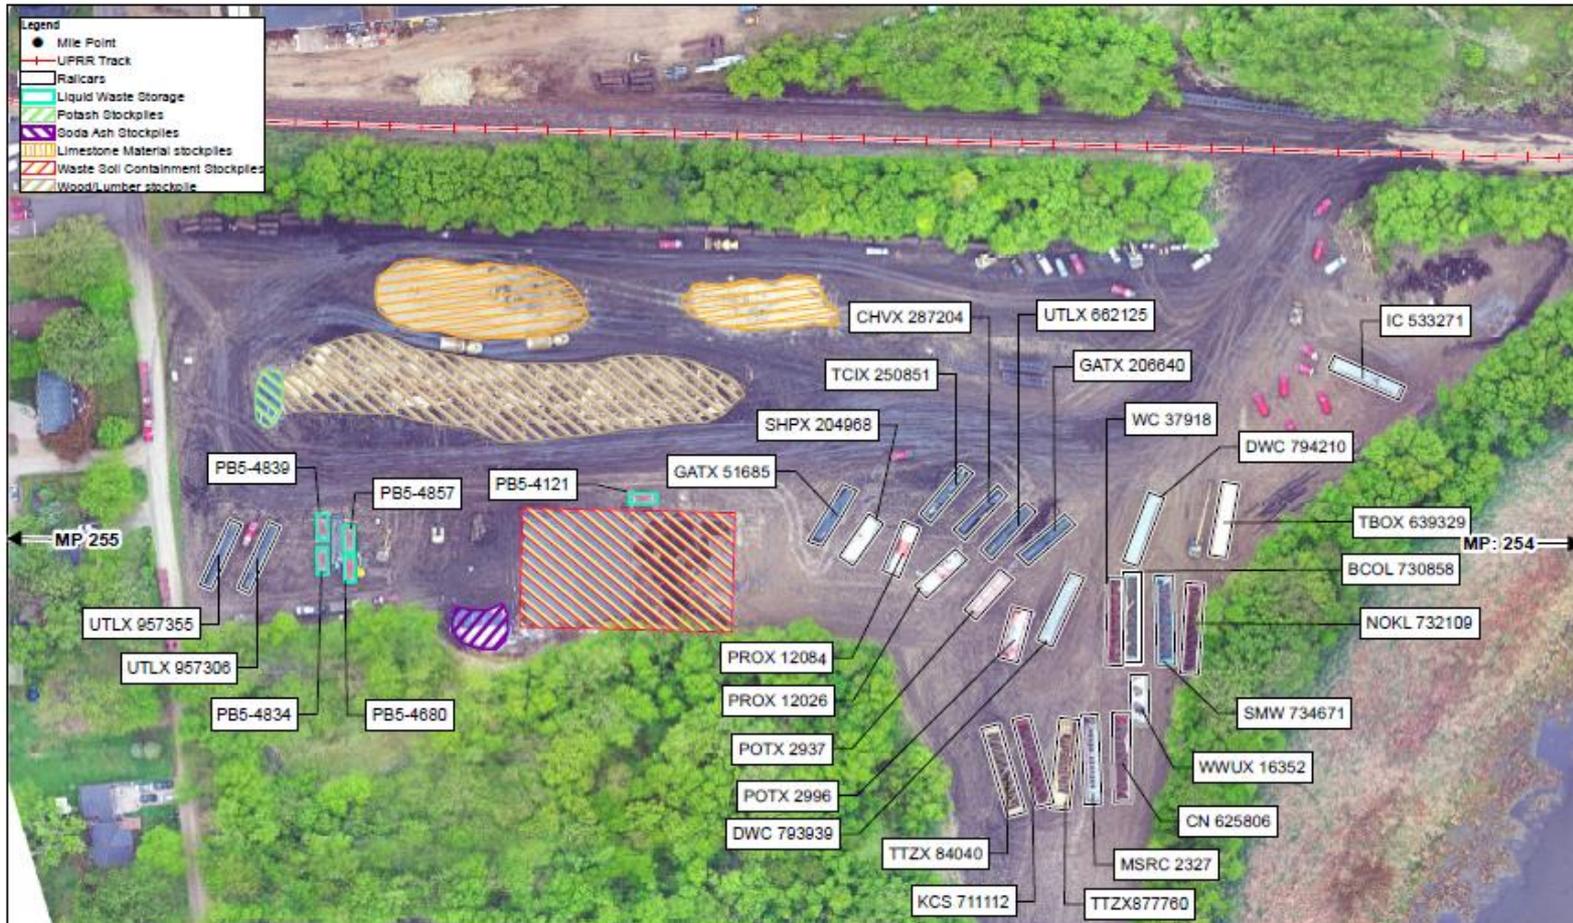
Staging Area management

– farm field lease.

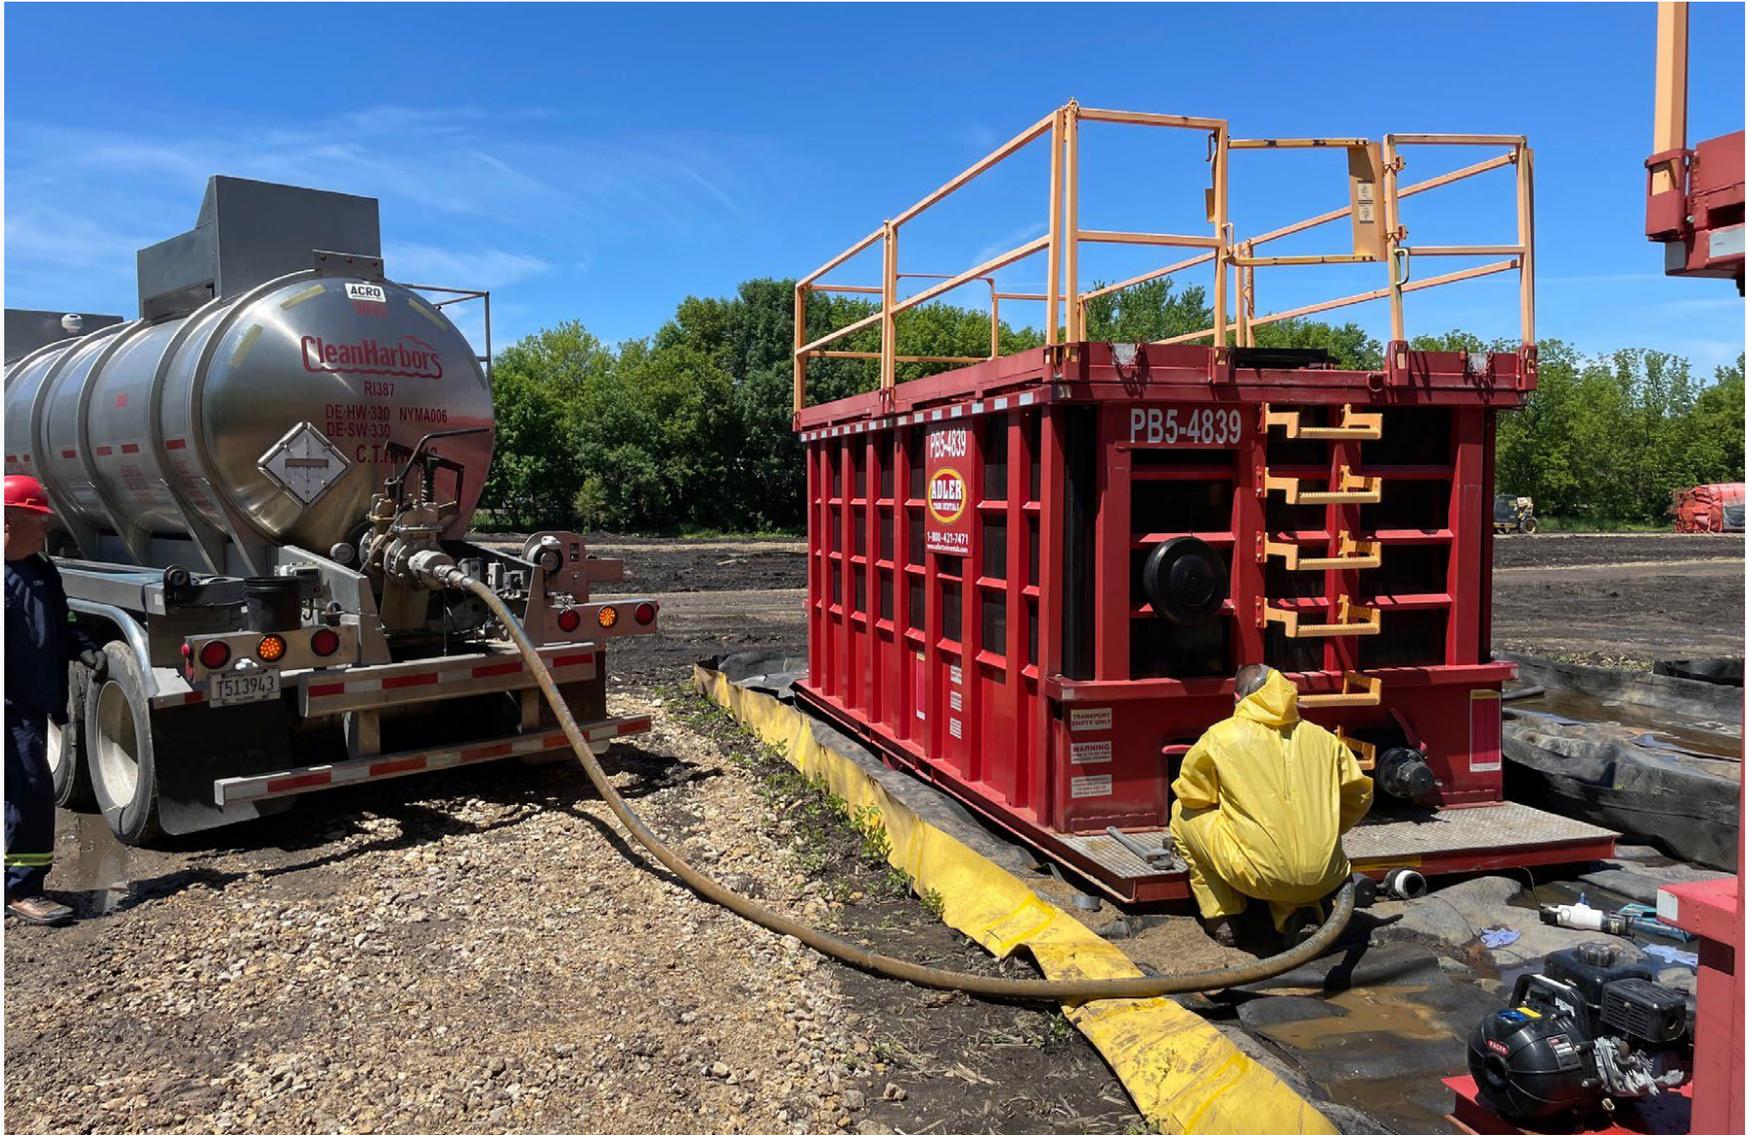
Pure Product HCL frac tank transfers - also, tank cleaning wastes.
