Freight Train Derailment and Chemical Spill

Goose Lake Federal Waterfowl Production Area
Albert Lea, Minnesota. May 15, 2021

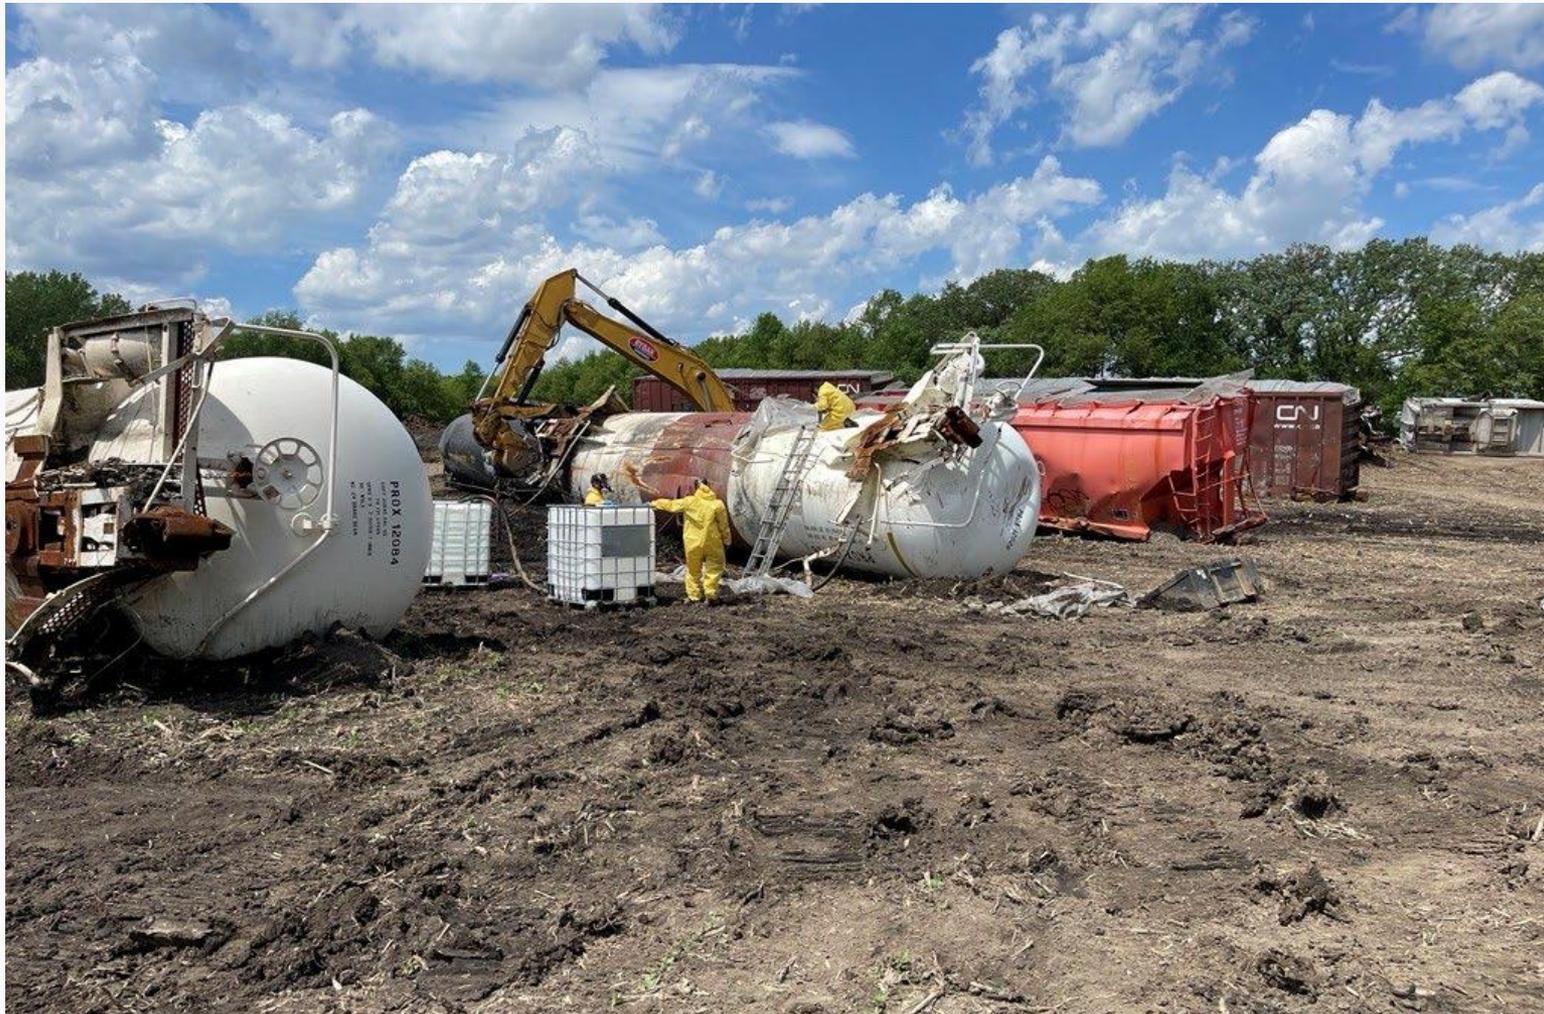
Hydrochloric Acid tanker cleanouts

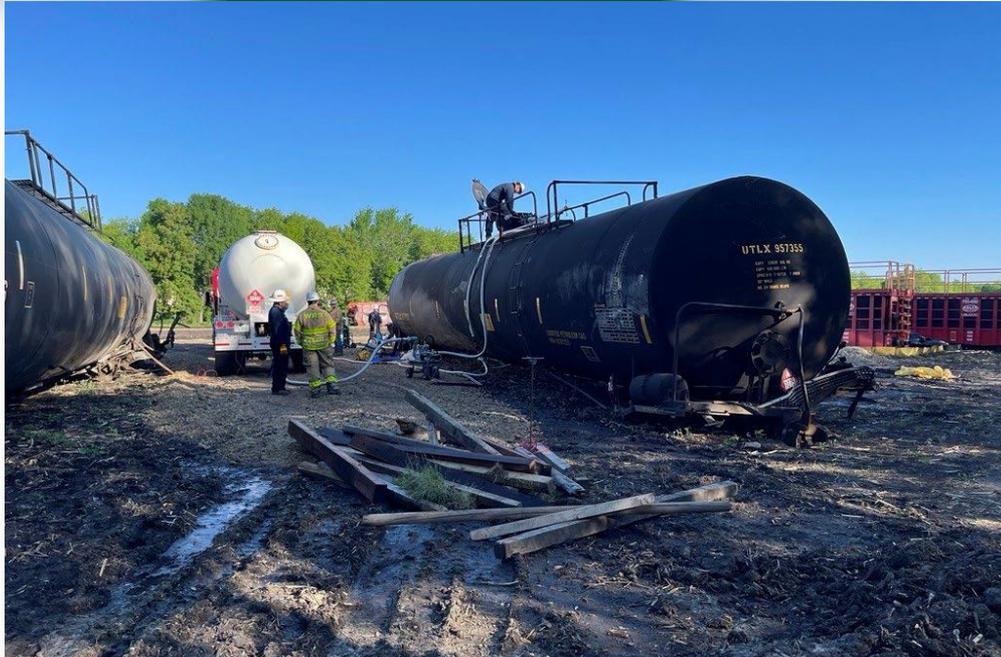
LPG transloading.

LPG Flaring of residuals.
- Roughly 450 gallons/car.

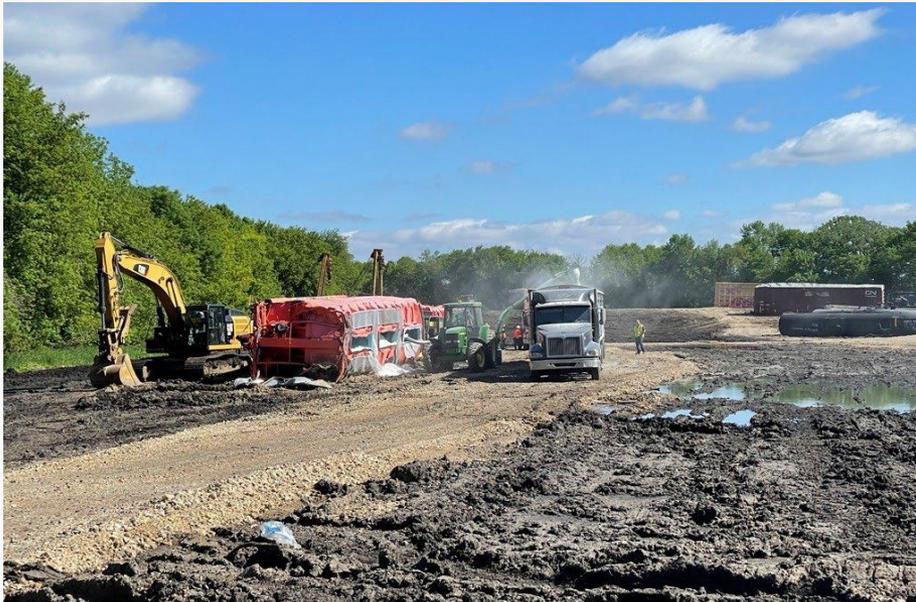
*Photo:
In-car potash transferred for re-use.*

- EPA may want to limit environmental footprint of incident.
 - Responsible Party may want to limit liabilities.
-
- 36.7 tons of spilled potash-KCL was sent to a landfill even though MN Department of Agriculture had been on site and offered to help with beneficial reuse as fertilizer with a local Coop.
 - A waste management plan was then developed.
