CRUDE OIL PIPELINE RELEASE

03-11-2022

Cahokia Creek, Edwardsville, Illinois, USA

Adam Vrabec
Federal On Scene Coordinator
U.S. Environmental Protection Agency

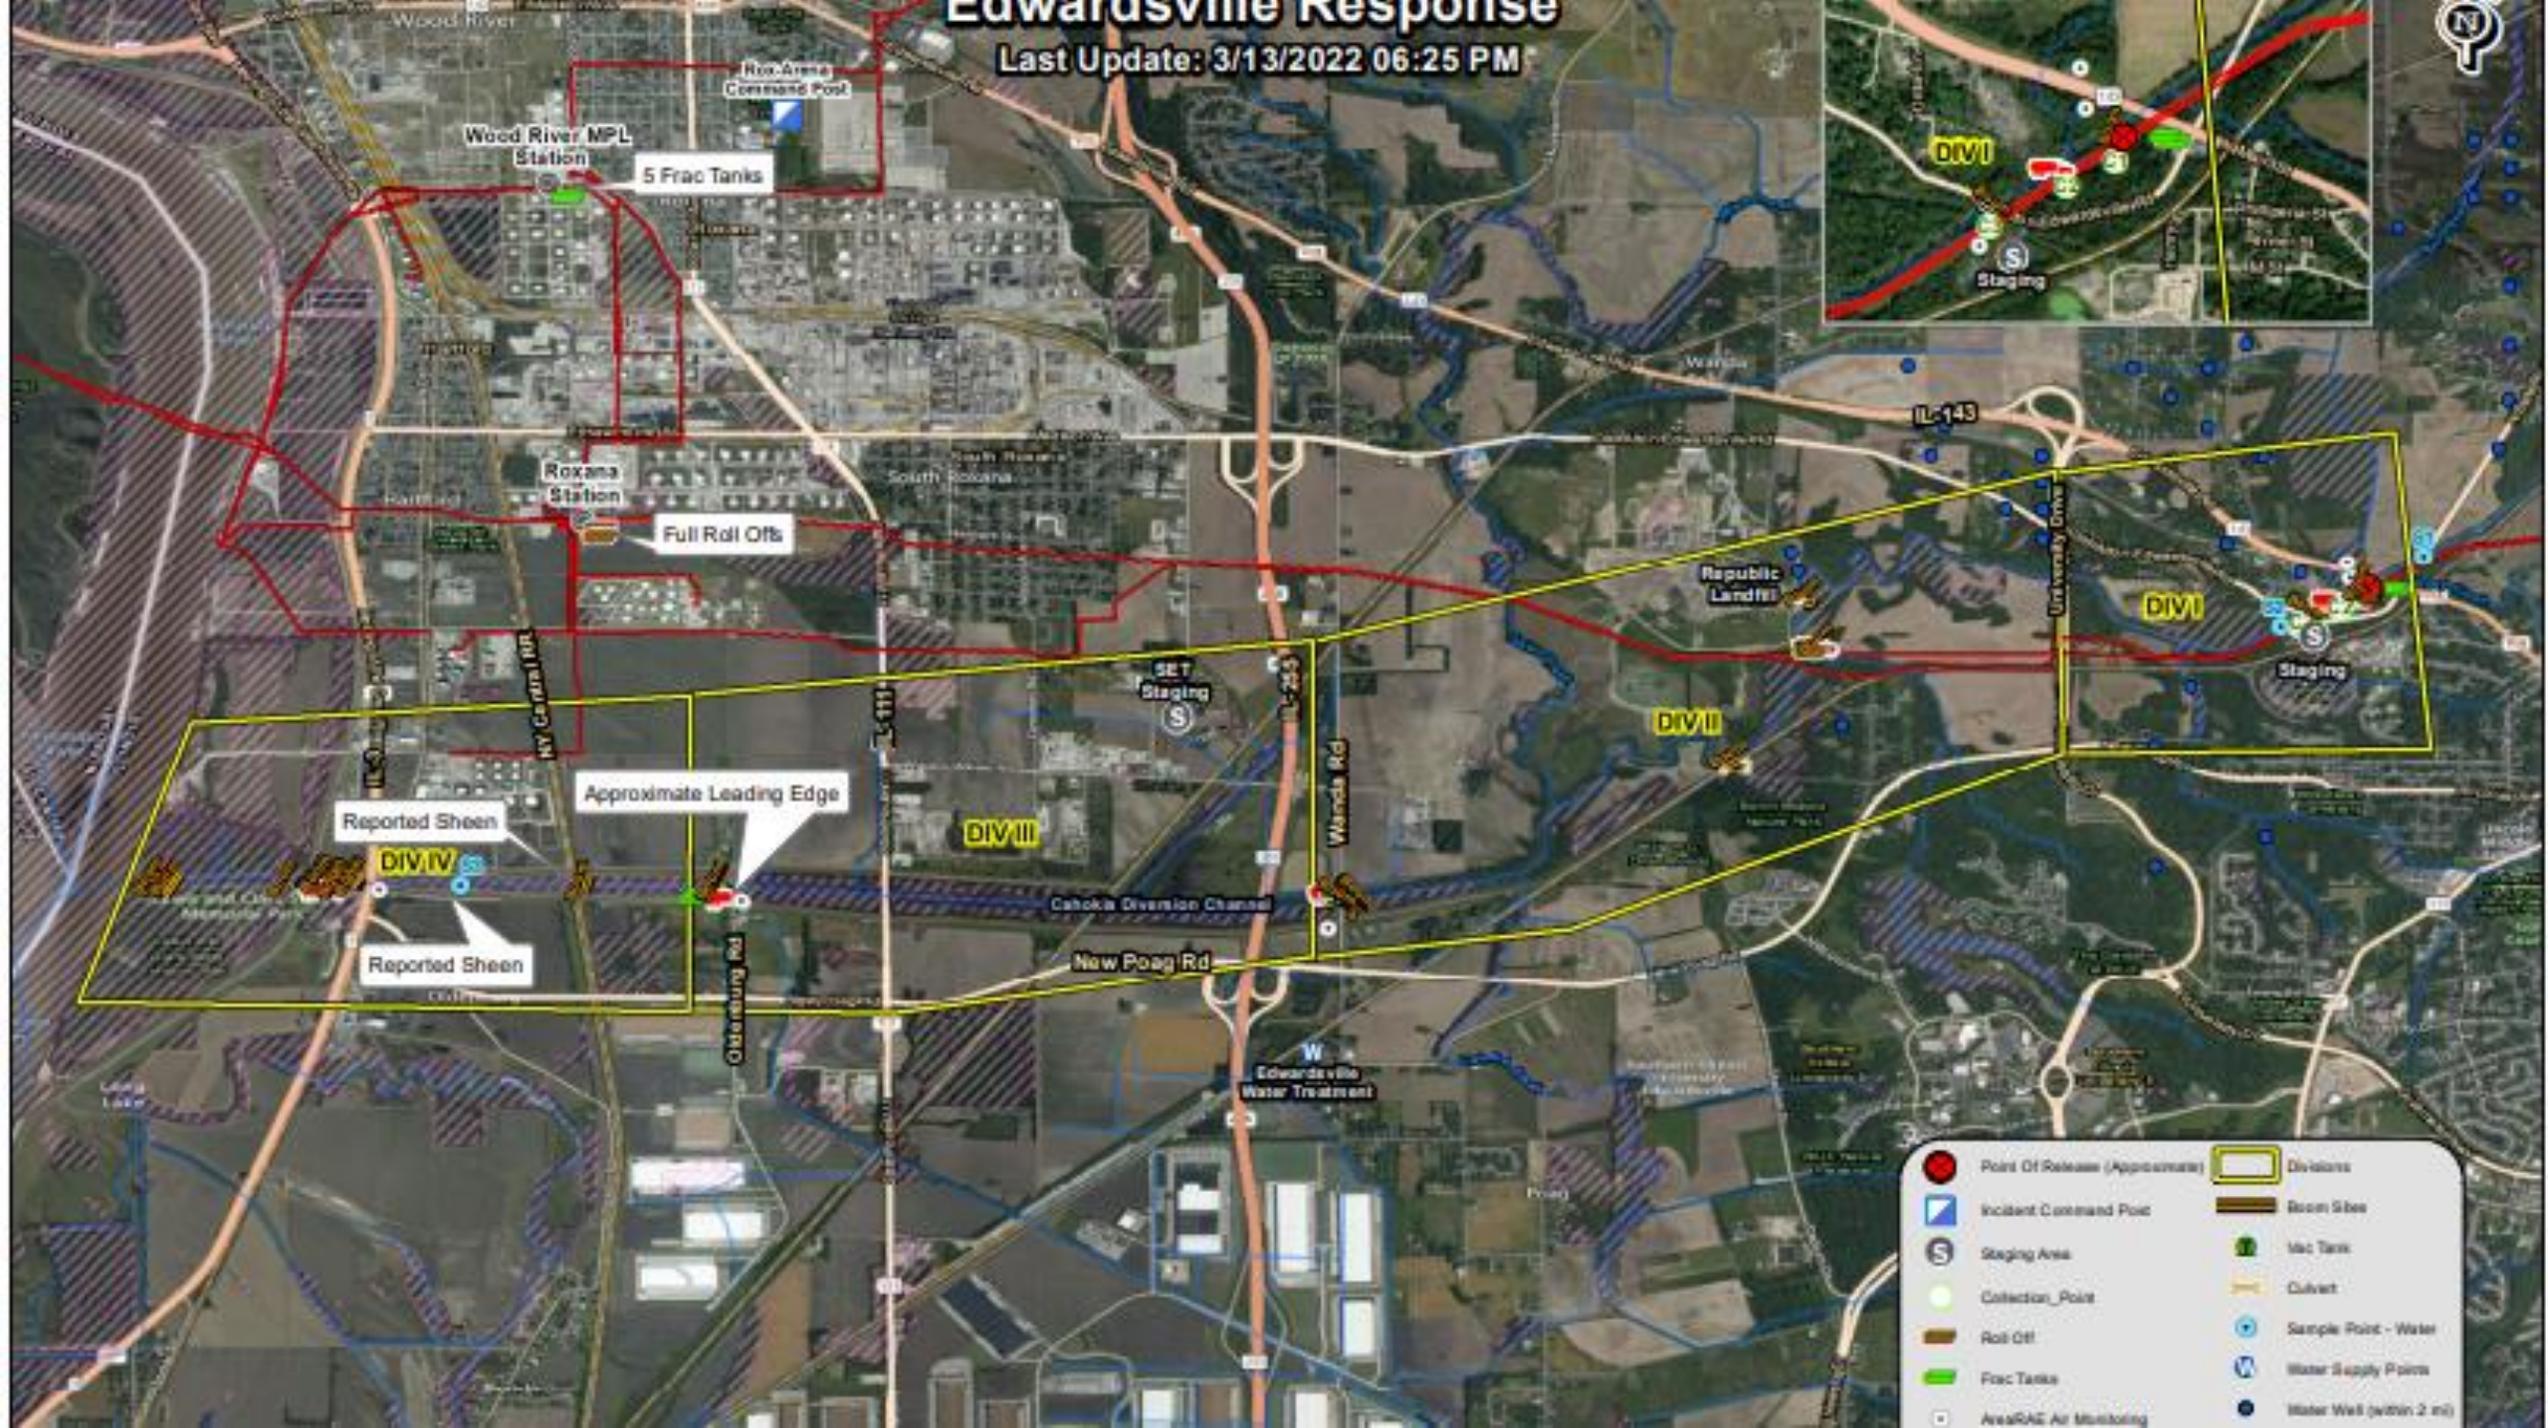
Edwardsville Response

DIVISIONS 1-4

**Division 1=Ground Zero @ Cahokia Creek, Hwy 143 & 159.
(Marathon / Geeding Construction /SET)**

**Division #2=Wanda Bridge (Marathon / Numerous Vac Truck
Companies)**

Division #3=Oldenberge Road (ERLLC / Marathon)

Division #4=Frontage Park (Marathon / Iron Eagle / ERLLC)

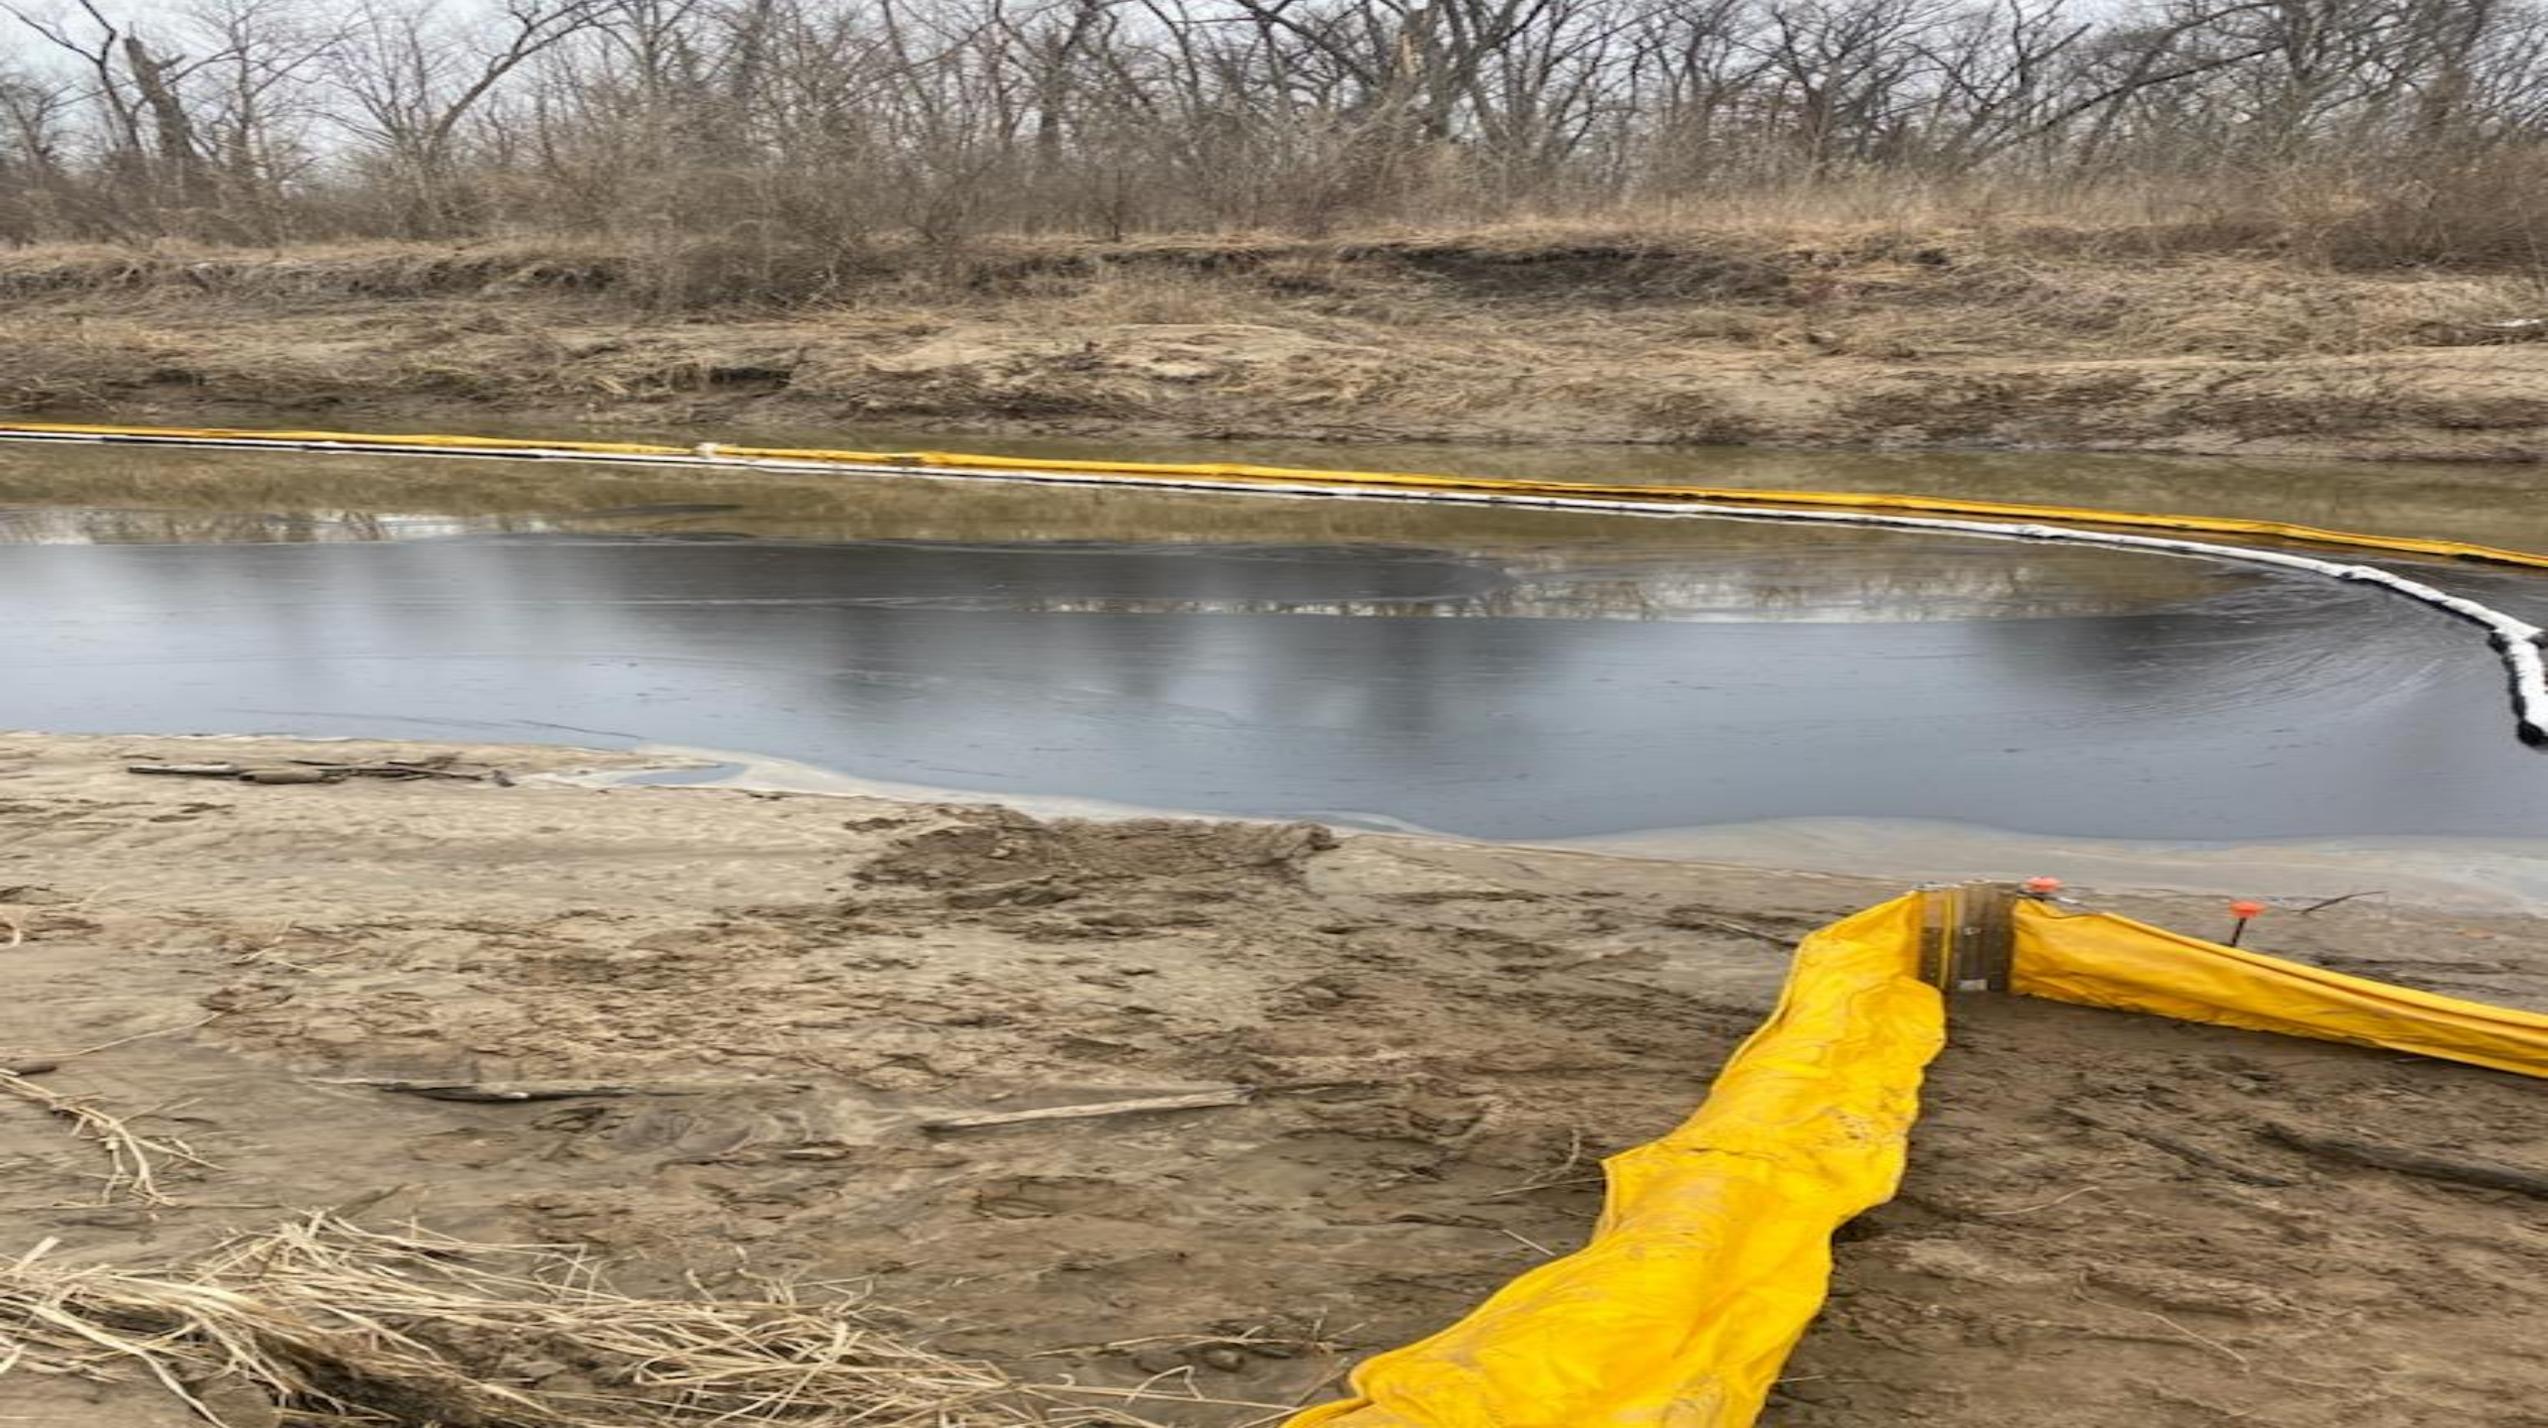
**OSRO DEPLOYING
BOOM BEHIND
LANDFILL**

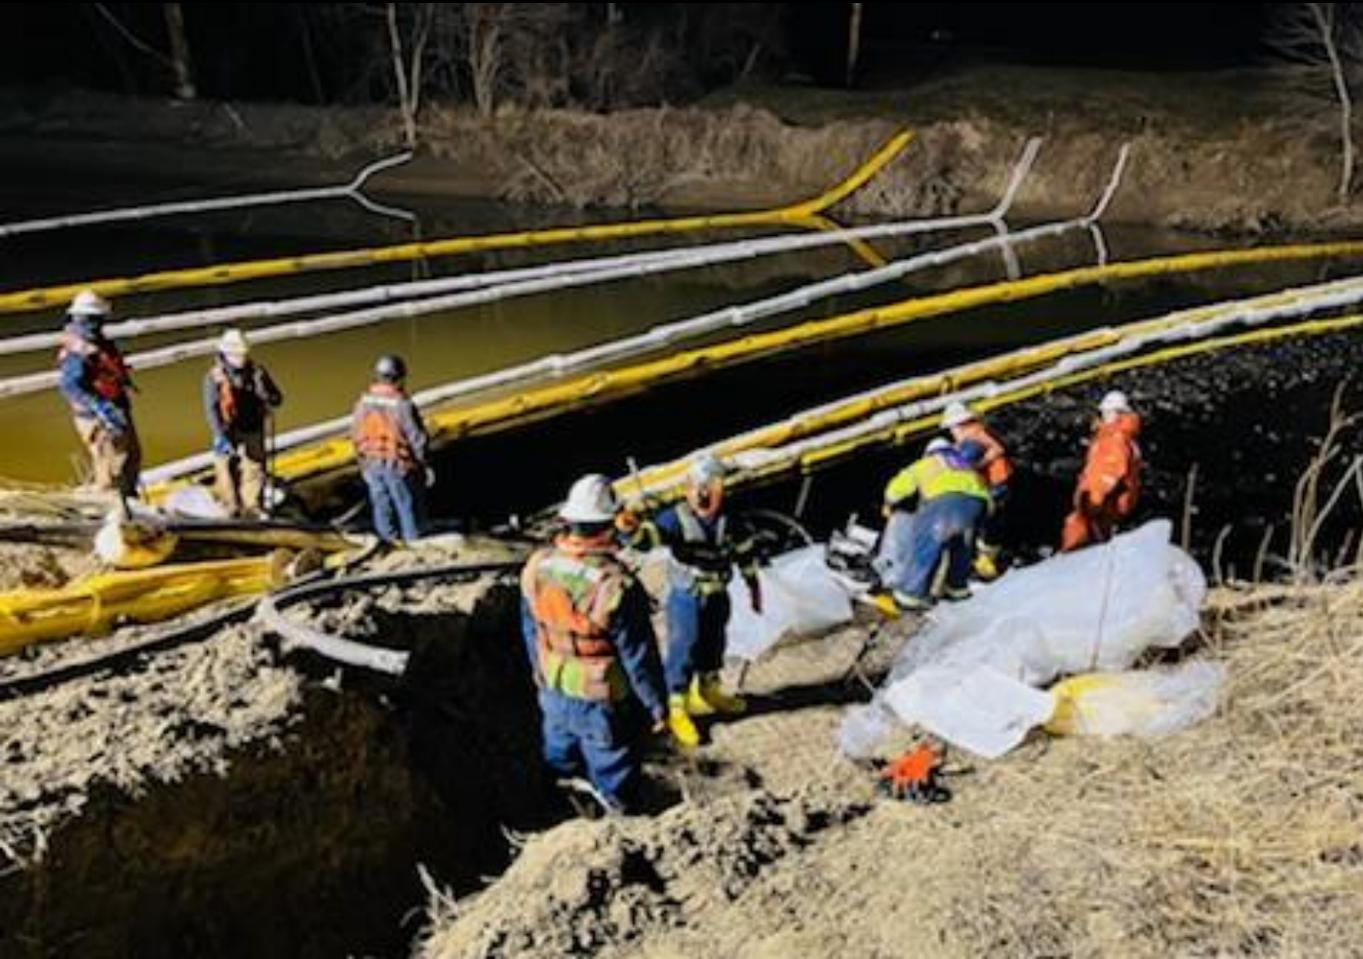
Division 3-Oldenburg Road.

**Note: No bulk oil got past
Div3.**

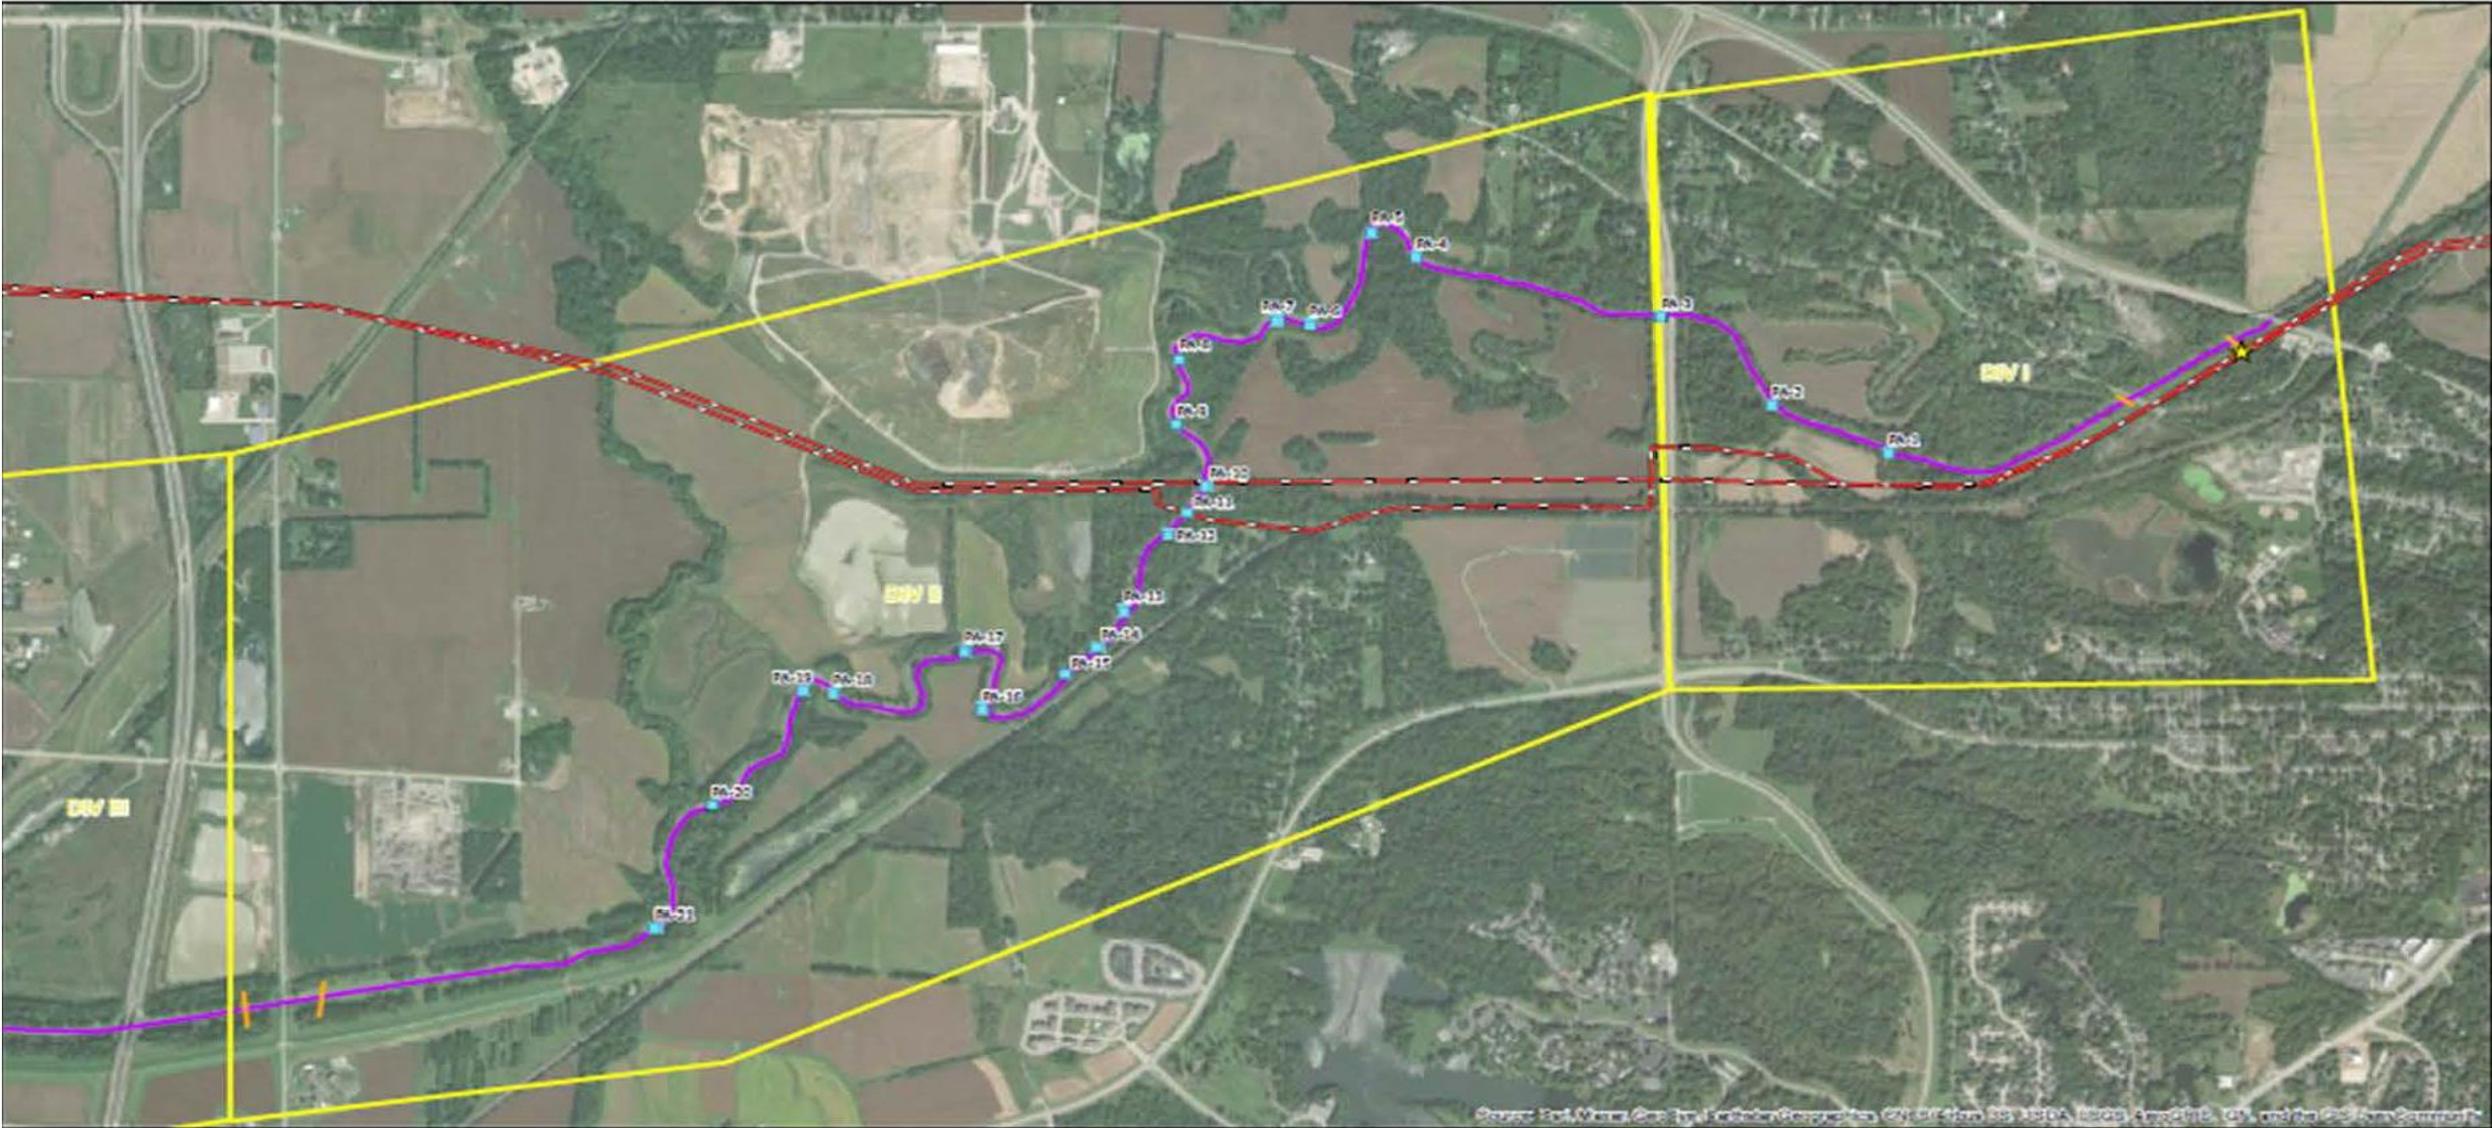
FIGURE 2

**Used to determine if submerged oil
was present in the creek**

**24 locations were identified for
assessment**

SEDIMENT ASSESSMENT POLING LOCATIONS
MARATHON
EDWARDSVILLE, IL

Sediment Assessment Poling Plan was created and executed

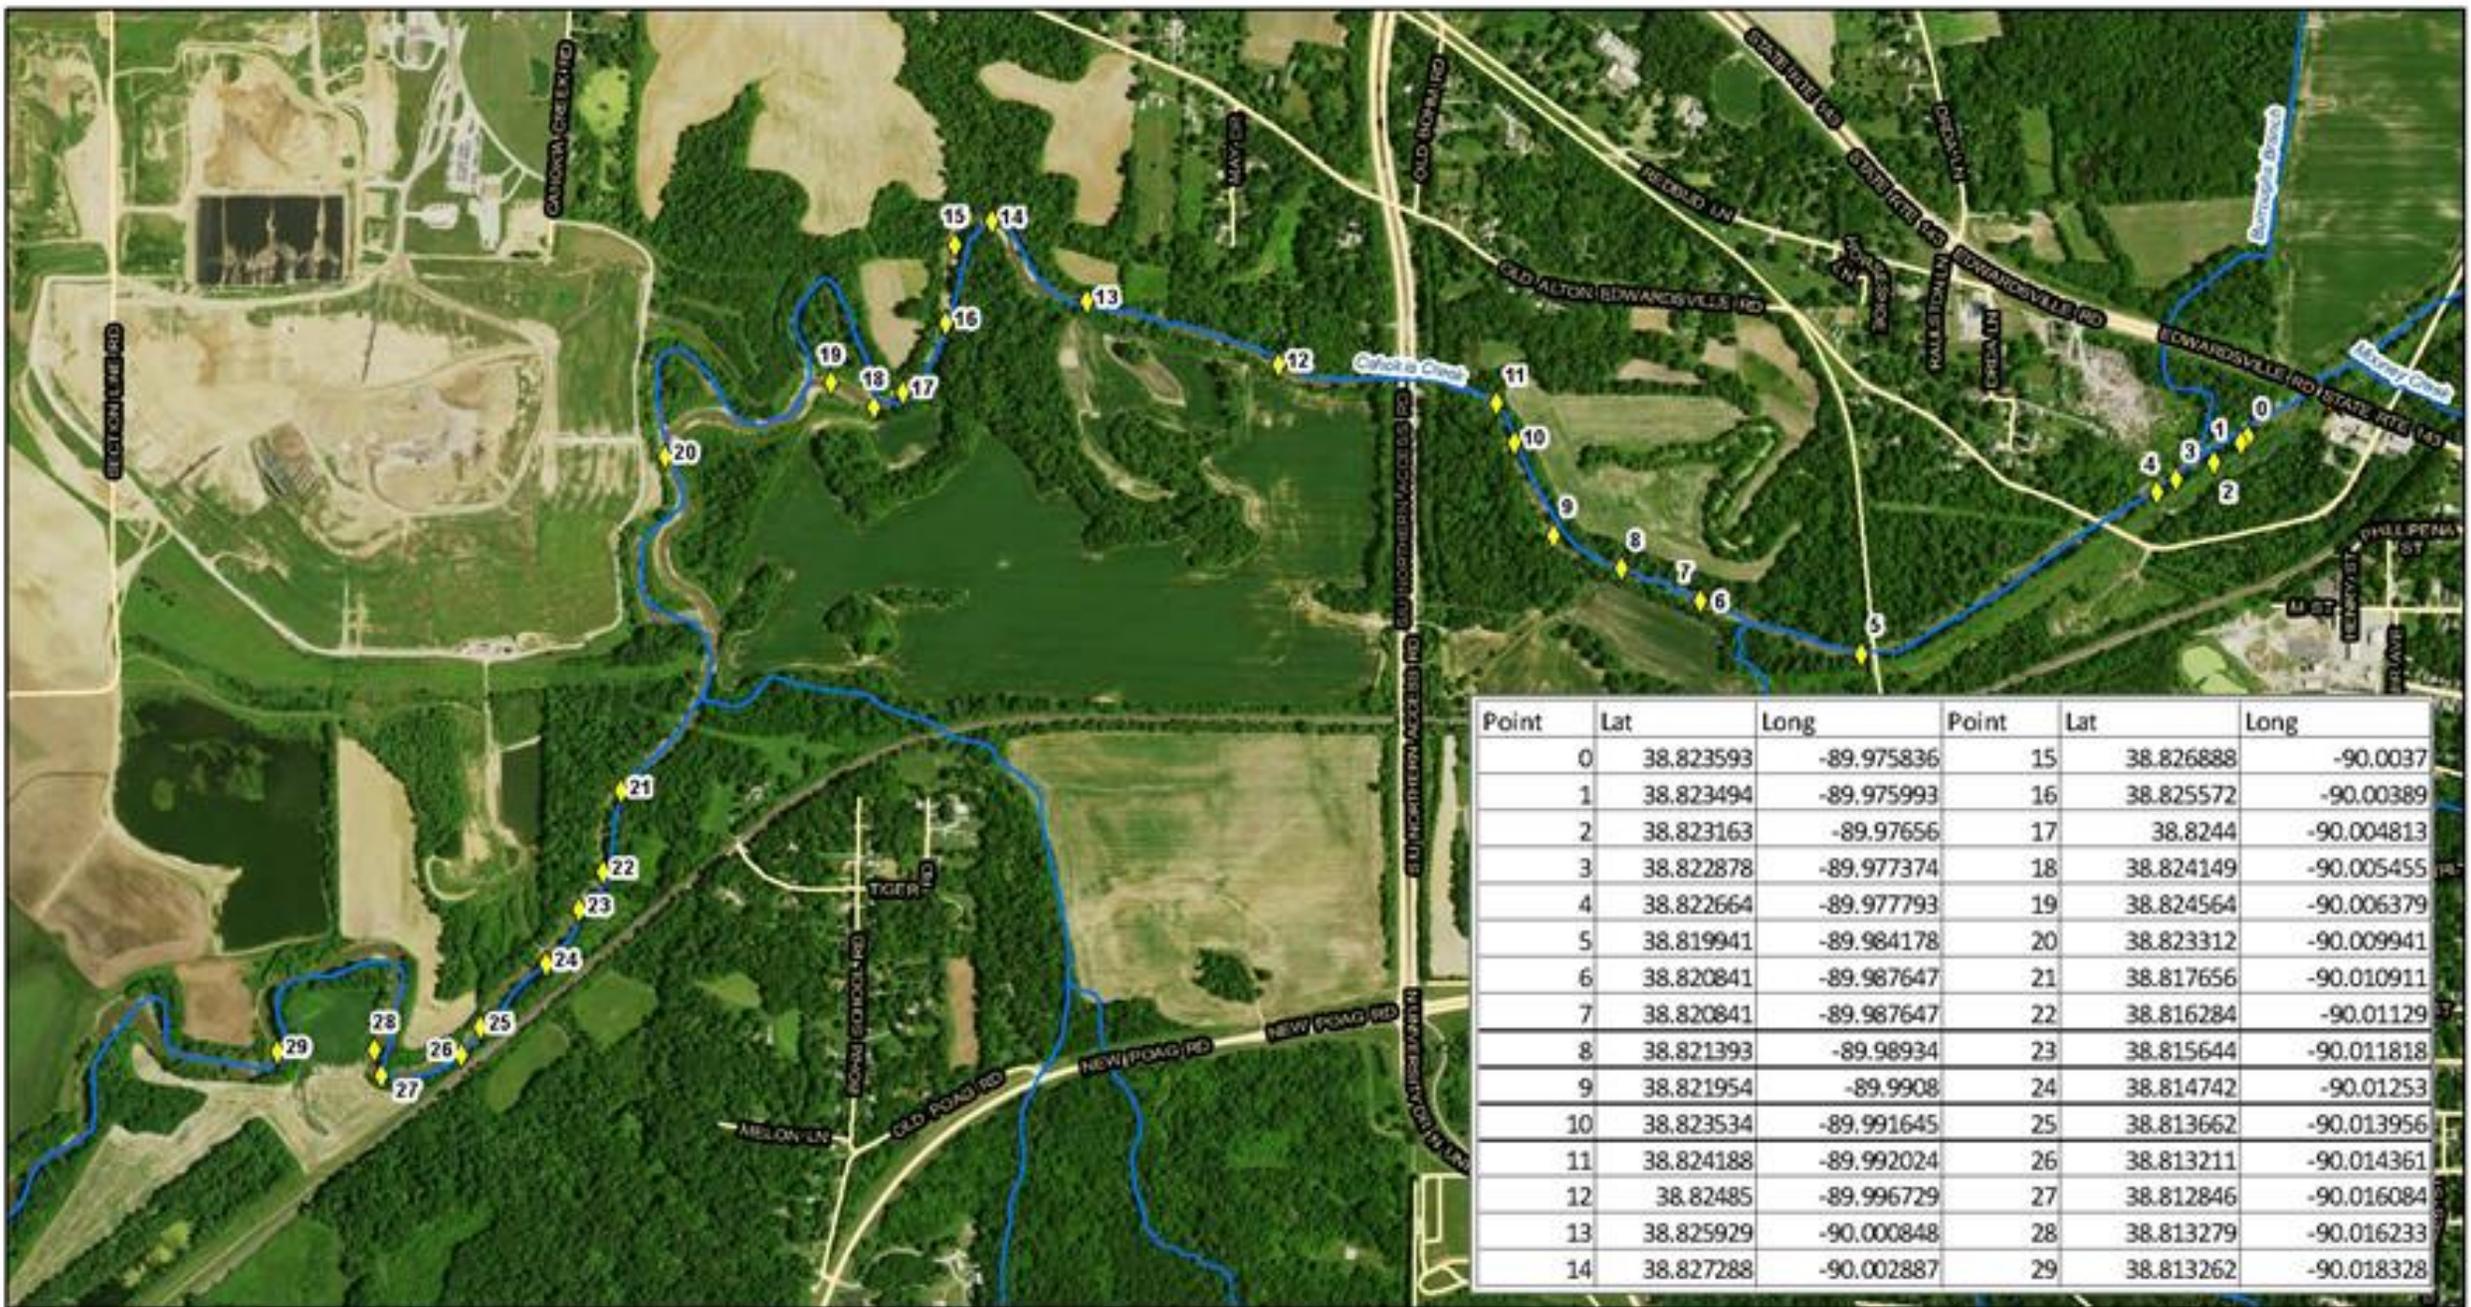
Edwardsville Response
Oil Recovery Locations
Upstream

Point	Lat	Long	Point	Lat	Long
0	38.823593	-89.975836	15	38.826888	-90.0037
1	38.823494	-89.975993	16	38.825572	-90.00389
2	38.823163	-89.97656	17	38.8244	-90.004813
3	38.822878	-89.977374	18	38.824149	-90.005455
4	38.822664	-89.977793	19	38.824564	-90.006379
5	38.819941	-89.984178	20	38.823312	-90.009941
6	38.820841	-89.987647	21	38.817656	-90.010911
7	38.820841	-89.987647	22	38.816284	-90.01129
8	38.821393	-89.98934	23	38.815644	-90.011818
9	38.821954	-89.9908	24	38.814742	-90.01253
10	38.823534	-89.991645	25	38.813662	-90.013956
11	38.824188	-89.992024	26	38.813211	-90.014361
12	38.82485	-89.996729	27	38.812846	-90.016084
13	38.825929	-90.000848	28	38.813279	-90.016233
14	38.827288	-90.002887	29	38.813262	-90.018328

★ Approximate Release Location

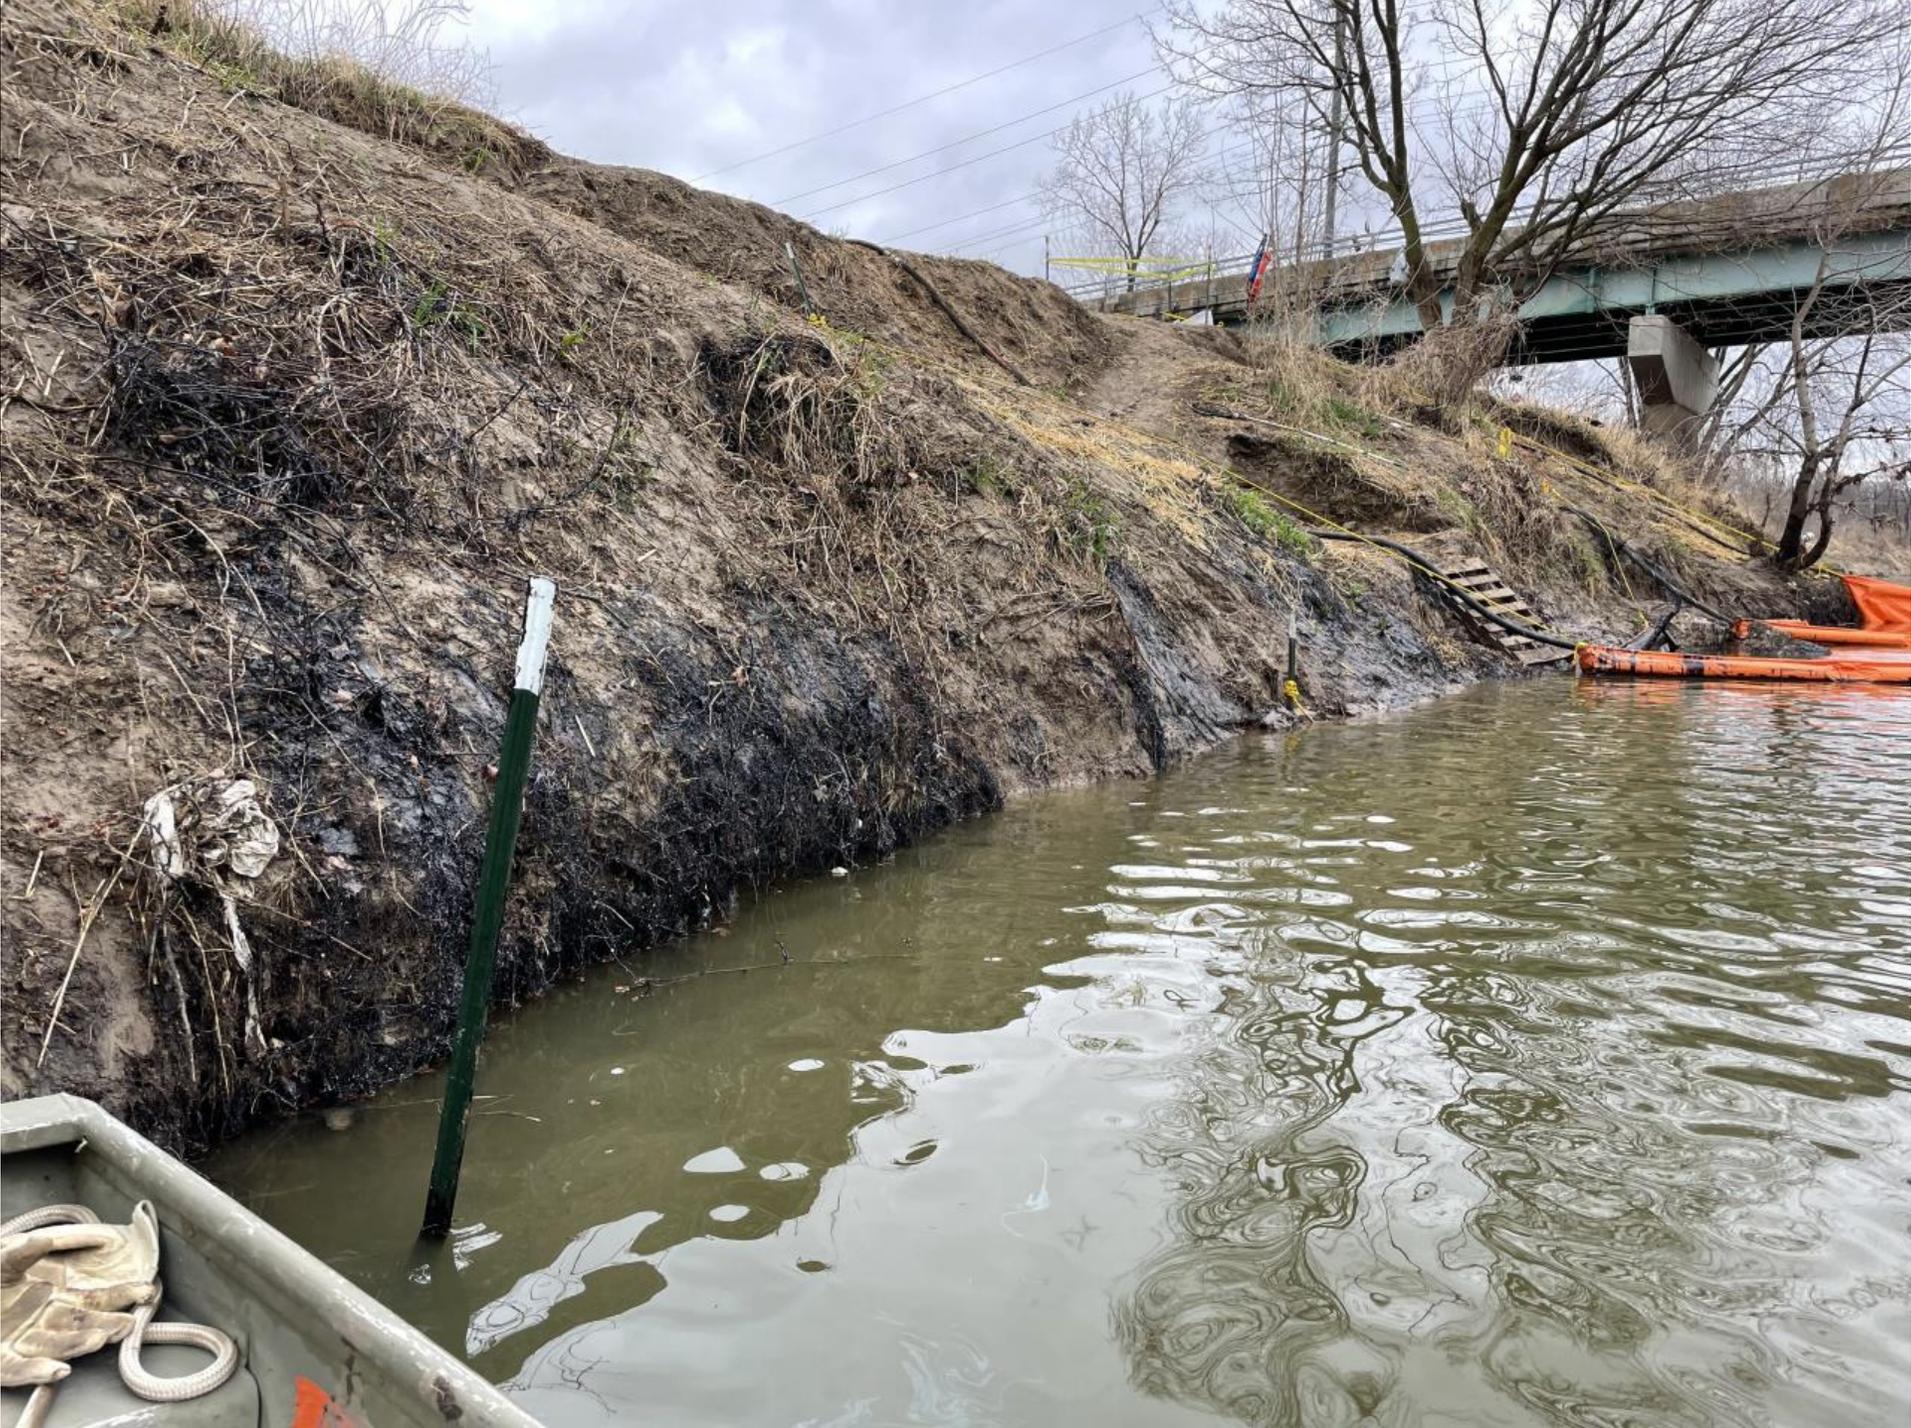
OSRO Boat Ops utilizing pumps, hoses and hand tools to remove contaminated debris caught in and around banks and other creek obstacles.

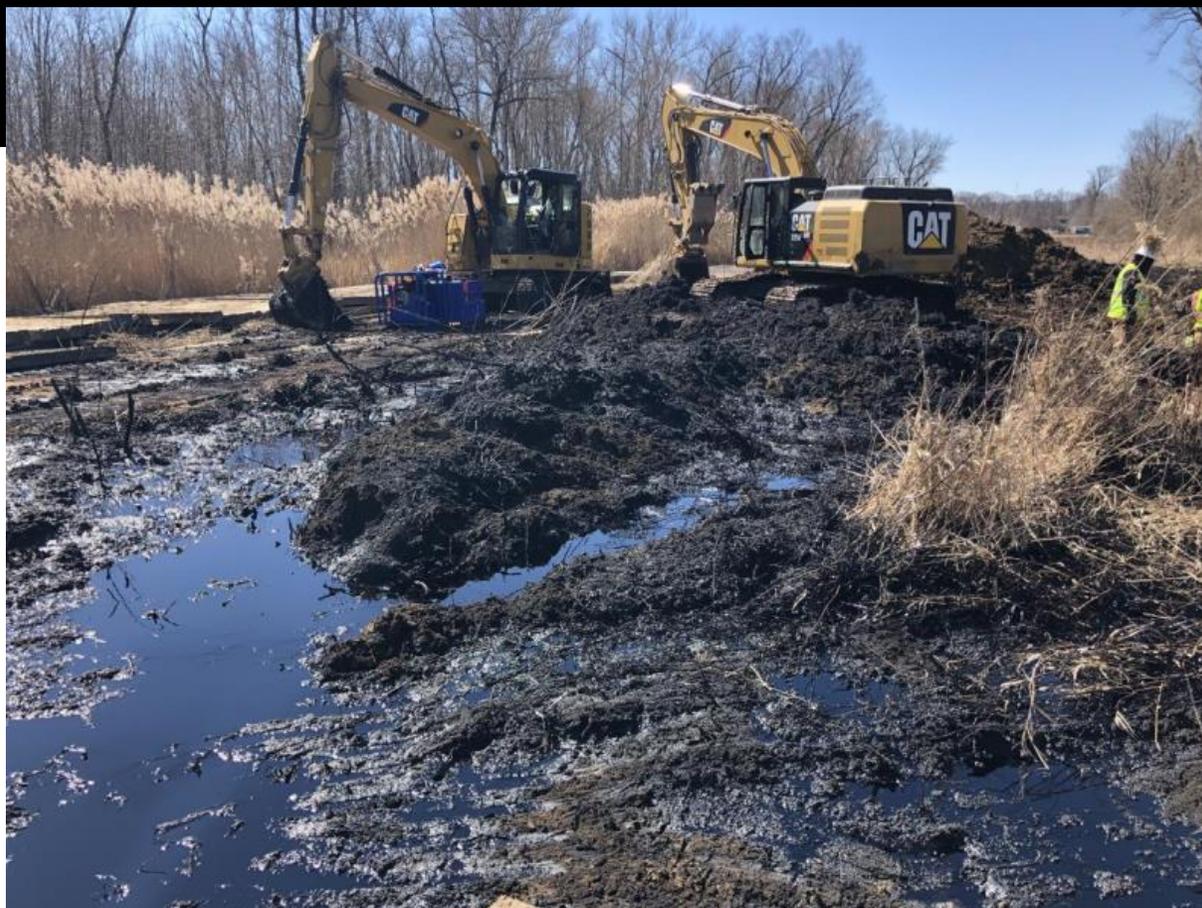
EXCAVATION OF IMPACTED SOIL NEAR SPILL LOCATION
