**Subject: Incident Response Letter Report
Perry Creek Pipeline Oil Spill Emergency Response
Oil City, Yazoo County, Mississippi
Federal Project Number (FPN): E07405
TDD No.: TNA-05-001-0021
Contract No.: EP-W-05-053**

PERRY CREEK OIL SPILL
TDD No. TNA-05-001-0021
OIL CITY, YAZOO COUNTY,
MISSISSIPPI

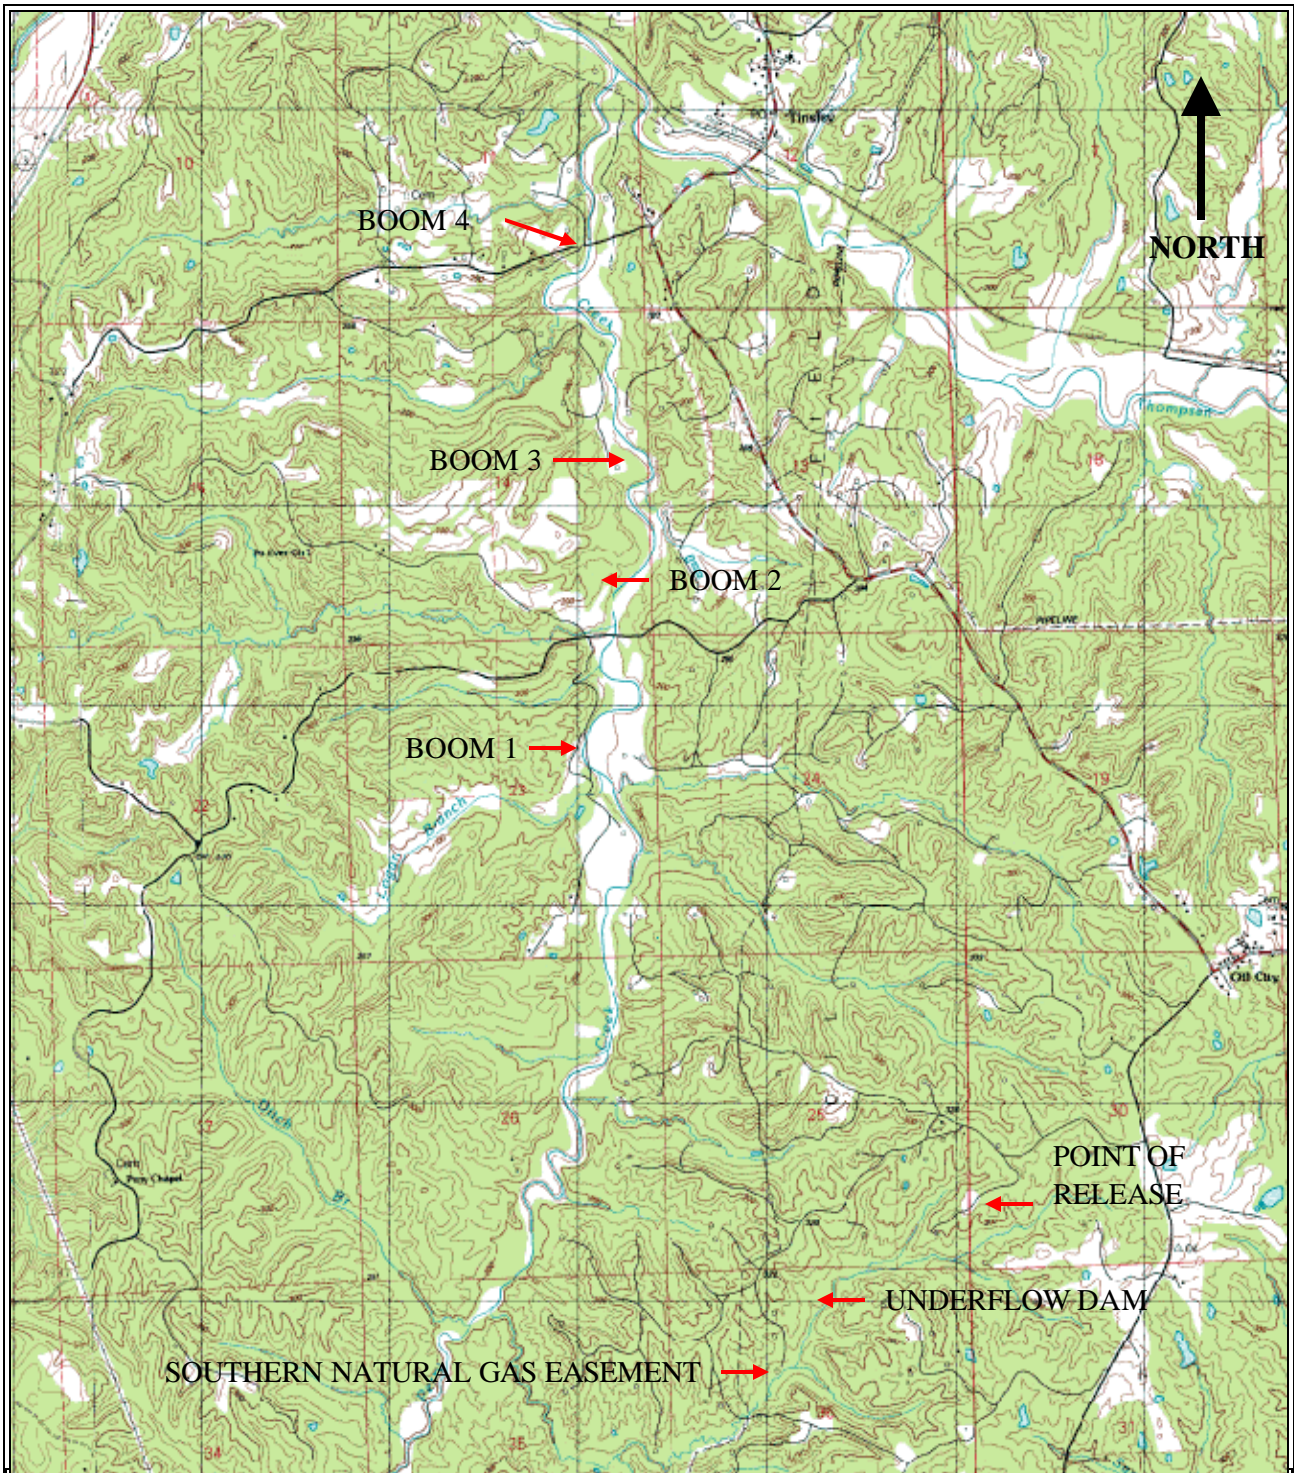
FIGURE 1 - TOPOGRAPHIC MAP

The oil-impacted area is approximately 4.5–5.5 miles long, beginning at the break in the pipeline. This point was designated as the Point of Release (POR). The POR is located off of Henderson Road, which is situated west of Oil City and south of Tinsley in Yazoo County. The latitude and longitude of the POR is 32°40.921' North and 90°27.002' West. Figure 1 illustrates the physical location of the POR, the oil-impacted area, and boom locations.

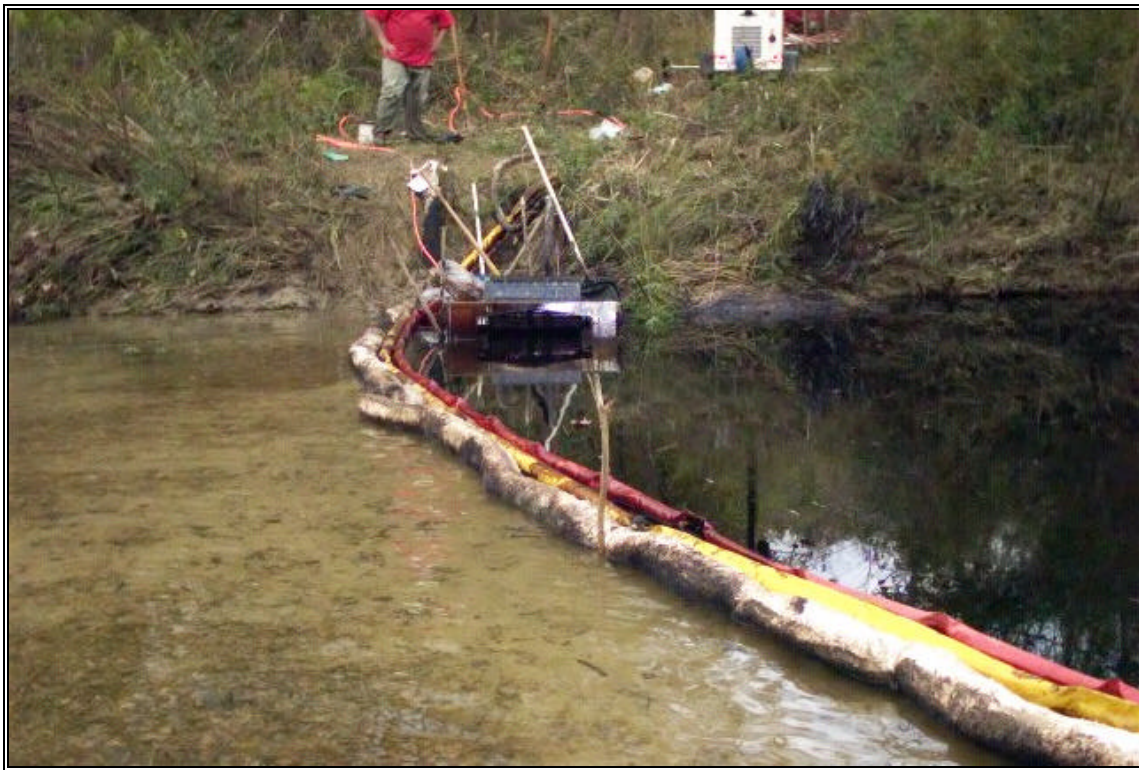
OFFICIAL PHOTOGRAPH No. 1
U.S. ENVIRONMENTAL PROTECTION AGENCY

Subject: Leading Edge of Spill at boom 3, Day 1.

pipeline and began working on the break in the pipeline. USES personnel were on site by 0900 and immediately began twenty-four hour oil recovery operations. A temporary cap was placed on the pipeline at 1530. Three oil-containing booms (Booms 1, 2, and 3) were in place along Perry Creek by 1600. Active oil recovery with oil skimmers and vacuum trucks commenced at the three boom locations by 1800.

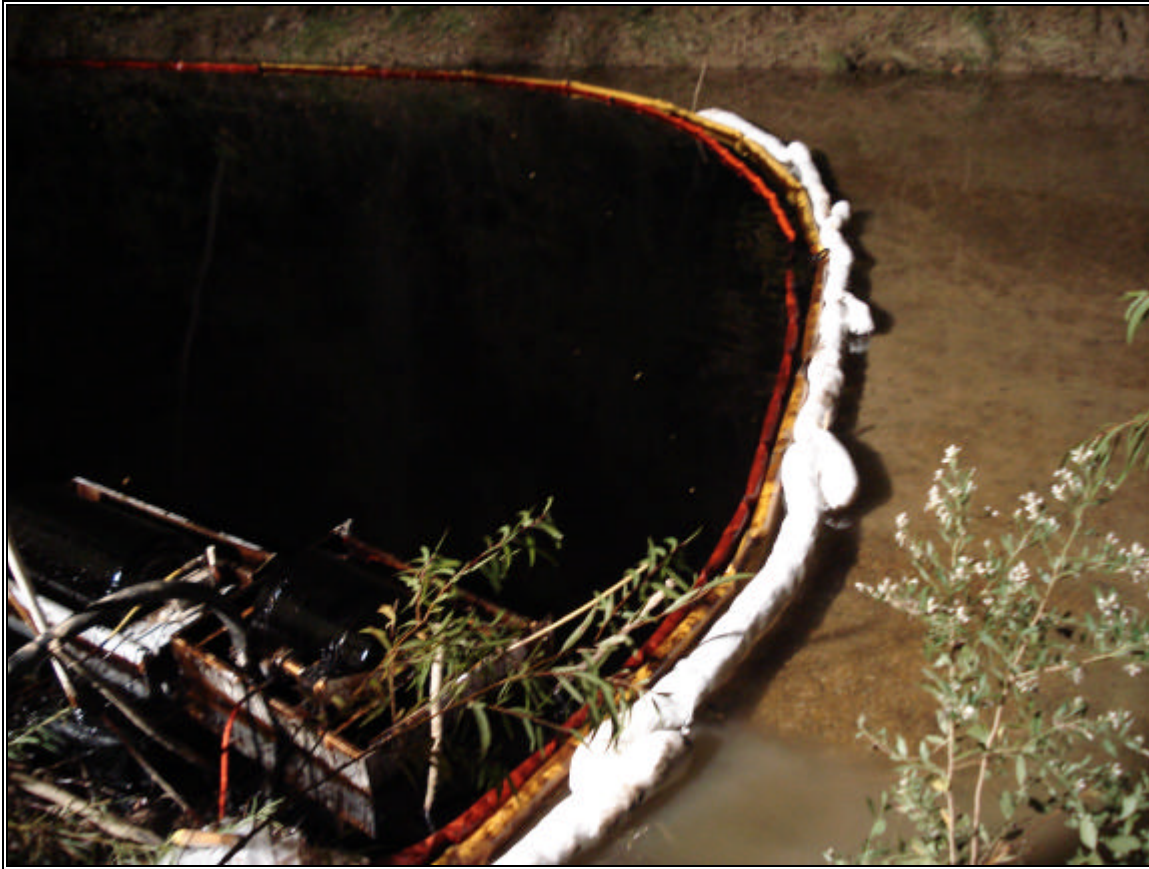
OFFICIAL PHOTOGRAPH No. 2
U.S. ENVIRONMENTAL PROTECTION AGENCY

Subject: Leading Edge of Spill at boom 3, Day 1.

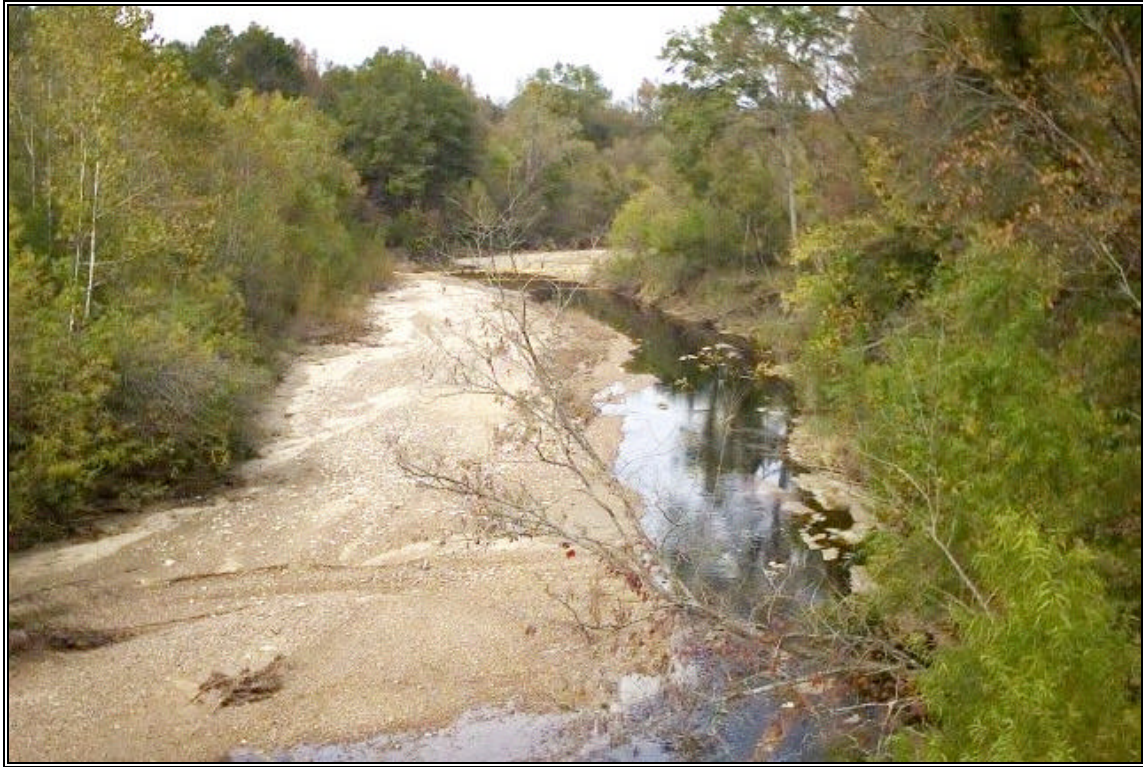
OFFICIAL PHOTOGRAPH No. 3
U.S. ENVIRONMENTAL PROTECTION AGENCY

Subject: Perry Creek looking downstream towards boom 1, Day 1.

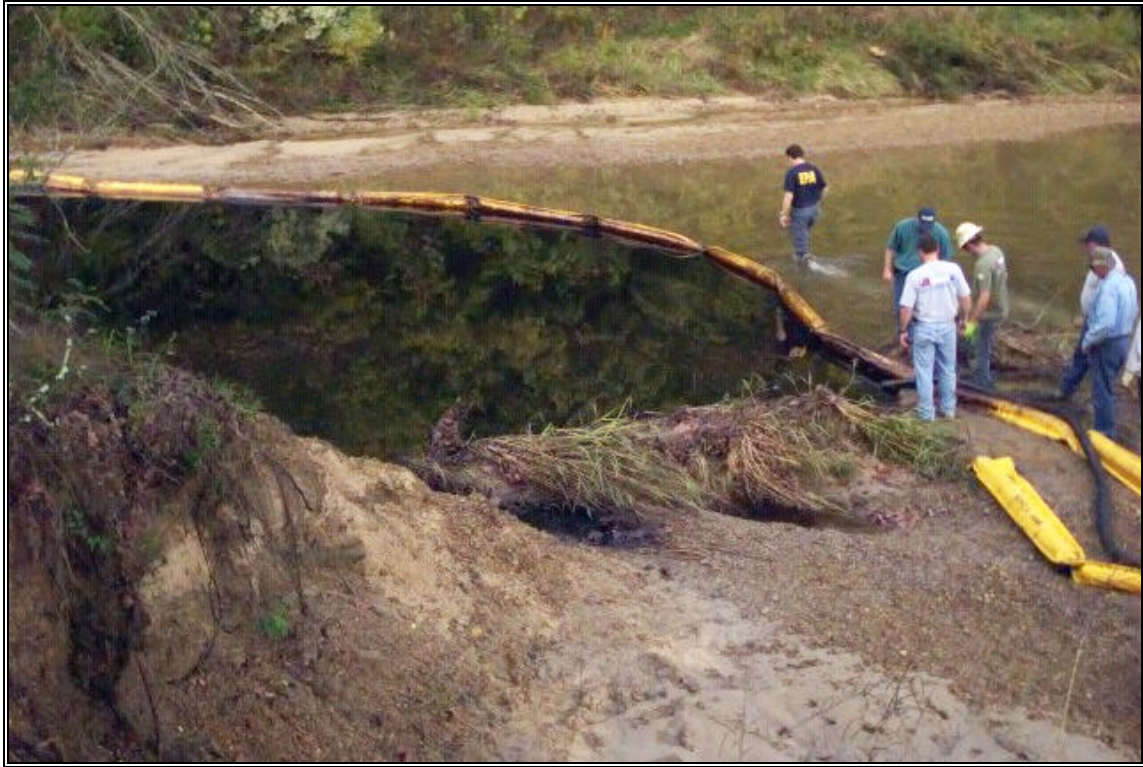
OFFICIAL PHOTOGRAPH No. 5
U.S. ENVIRONMENTAL PROTECTION AGENCY

Subject: Boom 1, Day 2.

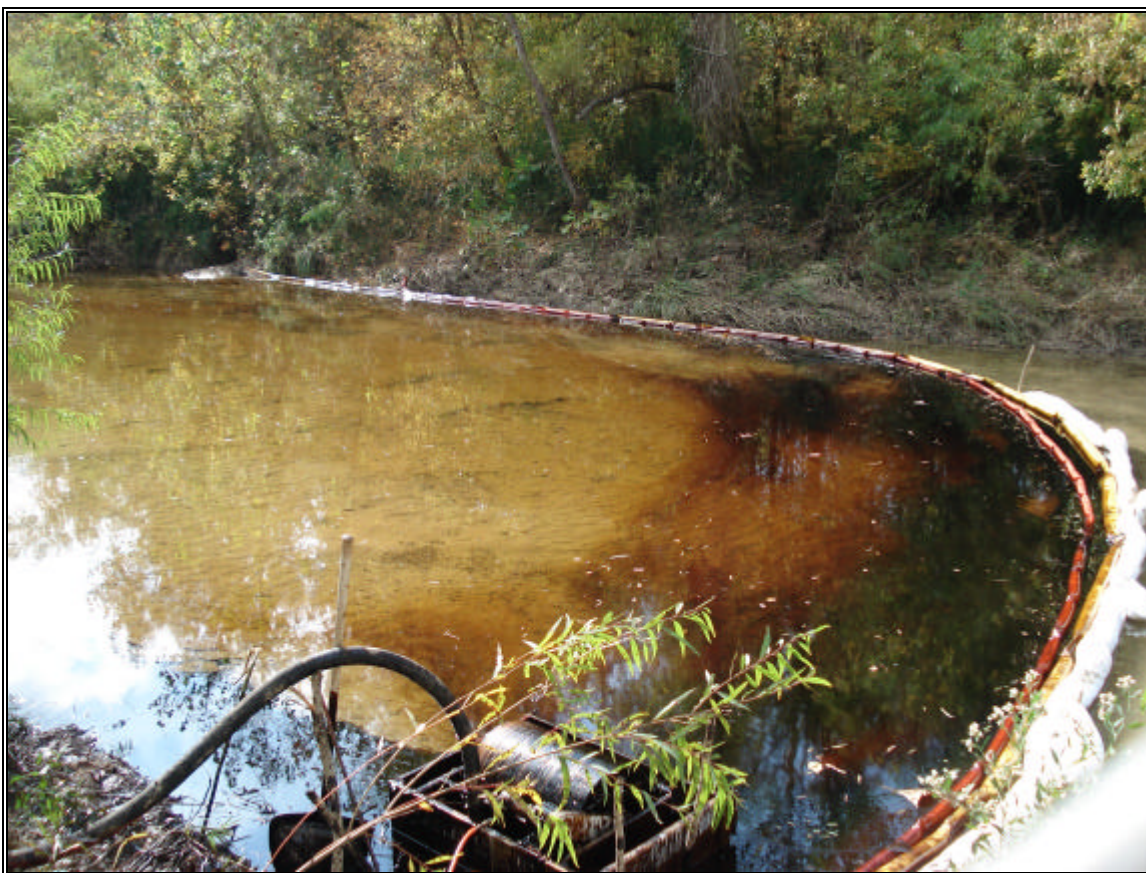
OFFICIAL PHOTOGRAPH No. 6
U.S. ENVIRONMENTAL PROTECTION AGENCY

Subject: Boom 3 (leading edge) facing upstream, Day 2.

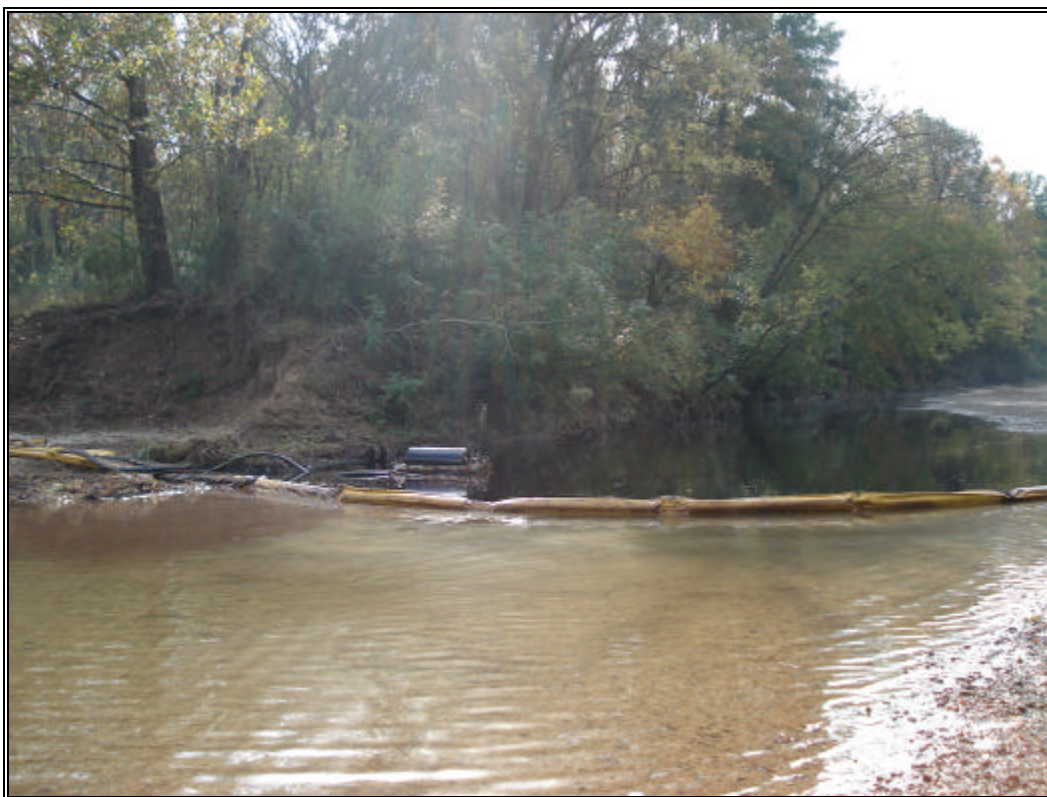
OFFICIAL PHOTOGRAPH No. 7
U.S. ENVIRONMENTAL PROTECTION AGENCY

Subject: Boom 1 (facing upstream), Day 2.

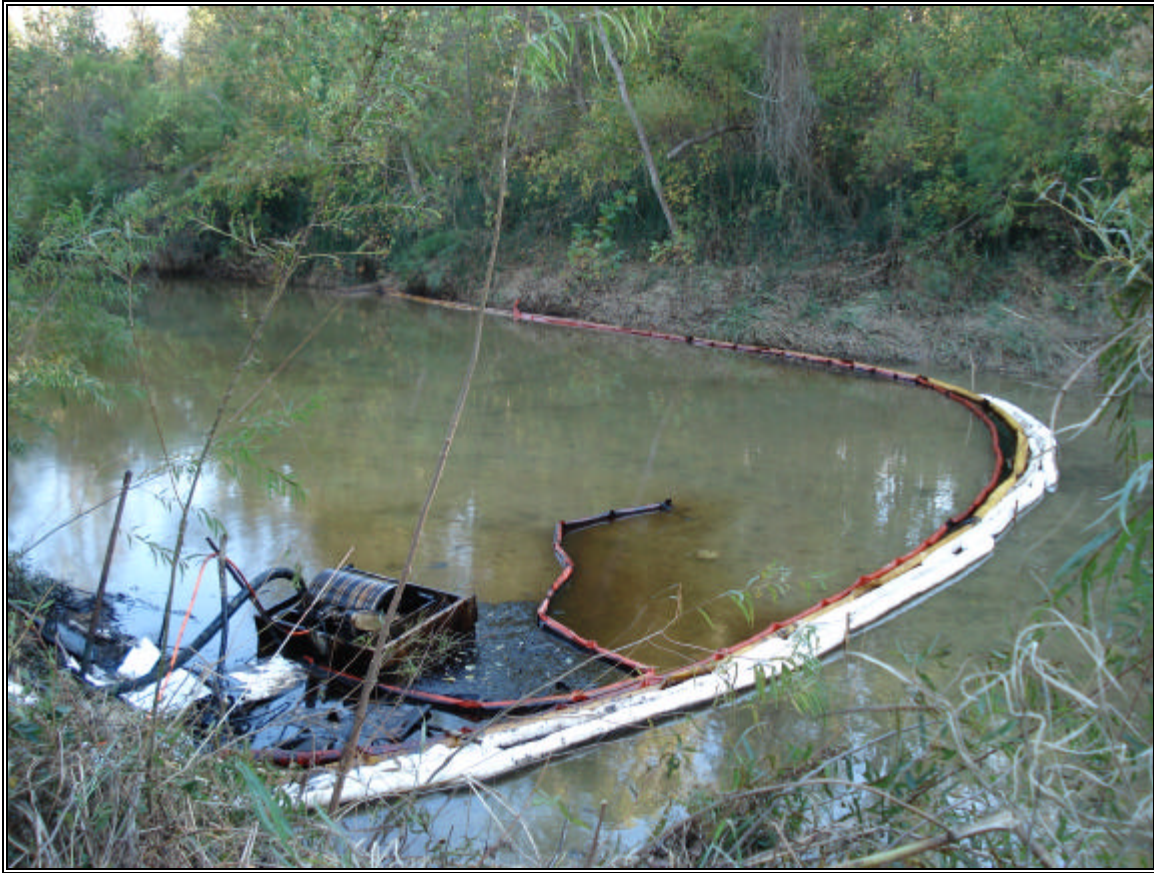
OFFICIAL PHOTOGRAPH No. 9
U.S. ENVIRONMENTAL PROTECTION AGENCY

Subject: Boom 3, Day 3.

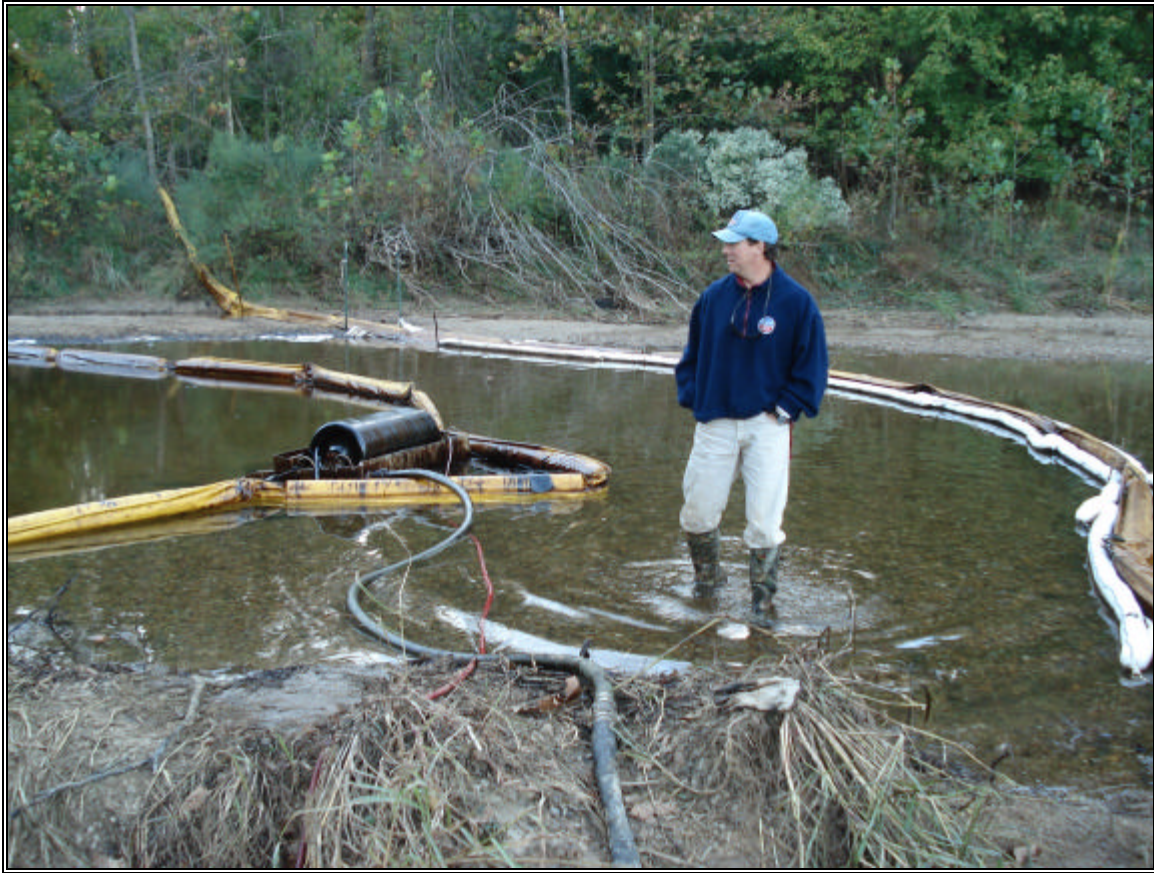
OFFICIAL PHOTOGRAPH No. 10
U.S. ENVIRONMENTAL PROTECTION AGENCY

Subject: Boom 1, Day 3.

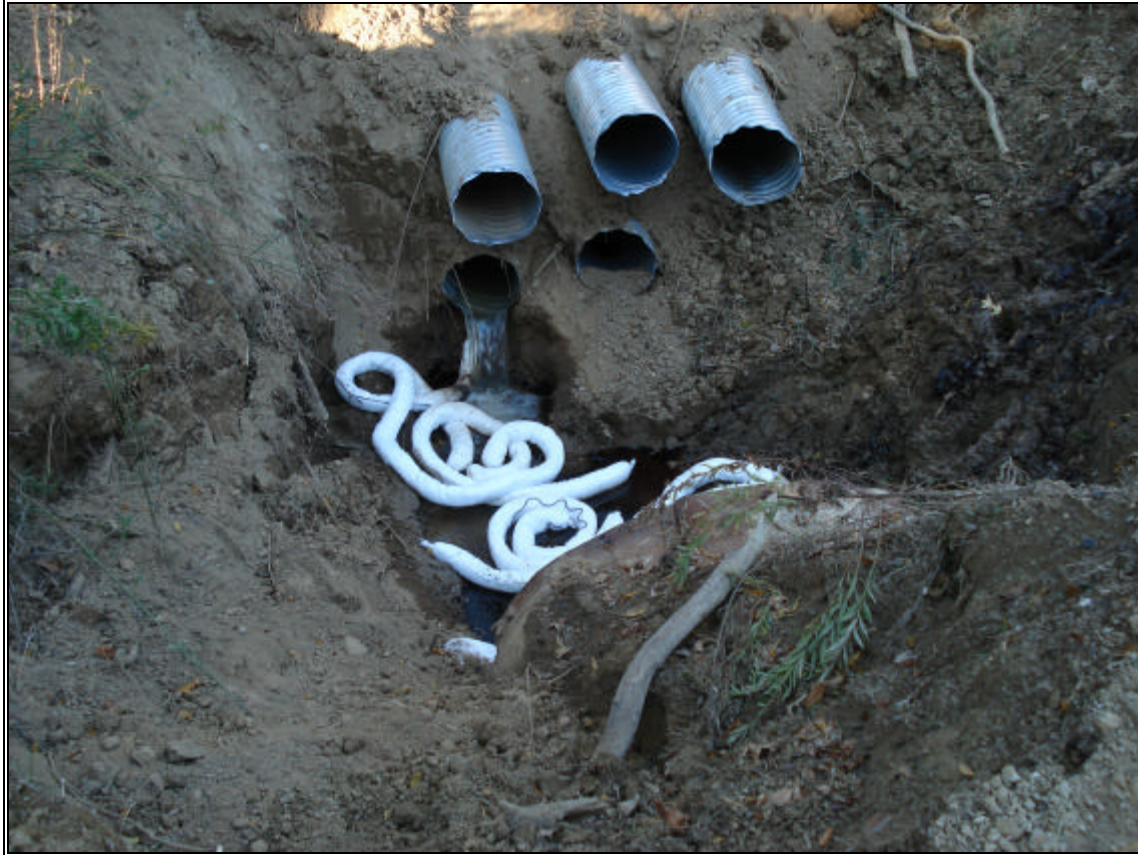
OFFICIAL PHOTOGRAPH No. 11
U.S. ENVIRONMENTAL PROTECTION AGENCY

Subject: Downstream side of underflow dam (facing upstream), Day 3.

At 0700 hours on November 2, 2006, construction of the underflow dam was completed and construction of a board road to the Southern Natural Gas pipeline easement began. Oil skimming operations continued at booms 1, 2, and 3. Skimming began at the underflow dam by 14:55.

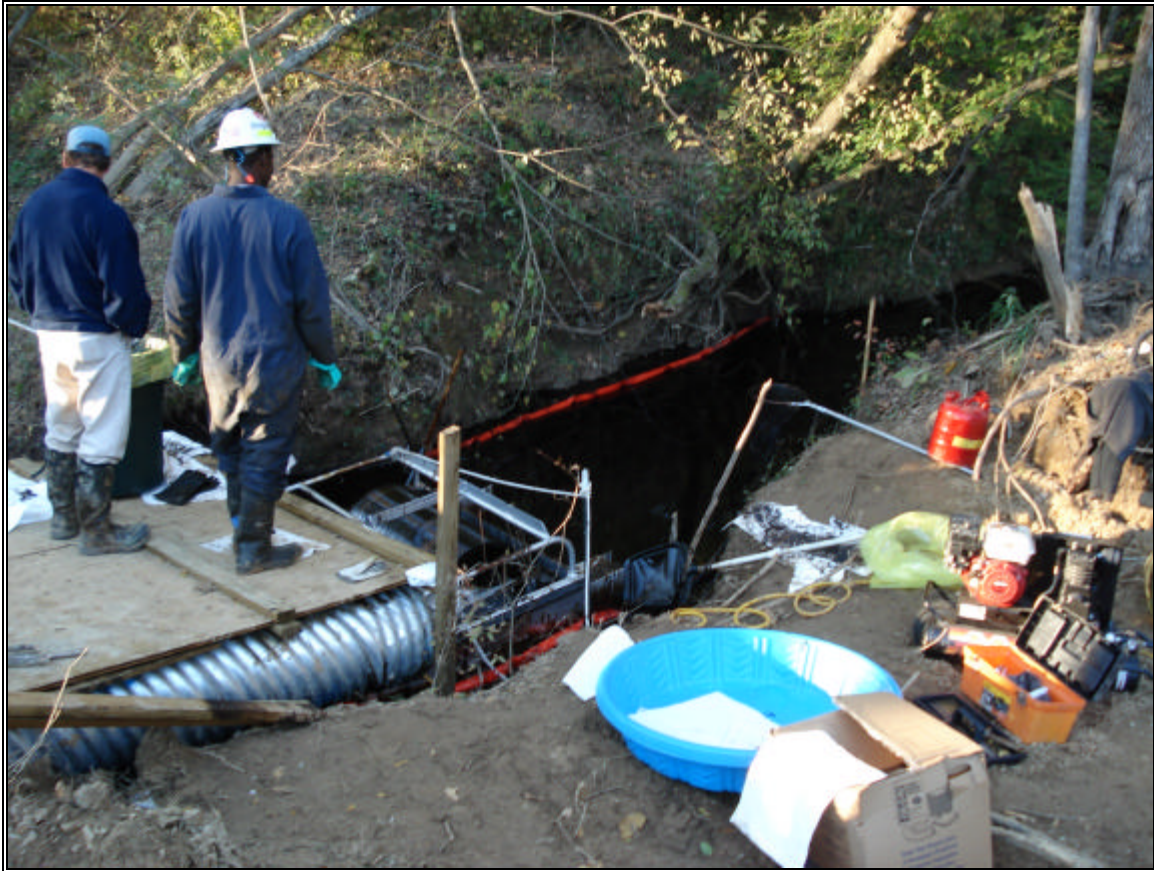
OFFICIAL PHOTOGRAPH No. 12
U.S. ENVIRONMENTAL PROTECTION AGENCY

Subject: Oil skimmer on upstream side of underflow dam (facing upstream), Day 3.

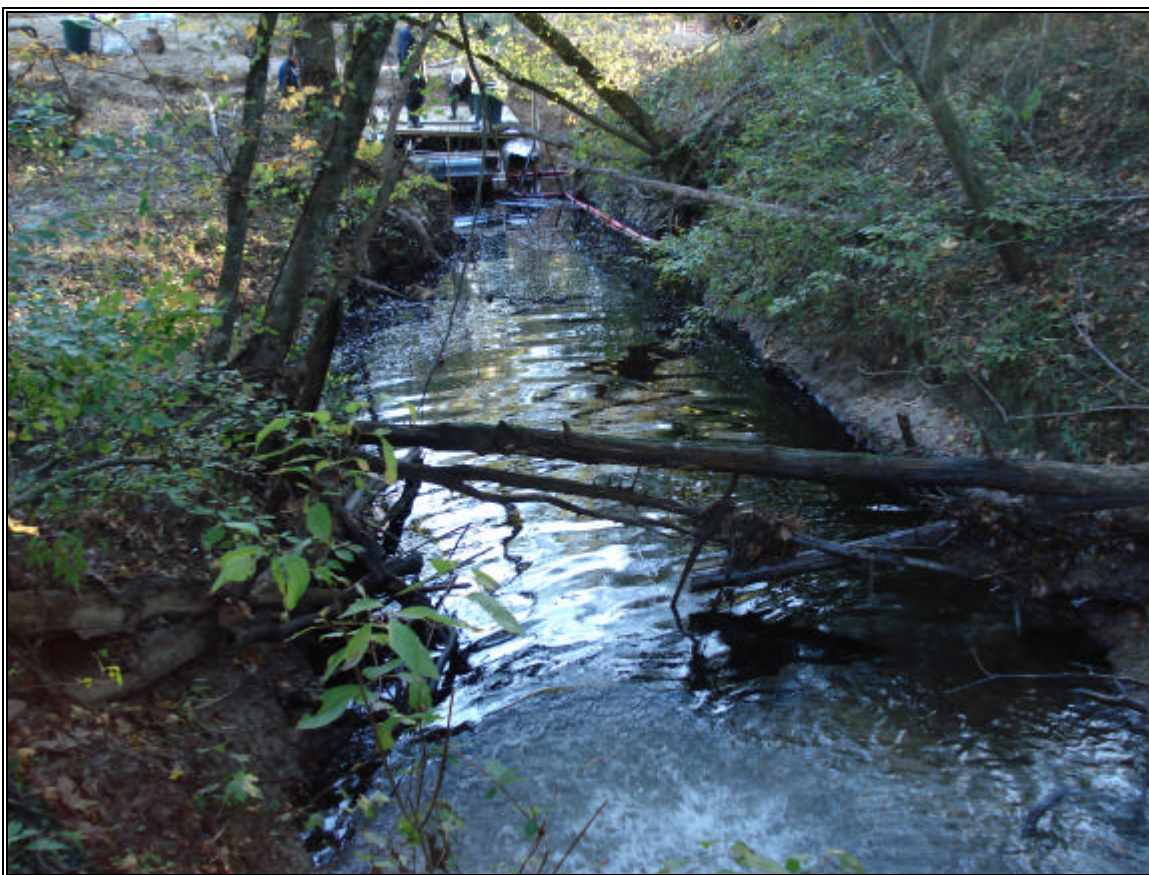
OFFICIAL PHOTOGRAPH No. 13
U.S. ENVIRONMENTAL PROTECTION AGENCY

Subject: Unnamed tributary upstream of underflow dam (facing downstream), Day 3.

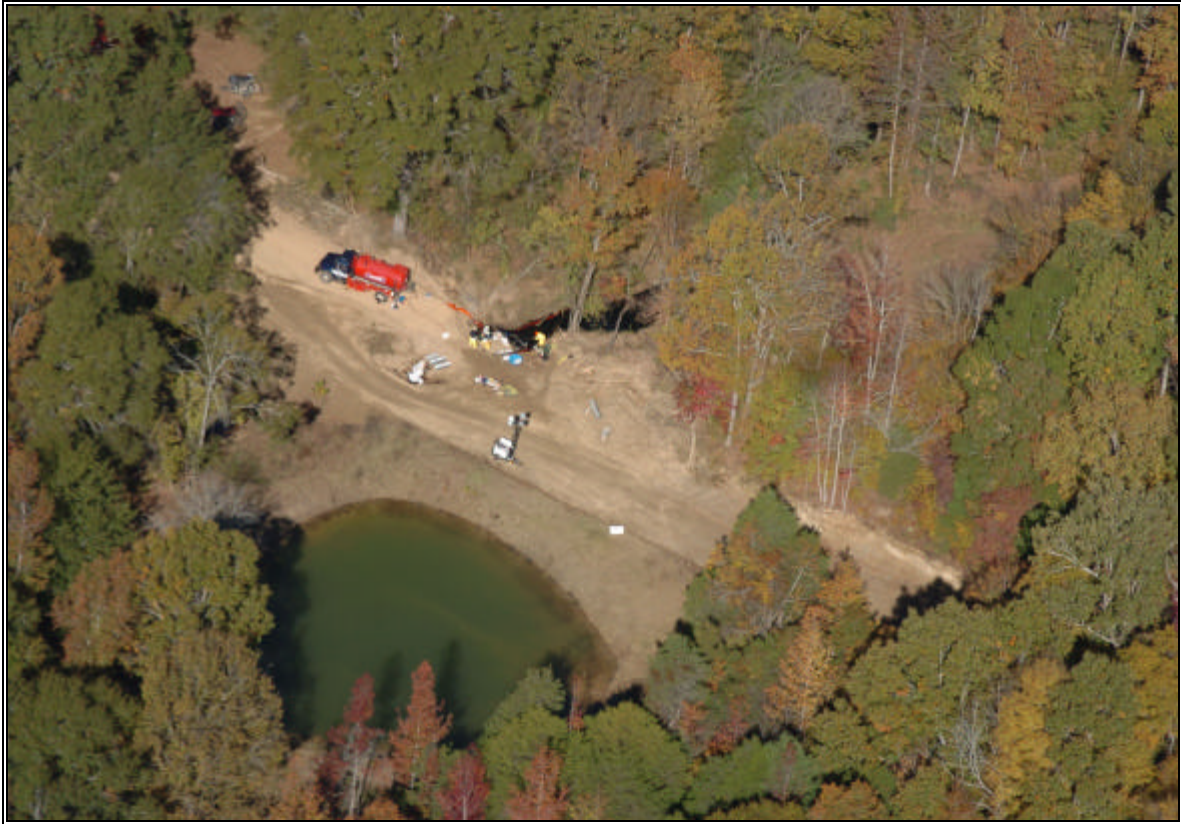
OFFICIAL PHOTOGRAPH No. 14
U.S. ENVIRONMENTAL PROTECTION AGENCY

Subject: Aerial photo of underflow dam, Day 4.

On November 3, 2006, a shoreline assessment was conducted by OSC Ullock, Ernie Shirley, MDEQ, and START. An aerial over-flight with photographic documentation was conducted by the Civil Air Patrol (CAP) during the morning hours and was completed by 12:55. At 14:00, oil skimming operations commenced at the Southern Natural Gas pipeline easement located downstream of the underflow dam. A photographic log containing copies of the photographs taken by the CAP is located in Appendix B.

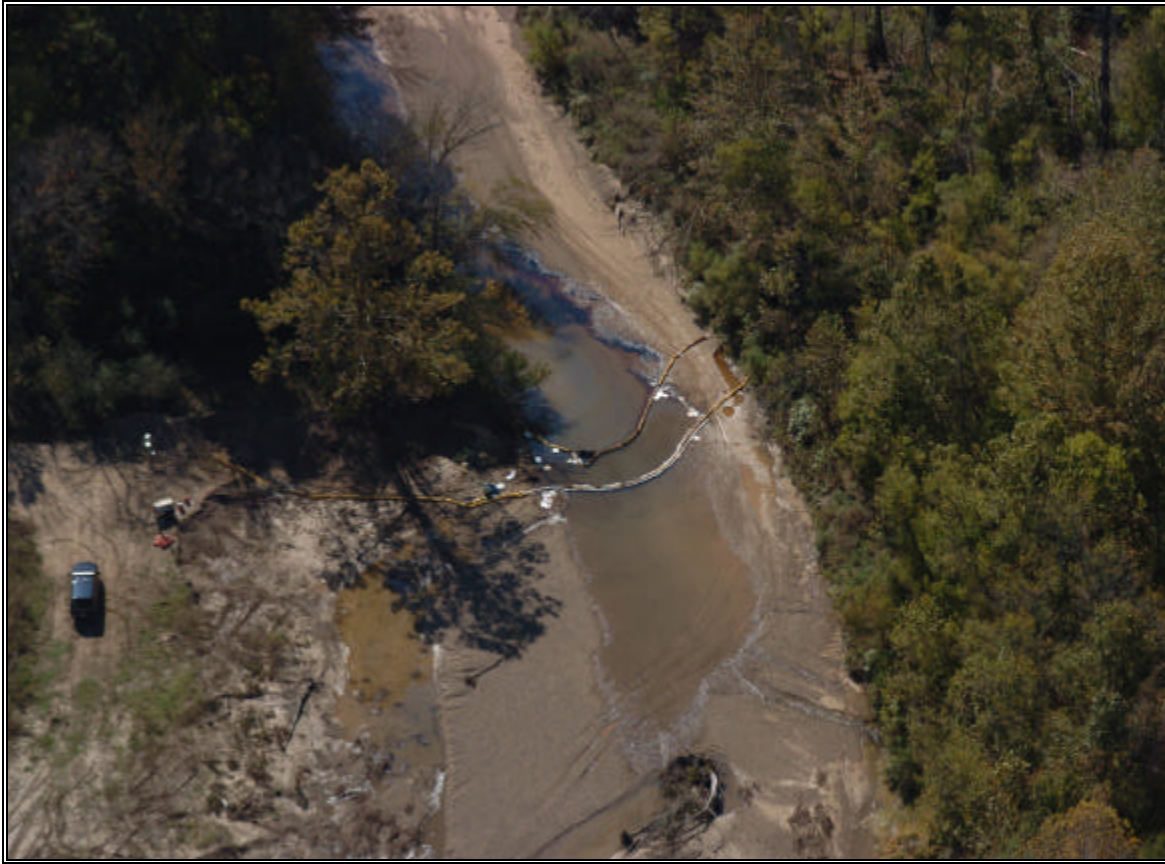
OFFICIAL PHOTOGRAPH No. 15
U.S. ENVIRONMENTAL PROTECTION AGENCY

Subject: Aerial photo of boom 1, Day 4.

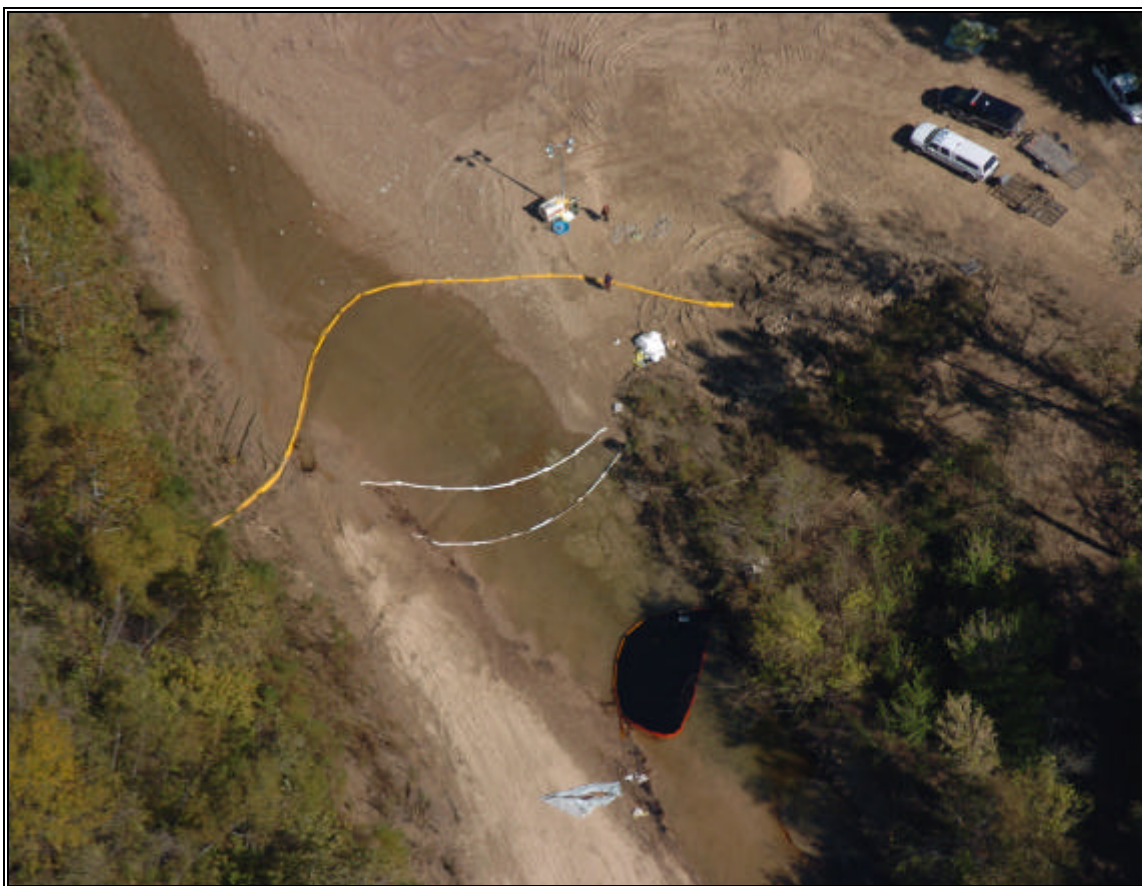
OFFICIAL PHOTOGRAPH No. 16
U.S. ENVIRONMENTAL PROTECTION AGENCY

Subject: Aerial photo of boom 2, Day 4.

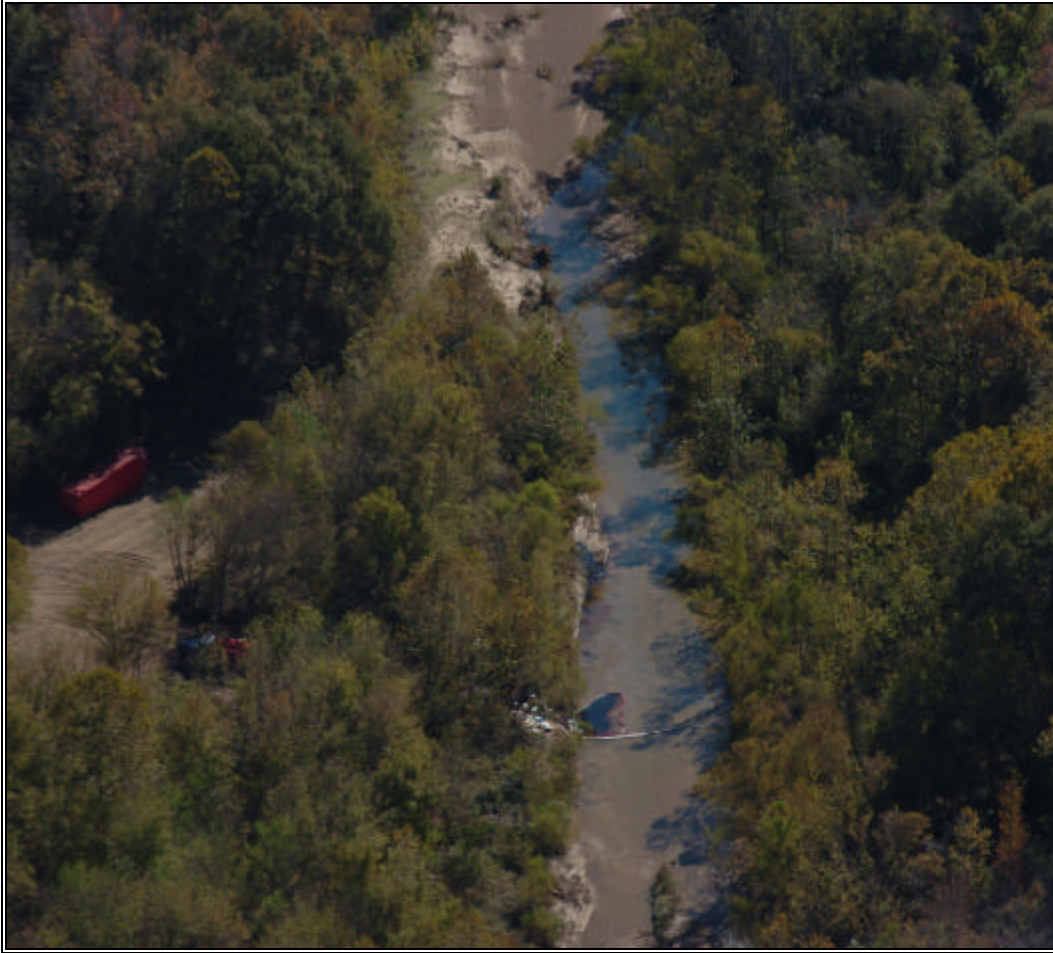
OFFICIAL PHOTOGRAPH No. 17
U.S. ENVIRONMENTAL PROTECTION AGENCY

Subject: Aerial photo of boom 3 (facing upstream), Day 4.

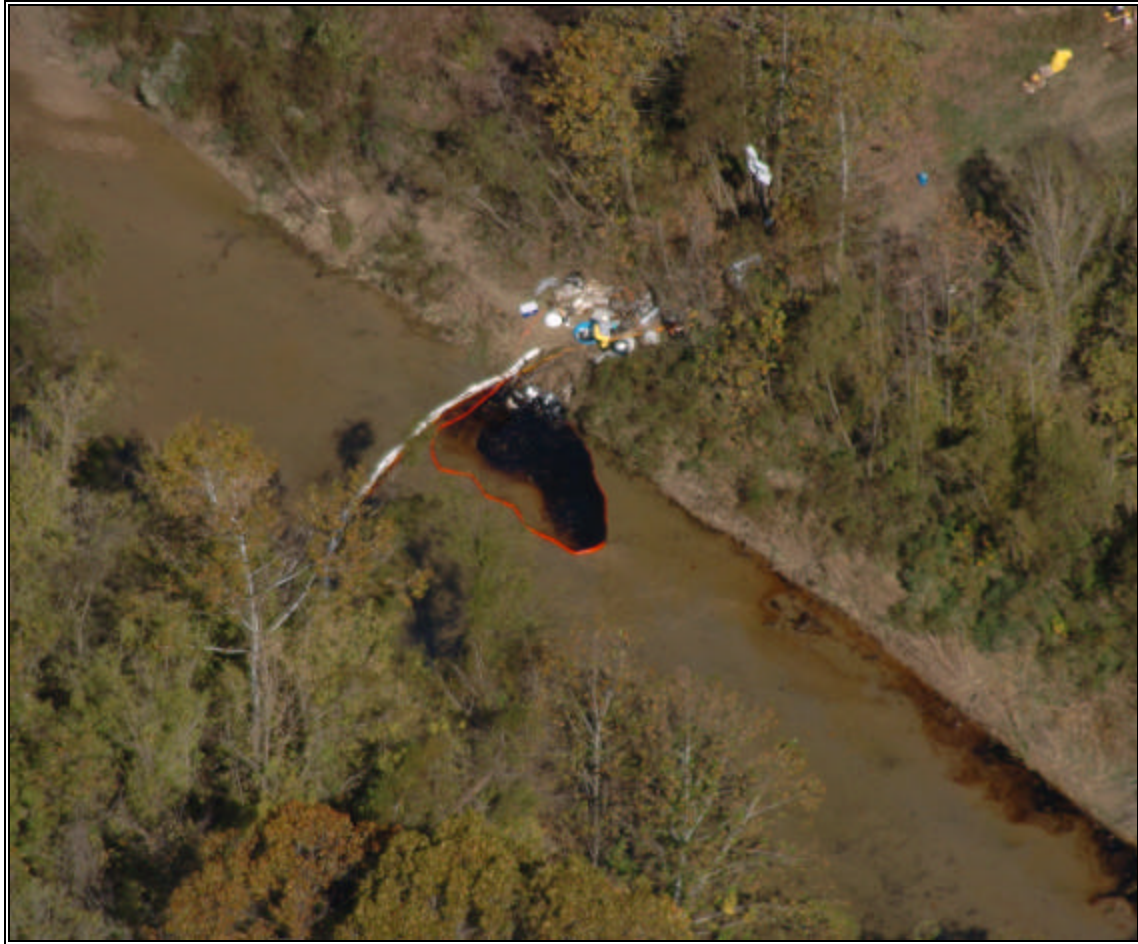
OFFICIAL PHOTOGRAPH No. 18
U.S. ENVIRONMENTAL PROTECTION AGENCY

Subject: Aerial photo of boom 3, Day 4.

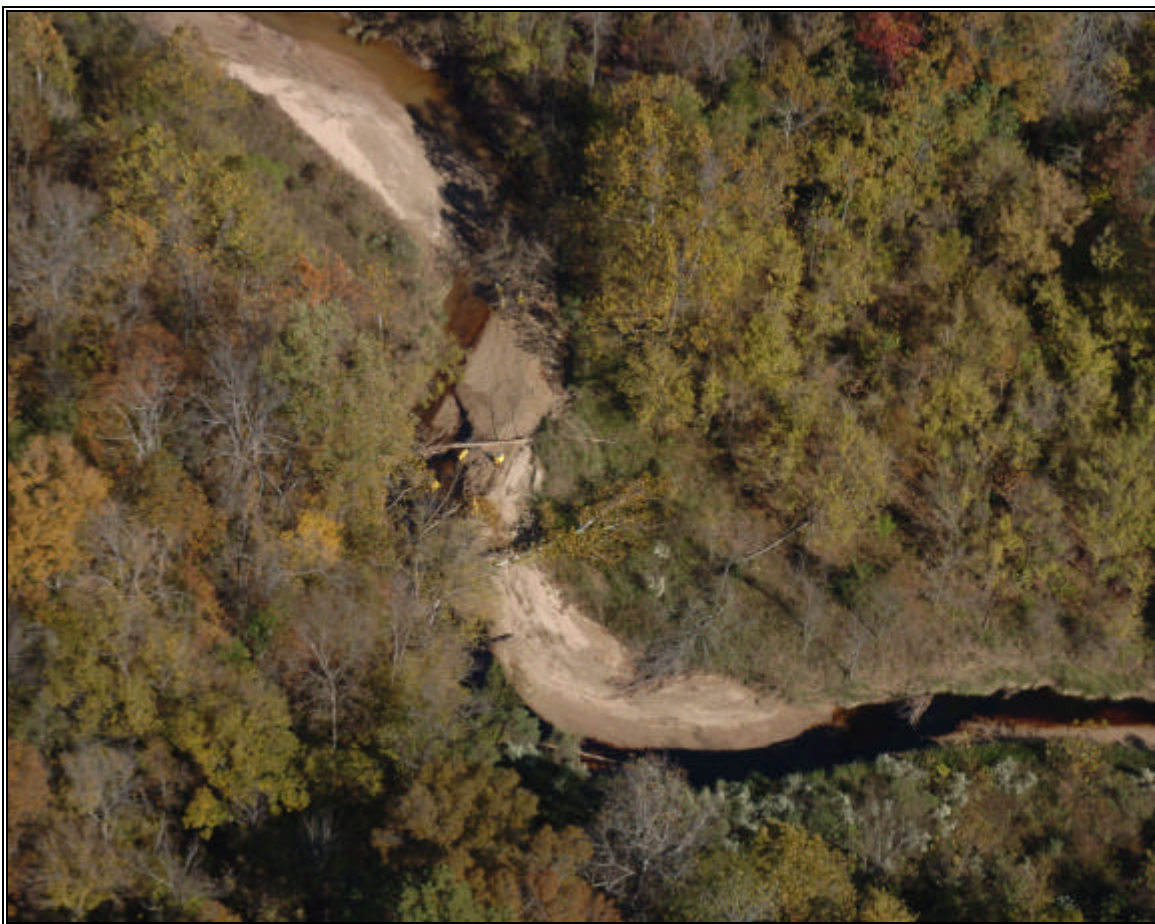
OFFICIAL PHOTOGRAPH No. 19
U.S. ENVIRONMENTAL PROTECTION AGENCY

Subject: Aerial photo of Perry Creek upstream of boom 1 and downstream of underflow dam, Day 4.

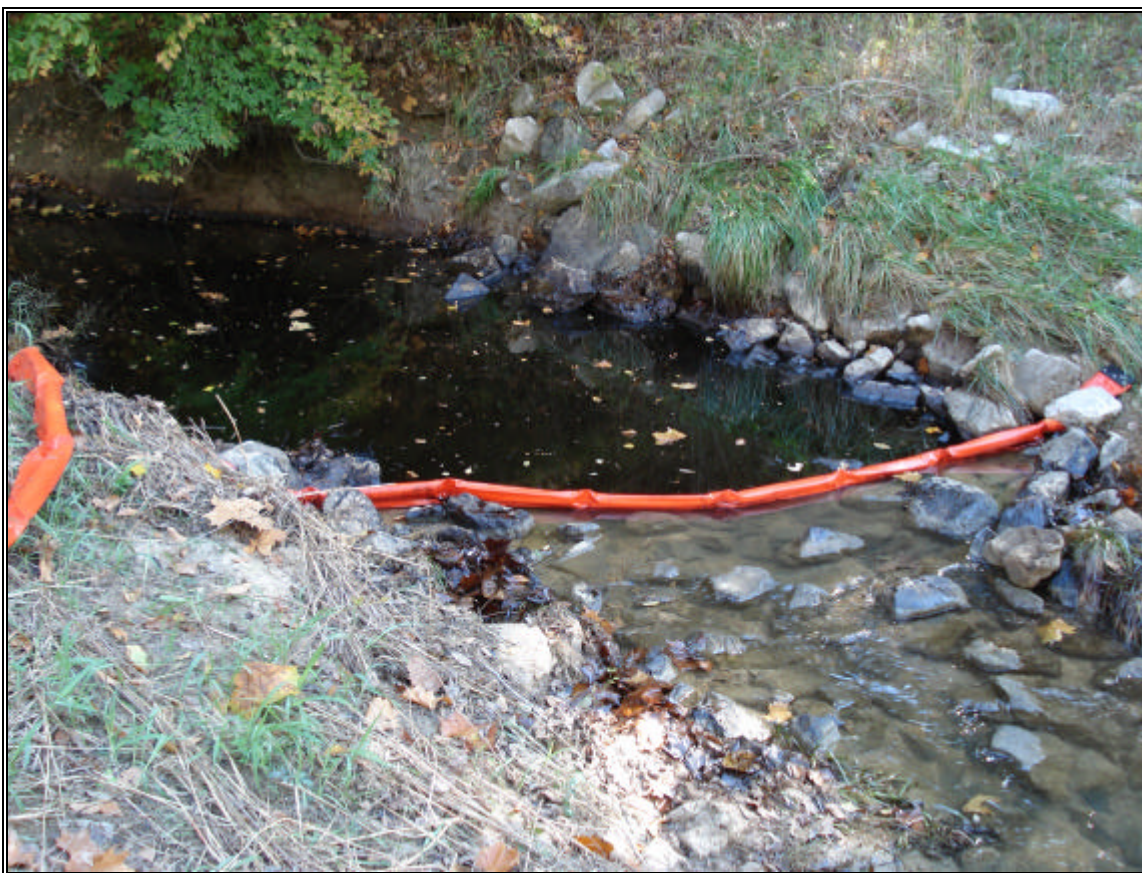
OFFICIAL PHOTOGRAPH No. 20
U.S. ENVIRONMENTAL PROTECTION AGENCY

Subject: boom at Southern Natural Gas pipeline easement, Day 4.

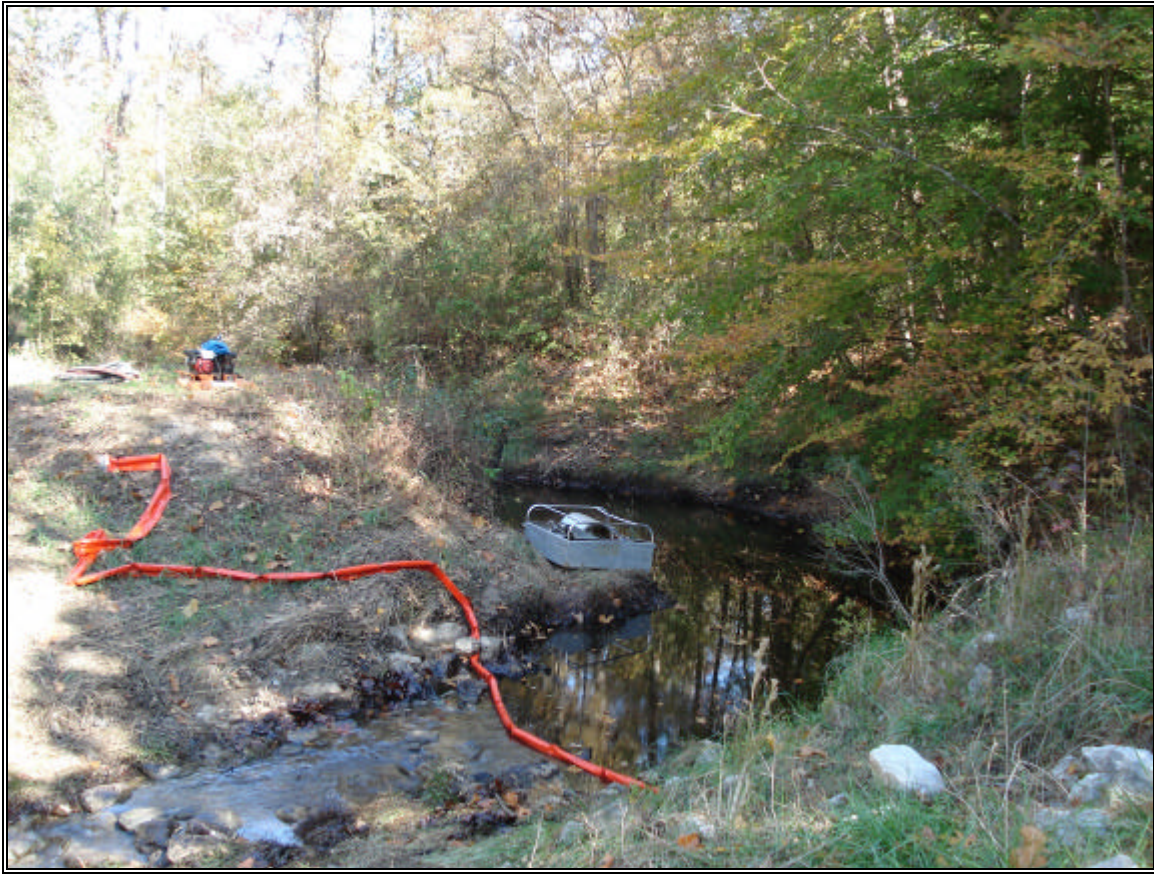
OFFICIAL PHOTOGRAPH No. 21
U.S. ENVIRONMENTAL PROTECTION AGENCY

Subject: Southern Natural Gas pipeline easement, Day 4.

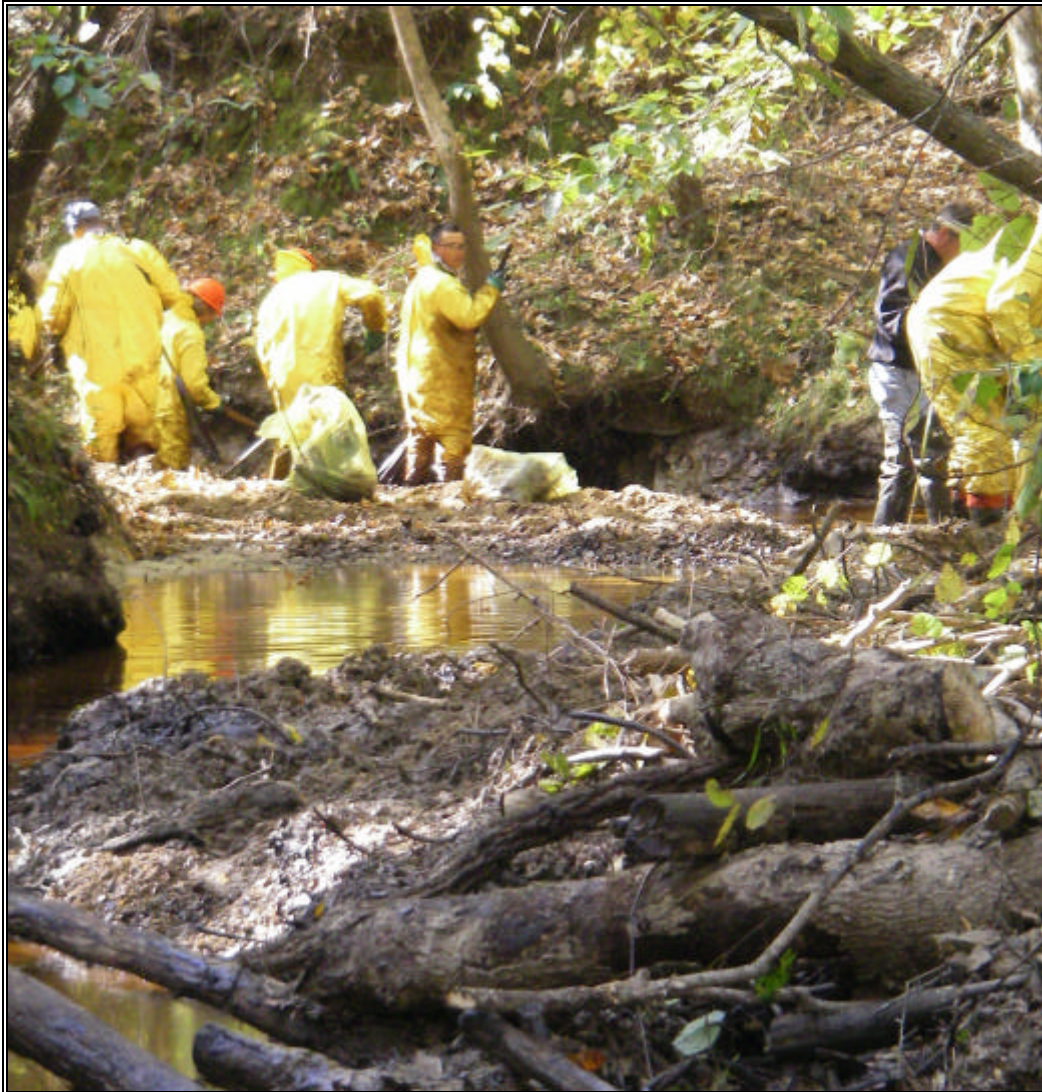
OFFICIAL PHOTOGRAPH No. 22
U.S. ENVIRONMENTAL PROTECTION AGENCY

Subject: USES crews clearing debris from unnamed tributary, Day 5.

Active oil skimming on the tributary and stream, clearing of oil-soaked debris in the upland areas, and washing oil down to collection points continued from November 4 through November 6, 2006. Oil skimmers were removed and Booms 1, 2, and 3 were cut by 16:00 due to a significant increase in water flow resulting from heavy rains in the area. At 17:00, an unsuccessful attempt was made to deploy another contingency boom downstream of Boom 4 near the confluence of Perry Creek and the Yazoo River. According to USES, approximately 90% of total oil spilled was recovered prior to the rain event on November 6, 2006.
