**Subject: Incident Response Letter Report
Perry Creek Pipeline Oil Spill Emergency Response
Oil City, Yazoo County, Mississippi
Federal Project Number (FPN): E07405
TDD No.: TNA-05-001-0021
Contract No.: EP-W-05-053**

PERRY CREEK OIL SPILL
TDD No. TNA-05-001-0021
OIL CITY, YAZOO COUNTY,
MISSISSIPPI

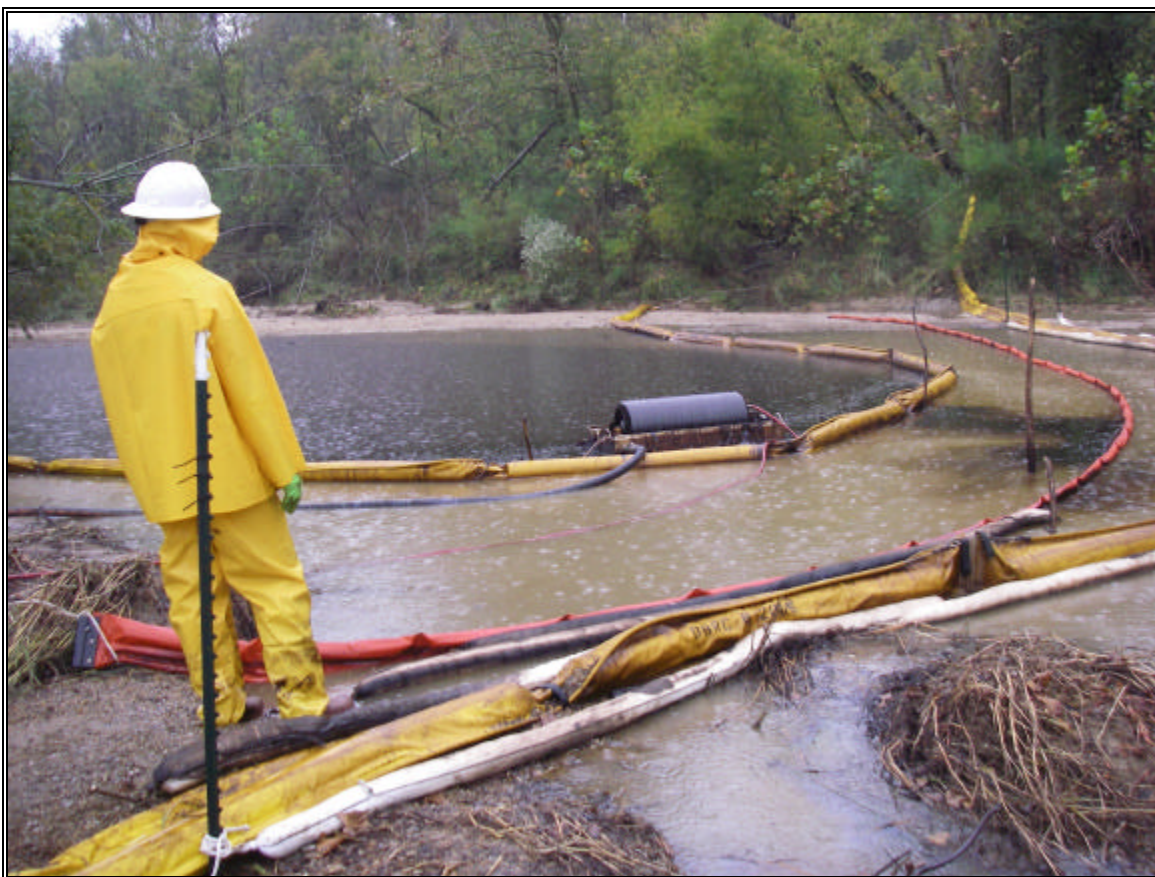
OFFICIAL PHOTOGRAPH No. 23
U.S. ENVIRONMENTAL PROTECTION AGENCY

Subject: Boom 1 beginning of rain event, Day 7.

Active oil skimming on the tributary and stream, clearing of oil-soaked debris in the upland areas, and washing oil down to collection points continued from November 4 through November 6, 2006. Oil skimmers were removed and Booms 1, 2, and 3 were cut by 16:00 due to a significant increase in water flow resulting from heavy rains in the area. At 17:00, an unsuccessful attempt was made to deploy another contingency boom downstream of Boom 4 near the confluence of Perry Creek and the Yazoo River. According to USES, approximately 90% of total oil spilled was recovered prior to the rain event on November 6, 2006.

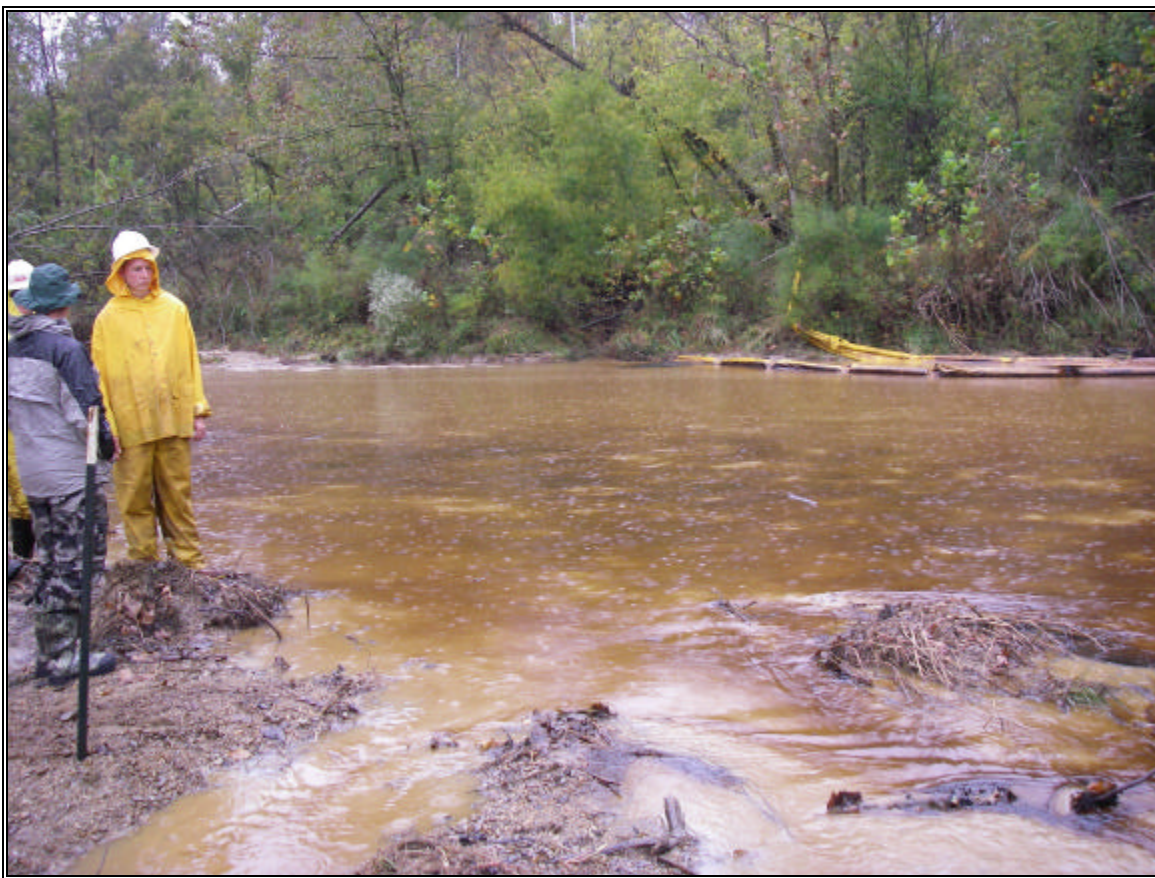
OFFICIAL PHOTOGRAPH No. 24
U.S. ENVIRONMENTAL PROTECTION AGENCY

Subject: Boom 1 cut during rain event, Day 7.

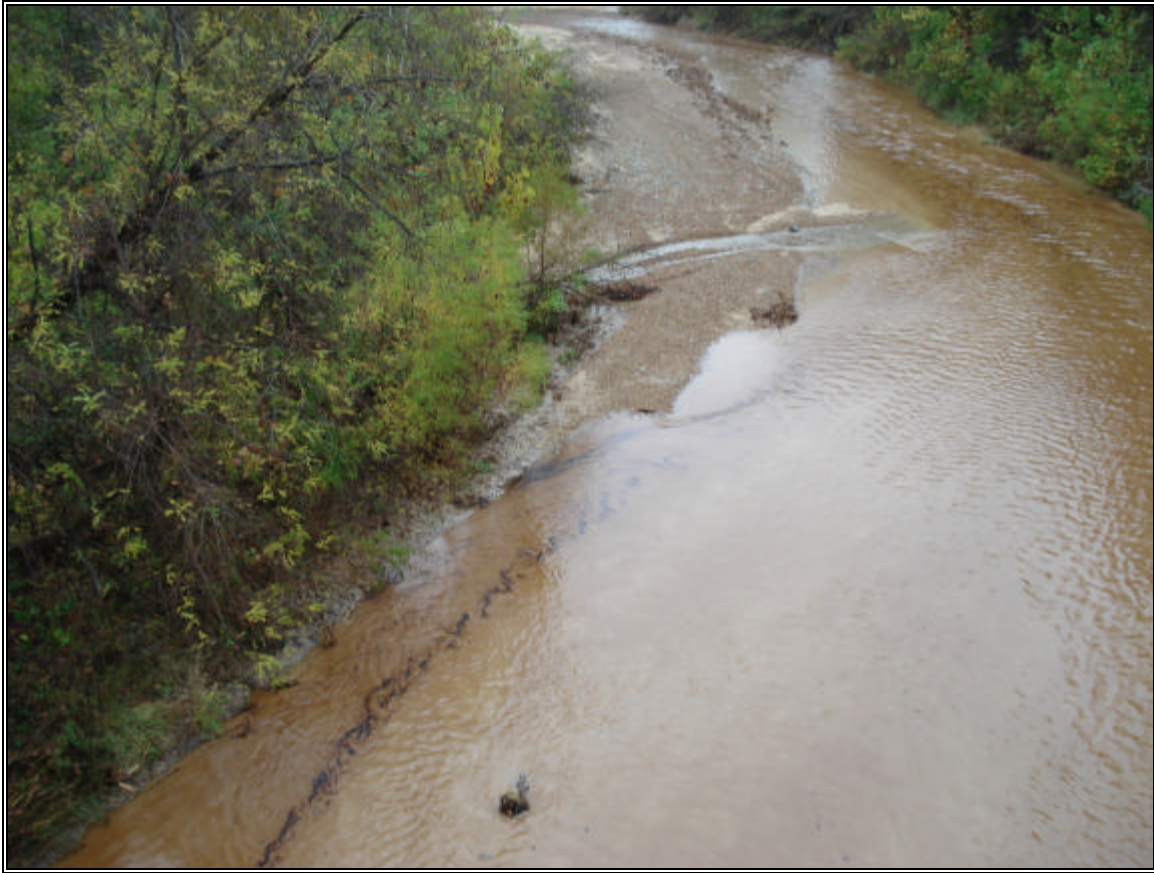
OFFICIAL PHOTOGRAPH No. 25
U.S. ENVIRONMENTAL PROTECTION AGENCY

Subject: Perry Creek during rain event downstream of boom 3 (facing downstream), Day 7.

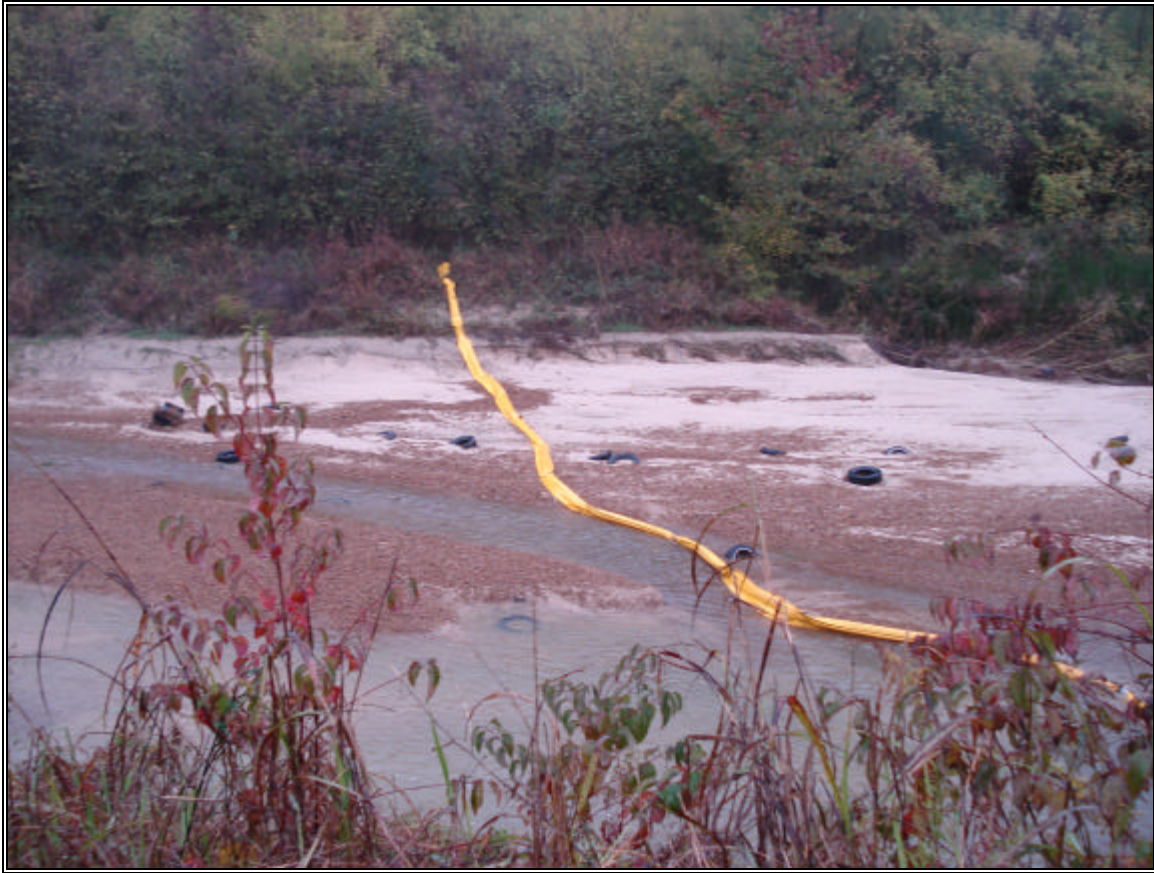
OFFICIAL PHOTOGRAPH No. 26
U.S. ENVIRONMENTAL PROTECTION AGENCY

Subject: Boom 4 day of rain event, Day 7.

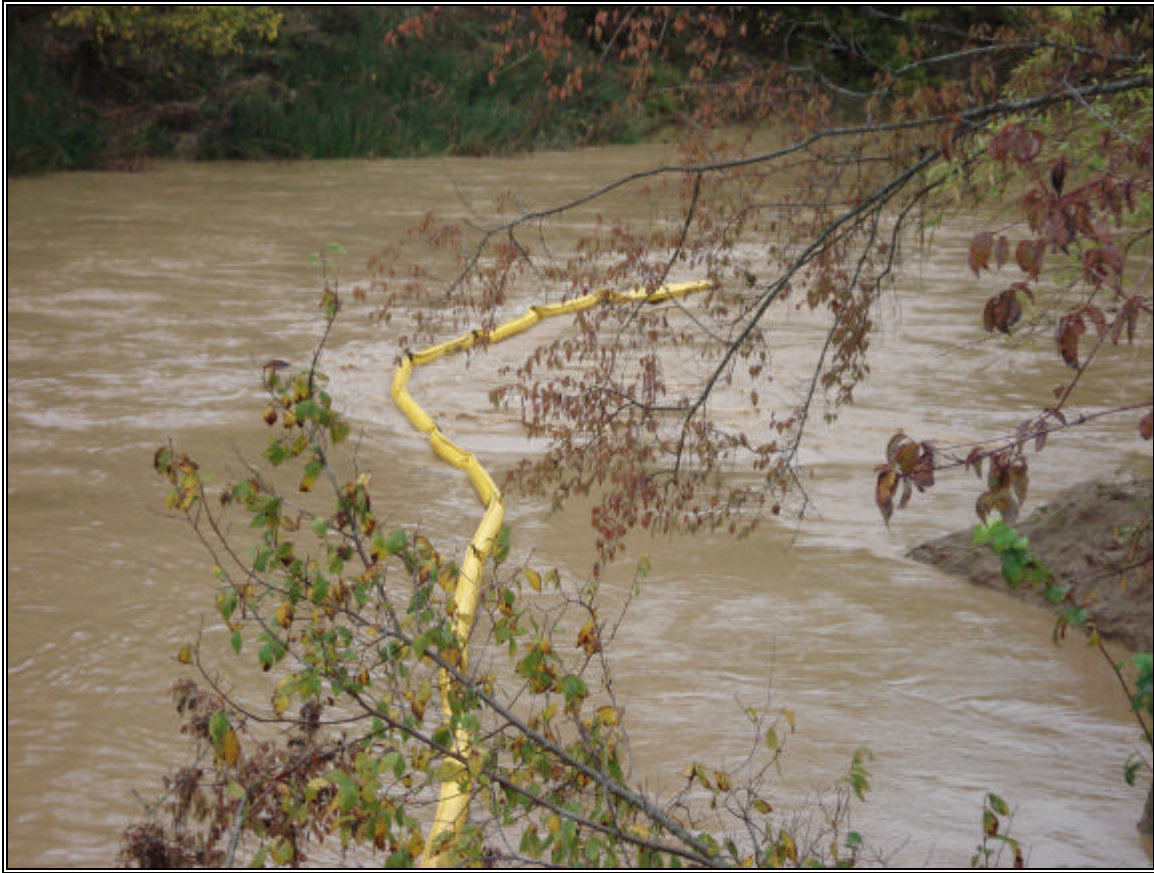
OFFICIAL PHOTOGRAPH No. 27
U.S. ENVIRONMENTAL PROTECTION AGENCY

Subject: Boom 4 morning after rain event, Day 8.

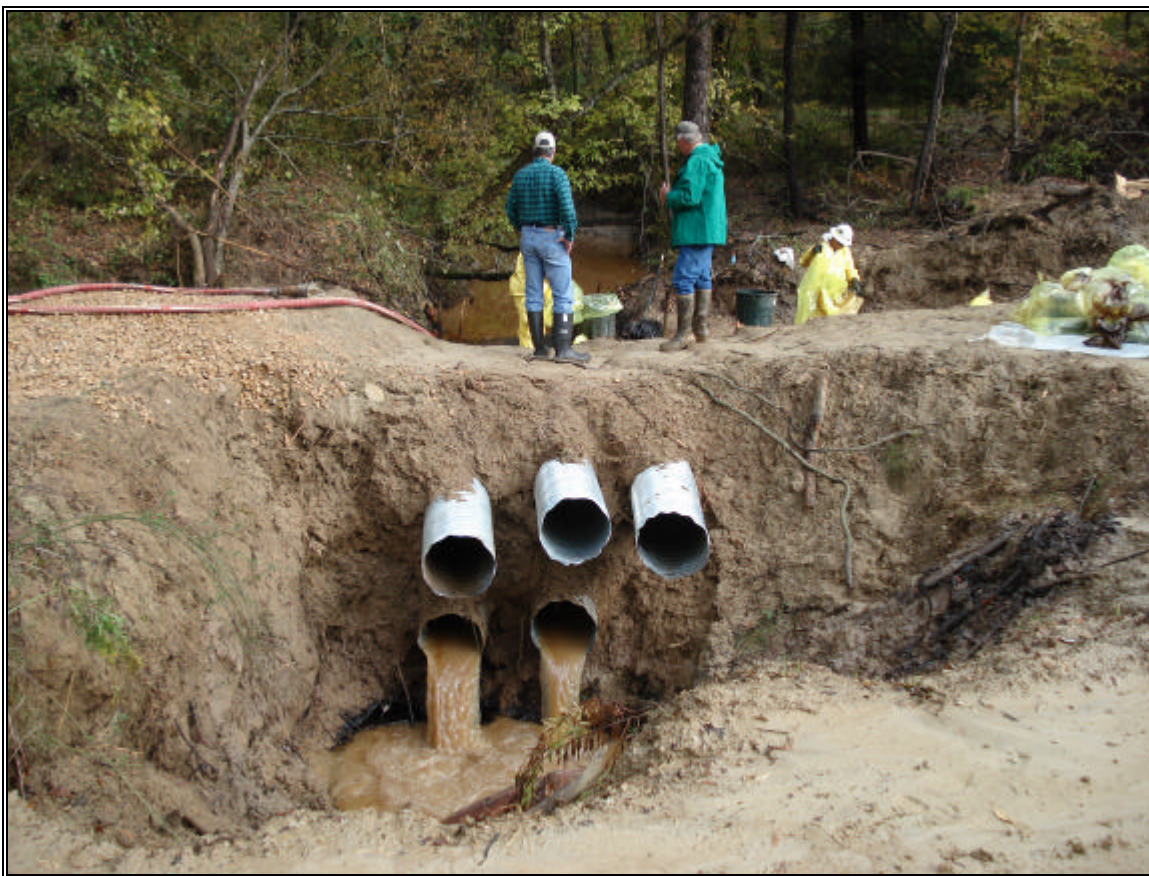
OFFICIAL PHOTOGRAPH No. 28
U.S. ENVIRONMENTAL PROTECTION AGENCY

Subject: Underflow dam-day after rain event (facing upstream), Day 8.

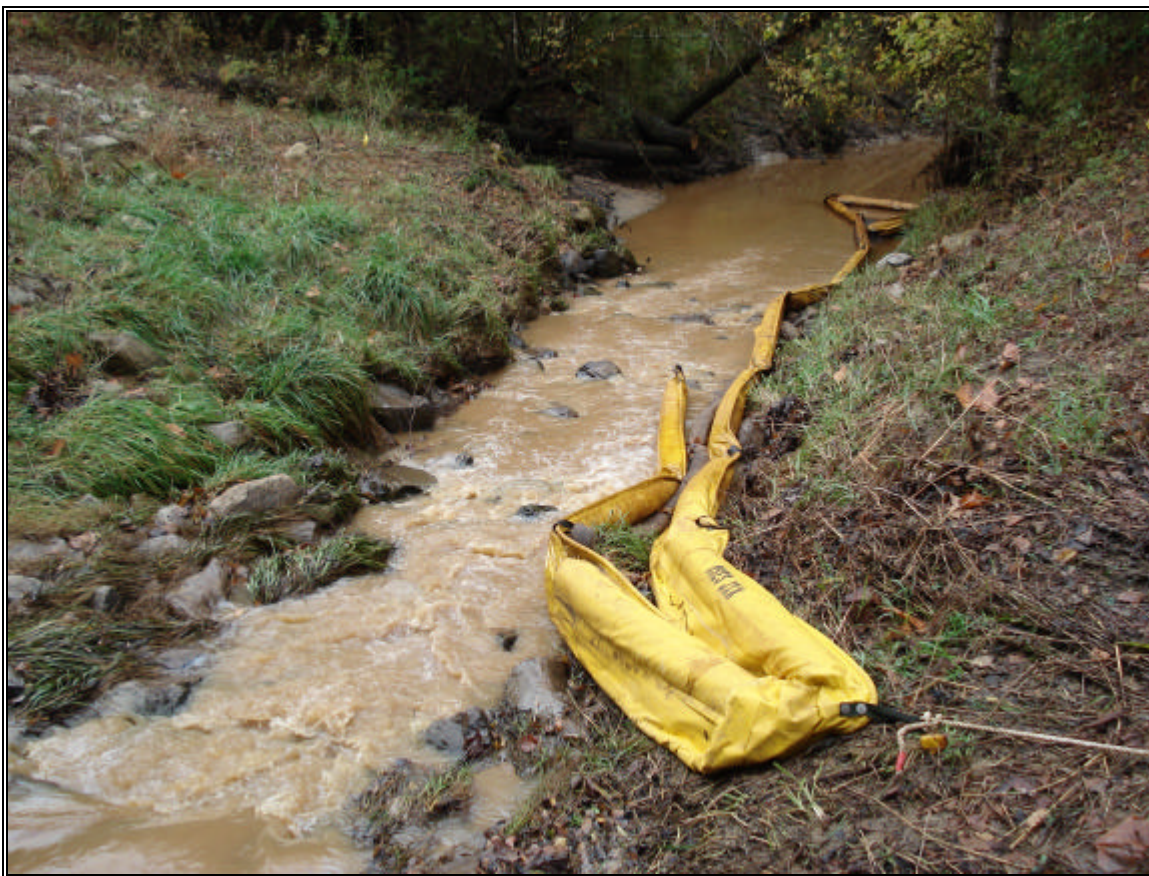
OFFICIAL PHOTOGRAPH No. 29
U.S. ENVIRONMENTAL PROTECTION AGENCY

Subject: Southern Natural Gas easement downstream of underflow-day after rain event
(facing upstream), Day 8.

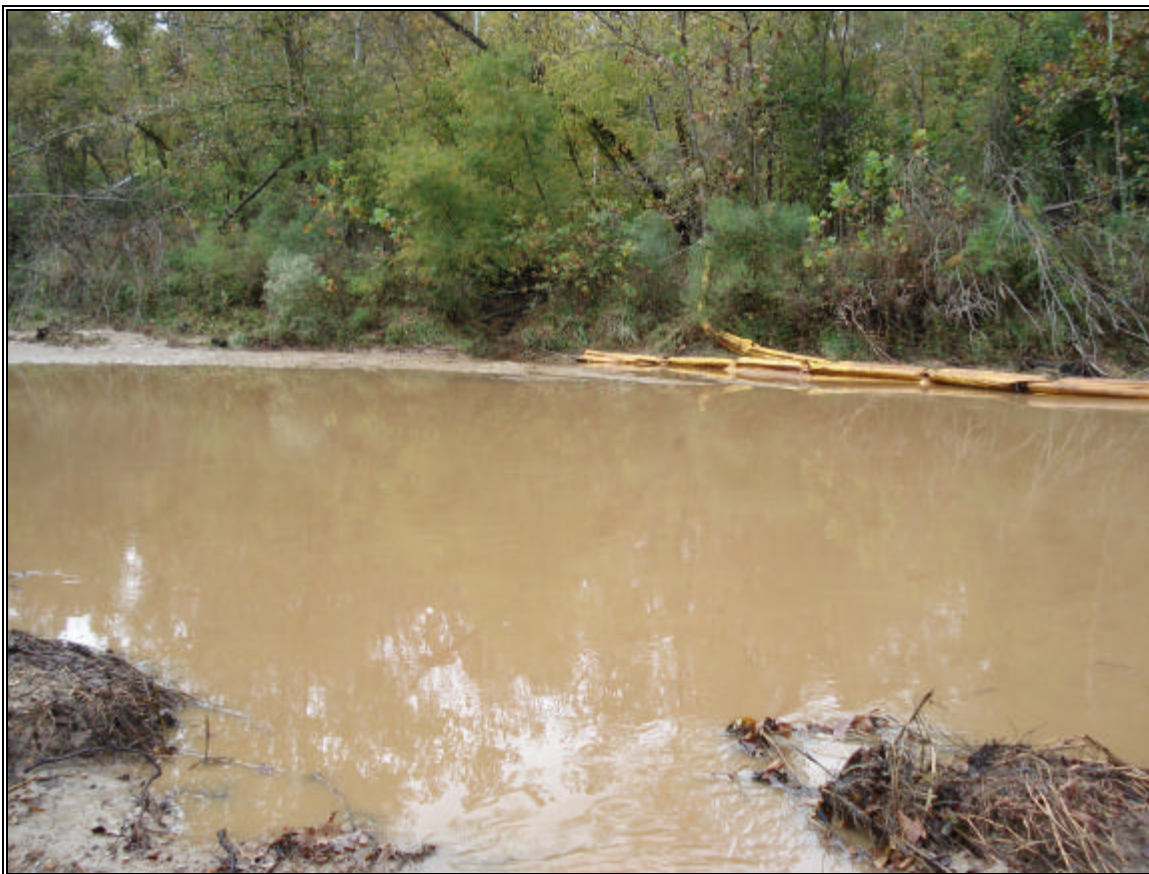
OFFICIAL PHOTOGRAPH No. 30
U.S. ENVIRONMENTAL PROTECTION AGENCY

Subject: Boom 1-day after rain event, Day 8.

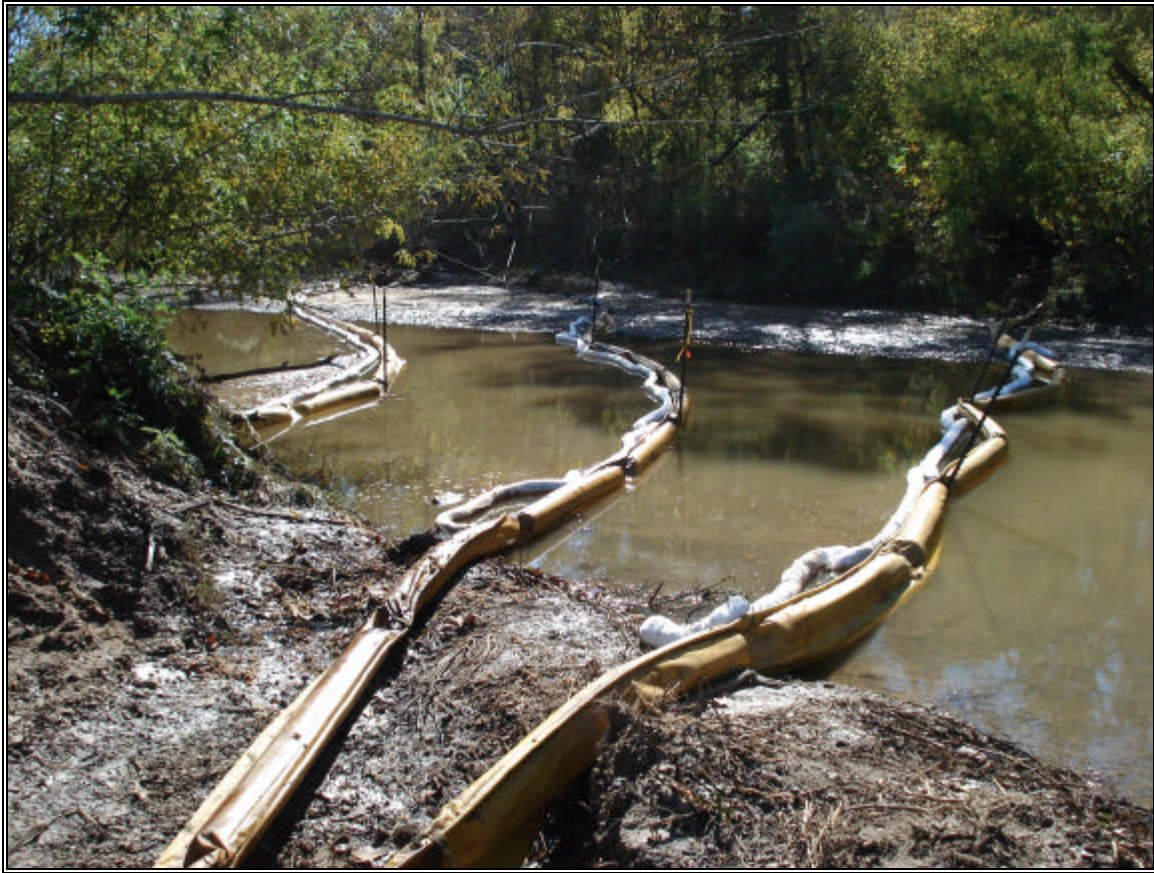
OFFICIAL PHOTOGRAPH No. 31
U.S. ENVIRONMENTAL PROTECTION AGENCY

Subject: Redeployment of boom 1-2nd day after rain event, Day 9.

On November 8, 2006, Booms 1 and 2 were deployed. Polishing and cleaning operations in the upland spill area continued throughout the day. Appendix B provides photographic details of the response from October 31 to November 8, 2006.
