Black Hills Plating

Rapid City, South Dakota

Background

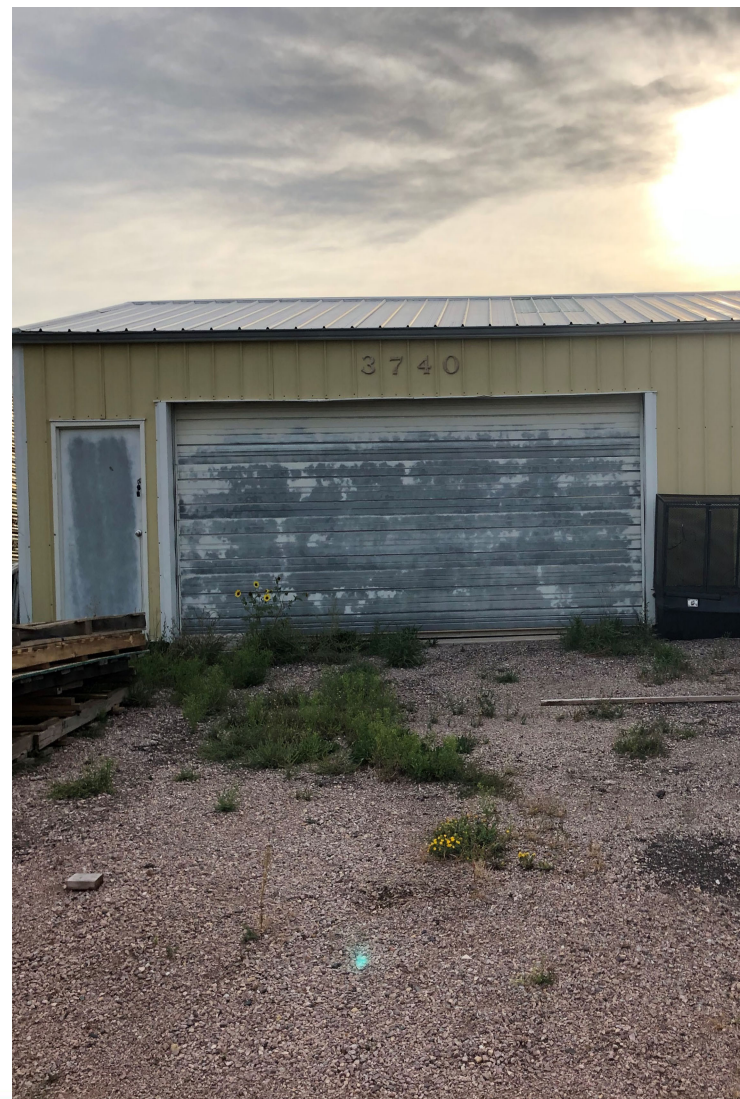
- Former metal plating business that lost their lease.
- Relocated chemicals and chemical wastes to a friend's garage for *temporary* storage.
- Business never got back up and running.
- DENR tried to work with the owner for compliance but they did not have the financial means to address wastes appropriately.

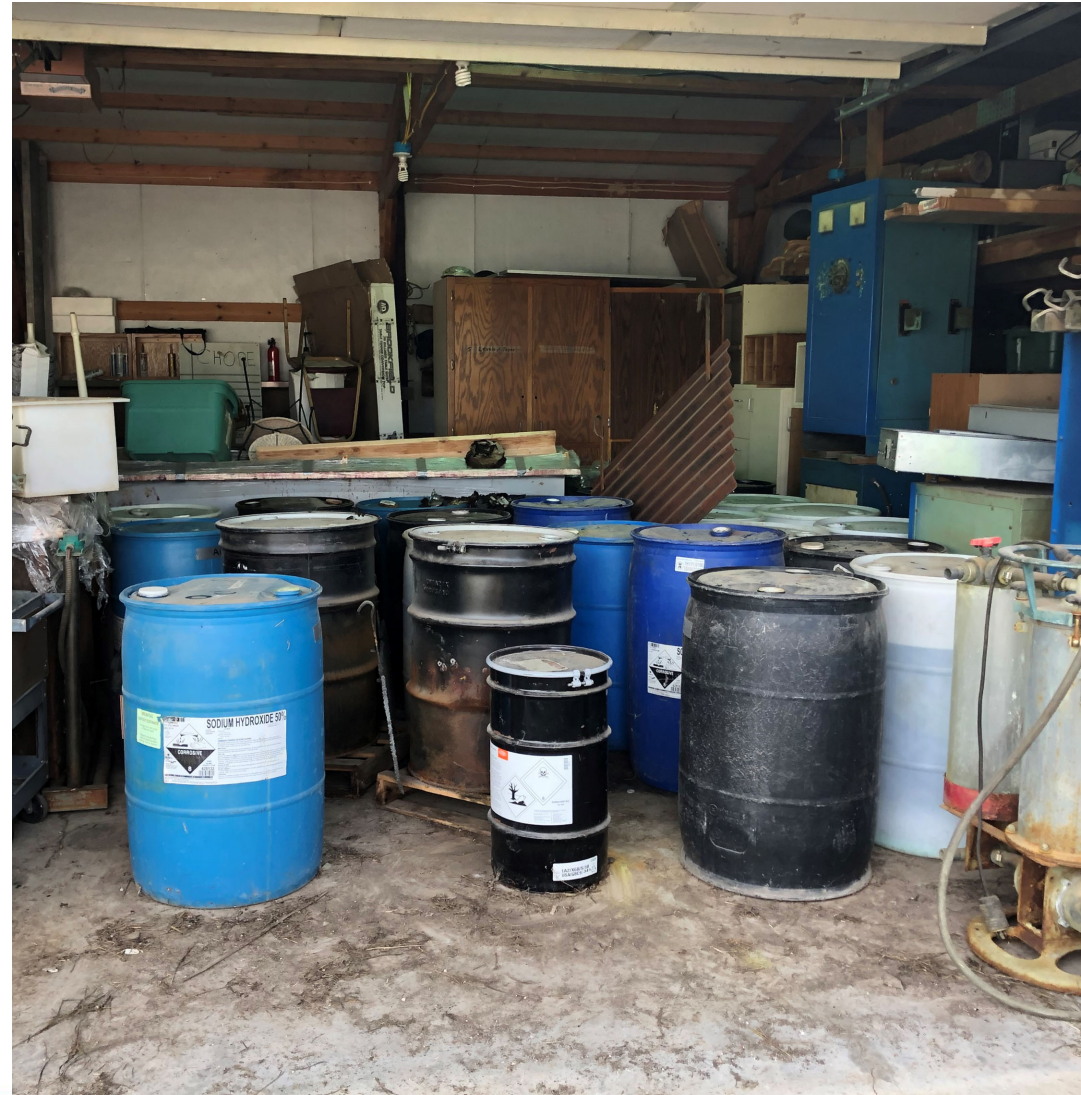
- EPA and Contractors mobilized to site to conduct assessment of the site and chemical wastes.
- Initial information was conveyed from DENR on contents and history

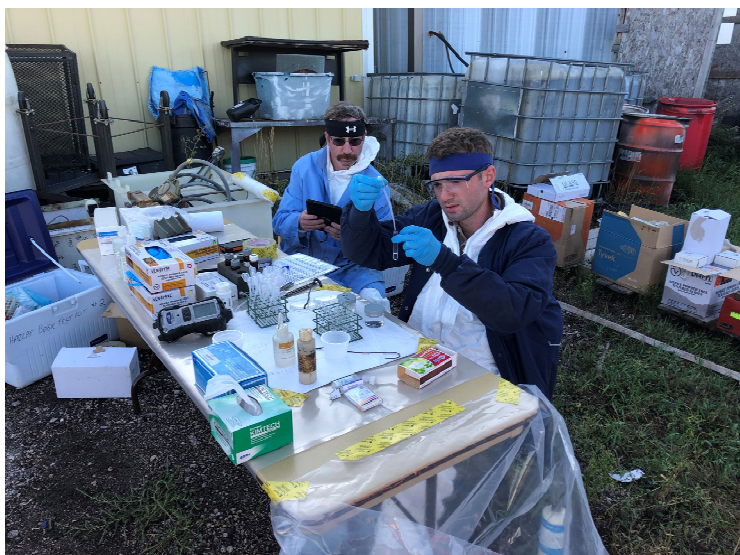
<u>HazClass</u>	<u>Drums</u>	<u>Tanks</u>	<u>Containers</u>	<u>Total</u>
5	13	2	6	21
6	6	2	-	8
8	-	-	14	14
9	6	-	20	26
Total	25	4	39	69

Examples: Sulfuric acid (93% solution), Sodium cyanide, Sodium hydroxide, Hydrochloric acid, Hexavalent chromate, &Unknowns

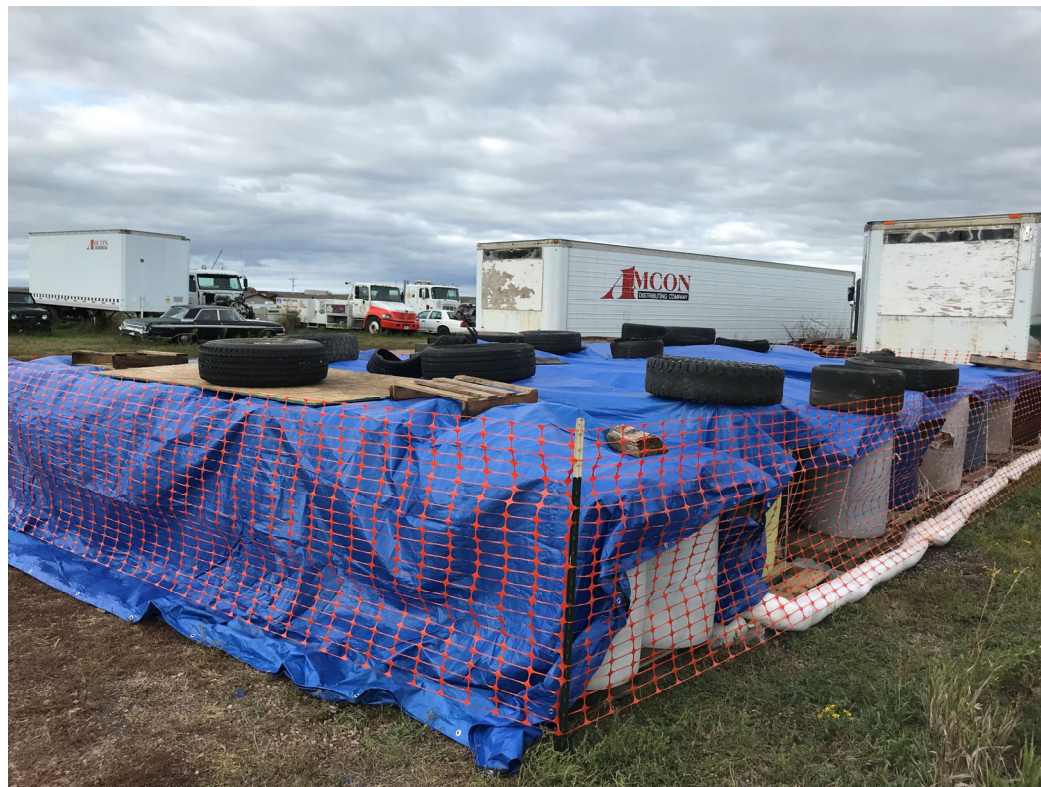
Once all chemical waste was stabilized, EPA created a temporary storage area to allow for time to secure transportation and disposal.

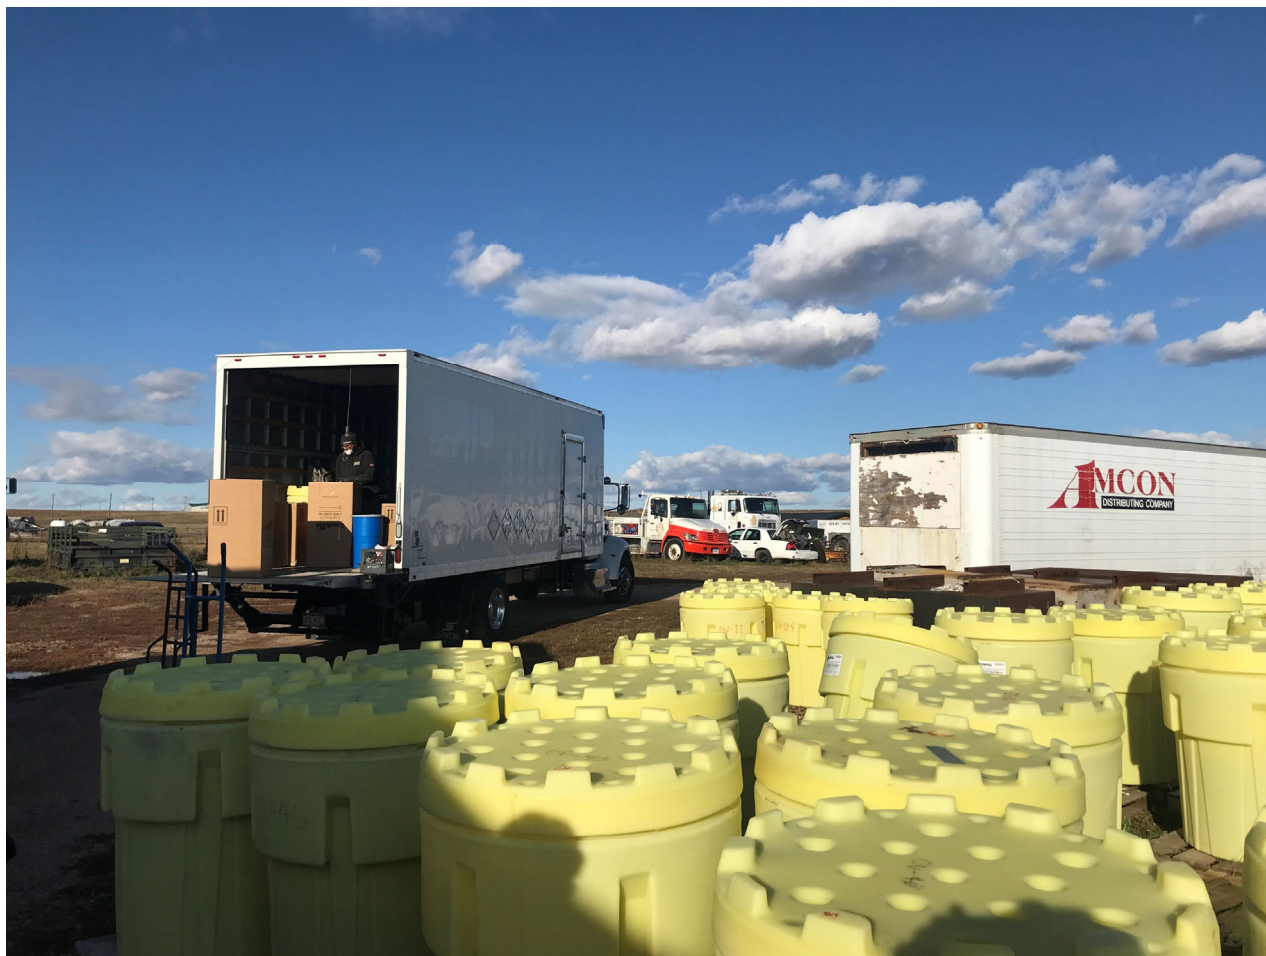
Secured contract
for off-site
transportation and
disposal of
chemical wastes
from the garage.

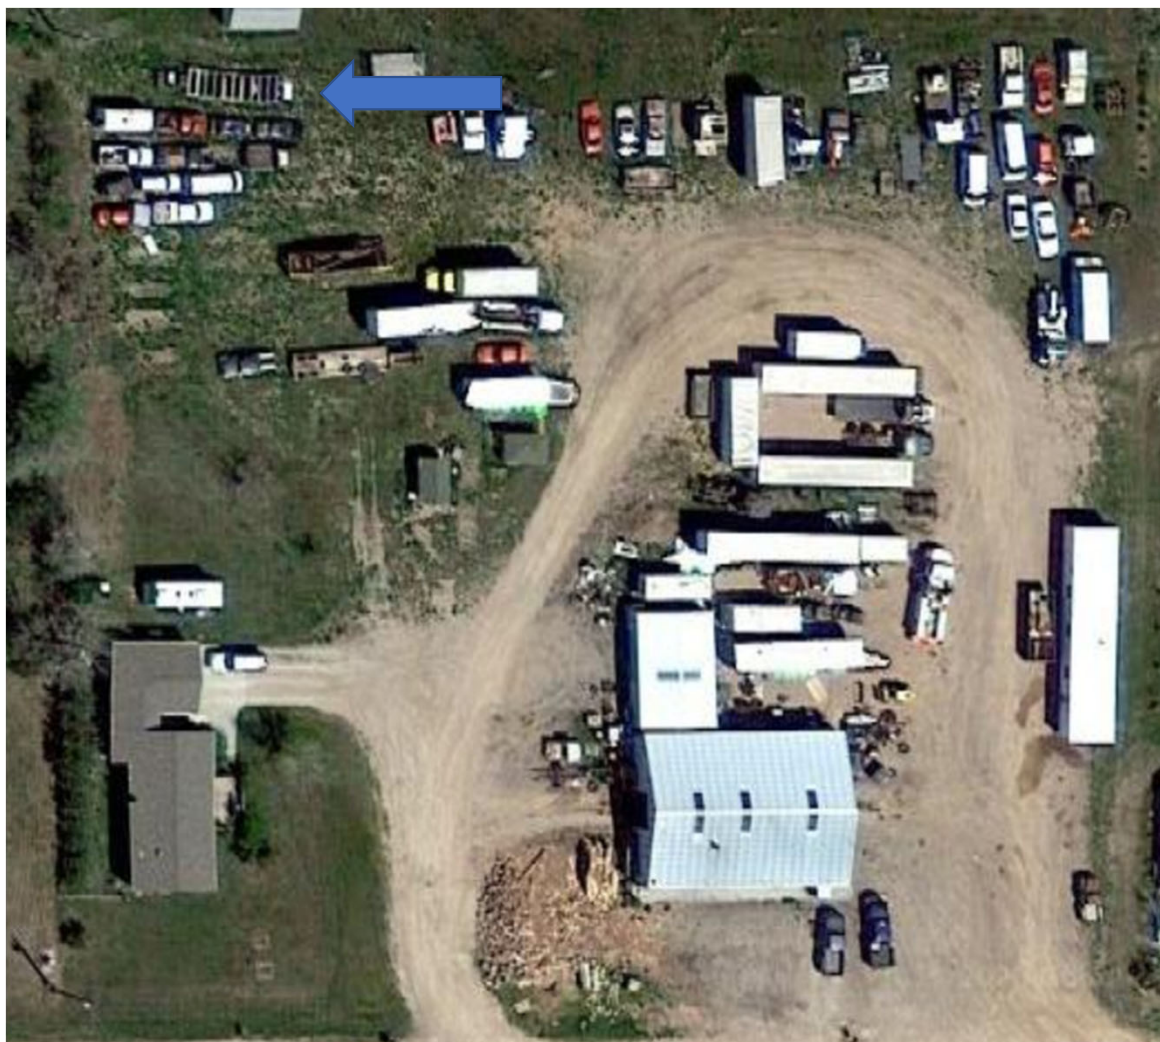
- An additional set of tanks were disclosed/discovered at the back of the property.
- Tanks were hidden away from garage area and previously not disclosed by waste owner or property owner.

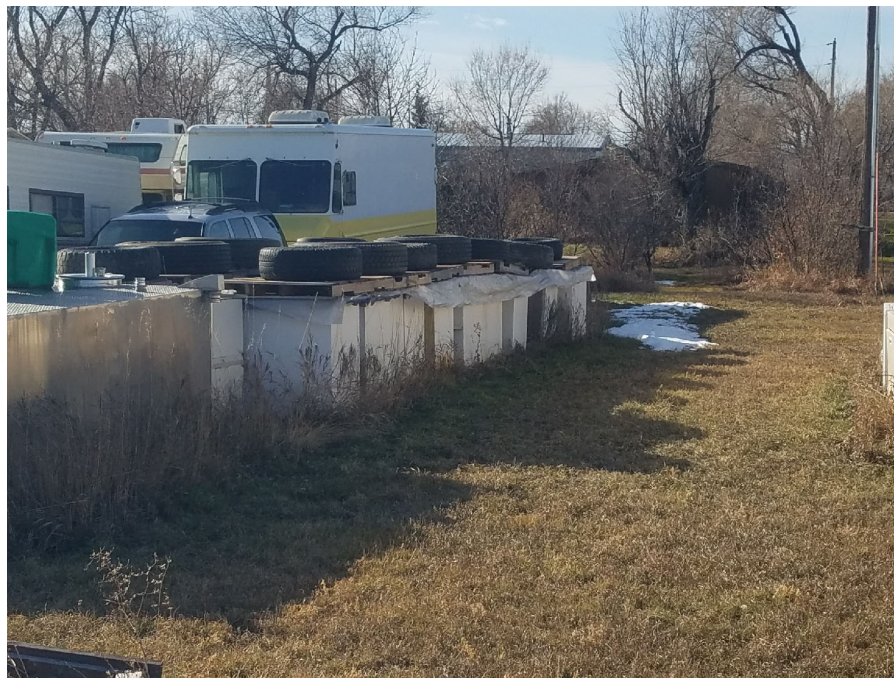
- Tanks were assessed by DENR and EPA
- Tanks were characteristic of impacted water (from environmental exposures)
- Identified as old process tanks by chemical waste owner.
- Tanks secured until EPA could remobilize

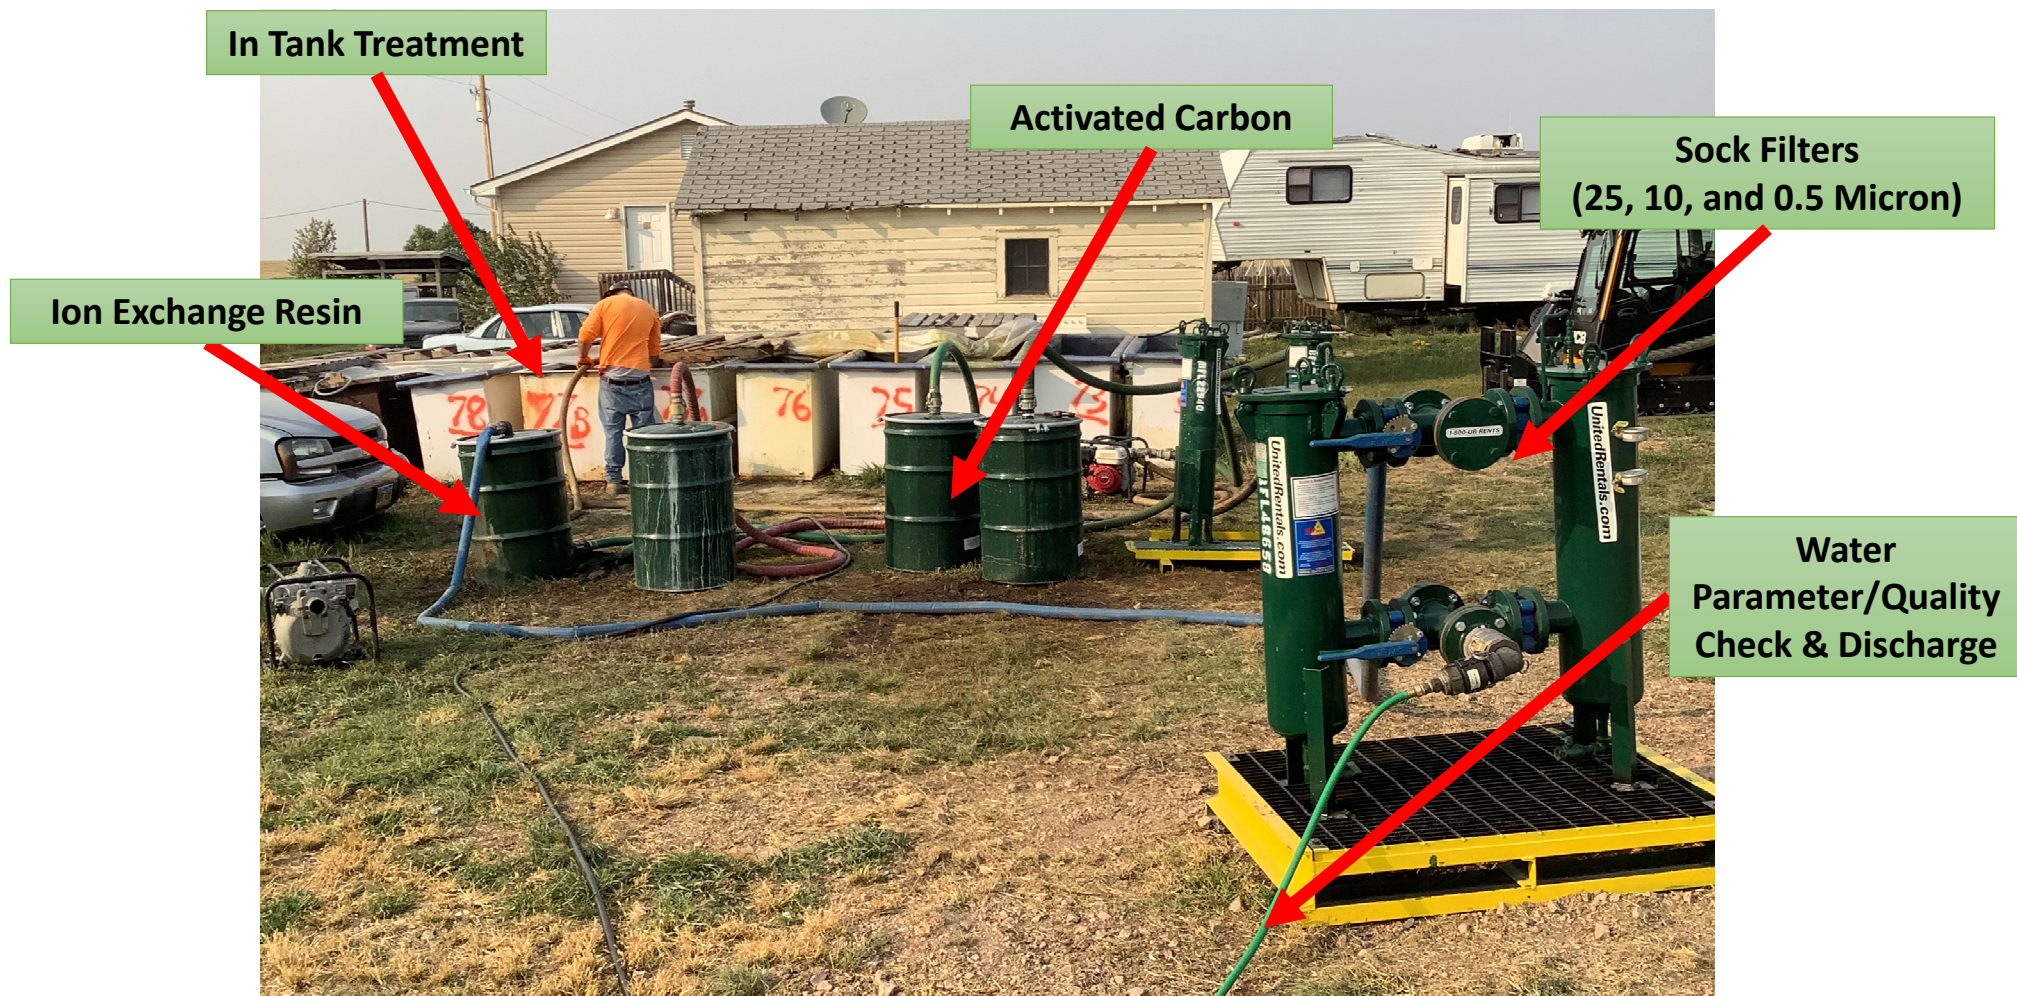
- Based on the tank assessments and site knowledge, EPA decided to treat and filter tanks on Site

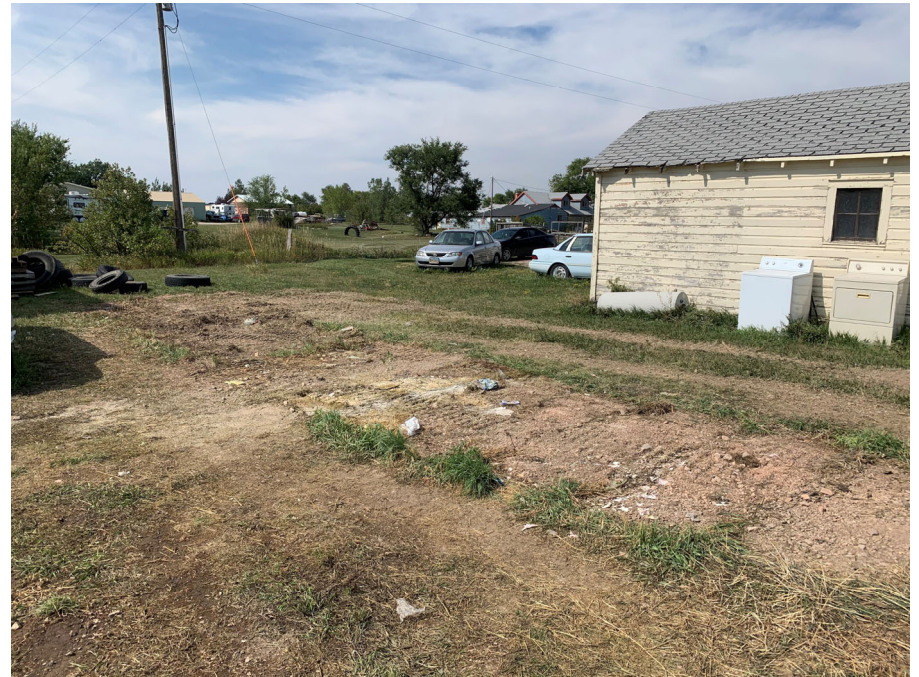
- All impacted water was treated and discharged per OSC direction on site.
- Tanks were sent off site for disposal
- Residue was solidified and set off site for disposal
