EPA Emergency Response Site Update
North Salt Lake Chemicals
June 7, 2023

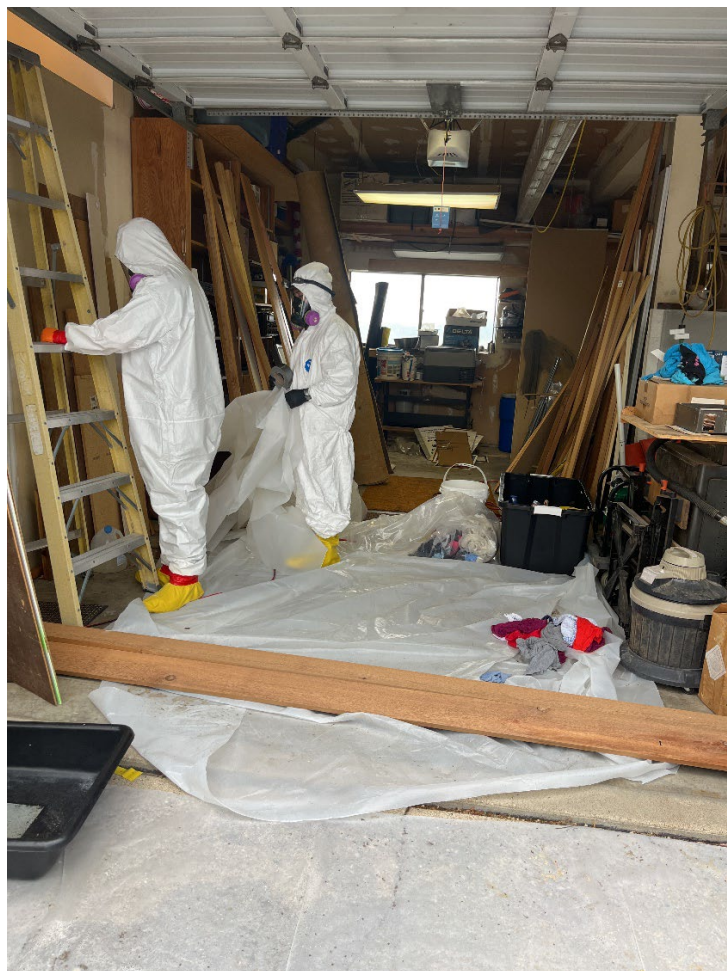
Response Team working in the garage.

The Team is still working its way through mercury contamination in the garage. Crew members are discovering beads of mercury, especially in one area towards the back. Personal items are being removed from the garage and tested. Most items are showing contamination. The crew erected a tent to facilitate the decontamination these items. The decontamination process involves using a chemical reagent to bind the mercury and/or allowing the items to vent. Air monitoring data is being collected inside and outside the tent throughout this process. The items will then be screened for mercury once again before being returned to the property owner. Items that cannot be decontaminated are being disposed of.

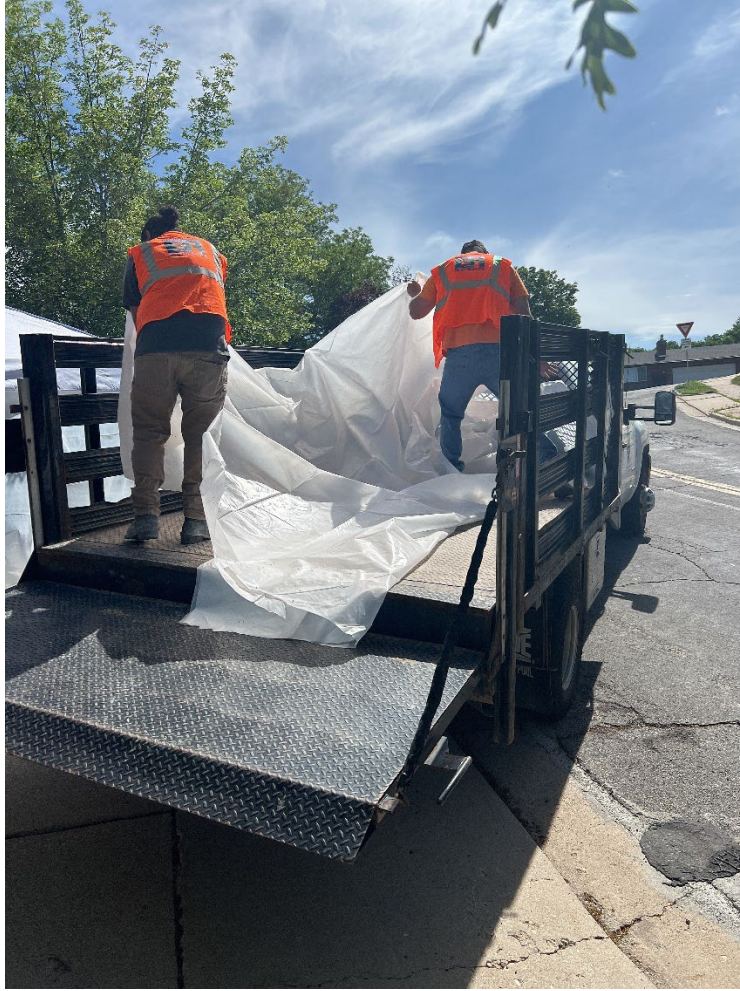
Response Team preparing first load for disposal.

The Team is also continuing to collect and process other chemicals from the garage for disposal. These chemicals are being sorted into hazard classes and waste streams before being packaged into secure containers for transport.
