Re: Progress update Letter 1
366-394 Wilson Avenue, Newark, NJ (the Site/Property)
General Facility Tracking Identification # NJN986663052

This letter summarizes the environmental scope of services performed by Envocare Environmental & Facility Management (ENVOCARE) at the above-referenced property after approval of sampling and quality assurance project plan.

STOCKPILE REPORT

Figure 1
Sample Location Map

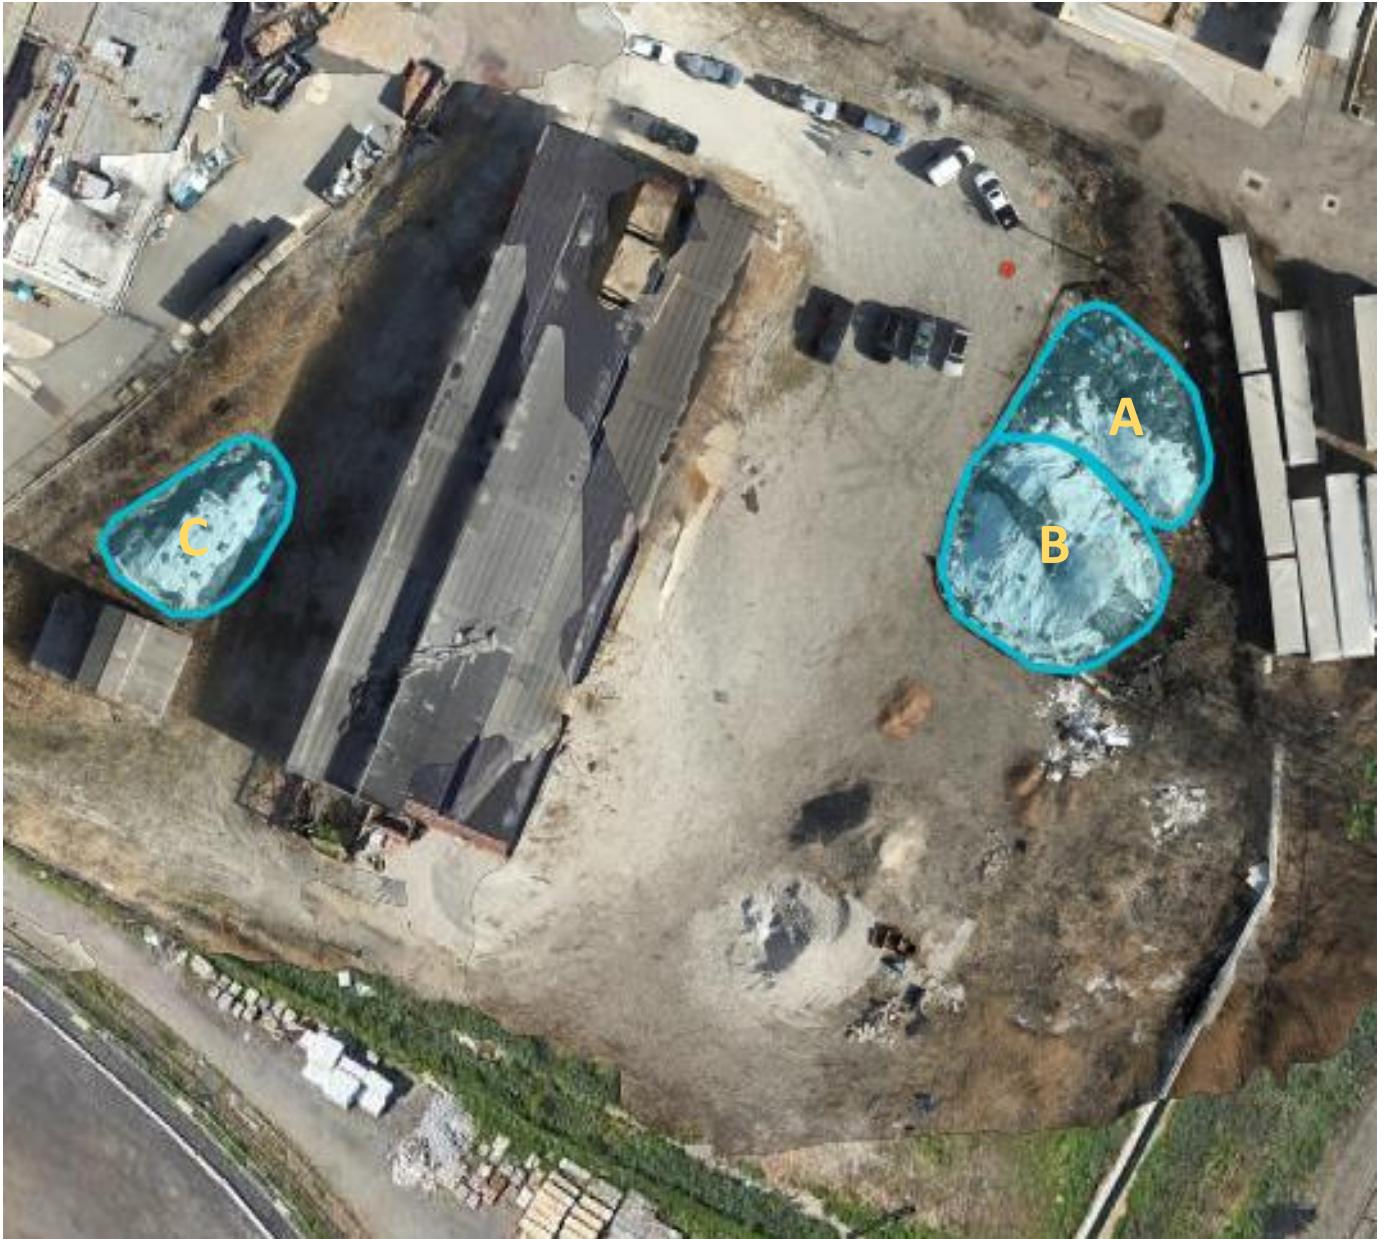
Exhibit A - Map

The volume calculation was done using a Linear Fit method. This is the best method to use for this project. Exhibit A shows three different piles that volume was calculated for. Exhibit B shows how much volume needs to be taken out for each pile. We conclude that a total of 727.68 cubic yards will need to be removed. Please account for a deviation of 10-15% for the final grading.

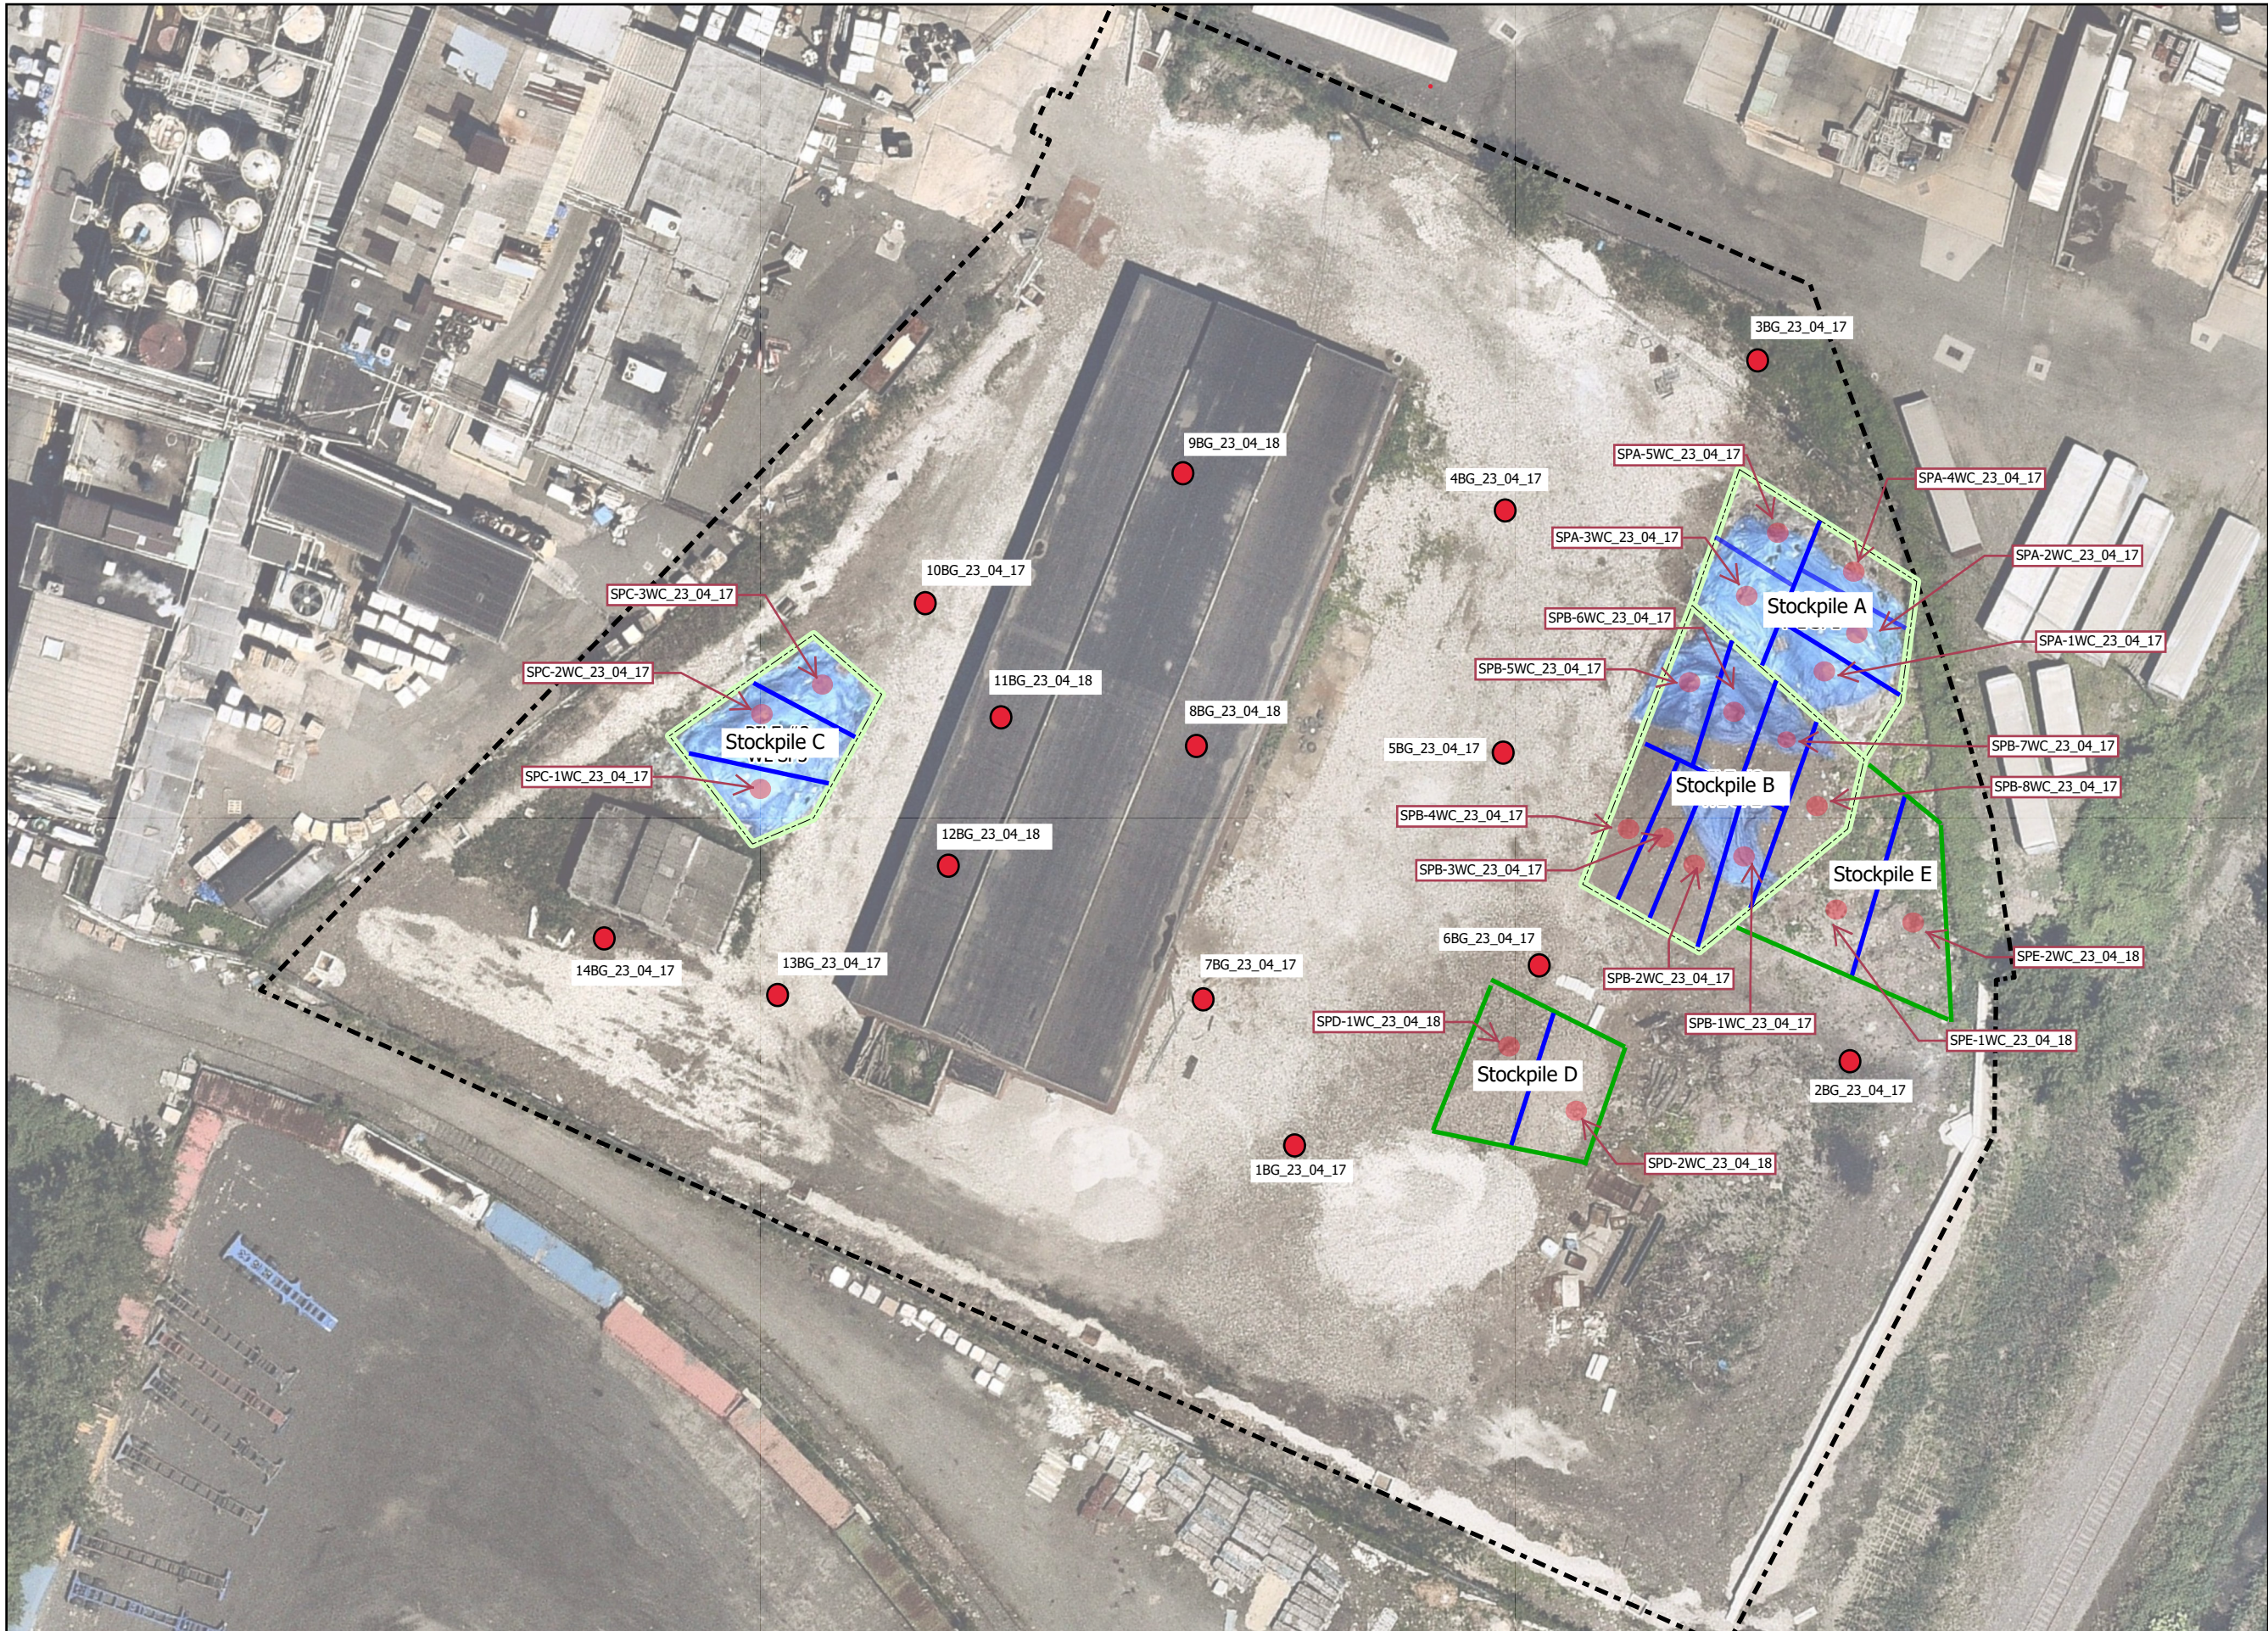
Between April 17th and 18th, 2023, stockpiles were sampled as directed by EPA for waste classification parameters to adhere to Clean Earth Disposal facility acceptance guidelines. In addition to the three stockpiles in the proposed scope of work, two more stockpiles were sampled for waste class parameters as per EPA OSC direction. These stockpiles were labeled stockpiles D and E which were located directly south of stockpile B and another located to the east adjacent to stockpile B respectively. Sample location figure shown in [Figure 1](#).
