August 21, 2023

**Subject: Nedlog Property Assessment Letter Report – Revision 0
Nedlog Property Assessment
Laramie, Albany County, Wyoming
EPA Contract Number: 68HE0820D0001
Technical Direction Number.: 2071-2304-07**

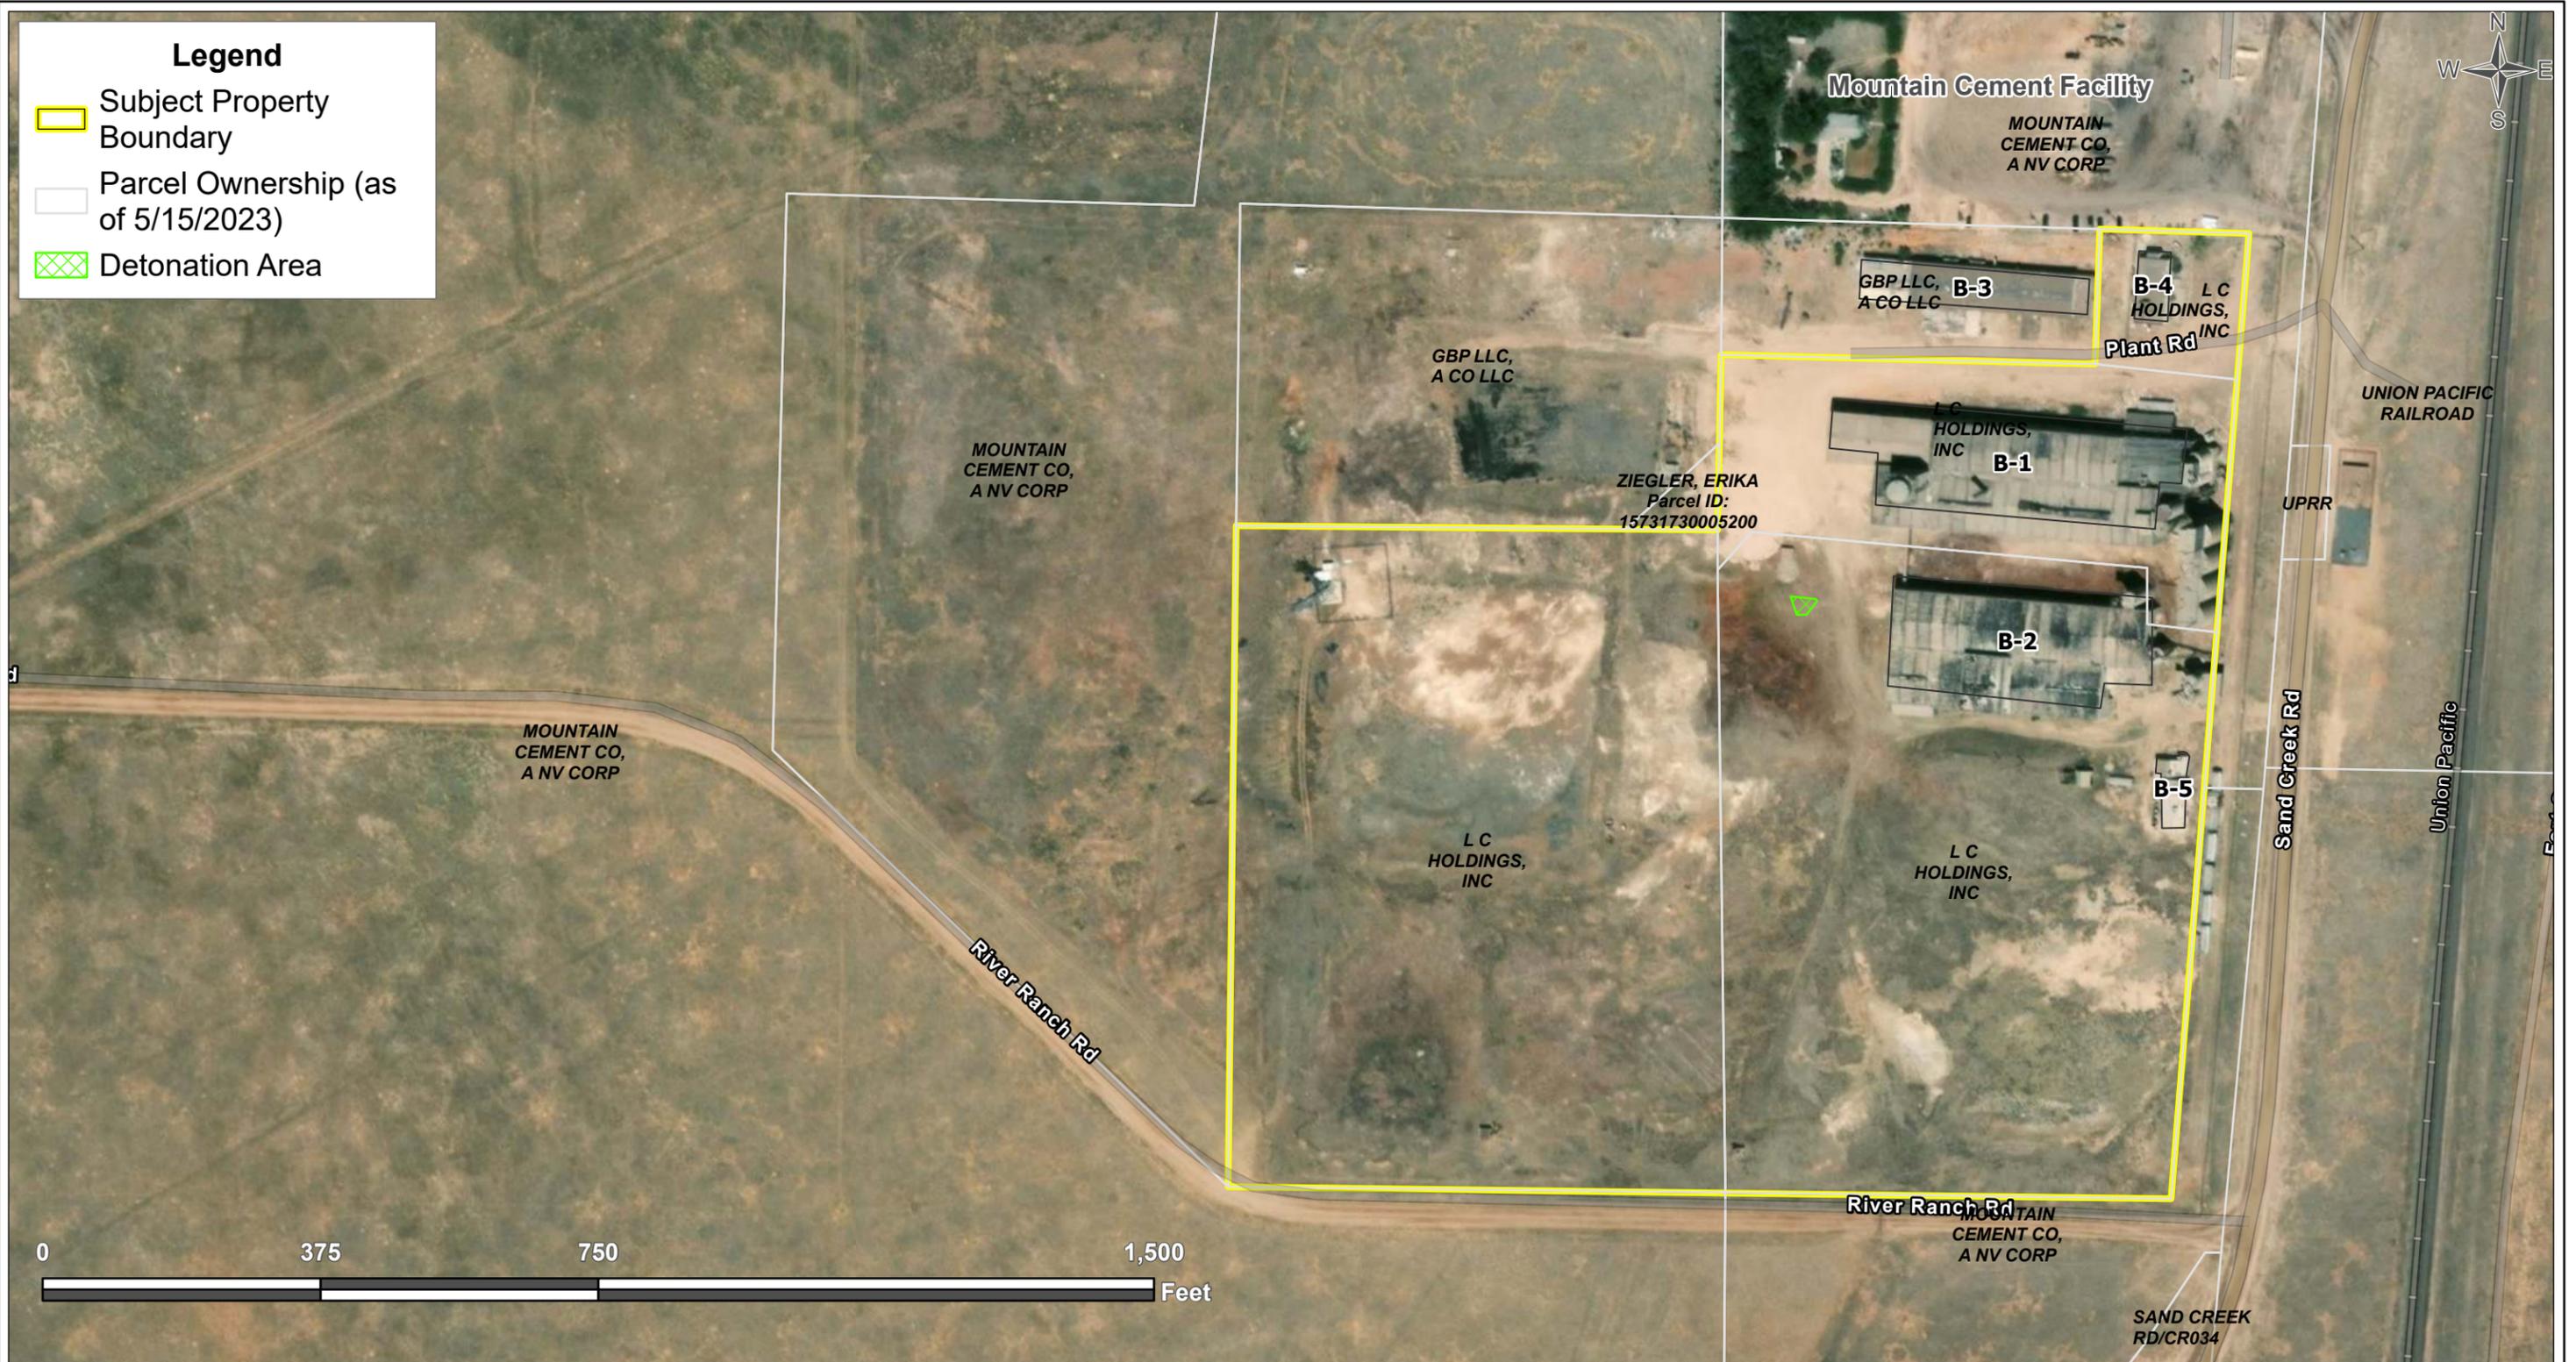
Figure 2
Subject Property Layout

The Site is located at 17 Sand Creek Road in Laramie, Albany County, Wyoming (Enclosure 1, Figure 1). The Site encompasses approximately 31.4 acres. An aerial view showing the site layout is provided on Figure 2 (Enclosure 1). The Site consists of a vacant property containing three manufactory buildings and one administrative and laboratory building. A fifth building (B-3 on Figure 2) is nearby, but off-site. Building B-3 was not included in the property assessment during this mobilization event.

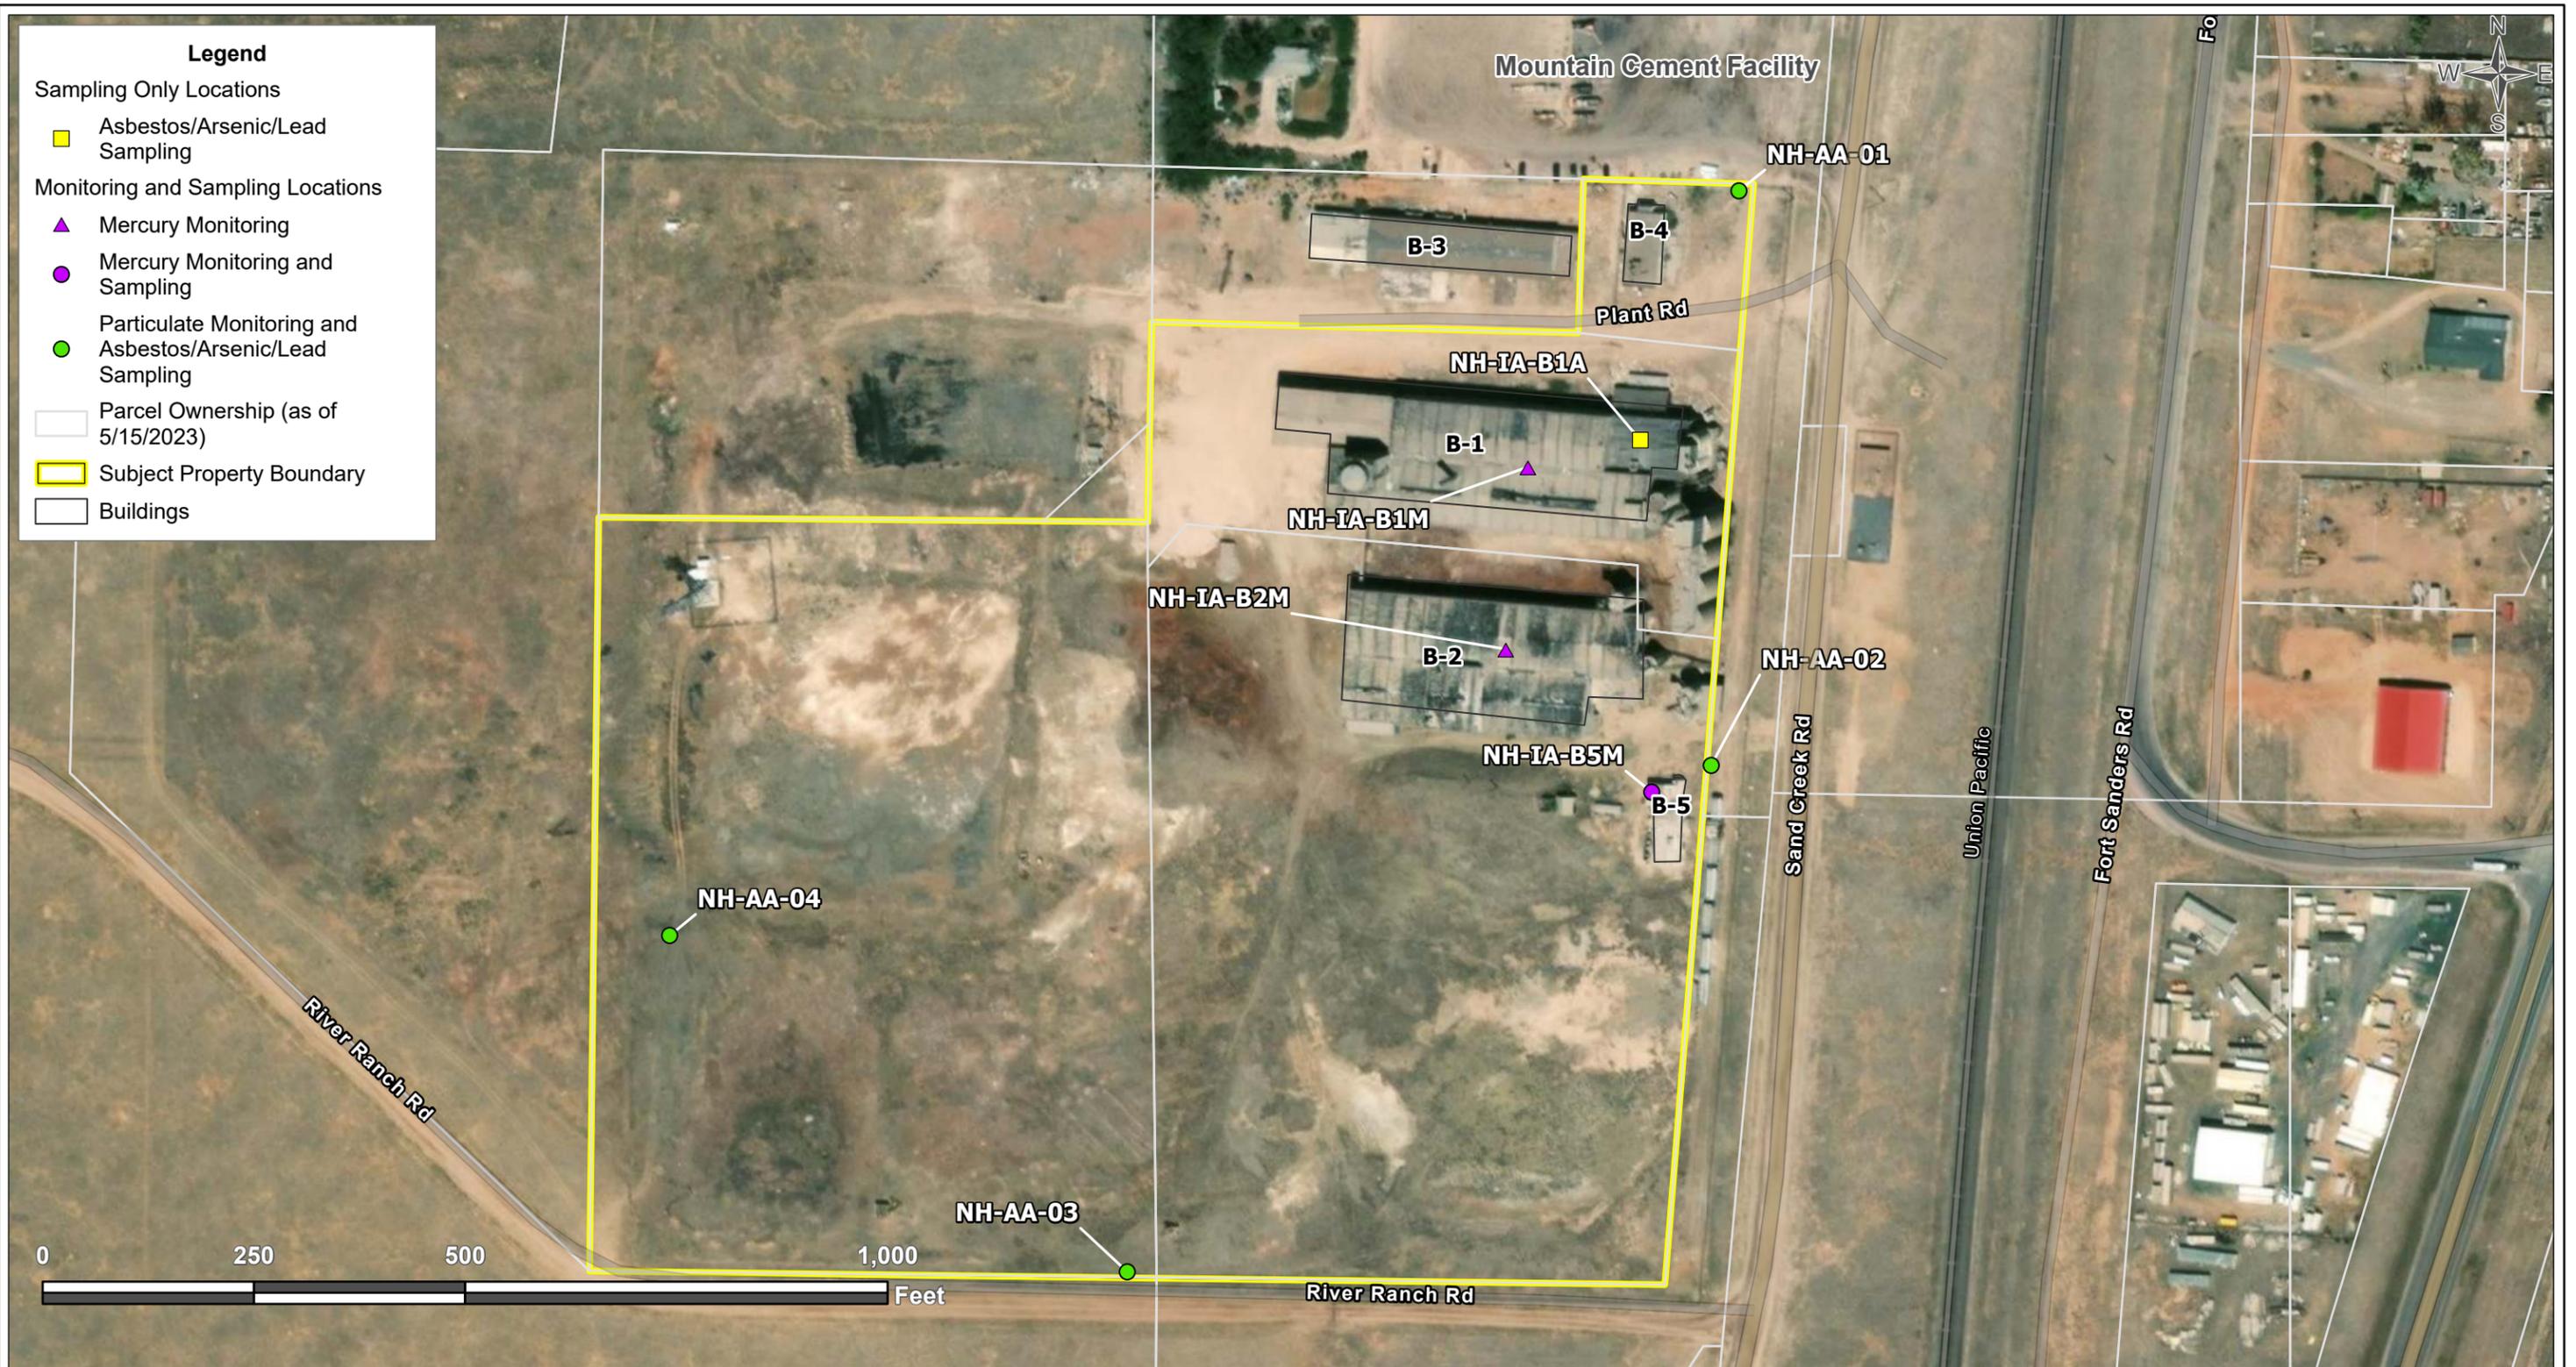
Figure 3
Air Monitoring and Sampling Locations

Notes:
 All locations are approximate.

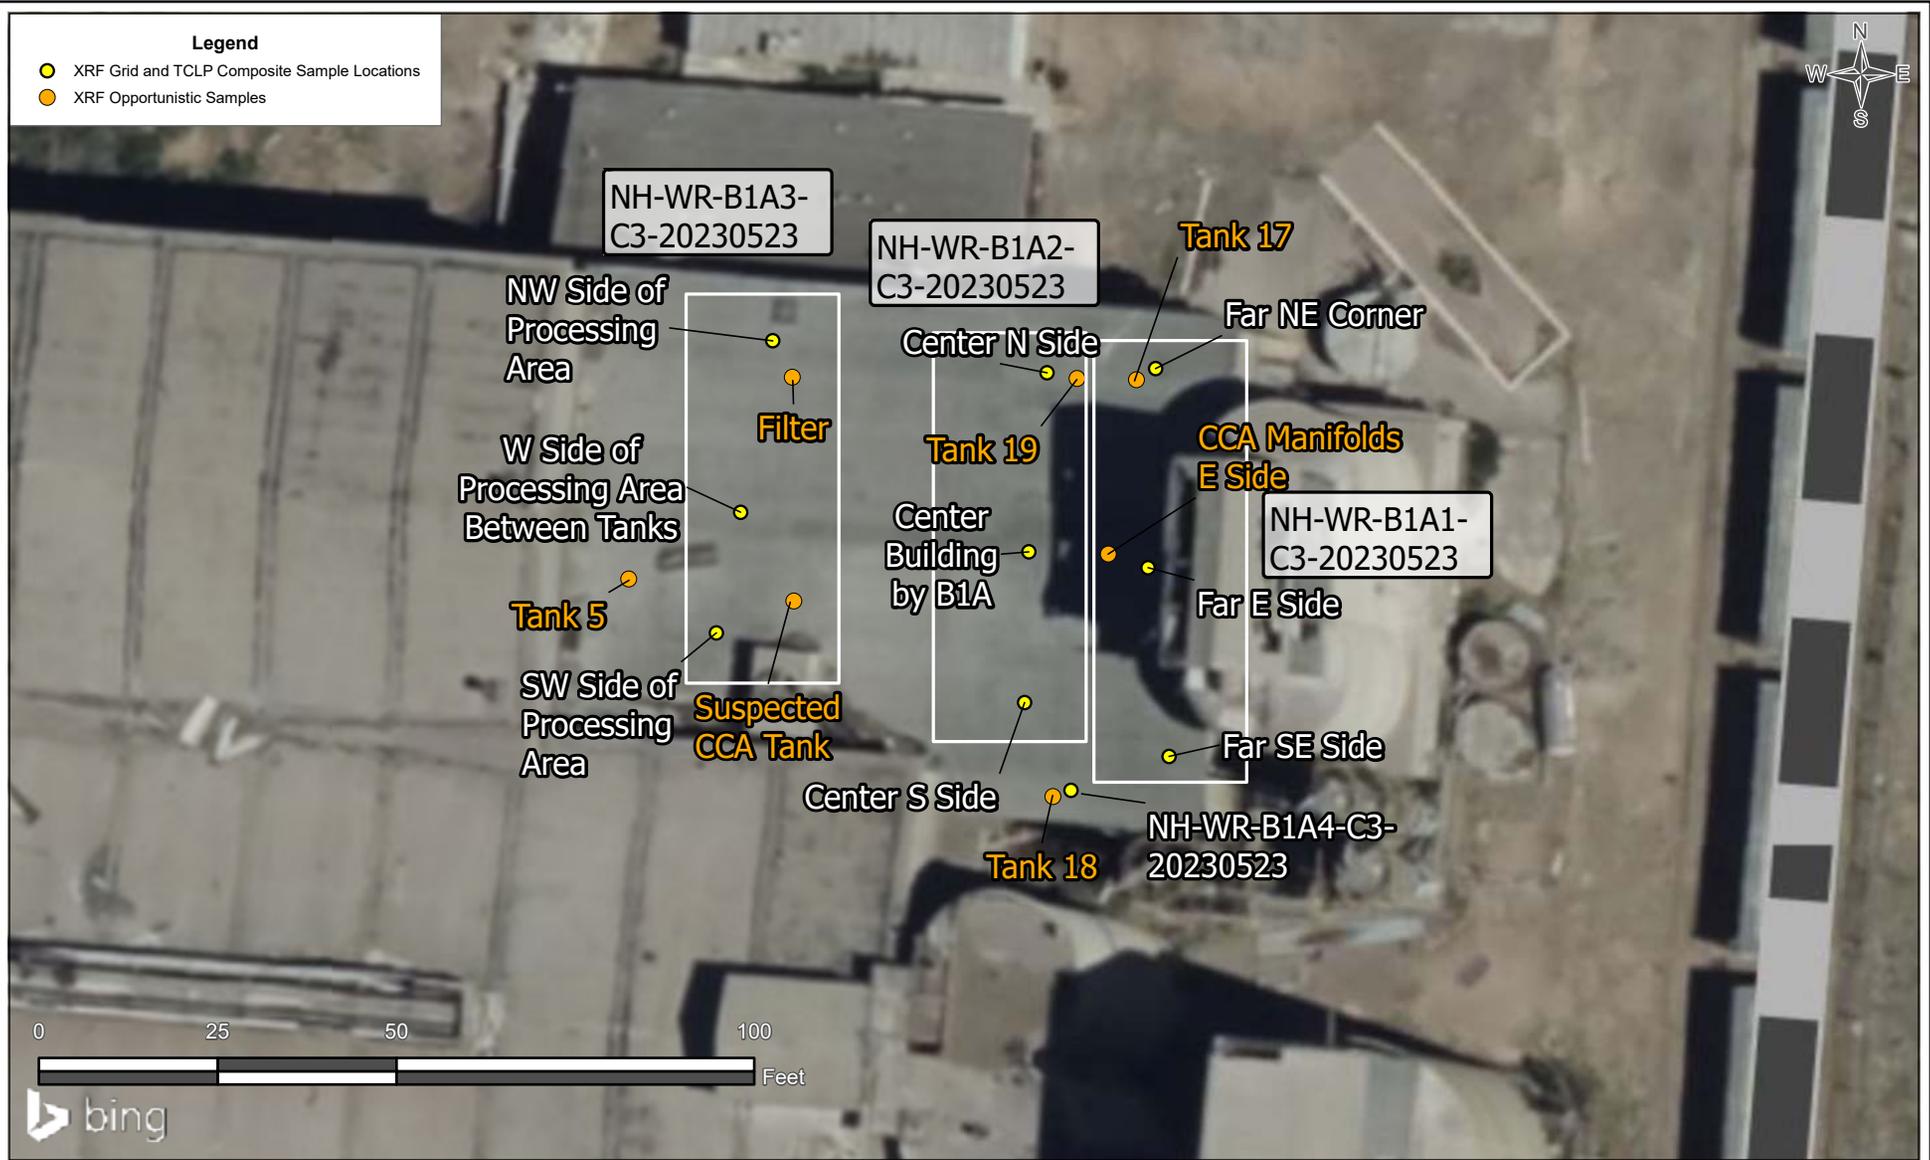
Nedlog Property Assessment
 17 Sand Creek Road
 Laramie, Albany County, Wyoming
Figure 4
XRF and TCLP Sample Locations

Notes:
 -Points represent the aliquot for the composite sample locations
 -Aliquot locations are approximated
 -White rectangles are the approximated composite areas for XRF Grid and TCLP composite sample locations
 -TCLP – Toxicity Characteristic Leaching Procedure
 -XRF – X-ray fluorescence

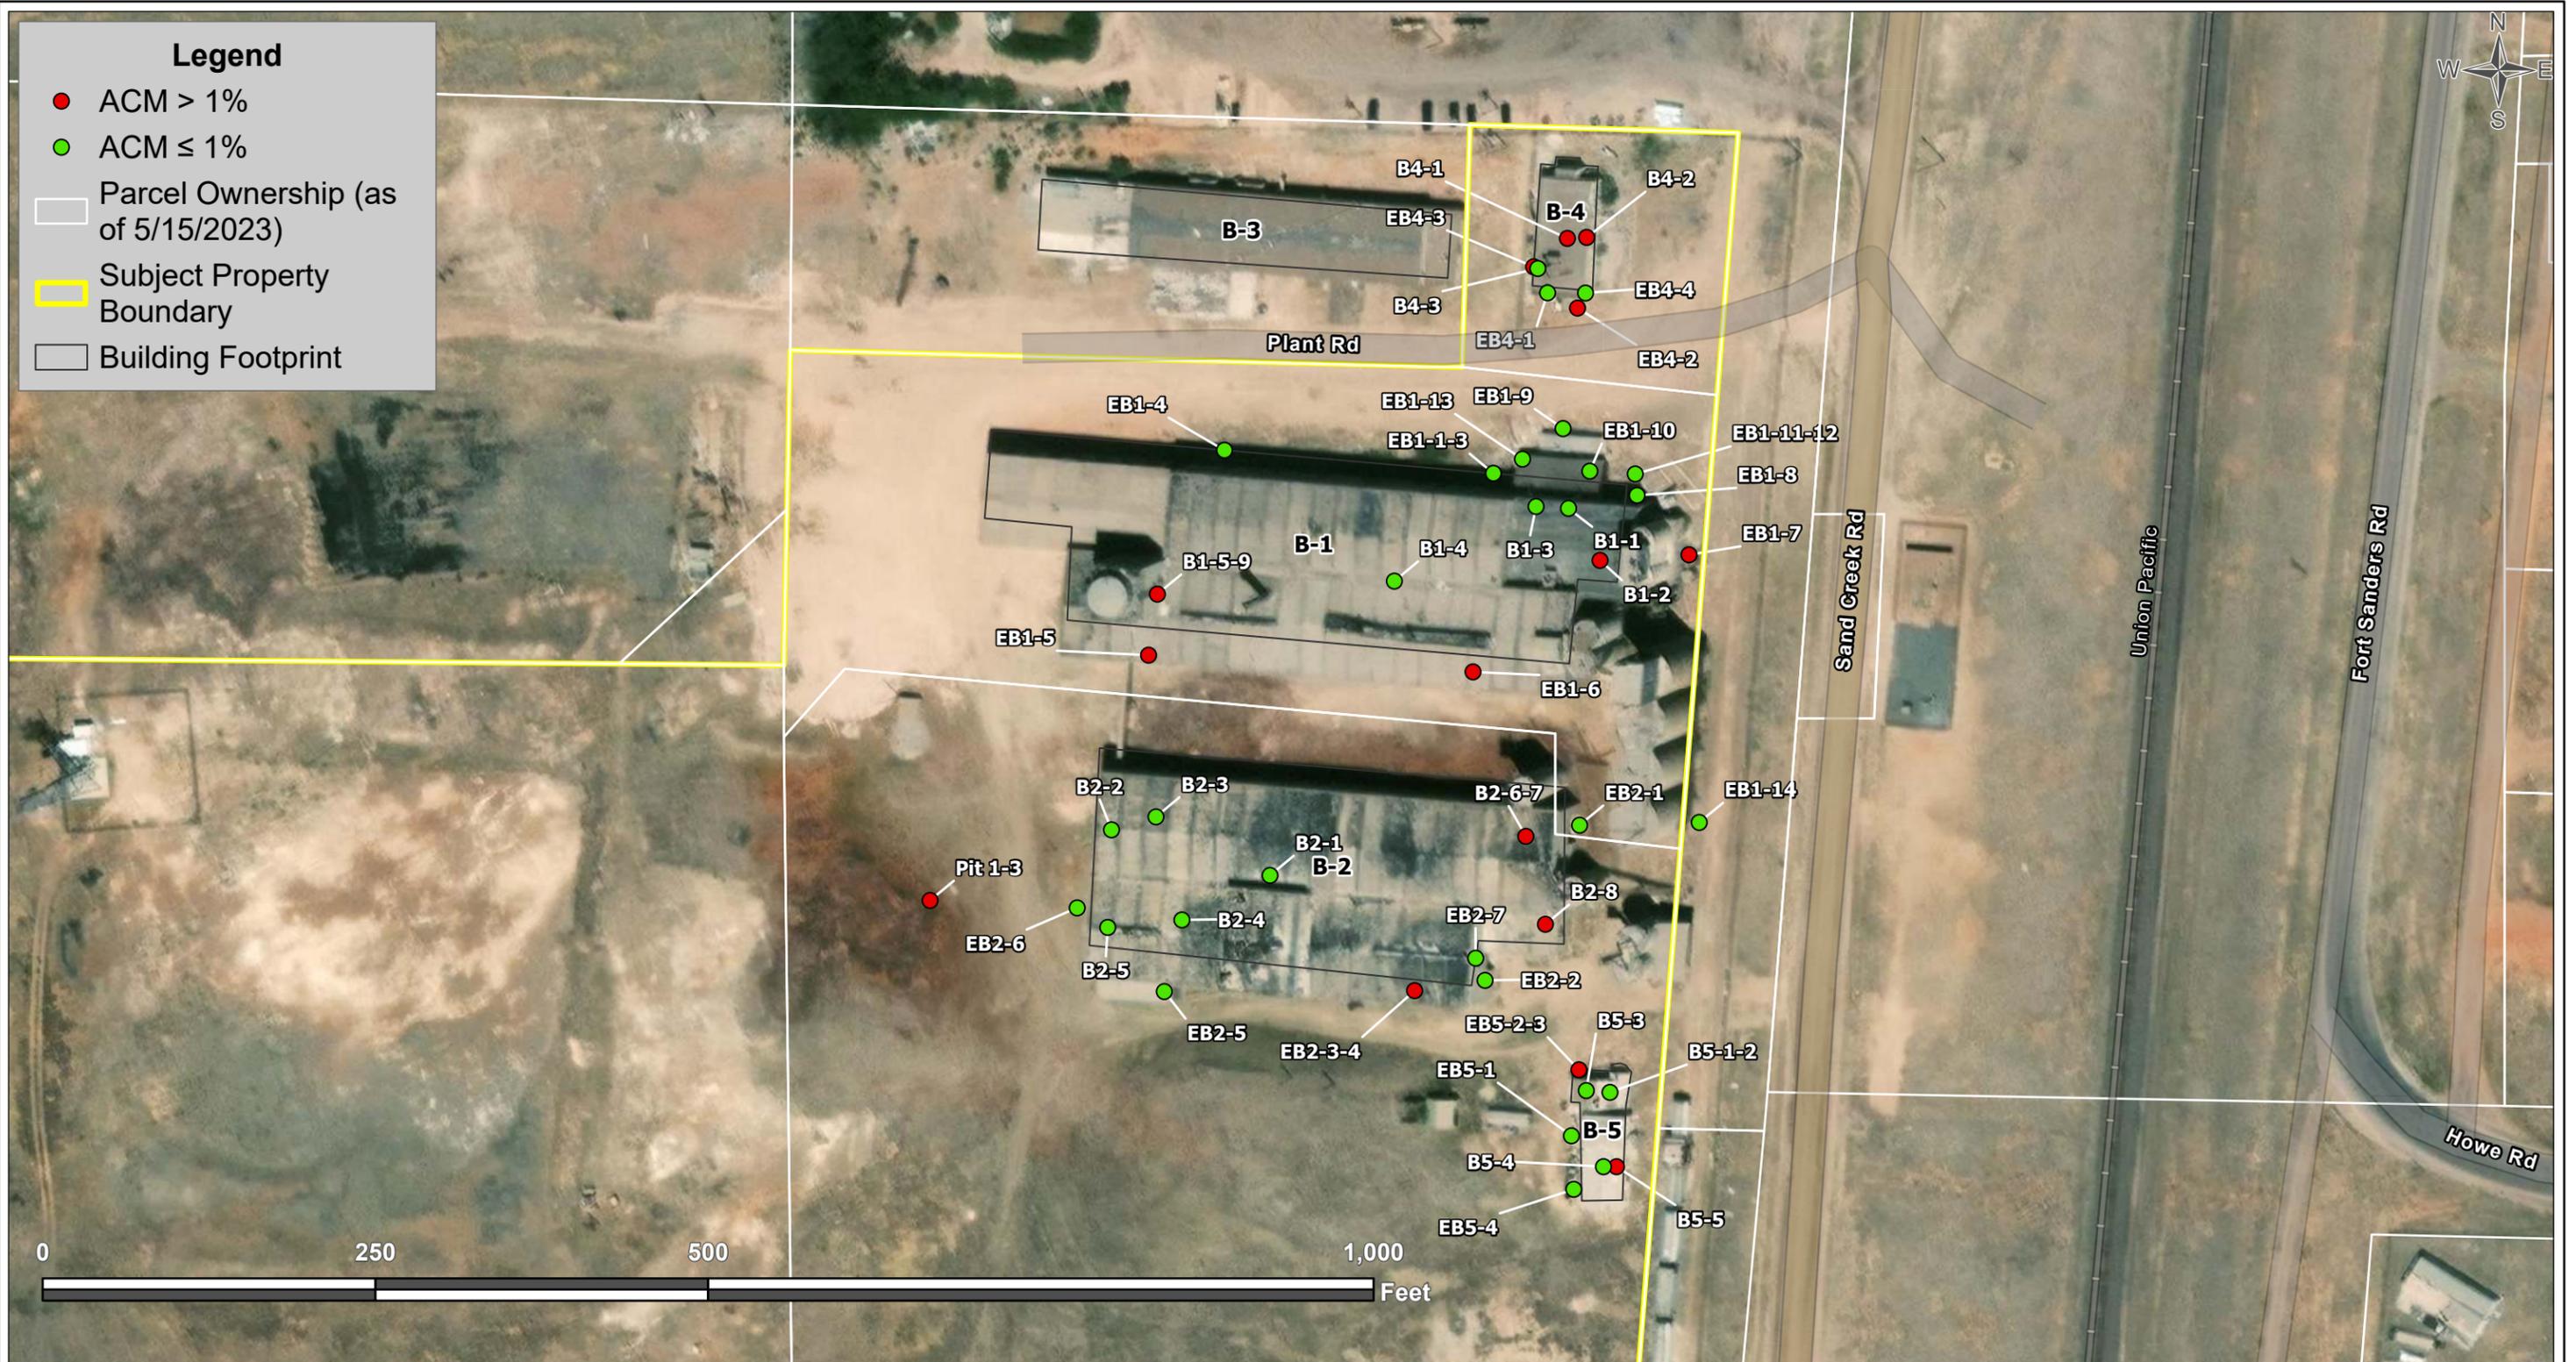
Figure 5
ACM Sample Locations

ACMs greater than 1 percent were identified in building components found in buildings B-1, B-2, B-4, and B-5, on the ground surface around the exterior of buildings B-1 and B-2, and buried in the ground west of building B-2.

Notes:
ACM - Asbestos-Containing Material

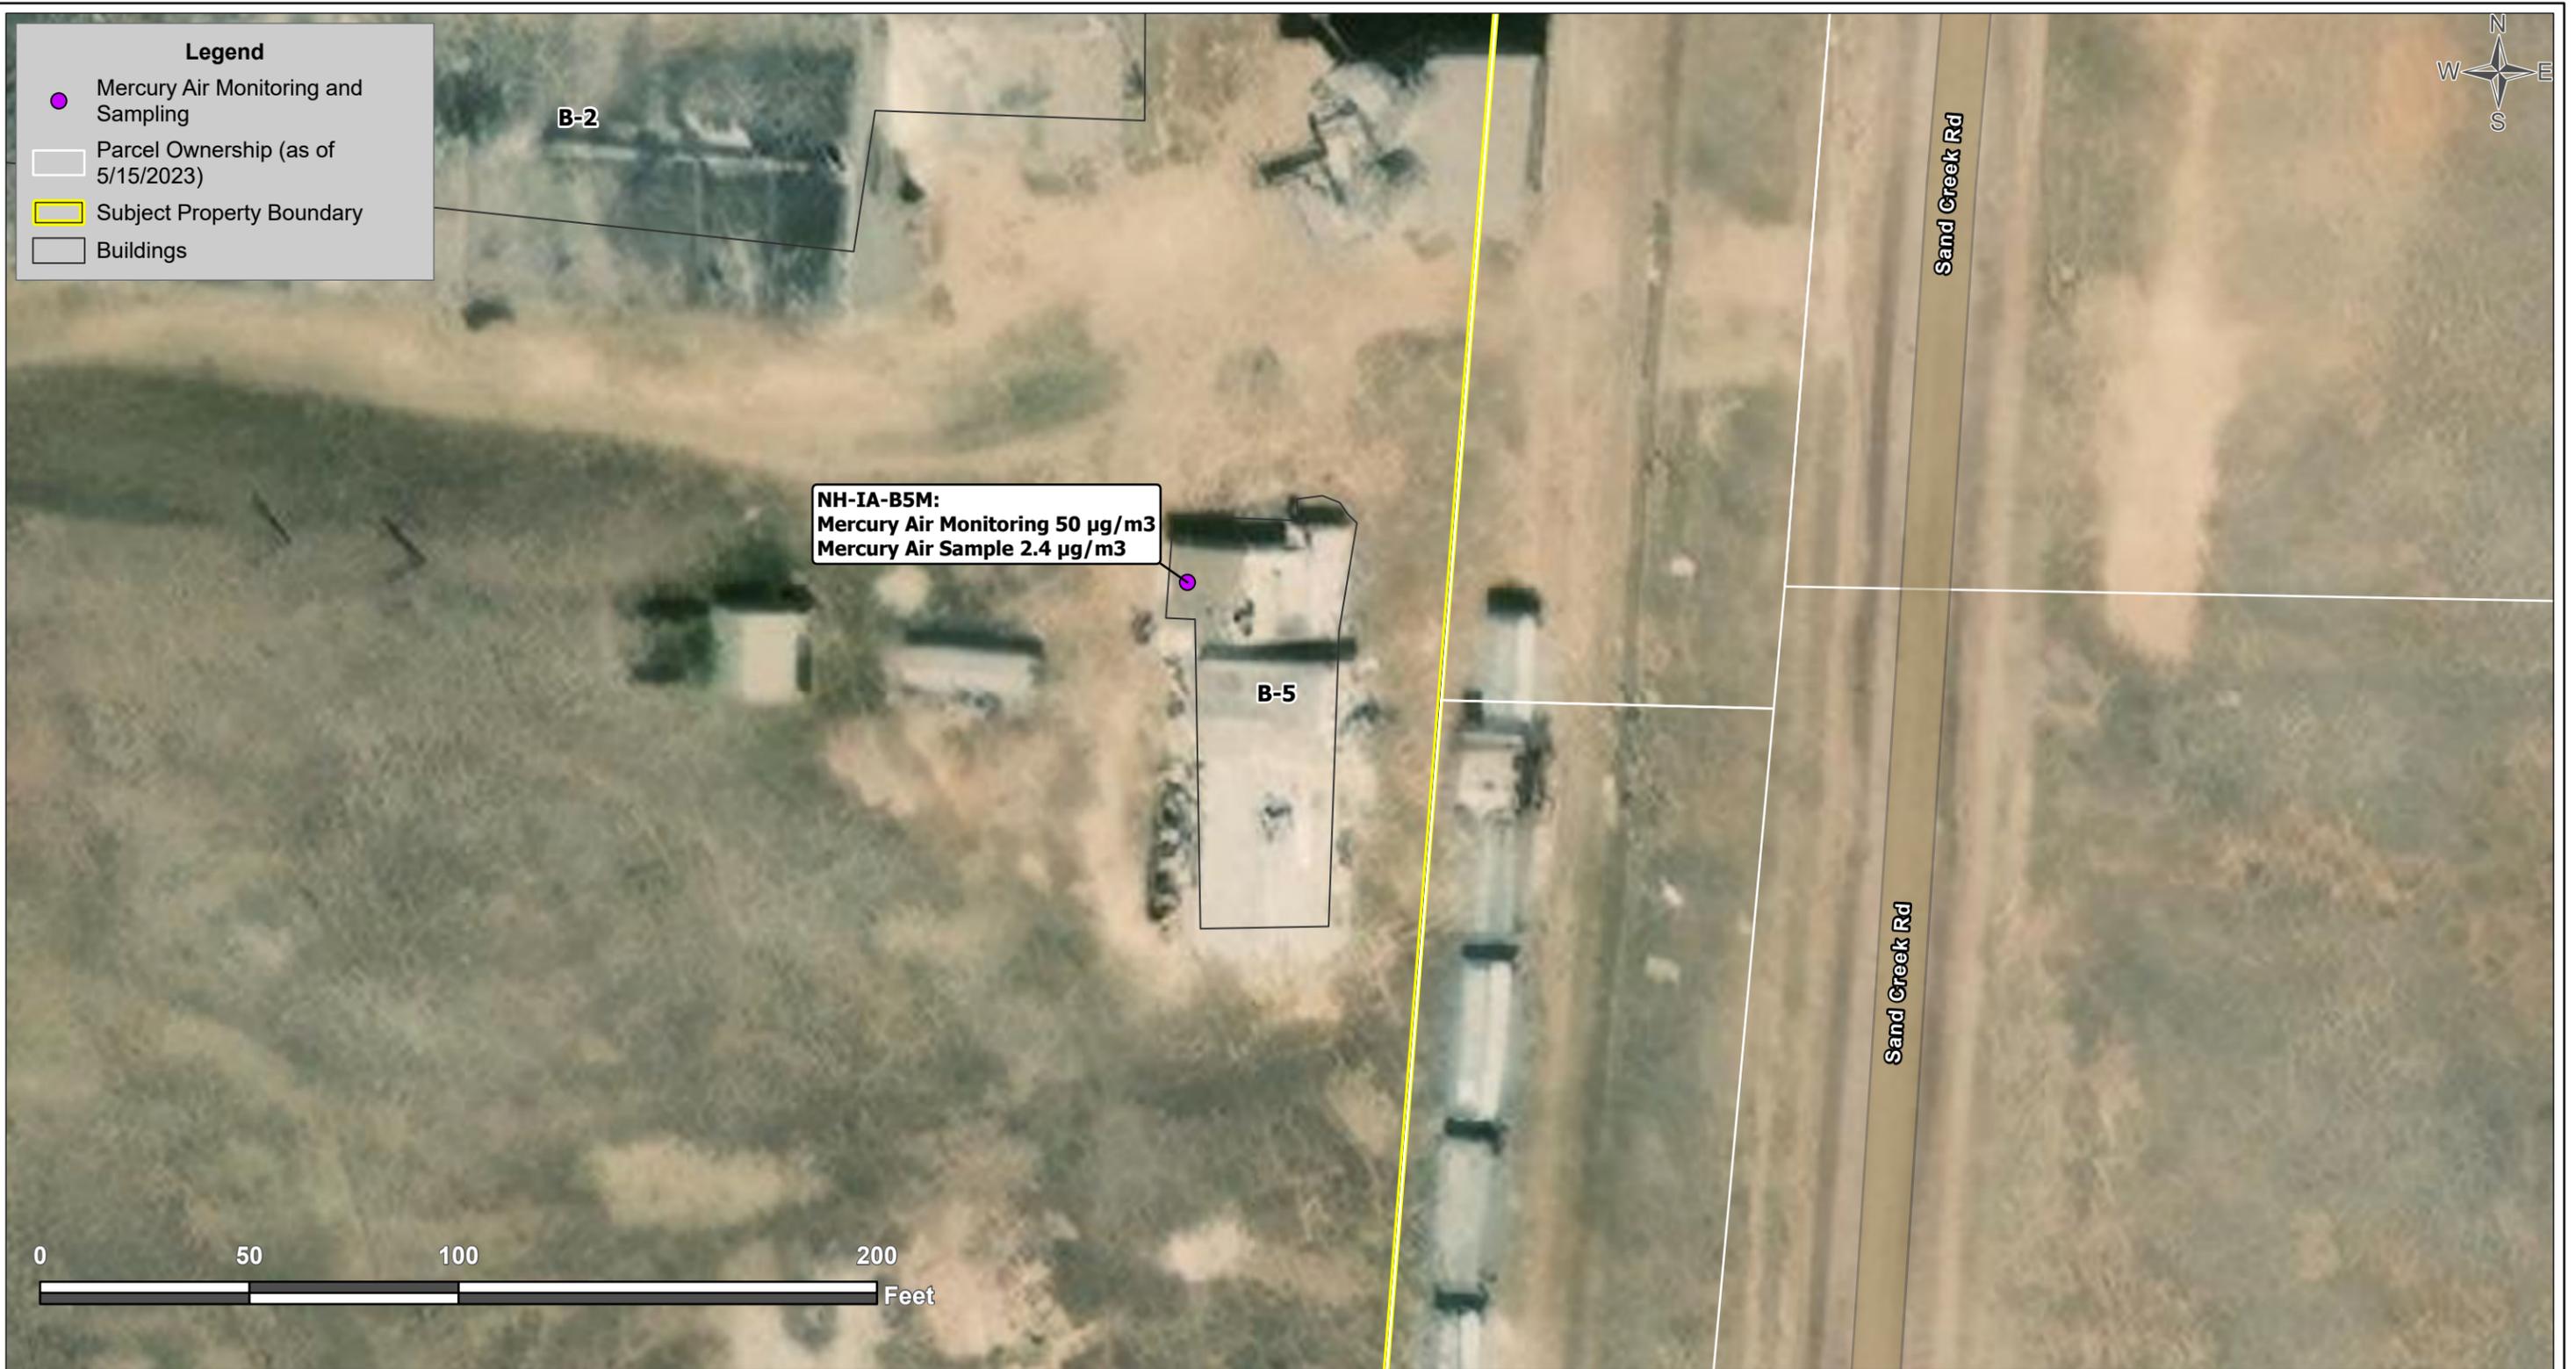
Figure 6
Mercury Air Monitoring and Sampling Results

One indoor air sample for mercury vapor was submitted to Pace Laboratories for analysis via NIOSH Method 6009. The analytical result was compared to the EPA Industrial Removal Management Level (RML) with a target risk of 10^{-4} and a hazard quotient of 1. Mercury was detected in the sample at a concentration of $2.4 \mu\text{g}/\text{m}^3$, which is greater than the RML and project screening level of $1.3 \mu\text{g}/\text{m}^3$. Table 3 (Enclosure 2) summarizes air analytical results. Mercury monitoring and sampling results are shown on Figure 6 (Enclosure 1).

Notes:
 - All locations are approximate.
 - µg/m3 - Micrograms per cubic meter
 - Mercury monitoring data collected with Lumex RA-915M.

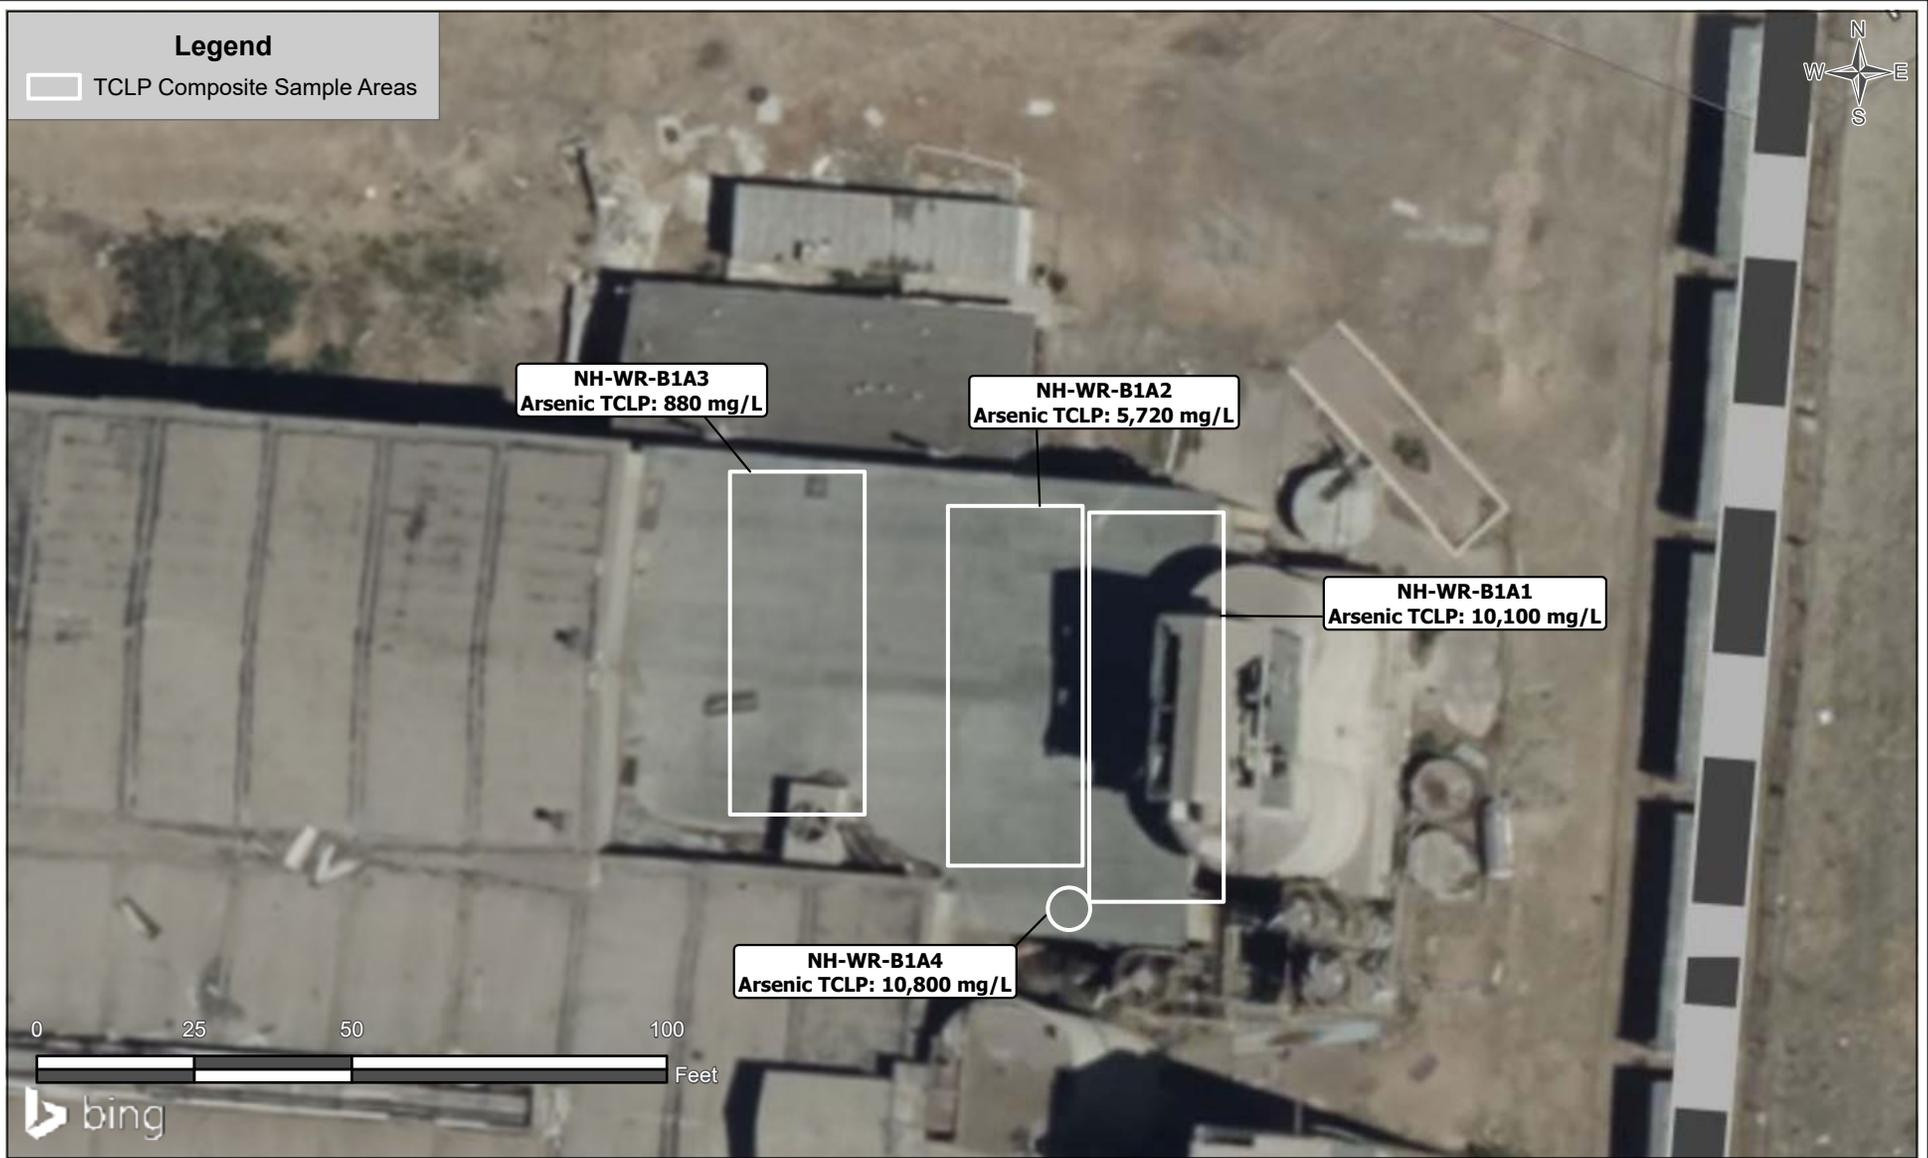
TCLP Composite Sample Areas

NH-WR-B1A3
Arsenic TCLP: 880 mg/L

NH-WR-B1A2
Arsenic TCLP: 5,720 mg/L

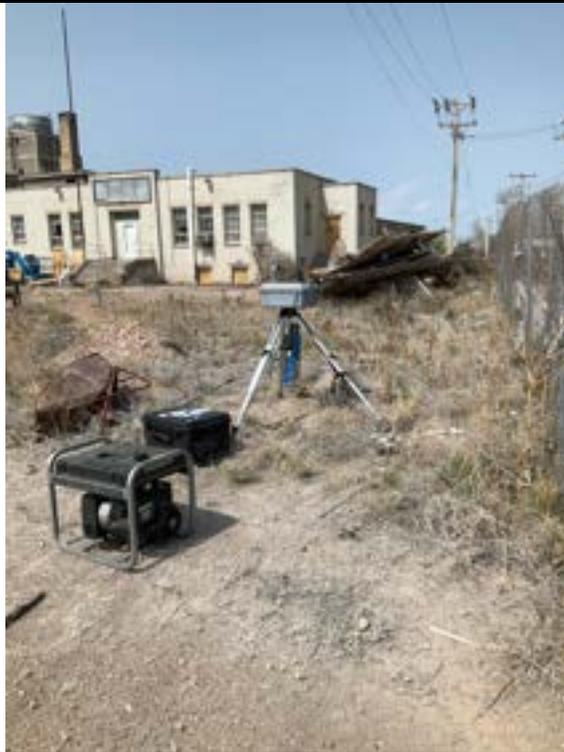
Date/Time Taken:	5/23/2023 Not Available
Photographer:	Foster_Lauren
Latitude:	41.265332
Longitude:	-105.602957
Photo Direction:	WSW
Category:	
Photo Description:	View of sample location NH-AA-01 facing west-southwest with laboratory-admin building (B-4) in background.
Photo Name:	Photos-20230523-163934.jpg

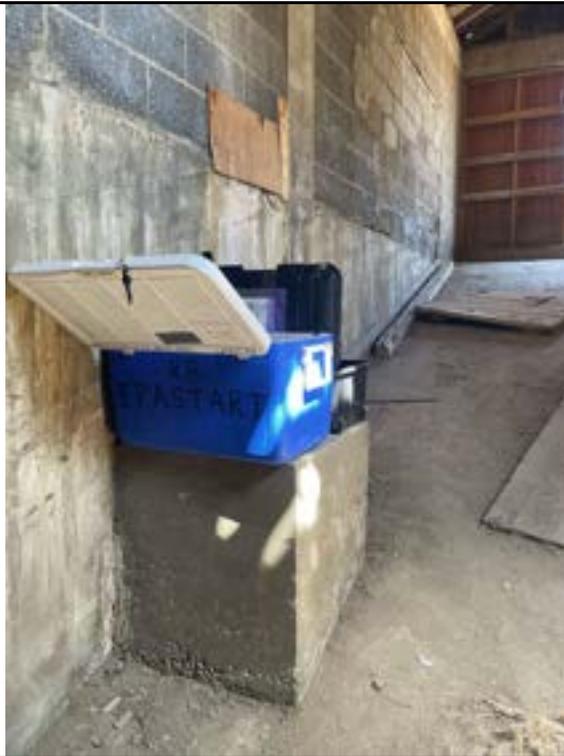
Date/Time Taken:	5/25/2023 Not Available
Photographer:	Foster_Lauren
Latitude:	41.26339
Longitude:	-105.60325
Photo Direction:	NNW
Category:	
Photo Description: Mercury vapor sample location in building B-5.	
Photo Name: Photos-20230525-170132.jpg

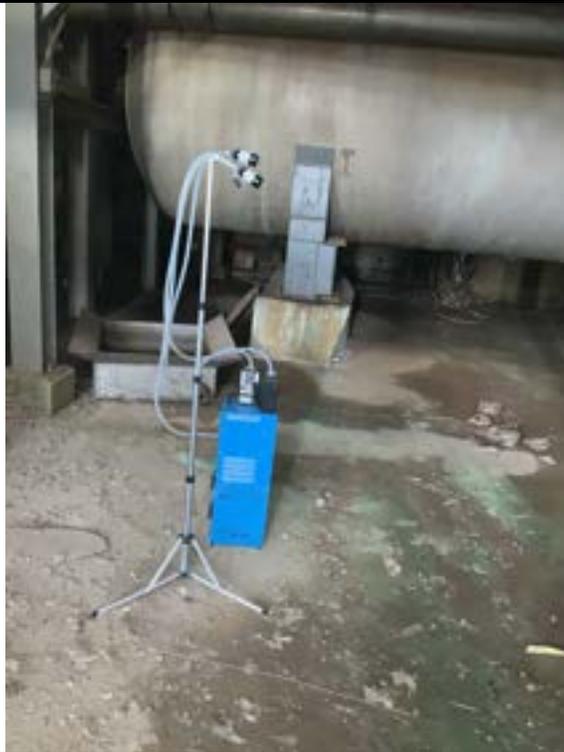
Date/Time Taken:	5/22/2023 3:55:00 PM
Photographer:	Foster_Lauren
Latitude:	41.26456
Longitude:	-105.603298
Photo Direction:	SE
Category:	
Photo Description: Close up view of air sampling location NH-IA-B1A.	
Photo Name: Photos-20230522-215545.jpg

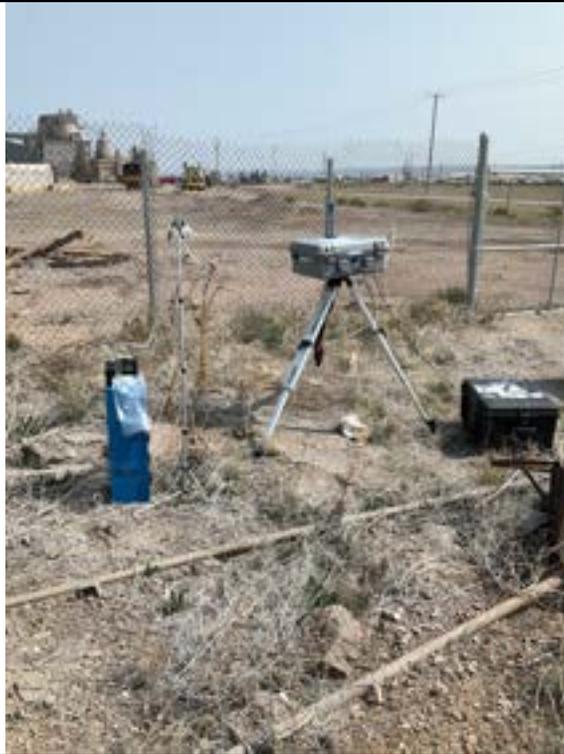
Date/Time Taken:	5/23/2023 10:38:00 AM
Photographer:	Foster_Lauren
Latitude:	41.265288
Longitude:	-105.603056
Photo Direction:	NNE
Category:	
Photo Description:	View of sample location NH-AA-01 facing north from along northern property boundary.
Photo Name:	Photos-20230523-163851.jpg

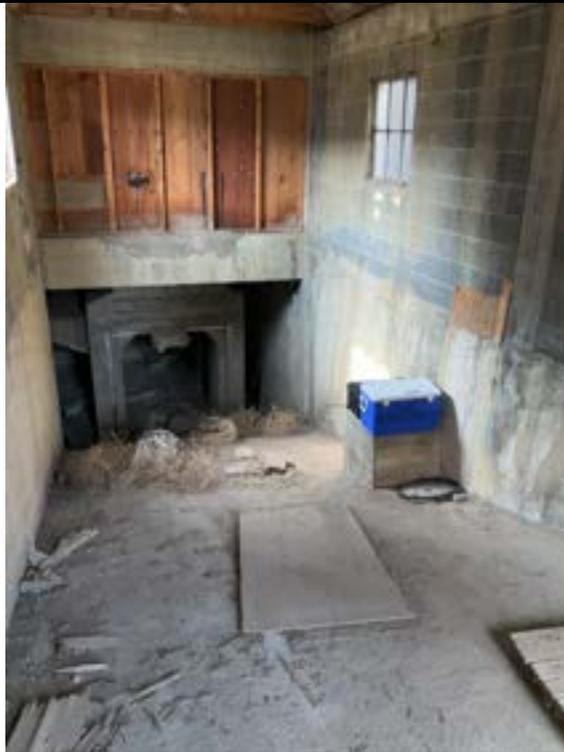
Date/Time Taken:	5/24/2023 Not Available
Photographer:	Foster_Lauren
Latitude:	41.263415
Longitude:	-105.603243
Photo Direction:	S
Category:	Assessment
Photo Description:	Mercury vapor monitoring in building B-5 on west side of building from north entrance.
Photo Name:	Photos-20230524-151057.jpg

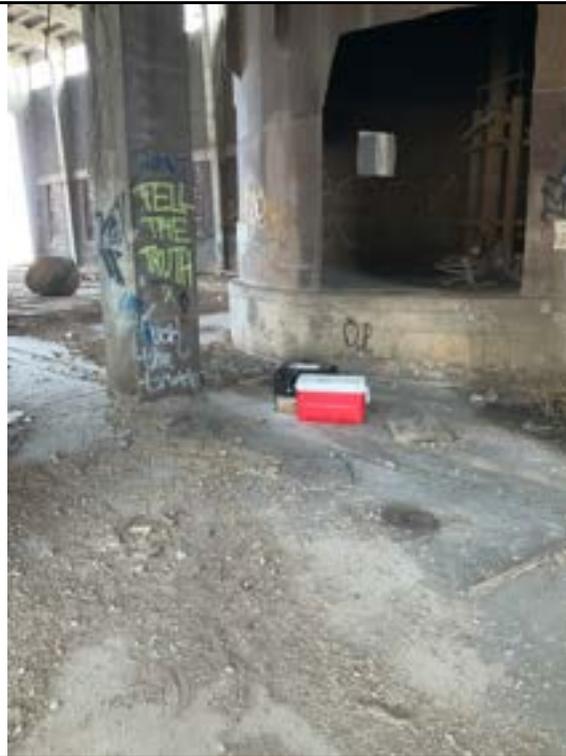
Date/Time Taken:	5/24/2023 Not Available
Photographer:	Foster_Lauren
Latitude:	41.264428
Longitude:	-105.603963
Photo Direction:	WNW
Category:	Assessment
Photo Description: Mercury vapor monitoring location in central portion of building B-1.	
Photo Name: Photos-20230524-144818.jpg

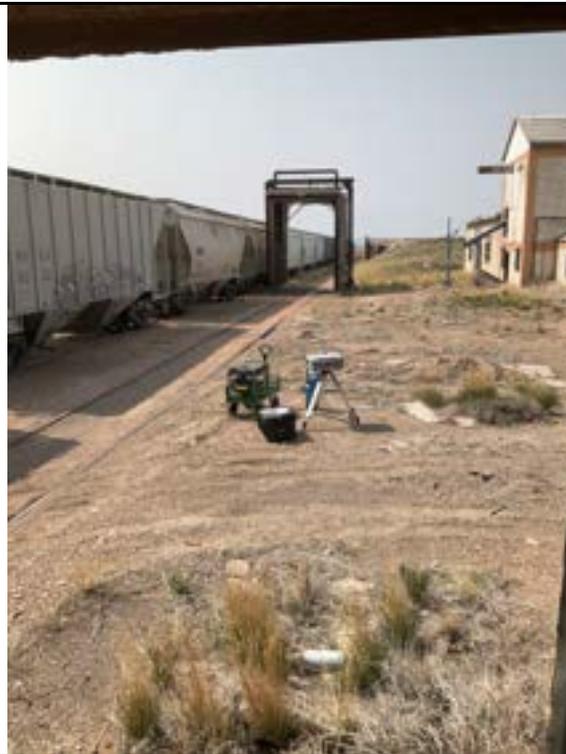
Date/Time Taken:	5/23/2023 10:25:00 AM
Photographer:	Foster_Lauren
Latitude:	41.263618
Longitude:	-105.603129
Photo Direction:	S
Category:	Assessment
Photo Description: View from north of station NH-AA-02, facing south. Building B-5 visible on west side of photo.	
Photo Name: Photos-20230523-162542.jpg

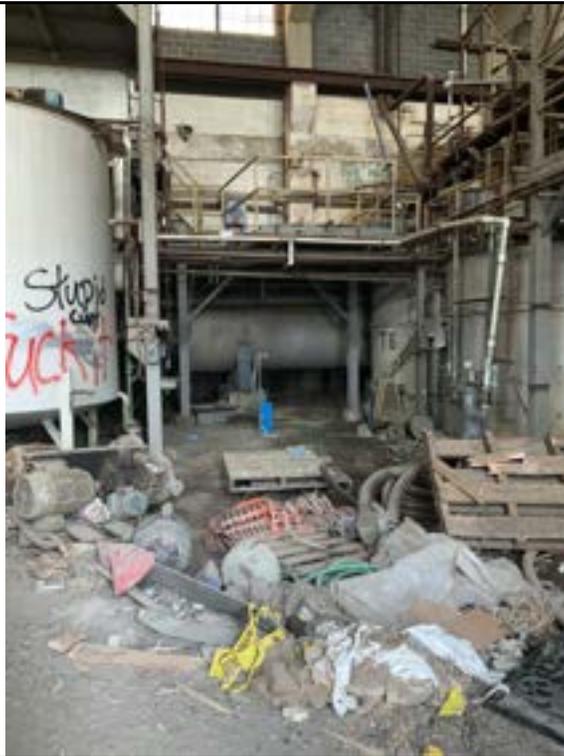
Date/Time Taken:	5/23/2023 Not Available
Photographer:	Foster_Lauren
Latitude:	41.264547
Longitude:	-105.60332
Photo Direction:	S
Category:	Removal
Photo Description: Overview of air sampling location NH-IA-B1A.	
Photo Name: Photos-20230522-215705.jpg
