August 21, 2023

**Subject: Nedlog Property Assessment Letter Report – Revision 0
Nedlog Property Assessment
Laramie, Albany County, Wyoming
EPA Contract Number: 68HE0820D0001
Technical Direction Number.: 2071-2304-07**

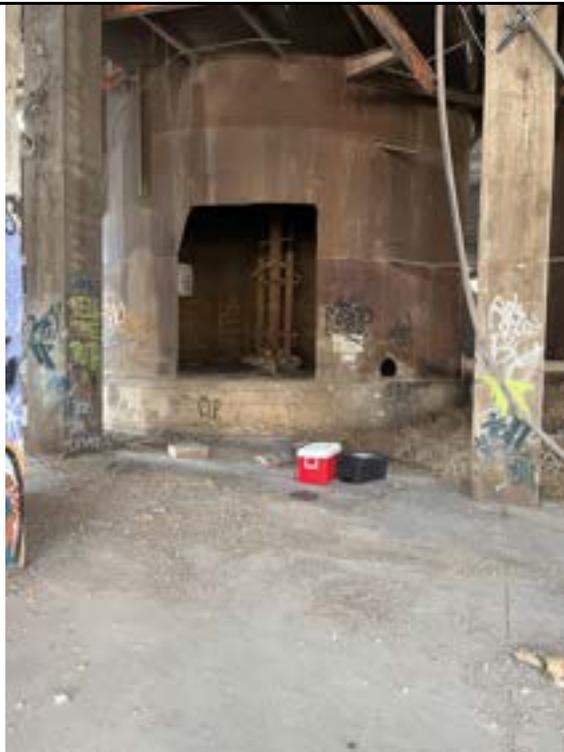
Date/Time Taken:	5/22/2023 Not Available
Photographer:	McAleese_Maura
Latitude:	41.264465
Longitude:	-105.603963
Photo Direction:	NW
Category:	Removal
Photo Description: Overview of Jerome mercury vapor analyzer setup in southern section of building B-1.	
Photo Name: Photos-20230522-223335.jpg

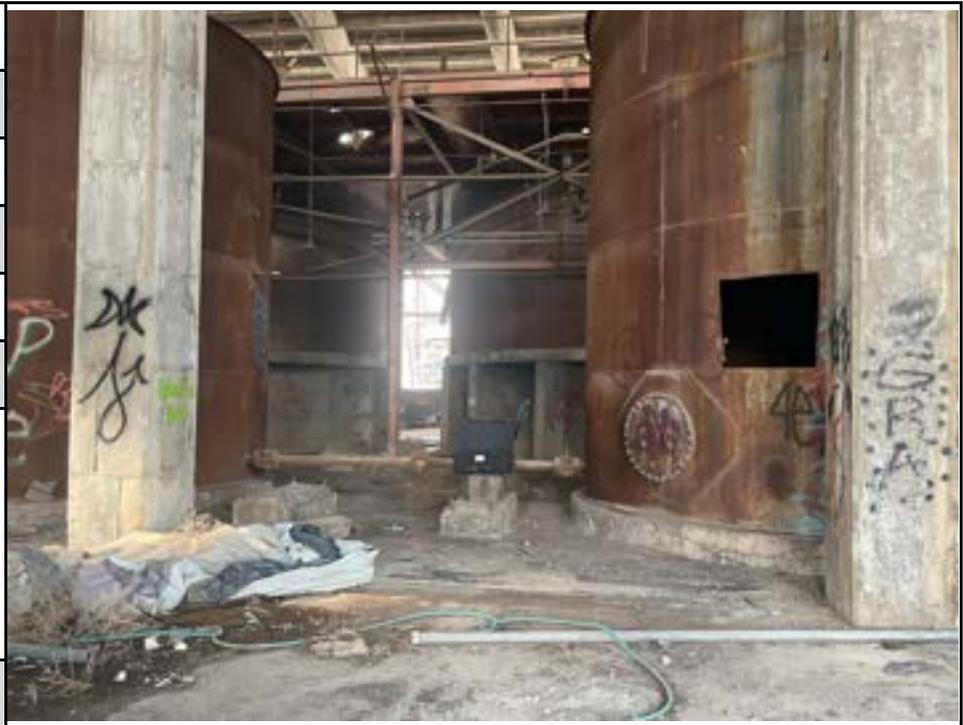
Date/Time Taken:	5/23/2023 Not Available
Photographer:	McAleese_Maura
Latitude:	41.263763
Longitude:	-105.603928
Photo Direction:	WSW
Category:	Removal
Photo Description:	Overview of monitoring location, building B-1.
Photo Name:	Photos-20230522-231230.jpg

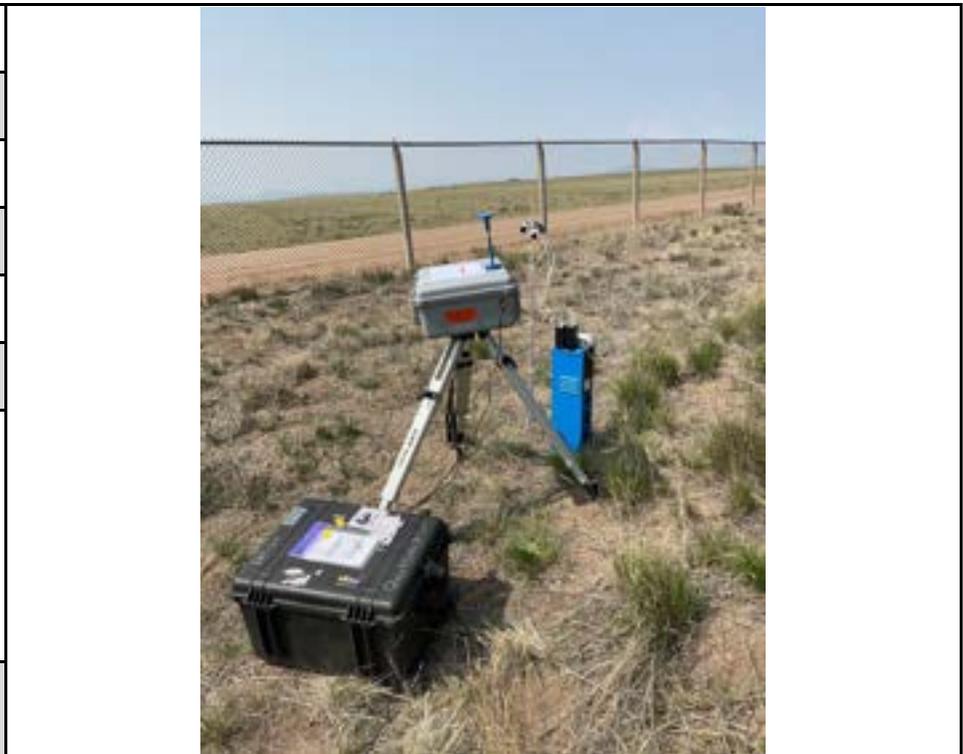
Date/Time Taken:	5/23/2023 10:46:00 AM
Photographer:	Broome_Chandler
Latitude:	41.261808
Longitude:	-105.605555
Photo Direction:	SW
Category:	Removal
Photo Description:	View of sample location NH-AA-03 on south border of property facing southwest.
Photo Name:	Photos-20230523-164624.jpg

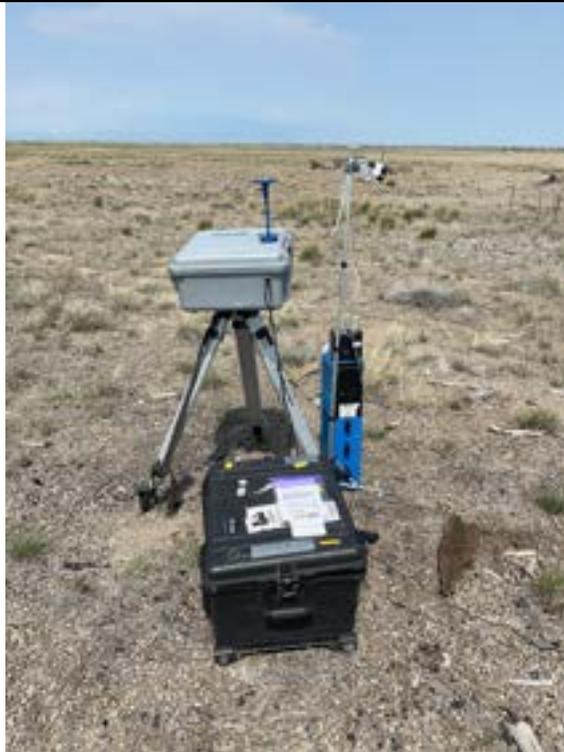
Date/Time Taken:	5/23/2023 11:06:00 AM
Photographer:	Broome_Chandler
Latitude:	41.262977
Longitude:	-105.60762
Photo Direction:	WNW
Category:	Removal
Photo Description: View of sample location NH-AA-04 in far southwest corner of property facing west-northwest.	
Photo Name: Photos-20230523-170626.jpg

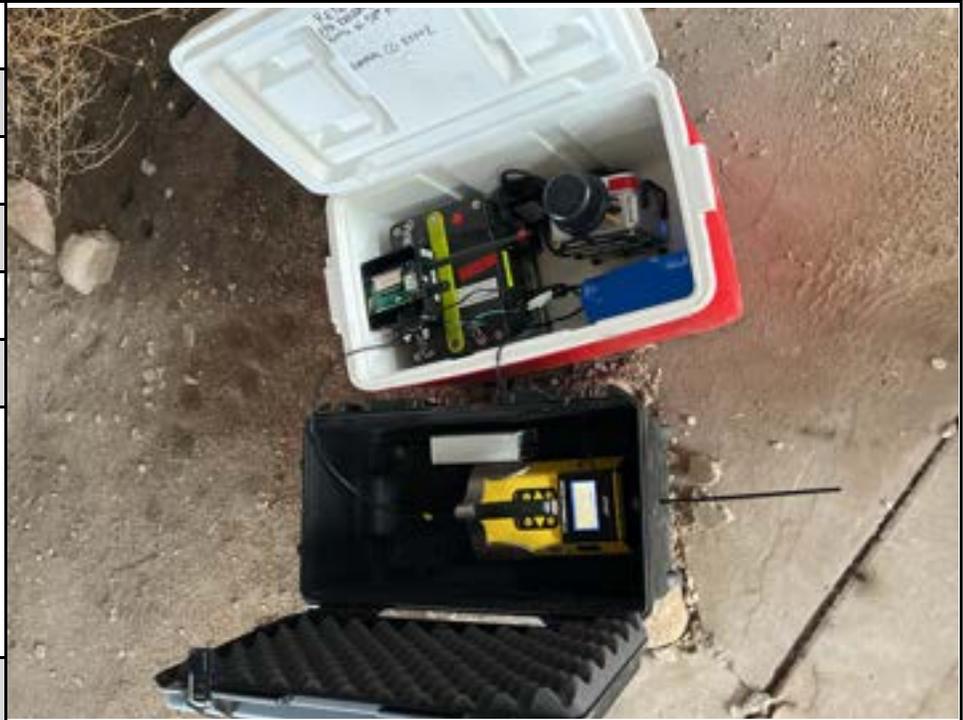
Date/Time Taken:	5/23/2023 11:31:00 AM
Photographer:	Foster_Lauren
Latitude:	41.264411
Longitude:	-105.603811
Photo Direction:	NW
Category:	Removal
Photo Description: Sample monitoring set up.	
Photo Name: Photos-20230523-173102.jpg

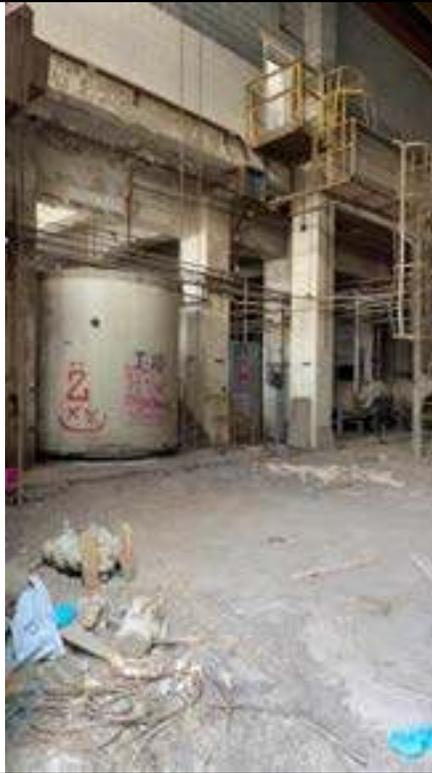
Date/Time Taken:	8/4/2023 2:51:35 PM
Photographer:	Brennan_John
Latitude:	Not available
Longitude:	Not available
Photo Direction:	Not available
Category:	Removal
Photo Description: Toxicity characteristic leaching procedure (TCLP) sample, building B-1, sample location 1.	
Photo Name: Photos-20230804-145133.jpg

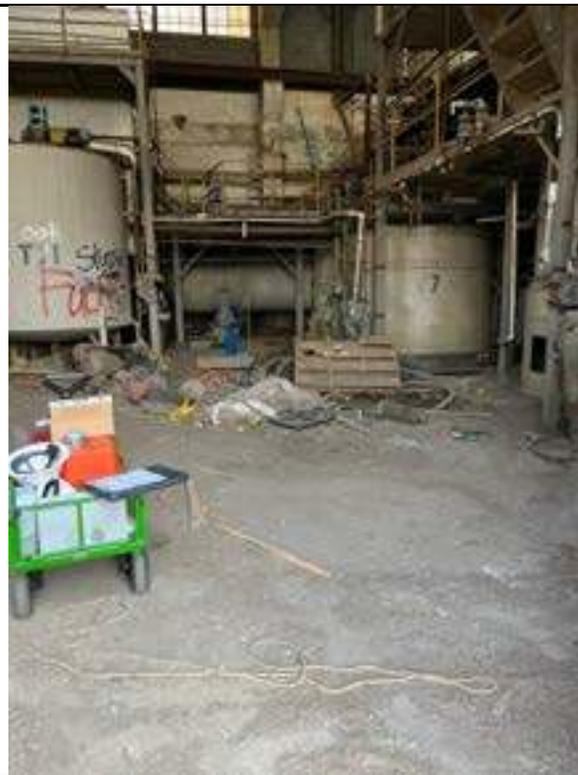
Date/Time Taken:	5/23/2023 2:54:00 PM
Photographer:	Brennan_John
Latitude:	Not available
Longitude:	Not available
Photo Direction:	Not available
Category:	Removal
Photo Description: TCLP sample, building B-1, sample location 2.	
Photo Name: Photos-20230804-145412.jpg

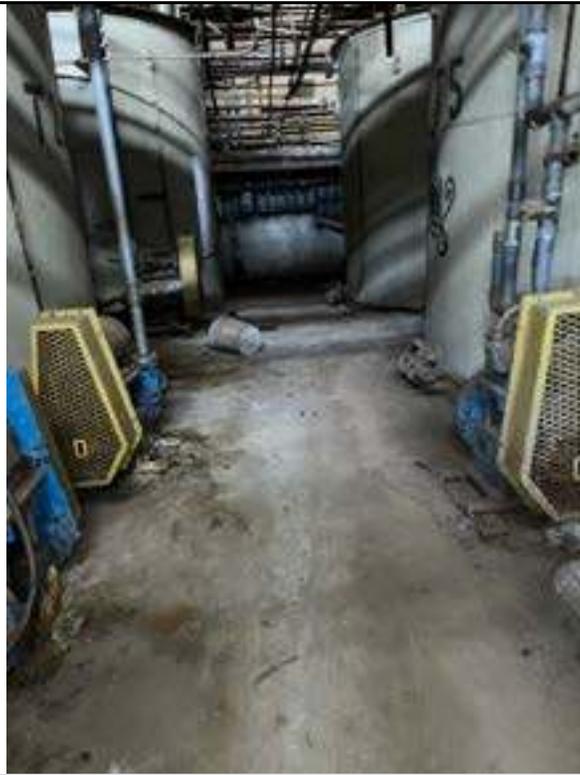
Date/Time Taken:	5/23/2023 2:54:00 PM
Photographer:	Brennan_John
Latitude:	Not available
Longitude:	Not available
Photo Direction:	Not available
Category:	Removal
Photo Description: TCLP sample, building B-1, sample location 3.	
Photo Name: Photos-20230804-145449.jpg

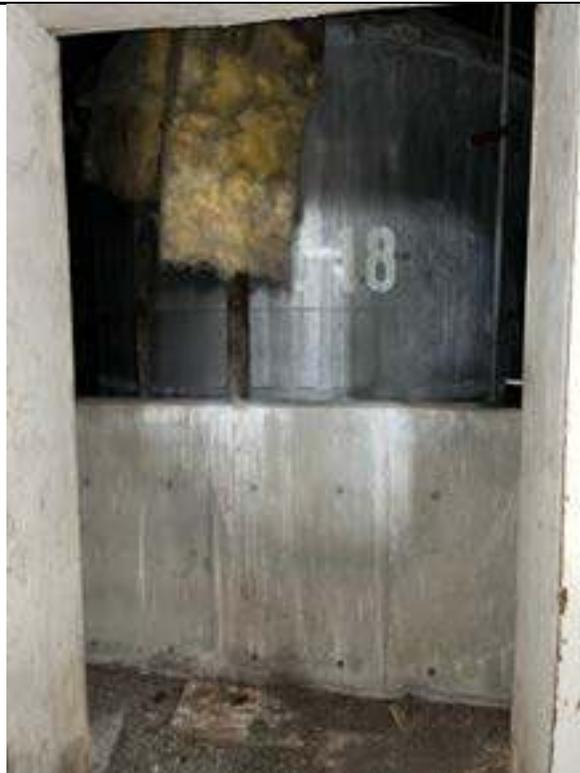
Date/Time Taken:	5/23/2023 2:55:00 PM
Photographer:	Brennan_John
Latitude:	Not available
Longitude:	Not available
Photo Direction:	Not available
Category:	Removal
Photo Description: TCLP sample, building B-1, sample location 4.	
Photo Name: Photos-20230804-145531.jpg

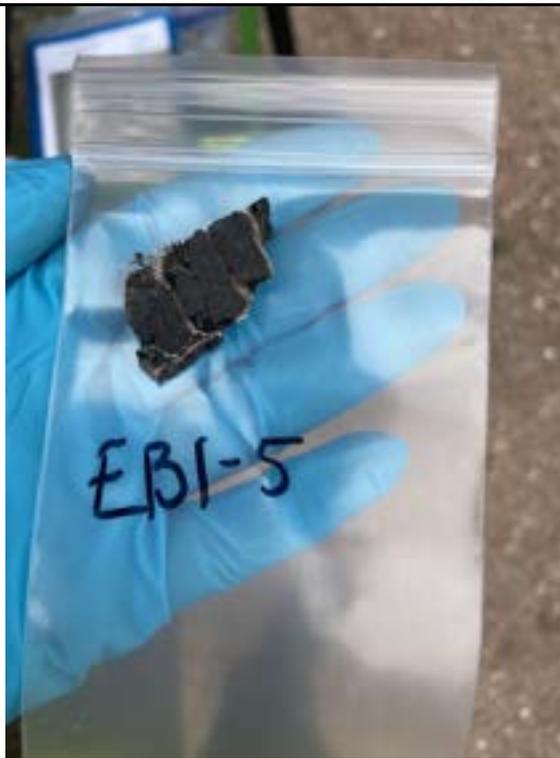
Date/Time Taken:	5/24/2023 12:32:00 PM
Photographer:	Brennan_John
Latitude:	41.264186
Longitude:	-105.603347
Photo Direction:	ENE
Category:	Removal
Photo Description:	(Sample EB1-6): Laboratory results indicate the material contains 20 percent chrysotile asbestos.
Photo Name:	IMG_4471.JPG

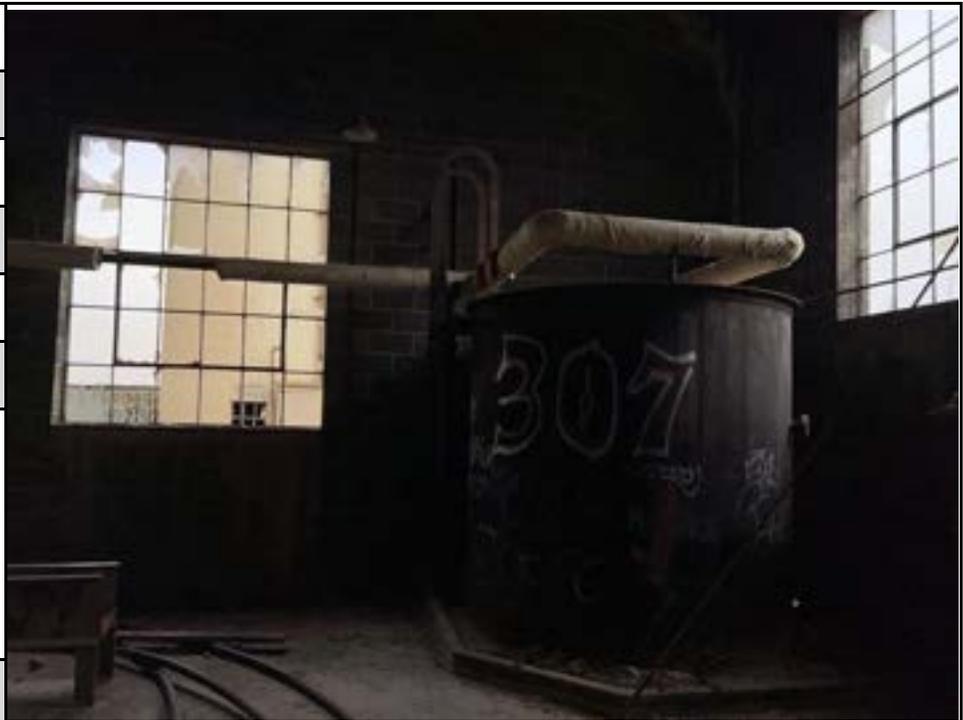
Date/Time Taken:	5/24/2023 1:18:00 PM
Photographer:	Brennan_John
Latitude:	Not available
Longitude:	Not available
Photo Direction:	Not available
Category:	Removal
Photo Description:	(Sample B2-8): Laboratory results indicate the white pipe wrap material contains 60 percent chrysotile asbestos.
Photo Name:	b2-8.jpg

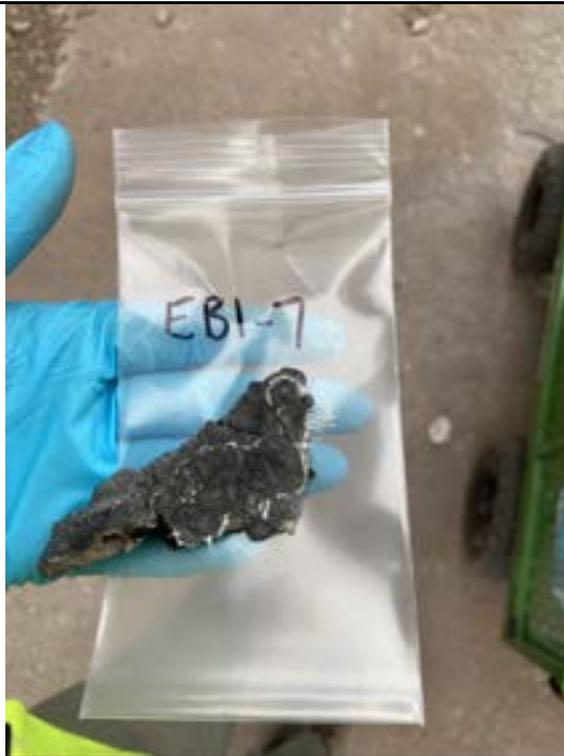
Date/Time Taken:	5/24/2023 2:54:00 PM
Photographer:	Brennan_John
Latitude:	41.26505
Longitude:	-105.603394
Photo Direction:	N
Category:	Removal
Photo Description: (Sample B4-1): Laboratory results indicate the material (gray floor tile and mastic) contains 20 percent chrysotile asbestos and trace chrysotile asbestos, respectively.	
Photo Name: B4-1c-and-1d- _2_.jpeg

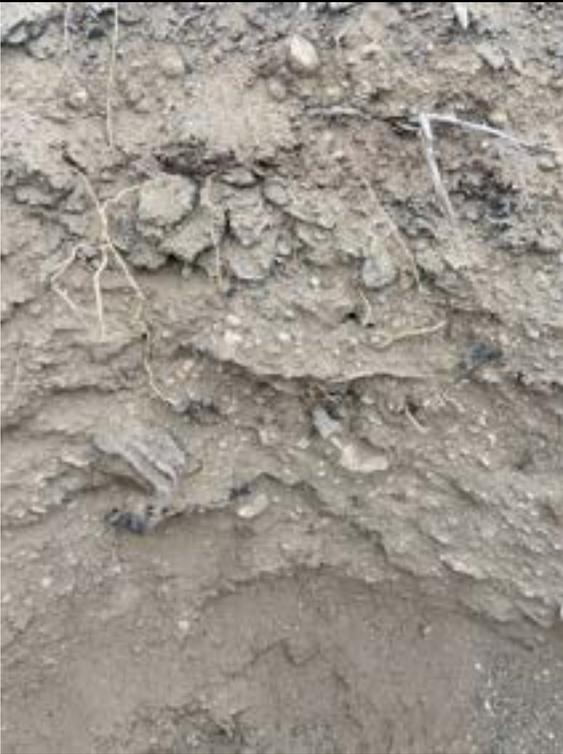
Photographer:	Brennan_John	
Latitude:	41.263581	
Longitude:	-105.605103	
Photo Direction:	NW	
Category:	Removal	
Photo Description: (Sample Pit-1): Laboratory results indicate the material contains 45 percent chrysotile asbestos.		
Photo Name: Pit-1_Pit-with-shingles.JPG

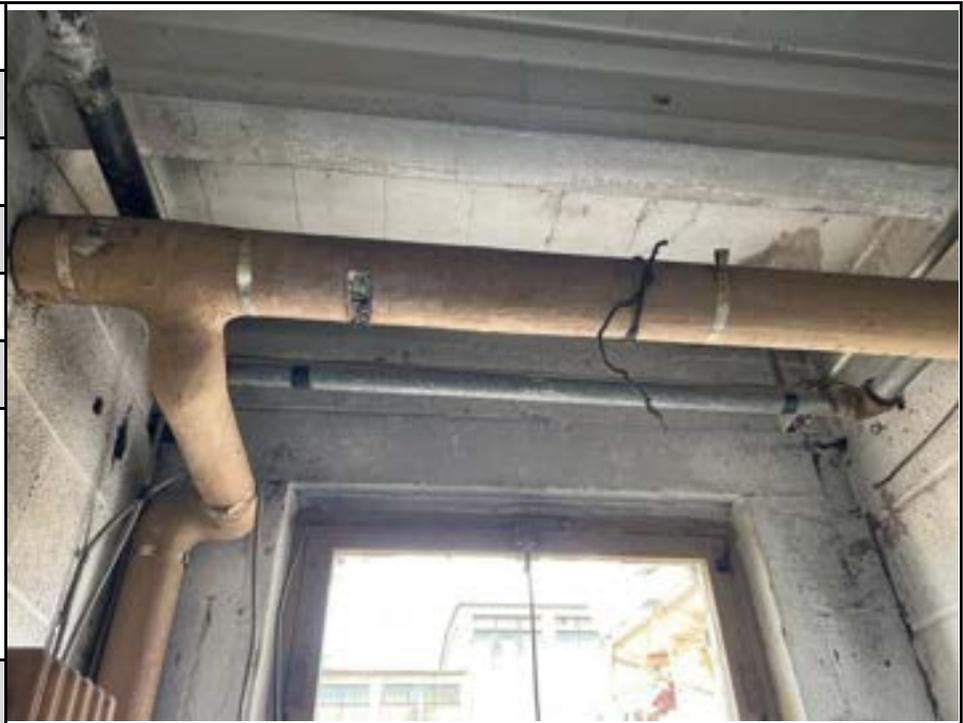
Date/Time Taken:	5/25/2023 3:42:00 PM
Photographer:	Brennan_John
Latitude:	41.264436
Longitude:	-105.604447
Photo Direction:	WSW
Category:	Removal
Photo Description:	(Sample B1-7): Laboratory results indicate the pipe wrap material contains 5 percent chrysotile asbestos.
Photo Name:	B1-7.JPG

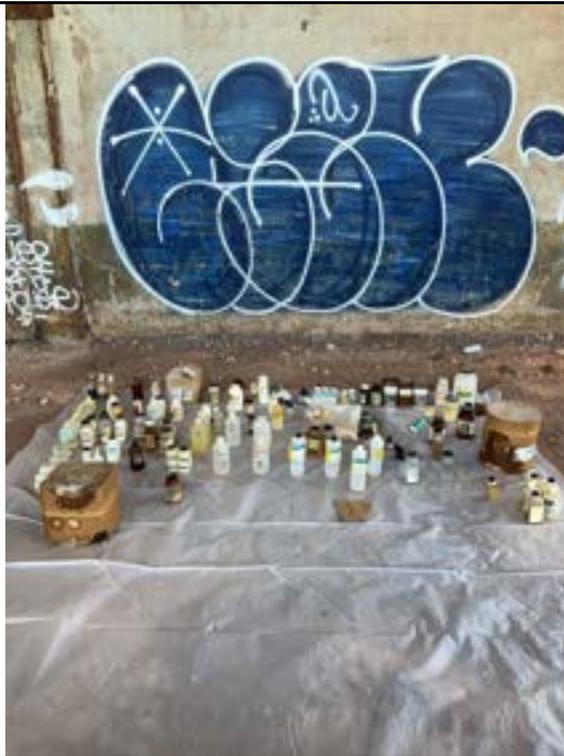
Date/Time Taken:	5/26/2023 10:35:00 AM
Photographer:	Foster_Lauren
Latitude:	41.264558
Longitude:	-105.604683
Photo Direction:	S
Category:	Assessment
Photo Description:	Contents of non-hazardous drum 1.
Photo Name:	Photos-20230526-163520.jpg

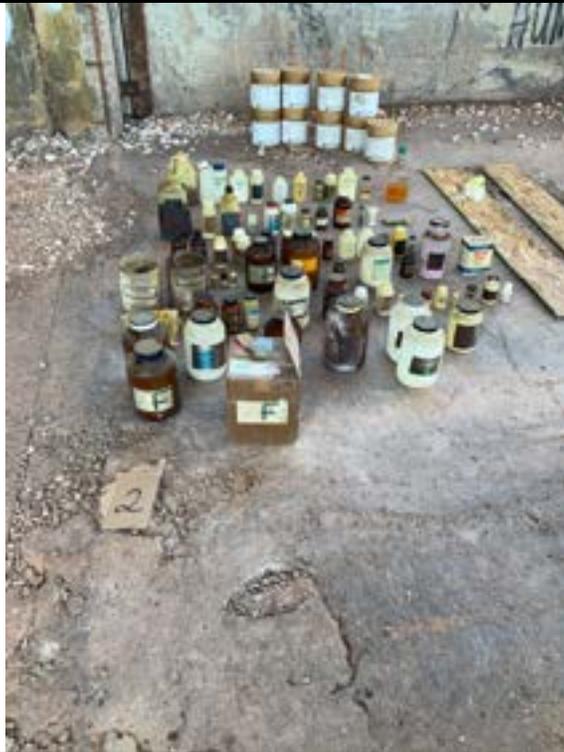
Date/Time Taken:	5/26/2023 10:33:00 AM
Photographer:	Foster_Lauren
Latitude:	41.264546
Longitude:	-105.604774
Photo Direction:	SSW
Category:	Assessment
Photo Description:	Contents of non-hazardous drum 2.
Photo Name:	Photos-20230526-163312.jpg

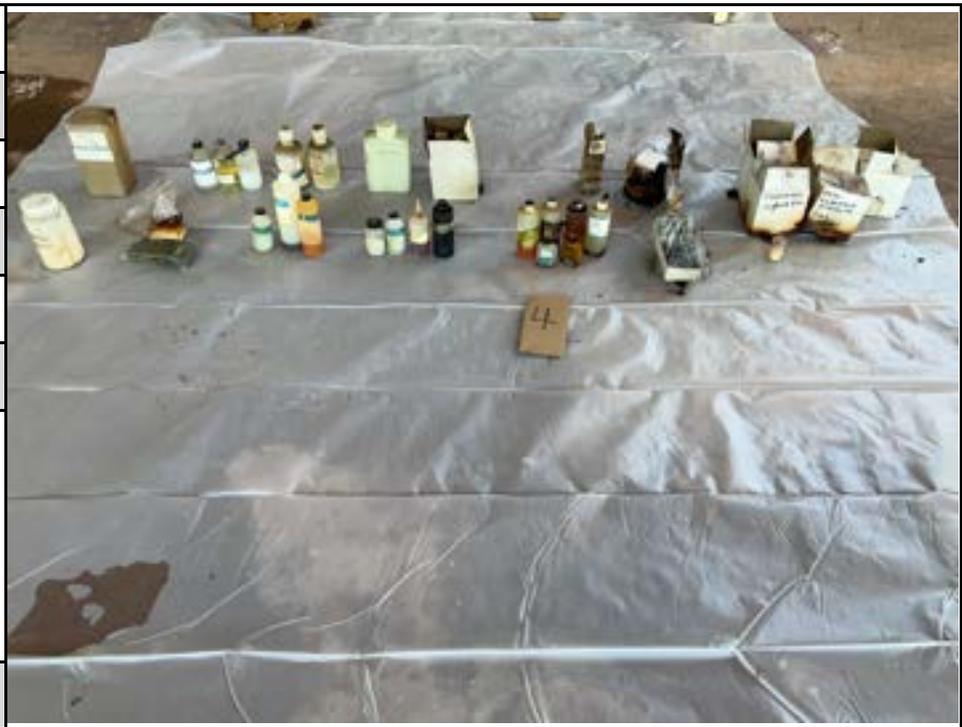
Date/Time Taken:	5/26/2023 10:37:00 AM
Photographer:	Foster_Lauren
Latitude:	41.264539
Longitude:	-105.604671
Photo Direction:	E
Category:	Removal
Photo Description:	Contents of non-hazardous drum 4.
Photo Name:	Photos-20230526-163756.jpg

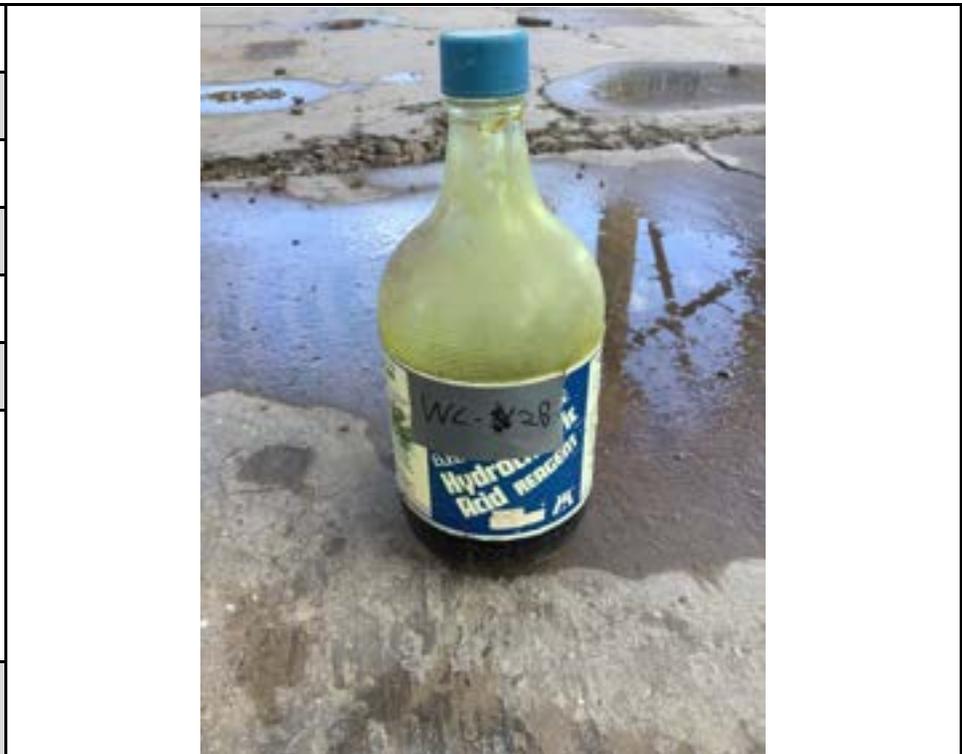
Date/Time Taken:	5/26/2023 10:28:00 AM
Photographer:	Brennan_John
Latitude:	41.264636
Longitude:	-105.604734
Photo Direction:	W
Category:	Assessment
Photo Description:	2-liter (L) Hydrochloric Acid Reagent Bottle with "Acid Dump" handwritten on side.
Photo Name:	Photos-20230526-163007.jpg

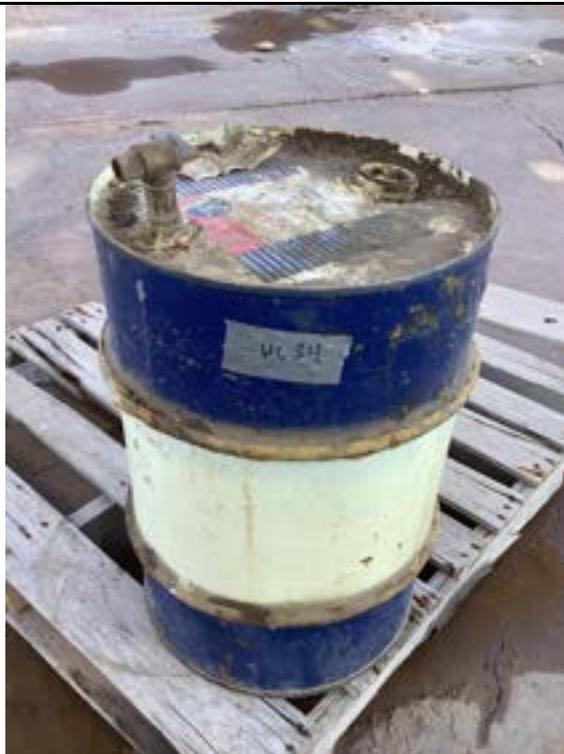
Date/Time Taken:	5/26/2023 10:36:00 AM
Photographer:	Brennan_John
Latitude:	41.264619
Longitude:	-105.604866
Photo Direction:	WNW
Category:	Assessment
Photo Description: 55-gallon metal drum of super cleaning agent.	
Photo Name: Photos-20230526-163644.jpg

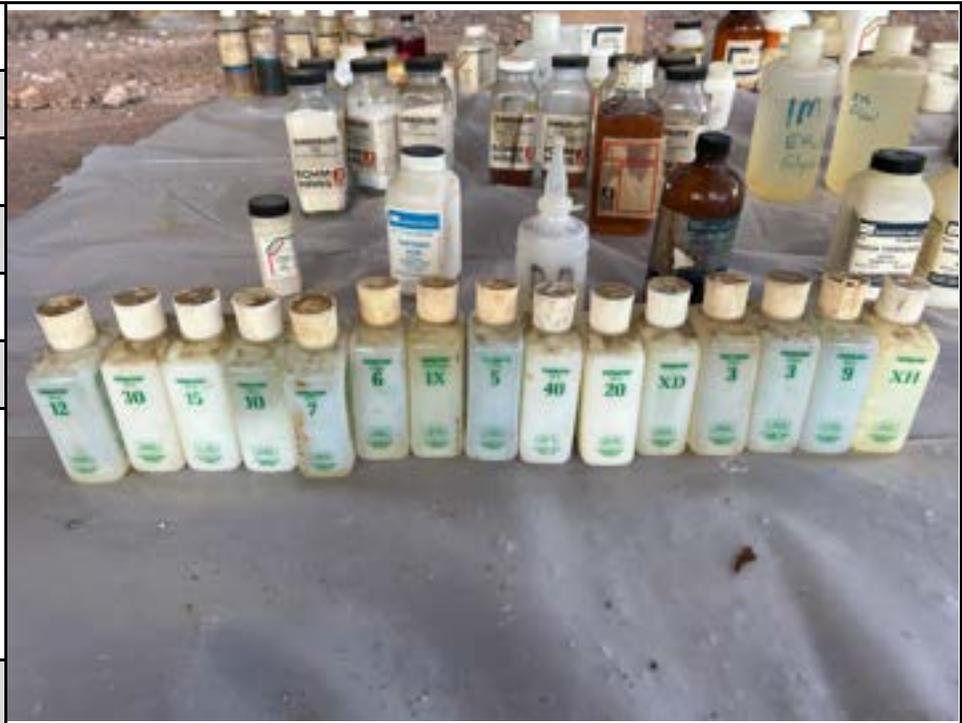
Date/Time Taken:	5/26/2023 11:58:00 AM
Photographer:	Reed_David
Latitude:	41.264531
Longitude:	-105.604658
Photo Direction:	E
Category:	Assessment
Photo Description:	Fifteen 200 milliliter (mL) bottles of various TERGITOL reagents.
Photo Name:	Photos-20230526-175816.jpg

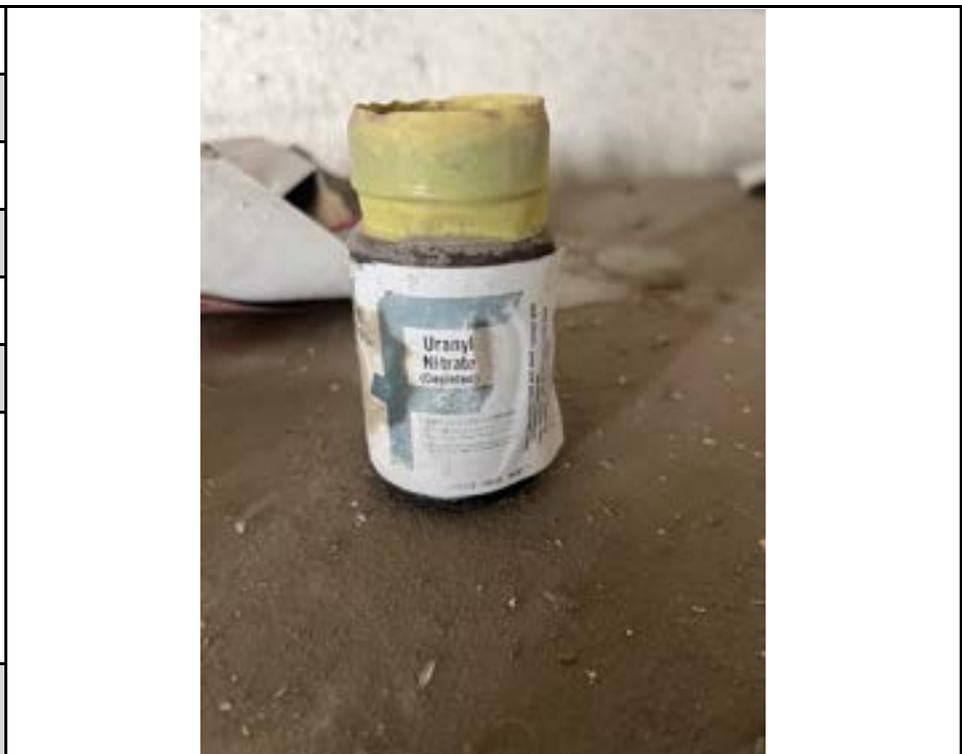
Date/Time Taken:	5/24/2023 2:56:00 PM
Photographer:	Brennan_John
Latitude:	41.265056
Longitude:	-105.603364
Photo Direction:	W
Category:	Removal
Photo Description:	4-ounce amber glass bottle of Uranyl Nitrate (depleted). Overpacked into paint bucket WC-1.
Photo Name:	Photo-May-24-2023_-14-56-05.jpg

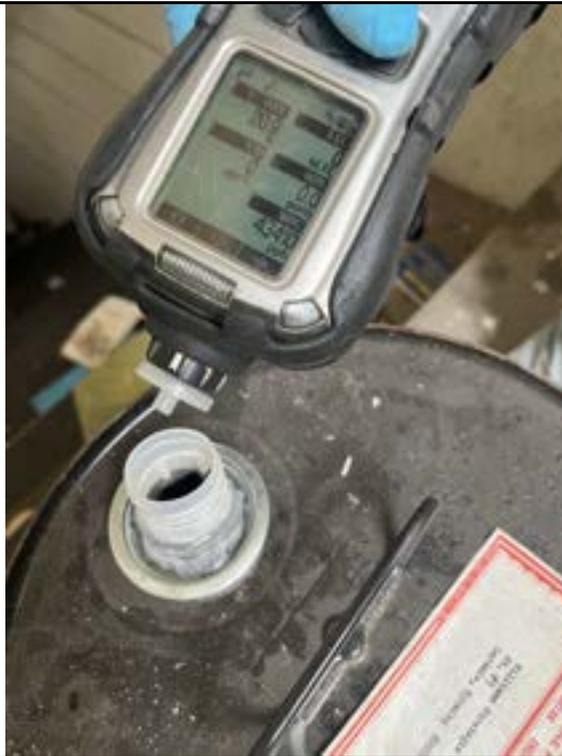
Date/Time Taken:	5/24/2023 3:01:00 PM
Photographer:	Brennan_John
Latitude:	41.265019
Longitude:	-105.603456
Photo Direction:	SSE
Category:	Removal
Photo Description:	High volatile organic compound readings from metal container WC-11 in Admin-Laboratory building.
Photo Name:	Photo-May-24-2023_-15-01-50.jpg

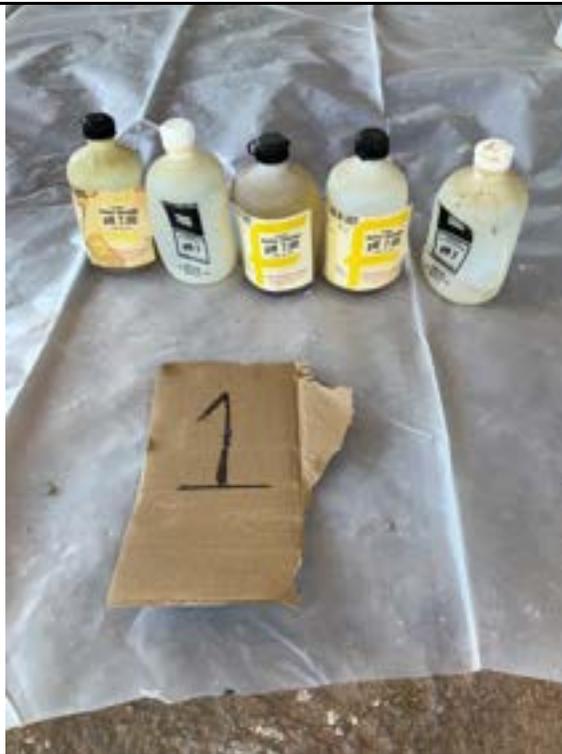
Date/Time Taken:	5/26/2023 10:45:00 AM
Photographer:	Foster_Lauren
Latitude:	41.264557
Longitude:	-105.604679
Photo Direction:	E
Category:	Removal
Photo Description:	Five 1-pint poly containers of buffer solution pH 7.
Photo Name:	Photos-20230526-164506.jpg

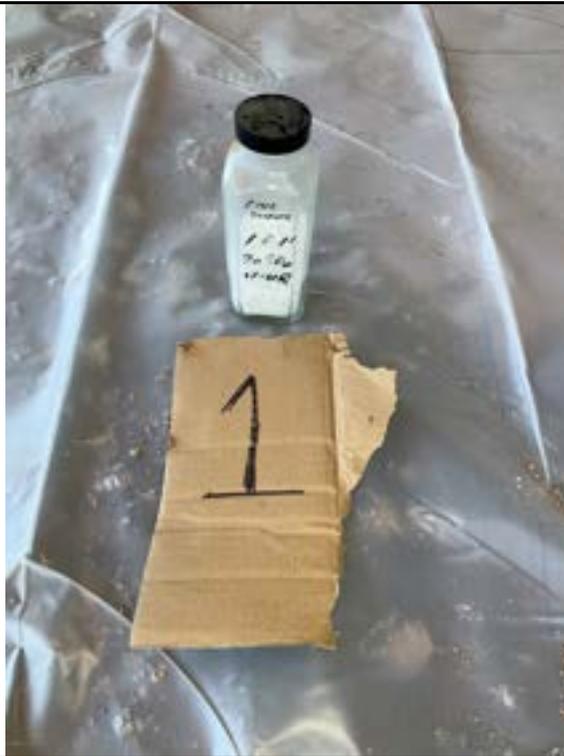
Date/Time Taken:	5/26/2023 10:53:00 AM
Photographer:	Foster_Lauren
Latitude:	41.264595
Longitude:	-105.604665
Photo Direction:	E
Category:	Removal
Photo Description:	500-mL glass container with white pellets, hand labeled: zinc sulfate, 19-11, ZnSO ₄ , VWR.
Photo Name:	Photos-20230526-165356.jpg

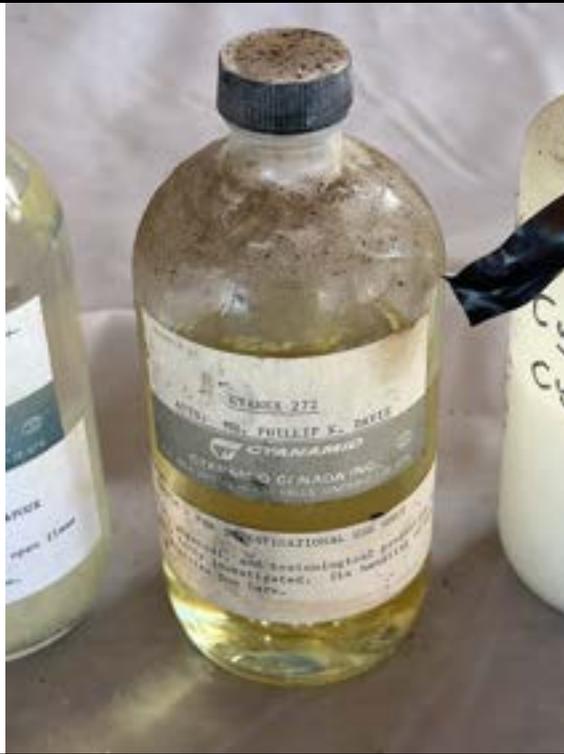
Date/Time Taken:	5/26/2023 11:08:00 AM
Photographer:	Reed_David
Latitude:	41.264511
Longitude:	-105.604604
Photo Direction:	SSW
Category:	Removal
Photo Description:	500-mL glass container of CYANEX 272.
Photo Name:	Photos-20230526-170856.jpg

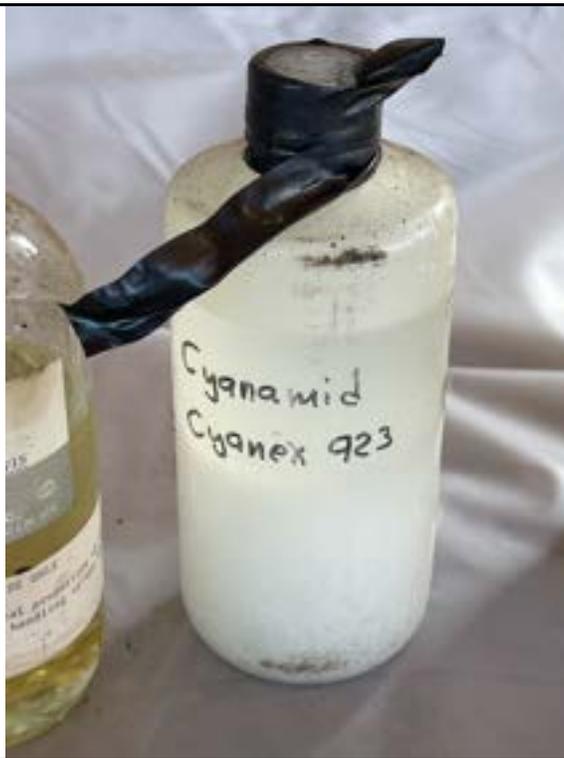
Date/Time Taken:	5/26/2023 11:09:00 AM
Photographer:	Reed_David
Latitude:	41.264535
Longitude:	-105.604622
Photo Direction:	SSW
Category:	Removal
Photo Description: 500-mL poly container of CYANEX 923.	
Photo Name: Photos-20230526-170926.jpg

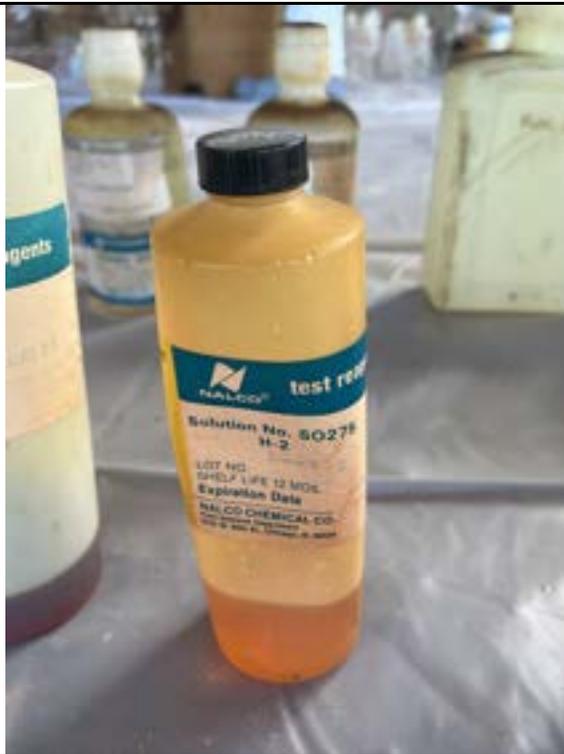
Date/Time Taken:	5/26/2023 11:17:00 AM
Photographer:	Reed_David
Latitude:	41.264492
Longitude:	-105.604603
Photo Direction:	S
Category:	Removal
Photo Description: 500-mL poly bottle of test solution S0275 H-2.	
Photo Name: Photos-20230526-171717.jpg

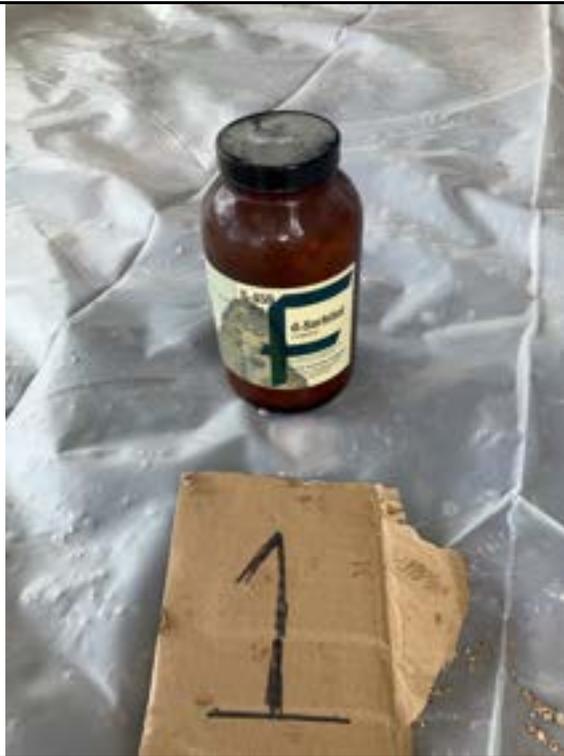
Date/Time Taken:	5/26/2023 12:06:00 PM
Photographer:	Foster_Lauren
Latitude:	41.264557
Longitude:	-105.604676
Photo Direction:	E
Category:	Removal
Photo Description: 1.5-L amber glass container labeled d-Sorbitol.	
Photo Name: Photos-20230526-180657.jpg

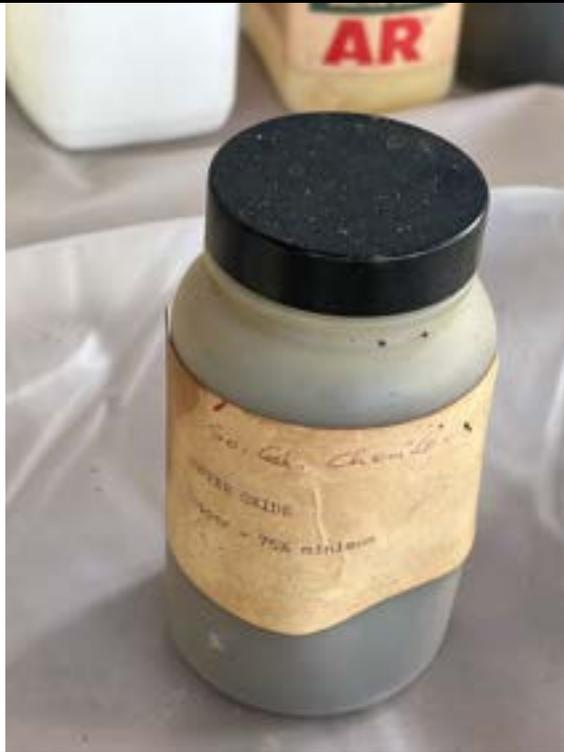
Date/Time Taken:	5/26/2023 12:22:00 PM
Photographer:	Reed_David
Latitude:	41.264502
Longitude:	-105.604595
Photo Direction:	SSW
Category:	Removal
Photo Description: 500-mL bottle labeled copper oxide.	
Photo Name: Photos-20230526-182259.jpg

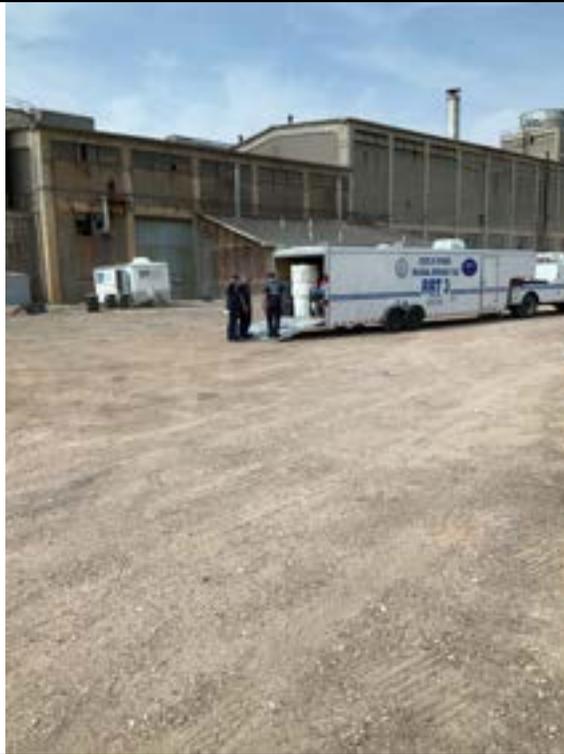
Date/Time Taken:	5/24/2023 10:15:00 AM
Photographer:	Foster_Lauren
Latitude:	41.264902
Longitude:	-105.603078
Photo Direction:	SW
Category:	Assessment
Photo Description:	Wyoming Regional Response Team on site to assess peroxide located in metals processing area in building B-1.
Photo Name:	Photos-20230524-161503.jpg

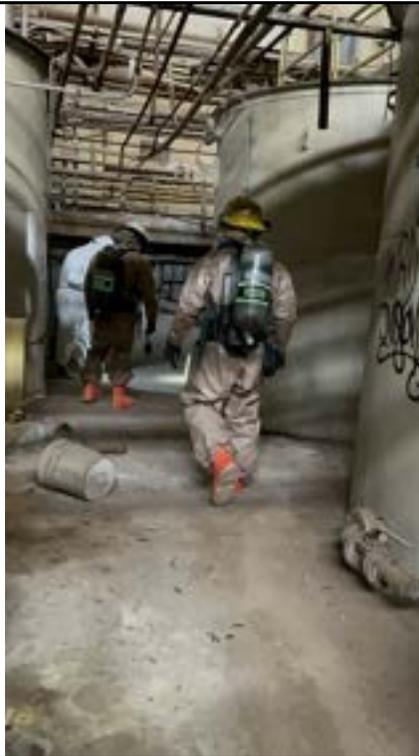
Date/Time Taken:	5/24/2023 12:36:00 PM
Photographer:	Brennan_John
Latitude:	41.264689
Longitude:	-105.603264
Photo Direction:	Not available
Category:	Removal
Photo Description: START and local fire department entering building B-1 to assess peroxide container.	
Photo Name: Photo-May-24-2023_-12-36-44.jpg

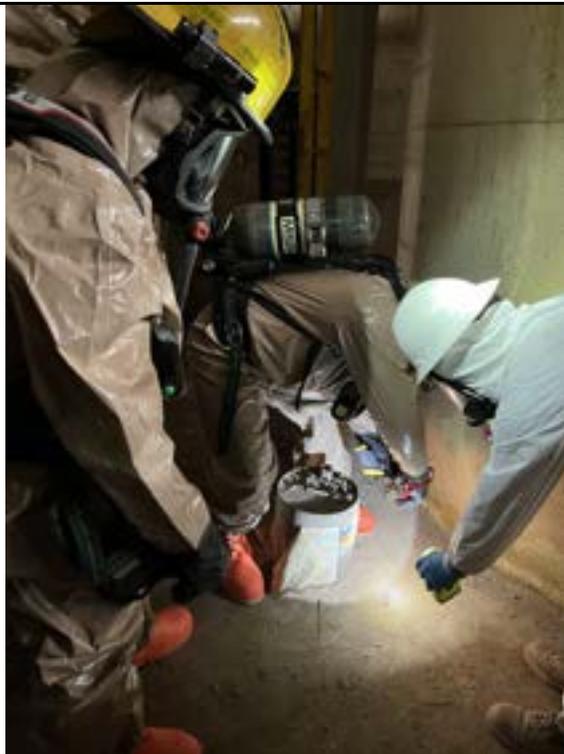
Date/Time Taken:	5/24/2023 12:38:00 PM
Photographer:	Brennan_John
Latitude:	41.30305
Longitude:	-105.583922
Photo Direction:	W
Category:	Removal
Photo Description: START and local fire department inspecting peroxide container.	
Photo Name: Photo-May-24-2023_-12-38-53.jpg

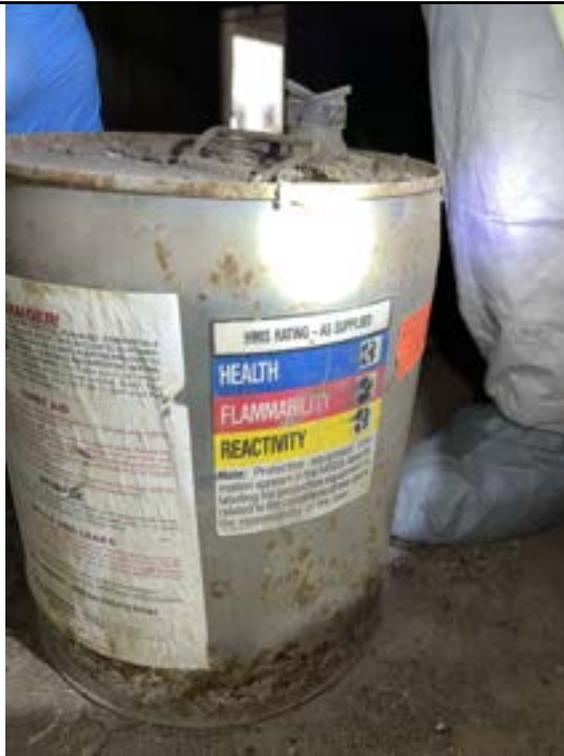
On May 23, 2023, START observed a 5-gallon metal container with an organic peroxide label located in the chemical processing area in the northeastern portion of building B-1 (Enclosure 3). Because of the explosive hazard associated with organic peroxide and the degraded condition of the container, EPA contacted the Laramie Fire Department (FD) for assistance. On May 24, 2023, the Laramie FD and Wyoming Regional Response Team (RRT) 3 arrived on-Site and developed a plan for on-Site treatment of the organic peroxide. Laramie FD and WY RRT 3 performed a Level B entry to assess the chemical location, then performed a Level A entry to remove the organic peroxide container from building B-1 and place it in an excavated detonation pit approximately 3 feet deep located west of building B-2 (Figure 2, Enclosure 1). On May 25, 2023, Laramie FD, WY RRT 3, and Laramie Police Department arrived on-Site and destroyed the organic peroxide through a controlled detonation using detonating cord.

Date/Time Taken:	5/23/2023 4:41:00 PM
Photographer:	Brennan_John
Latitude:	41.264533
Longitude:	-105.603408
Photo Direction:	NNE
Category:	Removal
Photo Description:	Front view with organic peroxide hazard label.
Photo Name:	Peroxide-container-2.jpg

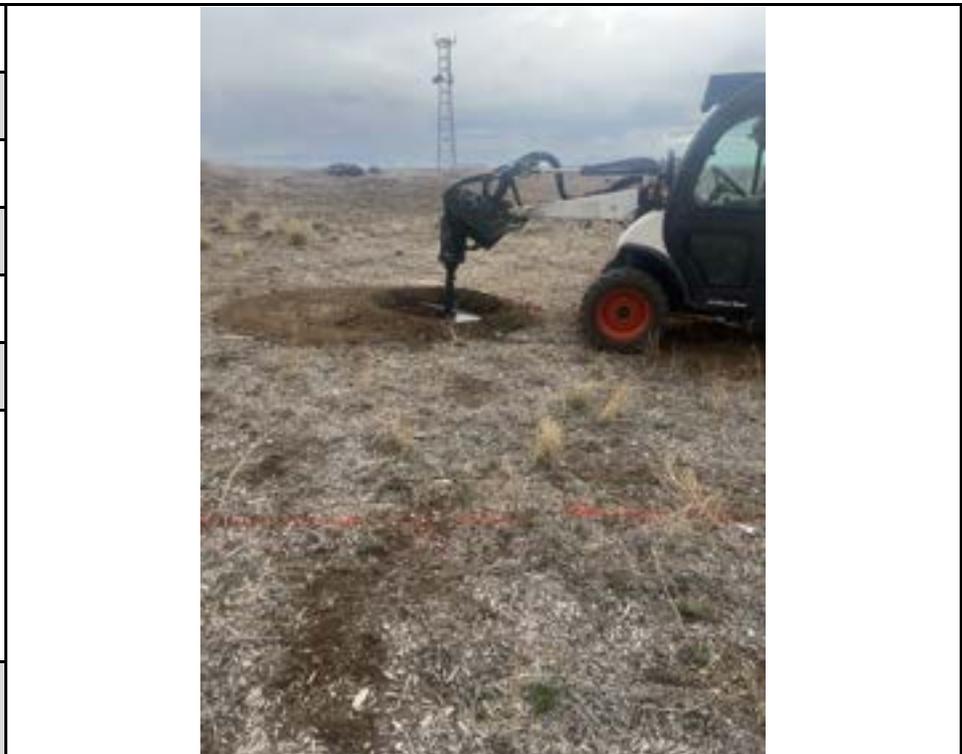
Date/Time Taken:	5/24/2023 1:31:00 PM
Photographer:	Brennan_John
Latitude:	41.263858
Longitude:	-105.605225
Photo Direction:	W
Category:	Removal
Photo Description:	Local fire department staff drilling hole in soil for controlled detonation of peroxide.
Photo Name:	Photo-May-24-2023_-13-31-43.jpg

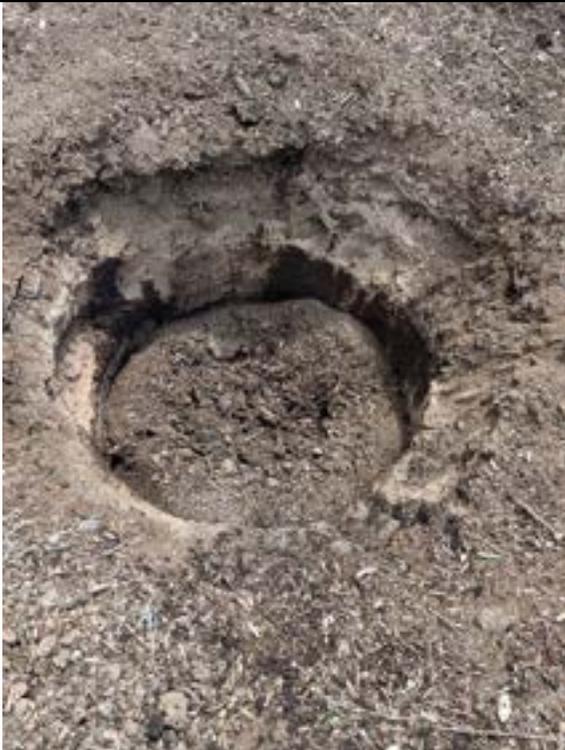
Photographer:	Brennan_John	
Latitude:	41.2639	
Longitude:	-105.605072	
Photo Direction:	SSW	
Category:	Removal	
Photo Description: Crater left by controlled detonation of peroxide before it was backfilled.		
Photo Name: Photo-May-25-2023_-14-22-50.jpg

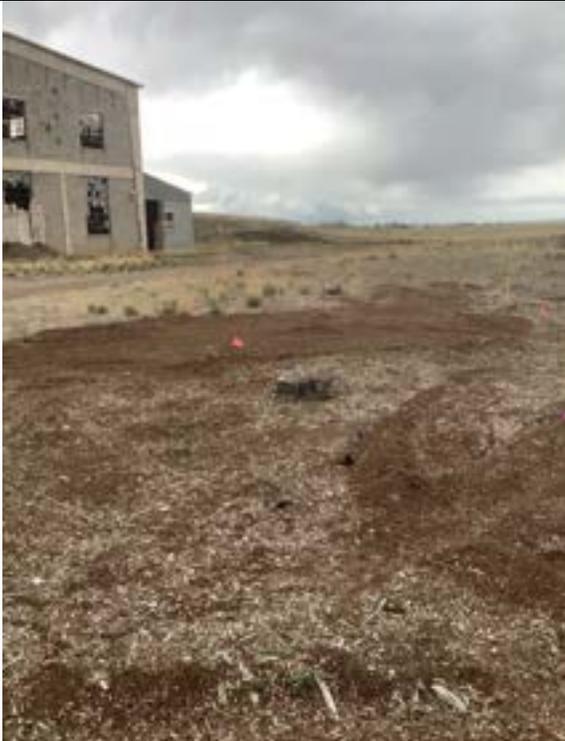
Photographer:	Foster_Lauren	
Latitude:	41.264125	
Longitude:	-105.604944	
Photo Direction:	ESE	
Category:	Assessment	
Photo Description: Detonation pit filled in following demolition of organic peroxide.		
Photo Name: Photos-20230526-203005.jpg

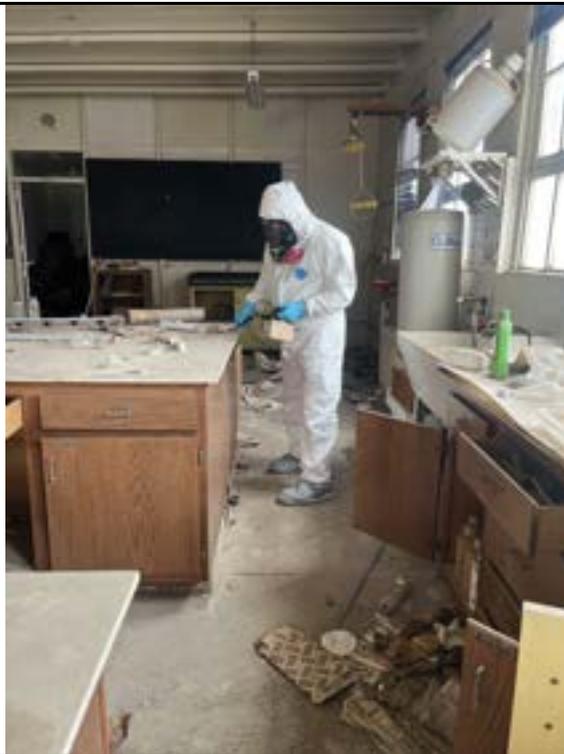
Date/Time Taken:	5/24/2023 2:54:00 PM
Photographer:	Brennan_John
Latitude:	41.26505
Longitude:	-105.603394
Photo Direction:	N
Category:	Removal
Photo Description: START screening for radiation in laboratory area admin/laboratory building B-4.	
Photo Name: Photo-May-24-2023_-14-54-20.jpg

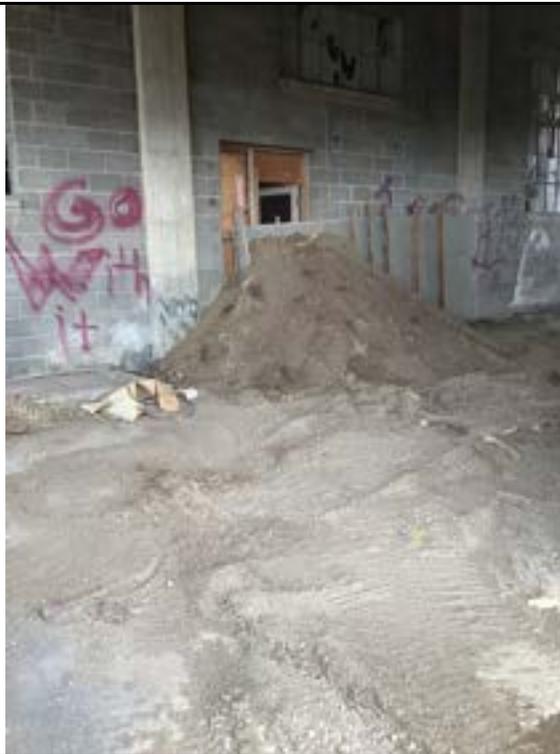
Date/Time Taken:	5/26/2023 2:32:00 PM
Photographer:	Broome_Chandler
Latitude:	41.263577
Longitude:	-105.604668
Photo Direction:	NE
Category:	Assessment
Photo Description: Restricted access to door on south side of building B-2.	
Photo Name: Photos-20230526-203212.jpg

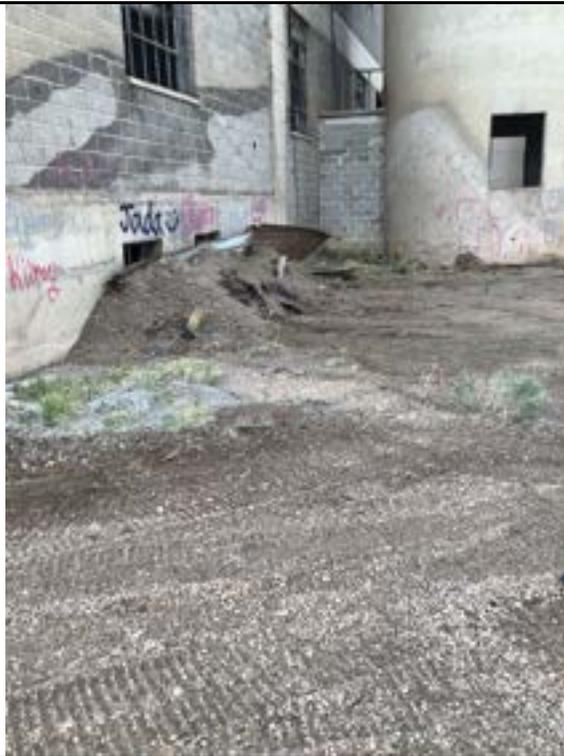
Date/Time Taken:	5/26/2023 2:34:00 PM
Photographer:	Broome_Chandler
Latitude:	41.263652
Longitude:	-105.603335
Photo Direction:	N
Category:	Assessment
Photo Description: Restricted access completed by Emergency and Rapid Response Services to east side of building B-2.	
Photo Name: Photos-20230526-203406.jpg
