August 21, 2023

**Subject: Nedlog Property Assessment Letter Report – Revision 0
Nedlog Property Assessment
Laramie, Albany County, Wyoming
EPA Contract Number: 68HE0820D0001
Technical Direction Number.: 2071-2304-07**

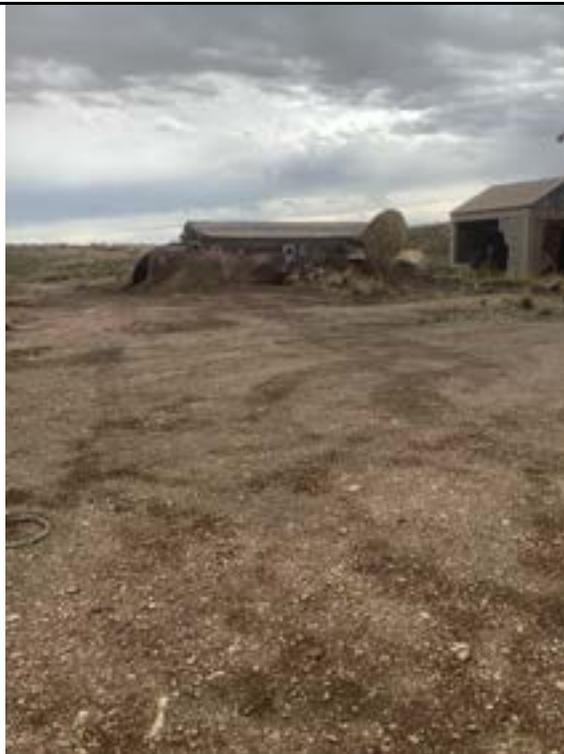
Date/Time Taken:	5/26/2023 2:41:00 PM
Photographer:	Broome_Chandler
Latitude:	41.263567
Longitude:	-105.603377
Photo Direction:	SSW
Category:	Assessment
Photo Description: Restricted access to shed west of building B-5 with debris and piles of dirt.	
Photo Name: Photos-20230526-204149.jpg

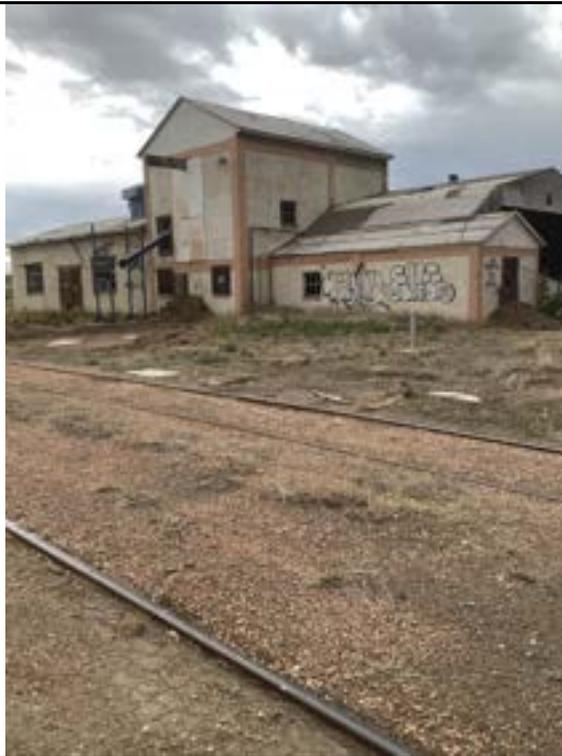
Date/Time Taken:	5/26/2023 2:46:00 PM
Photographer:	Broome_Chandler
Latitude:	41.264744
Longitude:	-105.603228
Photo Direction:	S
Category:	Assessment
Photo Description: Restricted access to building B-1 arsenic building.	
Photo Name: Photos-20230526-204651.jpg

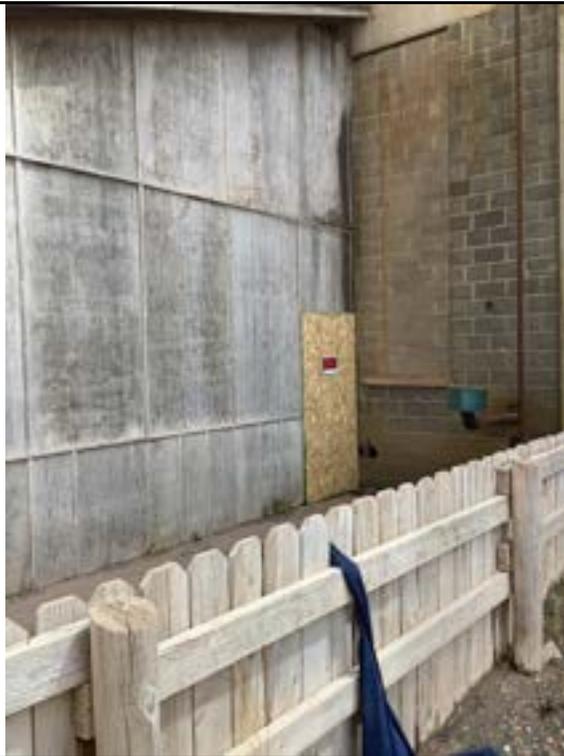
EPA, START, and ERRS observed and documented numerous signs of trespassing at the Site, including multiple unsecured access points to the property, damaged buildings with missing walls and open doors, and signs of vandalism including extensive graffiti and broken windows. From May 23 through 26, 2023, ERRS performed a variety of measures to increase security at the Site and prevent trespassing and unauthorized personnel from exposure to physical and chemical hazards at the Site. Warning signs, soil barriers, and wooden boards were strategically placed at entrances to the Site and various buildings; however, based on the size and condition of the buildings, and the number of entry points to the Site and buildings, the Site was unable to be completely secured from unauthorized entry. A photographic log depicting site conditions is provided in Enclosure 3.

Date/Time Taken:	5/26/2023 2:49:00 PM
Photographer:	Broome_Chandler
Latitude:	41.26485
Longitude:	-105.603413
Photo Direction:	N
Category:	Assessment
Photo Description: Restricted access to south side of building B-4.	
Photo Name: Photos-20230526-204937.jpg

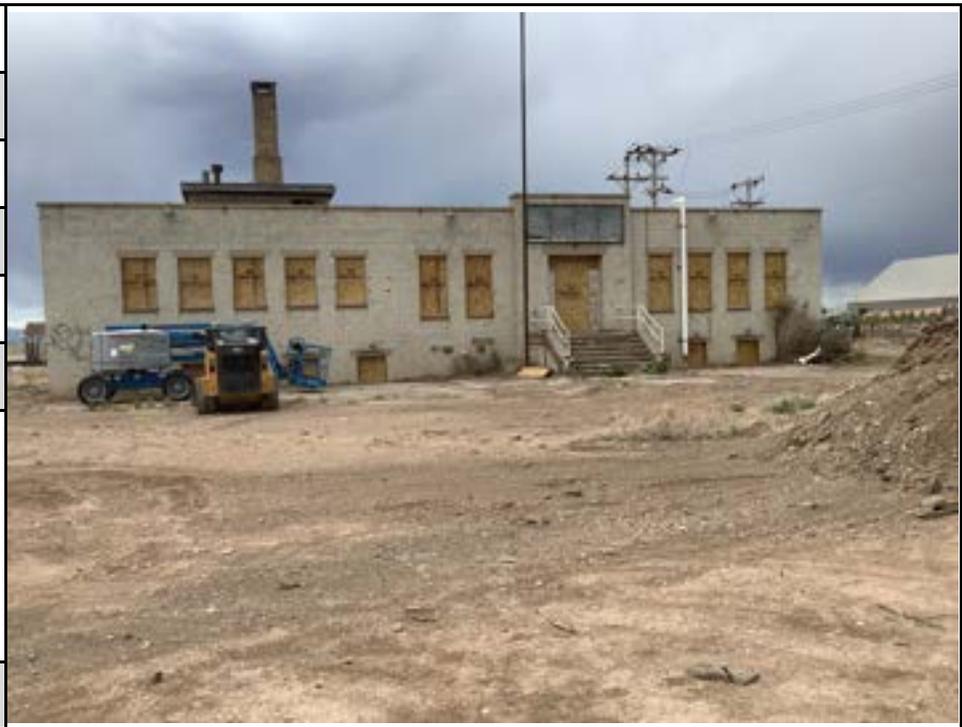
Date/Time Taken:	5/26/2023 2:50:00 PM
Photographer:	Broome_Chandler
Latitude:	41.265054
Longitude:	-105.603081
Photo Direction:	SSW
Category:	Assessment
Photo Description:	Restricted access to east side of building B-4.
Photo Name:	Photos-20230526-205043.jpg
