TRIP REPORT

***Pacific Producer Ammonia Release
Tacoma, Pierce County, Washington
Contract No.: 68HE0720D0005
Task Order No.: 68HE0720F0147-31***

November 2023

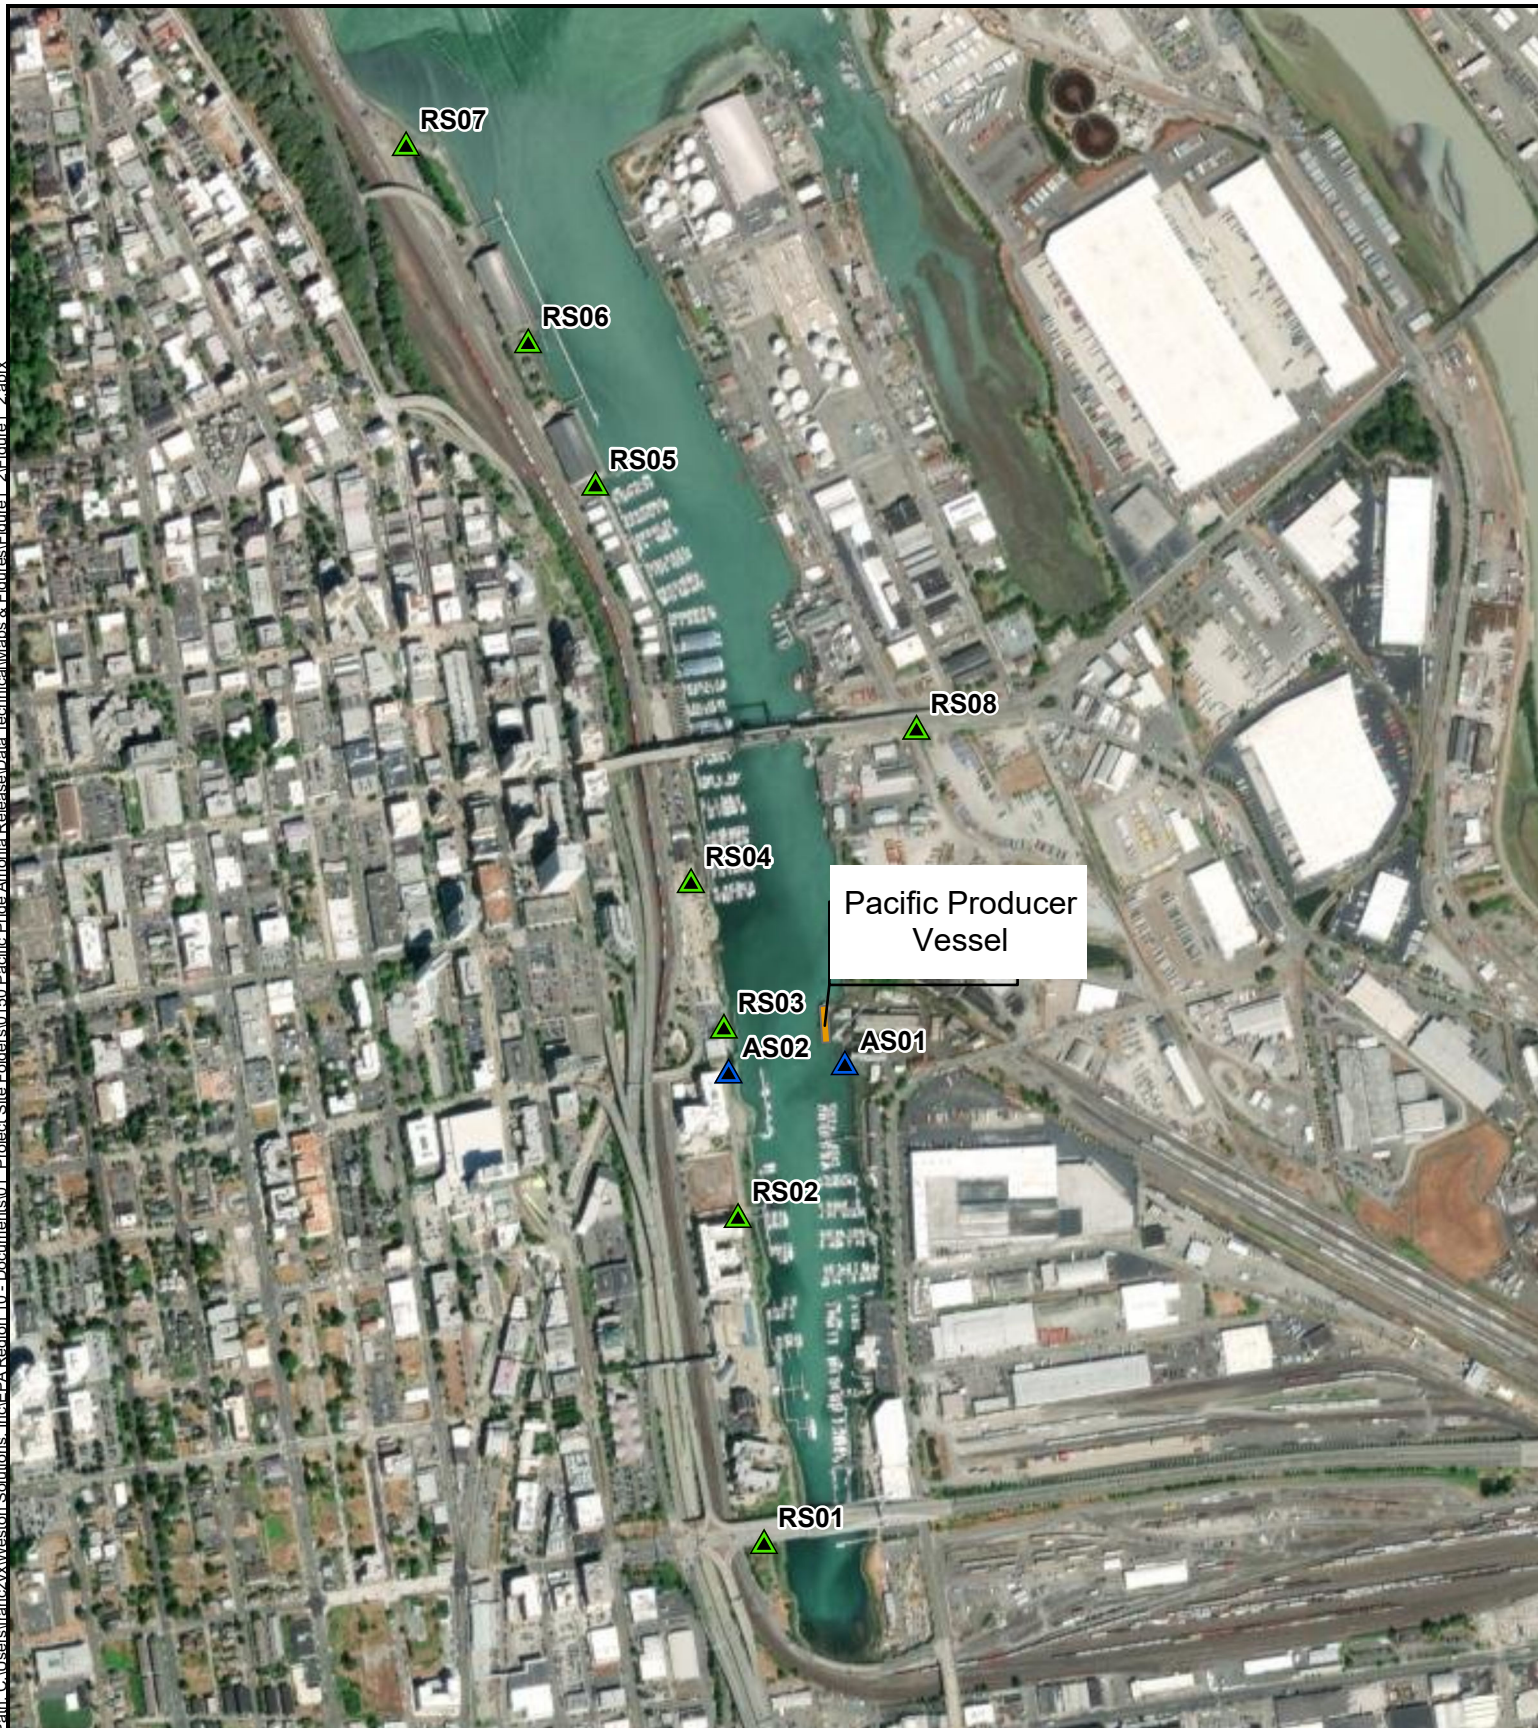
FIGURE 3
AIR MONITORING MAP
PACIFIC PRODUCER
AMMONIA RELEASE

Roving air monitoring was conducted overnight during the response, primarily on the southwestern and western side of the Thea Foss Waterway. Eight locations were selected based on areas of population density with public access (**Figure 3**). Using a handheld MultiRAE Pro, roving teams of two START personnel collected an average reading of ammonia and oxygen concentrations over the course of approximately one minute. Measurements were recorded using the ArcGIS Field Maps application to mark the location of measurement collection. No exceedances of either parameter were observed throughout the response.

START established two fixed air monitoring stations consisting of an AreaRAE Pro unit equipped with ammonia and oxygen sensors on a tripod at approximate height of the adult breathing zone. Air stations were denoted by the prefix “AS” followed by a two-digit, consecutive number. AS-01 was located on the pier, near the bow of the watercraft, and AS-02 was situated across the Thea Foss Waterway, in front of a multi-family residence (**Figure 3**). The air stations were monitored remotely using Honeywell Safety Suite Responder software, allowing START to identify any action level exceedances from a command post in real time. The software was programmed to alarm if any exceedances of the site-specific action levels. No concentrations above the site-specific action levels were observed during the course of the response (**Table 7-2**).

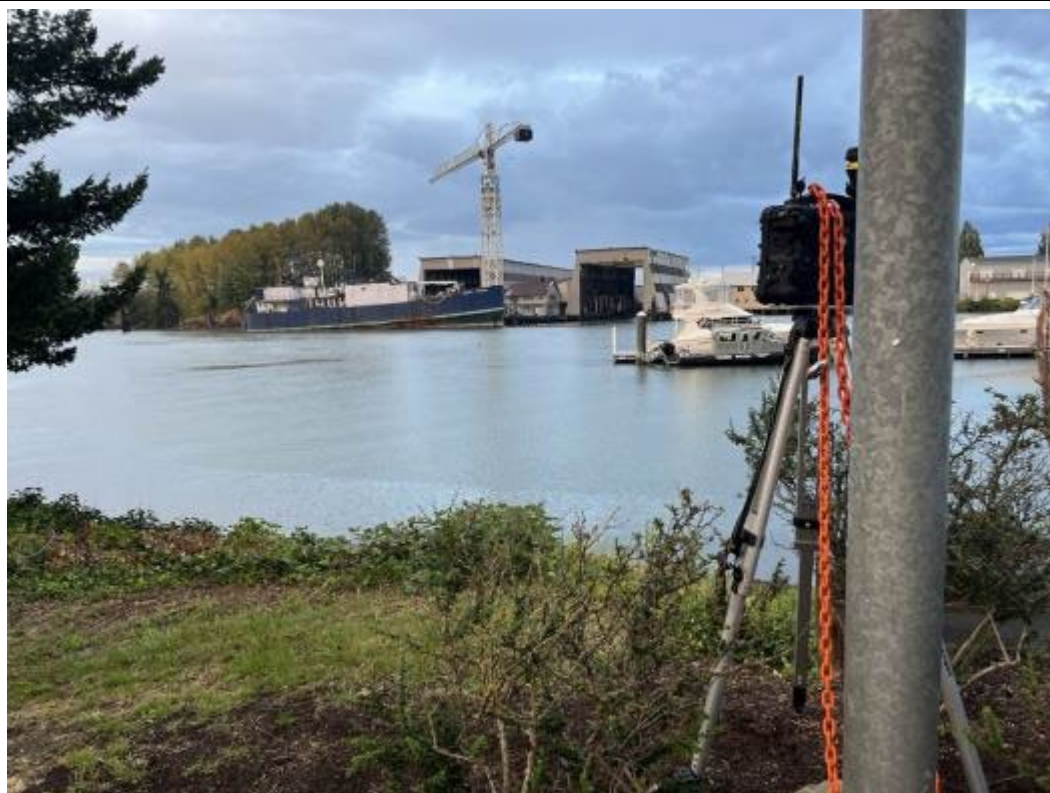
Photo No. 3	Date: 08/22/2023
Photo Coordinates	
Lat	47.25007
Long	-122.43405
Direction Photo Taken: Northeast	
Description: Stationary air monitoring station AS-02, with the F/V Pacific Producer visible in background.

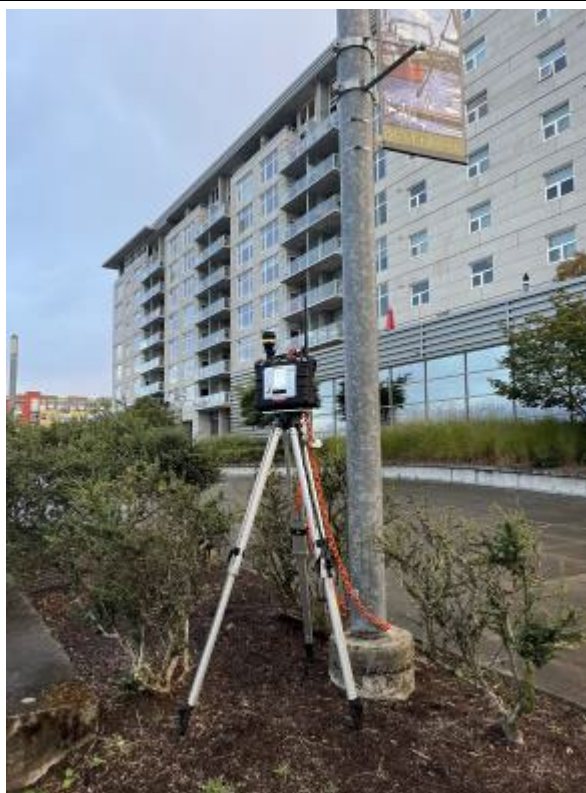
Photo No. 4	Date: 08/22/2023
Photo Coordinates	
Lat	47.25007
Long	-122.43405
Direction Photo Taken: Southwest	
Description: Alternate view of AS-02, with multifamily apartment unit in background.

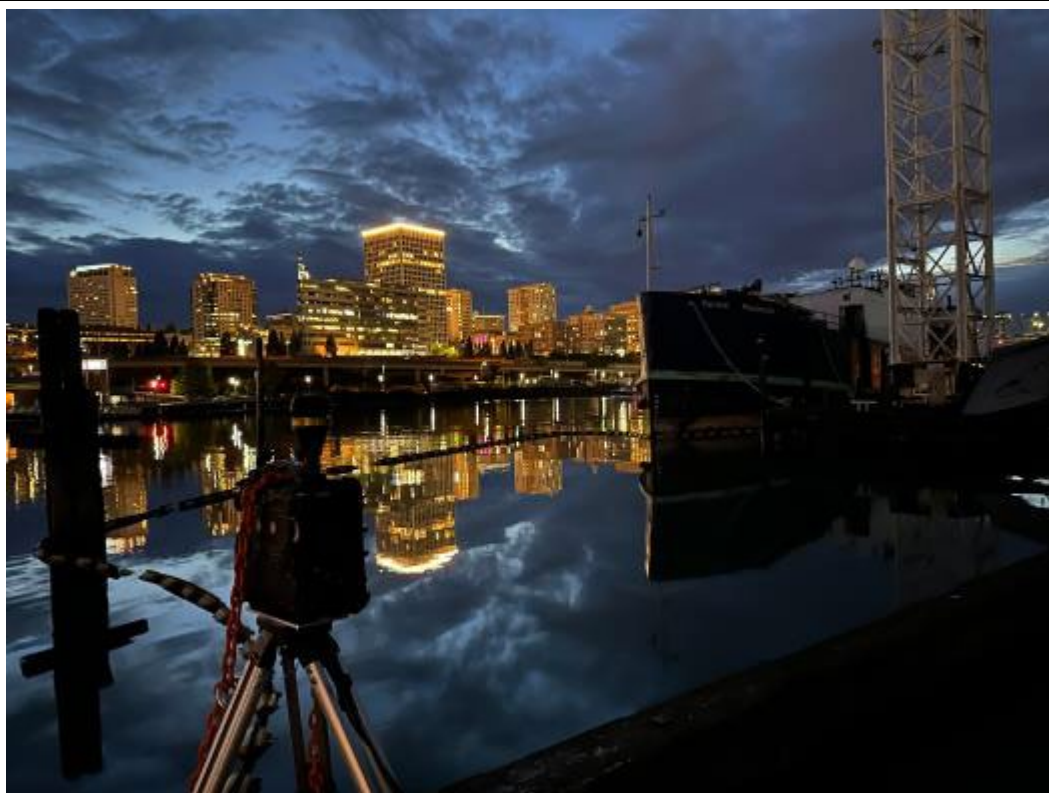
Photo No. 5	Date: 08/22/2023
Photo Coordinates	
Lat	47.249714
Long	-122.431778
Direction Photo Taken: Northwest	
Description: Overnight community air monitoring view from AS-01, situated on the dock near the F/V Pacific Producer.

Overnight, the AreaRAE Pro at AS-01 began to experience oxygen sensor drift, a common phenomenon in high humidity environments. As it was raining during the response, this is the most probable cause. The sensor was recalibrated using “zero air”, a blend of nitrogen and oxygen gases, which resolved the sensor drift. The issue did not reoccur.

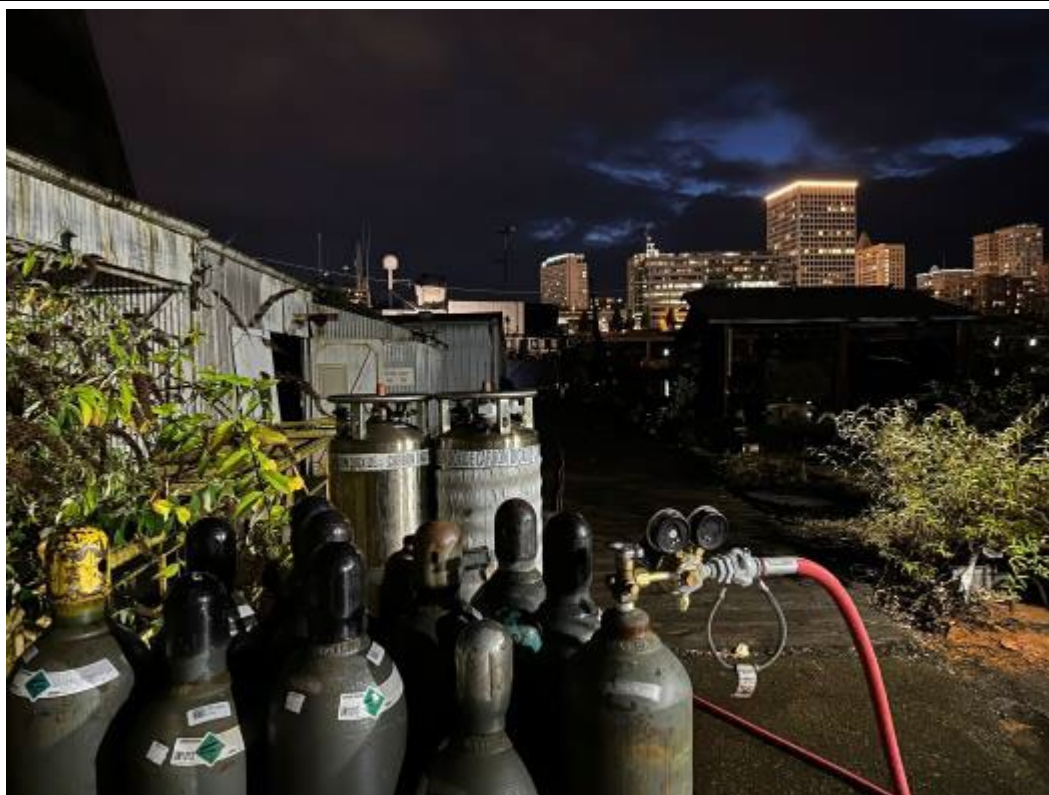
Photo No. 6	Date: 08/22/2023
Photo Coordinates	
Lat	47.250381
Long	-122.431283
Direction Photo Taken: West	
Description: Carbon dioxide compressed gas tanks. Gas was pumped into the watercraft to react with leaking ammonia and form a nonhazardous byproduct.

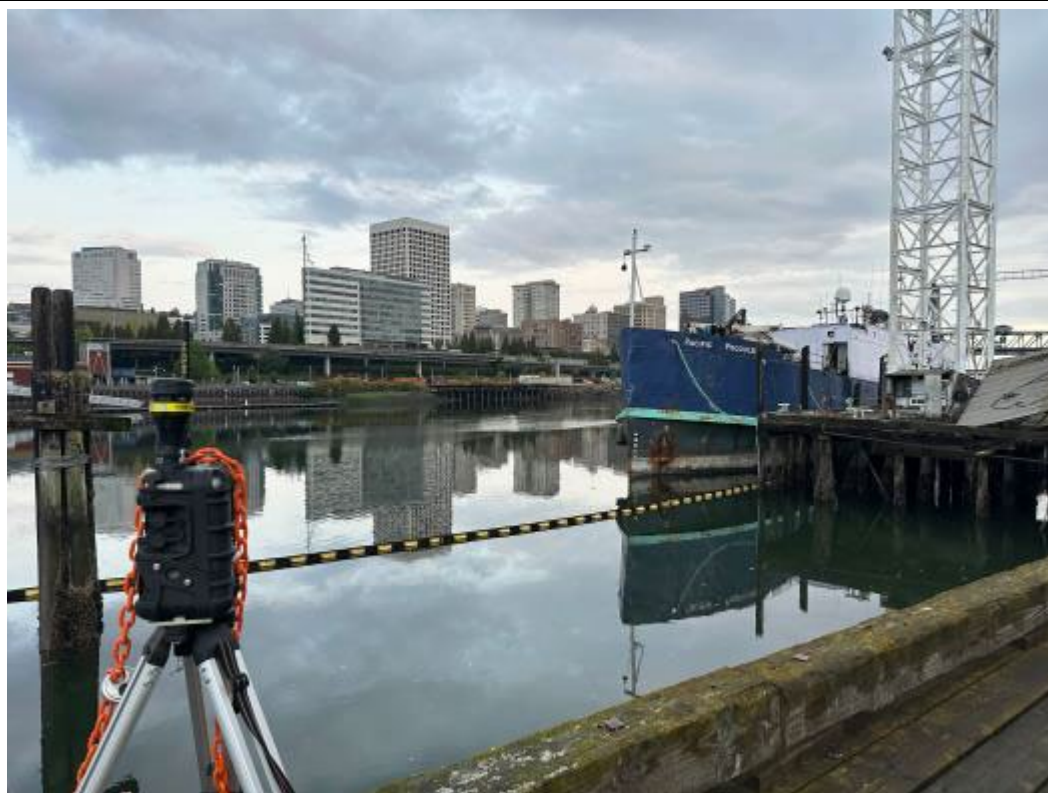
Photo No. 7	Date: 08/23/2023
Photo Coordinates	
Lat	47.249703
Long	-122.431733
Direction Photo Taken: Northwest	
Description: View from AS-01, with F/V Pacific Producer watercraft visible in background.

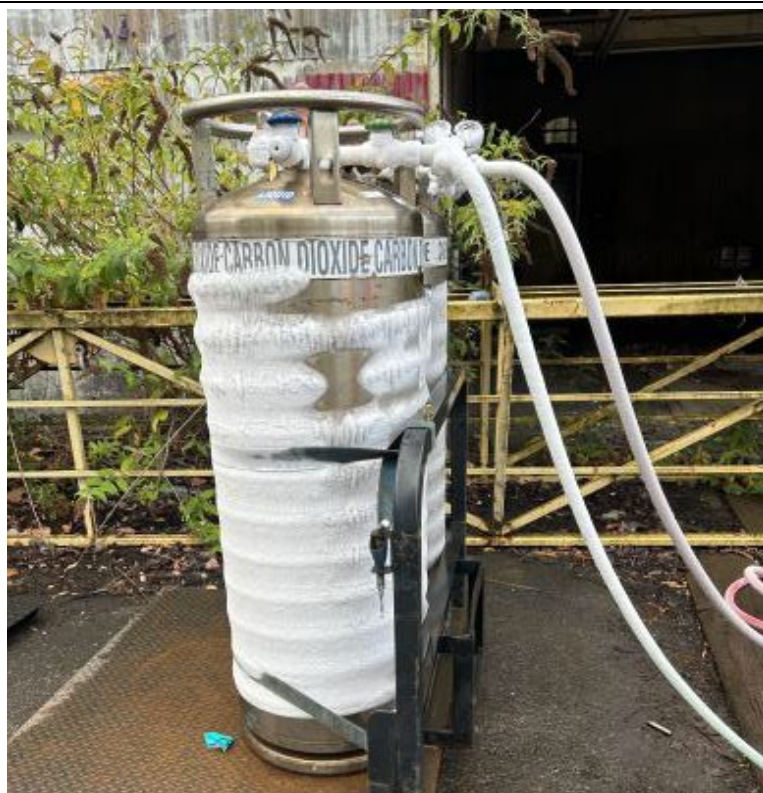
Photo No. 8	Date: 08/23/2023
Photo Coordinates	
Lat	47.253403
Long	-122.435317
Direction Photo Taken: South	
Description: Carbon dioxide compressed gas tanks.

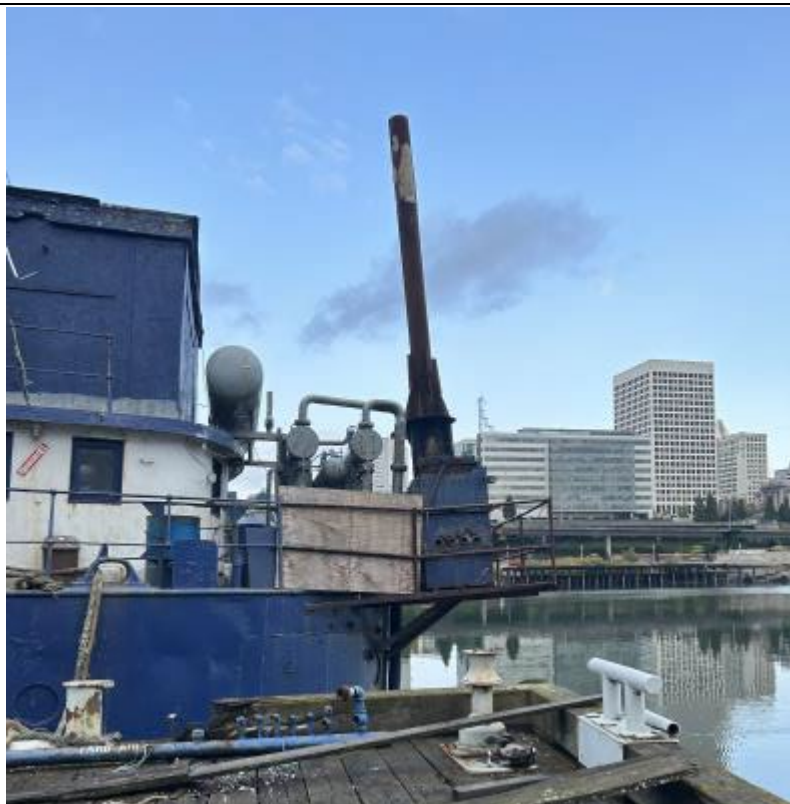
Photo No. 9		Date: 08/23/2023

Photo Coordinates			
Lat	47.25035		
Long	-122.431306		
Direction Photo Taken: South			
Description: Stern of the F/V Pacific Producer watercraft with ammonia tanks.

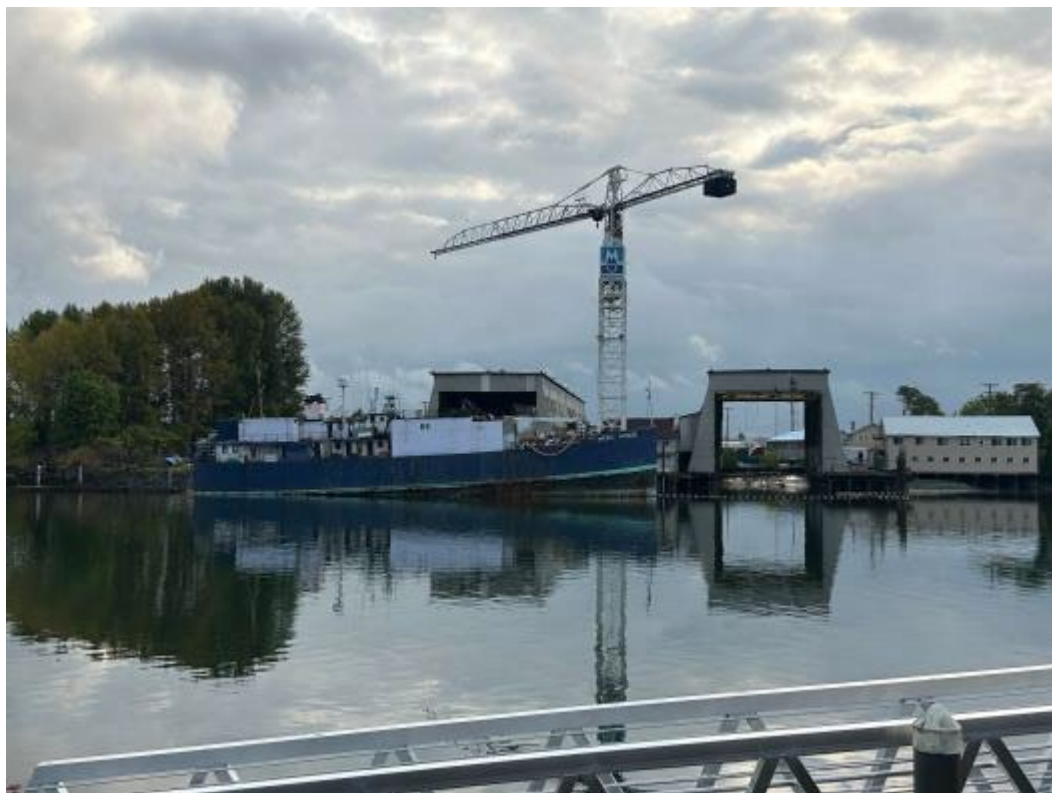
Photo No. 10		Date: 08/23/2023

Photo Coordinates			
Lat	47.249981		
Long	-122.433961		
Direction Photo Taken: Northeast			
Description: F/V Pacific Producer watercraft, moored at the Martinac Shipbuilding dock on the Thea Foss waterway.
