**Subject: Contract 68HERH19D0018; Task Order 68E0719F0190  
Elkem Carbide Site, 365 Carbide Lane, Keokuk, Lee County, Iowa  
Targeted Brownfields Assessment, Hazardous Materials Survey**

**TARGETED BROWNFIELDS ASSESSMENT  
HAZARDOUS MATERIALS SURVEY**

**ELKEM CARBIDE  
365 CARBIDE LANE  
KEOKUK, LEE COUNTY, IOWA**

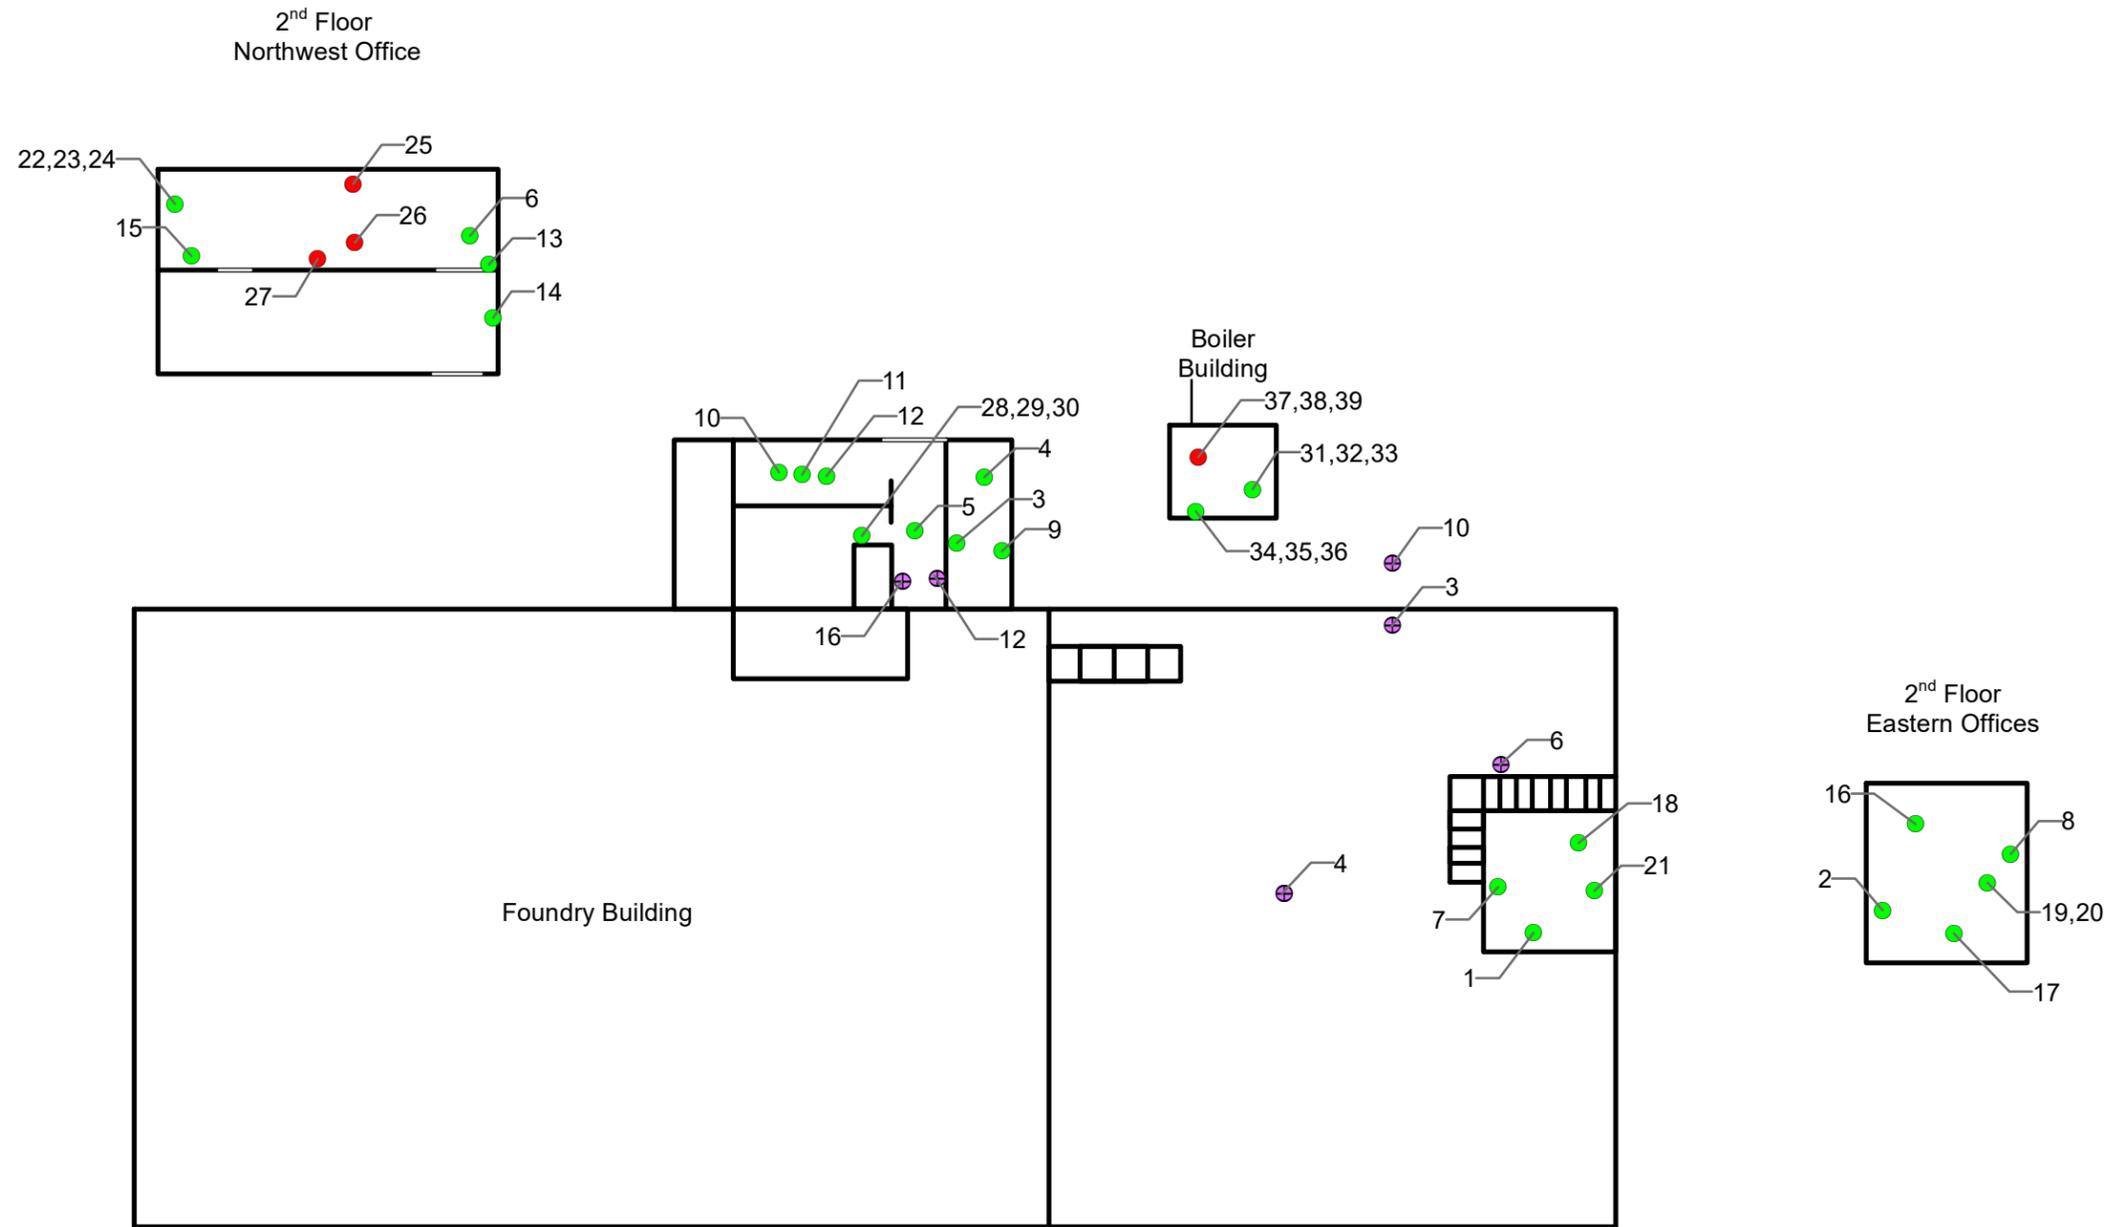
**Figure 1**  
Sample Location Map

PLM results from samples analyzed for ACM appear in the laboratory report in [Appendix D](#) and are summarized in [Table 1](#). Bolded data in [Table 1](#) indicate samples containing asbestos at concentrations greater than 1 percent. Figure 1 in [Appendix A](#) shows sample locations.

The figure key corresponds to the sample key table on Figure 1 in [Appendix A](#).

[Table 2](#) summarizes screening results for LBP by use of the XRF spectrometer. Bold data in [Table 2](#) indicate where LBP was detected at concentrations greater than or equal to 1.0 mg/cm<sup>2</sup>. Figure 1 in [Appendix A](#) shows positive LBP screening locations.

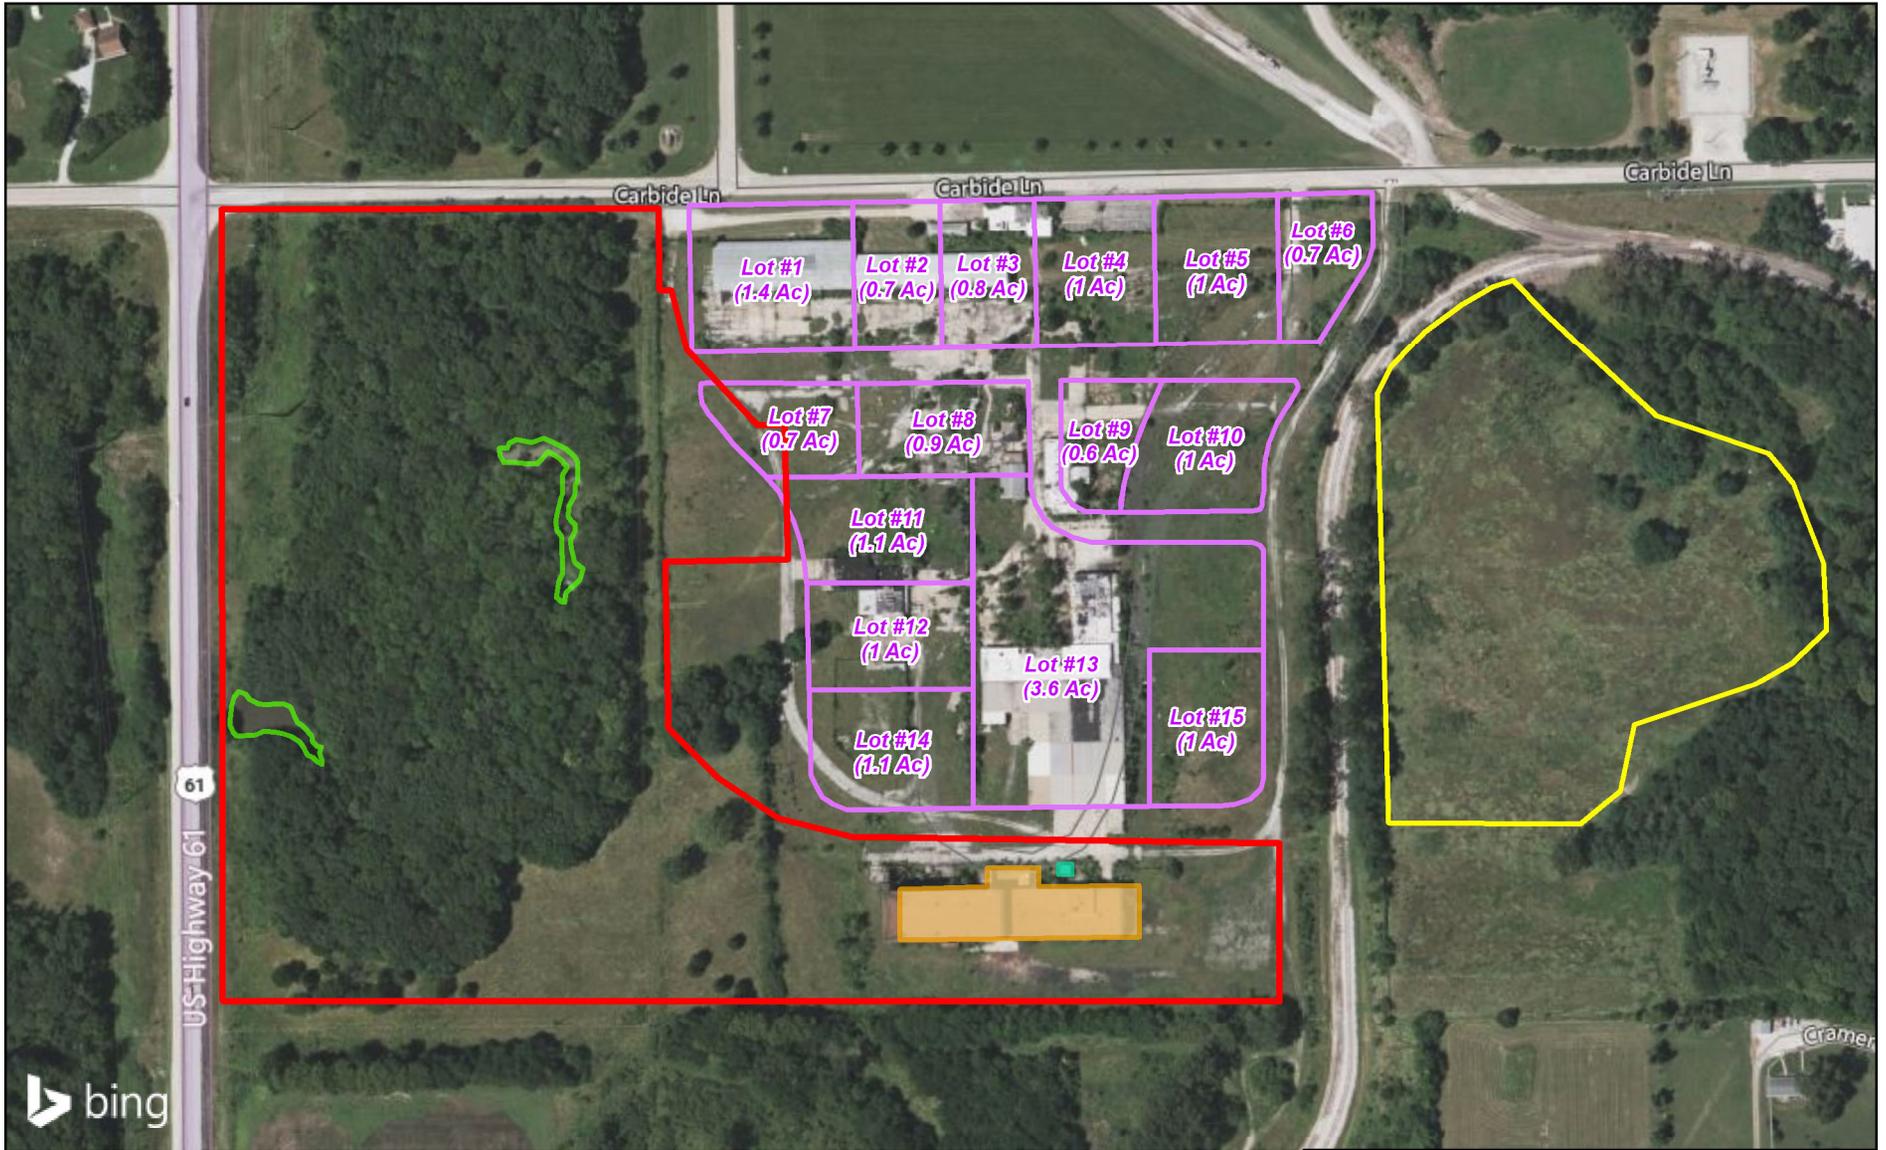
**FIGURE 2    SITE LAYOUT MAP**

**Figure 2**  
Site Layout Map

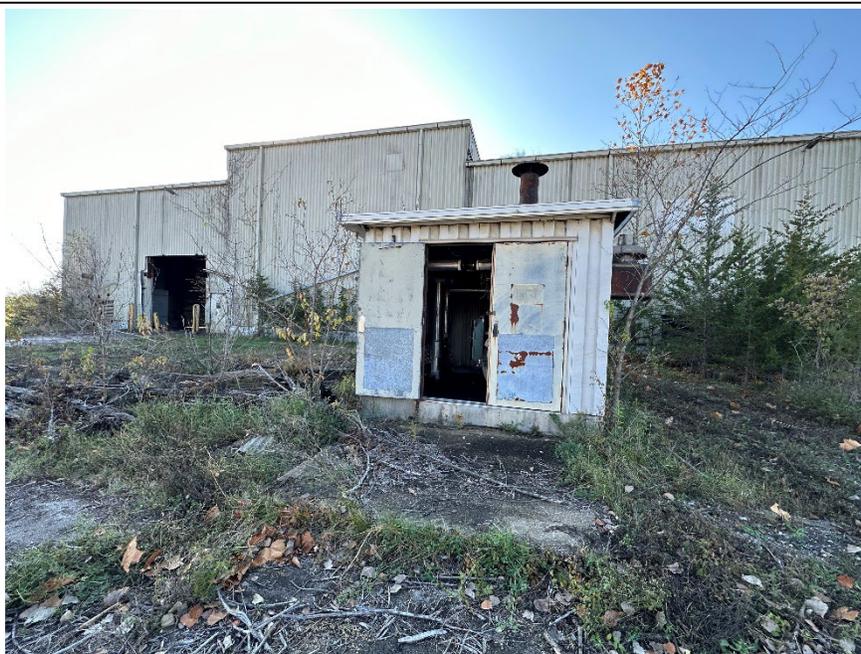
SUBTASK NO. 016.05	DESCRIPTION	This photograph shows the Foundry Building on the Site.	PHOTOGRAPH NO: 1
	CLIENT	U.S. Environmental Protection Agency (EPA)	
DIRECTION: South-southeast	PHOTOGRAPHER	Macy La Masney	DATE: 11/7/23

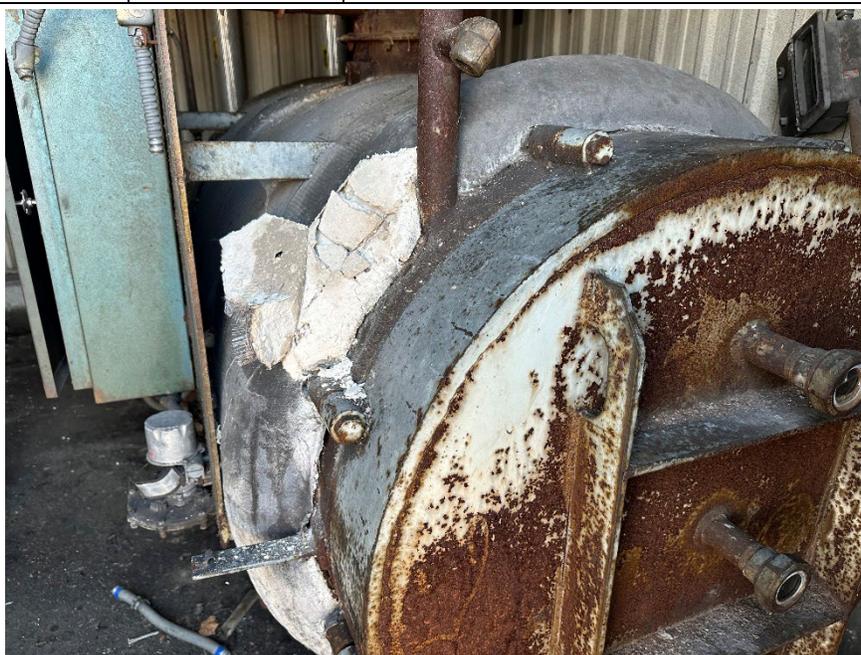
- Glue dots (approximately 200 square feet [SF]) behind wall covering in the 2<sup>nd</sup> Floor northwest office within the Foundry Building; and
- White tank insulation (approximately 100 SF) in the Boiler Building.

SUBTASK NO. 016.05	DESCRIPTION	This photograph shows confirmed asbestos-containing material (ACM) black mastic associated with white tank insulation in the Boiler Building.	PHOTOGRAPH NO: 2
	CLIENT	EPA	
DIRECTION: Southwest	PHOTOGRAPHER	Macy La Masney	DATE: 11/7/23

The ACM listed above should be removed by a licensed asbestos abatement contractor before demolition work disturbs the material. The removed waste must be transported to a disposal site approved to accept both friable and non-friable ACM. If the building is to be renovated and/or if plans do not include disturbing any of the above ACM materials, the ACM may remain in place.

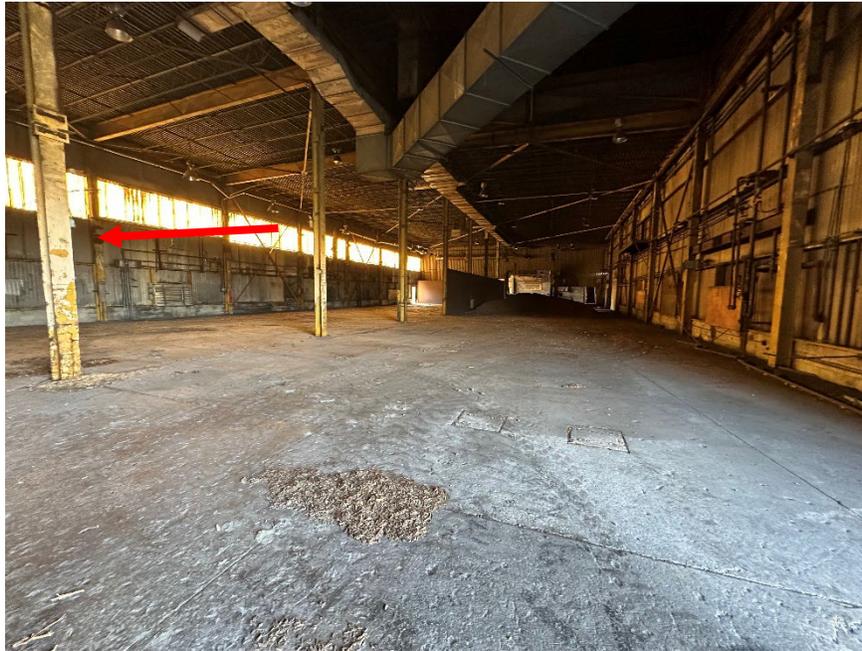
Approximately 4,432 SF of assorted colors of LBP were on a variety of substrates throughout the Foundry Building—including support beams, stair railing, bollards, and door frames.

SUBTASK NO. 016.05	DESCRIPTION	This photograph shows yellow lead-based paint (LBP) on the metal support beams in the main area of the Foundry Building.	PHOTOGRAPH NO: 3
	CLIENT	EPA	DATE: 11/7/23
DIRECTION: Southwest	PHOTOGRAPHER	Macy La Masney

If the LBP surfaces are affected during renovations or demolition at the Foundry Building, the Toeroek Team recommends that the contractor conducting the renovations comply with the Occupational Safety and Health Administration (OSHA) lead in construction standard—Title 29 of the *Code of Federal Regulations* (CFR), Part 1926.62. If the materials containing LBP are removed during renovation activities, a sample should be collected from the debris pile for Toxicity Characteristic Leaching Procedure (TCLP) analysis (40 CFR 261.24). Representative samples should be collected and analyzed for all eight metals specified in 40 CFR Part 261.24 (arsenic, barium, cadmium, chromium, lead, mercury, selenium, and silver). Laboratory results for TCLP and metals analyses would allow for determination of the proper method of disposal of the materials.

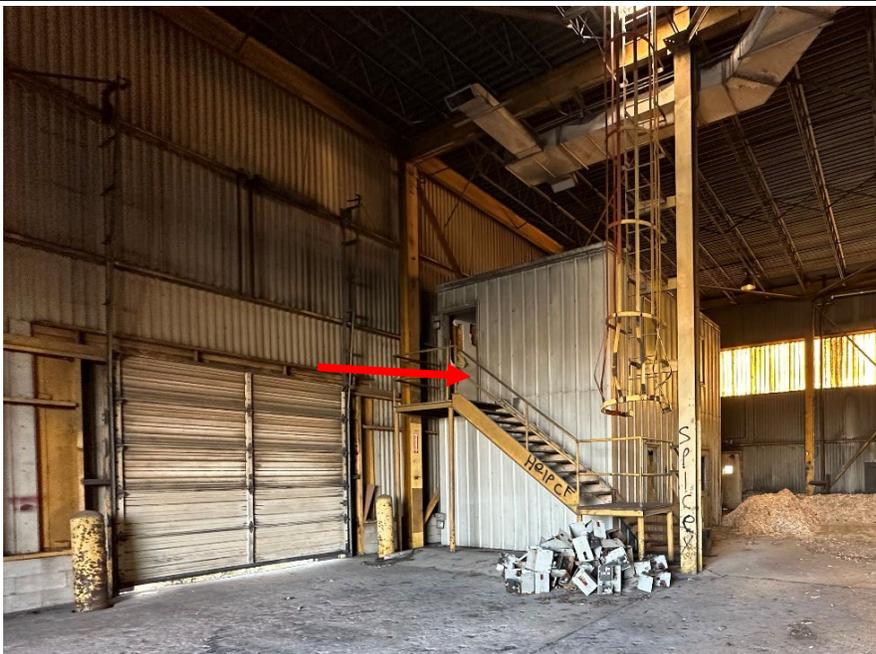
SUBTASK NO. 016.05	DESCRIPTION	This photograph shows yellow LBP on the metal stair railing near the eastern offices in the Foundry Building.	PHOTOGRAPH NO: 4
	CLIENT	EPA	DATE: 11/7/23
DIRECTION: Southeast	PHOTOGRAPHER	Macy La Masney

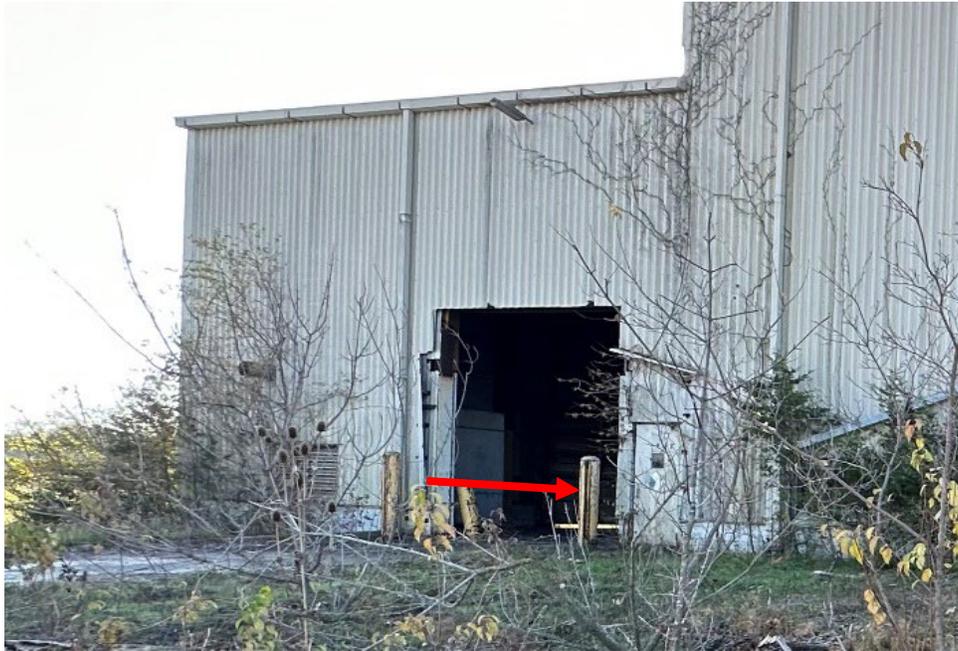
SUBTASK NO. 016.05	DESCRIPTION	This photograph shows yellow LBP on the metal bollards on the exterior of the Foundry Building.	PHOTOGRAPH NO: 5
	CLIENT	EPA	
DIRECTION: South-southeast	PHOTOGRAPHER	Macy La Masney	DATE: 11/7/23

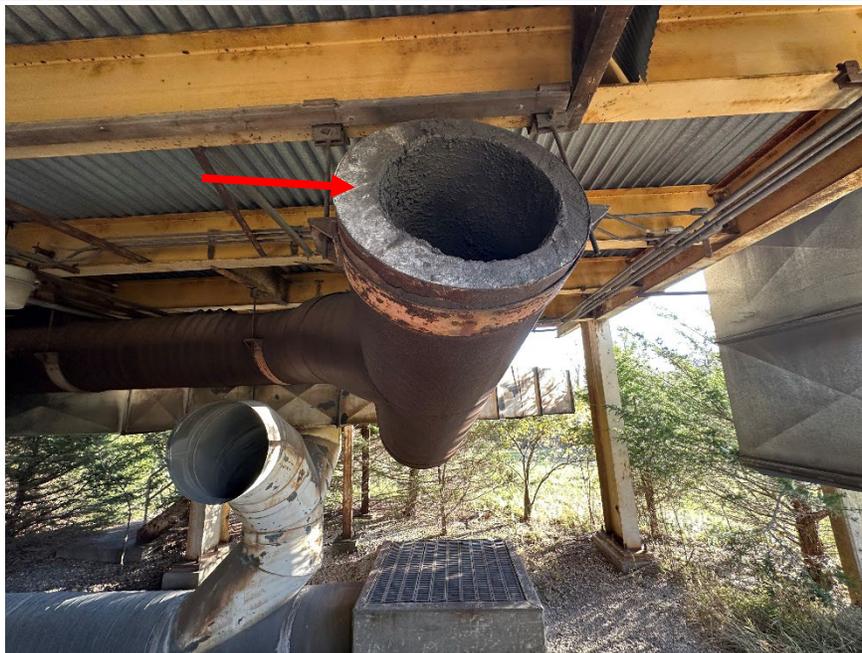
In addition, five fire doors were observed throughout the Foundry Building, approximately 5,500 SF of cementitious pipe insulation, and approximately 33,400 SF of roofing materials are assumed ACM. These locations were not sampled because of concerns with structural damage and safety.

SUBTASK NO. 016.05	DESCRIPTION	This photograph shows assumed ACM cementitious pipe insulation on exterior ducts on the Foundry Building.	PHOTOGRAPH NO: 6
	CLIENT	EPA	
DIRECTION: South	PHOTOGRAPHER	Macy La Masney	DATE: 11/7/23
