**Subject: Contract No. 68HERH19D0018; Task Order No. 68HE0719F0190
Joplin Union Depot
205 North Main Street, Joplin, Jasper County, Missouri
Analysis of Brownfields Cleanup Alternatives**

ANALYSIS OF BROWNFIELDS CLEANUP ALTERNATIVES

**JOPLIN UNION DEPOT
205 NORTH MAIN STREET
JOPLIN, JASPER COUNTY, MISSOURI**

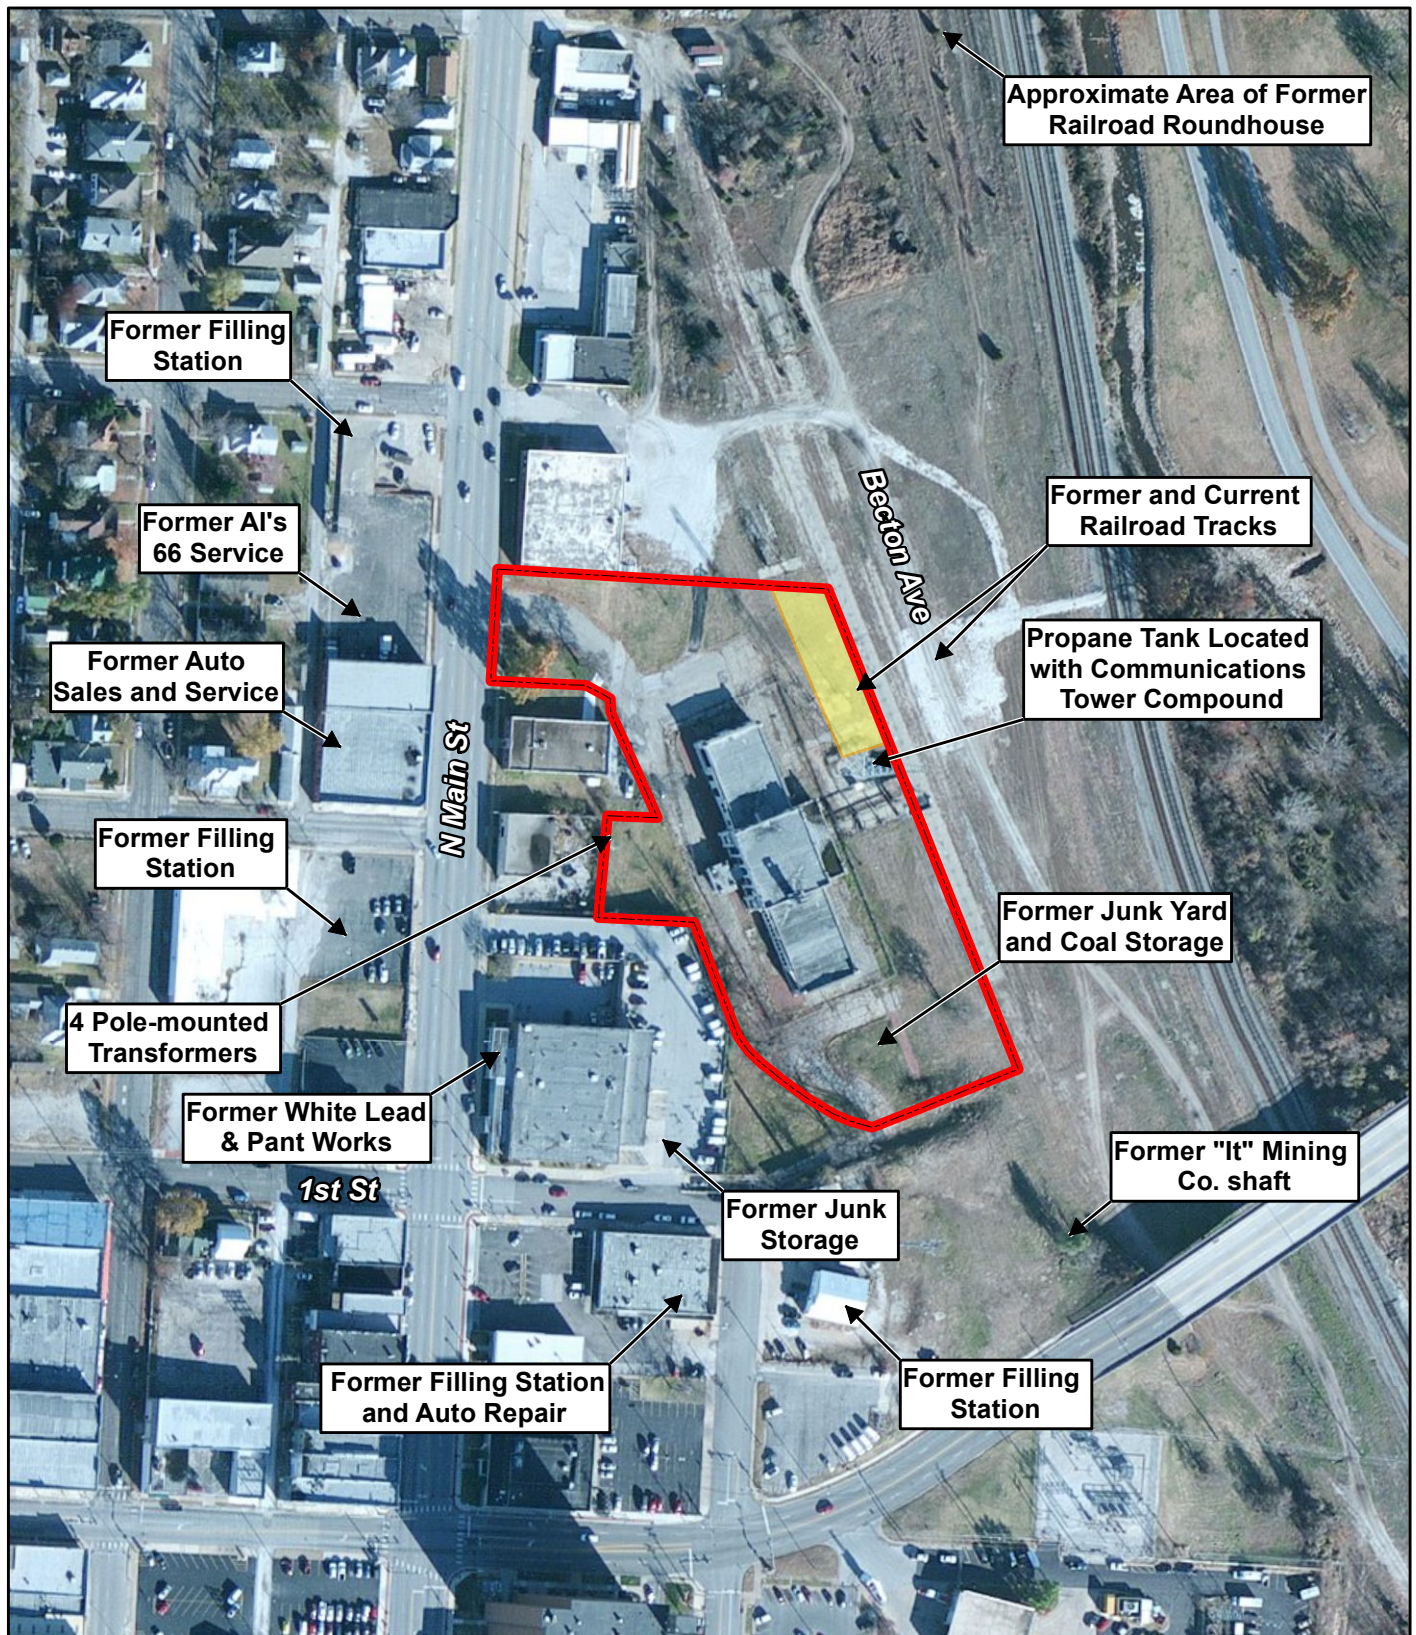
FIGURE 2 SITE LAYOUT MAP

The Site is within a mixed commercial and residential area of downtown Joplin. The Site hosts a vacant building formerly used as a railroad depot, as well as an active communications tower and associated compound for the Kansas City Southern railroad. Historical documentation indicates the Site was undeveloped until 1900, when multiple dwellings and a junkyard were developed. Construction of the building occurred sometime between 1900 and 1911, and currently encompasses approximately 23,816 square feet.

- A railroad spur was present on the Site from as early as 1950 (based on Sanborn maps) until 1967, and the Site was listed in city directories as Joplin Union Depot from 1964 to 1981. Further, railroad tracks were observed adjacent to the Site. The railroad tracks were considered to pose a REC for the Site because of possible contamination commonly associated with creosote-soaked railroad ties and metals.

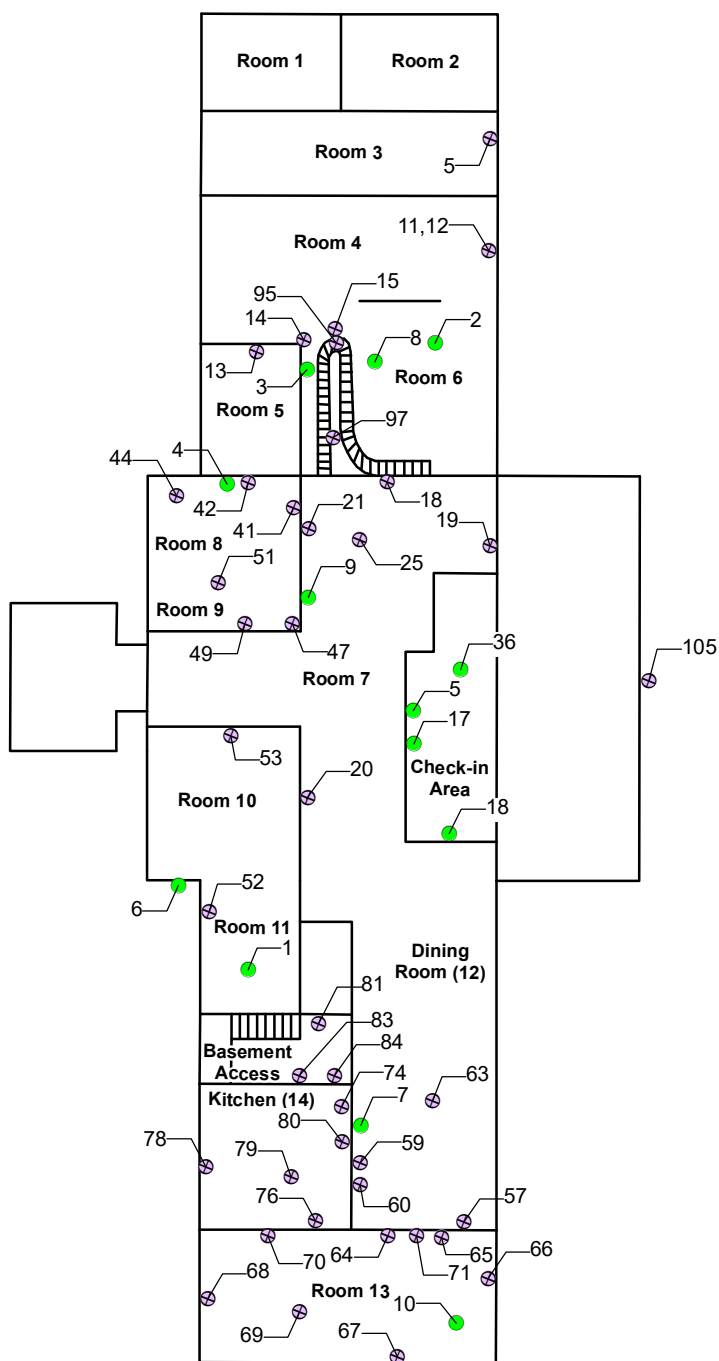
Figure 3
Sample Location Map - Hazardous Materials
First Floor

During the ACM survey portion of the HMS, the Toeroek Team collected 21 bulk samples of suspected ACM from the building. Collection of samples of building materials accorded with National Emissions Standards for Hazardous Air Pollutants (NESHAP) as adopted by EPA, and with AHERA protocols. Suspect ACM samples were analyzed via polarized light microscopy. AHERA defines ACM as any material or product that contains more than 1 percent asbestos. ACM sample locations appear on [Figure 3](#) and [Figure 4](#) in [Appendix A](#).

The ACM survey identified approximately 1,250 SF of black roof flashing on the roof as non-friable ACM.

During the LBP survey portion of the HMS, the Toeroek Team screened 108 surfaces in the building using a handheld x-ray fluorescence (XRF) spectrometer. LBP screening locations appear on [Figure 3](#) and [Figure 4](#) in [Appendix A](#). The HMS report describes LBP screening locations (Toeroek Team 2023c). The LBP survey accorded with protocols similar to the single-family housing inspection procedures in *Guidelines for the Evaluation and Control of LBP in Housing* (HUD Guidelines) (HUD 2012). HUD guidelines suggest that paint applied before 1978 may contain lead. HUD considers LBP as paint with lead

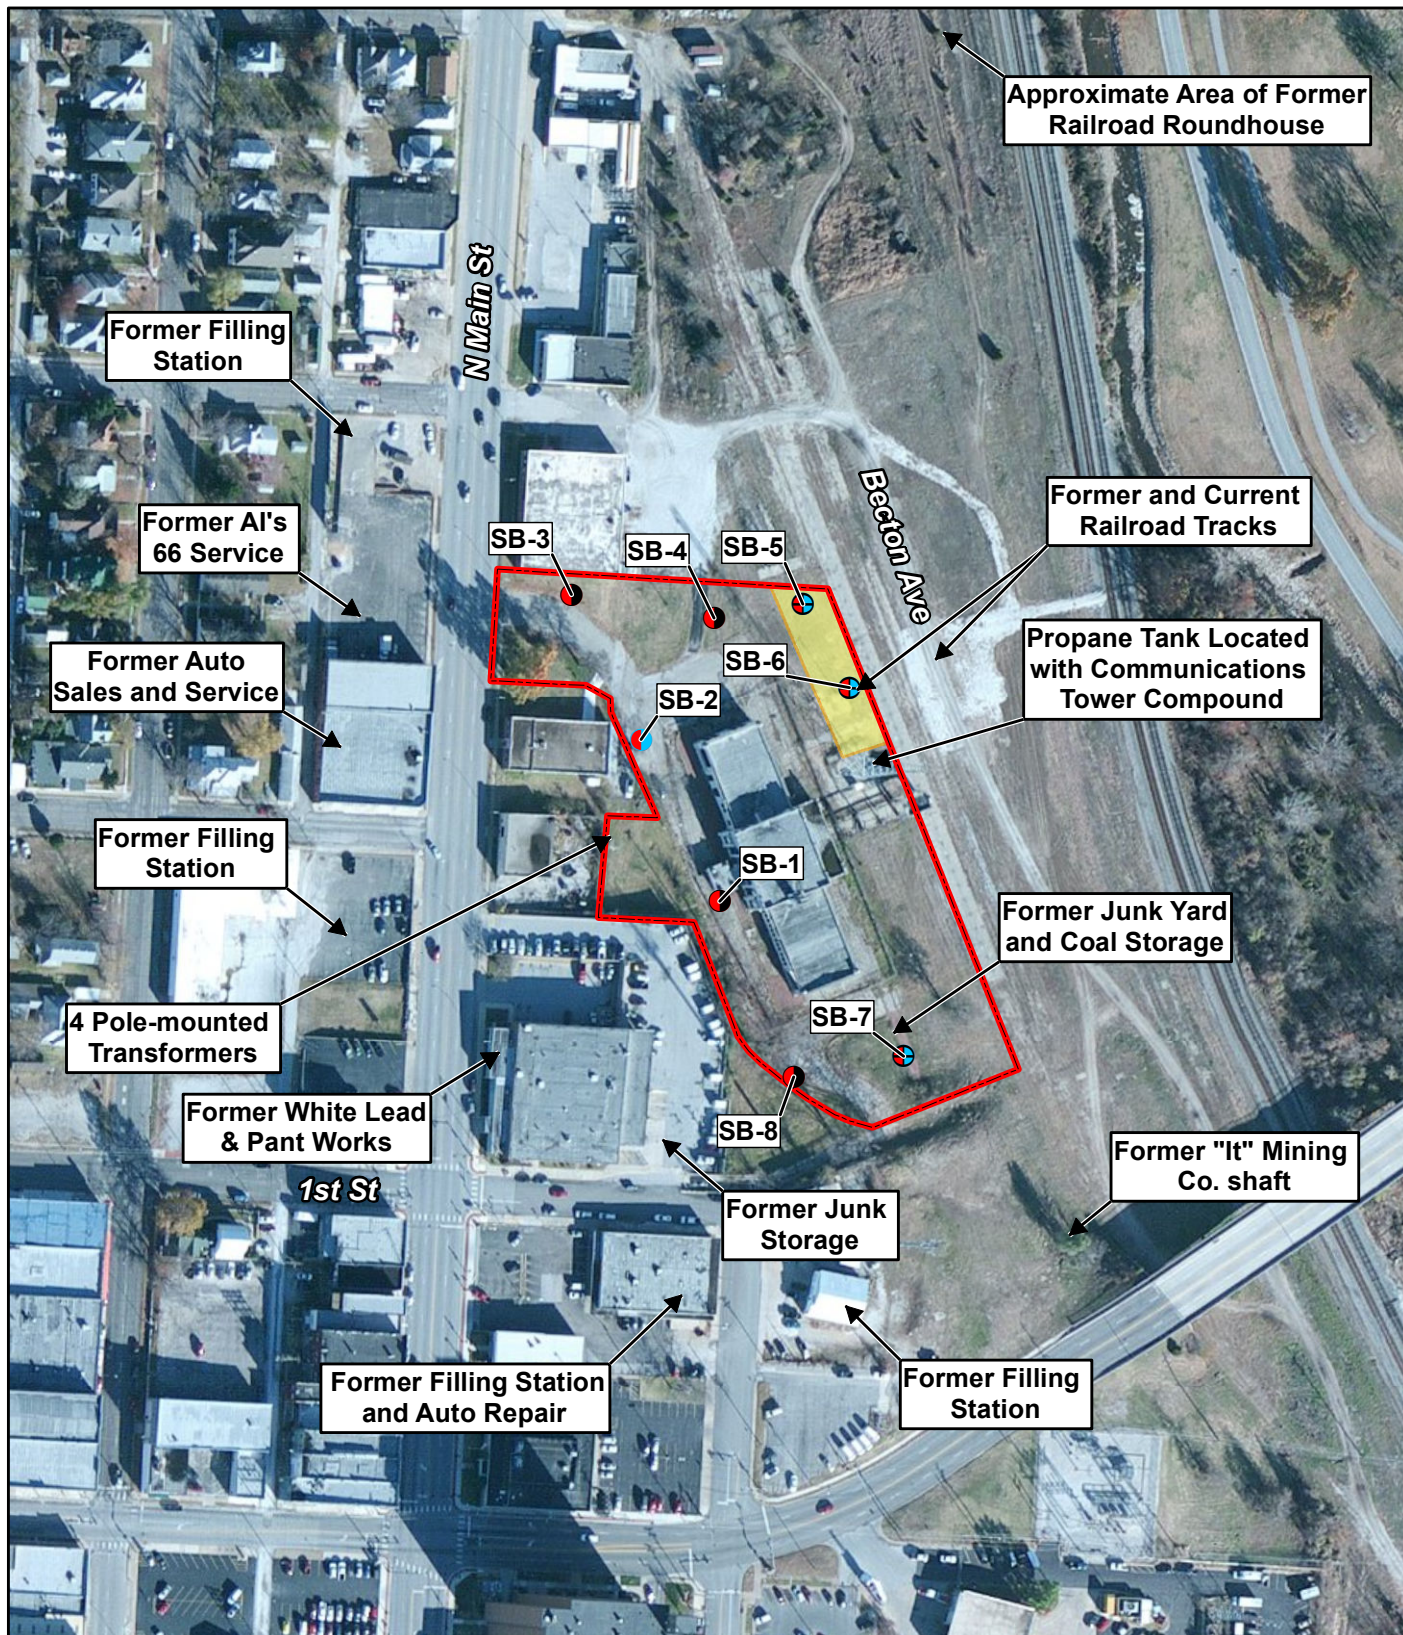
FIGURE 5 SAMPLE LOCATION MAP – SOIL, GROUNDWATER, AND SOIL GAS

As part of the Phase II ESA in 2023, the Toeroek Team collected a surface soil sample and a subsurface soil sample at eight locations across the Site (soil boring [SB]-1 through SB-8), ([Appendix A](#), [Figure 5](#)). Surface soil samples were collected within 0 to 3 feet bgs. Subsurface soil samples were collected within select intervals based on visual staining, detected odor, or elevated photoionization detector (PID) readings. If no staining/odor or elevated PID reading was noted, a sample was collected from the bottom of the soil core.

Metals were detected at concentrations that exceeded MRBCA RBTLs. In surface soil, the following metals were detected at concentrations exceeding MRBCA RBTLs in at least one surface soil sample (sample IDs indicated in parentheses).

- Arsenic – residential RBTL (SB-1, SB-2, SB-3, SB-5, SB-6, SB-8): The detections were consistent with naturally occurring concentrations (less than the maximum observed USGS concentration).
- Cadmium – residential RBTL (SB-1, SB-5): The USGS has not established a background concentration for cadmium.
- Lead – residential RBTL (SB-3, SB-4, SB-5, SB-6) and non-residential RBTL (SB-8): The detections above the residential RBTL were consistent with naturally occurring concentrations (less than the maximum observed USGS concentration),; however, the detection at SB-8 significantly exceeded the maximum observed USGS concentration.

- Arsenic – residential RBTL (SB-4, SB-7) and non-residential RBTL (SB-2, SB-3, SB-5, SB-8): Of these, the detections at SB-3, SB-5, and SB-8 exceeded the maximum observed USGS concentration.
- Beryllium - residential RBTL (SB-2, SB-7): The USGS has not established a background concentration for beryllium.
- Lead – non-residential RBTL (SB-7 and SB-8): The detections significantly exceeded the maximum observed USGS concentration.
- Thallium – non-residential RBTL (SB-1): The USGS has not established a background concentration for thallium.

The following locations have concentrations of metals that exceeded a non-residential RBTL that are not likely to be naturally occurring or for which no background information is available: surface soil at SB-8 and subsurface soil at SB-1, SB-2, SB-3, SB-5, SB-7, and SB-8.

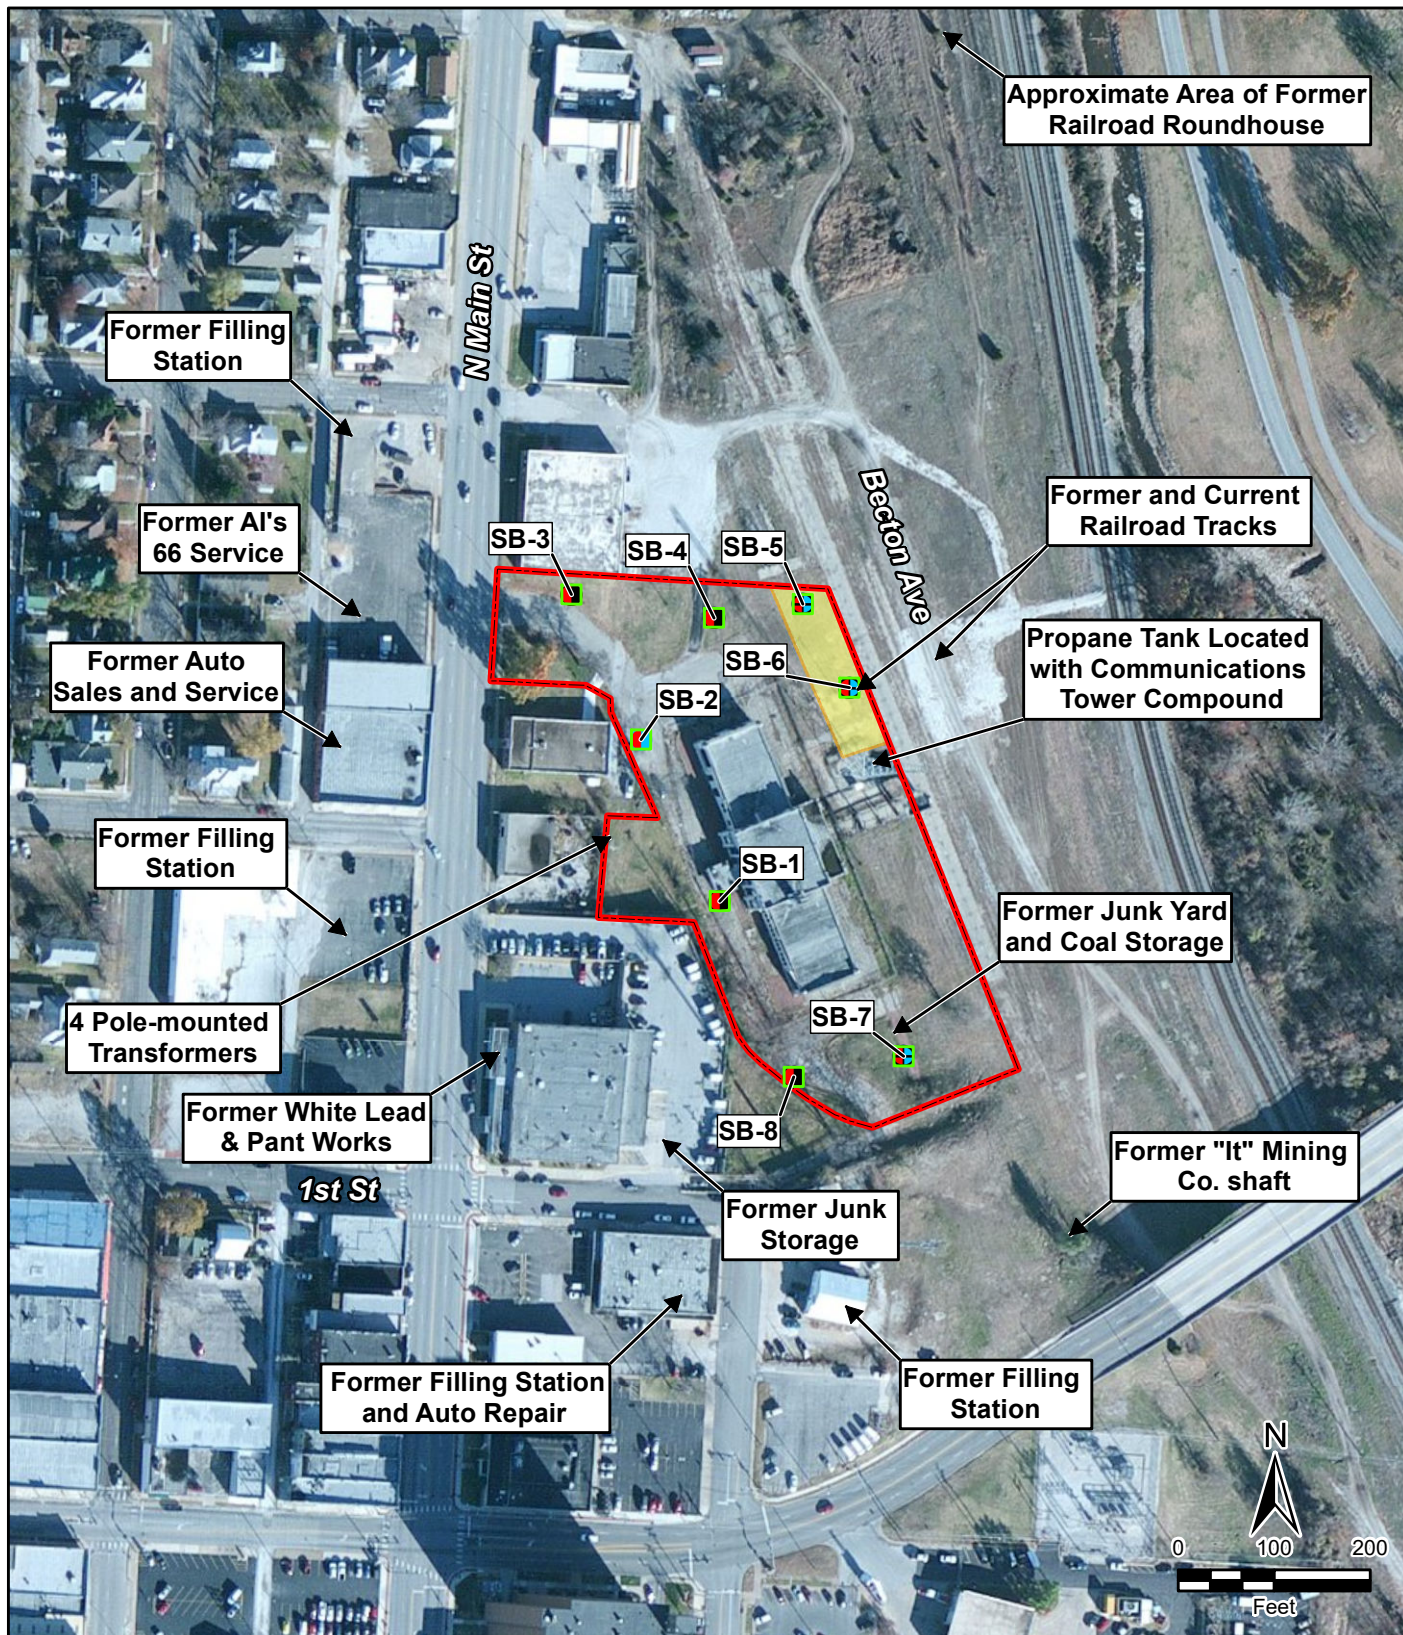
FIGURE 6 EXCAVATION AREA MAP

Soil excavation by qualified equipment operators would accord with applicable state and federal regulations. Excavation of at least 1,079 cy of soil is necessary to clean up the Site. Excavation will be difficult to implement due to the likelihood of contaminated soils extending at greater distances from the soil borings than the assumed distances above. Excavation would need to continue laterally and to depth until concentrations were below RBTLs. All waste soil excavated during this process would be transported for disposal off of the Site as either non-hazardous or hazardous waste, depending on results of TCLP analysis. For cost estimating purposes, assumptions are that none of the excavated soil would be used as backfill and all excavated soil would be handled as non-hazardous waste. In addition, planning for this alternative would require careful precautionary consideration concerning worker health and safety.

- Backfill: Excavated areas to be backfilled with clean material from off of the Site, graded, and seeded, as necessary, for redevelopment.
- Waste Disposal: Presumably, all excavated soil would be accepted at a landfill facility as non-hazardous waste.
