Omaha Lead Site Site Sketch

Sampling Address: [REDACTED]

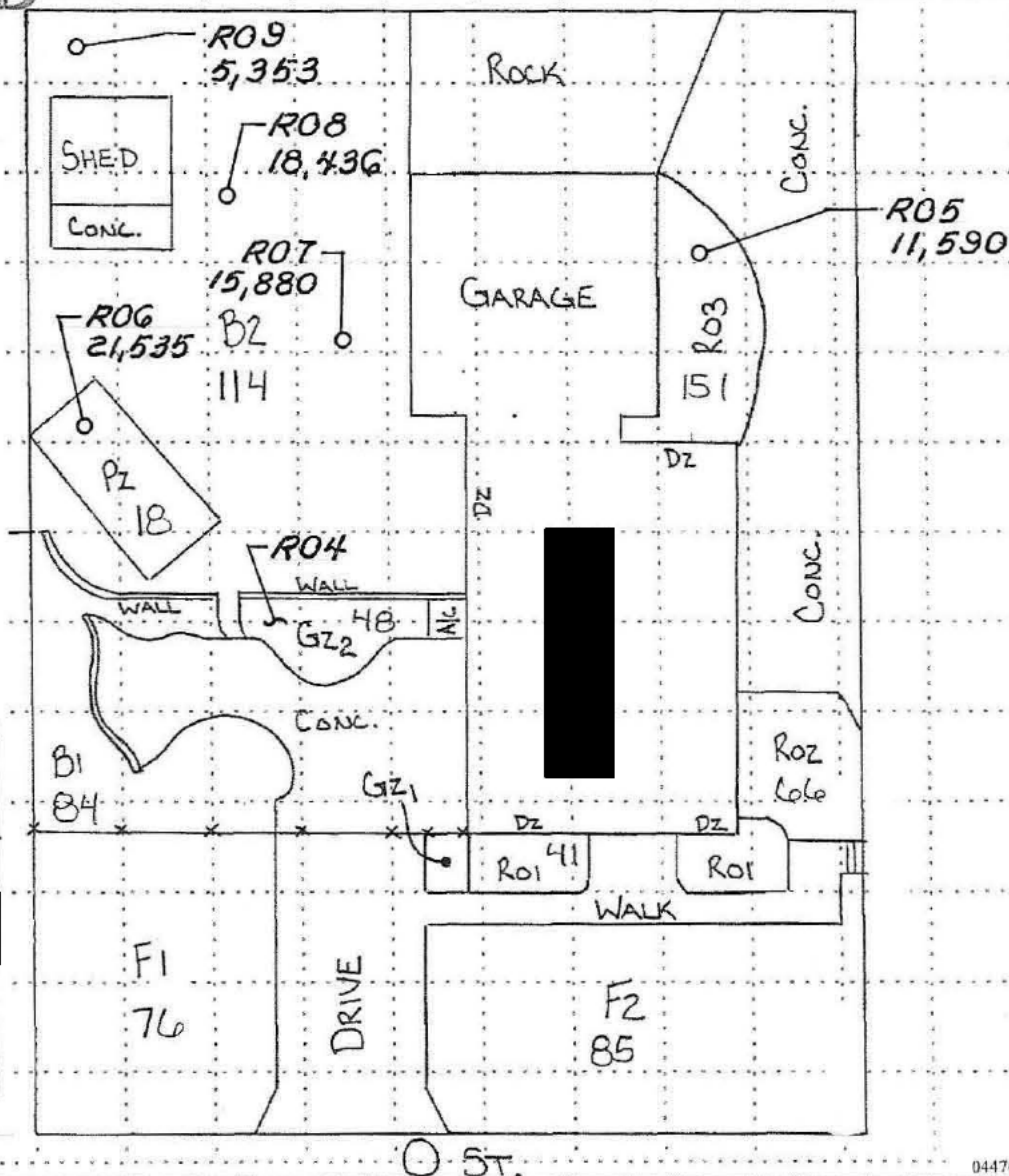
Note: The disparities of the lead readings are due to samples R05 - R09, are chunks of slag material that were found on the surface of the soil. Refer to Oracle comments.

R06SCPXA- 21,535 ppm
 R07SCPXA- 15,880 ppm
 R08SCPXA- 18,436 ppm
 R09SCPXA- 5,353 ppm

R01SCPXA- 41 ppm
 R02SCPXA- 66 ppm
 R03SCPXA- 151 ppm
 R04SCPXA- 48 ppm (GZ2)
 R05SCPXA- 11,590 ppm
