EPA Emergency Response Site Update

Helena Mercury Release

Operations Period 04

June 4, 2024

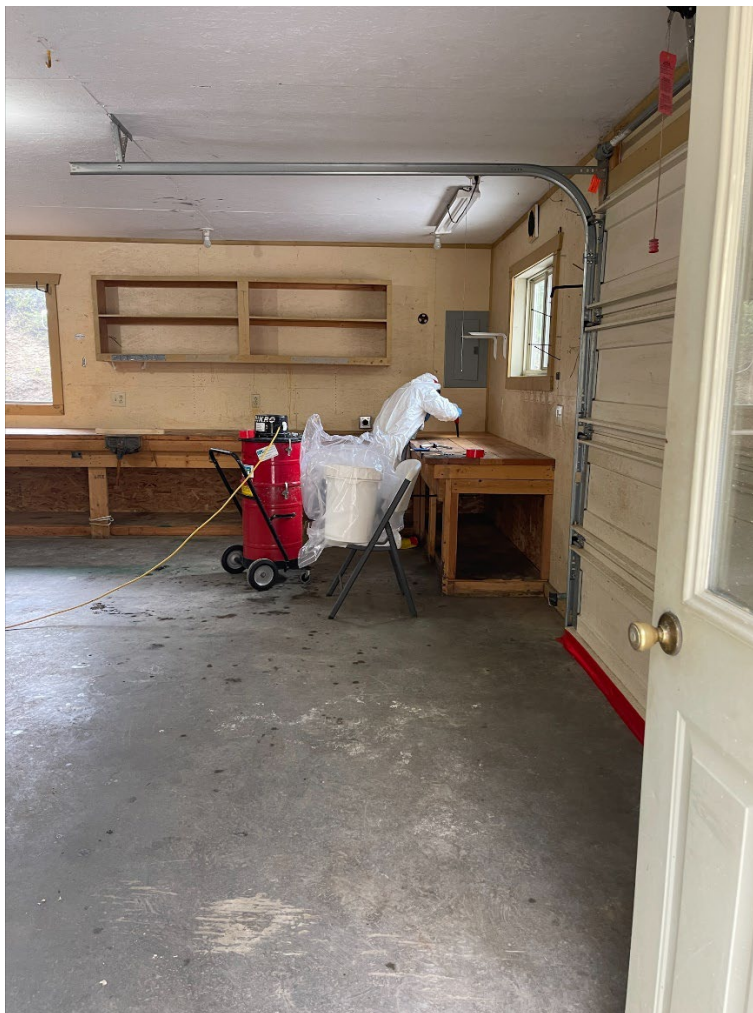
Preparing to remove the workbench.

The team used plastic sheeting to isolate the area around the workbench and began to slowly dismantle the shelves and bench in that area. Once a portion of the workbench was removed, the team found 2-inch pools of mercury and the element seeped from several newly exposed cavities. This element then dispersed across the floor of the containment within the exclusion zone each time requiring meticulous use of the mercury vacuum to clear the containment area. Work in this area will continue into the next Operations Period until the bench and plywood wall behind it is fully removed.

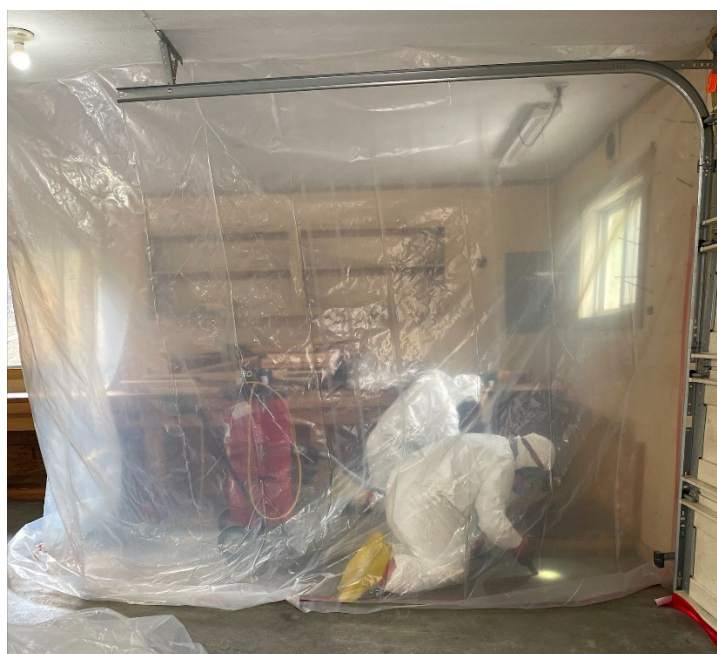
Clearing mercury as the workbench is removed.
