## EPA Emergency Response Site Update

Helena Mercury Release

Operations Period 06

June 6, 2024

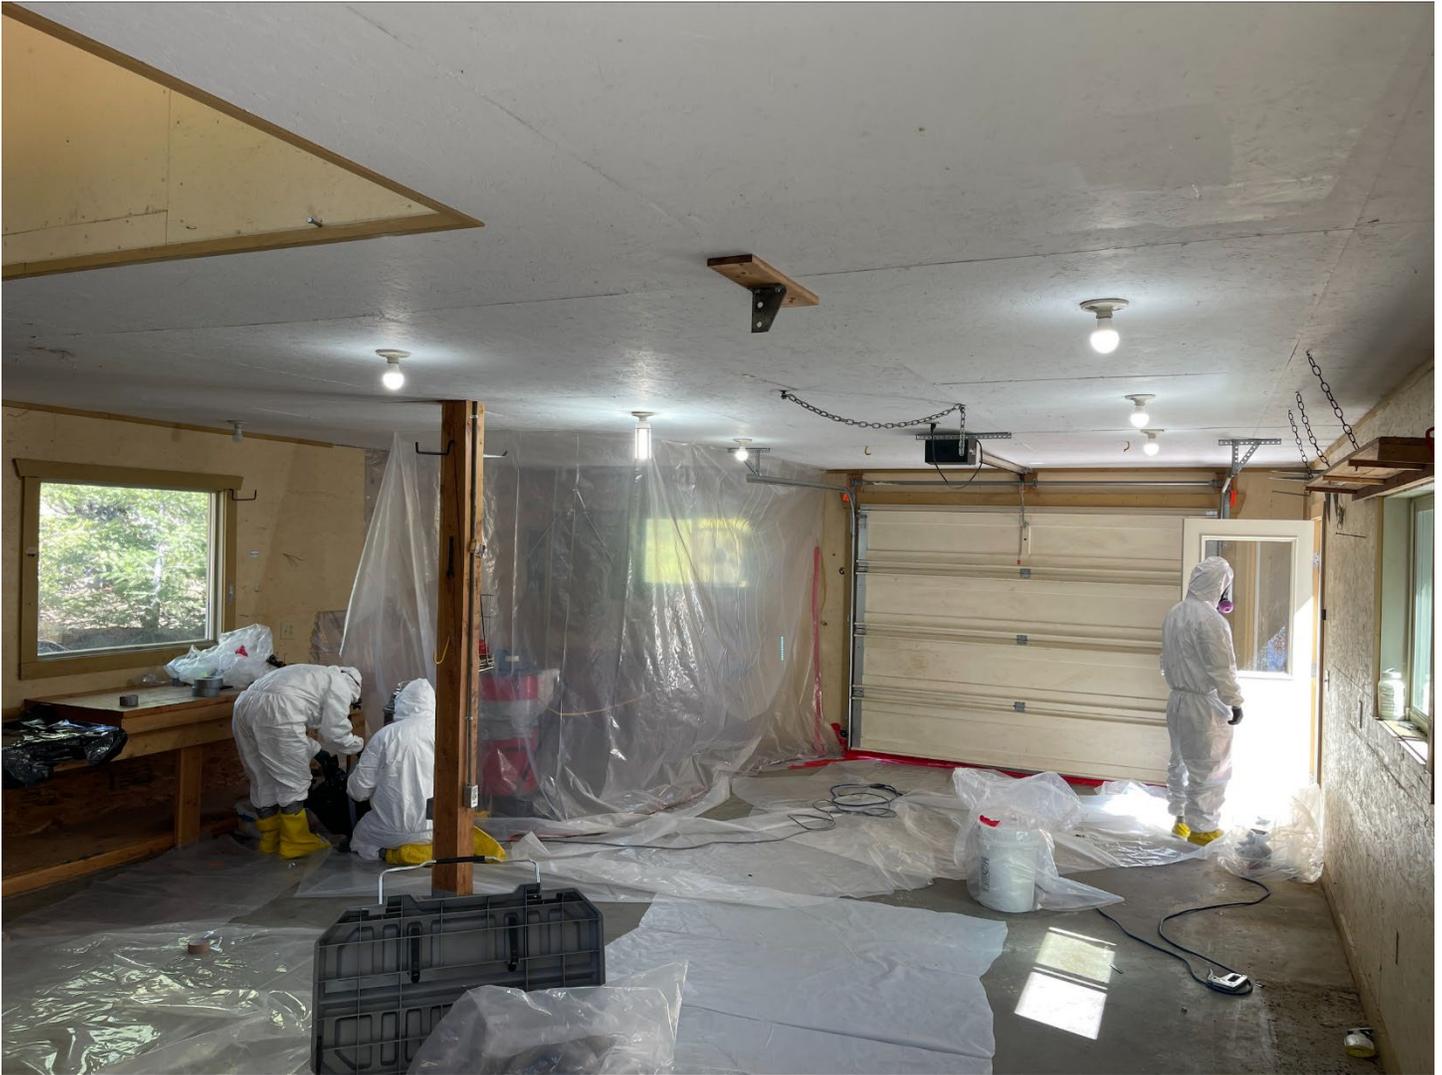
*Completing demolition of release area, additional wall removed.*

A replacement mercury vacuum was delivered to Helena around midnight on June 5. The vacuum was secured from a team sub-contractor of EPA's Emergency and Rapid Response Contractor (ERRS) located in Billings, Montana. This vacuum was used to complete the demolition and removal of the work bench area and all the recoverable mercury discovered there. Plywood on the north wall was also removed. The entire garage was then carefully re-vacuumed inch-by-inch with the mercury vacuum.

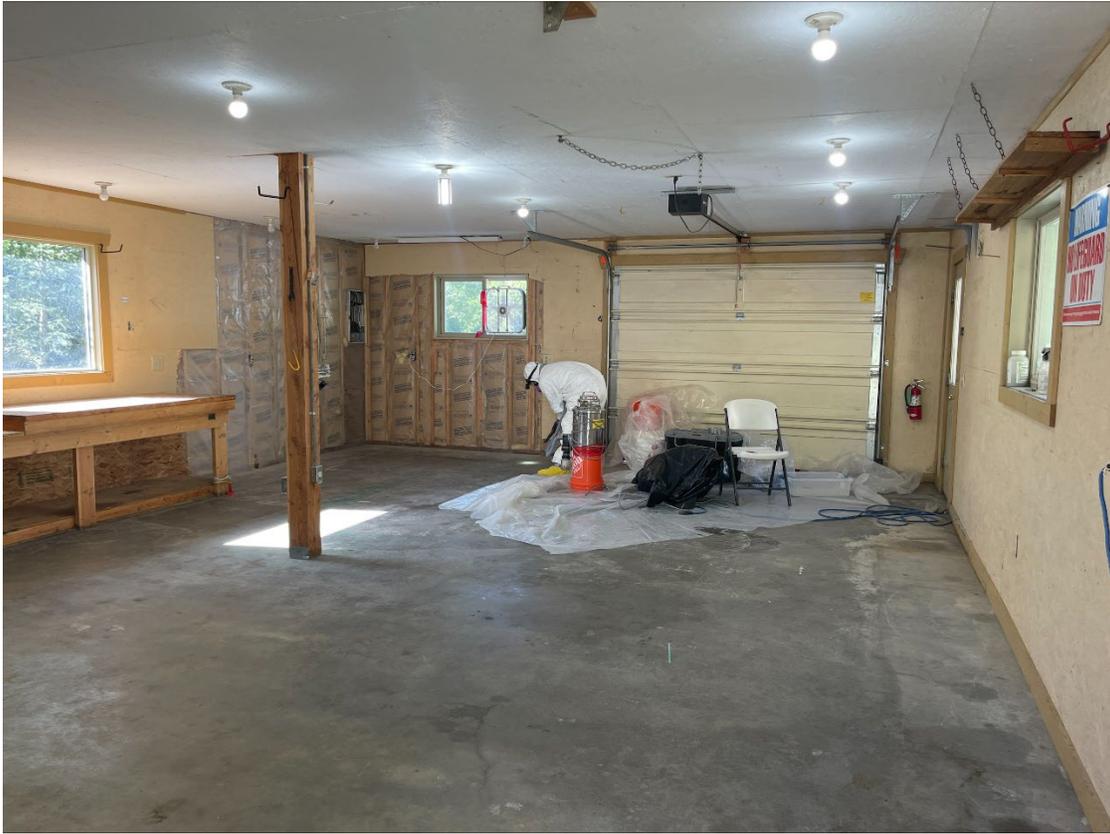
*Completing detailed vacuum of garage, note demolished bench area.*

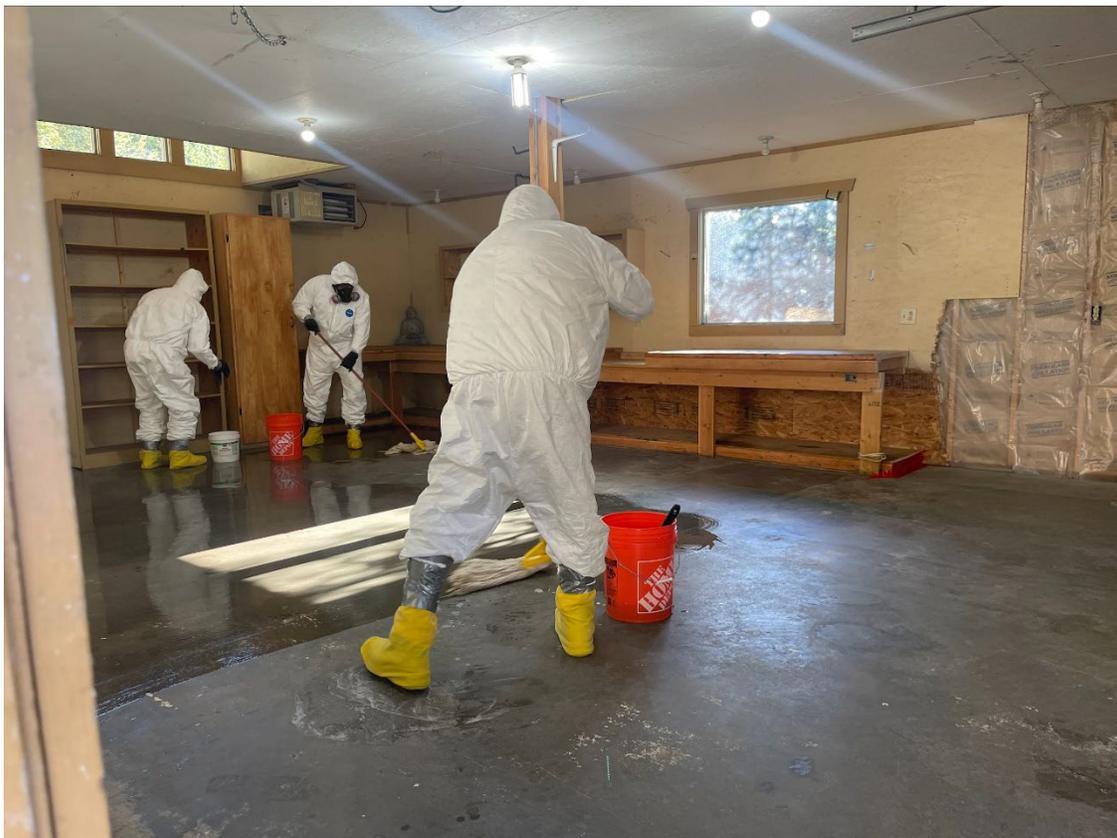
*Application of HgX to interior of garage.*

The response team then applied a generous amount of chemical reagent designed to produce a non-vaporizing sulfide when in contact with residual mercury. This chemical reagent does not work well on beads of mercury so once the reagent had dried and the garage had been thoroughly ventilated, EPA's Superfund
