Former Temple Stuart Mill  
24 Holman Street  
Templeton, Massachusetts

# PHASE I ENVIRONMENTAL SITE ASSESSMENT

ACM Group, Inc.  
March 2022

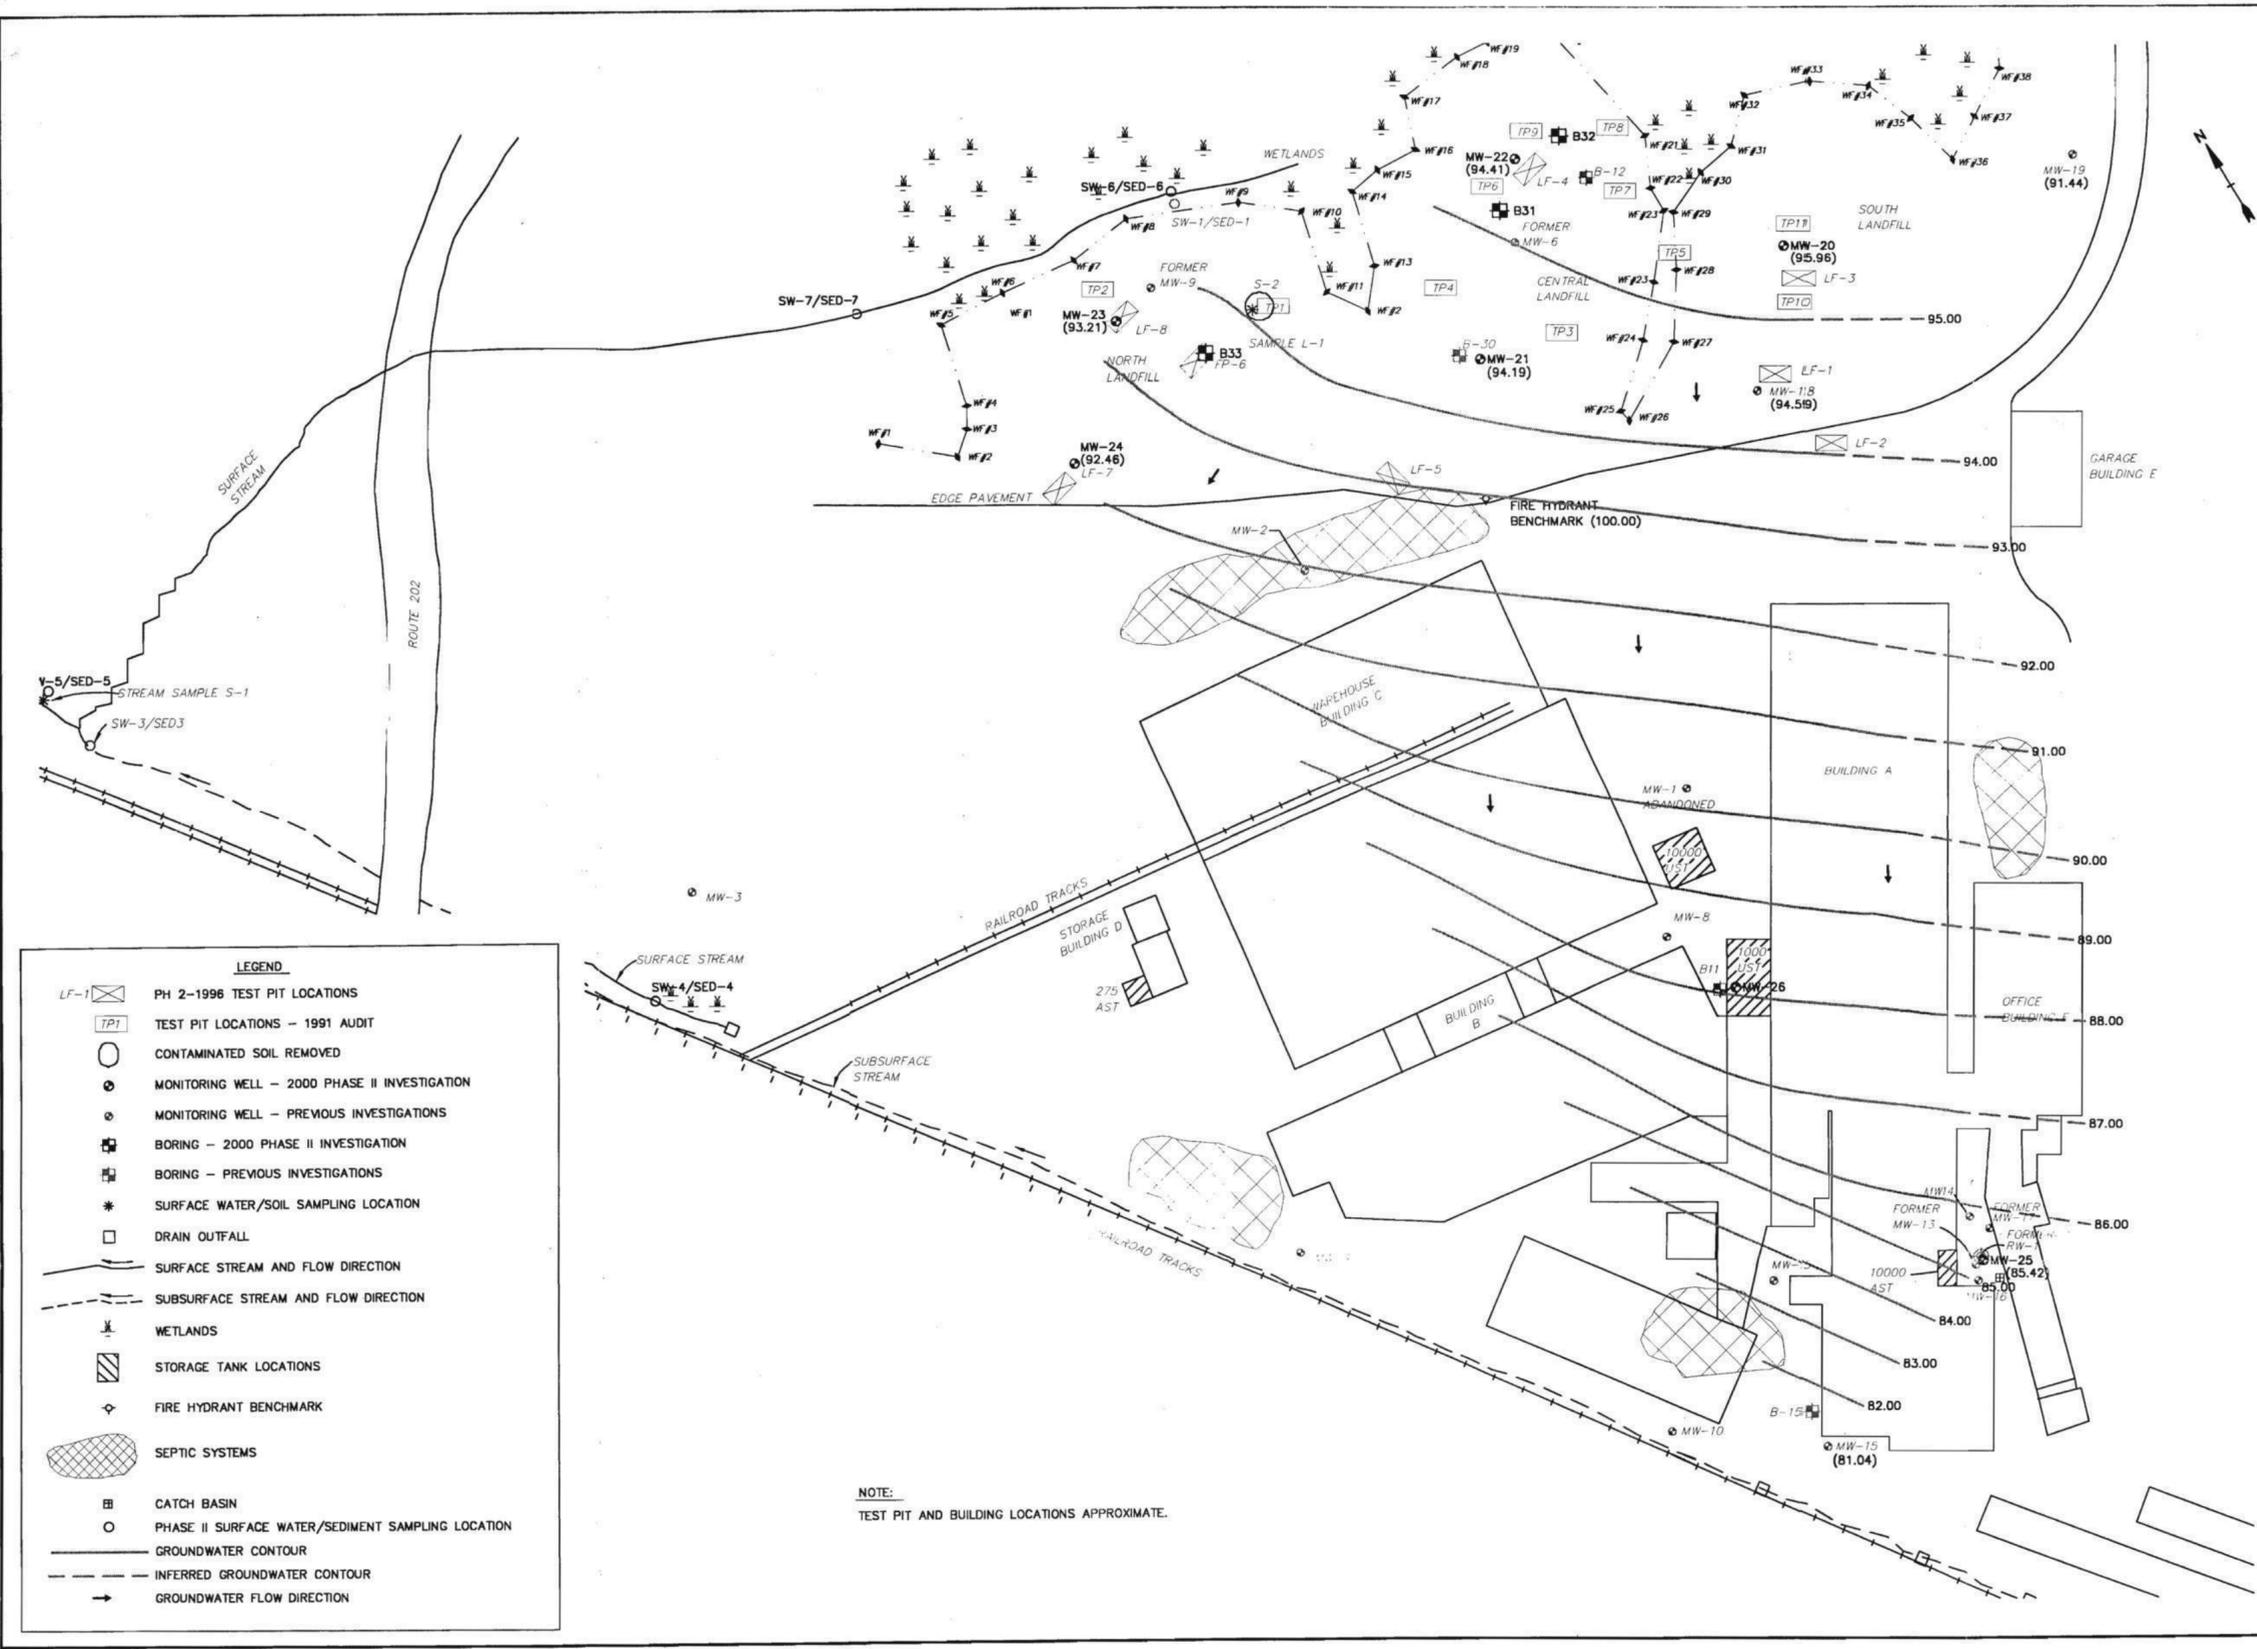
Mark	Date	Description
<input type="checkbox"/>		INITIAL ISSUE
PROJECT NO: T0052		
FILE: 110062/SITE		
DRAWN BY: ARG		
CHECKED BY: NEM		
APPROVED BY: ETJ		
FIGURE 4 PHASE II COMPREHENSIVE SITE ASSESSMENT PLAN		
SCALE: 1"=50'

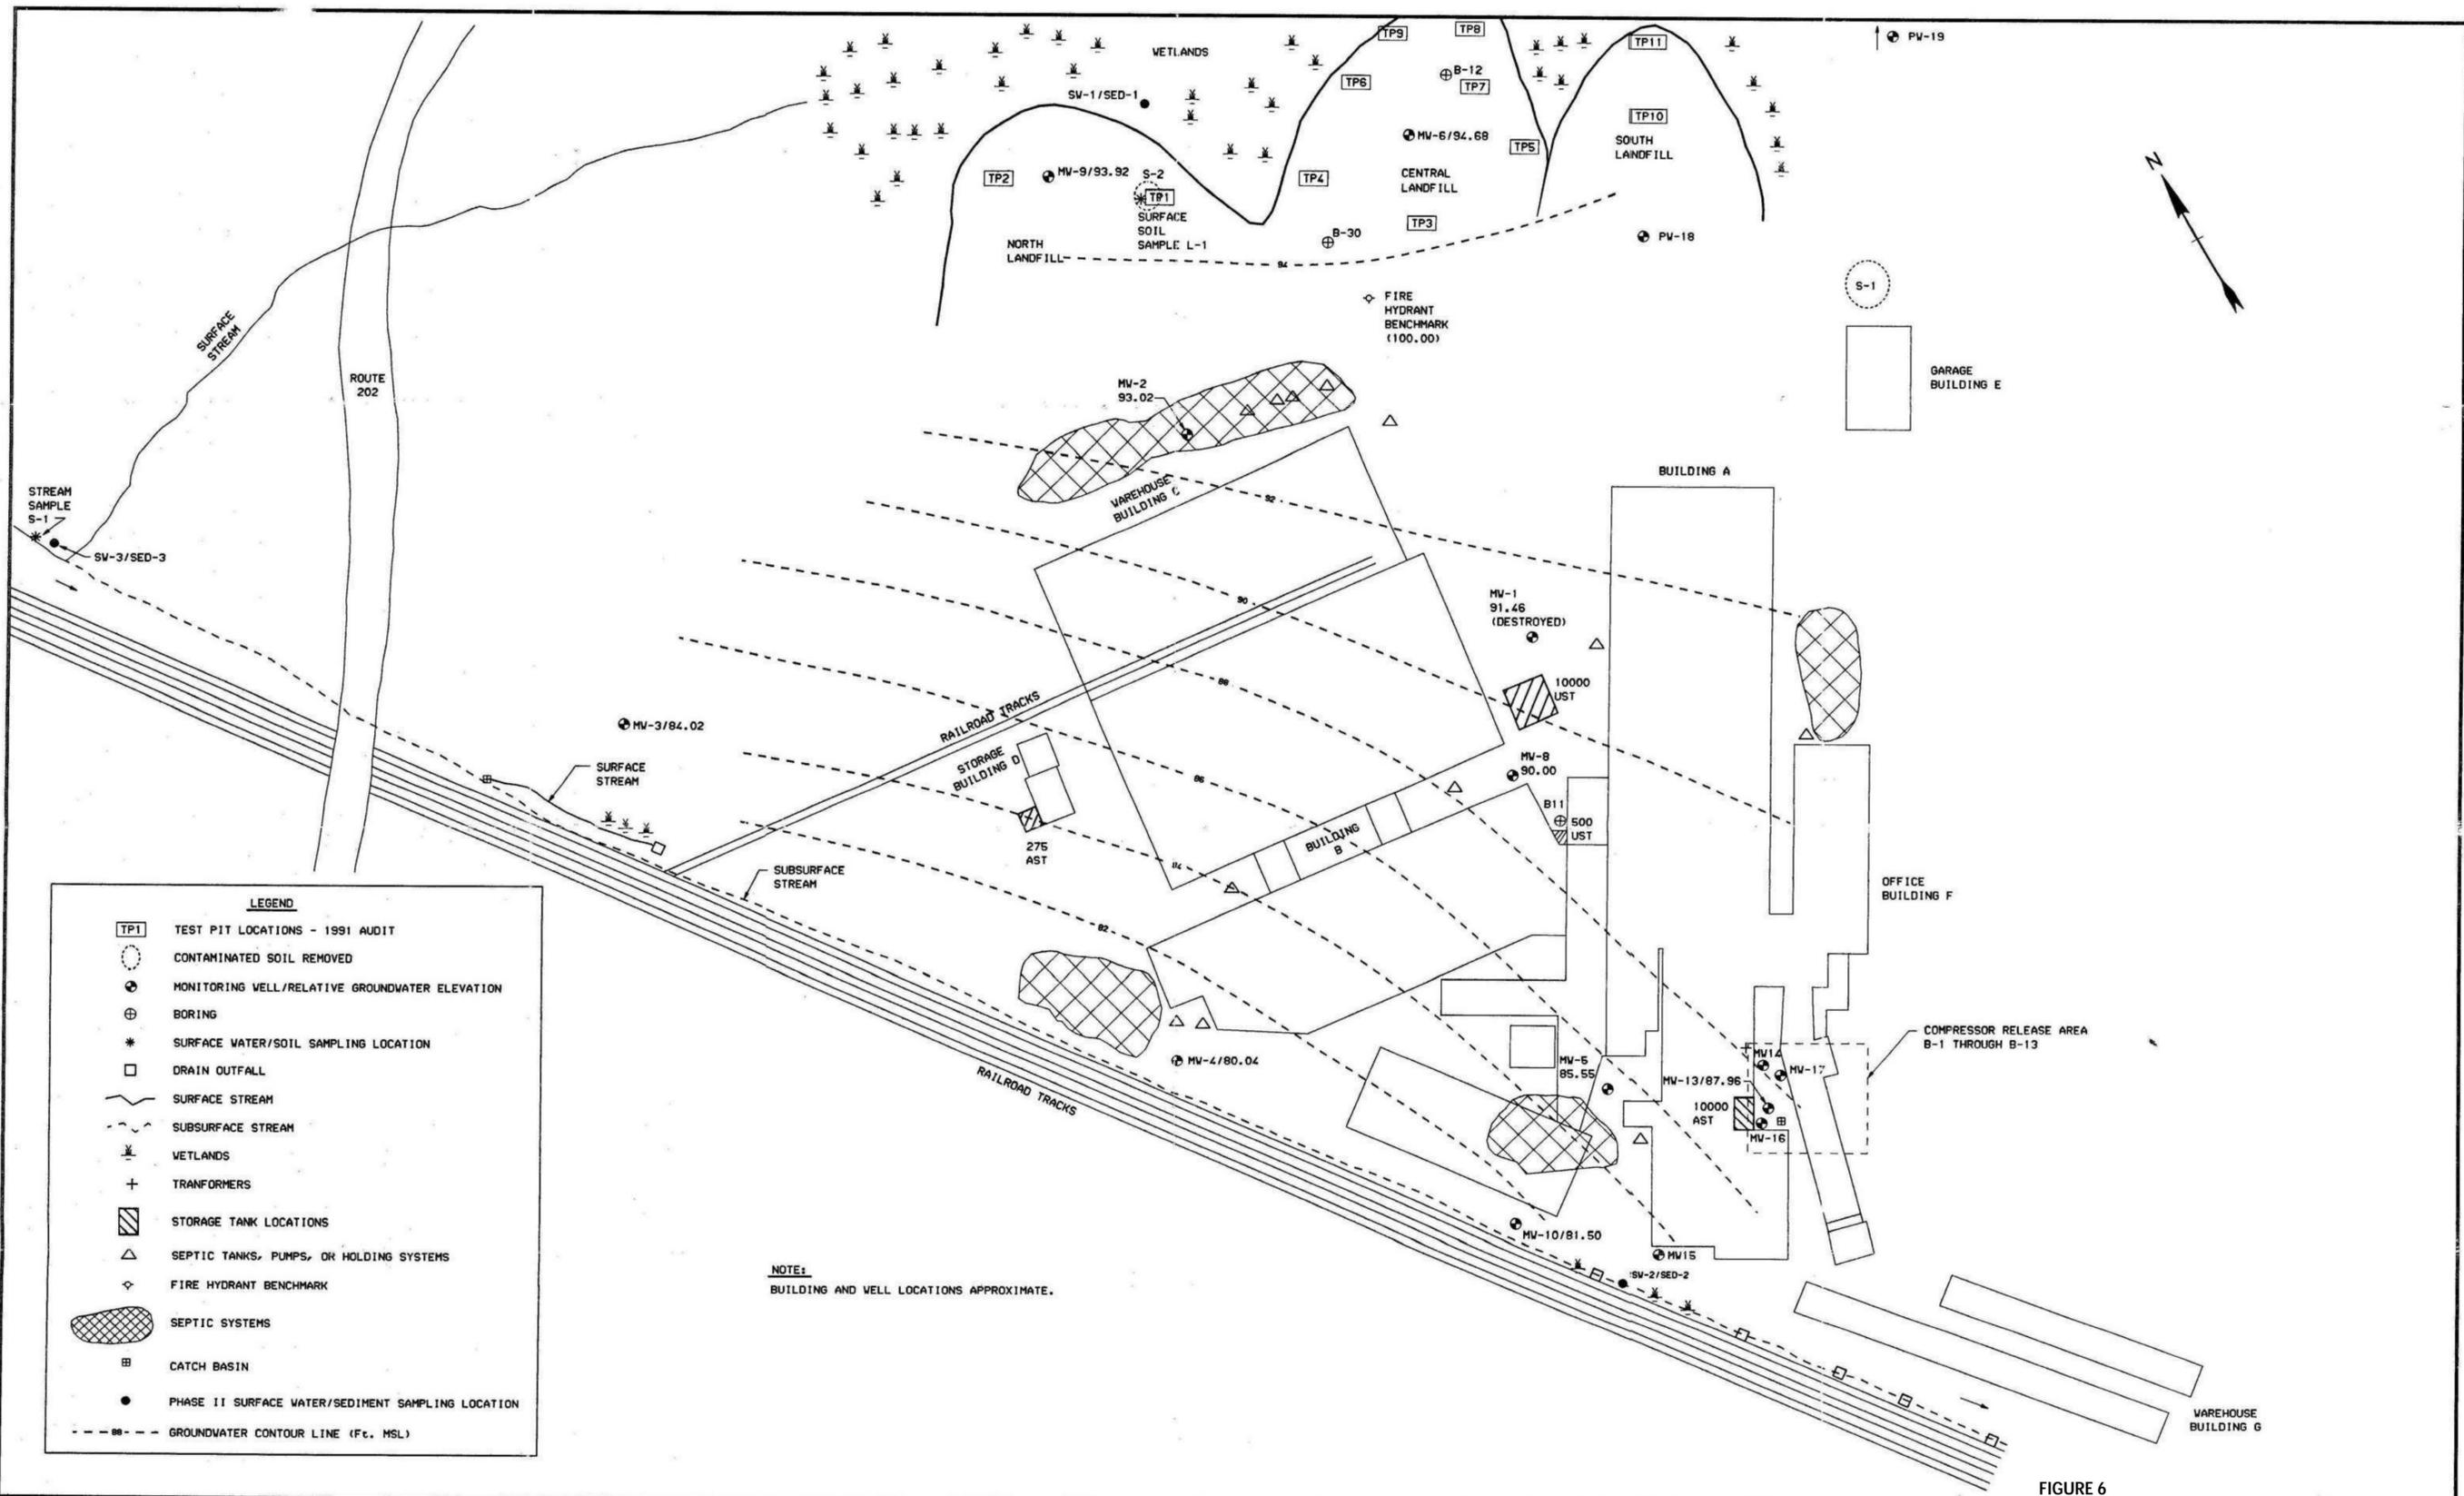
FIGURE 6

DRAWN BY: AMK		CHECKED BY: RBH		APPROVED BY: AK, ETJ	
NO.	DATE	REVISIONS		BY	
	10/14/93	GROUNDWATER CONTOURS		RBH	
	1/24/94	TEST PIT, MONITORING WELL AND SAMPLE LOCATIONS		MJM

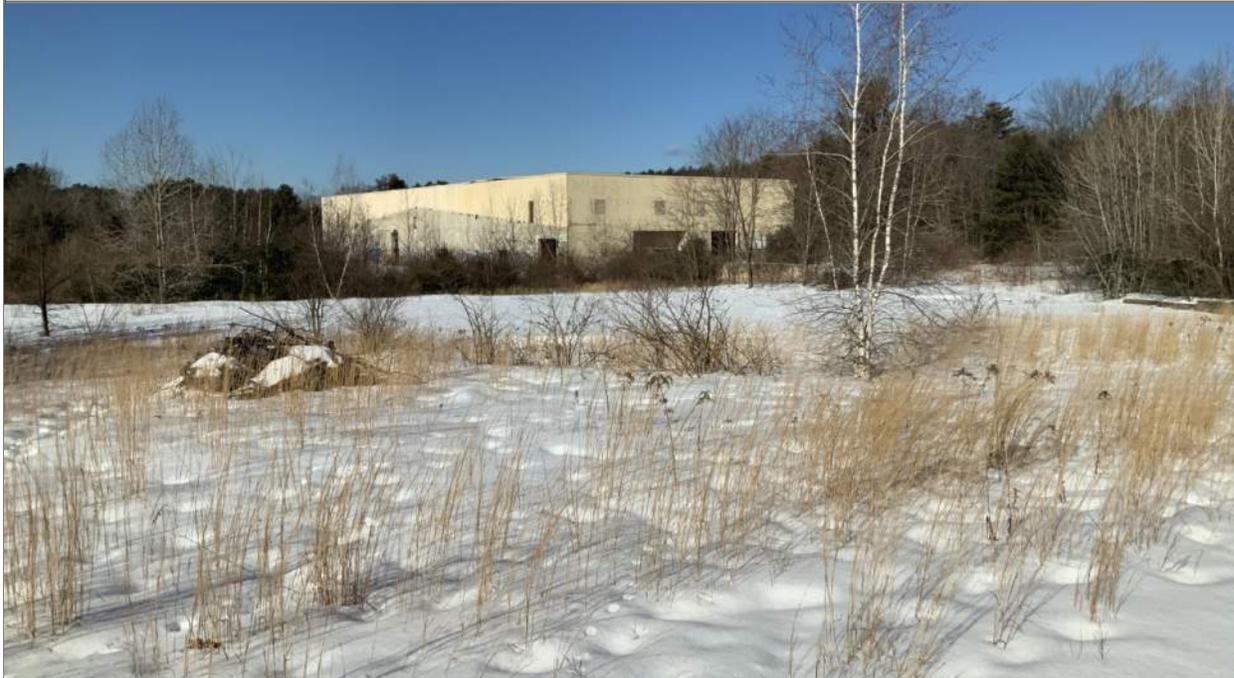
<b>Photograph No.: 1</b>	<b>Date:</b> 1/26/2022	<b>Direction Taken:</b> North
<b>Description:</b> Main warehouse building.

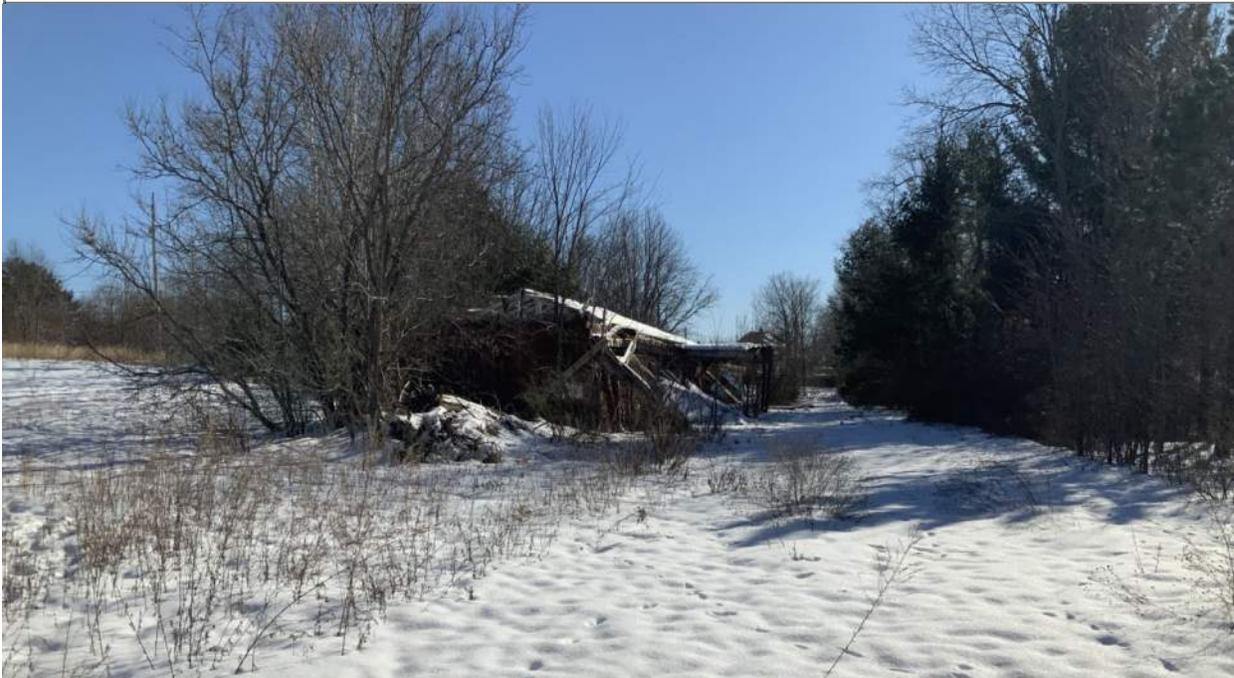
<b>Photograph No.: 2</b>	<b>Date:</b> 1/26/2022	<b>Direction Taken:</b> South
<b>Description:</b> Deteriorating former lumber storage barn.

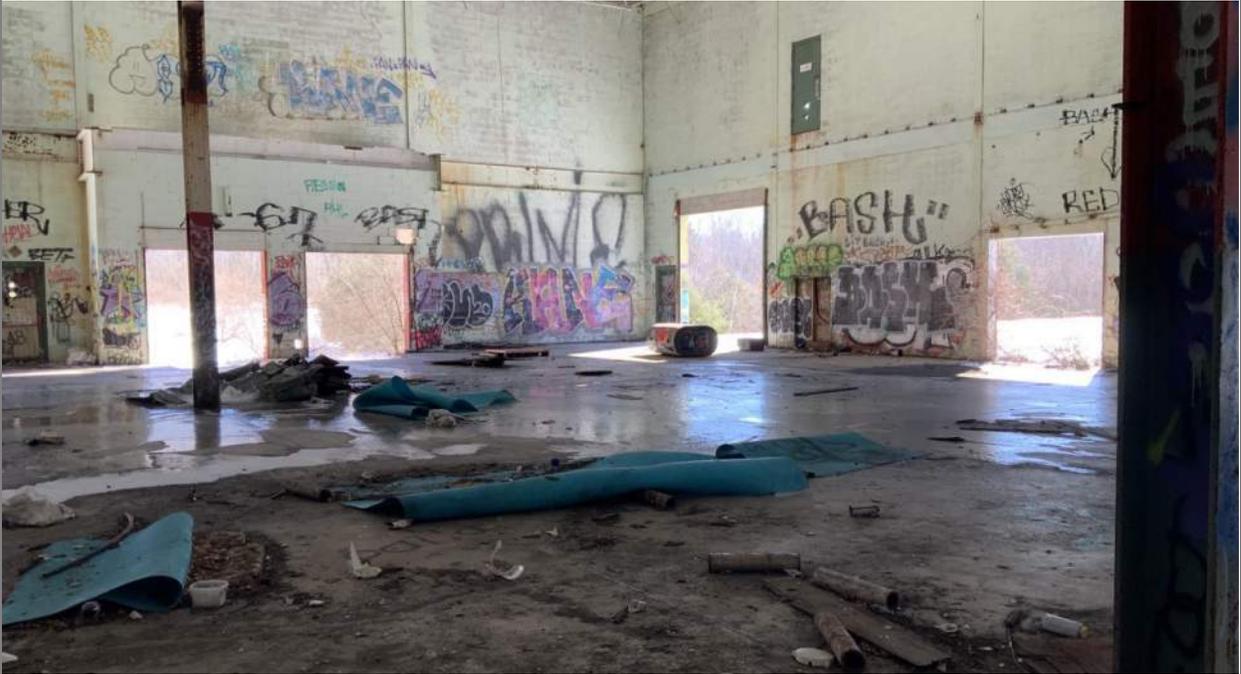
<b>Photograph No.:</b> 3	<b>Date:</b> 1/26/2022	<b>Direction Taken:</b> East
<b>Description:</b> Dumped pipe wrap insulation and 275-gallon fuel oil AST, among other debris, dumped in the warehouse building.

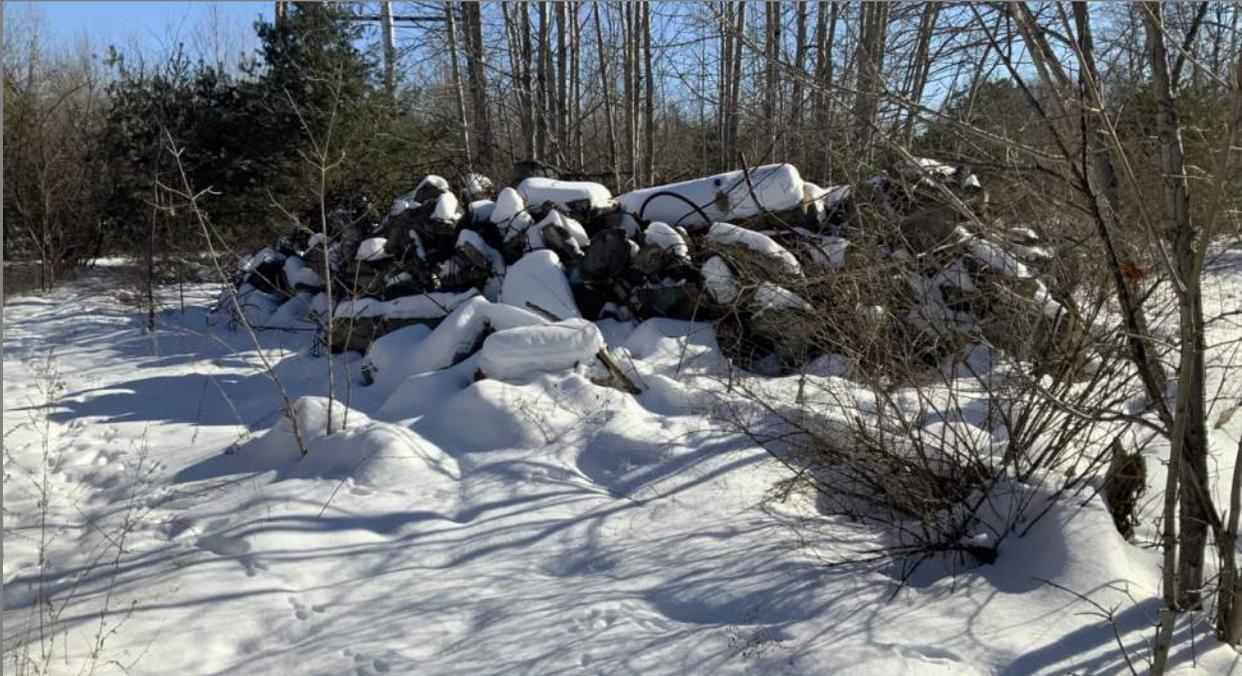
<b>Photograph No.:</b> 7	<b>Date:</b> 1/26/2022	<b>Direction Taken:</b> Southeast
<b>Description:</b> Concrete rubble pile, water tower legs visible in background.

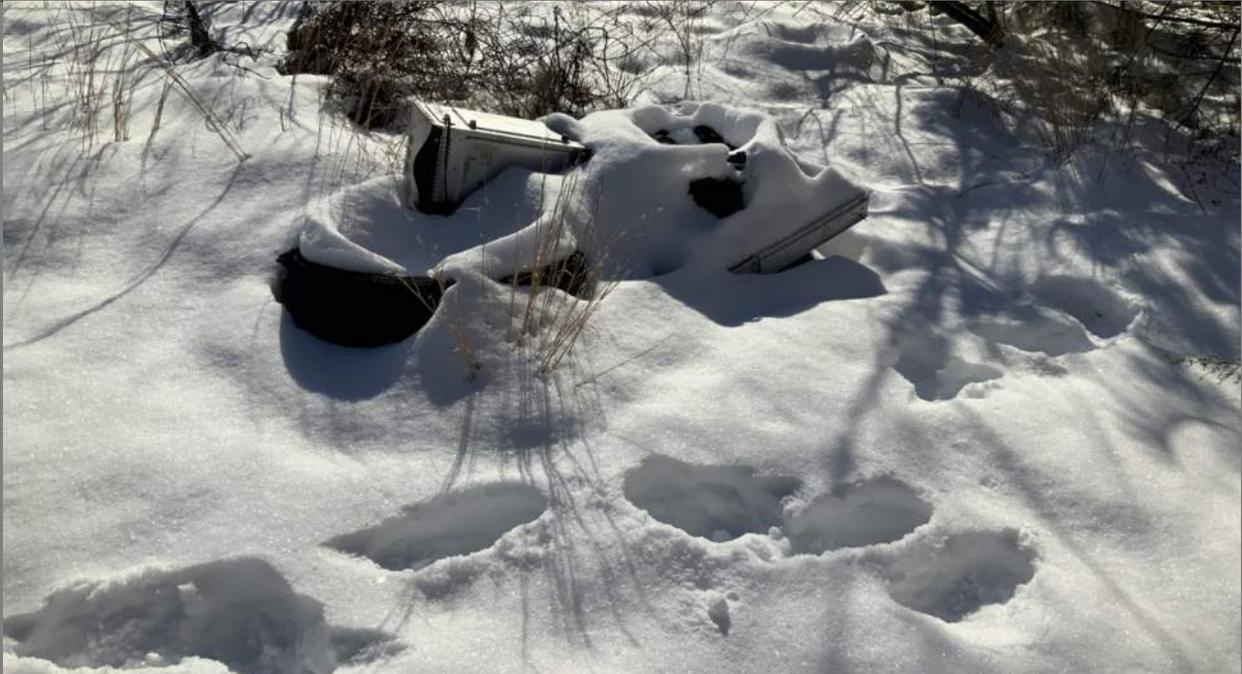
<b>Photograph No.:</b> 8	<b>Date:</b> 1/26/2022	<b>Direction Taken:</b> N/A
<b>Description:</b> Example of dumped household debris near eastern loading dock area of warehouse building.

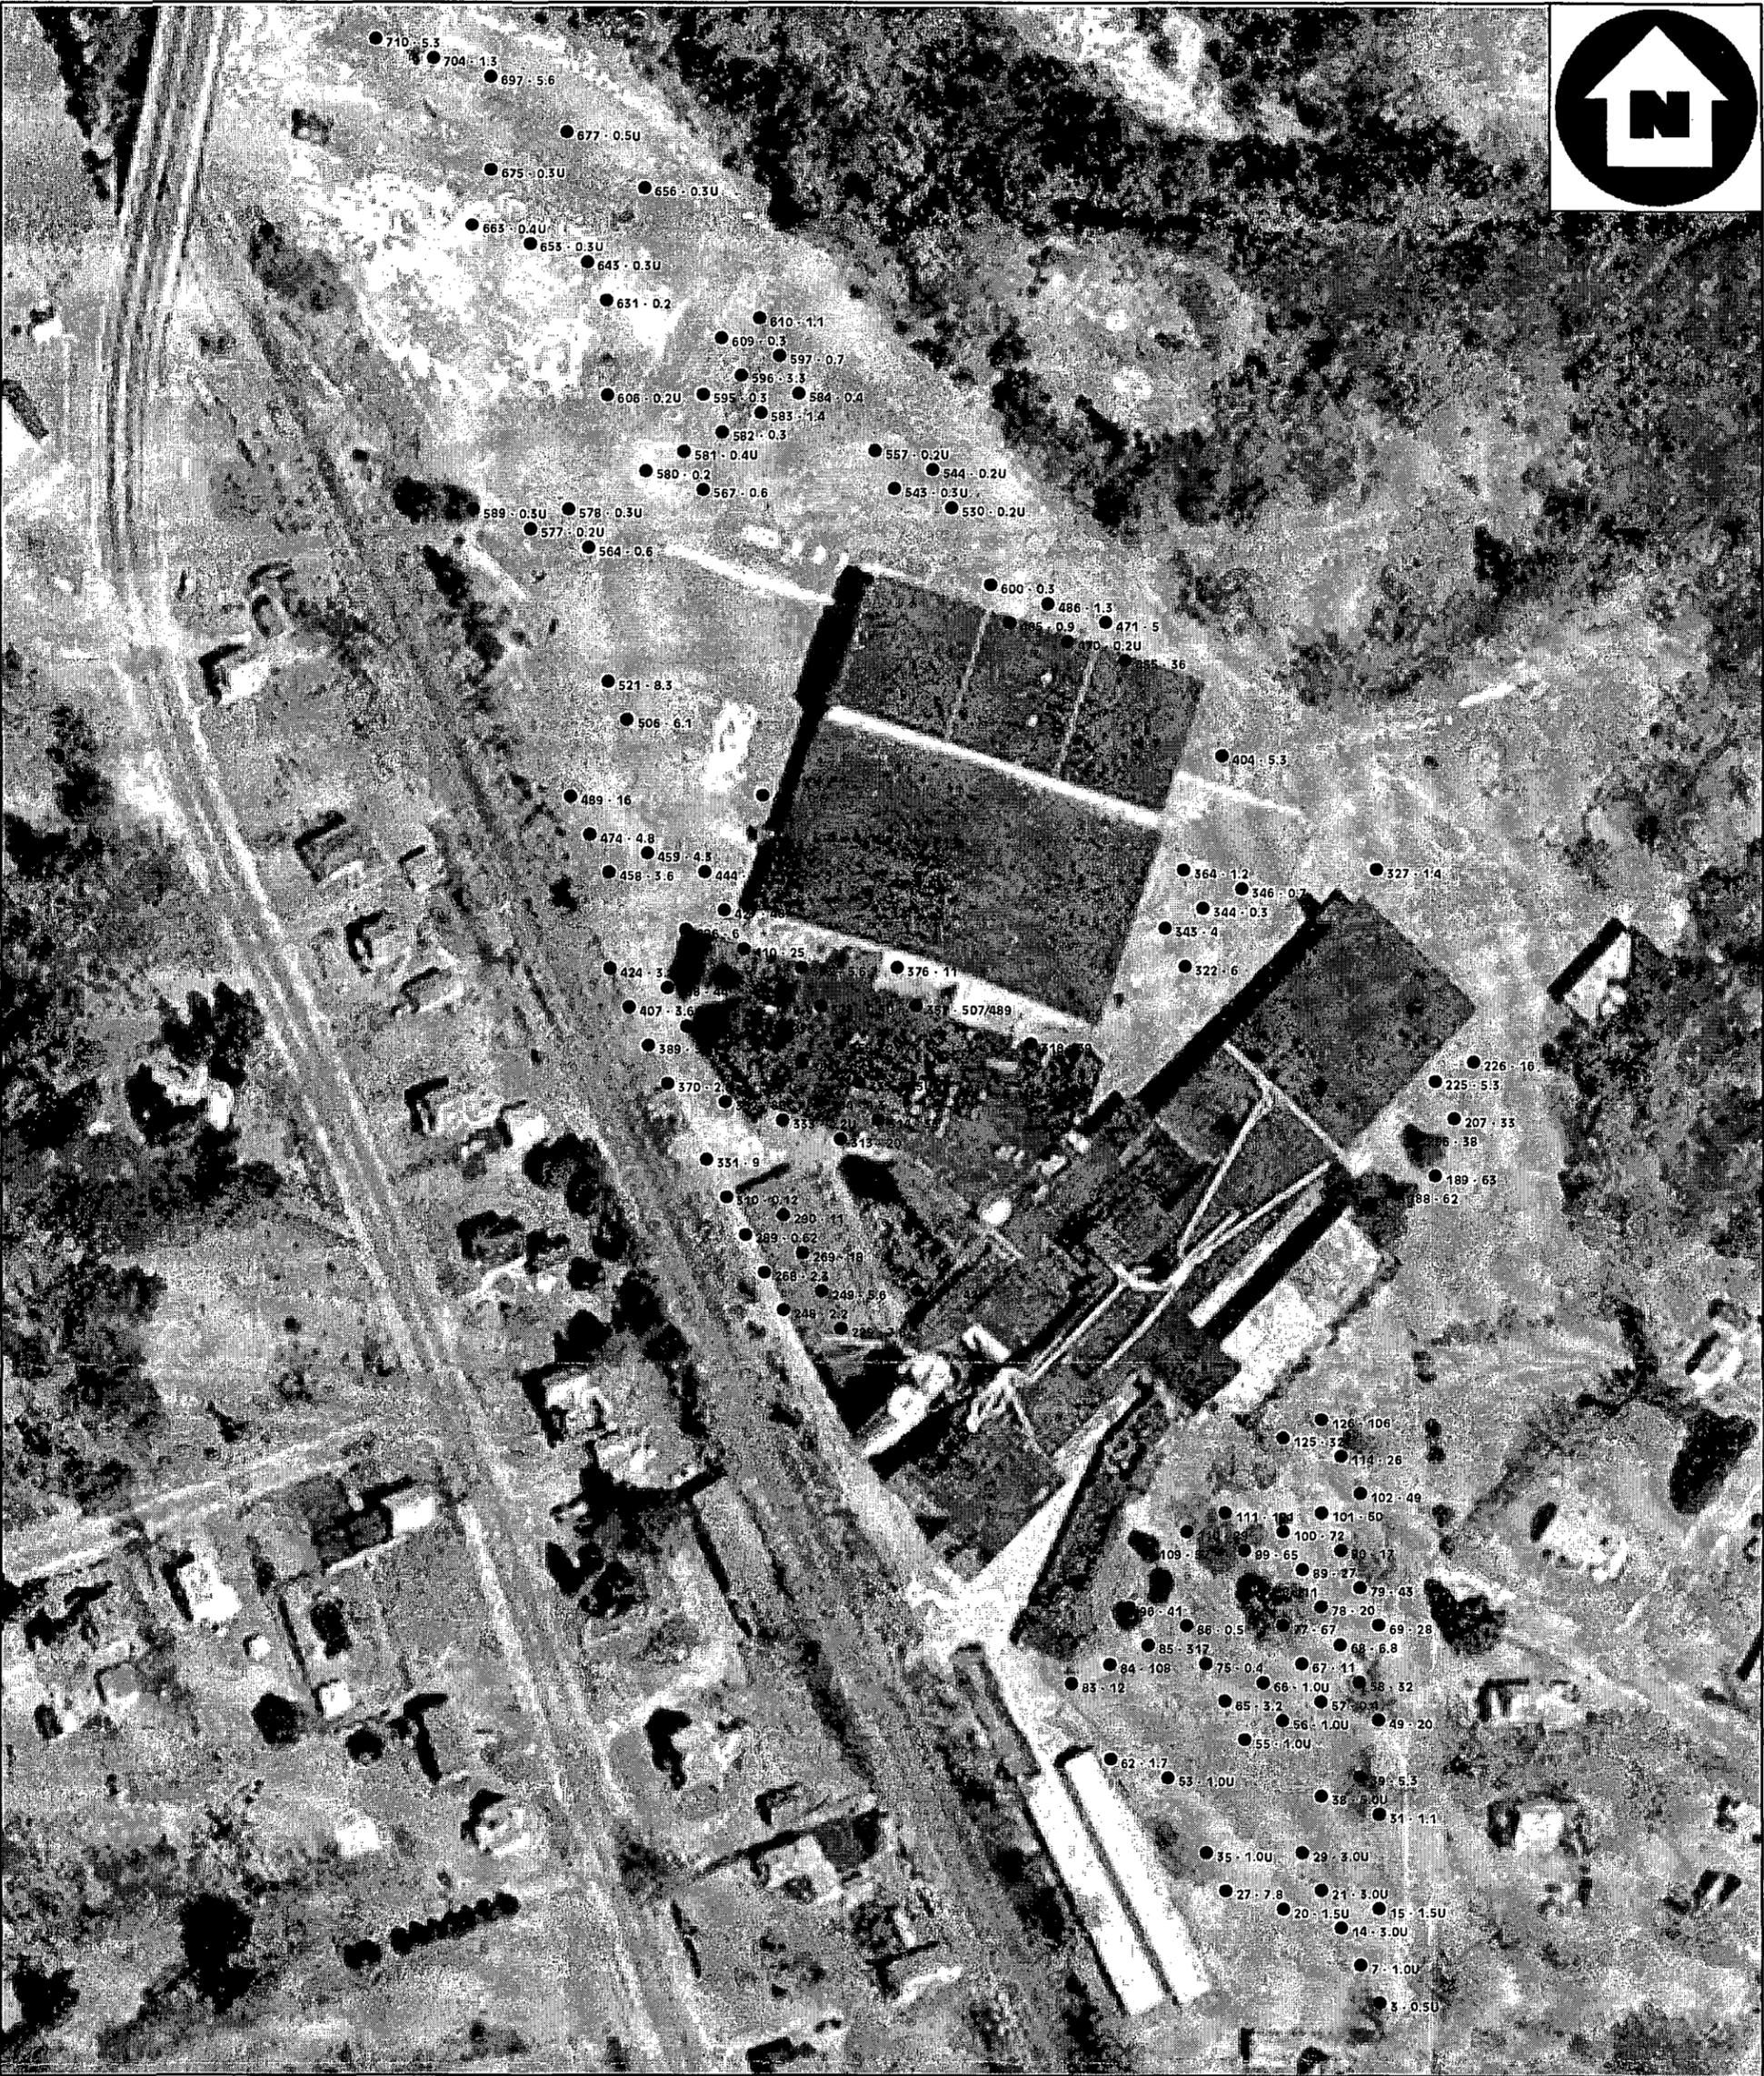
FIGURE 10

Between 14 May and 16 May 2003, SL Brennan and START member Mace collected surface soil samples, labeled SS-100 through SS-176 from the on-site landfill area. Two START Analytical Team members were on site to perform PCB field screening analysis of the samples [see Appendix D - Sampling Diagrams - Landfill Area Perimeter Soil Sampling Diagram (Figure 10)].

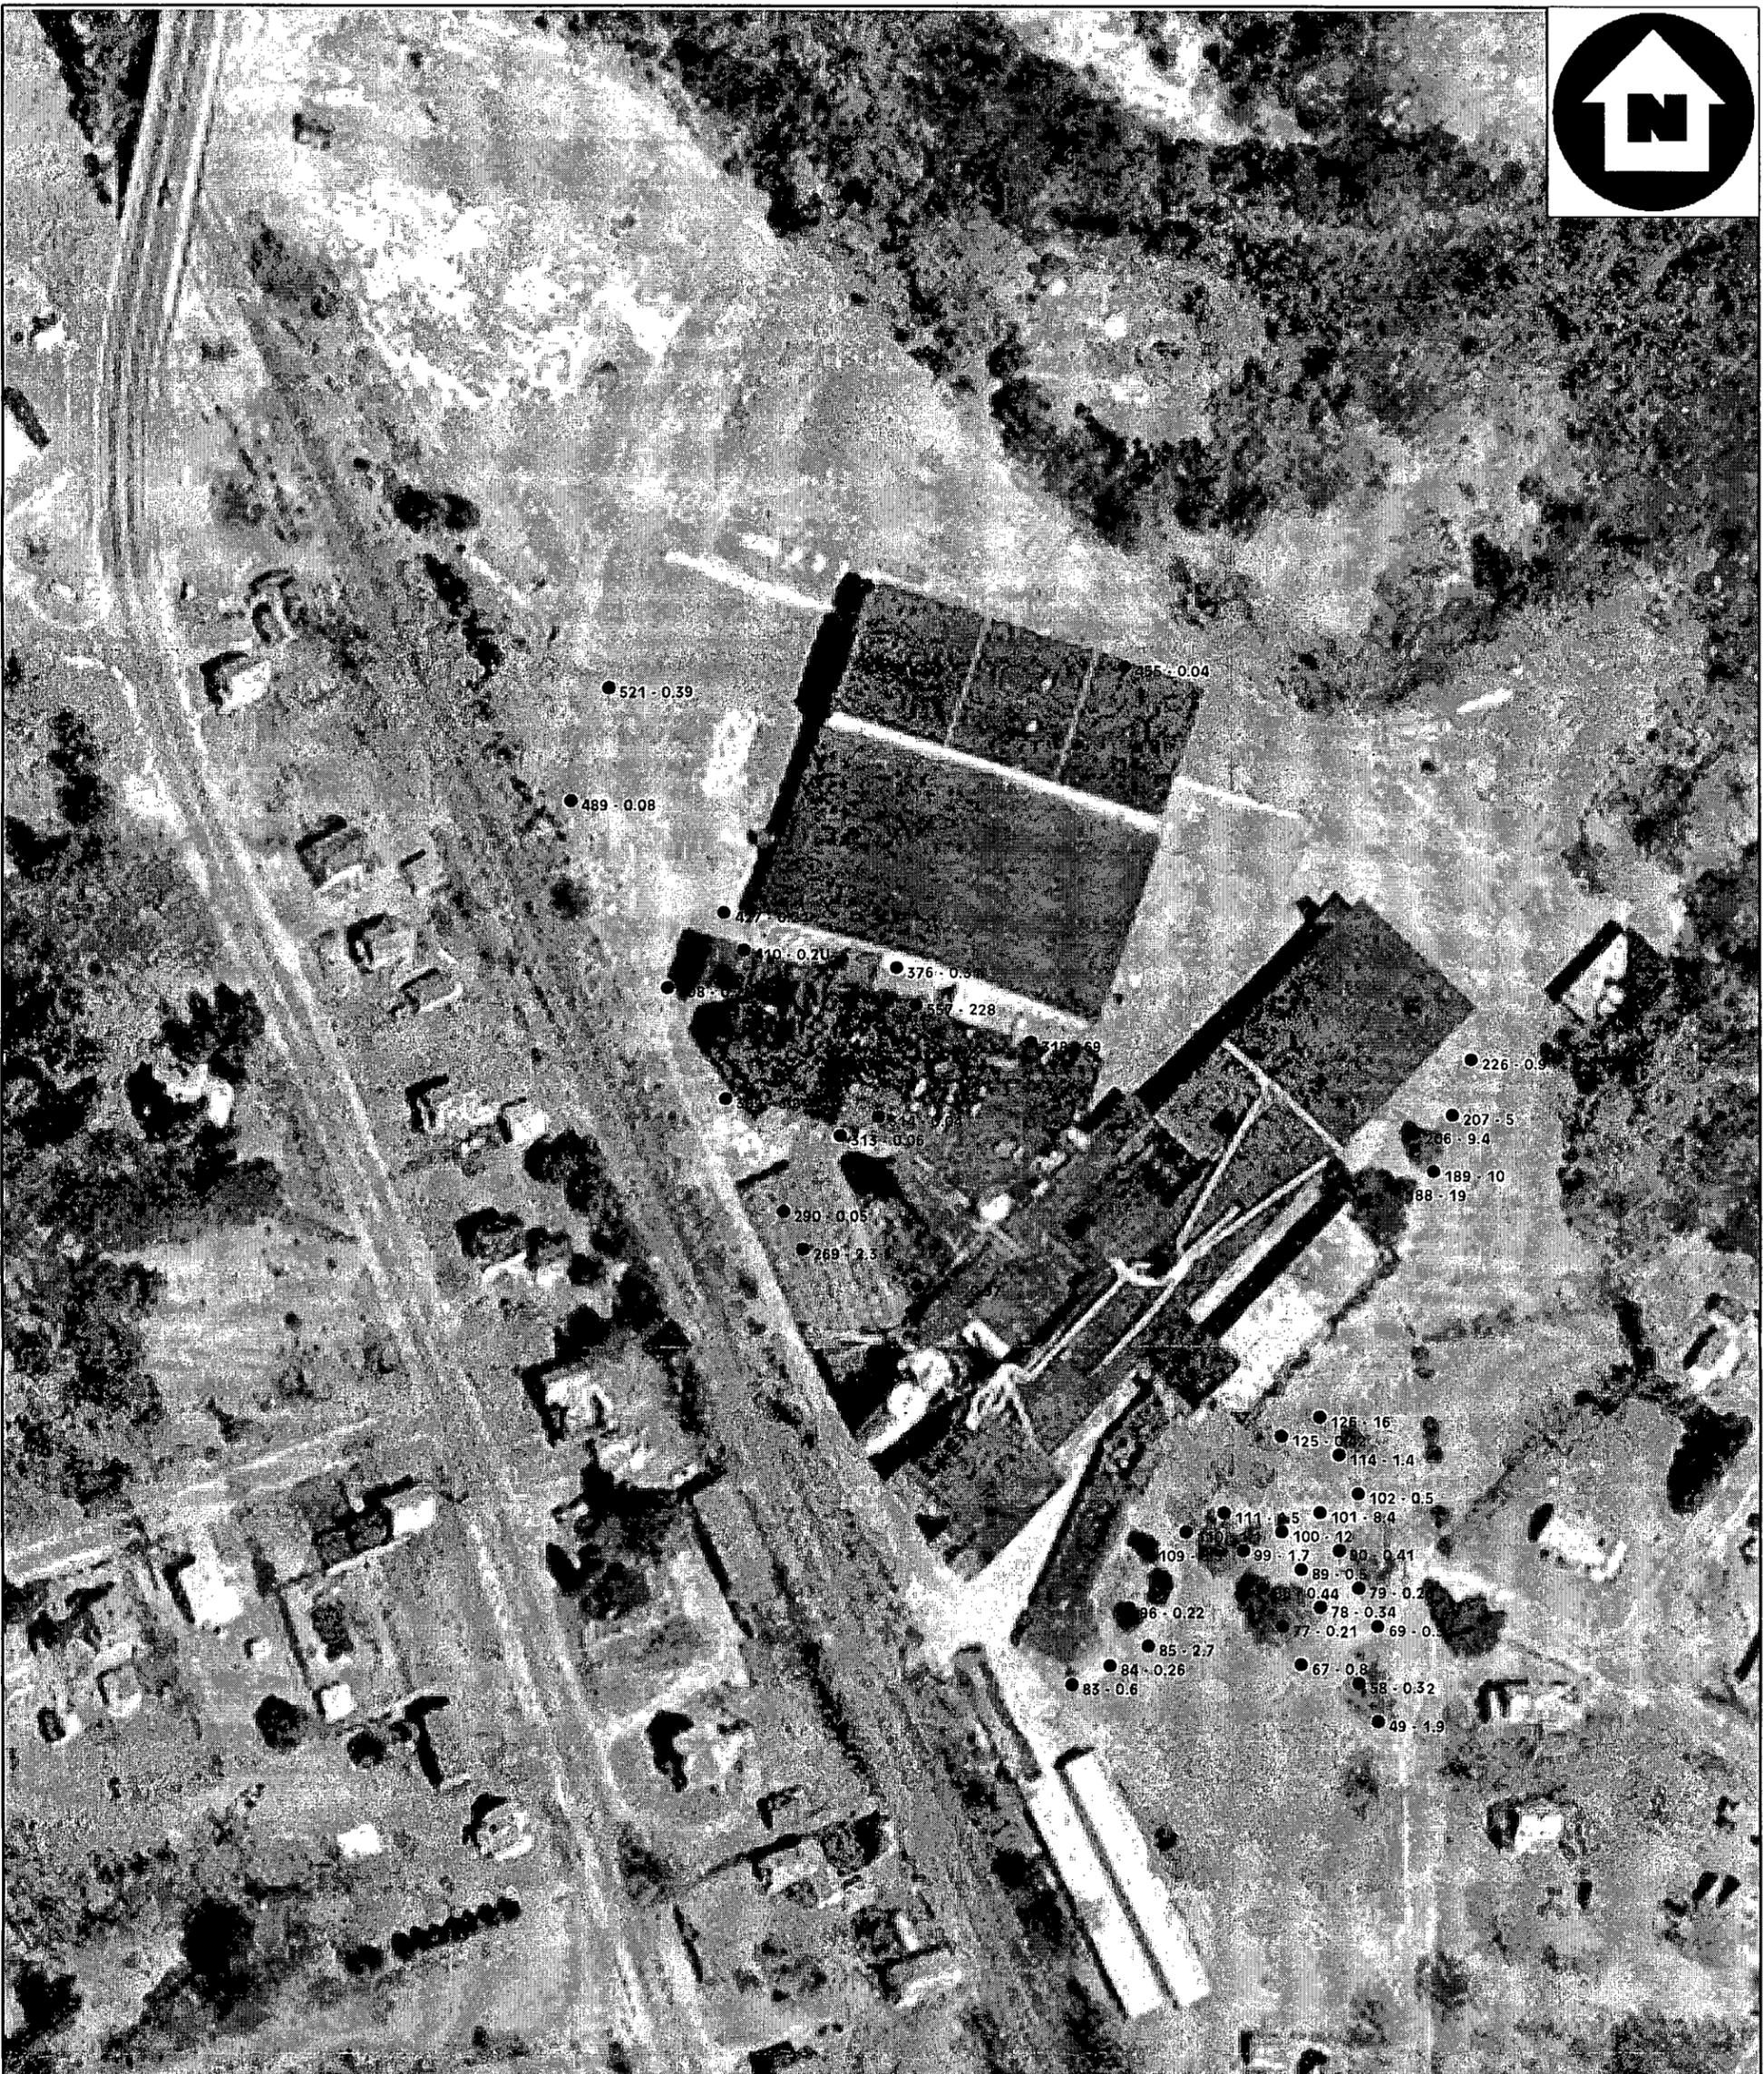
TDD NUMBER: 04-05-0011	CREATED BY: K. BRENNAN	CREATED ON: 09/03/2003
FILE LOCATION: E:\ARC_APRS\START2\TEMPLESTUARTX-X.APR		FIGURE 11

SL Brennan and START member Bill Mahany performed an extent-of-contamination survey of the on-site building area. START personnel established a 30-ft by 30-ft sampling grid over the accessible portions of the building area using GPS waypoint navigation. Surface soil samples were collected from each accessible sample location and relinquished to the EPA Mobile Laboratory for PCB field screening analysis [see Appendix D - Sampling Diagrams - Surface Soil Sample Location Diagram (Figure 11)].
