Former Temple Stuart Mill  
24 Holman Street  
Templeton, Massachusetts

# PHASE I ENVIRONMENTAL SITE ASSESSMENT

ACM Group, Inc.  
March 2022

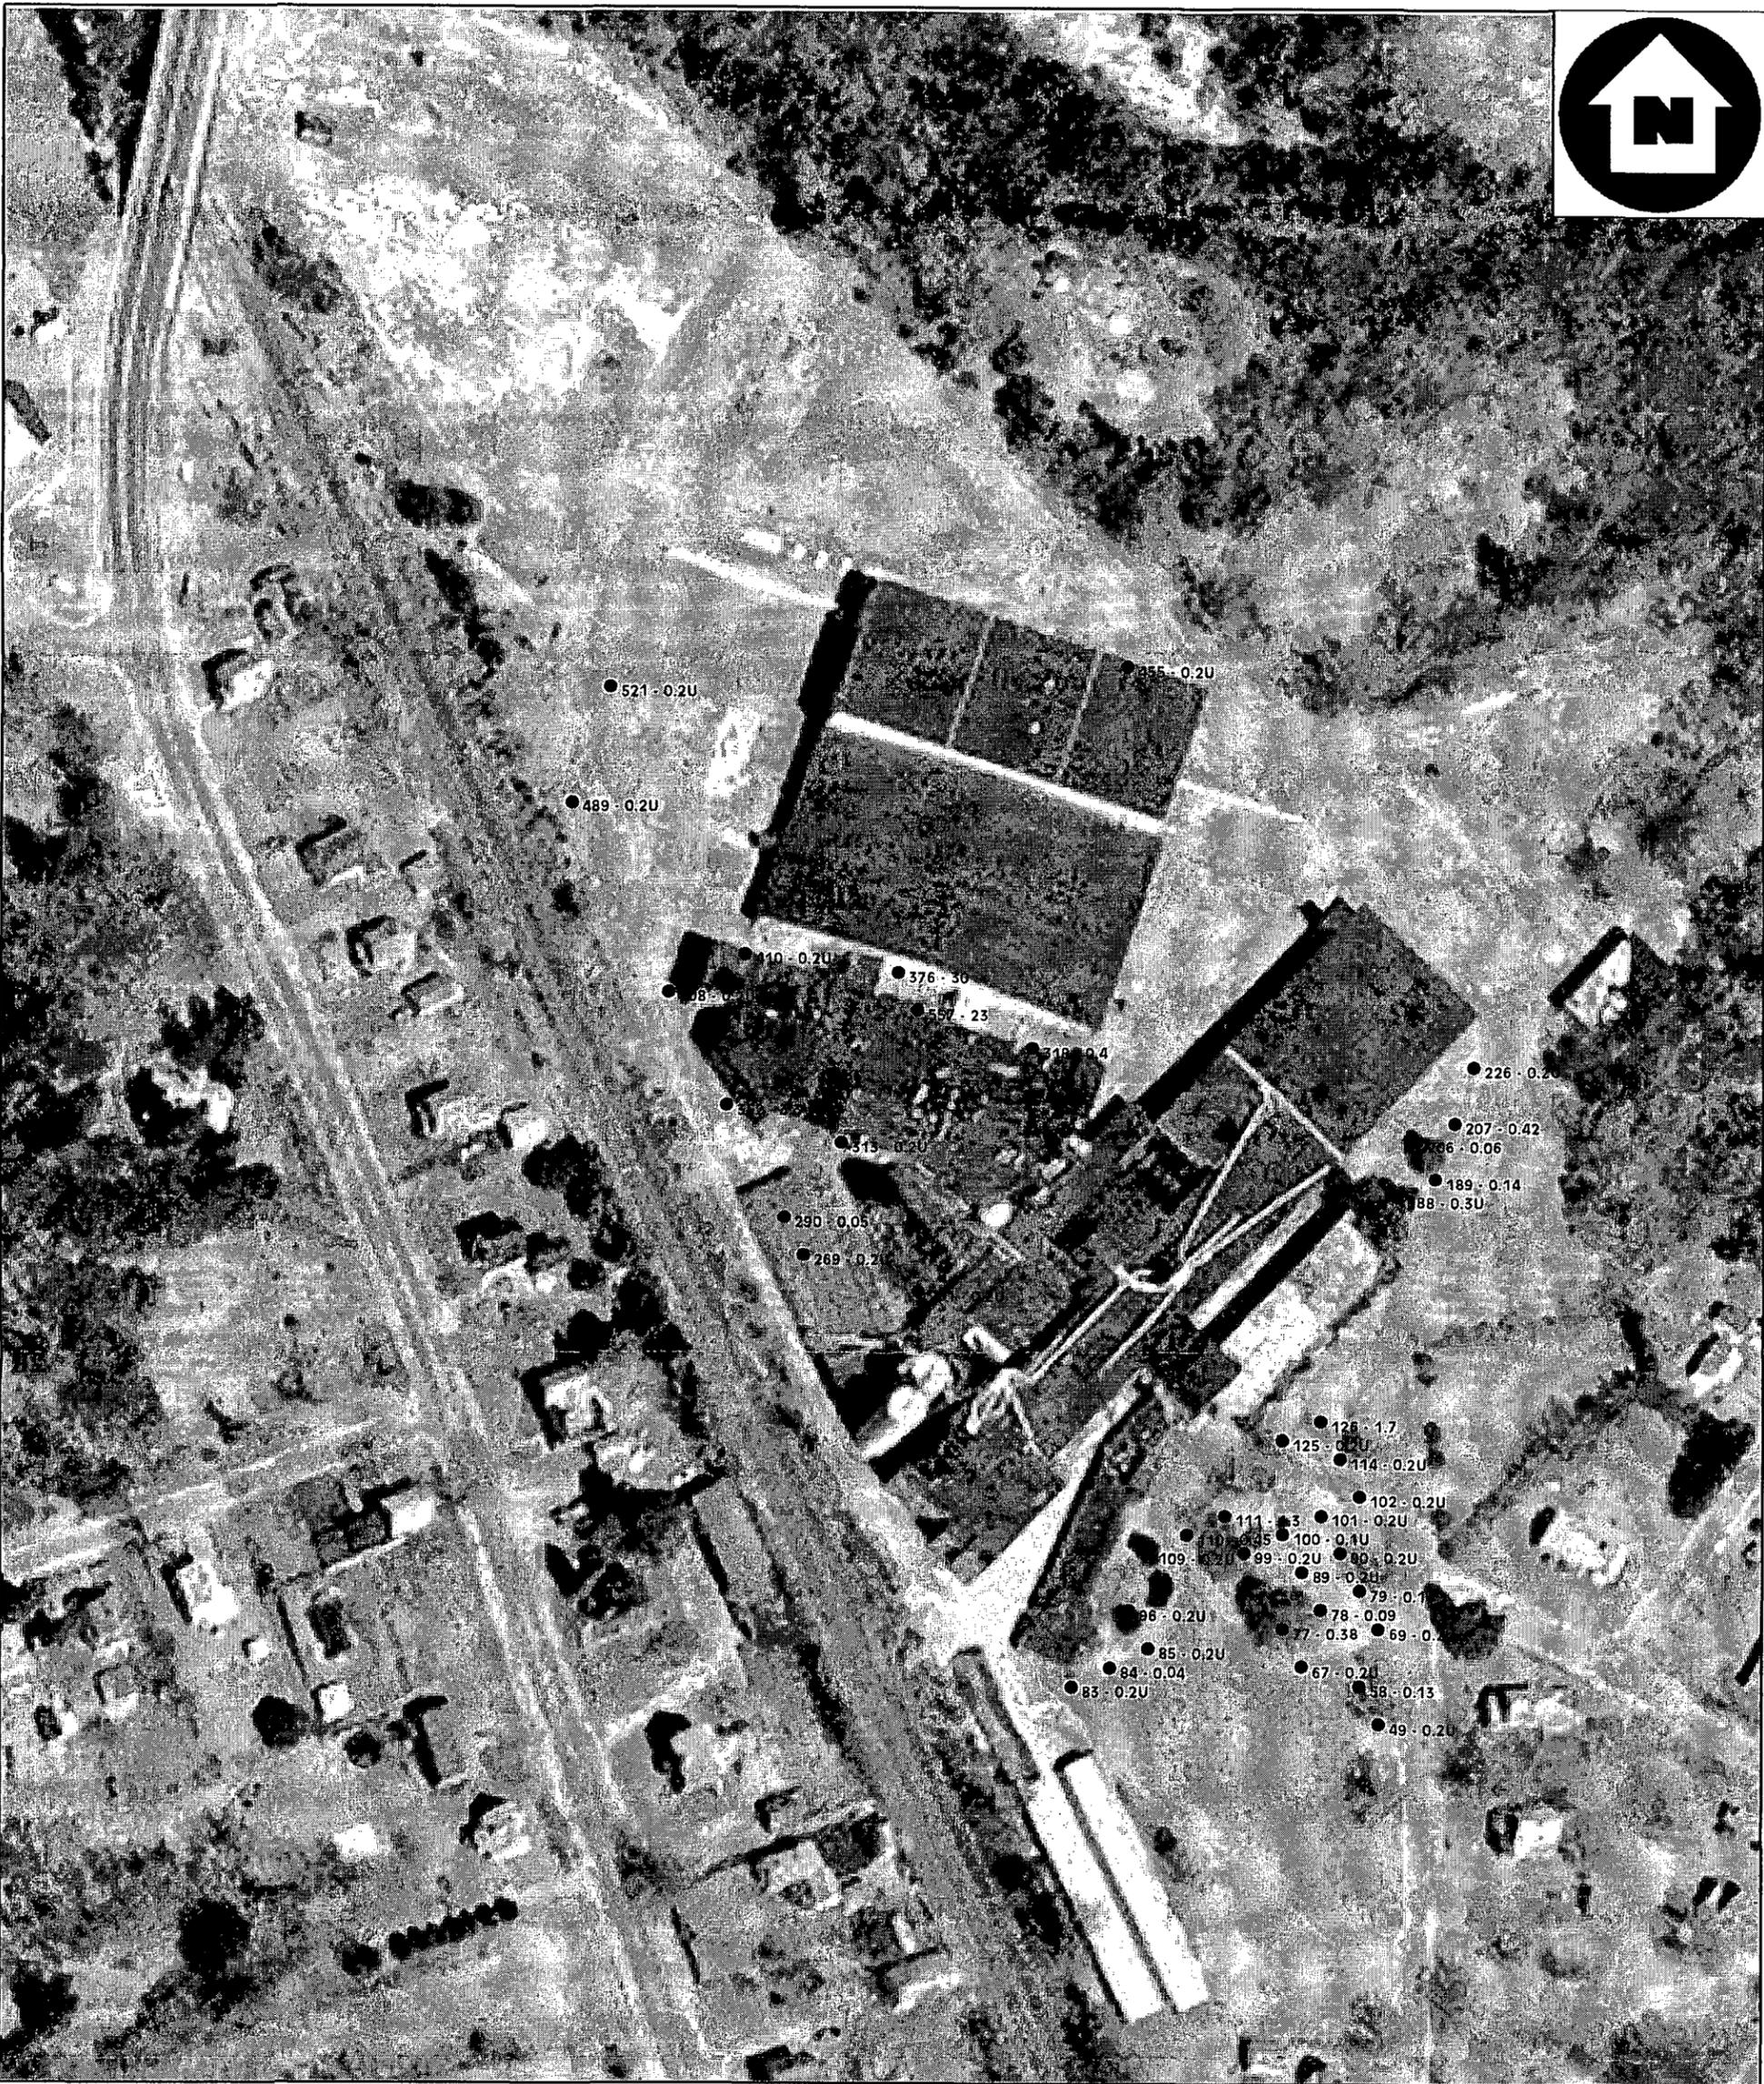
TDD NUMBER: 04-05-0011	CREATED BY: K. BRENNAN	CREATED ON: 09/03/2003
FILE LOCATION: E:\ARC_APRS\START2\TEMPLESTUARTX-X.APR		FIGURE 13

SL Brennan and START member Mahany continued the extent-of-contamination survey of the on-site building area. START personnel collected subsurface soil samples from previously marked grid sample locations as determined by the OSC. Samples were relinquished to the EPA Mobile Laboratory for PCB field screening analysis [see Appendix D - Sampling Diagrams - Soil Sample Location Diagram 0'-1' (Figure 12), Soil Sample Location Diagram 1'-2' (Figure 13), Soil Sample Location Diagram 2'-3' (Figure 14), Soil Sample Location Diagram 3'-4' (Figure 15)].
