**Subject: Contract No. 68HERH19D0018; Task Order No. 68E0719F0190  
Former Rath Buildings, 1442, 1508, 1620, and 1656 Sycamore Street,  
Waterloo, Black Hawk County, Iowa  
Analysis of Brownfields Cleanup Alternatives**

**ANALYSIS OF BROWNFIELDS CLEANUP ALTERNATIVES**  
**FORMER RATH BUILDINGS**  
**1442, 1508, 1620, 1656 SYCAMORE STREET, WATERLOO, IOWA**

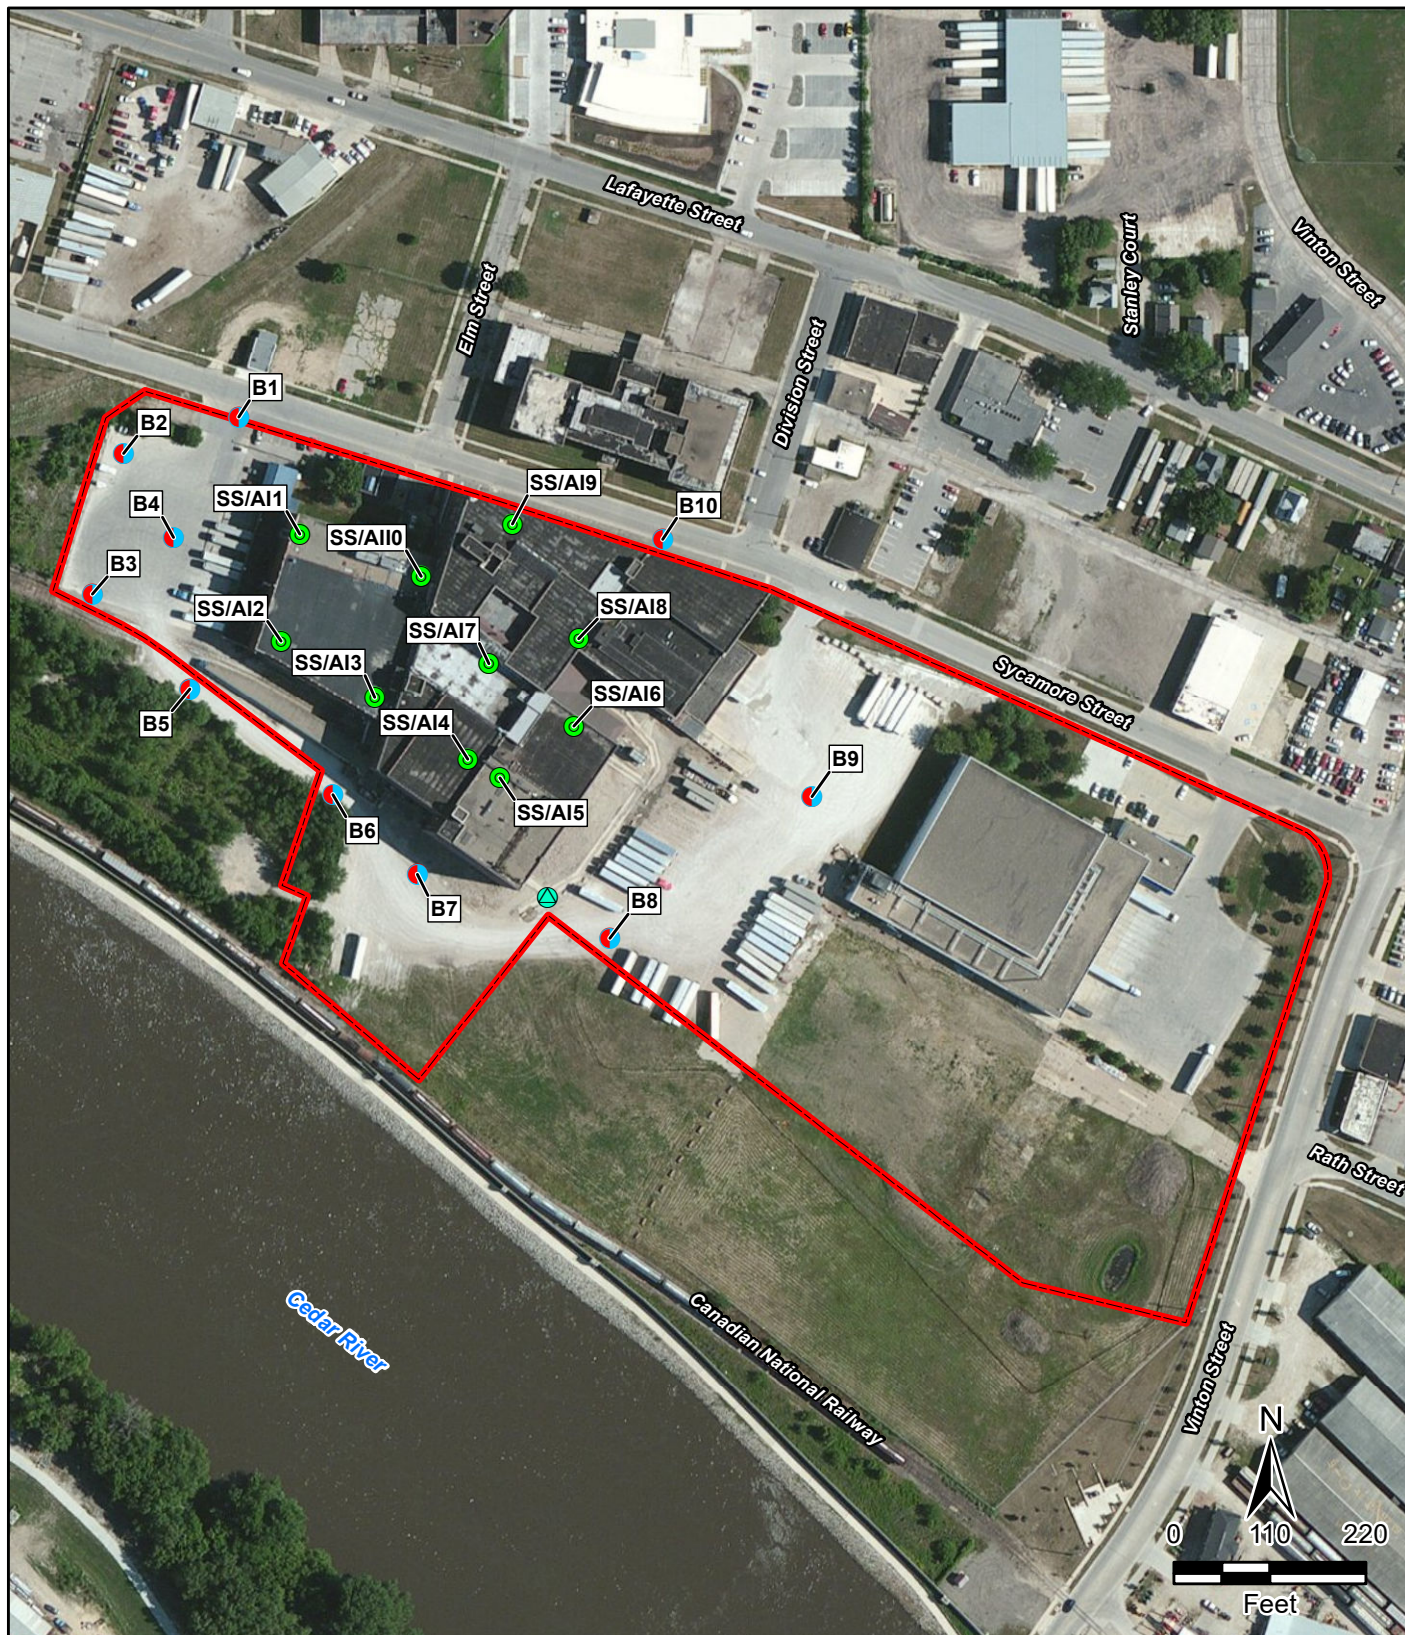
- ● DPT soil/groundwater/  
soil-gas sample location
- Outdoor ambient air  
sample location
- Sub-slab soil gas/  
indoor air sample location
- Approximate  
site boundary
- DPT Direct-push  
technology

This ABCA evaluates the following at the subject property: contaminants in subsurface soil, and groundwater; vapor intrusion; ACM; and LBP. The sections below discuss contaminants/materials identified during the Phase II ESA and HMS at the subject property. Additional details about sampling methodology and detected constituents are in the Phase II ESA (Toeroek Team 2022a) and HMS (Toeroek Team 2022b) reports. [Figure 2](#) in [Appendix A](#) shows sample locations for environmental media.
