**REMOVAL PROGRAM
PRELIMINARY ASSESSMENT/
SITE INVESTIGATION REPORT
FOR THE
RIVERSIDE SQUARE PCB SITE
HYDE PARK (BOSTON), SUFFOLK COUNTY,
MASSACHUSETTS
9 JUNE 2011 AND 19 - 21 JULY 2011**

U.S. Environmental Protection Agency
Region I
Emergency Planning and Response Branch
5 Post Office Square, Suite 100
Boston, MA 02109-3912

Weston Solutions, Inc.
Region I
Superfund Technical Assessment and Response Team III (START)
3 Riverside Drive
Andover, MA 01810

November 2011

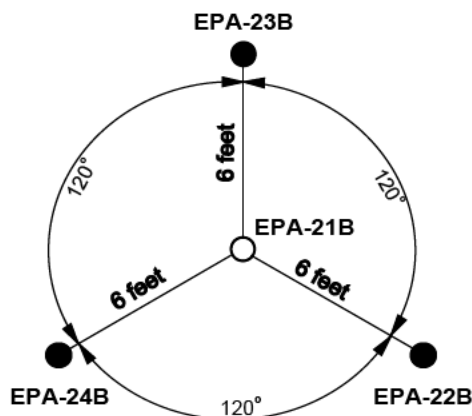
Three additional sample locations (EPA-22B, EPA-23B, and EPA-24B) were marked with pin flags around sample EPA-21B. These three sample locations were measured at a 6-foot radius from EPA-21B and were situated approximately 120 degrees around EPA-21B (see diagram below).

This procedure was used throughout the sampling event to re-locate previous sampling locations where elevated concentrations of PCBs were detected. An additional soil sample location (EPA-25B) was marked in the central portion of the property (see Appendix A, Figure 3B) and a duplicate sample (EPA-26B) was marked at EPA-21B.

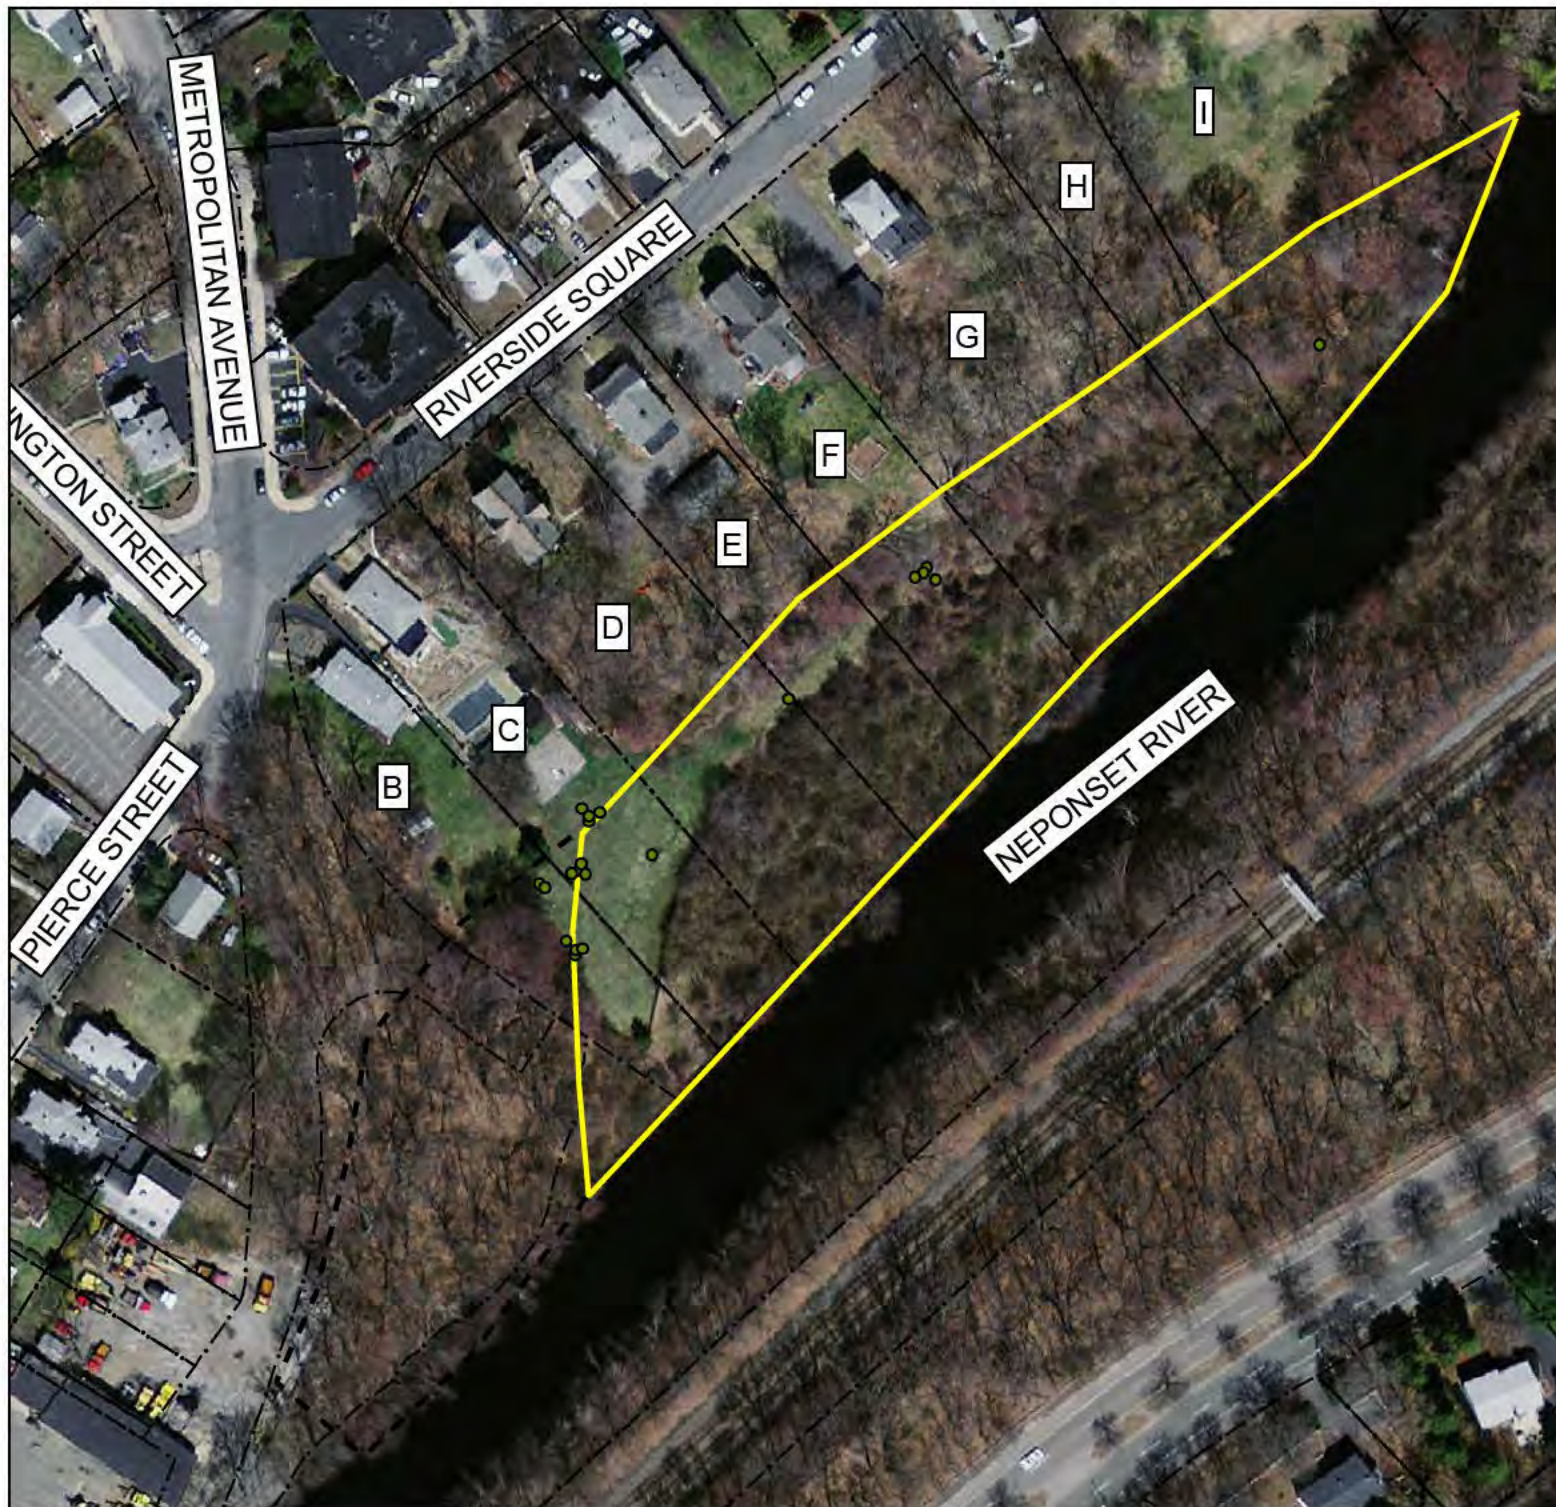
Figure 2

Site Diagram

The site consists of eight residential properties located along the northern bank of the Neponset River. The backyards of the residences are located on the south side of Riverside Square, and slope down approximately 20 to 45 feet toward the Neponset River (see Appendix A, Figure 2) [3]. On-site features include the residences, garages, paved driveways, sheds, swimming pools, maintained and unmaintained lawns, and wooded areas. Access is restricted to the residences by the Neponset River and fences enclosing the properties (see Appendix A, Figure 2).

The site consists of eight residential properties located along the northern bank of the Neponset River. The backyards of the residences are located on the south side of Riverside Square, and slope down approximately 20 to 45 feet toward the Neponset River (see Appendix A, Figure 2) [3].

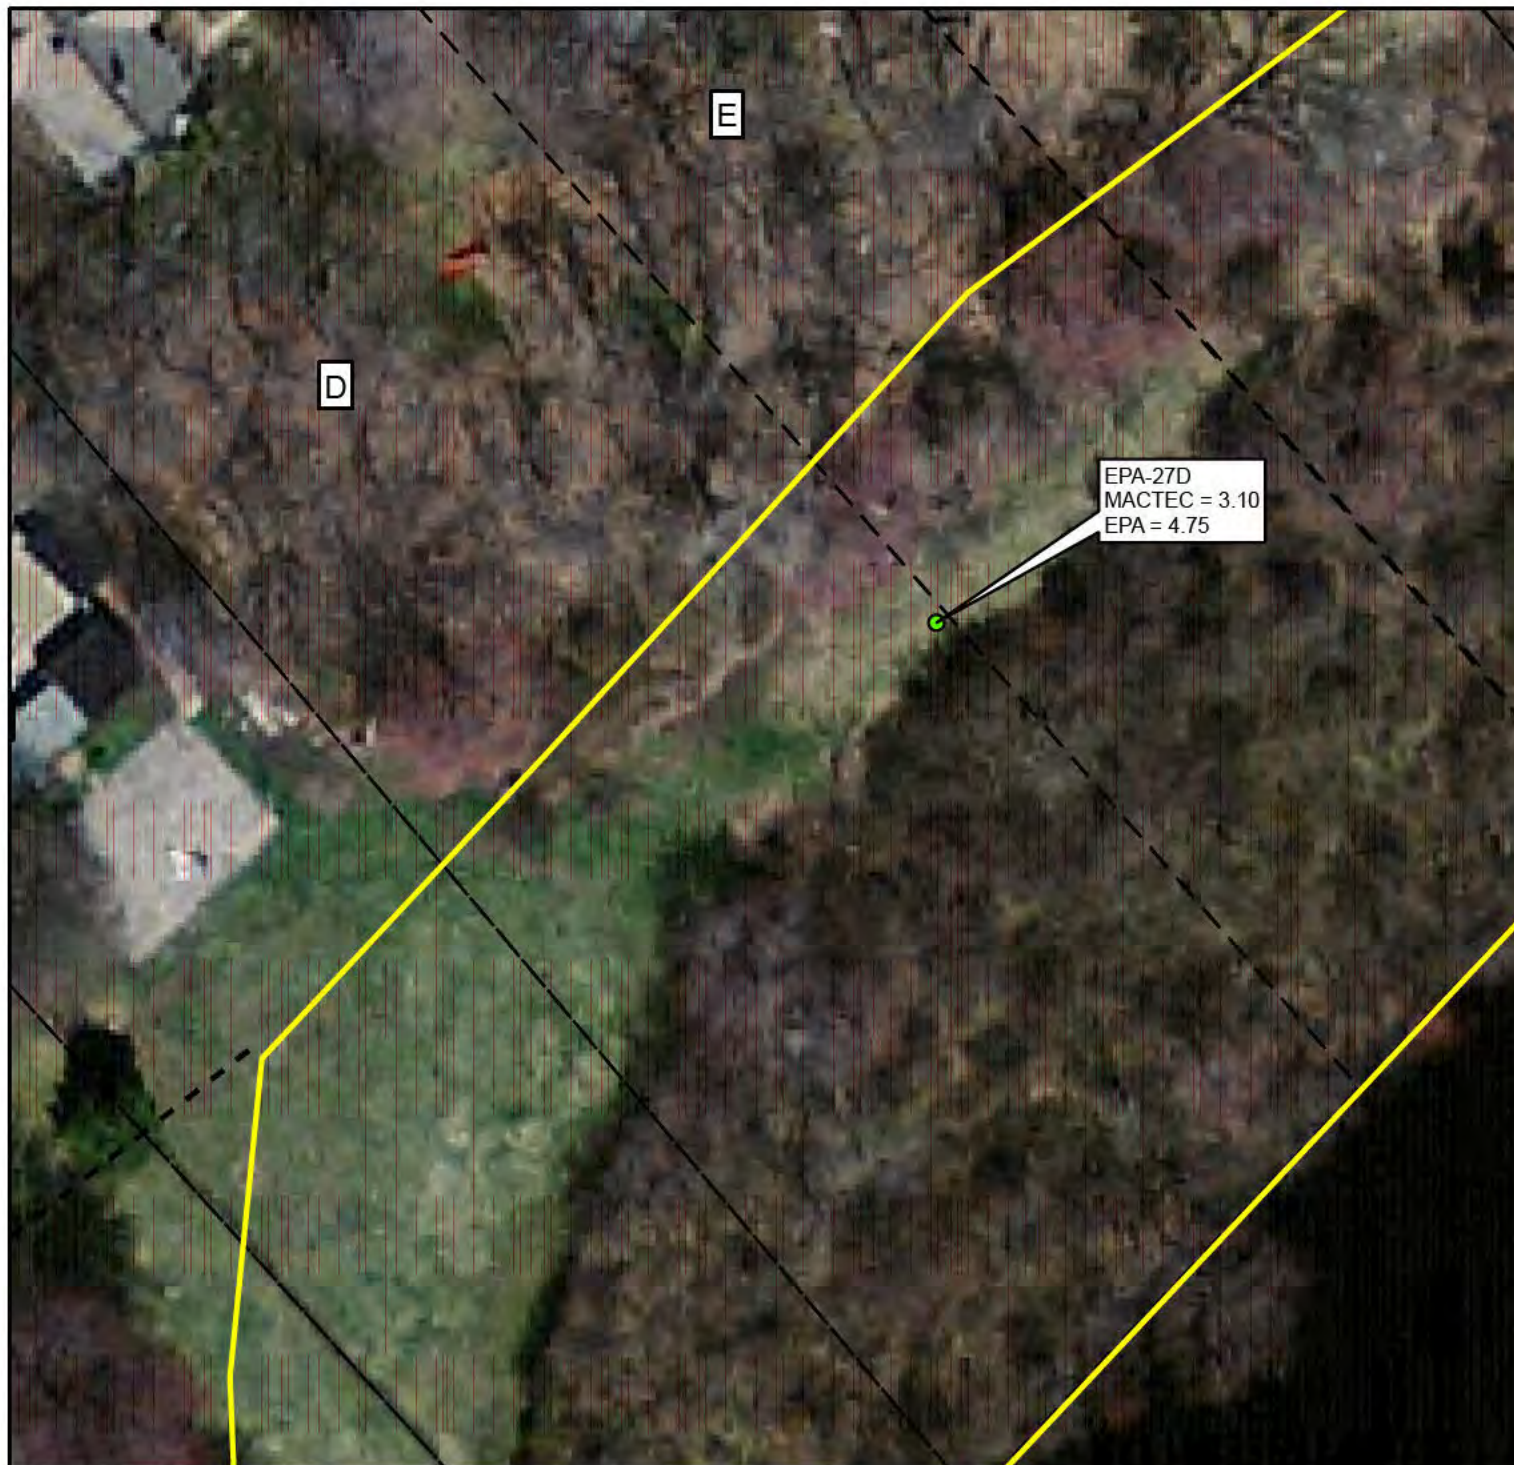
Figure 3-D
Property D
Surface Soil Sample Results Map
Total Polychlorinated Biphenyls
Riverside Square PCB Site
Boston, MA

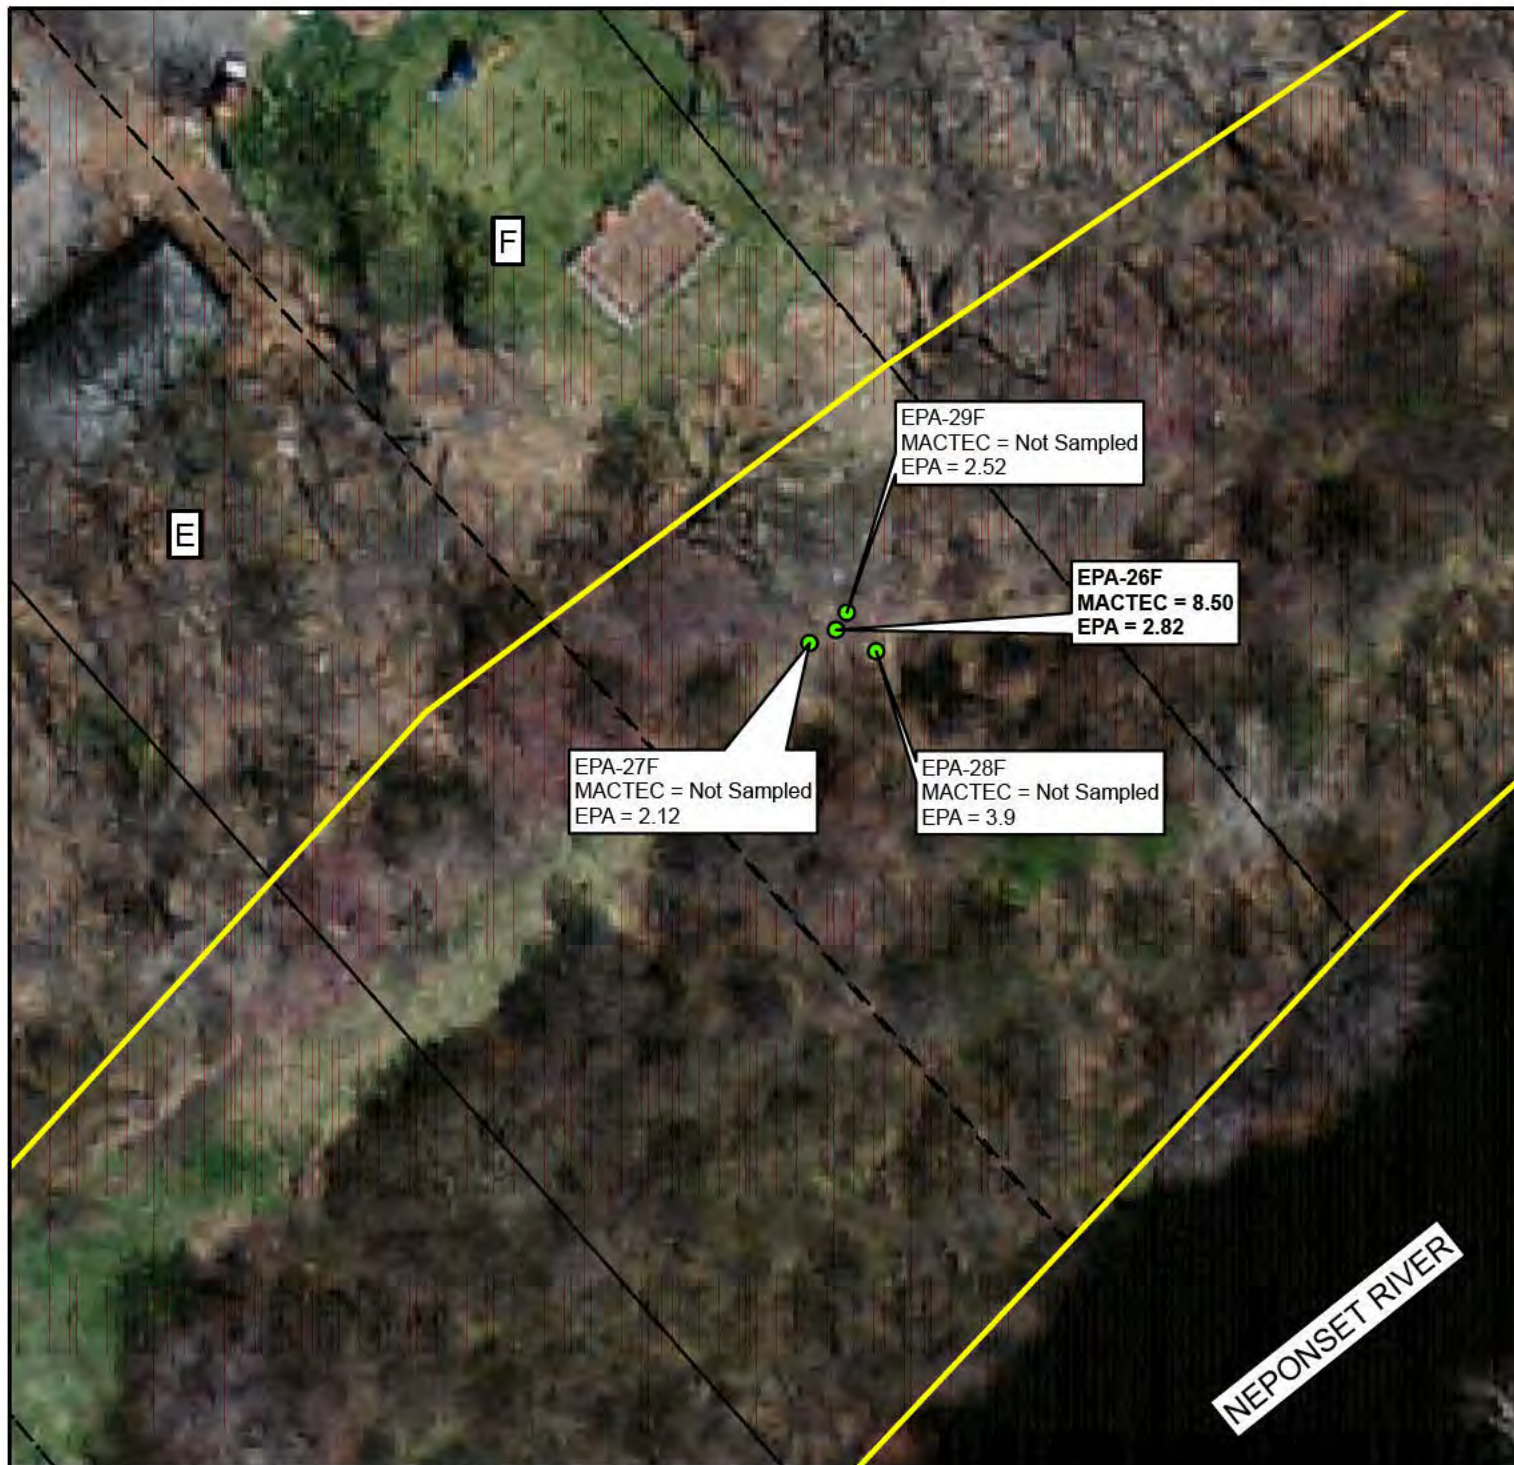
Figure 3-F
Property F
Surface Soil Sample Results Map
Total Polychlorinated Biphenyls

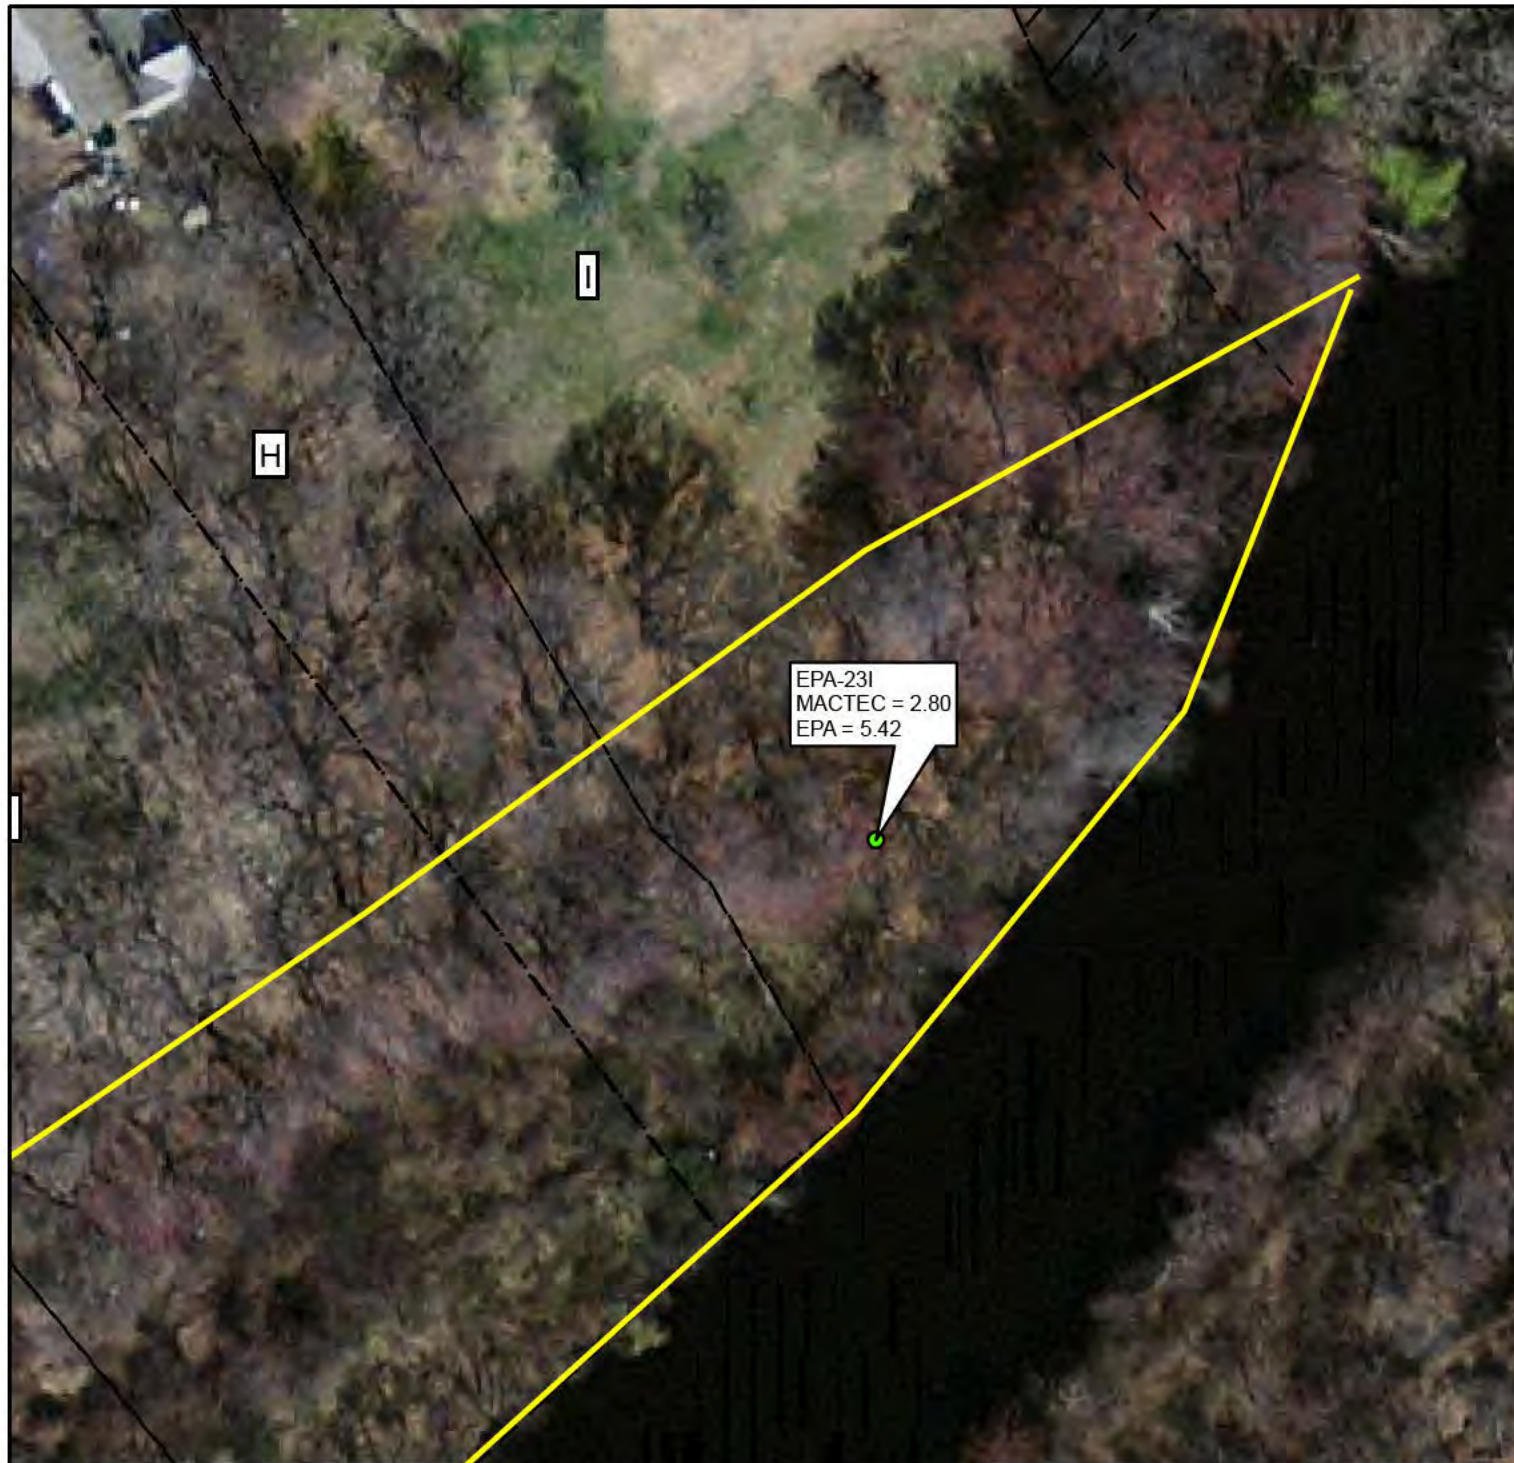
Figure 3-I
Property I
Surface Soil Sample Results Map
Total Polychlorinated Biphenyls
Riverside Square PCB Site
Boston, MA

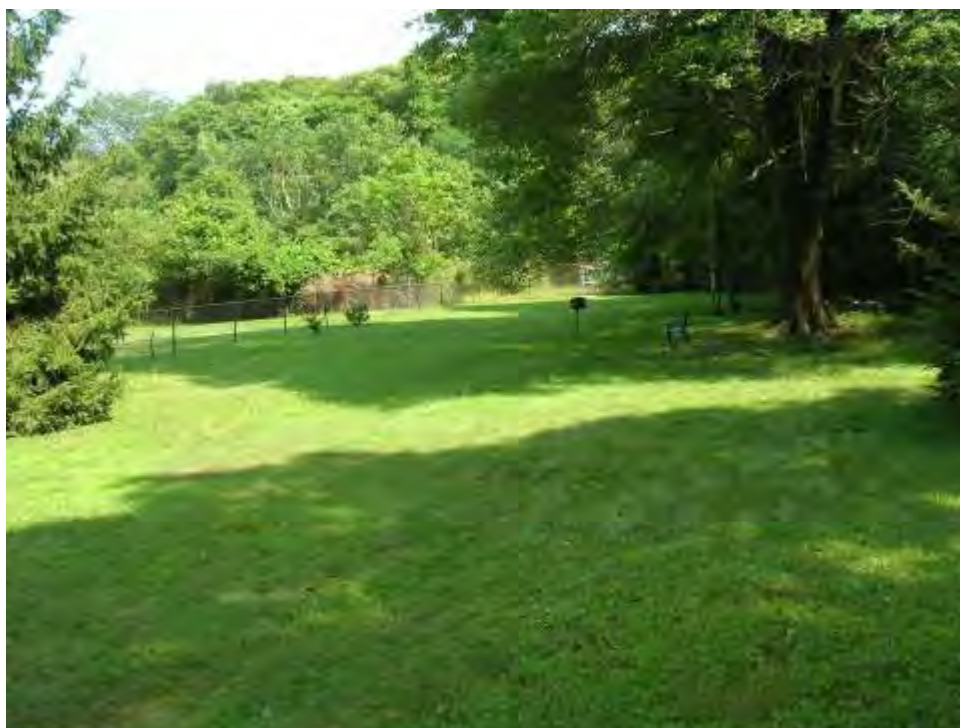
SCENE: View of the backyards of Properties B and C where samples were collected. Photograph taken facing west.

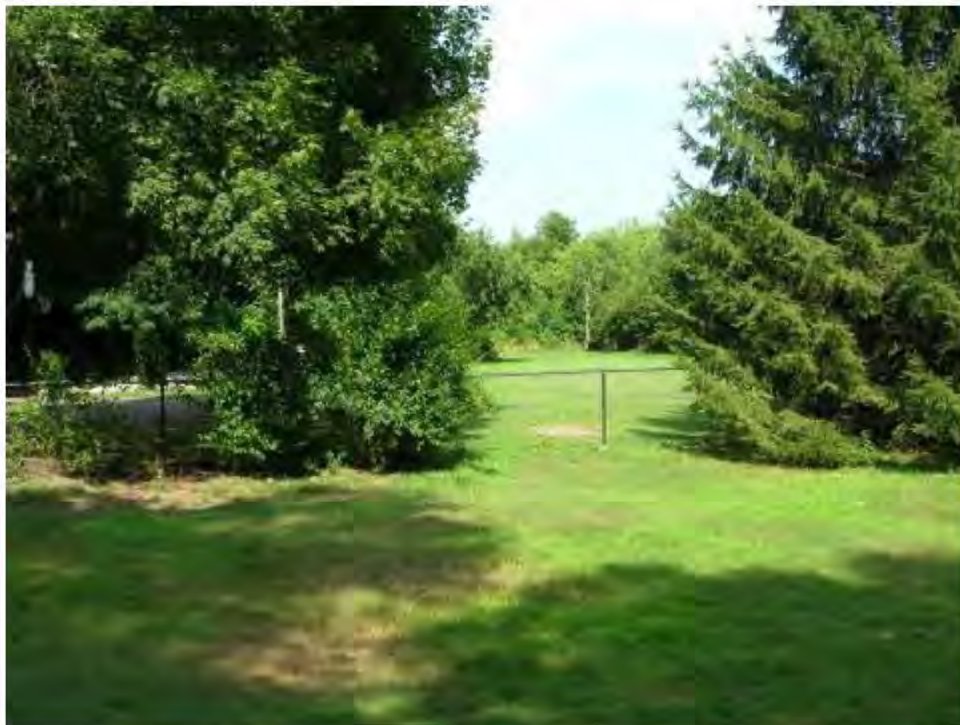
SCENE: View of the backyards of Properties B, C, and D where samples were collected. Photograph taken facing west.

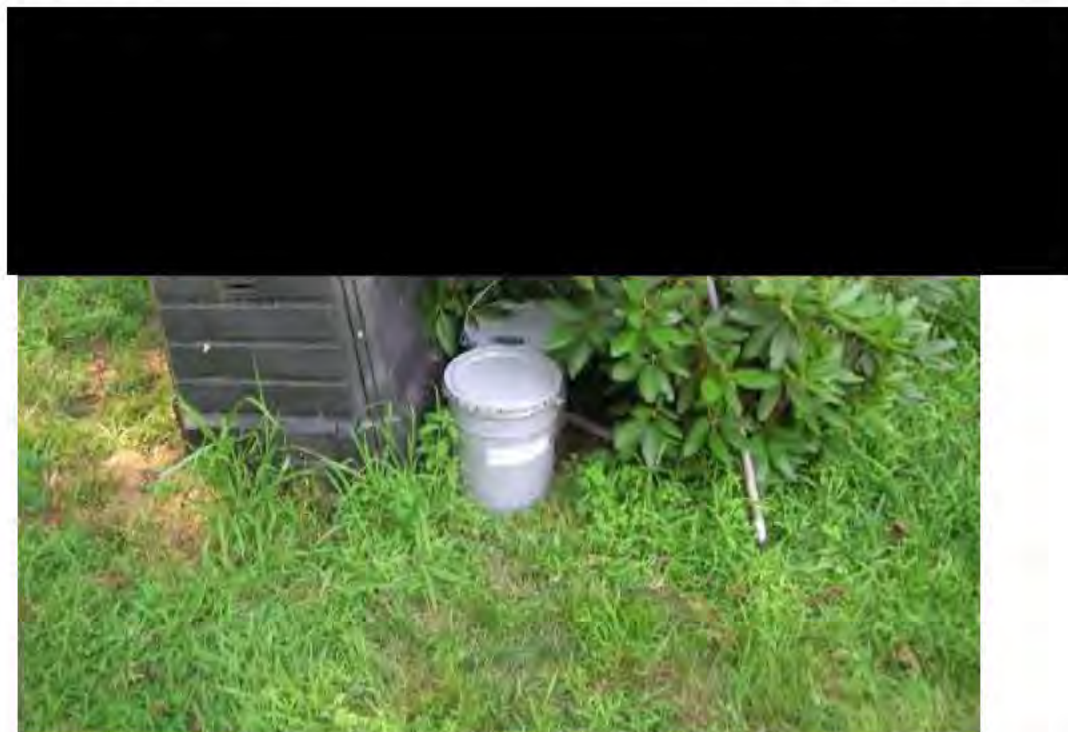
SCENE: View two 5-gallon metal pails containing investigation-derived wastes (IDW) generated on 19 July 2011. Pails are located on the northwestern side of the shed on Property B. Photograph taken facing southeast.

One rinsate (equipment blank) sample (RB-01) was collected following equipment decontamination. All investigation-derived waste (IDW) (decontamination liquids) generated during the day (approximately 7 gallons) were containerized in two 5-gallon metal pails. Pail covers (containing gaskets) were placed on the two pails, labels were placed on the pails, and the pails were placed in a hidden area behind the shed on Property B, pending off-site disposal by a licensed hazardous waste company. START photo-documented the location of these pails.

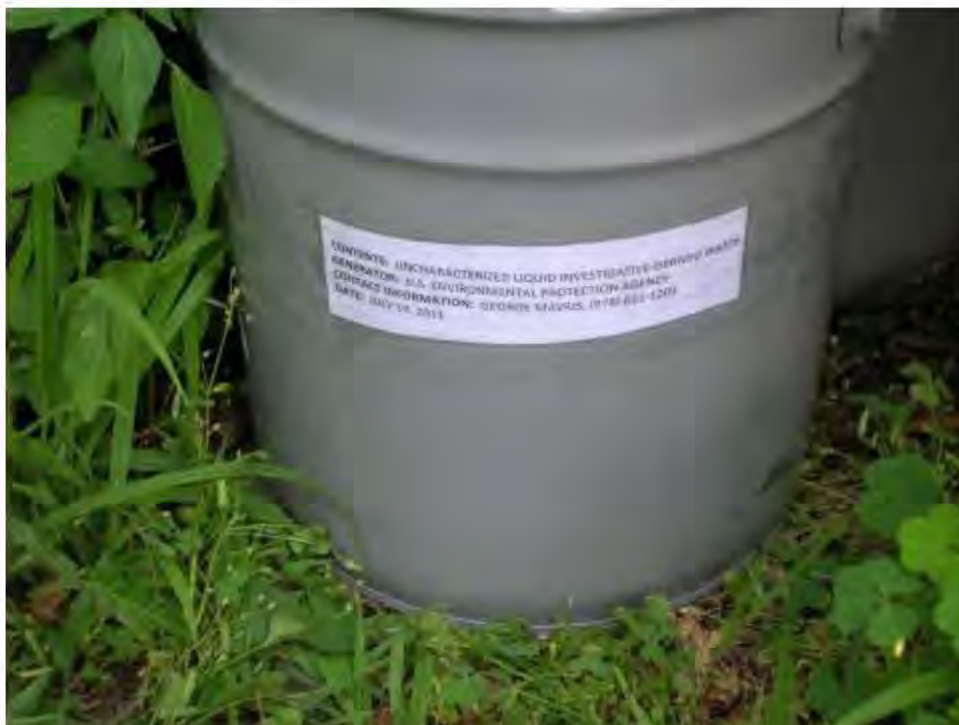
SCENE: Close-up view of the label placed on 5-gallon pails containing IDW and stored on the northwestern side of the shed on Property B. Photograph taken facing southeast.

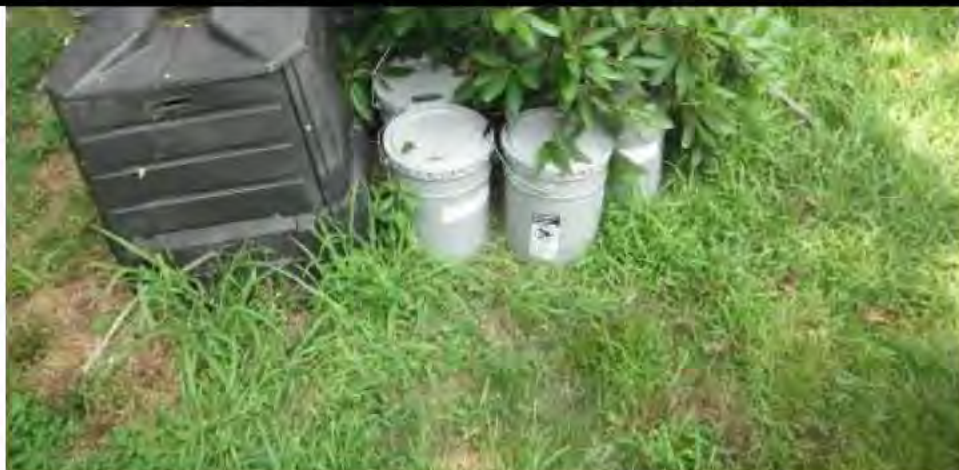
SCENE: View of four 5-gallon metal pails containing IDW generated on 19 and 20 July 2011. Pails are located on the northwestern side of the shed on Property B. Photograph taken facing southeast.

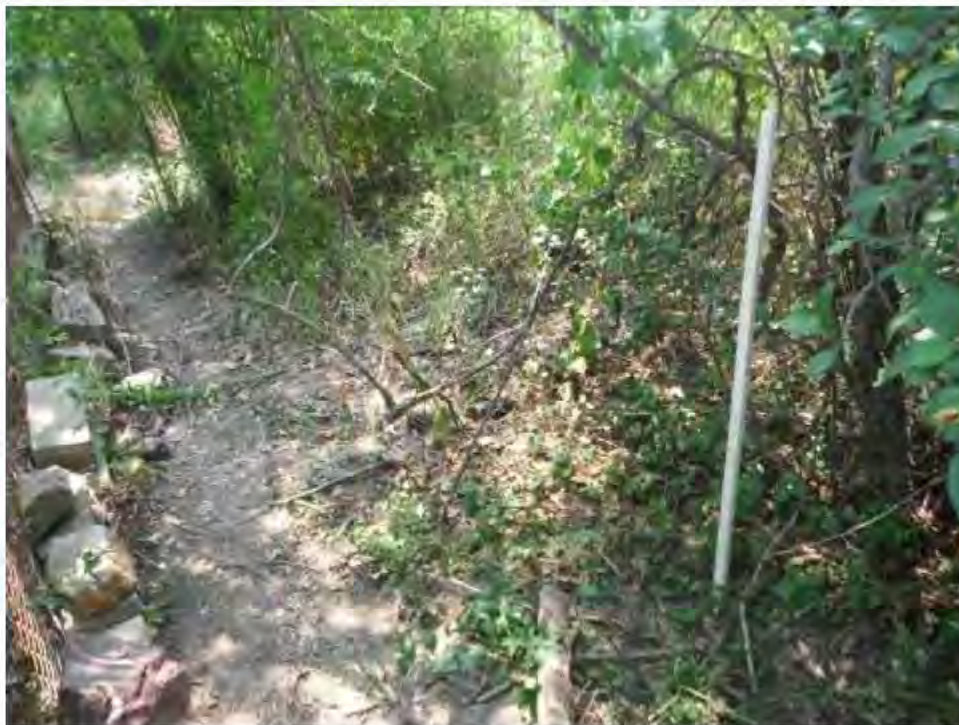
SCENE: View of sample location EPA-29H located along the southeastern section of Property H. Photograph taken facing northwest.

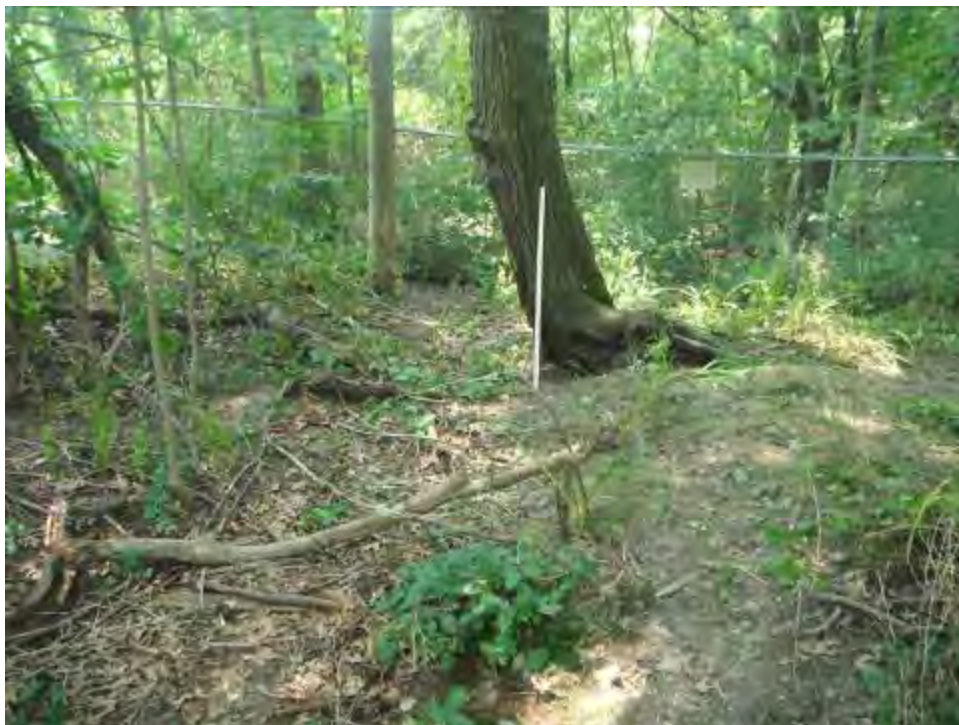
SCENE: View of sample location EPA-28H located along the southwestern section of Property H. Photograph taken facing southwest.

Previous sampling locations SS-27 and SS-28 (where 6.1 and 7.5 mg/Kg of total PCBs were previously detected, respectively) could not be located using a GPS unit due to the inadequate satellite signals resulting from the dense tree cover on the property. START estimated the locations of SS-27 and SS-28 based on the aerial maps and ground features; however, the property owner disputed the location of SS-28. OSC Bzenas discussed this issue with the property owner and an agreement was reached to place SS-28 at a different location. Since the GPS unit could not be used to record the locations of SS-27 and SS-28, a tape measure was used to measure their approximate locations along the fence lines on both sides of the property. Sample location SS-27 was located approximately 30 feet north of the southeast corner of the fence and 5 feet west of the fence; and SS-28 was located approximately 70 feet north of the southwest corner of the fence and approximately 12 feet east of the fence (see Appendix A, Figure 3H). Wooden stakes were used to mark the locations of SS-27 and SS-28, and these sample locations were designated as EPA-27H and EPA-28H, respectively.

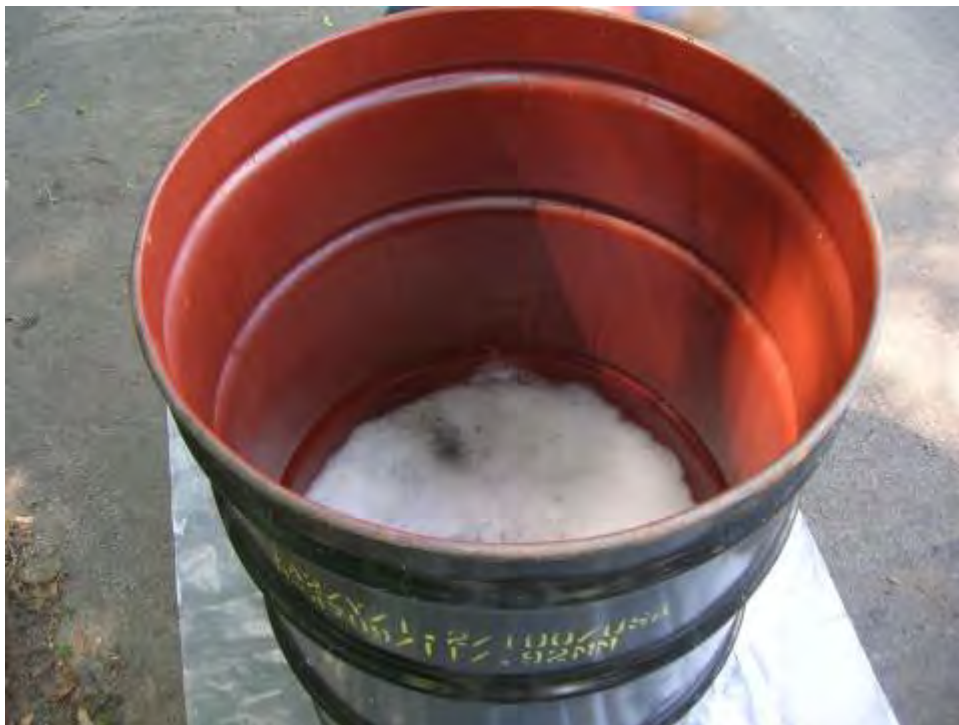
SCENE: View of IDW liquids transferred from the four 5-gallon pails and into one 55-gallon drum for off-site disposal.

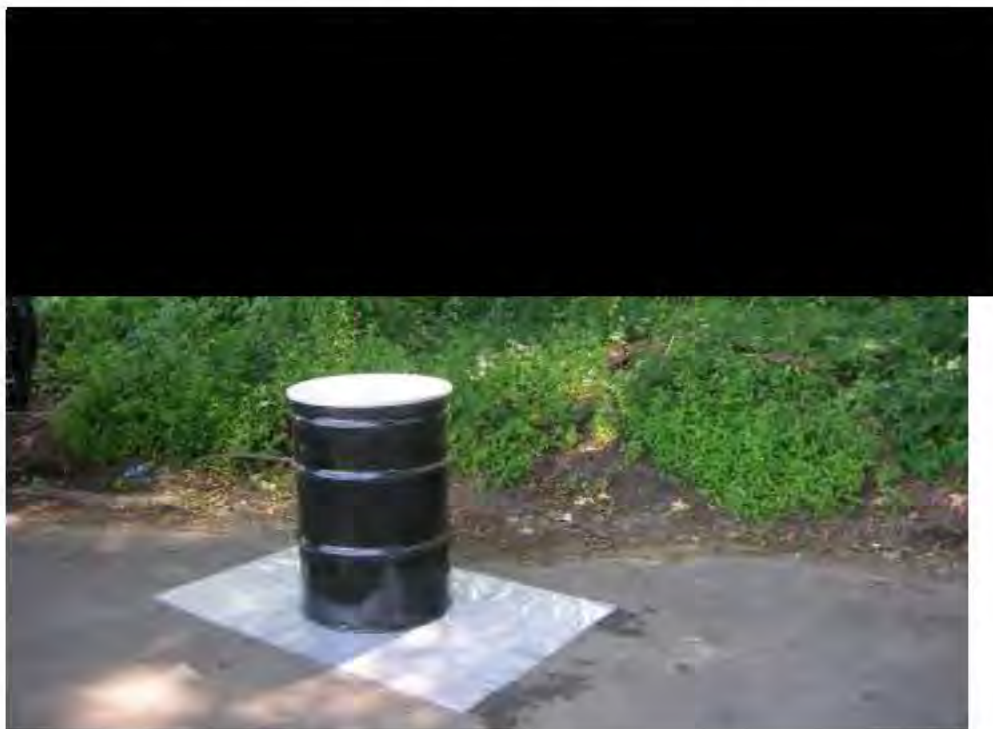
SCENE: View of 55-gallon drum with lid secured and awaiting pick up for off-site disposal. Photograph taken facing northwest.

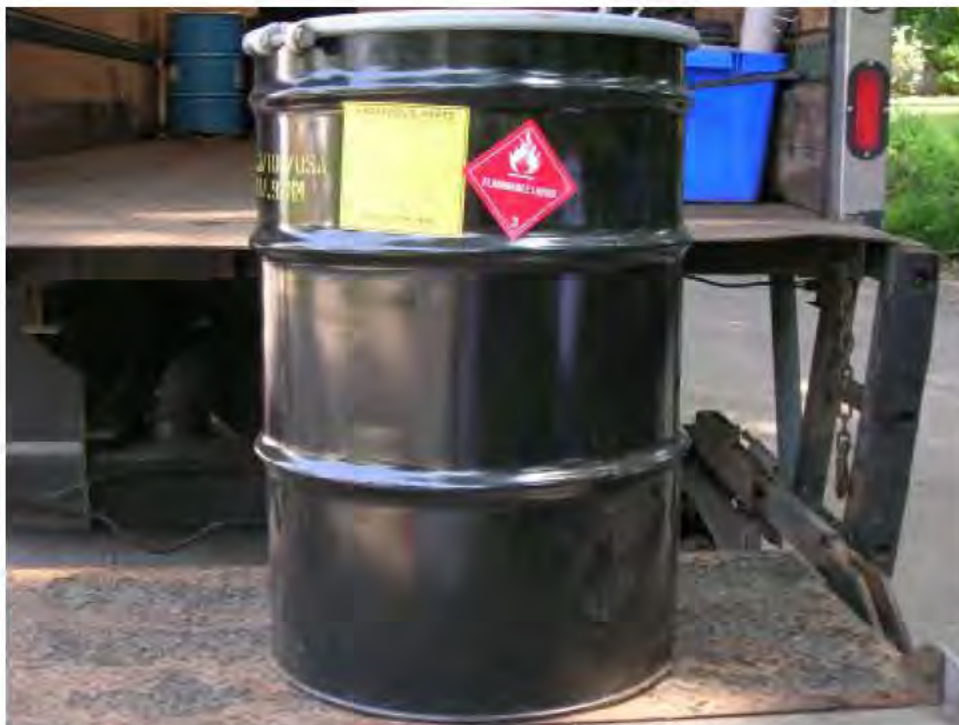
SCENE: View of labeled 55-gallon drum on tailgate of truck to be transported off-site for disposal.

General Chemical Corp. arrived on site to pick up the drum for off-site disposal at the Cycle Chem Inc. Facility in Elizabeth, New Jersey. The drum was labeled by General Chemical Corp. and placed in a truck. OSC Sherrin signed the hazardous waste manifest and Land Ban Restriction form. START photo-documented site activities. The General Chemical Corp. truck departed the site. START members G. Mavris and R. Sharp departed the site, concluding site activities for the PA/SI.

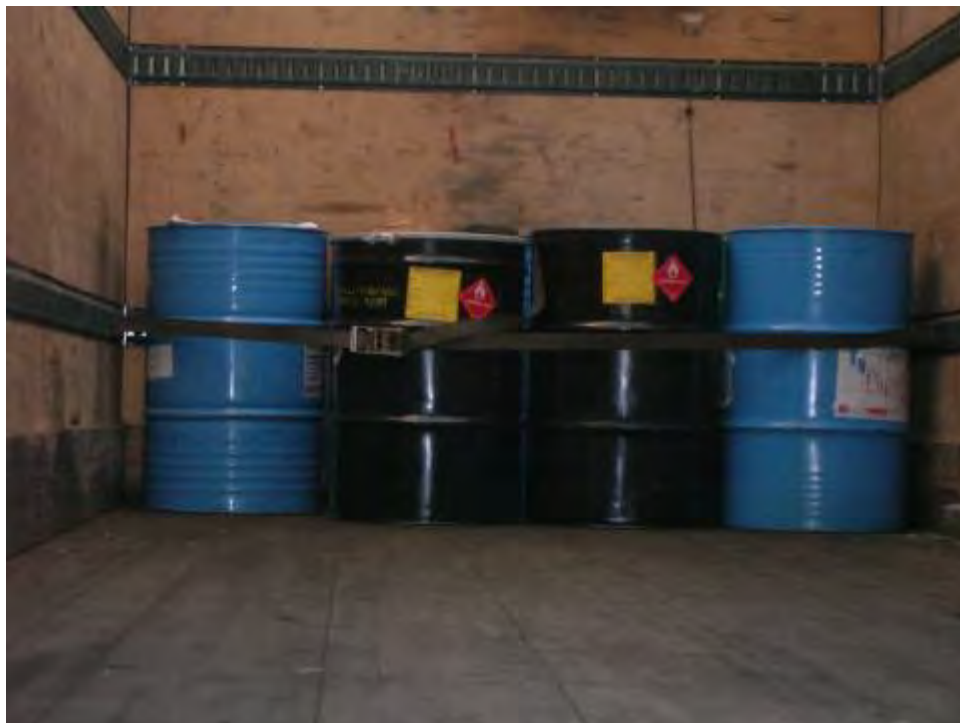
SCENE: View of 55-gallon drum secured in back of truck for off-site disposal.
