**FINAL
SITE INSPECTION REPORT
FORMER ANTOINE LAUNDRY
125 AVENIDA ISLA VERDE
CAROLINA, PUERTO RICO**

EPA ID No.: PRR000020396

EPA Contract No.: 68HE0222F0035
Document Control No.: SAT-V.6405.0321

July 2024

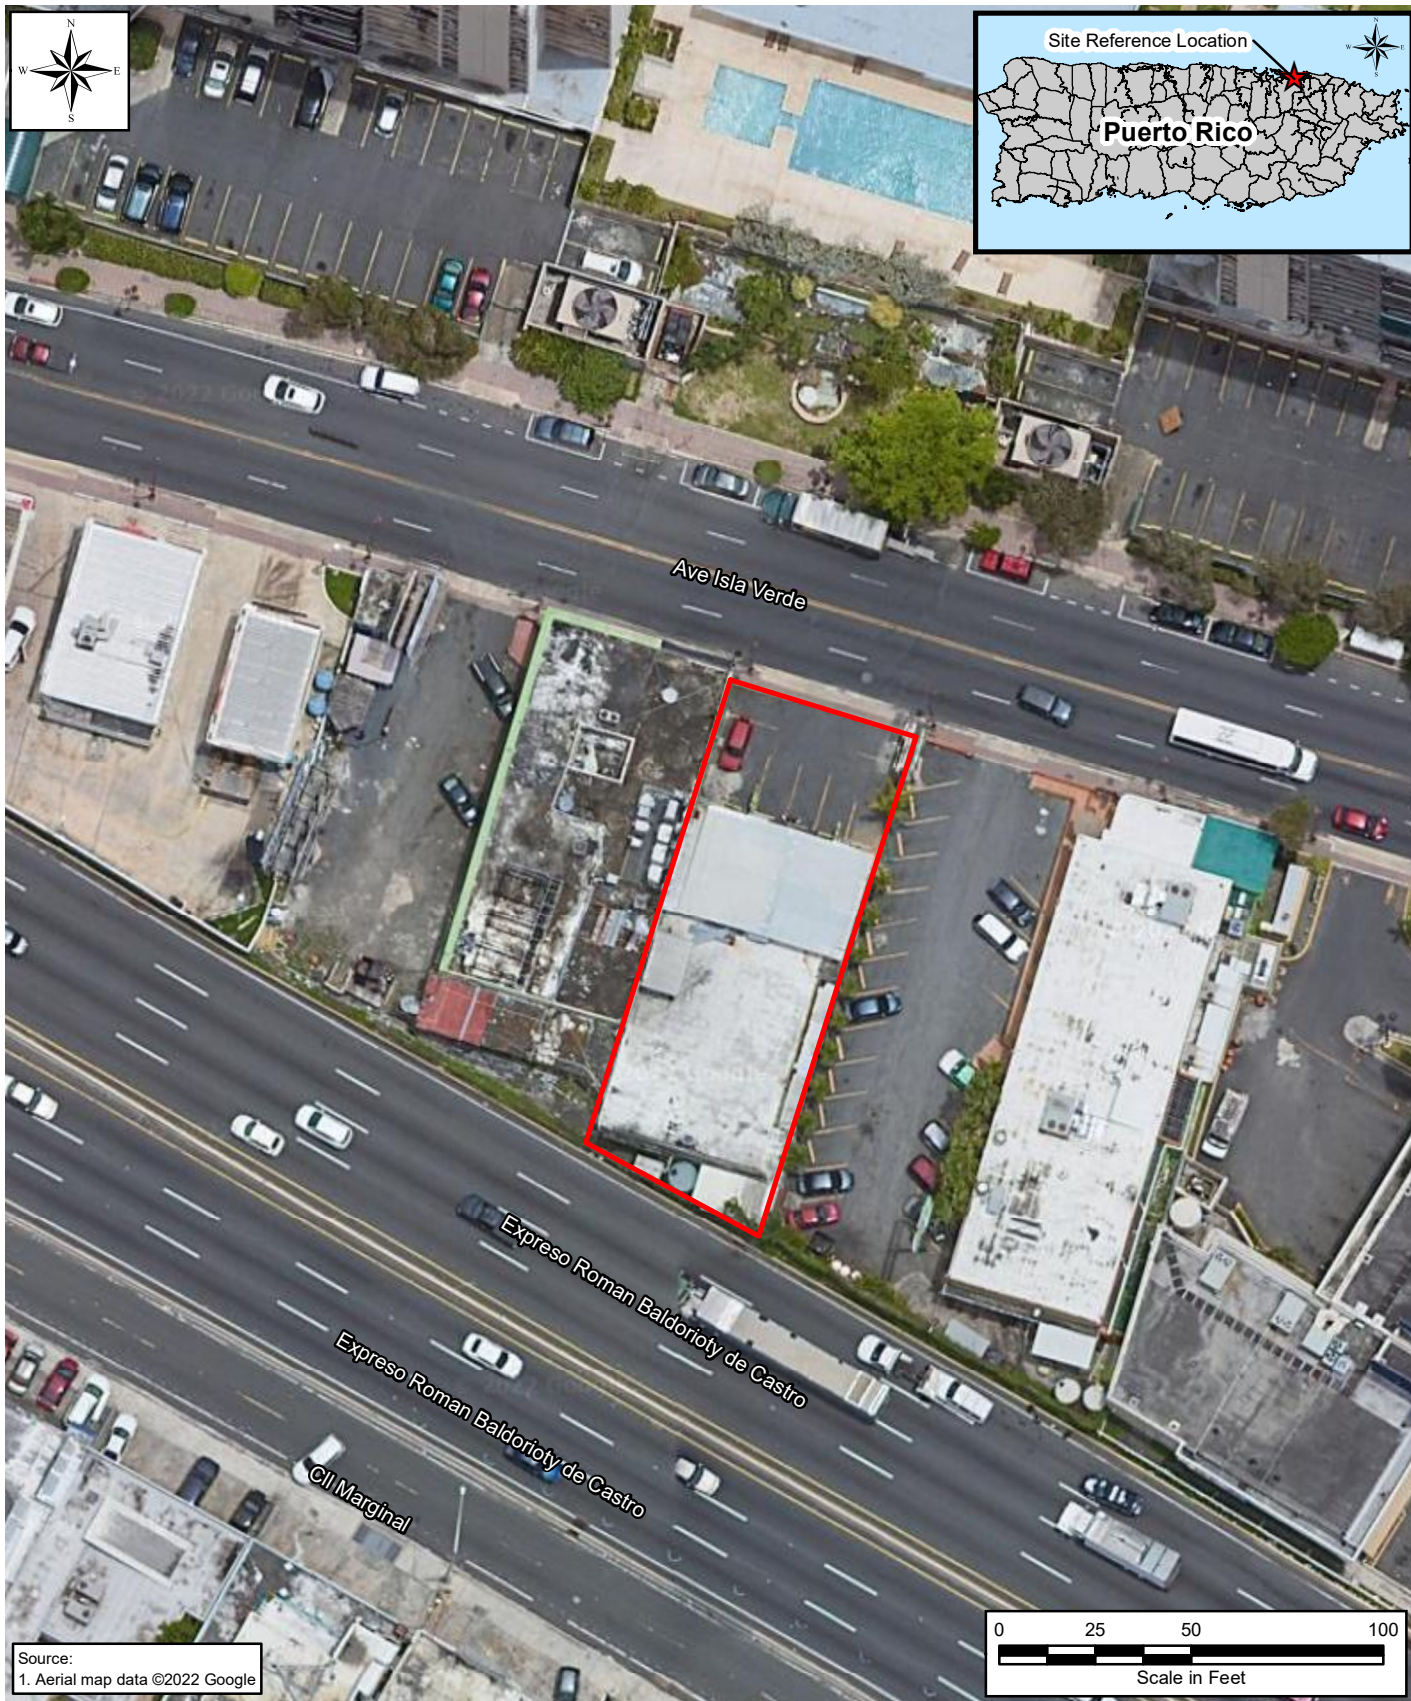
On March 31, 2022, Region 2 SAT performed reconnaissance activities at the site and vicinity in support of the Preliminary Assessment (PA). From publicly accessible sidewalks and neighboring parking areas, SAT observed that the exterior portion of the site was completely paved with asphalt and concrete in good condition and that topography is generally flat. A storm drain was observed on the east side of the building, directly in front of the adjacent business [Ref. 9, pp. 2-3]. **Figure 2** presents a Site Map.

SITE MAP
FORMER ANTOINE LAUNDRY
125 AVE ISLA VERDE, CAROLINA, PR
