# CARTER CARBURETOR SUPERFUND SITE REMOVAL ACTION FINAL REPORT

## **Carter Carburetor**

2800-2840 North Spring Street  
St. Louis, MO

Issued On: 10 April 2020

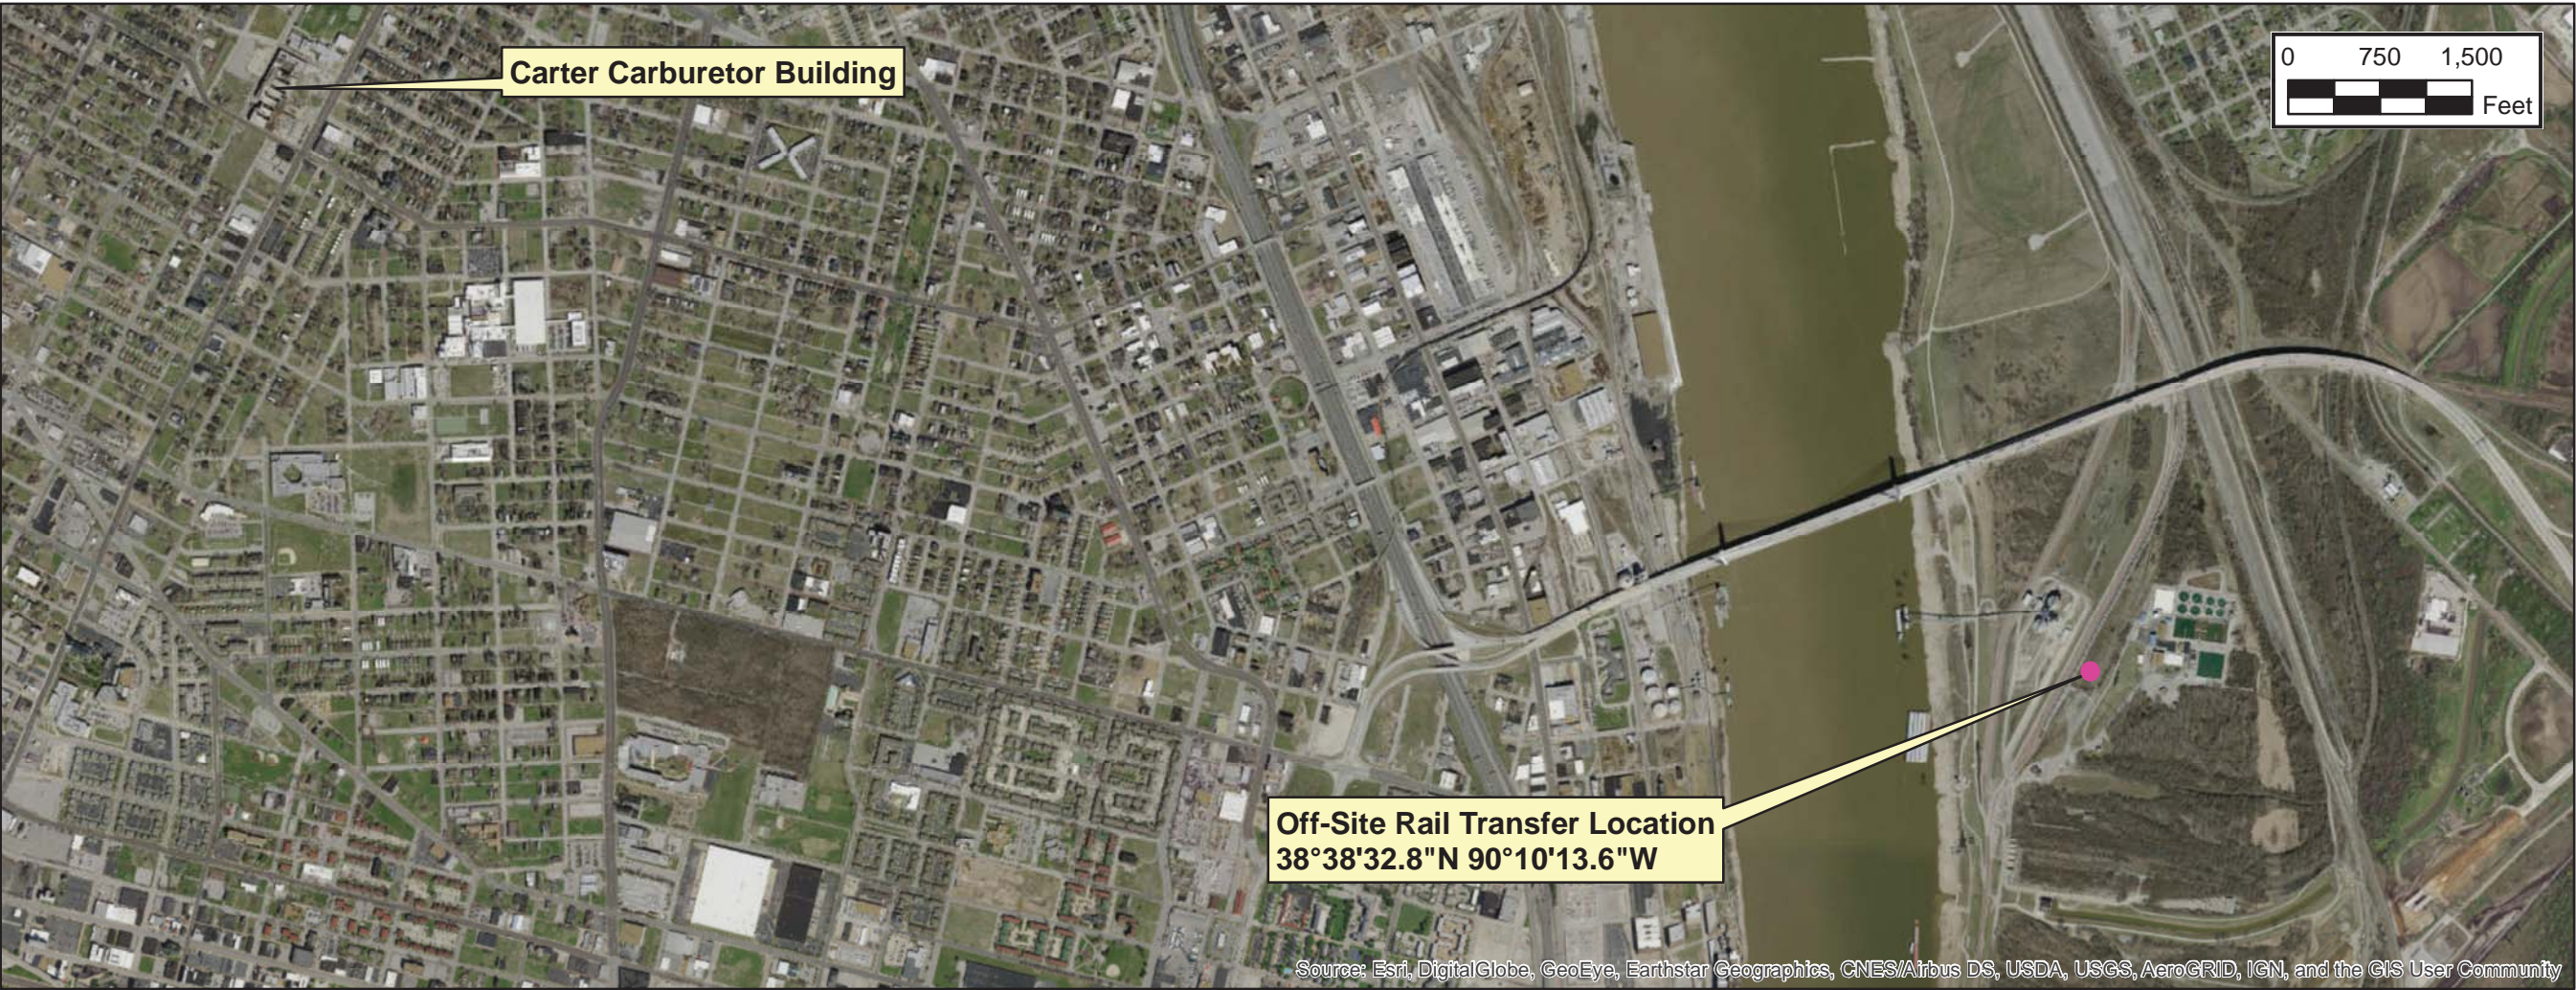
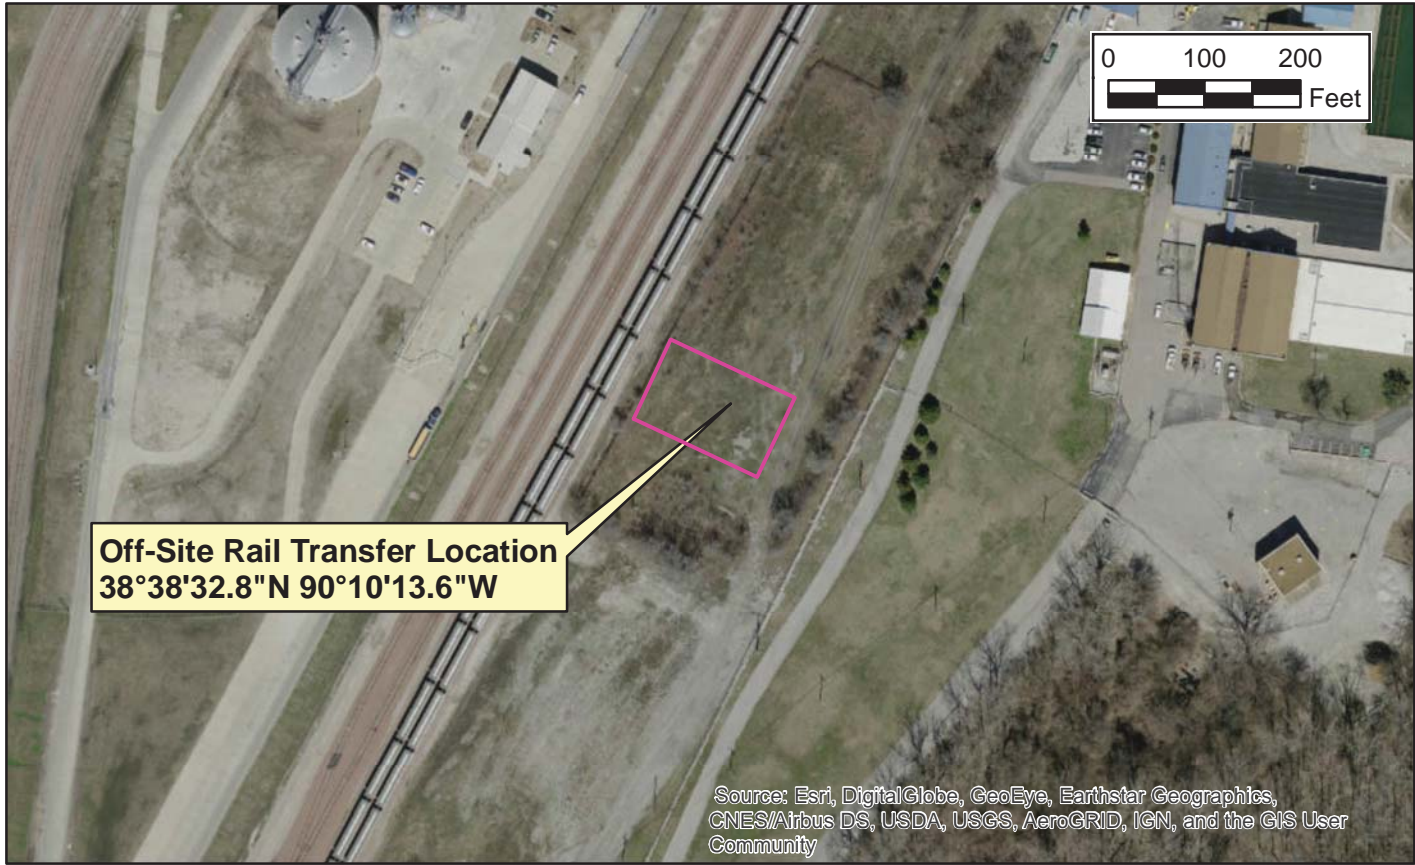
FIGURE NO.  
**9**

EAST ST. LOUIS  
MISSOURI
