Phase II Environmental Site Assessment 200 Magnolia Street Winchester, Kentucky

**Phase II Environmental Site Assessment
200 Magnolia Street
Winchester, Kentucky**

Milgrom Group

**Hall & Associates, Inc.
223 South Main Street
Versailles, Kentucky 40383**

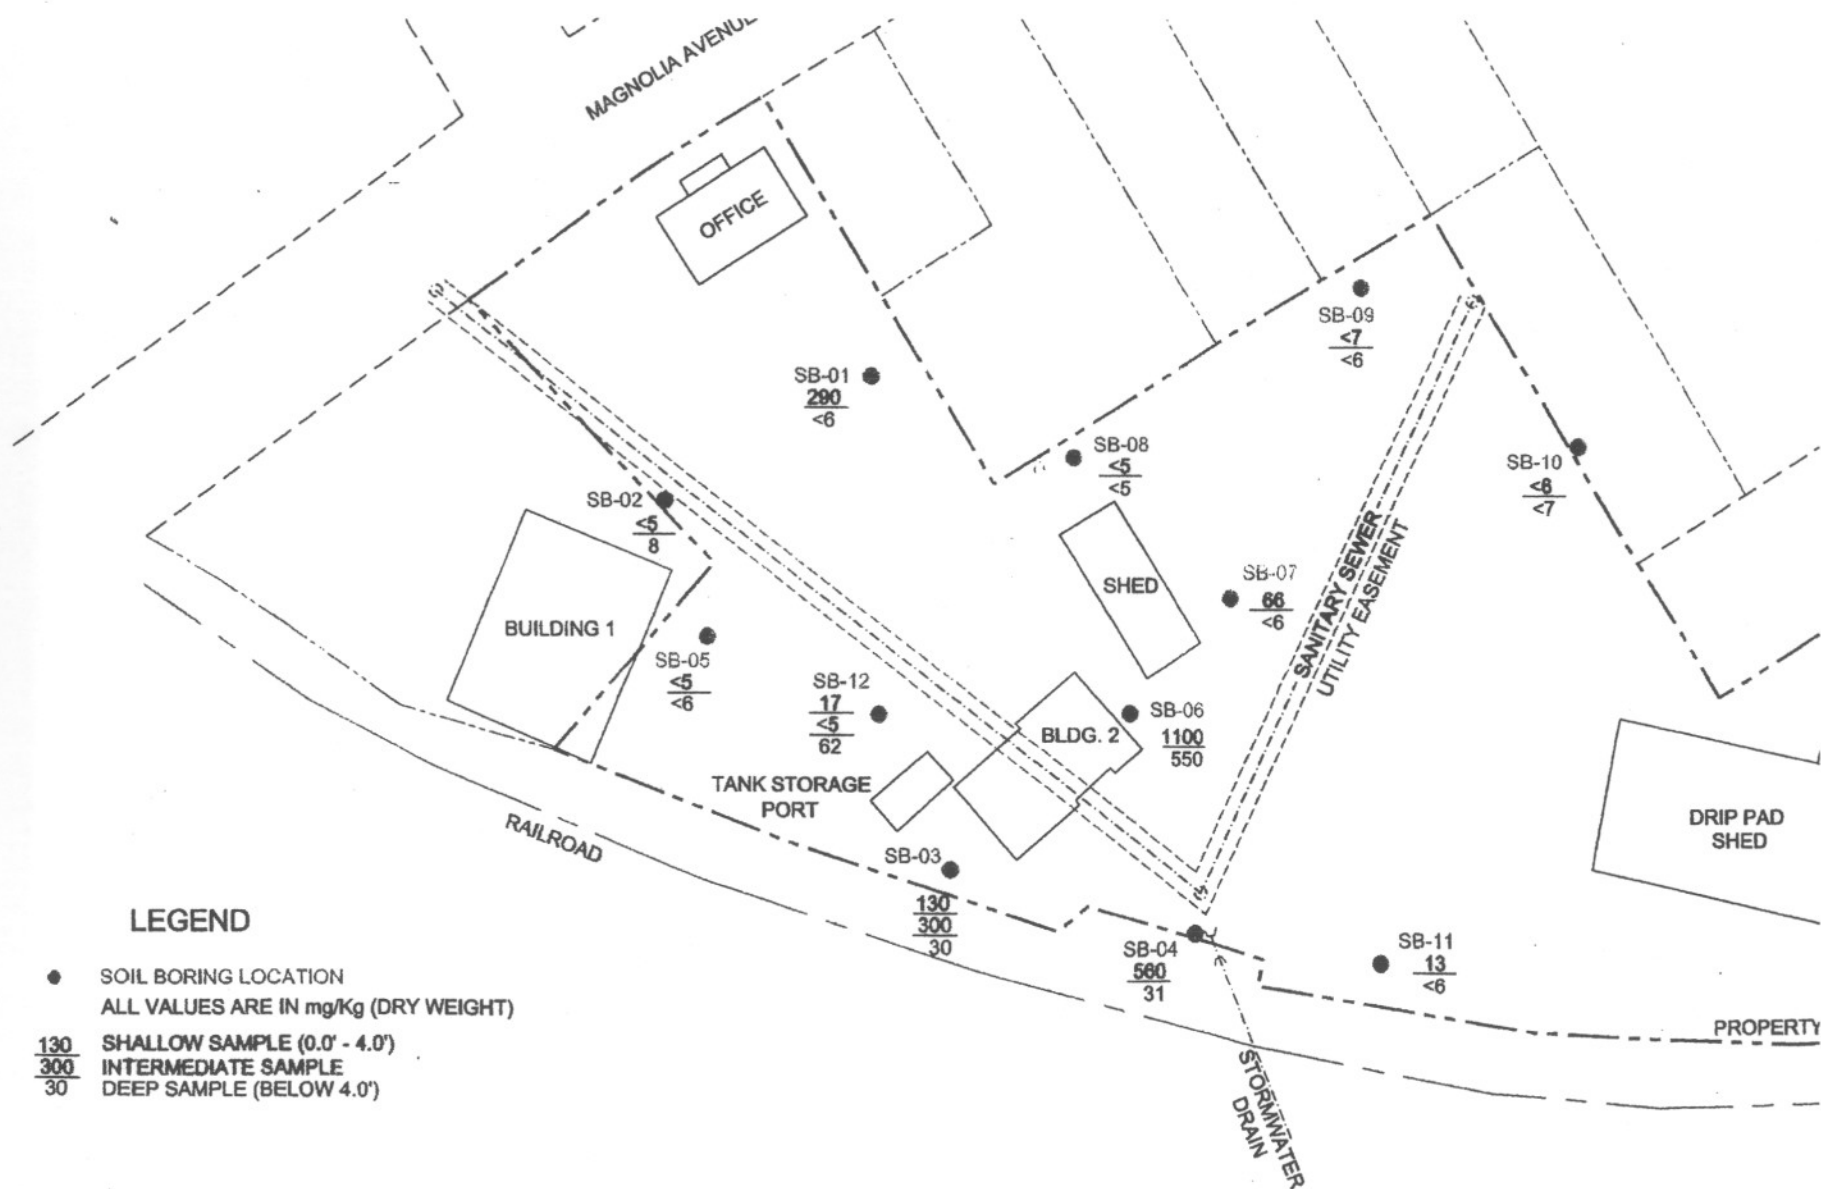
Results of total metals analysis are presented in Table 6.3. As can be seen, the sample identifier indicates the boring number and the sample interval depth in feet. Plots of the results on a site map for each metal can be found as Figures 1, 2, and 3.

Affected media at the site includes soil/sediments and groundwater. As can be seen in Figures 1, 2, and 3, contaminant levels seem to originate at the maintenance shed. Because of the low levels seen in off-site stream sediments and because background levels have not been adequately established in this area, it is uncertain whether these sediments are affected. If affected it is also uncertain if other sources of contaminants are present in the drainage basin of the stream.

Levels of contaminants in the soil show elevated levels of arsenic, chromium and copper. The chromium appears to be almost exclusively in the trivalent form. Based on the sole TCLP result, the chromium and arsenic appear to be well bound in the soils and relatively non-leachable. As expected, levels fall off with depth and distance from the maintenance building. However, near the building, significant levels are noted down to bedrock.

- 1) In-situ stabilization or removal of contaminated soils should take place.
- 2) Site based goals for immobilization or cleanup must be first determined. These levels will guide activities.
