**COMPREHENSIVE ENVIRONMENTAL RESPONSE,
COMPENSATION AND LIABILITY ACT
EMERGENCY RESPONSE REPORT**

**TENNESSEE WHEEL AND RUBBER
NASHVILLE, DAVIDSON COUNTY, TENNESSEE
EPA CONTRACT No. EP-W-05-054
TDD No. TTEMI-05-001-0017**

**CERCLA EMERGENCY RESPONSE REPORT
TENNESSEE WHEEL AND RUBBER
NASHVILLE, DAVIDSON COUNTY, TENNESSEE
EPA CONTRACT No. EP-W-05-054
TDD No. TTEMI-05-001-0017**

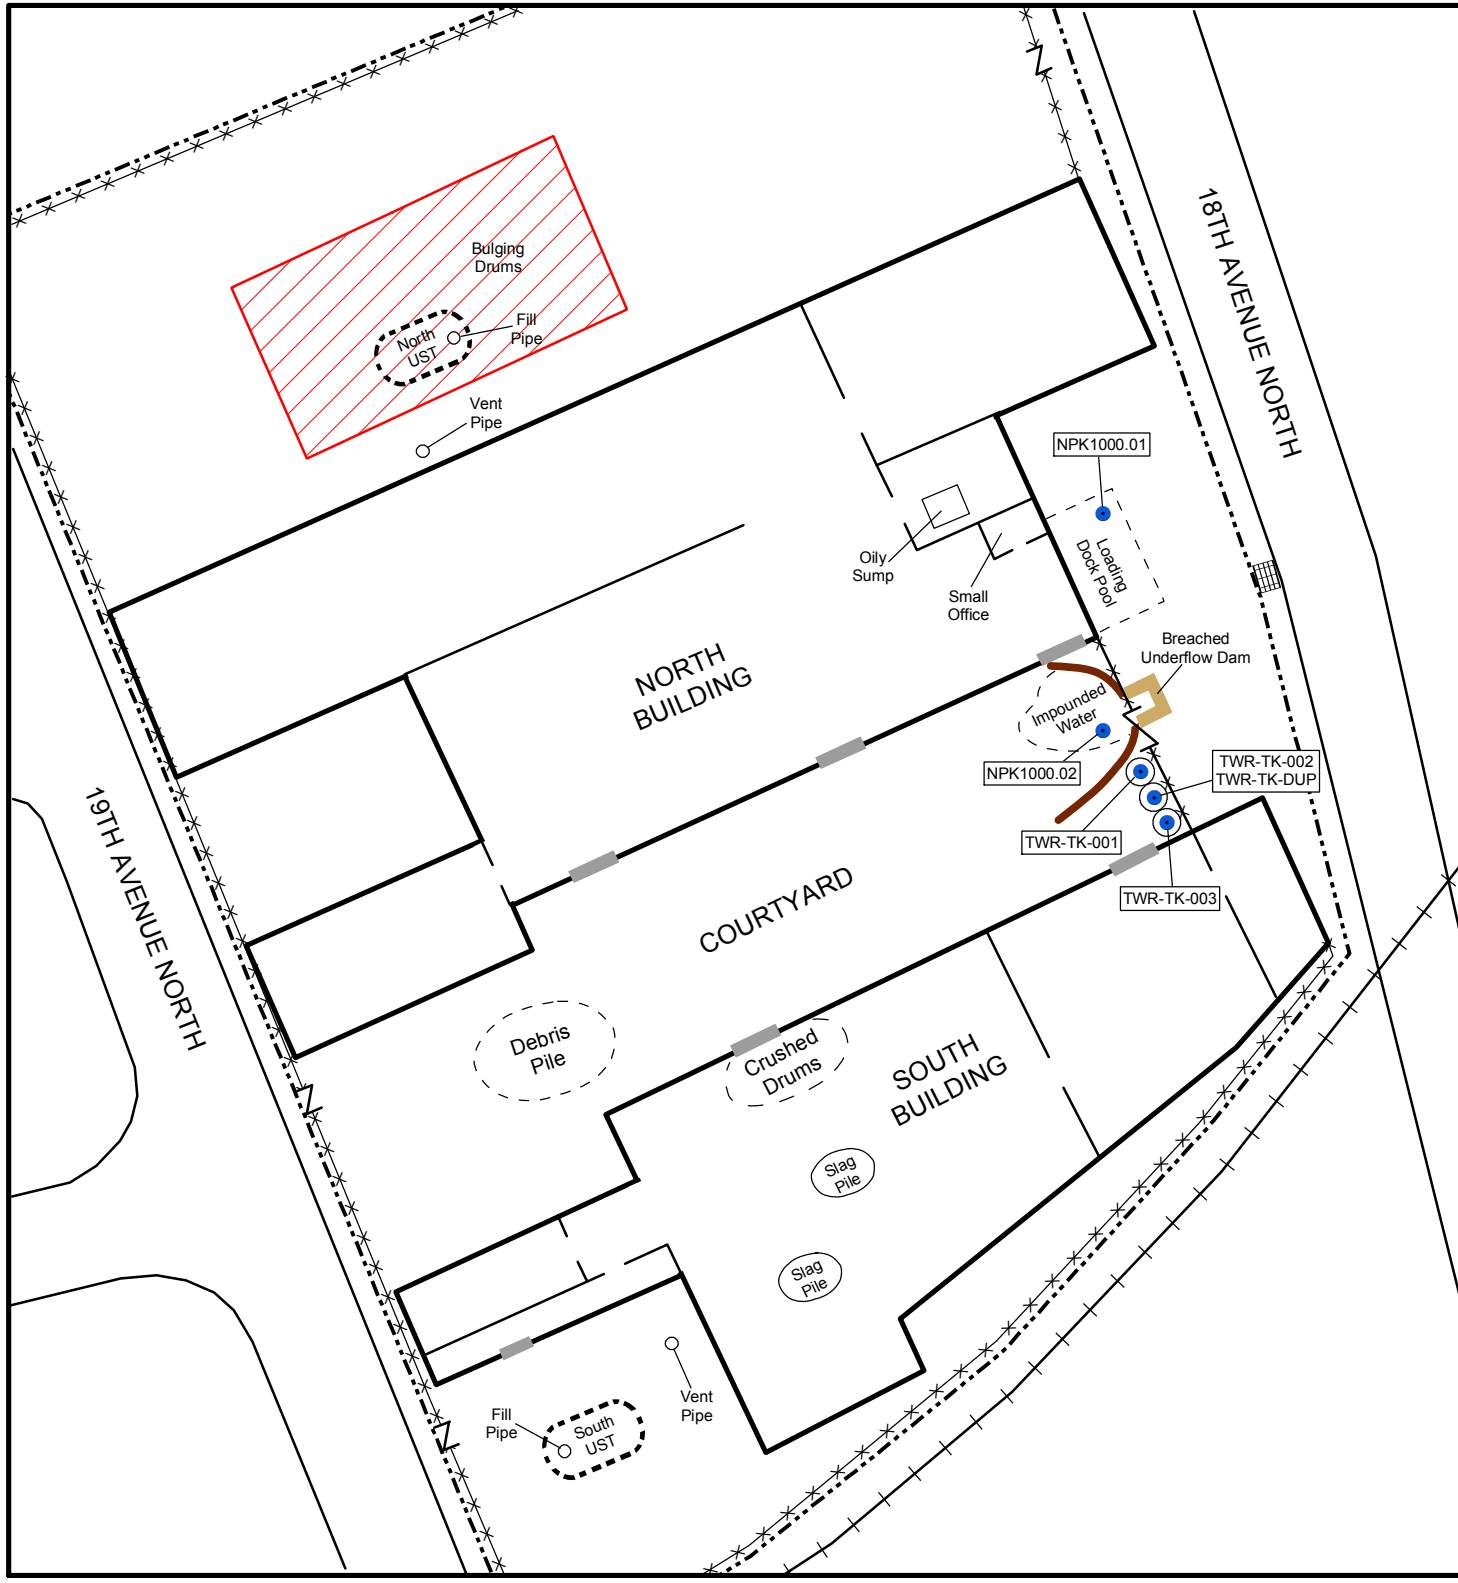
**FIGURE 2
SITE LAYOUT AND
WASTEWATER SAMPLING
LOCATION MAP**

Multiple drums containing various chemicals and oils related to the former manufacturing process were stored in on-site buildings as well as outside the buildings (see Figure 2). The two buildings on the site were designated as the “north” and “south” buildings, and the area between the two buildings was designated as the “courtyard.” Access to the property, both the exterior and the interior of each building, was not restricted prior to the emergency removal action. The condition of the buildings and property indicated that vandalism, theft, and vagrancy had likely occurred at the site.

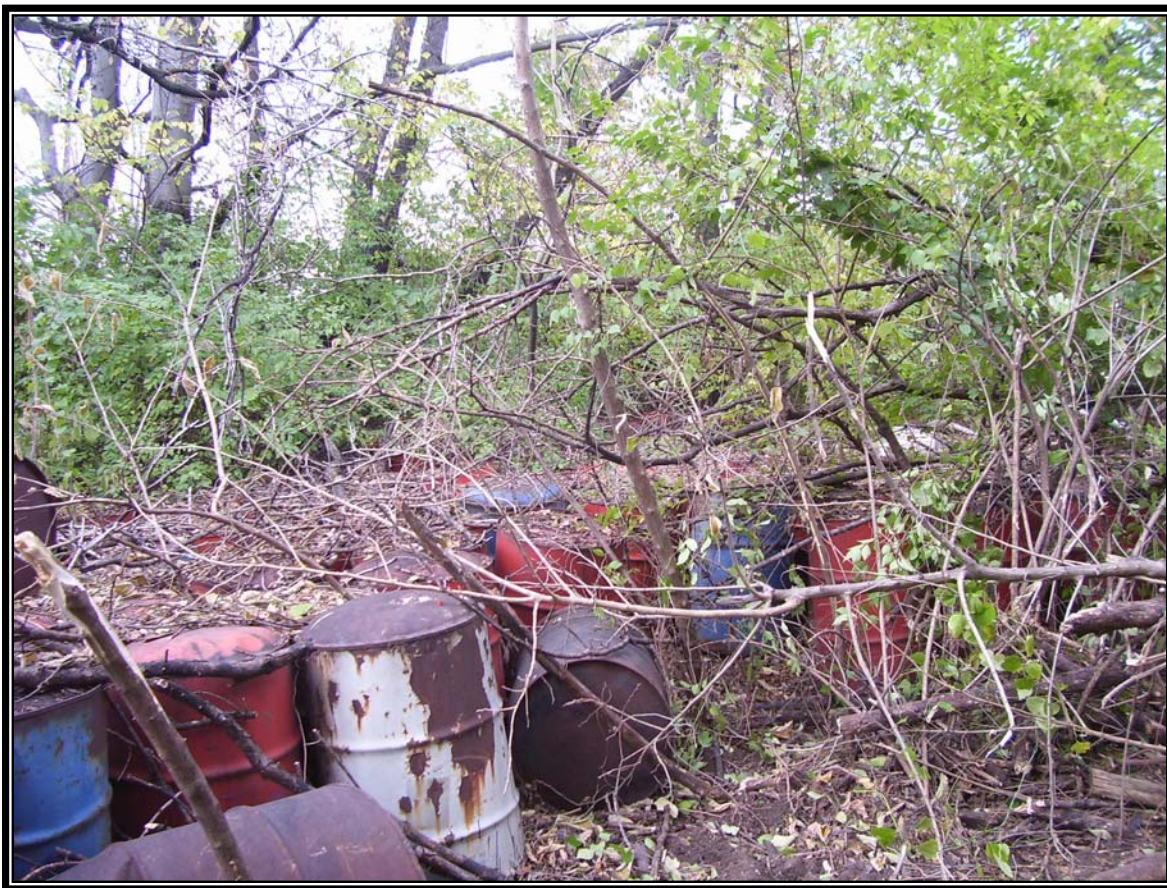
OFFICIAL PHOTOGRAPH NO. 1
U.S. ENVIRONMENTAL PROTECTION AGENCY
TENNESSEE WHEEL AND RUBBER
NASHVILLE, DAVIDSON COUNTY, TENNESSE

Subject: Drums in area of dense vegetation on the northern portion of the site.

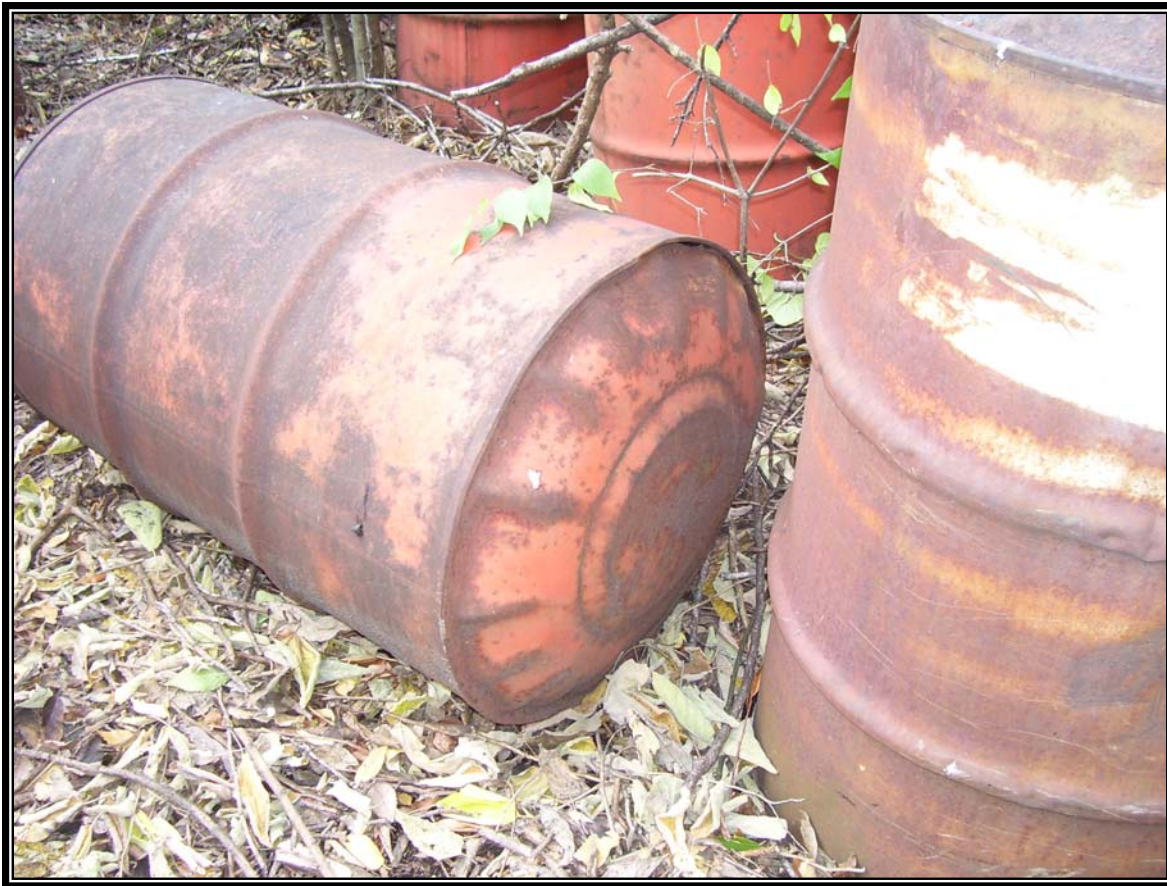
**OFFICIAL PHOTOGRAPH NO. 2
U.S. ENVIRONMENTAL PROTECTION AGENCY
TENNESSEE WHEEL AND RUBBER
NASHVILLE, DAVIDSON COUNTY, TENNESSE**

Subject: A typical bulging drum removed from area of overgrown vegetation near the northern property boundary.

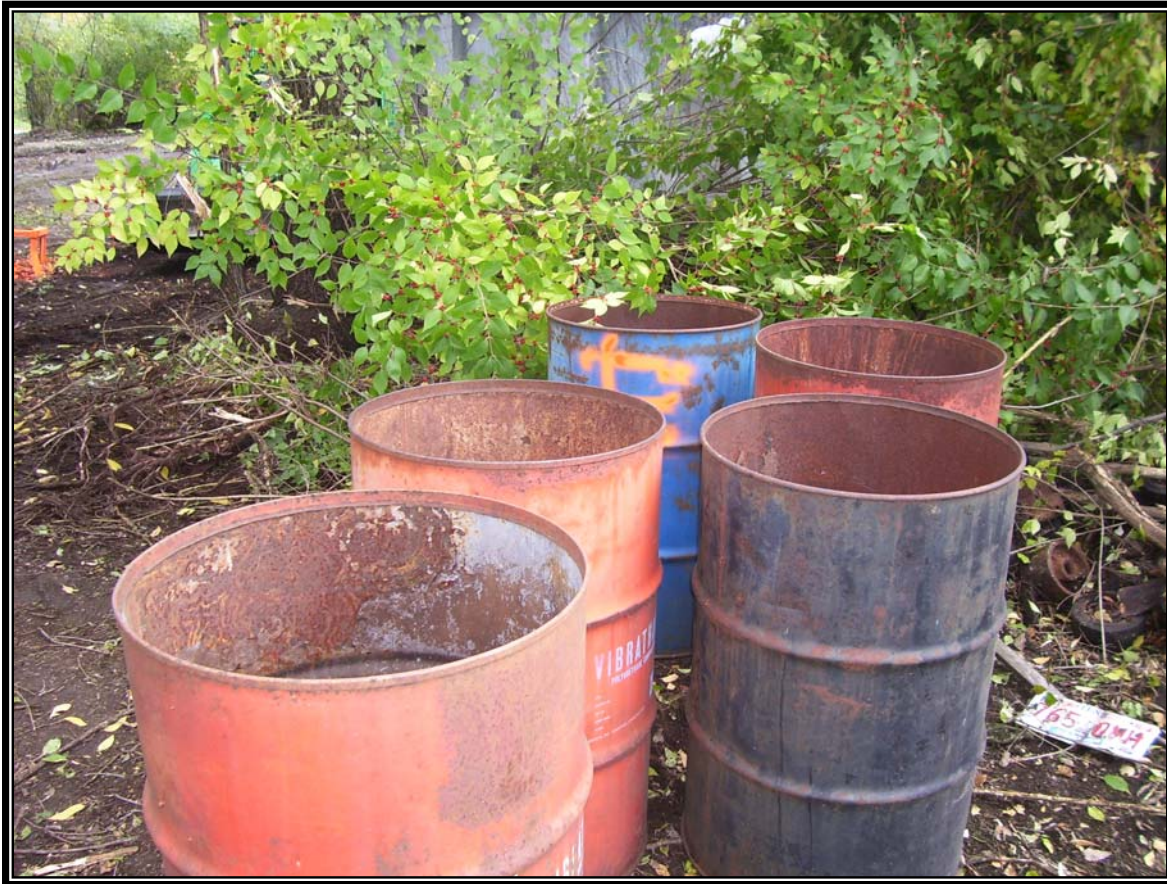
OFFICIAL PHOTOGRAPH NO. 3
U.S. ENVIRONMENTAL PROTECTION AGENCY
TENNESSEE WHEEL AND RUBBER
NASHVILLE, DAVIDSON COUNTY, TENNESSE

Subject: Typical empty drums removed from the overgrown vegetation.

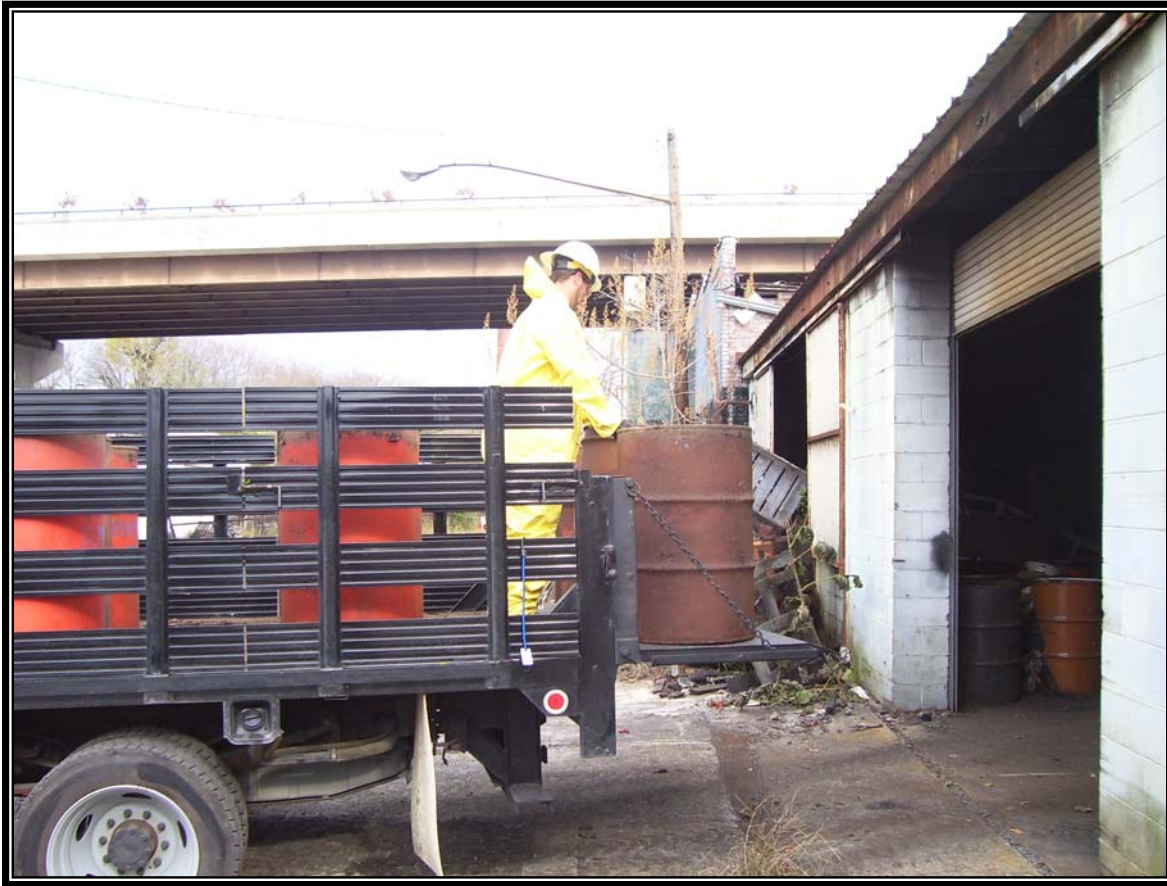
OFFICIAL PHOTOGRAPH NO. 5
U.S. ENVIRONMENTAL PROTECTION AGENCY
TENNESSEE WHEEL AND RUBBER
NASHVILLE, DAVIDSON COUNTY, TENNESSE

Subject: Loading of drums onto a flat-bed truck for transport to the on-site drum storage area.

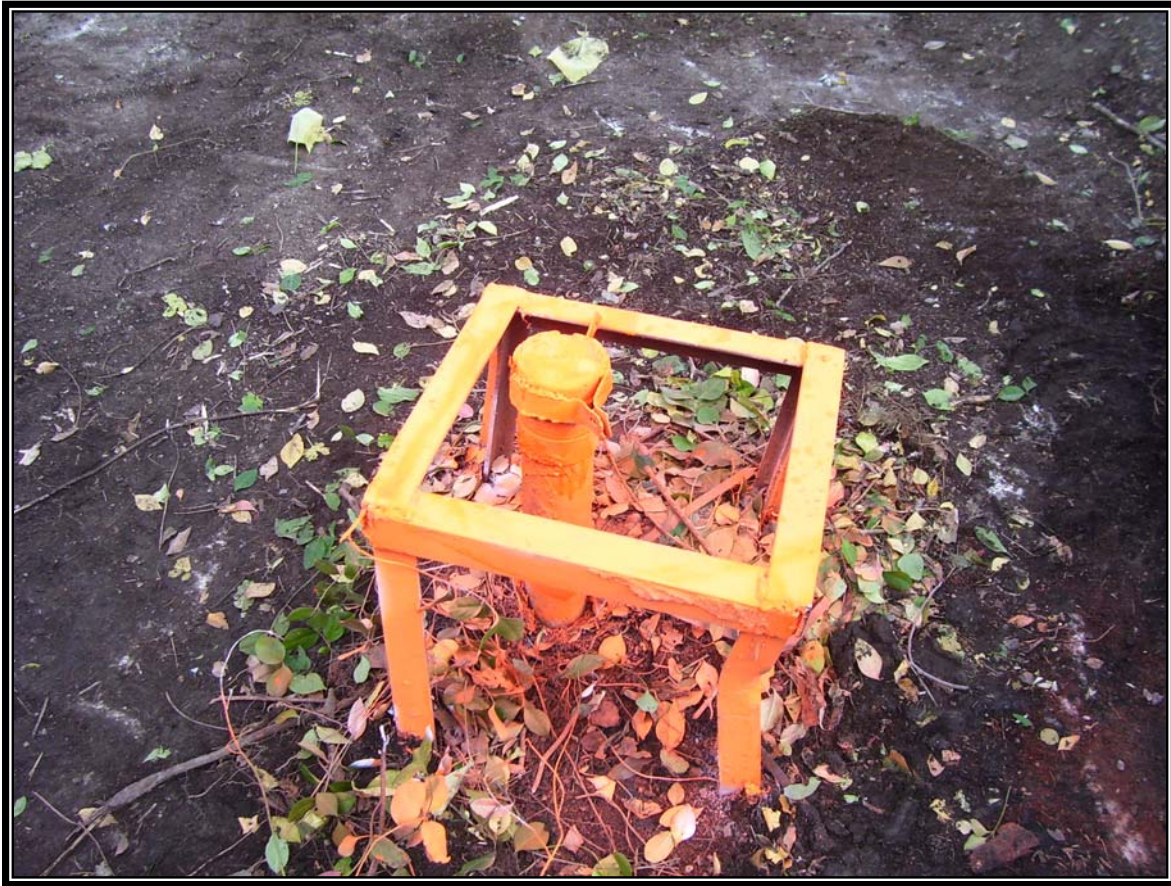
OFFICIAL PHOTOGRAPH NO. 8
U.S. ENVIRONMENTAL PROTECTION AGENCY
TENNESSEE WHEEL AND RUBBER
NASHVILLE, DAVIDSON COUNTY, TENNESSE

Subject: Underground storage tank (UST) fill port discovered during clearing and grubbing activities near the northern boundary of the site. The fill port was marked with highly visible safety paint by SWS personnel.

vegetation. SWS personnel conspicuously painted the fill port with orange marking paint to preclude accidental damage during operations.

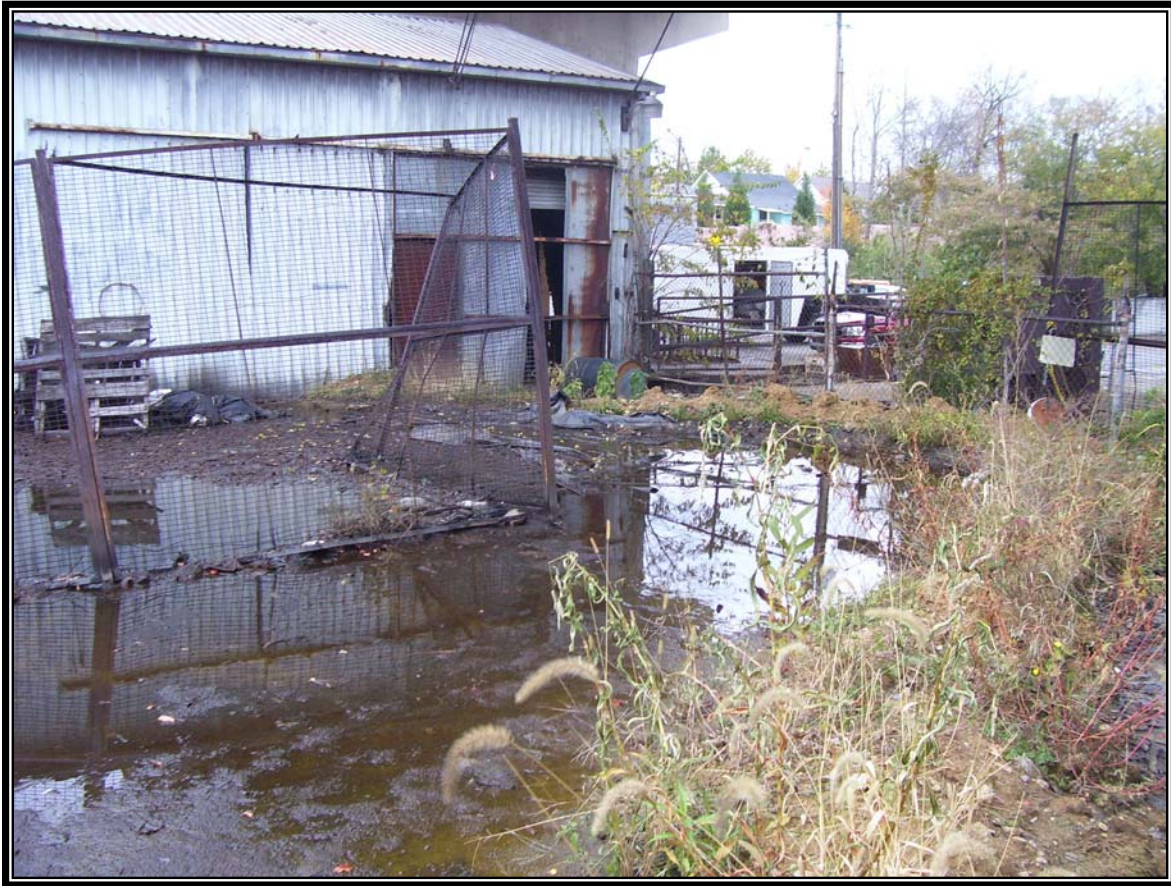
OFFICIAL PHOTOGRAPH NO. 9
U.S. ENVIRONMENTAL PROTECTION AGENCY
TENNESSEE WHEEL AND RUBBER
NASHVILLE, DAVIDSON COUNTY, TENNESSEE

Subject: Standing water impounded in the courtyard by the underflow dam erected during the initial response.

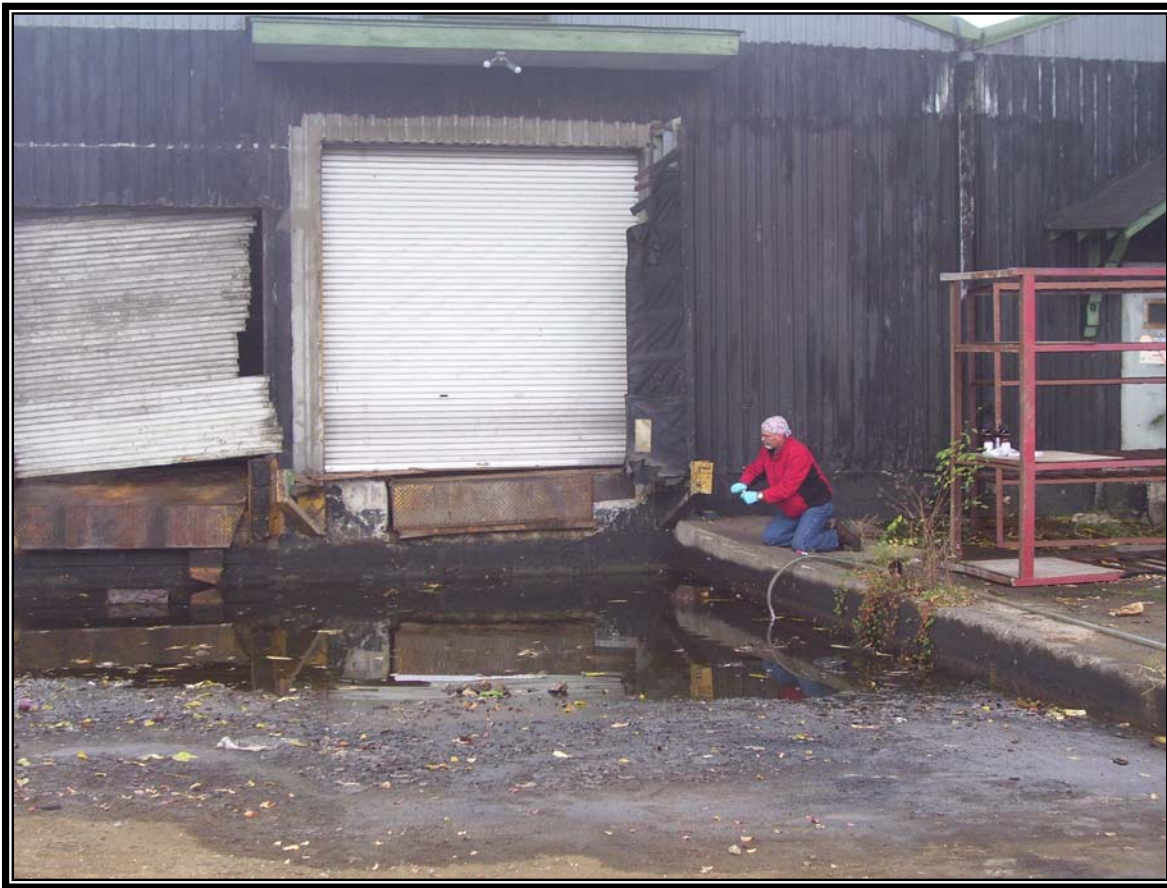
OFFICIAL PHOTOGRAPH NO. 10
U.S. ENVIRONMENTAL PROTECTION AGENCY
TENNESSEE WHEEL AND RUBBER
NASHVILLE, DAVIDSON COUNTY, TENNESSE

The underflow dam erected in the courtyard during the initial response was retaining a substantial amount of storm water. After assuring that there was no evidence of oil sheen and using litmus paper to verify that the pH was in the neutral range, OSC Mr. Andrews tasked SWS personnel breach the dam and allow the impounded water to drain via gravity into another pool of water located at the loading dock on the eastern side of the north building. SWS later used a diaphragm pump to drain the area behind the underflow dam. Approximately one-half of the water impounded by the underflow dam was pumped prior to the end of daily operations.

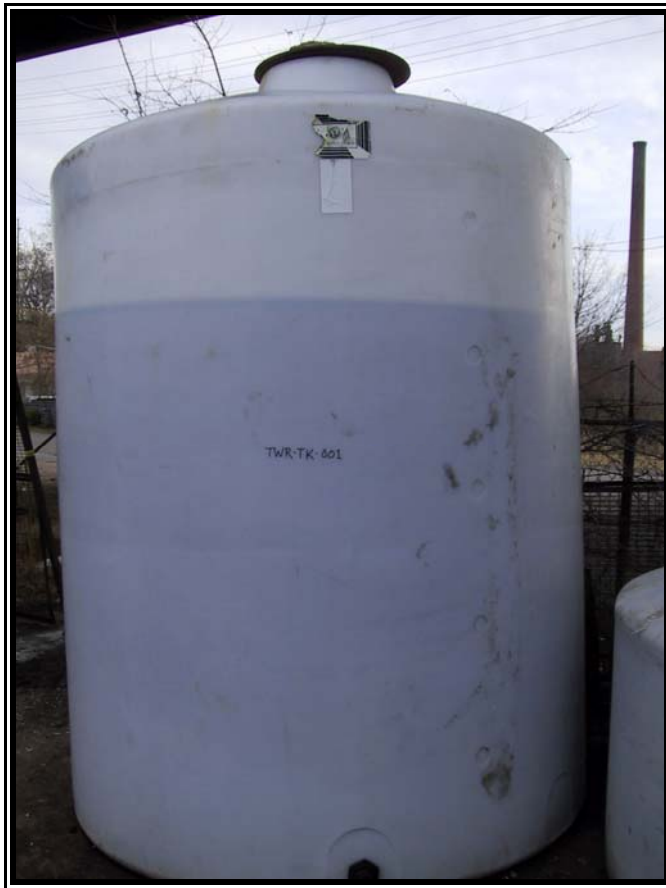
**OFFICIAL PHOTOGRAPH NO. 11
U.S. ENVIRONMENTAL PROTECTION AGENCY
TENNESSEE WHEEL AND RUBBER
NASHVILLE, DAVIDSON COUNTY, TENNESSE**

Subject: Portable tank (TWR-TK-001) used to impound site groundwater and water pumped from drums and containers on site pending sampling. Sampling results indicated that the water in all three tanks was nonhazardous and the City of Nashville publicly-owned treatment works (POTW) agreed to allow the water to be pumped or released into a nearby storm drain.

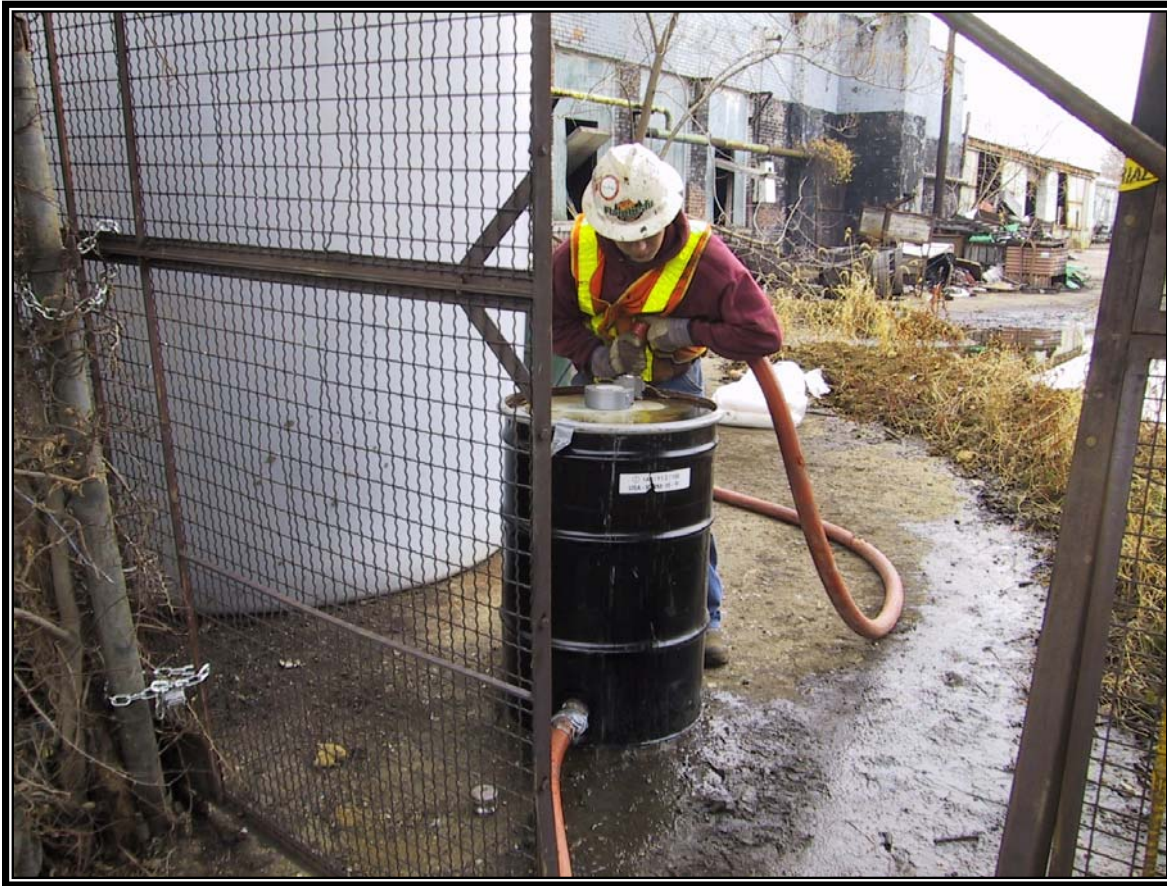
OFFICIAL PHOTOGRAPH NO. 14
U.S. ENVIRONMENTAL PROTECTION AGENCY
TENNESSEE WHEEL AND RUBBER
NASHVILLE, DAVIDSON COUNTY, TENNESSE

Subject: SWS personnel pumping tank water through an inline filter sock (inside drum) prior to discharge to the POTW via a nearby storm drain.

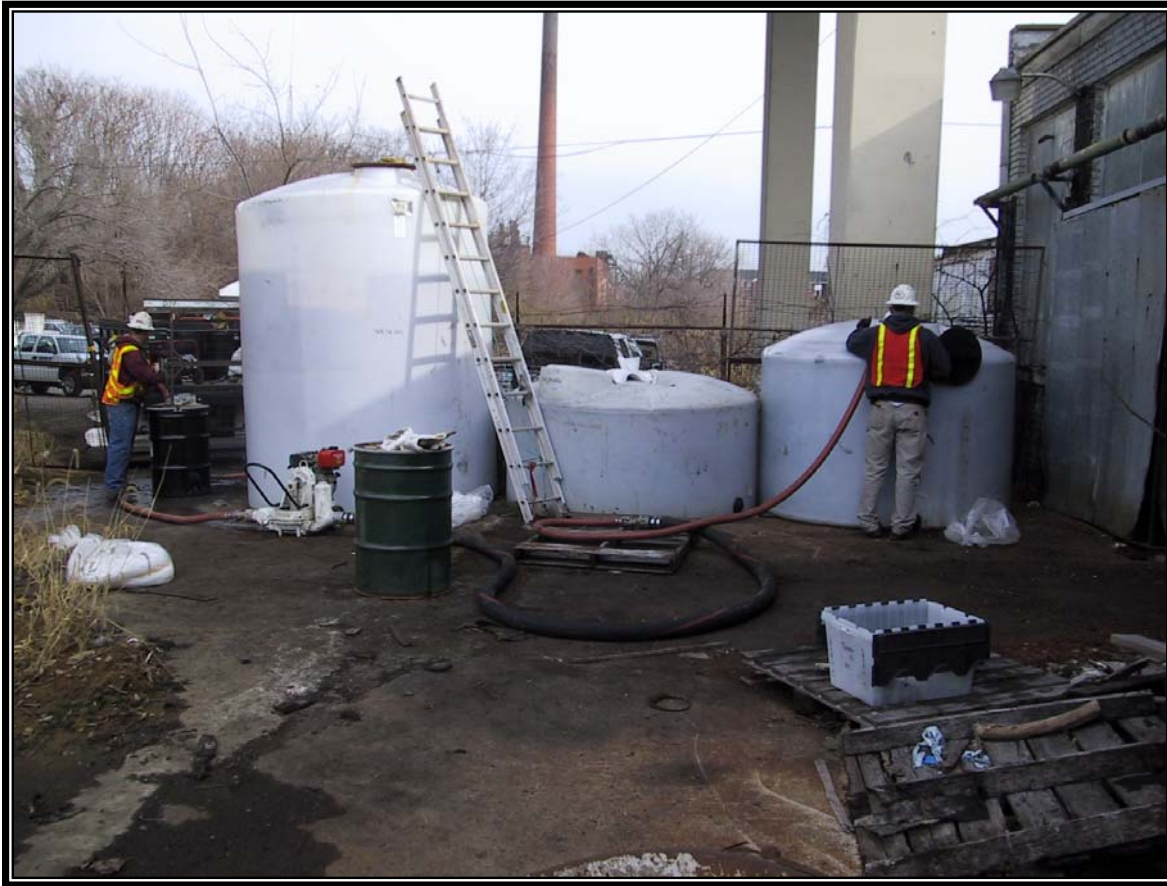
OFFICIAL PHOTOGRAPH NO. 17
U.S. ENVIRONMENTAL PROTECTION AGENCY
TENNESSEE WHEEL AND RUBBER
NASHVILLE, DAVIDSON COUNTY, TENNESSE

Subject: SWS personnel actively pumping water from tank TWR-TK-003 to the storm drain via an inline filter sock.

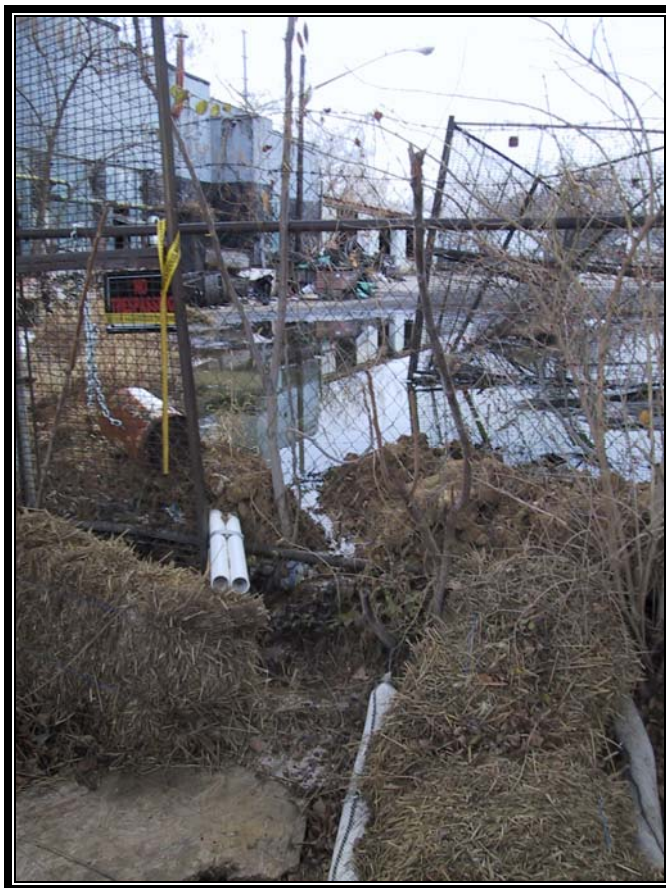
OFFICIAL PHOTOGRAPH NO. 18
U.S. ENVIRONMENTAL PROTECTION AGENCY
TENNESSEE WHEEL AND RUBBER
NASHVILLE, DAVIDSON COUNTY, TENNESSE

Subject: Underflow dam breached to allow water to gravity flow to the POTW via a nearby storm drain.

At 1040, Mr. Roop and Mr. Cox of TDEC arrived to review operations. All tanks were empty by 1114. KEMRON and SWS were also tasked by EPA to locate any additional containers of suspected hazardous substances and stage them for disposal with the balance of the waste from the initial response. KEMRON inventoried all site waste in order to arrange disposal or recycling as appropriate. Additionally, the water impounded by the underflow dam erected in the courtyard during the initial response was again pumped to the POTW. With the approval of OSC Mr. Sims, the dam was also breached and allowed to flow via gravity to the storm drain.

1139 CALLED FOSC SEMS AND ASKED IF
WE COULD CRACK THE UNDERFLOW
DAM AND LET THE WATER DRAIN
TO THE STORM DRAIN NATURALLY;
FOSC SEMS AGREED

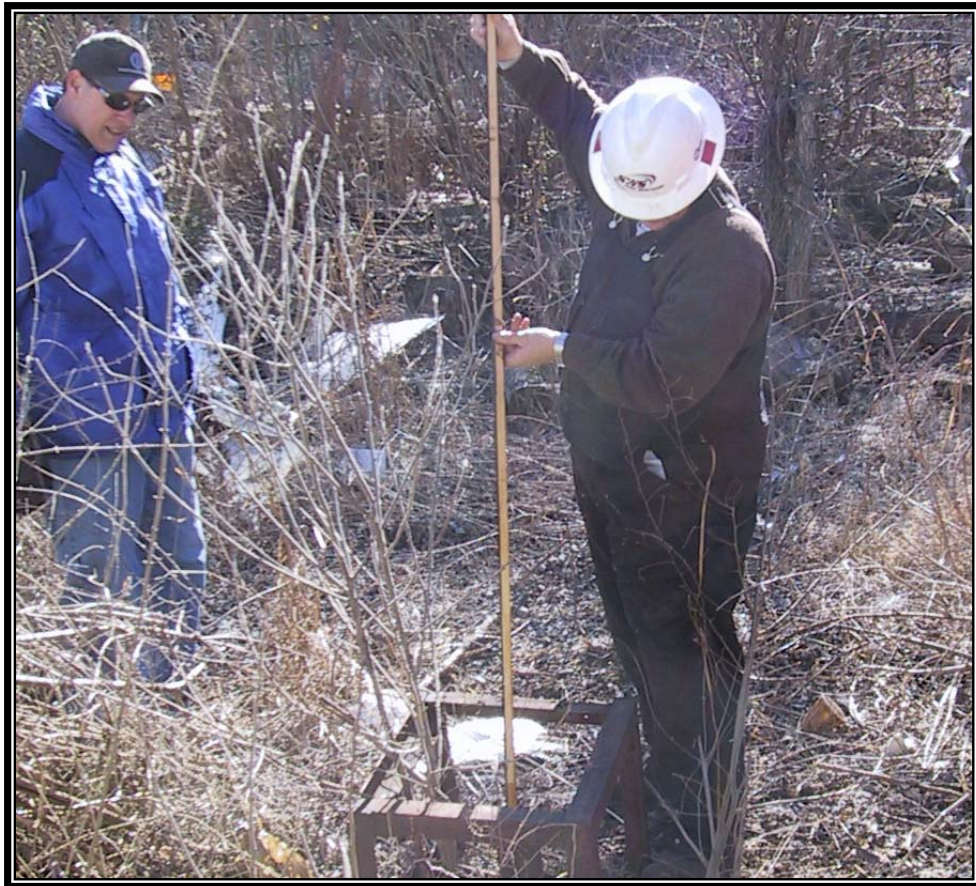
**OFFICIAL PHOTOGRAPH NO. 20
U.S. ENVIRONMENTAL PROTECTION AGENCY
TENNESSEE WHEEL AND RUBBER
NASHVILLE, DAVIDSON COUNTY, TENNESSE**

Subject: UST discovered in the southwestern portion of the site.

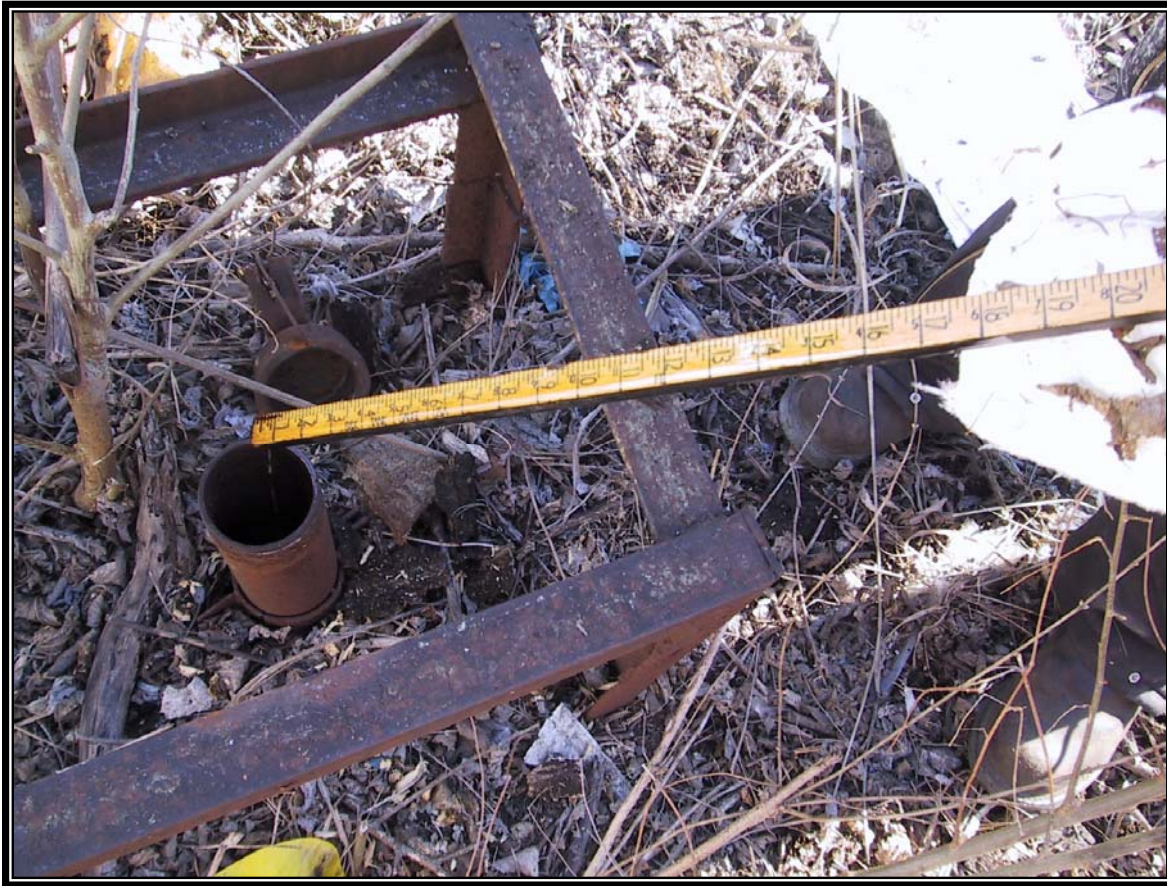
OFFICIAL PHOTOGRAPH NO. 21
U.S. ENVIRONMENTAL PROTECTION AGENCY
TENNESSEE WHEEL AND RUBBER
NASHVILLE, DAVIDSON COUNTY, TENNESSE

Subject: Close-up view of gauge stick coated with presumed fuel oil from UST discovered in the southwestern portion of the site.

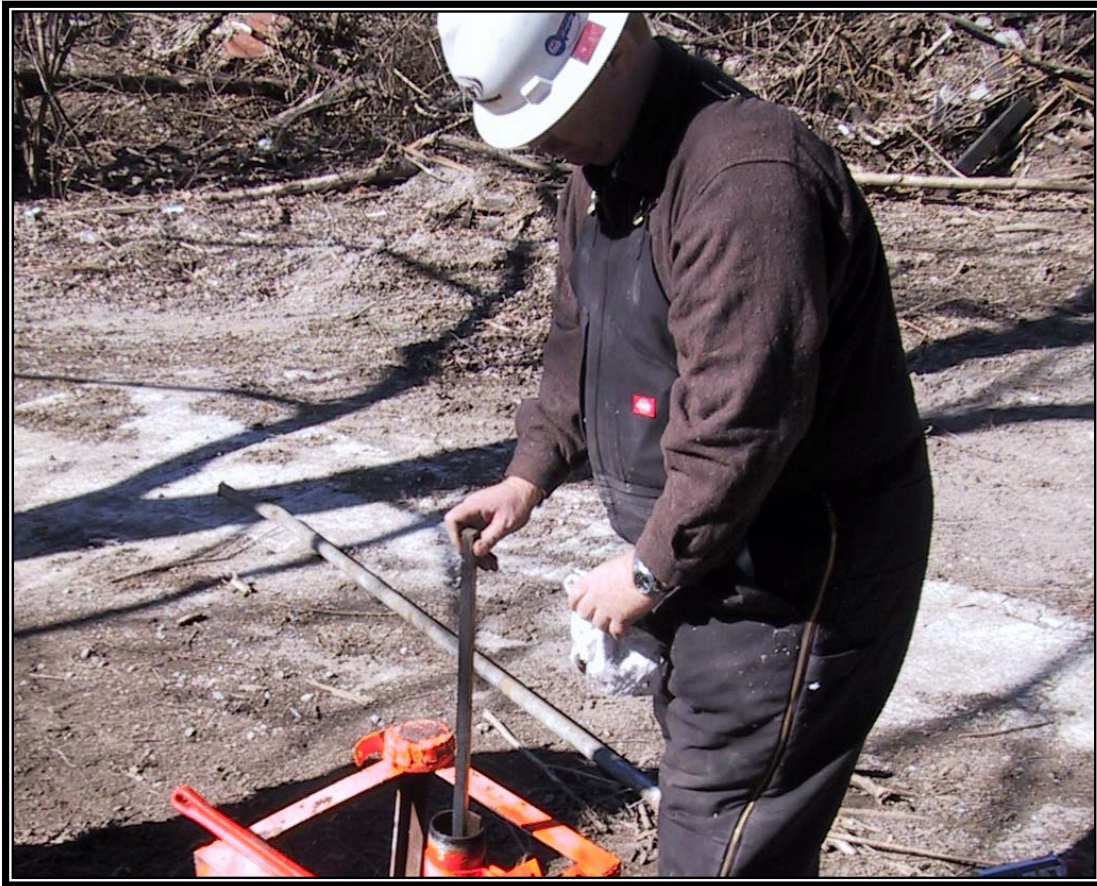
OFFICIAL PHOTOGRAPH NO. 22
U.S. ENVIRONMENTAL PROTECTION AGENCY
TENNESSEE WHEEL AND RUBBER
NASHVILLE, DAVIDSON COUNTY, TENNESSEE

Subject: UST discovered in the northern portion of the site.

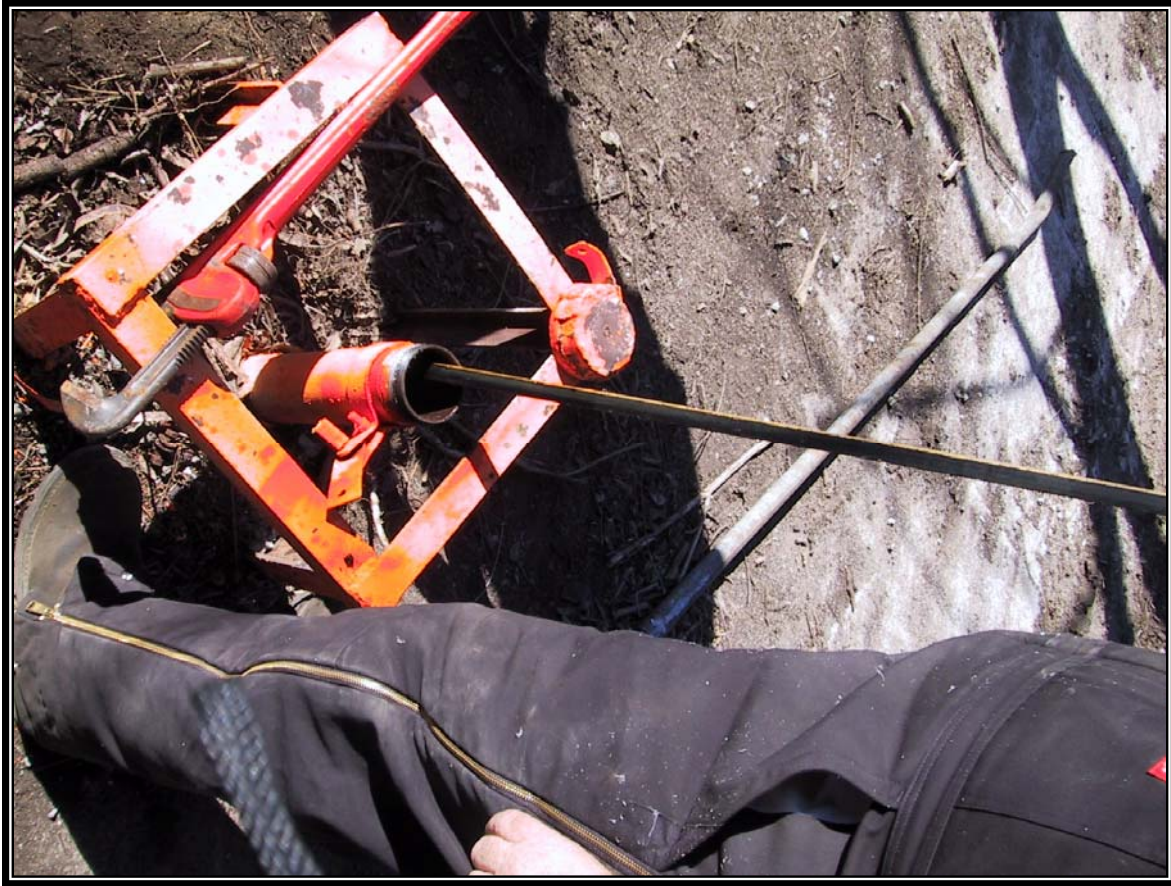
OFFICIAL PHOTOGRAPH NO. 23
U.S. ENVIRONMENTAL PROTECTION AGENCY
TENNESSEE WHEEL AND RUBBER
NASHVILLE, DAVIDSON COUNTY, TENNESSEE

Subject: Close-up view of gauge stick coated with presumed fuel oil from UST discovered in the northern portion of the site.

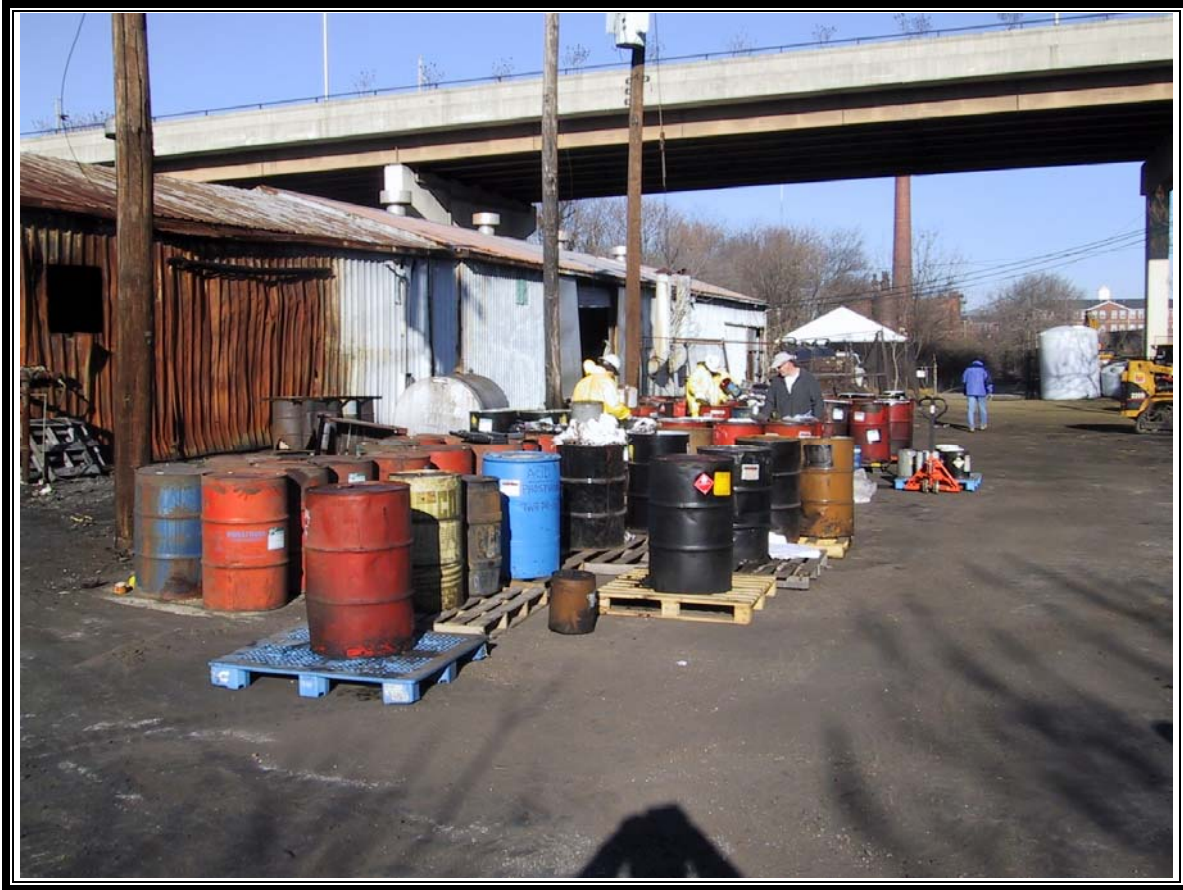
OFFICIAL PHOTOGRAPH NO. 25
U.S. ENVIRONMENTAL PROTECTION AGENCY
TENNESSEE WHEEL AND RUBBER
NASHVILLE, DAVIDSON COUNTY, TENNESSEE

Subject: Waste staging for shipment.

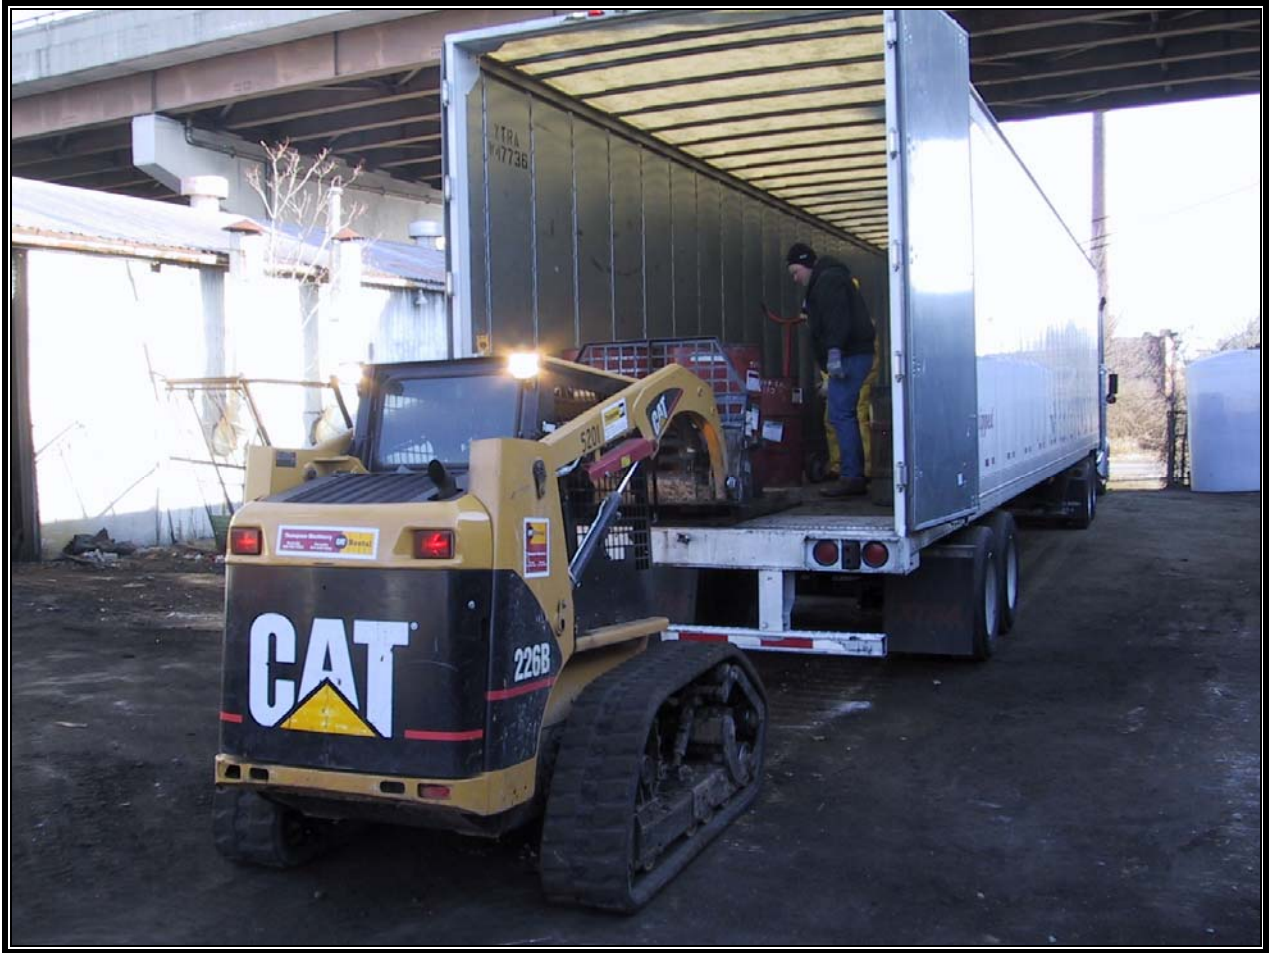
OFFICIAL PHOTOGRAPH NO. 26
U.S. ENVIRONMENTAL PROTECTION AGENCY
TENNESSEE WHEEL AND RUBBER
NASHVILLE, DAVIDSON COUNTY, TENNESSE

Subject: Waste staging, labeling, and documentation for shipment.

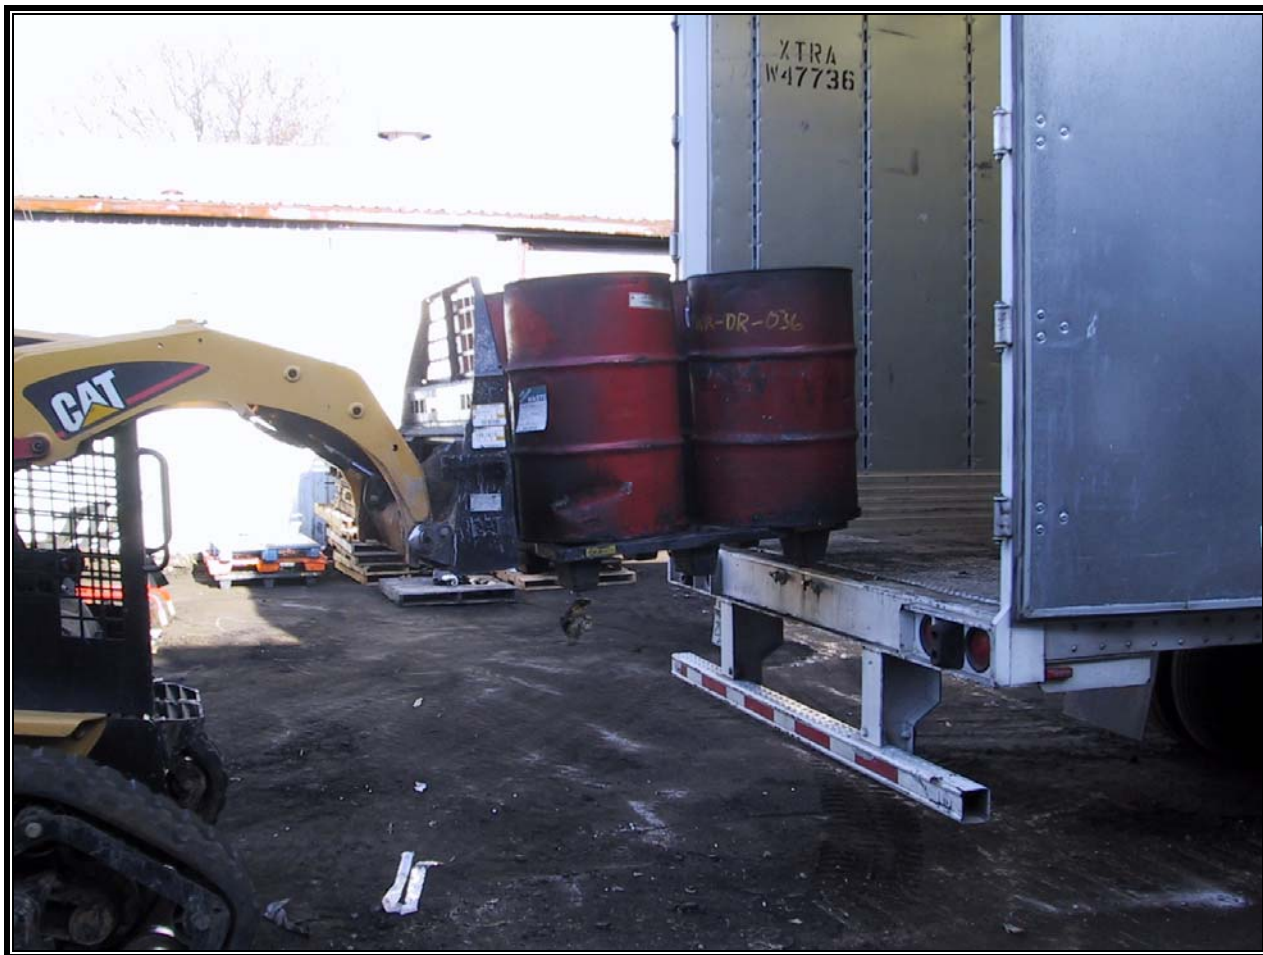
OFFICIAL PHOTOGRAPH NO. 27
U.S. ENVIRONMENTAL PROTECTION AGENCY
TENNESSEE WHEEL AND RUBBER
NASHVILLE, DAVIDSON COUNTY, TENNESSE

Subject: Loading waste aboard the transport vehicle (1).
