**COMPREHENSIVE ENVIRONMENTAL RESPONSE,
COMPENSATION AND LIABILITY ACT
EMERGENCY RESPONSE REPORT**

**TENNESSEE WHEEL AND RUBBER
NASHVILLE, DAVIDSON COUNTY, TENNESSEE
EPA CONTRACT No. EP-W-05-054
TDD No. TTEMI-05-001-0017**

**CERCLA EMERGENCY RESPONSE REPORT
TENNESSEE WHEEL AND RUBBER
NASHVILLE, DAVIDSON COUNTY, TENNESSEE
EPA CONTRACT No. EP-W-05-054
TDD No. TTEMI-05-001-0017**

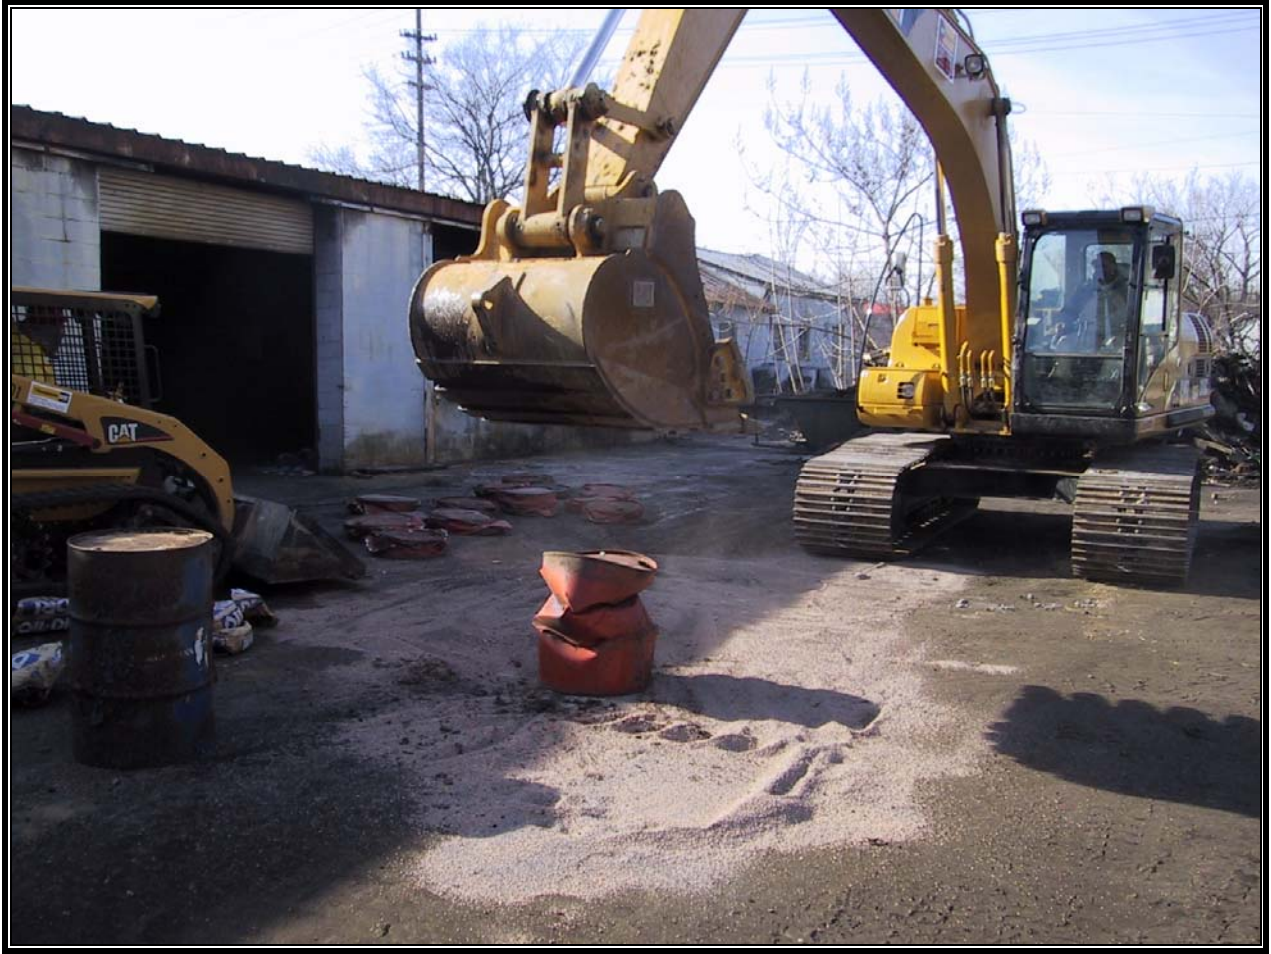
OFFICIAL PHOTOGRAPH NO. 28
U.S. ENVIRONMENTAL PROTECTION AGENCY
TENNESSEE WHEEL AND RUBBER
NASHVILLE, DAVIDSON COUNTY, TENNESSE

Subject: Empty drum crushing activities (1).

KEMRON arranged for Nashville Barrel and Drum to collect and recycle empty drums in good condition. An excavator operated by CMC, Inc., another EPA Region 4 ERRS contractor, would be utilized to crush empty drums that were unsuitable for recycling. The crushed drums would remain at the site.

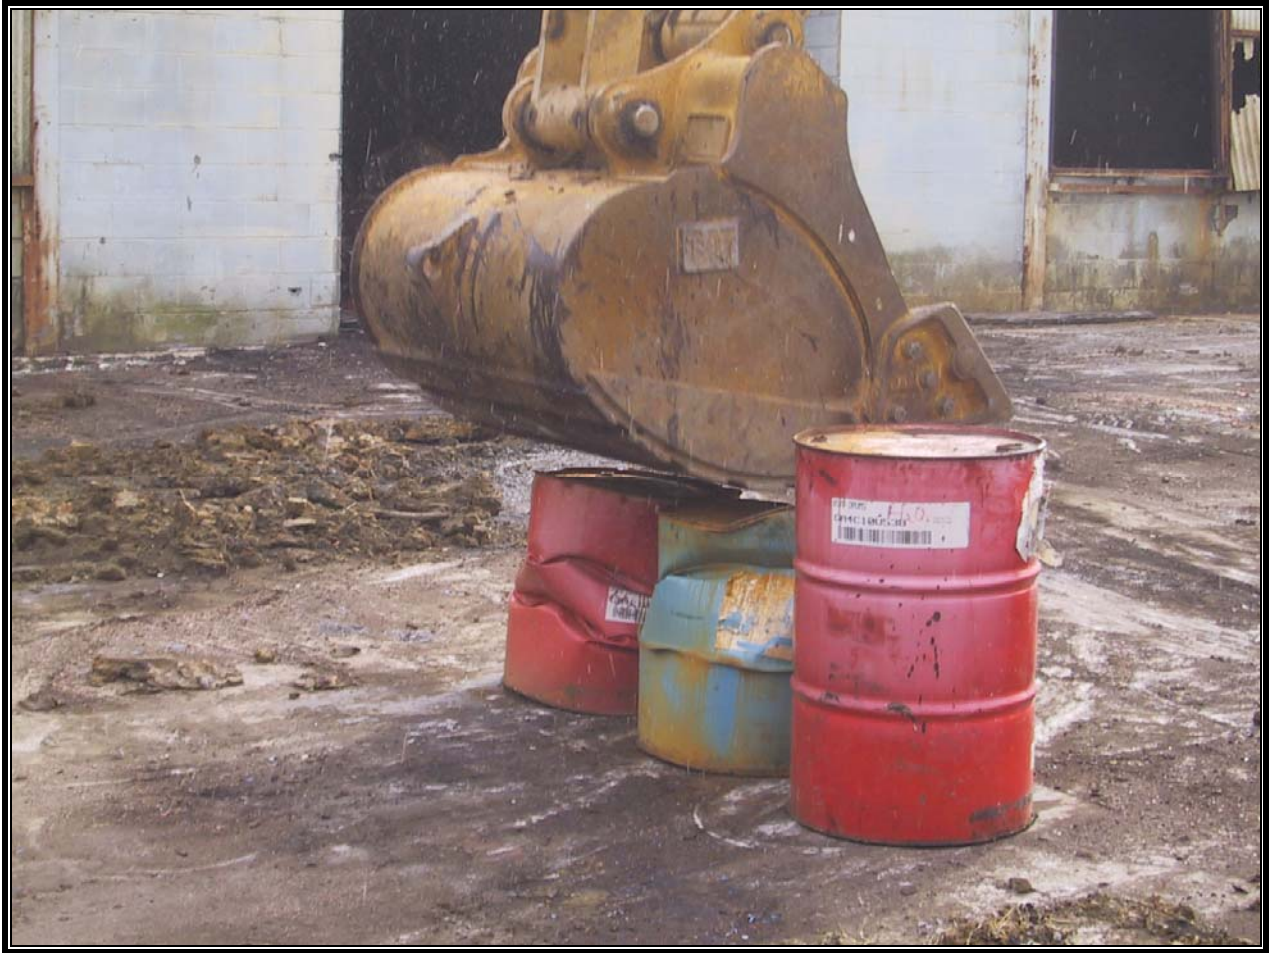
OFFICIAL PHOTOGRAPH NO. 30
U.S. ENVIRONMENTAL PROTECTION AGENCY
TENNESSEE WHEEL AND RUBBER
NASHVILLE, DAVIDSON COUNTY, TENNESSE

Subject: Empty drums staged within the south building to preclude impacting site runoff.

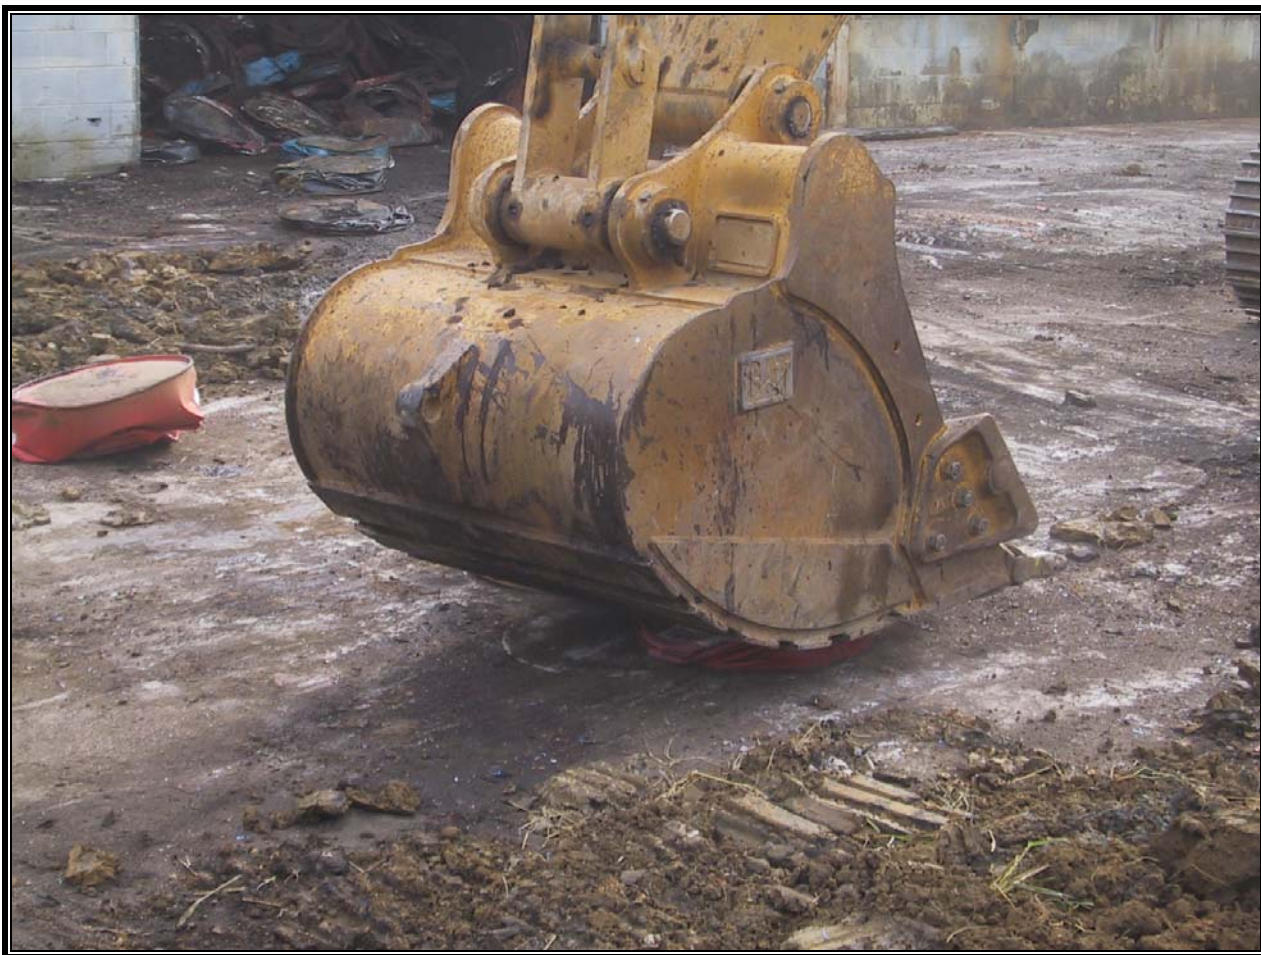
**OFFICIAL PHOTOGRAPH NO. 31
U.S. ENVIRONMENTAL PROTECTION AGENCY
TENNESSEE WHEEL AND RUBBER
NASHVILLE, DAVIDSON COUNTY, TENNESSE**

Subject: Empty drum crushing activities (2).

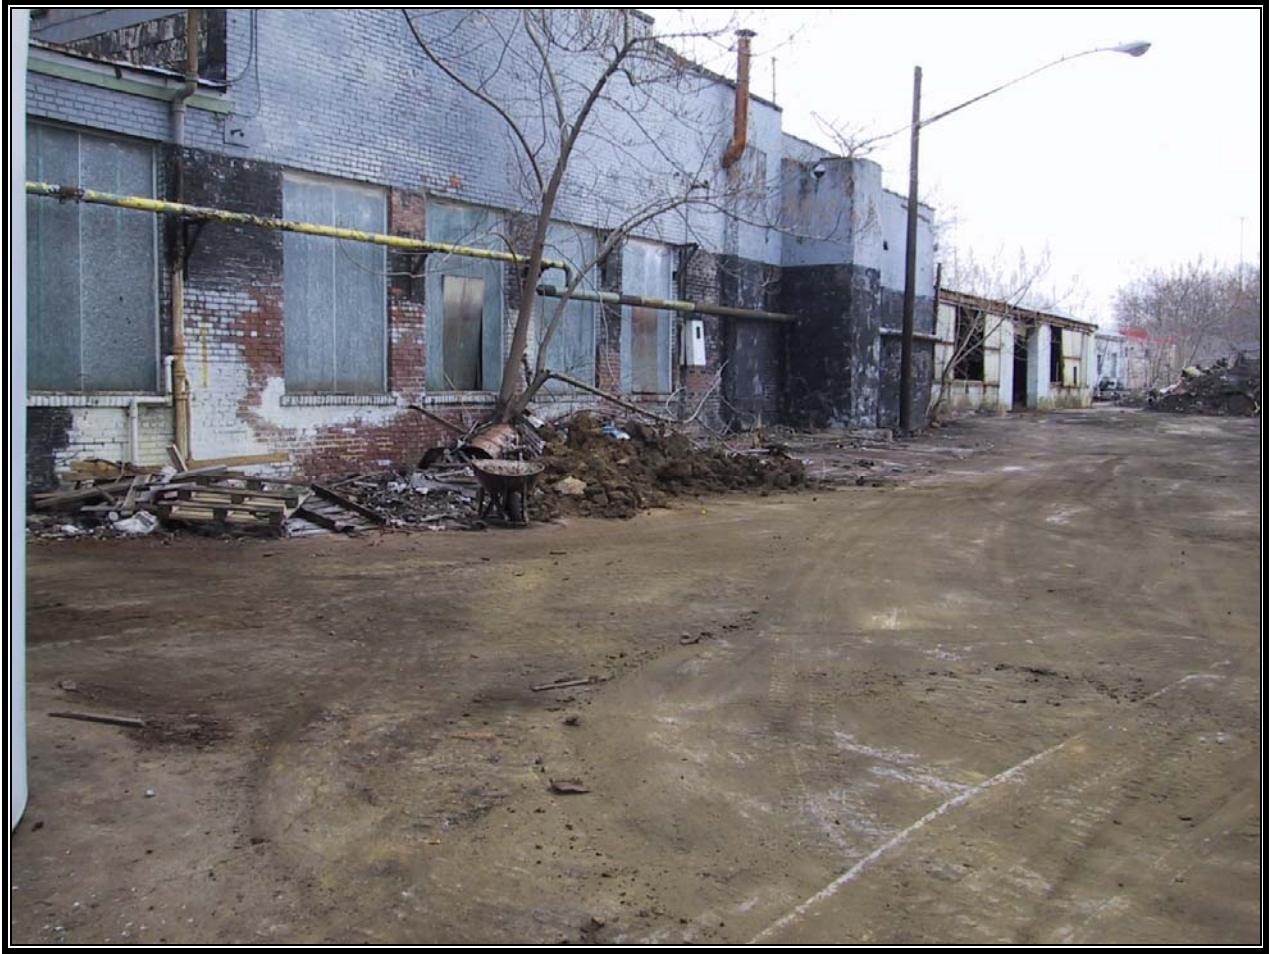
OFFICIAL PHOTOGRAPH NO. 33
U.S. ENVIRONMENTAL PROTECTION AGENCY
TENNESSEE WHEEL AND RUBBER
NASHVILLE, DAVIDSON COUNTY, TENNESSE

Subject: Northern side of the courtyard prior to demobilization, including debris pile.

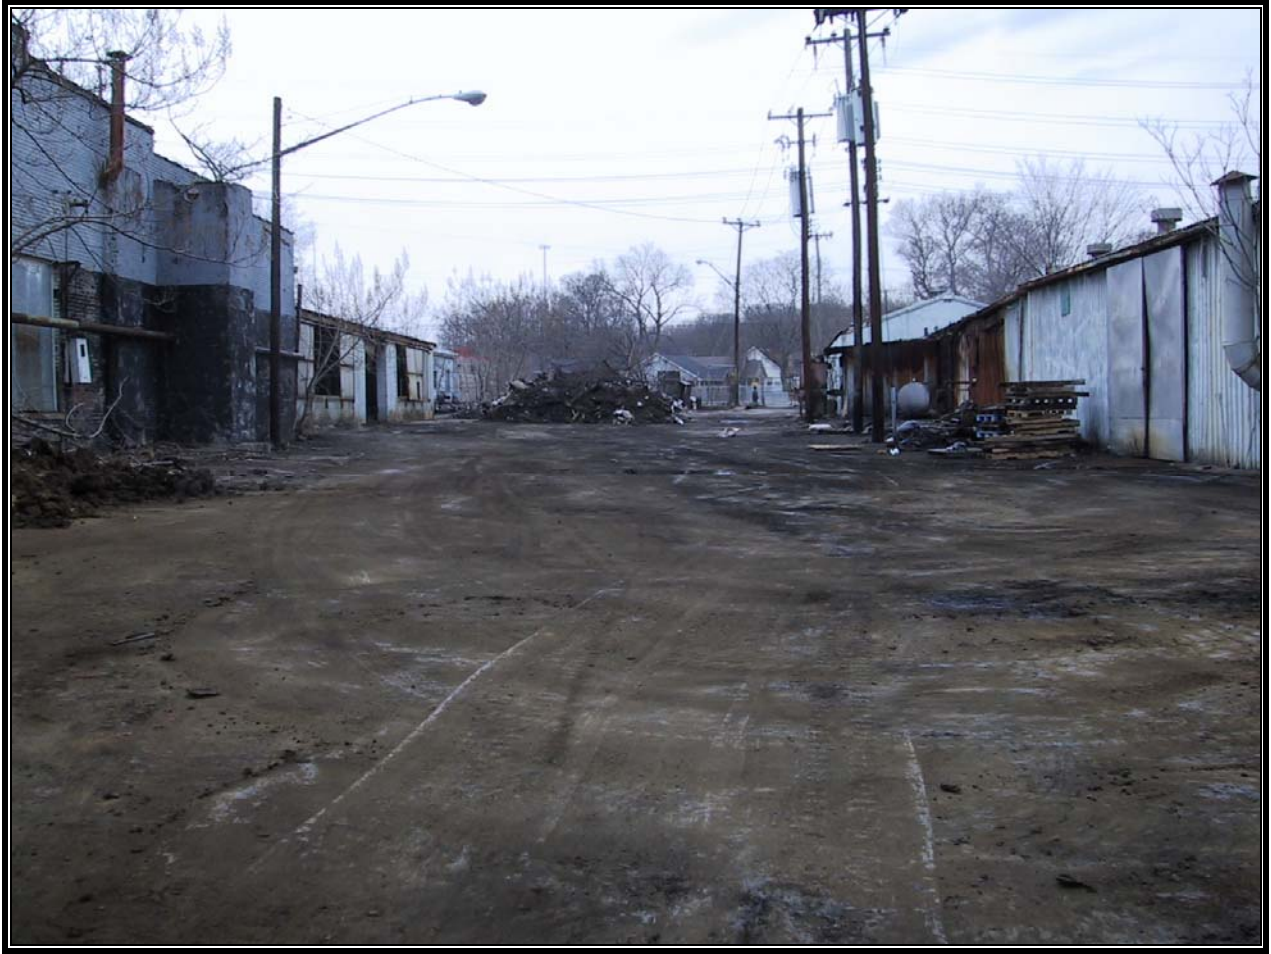
**OFFICIAL PHOTOGRAPH NO. 34
U.S. ENVIRONMENTAL PROTECTION AGENCY
TENNESSEE WHEEL AND RUBBER
NASHVILLE, DAVIDSON COUNTY, TENNESSE**

Subject: Southern side of the courtyard prior to demobilization.

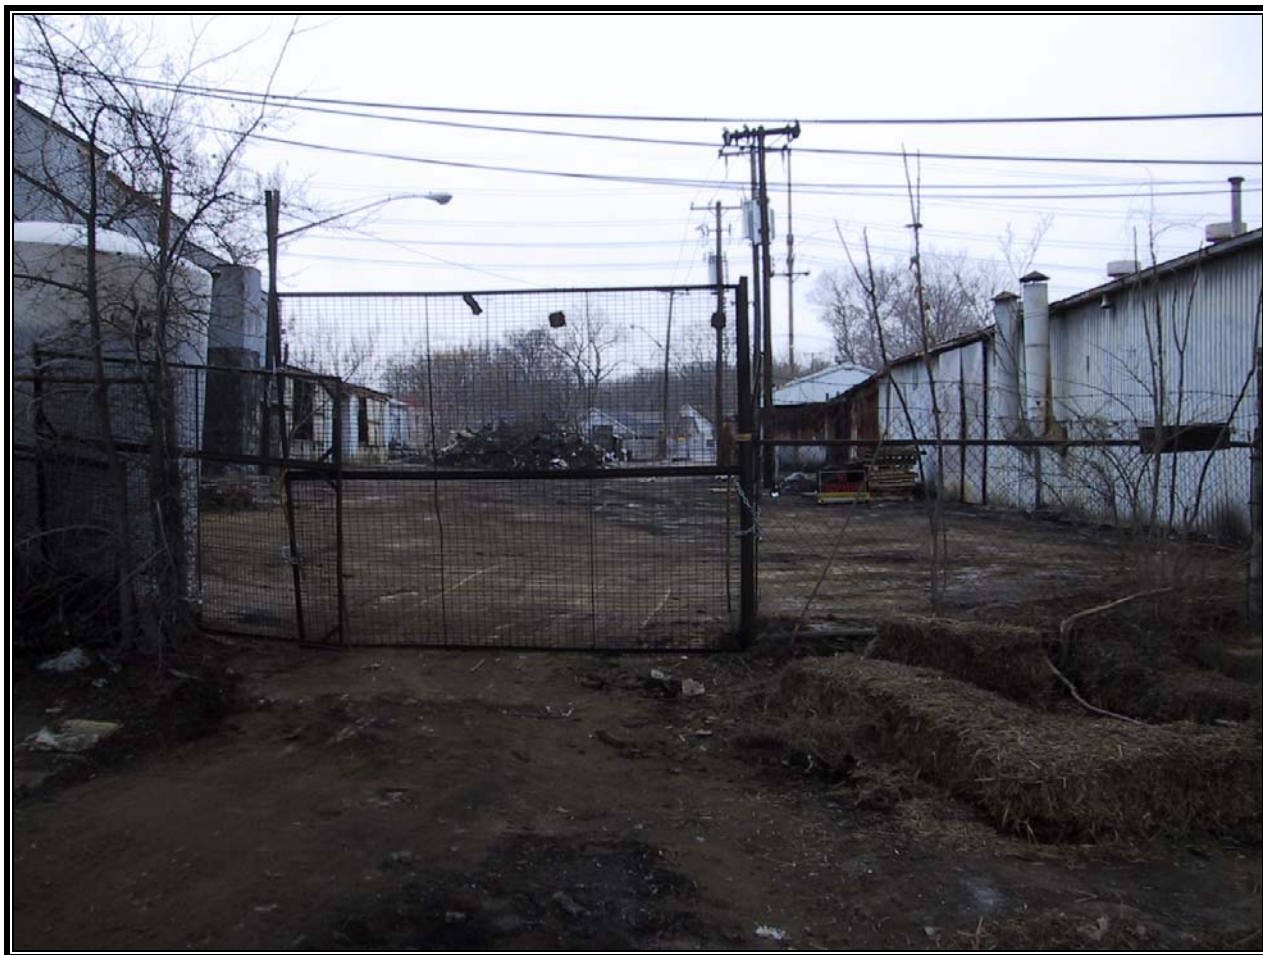
OFFICIAL PHOTOGRAPH NO. 35
U.S. ENVIRONMENTAL PROTECTION AGENCY
TENNESSEE WHEEL AND RUBBER
NASHVILLE, DAVIDSON COUNTY, TENNESSE

Subject: Courtyard prior to demobilization.

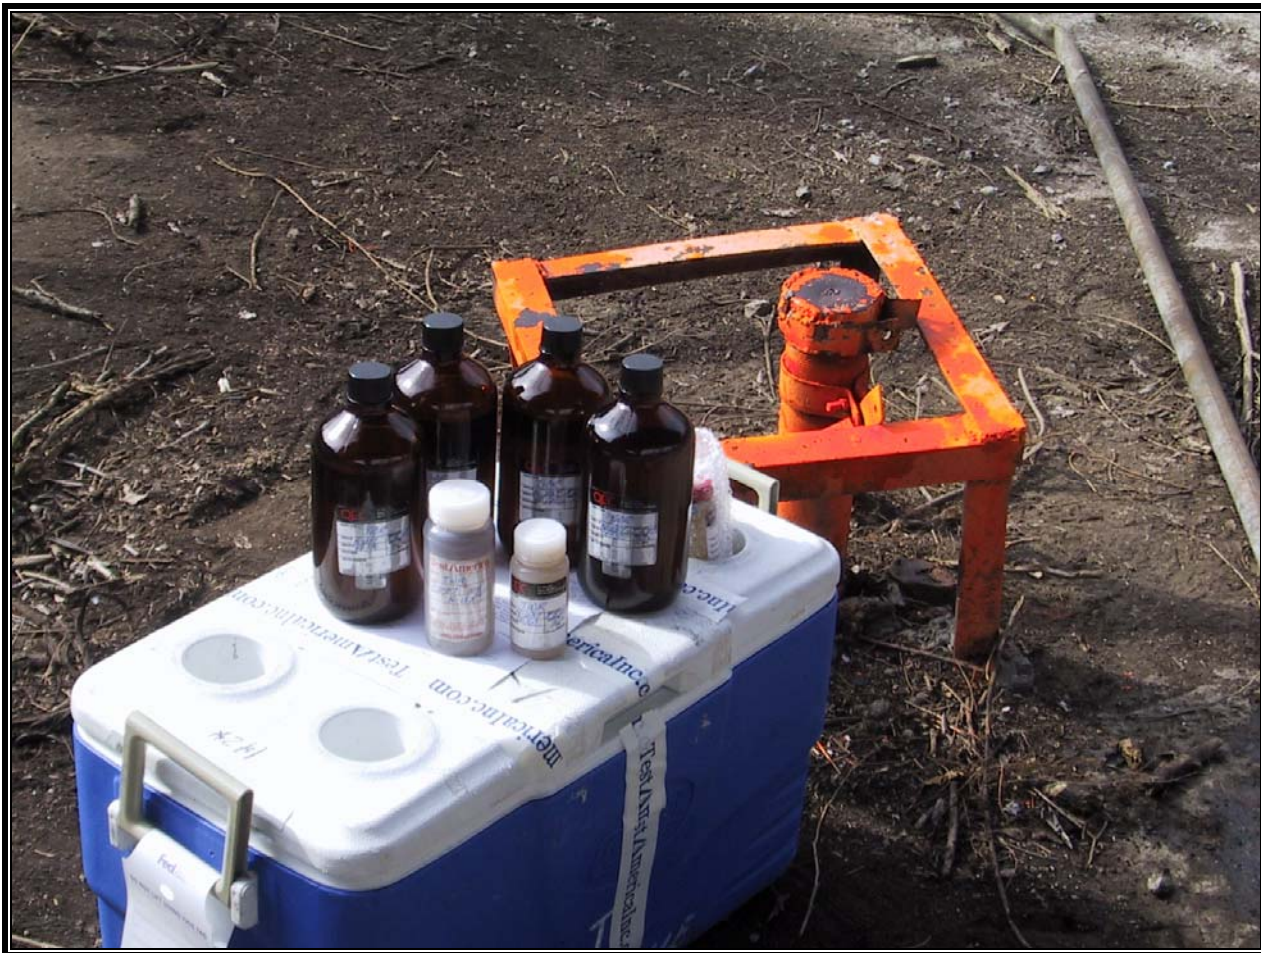
OFFICIAL PHOTOGRAPH NO. 36
U.S. ENVIRONMENTAL PROTECTION AGENCY
TENNESSEE WHEEL AND RUBBER
NASHVILLE, DAVIDSON COUNTY, TENNESSEE

Subject: Secured gate prior to demobilization.

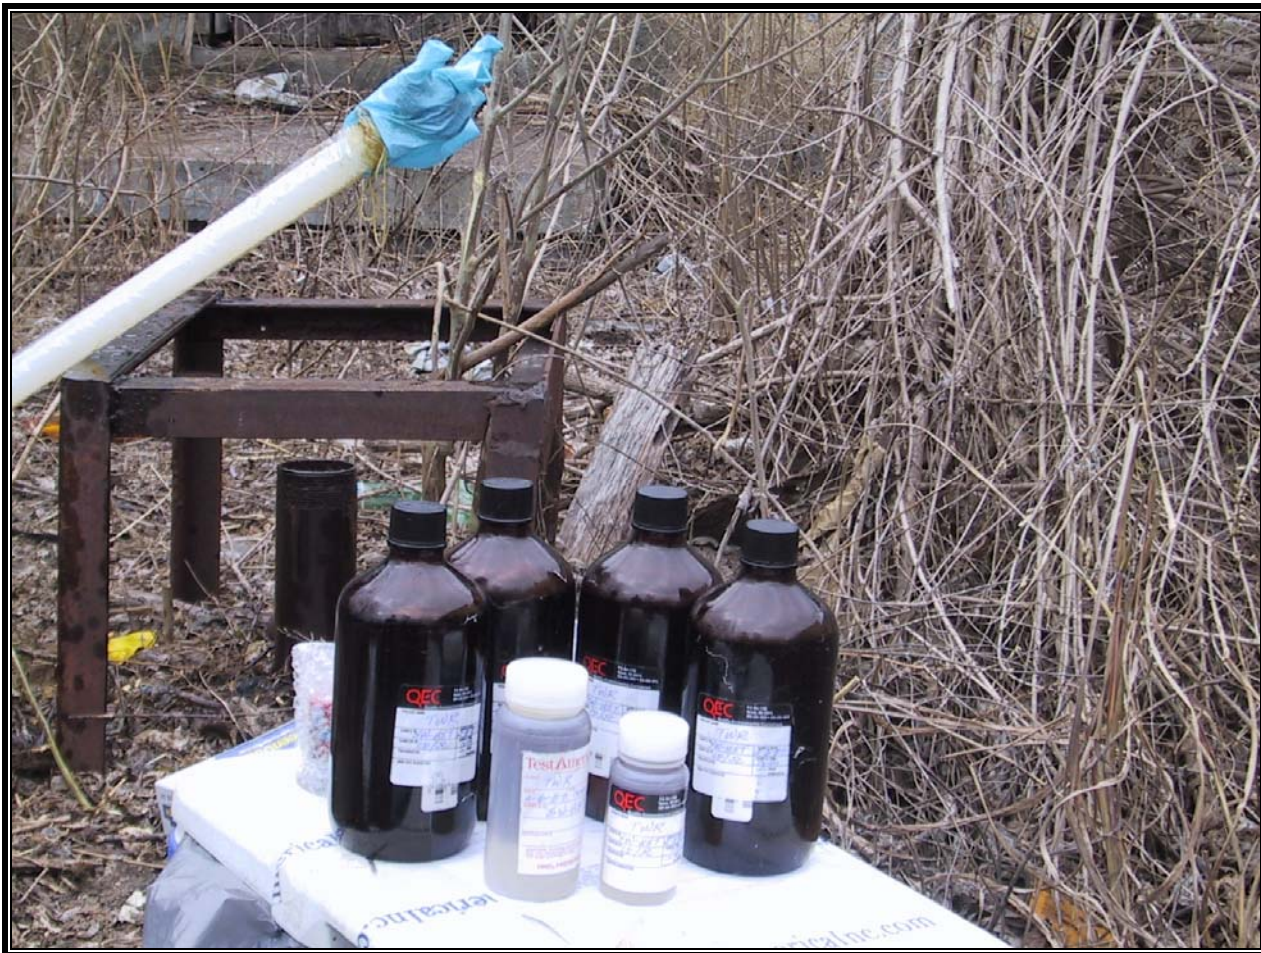
OFFICIAL PHOTOGRAPH NO. 37
U.S. ENVIRONMENTAL PROTECTION AGENCY
TENNESSEE WHEEL AND RUBBER
NASHVILLE, DAVIDSON COUNTY, TENNESSE

Subject: Samples collected from the north UST.

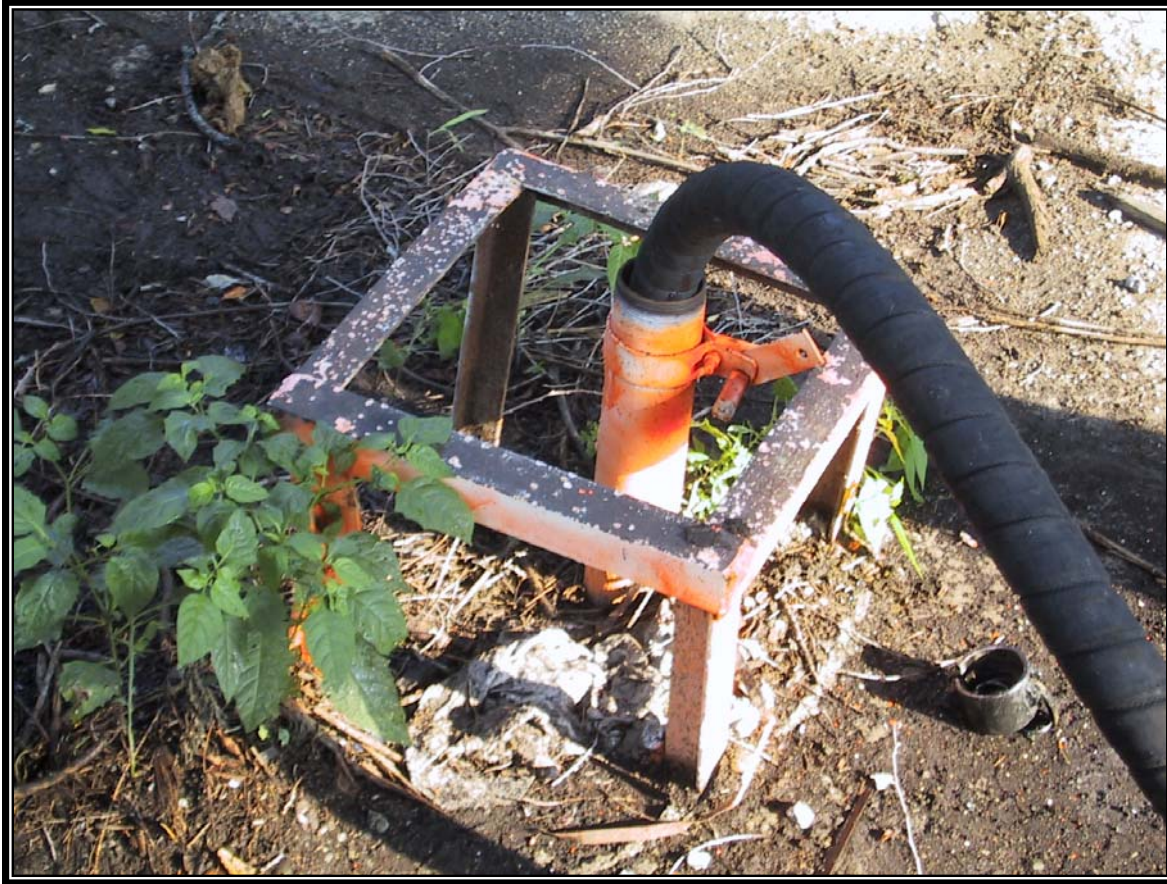
**OFFICIAL PHOTOGRAPH NO. 38
U.S. ENVIRONMENTAL PROTECTION AGENCY
TENNESSEE WHEEL AND RUBBER
NASHVILLE, DAVIDSON COUNTY, TENNESSE**

Subject: Universal Environmental Services, LLC (Universal) uses vacuum truck to pump
material remaining in the north UST.

- ❖ Sampling, pumping, transportation and recycling of 625 gallons of fuel oil identified in two USTs (see Attachments 6 and 7).

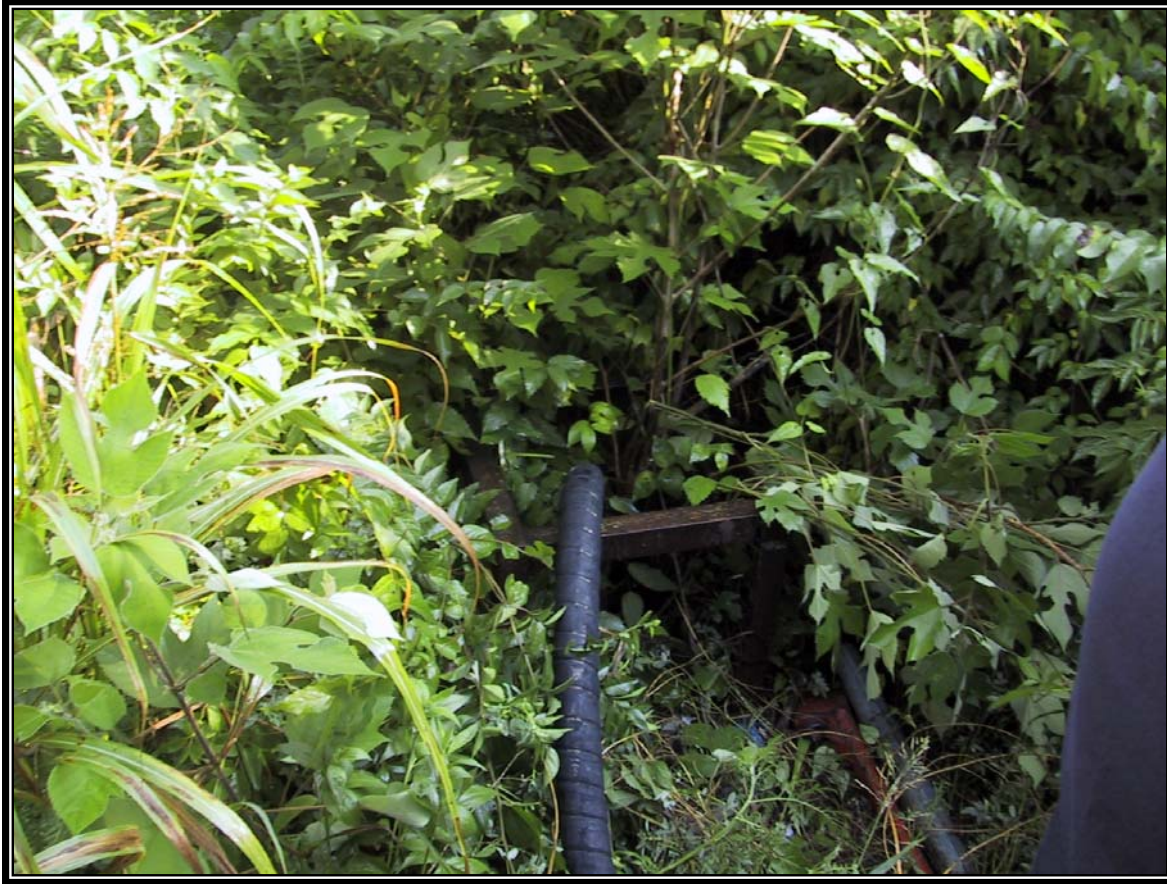
**OFFICIAL PHOTOGRAPH NO. 40
U.S. ENVIRONMENTAL PROTECTION AGENCY
TENNESSEE WHEEL AND RUBBER
NASHVILLE, DAVIDSON COUNTY, TENNESSE**

Subject: Universal vacuum truck used to pump USTs discovered at the site.
