**REMOVAL PROGRAM
AFTER ACTION REPORT
FOR THE
MURPHY PROPERTY (263 SALEM ST.) SITE
WOBURN, MIDDLESEX COUNTY, MASSACHUSETTS
27 AUGUST 2007 THROUGH 2 NOVEMBER 2007**

Weston Solutions, Inc.
Superfund Technical Assessment and Response Team (START)
3 Riverside Drive
Andover, Massachusetts 01810

March 2008

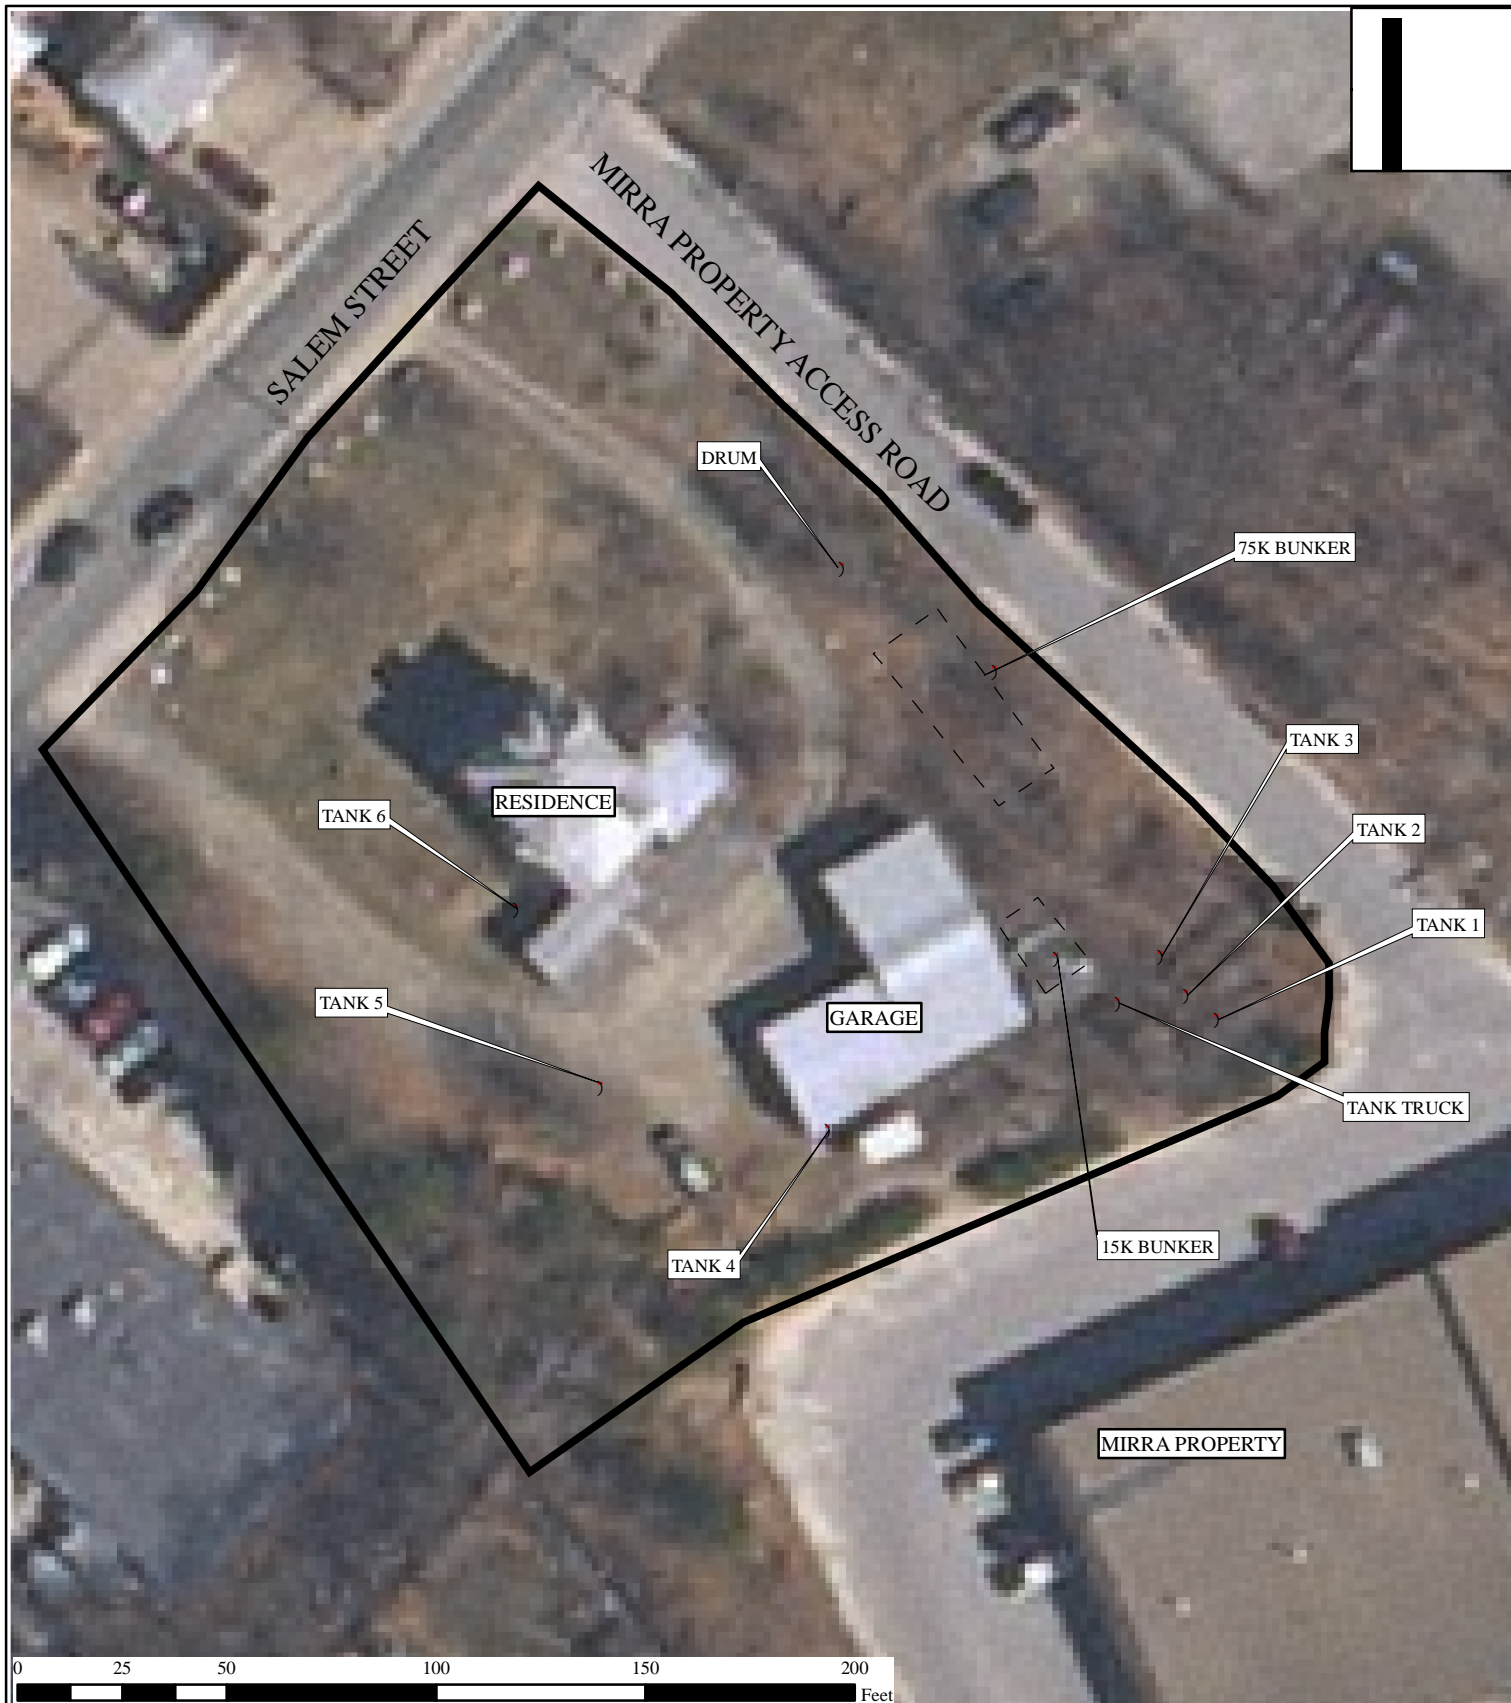
Site Diagram (Figure 2)

SITE DIAGRAM

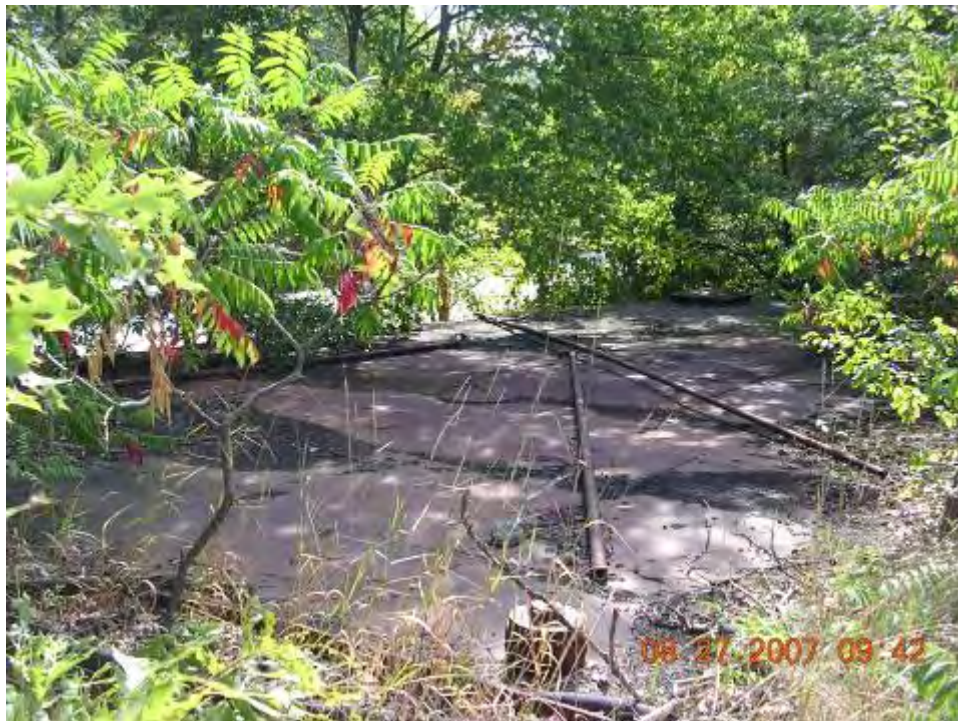
SCENE: View of the steel top of the 75,000-gallon (75K) bunker. Photograph taken facing southeast.

On 5 September 2007, Fleet Environmental Services, LLC (Fleet) member Bob Murphy was on site to meet with RM Blodgett and to inspect the 75K bunker in preparation for cutting the steel top.

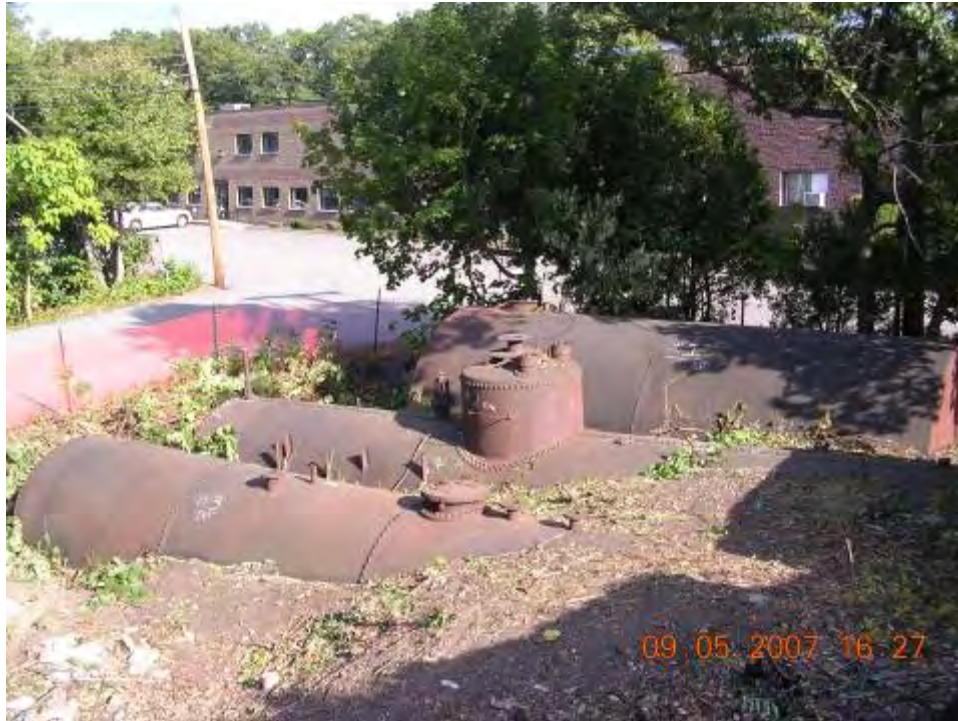
SCENE: View of Tank Nos. 1, 2, and 3 following clearing activities. Photograph taken facing southeast.

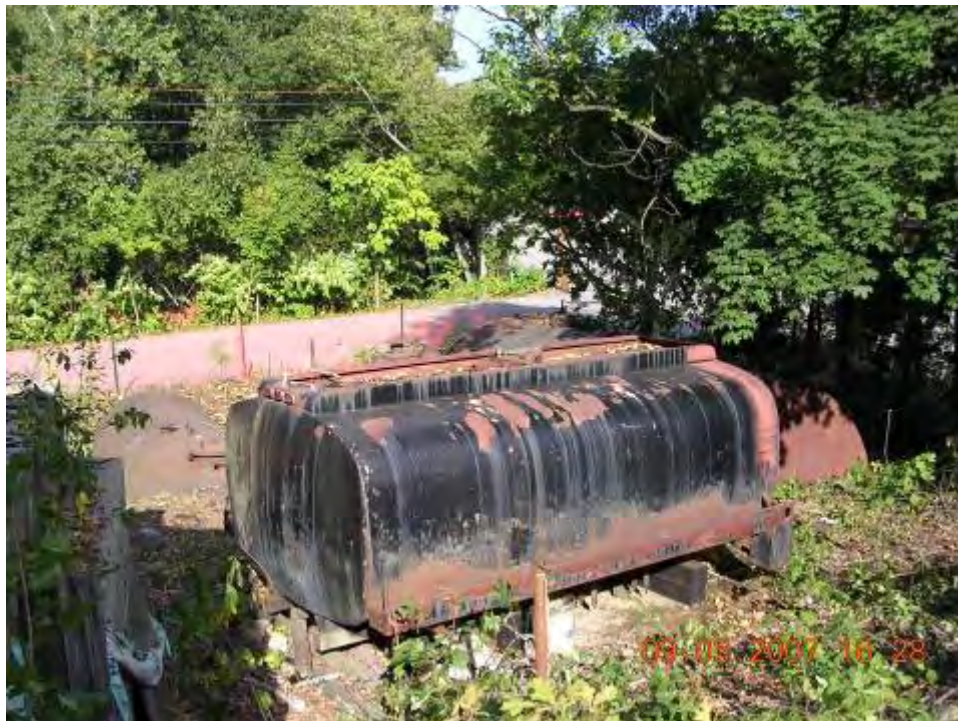
SCENE: View of the Tank Truck following clearing activities. Photograph taken facing southeast.

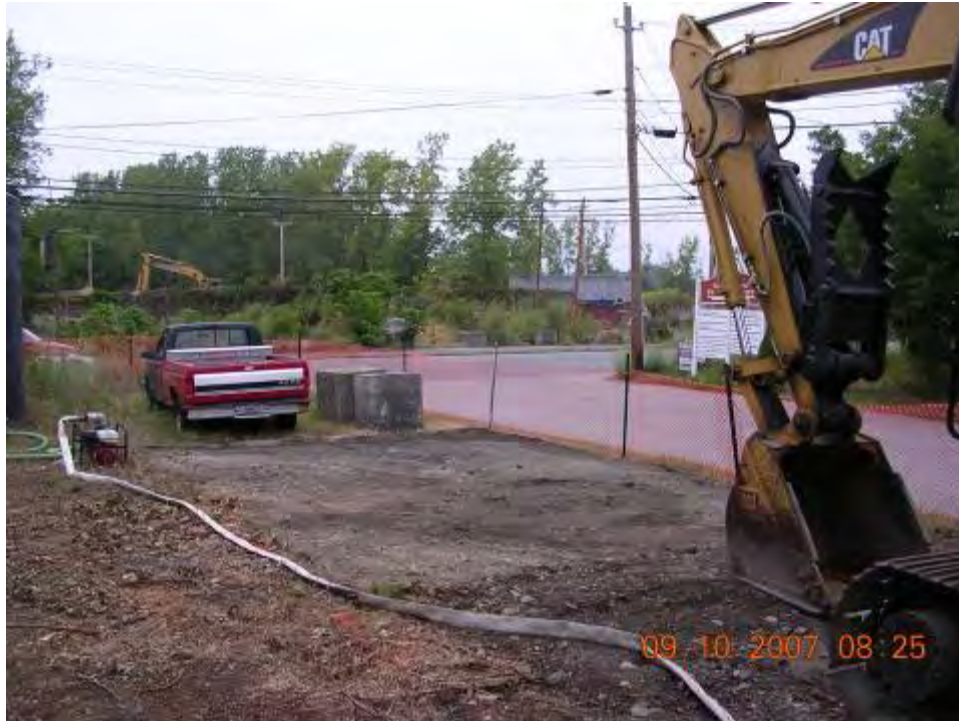
SCENE: View of soil excavation in grid SS-31. Photograph taken facing northeast.

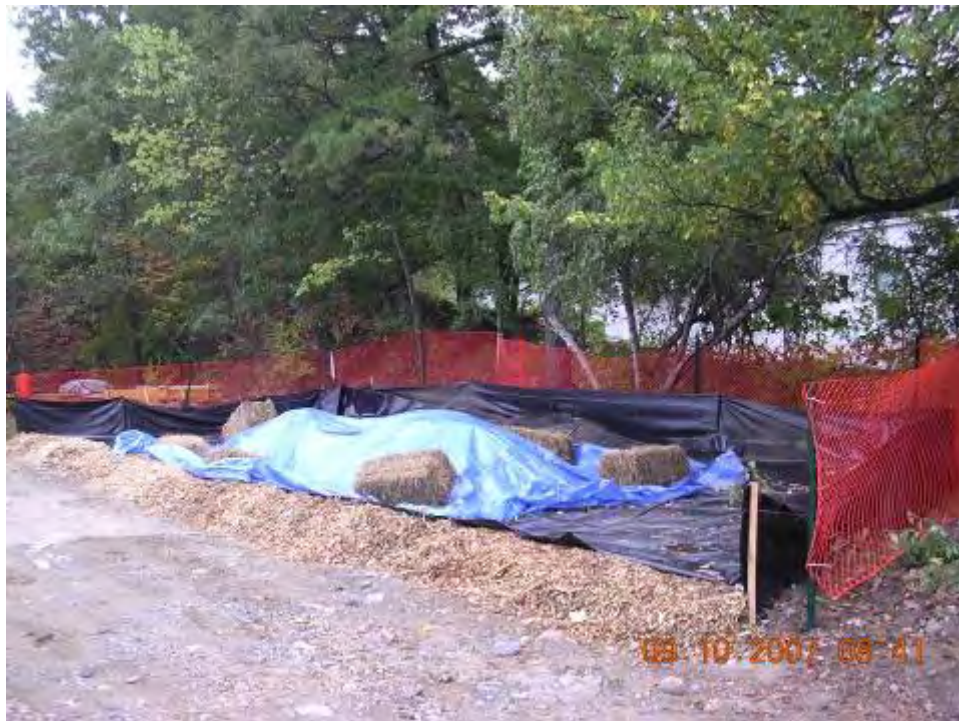
SCENE: View of the lead-contaminated soil stockpile. Photograph taken facing southwest.

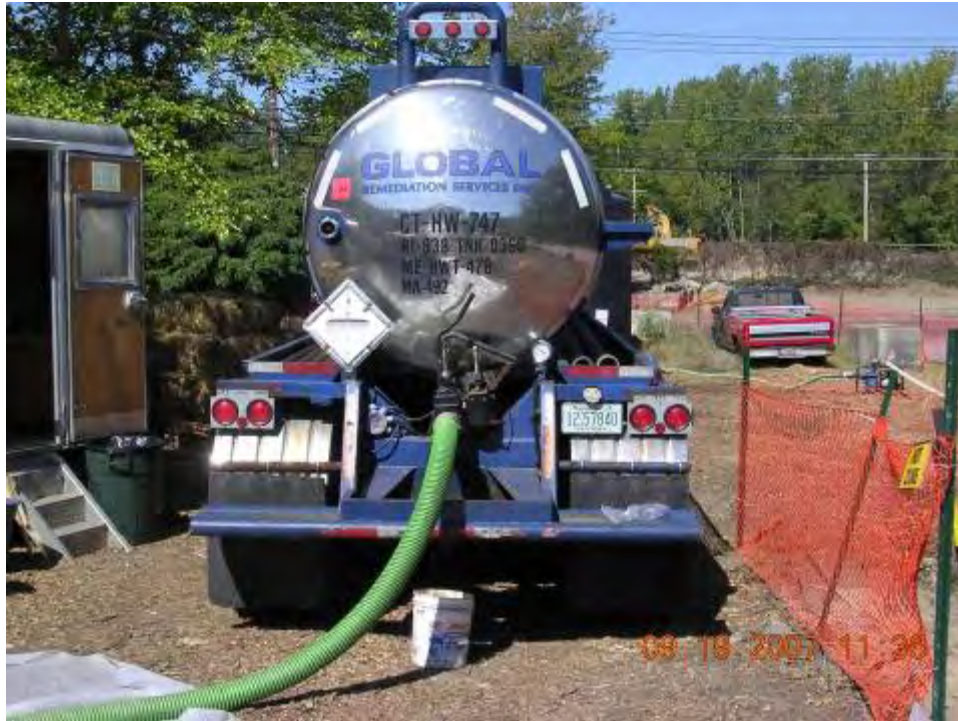
SCENE: View of a tanker truck pumping the liquid contents of the 75K and 15,000-gallon (15K) bunkers. Photograph taken facing north.

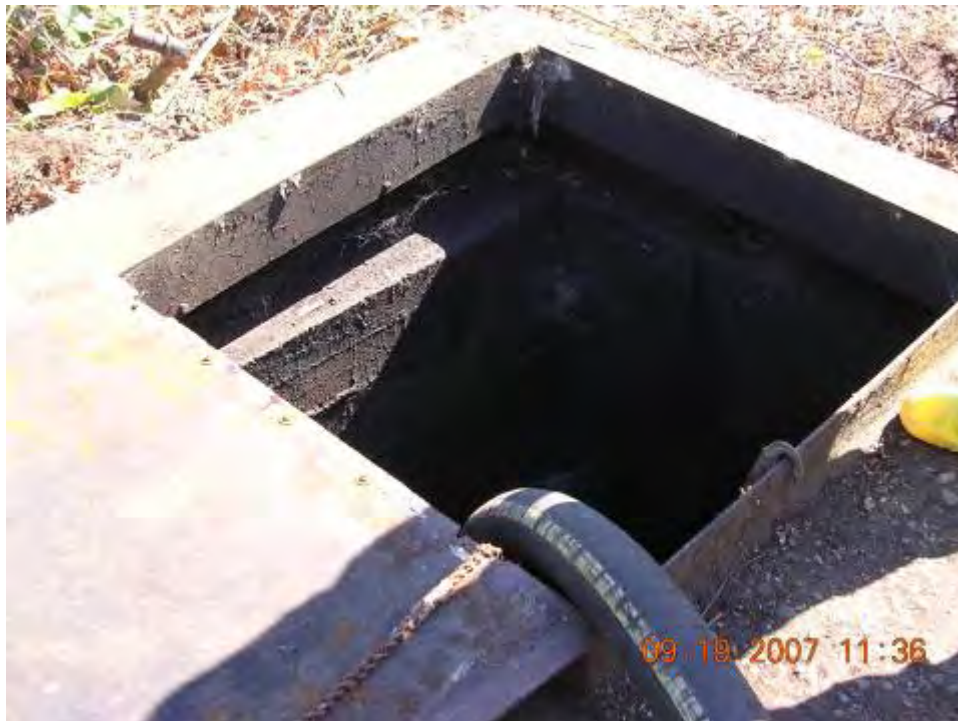
SCENE: View of the 75K bunker being pumped of its contents. Photograph taken facing southeast.

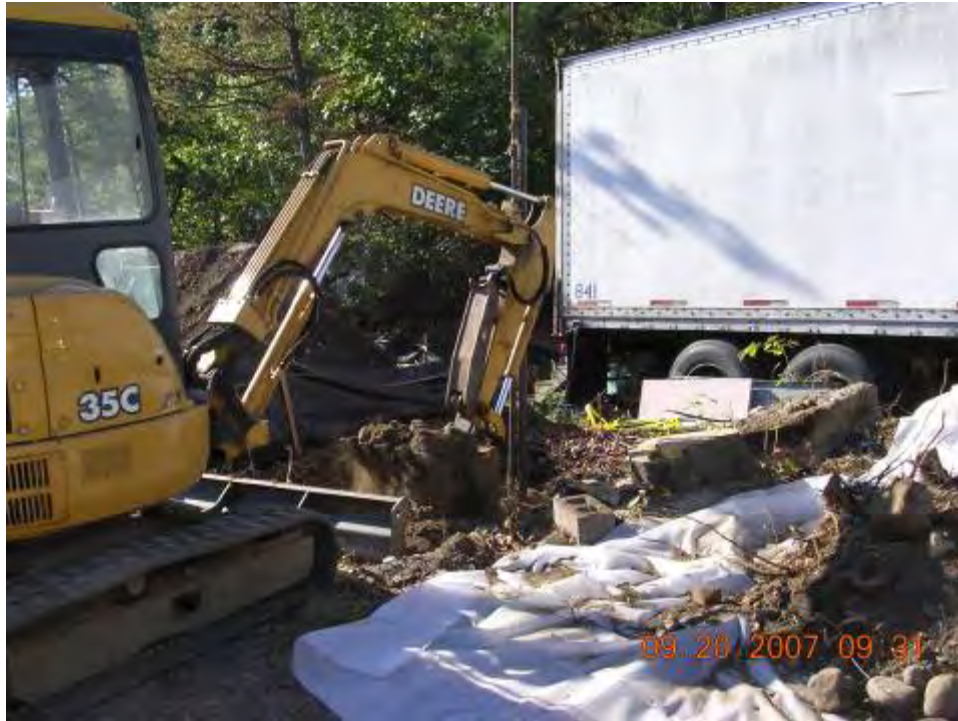
SCENE: View of Massachusetts Department of Environmental Protection (MassDEP) contractor, Enpro Services, Inc., (Enpro), excavating soil to remove Tank No. 5. Photograph taken facing southwest.

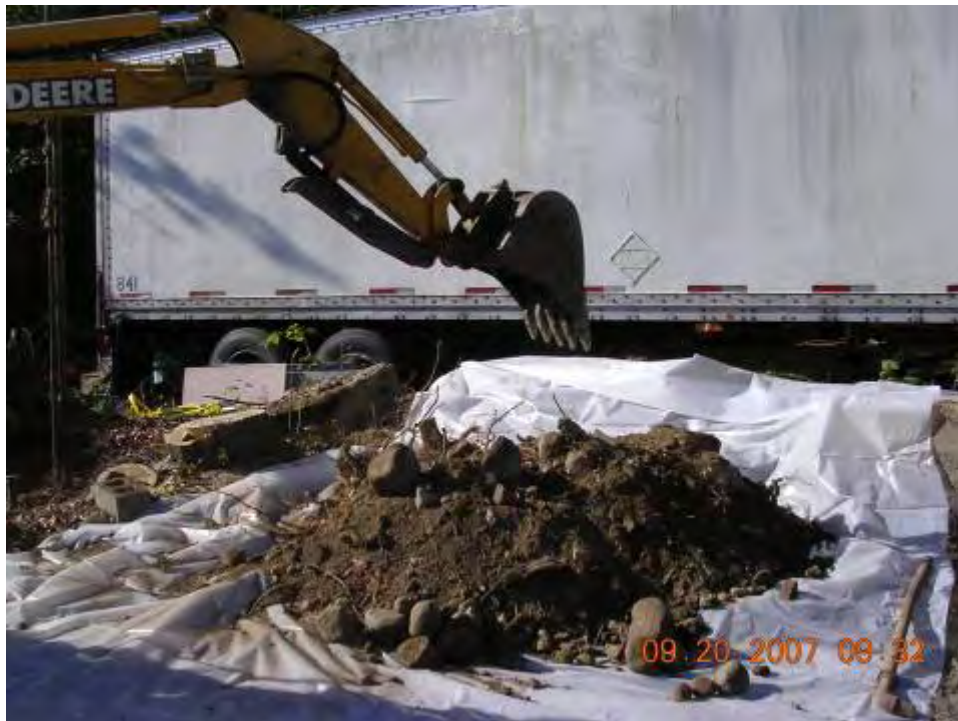
SCENE: View of Enpro staging excavated soil from Tank No. 5 on polyethylene sheeting. Photograph taken facing southwest.

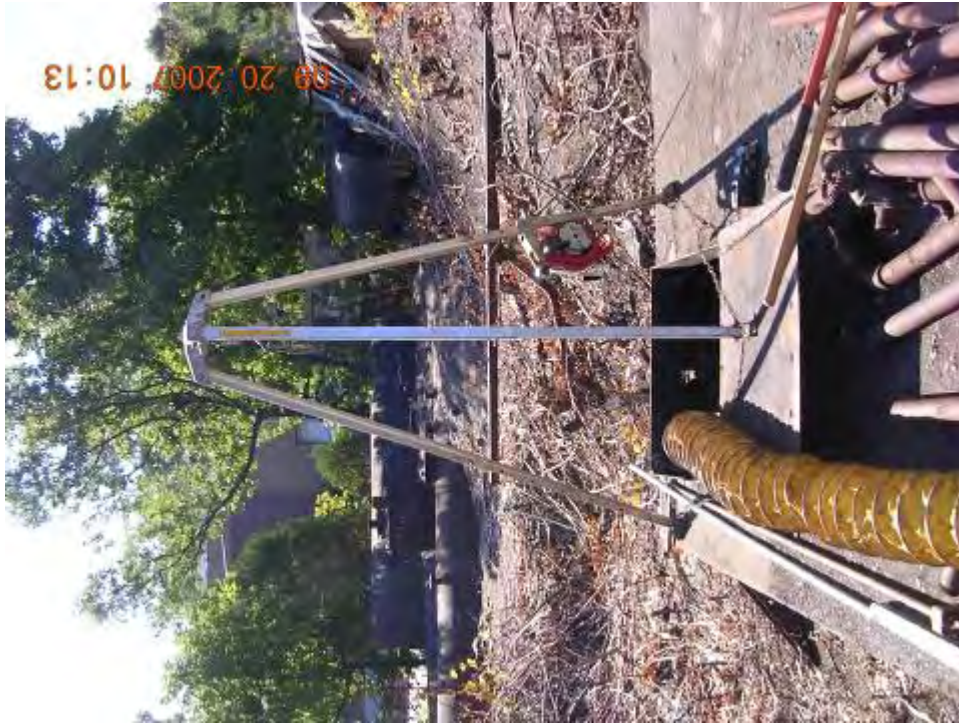
SCENE: View of confined space entry activities being conducted to decontaminate the 75K bunker. Photograph taken facing south.

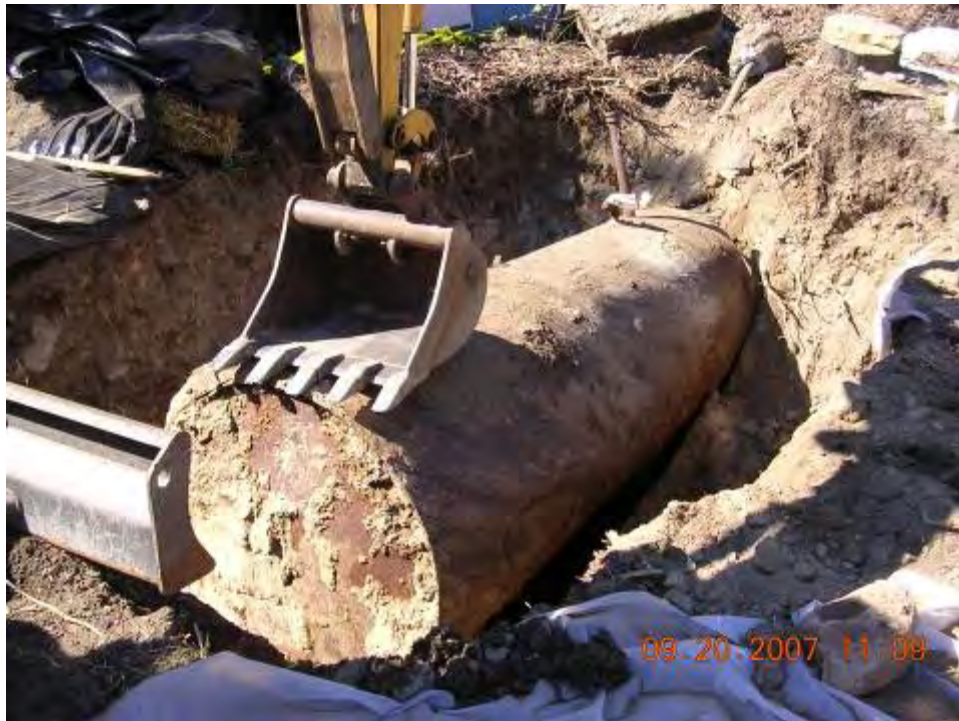
SCENE: View of Enpro removing Tank No. 5. Photograph taken facing southwest.

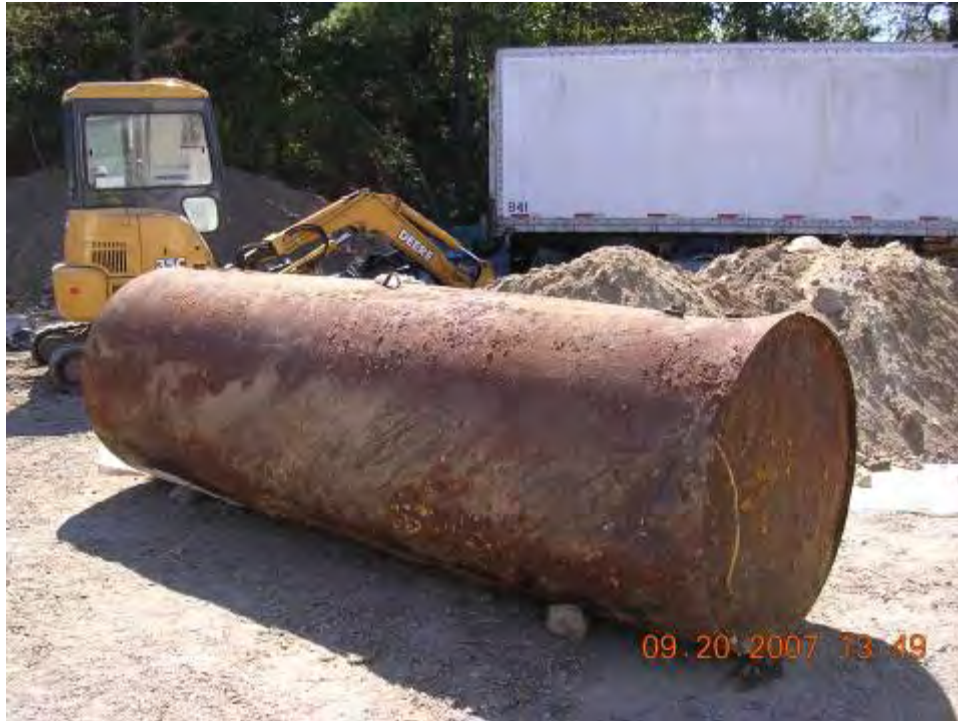
SCENE: View of Tank No. 5 after removal. Photograph taken facing southwest.

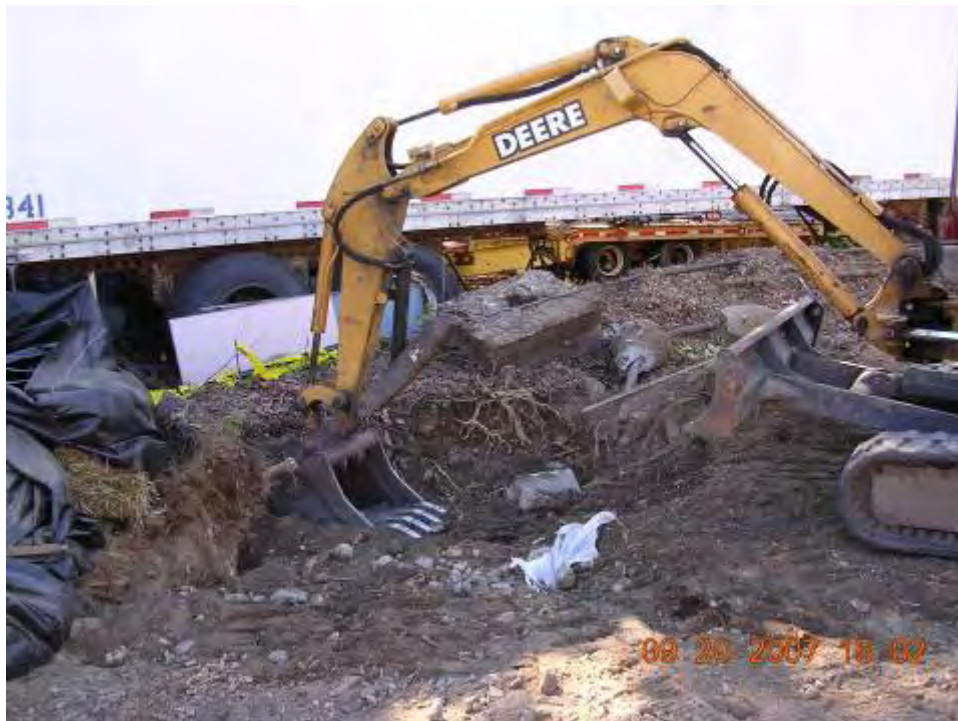
SCENE: View of the backfilling of the Tank No. 5 excavation. Photograph taken facing west.

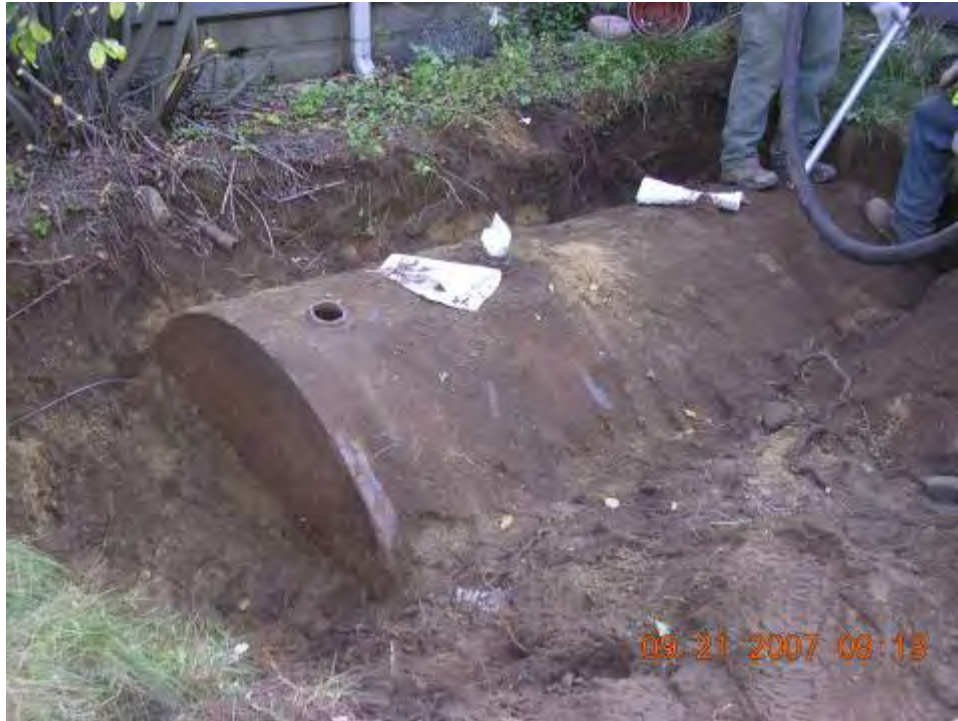
SCENE: View of MassDEP contractor Enpro, pumping out the contents of Tank No. 6. Photograph taken facing southeast.

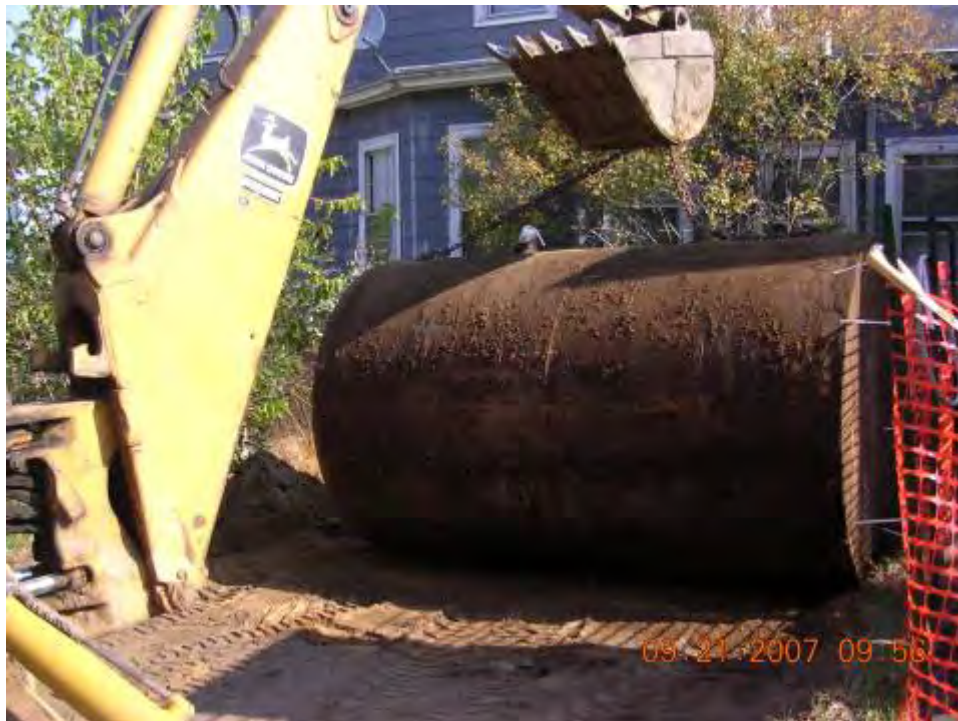
SCENE: View of the removal of Tank No. 6. Photograph taken facing east.

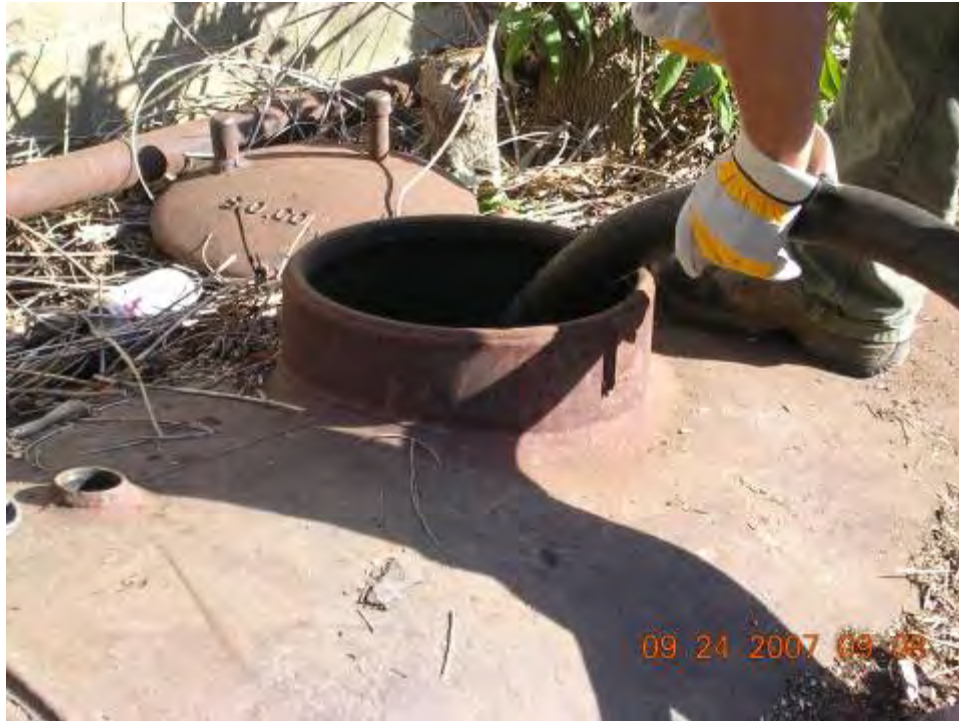
SCENE: View of MassDEP contractor Enpro, pumping out the contents of Tank No. 4. Photograph taken facing northeast.

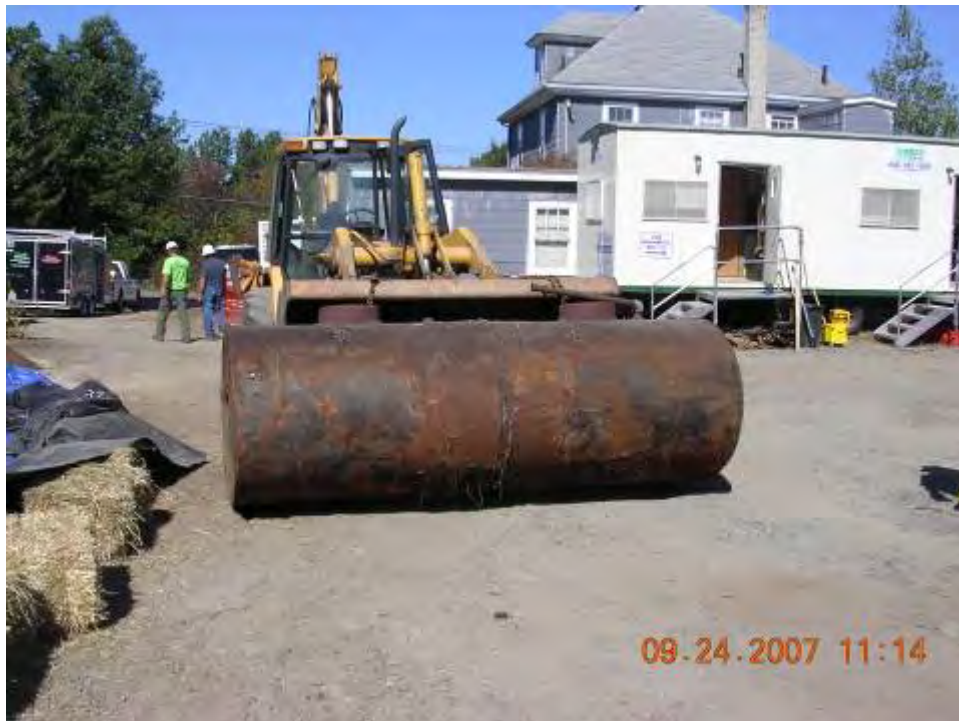
SCENE: View of Tank No. 4 after removal. Photograph taken facing north.

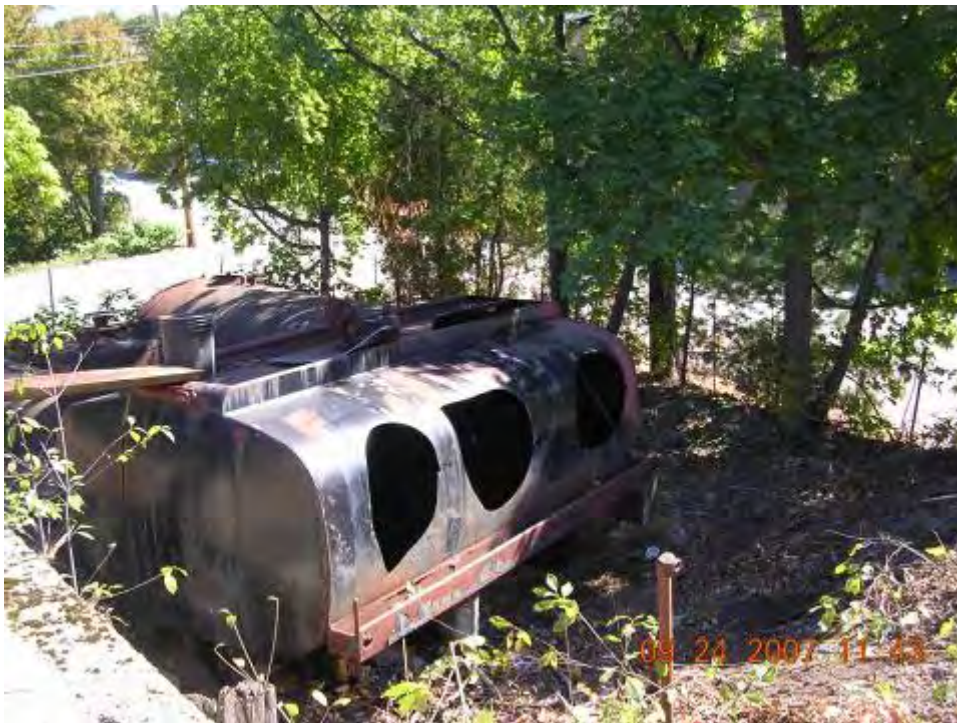
SCENE: View of the cut and cleaned Tank Truck. Photograph taken facing southeast.

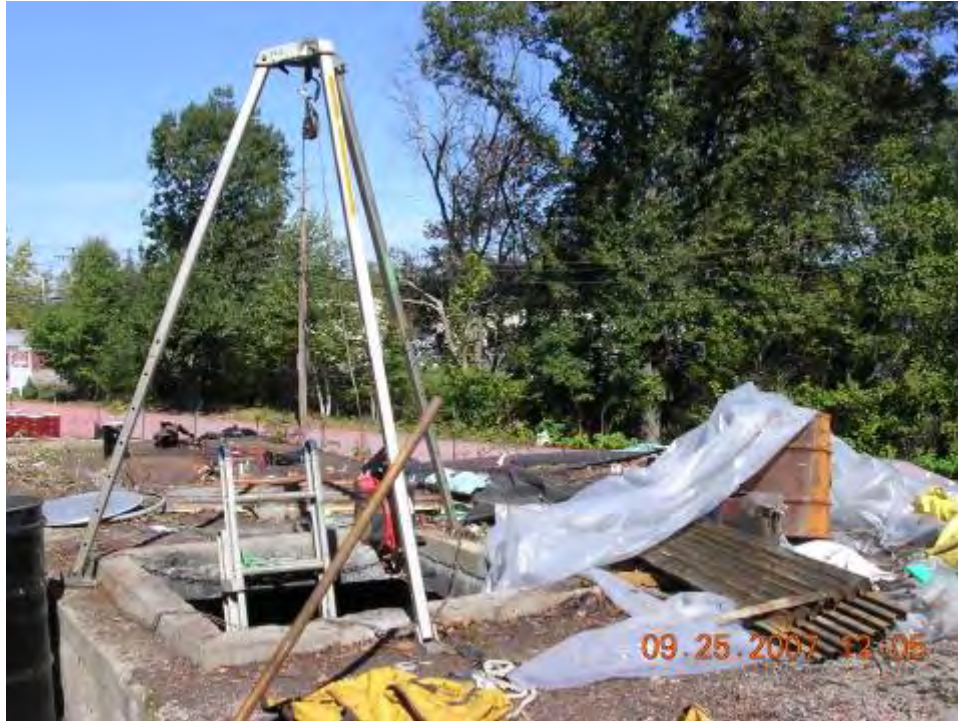
SCENE: View of confined space entry activities being conducted to decontaminate the 15K bunker. Photograph taken facing northeast.

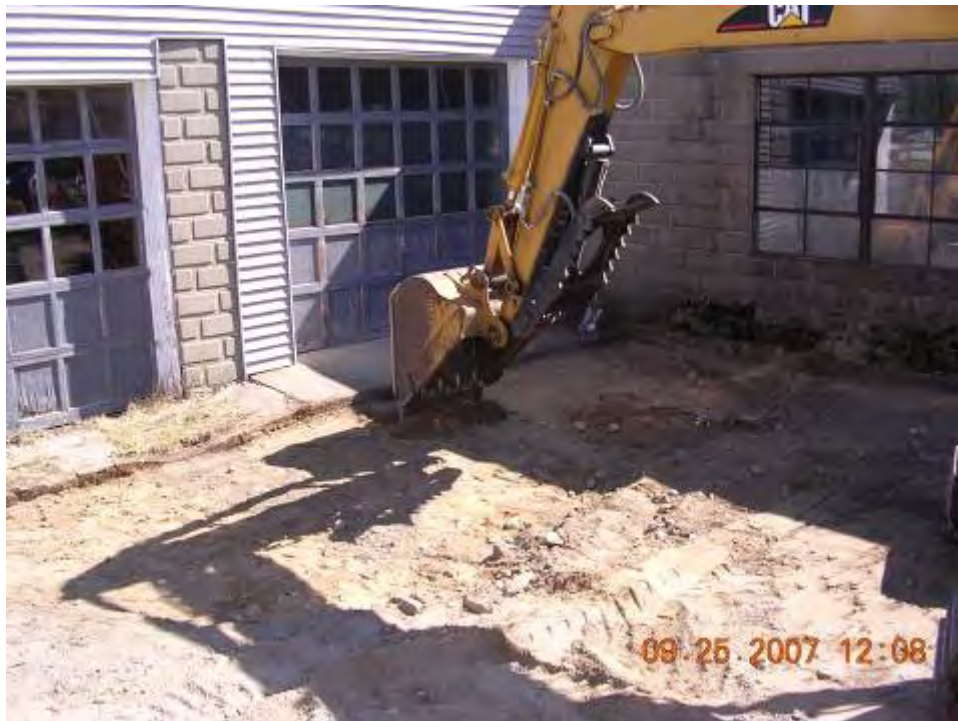
SCENE: View of soil excavation in grid SS-39, in front of the garage. Photograph taken facing southeast.

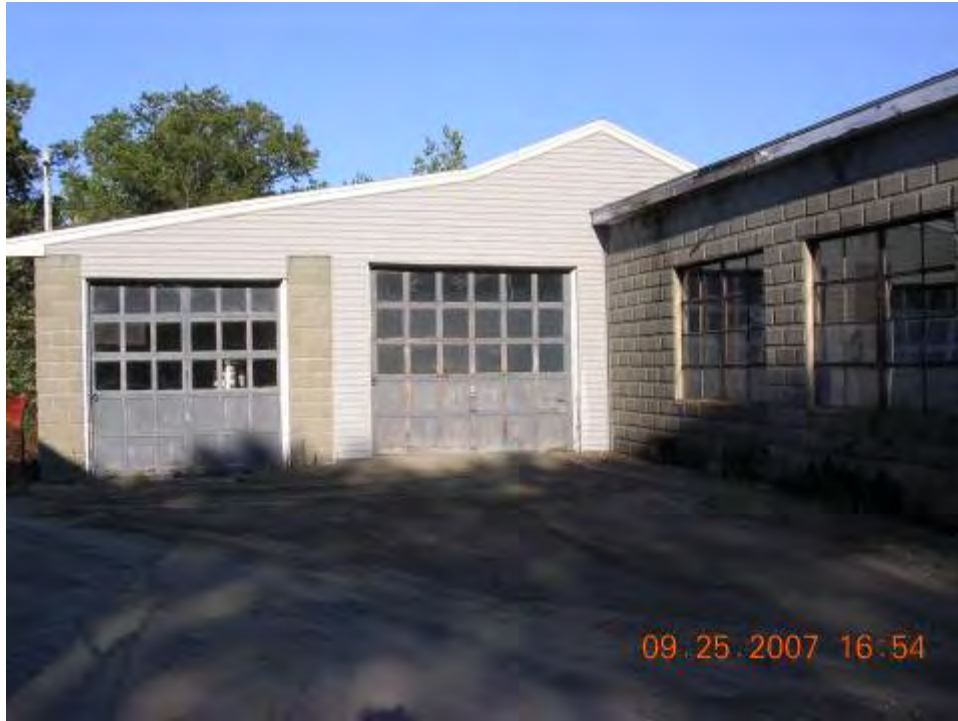
SCENE: View of the backfilled area in front of the garage. Photograph taken facing east.

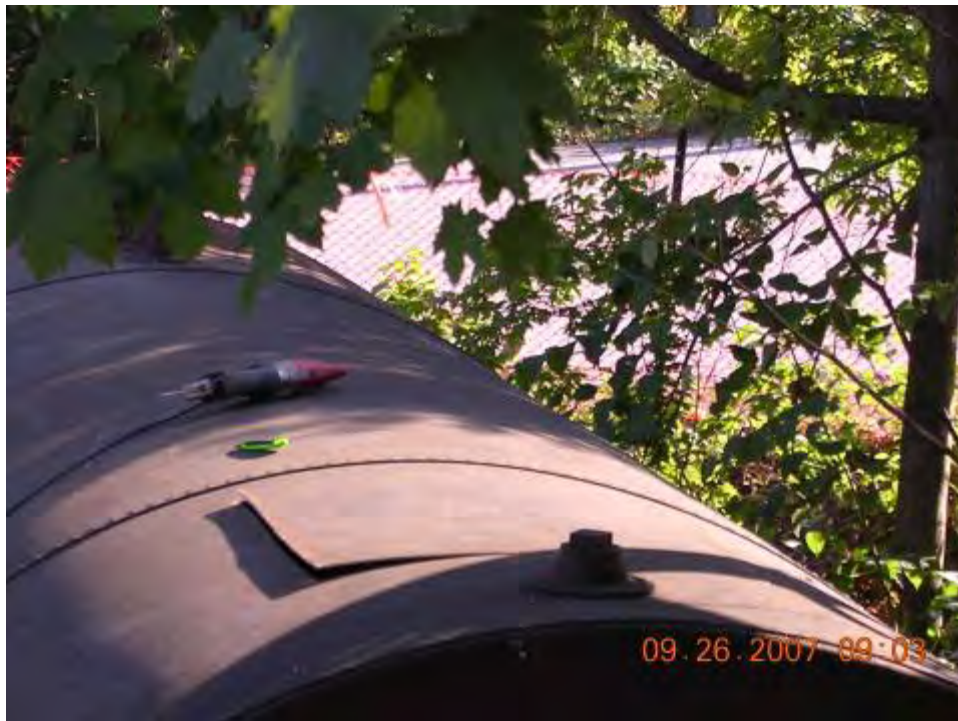
SCENE: View of access openings being cut in Tank No. 1. Photograph taken facing northeast.

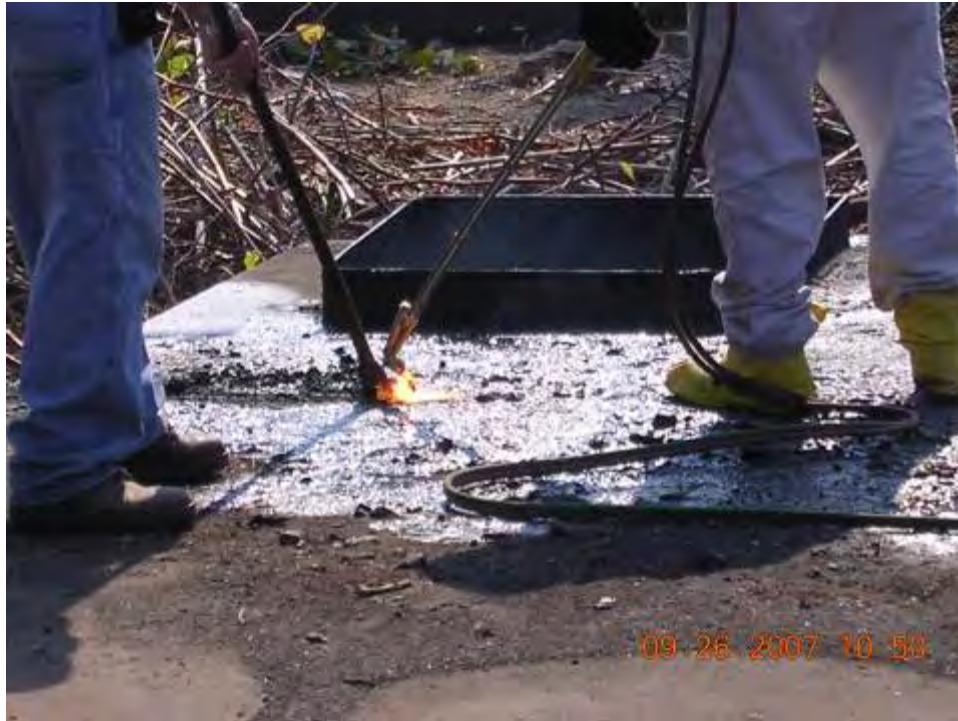
SCENE: View of a section of the steel top being cut off of the 75K bunker. Photograph taken facing north.

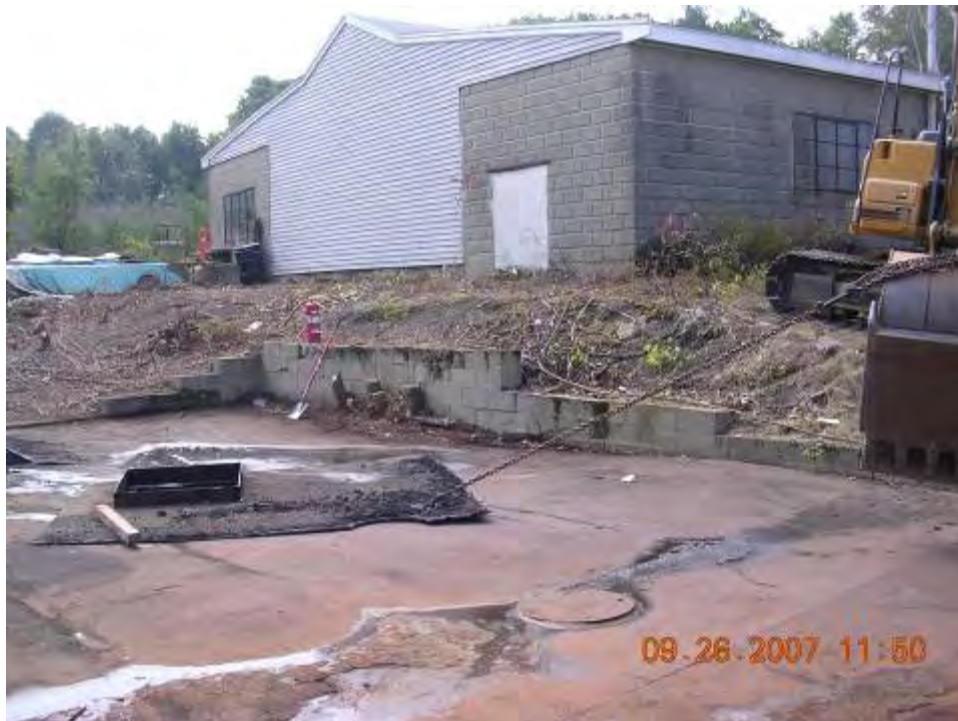
SCENE: View of the excavator removing the cut steel sections of the 75K bunker. Photograph taken facing southwest.

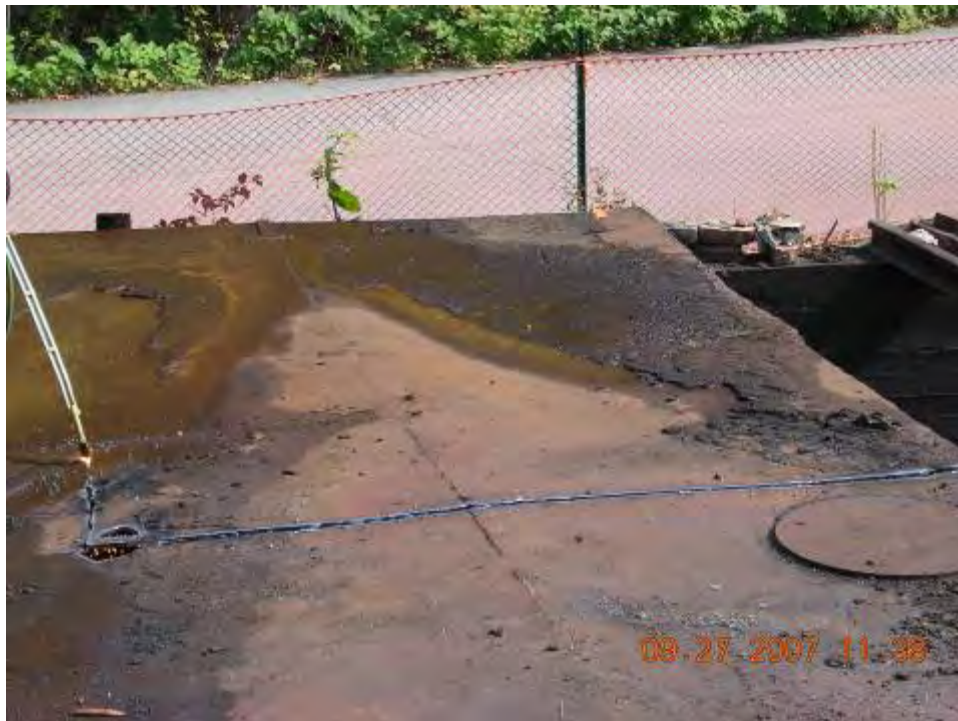
SCENE: View of a section of the steel top being cut off the 75K bunker. Photograph taken facing east.

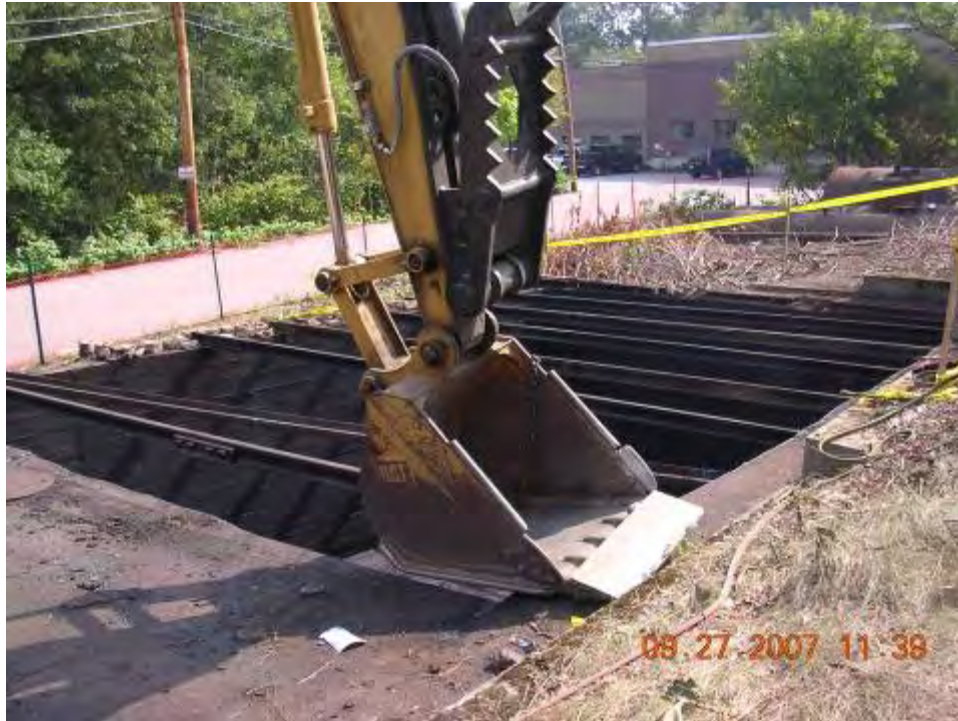
SCENE: View of the 75K bunker with sections of the steel top removed. Photograph taken facing southeast.

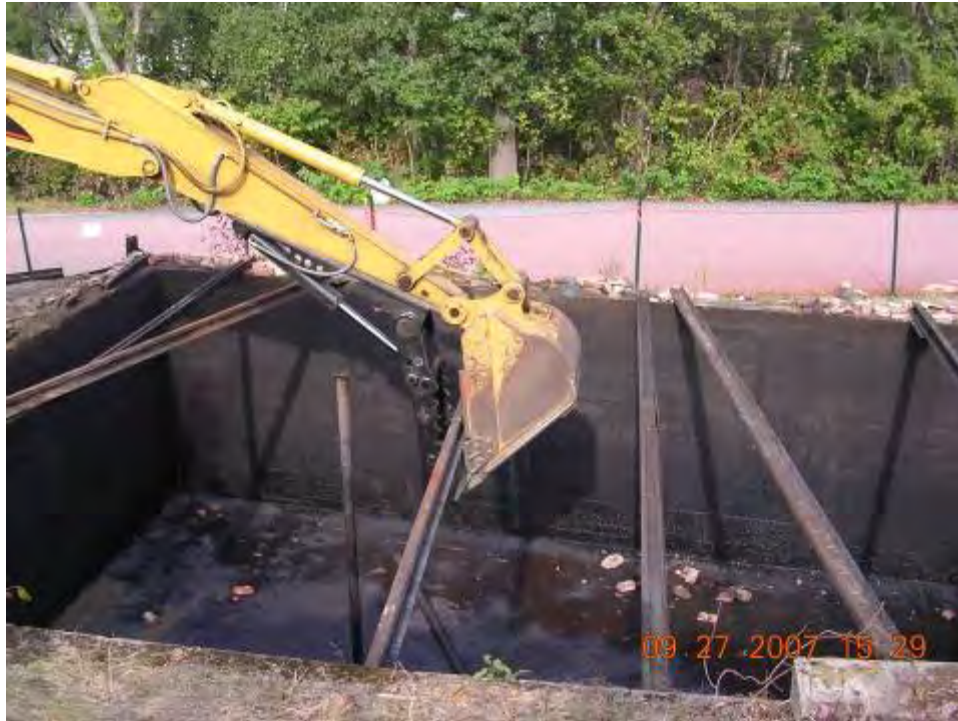
SCENE: View of the removal of the steel support beams from the 75K bunker. Photograph taken facing east.

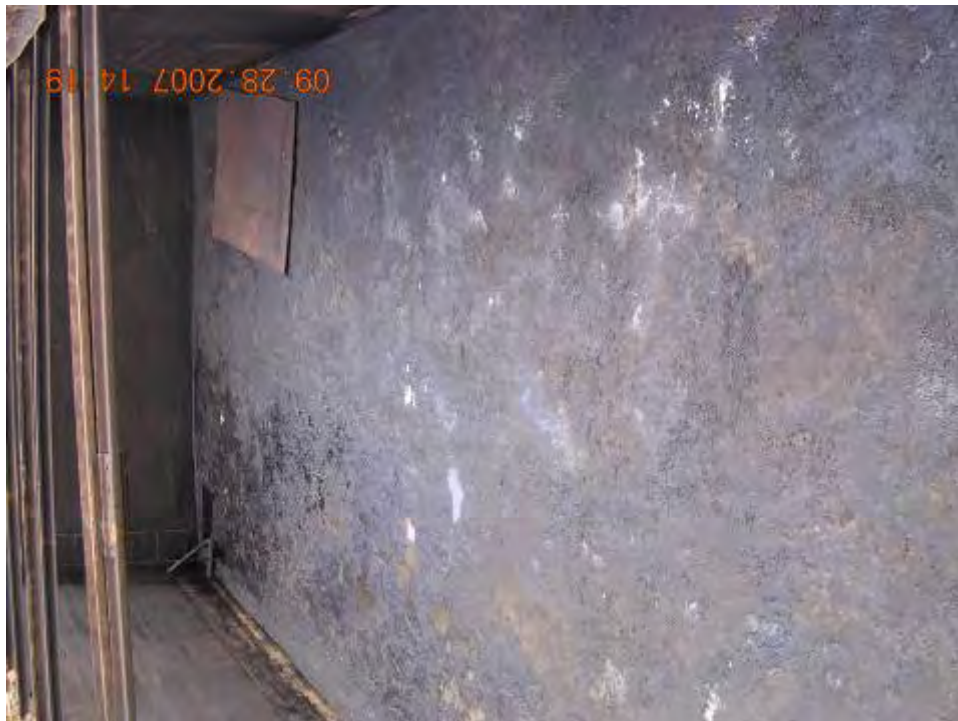
SCENE: View of the floor of the 75K bunker following final cleaning. Photograph taken facing south.
