**REMOVAL PROGRAM
AFTER ACTION REPORT
FOR THE
MURPHY PROPERTY (263 SALEM ST.) SITE
WOBURN, MIDDLESEX COUNTY, MASSACHUSETTS
27 AUGUST 2007 THROUGH 2 NOVEMBER 2007**

Weston Solutions, Inc.
Superfund Technical Assessment and Response Team (START)
3 Riverside Drive
Andover, Massachusetts 01810

March 2008

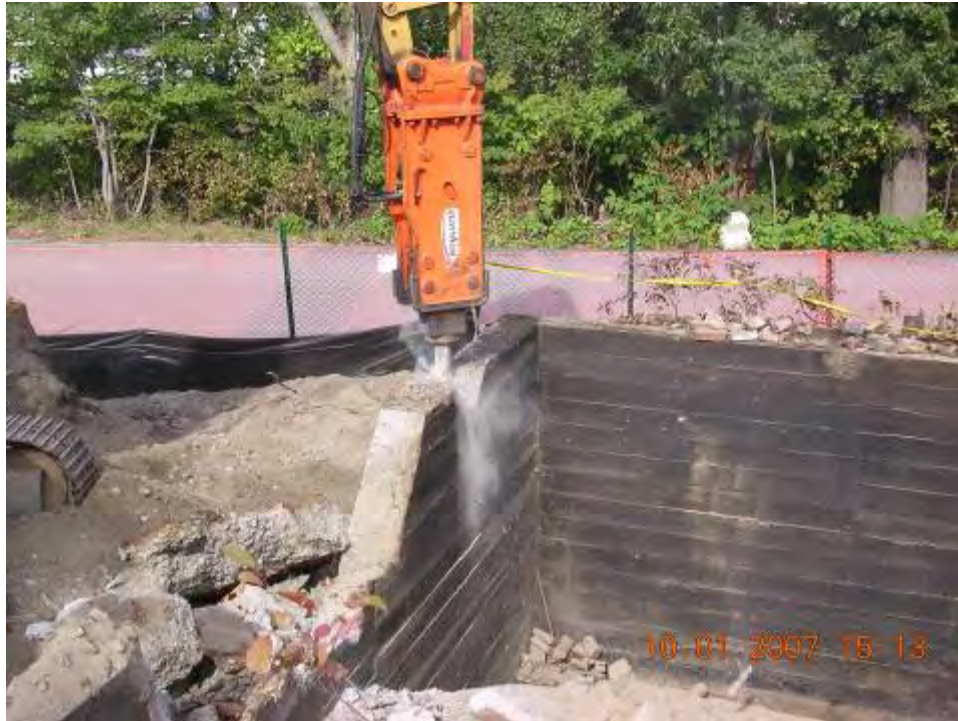
SCENE: View of the hoe-ram being utilized to demolish the north wall of the 75K bunker. Photograph taken facing east.

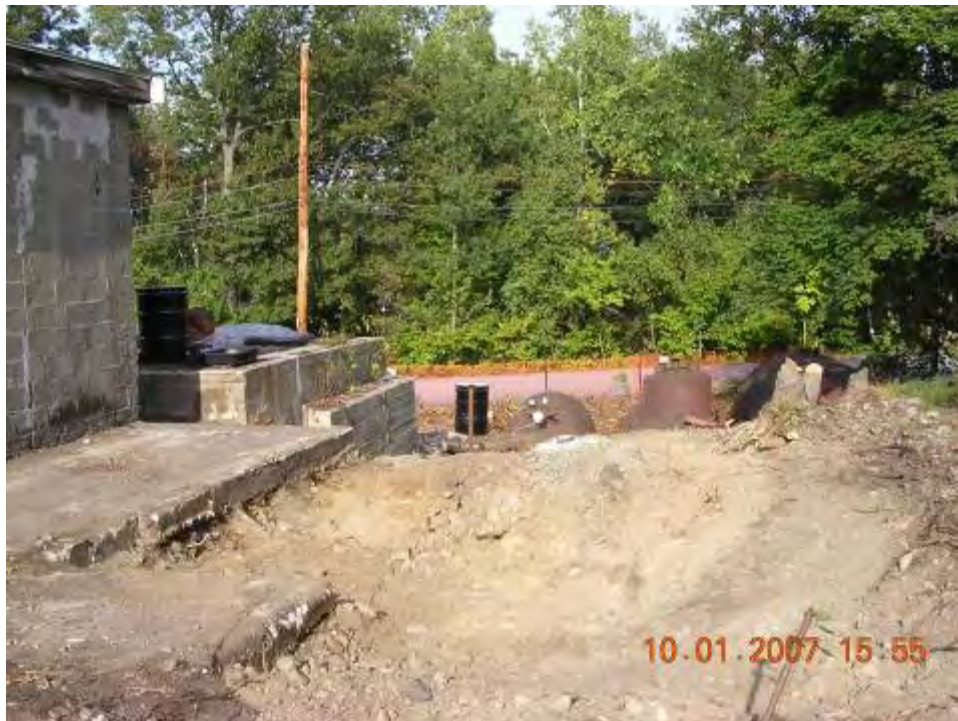
SCENE: View of excavation of grids SS-103 and SS-107. Photograph taken facing east.

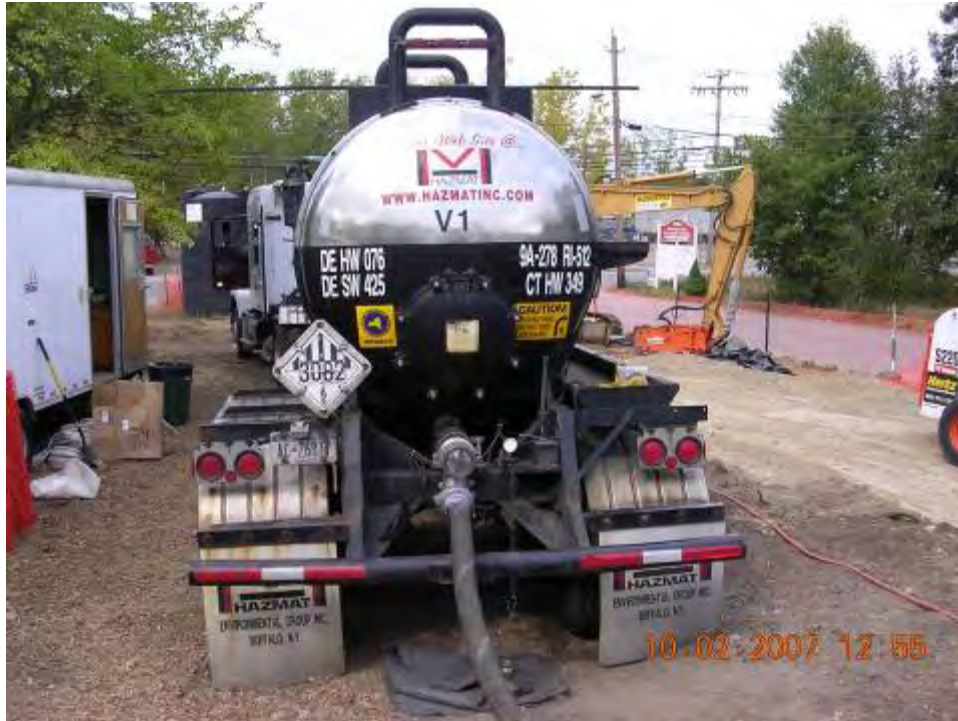
SCENE: View of HazMat Inc., pumping the contents of Tank Nos. 1 and 2. Photograph taken facing north.

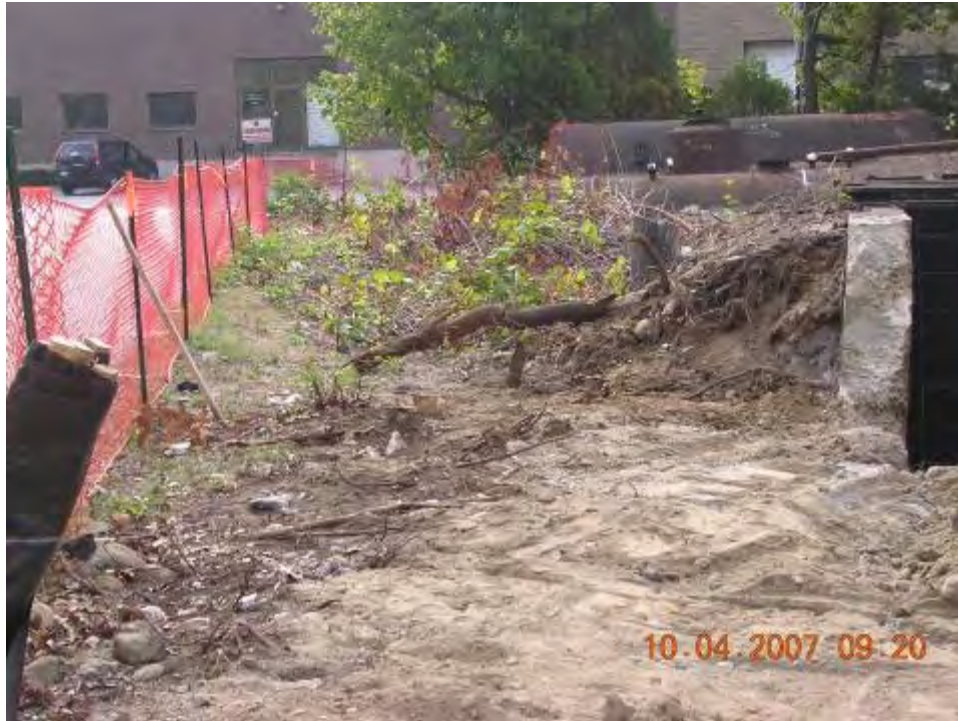
SCENE: View of soil excavation along the east wall of the bunker in grids SS-67, -70, and -74. Photograph taken facing south.

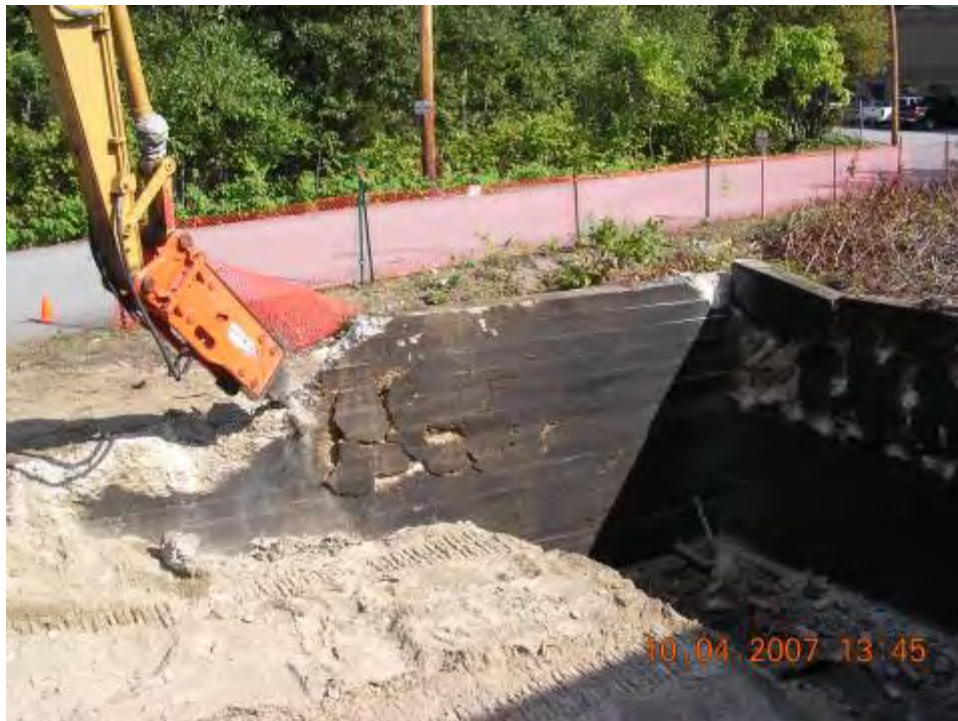
SCENE: View of the hoe-ram demolishing the east wall of the 75K bunker. Photograph taken facing southeast.

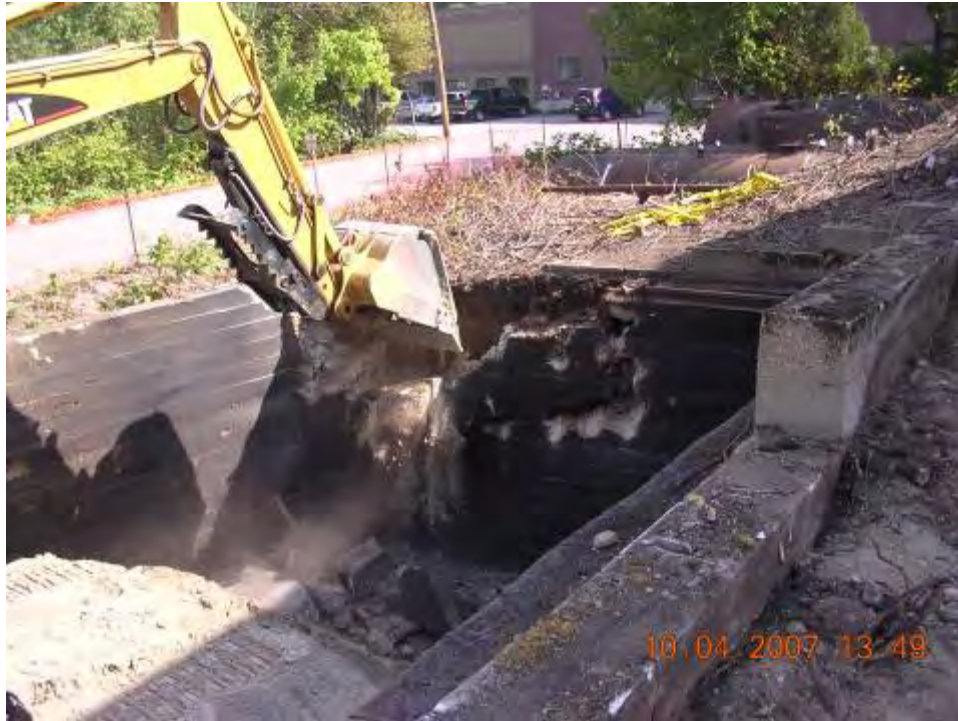
SCENE: View of the demolition of the south wall of the 75K bunker. Photograph taken facing southeast.

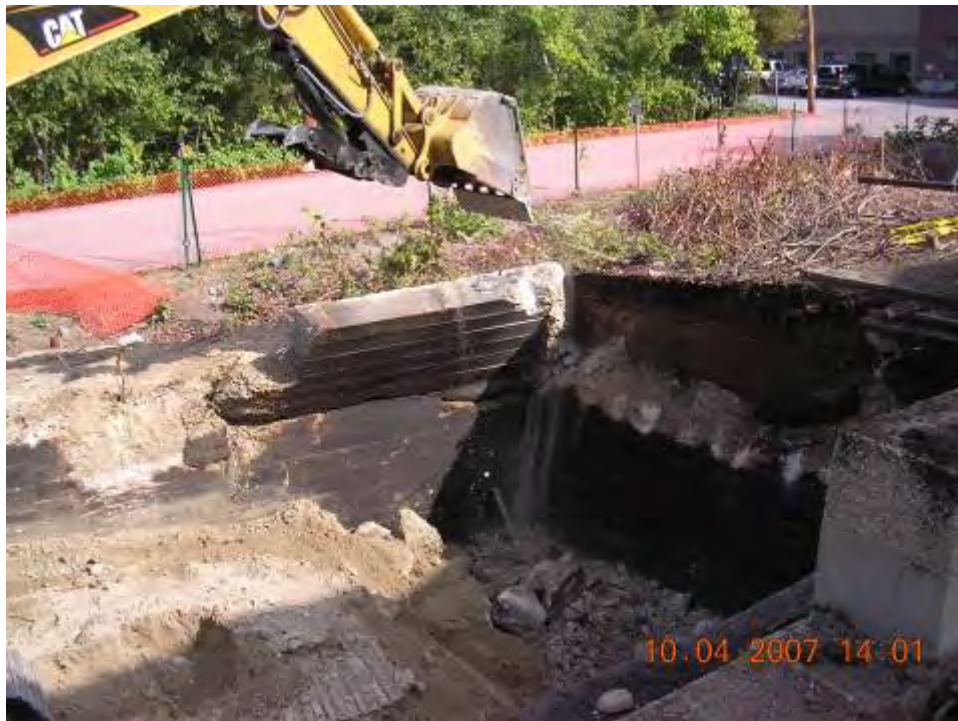
SCENE: View of the demolition of the east wall of the 75K bunker. Photograph taken facing southeast.

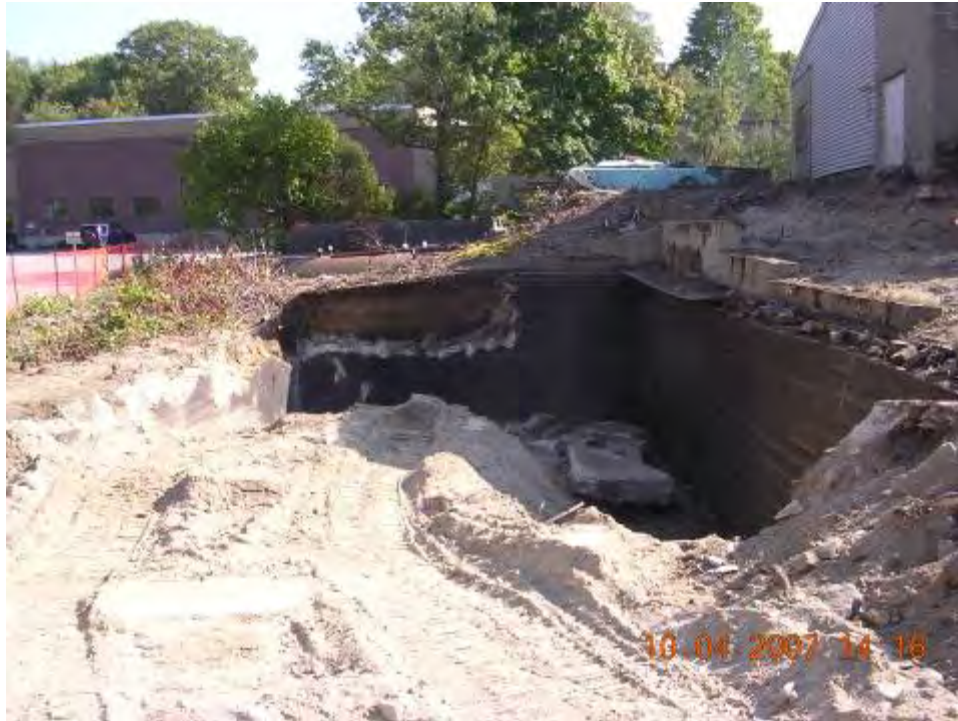
SCENE: View of the partially backfilled 75K bunker with the walls removed. Photograph taken facing south.

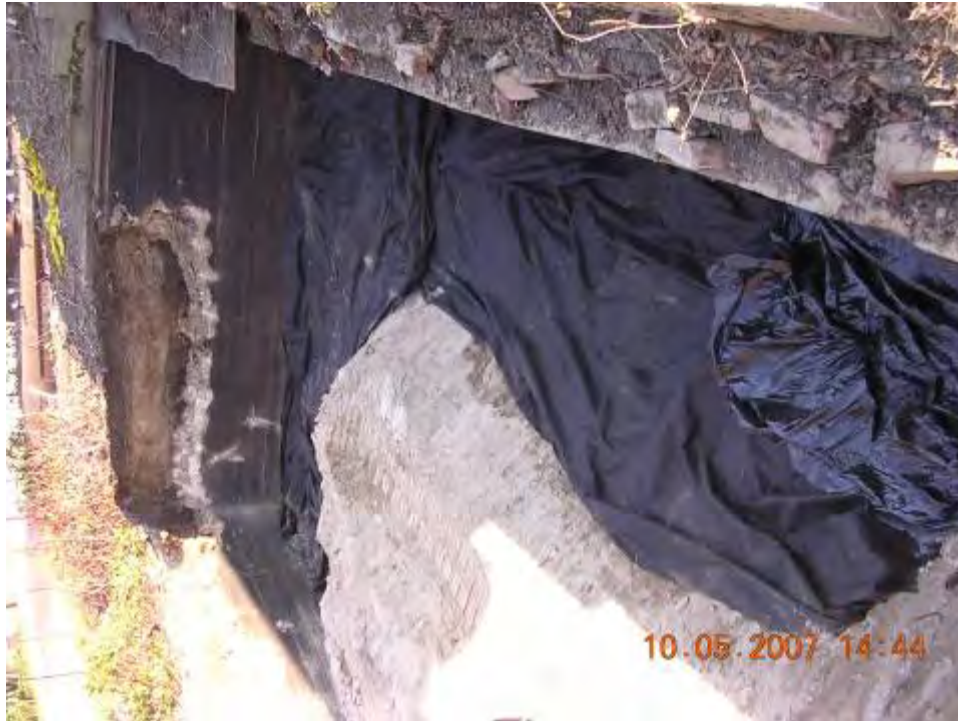
SCENE: View of geotextile fabric installed in the 75K bunker. Photograph taken facing south

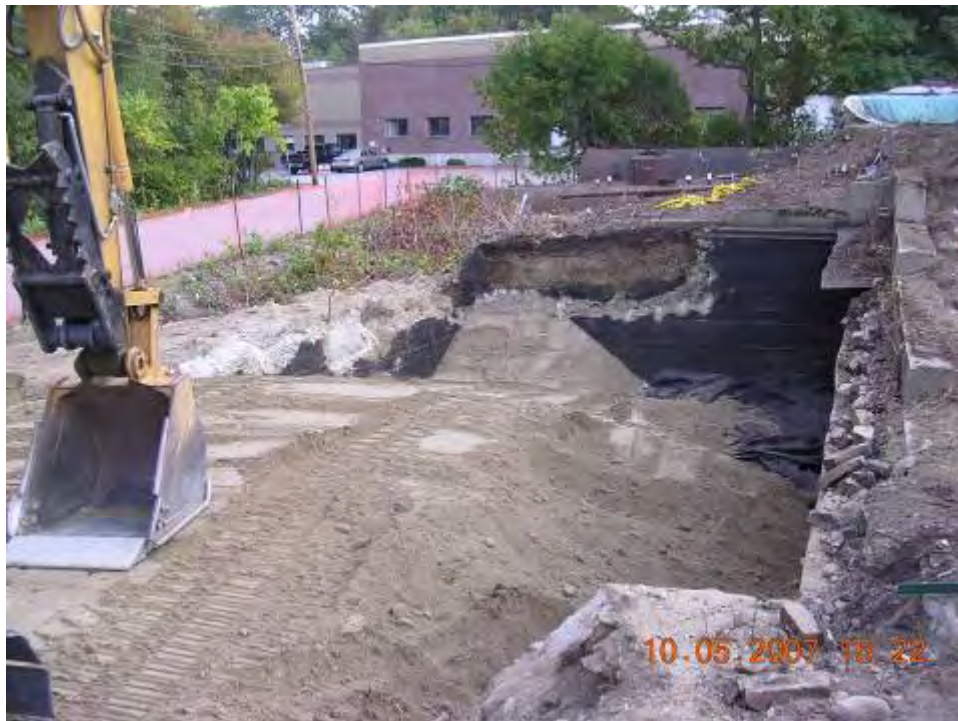
SCENE: View of the backfilling of the 75K bunker. Photograph taken facing south.

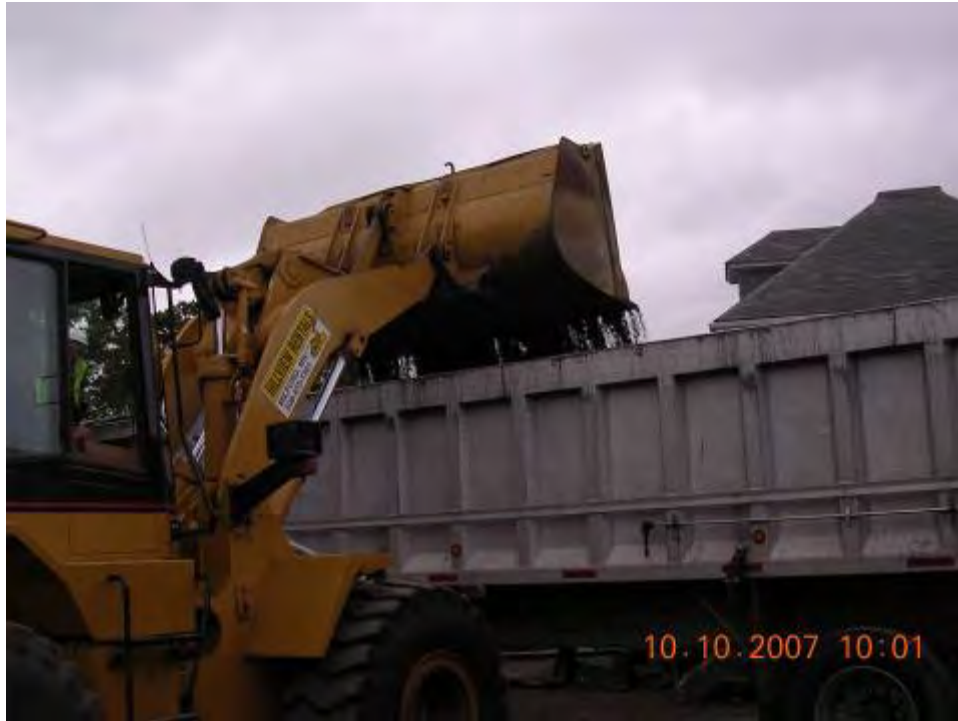
SCENE: View of polychlorinated biphenyl (PCB)-contaminated soil being loaded for disposal. Photograph taken facing northeast.

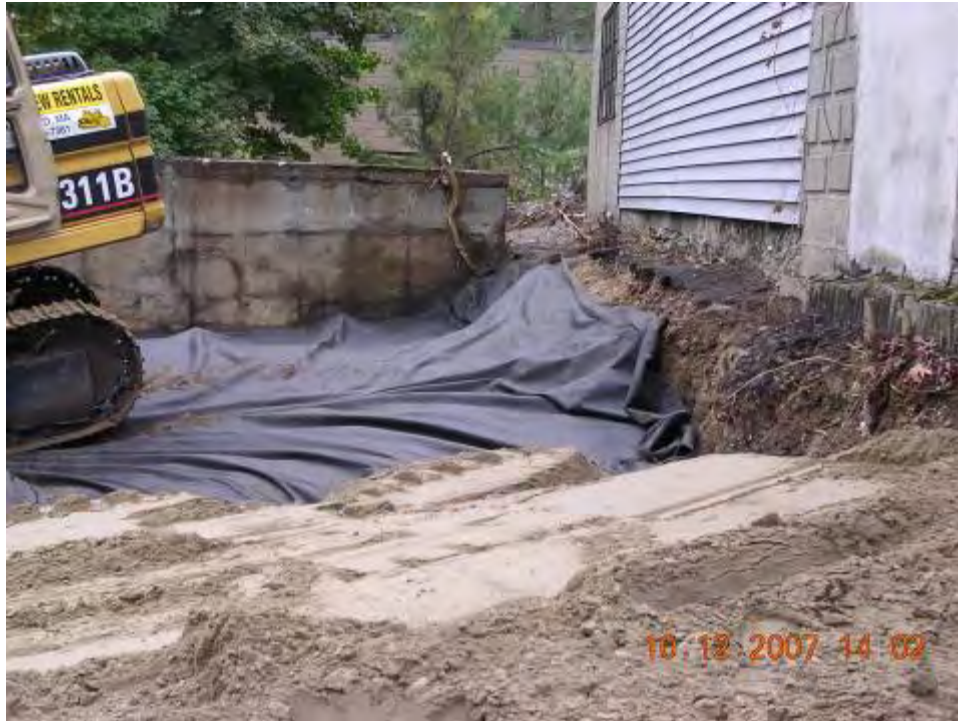
SCENE: View of grid SS-113 covered with geotextile fabric prior to backfilling. Photograph taken facing south.

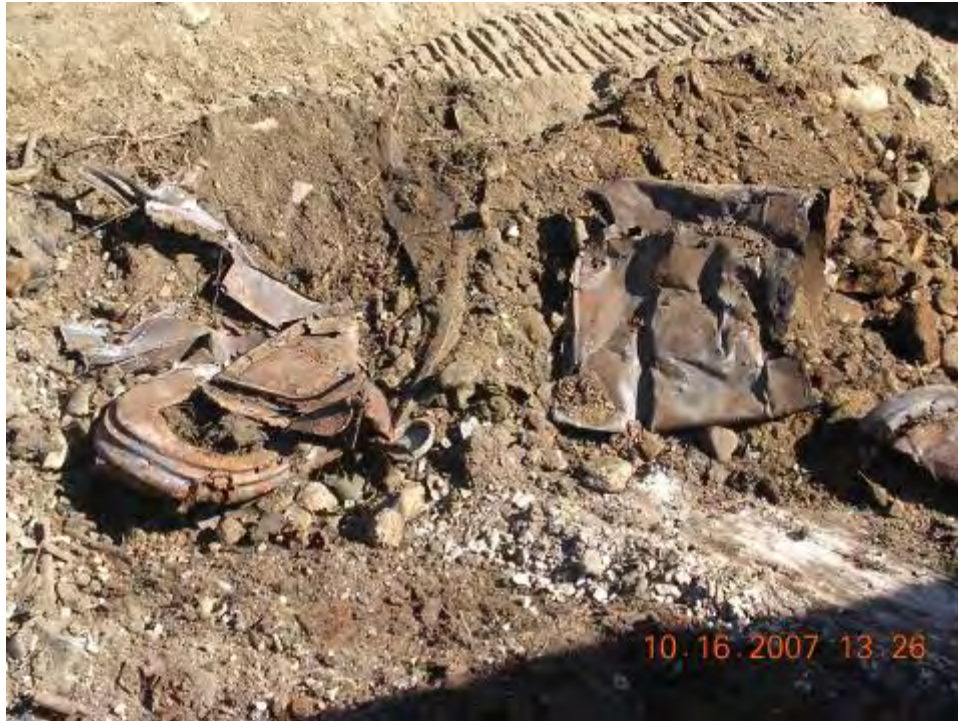
SCENE: View of household debris in grids SS-78 and SS-81. Photograph taken facing east.

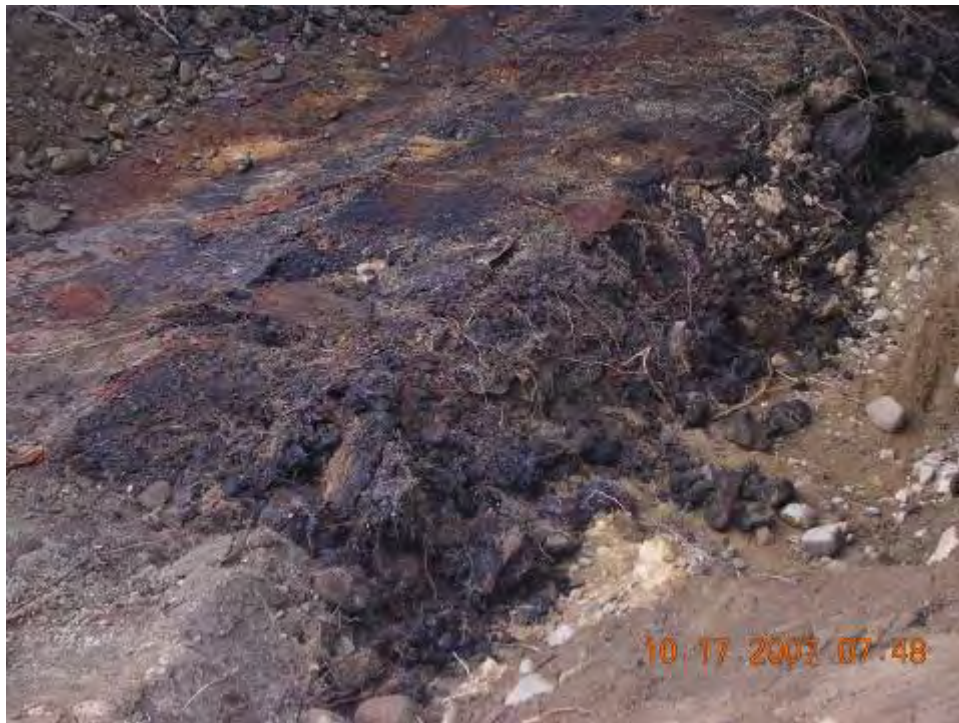
SCENE: View of oil-stained soil in the Tank No. 3 grave. Photograph taken facing southwest.

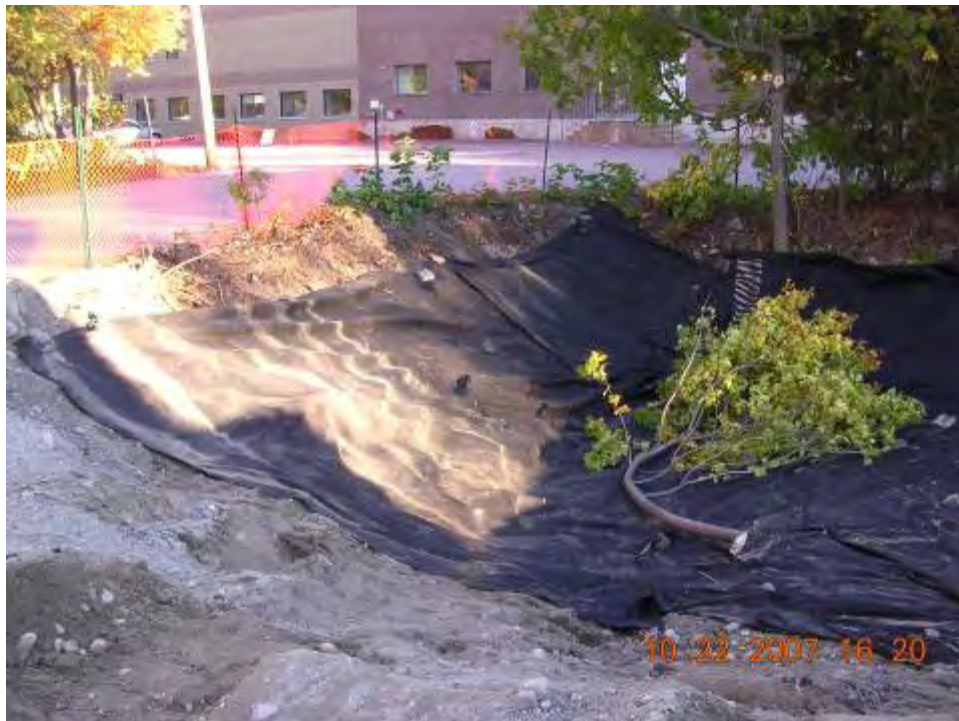
SCENE: View of geotextile fabric in the former tank location area prior to backfilling. Photograph taken facing southeast.

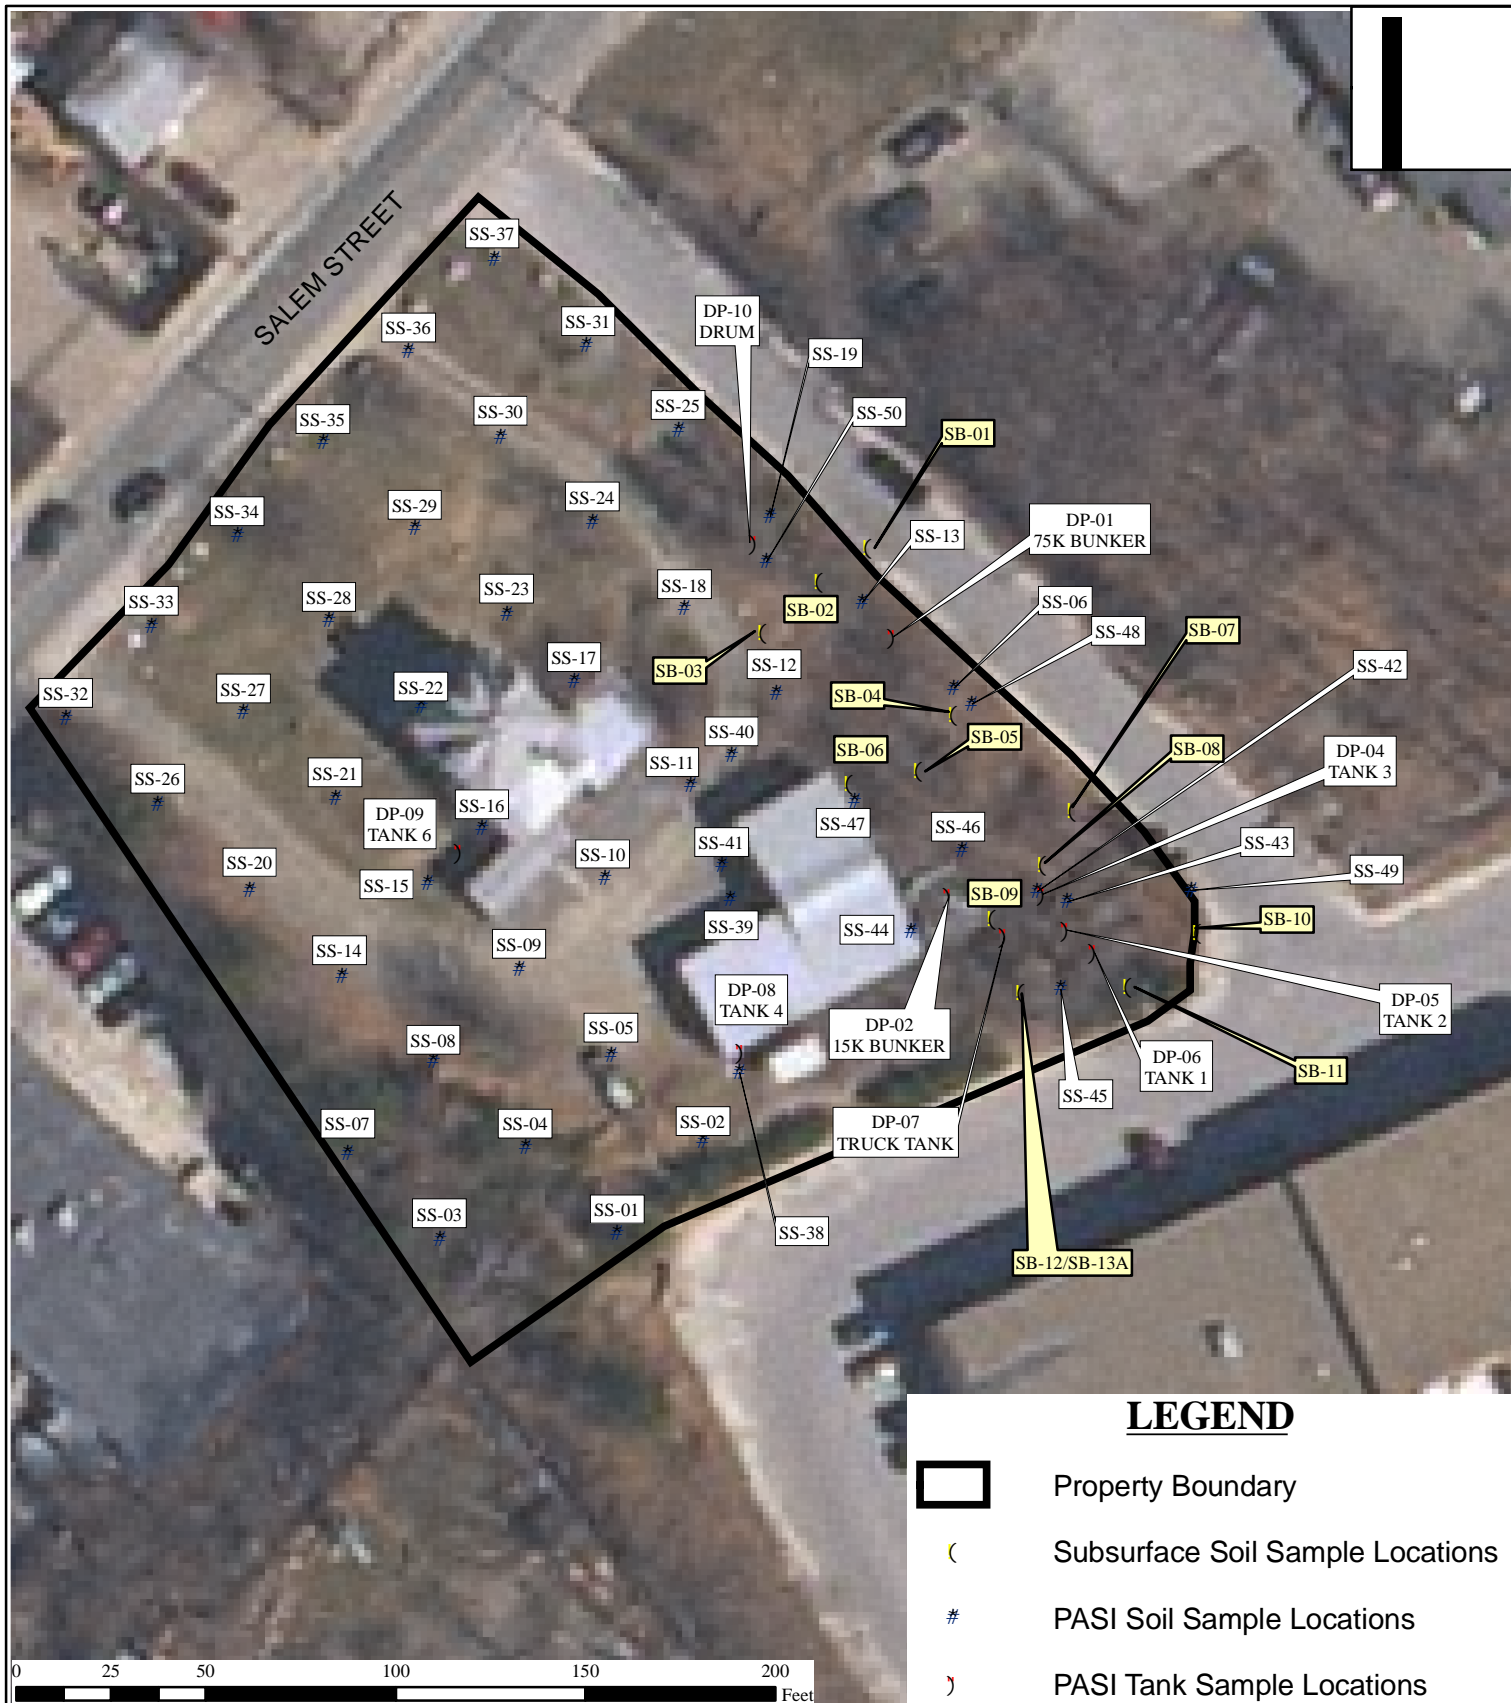
Subsurface Soil Sample Location Map (Figure 3)

**SUBSURFACE SOIL
SAMPLE LOCATION MAP**

On 28 August 2007, START members Kyle Brennan, Lauren Cook, Carolyn Imbres, Bill Mahany, and Keith Wheeler were on site to collect subsurface soil samples to determine the vertical extent of contamination [6]. Sample locations were recorded using a Trimble Pathfinder Pro XRS Global Positioning System (GPS) unit [see Appendix D – Subsurface Soil Sample Location Map (Figure 3)] [7].
