**Final Work Plan for
Demolition Activities and
Post-Cleanup Sampling**

**Williams B Lease
Tank Battery Facility
Cat Canyon Oilfield,
Santa Barbara County, California**

**021-10201-00/027
July 18, 2008**

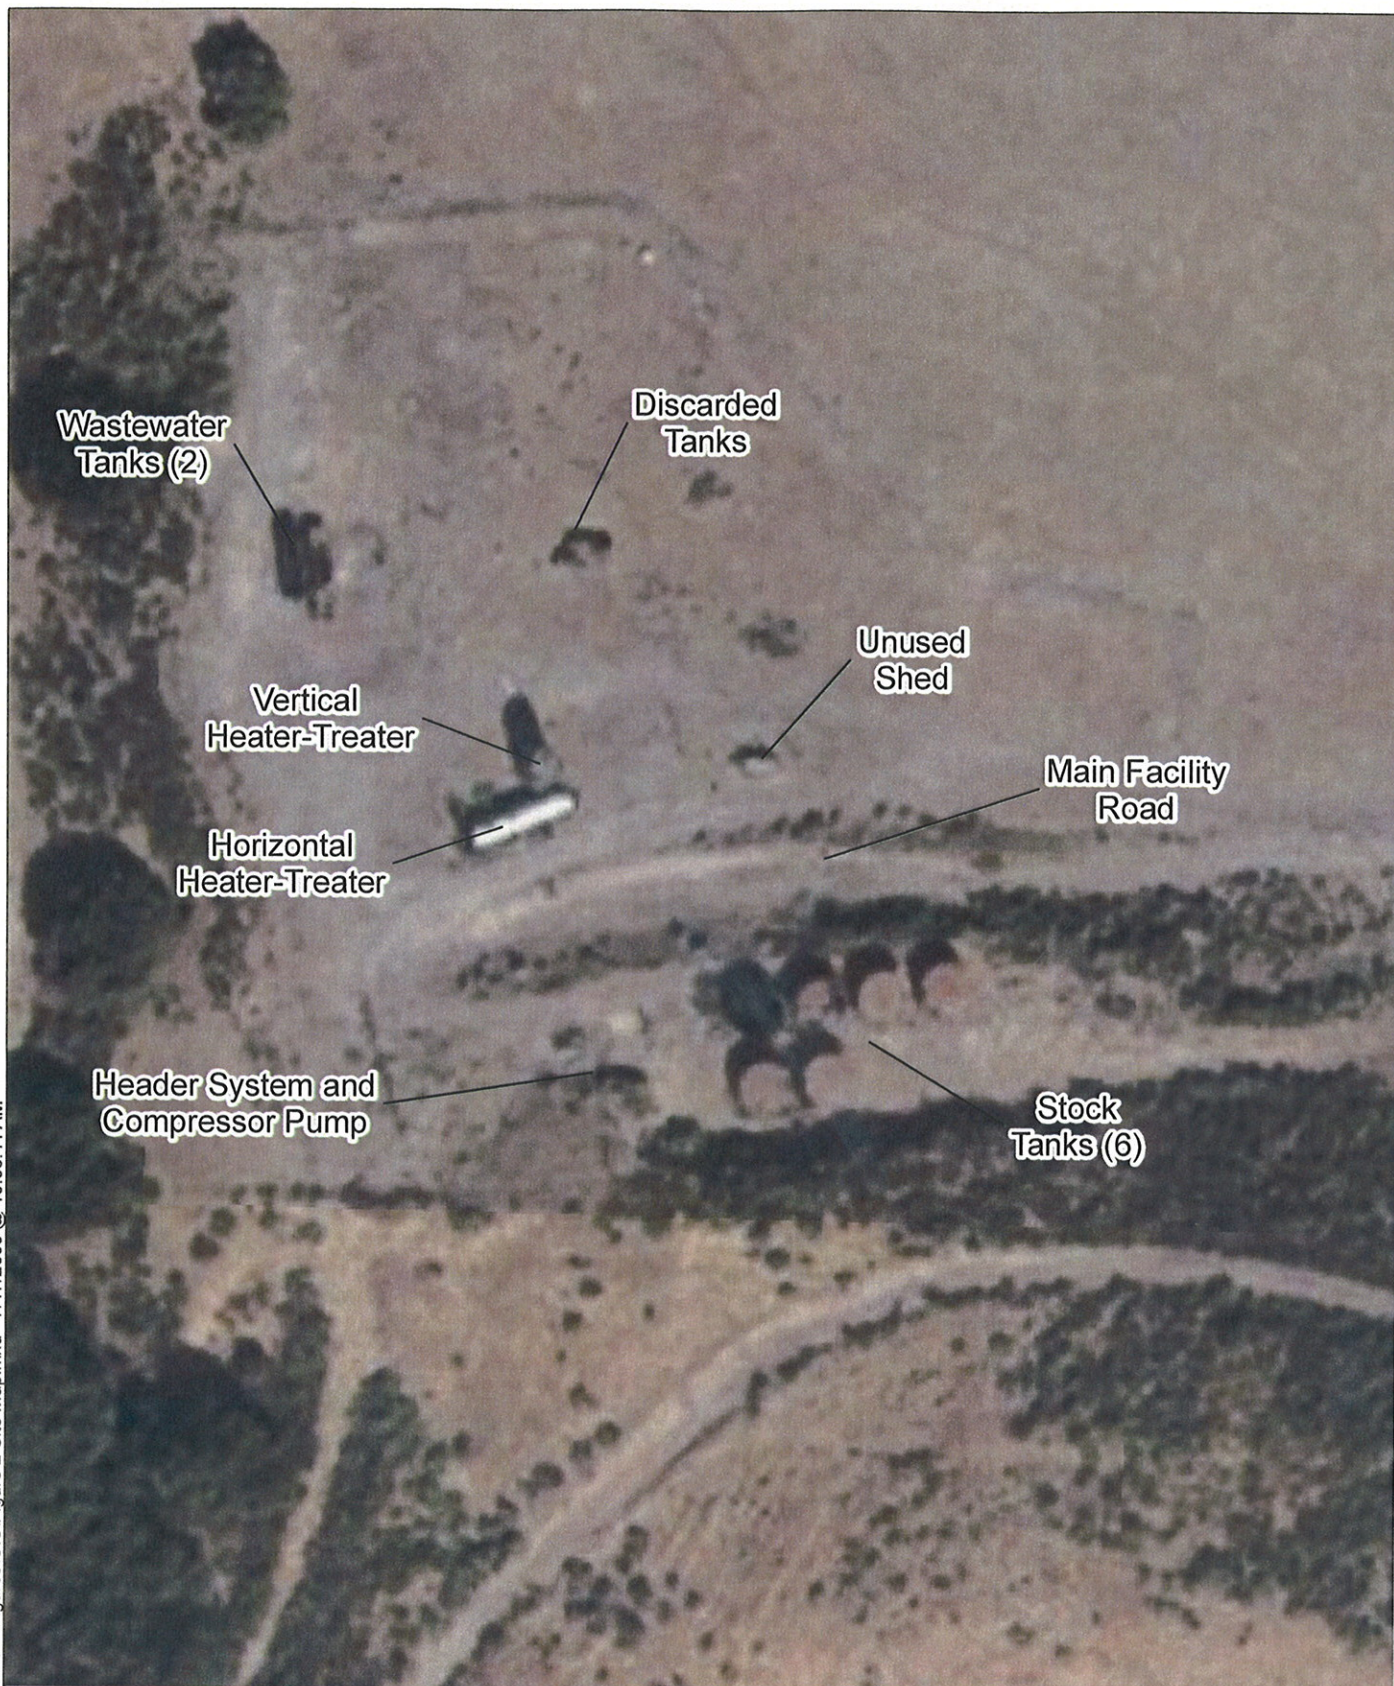
Figure 2

LFR conducted field inspections at the Site on April 11 and May 13, 2008. The principal features of concern (Figure 2) include the following:

Site Map

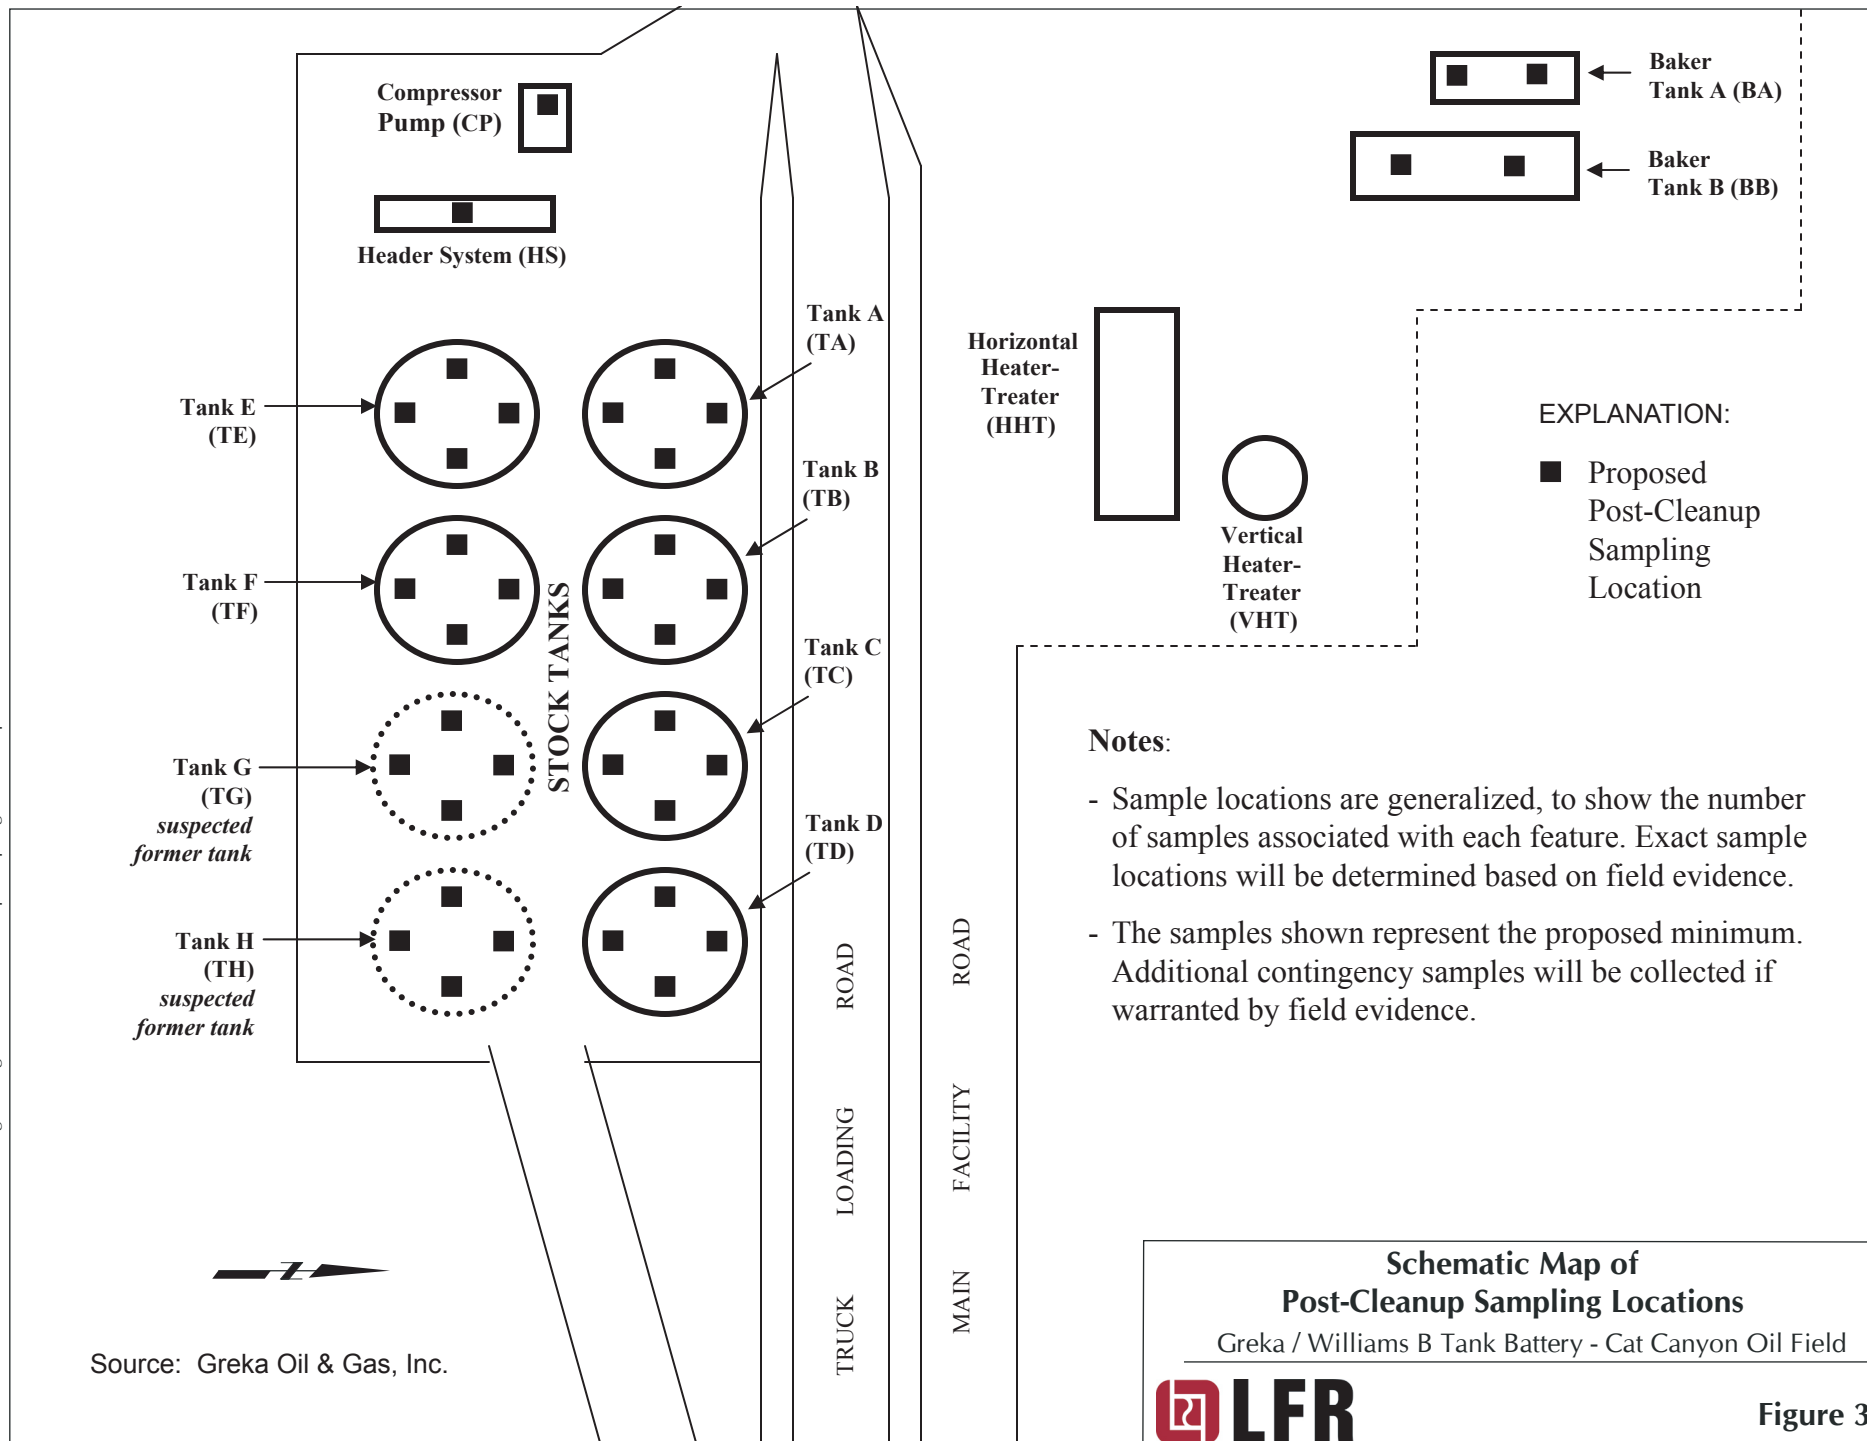
the six existing tanks have been designated as “Tank A to Tank F” on Figure 3, with corresponding two-letter abbreviations of “TA” to “TF”.

A header system and compressor pump are located to the west of the stock tanks. These features have been assigned the two-letter abbreviations of “HS” and “CP” on Figure 3.

- **Baker Tanks.** Two portable rectangular tanks (“baker tanks”) are located on the northern side of the Main Facility Road. For purposes of this Work Plan, the western tank has been designated as “Baker Tank A”, and the eastern tank has been designated as “Baker Tank B”. These features have been assigned the two-letter abbreviations of “BA” and “BB” on Figure 3.

Confirmation samples will be collected in association with the existing tanks and other features at the Site, as follows (Figure 3):

- **Stock tanks:** A minimum of four confirmation samples will be collected in each cardinal direction beneath the footprint of each of the six existing stock tanks. This represents a minimum of 24 samples total.
- **Possible former stock tank locations:** There are presently six stock tanks at the Site, in two rows: the northern row has four tanks, while the southern row has only two. There is visual evidence that there may have been one or two

A minimum of four confirmation samples will be collected in each cardinal direction beneath the assumed footprints of the two possible former stock tank locations. This represents a minimum of eight samples total.

- **Header system/compressor pump:** A minimum of two confirmation samples will be collected in the area of the header system and compressor pump, to the west of the stock tanks.

- **Baker tanks:** A minimum of two confirmation samples will be collected beneath the footprint of each baker tank. This represents a minimum of four samples total.

The tanks and vessels at the Site were described above in Section 1.1; individual tank designations and abbreviations are shown on Figure 3. It is anticipated that the tanks and vessels at the Site may contain petroleum-affected water, petroleum fluids, or residual solids. The combined volume of materials currently in the tanks/vessels at the Site may be preliminarily estimated at approximately 44,500 gallons. This volume estimate includes the following:

The assumed excavation area defined above is substantially larger than the area occupied by the six existing stock tanks (which are only about 22 feet in diameter each). For planning purposes, it has been assumed that the excavation area will be large enough to include the two possible former stock tank locations (TG and TH on Figure 3), and the compressor pump and header system (CP and HS on Figure

3), as well as the six existing stock tanks (TA to TF on Figure 3). The exact area of the excavation will be based on field evidence for hydrocarbons in soil.
