**FINAL  
REMOVAL ACTION REPORT  
OWENS PLATING REMOVAL  
RAINBOW CITY, ETOWAH COUNTY, ALABAMA  
EPA ID NO. AID981469992**

**Subject: Final Removal Action Report  
Owens Plating Removal  
Rainbow City, Etowah County, Alabama  
EPA Contract No. EP-W-05-054  
Technical Direction Document No. TTEMI-05-001-0037**

**FINAL REMOVAL ACTION REPORT**

**OWENS PLATING REMOVAL  
RAINBOW CITY, ETOWAH COUNTY, ALABAMA  
EPA ID NO. AID981469992**

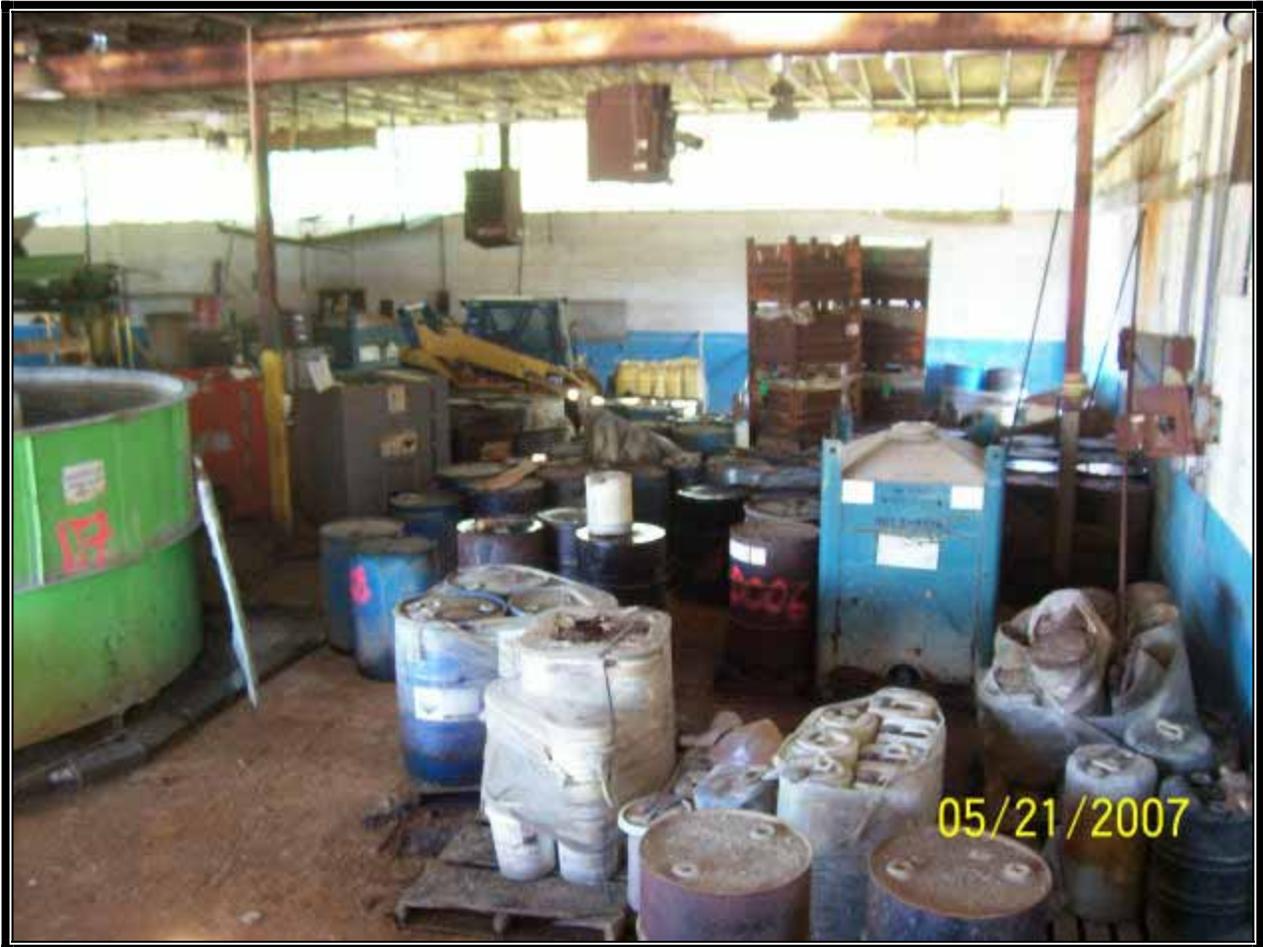
**OFFICIAL PHOTOGRAPH NO. 1  
U.S. ENVIRONMENTAL PROTECTION AGENCY**

**Subject:** Containers in Area E prior to removal activities.

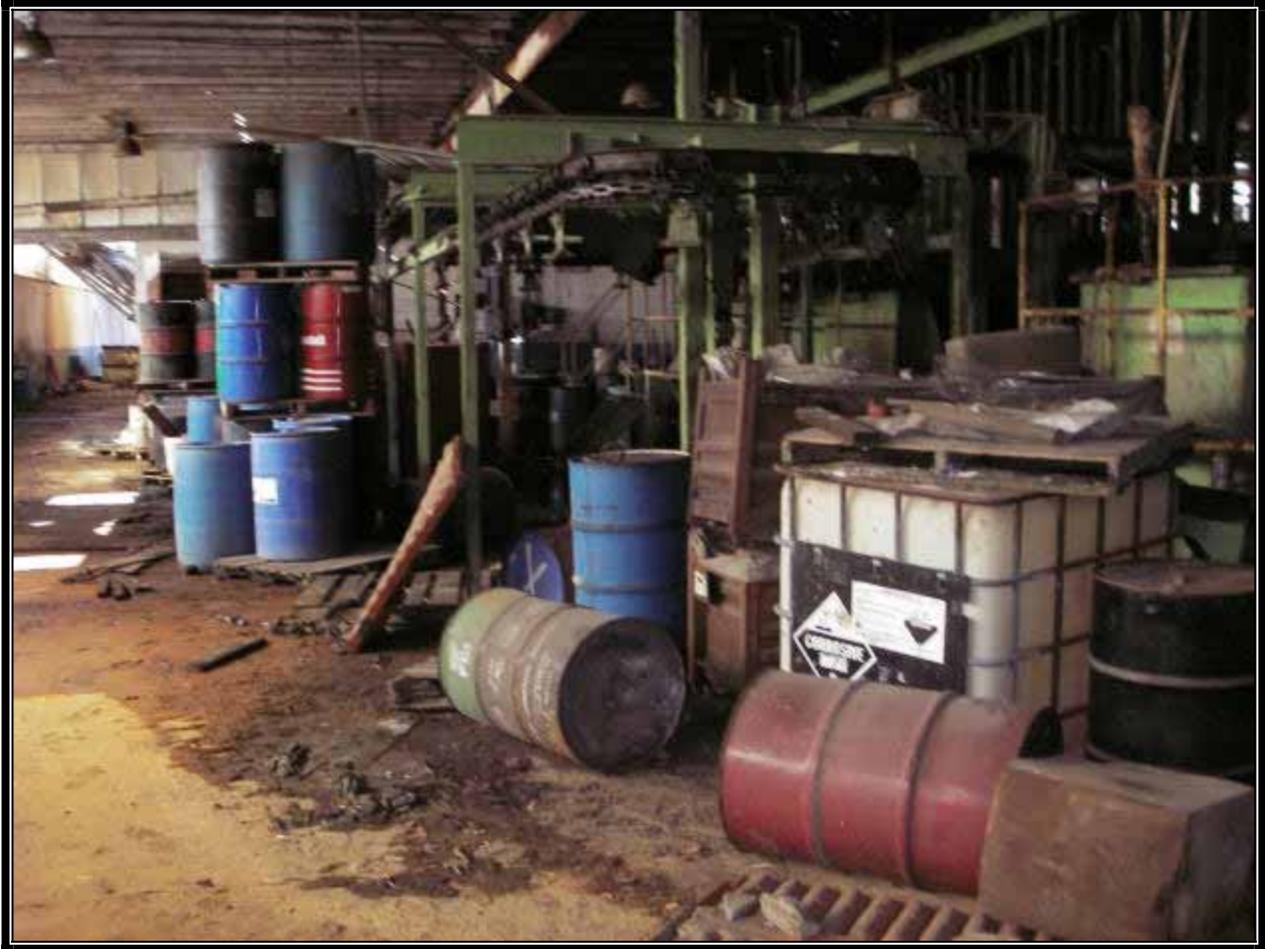
**OFFICIAL PHOTOGRAPH NO. 2**  
**U.S. ENVIRONMENTAL PROTECTION AGENCY**

**Subject:** Containers in Area E prior to removal activities.

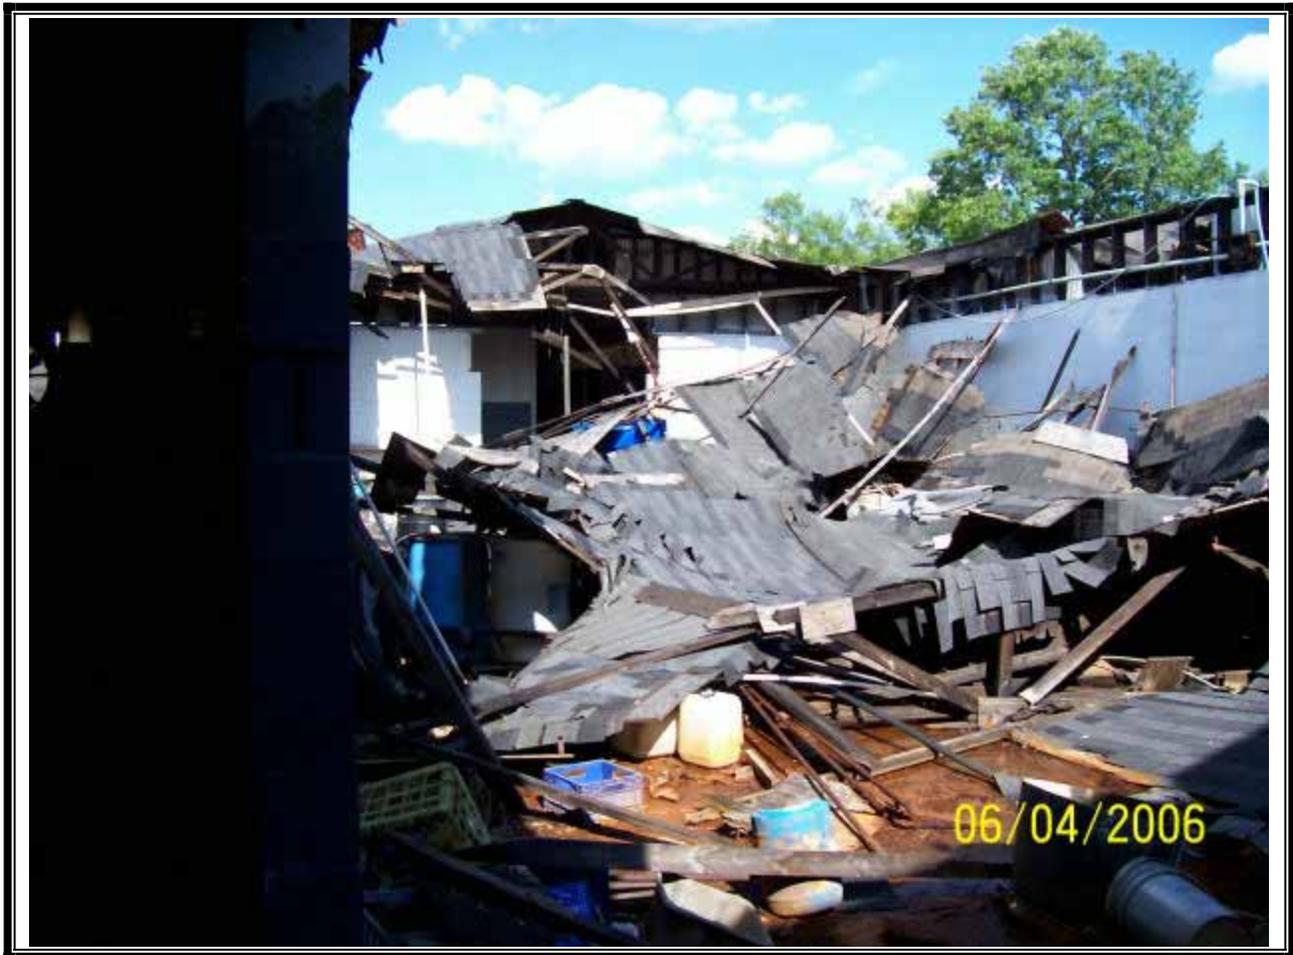
**OFFICIAL PHOTOGRAPH NO. 3  
U.S. ENVIRONMENTAL PROTECTION AGENCY**

**Subject:** Collapsed roof covering containers in Area G.

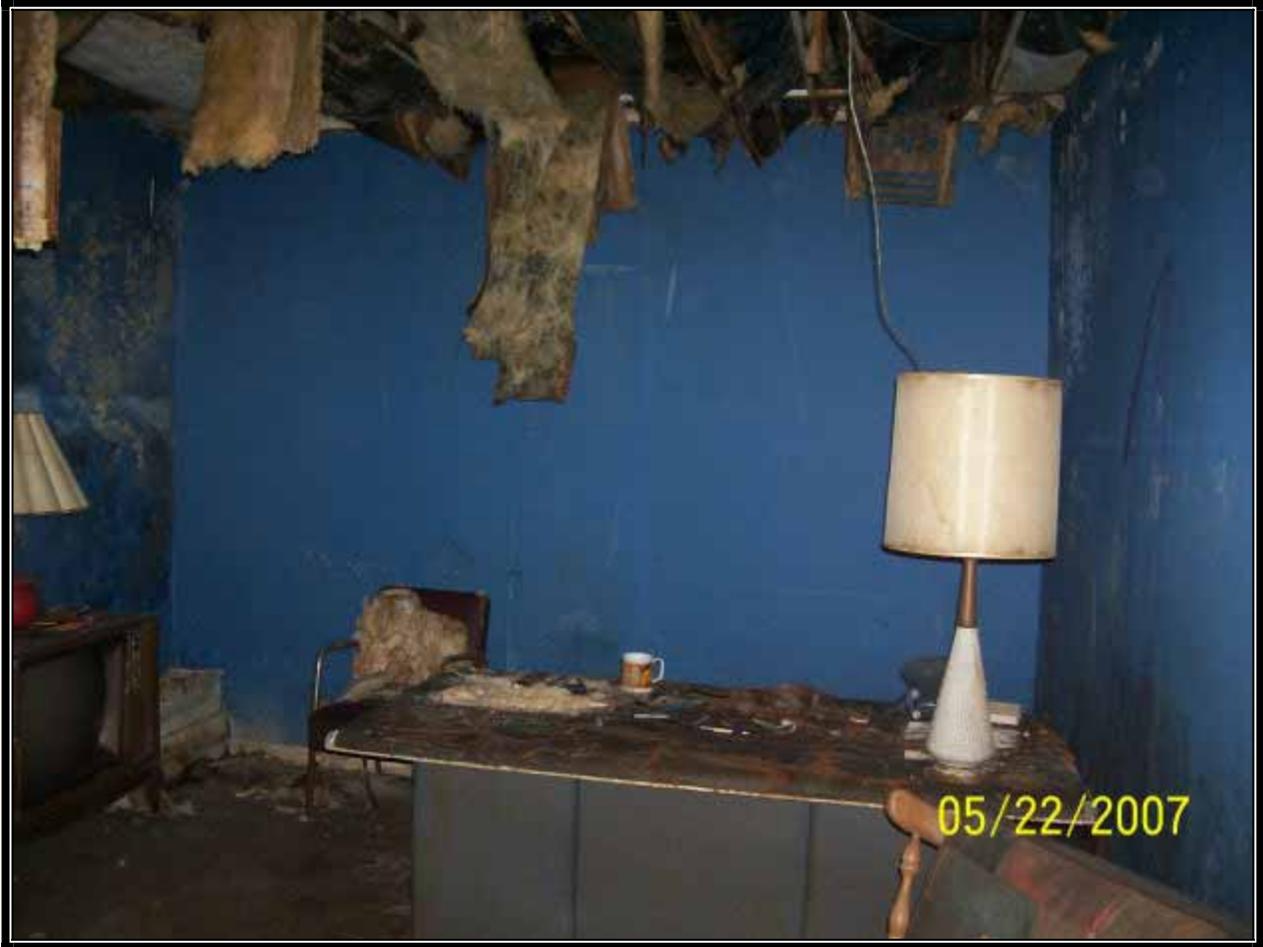
**OFFICIAL PHOTOGRAPH NO. 4**  
**U.S. ENVIRONMENTAL PROTECTION AGENCY**

**Subject:** Deteriorated condition of the office areas prior to demolition. The numerous leaks in the roof contributed heavily to the deterioration and caused serious mold issues for workers when entering the office areas.

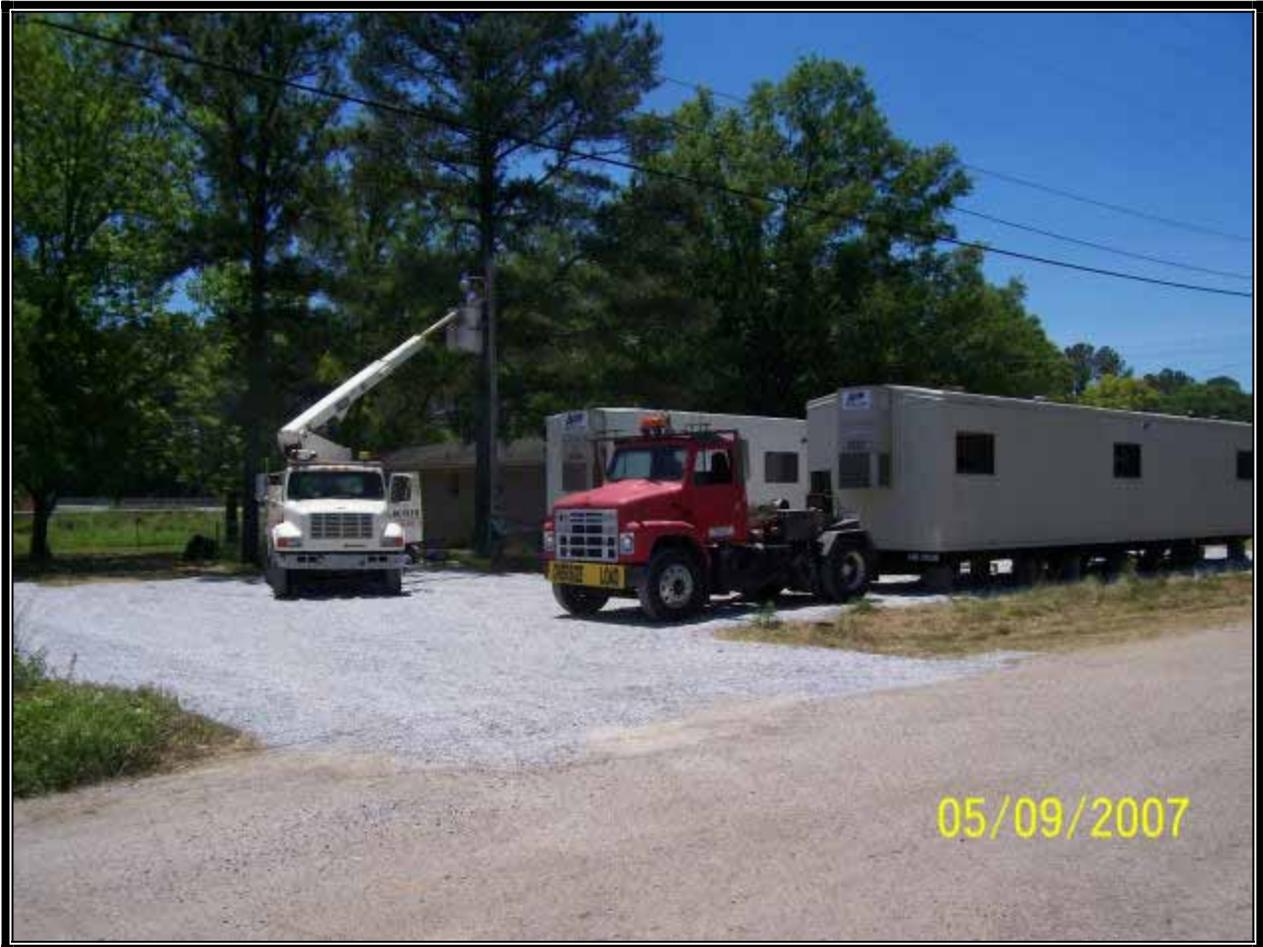
**OFFICIAL PHOTOGRAPH NO. 5**  
**U.S. ENVIRONMENTAL PROTECTION AGENCY**

**Subject:** Setup of site infrastructure. CMC mobilized office trailers, crew trailers, and sanitary facilities and connected utilities.

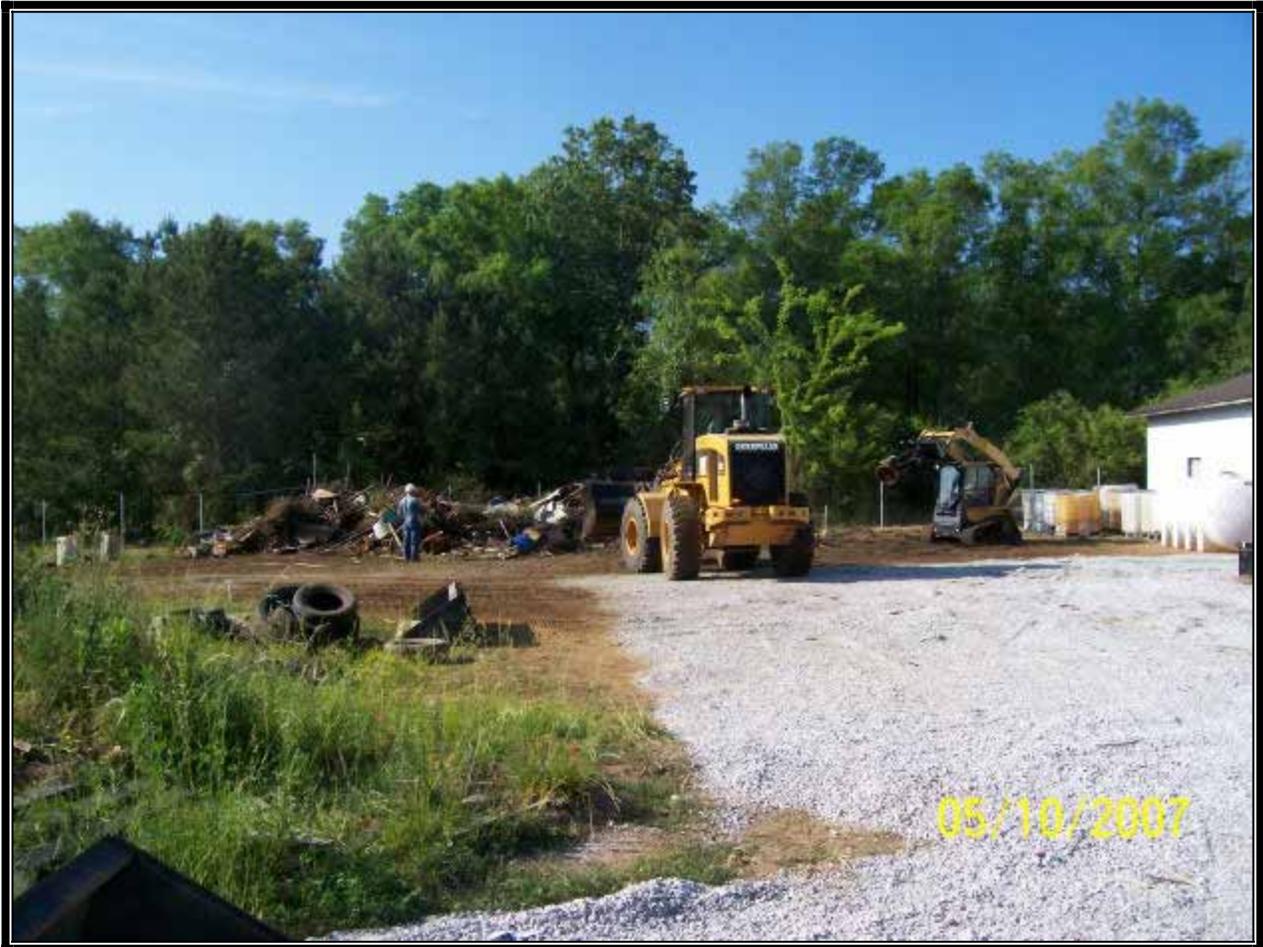
**OFFICIAL PHOTOGRAPH NO. 6  
U.S. ENVIRONMENTAL PROTECTION AGENCY**

**Subject:** Removal of debris to gain access to the rear of the site and the east entrance to the building. CMC created workspace by removing debris and coalescing soil piles. The debris was removed as non-hazardous material, and the soil was eventually mixed into the sludge as a solidifying agent.

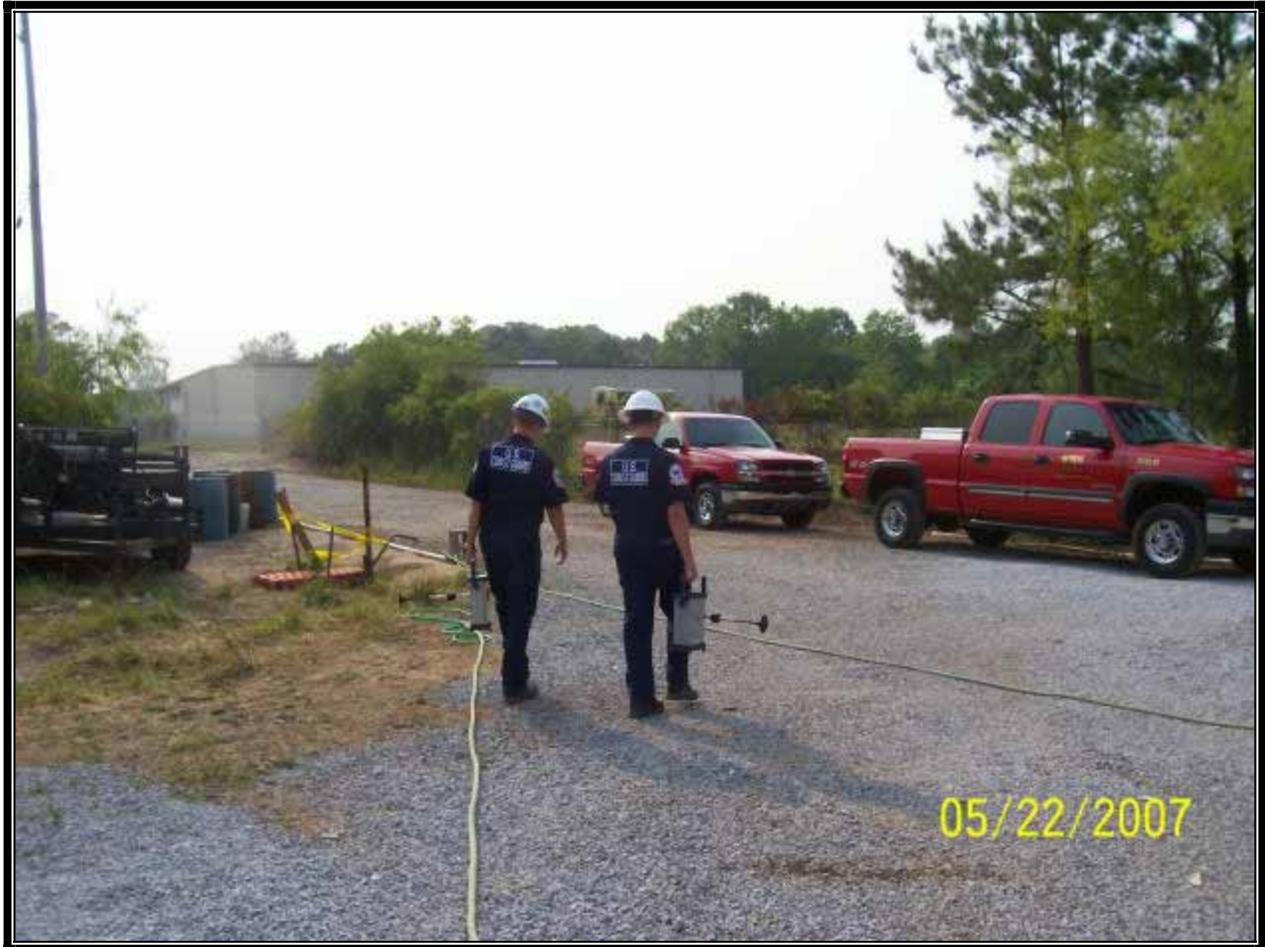
**OFFICIAL PHOTOGRAPH NO. 7**  
**U.S. ENVIRONMENTAL PROTECTION AGENCY**

**Subject:** United States Coast Guard personnel setting out DataRAM particulate monitors. The monitors were used to track off-site dust migration throughout the removal process. If off-site migration was noted, dust suppression measures were enacted.

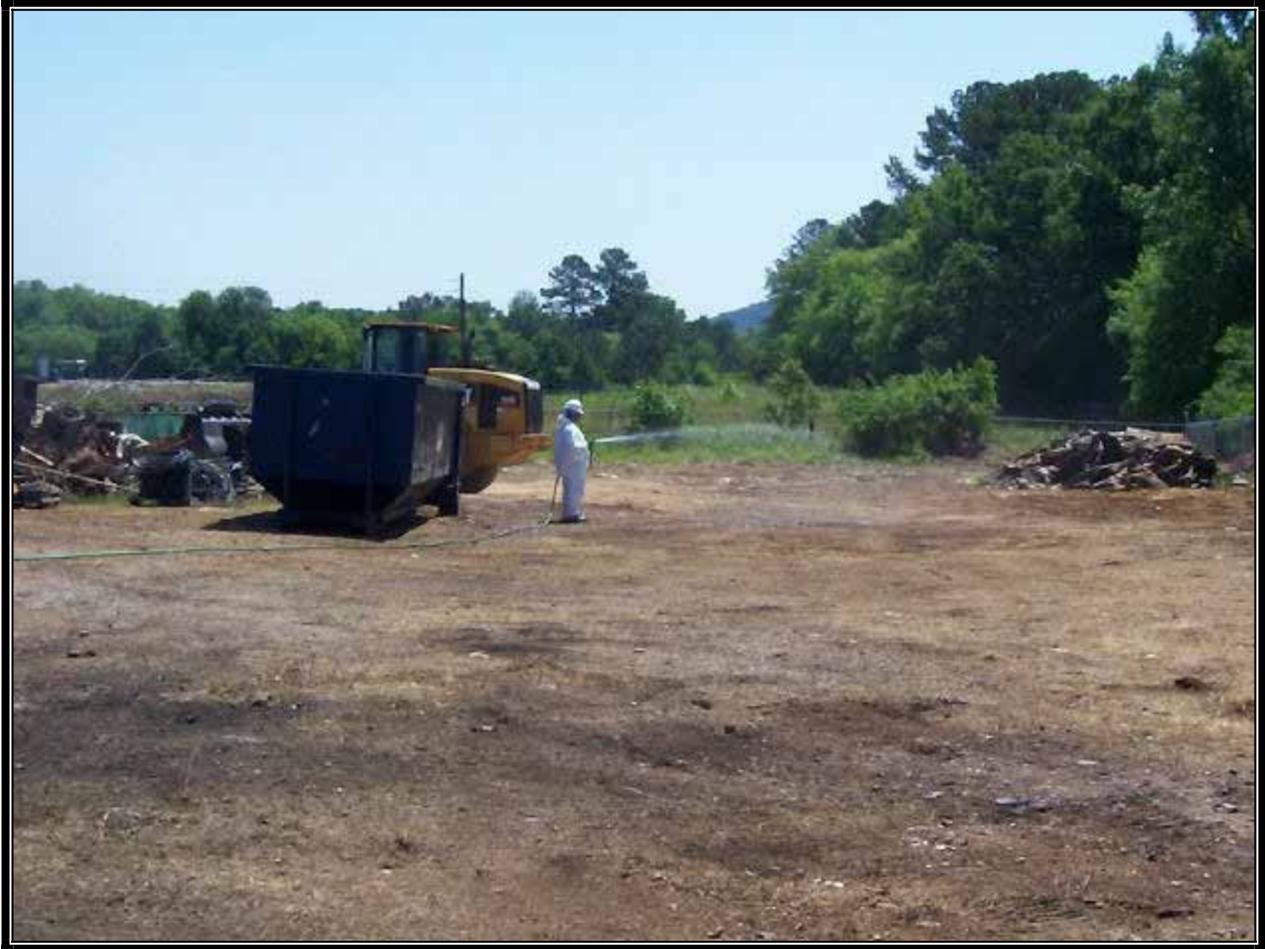
**OFFICIAL PHOTOGRAPH NO. 8**  
**U.S. ENVIRONMENTAL PROTECTION AGENCY**

**Subject:** CMC suppressing dust. A simple garden hose was used to keep the dirt in the rear of the lot damp. A more sophisticated system was unnecessary because the area was small.

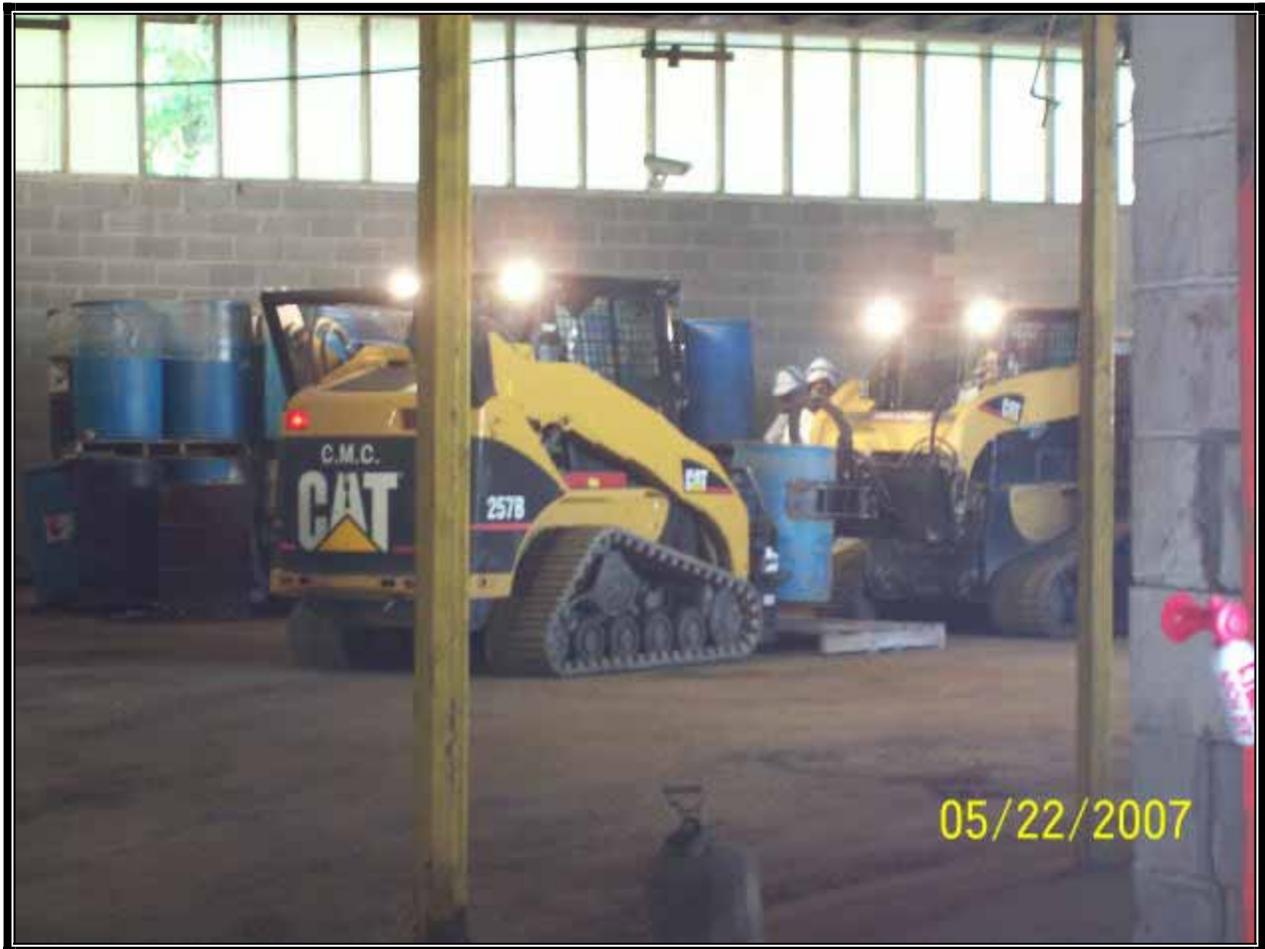
**OFFICIAL PHOTOGRAPH NO. 11  
U.S. ENVIRONMENTAL PROTECTION AGENCY**

**Subject:** Unstacking and staging of containers. CMC used a grapple to remove double-stacked drums and arrange them in orderly rows to facilitate sampling and emergency removal of leaking containers.

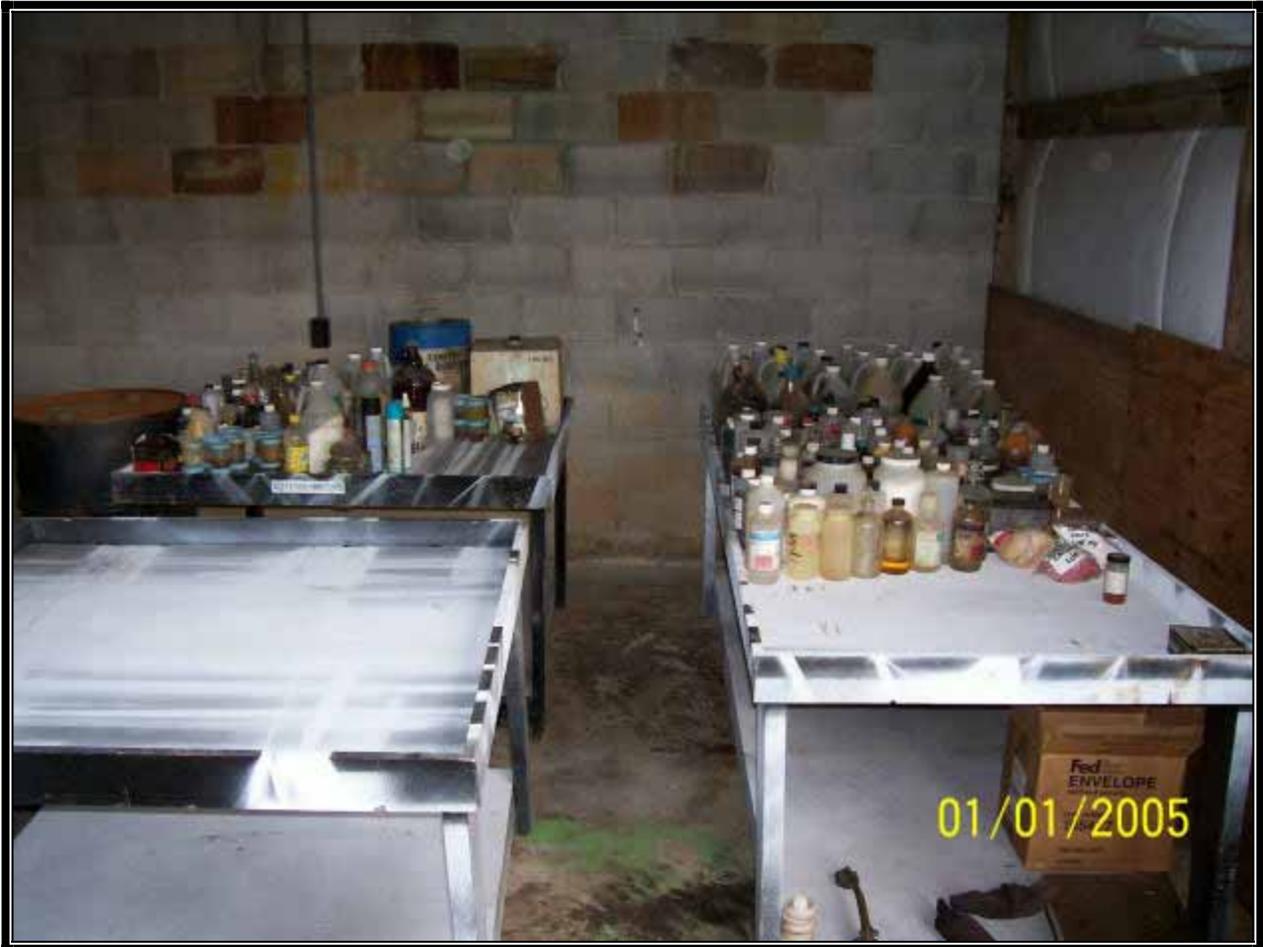
**OFFICIAL PHOTOGRAPH NO. 12**  
**U.S. ENVIRONMENTAL PROTECTION AGENCY**

**Subject:** Small containers removed from the laboratory. Approximately 320 small containers were removed from the laboratory in Area I. Additional small containers were scattered throughout the building and were added to the collection. NOTE: The camera date stamp is inaccurate.

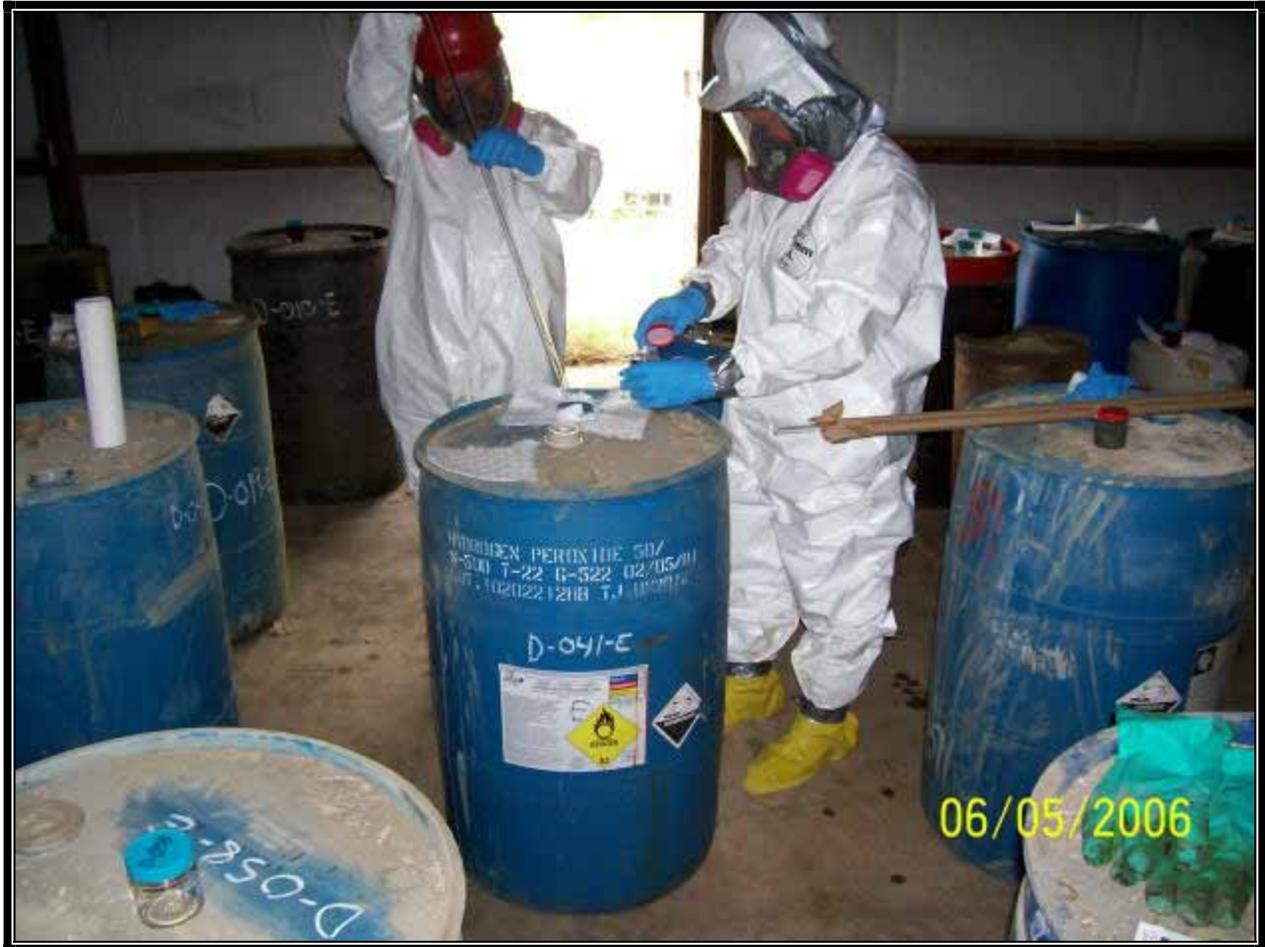
**OFFICIAL PHOTOGRAPH NO. 14**  
**U.S. ENVIRONMENTAL PROTECTION AGENCY**

**Subject:** Drum Sampling. CMC downgraded the level of protection from the Level B personal protective equipment (PPE) normally used for drum sampling to Level C based on discussions between START, Emergency and Rapid Response Services (ERRS), and U.S. Environmental Protection Agency (EPA) representatives, and conversations with former operators about the nature of the chemicals present.

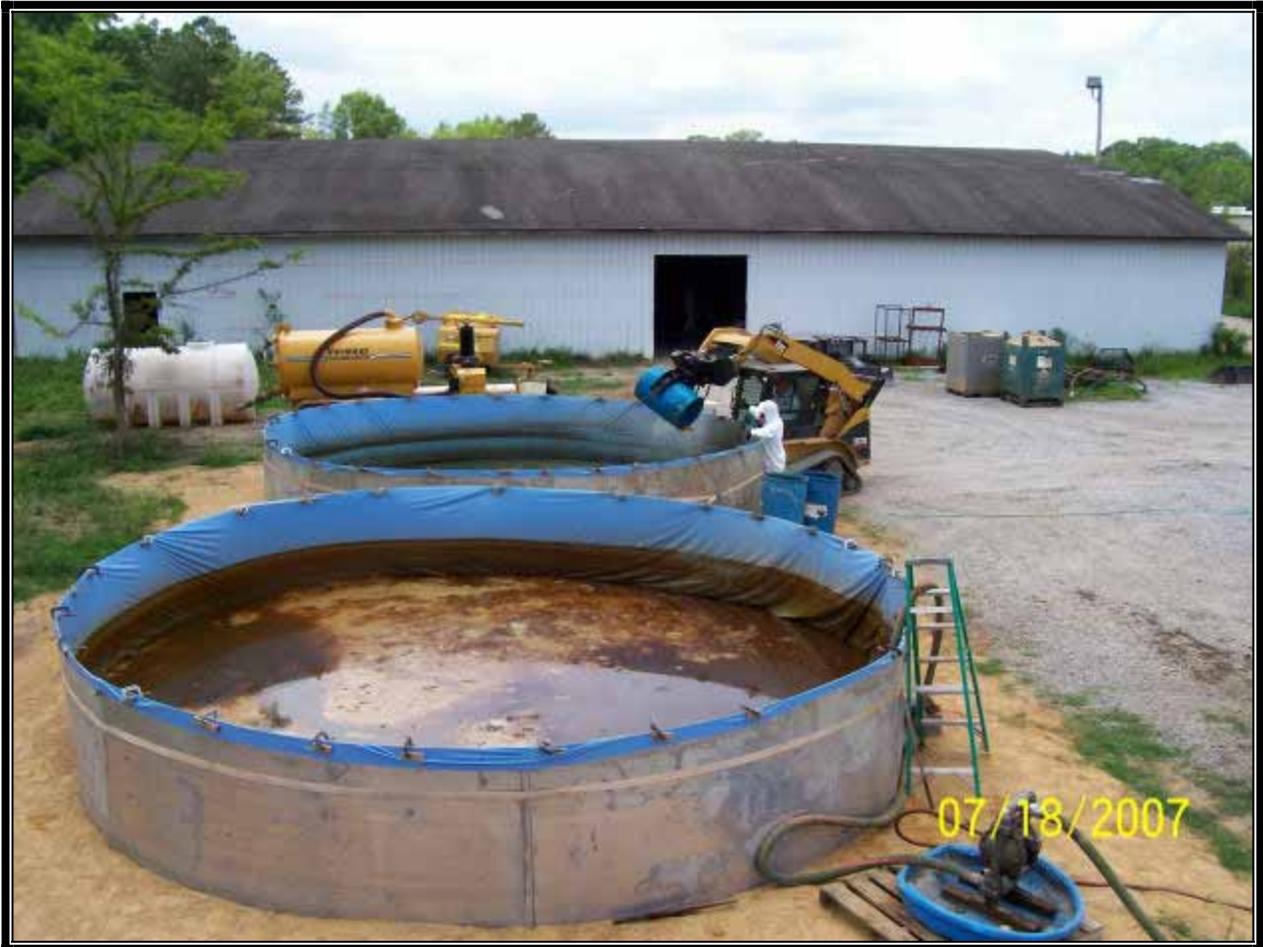
**OFFICIAL PHOTOGRAPH NO. 16  
U.S. ENVIRONMENTAL PROTECTION AGENCY**

**Subject:** Bulking of acid liquids. CMC bulked acids, bases, and oxidizers together. Two mixing containers were used to allow for reactions to proceed in one while bulking could still continue in the other.

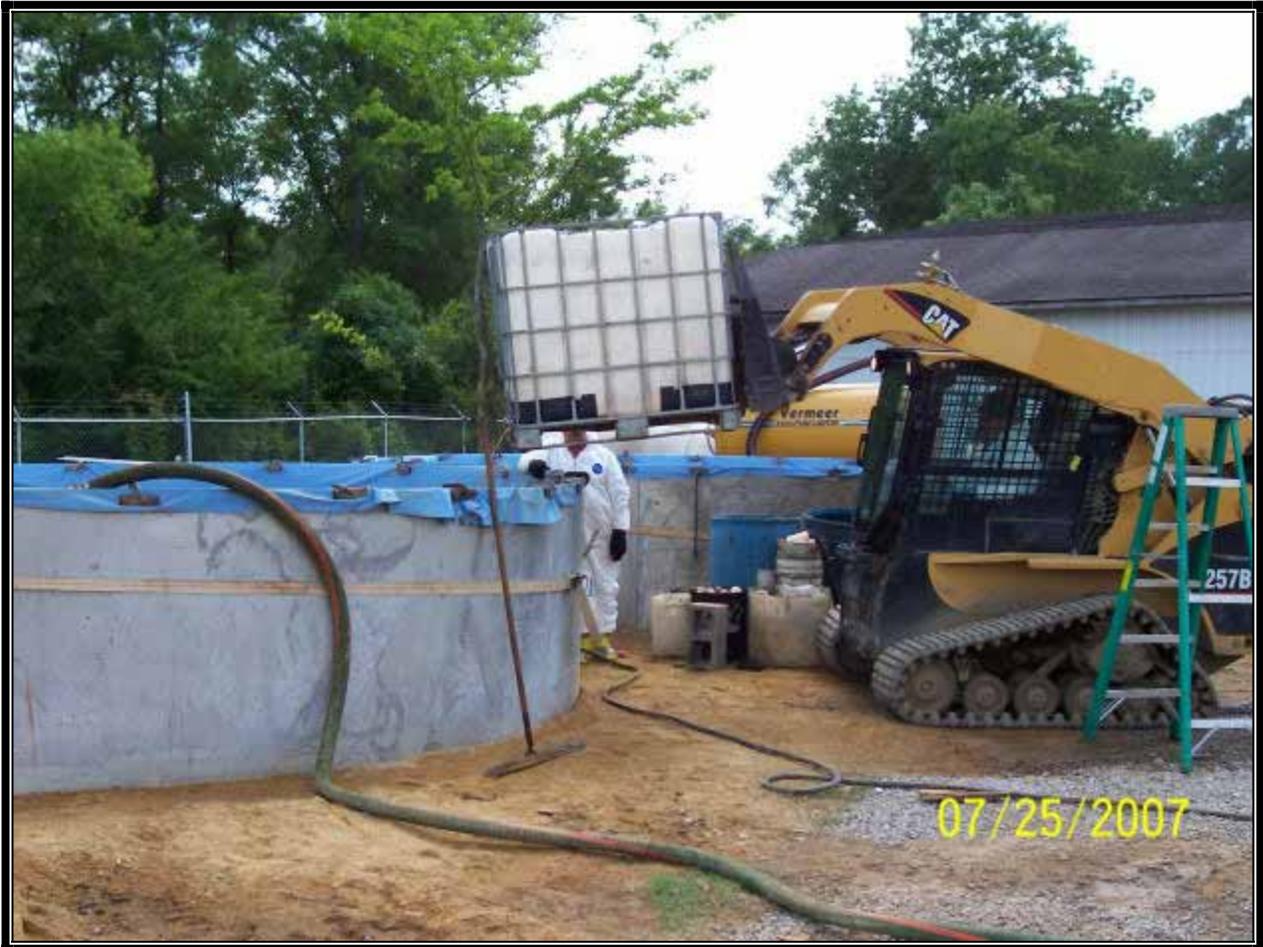
**OFFICIAL PHOTOGRAPH NO. 17  
U.S. ENVIRONMENTAL PROTECTION AGENCY**

**Subject:** Bulking of neutral liquids. Rinsate from debris as well as neutral liquids in drums were mixed in the pool to allow any reaction to occur prior to being placed into frac tanks. No reactions occurred during this process.

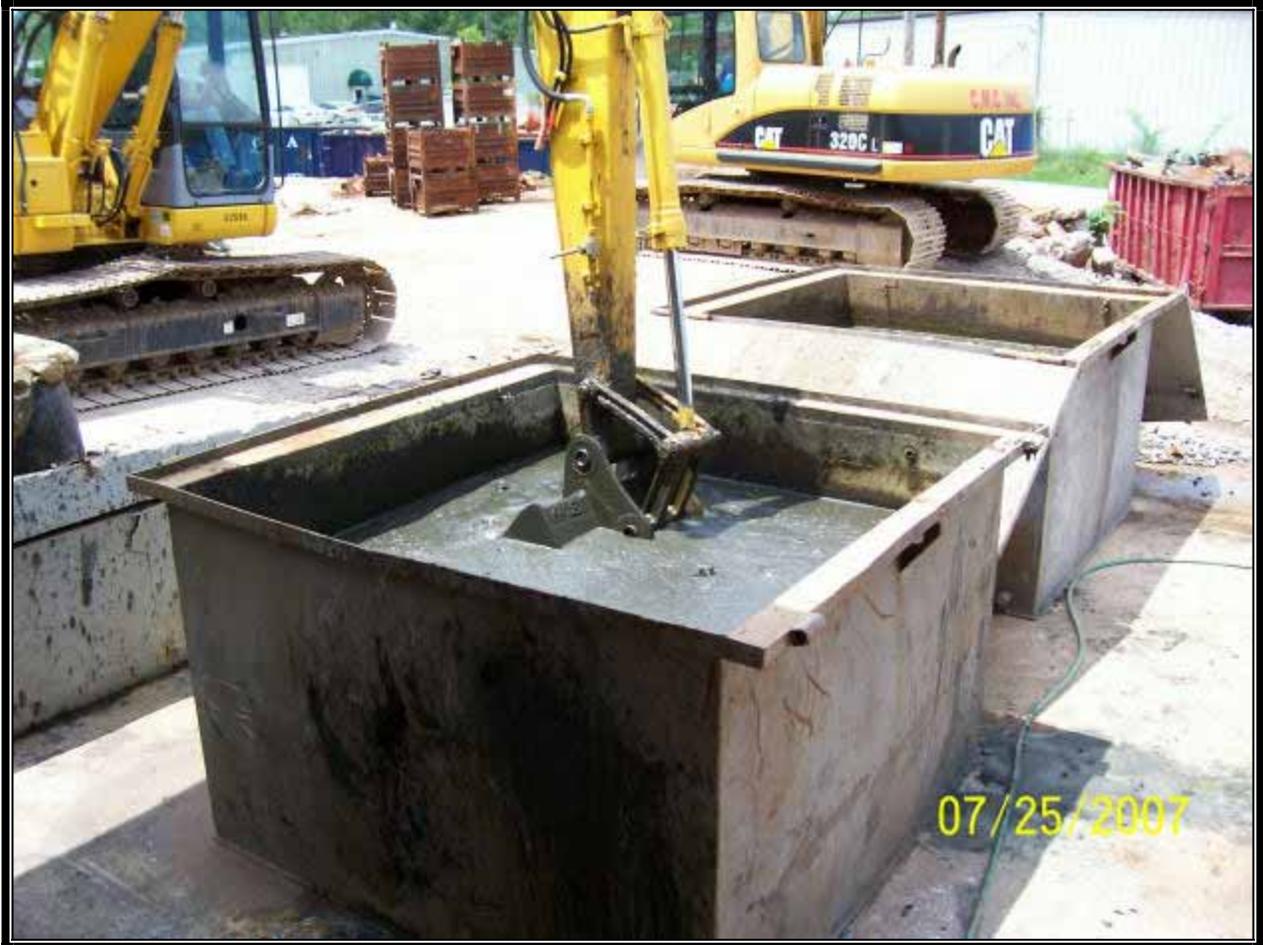
**OFFICIAL PHOTOGRAPH NO. 18  
U.S. ENVIRONMENTAL PROTECTION AGENCY**

**Subject:** Bulking of flammable liquids. An oil/water separator was made from a tote. Water was allowed to flow out the bottom spigot into the neutral liquids. The lighter organics were collected in a separate tank for later disposal.

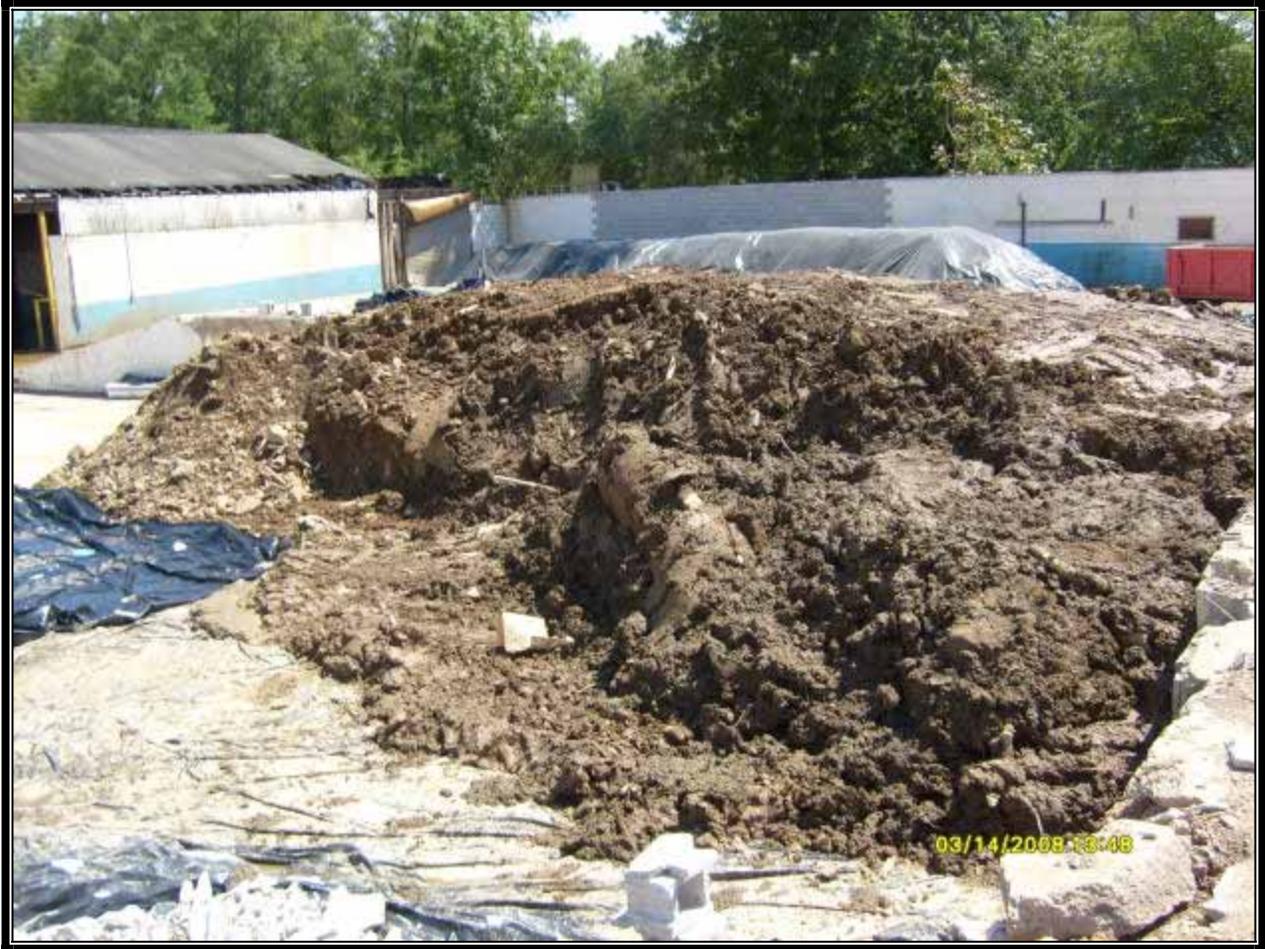
**OFFICIAL PHOTOGRAPH NO. 23**  
**U.S. ENVIRONMENTAL PROTECTION AGENCY**

**Subject:** Solidification of sludge. After determining that portland cement was the most cost effective method of solidification, CMC used a trackhoe to mix portions of sludge until a solid texture was obtained. The sludge was then staged on site until disposal arrangements could be made. NOTE: The camera date stamp is incorrect.

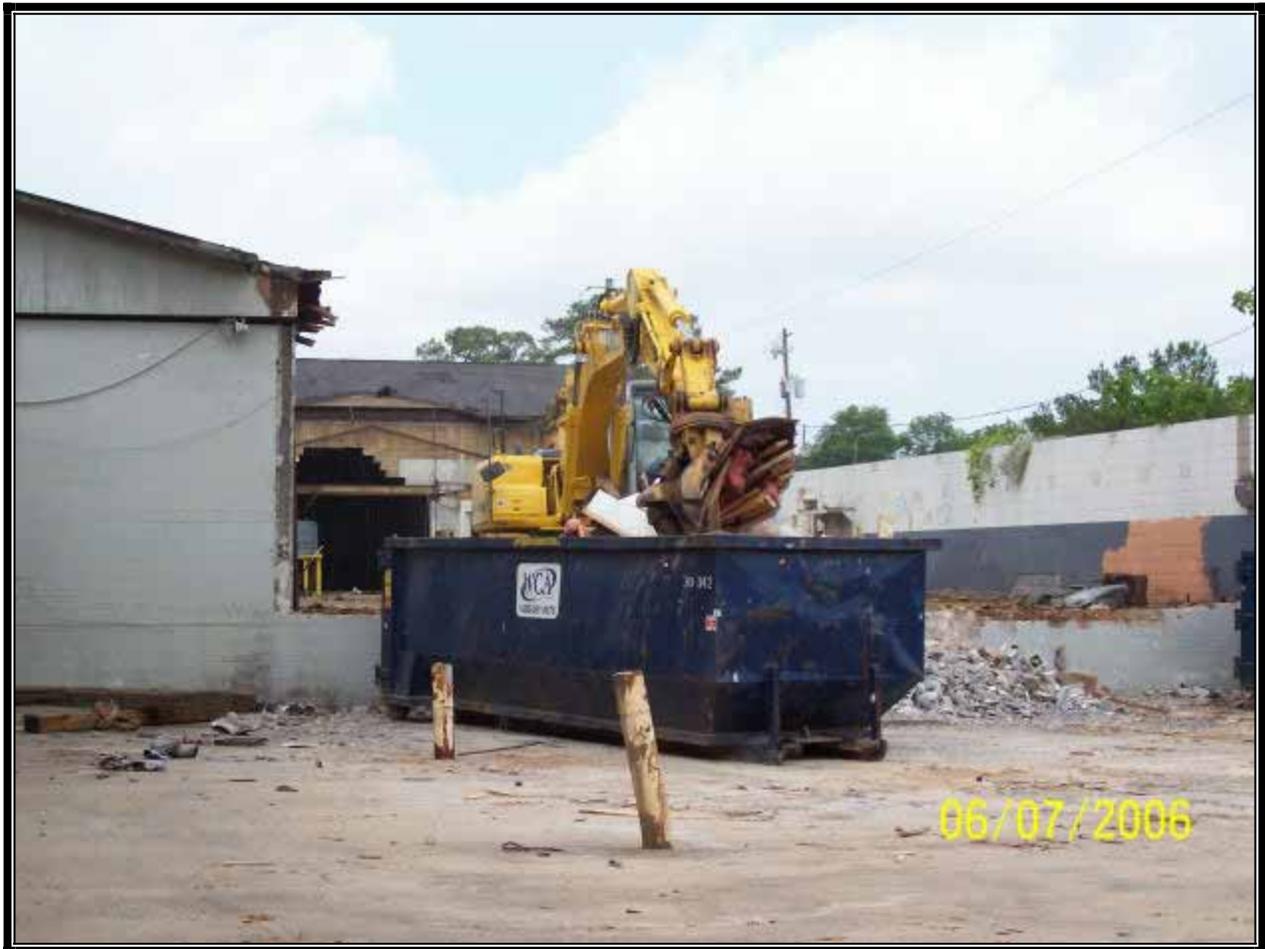
**OFFICIAL PHOTOGRAPH NO. 29**  
**U.S. ENVIRONMENTAL PROTECTION AGENCY**

**Subject:** Removal of containers from beneath the collapsed roof in Area G. The containers were subsequently staged for sampling.

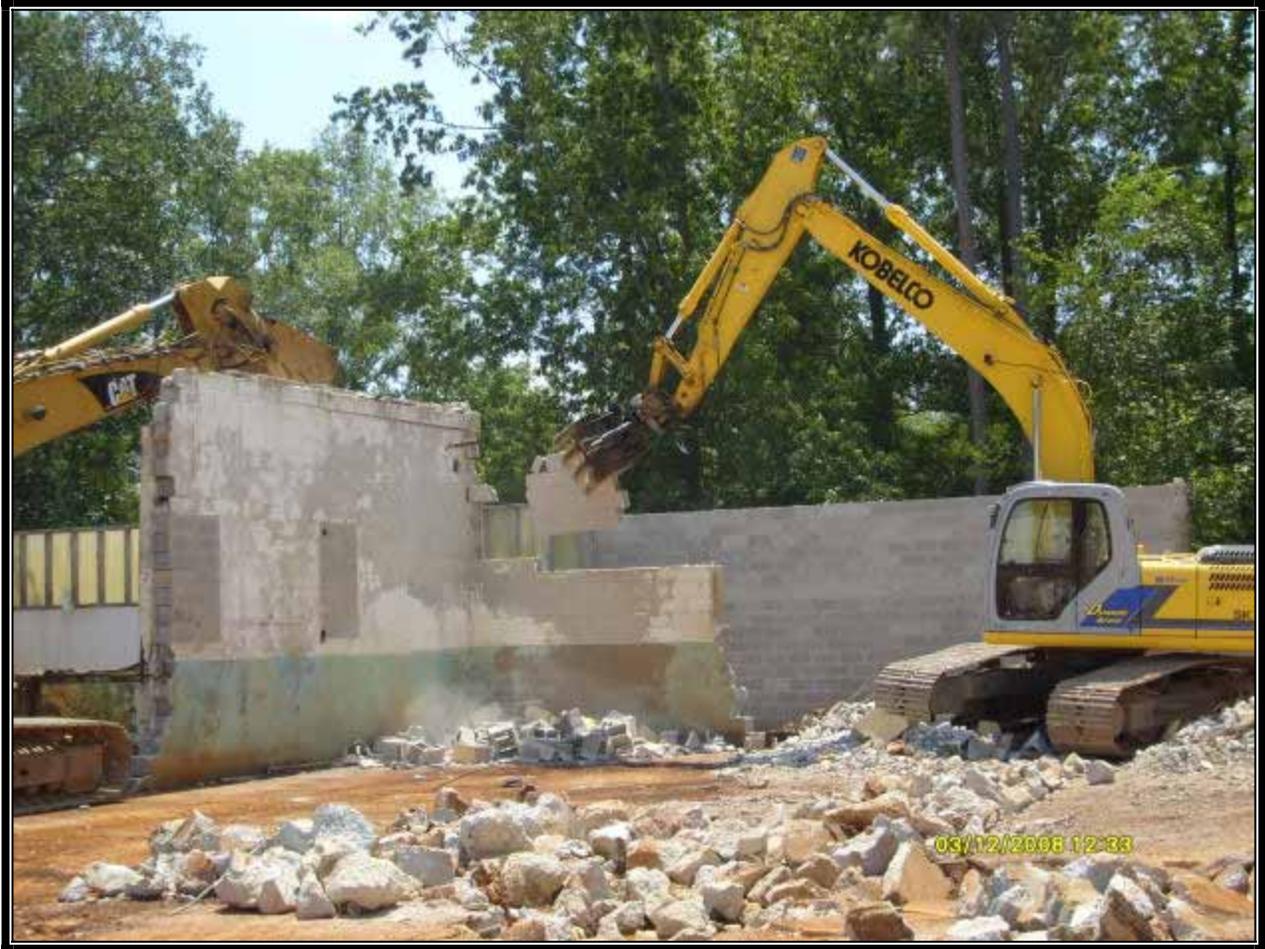
**OFFICIAL PHOTOGRAPH NO. 31  
U.S. ENVIRONMENTAL PROTECTION AGENCY**

**Subject:** Demolition of the office section of the building. EPA originally desired to save these sections from demolition, but subsequent examination showed them too damaged to safely leave standing.

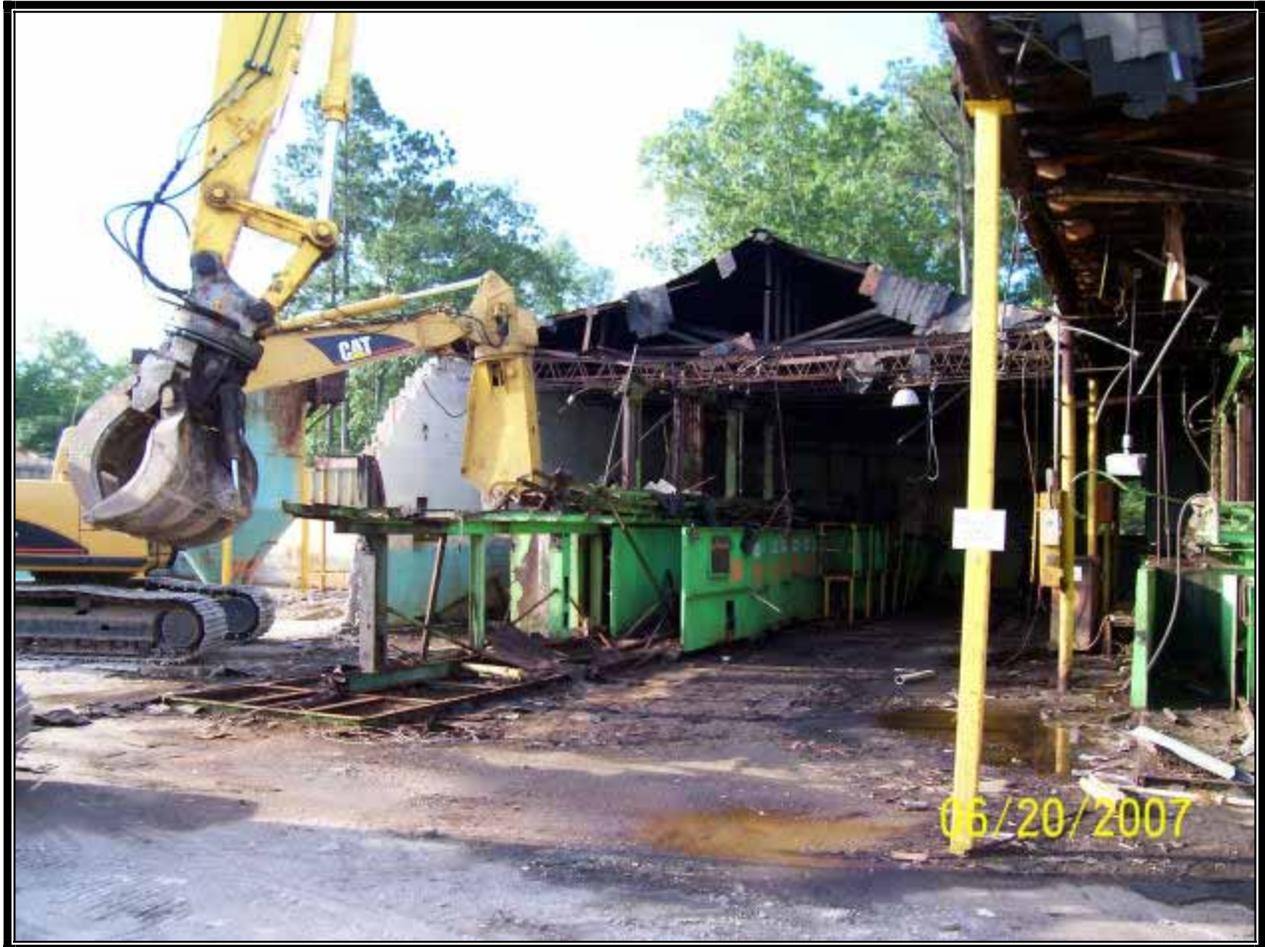
**OFFICIAL PHOTOGRAPH NO. 33  
U.S. ENVIRONMENTAL PROTECTION AGENCY**

**Subject:** Removal of building from around vats. The building was removed from over the vats to allow heavy equipment to get in and cut the steel framework of the vat lines and drag the vats to remove the sludge.
