**FINAL  
REMOVAL ACTION REPORT  
OWENS PLATING REMOVAL  
RAINBOW CITY, ETOWAH COUNTY, ALABAMA  
EPA ID NO. AID981469992**

**Subject: Final Removal Action Report  
Owens Plating Removal  
Rainbow City, Etowah County, Alabama  
EPA Contract No. EP-W-05-054  
Technical Direction Document No. TTEMI-05-001-0037**

**FINAL REMOVAL ACTION REPORT**

**OWENS PLATING REMOVAL  
RAINBOW CITY, ETOWAH COUNTY, ALABAMA  
EPA ID NO. AID981469992**

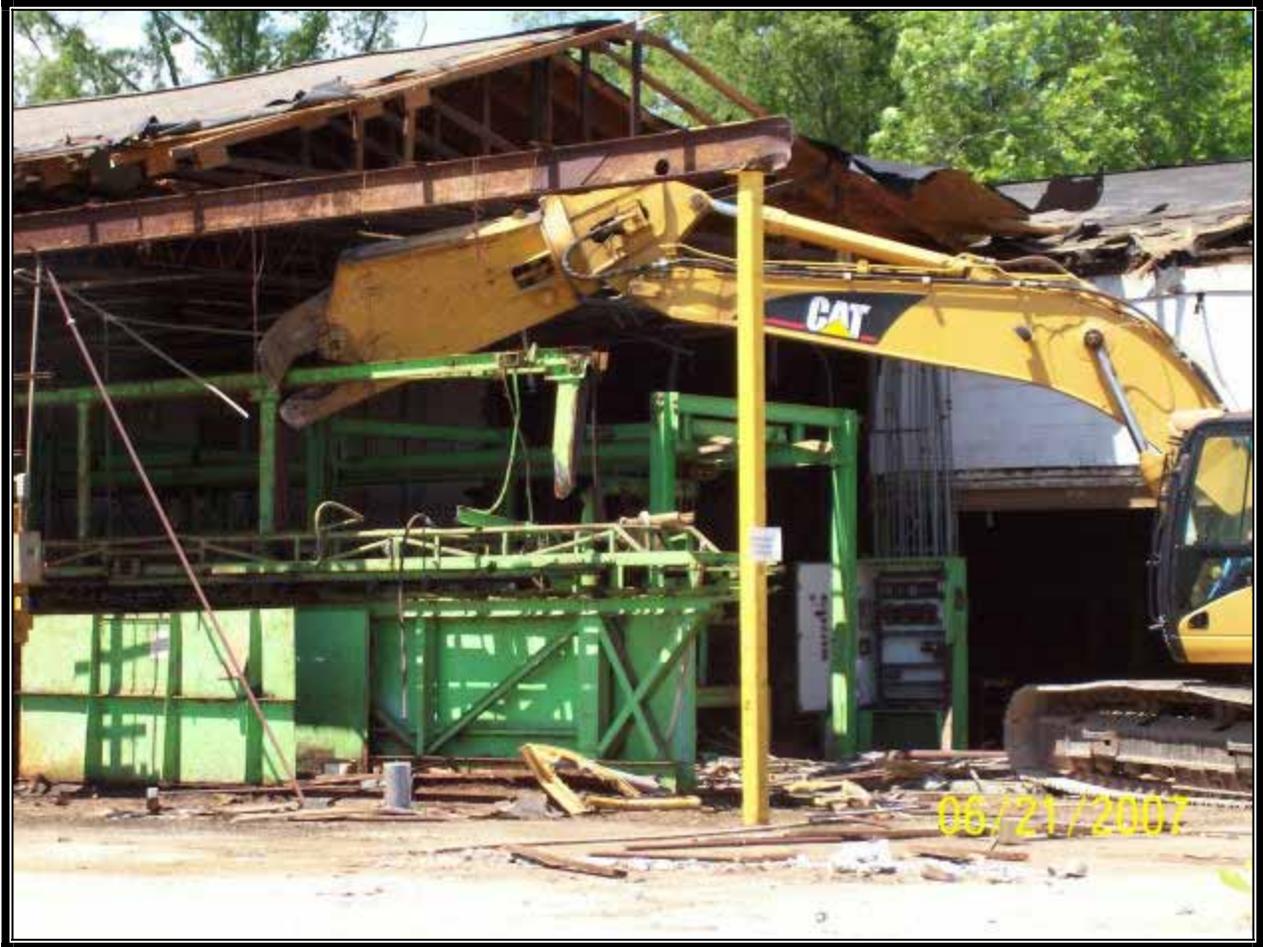
**OFFICIAL PHOTOGRAPH NO. 34**  
**U.S. ENVIRONMENTAL PROTECTION AGENCY**

**Subject:** Vat removal. Using metal shears, CMC cut the vat line frames and dragged the vats out to a work area to remove the sludge.

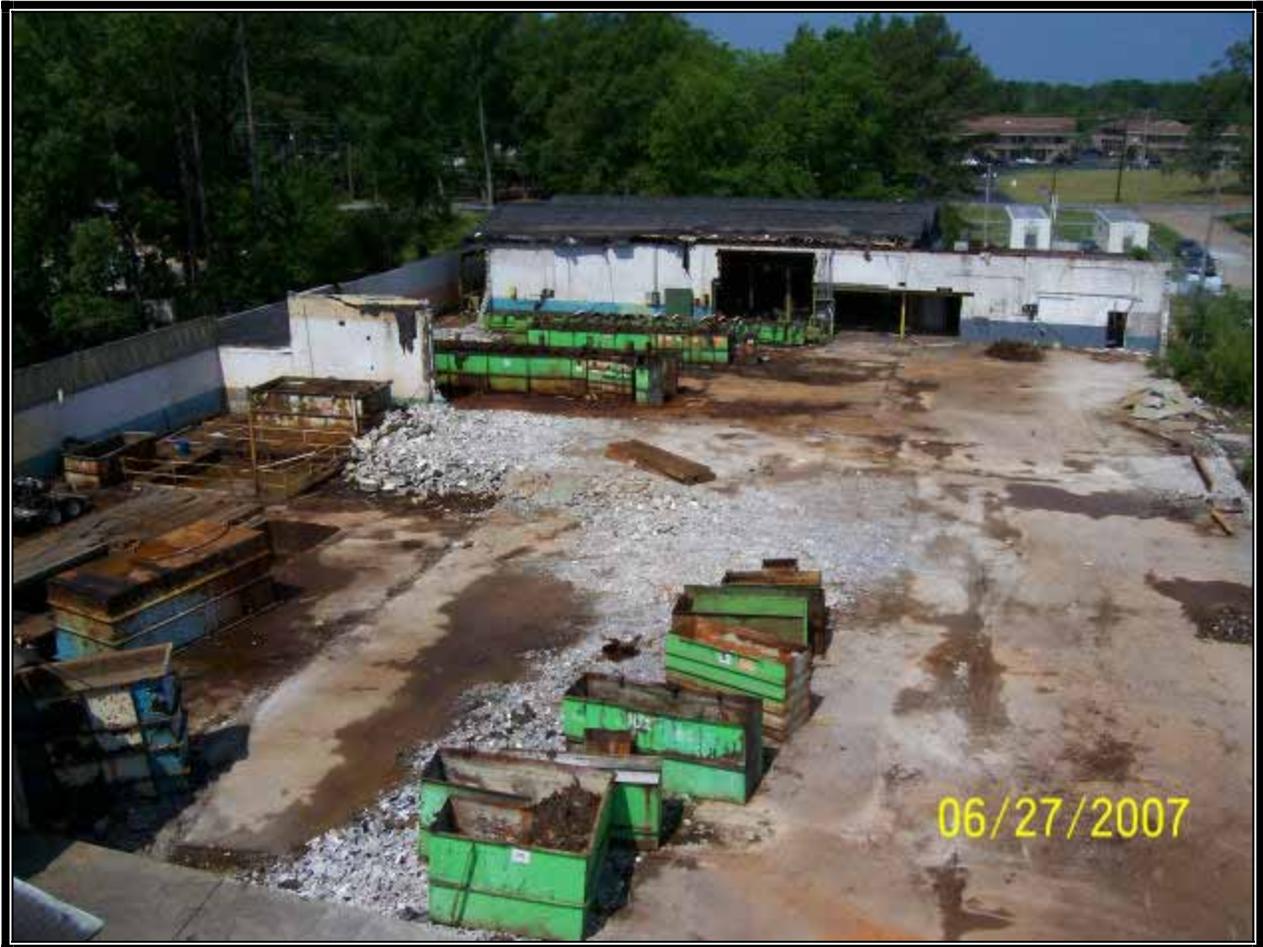
**OFFICIAL PHOTOGRAPH NO. 35**  
**U.S. ENVIRONMENTAL PROTECTION AGENCY**

**Subject:** Vat removal. The metal frames of the vat lines were cut into short pieces and sent off site for recycling.

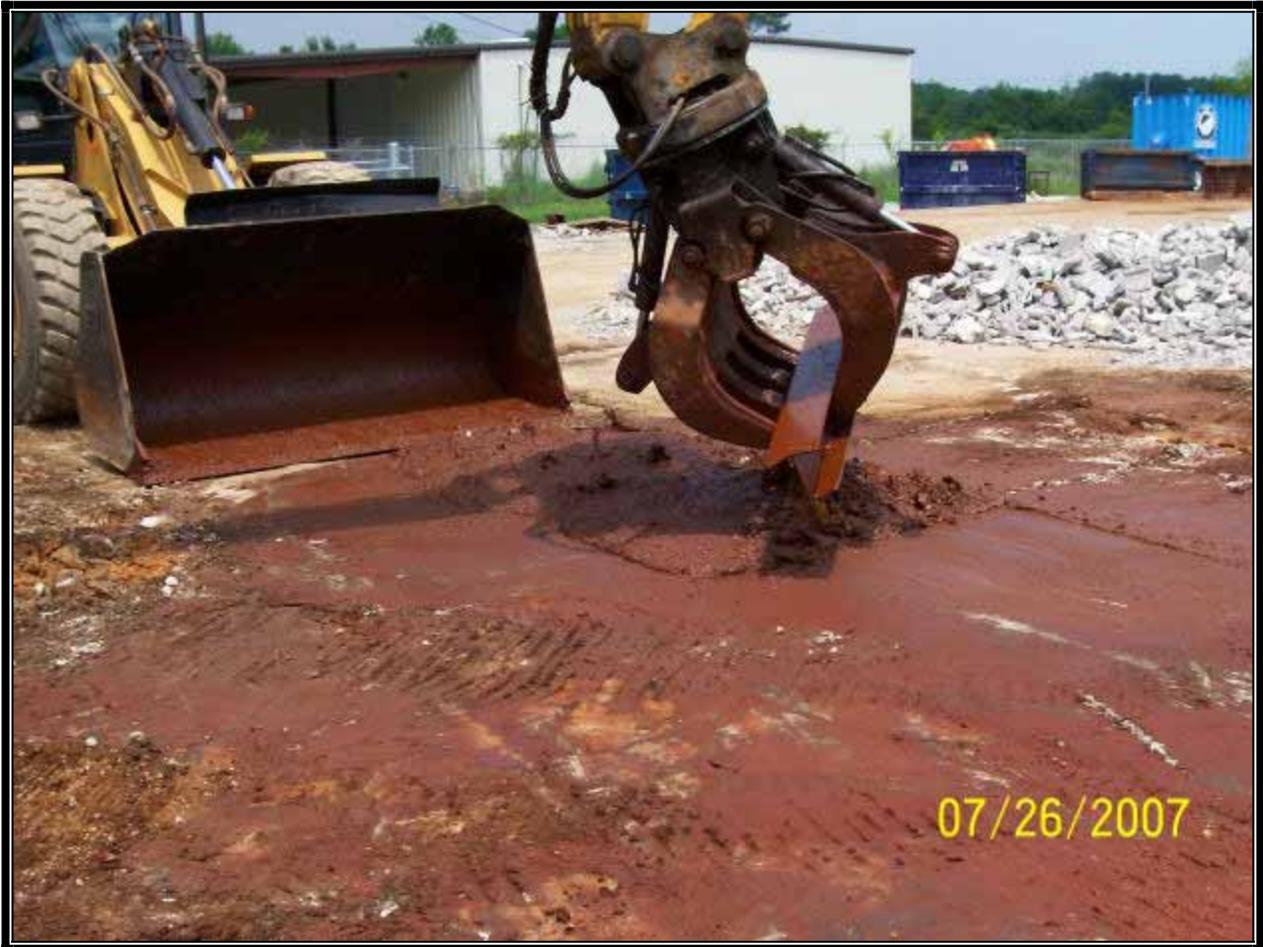
**OFFICIAL PHOTOGRAPH NO. 37**  
**U.S. ENVIRONMENTAL PROTECTION AGENCY**

**Subject:** Vat sludge removal. Many of the vats contained liquids and sludge, but were not removeable by mechanical means because of the large amount of debris and production material in the vats. CMC elected to simply dump these out and scrape up the sludge with heavy equipment. The concrete where this was done was stained from leaking vats prior to the initiation of removal activities and was chosen for this reason.

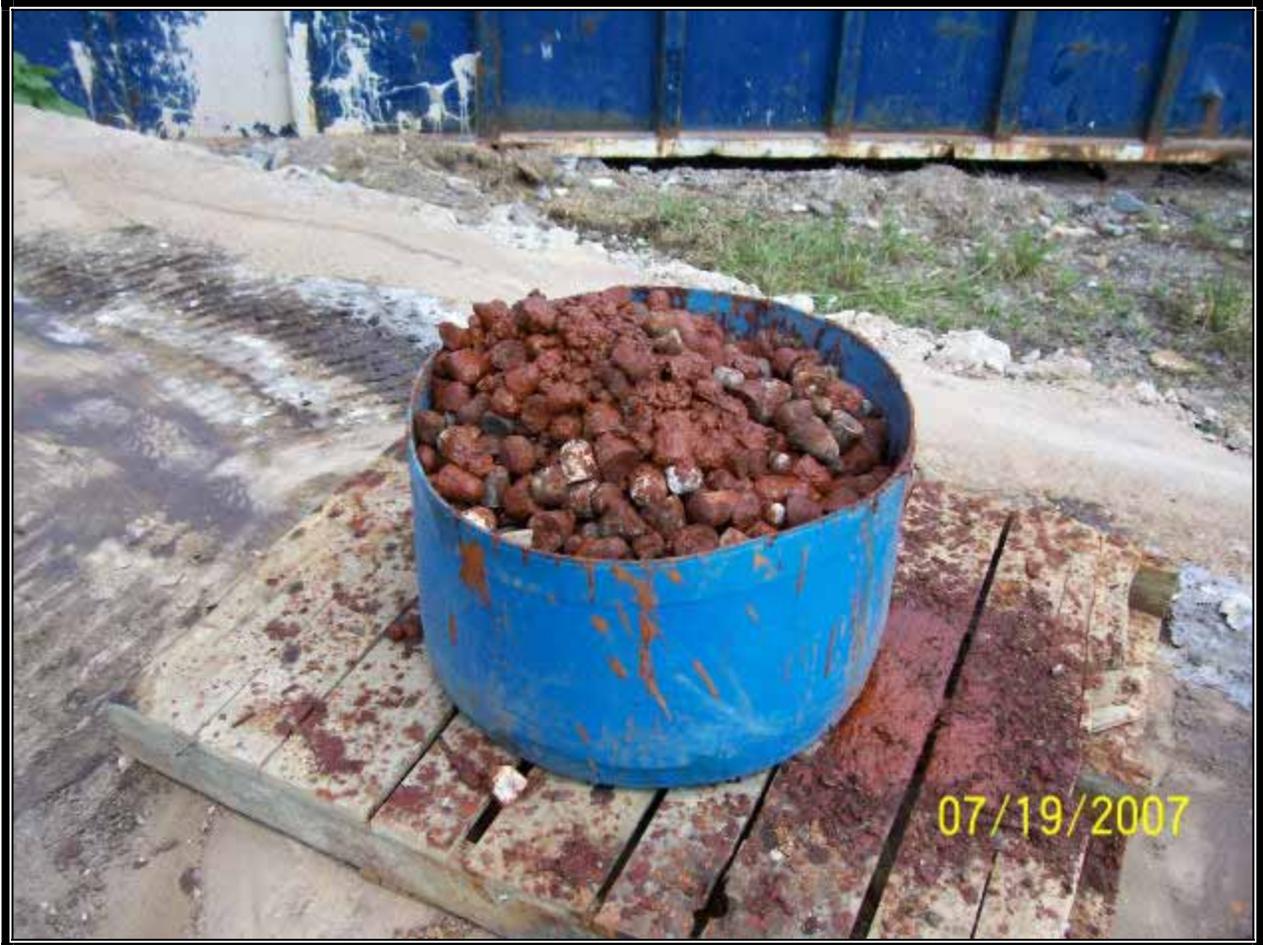
**OFFICIAL PHOTOGRAPH NO. 38**  
**U.S. ENVIRONMENTAL PROTECTION AGENCY**

**Subject:** Vat sludge cleanup. After dumping these vats out, CMC used heavy equipment and large pieces of metal as a scoop to place the sludge into containers. Note the staining of the concrete that was subsequently removed.

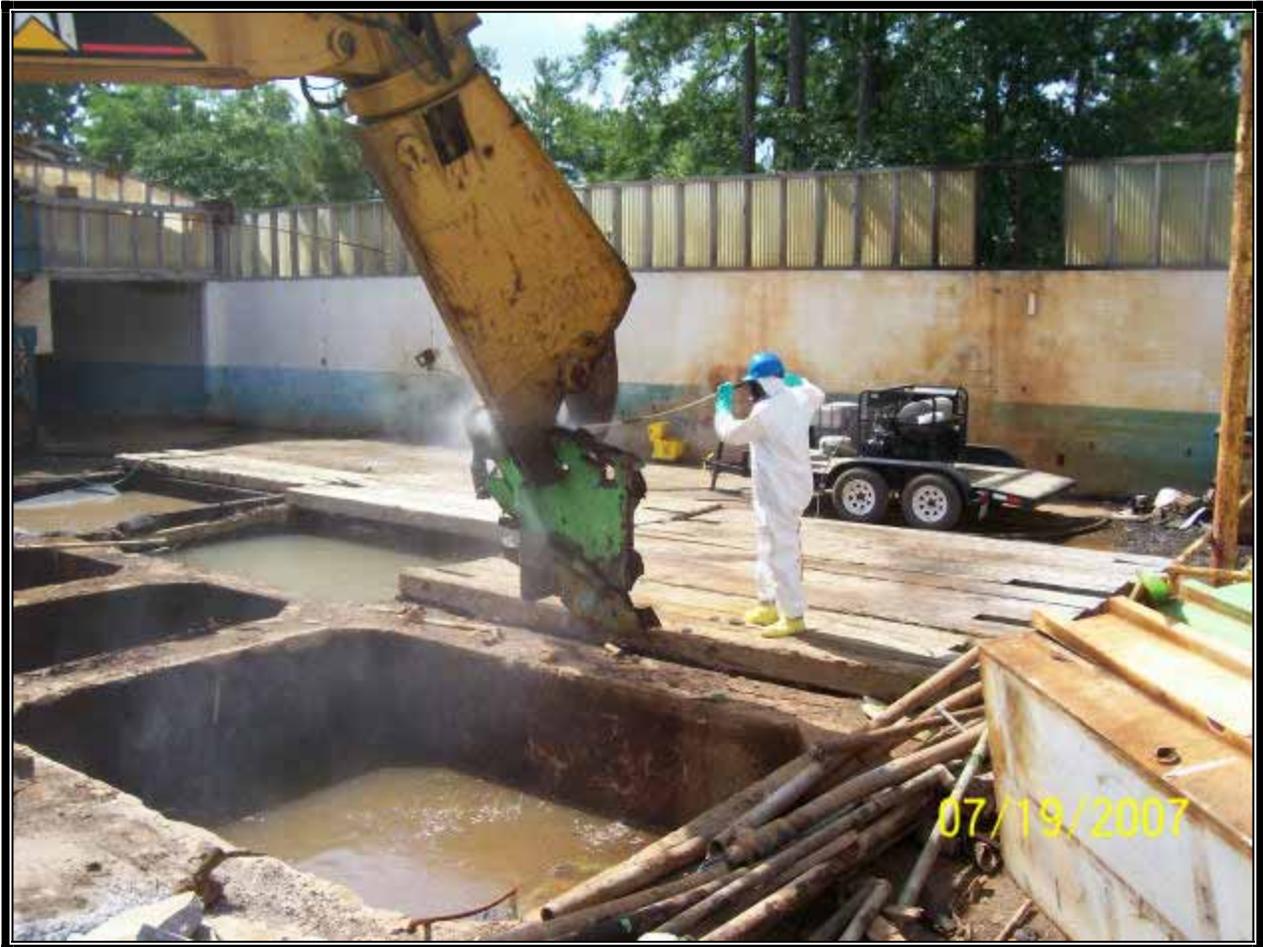
**OFFICIAL PHOTOGRAPH NO. 40**  
**U.S. ENVIRONMENTAL PROTECTION AGENCY**

**Subject:** Vat destruction. CMC used large metal shears to cut the vats into manageable pieces prior to decontamination.

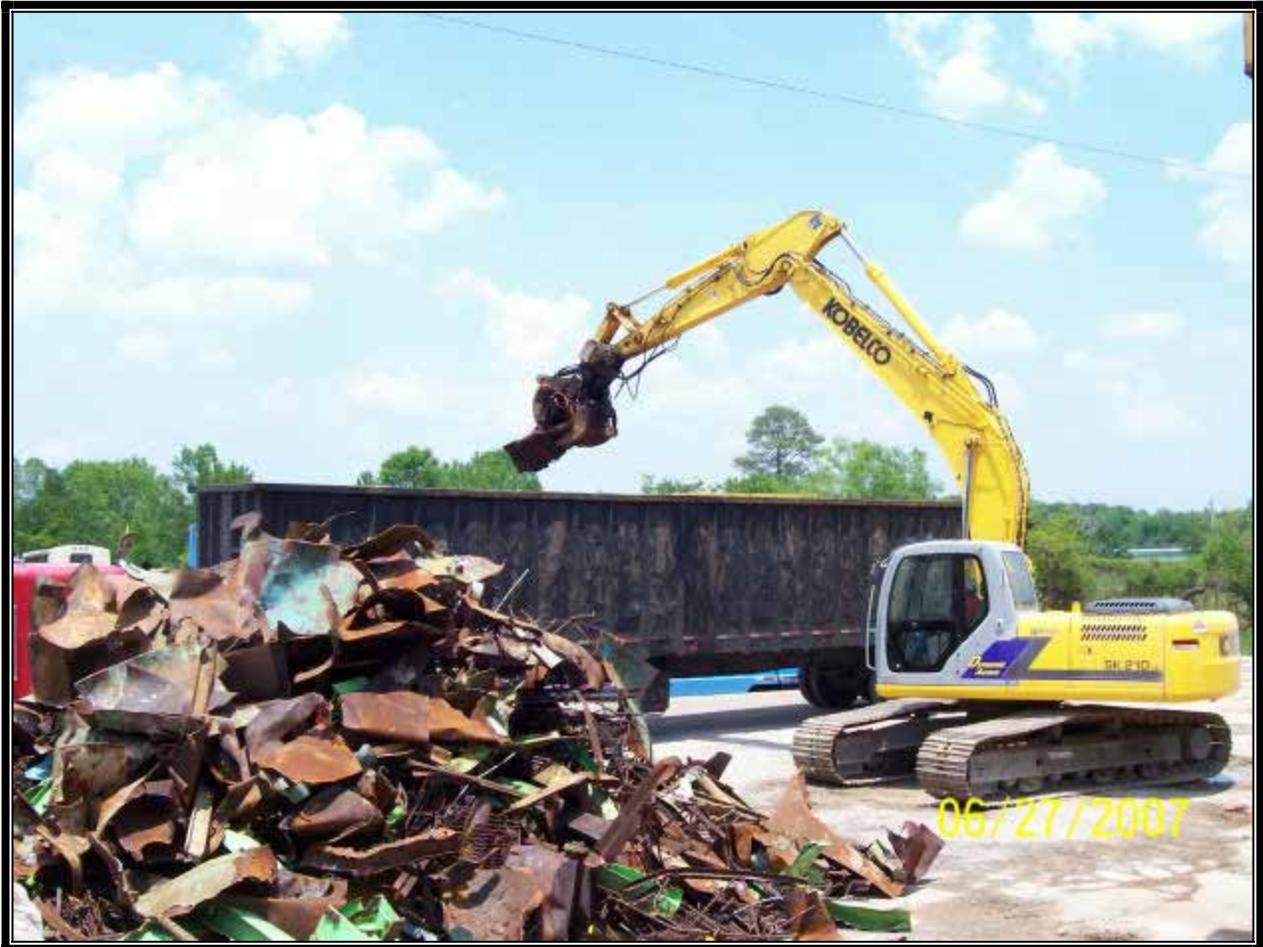
**OFFICIAL PHOTOGRAPH NO. 42  
U.S. ENVIRONMENTAL PROTECTION AGENCY**

**Subject:** Decontaminated vat metal. Note the color difference from the metal shown in Photograph 39.

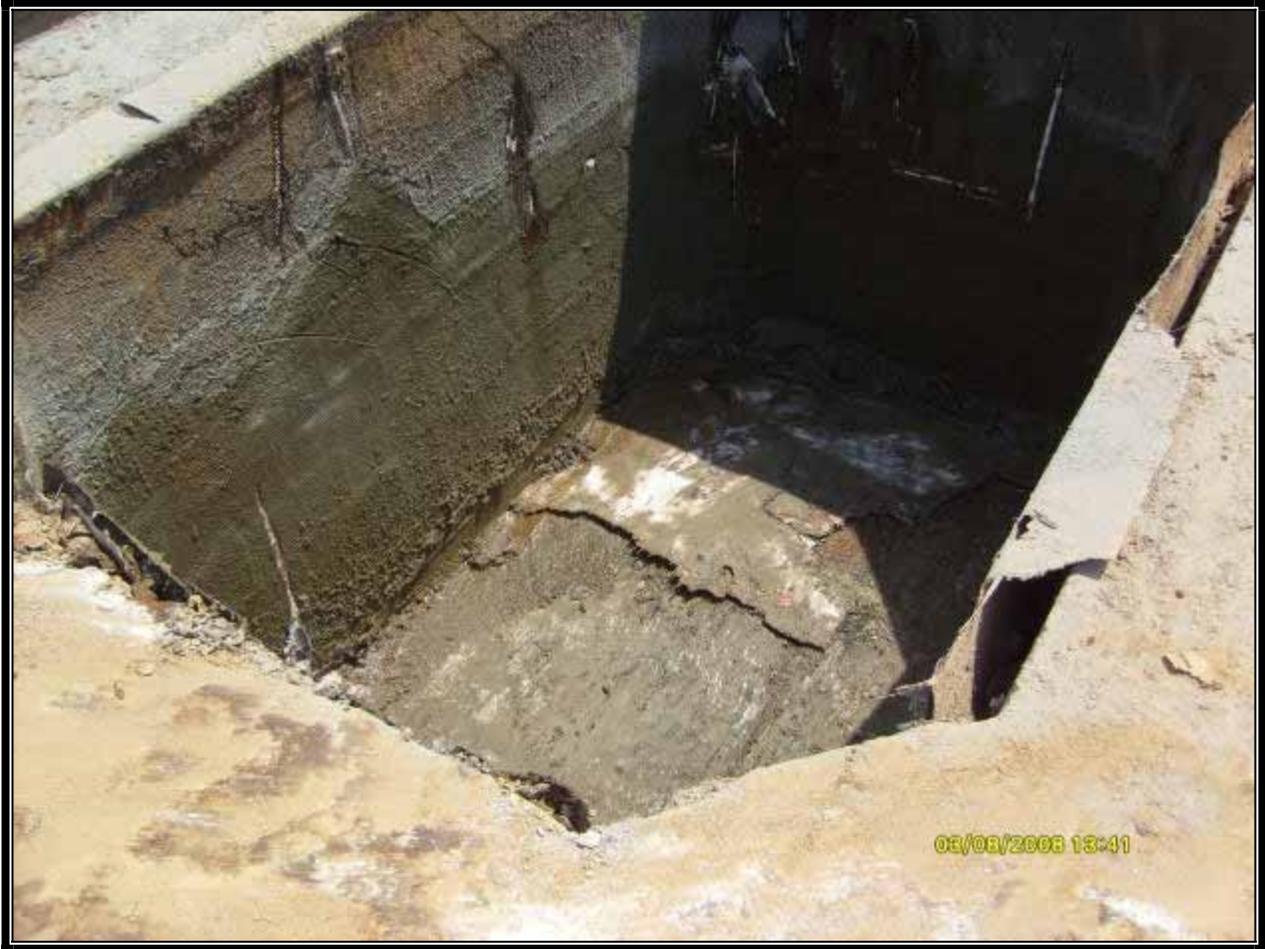
**OFFICIAL PHOTOGRAPH NO. 44**  
**U.S. ENVIRONMENTAL PROTECTION AGENCY**

**Subject:** Concrete removal. CMC used a hydraulic ram to break the concrete up in heavily stained areas. NOTE: The camera date stamp is incorrect.

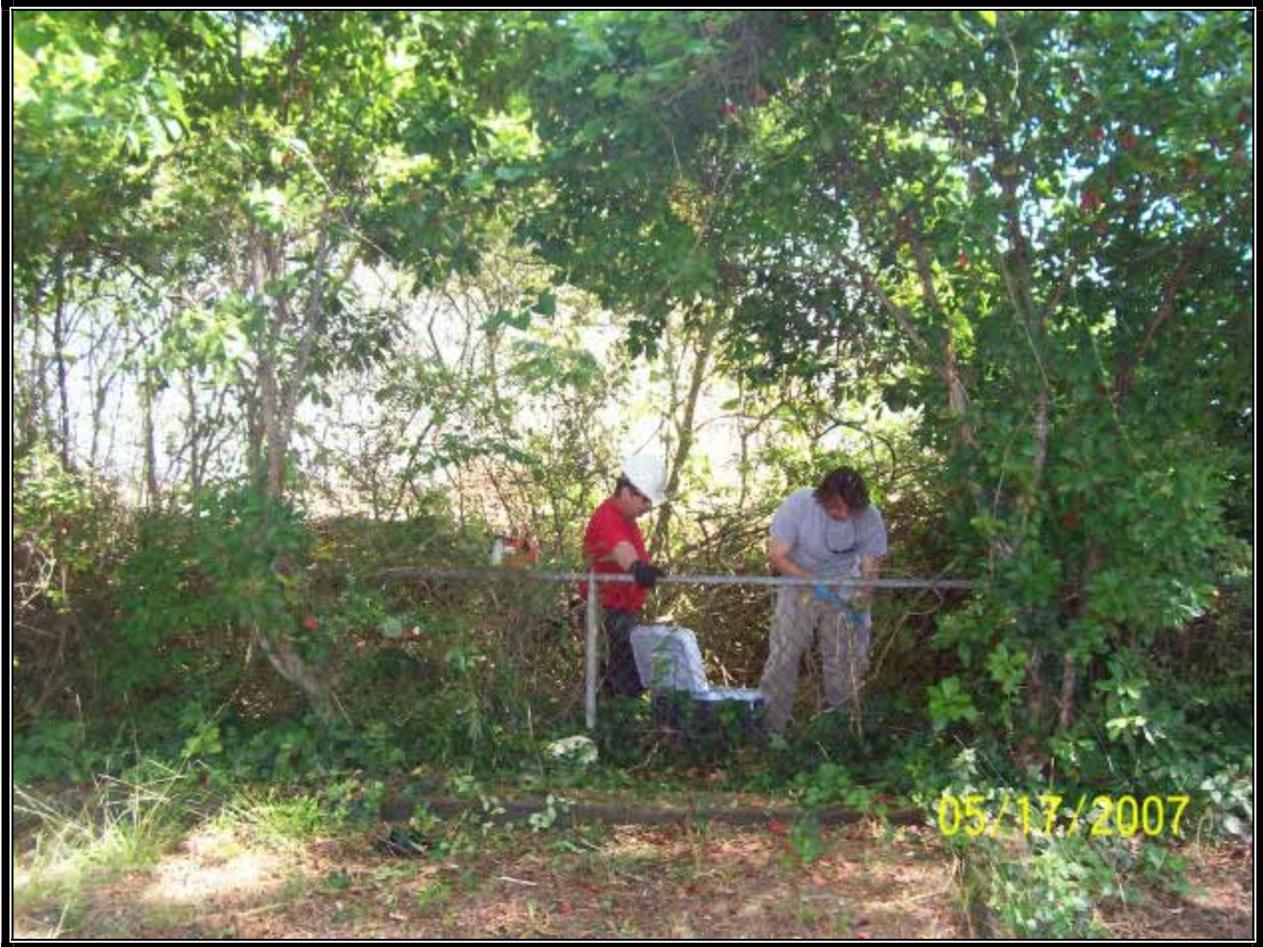
**OFFICIAL PHOTOGRAPH NO. 51**  
**U.S. ENVIRONMENTAL PROTECTION AGENCY**

**Subject:** Soil X-ray fluorescence (XRF) analysis. START used the XRF to screen site soils prior to laboratory analysis. Correlation between laboratory and XRF analysis was poor, leading to the abandonment of XRF analysis for the remainder of site activities.

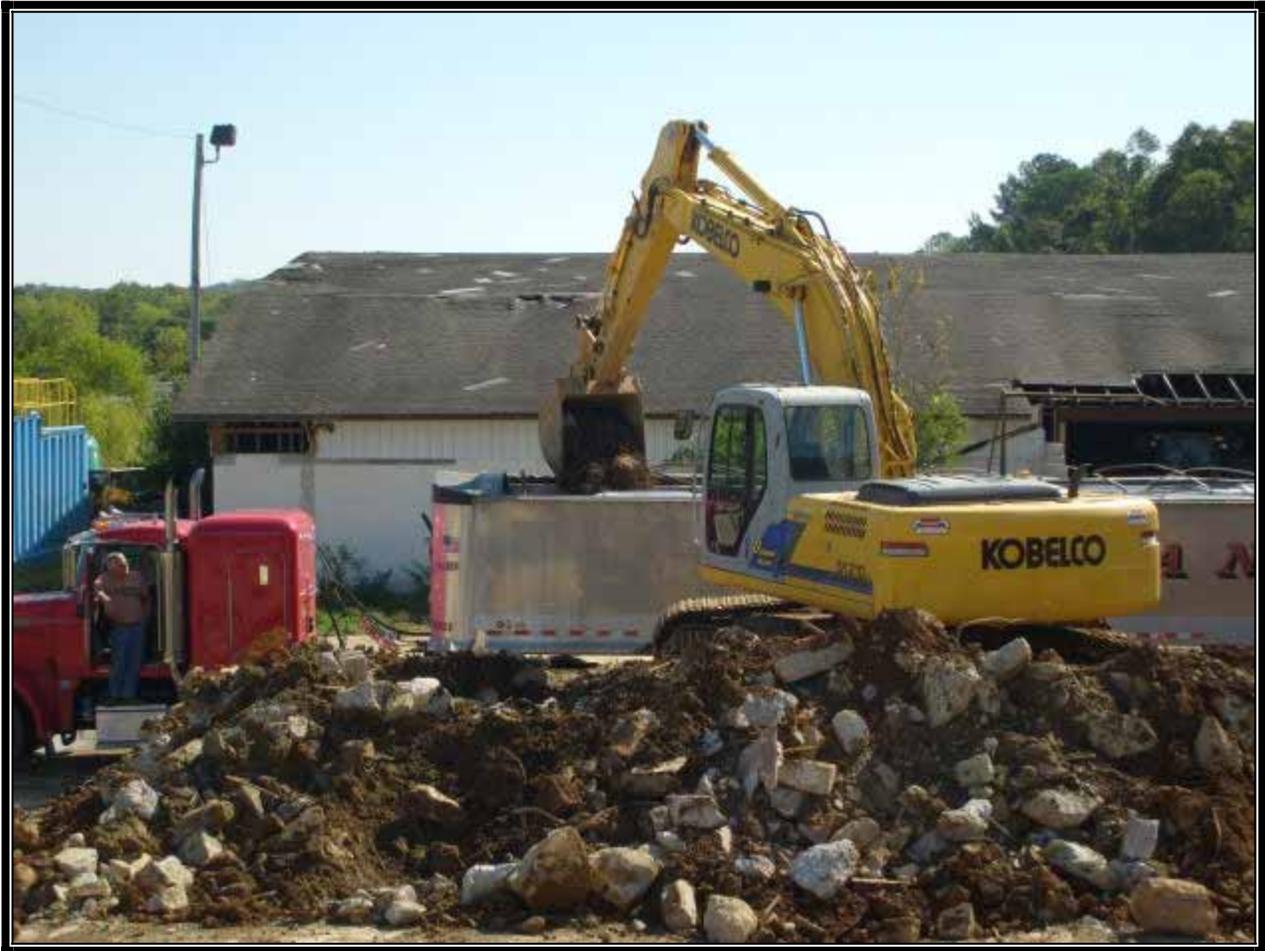
**OFFICIAL PHOTOGRAPH NO. 52**  
**U.S. ENVIRONMENTAL PROTECTION AGENCY**

**Subject:** Loading of solidified sludge. CMC shipped 1,536 tons of solidified sludge off site as hazardous waste.

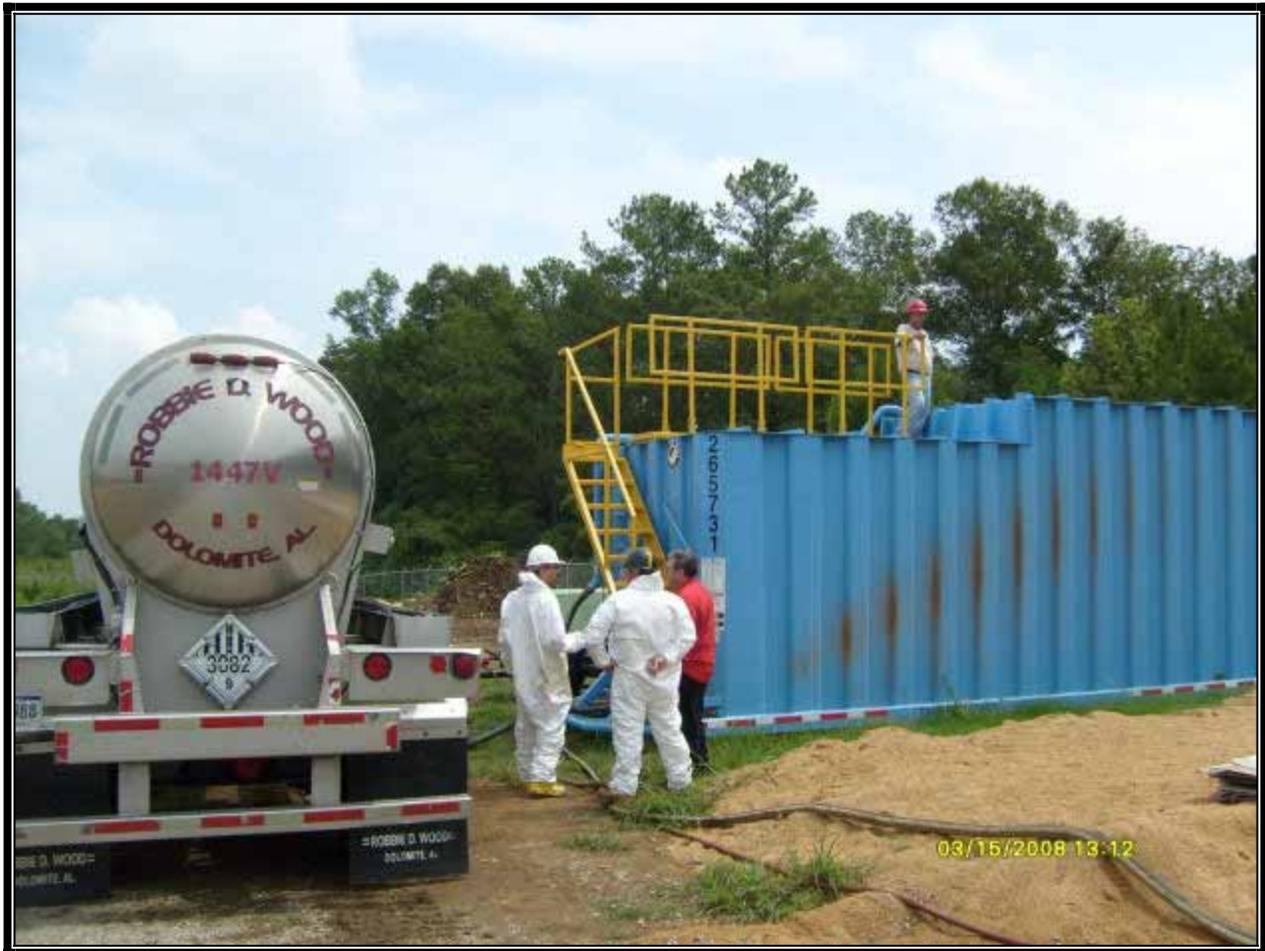
**OFFICIAL PHOTOGRAPH NO. 53**  
**U.S. ENVIRONMENTAL PROTECTION AGENCY**

**Subject:** Loading of neutral liquids. CMC transported 67,489 gallons of neutral liquids off site as hazardous waste due to chromium contamination. NOTE: The camera date stamp is incorrect.

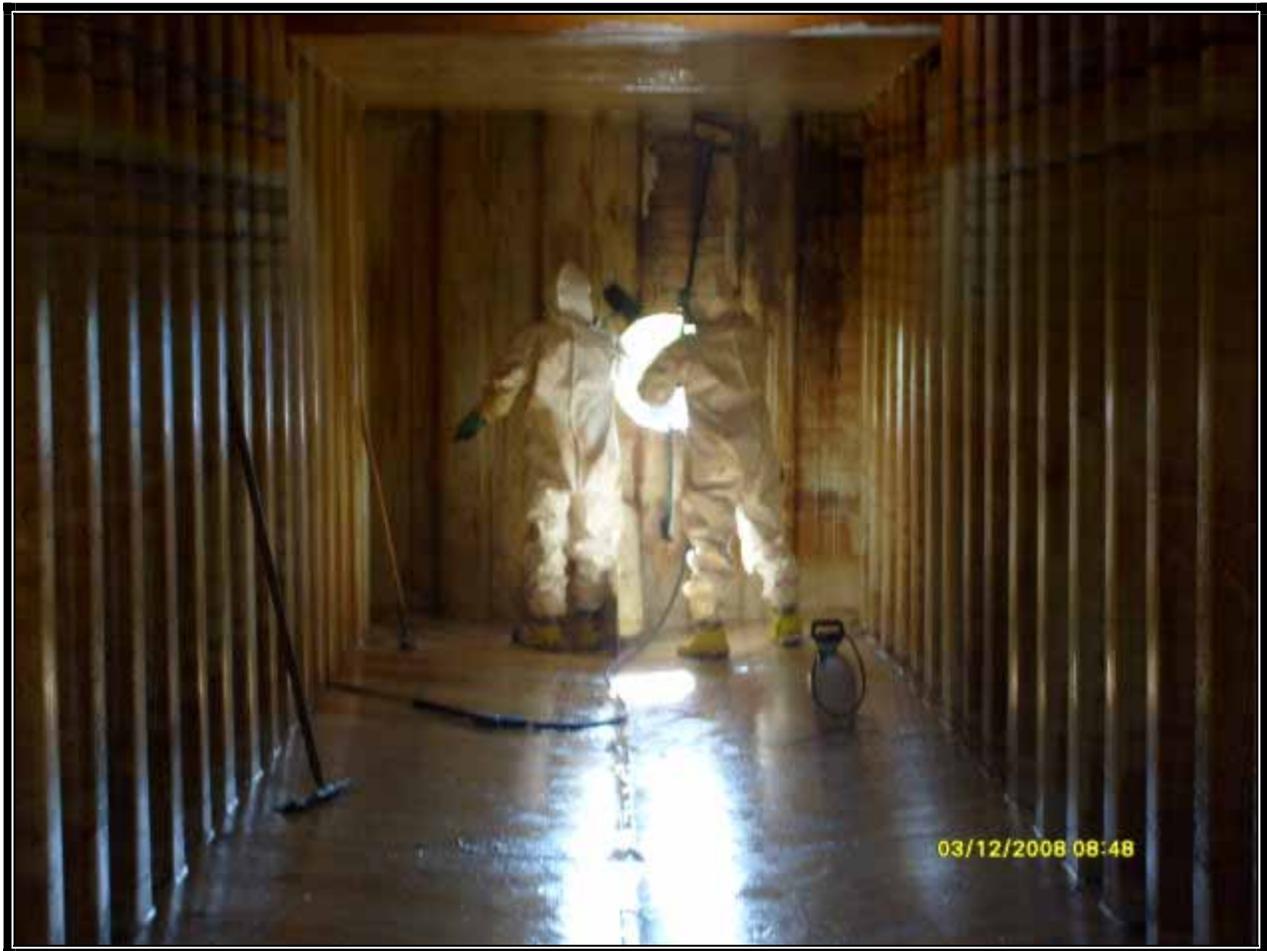
**OFFICIAL PHOTOGRAPH NO. 54**  
**U.S. ENVIRONMENTAL PROTECTION AGENCY**

**Subject:** Decontamination of frac tanks. CMC performed a permit-required confined-space-entry to remove contamination from inside the frac tanks prior to their demobilization. START acted as the entrance supervisor and monitored the air to ensure worker safety.

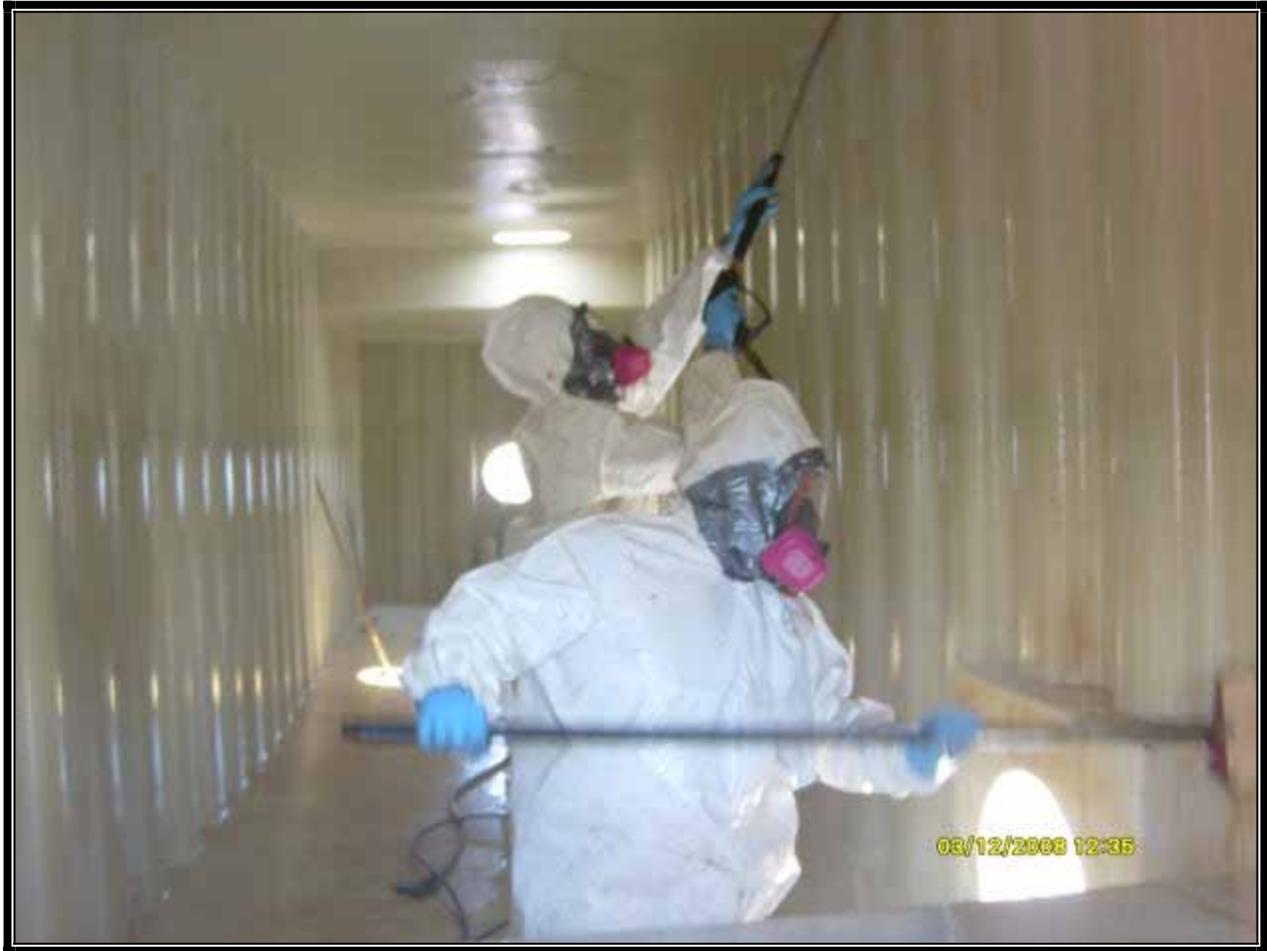
**OFFICIAL PHOTOGRAPH NO. 55**  
**U.S. ENVIRONMENTAL PROTECTION AGENCY**

**Subject:** Frac tanks after decontamination. A strong surfactant was required to remove the oily film.

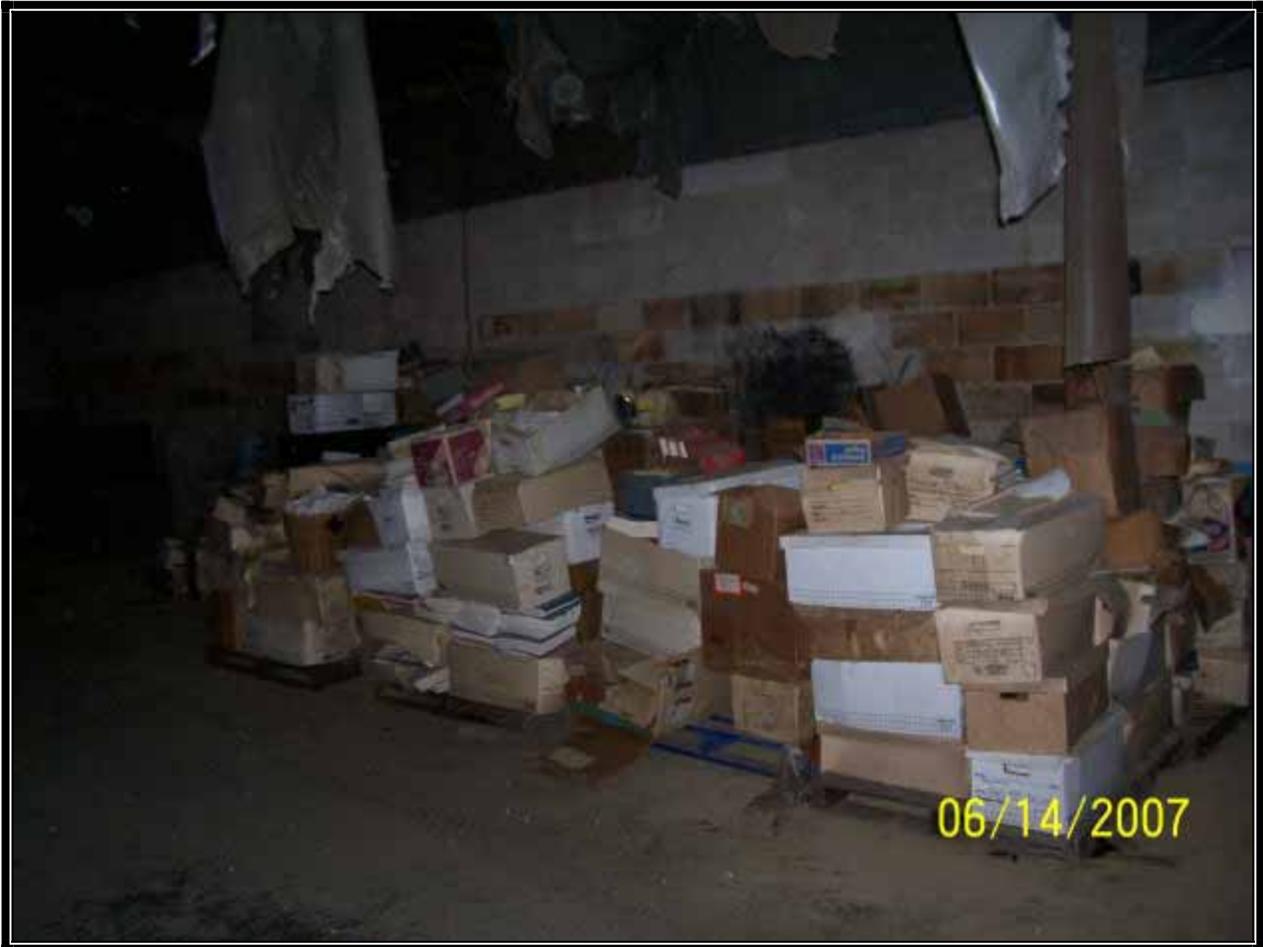
**OFFICIAL PHOTOGRAPH NO. 56**  
**U.S. ENVIRONMENTAL PROTECTION AGENCY**

**Subject:** Business records. EPA removed all business files from the office areas of the building prior to demolition. EPA cost recovery and criminal investigators later reviewed these documents. Those remaining were later disposed of with the construction debris.

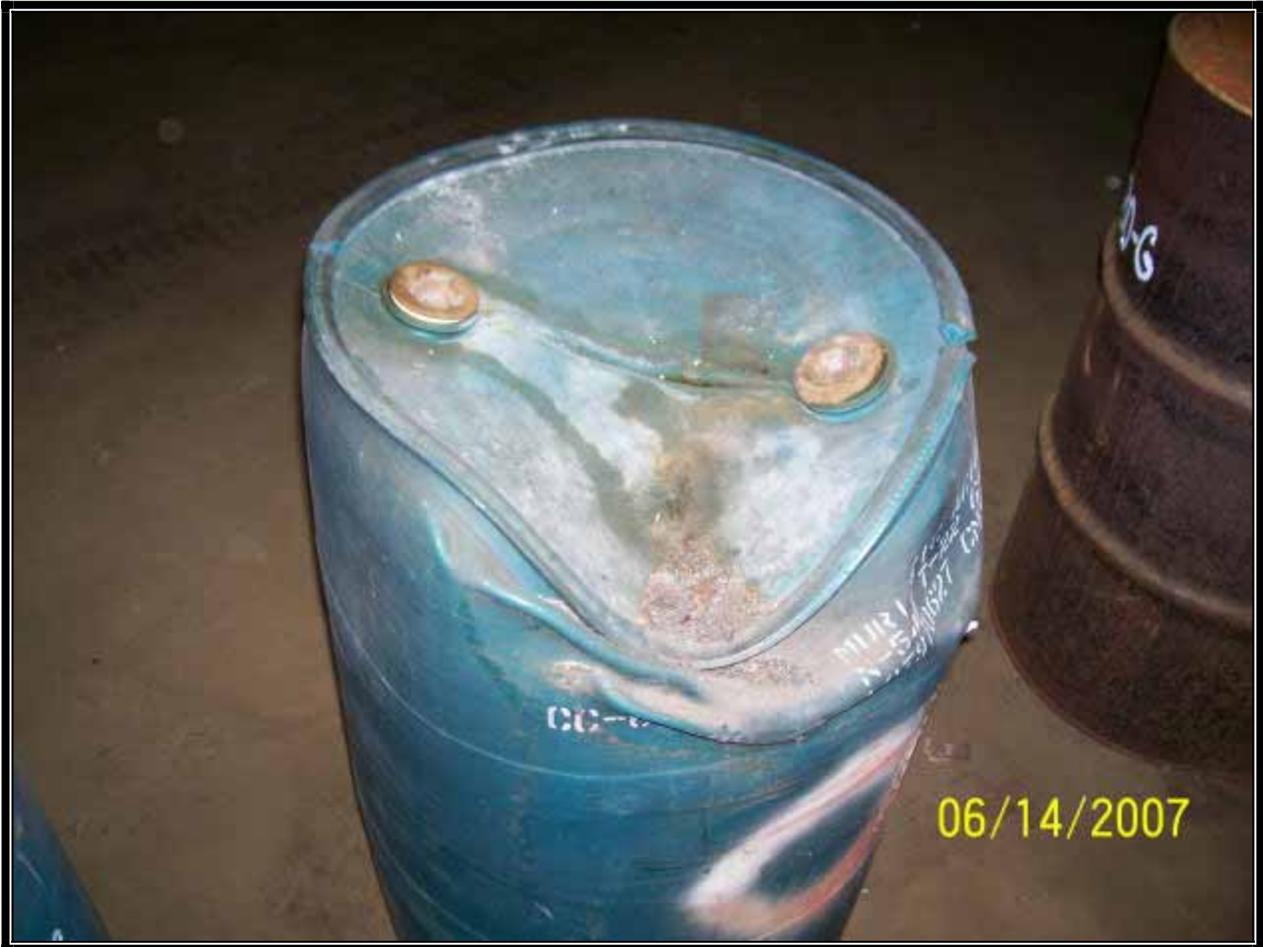
**OFFICIAL PHOTOGRAPH NO. 57**  
**U.S. ENVIRONMENTAL PROTECTION AGENCY**

**Subject:** Melted drums. Although no fire was ever recorded at the facility, several drums were found to have been exposed to some significant heat source, melting parts of them. A sister facility owned by the former owner did burn down after BEP Development, LLC, purchased the facility, and anecdotal evidence from former employees indicates the former owner moved several containers from the burned facility to this facility.

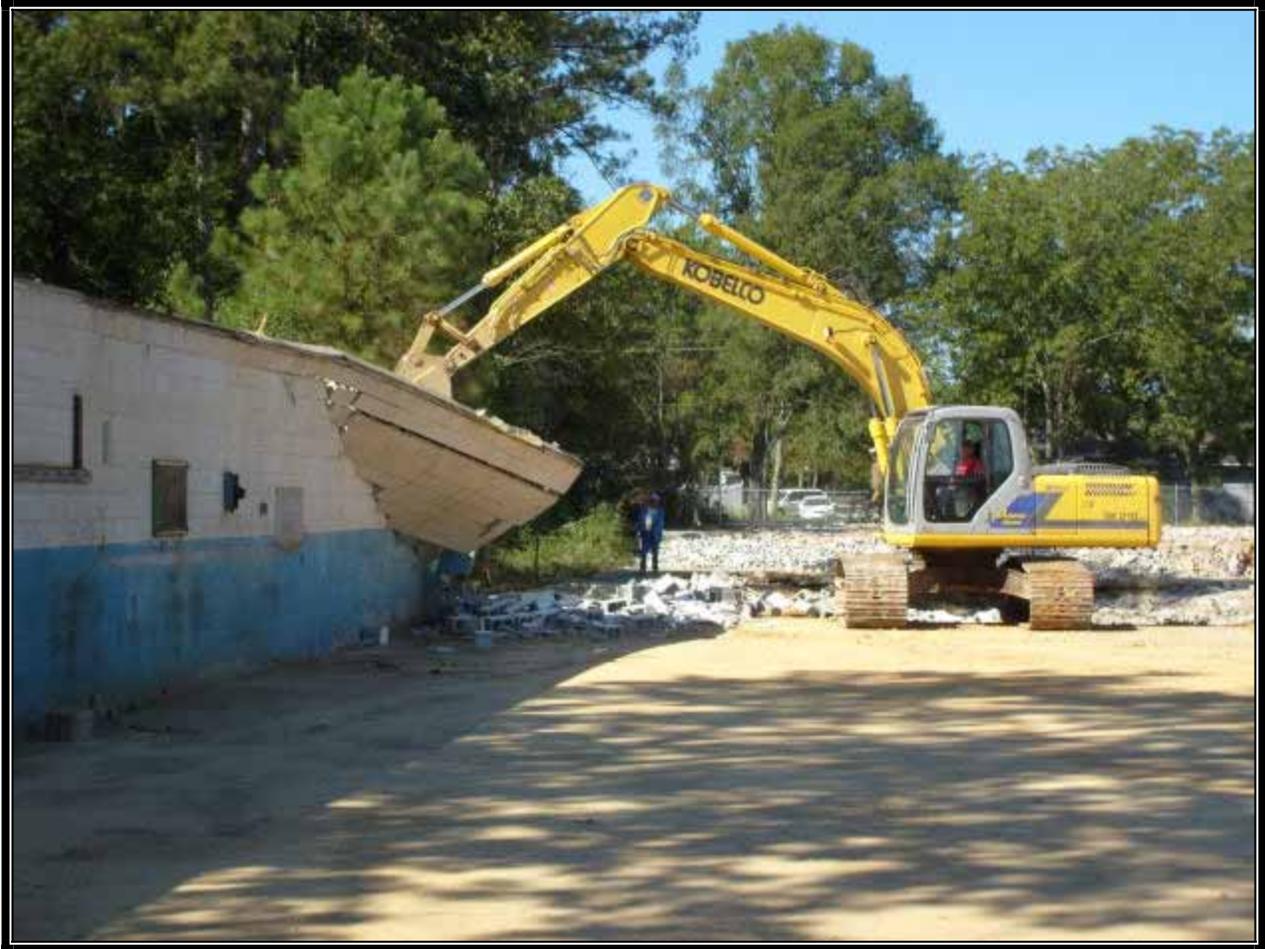
**OFFICIAL PHOTOGRAPH NO. 58**  
**U.S. ENVIRONMENTAL PROTECTION AGENCY**

**Subject:** Final demolition. As a final act before demobilization, CMC tore down the barrier wall between the facility and the nearby residences. The block was used to fill in the WWTP excavation.

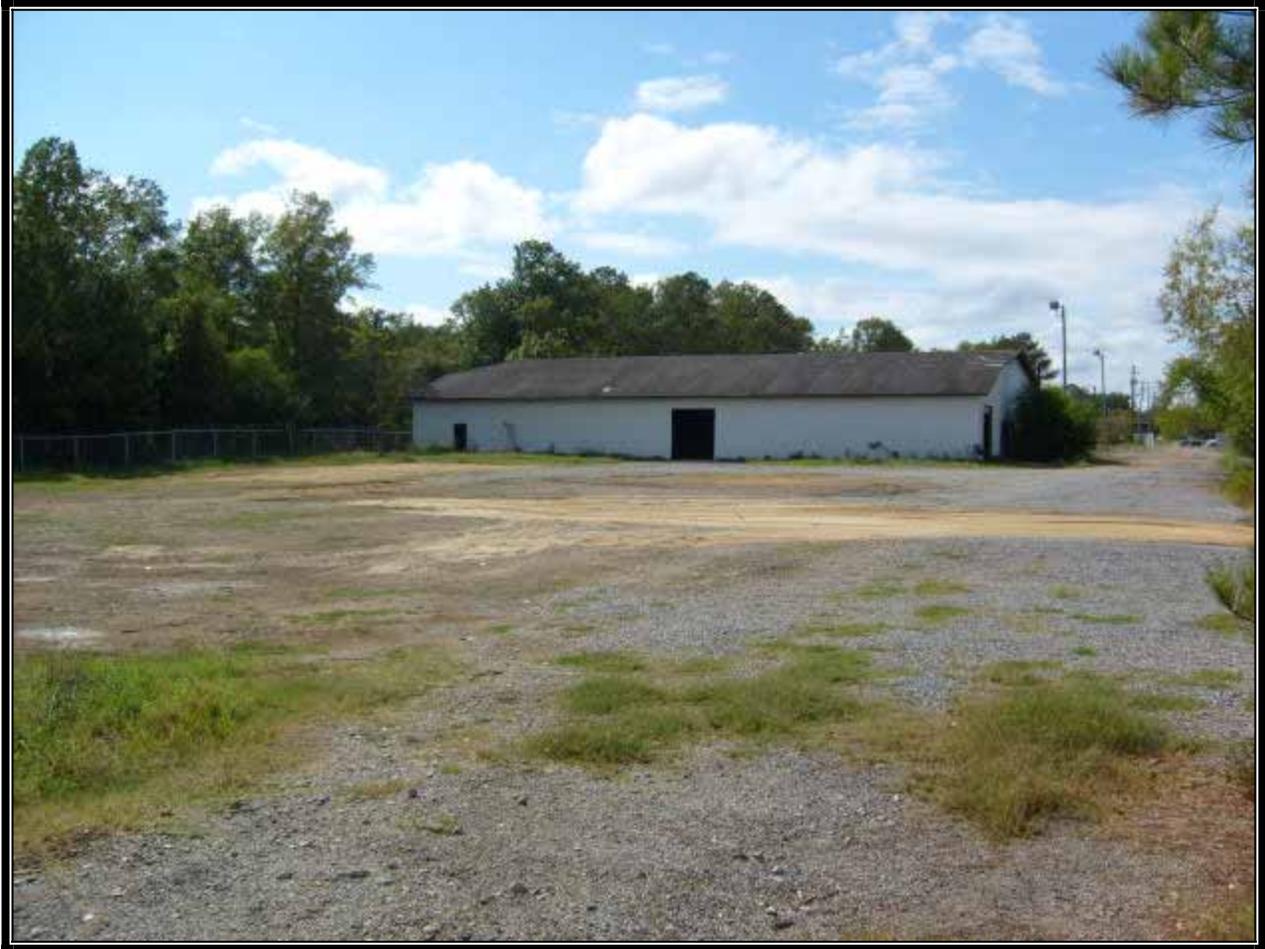
**OFFICIAL PHOTOGRAPH NO. 59**  
**U.S. ENVIRONMENTAL PROTECTION AGENCY**

**Subject:** Post-demobilization site conditions. The rear of the building as viewed from the back fence.

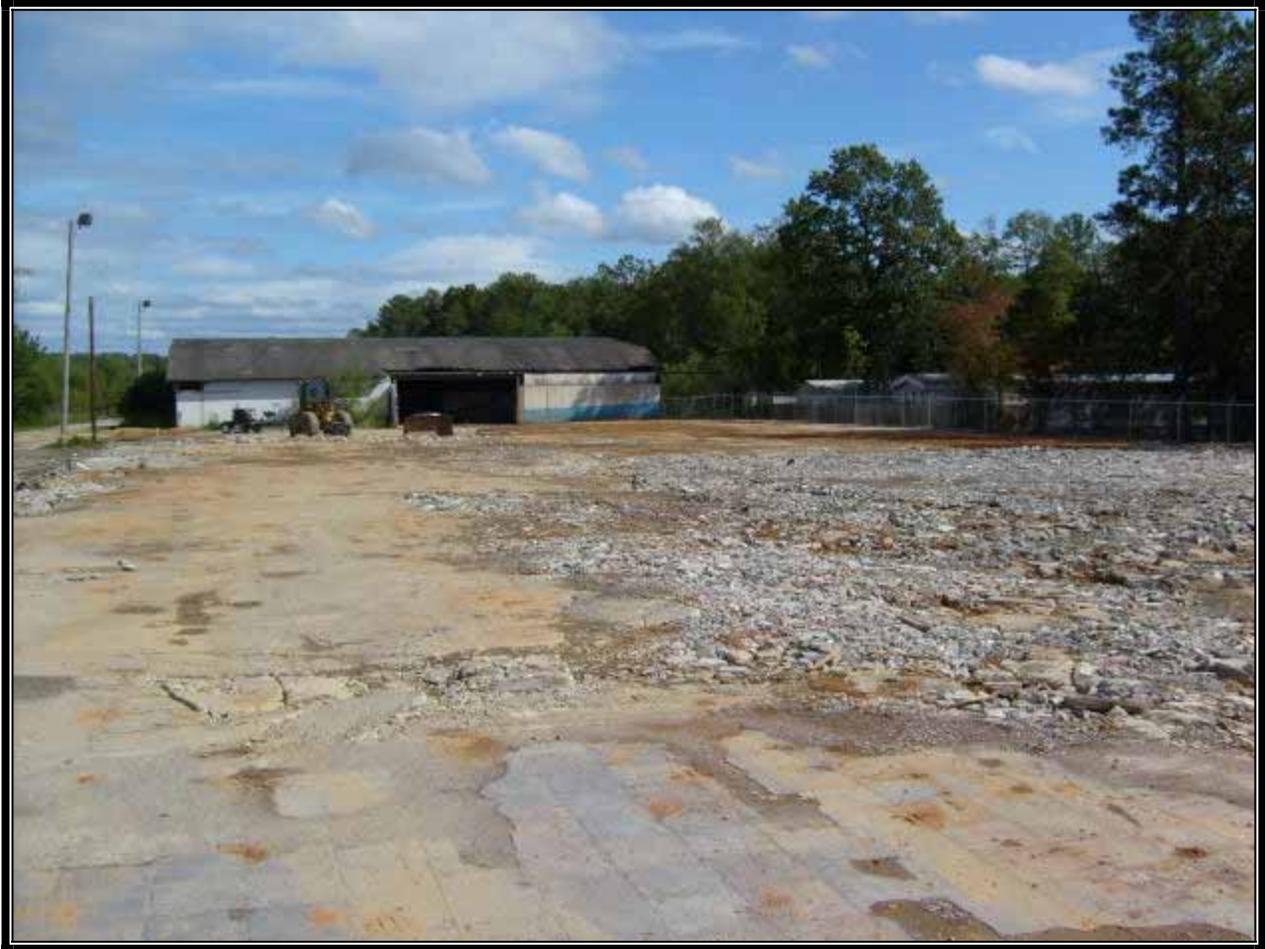
**OFFICIAL PHOTOGRAPH NO. 60**  
**U.S. ENVIRONMENTAL PROTECTION AGENCY**

**Subject:** Post-demobilization site conditions. The foundation slab and remaining portion of the building. Note the filled in areas.

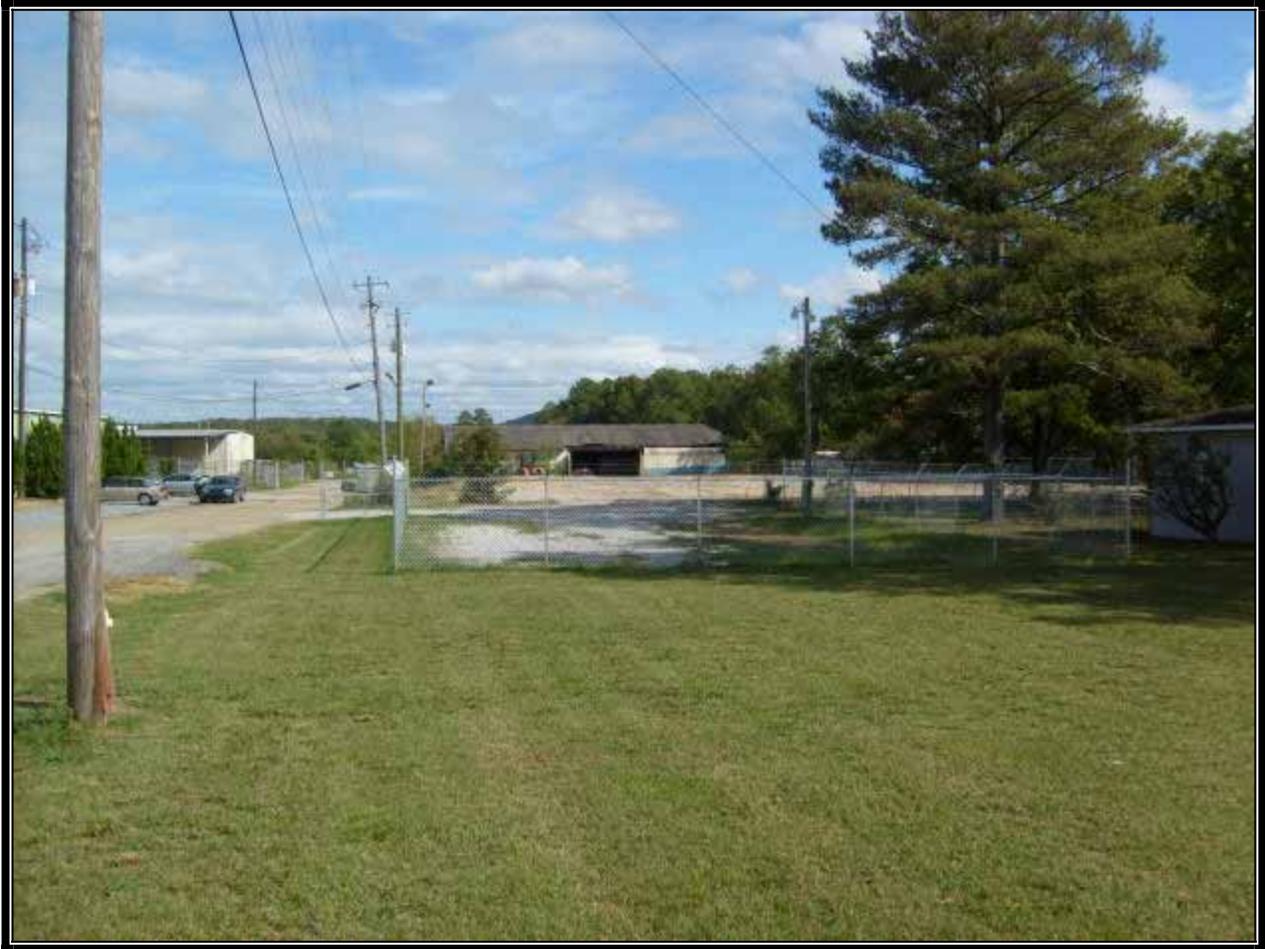
**OFFICIAL PHOTOGRAPH NO. 61**  
**U.S. ENVIRONMENTAL PROTECTION AGENCY**

**Subject:** Post-demobilization site conditions. The property as viewed from Sutton Bridge Road. The fence was left up and completed to fully encircle the site. Once CMC removed its remaining equipment, the gates would be closed and locked.
