**LOUISIANA ABANDONED OIL FACILITY
SITE ASSESSMENT SUMMARY REPORT**

**Quality Petroleum, Inc.-Hoffman, et al.
Caddo Parish, Louisiana
FPN: E06614
EPA ID: 09-E-1181**

May 23, 2008

**Prepared by:
Ecology & Environment, Inc.
Baton Rouge, Louisiana**

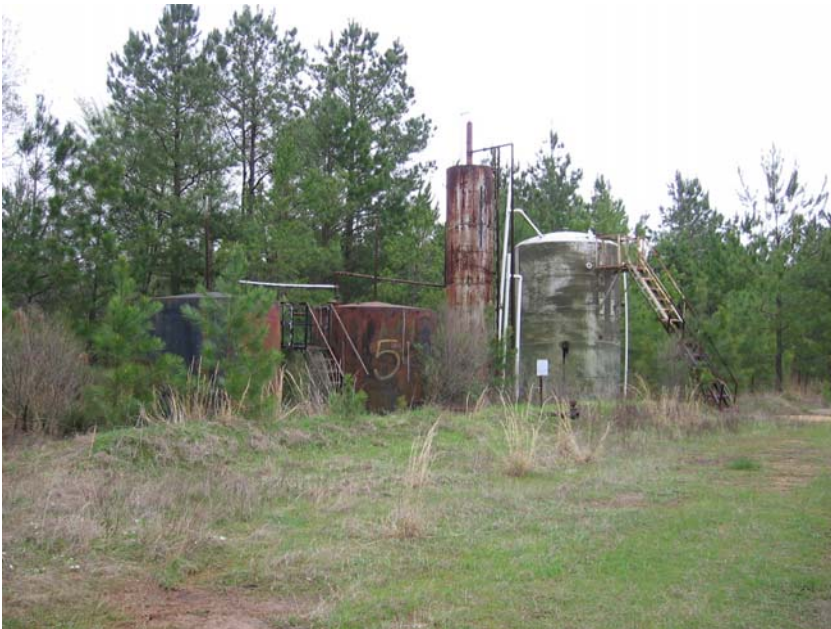
Site Name: Quality Petroleum, Inc.-Hoffman, et al. **Project No.:** E06614
Photo No.: 0101 **Direction:** NW **Contract No.**
Date: 04/01/2008 **Time:** 1:20:00 PM **Photographer/Witness:** Farrar, Will/N/A
Description: E06614: AST1 through AST3 and S1 in CONT1.

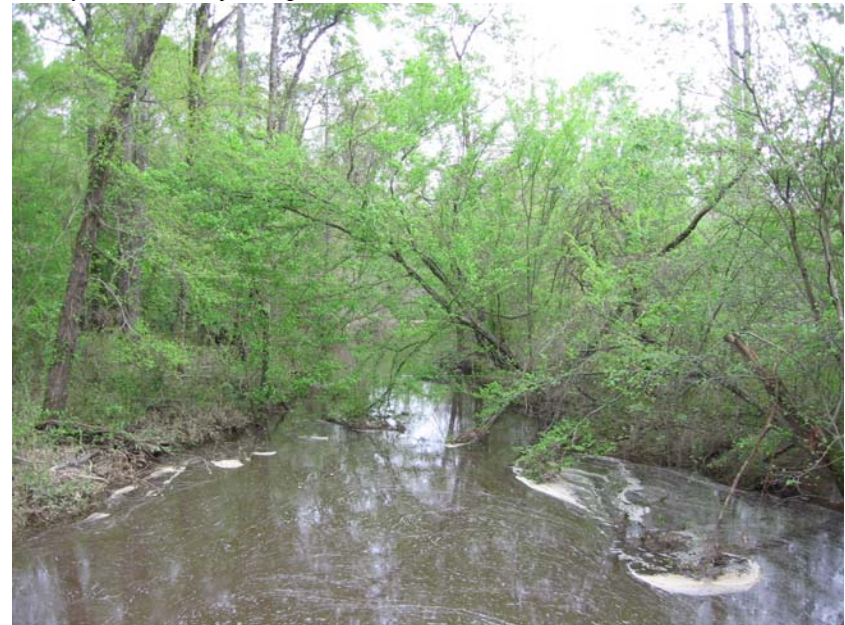
Site Name: Quality Petroleum, Inc.-Hoffman, et al. **Project No.:** E06614
Photo No.: 0104 **Direction:** SW **Contract No.**
Date: 04/01/2008 **Time:** 1:34:00 PM **Photographer/Witness:** Farrar, Will/N/A
Description: E06614: Unnamed NHD tributary of Caddo Lake just upstream of facility drainage outfall.

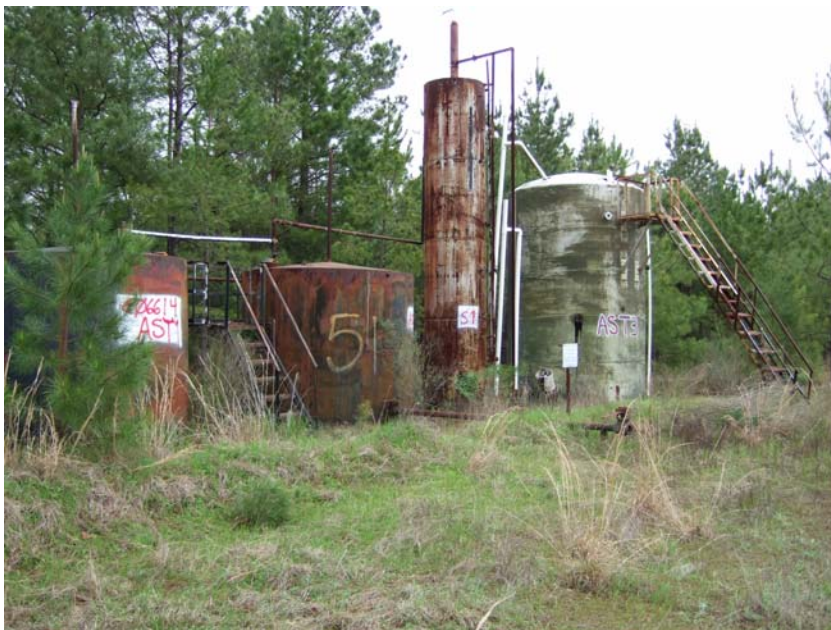
Site Name: Quality Petroleum, Inc.-Hoffman, et al. **Project No.:** E06614
Photo No.: 0201 **Direction:** NW **Contract No.:**
Date: 04/05/2008 **Time:** 9:28:00 AM **Photographer/Witness:** Sekerka, Robert/Johnson, Colin
Description: E06614: AST1, AST2, AST3, and S1 in CONT1.

Site Name: Quality Petroleum, Inc.-Hoffman, et al. **Project No.:** E06614
Photo No.: 0201 **Direction:** NW **Contract No.**
Date: 04/05/2008 **Time:** 9:28:00 AM **Photographer/Witness:** Sekerka, Robert/Johnson, Colin
Description: E06614: AST1, AST2, AST3, and S1 in CONT1.

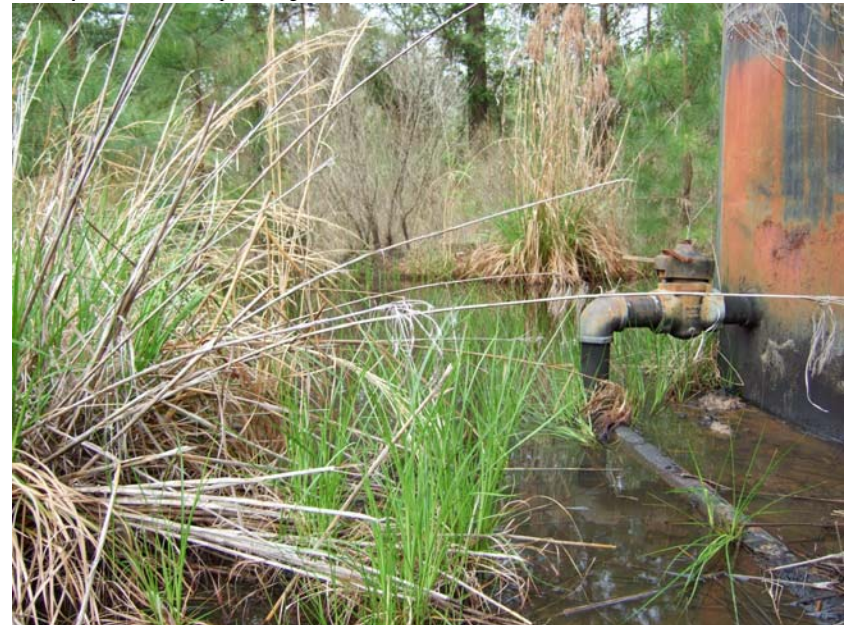
Site Name: Quality Petroleum, Inc.-Hoffman, et al. **Project No.:** E06614
Photo No.: 0204 **Direction:** SW **Contract No.:**
Date: 04/05/2008 **Time:** 9:34:00 AM **Photographer/Witness:** Sekerka, Robert/Johnson, Colin
Description: E06614: Oily sheen on pooled water southwest of AST1 in CONT1.

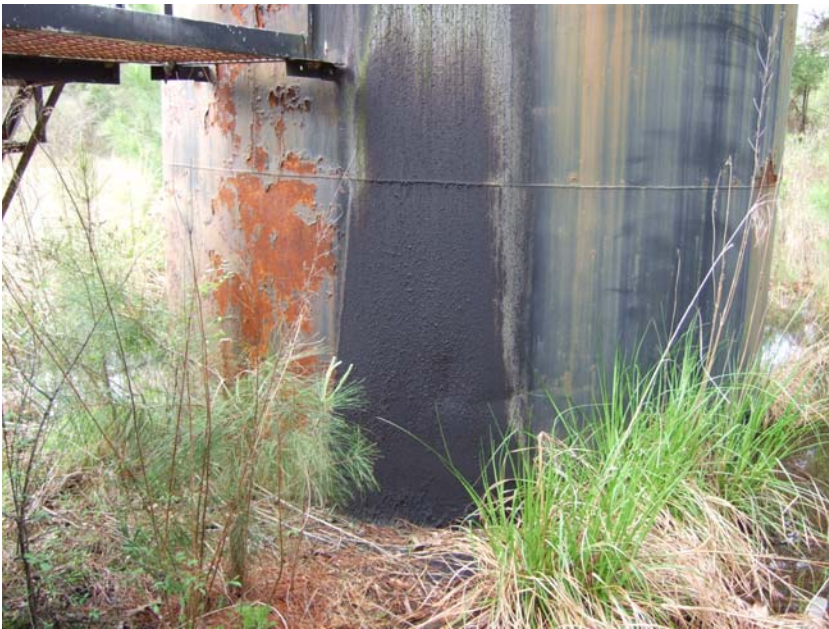
Site Name: Quality Petroleum, Inc.-Hoffman, et al. **Project No.:** E06614
Photo No.: 0205 **Direction:** SW **Contract No.**
Date: 04/05/2008 **Time:** 9:35:00 AM **Photographer/Witness:** Sekerka, Robert/Johnson, Colin
Description: E06614: Rust, corrosion and signs of prior oily seepage on AST1.

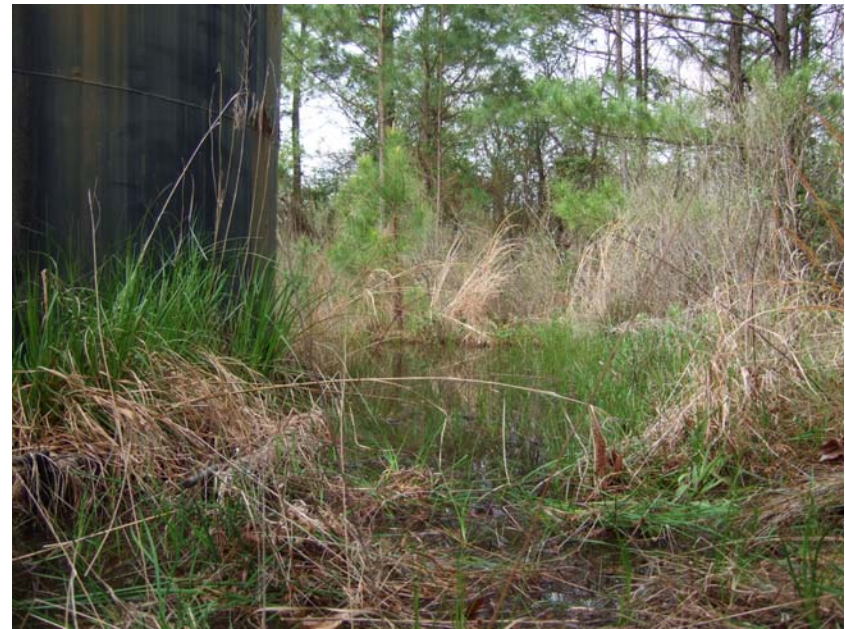
Site Name: Quality Petroleum, Inc.-Hoffman, et al. **Project No.:** E06614
Photo No.: 0206 **Direction:** SW **Contract No.**
Date: 04/05/2008 **Time:** 9:36:00 AM **Photographer/Witness:** Sekerka, Robert/Johnson, Colin
Description: E06614: Pooled water around AST1 Inside CONT1.

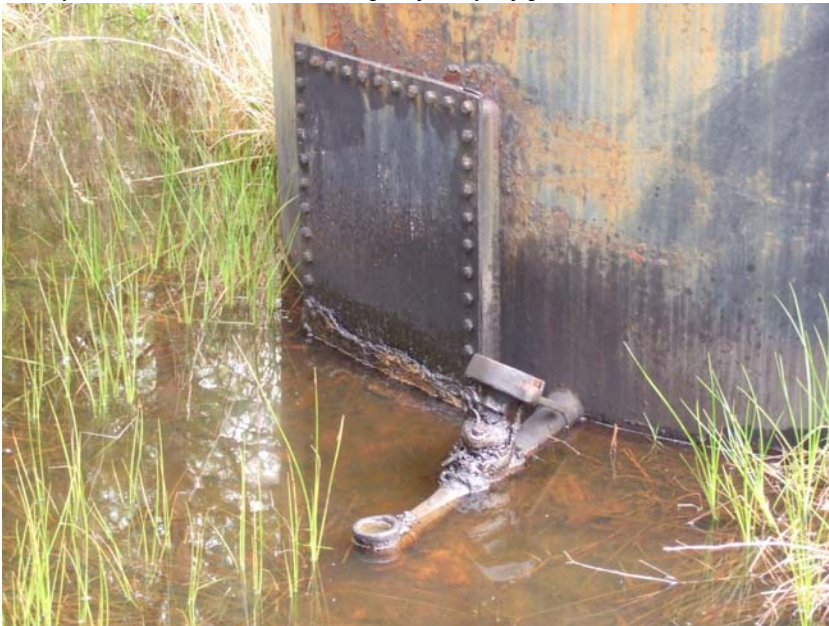
Oily liquid seeping through delaminated metal at the base of AST1 and AST3 created areas of oil-saturated soil in most of CONT1. Soil cores revealed that oil-saturated soil extended to a maximum depth of 1 foot BGS. A breach eroded in southern earthen berm of CONT1 significantly reduced the containment capacity and allowed it to drain oily water to adjacent waterways. Water with an oily sheen was pooled up to a depth of 0.5 foot in the southern portion of CONT1. Medium pines and vegetation were present in CONT1. Lack of maintenance was evident from the heavily overgrown condition, eroding berms, and the oil-saturated soil in CONT1.

Site Name: Quality Petroleum, Inc.-Hoffman, et al. **Project No.:** E06614
Photo No.: 0207 **Direction:** NW **Contract No.**
Date: 04/05/2008 **Time:** 9:37:00 AM **Photographer/Witness:** Sekerka, Robert/Johnson, Colin
Description: E06614: Rust, corrosion and oily liquid seeping through the delaminated metal on the man way at the base AST1.

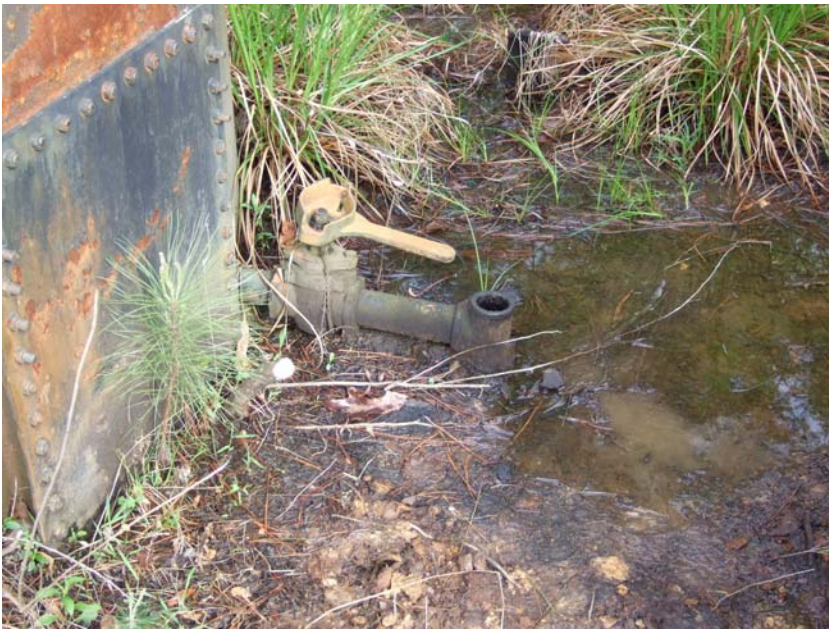
Site Name: Quality Petroleum, Inc.-Hoffman, et al. **Project No.:** E06614
Photo No.: 0209 **Direction:** Down **Contract No.:**
Date: 04/05/2008 **Time:** 9:38:00 AM **Photographer/Witness:** Sekerka, Robert/Johnson, Colin
Description: E06614: Oil saturated soil surrounding valve on AST2.

Site Name: Quality Petroleum, Inc.-Hoffman, et al. **Project No.:** E06614
Photo No.: 0209 **Direction:** Down **Contract No.**
Date: 04/05/2008 **Time:** 9:38:00 AM **Photographer/Witness:** Sekerka, Robert/Johnson, Colin
Description: E06614: Oil saturated soil surrounding valve on AST2.

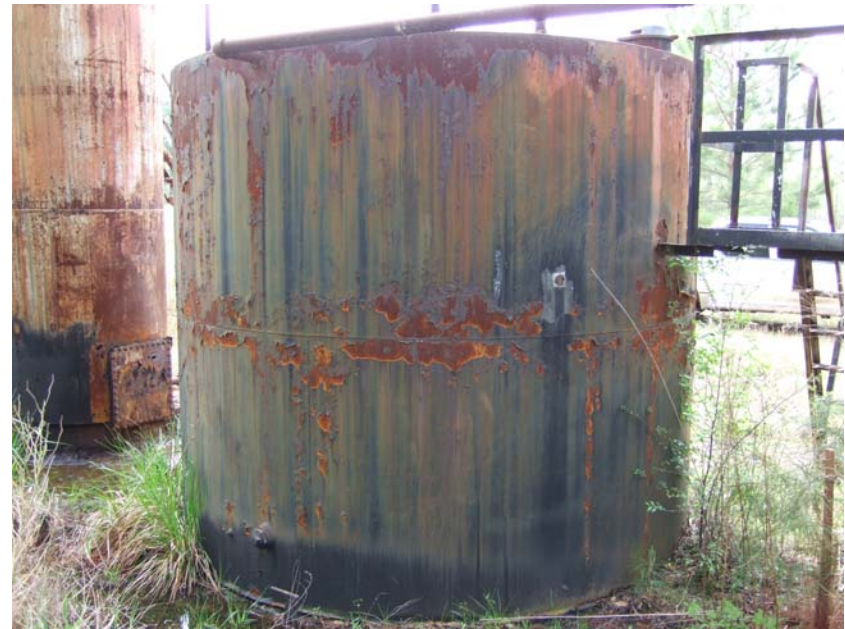
Site Name: Quality Petroleum, Inc.-Hoffman, et al. **Project No.:** E06614
Photo No.: 0210 **Direction:** E **Contract No.:**
Date: 04/05/2008 **Time:** 9:39:00 AM **Photographer/Witness:** Sekerka, Robert/Johnson, Colin
Description: E06614: Rust, corrosion and delaminated metal on AST2.

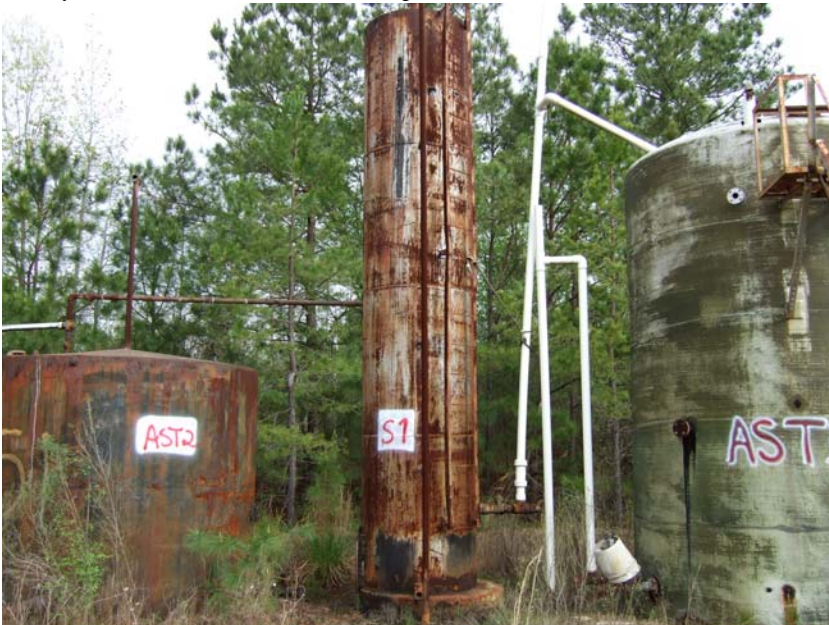
Site Name: Quality Petroleum, Inc.-Hoffman, et al. **Project No.:** E06614
Photo No.: 0211 **Direction:** W **Contract No.:**
Date: 04/05/2008 **Time:** 9:40:00 AM **Photographer/Witness:** Sekerka, Robert/Johnson, Colin
Description: E06614: Rust, corrosion and delaminated metal on S1.

Condition details: S1 had extensive rust, corrosion, and delaminated metal near its base and on connected flow lines. Oil staining around the tank indicated prior discharge to the environment.				Location: <input type="checkbox"/> Inside Cont. <input checked="" type="checkbox"/> Breathing Zone <input type="checkbox"/> Outside Cont.			
				Equipment: MultiREA PID+4gas Parameter: PID			
				Readings: 0 PPM <input type="checkbox"/> Background			
				Additional comments:

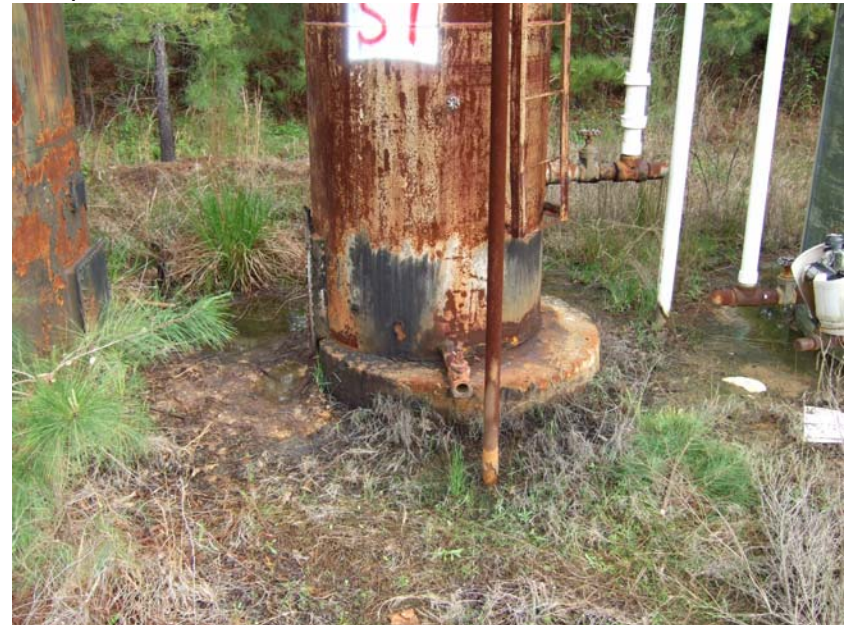
Site Name: Quality Petroleum, Inc.-Hoffman, et al. **Project No.:** E06614
Photo No.: 0212 **Direction:** W **Contract No.:**
Date: 04/05/2008 **Time:** 9:41:00 AM **Photographer/Witness:** Sekerka, Robert/Johnson, Colin
Description: E06614: Rust, corrosion and delaminated metal at base of S1.

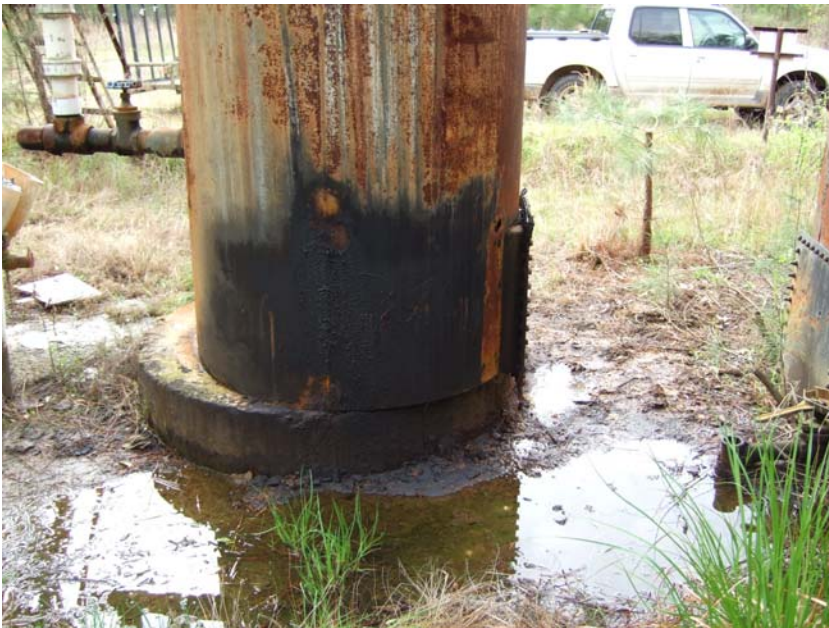
Site Name: Quality Petroleum, Inc.-Hoffman, et al. **Project No.:** E06614
Photo No.: 0213 **Direction:** E **Contract No.:**
Date: 04/05/2008 **Time:** 9:41:00 AM **Photographer/Witness:** Sekerka, Robert/Johnson, Colin
Description: E06614: Rust, corrosion and delaminated metal at base of S1 and evidence of prior oil release.

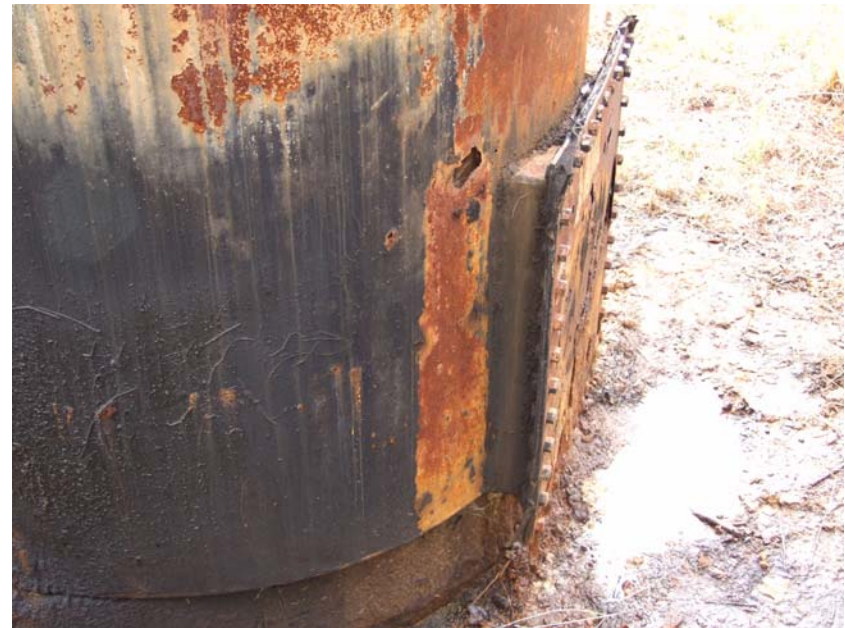
Site Name: Quality Petroleum, Inc.-Hoffman, et al. **Project No.:** E06614
Photo No.: 0214 **Direction:** Down **Contract No.:**
Date: 04/05/2008 **Time:** 9:42:00 AM **Photographer/Witness:** Sekerka, Robert/Johnson, Colin
Description: E06614: Rust, corrosion and delaminated metal on S1.

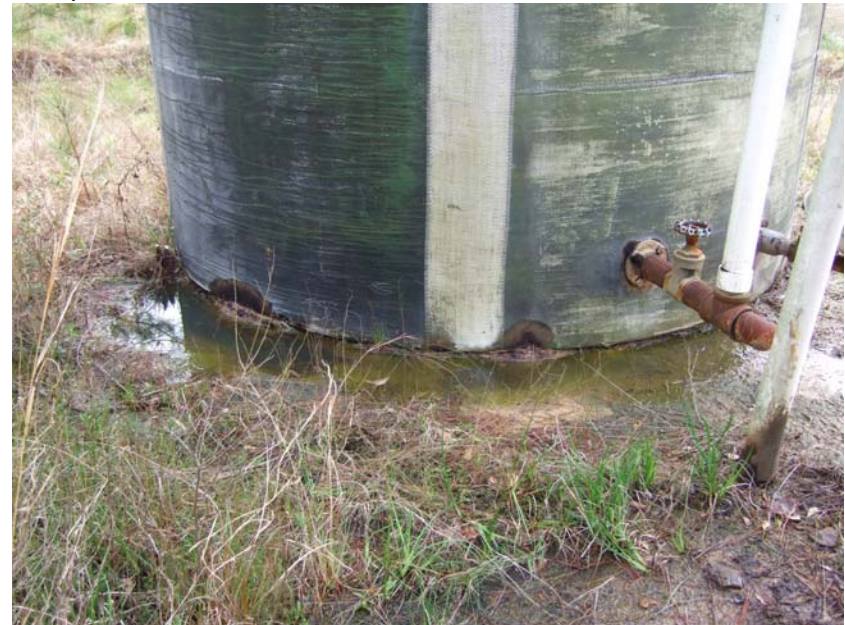
Site Name: Quality Petroleum, Inc.-Hoffman, et al. **Project No.:** E06614
Photo No.: 0216 **Direction:** Down **Contract No.:**
Date: 04/05/2008 **Time:** 9:44:00 AM **Photographer/Witness:** Sekerka, Robert/Johnson, Colin
Description: E06614: Oily liquid seeping through the chipped and peeling fiberglass at the base of AST3.

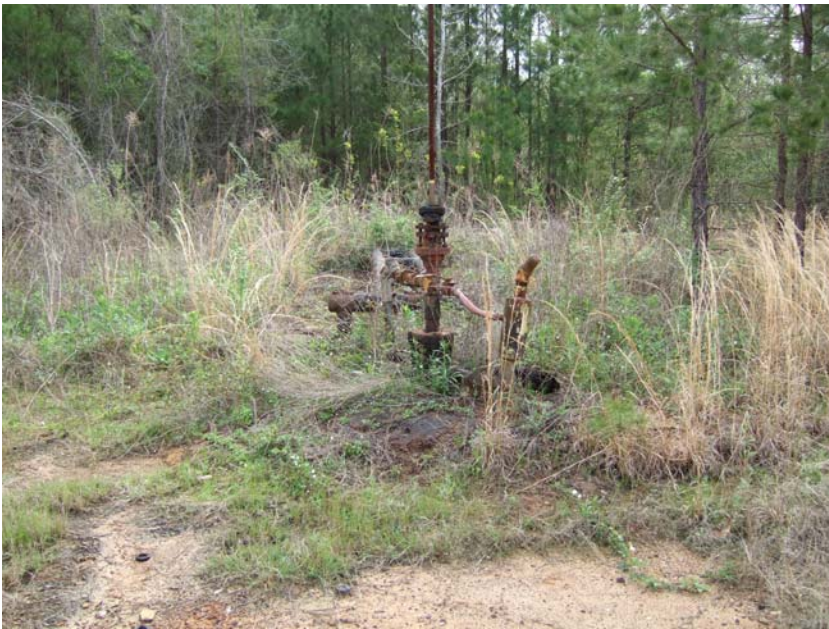
Site Name: Quality Petroleum, Inc.-Hoffman, et al. **Project No.:** E06614
Photo No.: 0217 **Direction:** E **Contract No.**
Date: 04/05/2008 **Time:** 9:48:00 AM **Photographer/Witness:** Sekerka, Robert/Johnson, Colin
Description: E06614: Pump jack stand for Hoffman, et al. Well No. 001 (SN 179621).

Well Status Table: Complete for each well			
Well Name and Number: Hoffman, et al.		001	
Serial Number: 179621	Latitude (DMS) 32° 50' 32.4"	Longitude (DMS) 94° 1' 44.3"	DOP:
Well Status*: not flowing - connected	Condition**: corroded	Terrain: upland (upland; lowland; marsh; water; unknown)	
Is Oil Leaking? <input type="radio"/> Yes <input checked="" type="radio"/> No	If Yes, Describe:		
Well Association***: Position	Grade above (above; at; below; unknown)		
NORM/Air monitoring: <input type="checkbox"/> Background	Elevation (inches): 10		
Comments (describe well, pumping unit attached, etc.): A sucker rod is located in the well head and a pump jack stand is located next to the well. The pump jack is not present.

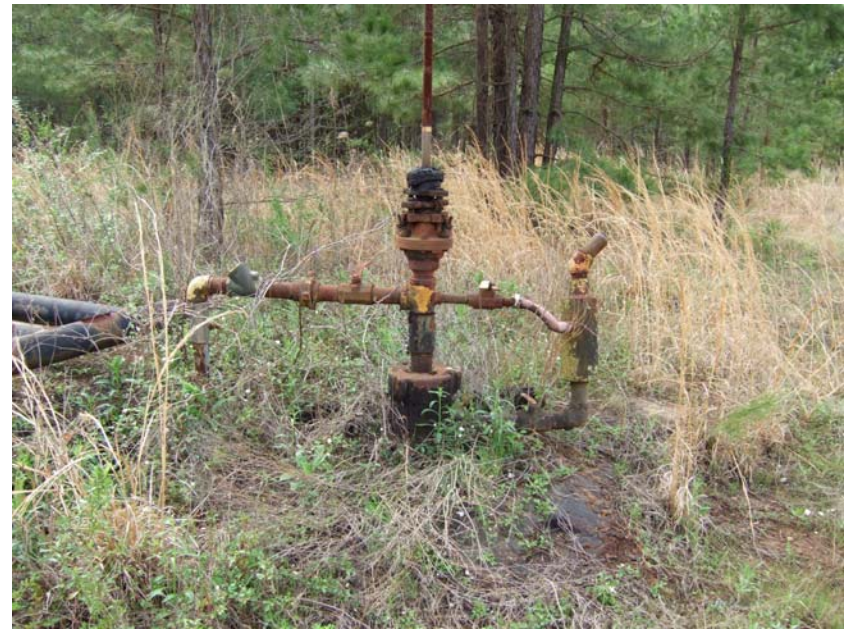
The wellhead for SN 179621 was located at the coordinates reported by LDNR and its condition was documented. The wellhead and the connected flow lines were heavily corroded. An empty 55-gallon drum was located east of the wellhead.

Site Name: Quality Petroleum, Inc.-Hoffman, et al. **Project No.:** E06614
Photo No.: 0218 **Direction:** NE **Contract No.**
Date: 04/05/2008 **Time:** 9:48:00 AM **Photographer/Witness:** Sekerka, Robert/Johnson, Colin
Description: E06614: Wellhead for SN 179621.

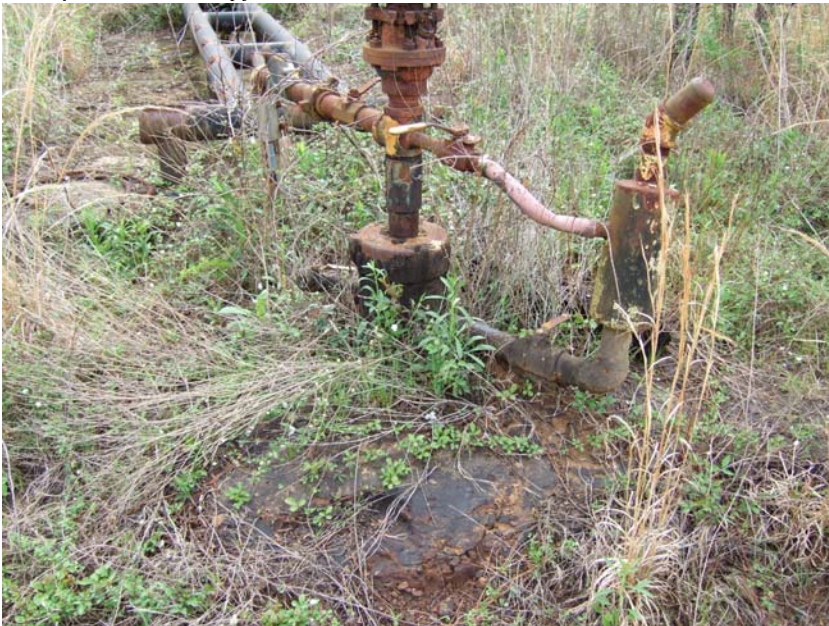
Site Name: Quality Petroleum, Inc.-Hoffman, et al. **Project No.:** E06614
Photo No.: 0219 **Direction:** Down **Contract No.**
Date: 04/05/2008 **Time:** 9:49:00 AM **Photographer/Witness:** Sekerka, Robert/Johnson, Colin
Description: E06614: Oil saturated soil around wellhead for SN 179621.

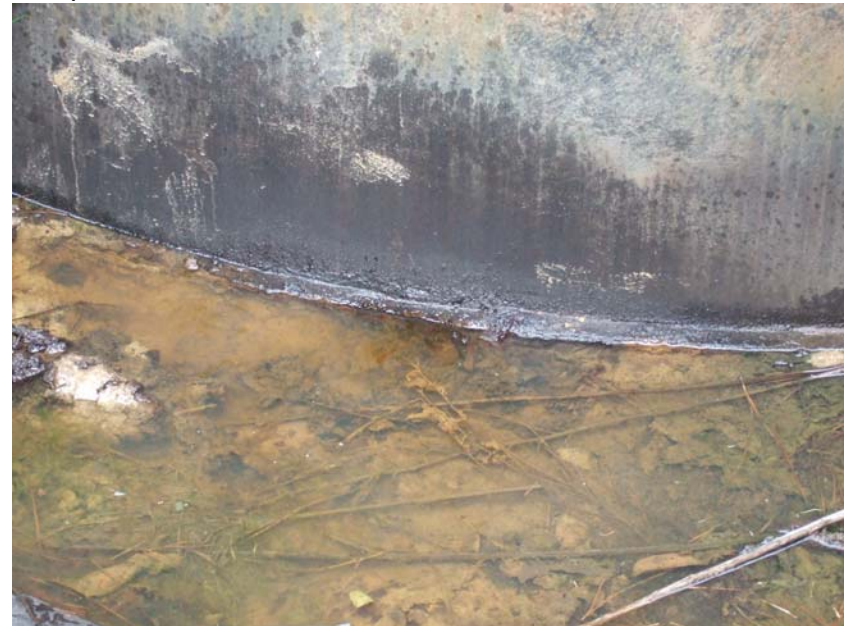
Site Name: Quality Petroleum, Inc.-Hoffman, et al. **Project No.:** E06614
Photo No.: 0220 **Direction:** Down **Contract No.**
Date: 04/05/2008 **Time:** 10:12:00 A **Photographer/Witness:** Sekerka, Robert/Johnson, Colin
Description: E06614: Pooled water around base of AST1.

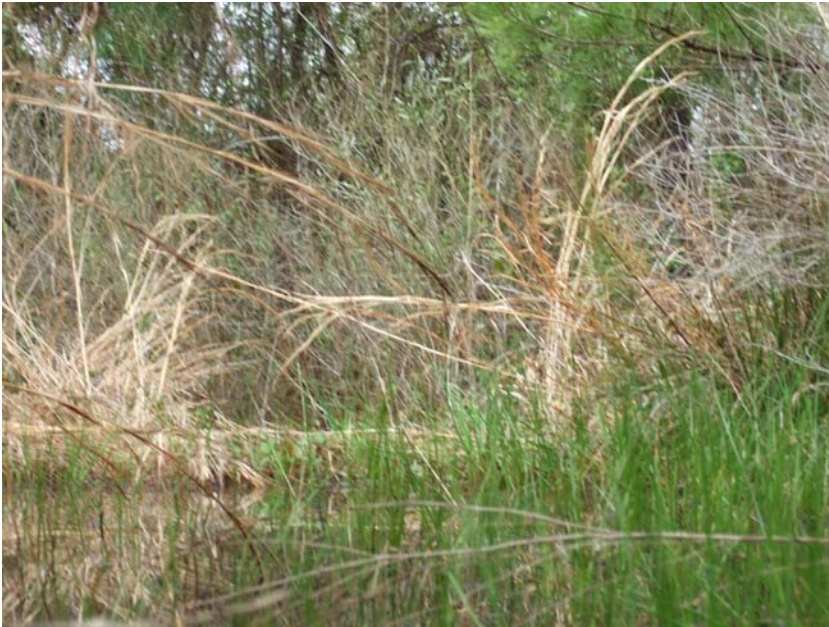
Site Name: Quality Petroleum, Inc.-Hoffman, et al. **Project No.:** E06614
Photo No.: 0221 **Direction:** SW **Contract No.**
Date: 04/05/2008 **Time:** 10:13:00 A **Photographer/Witness:** Sekerka, Robert/Johnson, Colin
Description: E06614: Pooled water accumulated in CONT1.

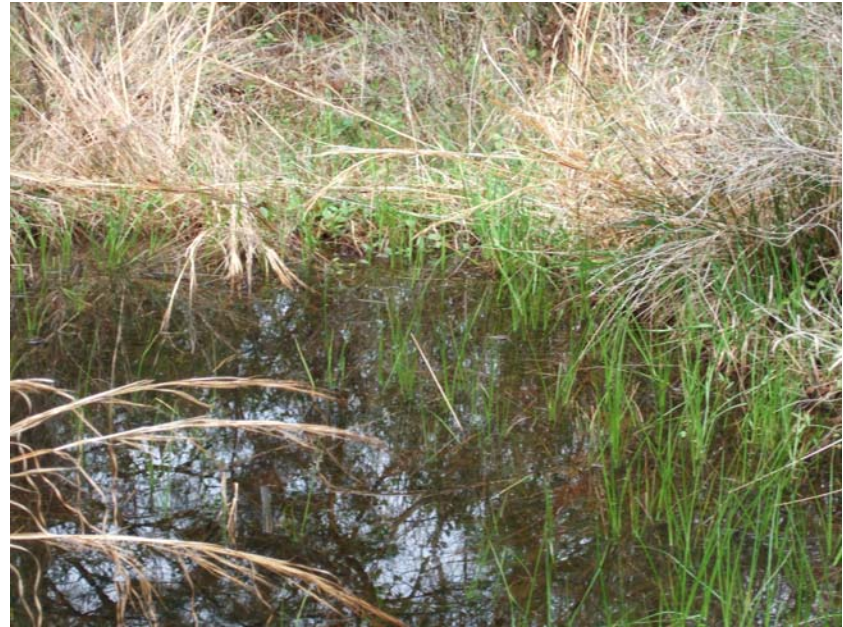
Details: The breach in CONT1 significantly reduced containment capacity and allowed drainage to the environment. Lack of maintenance was evident from the heavily overgrown condition, eroding berms, and the oil-saturated soil in CONT1.

Site Name: Quality Petroleum, Inc.-Hoffman, et al. **Project No.:** E06614
Photo No.: 0222 **Direction:** SW **Contract No.**
Date: 04/05/2008 **Time:** 10:13:00 A **Photographer/Witness:** Sekerka, Robert/Johnson, Colin
Description: E06614: Oily sheen on water pooled in southwest end of CONT1 (Note breach through CONT1 in background).

Site Name: Quality Petroleum, Inc.-Hoffman, et al. **Project No.:** E06614
Photo No.: 0222 **Direction:** SW **Contract No.:**
Date: 04/05/2008 **Time:** 10:13:00 A **Photographer/Witness:** Sekerka, Robert/Johnson, Colin
Description: E06614: Oily sheen on water pooled in southwest end of CONT1 (Note breach through CONT1 in background).

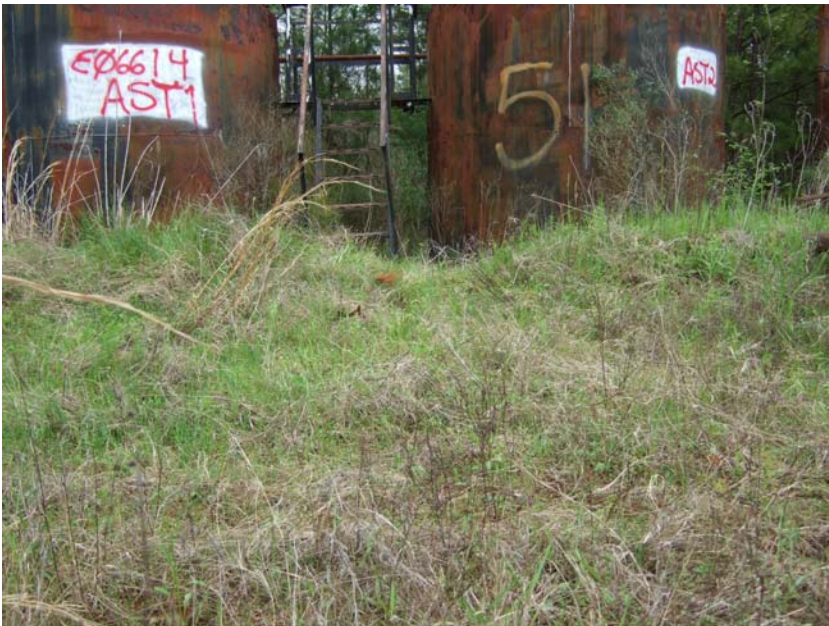
Site Name: Quality Petroleum, Inc.-Hoffman, et al. **Project No.:** E06614
Photo No.: 0223 **Direction:** W **Contract No.**
Date: 04/05/2008 **Time:** 10:15:00 A **Photographer/Witness:** Sekerka, Robert/Johnson, Colin
Description: E06614: Shallow breach on southeast berm of CONT1.

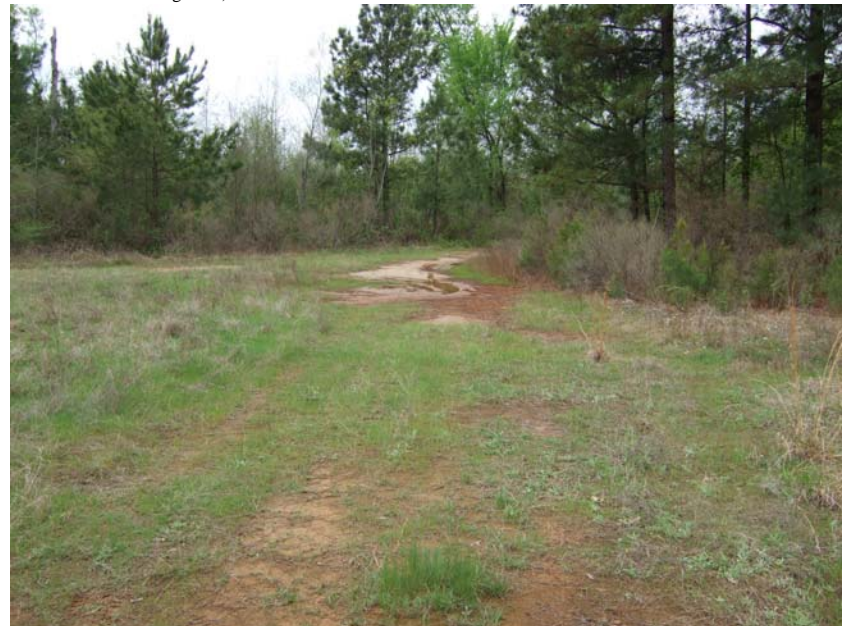
Site Name: Quality Petroleum, Inc.-Hoffman, et al. **Project No.:** E06614
Photo No.: 0224 **Direction:** W **Contract No.**
Date: 04/05/2008 **Time:** 10:15:00 A **Photographer/Witness:** Sekerka, Robert/Johnson, Colin
Description: E06614: Drainage ditch on north side of facility access road.

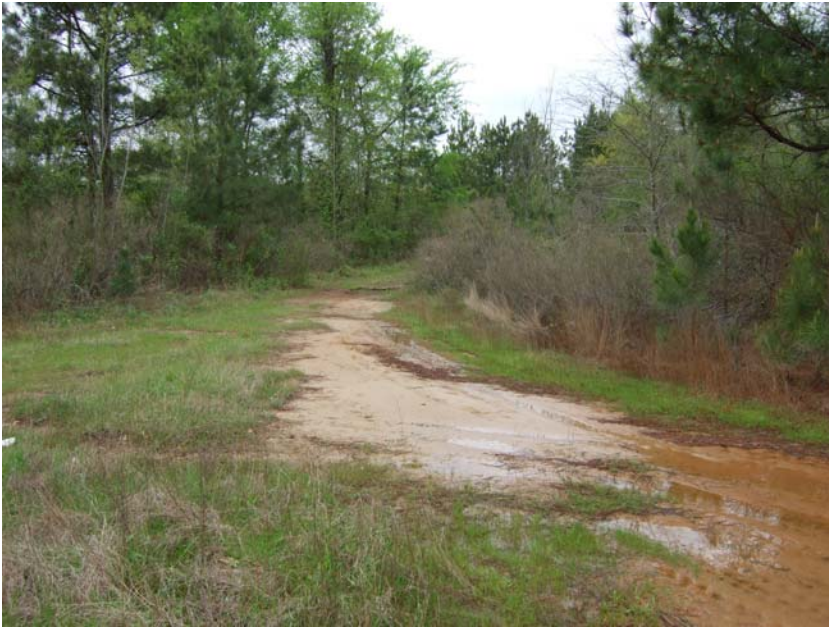
Site Name: Quality Petroleum, Inc.-Hoffman, et al. **Project No.:** E06614
Photo No.: 0225 **Direction:** SW **Contract No.**
Date: 04/05/2008 **Time:** 10:15:00 A **Photographer/Witness:** Sekerka, Robert/Johnson, Colin
Description: E06614: Drainage ditch on north side of facility access road.

Site Name: Quality Petroleum, Inc.-Hoffman, et al. **Project No.:** E06614
Photo No.: 0225 **Direction:** SW **Contract No.:**
Date: 04/05/2008 **Time:** 10:15:00 A **Photographer/Witness:** Sekerka, Robert/Johnson, Colin
Description: E06614: Drainage ditch on north side of facility access road.

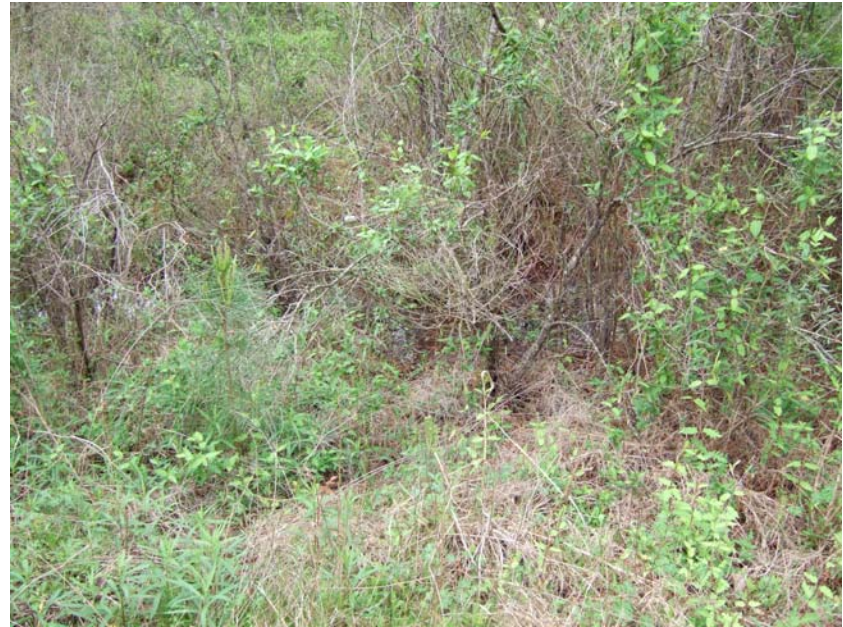
Site Name: Quality Petroleum, Inc.-Hoffman, et al. **Project No.:** E06614
Photo No.: 0226 **Direction:** S **Contract No.**
Date: 04/05/2008 **Time:** 10:16:00 A **Photographer/Witness:** Sekerka, Robert/Johnson, Colin
Description: E06614: Drainage pathway to NHD tributary to Caddo Lake south of access road.

Site Name: Quality Petroleum, Inc.-Hoffman, et al. **Project No.:** E06614
Photo No.: 0226 **Direction:** S **Contract No.:**
Date: 04/05/2008 **Time:** 10:16:00 A **Photographer/Witness:** Sekerka, Robert/Johnson, Colin
Description: E06614: Drainage pathway to NHD tributary to Caddo Lake south of access road.

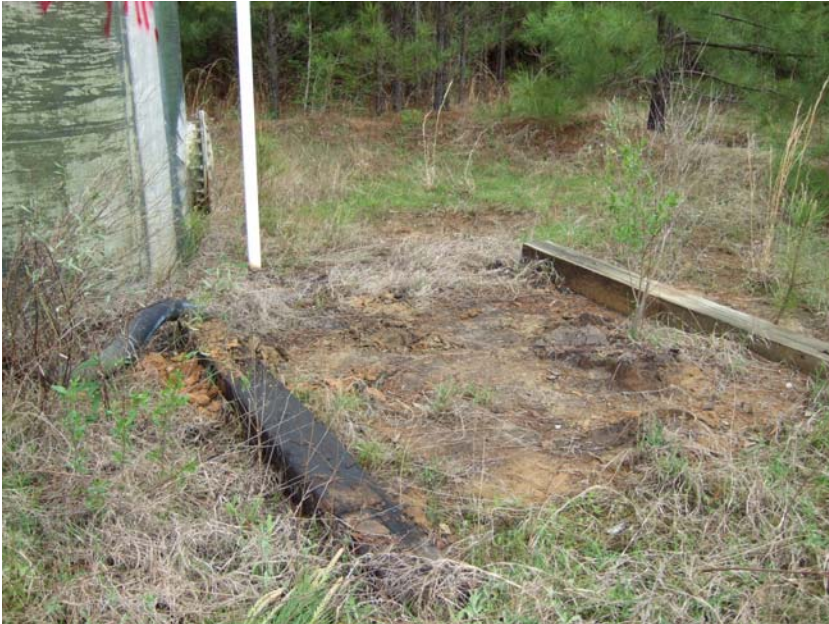
Site Name: Quality Petroleum, Inc.-Hoffman, et al. **Project No.:** E06614
Photo No.: 0227 **Direction:** W **Contract No.**
Date: 04/05/2008 **Time:** 10:31:00 A **Photographer/Witness:** Sekerka, Robert/Johnson, Colin
Description: E06614: Former equipment location on east side of AST3.

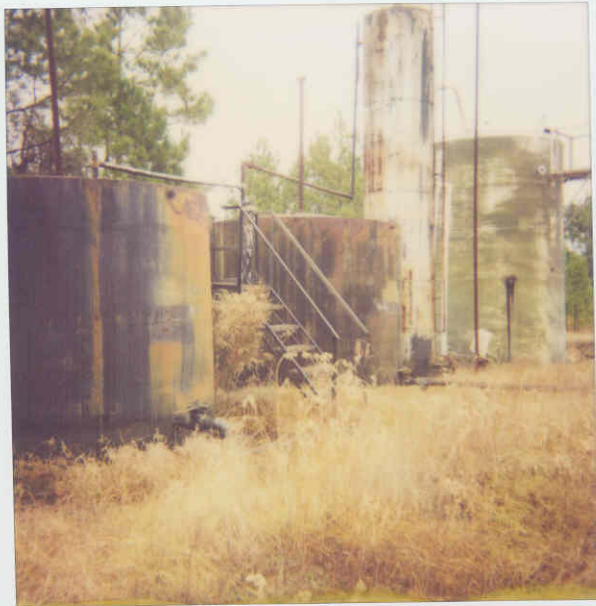
Quality Petroleum, Inc. (Q008)
Hoffman ETAL #001 Production Facility
Sec. 4, T21N, R16W
CPI (2152) Caddo (009) 12-5-02

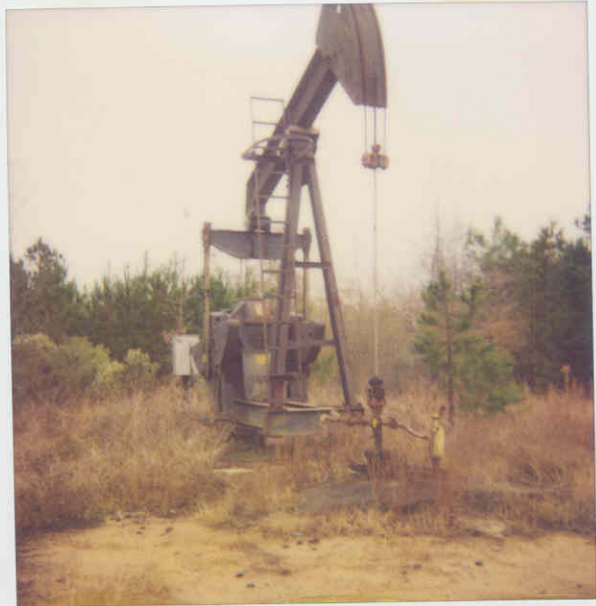
Quality Petroleum, Inc. (Q008)
Hoffman ETAL #1 S.N. 179621
Sec. 4, T21N, R16W
CPI (2152) Caddo (009) 12-5-02
