REMOVAL ACTION COMPLETION REPORT

**Atmos Energy Corporation
Former Manufactured Gas Plant
Third and Elm Streets
Owensboro, Kentucky**

***Re: Removal Action Completion Report
Atmos Energy Corporation
Third and Elm Streets
Owensboro, Daviess County, Kentucky
EPA ID #KYD980838395 / AI #51994
Linebach Funkhouser Project Number 163-07***

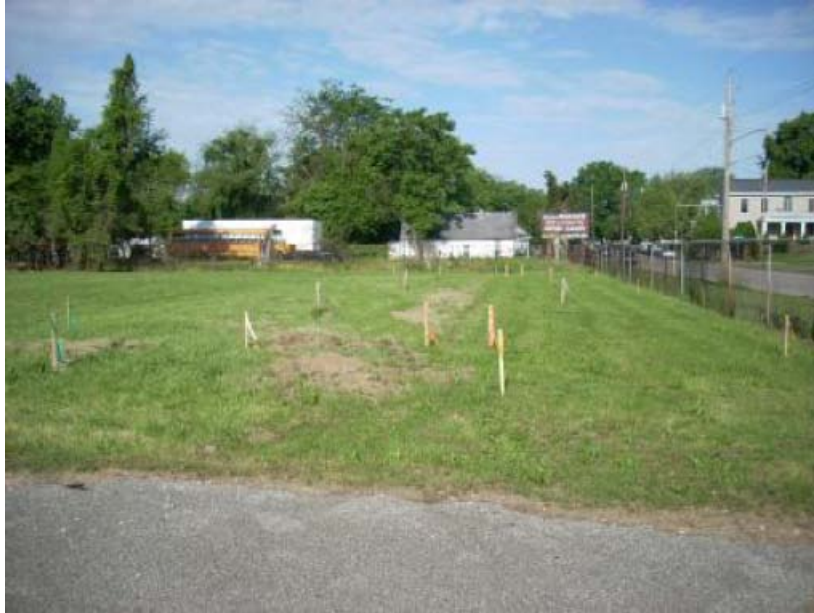
Week of May 19-23, 2008: Detention Basin
Layout (Looking West)

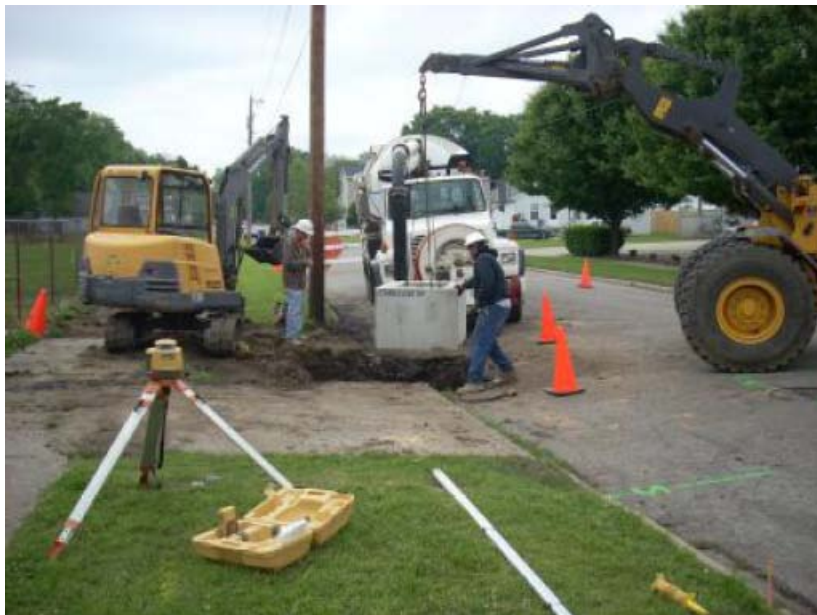
Week of May 19-23, 2008: Installing Storm Sewer Box on W
3rd Street (Looking West)

Sewer line/culvert installation work involved limited digging outside the property boundaries and within the right-of-way of a small portion of 3rd Street itself. Traffic control devices were utilized to control traffic around the work area. Excess excavated materials from the 3rd Street excavation were spread across a portion of the site for later coverage underneath the asphalt cap. Air monitoring was conducted around the work area to ensure that there were no significant issues involving potential exposure to wind blown dust. Excavated areas created by the storm sewer construction were restored by the end of the week.

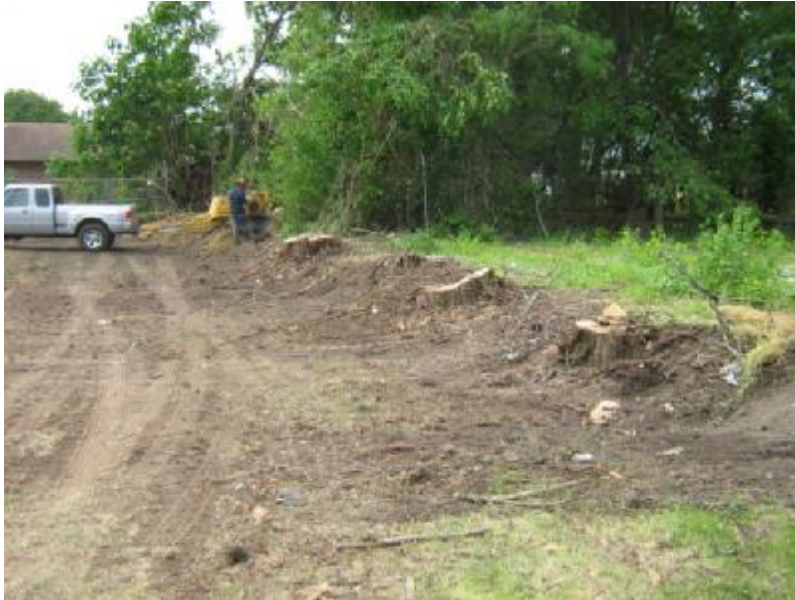
Week of May 19-23, 208: Grinding Stumps along West Fence Line (Looking South)

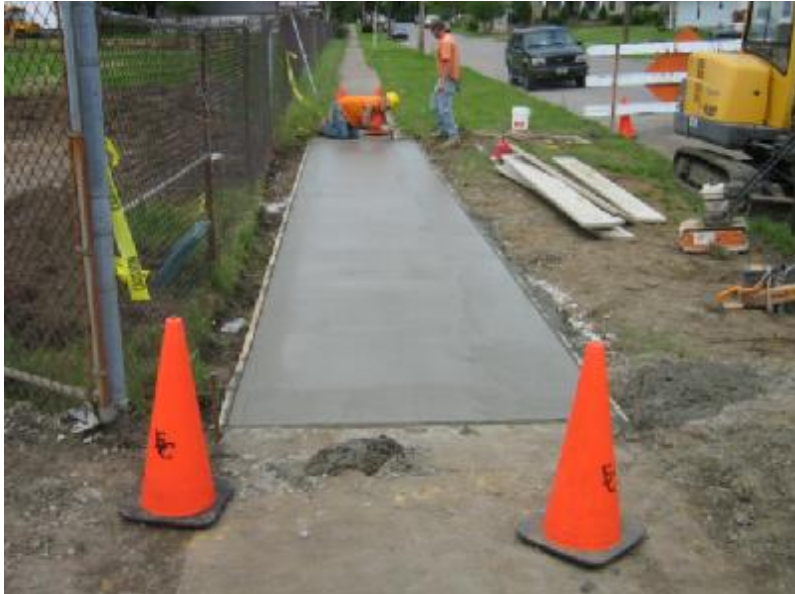
Week of May 19-23, 2008: Replacing Concrete Sidewalk on South Side of W 3rd St. (Looking West)

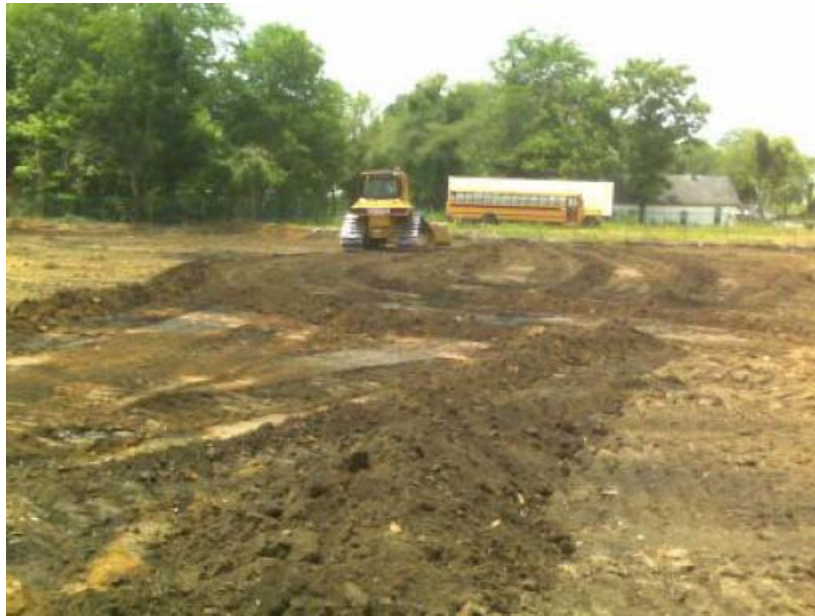
Week of June 2-6, 2008: Start of Site Grading
After Top Soil Removal (Looking West)

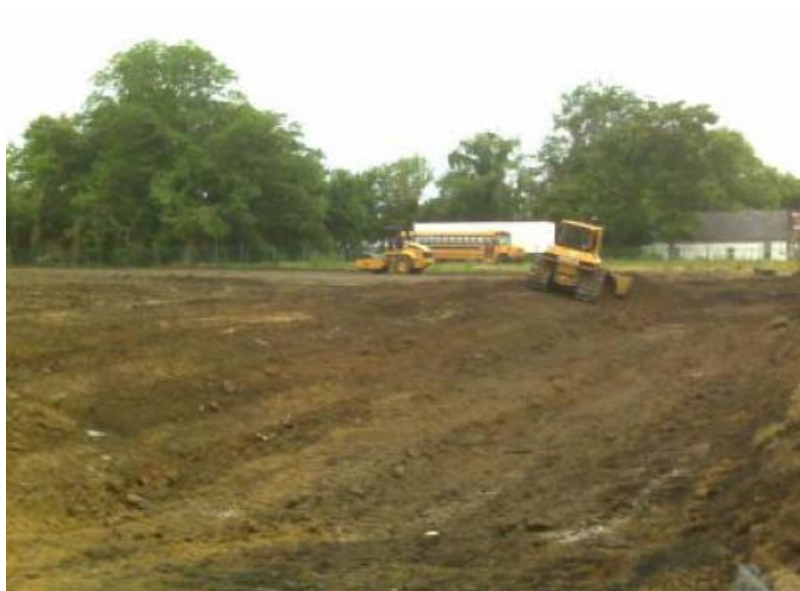
Week of June 2-6, 2008: Shaping Detention Basin
(Looking West)

Detention basin soils work and associated site grading activities were initiated on June 2, 2008. Soils excavated from the basin were spread over the adjacent area of the site to the south, and then graded across that area to achieve the sub-grade topographic conditions required for the planned resurfacing. A global positioning system (GPS) was utilized by the earthwork contractor to ensure that soils in the basin area were removed to the appropriate elevation specified in the detention basin design plan approved by the City of Owensboro.

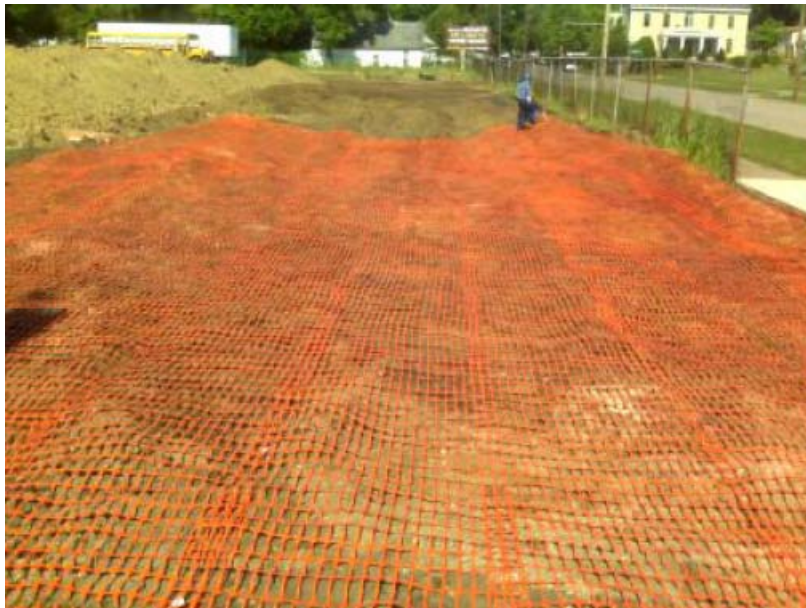
Week of June 2-6, 2008: Installing Warning Marker in Detection Basin (Looking West)

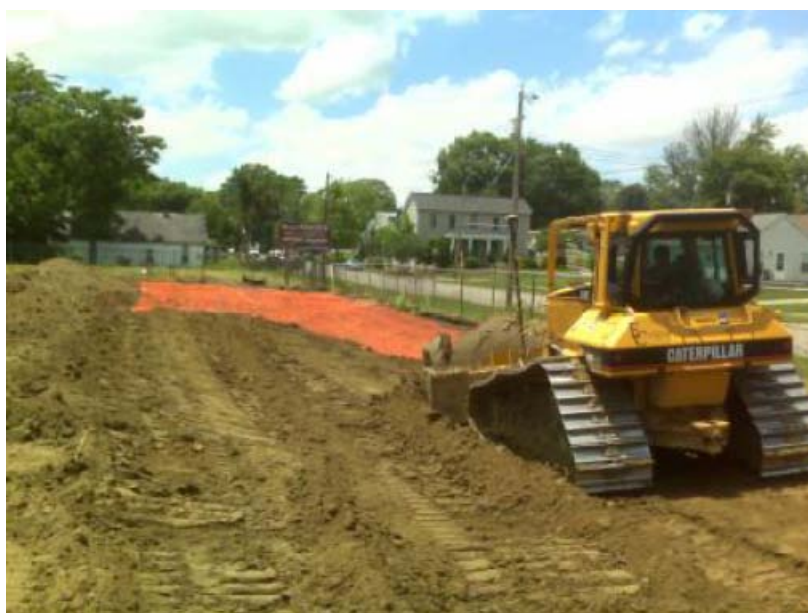
Week of June 2-6, 2008: Installing Clean Soil Cap in Detention Basin (Looking West)

A natural soil cover (silty clay) with a minimum thickness of one foot was laid down over the orange webbing material across the retention basin and entire northern section of the site (i.e. the portion not covered by asphalt paving). To confirm the thickness of the cover, the natural soil cap area was conceptually divided into six approximately equi-distant north-south trending transects, and a spade was used to penetrate the cover material at 3 points across each transect. Of the 18 locations checked, only one, in the center portion of the detention basin, had a measured thickness of less than 1 foot (measured thickness was 0.8 feet at that location). Additional clean soil material was brought in and spread throughout the central portion of the basin, creating a soil cover exceeding 1 foot thick at the previously referenced location. After the natural soil cover was emplaced, it was seeded and overlain by a straw cover.

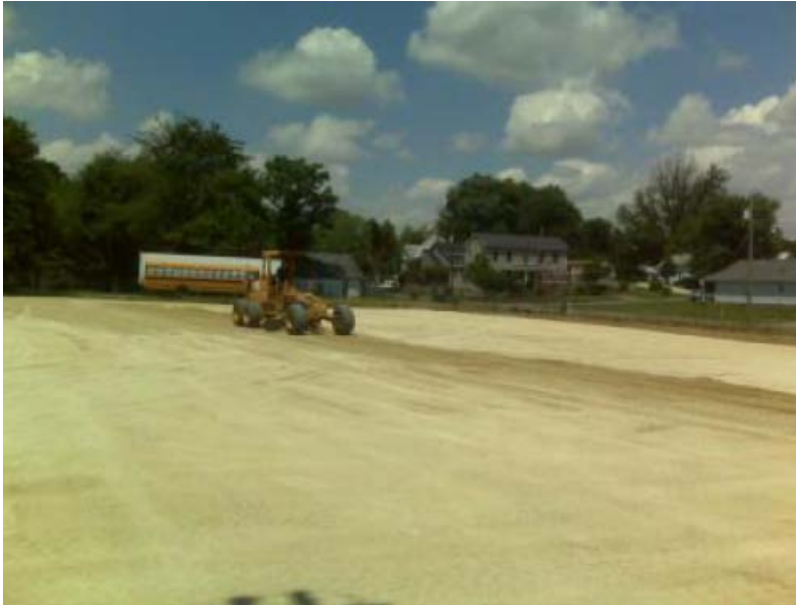
Week of June 2-6, 2008: Installing Gravel Base for
Parking Lot (Looking Northwest)

Soil within the majority of the property boundary was covered by asphalt pavement (Figure 2). Soil and fill lying within this area was initially graded to achieve topographic conditions to promote proper drainage for the overlying asphalt cover. A three to four-inch thick base layer of dense-grade limestone aggregate was then spread across the site, compacted, and allowed several days to settle. An approximately 2-inch thick layer of asphalt base was then added, followed by a 1-inch thick layer of asphalt finish.

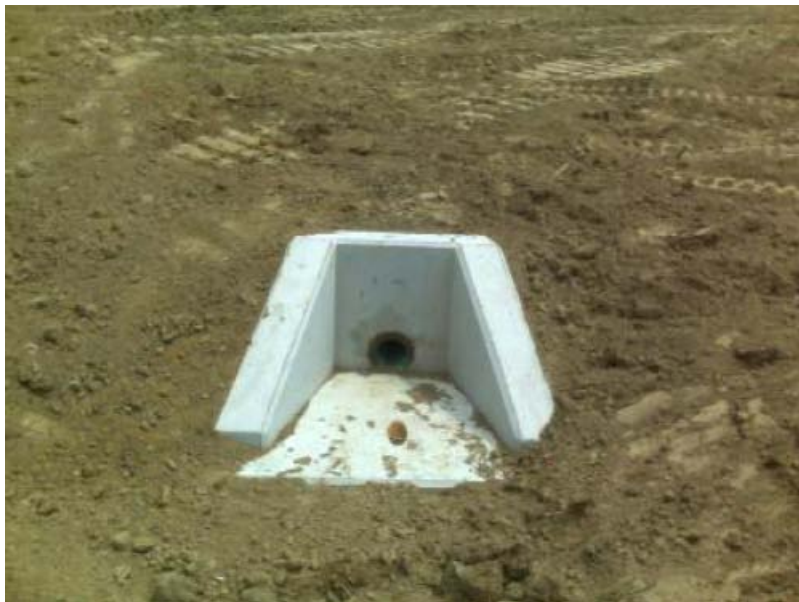
Week of June 2-6, 2008: Concrete Head Wall
Installed in Drainage Basin (Looking East)

A culvert was installed in the basin to route surface water through buried piping to the city stormwater sewer system beneath 3rd Street. After the basin area had been excavated and shaped in accordance with the City's design requirements, orange plastic webbing (i.e. barrier fencing) was horizontally spread across virtually the entire detention basin and adjacent area designed to receive the natural soil cover. The area containing the detention basin and natural soil cover is shown in Figure 2.

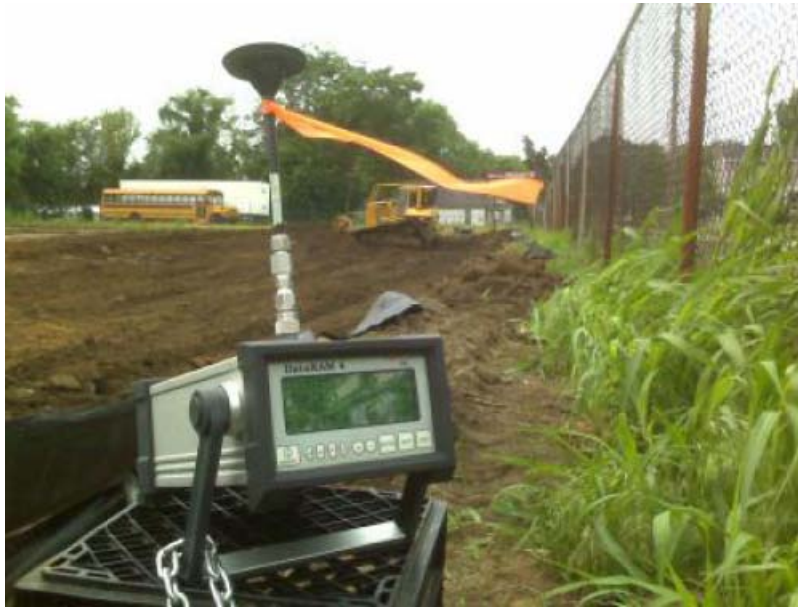
Week of June 2-6, 2008: Air Monitoring at Downgradient Fenceline During Site Activities

Particulate monitoring was employed during detention basin construction and site grading, until the protective gravel and natural cover material were in place. The particulate monitoring was conducted using two real-time DataRam 4 particulate monitors manufactured by Thermo Electron Corporation, capable of monitoring particulate matter less than ten microns (PM₁₀).

Dust monitors were relocated on the site, as needed, to reflect wind direction changes. Monitoring equipment was calibrated daily and placed upwind and downwind of the work area. No exceedences of the USEPA/KDEP approved action level (1 mg/m³ over an integrated period not to exceed 15 minutes) were demonstrated by the monitoring. Nonetheless, as an extra conservative measure, a water truck with an atomizing sprayer was used to suppress on-site visible dust prior to the time when site cover materials were in place. Dust monitoring logs are included in Appendix C.

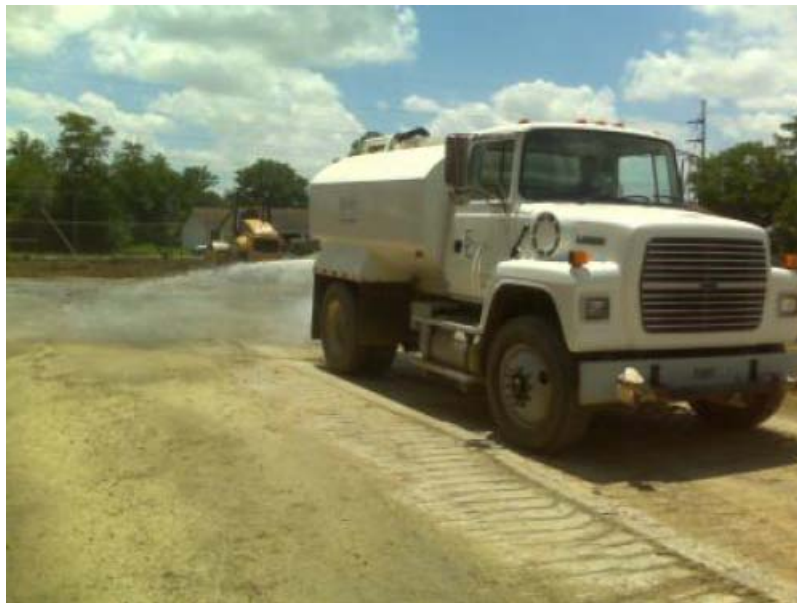
Week of June 2-6, 2008: Applying Water for Dust Control during Site Activities (Looking South)

Air monitoring conducted during construction activities included a fugitive dust suppression and particulate monitoring program to monitor potential exposure of on-site personnel and the public around the Site to affected dust. The potential exposure period to affected dust was limited to the week of June 2, 2008, between the time when Site grading work was initiated and the gravel or clean fill subgrade layer was laid down.

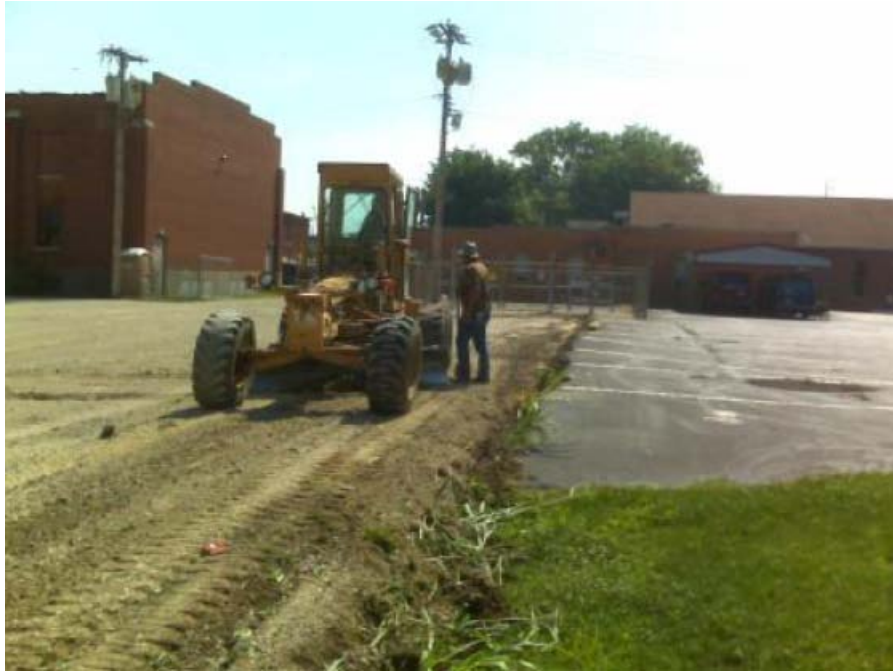
Final Grading on June 19, 2008 after Fence Removed on South Property Line (Looking East)

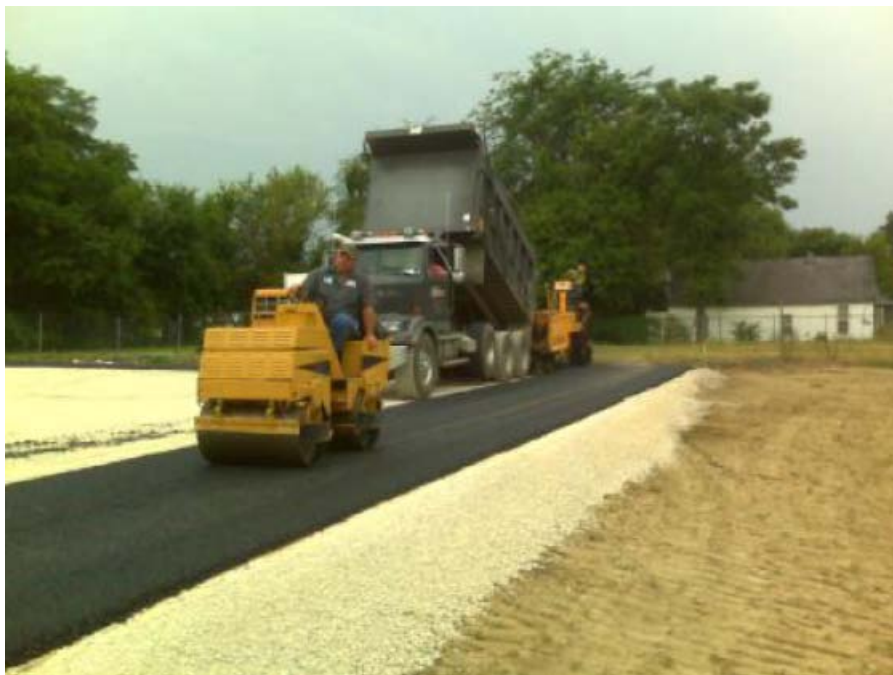
Paving Base Layer on Northwest Corner of Site on June 20, 2008
(Looking West)

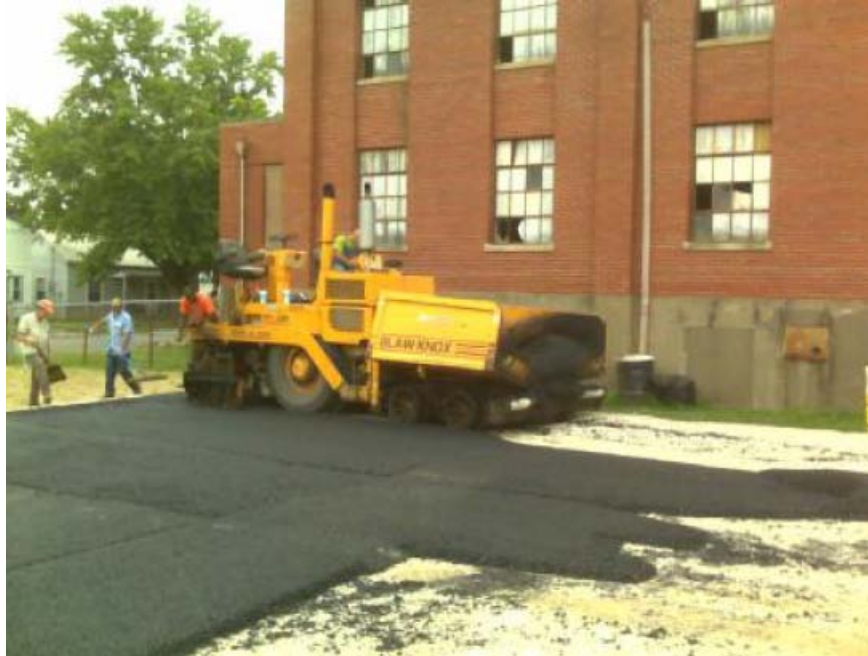
Paving Base Layer on Northeast Corner of Site on June 20, 2008
(Looking Northeast)

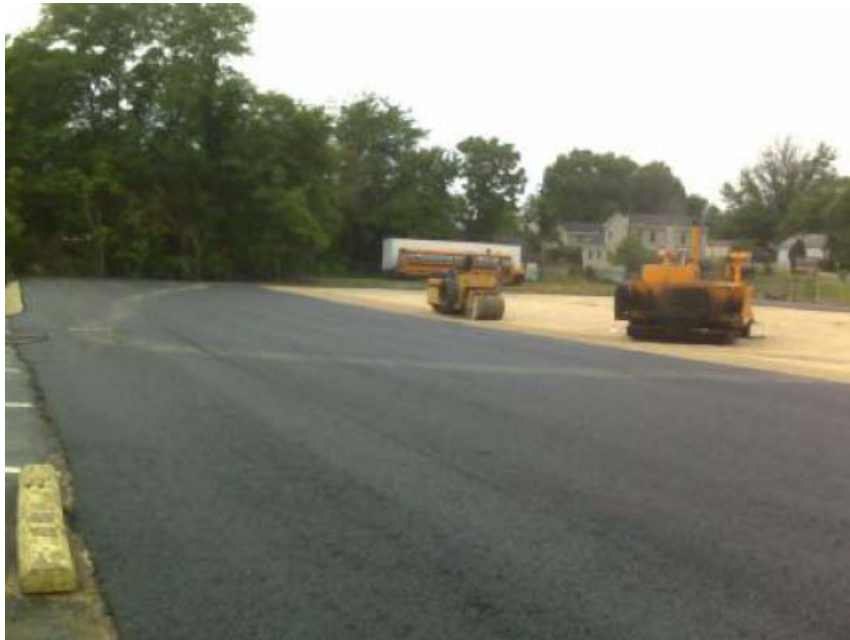
Extent of Base Layer on South Property Line on June 20, 2008
(Looking West)

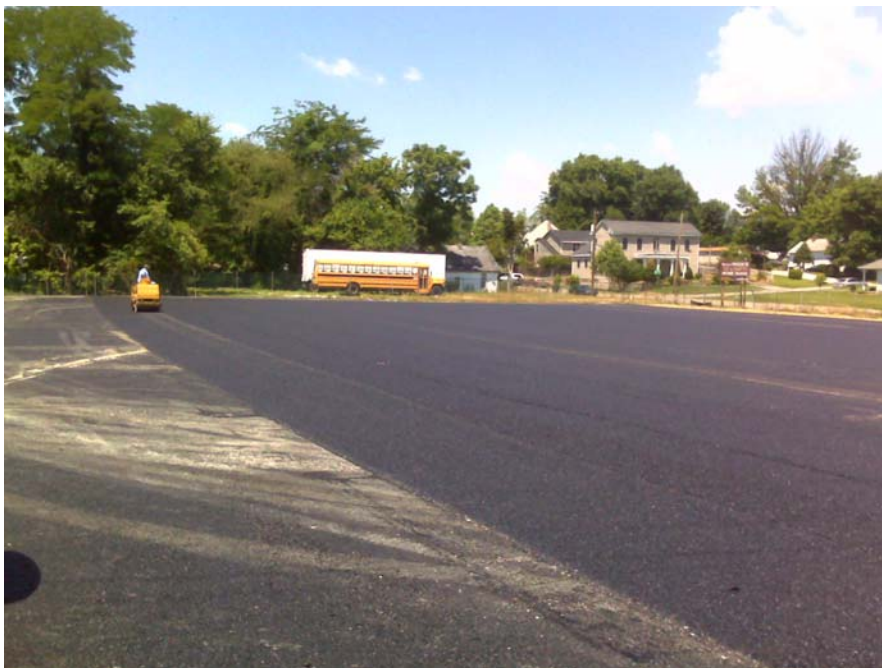
Rolling asphalt base layer on June 23 (Looking West)

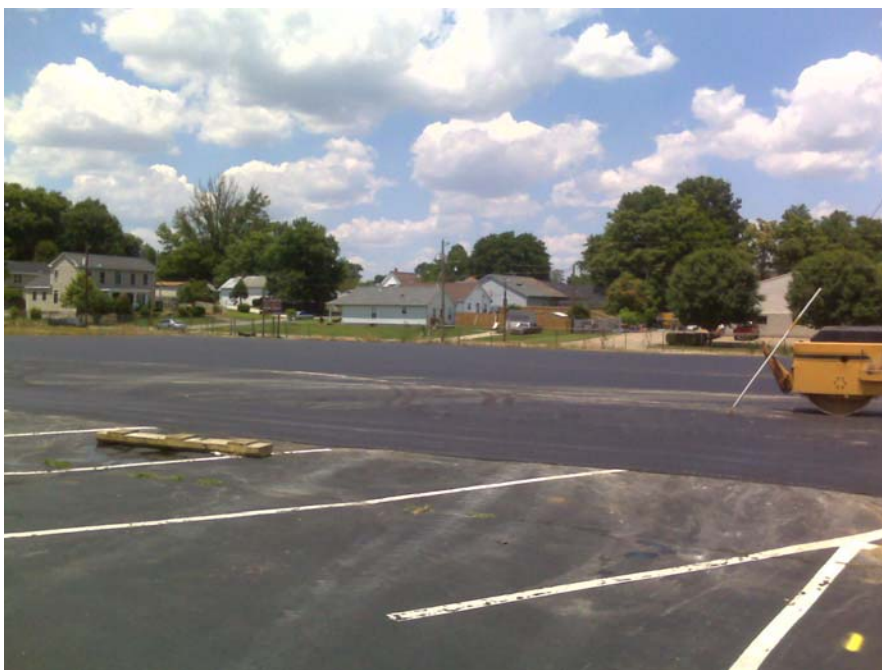
Asphalt Base Layer Completed on June 23, 2008
(Looking Northeast)

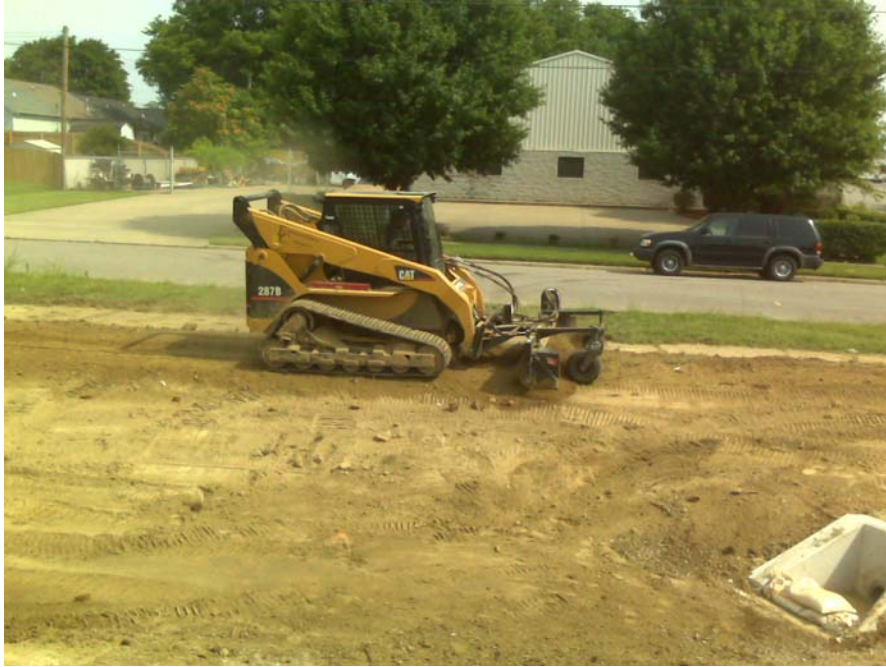
Raking soil cover along north property line on June 25, 2008
(Looking North)

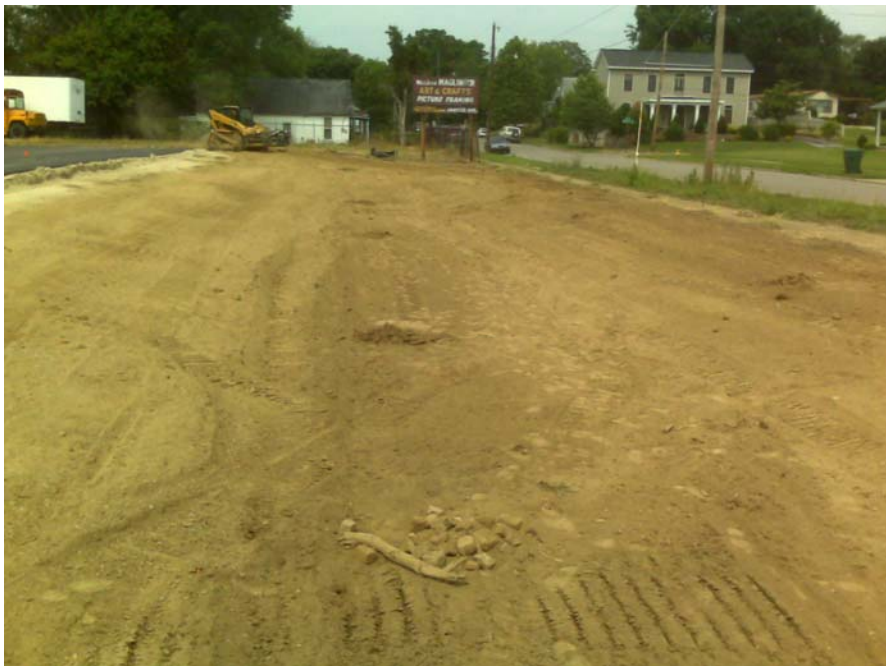
Soil Cover Confirmation Sampling on June 25, 2008 (Looking West)

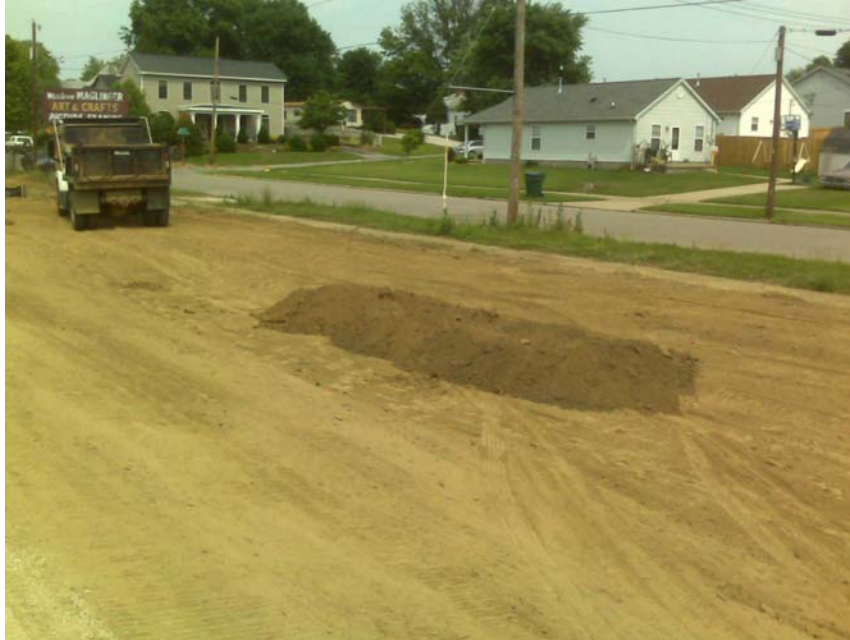
Additional Soil Cover Added to Detention Basin on June 25, 2008
(Looking Northwest)

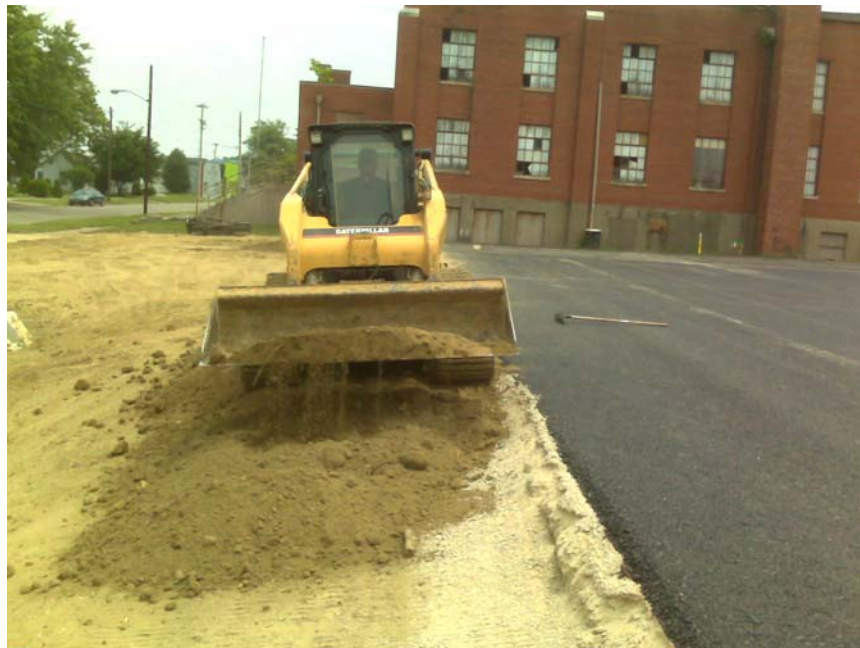
Clean Soil Added to North Edge of Cap for Landscaping on June 25, 2008
(Looking East)

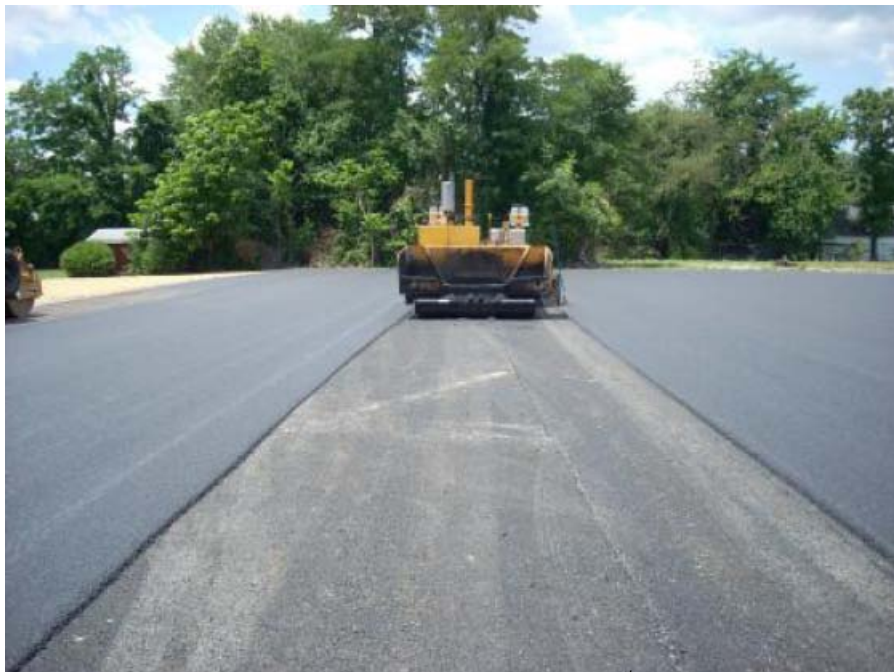
Installing finish layer of asphalt to cap on July 1st, 2008 (Looking West)

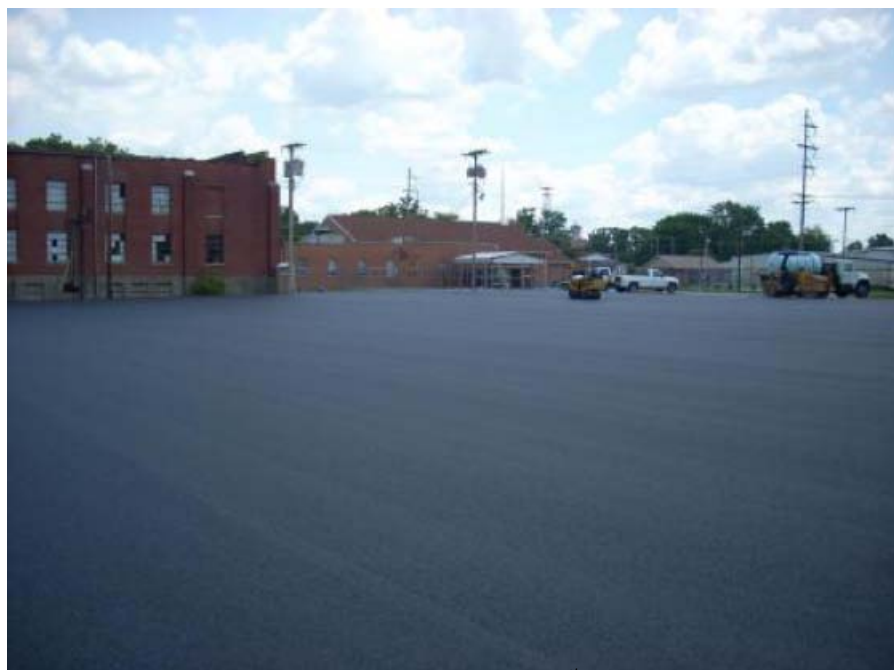
Finish Layer of Asphalt Completed on July 1st, 2008 (Looking Southeast)

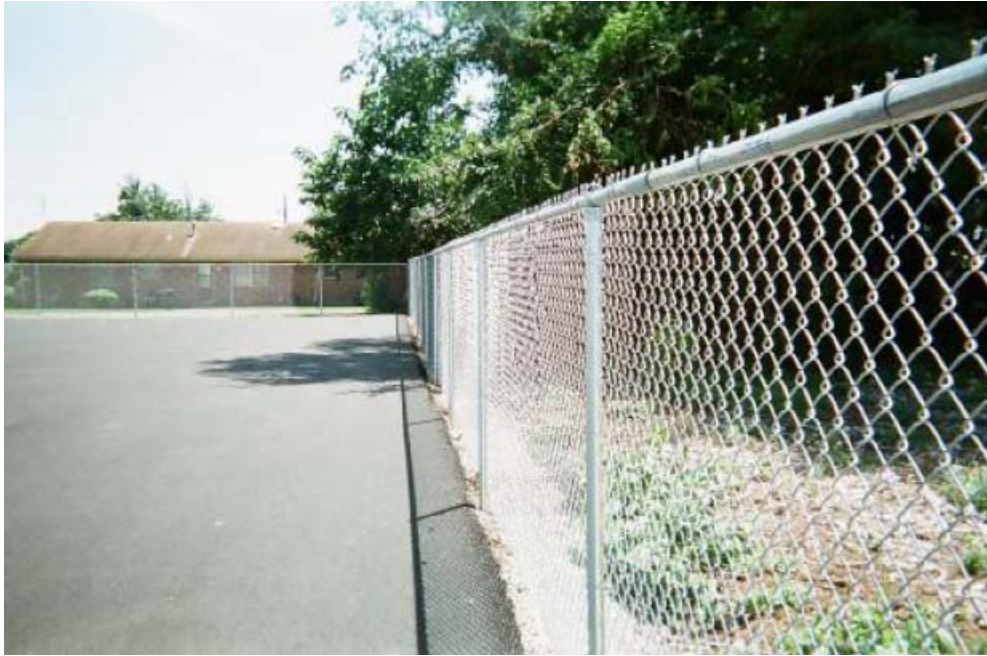
Week of July 7-11, 2008: Installed Fencing on West and South Boundary of Site (Looking South)

Following completion of the asphalt paving and natural soil cover, a 6-foot tall chain-link security fence was installed around the entire site perimeter. Lockable gates suitable for vehicle access were installed on the north and south sides of the property, and a pedestrian entrance gate was installed near the southeast corner (Figure 2).

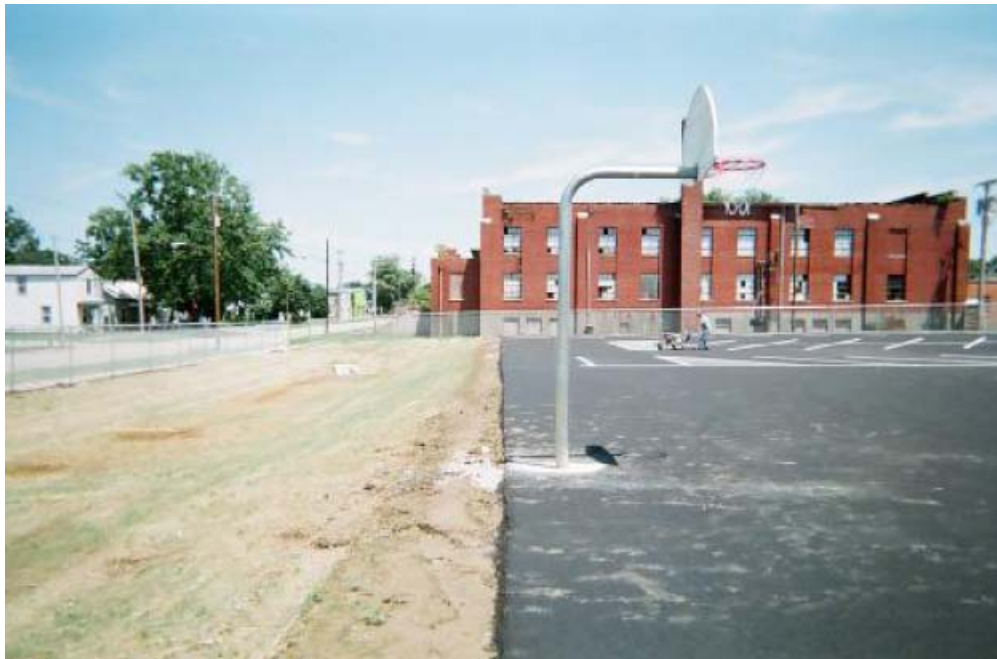
Week of July 7-11, 2008: Installed Basketball Goal (Looking East)

In accordance with Atmos Energy's agreement with the Fourth Avenue Baptist Church, the asphalt paved cover was cosmetically modified to support recreational use by the Church. A mulched playground area and a wood-floored gazebo were installed on top of the asphalt pavement in the southwest corner of the site. Basketball goals and marking for an outdoor court were added north of the gazebo. The central and eastern areas of the site were striped for use as a vehicle parking area. Landscaping shrubbery was added along the eastern border of the asphalt cover. Care was taken during the landscaping work so as not to penetrate into the underlying affected soil. Locations of landscaping and recreational additions are shown in Figure 2.

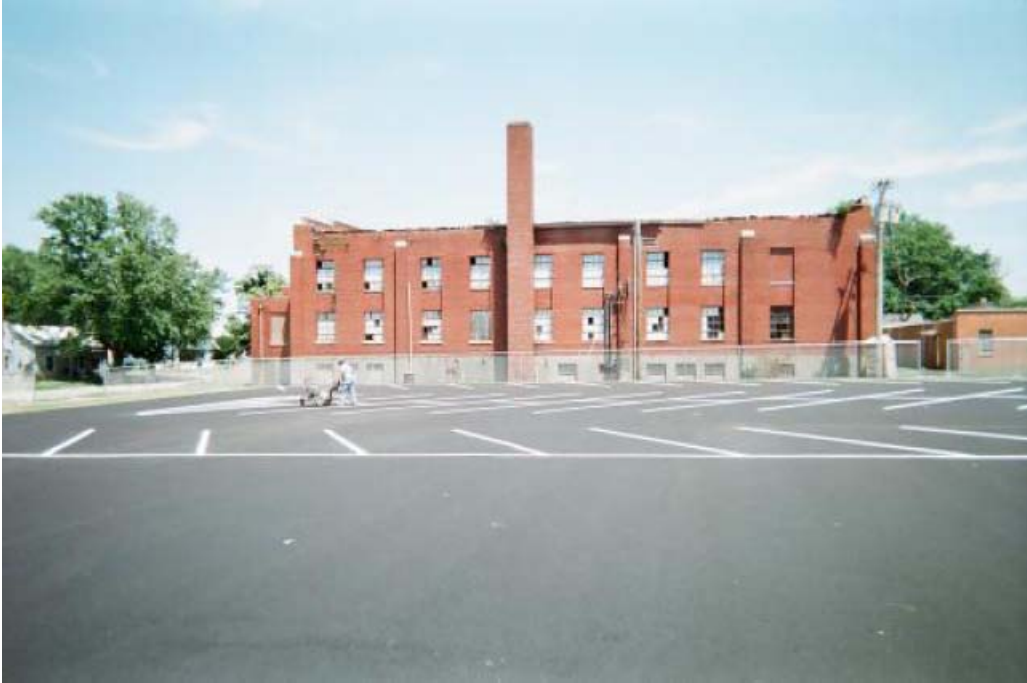
Week of July 7-11, 2008: Striping of Parking
Lot (Looking East)

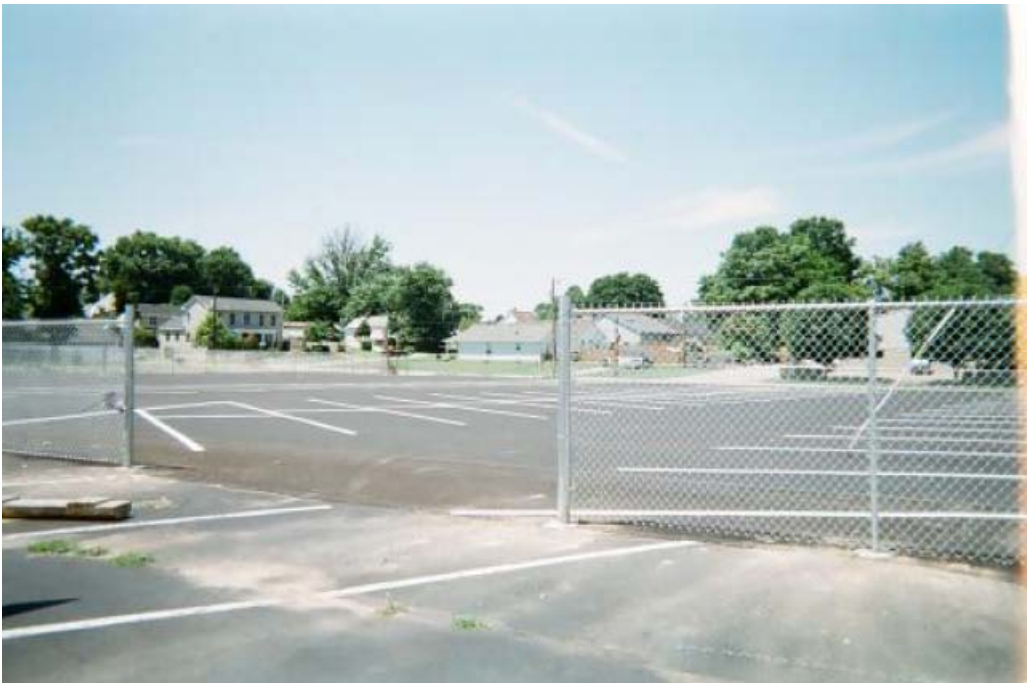
Week of July 7-11, 2008: Fencing and Striped Parking Lot
(Looking Northwest)

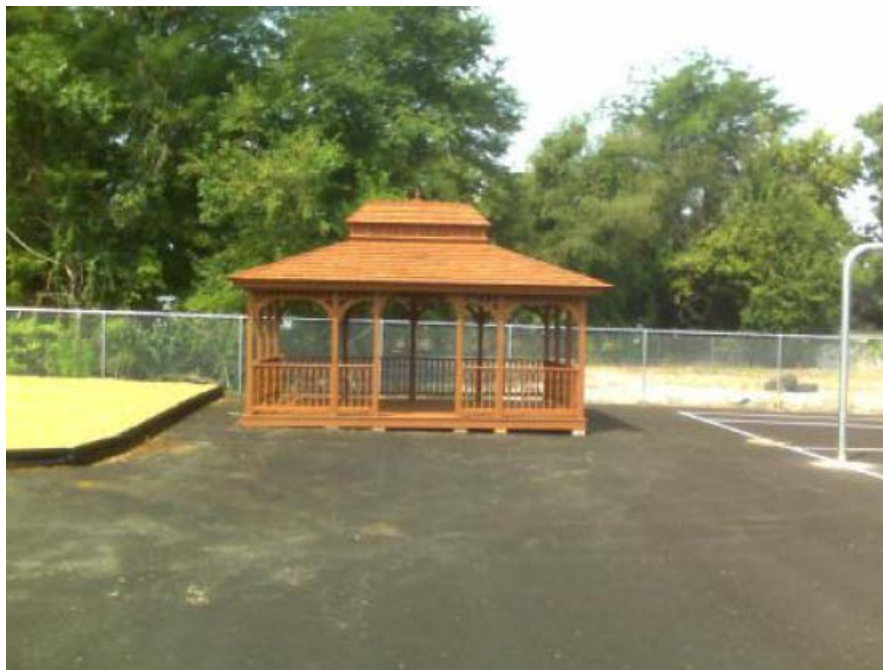
August 4, 2008: Gazebo Installed Between Playground and Basketball Court (Looking West)

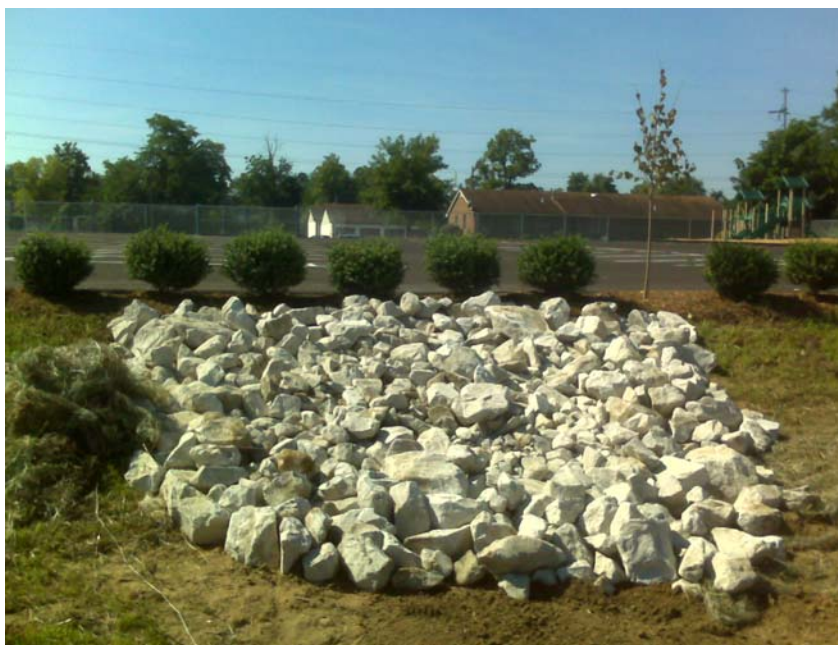
August 13, 2008: Riprap Emplaced for Erosion Control (Looking South)

Based on observations of the site cover made by LFI and Atmos personnel in August of 2008, riprap was added as an erosion protection feature along a limited section of the northern border of the asphalt cover (Figure 2). The riprap consisted of stones emplaced on top of the natural soil cover at a location where surface water runoff across the asphalt pavement was showing preliminary signs of channeling. The riprap was extended down the slope of the detention basin, covering an area of adequate size to provide a substantial degree of erosion protection. The area will be checked by Atmos as part of the ongoing site cover monitoring and maintenance program described in Section 4.0.
