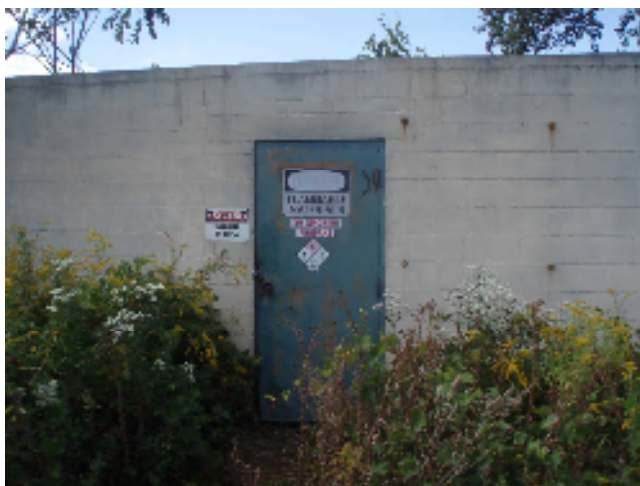
<b>Photograph No.:</b>	1	<b>Orientation:</b>	West
<b>TDD Number:</b>	S05-0808-004	<b>Date:</b>	September 10, 2008
<b>Photographer:</b>	R. Bugg, START	<b>Site Name:</b>	Plabell Rubber Manufacturing Plant
<b>Location:</b>	Toledo, Lucas County, Ohio		
<b>Subject:</b>	Entrance to the flammable storage building (FSB).

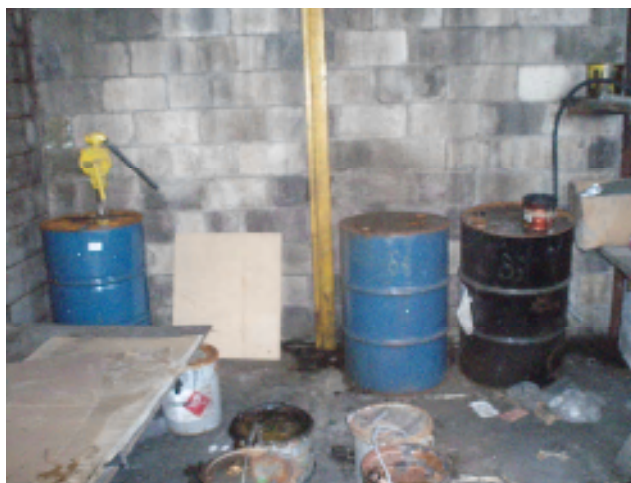
<b>Photograph No.:</b>	2	<b>Orientation:</b>	West
<b>TDD Number:</b>	S05-0808-004	<b>Date:</b>	September 10, 2008
<b>Photographer:</b>	R. Bugg, START	<b>Site Name:</b>	Plabell Rubber Manufacturing Plant
<b>Location:</b>	Toledo, Lucas County, Ohio		
<b>Subject:</b>	Drums D-85, D-86, and D-87 (black drum). The area to the left is the makeshift bed that is held up by flammable containers. START staged the containers in the middle of the building but were scattered throughout the building the next day.

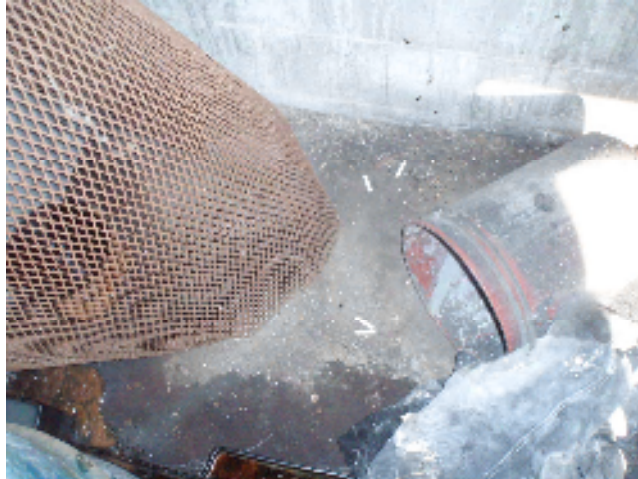
<b>Photograph No.:</b>	3	<b>Orientation:</b>	West
<b>TDD Number:</b>	S05-0808-004	<b>Date:</b>	September 11, 2008
<b>Photographer:</b>	R. Bugg, START	<b>Site Name:</b>	Plabell Rubber Manufacturing Plant
<b>Location:</b>	Toledo, Lucas County, Ohio		
<b>Subject:</b>	The southwest corner of FSB where the stained unknown material that overflowed from the spill pallet of drum D-84. Near the stained material were cigarette butts. Drum D-84 had a flashpoint of 86°F.

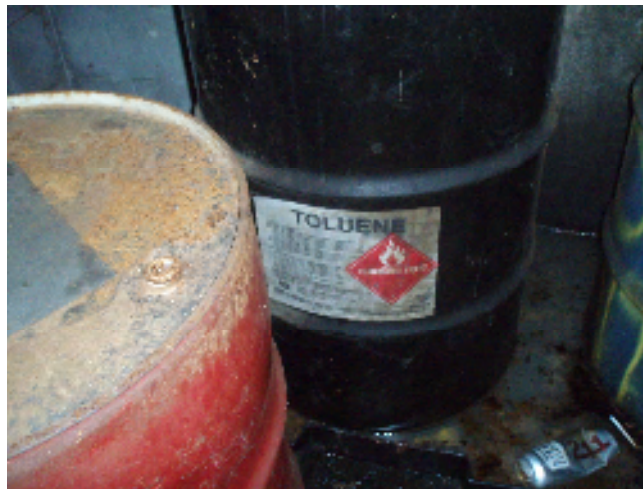
<b>Photograph No.:</b>	4	<b>Orientation:</b>	Southeast
<b>TDD Number:</b>	S05-0808-004	<b>Date:</b>	September 11, 2008
<b>Photographer:</b>	R. Bugg, START	<b>Site Name:</b>	Plabell Rubber Manufacturing Plant
<b>Location:</b>	Toledo, Lucas County, Ohio		
<b>Subject:</b>	The southeast corner of FSB where drum D-82 (labeled Toluene) was located. Drum D-83 (blue drum) and drum D-82 were staged on a spill pallet. The unknown material overflow from the spill pallet to the FSB floor.

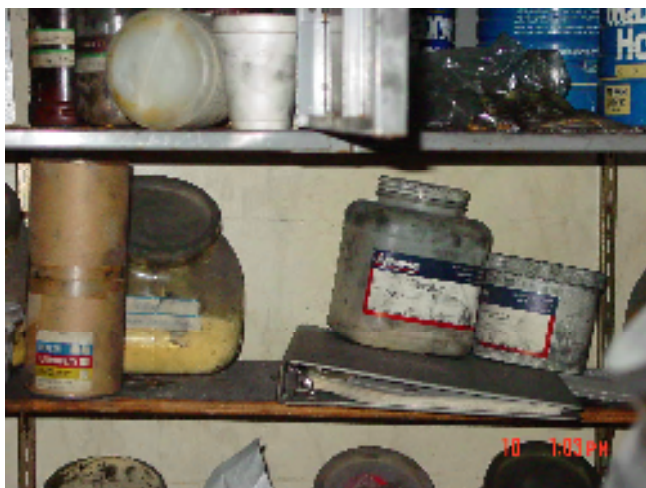
<b>Photograph No.:</b>	5	<b>Orientation:</b>	East
<b>TDD Number:</b>	S05-0808-004	<b>Date:</b>	September 10, 2008
<b>Photographer:</b>	R. Bugg, START	<b>Site Name:</b>	Plabell Rubber Manufacturing Plant
<b>Location:</b>	Toledo, Lucas County, Ohio		
<b>Subject:</b>	One of the filled cabinets in the research laboratory. It was estimated the research laboratory contain 350 small containers.

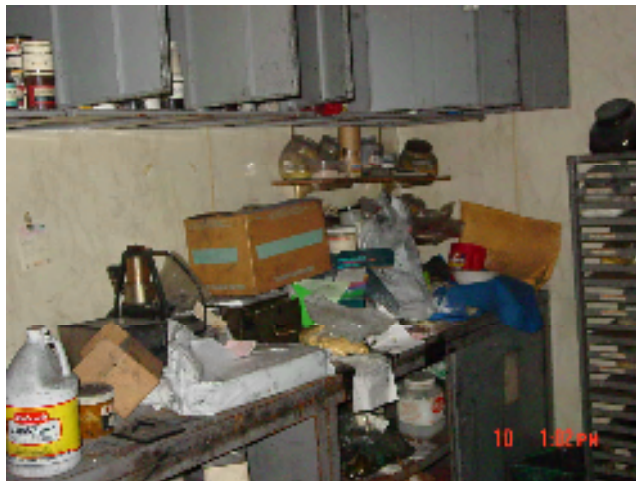
<b>Photograph No.:</b>	6	<b>Orientation:</b>	Southeast
<b>TDD Number:</b>	S05-0808-004	<b>Date:</b>	September 10, 2008
<b>Photographer:</b>	R. Bugg, START	<b>Site Name:</b>	Plabell Rubber Manufacturing Plant
<b>Location:</b>	Toledo, Lucas County, Ohio		
<b>Subject:</b>	The location of the research laboratory in Bld-1. START estimated that the research laboratory contained over 350 small containers.

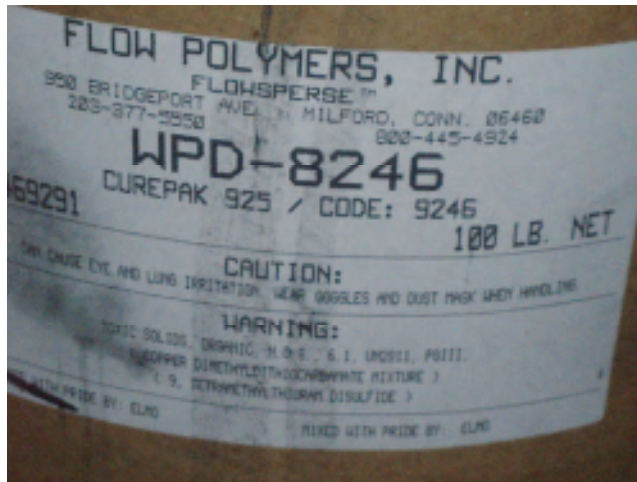
<b>Photograph No.:</b>	7	<b>Orientation:</b>	East
<b>TDD Number:</b>	S05-0808-004	<b>Date:</b>	September 10, 2008
<b>Photographer:</b>	R. Bugg, START	<b>Site Name:</b>	Plabell Rubber Manufacturing Plant
<b>Location:</b>	Toledo, Lucas County, Ohio		
<b>Subject:</b>	The drum label from D-66 which contained copper dimethyldithiocarbonate. During the inventory reconnaissance, a total of 10 drums (3 in Bld-1 and 7 in Bld-2) were found that contained copper dimethyldithiocarbonate.

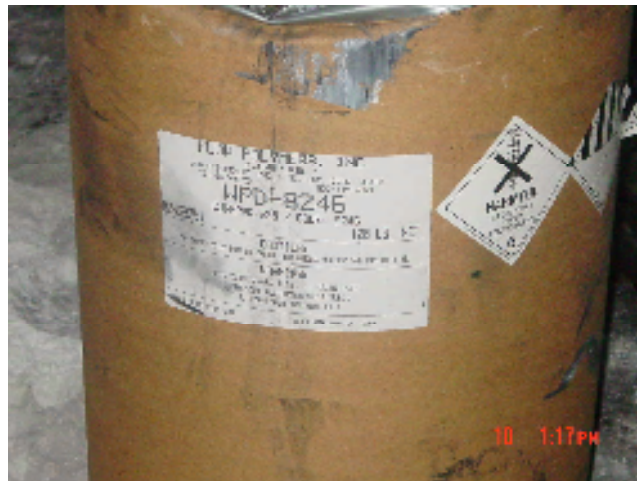
<b>Photograph No.:</b>	8	<b>Orientation:</b>	East
<b>TDD Number:</b>	S05-0808-004	<b>Date:</b>	September 10, 2008
<b>Photographer:</b>	R. Bugg, START	<b>Site Name:</b>	Plabell Rubber Manufacturing Plant
<b>Location:</b>	Toledo, Lucas County, Ohio		
<b>Subject:</b>	Drum D-66 with the specific name and manufacturer label along with the label "Harmful Stow Away from foodstuffs".
