## Report of Progress, October 31, 2008

Pursuant to Administrative Settlement Agreement and Order on Consent for Removal Action

Countywide Recycling and Disposal Facility  
East Sparta, Stark County, Ohio  
Respondent: Republic Services of Ohio II, LLC (Republic)

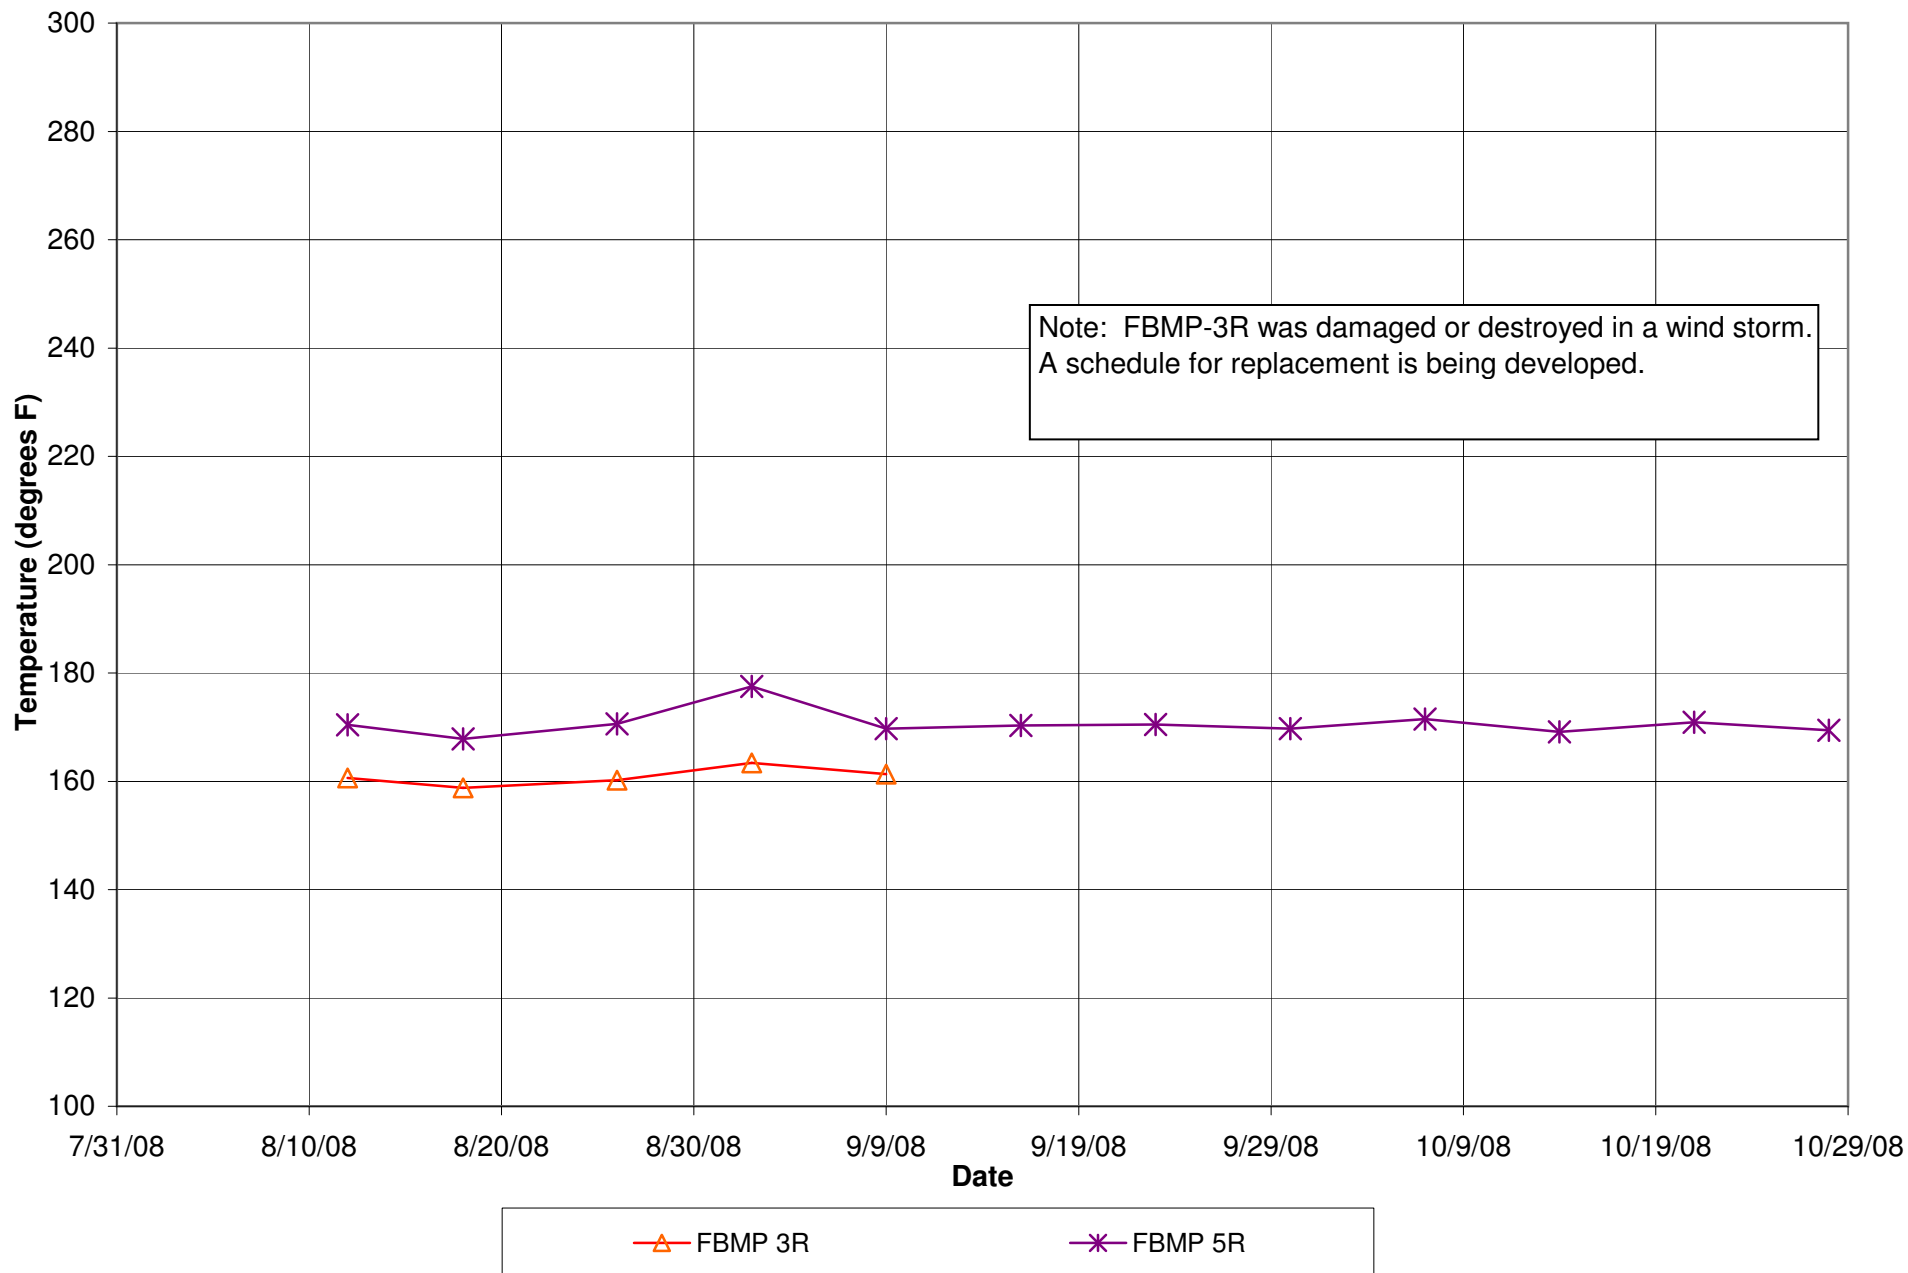
## ATTACHMENT A-2

# In-situ Temperatures - FBMPS within the Isolation Break Excavation

## Maximum Readings per Date per FBMP Boring

Throughout October, readings were obtained from the FBMP temperature probes. Results are presented in Attachment A-2. No significant increasing or decreasing temperature trends are apparent.

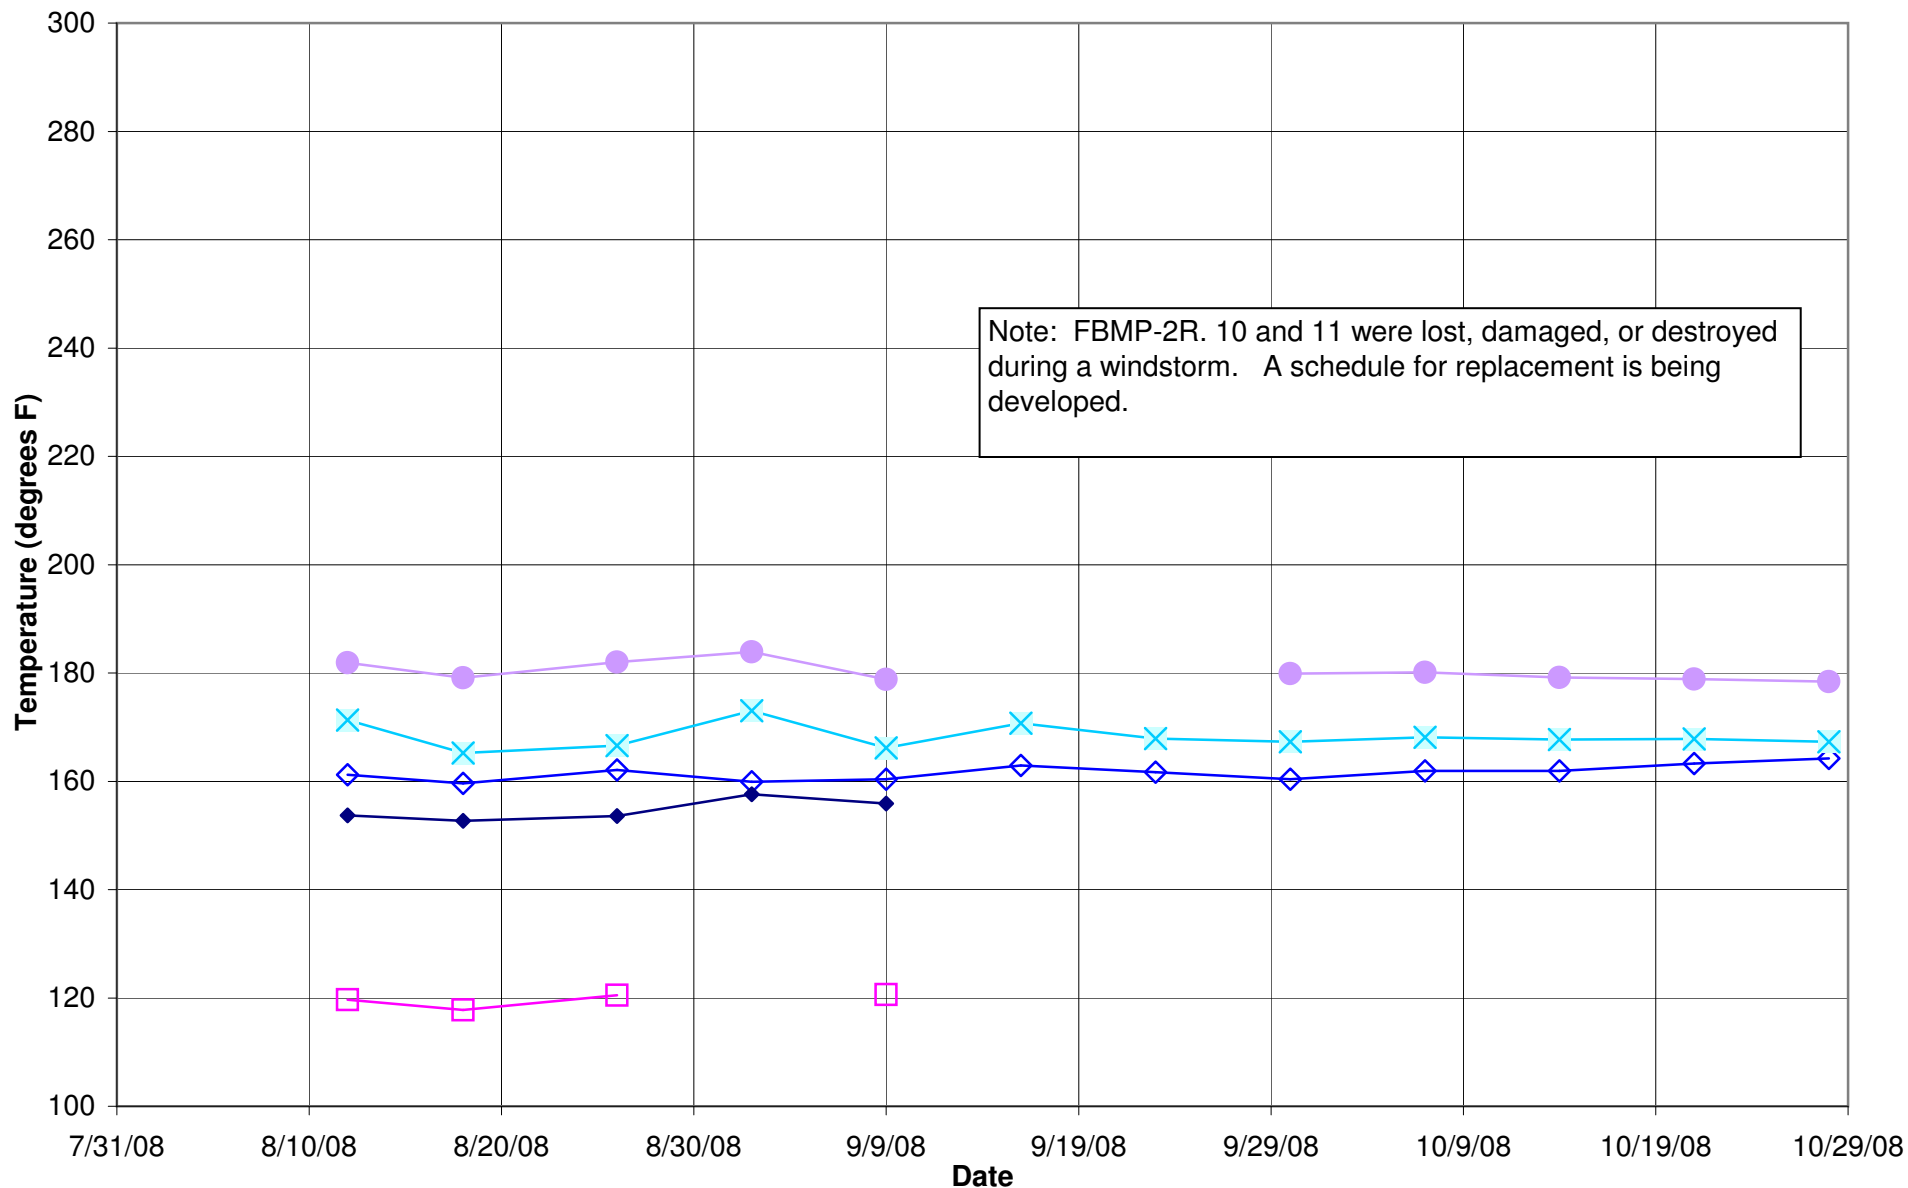
# In-situ Temperatures - FBMPs within 150 ft of the Isolation Break Excavation

## Maximum Readings per Date per FBMP Boring

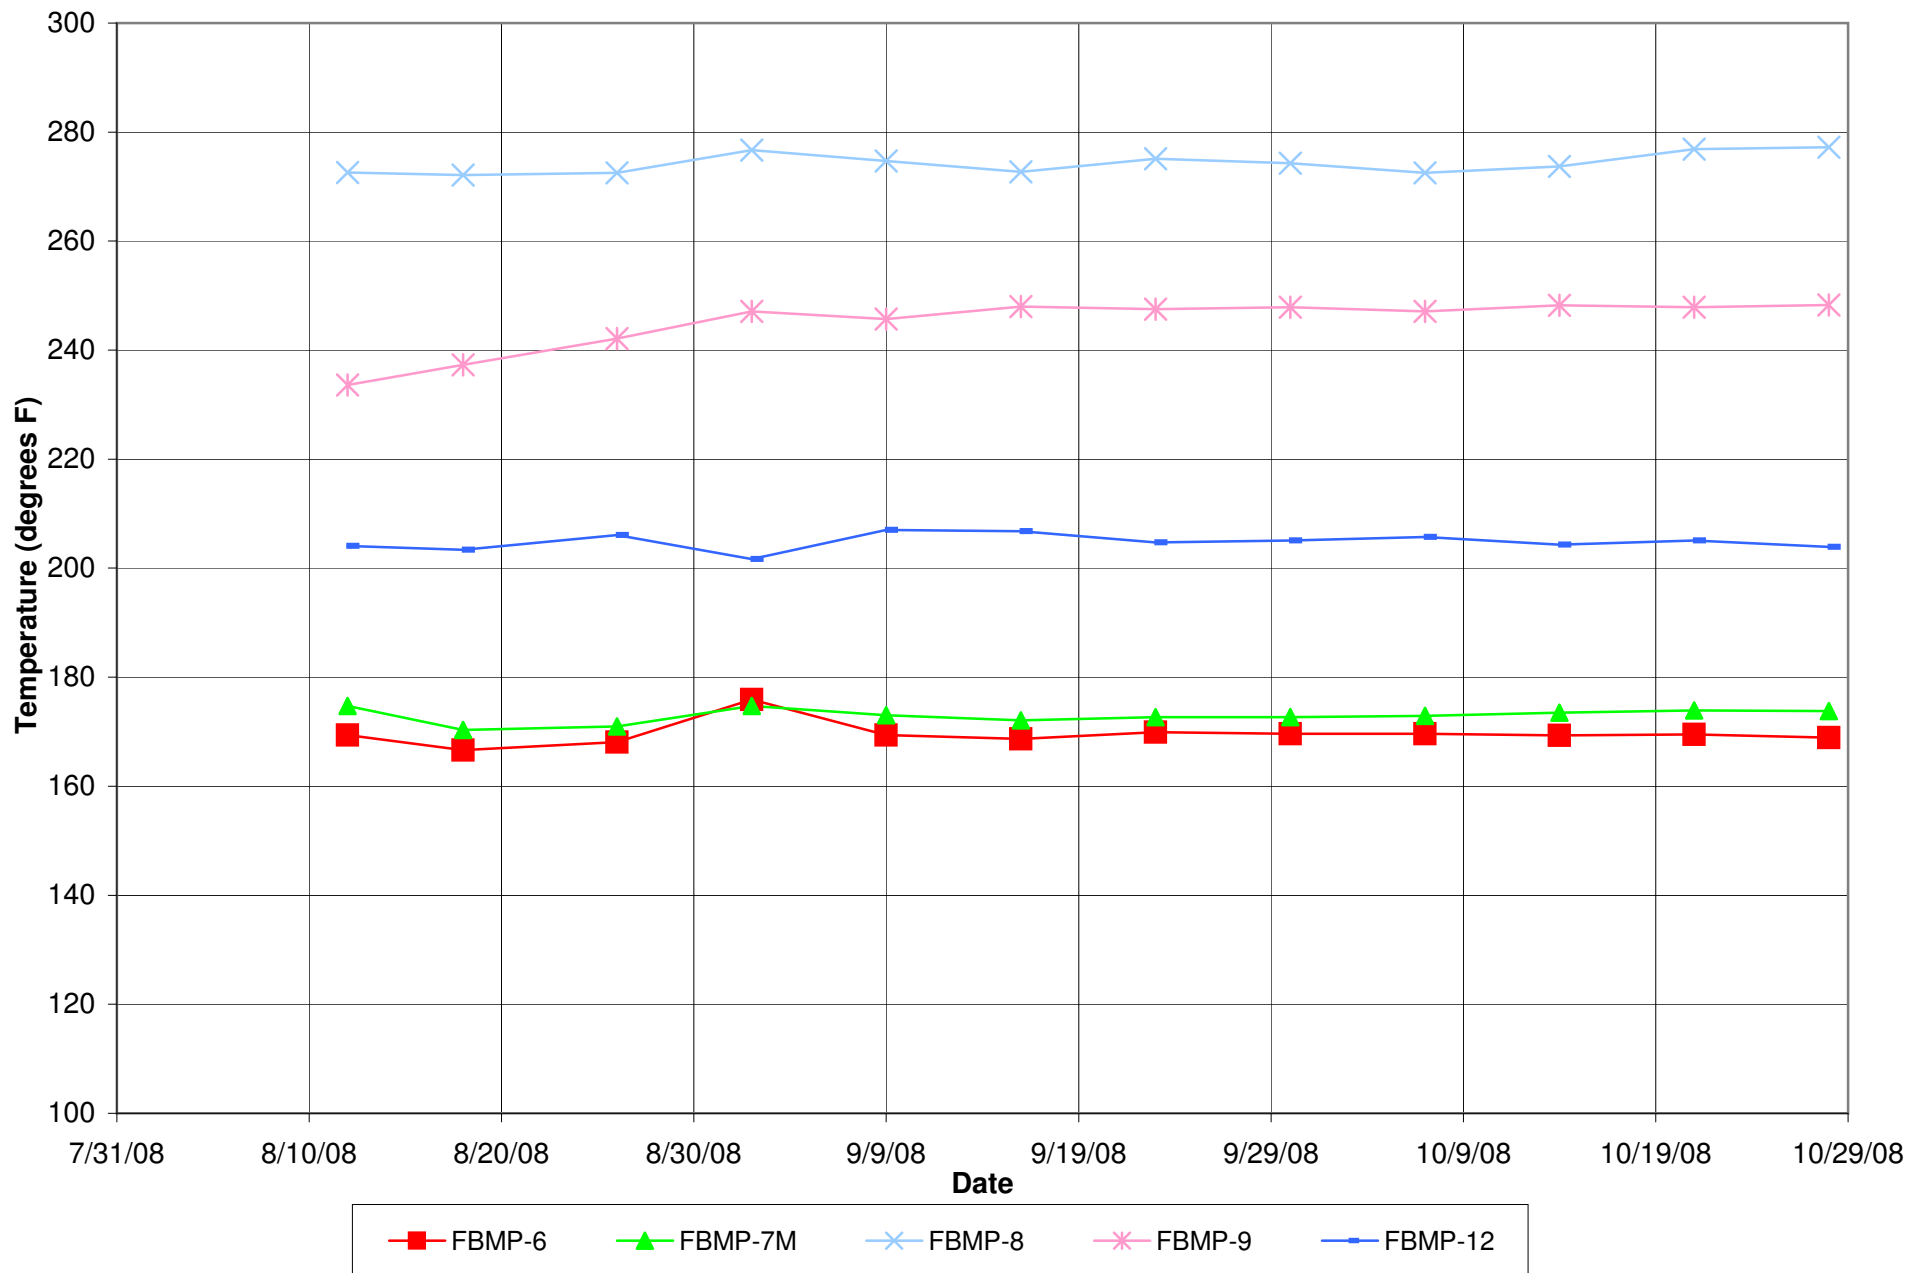
**In-situ Temperatures - FBMPs beyond 150 ft from Isolation Break Excavation**  
**Maximum Readings per Date per FBMP Boring**

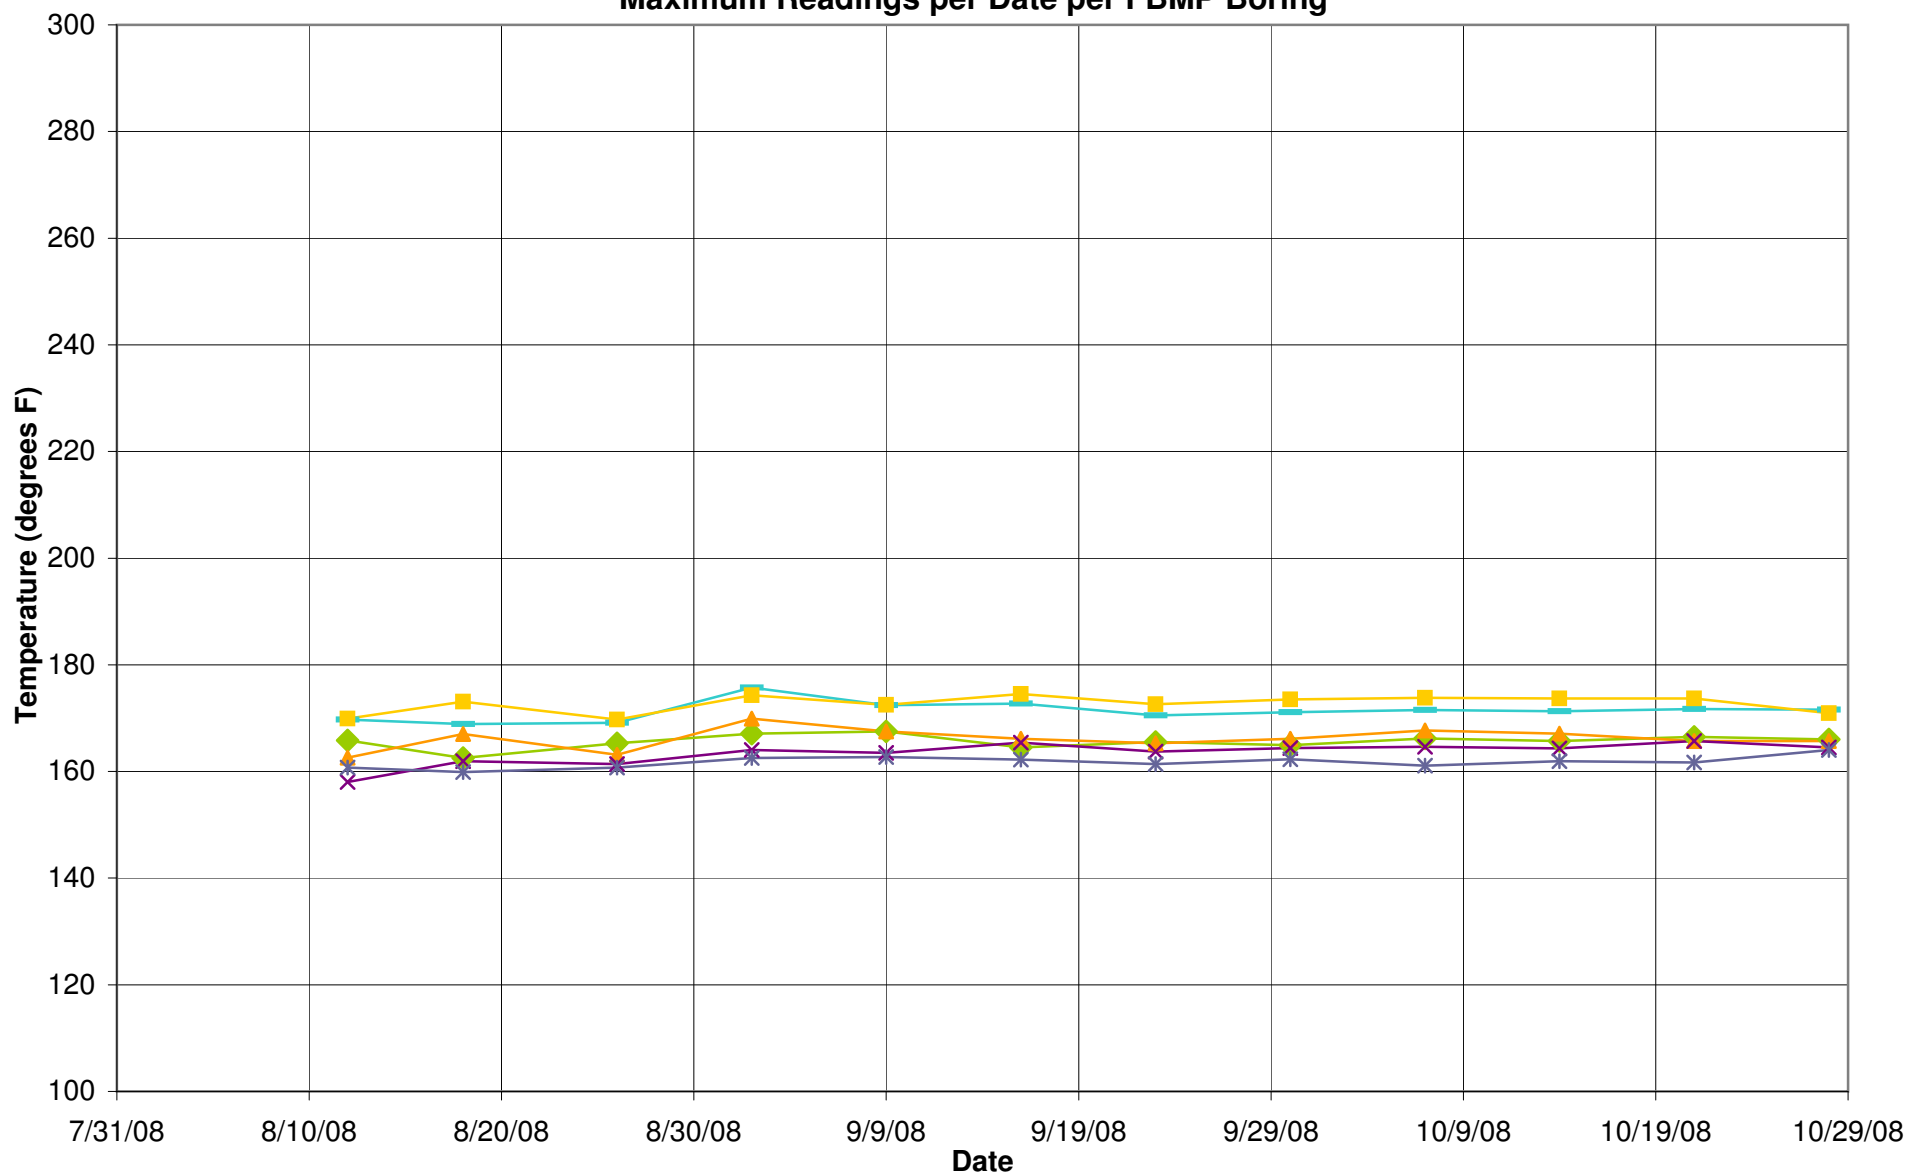
**In-situ Temperatures - West Slope FBMPs**  
**Maximum Readings per Date per FBMP Boring**

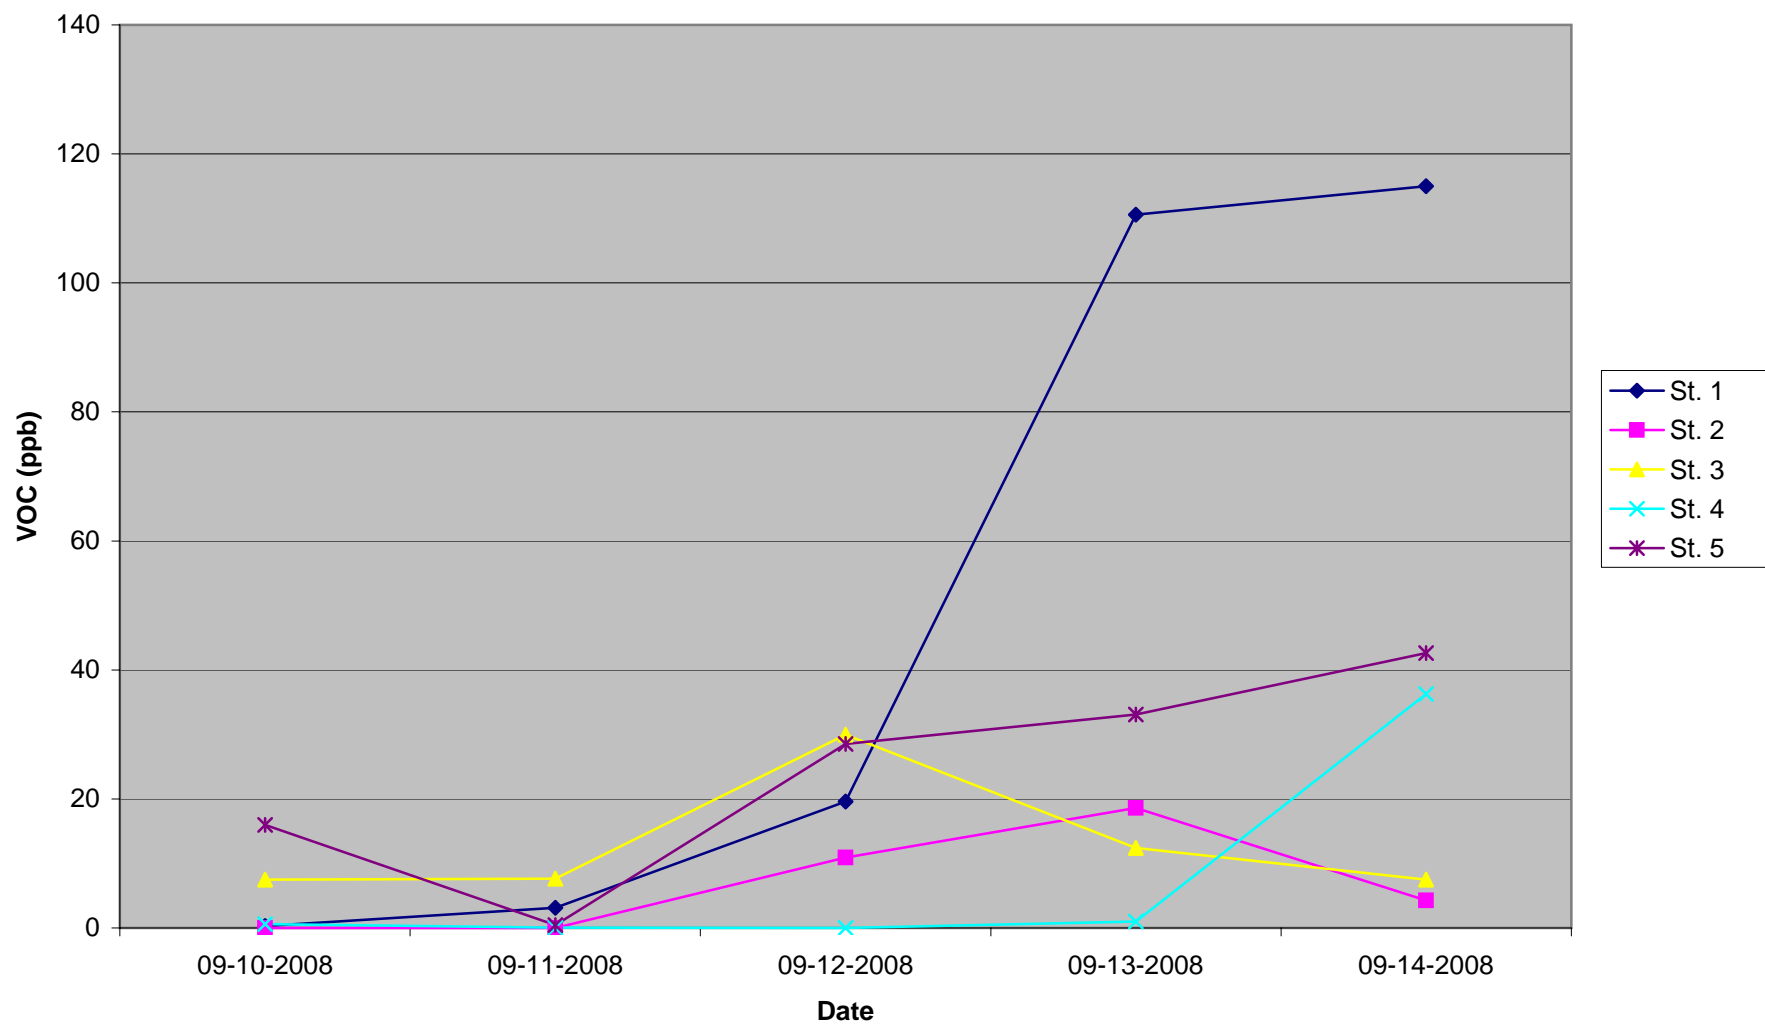
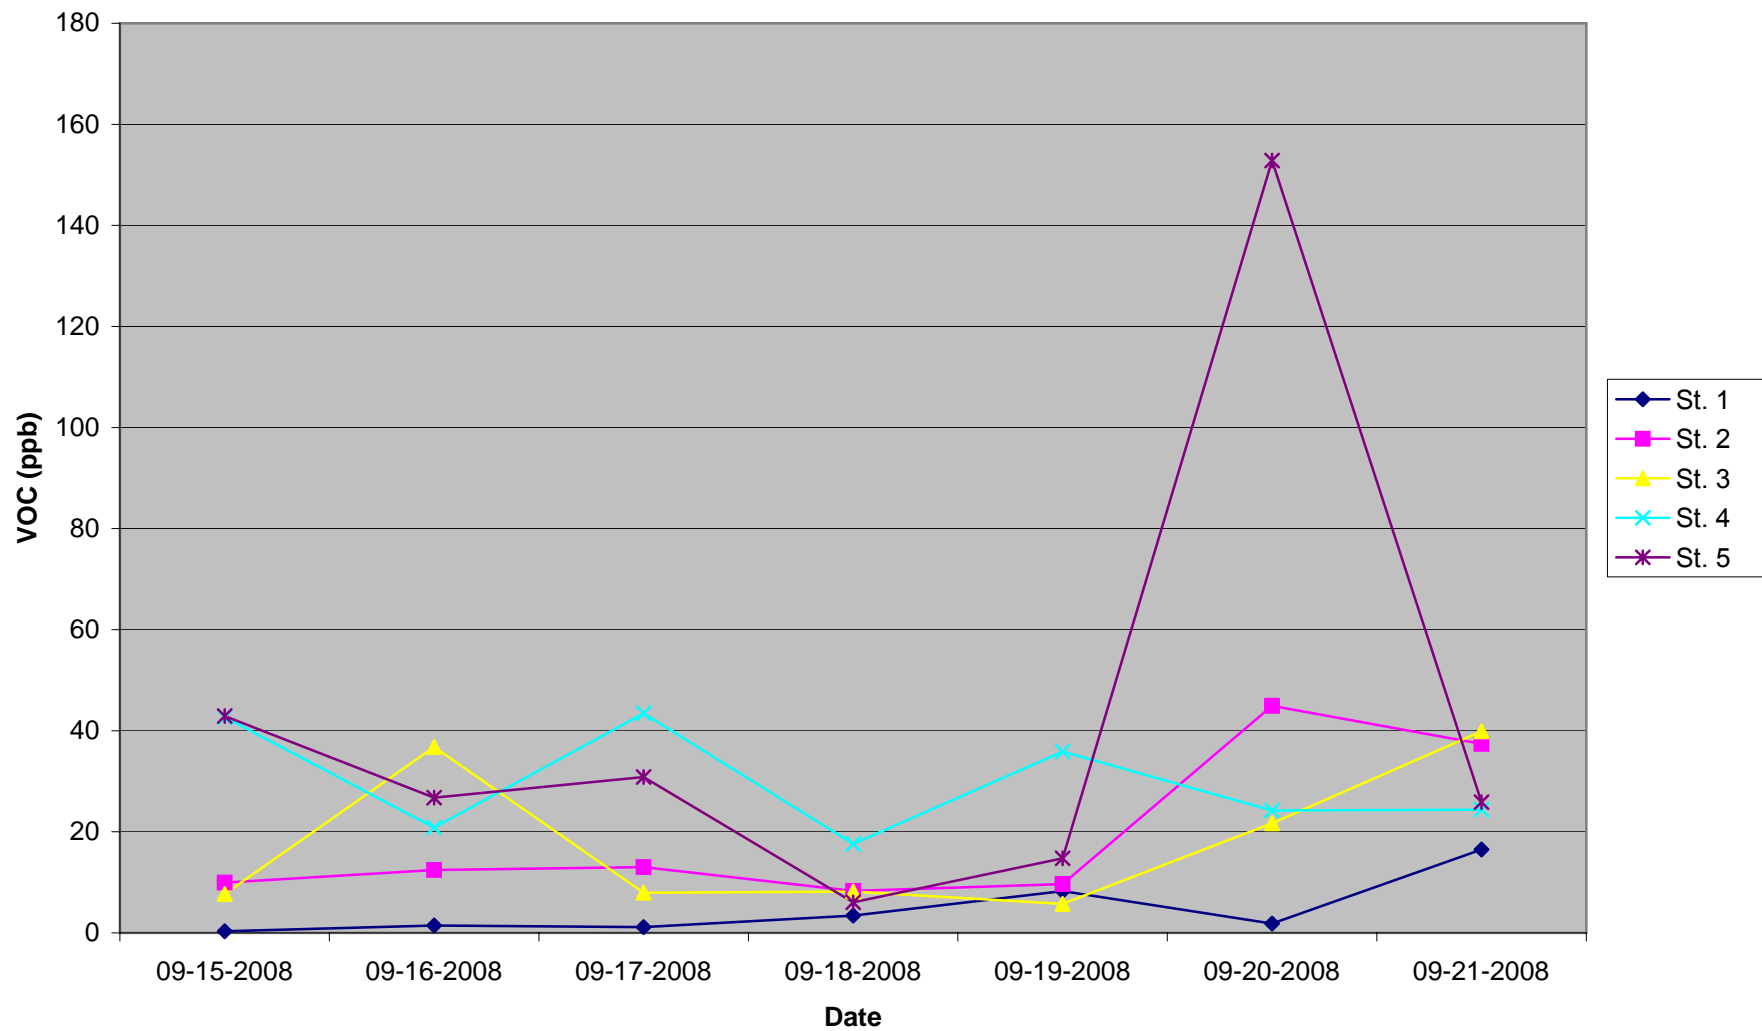
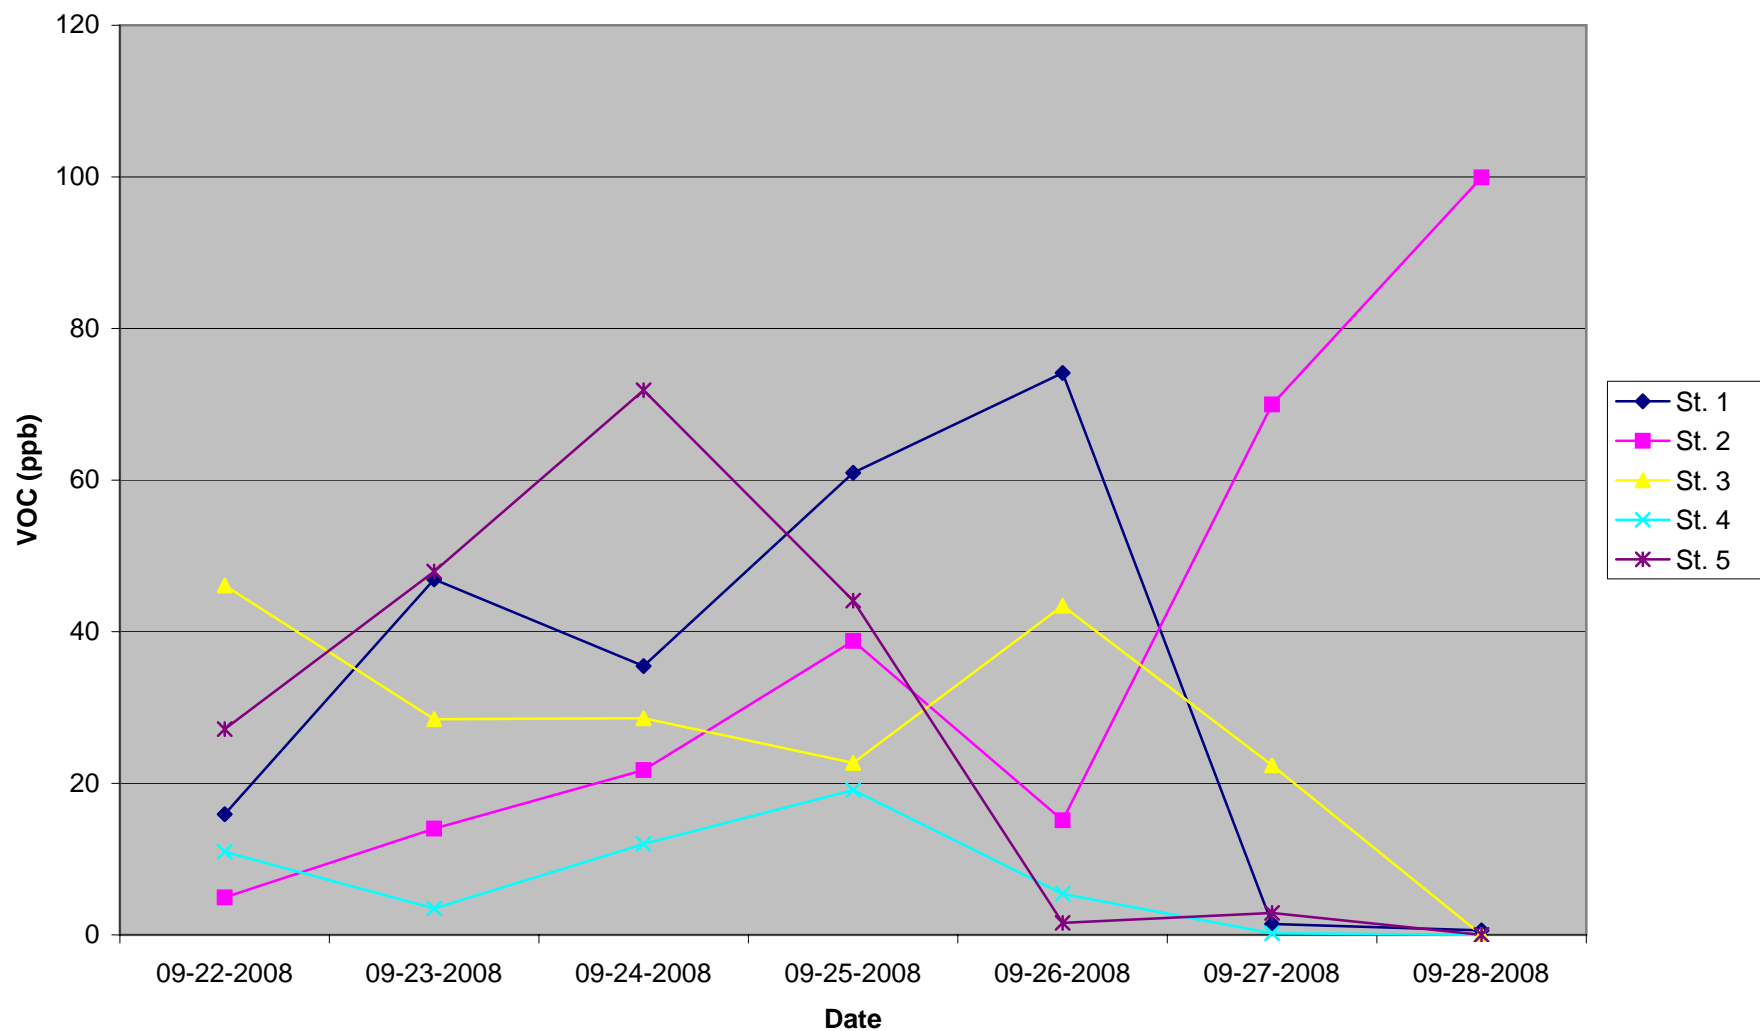
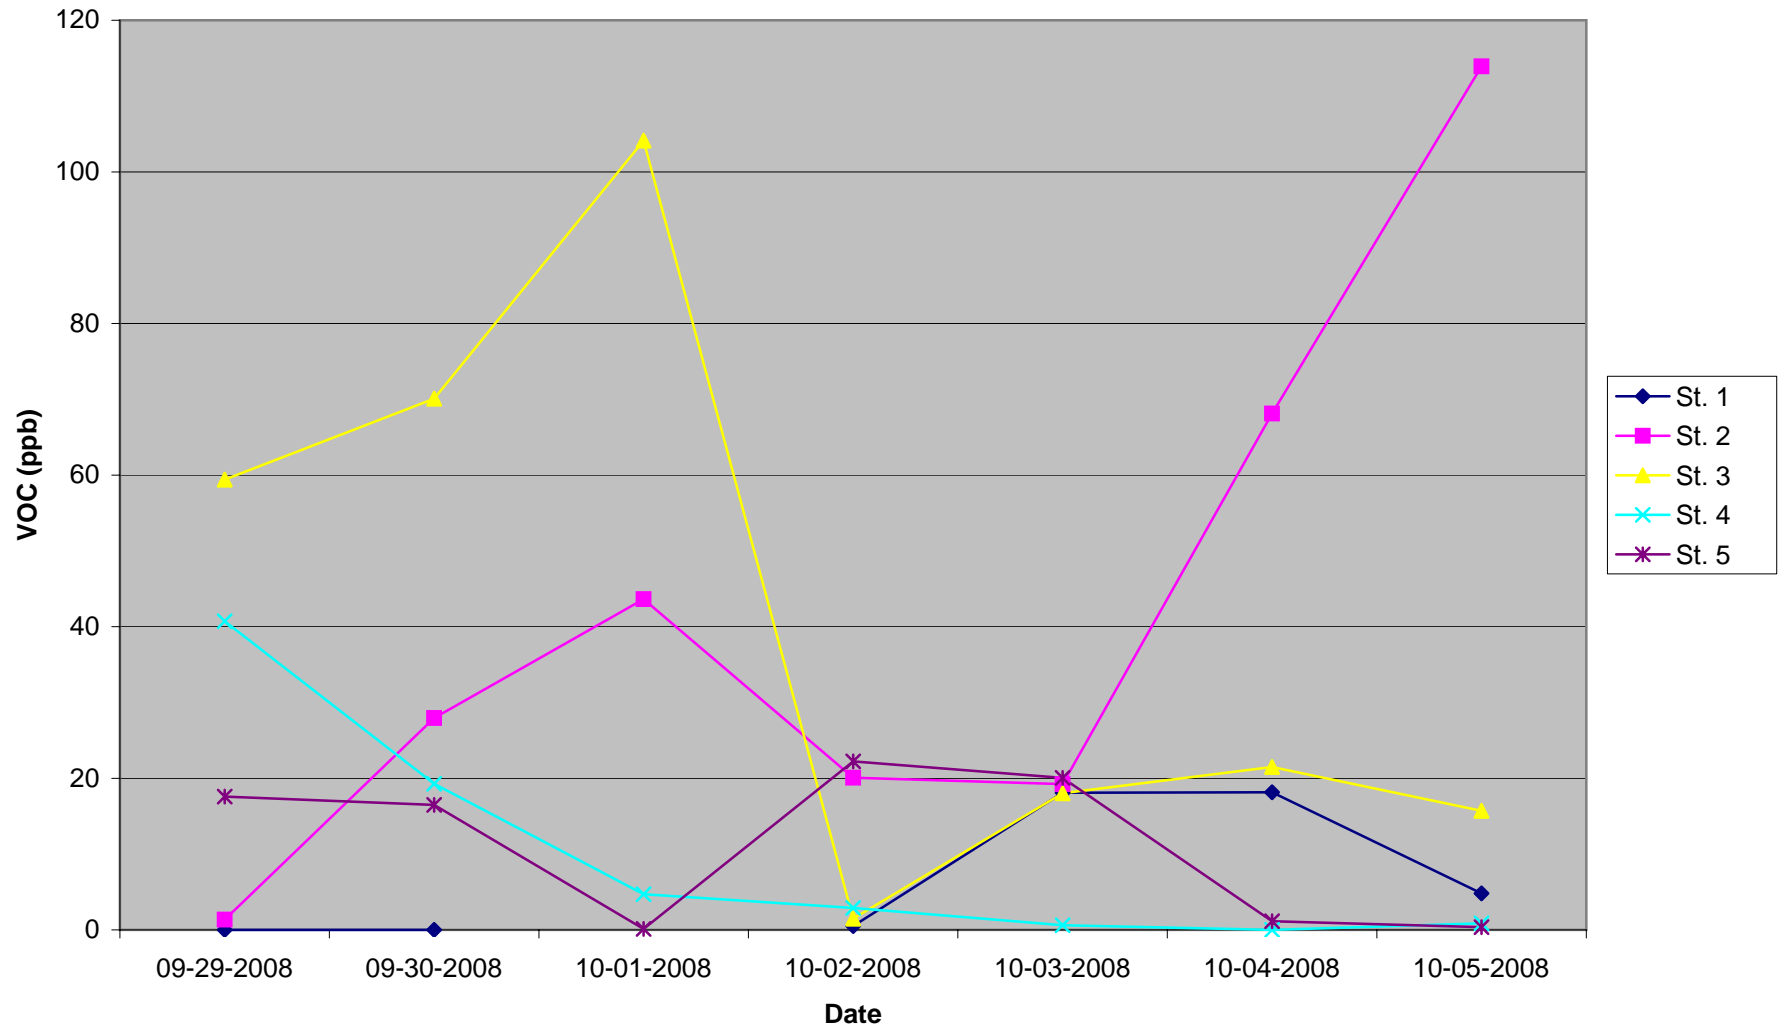
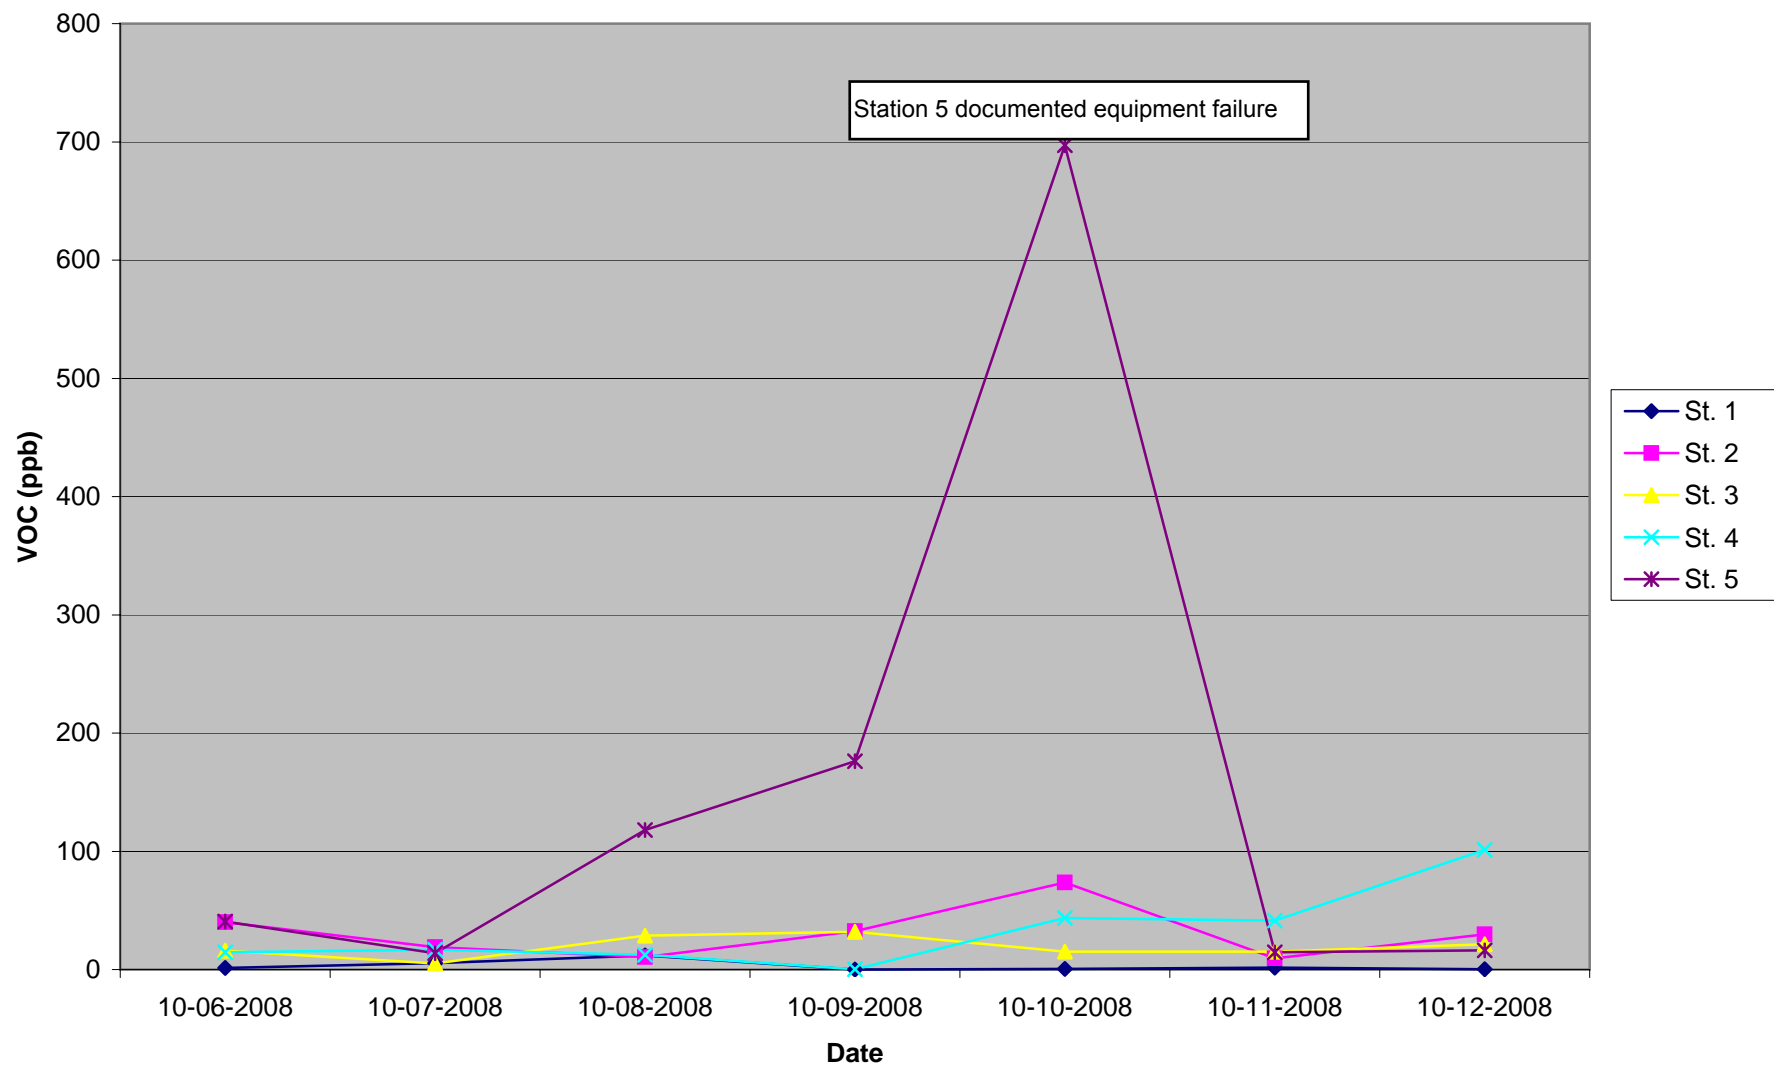
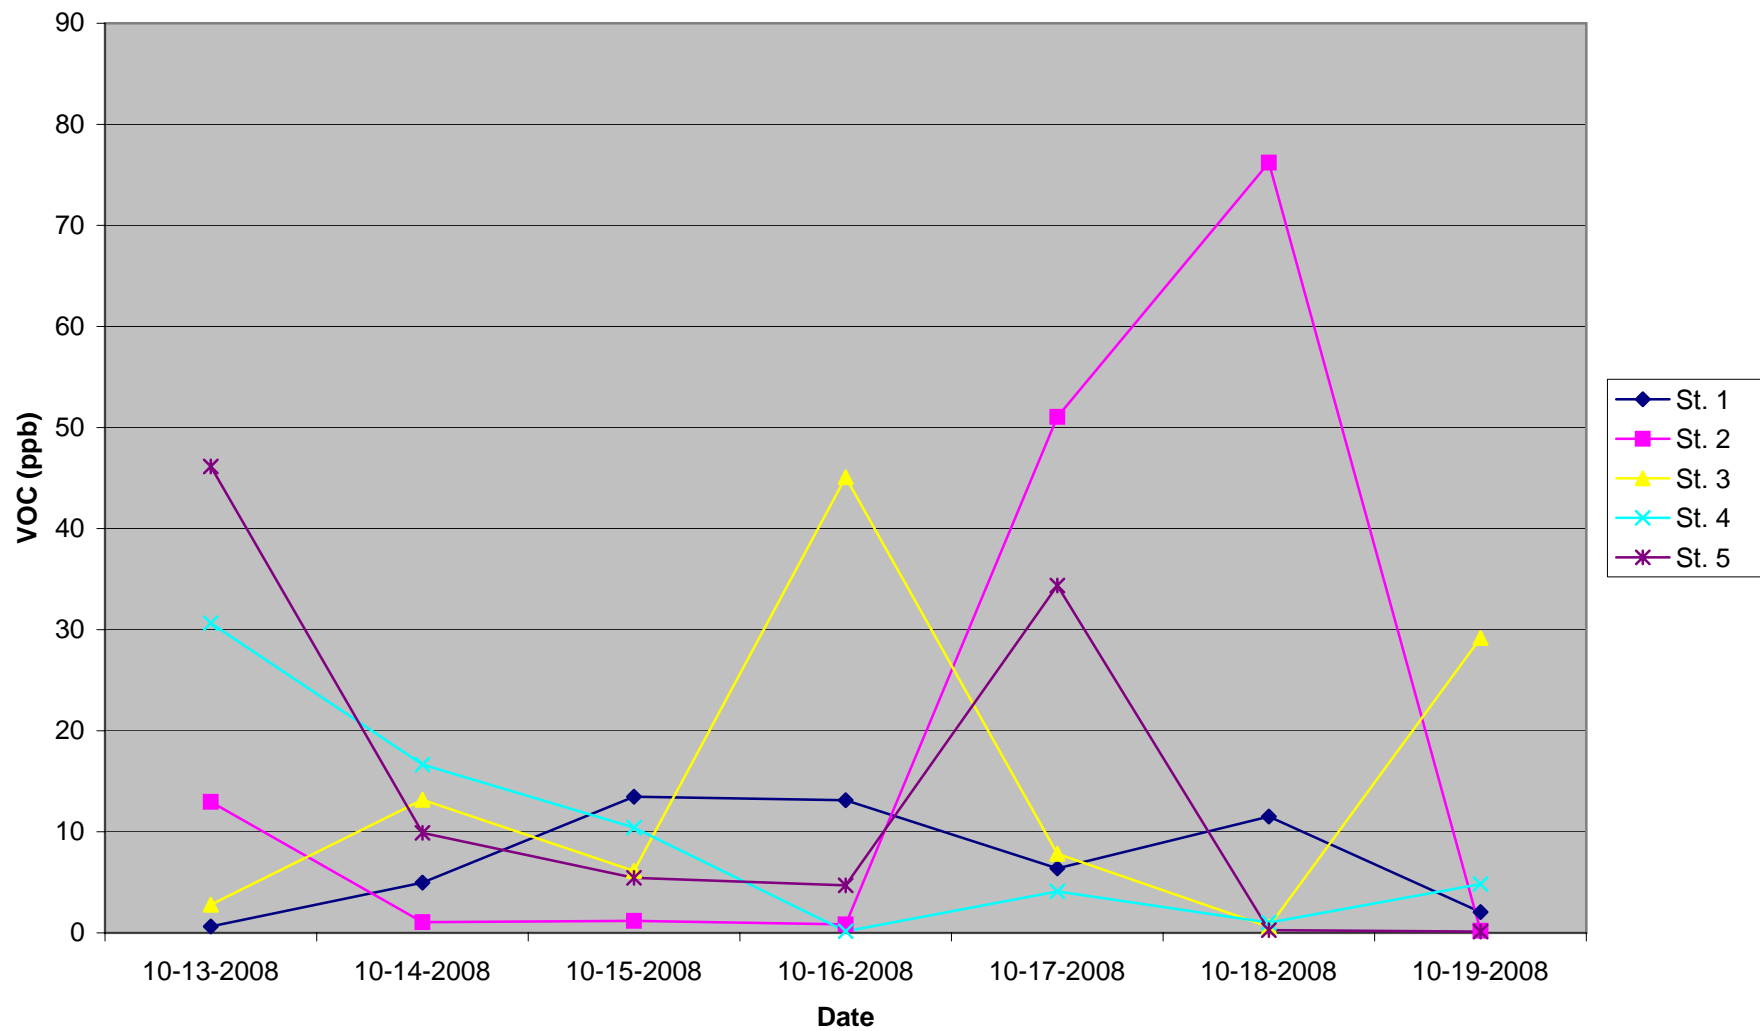
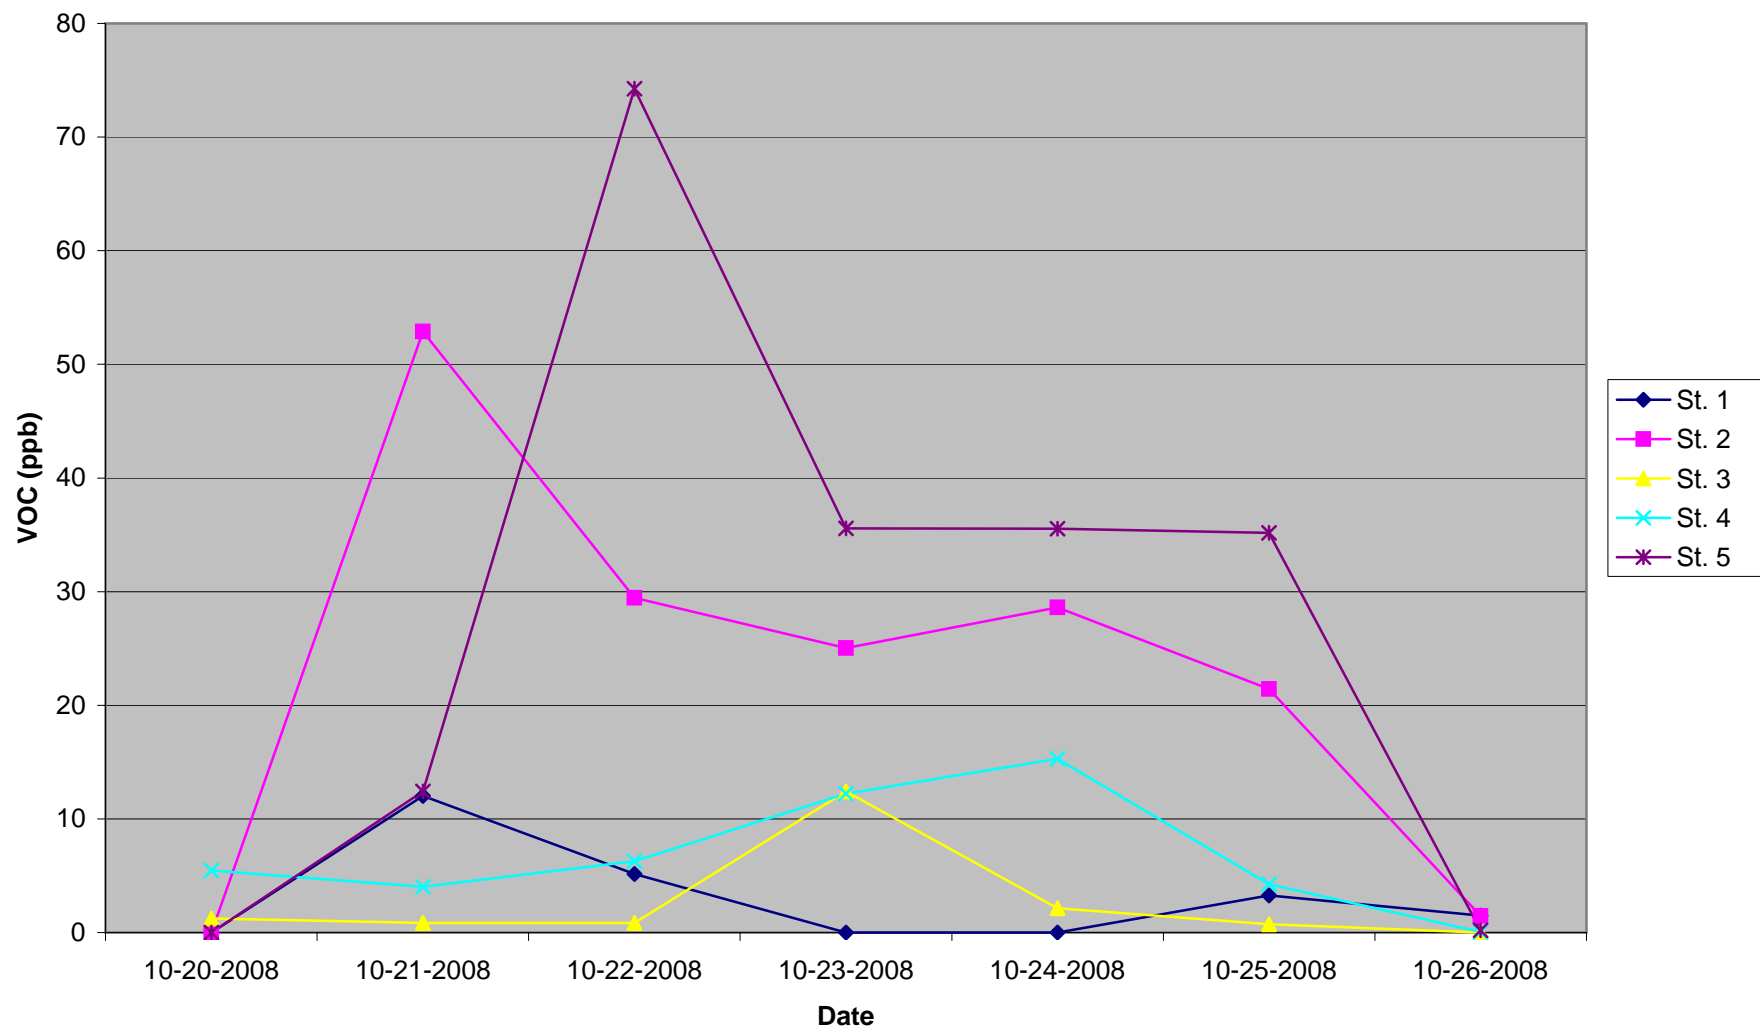
## ATTACHMENT C

**Stage B**  
**24 Hour Average Weekly Summary**

Stage B – Interim Fixed Continuous Monitoring. This monitoring was continued through October. Occasional SUMMA canisters were collected for TO-15 analyses based on verified PID readings greater than 250 ppb. Detailed daily graphs and wind roses of this monitoring are posted on the FTP site at <ftp://ftp.earthtech.com/> in the "Stage B Results" subfolder of the "Ambient Air Monitoring" folder. Summary daily average graphs are provided in Attachment C of this Progress report.

Preliminary review of the data indicates occasional transient VOC elevations associated with specific site activities and changes in wind speed and direction. On 10/9/2008-10/10/2008, Site 5 readings averaged approximately 700 parts per billion VOCs; however, these readings were verified to be due to pump error by a technician on site who then replaced the pump. To date, Stage B results indicate typical levels of VOCs based on historical monitoring at the site. A detailed summary and analysis of Stage B data will be prepared by CTEH after the conclusion of Stage B ambient air monitoring.
