## Report of Progress, October 31, 2008

Pursuant to Administrative Settlement Agreement and Order on Consent for Removal Action

Countywide Recycling and Disposal Facility  
East Sparta, Stark County, Ohio  
Respondent: Republic Services of Ohio II, LLC (Republic)

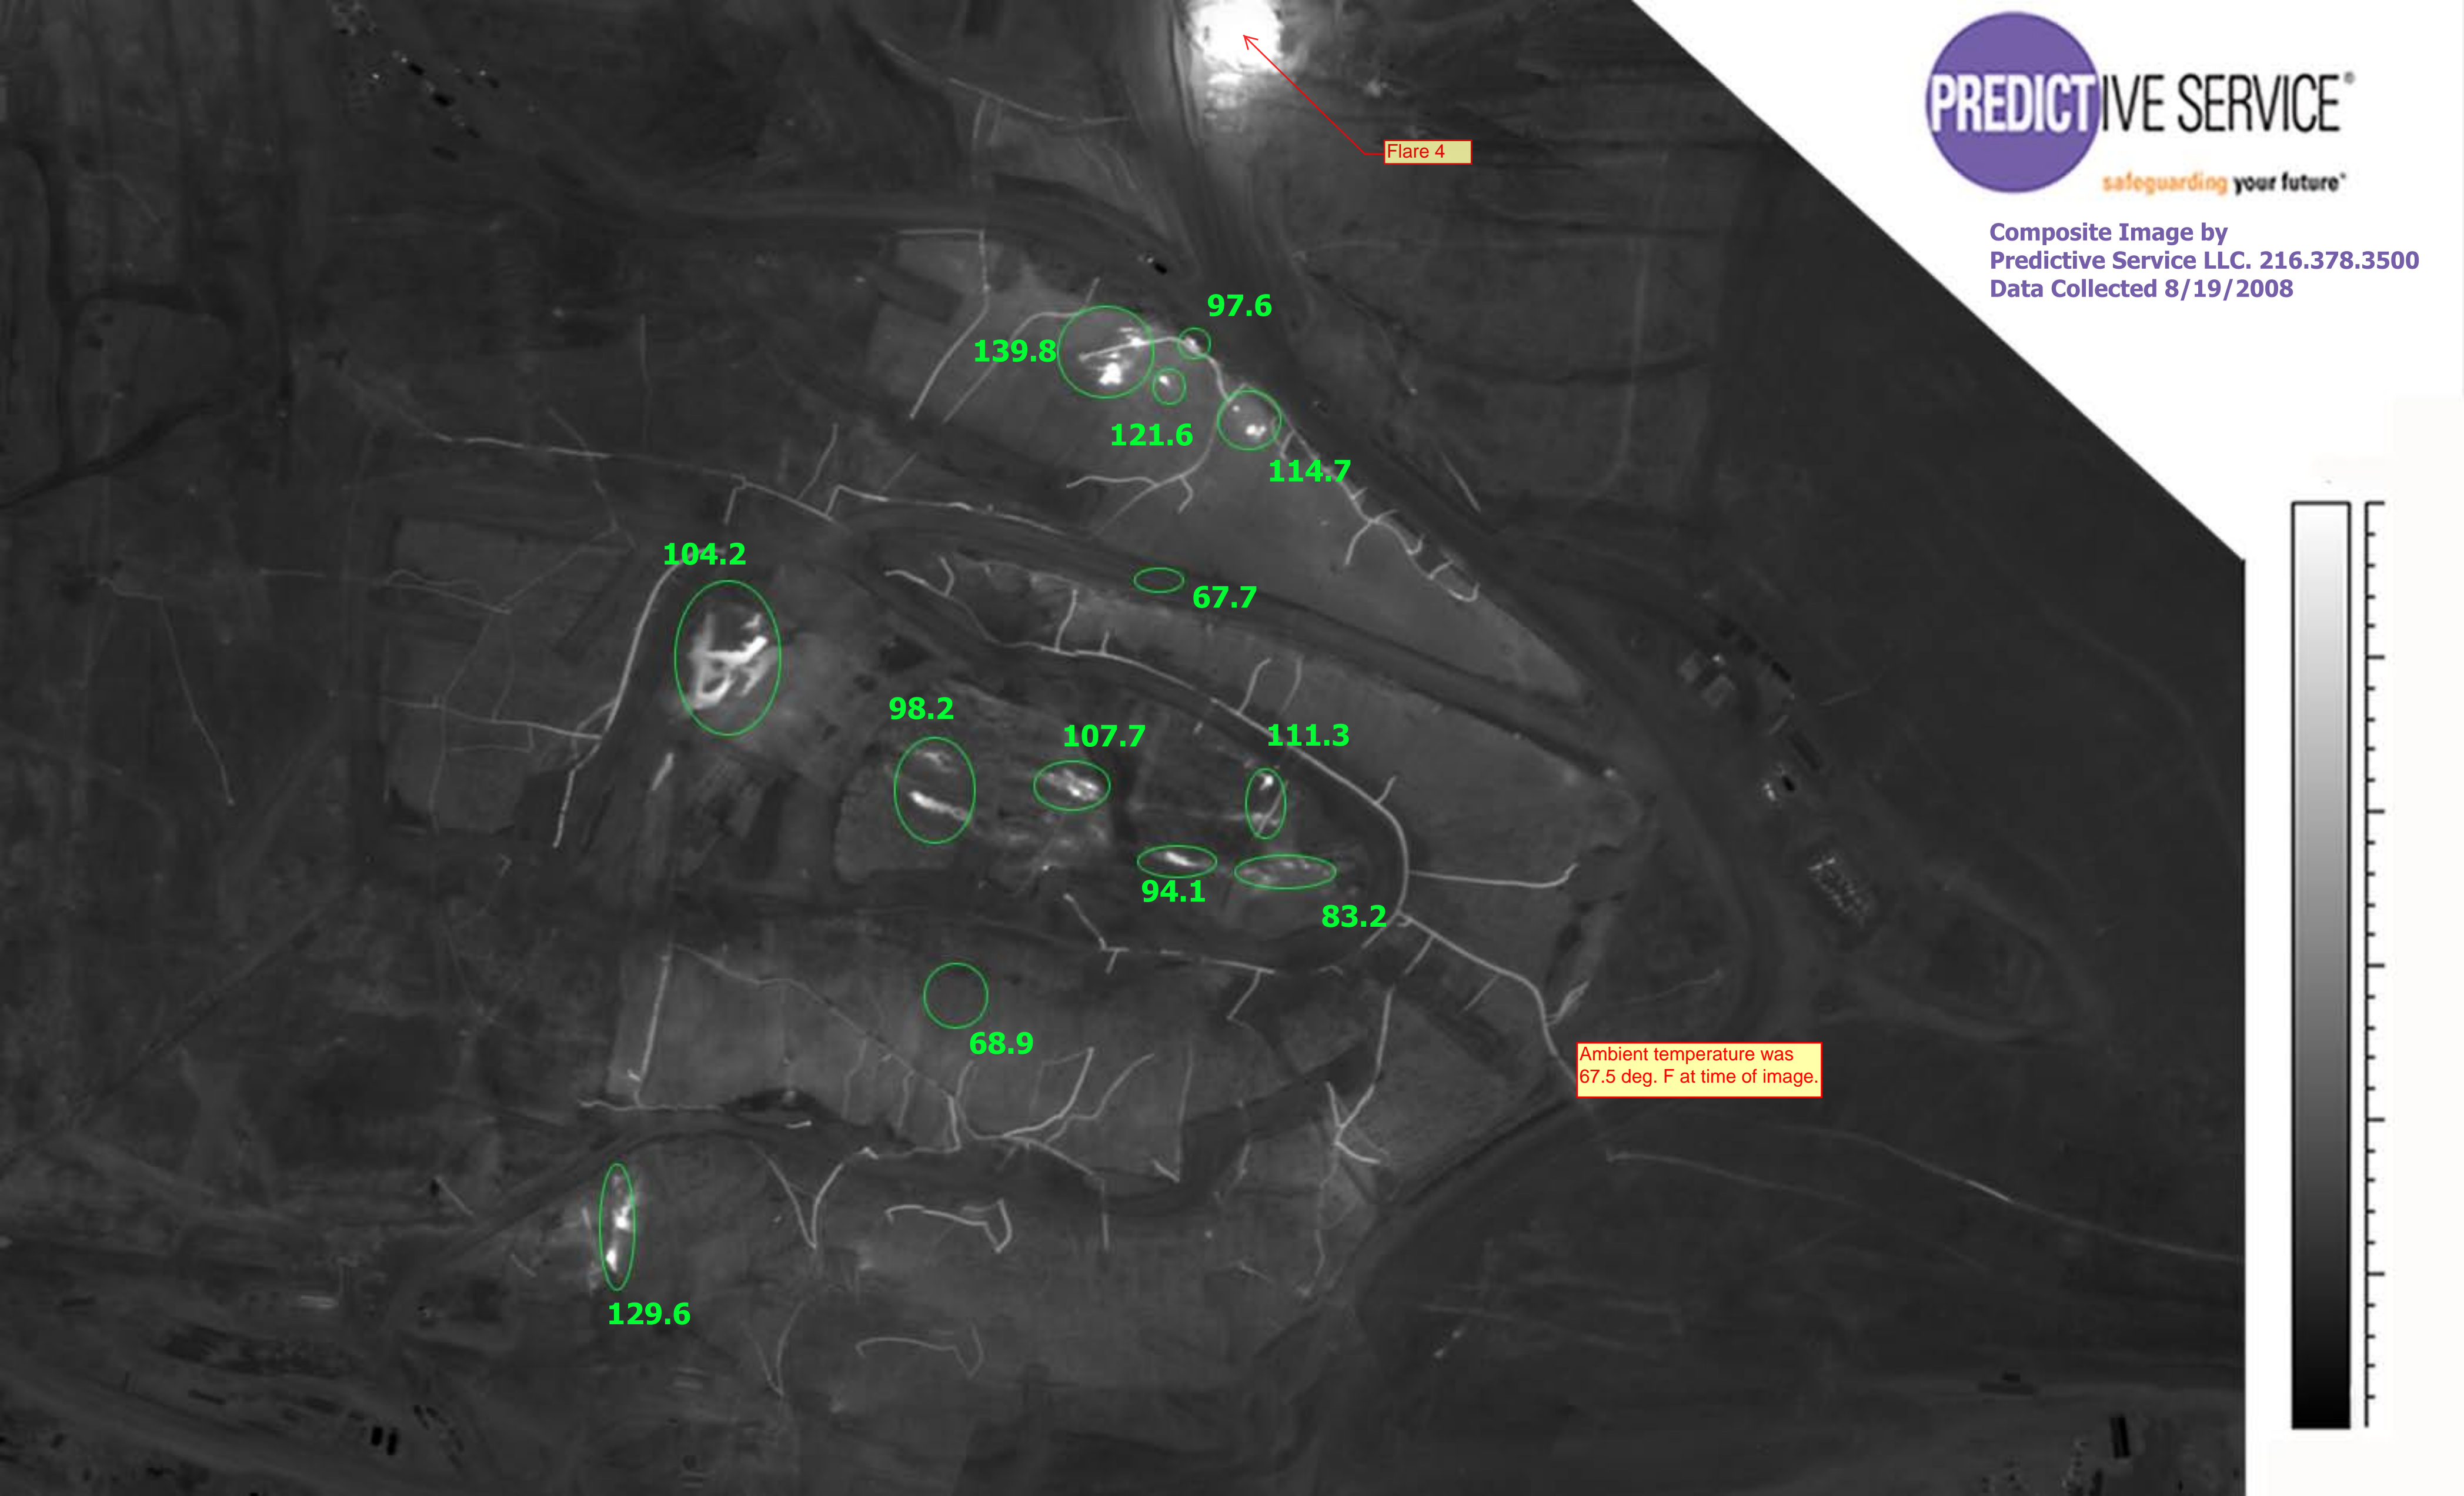
Composite Image by  
Predictive Service LLC. 216.378.3500  
Data Collected 8/19/2008

August 2008 and October 2008 aerial infrared images are provided in Attachment D along with a diagram to outline the approximate coverage of the images. Both images were taken in the pre-dawn hours. The ambient air temperature during the August image was 67.5° F and during the October image was 43° F. Comparison of these images generally shows the same subcap warm areas attributed to subcap leachate outbreaks and transmittal of gas through subcap cracking. Any changes appear to reflect correlation to the ambient air temperatures, with no large aerial changes or trends.

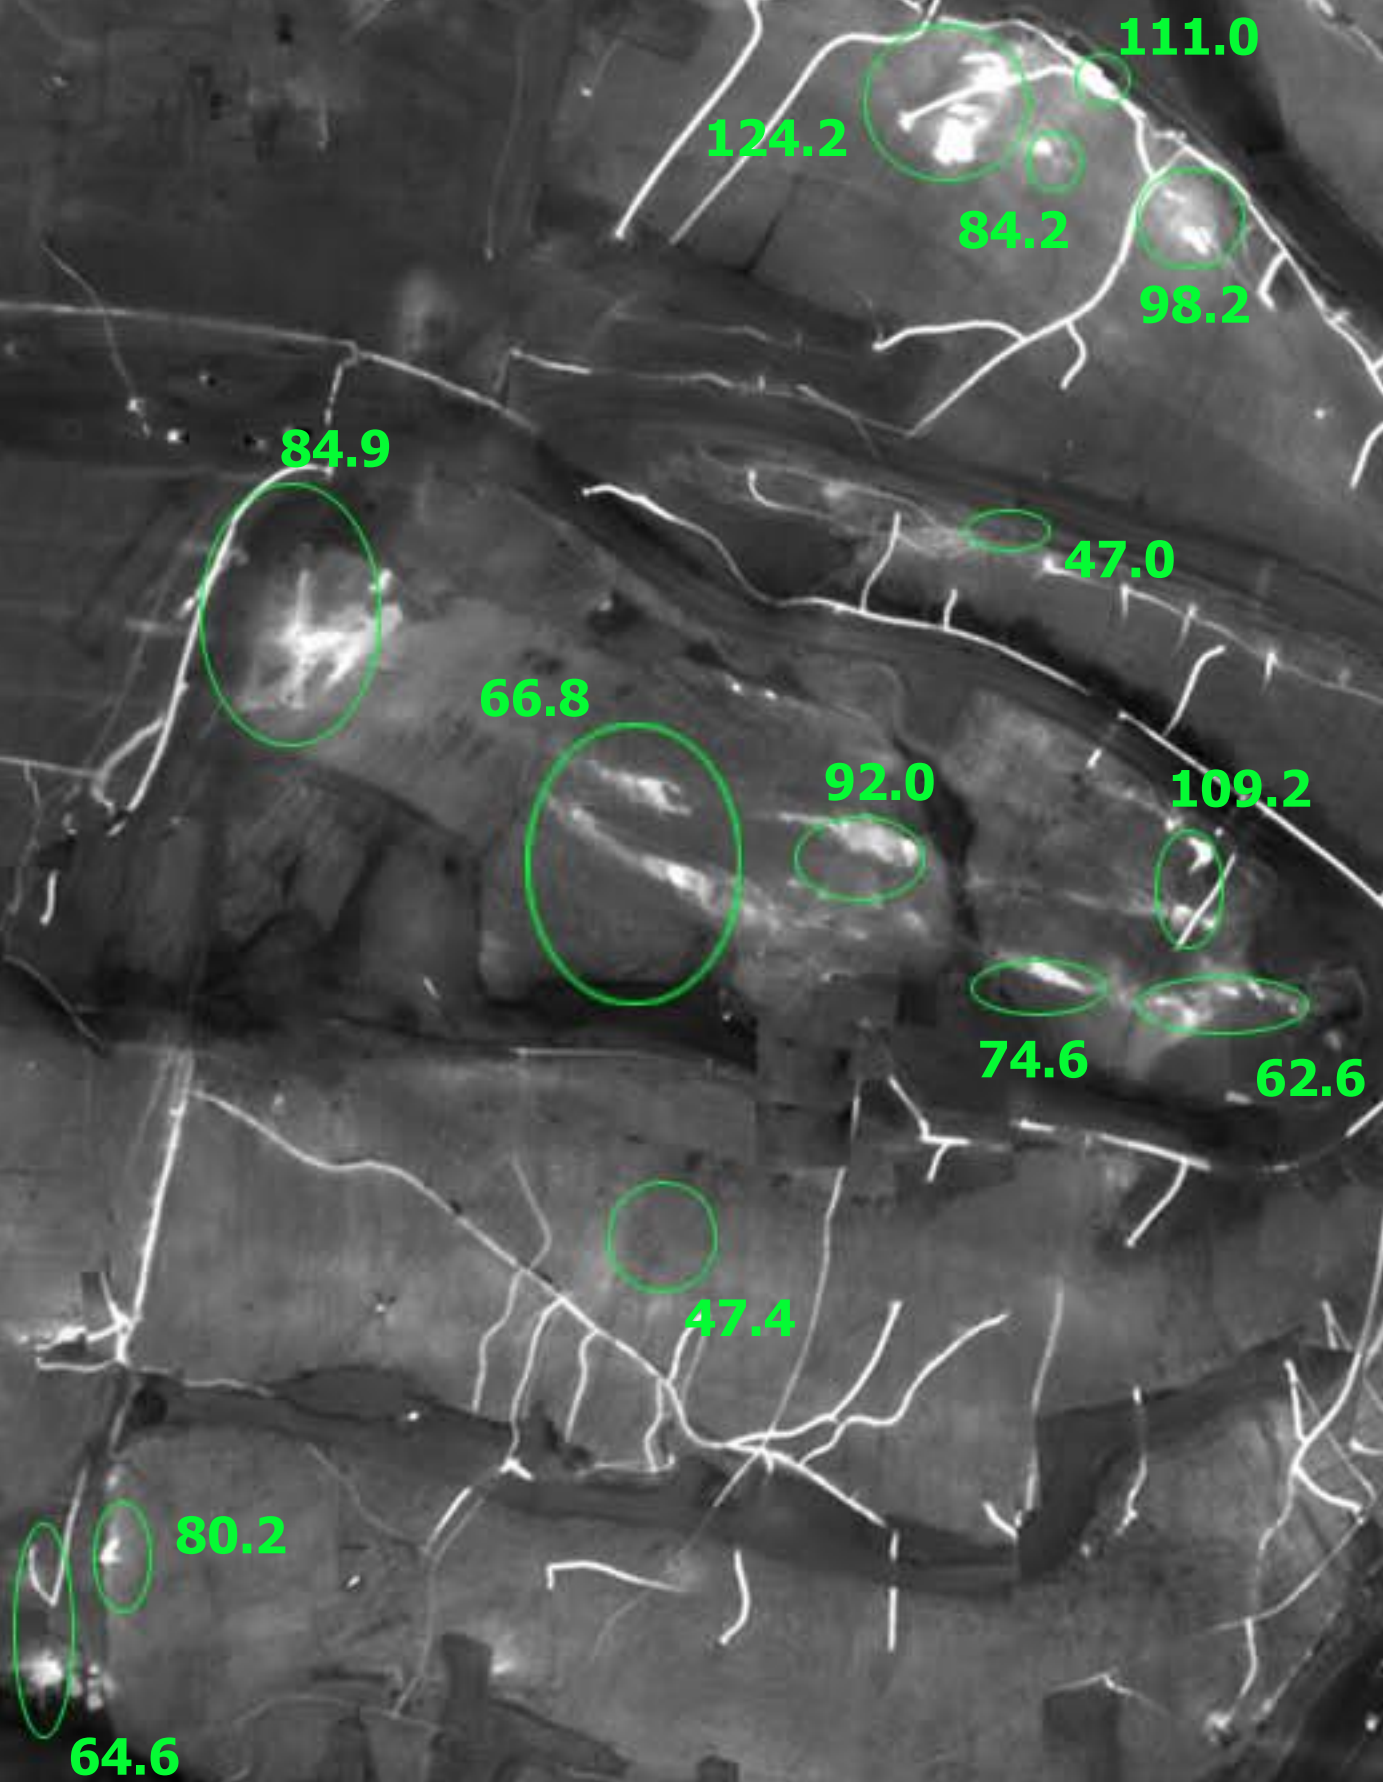
Composite Image by  
Predictive Service LLC. 216.378.3500  
Data Collected 10/24/2008

AMBIENT TEMPERATURE WAS  
43 DEG. F AT TIME OF IMAGE.
