Subject: Vapor Sampling Letter Report, Revision 2
Mills Gap
Asheville, Buncombe County, North Carolina
Contract No. EP-W-05-053
Technical Direction Document (TDD) No.: TNA-05-001-0043

MILLS GAP
 ASHEVILLE, BUNCOMBE COUNTY, NORTH CAROLINA
 TDD No. TNA-05-001-0043

August 2008 Soil Vapor Sampling Results

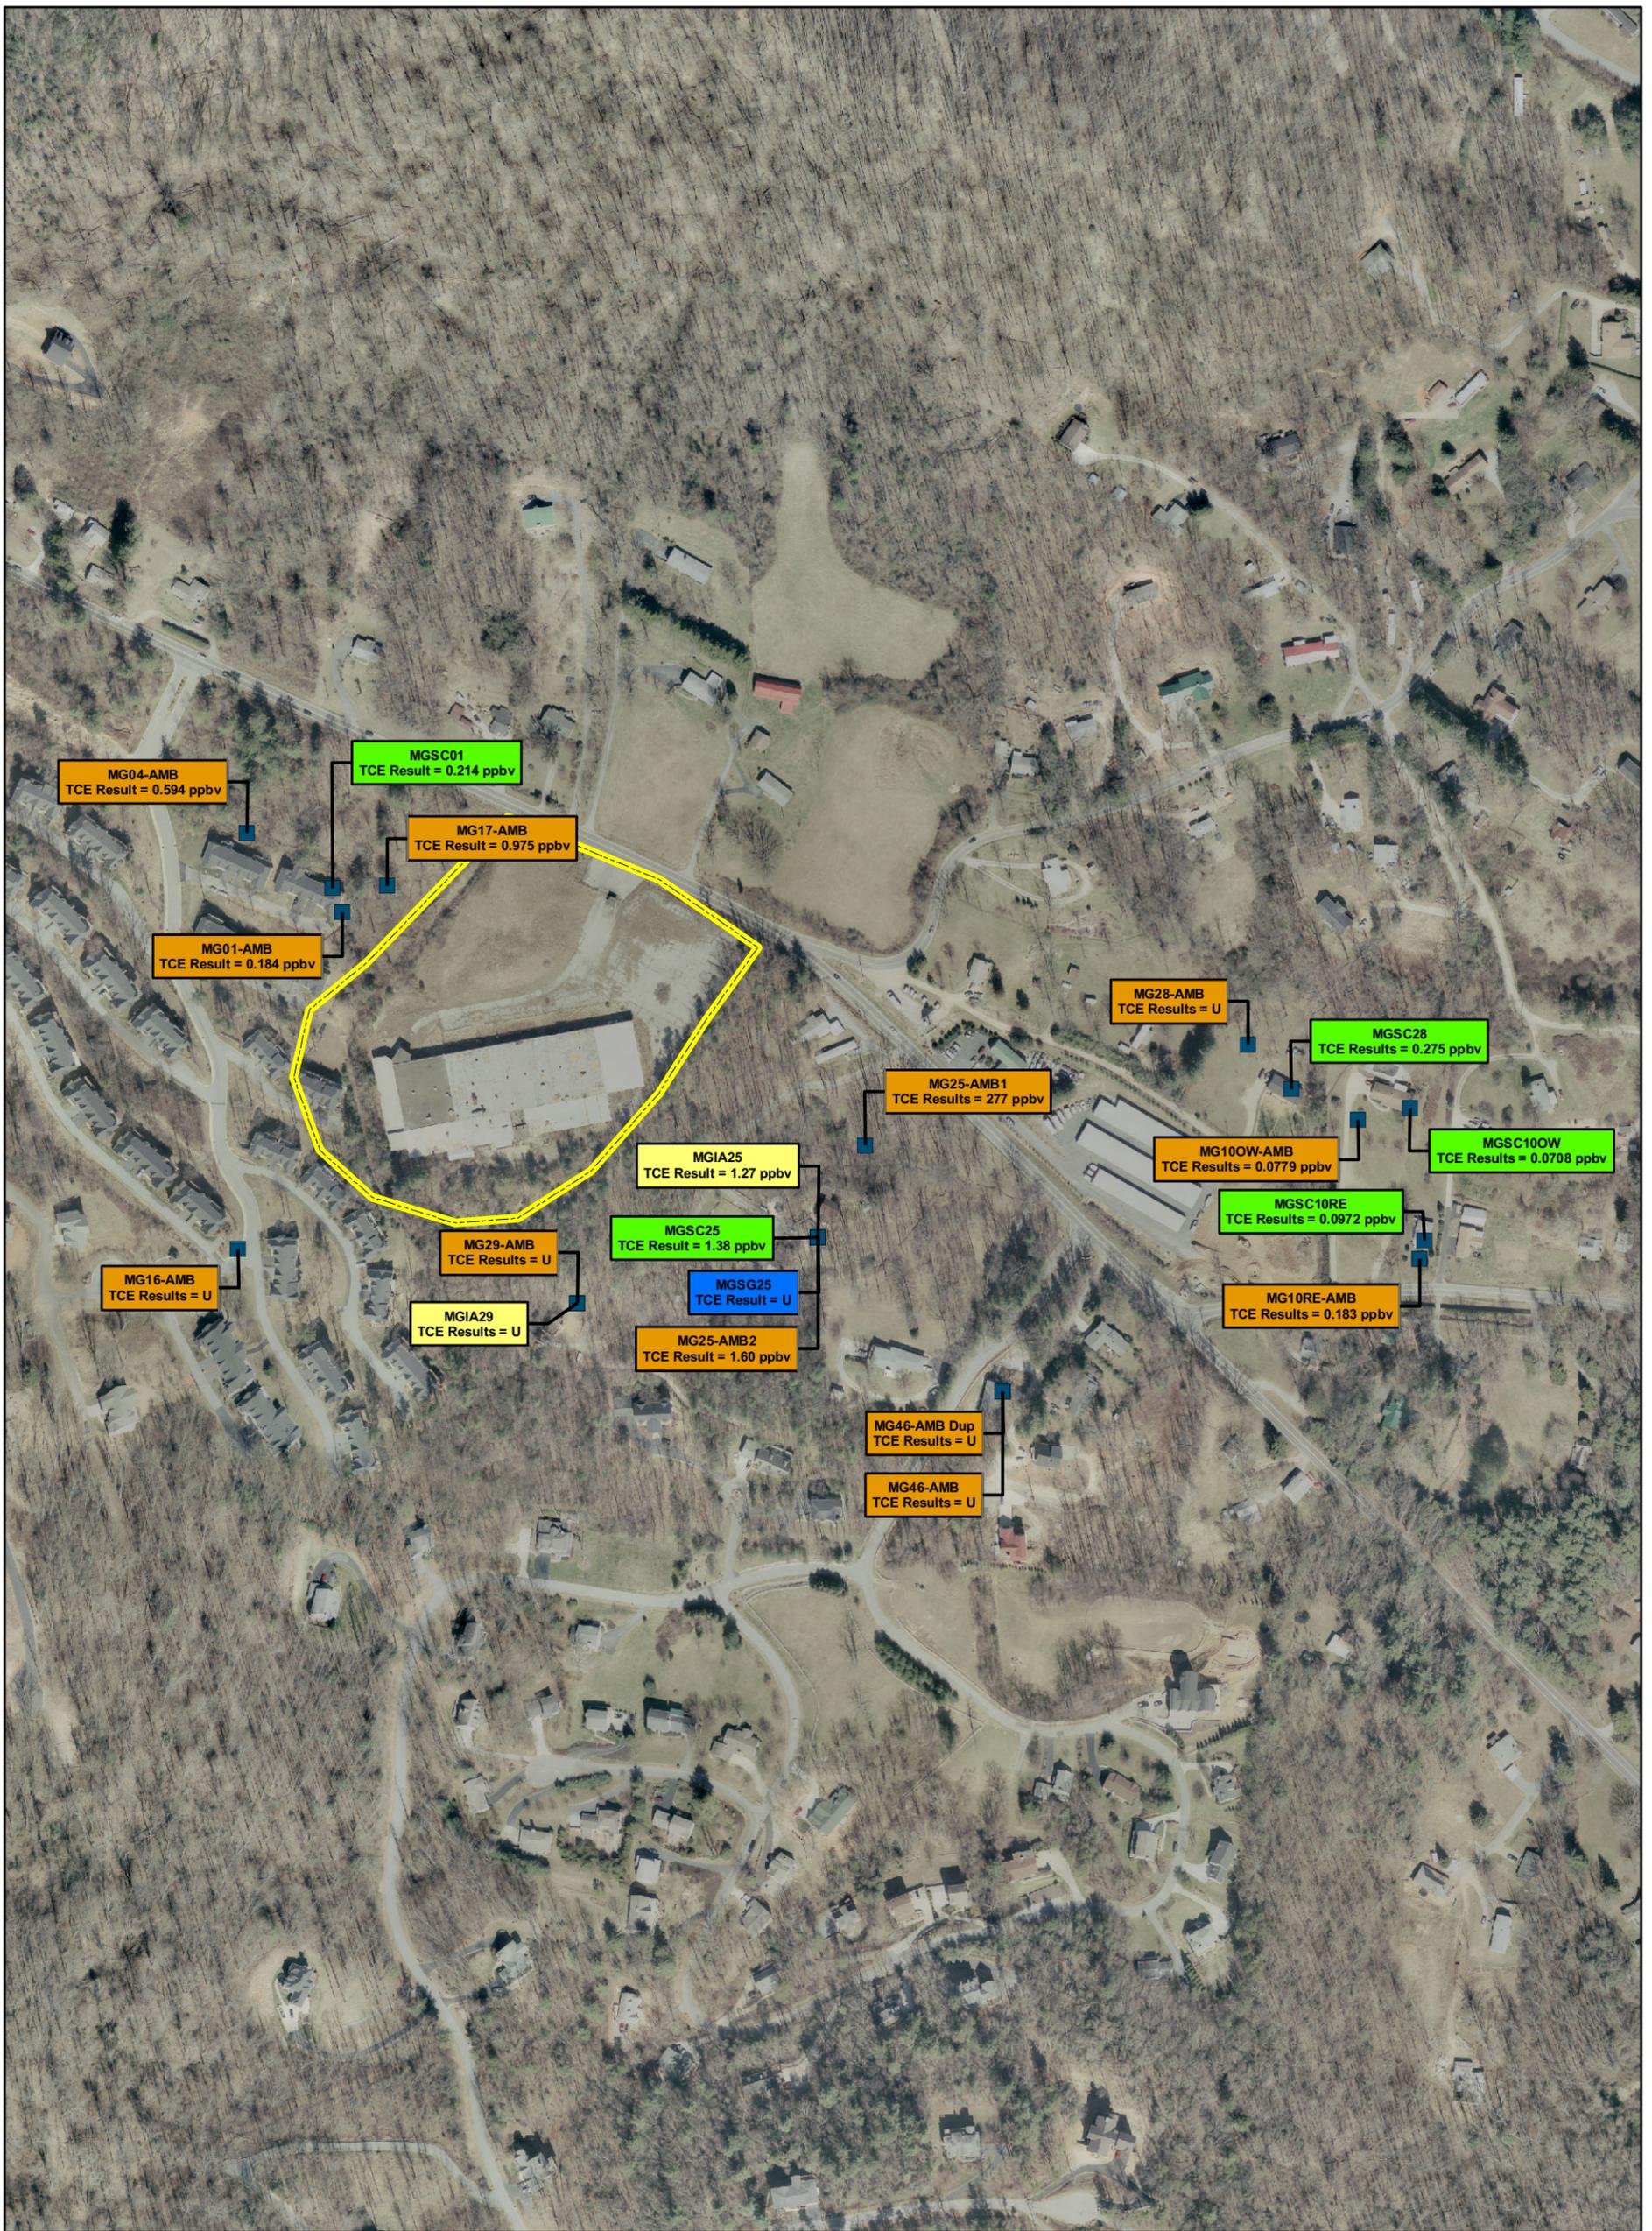
- Sample Location
- Site Location
- MGSC25 = CRAWL SPACE SUMMA CANISTER SAMPLE
- MG25-AMB2 = AMBIENT SUMMA CANISTER SAMPLE
- MGSG25 = SOIL GAS SAMPLE
- MGIA25 = SUMMA CANISTER INDOOR AIR SAMPLE

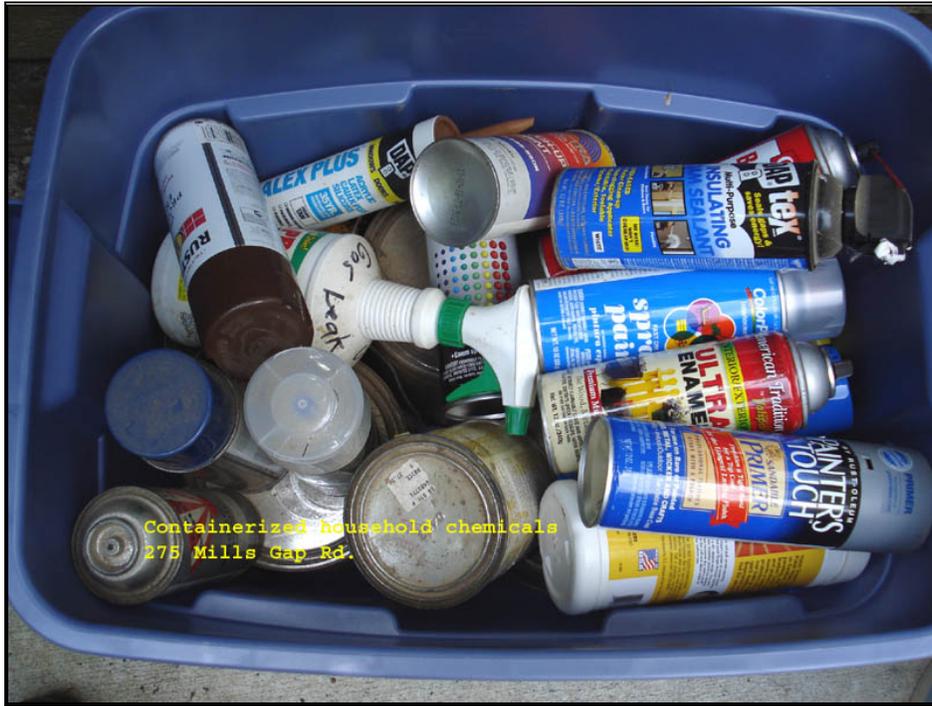
Official Photograph No. 1

Site Name: Mills Gap **Date:** August 5, 2008
Location: Asheville, Buncombe County, NC **TDD No:** TNA-05-001-0043
Photographer: Ryan Stubbs, START
Subject: View of household chemicals containerized prior to vapor sampling.

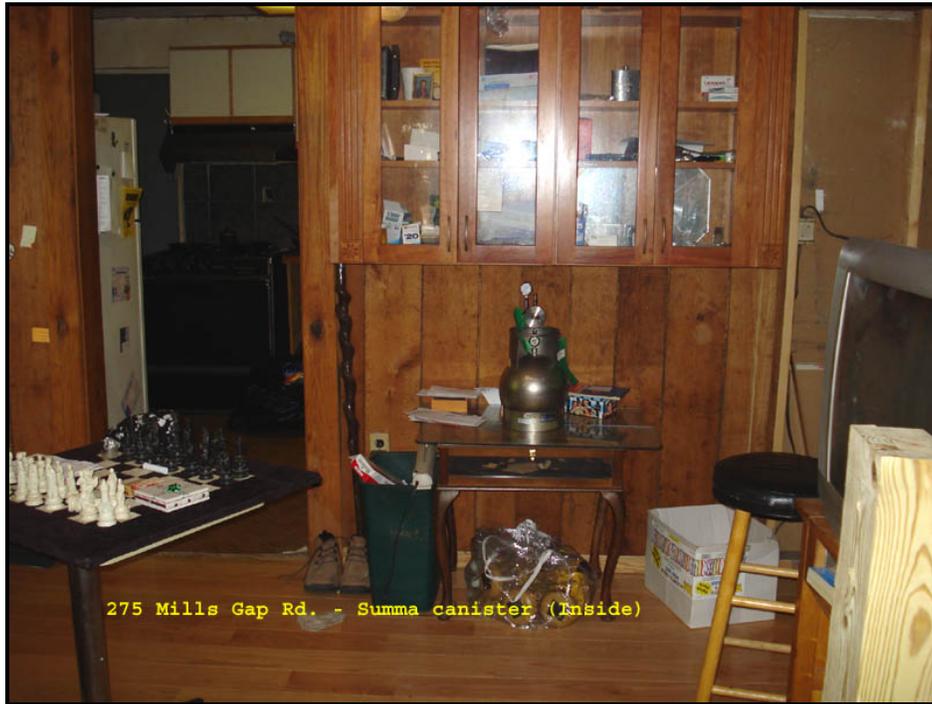
Official Photograph No. 2

Site Name: Mills Gap **Date:** August 6, 2008
Location: Asheville, Buncombe County, NC **TDD No:** TNA-05-001-0043
Photographer: Ryan Stubbs, START
Subject: View of indoor air sample collected at 275 Mills Gap Road.

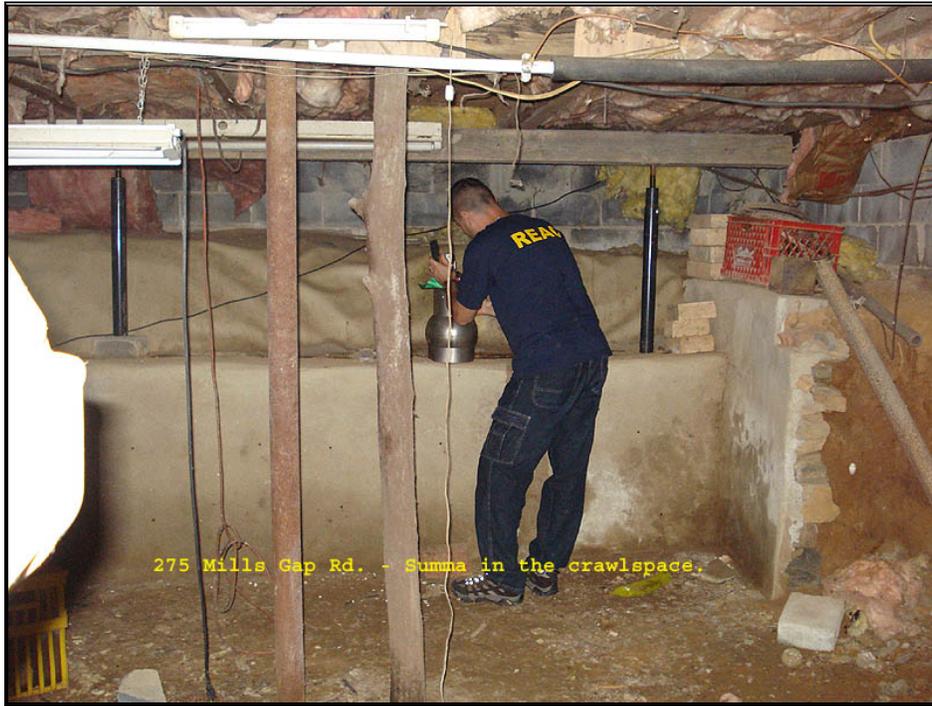
Official Photograph No. 3

Site Name: Mills Gap **Date:** August 6, 2008
Location: Asheville, Buncombe County, NC **TDD No:** TNA-05-001-0043
Photographer: Ryan Stubbs, START
Subject: View of sample being collected in the crawlspace at 275 Mills Gap Road.

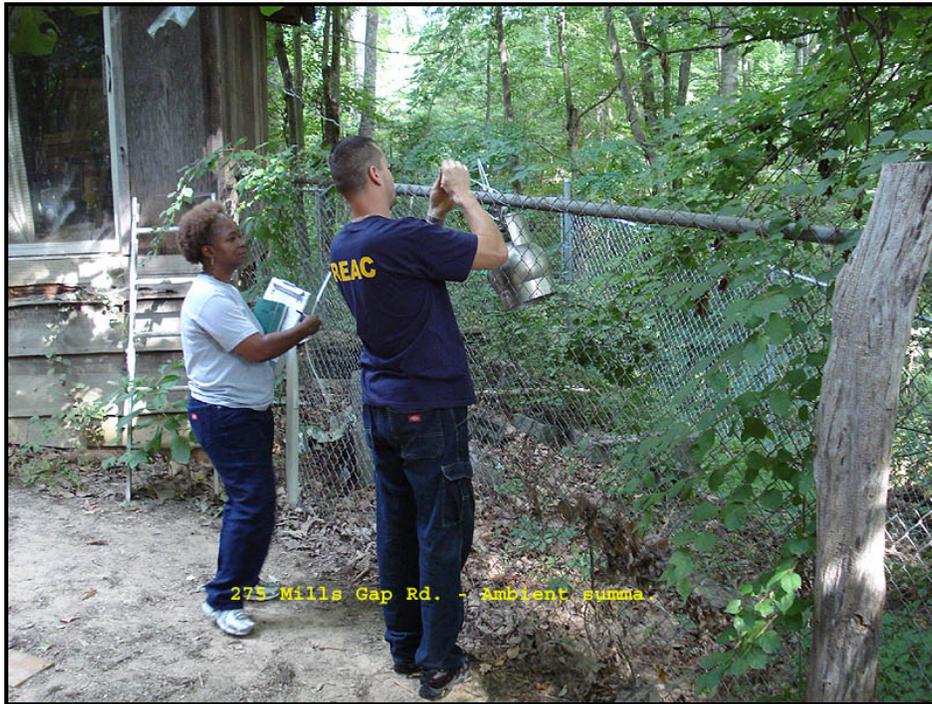
Official Photograph No. 4

Site Name: Mills Gap **Date:** August 6, 2008
Location: Asheville, Buncombe County, NC **TDD No:** TNA-05-001-0043
Photographer: Ryan Stubbs, START
Subject: View of REAC setting up an ambient air sample at 275 Mills Gap Road.

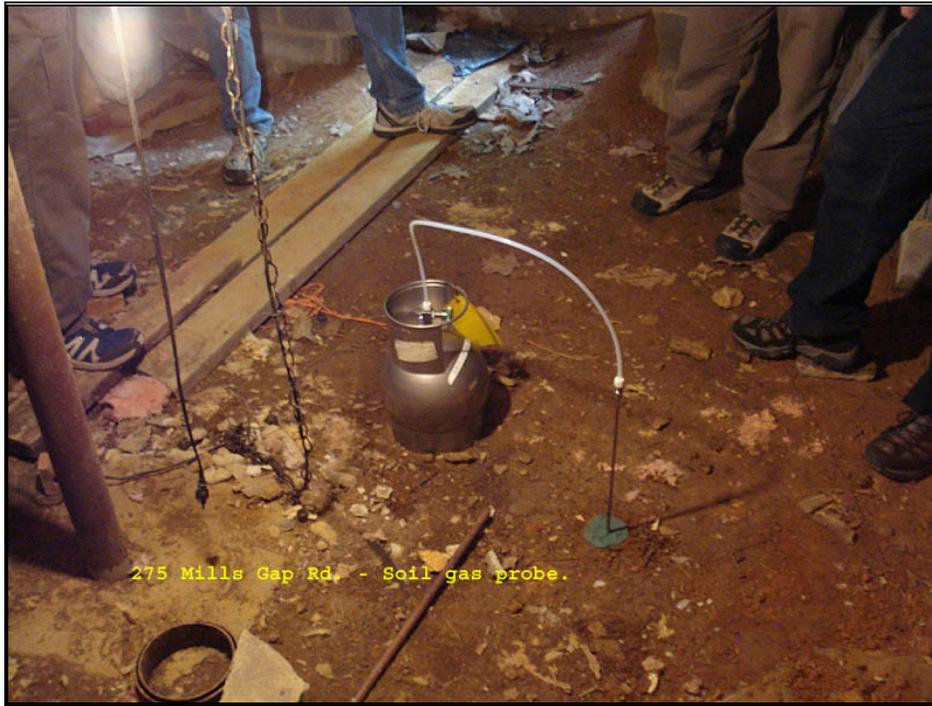
Official Photograph No. 5

Site Name: Mills Gap **Date:** August 7, 2008
Location: Asheville, Buncombe County, NC **TDD No:** TNA-05-001-0043
Photographer: Ryan Stubbs, START
Subject: View of a soil gas sample being collected at 275 Mills Gap Road.

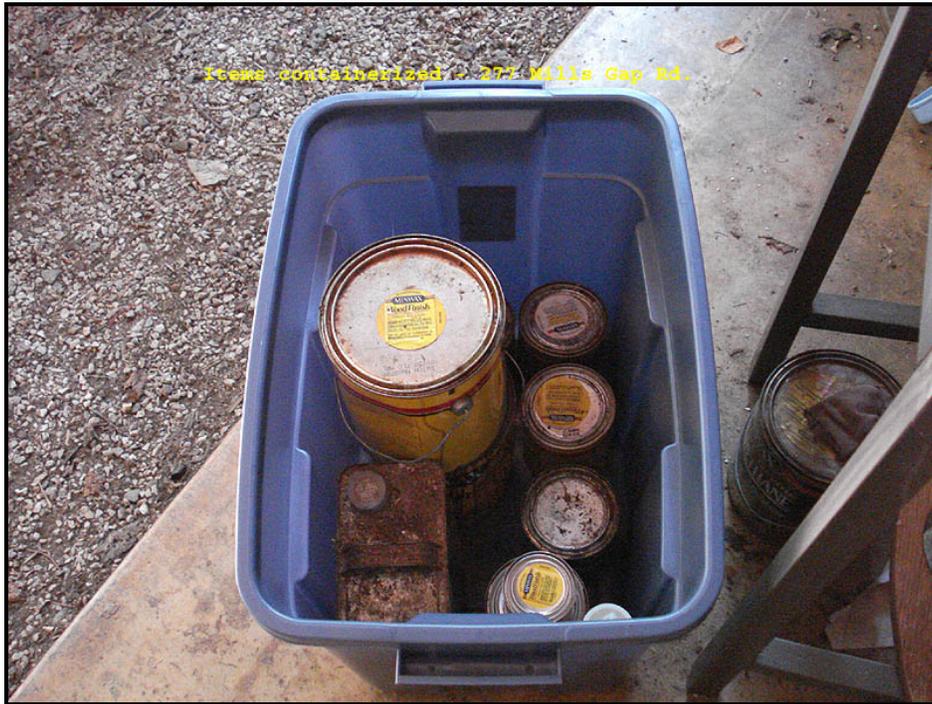
Official Photograph No. 6

Site Name: Mills Gap **Date:** August 5, 2008
Location: Asheville, Buncombe County, NC **TDD No:** TNA-05-001-0043
Photographer: Ryan Stubbs, START
Subject: View of household chemicals containerized at 277 Mills Gap Road prior to vapor sampling.

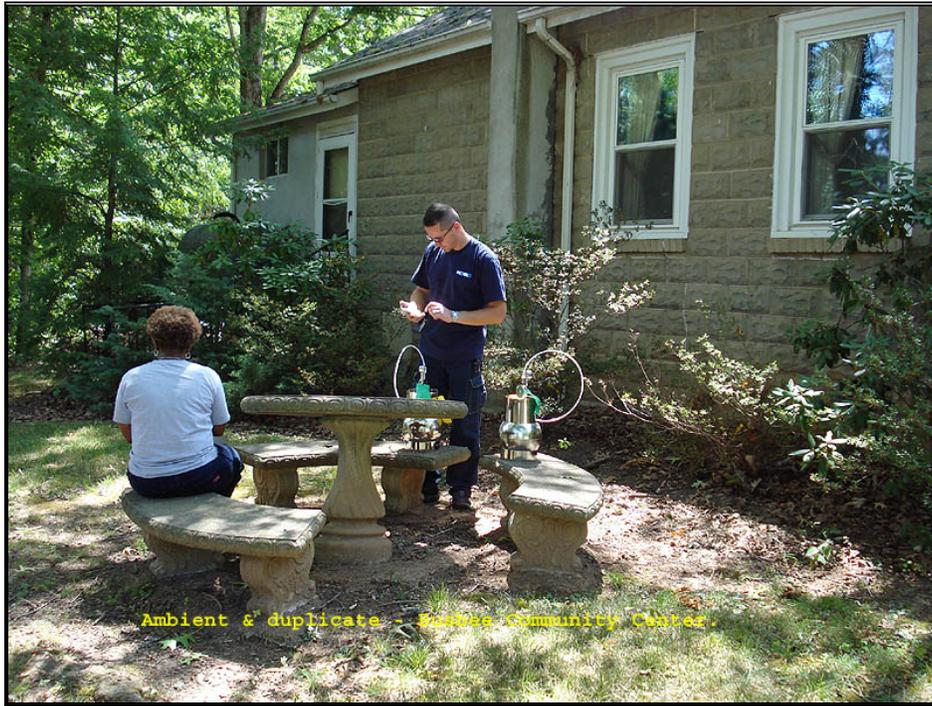
Official Photograph No. 9

Site Name: Mills Gap **Date:** August 6, 2008
Location: Asheville, Buncombe County, NC **TDD No:** TNA-05-001-0043
Photographer: Ryan Stubbs, START
Subject: View of REAC setting up ambient air samples at the Busbee Community Center.

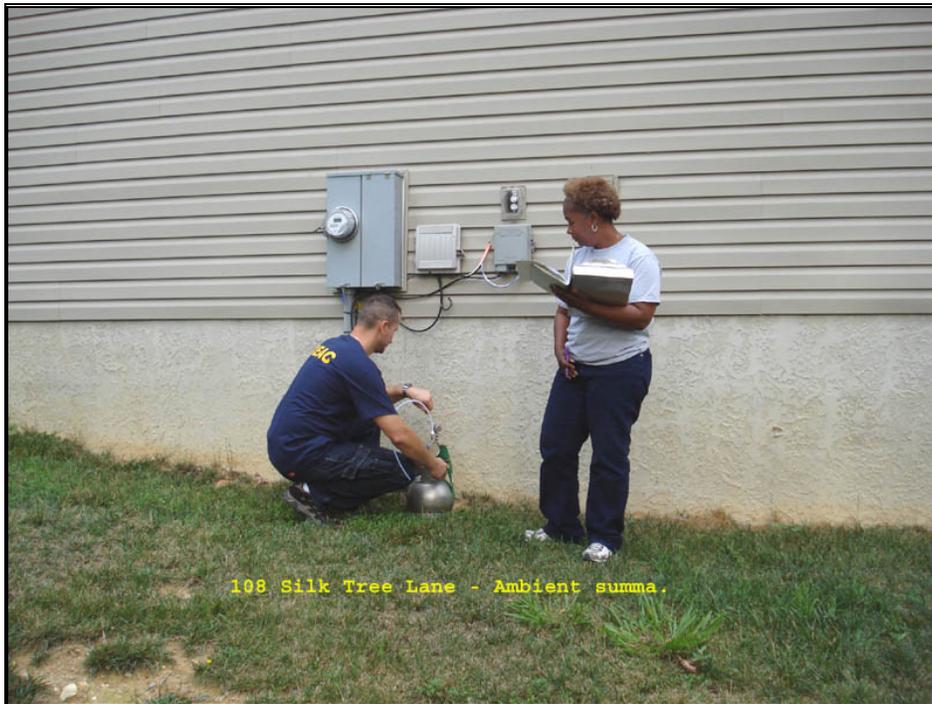
Official Photograph No. 10

Site Name: Mills Gap **Date:** August 6, 2008
Location: Asheville, Buncombe County, NC **TDD No:** TNA-05-001-0043
Photographer: Ryan Stubbs, START
Subject: View of an ambient air sample being set up at the Southside Village.
