**Subject: Incident Response Letter Report  
Waterworks Creosote Spill  
Columbus, Lowndes County, Mississippi  
TDD No.: TNA-05-001-0087  
Contract No. EP-W-05-053**

**WATERWORKS CREOSOTE ER  
COLUMBUS, LOWNDES COUNTY,  
MISSISSIPPI**  
TDD No: 05-001-0087

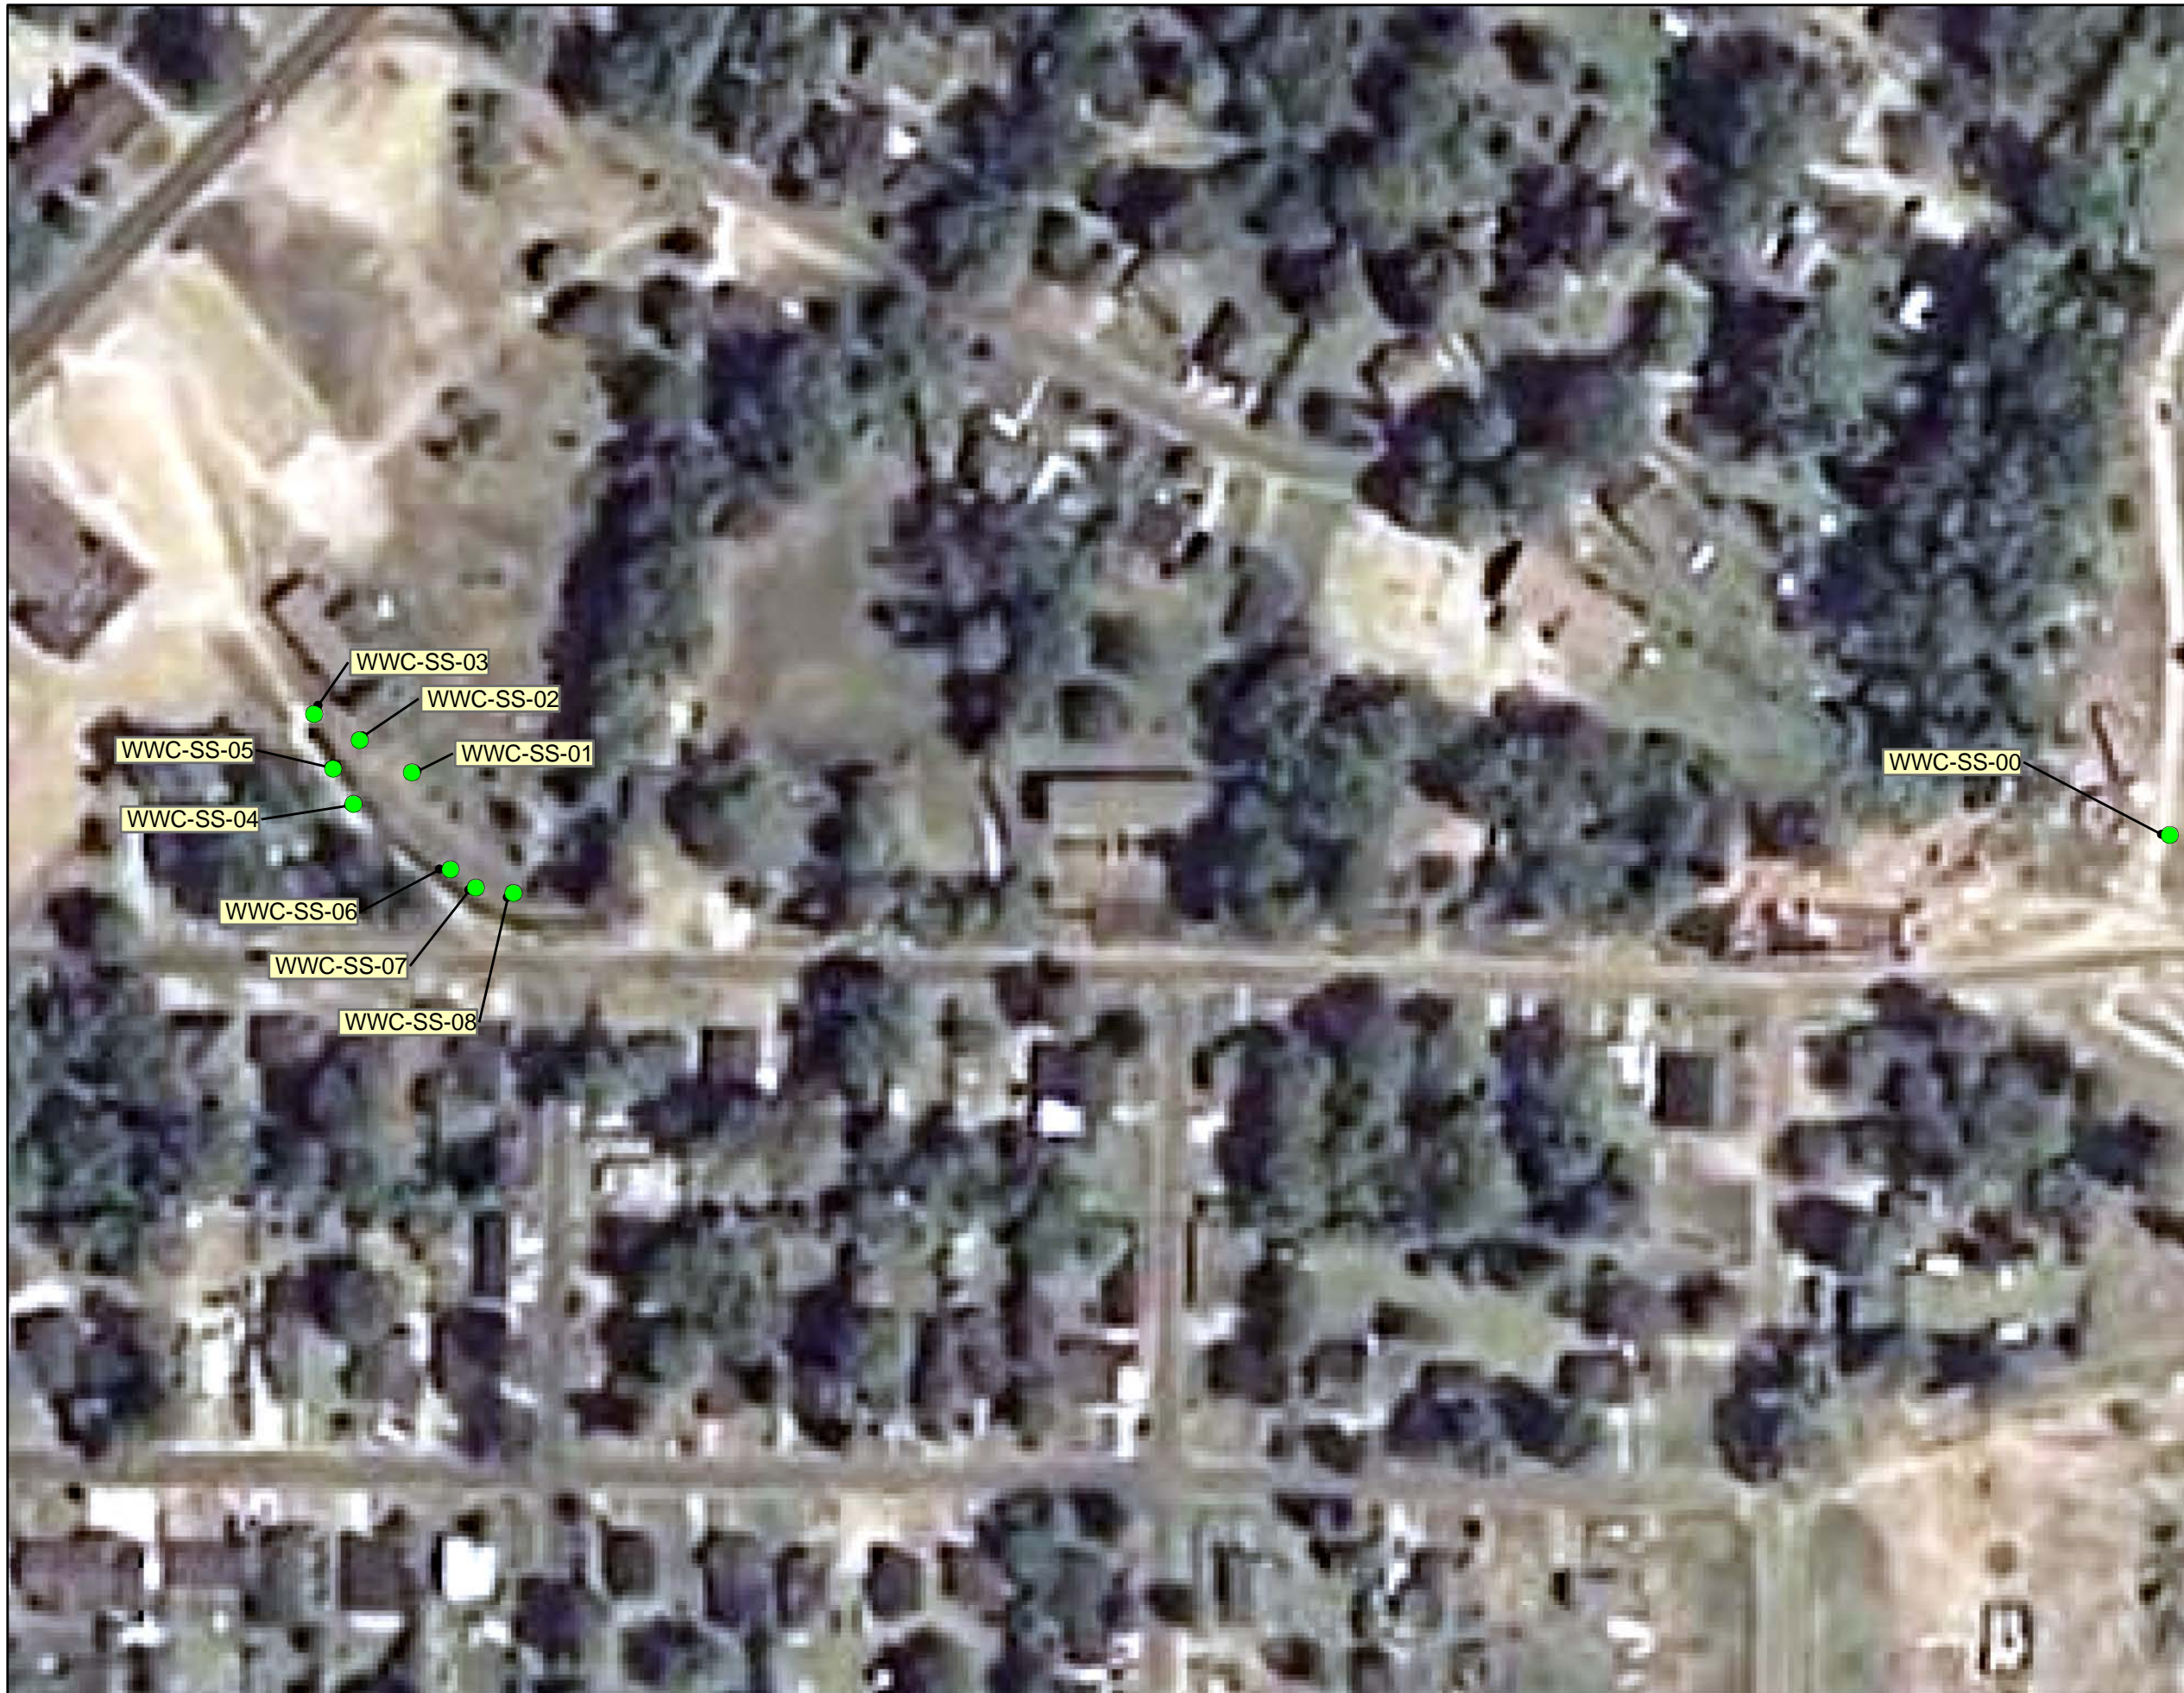
**FIGURE 2  
HEADSPACE SAMPLE LOCATIONS**

START began collecting samples (3-point composite samples) for headspace analysis at various locations throughout the site. START collected one background soil sample (WWC-SS-00) south of the site near a baseball field and local park located within 0.5-miles of the site, two soil samples (WWC-SS-01 and WWC-SS-02) from a concrete/soil mixture pile created by the property owner, three sediment/soil samples (WWC-SS-03, WWC-SS-04, and WWC-SS-05) from the unnamed ditch that borders the church property near the southwest border, and three sediment/soil samples (WWC-SS-06, WWC-SS-07, and WWC-SS-08) from between two concrete culverts that lie in the unnamed ditch (see Figure 2 for headspace locations). Each sample was placed in a ziplock bag for headspace analysis utilizing a Minirae Photionization Detector (PID). Results for the headspace analysis can be found on Table 1 located in Attachment B. Air readings on the Minirae PID for the specific soil locations throughout the site ranged from 0 parts per billion (ppb) in the background sample to 1,748 ppb at WWC-SS-02.

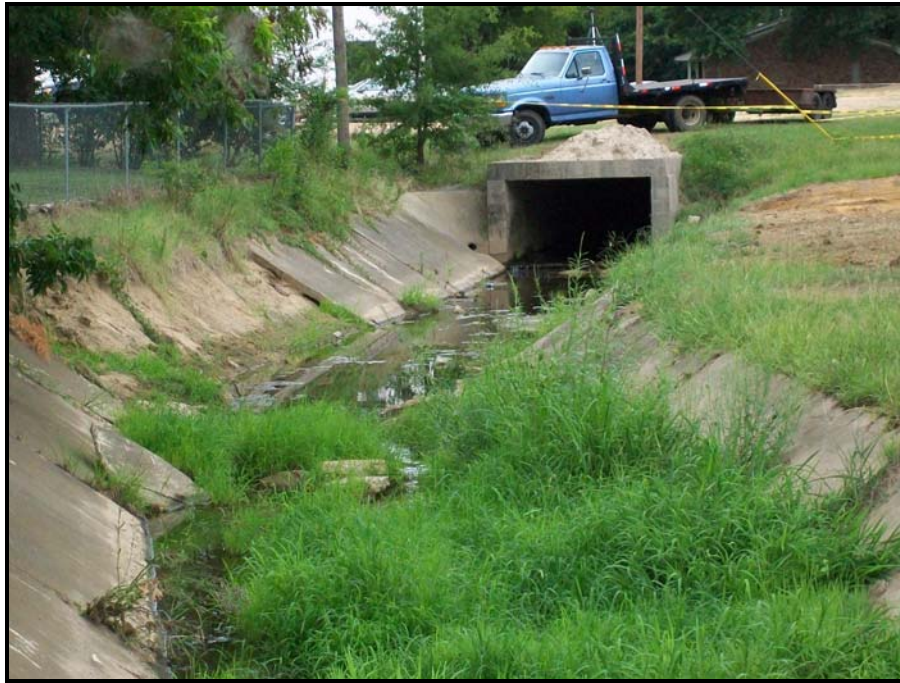
**Photograph No.: 1**

**Subject:** Center of culvert looking Northwest. General area where screening samples WWC-SS-03 through WWC-SS-05 were collected.

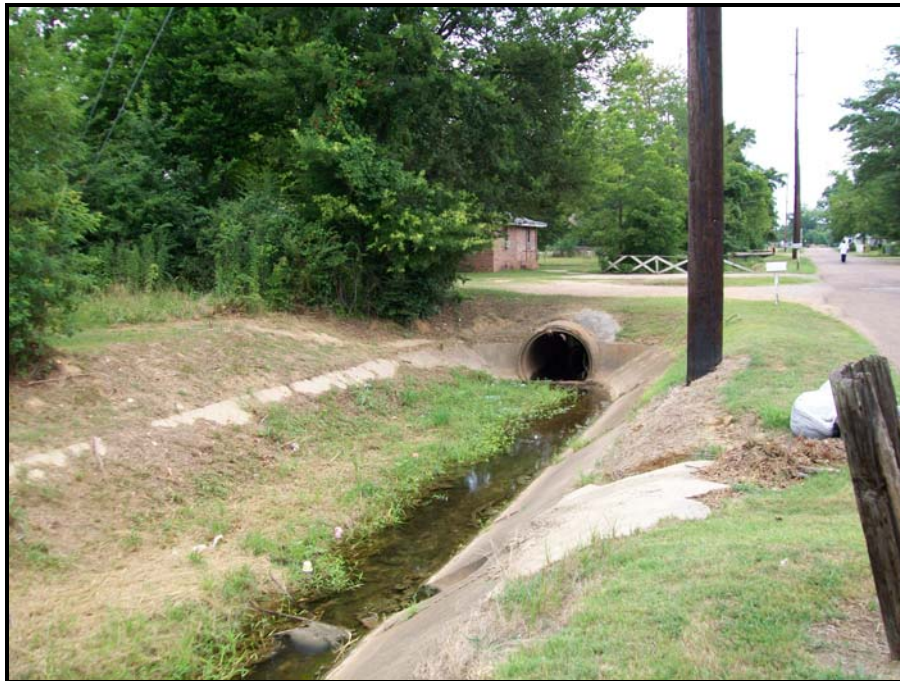
**Photograph No.: 2**

**Subject:** Center of culvert facing Southeast. General area where screening samples WWC-SS-06 through WWC-SS-08 were collected.

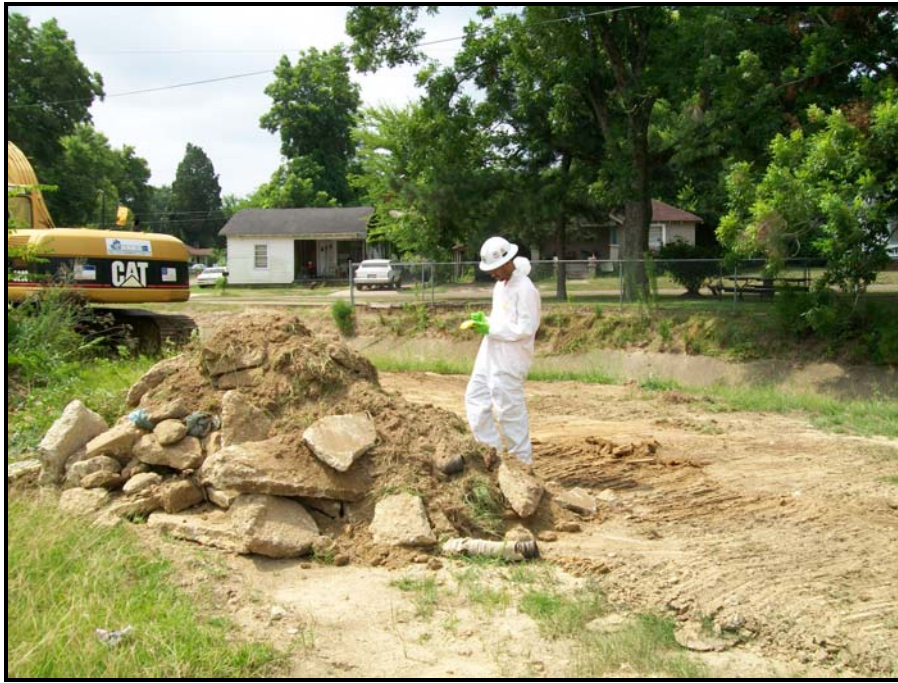
**Photograph No.: 3**

**Subject:** Picture taken facing South; Area where screening sample WWC-SS-01 was collected.

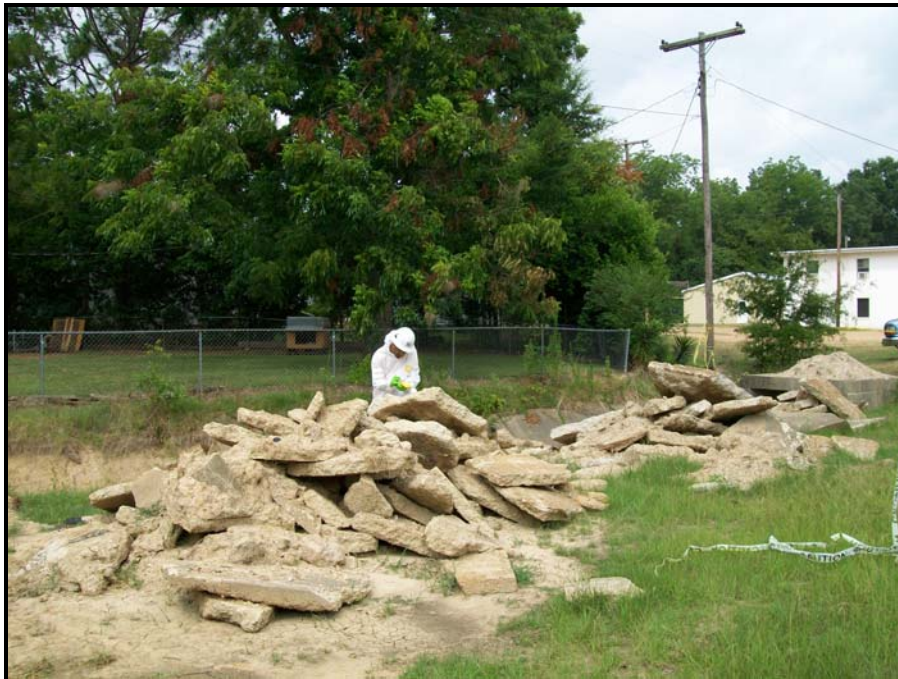
**Photograph No.: 4**

**Subject:** Picture taken facing Southwest; Area of mostly concrete where screening sample WWC-SS-02 was collected.

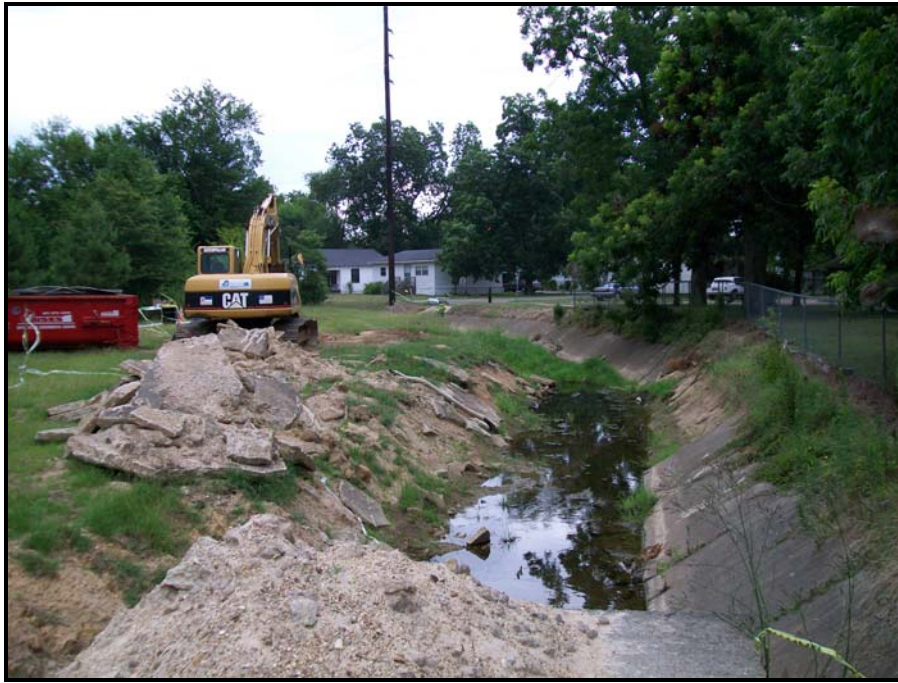
**Photograph No.: 5**

**Subject:** Picture taken facing Southeast. Screening samples WWC-SS-03 and WWC-SS-04 collected from left bank of stream and WWC-SS-05 collected from right side of stream.

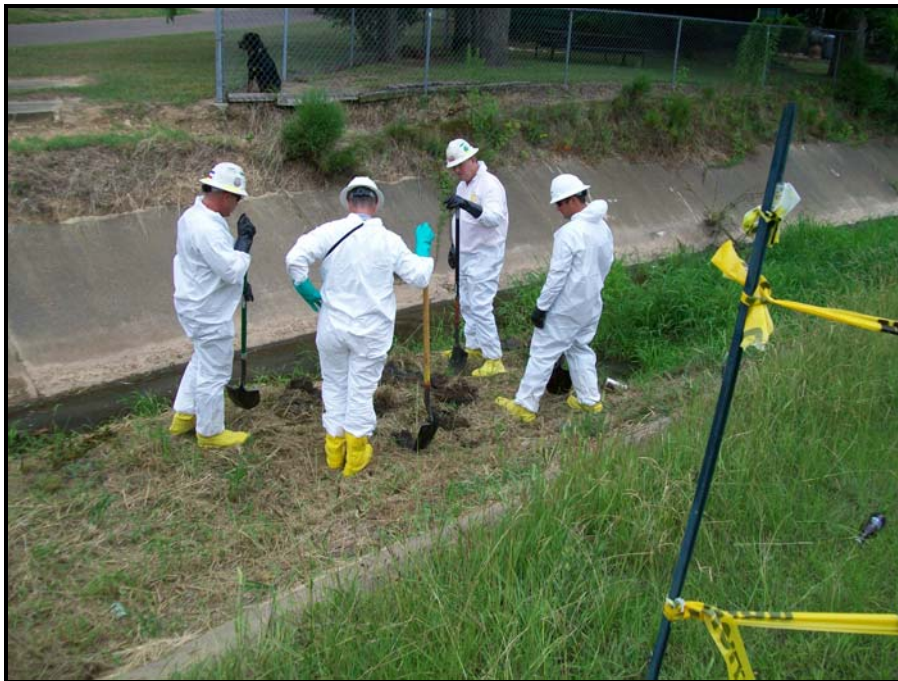
**Photograph No.: 6**

**Subject:** Picture taken facing Southwest. Screening sample WWC-SS-06 was collected from the sediment build up within the bend in the culvert.

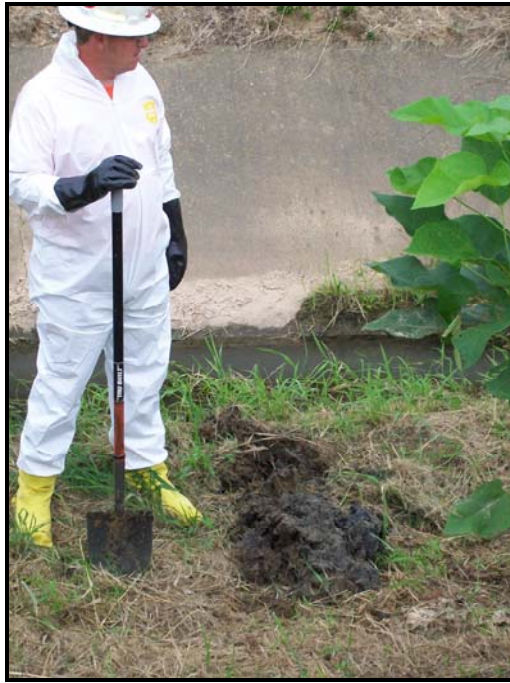
**Photograph No.: 7**

**Subject:** Picture taken facing South. Screening sample WWC-SS-07 was collected within the bend of the culvert.

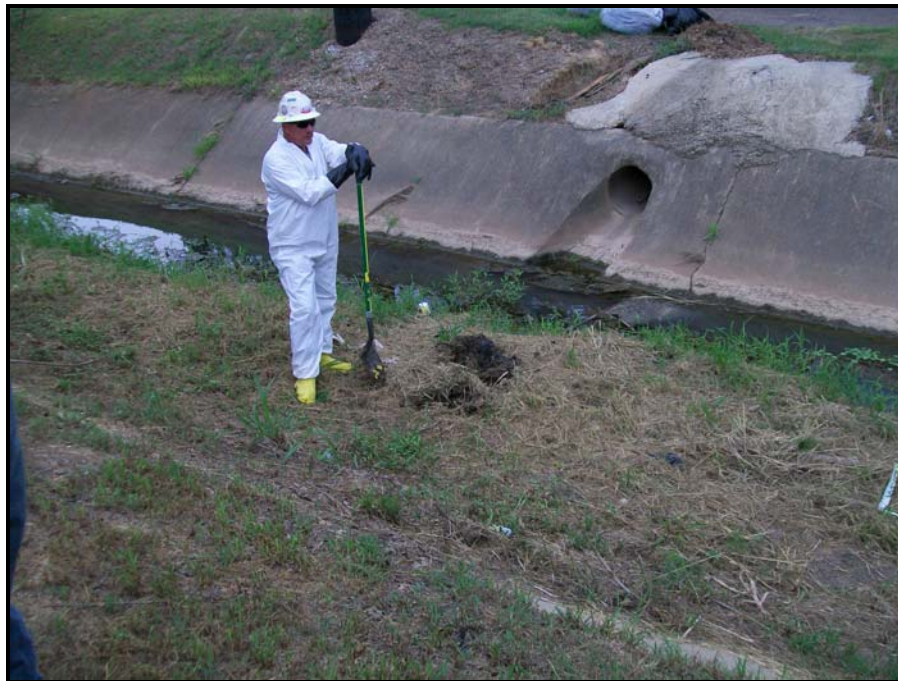
**Photograph No.: 8**

**Subject:** Picture taken facing Southeast. Screening sample WWC-SS-08 collected in the bend of the culvert.

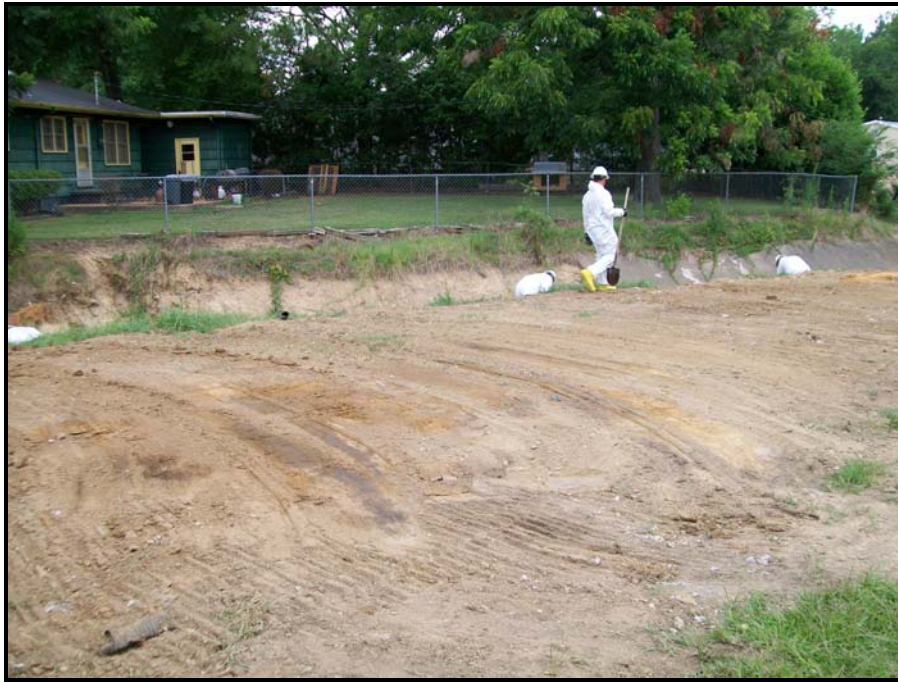
**Photograph No.: 9**

**Subject:** Picture taken facing Southwest. Area shown was the general location for screening samples WWC-SS-01 and WWC-SS-02 after cleanup began.

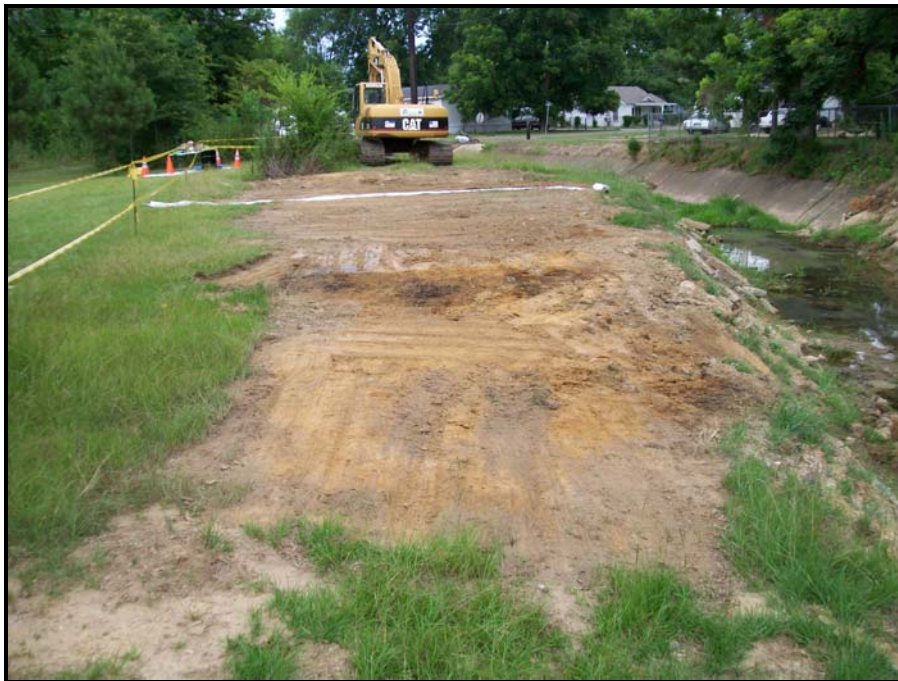
**Photograph No.: 10**

**Subject:** Picture taken facing East showing clean up of area. This area was where screening samples WWC-SS-01 and WWC-SS-02 were collected.

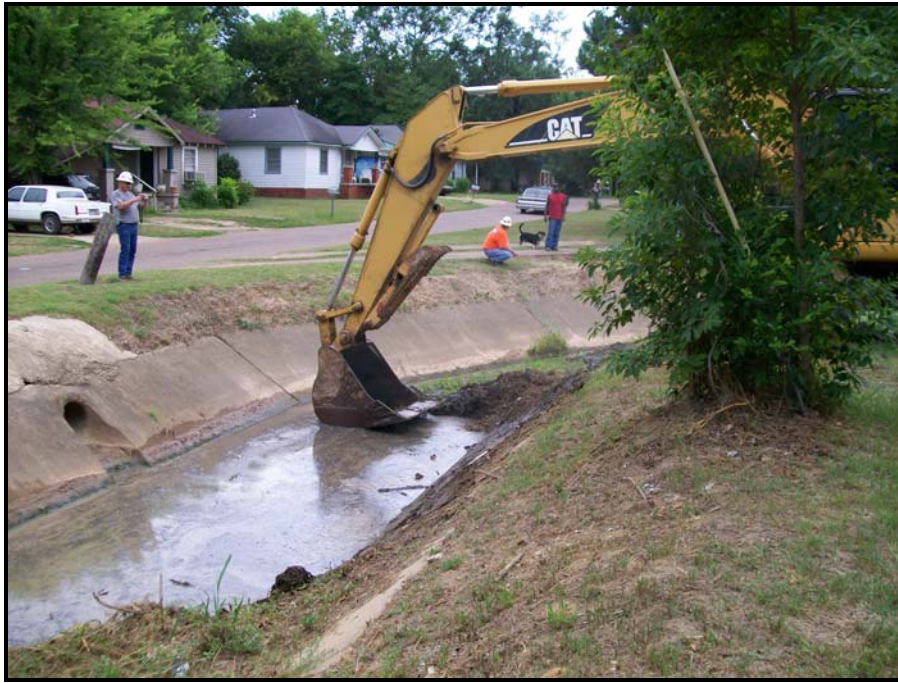
**Photograph No.: 11**

**Subject:** Picture taken facing Southwest during clean up activities. Picture depicting the area where screening samples WWC-SS-06 through WWC-SS-08 were collected.

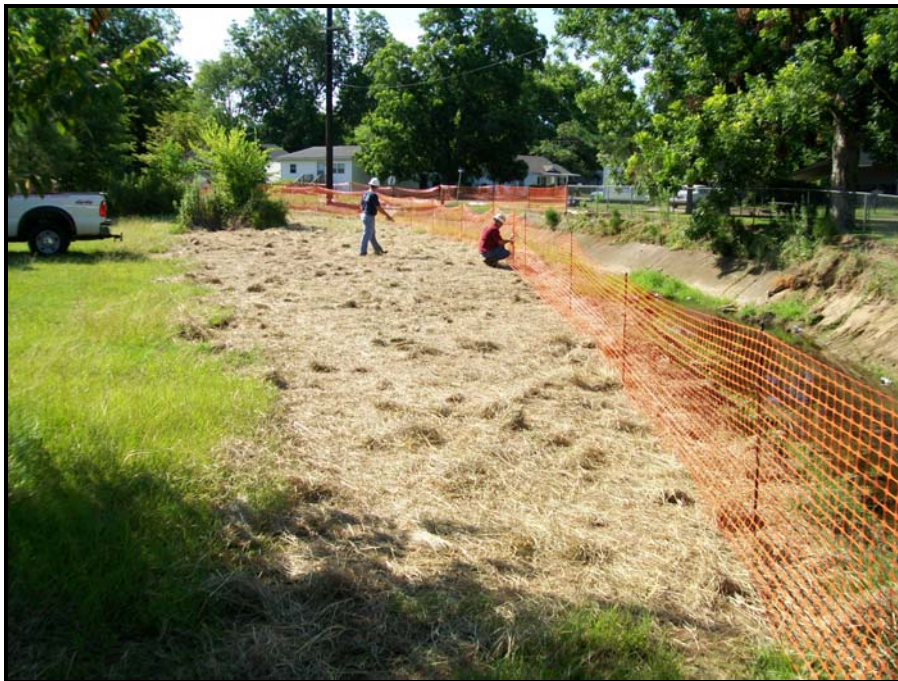
**Photograph No.: 12**

**Subject:** Picture taken facing Southeast of cleanup area where screening samples WWC-SS-01 and WWC-SS-02 were collected.

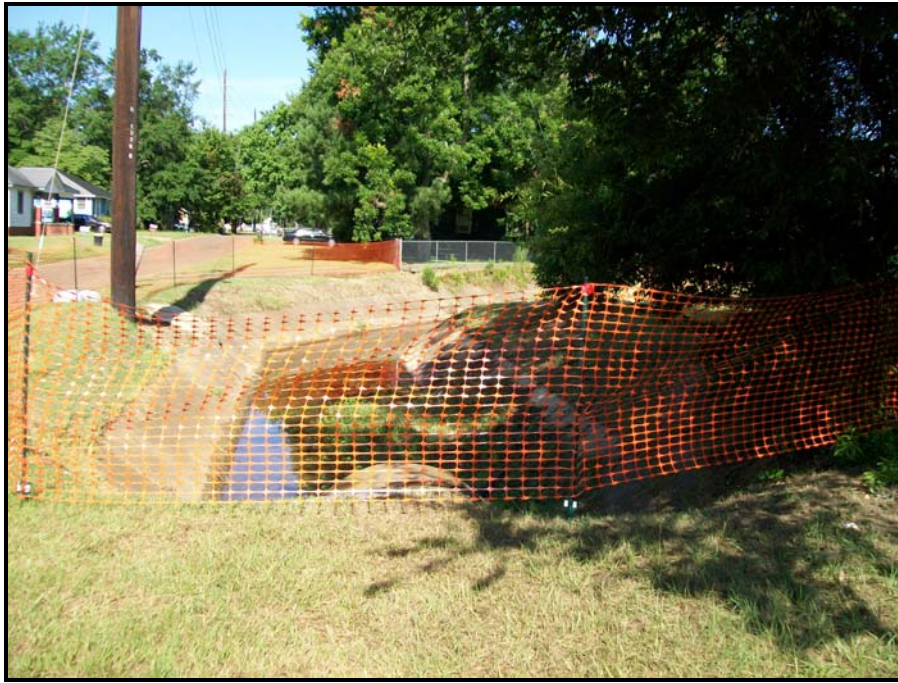
**Photograph No.: 13**

**Subject:** Picture taken facing Southeast and shows completed cleanup of culvert bend.

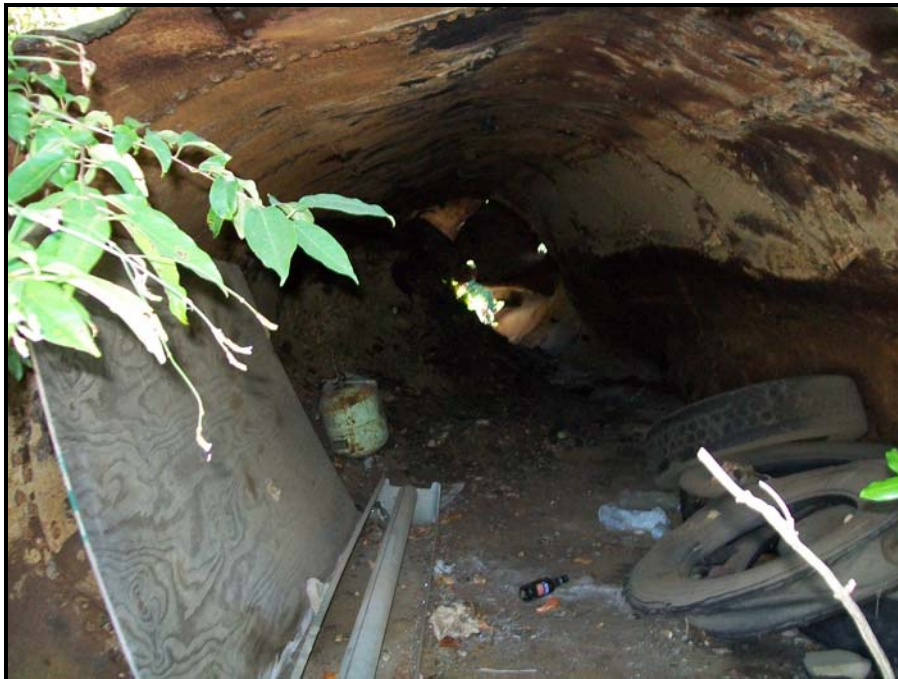
**Photograph No.: 14**

**Subject:** Picture taken facing North of the interior of cylinder. A sample was collected for analytical parameters from dirt mound located on left side midway back.
