*Handwritten signature*  
**RECEIVED**  
**FEB 05 1991**  
**REMOVAL PROGRAM**  
**PRELIMINARY ASSESSMENT**  
**SITE INVESTIGATION**  
**FOR**  
**MARINO PROPERTY SITE**  
**MIDDLETOWN, CONNECTICUT**

U.S. Environmental Protection Agency  
Emergency Planning and Response Branch  
60 Westview Street  
Lexington, MA 02173

ROY F. WESTON, INC.  
Technical Assistance Team  
Region I

December 1990

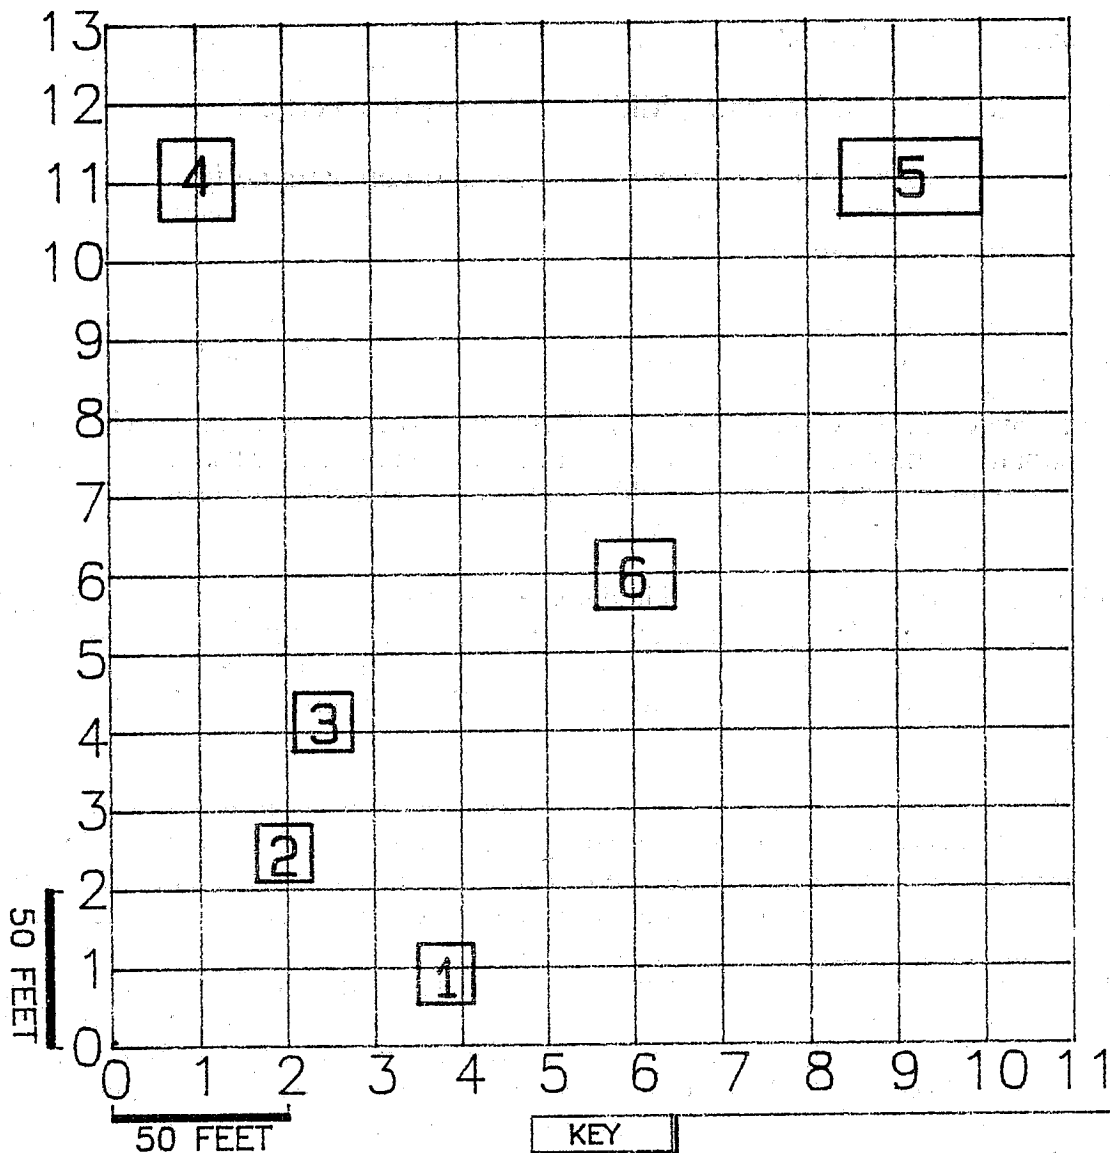
FIGURE: 1

After completion and inspection of the resulting electromagnetic data, a 100 gamma contour interval was chosen to best depict the subsurface electromagnetic anomalies. A two-dimensional gamma isoconcentration map indicating areas of equal total magnetic intensity (Figure 2) indicates several electromagnetic anomalies in the area of investigation. The magnetic anomaly patterns generated by the gamma isoconcentration map delineate the extent, location and shape of a given electromagnetic source (i.e. iron or steel object(s)). When interpreting the gamma isoconcentration map, each anomaly will have a positive and negative component.

The electromagnetic source generating the anomaly is usually located at the inflection point between a high and low gamma reading. More exactly, the electromagnetic source is

SUBSURFACE ELECTROMAGNETIC CONDUCTORS  
MARINO PROPERTY  
MIDDLETOWN, MIDDLESEX COUNTY  
CONNECTICUT

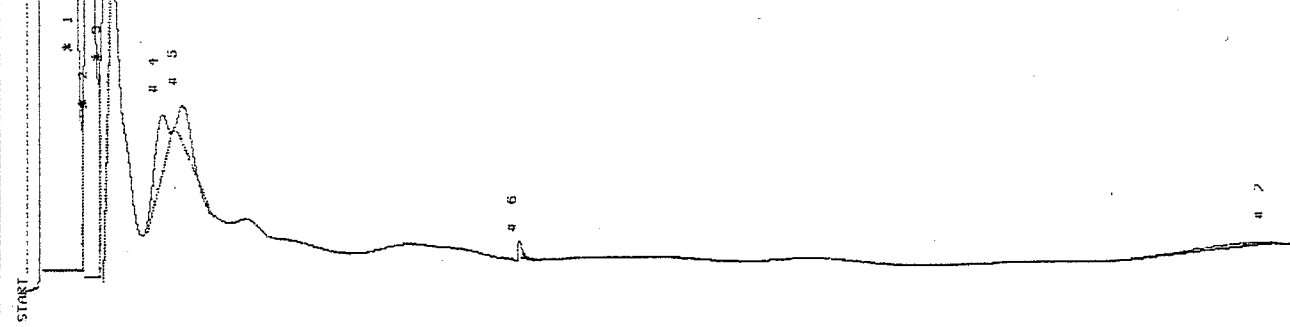
Photovac analysis of the soil gas sample collected from station # EM 1, SG1, contained six early eluting unidentified peaks, four off scale, between the range of trans-1,2-dichloroethylene and chlorobenzene. See chromatogram of soil gas collected at subsurface electromagnetic anomaly: EM 1, SG1, for further details. There are 18 EPA New England Regional Laboratory (NERL) target compounds which fall in this range. See Figure 2 for further details. Sample injection volume was 200 uL.

SUBSURFACE ELECTROMAGNETIC ANOMALY: EM 1, SG1, INJECTION VOLUME: 200 uL

STOP # 500.0  
SAMPLE RUN  
ANALYSIS # 12  
TEMPERATURE 24  
GAIN 100  
OCT 31 1998 15:13  
PARING SOIL GAS  
EM HOT SPOT 1  
200 UL STR S

COMPOUND NAME	PEAK	R.T.	AREA/PPH
UNKNOWN	1	12.5	34.9
UNKNOWN	2	24.5	6.2
UNKNOWN	3	38.8	1.6
UNKNOWN	4	53.5	852.7
UNKNOWN	5	61.6	855.8
UNKNOWN	6	194.2	26.2
UNKNOWN	7	186.3	322.7

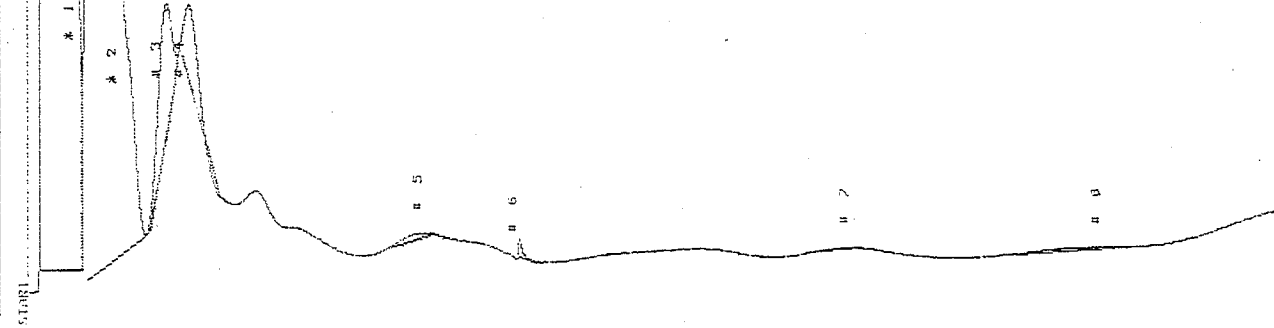
Photovac analysis of the soil gas sample collected from station #EM 1, SG2, contained four early eluting unidentified peaks, two off scale, between the range of trans-1,2-dichloroethylene and chlorobenzene. See chromatogram of soil gas collected at subsurface electromagnetic anomaly: EM 1, SG2, for further details. There are 18 EPA NERL target compounds which fall in this range. See Figure 2 for further details. The chromatogram is analogous to chromatogram EM 1, SG1 suggesting similar volatile organic compounds (VOCs). In addition, the chromatogram indicates four later eluting compounds suggestive

SUBSURFACE ELECTROMAGNETIC ANOMALY: EM 1, SG2, INJECTION VOLUME: 100 uL

STOP # 500.0  
SAMPLE RUN  
ANALYSIS # 13  
TEMPERATURE 24  
GAIN 100  
OCT 31 1998 15:25  
PARING SOIL GAS  
EM HOT SPOT 1  
100 UL STR N 502

COMPOUND NAME	PEAK	R.T.	AREA/PPH
UNKNOWN	1	12.9	48.3
UNKNOWN	2	38.1	32.6
UNKNOWN	3	55.1	2.1
UNKNOWN	4	64.8	1.6
UNKNOWN	5	132.5	168.8
UNKNOWN	6	134.2	22.6
UNKNOWN	7	323.9	81.9
UNKNOWN	8	422.3	131.2

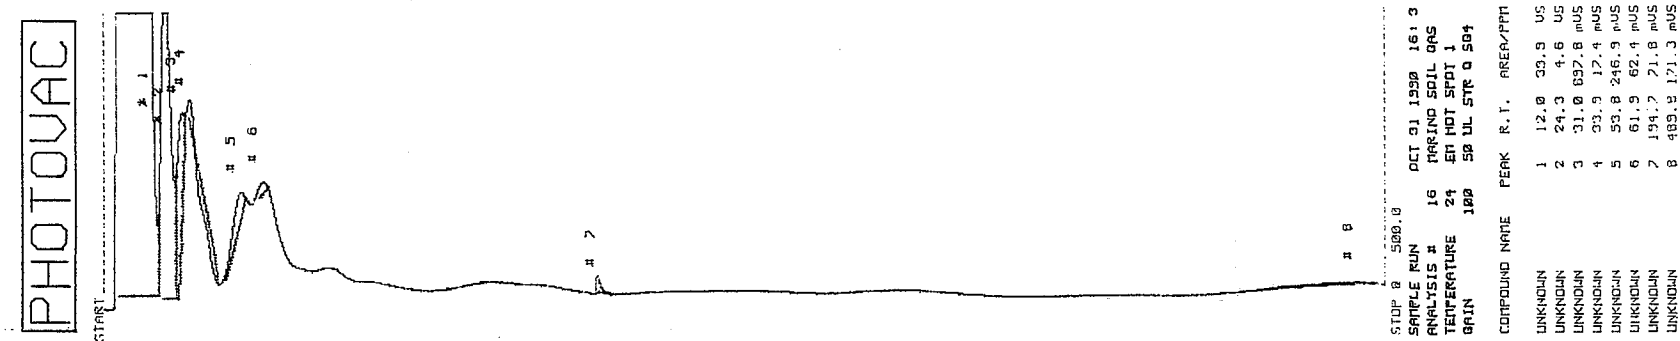
SUBSURFACE ELECTROMAGNETIC ANOMALY: EM 1, SG4, INJECTION VOLUME: 50 uL

COMPOUND NAME	PEAK	R.T.	AREA/PPH
UNKNOWN	1	6.3	3.1
UNKNOWN	2	9.4	1.2
UNKNOWN	3	12.8	428.9
UNKNOWN	4	17.4	3.8
UNKNOWN	5	24.6	494.8
UNKNOWN	6	33.8	438.2
UNKNOWN	7	53.2	188.2
UNKNOWN	8	135.1	11.2

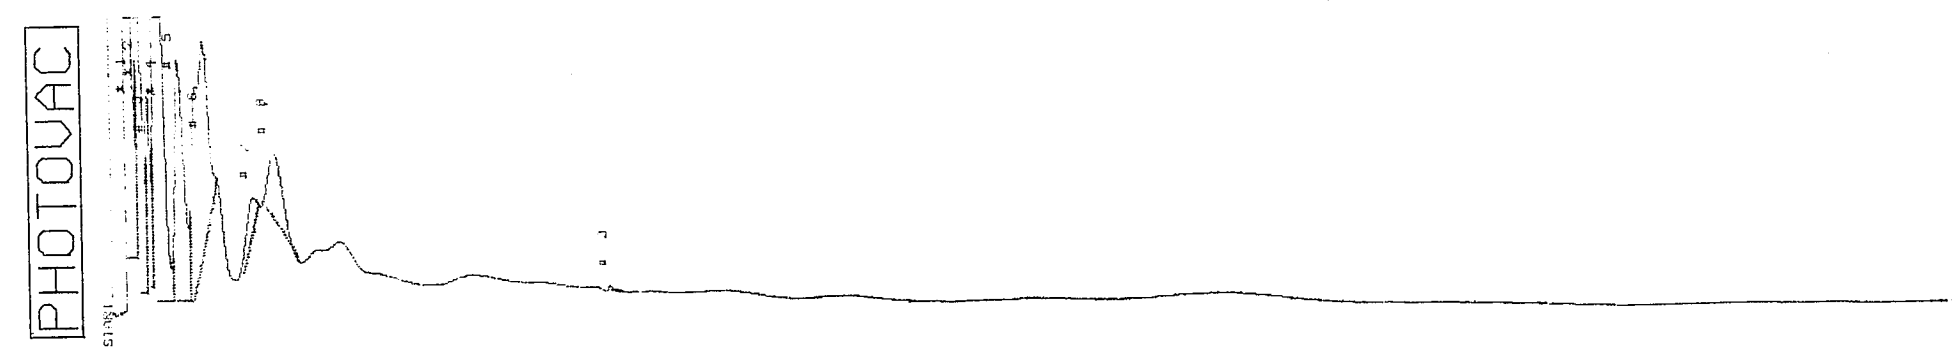
SUBSURFACE ELECTROMAGNETIC ANOMALY: EM 5, SG3, INJECTION VOLUME: 50 uL

STOP #	606.7	NOU	1	1330	13116
SAMPLE RUN					
ANALYSIS #	25	PARINO SOIL GAS			
TEMPERATURE	91	EN HOT SPOT 5			
GRAIN	100	25 UL STR p 502			
COMPOUND NAME	PEAK	R.T.	AREA/PPM		
UNKNOWN	1	7.0	1.0	US	
UNKNOWN	2	10.6	1.2	US	
UNKNOWN	3	13.8	637.7	US	
UNKNOWN	4	17.9	3.0	US	
UNKNOWN	5	24.4	1.6	US	
UNKNOWN	6	32.7	2.1	US	
UNKNOWN	7	93.8	102.8	US	
UNKNOWN	8	56.8	50.9	US	
UNKNOWN	9	135.5	20.0	US

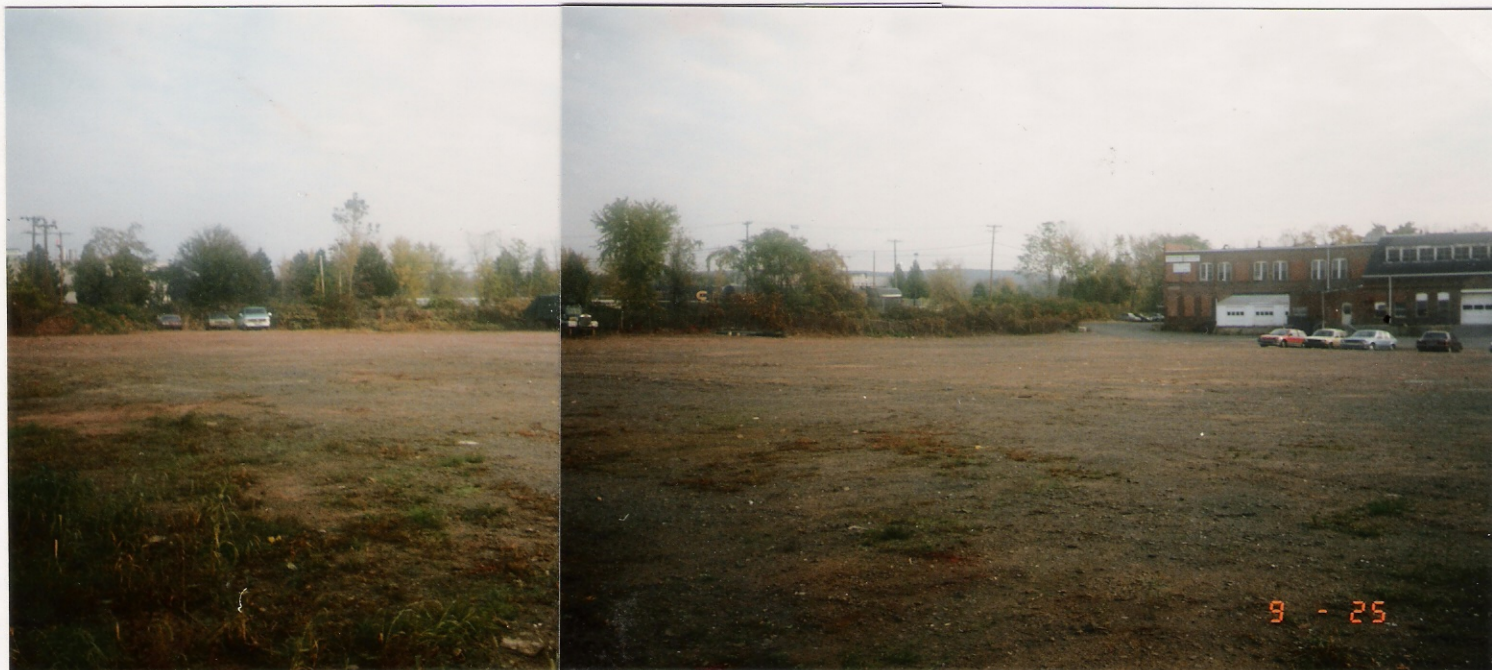
SCENE: MARINO PROPERTY FROM THE WEST BORDER OF THE SITE: FRAMES 1 & 2.  
SITE NAME: MARINO PROPERTY LOCATION: MIDDLETOWN, CONNECTICUT  
FRAME NUMBER: 1 DATE: 10/31/90 TIME: 0925 SKY CONDITION: CLEAR  
PHOTO BY: ERIC FAHLE WITNESSES: MICHAEL LOMBARI,  
CAMERA: OLYMPUS SETTING: AUTOMATIC FILM TYPE: 35MM FILM ROLL: 35583

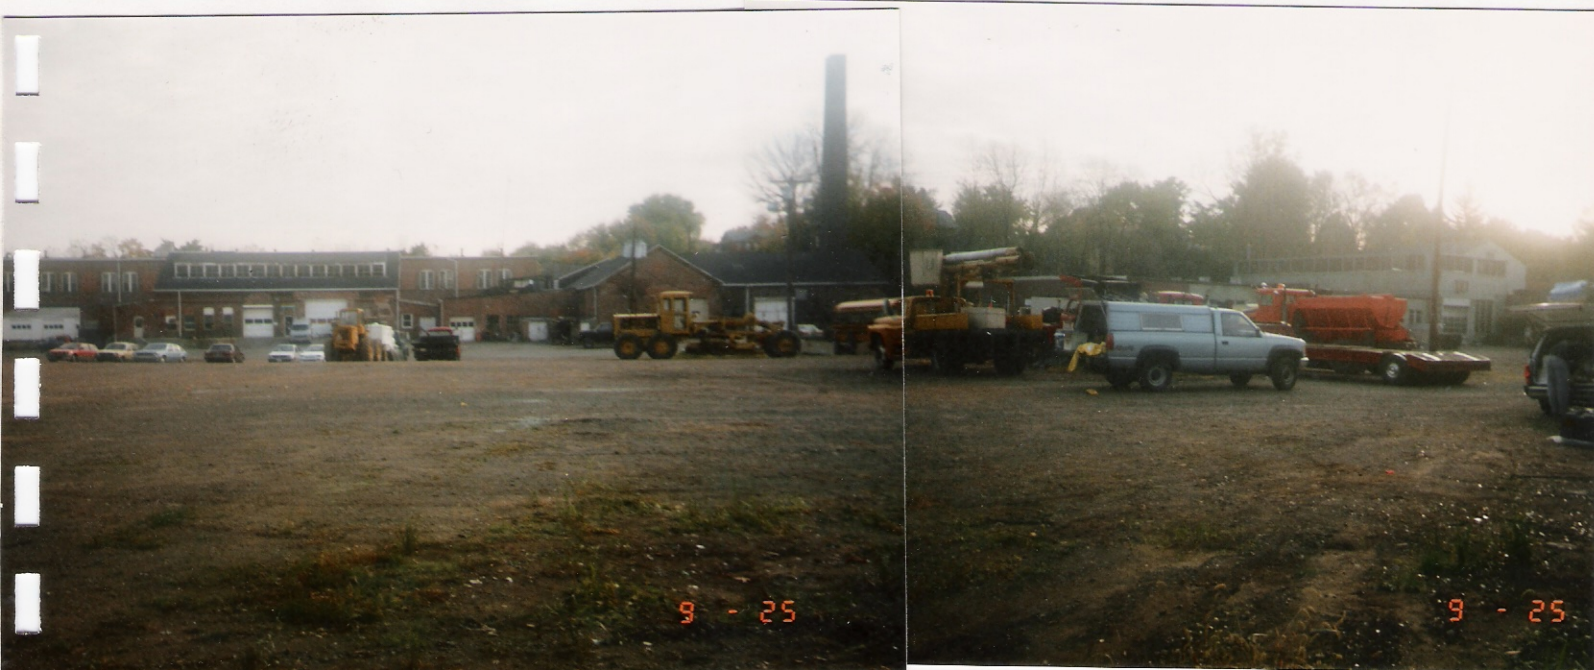
SCENE: MARINO PROPERTY FROM THE WEST BORDER OF THE SITE: FRAMES 3 & 4.  
SITE NAME: MARINO PROPERTY LOCATION: MIDDLETOWN, CONNECTICUT  
FRAME NUMBER: 3 DATE: 10/31/90 TIME: 0925 SKY CONDITION: CLEAR  
PHOTO BY: ERIC FAHLE WITNESSES: MICHAEL LOMBARI,  
CAMERA: OLYMPUS SETTING: AUTOMATIC FILM TYPE: 35MM FILM ROLL: 35583

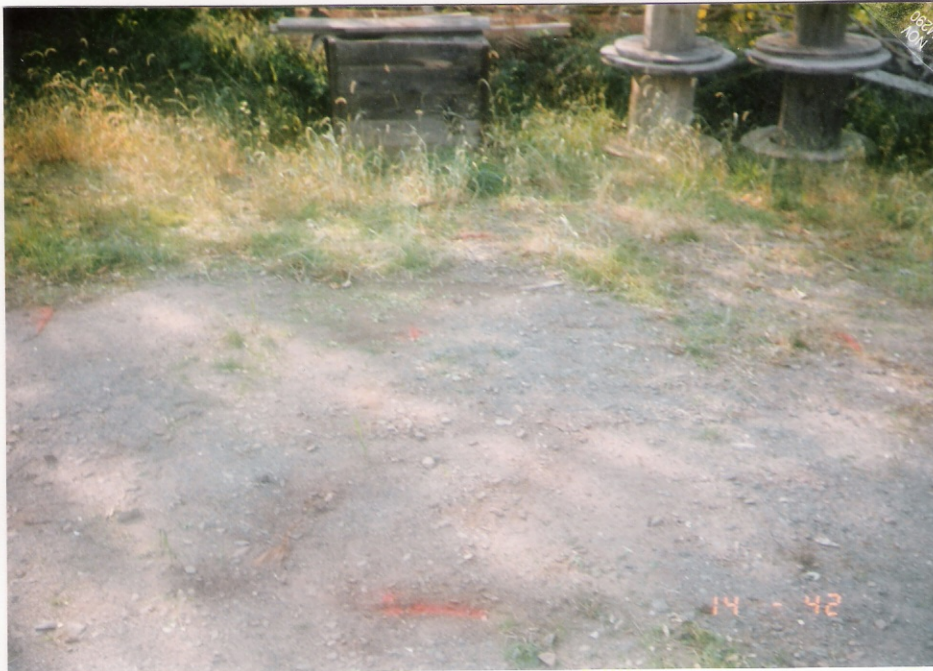
SCENE: LOCATION OF ELECTROMAGNETIC CONDUCTOR #2 AS INDICATED BY EM31-D.  
SITE NAME: MARINO PROPERTY LOCATION: MIDDLETOWN, CONNECTICUT  
FRAME NUMBER: 12 DATE: 11/01/90 TIME: 1442 SKY CONDITION: CLEAR  
PHOTO BY: ERIC FAHLE WITNESSES: MICHAEL LOMBARI,  
CAMERA: OLYMPUS SETTING: AUTOMATIC FILM TYPE: 35MM FILM ROLL: 35583

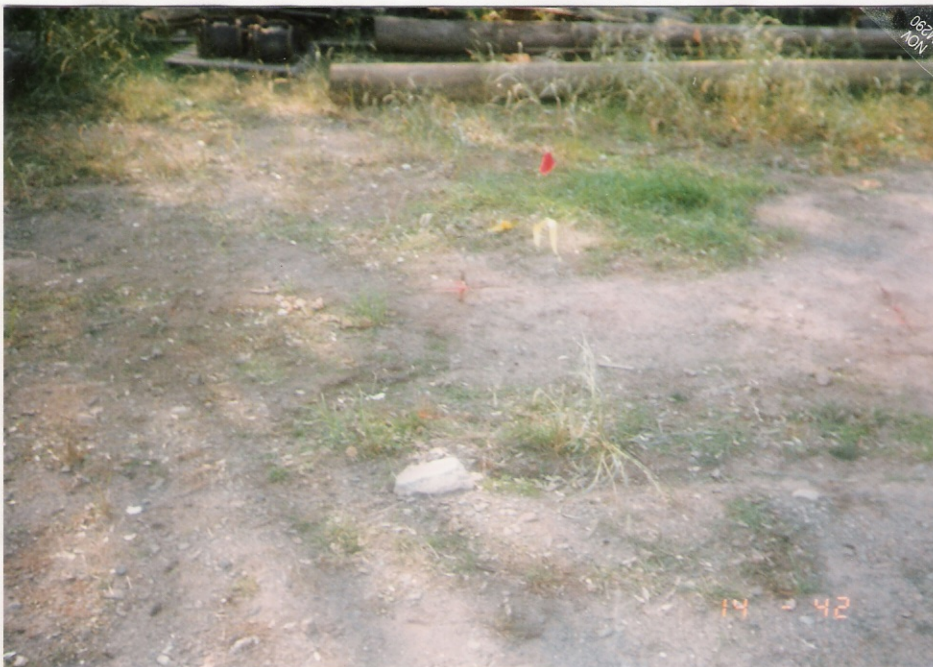
SCENE: LOCATION OF ELECTROMAGNETIC CONDUCTOR #3 AS INDICATED BY EM31-D.  
SITE NAME: MARINO PROPERTY LOCATION: MIDDLETOWN, CONNECTICUT  
FRAME NUMBER: 13 DATE: 11/01/90 TIME: 1442 SKY CONDITION: CLEAR  
PHOTO BY: ERIC FAHLE WITNESSES: MICHAEL LOMBARI,  
CAMERA: OLYMPUS SETTING: AUTOMATIC FILM TYPE: 35MM FILM ROLL: 35583

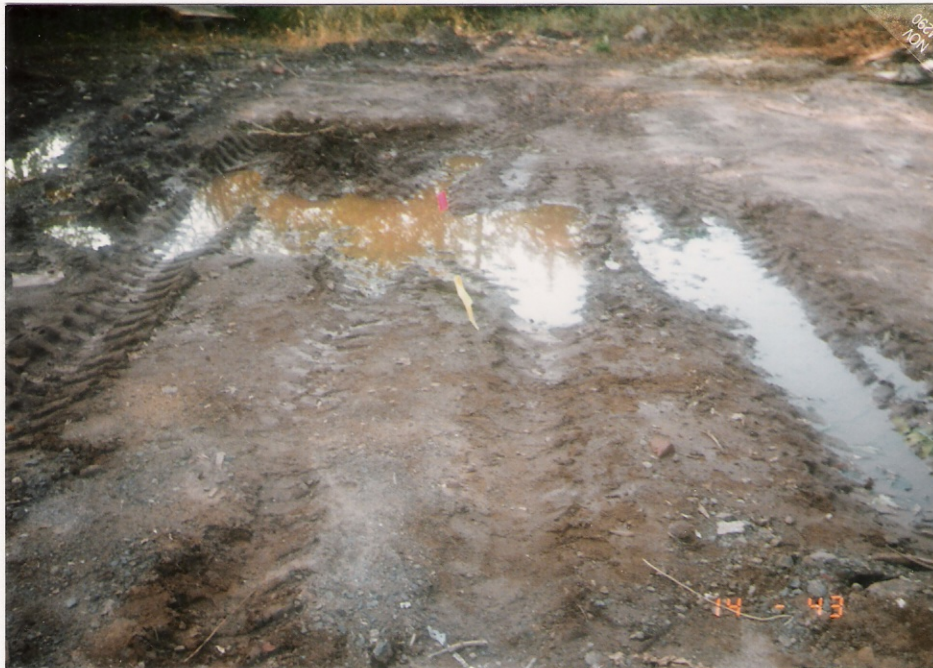
SCENE: LOCATION OF ELECTROMAGNETIC CONDUCTOR #4 AS INDICATED BY EM31-D.  
SITE NAME: MARINO PROPERTY LOCATION: MIDDLETOWN, CONNECTICUT  
FRAME NUMBER: 13 DATE: 11/01/90 TIME: 1442 SKY CONDITION: CLEAR  
PHOTO BY: ERIC FAHLE WITNESSES: MICHAEL LOMBARI,  
CAMERA: OLYMPUS SETTING: AUTOMATIC FILM TYPE: 35MM FILM ROLL: 35583

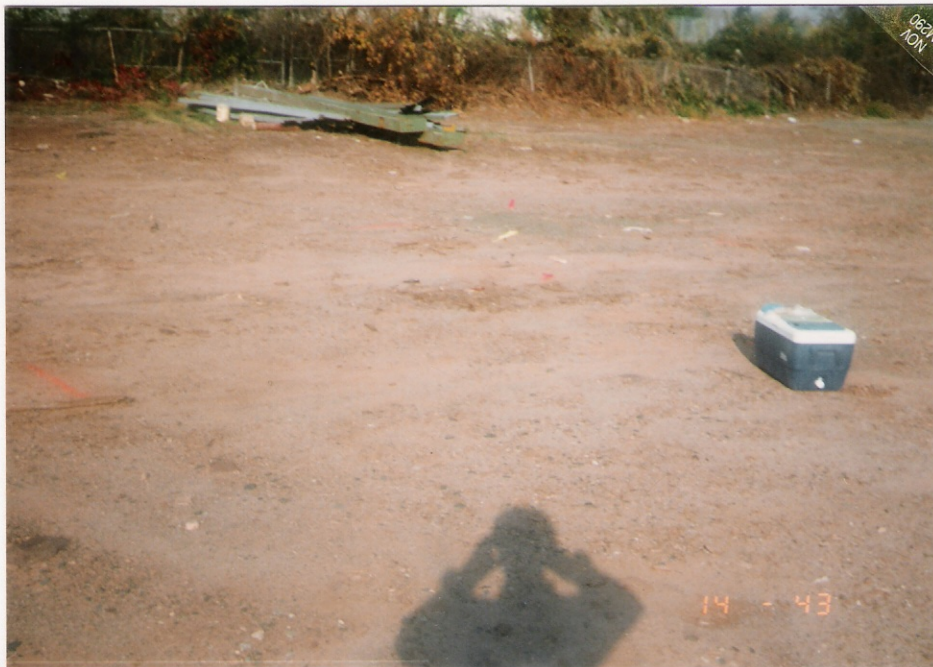
SCENE: LOCATION OF ELECTROMAGNETIC CONDUCTOR #5 AS INDICATED BY EM31-D.  
SITE NAME: MARINO PROPERTY LOCATION: MIDDLETOWN, CONNECTICUT  
FRAME NUMBER: 14 DATE: 11/01/90 TIME: 1443 SKY CONDITION: CLEAR  
PHOTO BY: ERIC FAHLE WITNESSES: MICHAEL LOMBARI,  
CAMERA: OLYMPUS SETTING: AUTOMATIC FILM TYPE: 35MM FILM ROLL: 35583

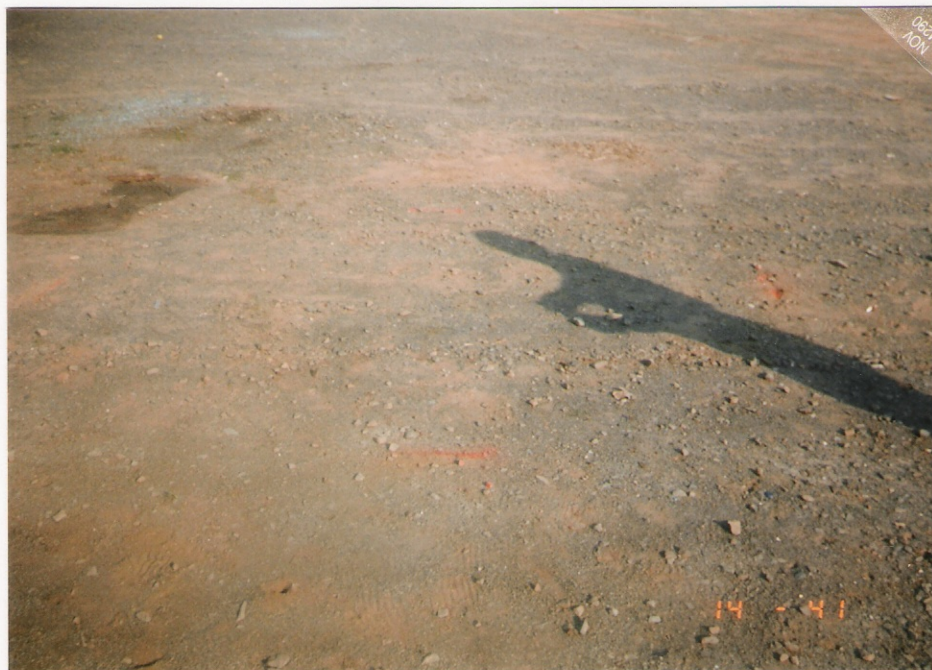
SCENE: LOCATION OF ELECTROMAGNETIC CONDUCTOR #6 AS INDICATED BY EM31-D.  
SITE NAME: MARINO PROPERTY LOCATION: MIDDLETOWN, CONNECTICUT  
FRAME NUMBER: 11 DATE: 11/01/90 TIME: 1441 SKY CONDITION: CLEAR  
PHOTO BY: ERIC FAHLE WITNESSES: MICHAEL LOMBARI,  
CAMERA: OLYMPUS SETTING: AUTOMATIC FILM TYPE: 35MM FILM ROLL: 35583

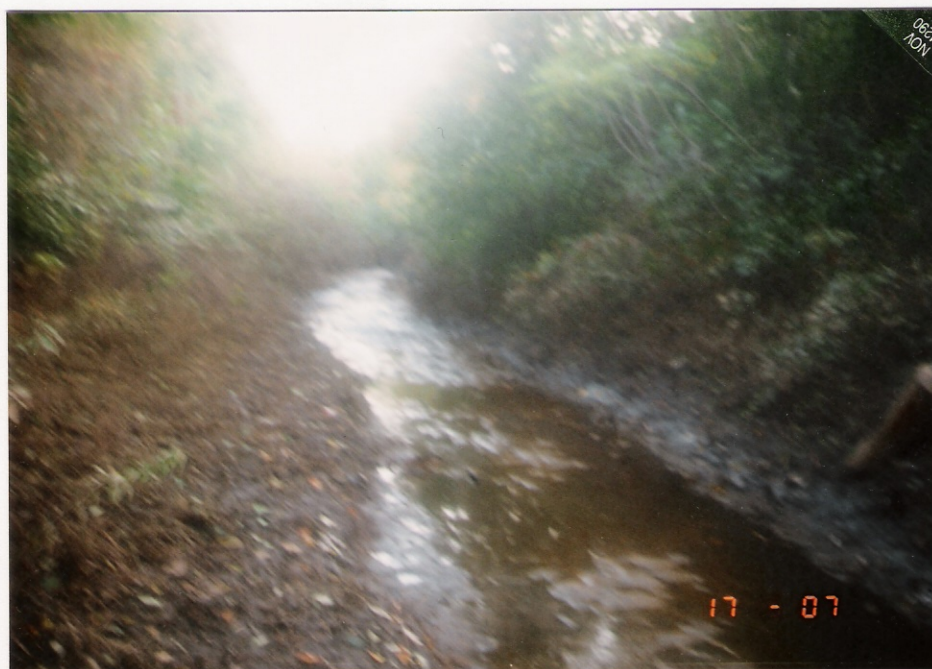
SCENE: VIEW OF THE STREAM THAT RUNS ALONG THE WEST BORDER OF THE PROPERTY  
SITE NAME: MARINO PROPERTY LOCATION: MIDDLETOWN, CONNECTICUT  
FRAME NUMBER: 16 DATE: 11/01/90 TIME: 1707 SKY CONDITION: CLEAR  
PHOTO BY: ERIC FAHLE WITNESSES: MICHAEL LOMBARI,  
CAMERA: OLYMPUS SETTING: AUTOMATIC FILM TYPE: 35MM FILM ROLL: 35583

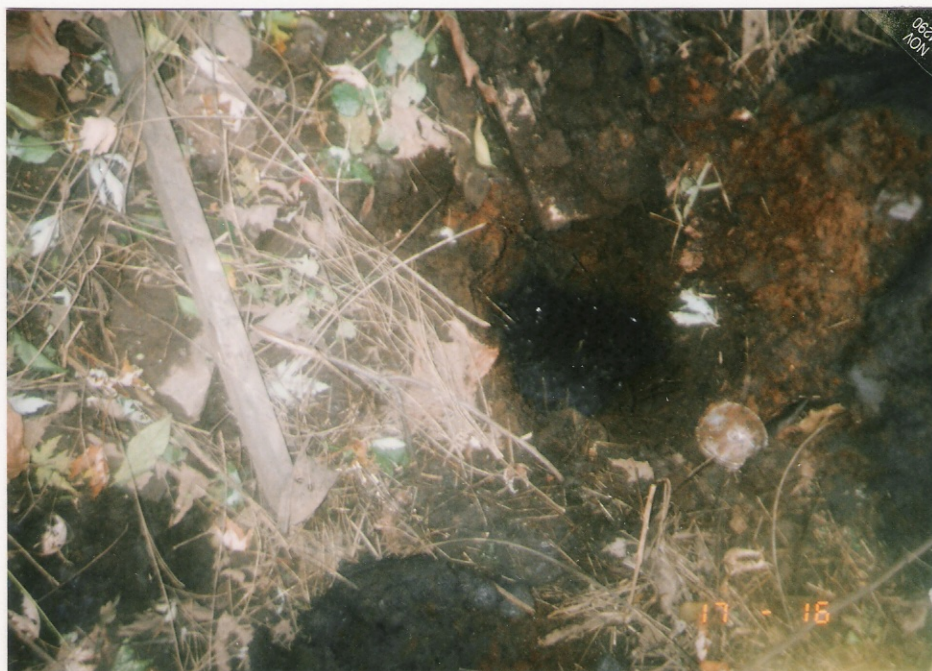
SCENE: VIEW OF COLLECTION LOCATION FOR SAMPLE #81624 AT THE STREAM EDGE.  
SITE NAME: MARINO PROPERTY LOCATION: MIDDLETOWN, CONNECTICUT  
FRAME NUMBER: 18 DATE: 11/01/90 TIME: 1716 SKY CONDITION: CLEAR  
PHOTO BY: ERIC FAHLE WITNESSES: MICHAEL LOMBARI,  
CAMERA: OLYMPUS SETTING: AUTOMATIC FILM TYPE: 35MM FILM ROLL: 35583

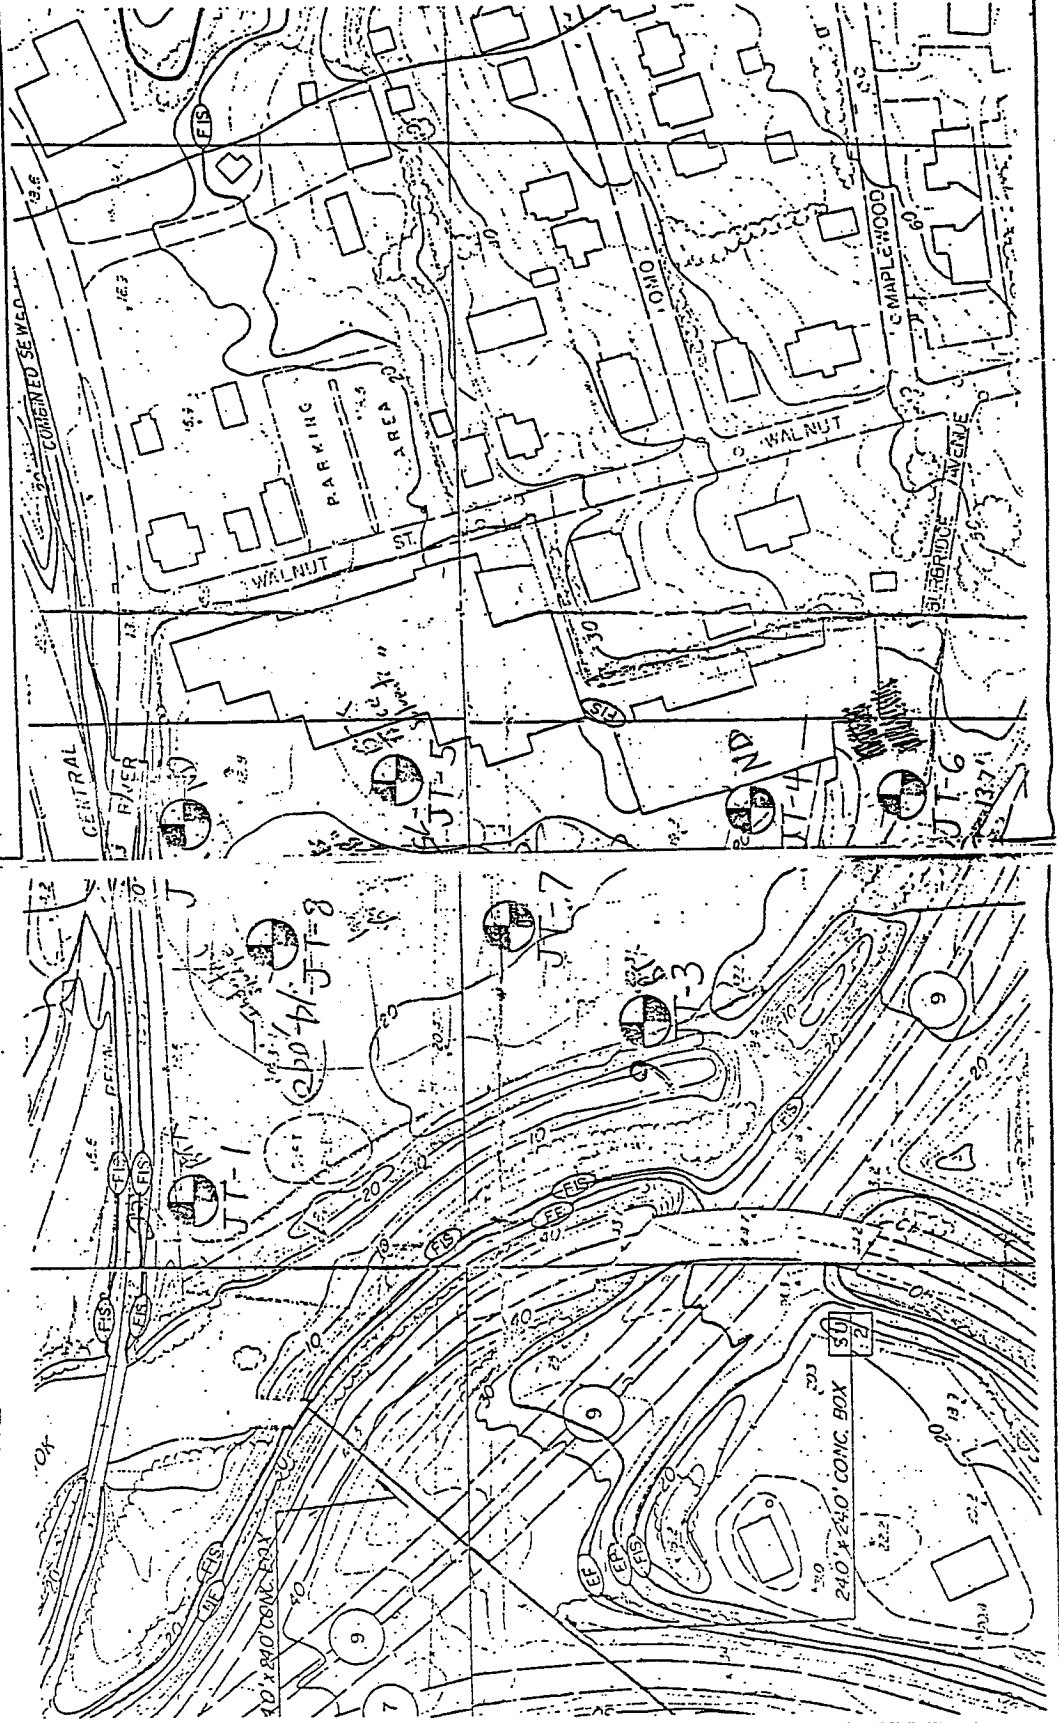
JOB 50 WALNUT ST. MIDDLETOWN, CT.  
 SHEET NO. \_\_\_\_\_ OF \_\_\_\_\_  
 CALCULATED BY \_\_\_\_\_ DATE 12/4/85  
 CHECKED BY \_\_\_\_\_ DATE \_\_\_\_\_  
 SCALE 1" = 100'
