**Subject: Incident Response Letter Report
Lexington Avenue Mercury
Pensacola, Escambia County, Florida
TDD No.: TNA-05-001-0104
Contract No.: EP-W-05-053**

LEXINGTON AVENUE MERCURY
PENSACOLA, ESCAMBIA COUNTY, FL

TDD No: TNA-05-001-0104

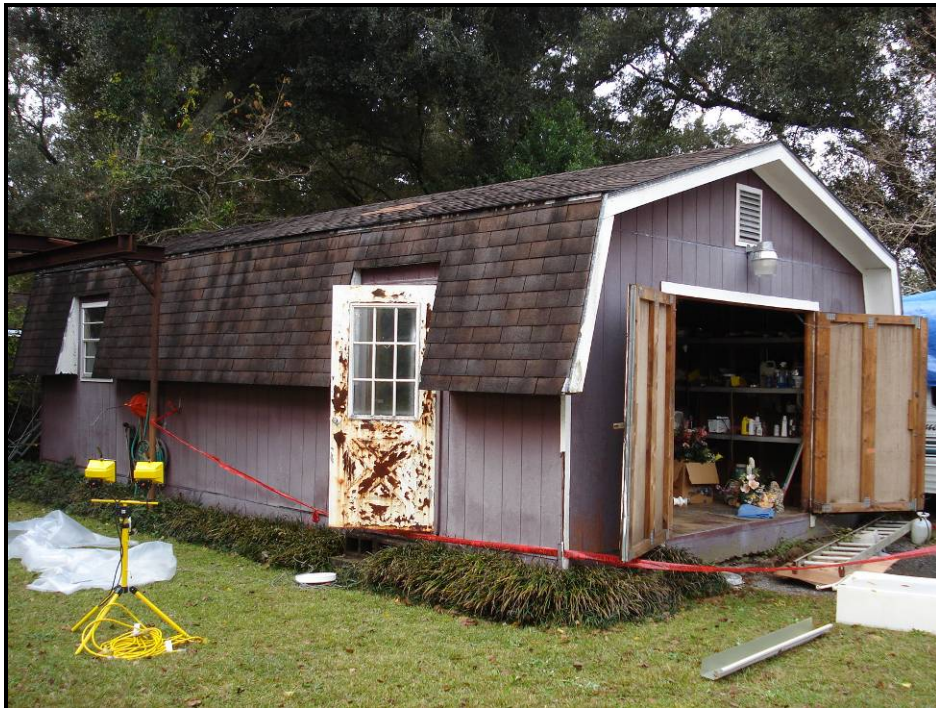
Official Photograph No. 2

Site Name: Lexington Avenue Mercury
Location: Pensacola, Escambia County, FL
Photographer: Ryan Stubbs, START
Subject: View of the shed where the mercury was discovered.

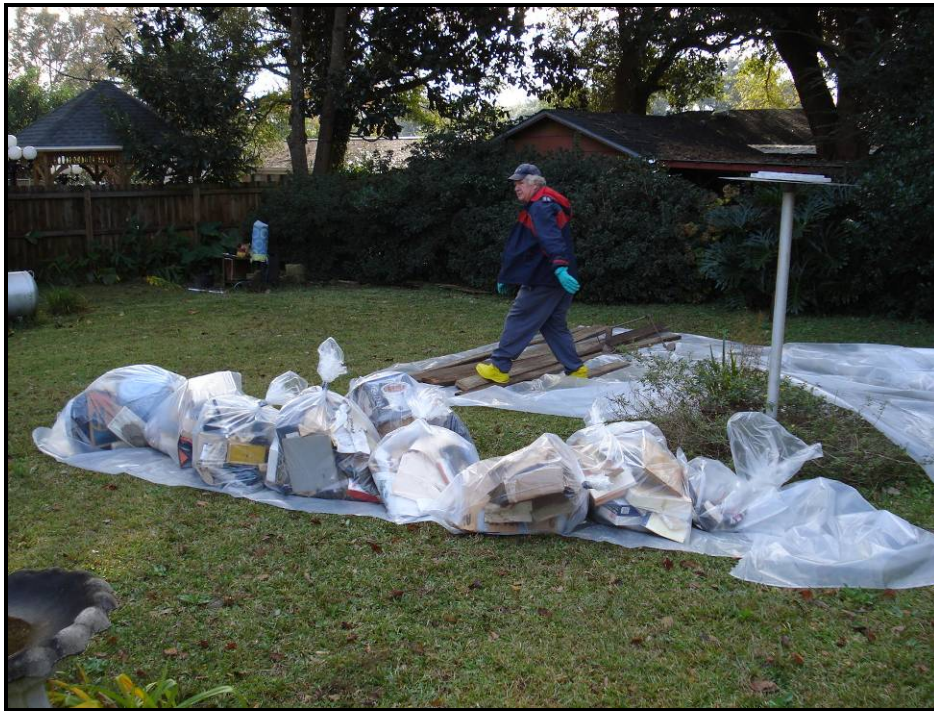
Official Photograph No. 3

Site Name: Lexington Avenue Mercury
Location: Pensacola, Escambia County, FL
Photographer: Ryan Stubbs, START
Subject: View of items removed from the shed.

Removal actions at the site included the segregation and removal of contaminated items, invasive measures including the removal of flooring and siding, heating/venting activities, and continual assessments of air quality. SWS was instructed by the EPA OSC to remove and bag the items found on the workbench due to elevated mercury readings identified inside the shed. SWS was also instructed to remove approximately half of the floor boards and approximately two thirds of the exterior wall boards on the east side of the shed. Once the impacted building materials were removed from the shed, SWS used a solution of water mixed with cupric sulfate and sodium thiosulfate to bind up the free mercury. The mixture was sprayed on the 2 inch by 6 inch (2x6) wood supports, 4 inch by 6 inch (4x6) beam, and the soil beneath the shed. Magnesium sulfate, also known as Epsom salt, was also used on the remaining floor boards and the soil beneath the shed to further bind up any remaining mercury. SWS removed approximately five 55-gallon drums of mercury-contaminated soil and Mondo grass (known as monkey grass), and filled nine polyurethane bags with miscellaneous items consisting primarily of cardboard boxes and books that had been in contact with the spilled mercury on the workbench. SWS handled the disposal of the all removed items, soil, and building materials. Laboratory analytical results of waste disposal samples will be submitted under separate cover to the EPA by SWS.

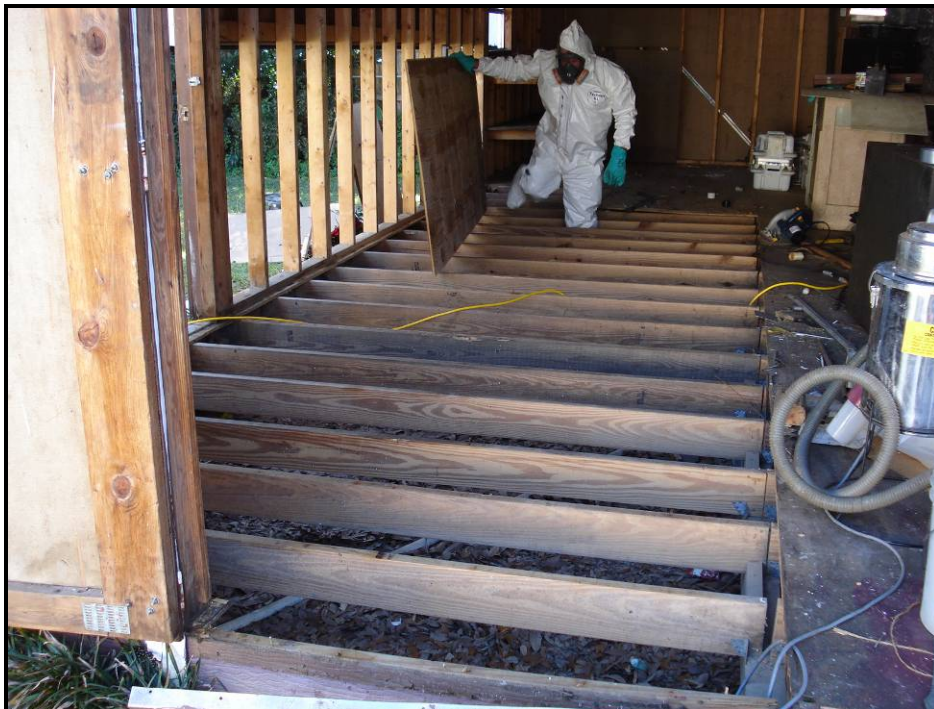
Official Photograph No. 4

Site Name: Lexington Avenue Mercury
Location: Pensacola, Escambia County, FL
Photographer: Ryan Stubbs, START
Subject: View of SWS removing floor boards from the shed.

0850 ERRS - Mike + START Studs
discussing how much flooring
to remove. One sheet wide
down to the window will
be removed + replaced. Same
with the exterior wall one
sheet from bottom down to
window will be removed +
replaced. RS

0935 ^{RS}ERRS ^{SWS}Harry done vacuuming
the floor + beginning to
remove floorboards. RS
START took readings with
Lumex in breathing zone
and got up to 4,600 ng/m³.
Got 750,000 on the exterior
where mercury exited the
shed into the monkey grass.

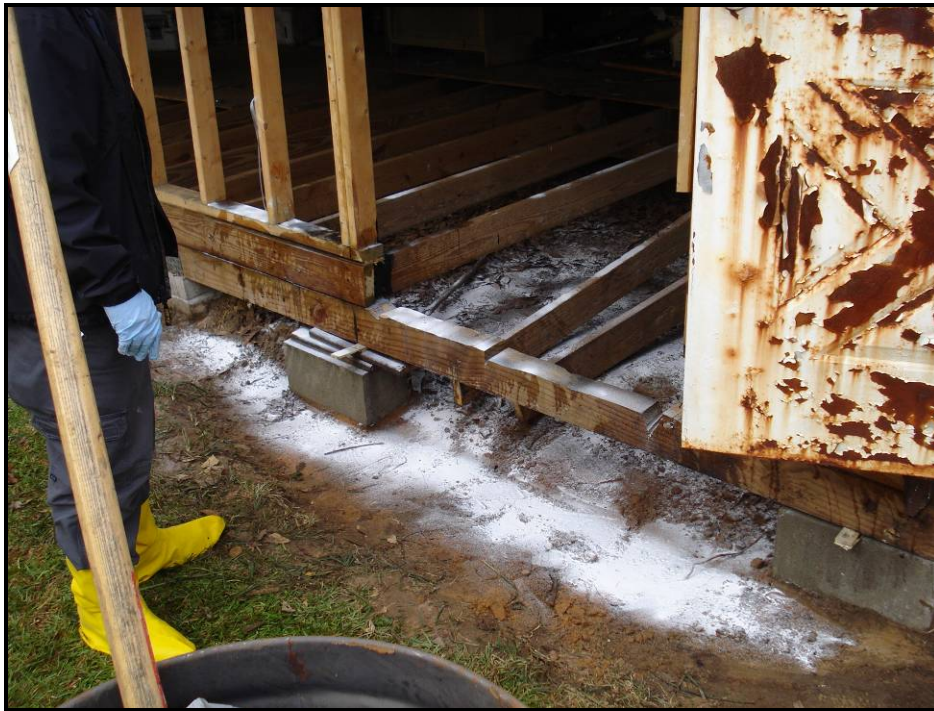
Official Photograph No. 5

Site Name:	Lexington Avenue Mercury	Date:	December 17, 2009
Location:	Pensacola, Escambia County, FL	TDD No:	TNA-05-001-0104
Photographer:	Ryan Stubbs, START		
Subject:	View of Epsom salt on the soil beneath the shed.

- 0700 Weather: 48°F + cloudy
- 0720 START Stubbs on site. OSC-Russell and SWS already on site ready to resume activities.
- 0730 START + OSC screened hot zone of shed and all readings were below 4,000 ng/m³ except one hot spot of 28,000 that was most likely do to the poly drop sheet + brush that was used yesterday. More Cupric Sulfate solution which was earlier referred to as Copper Sulfate was sprayed on the wood framing. Sodium Thiosulfate is also in the solution and gives the solution a blackish tint. Epsom Salt (photo of bag) was also sprinkled on top of the soil to bind up to remaining Hg.
- 0745 STARTS Heating shed.

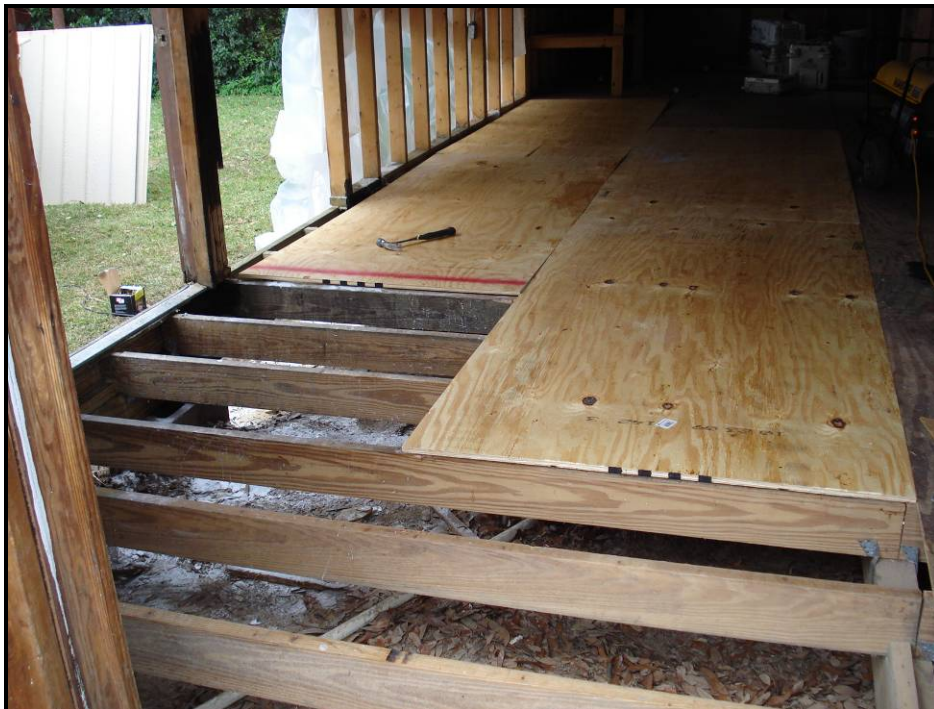
Official Photograph No. 6

Site Name:	Lexington Avenue Mercury	Date:	December 17, 2009
Location:	Pensacola, Escambia County, FL	TDD No:	TNA-05-001-0104
Photographer:	Ryan Stubbs, START		
Subject:	View of newly installed floor boards in the shed.

- 1050 START Stubbs headed to hotel to get package (Lumex filters, PPE) that was sent by GZ.
- 1154 START back on site. SWS installed new plywood floor boards in the shed.
- 1230 Lunch RS
- 1300 Resuming activities, SWS putting wall boards on shed.
- 1310 Turned off heaters in shed and allowing shed to cool off for another screening.
- 1320 SWS nailing down floorboards.
- 1350 Shut the doors to shed and letting it set before screening. All the ext. wall boards and floor boards have been replaced.
- 1405 START + OSC changed filters on Lumex (both units: one EPA unit + SWS's unit).
Units "on stream" + on charge.
- 1425 Baseline test on Lumex Unit #834, R% = 11.
- 1425 Weather: Cold ($\approx 45^{\circ}\text{F}$) + raining.

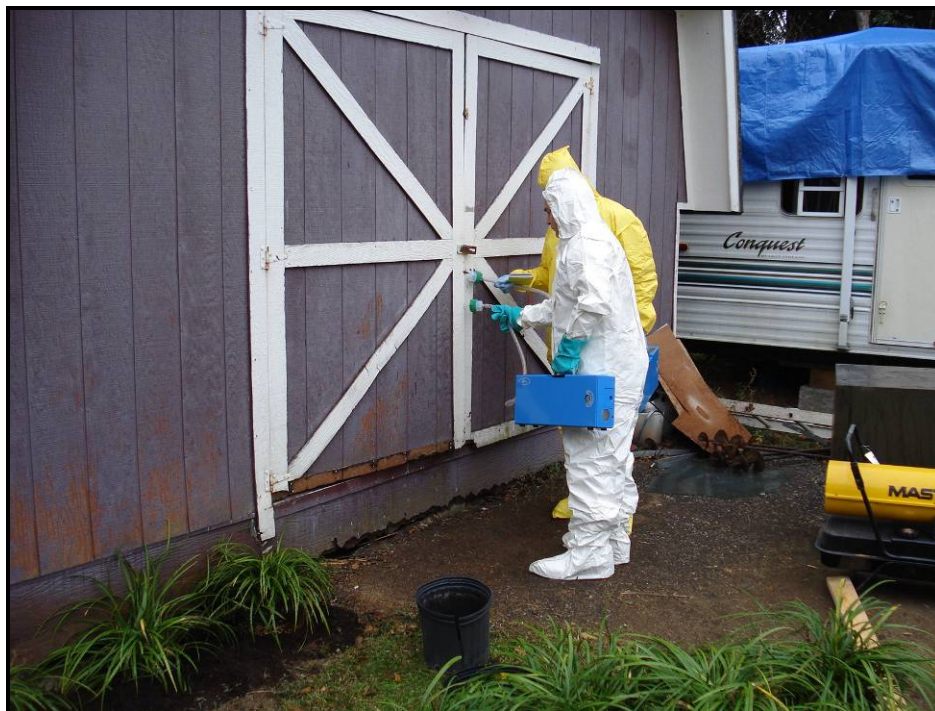
Official Photograph No. 7

Site Name:	Lexington Avenue Mercury	Date:	December 17, 2009
Location:	Pensacola, Escambia County, FL	TDD No:	TNA-05-001-0104
Photographer:	SWS		
Subject:	View of START and OSC screening the shed for mercury vapors.

Heating/venting procedures were performed on the shed prior to confirmation screening. Confirmation screening was conducted in the shed over a period of 6.5 hours. With the doors shut and polyurethane plastic over the 2 foot by 3 foot opening in the back wall, the air space within the shed was allowed to settle for 30 minutes then the area was heated for 15 minutes using a space heater. The air space within the shed was then again allowed to settle for 15 minutes prior to each set of confirmation screenings using the Lumex[®] MVA. The ambient temperature inside the shed was maintained in a range of 70-75 degrees Fahrenheit throughout the confirmation screening process. Five locations in the shed (near the four corners and center of the shed) were established as confirmation screening locations. A total of six sets of screenings were conducted over the 6.5 hour confirmation screening process. A 30-second average reading was collected using the Lumex[®] MVA at each of the five designated screening locations and those five were then averaged. An overall average was calculated from the six sets of readings. The

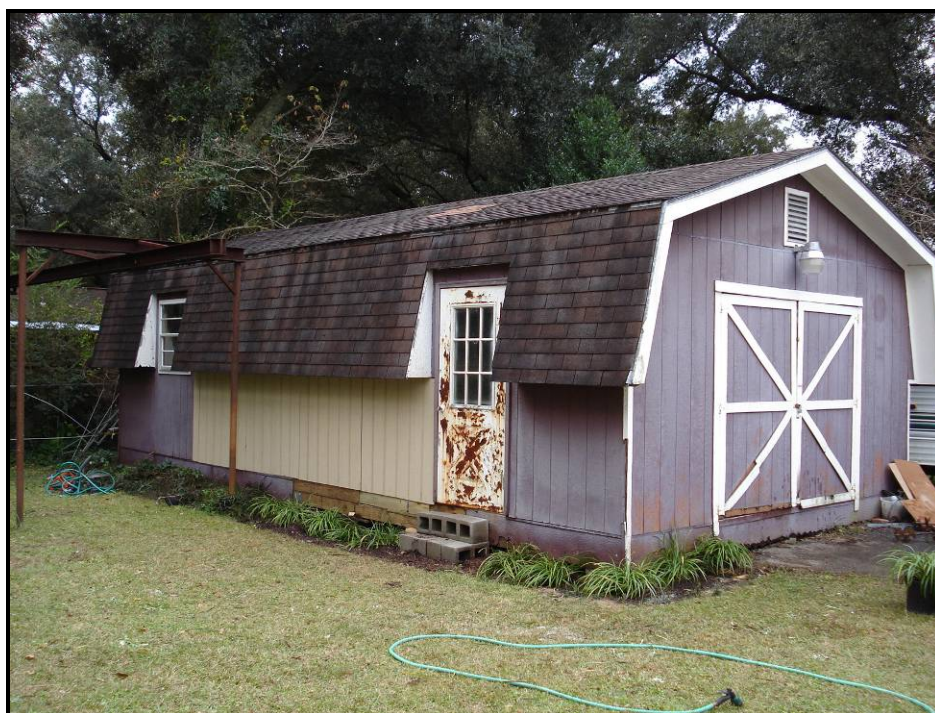
Official Photograph No. 8

Site Name:	Lexington Avenue Mercury	Date:	December 18, 2009
Location:	Pensacola, Escambia County, FL	TDD No:	TNA-05-001-0104
Photographer:	Ryan Stubbs, START		
Subject:	View of shed following confirmation screening and restoration.

overall average of the confirmation screening was 1,399 ng/m³, which was well below the site specific action level of 10,000 ng/m³. The confirmation screening readings are presented in Attachment C. Upon completion of the confirmation screening, OTIE START demobilized from the site at approximately 1600 CST on December 18, 2009.
