**Subject: Incident Response Letter Report  
Severn Peanut Company Fire  
Severn, North Hampton County, North Carolina  
TDD No.: TNA-05-001-0091  
Contract No. EP-W-05-053**

SEVERN PEANUT COMPANY FIRE  
SEVERN,  
NORTH HAMPTON COUNTY,  
NORTH CAROLINA  
TDD No: TNA-05-001-0091

**ATTACHMENT C**  
**Photographic Log**

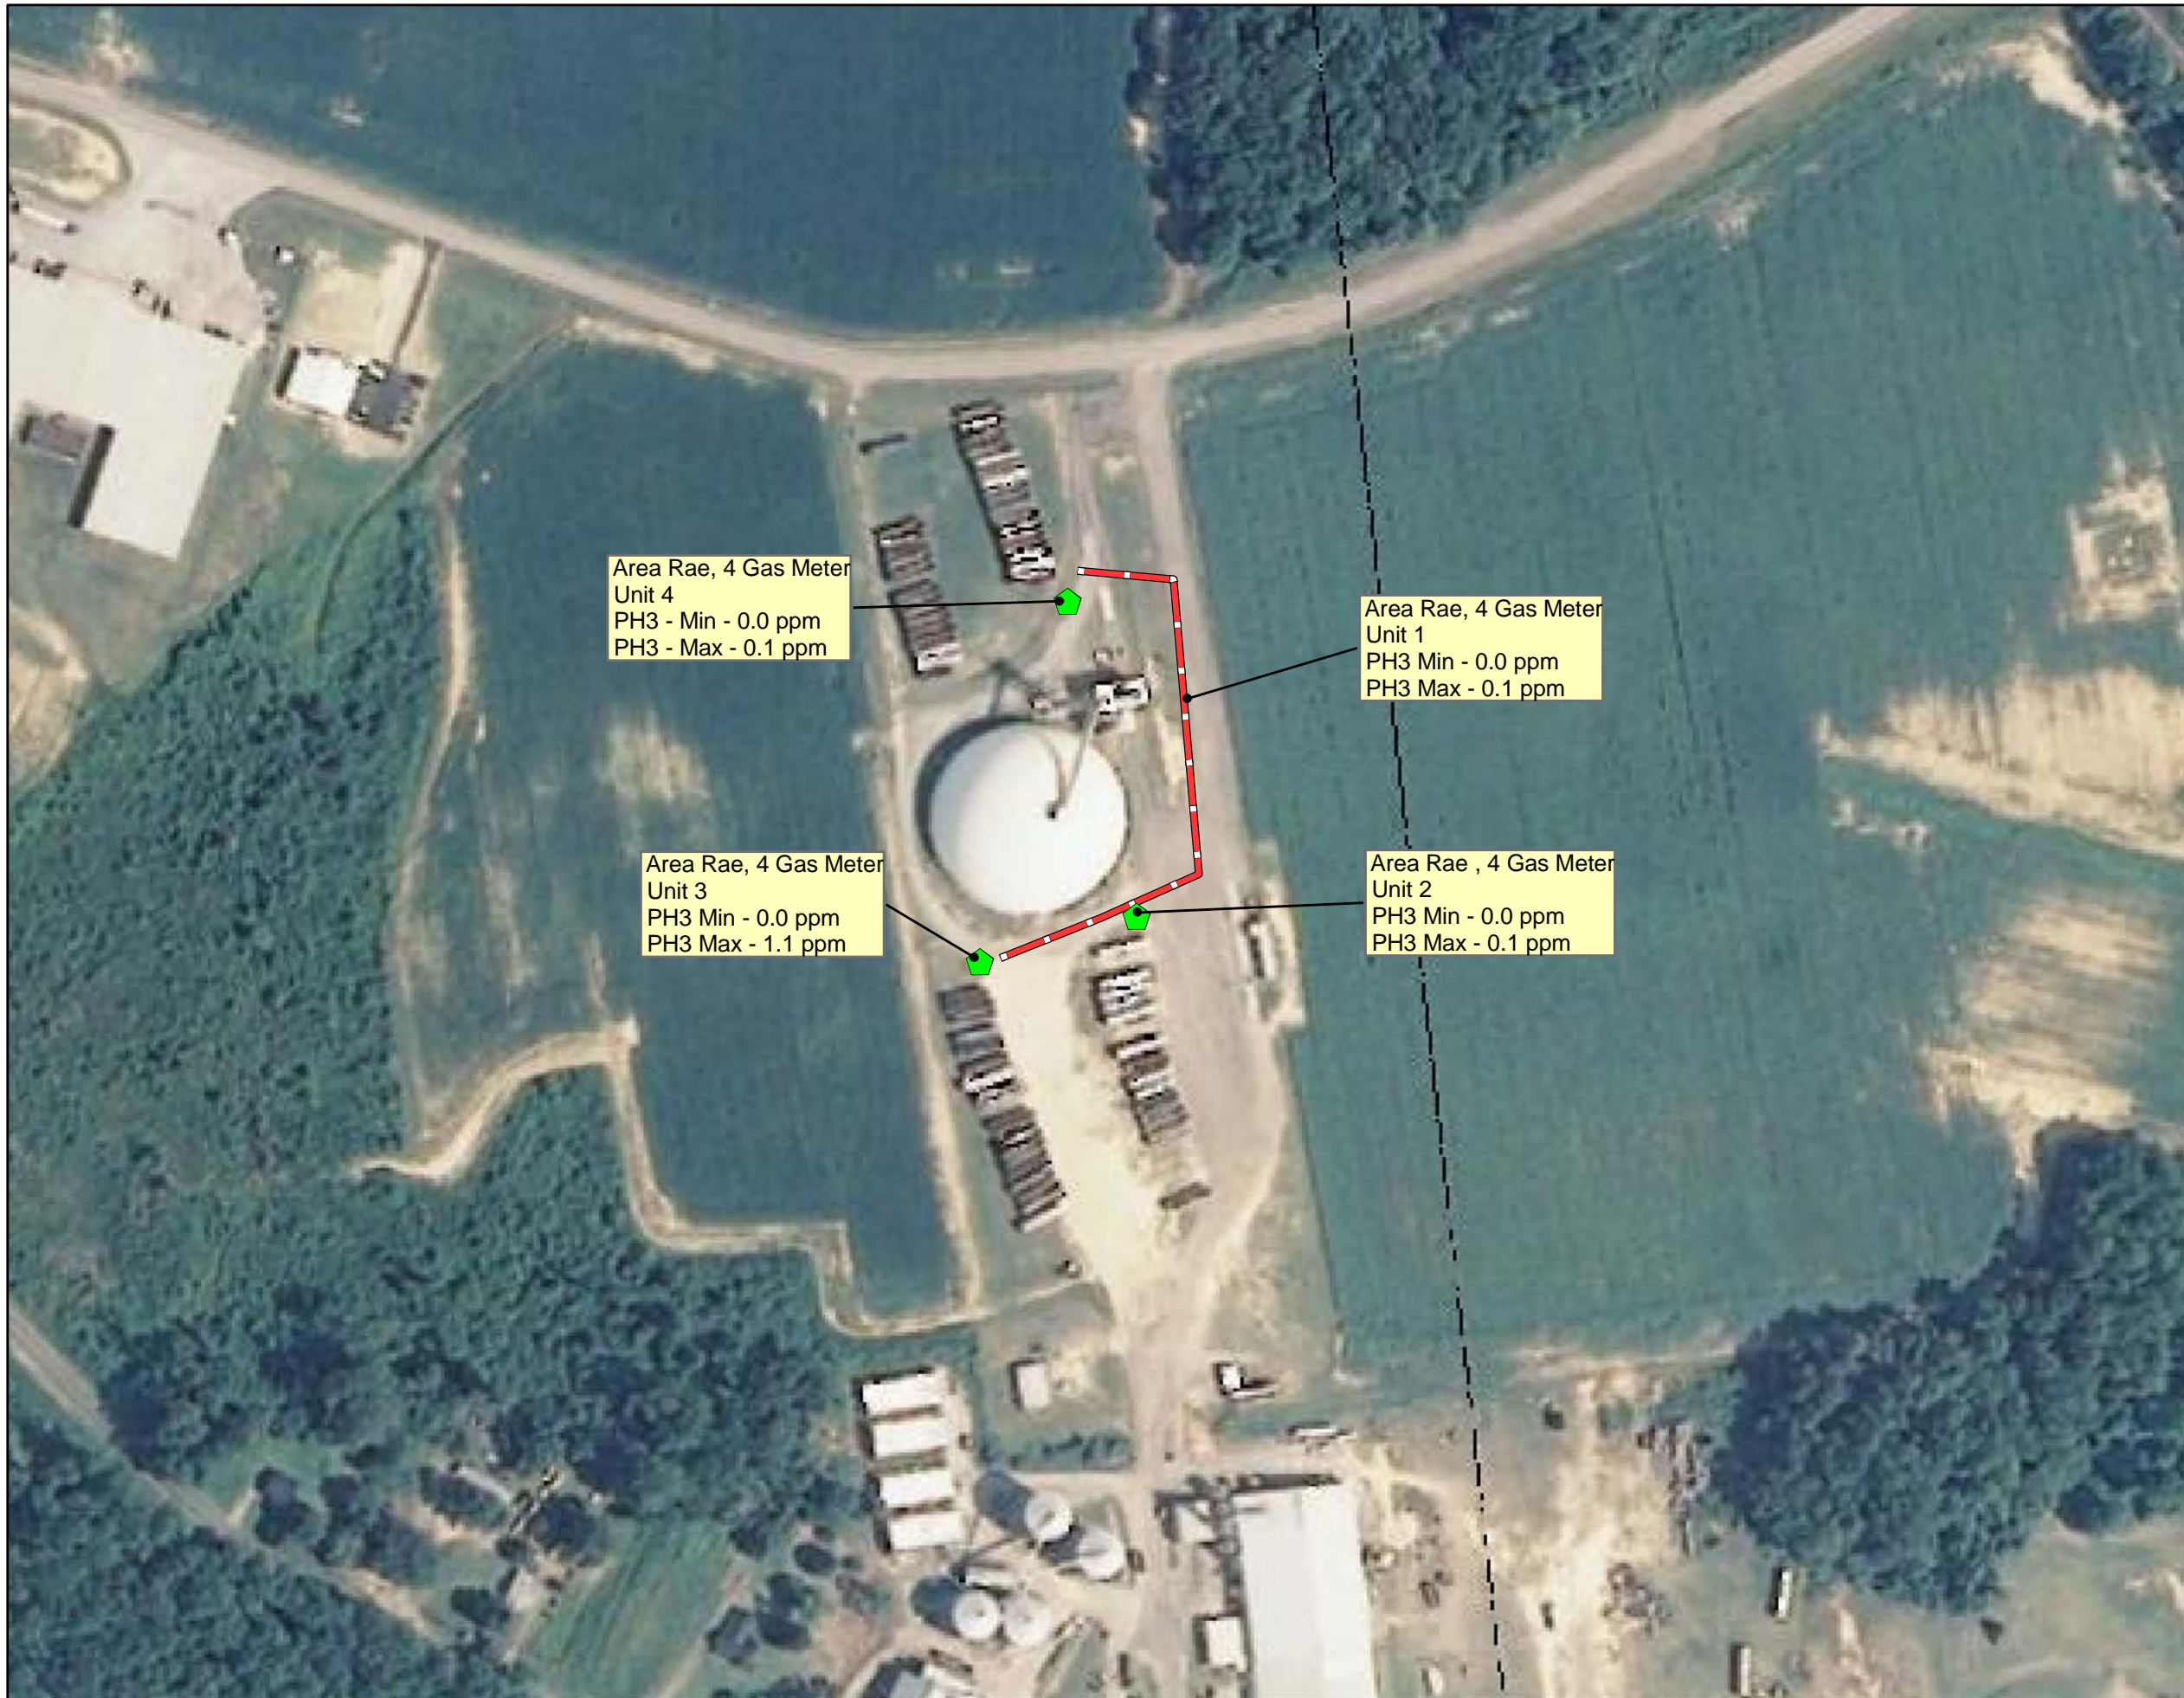
**FIGURE 4**  
**MOBILE AND STATIONARY**  
**AREA RAE LOCATIONS**

Readings taken on 08/16/09

EPA and START began air monitoring activities around the perimeter of the dome using the AreaRAEs. No elevated levels of phosphine were detected outside the dome. Interior levels of phosphine attained using the tube extending into the dome continued to drop. A crew consisting of two members from IFC and one START member traveled to the top of the dome in level B personal protective equipment (PPE) to perform a reconnaissance of the “nut house”, which is the structure on top of the dome where the plate opens up into the dome. START brought an AreaRAE, a camera, and a thermocouple to attain information regarding the characteristics of the atmosphere within the dome. IFC brought additional tubing to lower equipment down the hatch and obtain phosphine readings. During the time the crew members were in the “nut house”, phosphine levels were on the order of 10 ppm, with a maximum of 17 ppm and a minimum of 4 ppm at the door. CO maxed out at 1,500 ppm. It was noted on the AreaRAE sensor sheets that for every 50 ppm of CO present, phosphine levels may have been inaccurately detected at 1 ppm. Once the crew descended from the top of the dome, data from the AreaRAE was downloaded and saved. The AreaRAE readings are provided as Attachment B.

The EPA OSC and START personnel set up three AreRAEs along a 50' perimeter surrounding the dome. Two units were placed downwind, and one unit upwind where ground support teams were staged. The fourth unit was attached to the EPA vehicle and was operated as a mobile unit. A weather station, with wind vein, was also attached to the vehicle. A wind sock was placed at the top of the tower by EPA and START for all responders to view during operations.

extreme cooling of the conveyor system by the dry ice. Once the operations were complete, the plate was replaced and sealed until the morning of August 17, 2009. During operations, downwind AreaRAE (number 3) reached a maximum value of 0.7 ppm for phosphine. A Draeger® tube reading was taken next to the unit, and no elevated readings were indicated. The mobile unit was driven in accordance with wind direction, and no additional elevated readings were attained.

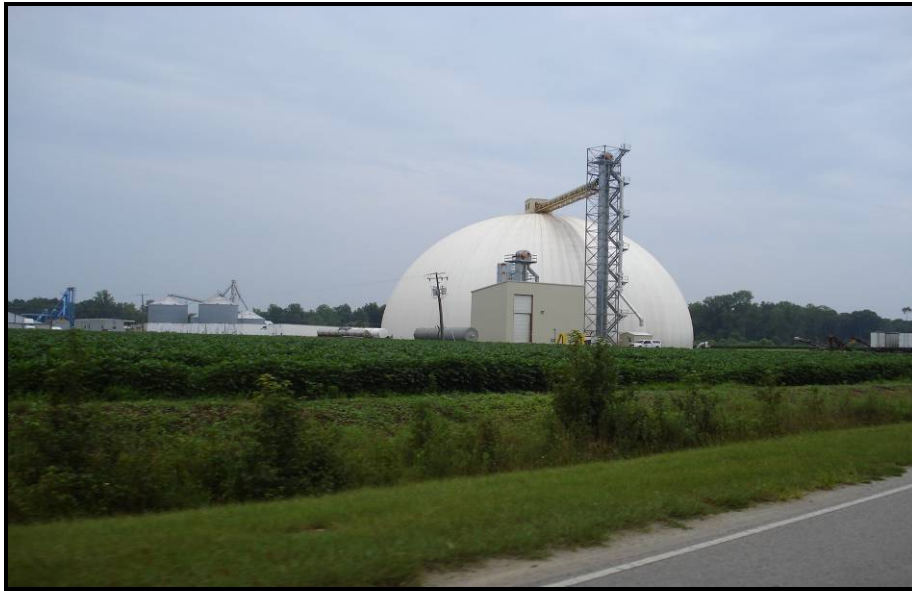
**Photograph No.: 1**

**Subject:** Severn Peanut Company dome. The silo holds 21 million pounds of peanuts.

Severn Peanut Company houses the largest dome silo of its kind in the country. The dome is 192 feet (‘) in diameter by 100’ high. The walls of the dome are constructed with 22 inch (”) thick concrete at the base, tapering to 10” thick at the top. Within the concrete there is 3” thick R19 insulation and a membrane roof on the exterior. The silo holds a total of 21 million pounds of peanuts, which occupy an

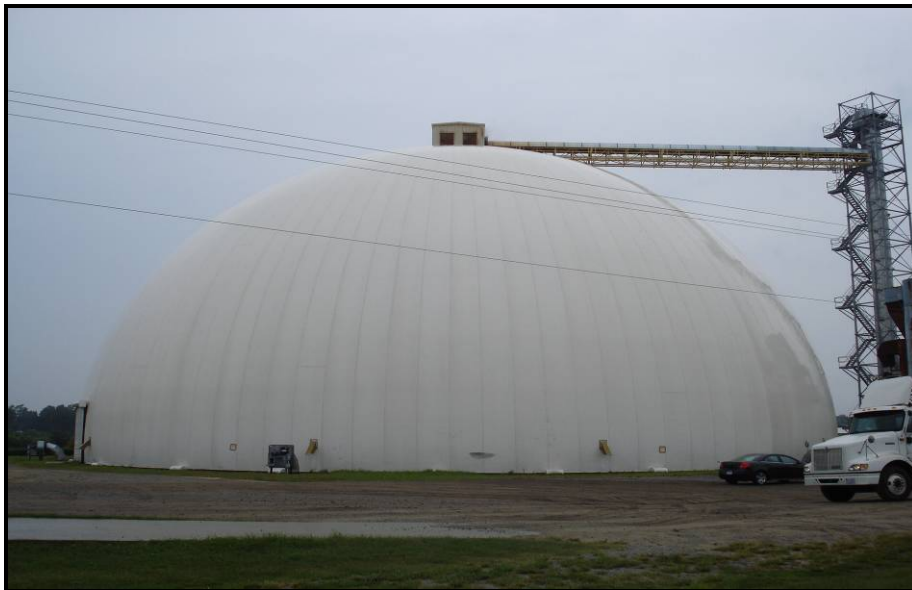
**Photograph No.: 2**

**Subject:** Severn Peanut Company dome. The silo holds 21 million pounds of peanuts.

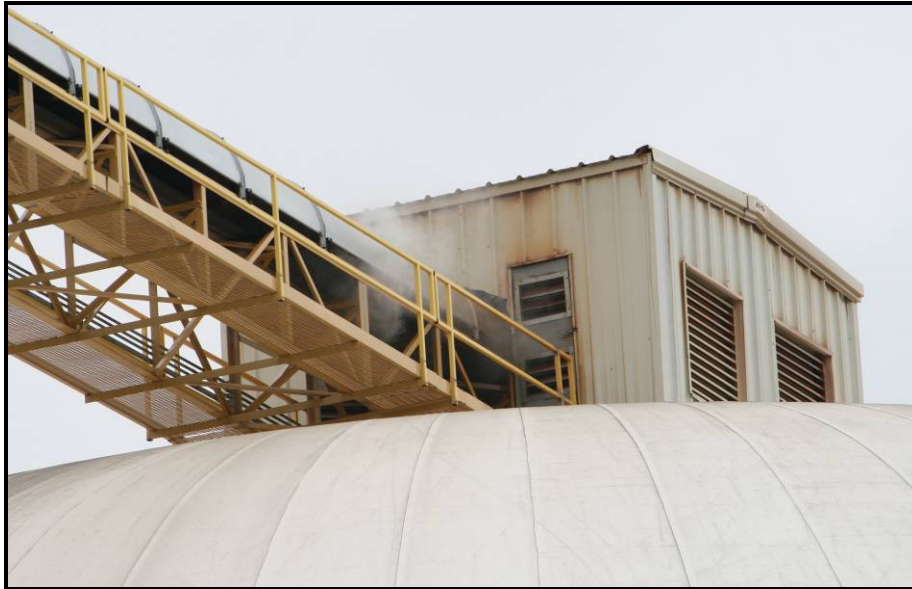
**Photograph No.: 3**

**Subject:** Severn Peanut Company dome. Smoke from the "nut house".

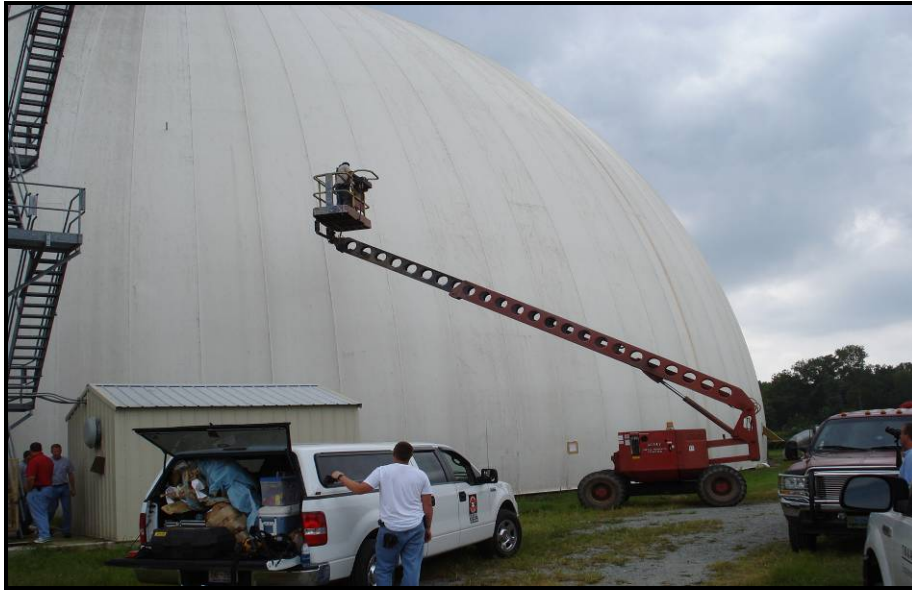
**Photograph No.:** 7

**Subject:** Installation of sampling tubing.

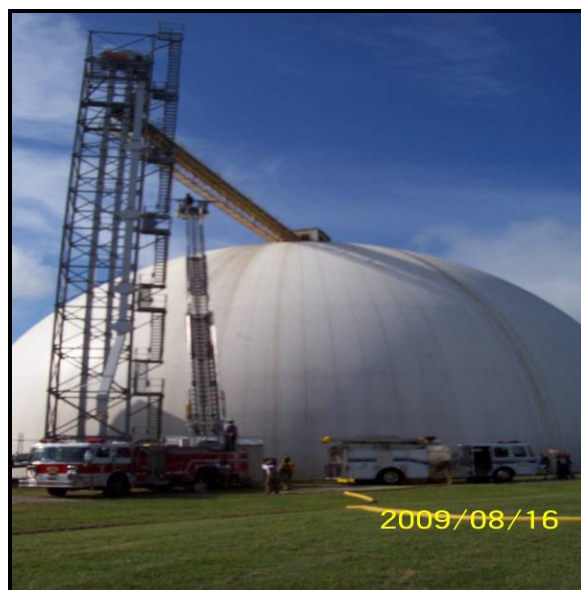
**Photograph No.: 12**

**Subject:** First Responders removing dome plate, obtaining temperature readings, installing thermo couplers and recording air quality readings from AreaRaes.

Prior to the entry team's ascent to the top, Draeger® readings were taken from the tube descending into the dome. Phosphine readings were approximately 1.5 ppm. The team, composed of three Williams Fire Specialists, traveled to the dome house in full turn out gear and supplied air. They carried the QRAE monitoring device with them. Once in the dome house, the team removed the plate from the floor of the dome, obtained temperature readings with a thermocouple cable, and collected air quality readings with the QRAE. Phosphine levels reached a maximum value of 4 ppm, with CO reaching 350 ppm. The team completed the entry and began their descent within approximately 20 minutes.

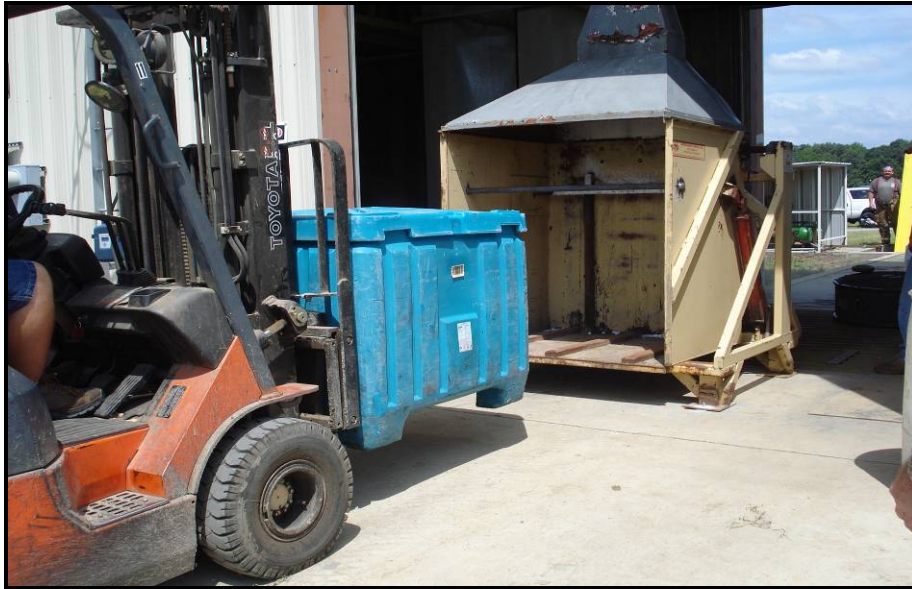
**Photograph No.: 13**

**Subject:** Addition of 76,000 pounds of dry ice for fire suppression.

Plant personnel began dry ice operations after the entry crew safely reached the ground. A 4-gas meter was given to the operator of the conveyor system to ensure adequate oxygen levels. A total of 76,000 lbs of dry ice were loaded into the dome by 1900 hrs. A 2 minute delay between loads was applied due to

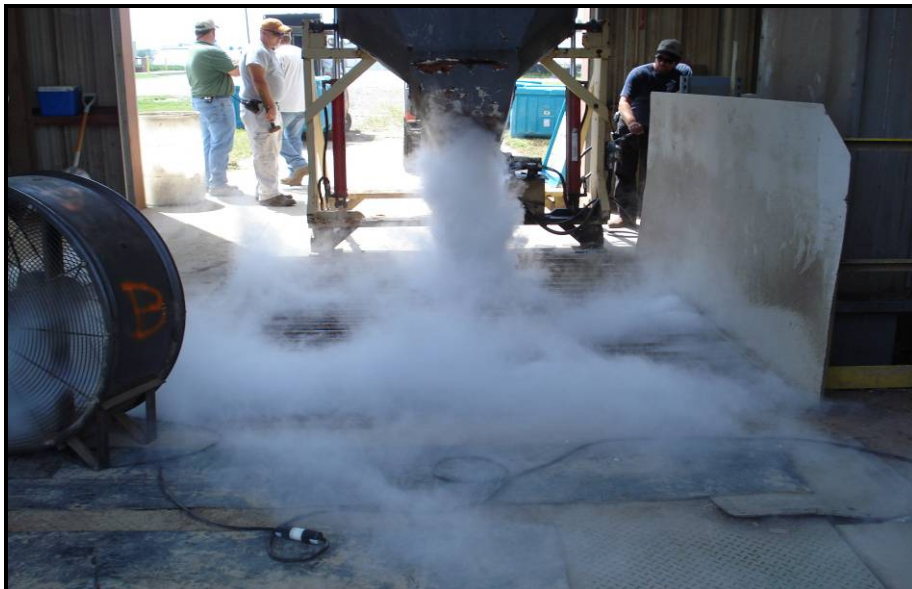
**Photograph No.: 14**

**Subject:** Addition of 76,000 pounds of dry ice for fire suppression.
