SUBJECT: Report Transmittal, Geophysical Investigation, Crowder's Mountain Drum Site, Kings Mountain, Cleveland County North Carolina; SESD Project No. 10-0098

Report
Geophysical Investigation
Crowder's Mountain Drum Site
Kings Mountain, Cleveland County, North Carolina
Dates of Investigation: November 16-17, 2009

Title: Report, Geophysical Investigation, Crowder's Mountain Drum Site,
Kings Mountain, Cleveland County, North Carolina
SESD Project ID: 10-0098

Document Type: Investigation Final Report

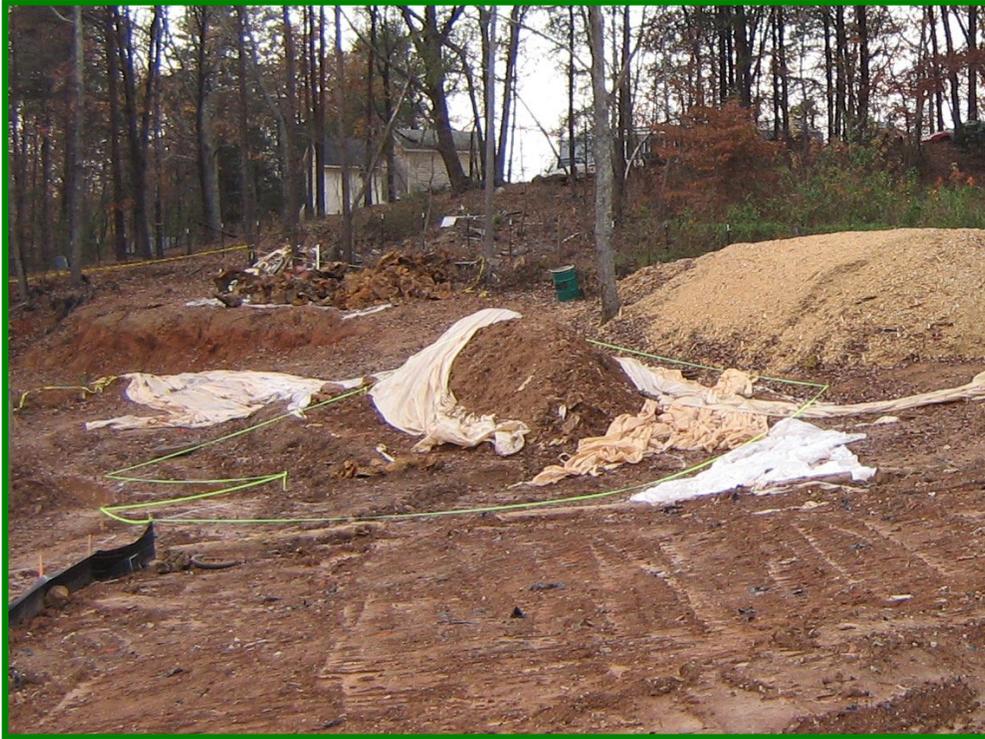
*West Area Anomaly (Green Flagging)
Crowder's Mountain Drum Site*

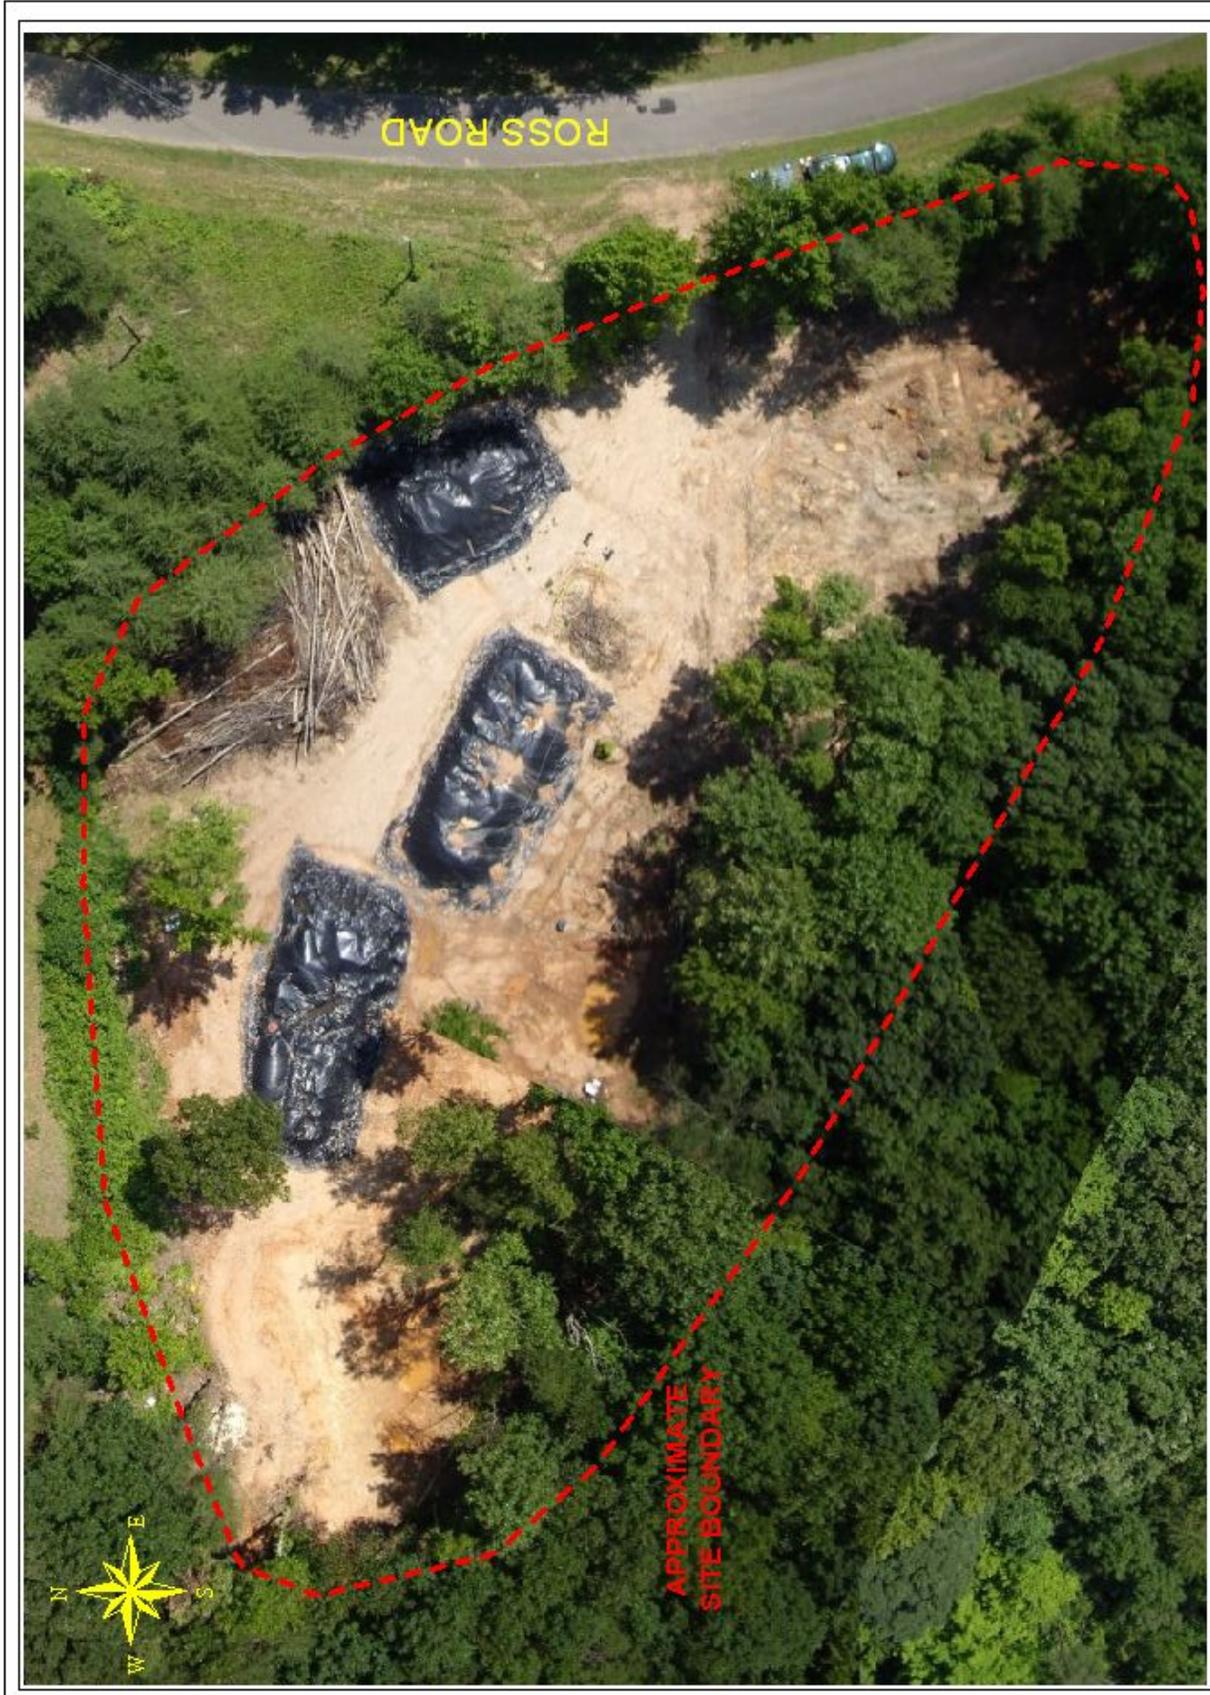
Figure 2
Site Map
Crowder's Mountain Drum Site
Kings Mountain, Cleveland County, North Carolina

In the summer of 2009, Region 4 USEPA, Emergency Response and Removal Branch began the clean-up of the Crowder's Mountain Drum Site. Figure 2, Site Map, depicts the site as of August 2009. The site was cleared and numerous drums were excavated, many in poor condition, as well as quantities of soil contaminated with various solvents and paint waste. After initiation of the removal, it was determined by the On-Scene Coordinator that further investigation, to more precisely define the areas containing buried drums, was warranted. At this point, the removal activities were suspended and SESD was contacted regarding conducting a geophysical investigation to provide more detailed information with respect to the locations of additional buried drums at the site. This report details the findings of this investigation.

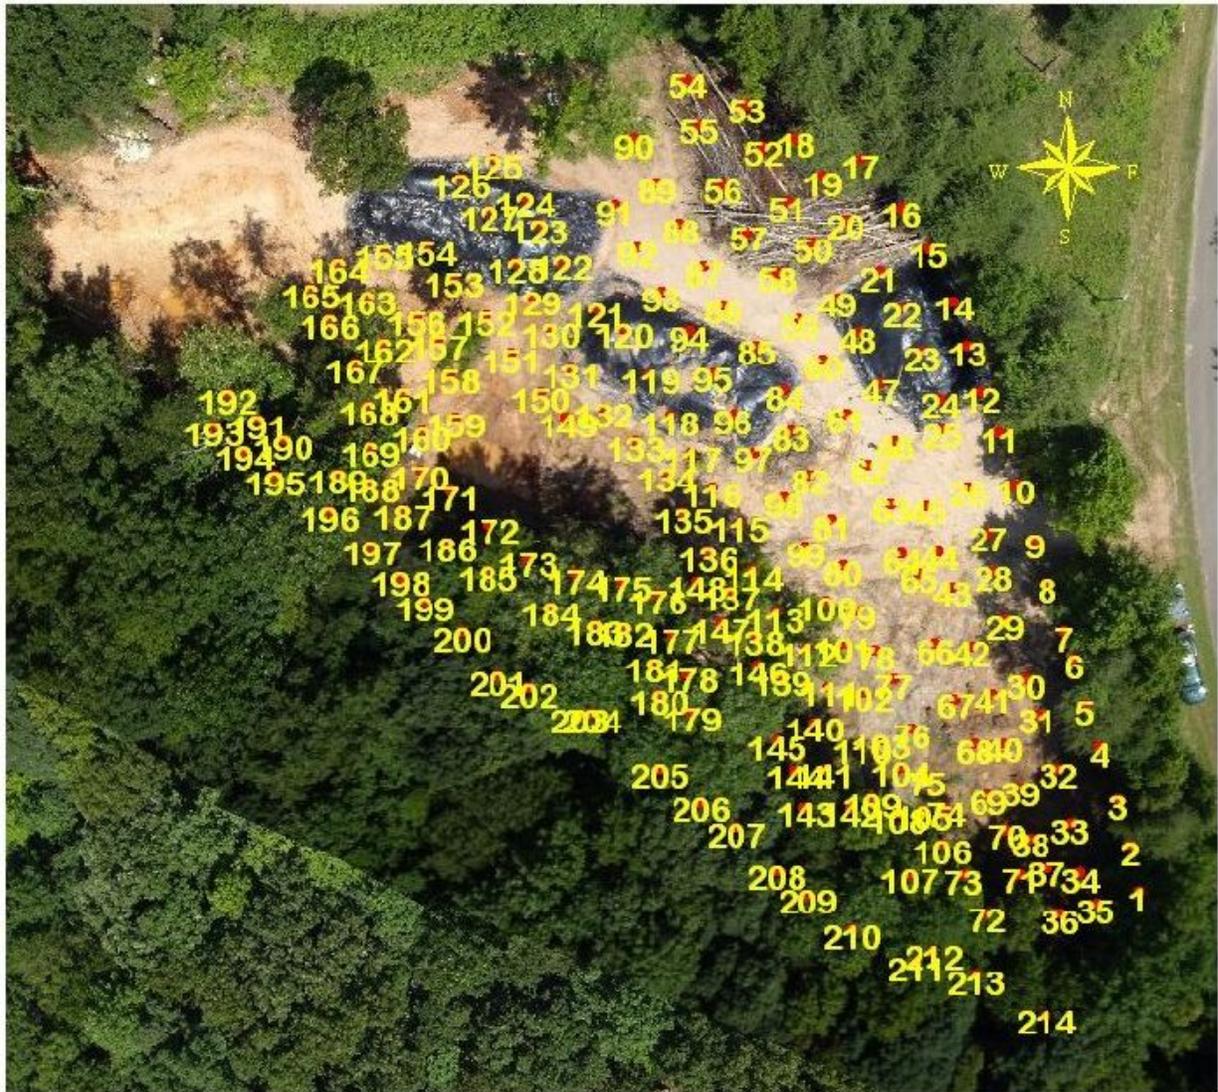
Figure 3
Survey Grid
Geophysical Investigation
Crowder's Mountain Drum Site
Kings Mountain, Cleveland County, North Carolina

Upon arrival at the site on November 16, 2009, the survey grid to be used to obtain the total magnetic field data was established. One survey team member paced the grid, establishing points at approximately 12 feet – 15 feet centers, marking each measurement point with orange spray paint. The remaining survey member followed with a Trimble®

GeoXH global positioning system (GPS) unit and logged the geographic coordinates (WGS84) of each measurement point. Figure 3, Survey Grid, shows the grid established for this investigation. This activity was an accredited activity conducted in accordance with SESDPROC-110-R2, Global Positioning System.

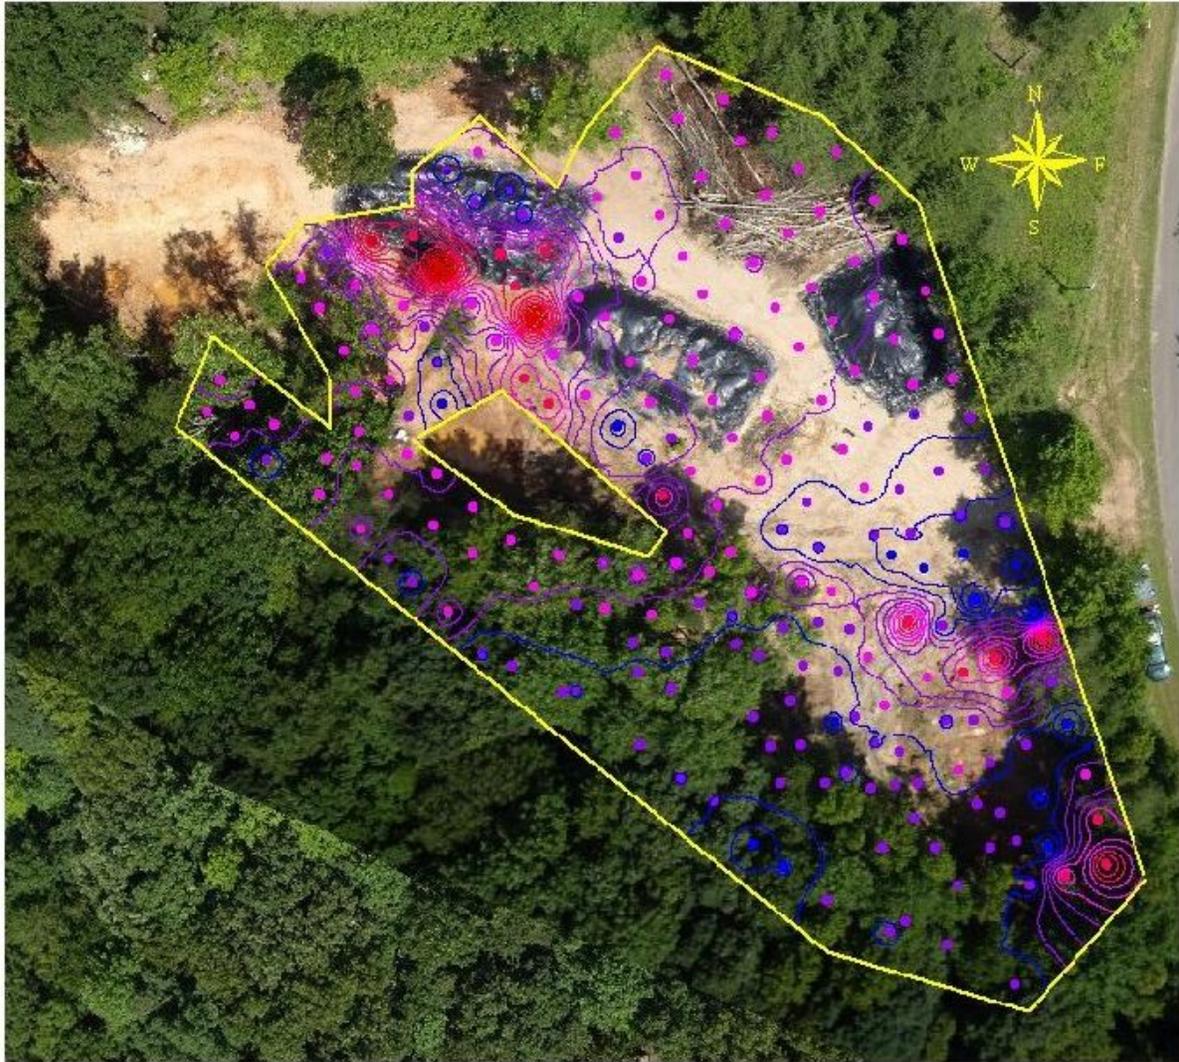
Figure 4
Contoured Total Magnetic Field Data
Geophysical Investigation
Crowder's Mountain Drum Site
Kings Mountain, Cleveland County, North Carolina

An ArcView® project was created with the geographic coordinate shapefile of the grid measurement locations and the downloaded total magnetic field data. These data are found in the table, Total Magnetic Field Intensity Measurements, in the tables section at the end of this report. ArcView® Spatial Analysis was used to contour the total magnetic field data, generating a color-graded contour map, shown in Figure 4, Contoured Total Magnetic Field Data. Three distinct anomalous areas present themselves in the contoured data. These are shown in Figure 4 and are identified as the West Area and East Areas 01 and 02.

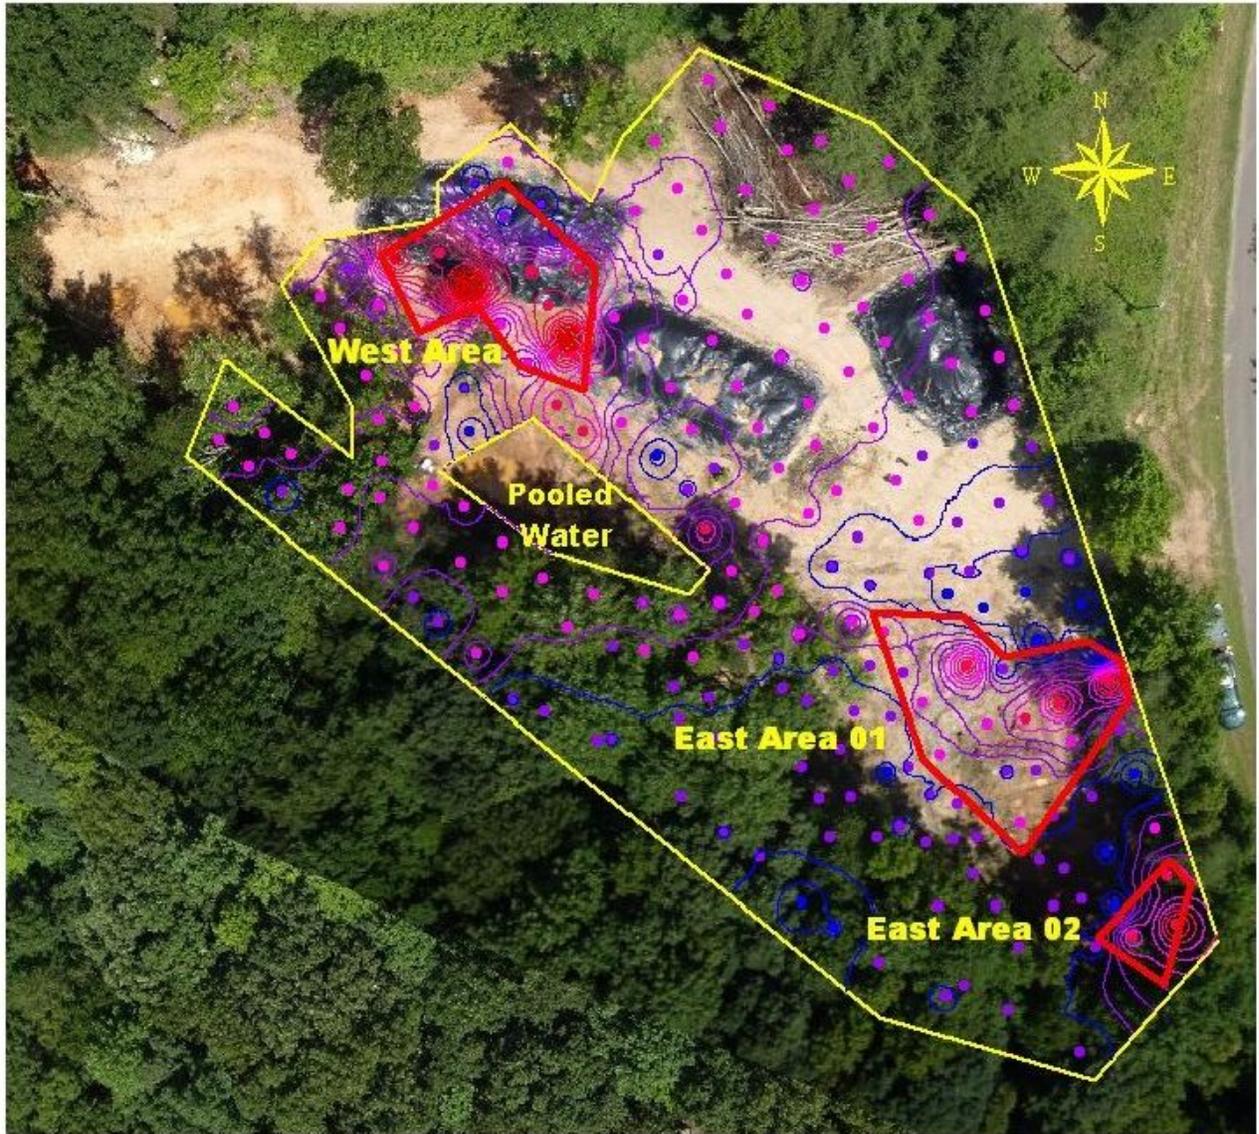
Figure 5
Approximate Boundaries, Anomalous Areas
Geophysical Investigation
Crowder's Mountain Drum Site
Kings Mountain, Cleveland County, North Carolina

After the data was contoured in the field, each of the three identified areas was ground-truthed with electromagnetic induction using a Fisher® TW-6 M-Scope Pipe and Cable Locator. This activity was conducted outside of the scope of SESD's ISO 17025 field activities accreditation, however, it was conducted in accordance with the instrument manufacturers operating manual. There was very good agreement between the Fisher® instrument response and the three anomalies indicated by the magnetometry. There was little or no instrument response during surveys of the site conducted outside of the identified anomalies, however, there was a significant response while over the areas in the general vicinity of each of the contour anomalies. The boundary of each area, as indicated by a distinct drop in instrument response while moving away from the approximate center of the anomaly, was marked with white spray paint, as well as survey stakes and flagging. The boundary or area of each anomalous feature was also mapped using GPS for import into the ArcView® project created for the total magnetic field data contouring. Each of the three areas, as defined by the Fisher® instrument response, is shown in Figure 5, Approximate Boundaries, Anomalous Areas.

Based on the total magnetic field data contouring of proton precession magnetometer measurements and subsequent ground-truthing using electromagnetic induction, three distinctly anomalous areas were identified by this geophysical investigation. These areas, presented in Figure 5, are identified as the West Area and East Areas 01 and 02.
