**Subject: April 2012 Cove Transfer Station 1 (TS1) Field Assessment;
Addendum Letter Report to the Cove Transfer Station Sites 1 and 2
Abandoned Uranium Mine Waste Removal Assessment Report; Cove,
Apache County, Arizona; February 2012.
TDD No.: TO2-09-11-10-0002; Project No.: EE-002693-2162**

**APRIL 2012 FIELD ASSESSMENT
COVE TRANSFER STATION 1 (TS1)**
Cove, Apache County, Arizona

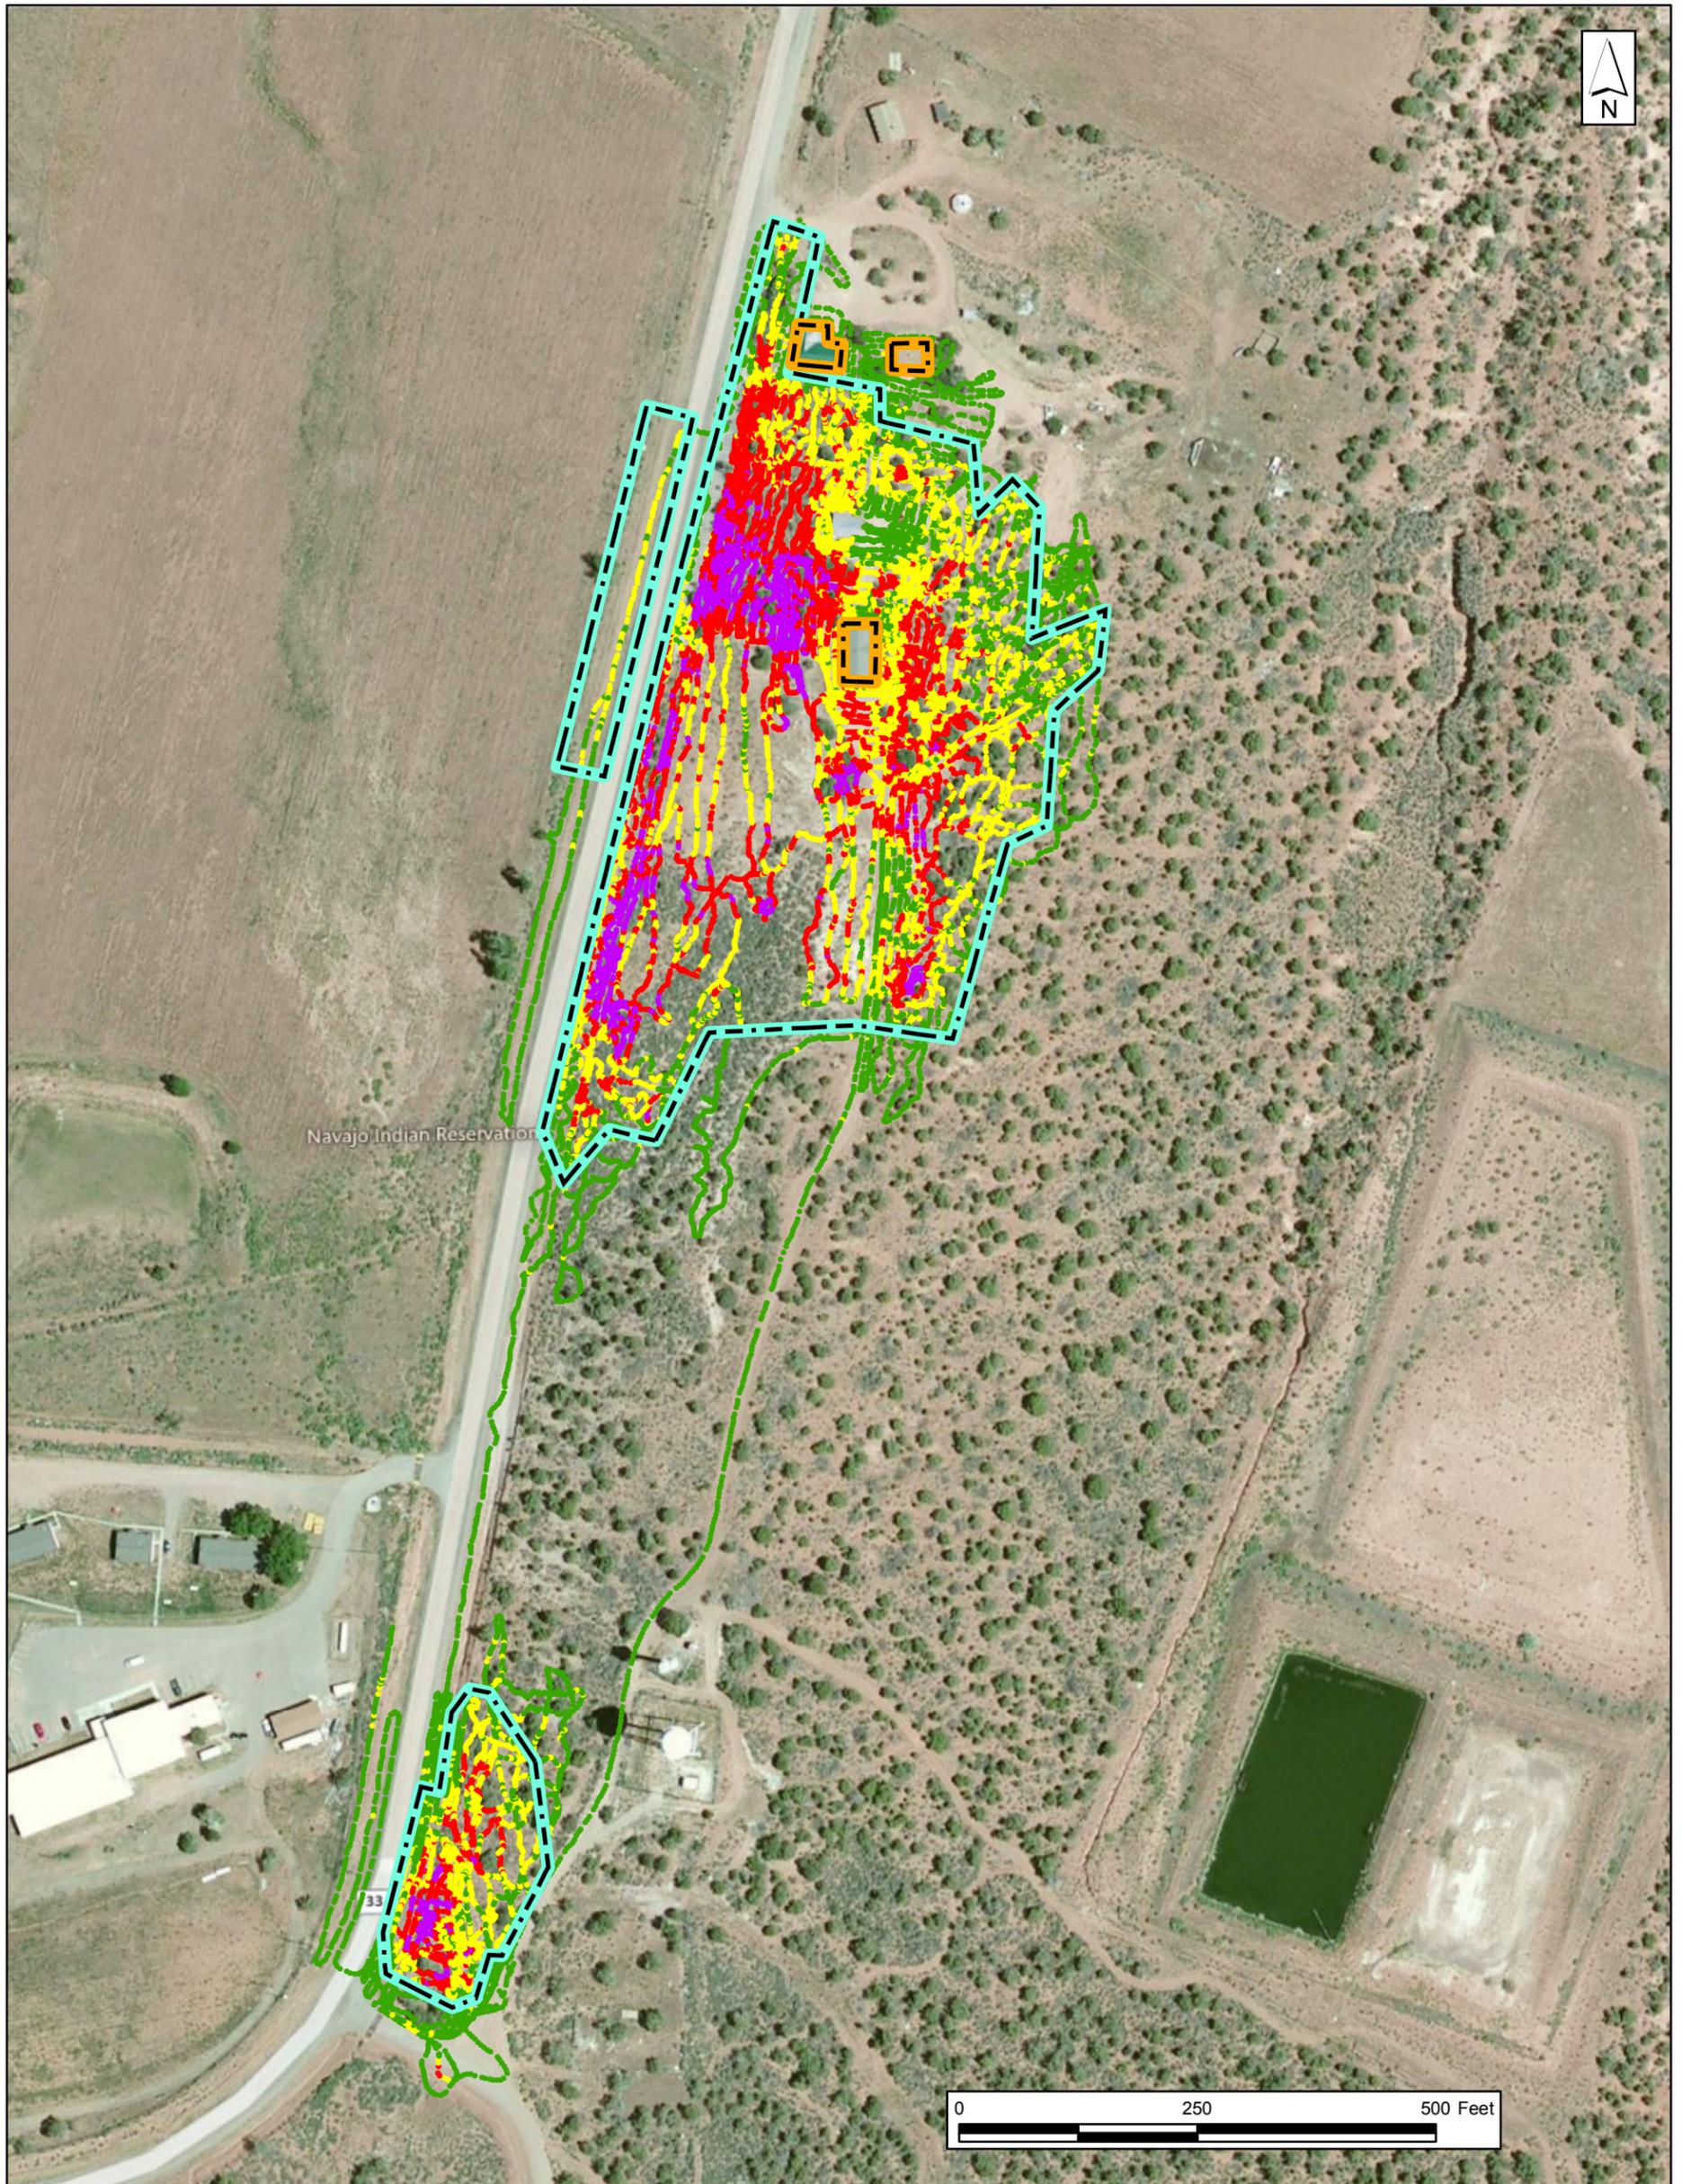
Figure 2a
Transfer Station 1
Surface Gamma Activity and
Excavation Boundaries
Cove, Apache County, Arizona

Based on the additional gamma activity scan data collected at TS1 during April 2012, the estimated removal boundary of soil impacted by abandoned uranium mine waste above the DCGL of 2 pCi/g is approximately 339,087 square feet, with an estimated average depth of 1 foot below ground surface. The estimated volume of soil that will need to be removed from TS1 is approximately 12,559 cubic yards. The April 2012 gamma activity scan data and estimated removal boundaries for TS1 are presented as Figure 2a (Appendix A).

- The estimated removal boundary of soil impacted by abandoned uranium mine waste above the site-specific DCGL of 2 pCi/g is approximately 339,087 square feet, with an estimated average depth of 1 foot below ground surface. The estimated volume of soil that will need to be removed from TS1 is approximately 12,559 cubic yards.

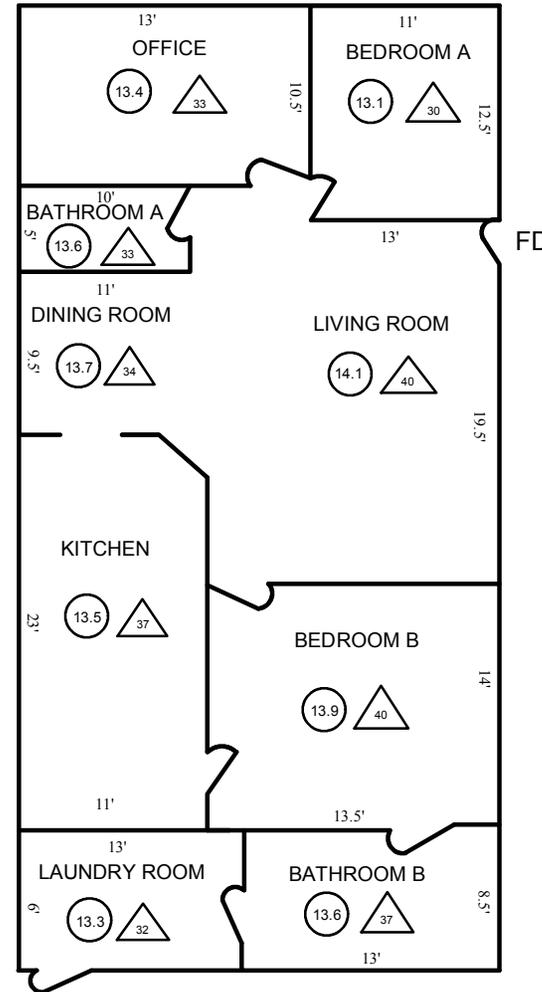
Figure 2b
Transfer Station 1
Residential Radiation Survey
Cove, Apache County, Arizona

Based on the April 2012 interior gamma activity scan measurements, slightly elevated gamma radiation areas were identified from the residence within the Kitchen and Bathroom B at 37 kcpm, and within the Living Room and Bedroom B at 40 kcpm. These slightly elevated gamma activity measurements are most likely attributable to residual uranium-bearing dust being transported from outside at TS1 into the residence from common human activity (i.e., dust from shoes). The collected April 2012 interior gamma activity scan measurements are presented as Figure 2b (Appendix A).

- Residential interior gamma activity scan measurements were slightly elevated within the Kitchen and Bathroom B at 37 kcpm, and within the Living Room and Bedroom B at 40 kcpm. These slightly elevated gamma activity scan measurements are most likely attributable to residual uranium-bearing dust being transported from outside at TS1 into the residence from common human activity.

Ceiling Height = 8'
 Exterior Dimensions = 28' X 56'
 Structure built on 2.5' of cement block
 on top of concrete footers.

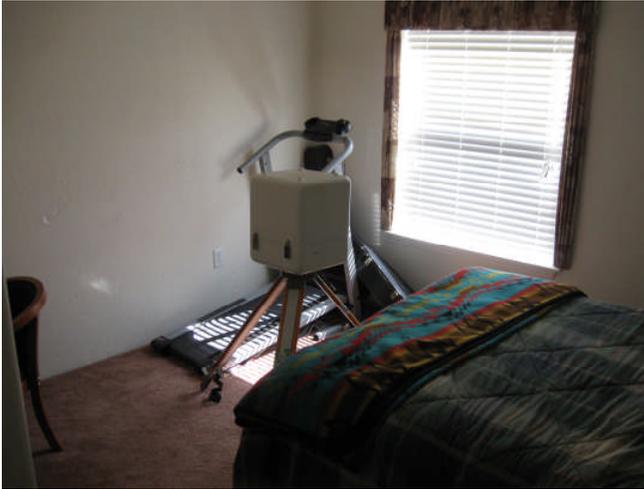
PHOTOGRAPH #1

Description: View of the HPIC interior gamma exposure dose rate measurements within Bedroom A of the residence located at TS1.

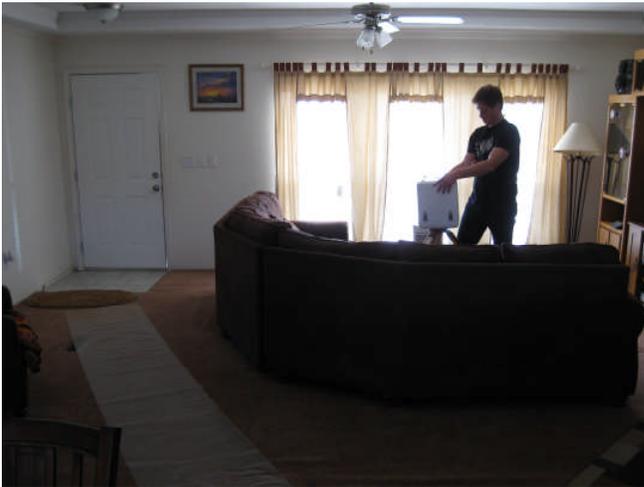
PHOTOGRAPH #2

Description: View of the HPIC setup prior to collection of interior gamma exposure dose rate measurements within the Living Room of the residence located at TS1.

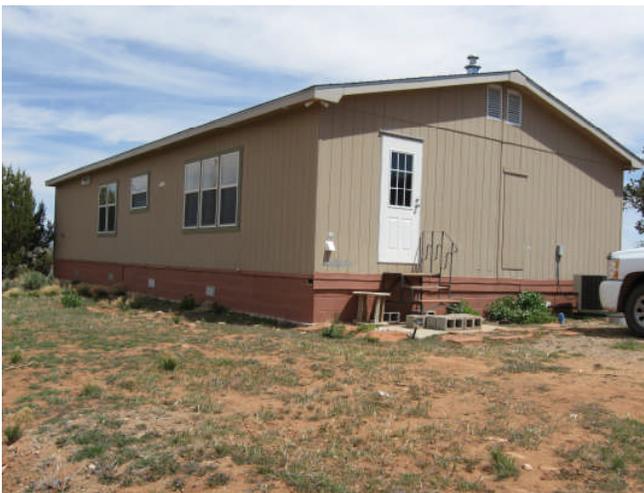
PHOTOGRAPH #3

Description: Exterior view of residence located at TS1.

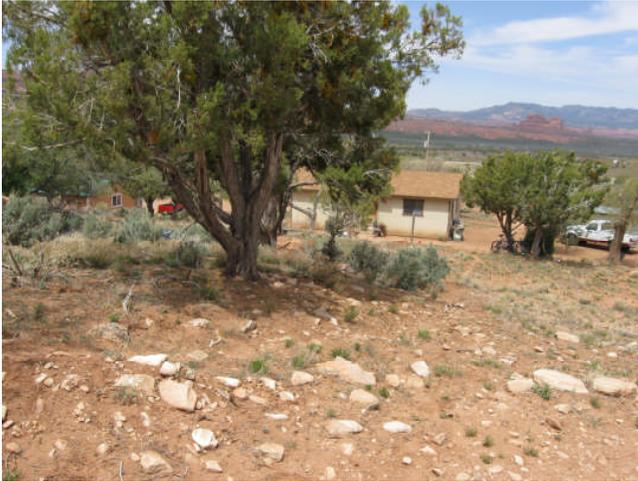
PHOTOGRAPH #4

Description: View of slope located north of residence at TS1 and neighboring residence located further north.

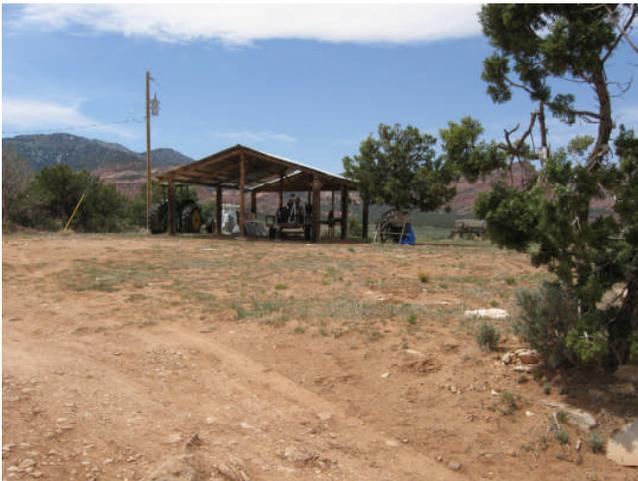
PHOTOGRAPH #5

Description: View of wood frame/metal roof structure located north of the residence at TS1.

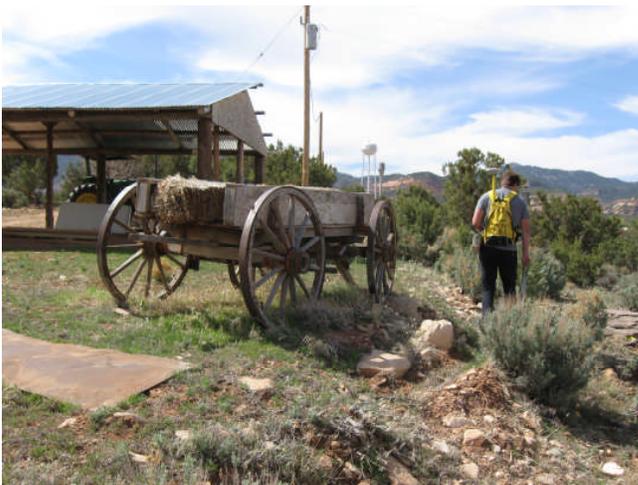
PHOTOGRAPH #6

Description: View of gamma activity scan north of the residence located at TS1.
