TS-PIC-20809961S/20909961S
December 2008

AERIAL PHOTOGRAPHIC ANALYSIS OF IRON KING MINE/HUMBOLDT SMELTER SITE

Dewey-Humboldt, Arizona

EPA Region 9

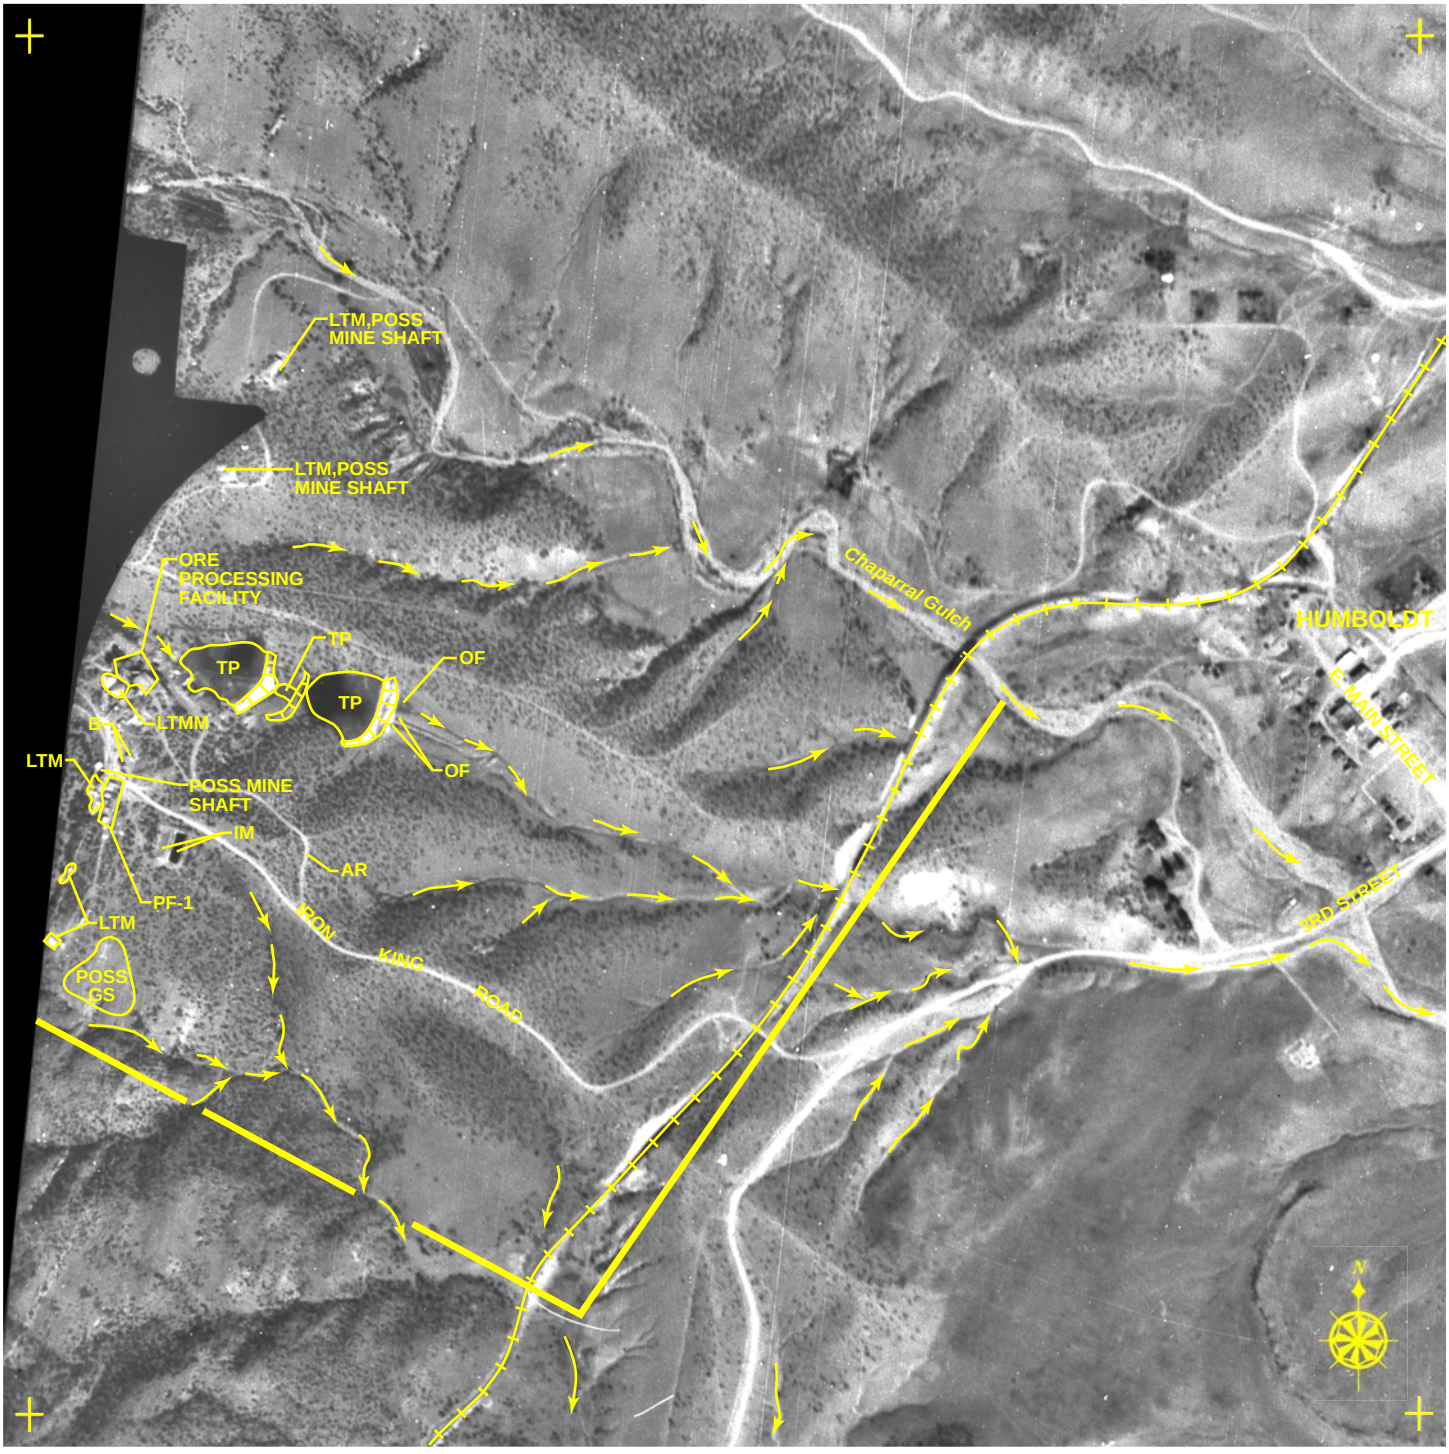
FIGURE 3. IROM KING MINE, OCTOBER 13, 1940. APPROX. SCALE 1:5,000.

OCTOBER 13, 1940 (FIGURE 3)

A dirt access road (AR) leads north from the area of the Ore Processing Facility past two possible mine shafts, each of which has light-toned material (LTM) (likely spoil) adjacent to it.

Processing facility PF-1 appears to be operational and is located south of Iron Mine Road. Processing facility PF-1 is composed of four buildings and other associated nearby features: two impoundments (IM), light-toned material, and a nearby possible mine shaft. Drainage from processing facility PF-1 flows to the southeast through an unnamed tributary of the Galena Gulch. Light-toned material is noted at two locations south of processing facility PF-1. A dirt access road (not annotated) leads from the processing facility to a large possible ground scar (GS). The possible ground scarred area slopes to the south away from the access road to the edge of a drainage channel.

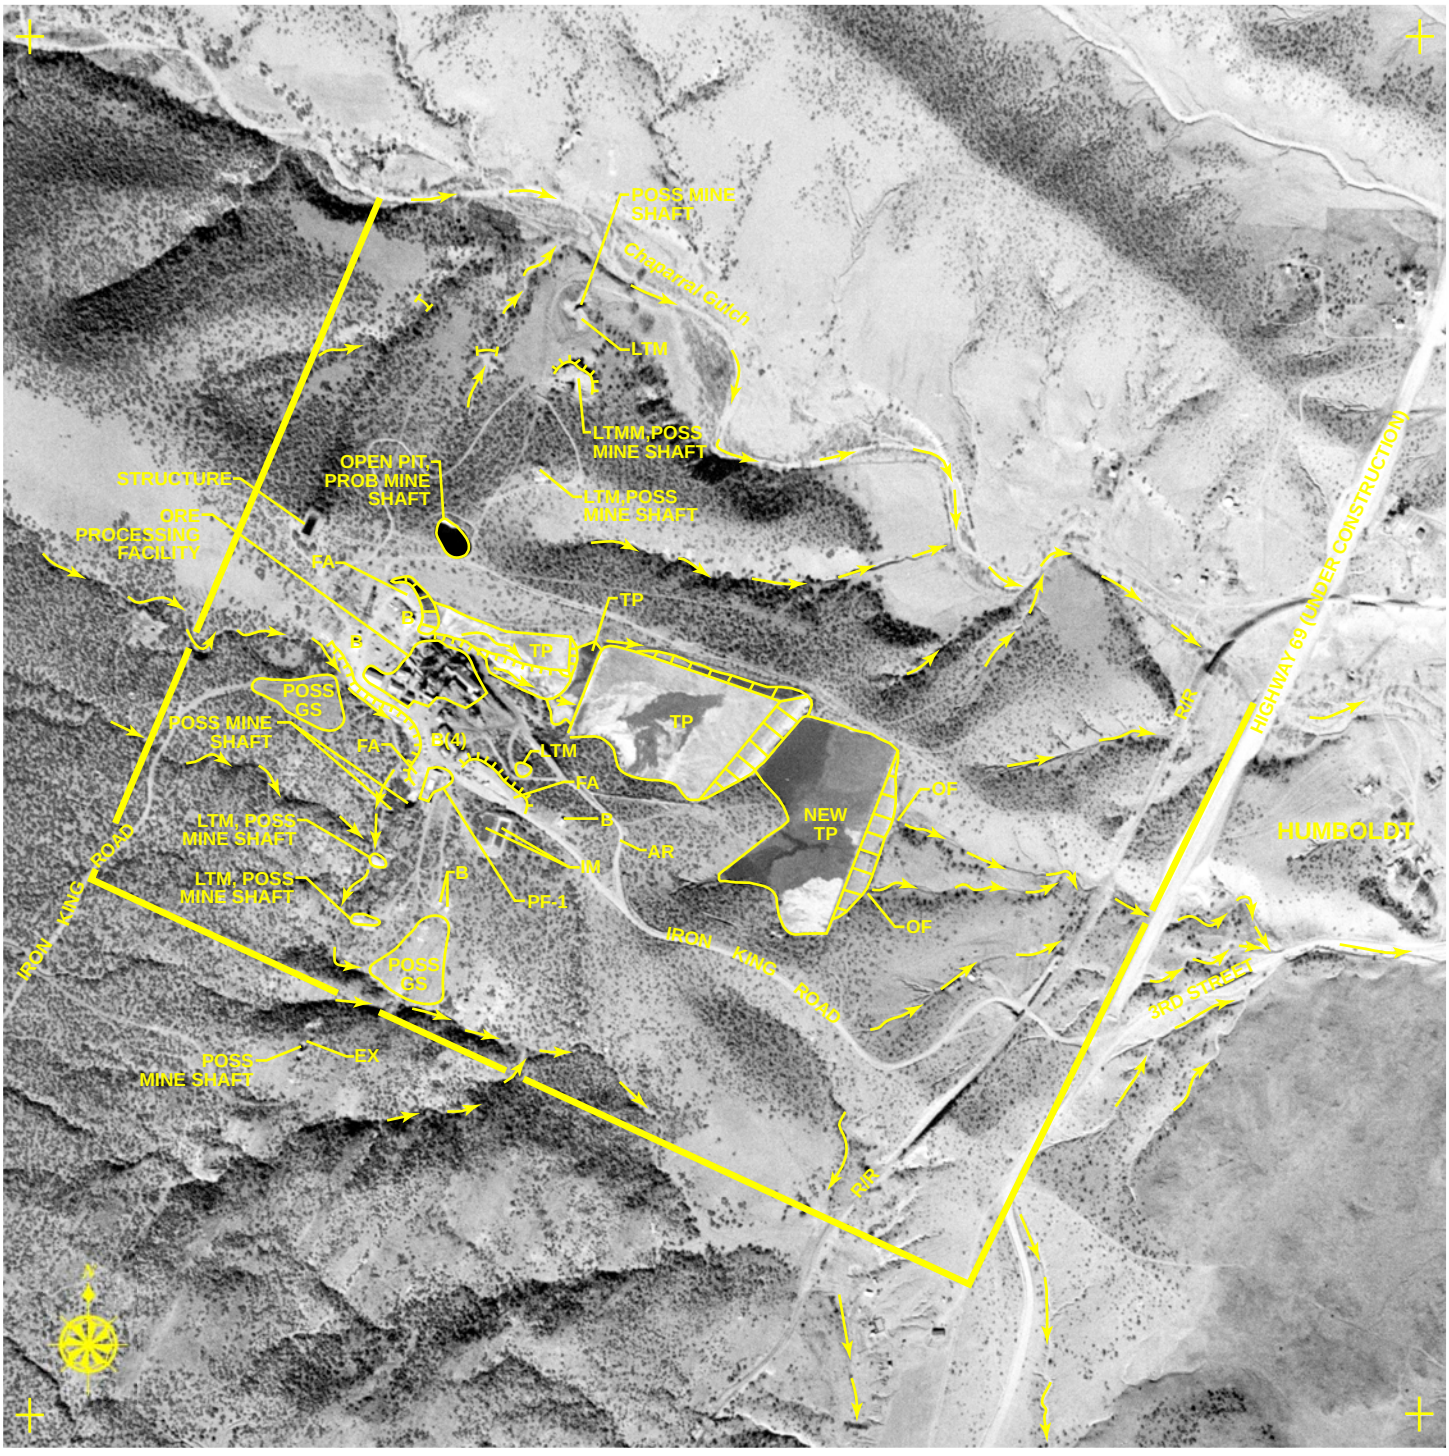
FIGURE 4. IRON KING MINE, NOVEMBER 25, 1953. APPROX. SCALE 1:5,300.

NOVEMBER 25, 1953 (FIGURE 4)

Since 1940 an open pit and a probable mine shaft have been excavated due north of the Ore Processing Facility. North of the Ore Processing Facility, near Chaparral Gulch, a new possible mine shaft and associated light-toned material are noted. Mining operations at the possible mine shaft located nearby to the south, in place in 1940, have been ongoing since 1940 at this location. More light-toned material (likely mine spoil) has been deposited around the entrance to the possible mine shaft.

Processing facility PF-1 remains operational and now is composed of three buildings, and a possible vertical tank, and a possible horizontal tank. Two possible mine shafts, not visible on the 1940 photographs, and associated light-toned material are located on the southwest side of processing facility PF-1. The two impoundments located to the east each contain standing liquid (not annotated). Two new small buildings (B) have been built south of the processing plant, at the end of the access road on the northern edge of the ground scarred area.

Fill material has been placed in fill areas (FA) around the Ore Processing Facility and processing facility PF-1 creating flat fill areas used to conduct facility operations. Numerous buildings have been constructed around the two facilities since 1940. These buildings likely serve support ancillary functions for operations at the two facilities.

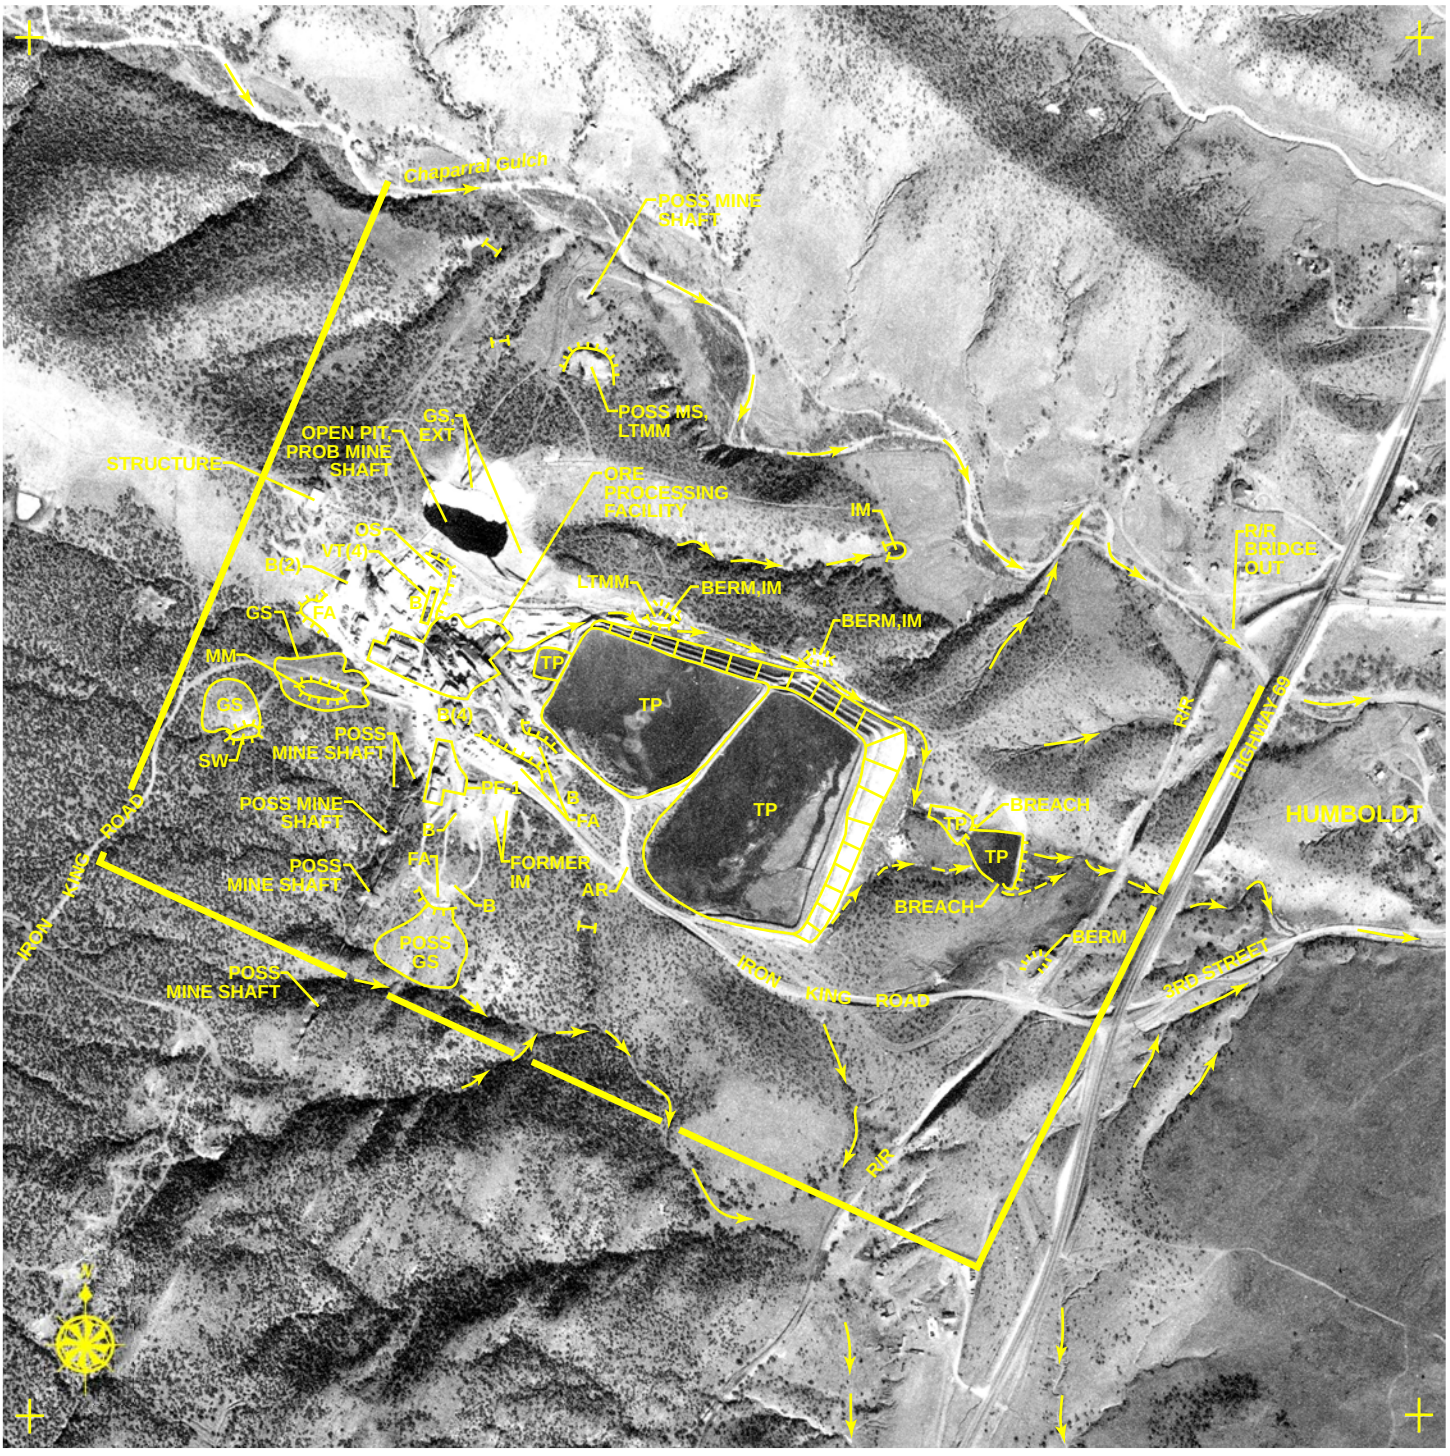
FIGURE 5. IRON KING MINE, JANUARY 15, 1964. APPROX. SCALE 1:5,300.

JANUARY 15, 1964 (FIGURE 5)

The Ore Processing Facility continues to be operational and has been significantly expanded since 1953. There are now ten buildings, eight vertical tanks, overhead pipes, and staining on the surface of the facility. The tailings ponds, operating at the Ore Processing Plant in 1953, have been reconfigured and expanded. A drainage channel and two impoundments that may function as overflow catchments have been constructed along the northern bottom edge of the tailings dam. The channel directs some of the discharge from the facility into two, relatively smaller tailings ponds that have been constructed to the east, downstream from the other tailings ponds. Breaches in the berms of the two new ponds appear to allow liquid to circumvent the ponds. An outfall into the drainage channel is also noted at the base of the easternmost tailings pond.

The fill areas around the Ore Processing Facility have been expanded, likely to accommodate expansion of activities at the facility. Four vertical tanks (VT), buildings (not all are annotated), and vehicles/equipment (not annotated) are on the fill area north of the Ore Processing Facility. The open pit, located north of the Ore Processing Facility, has been expanded and ground scars from the extraction (EXT) of materials from around the rim of the pit are noted. The amount of light-toned material deposited adjacent to the possible mine shaft northeast of the open pit has increased, indicating continued ore extraction at this location. An impoundment has been constructed along a tributary of the Chaparral Gulch that drains the area east of the open pit. The impoundment contains liquid (not annotated) at this time.

Processing facility PF-1 remains in operation. The facility is now composed of four buildings. The two impoundments, located to the east, are dry and no longer appear to be in use. The fill area (not annotated) around processing facility PF-1 has been expanded, likely to accommodate expansion of activities at the facility. A dirt access road leads south from the vicinity of processing facility PF-1 to a fill area located adjacent to the possible ground scarred area first noted in 1940.

The railroad bridge that crossed the Chaparral Gulch has been removed.

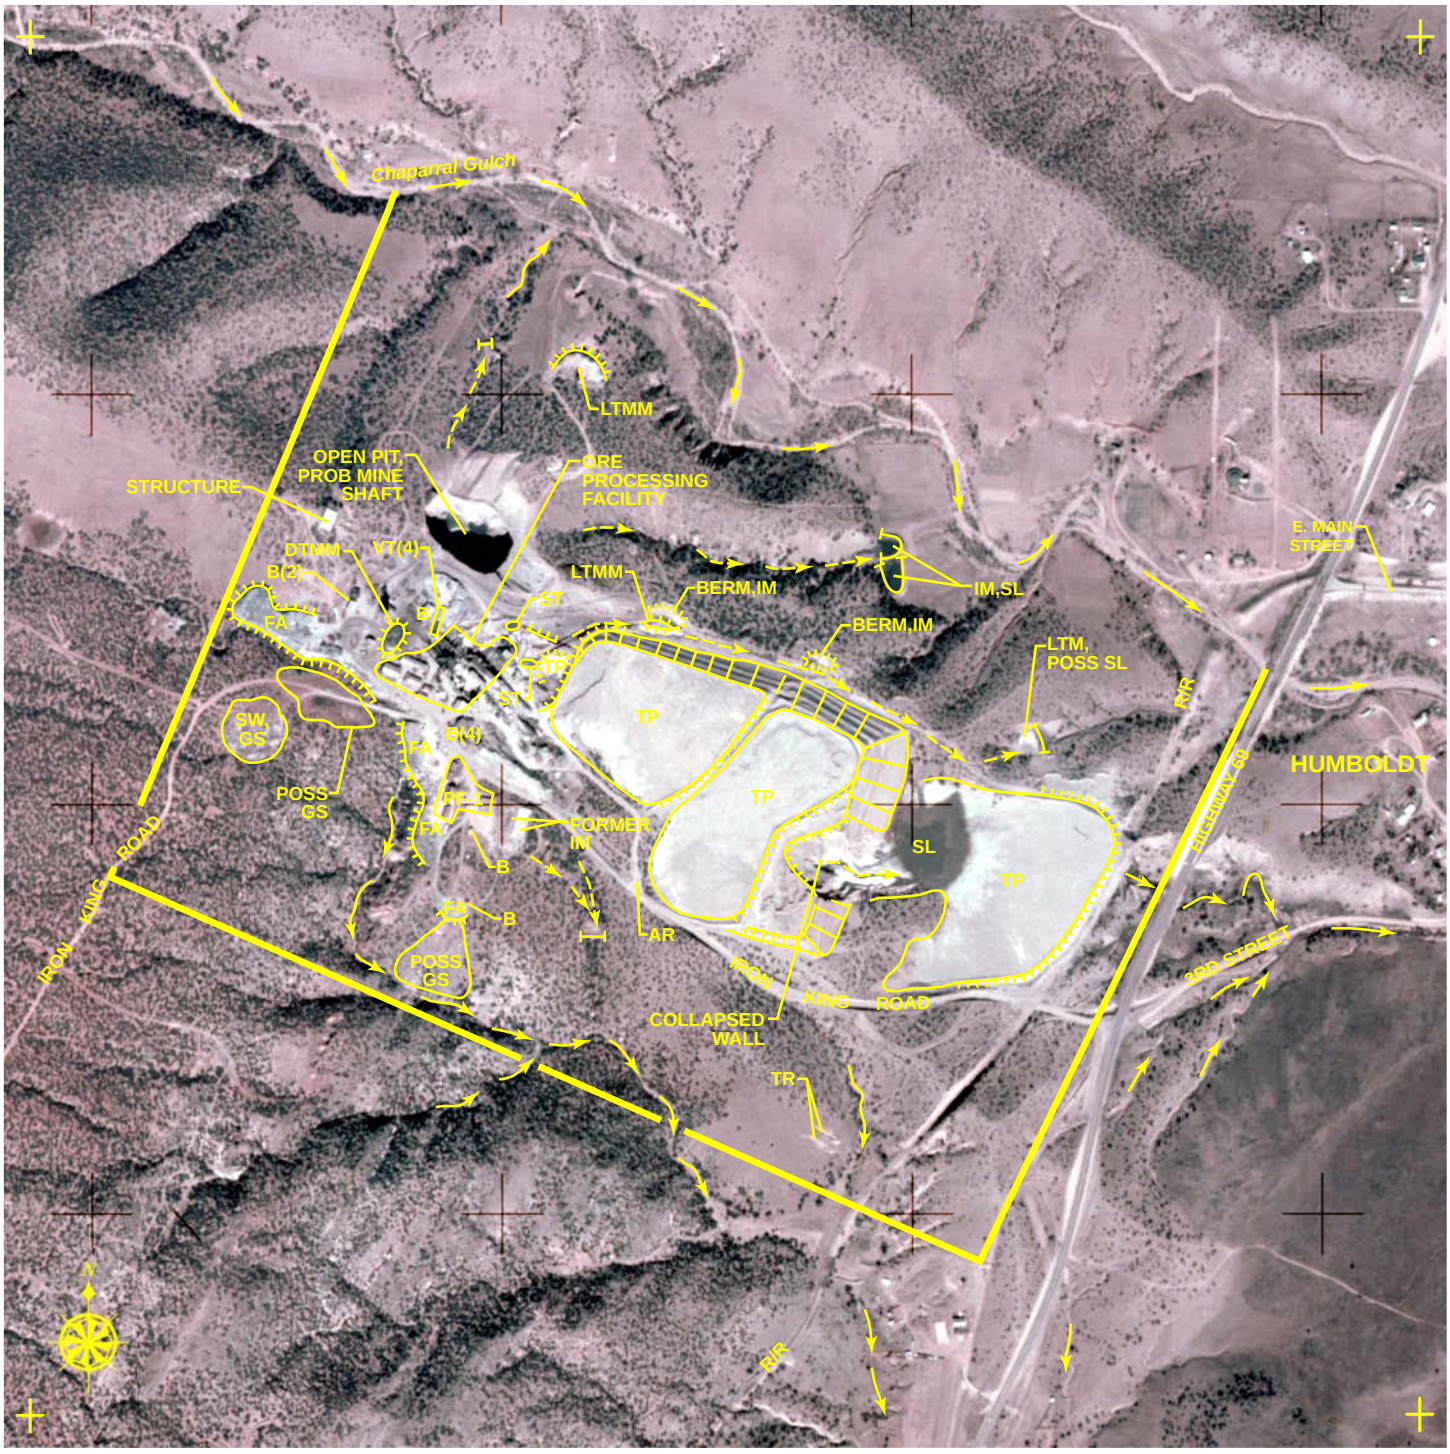
FIGURE 6. IRON KING MINE, FEBRUARY 6, 1970. APPROX. SCALE 1:5,300.

FEBRUARY 6, 1970 (FIGURE 6)

Processing facility PF-1 remains in operation. The fill area to the west and south of processing facility PF-1 has been enlarged, likely to accommodate operations at the facility. No other environmentally significant change is noted in association with the facility.

Two open trenches (TR) have been dug on the side of a hill south of Iron King Road near the railroad line (R/R). No established access road leads to this area.

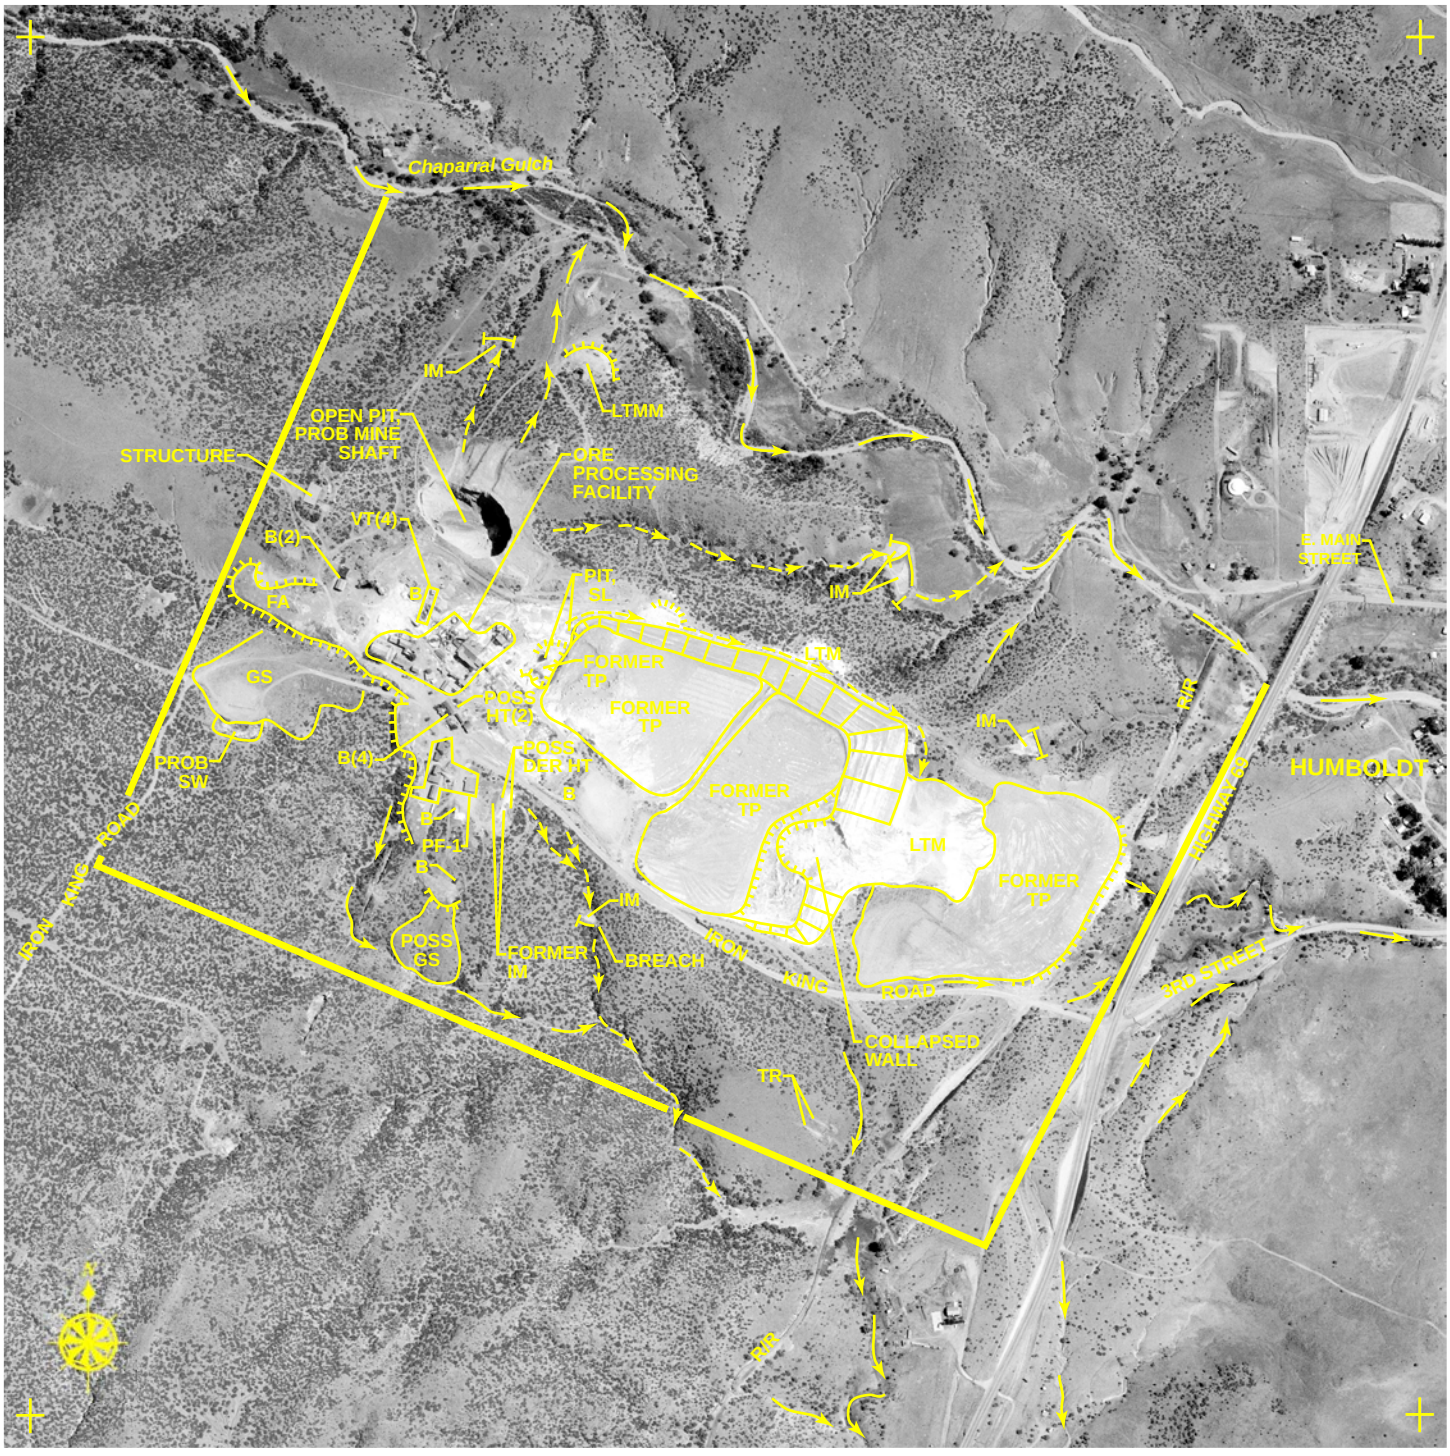
FIGURE 7. IRON KING MINE, JUNE 27, 1973. APPROX. SCALE 1:5,300.

JUNE 27, 1973 (FIGURE 7)

The Ore Processing Facility no longer appears to be in operation. There are now ten buildings and ten empty vertical tanks on the facility that do not appear to be in use. The tailings ponds are empty and much of their upper surfaces have been graded. Few vehicles are parked in the area. The photography was taken on a Wednesday, a work day. The dark-toned mounded material noted west of the facility in 1970 has been removed. The ground scarred area, located west of the Ore Processing Facility, has been enlarged and the scattered waste noted on the surface of the area in 1970 is no longer visible. Probable solid waste continues to be visible along the southern edge of the area. The amount of probable solid waste material at this ground scarred area does not appear to have significantly changed since 1970. Material has been extracted (not annotated) from a section of the fill area noted north of the ground scarred area. Two depressions or pits containing standing liquid (SL) are visible in the dry bottom of the small, westernmost former tailings pond. The impoundments located along a tributary of the Chaparral Gulch that drains the area east of the open pit are empty. The southern impoundment has been breached.

Processing plant PF-1 appears be in operation. Three vertical tanks, vehicles and equipment (not annotated), and five buildings are visible on the facility. East of the facility are two possible derelict (DER) horizontal tanks (HT) that have been placed in and adjacent to the easternmost former impoundment. The western former impoundment (not annotated) has been filled in.

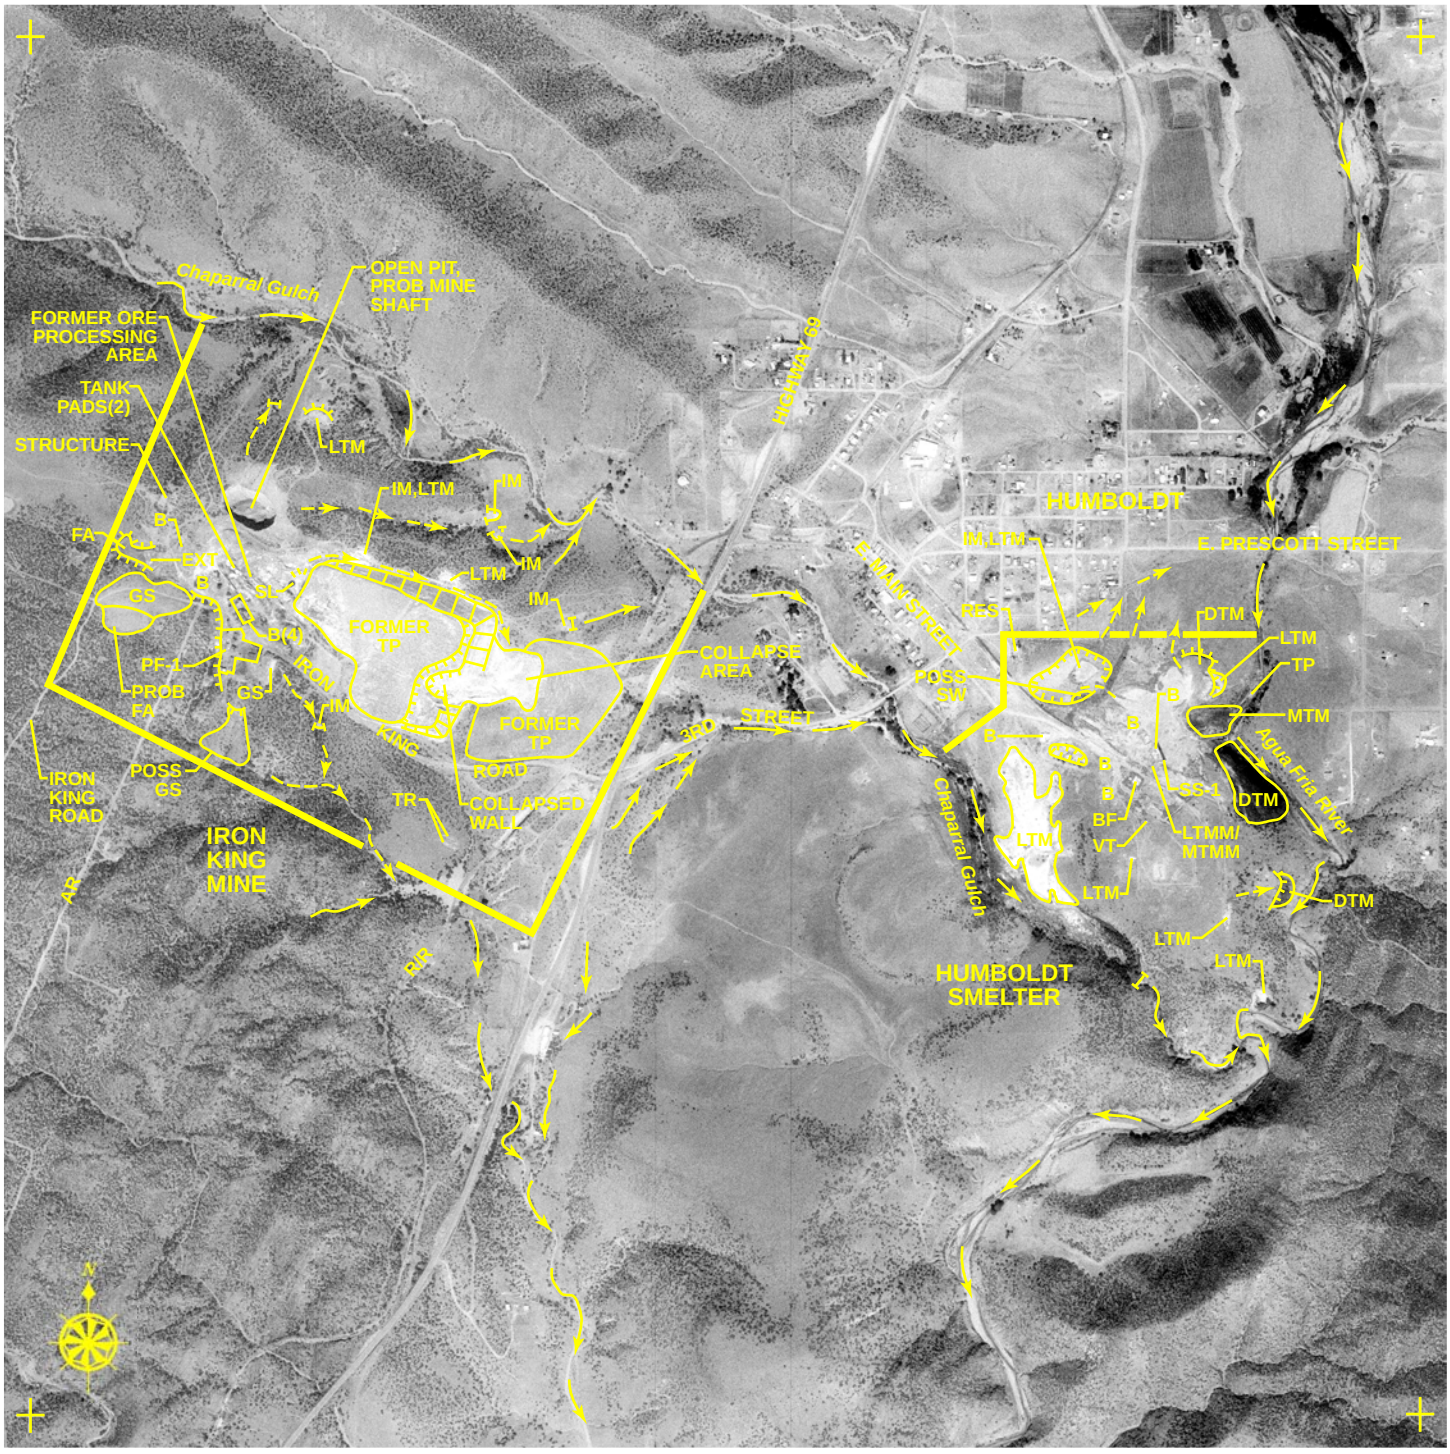
FIGURE 8. IRON KING MINE/HUMBOLDT SMELTER SITE, SEPTEMBER 25, 1980. APPROX. SCALE 1:9,800.

SEPTEMBER 25, 1980 (FIGURE 8)

Most of the buildings and all the tanks have been removed from the location of the Former Ore Processing Facility. Two tank pads are visible at the location of the former facility. A probable fill area is located on the southern portion of the ground scarred area located west of the former facility. The probable fill area is located at the former location of probable solid waste, which is no longer visible. Material has been extracted from the fill area located north of Iron King Road.

Processing facility PF-1 appears to be in operation and eight buildings are on the facility. The two possible derelict horizontal tanks located near the former impoundment in 1970 have been removed. A ground scar remains at the locations of the easternmost former impoundment.

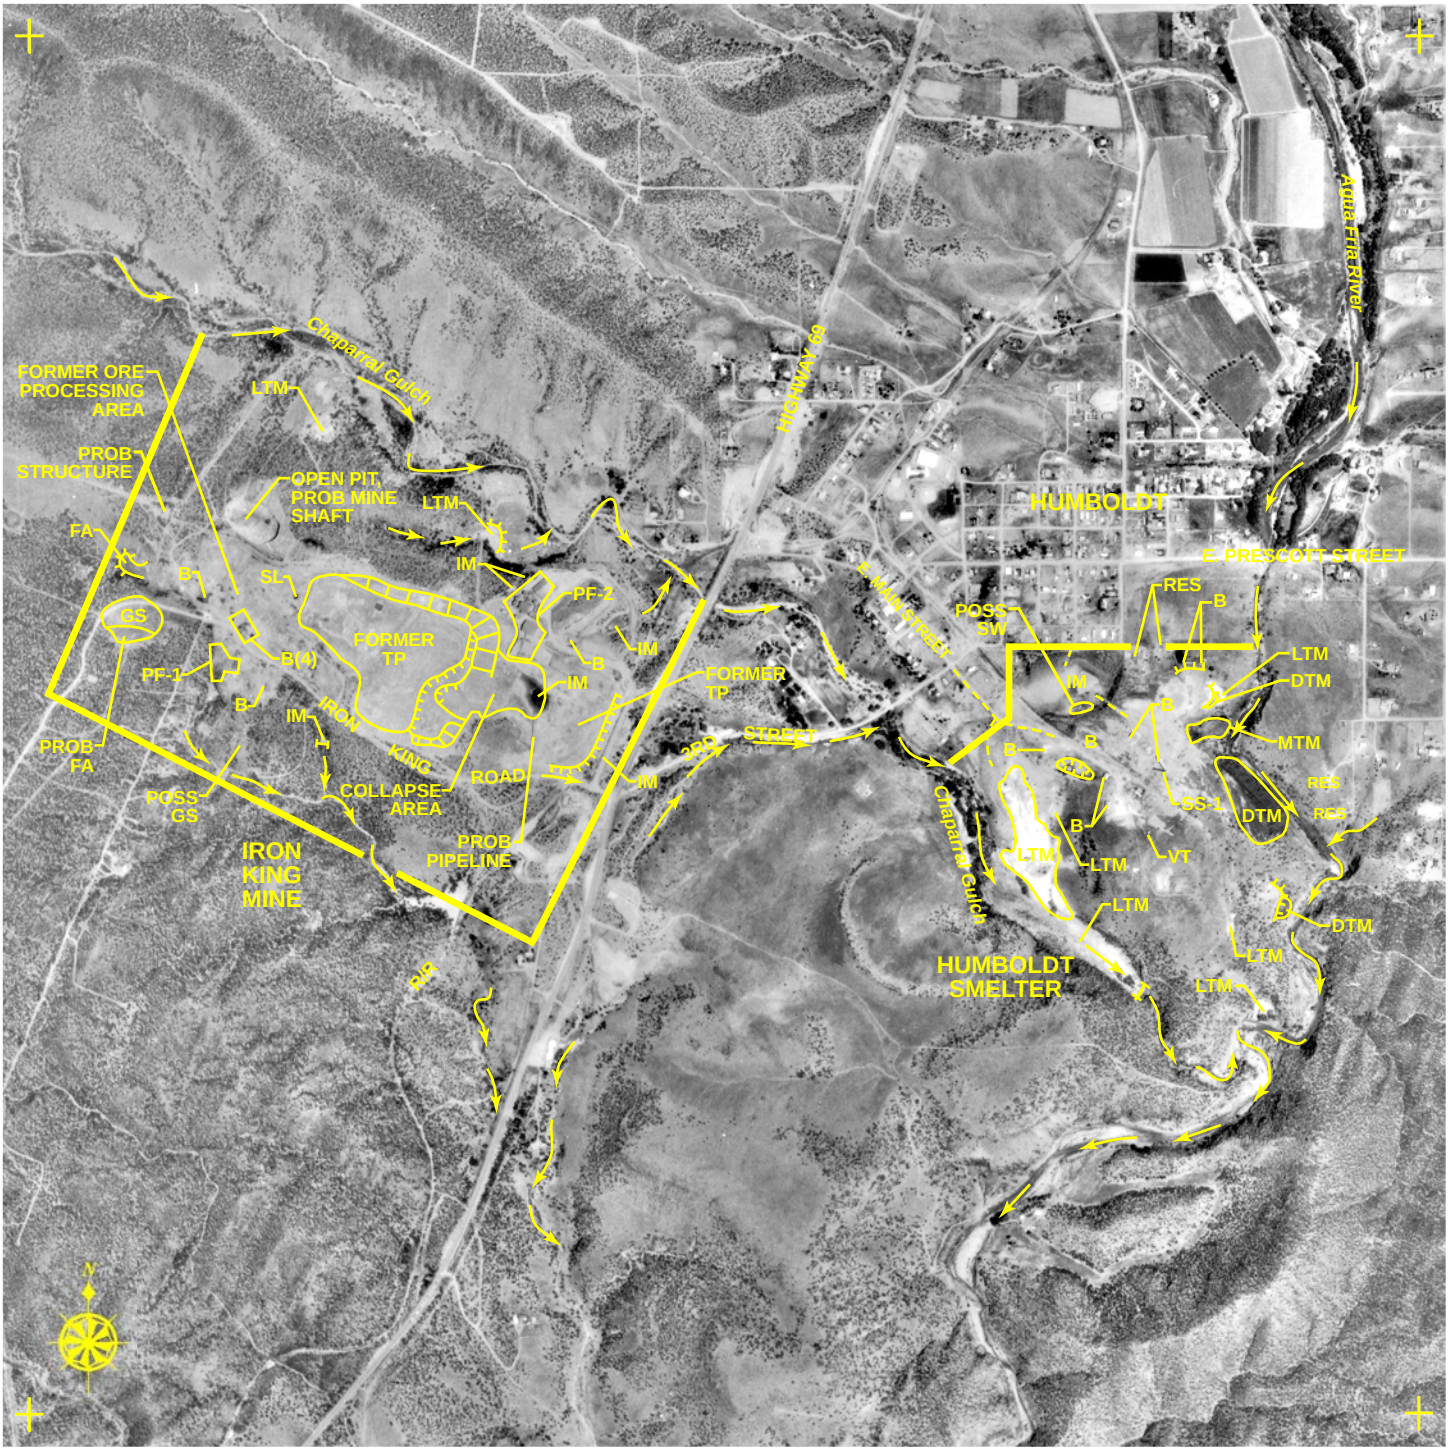
FIGURE 9. IRON KING MINE/HUMBOLDT SMELTER SITE, JUNE 5, 1992. APPROX. SCALE 1:9,800.

JUNE 5, 1992 (FIGURE 9)

Processing facility PF-2 has been built north of the easternmost former tailings pond. The facility is composed of three buildings, five tanks, and overhead pipes and appears to be in operation. Two liquid-filled impoundments are located adjacent to the west side of the facility. A drainage channel (not annotated) links the impoundments to an unnamed tributary of the Chaparral Gulch.

South of processing facility PF-2 is a building and an impoundment, each of which is likely associated with the facility. The impoundment, which has been built in a tributary of the Chaparral Gulch, contains standing liquid (not annotated). Another impoundment is located in the collapse area of a former tailings pond. A probable pipeline or hose appears to drain liquid from the impoundment into an unnamed tributary of the Galena Gulch.

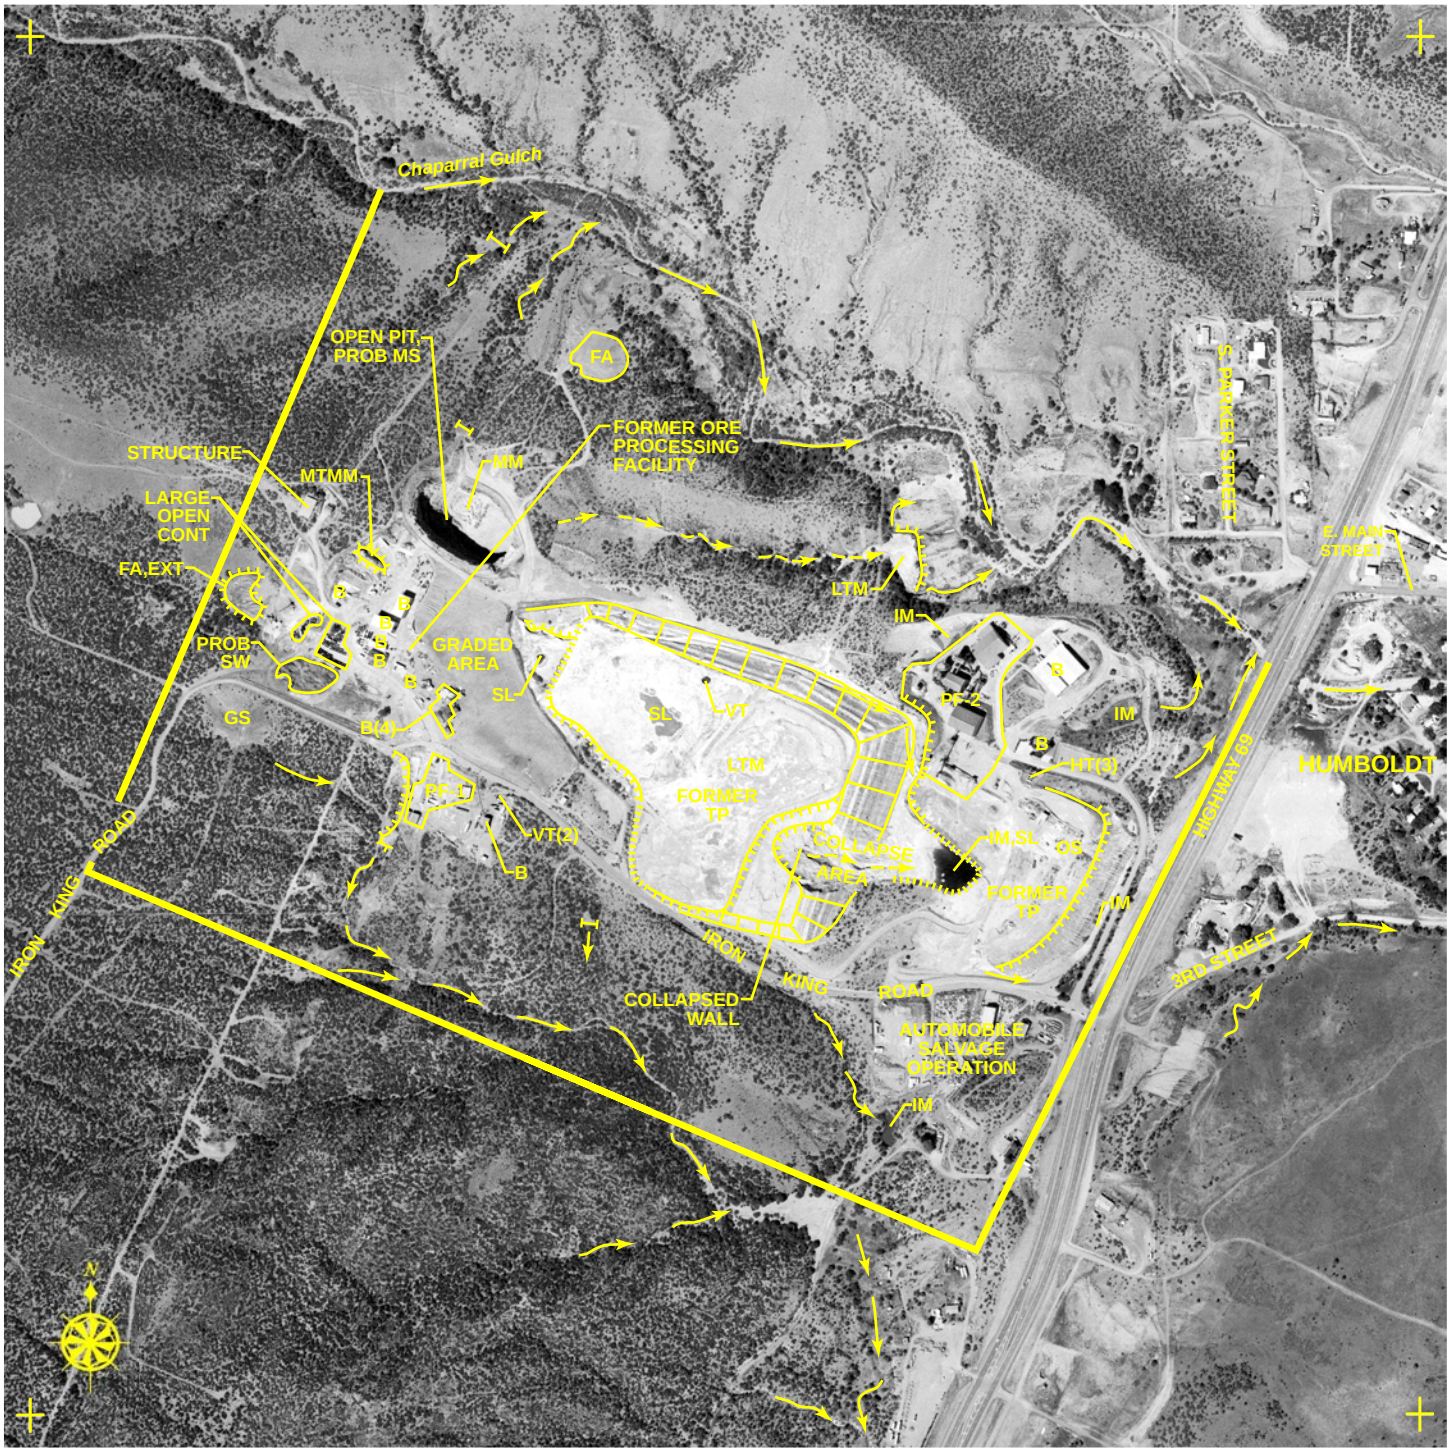
FIGURE 10. IRON KING MINE, SEPTEMBER 20, 2003. APPROX. SCALE 1:5,300.

SEPTEMBER 20, 2003 (FIGURE 10)

Only two buildings remain at the location of processing facility PF-1. Two vertical tanks are located east of the area.

Processing facility PF-2 appears to be in operation and is composed of three buildings, seven vertical tanks, and overhead pipes. A new building has been constructed east of the facility and an impoundment has been constructed along Highway 69 at the eastern boundary of the mine. Part of a former tailings pond is being used as an open storage area for the processing facility. Three horizontal tanks stand north of the open storage area. The impoundment, which contains standing liquid, is located in the collapse area of a former tailings pond. A drainage channel located along the northern bottom edge of the tailings dam directs surface flow into the impoundment.

An automobile salvage facility is operating in the southeast corner of this section of the Iron King Mine/Humboldt Smelter site.

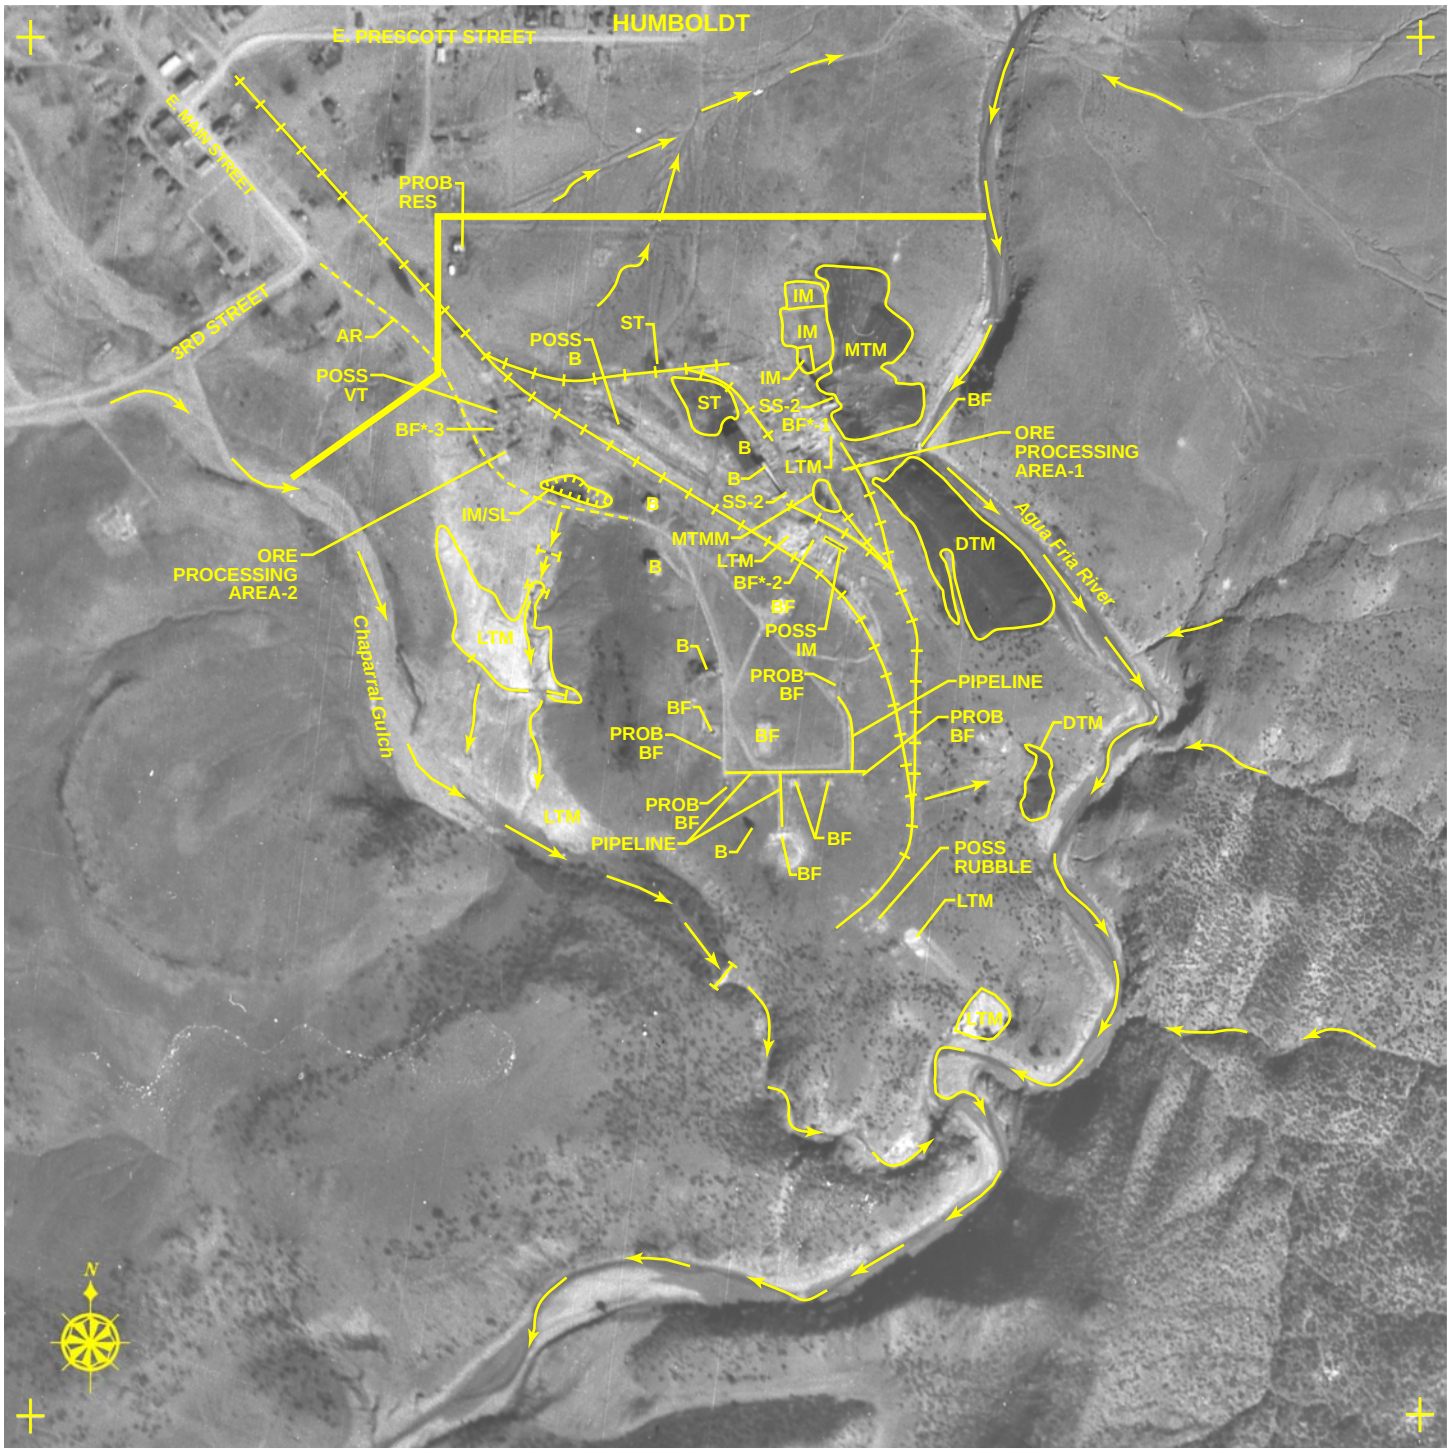
FIGURE 11. HUMBOLDT SMELTER, OCTOBER 13, 1940. APPROX. SCALE 1:4,500.

OCTOBER 13, 1940 (FIGURE 11)

The Humboldt Smelter section of the Iron King Mine/Humboldt Smelter site is situated on a hill that overlooks the Agua Fria River, the Chaparral Gulch, and the confluence of these two drainageways. The Humboldt Smelter is located east of Highway 69 on the outskirts of the southern section of Humboldt, Arizona. A probable residence (RES) is located along the northwestern border of the smelter near 3rd Street. Access to the Humboldt Smelter is via both East Main Street and a network of rail lines that enter the Humboldt Smelter from the northwest. Features and conditions on the Humboldt Smelter indicate that ore processing activities have occurred in this section of the Iron King Mine/Humboldt Smelter site prior to 1940. Remnants of ore processing activities are located in two areas of the site (Ore Processing Area-1 and Ore Processing Area-2).

Ore Processing Area-1 is located in the eastern section of the Humboldt Smelter and is situated on top of a hill, overlooking the Agua Fria River. A network of rail lines and access roads, which provides access to the area, enters the area from Humboldt. Five railroad spurs end in this area. Remnants of former ore processing operations including building foundations, probable rubble, and areas covered with light-toned material (all are not annotated) are visible at Ore Processing Area-1. Two areas containing multiple building foundations (BF*-1, BF*-2) and associated rubble (not annotated) are visible. Two smokestacks (SS) and two buildings are visible near building foundation BF*-1. One stack is connected to one of the two buildings in the area. Dark-toned ground stains cover the surface along the rail line north of the buildings. A lone smokestack stands in the northeast section of the site.

West of the large dark-toned mounded material, a mound of medium-toned material has been deposited in the form of a ramp at the end of a rail spur; an empty possible impoundment is located nearby. A possible former impoundment is located near building foundation BF*-2.

Along the rivers edge, adjacent to the northeast corner of the large mound of dark-toned material is a building foundation, likely a former pump house.

Ore Processing Area-2 includes the area atop and along a hillside overlooking the Chaparral Gulch in the western portion of the Humboldt Smelter section of the site. Multiple building foundations (BF*-3), likely remnants of an ore processing facility, are located between the main rail line and the access road that leads into the area from East Main Street. A possible vertical tank still remains at this location. To the east an impoundment that contains standing liquid is located in a depression formed by the bed the access road and the headwaters of a drainage channel that flows into the Chaparral Gulch. Down slope to the south, toward the Chaparral Gulch, dams have been built astride drainage channels so as to form a series of tailings ponds (not annotated). All the dams are breached. Light-toned materials (tailings) have been deposited in and along the drainage channel behind the southernmost dam. Some light-toned material also appears to have been washed down the slope to the banks of the Chaparral Gulch.

channel leads down slope from the area of a rail spur to the dark-toned material. On the slope above the light-toned material is probable rubble. The arrangement of the rubble suggests that this is the location of a former processing facility.

In the center of the smelter, south of Ore Processing Area-1, is an array of buildings and building foundations that are connected to one another by a network of sidewalks (not annotated). The function of the apparently associated buildings that were located at this location cannot be ascertained from the aerial photographs. The building foundations in this area of the smelter will no longer be annotated or discussed unless significant environmental change is noted in association with them.
